# Water Quality Trading Plan

## Village of Belmont

Lafayette County, Wisconsin

# **Belmont Water Quality Trading Plan**

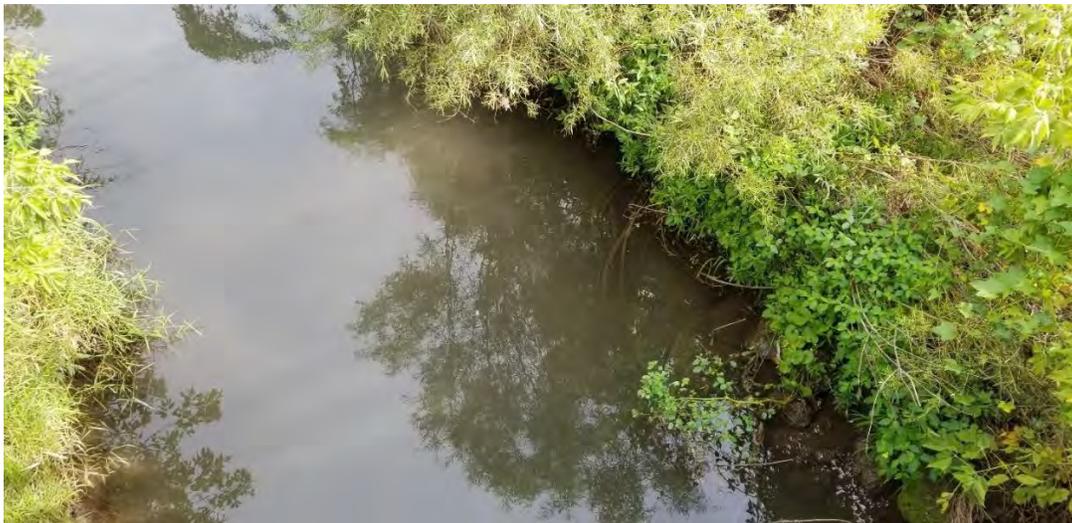
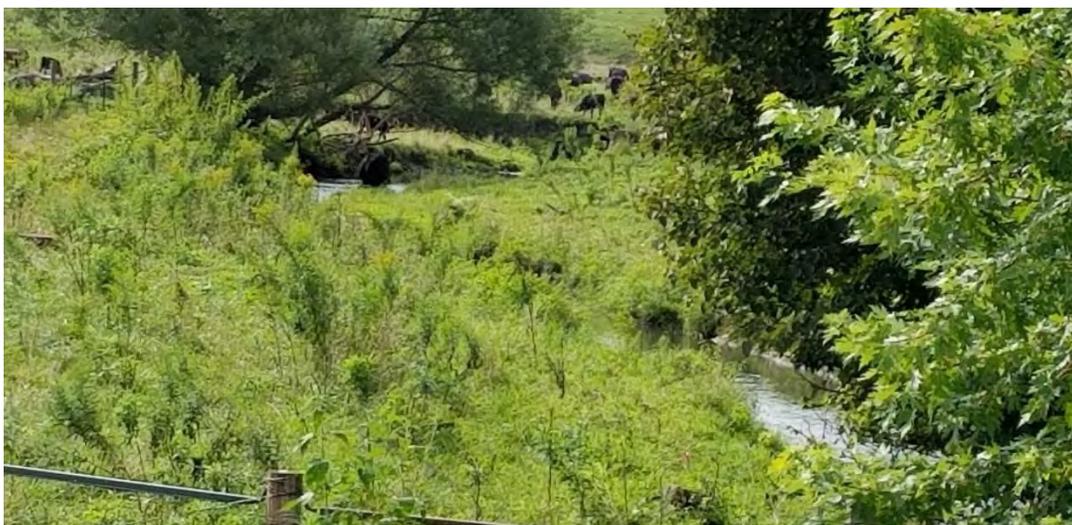
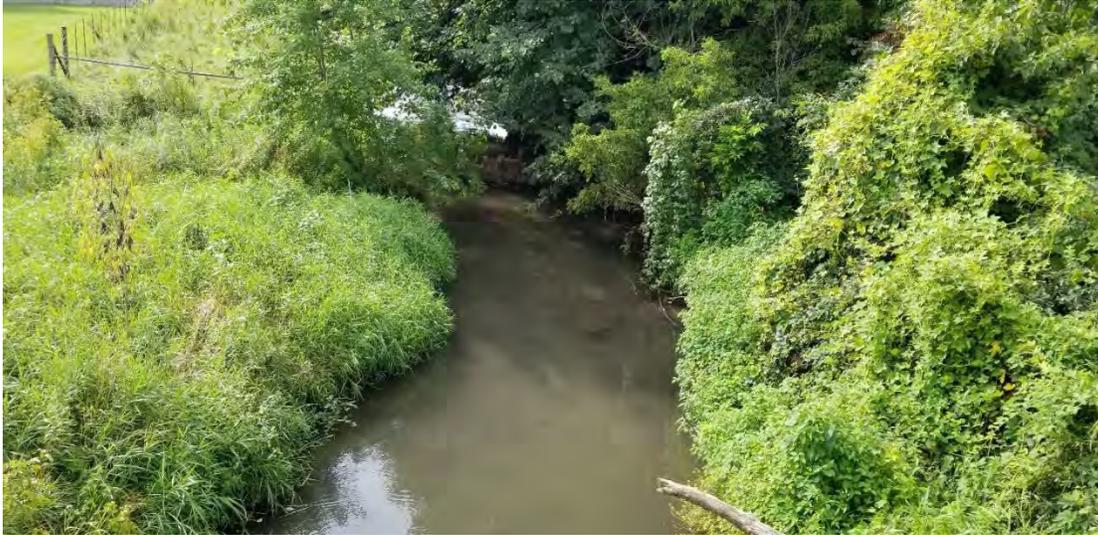
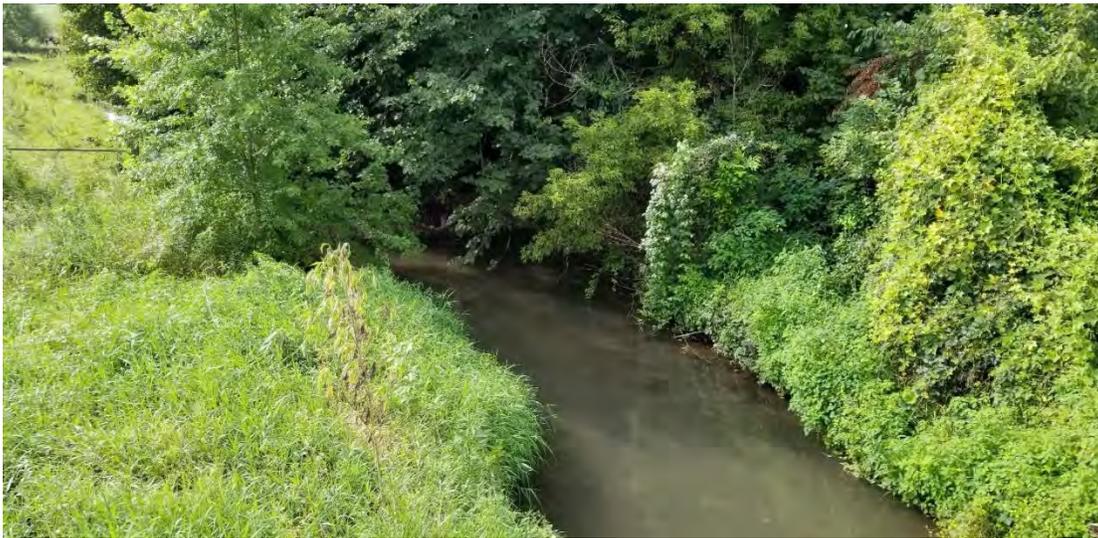
Category-SEVERE

U-shaped, bare banks with some trees falling in and growing out of the bank.

*Figure 1.1: 1E/1W East of County G Bridge*

*Figure 1.2: 1E/1W at County G Bridge*

Figure 1.3: 1E/1W at County G Bridge

Figure 1.4: 1E/1W at County G Bridge

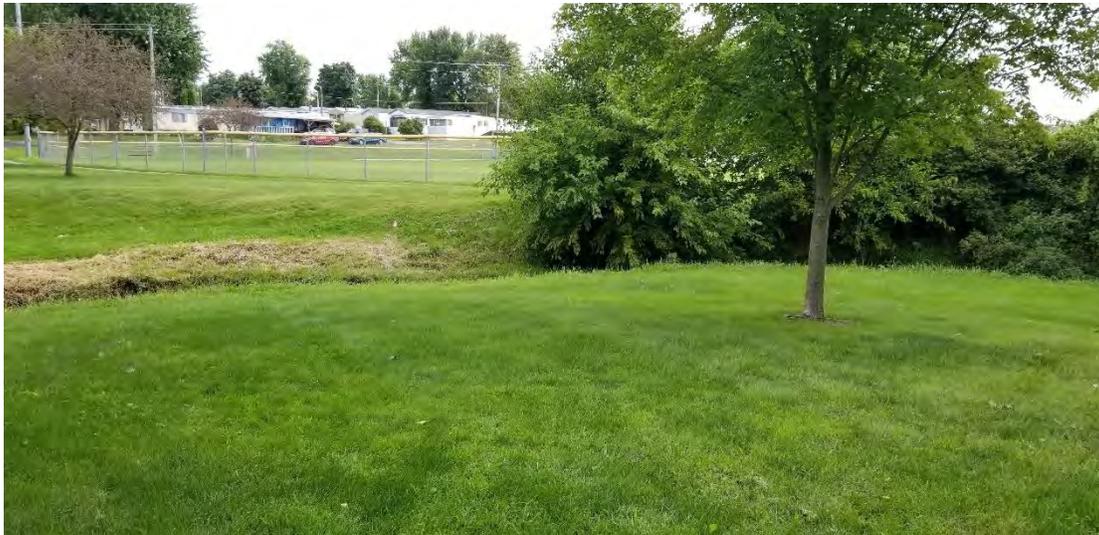
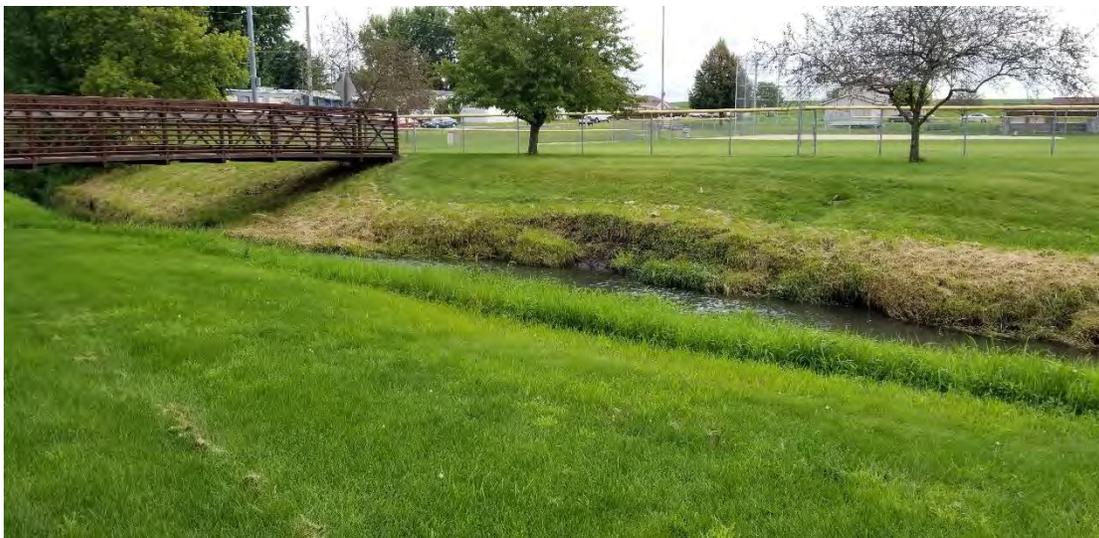
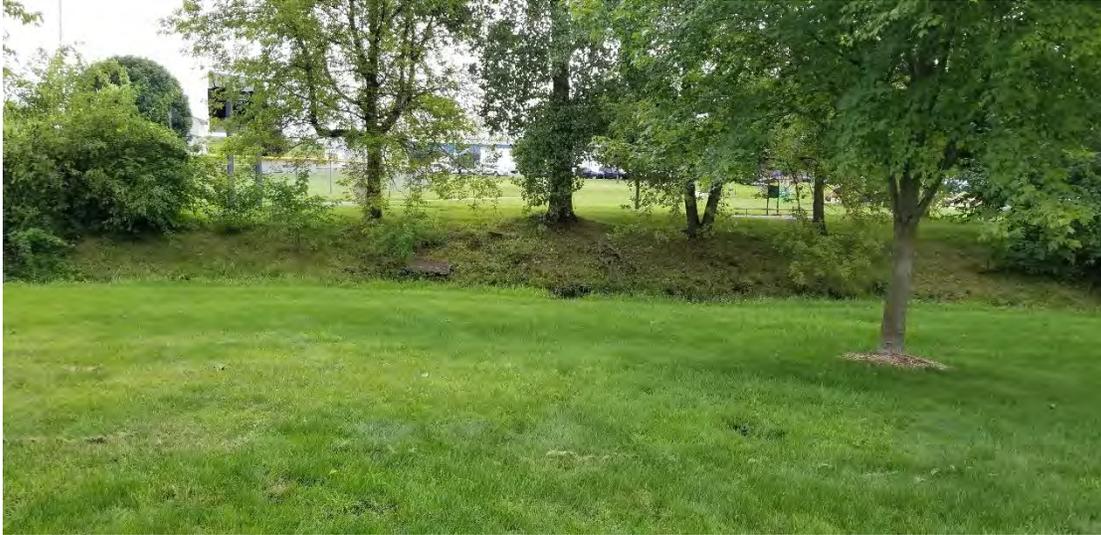
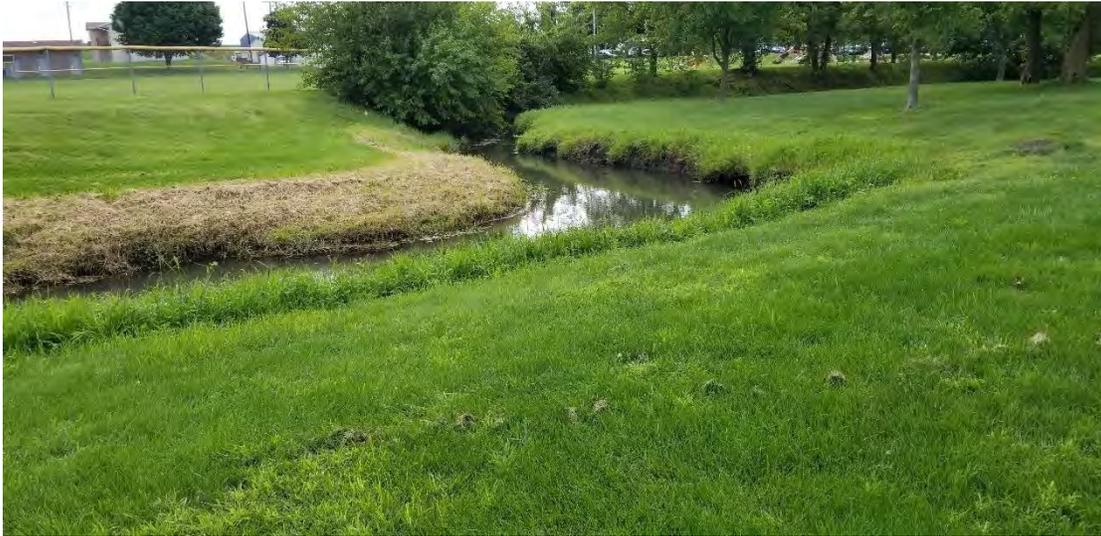
Category-SLIGHT

Some bank slumping with vegetation overhang

*Figure 3.1: 3A*

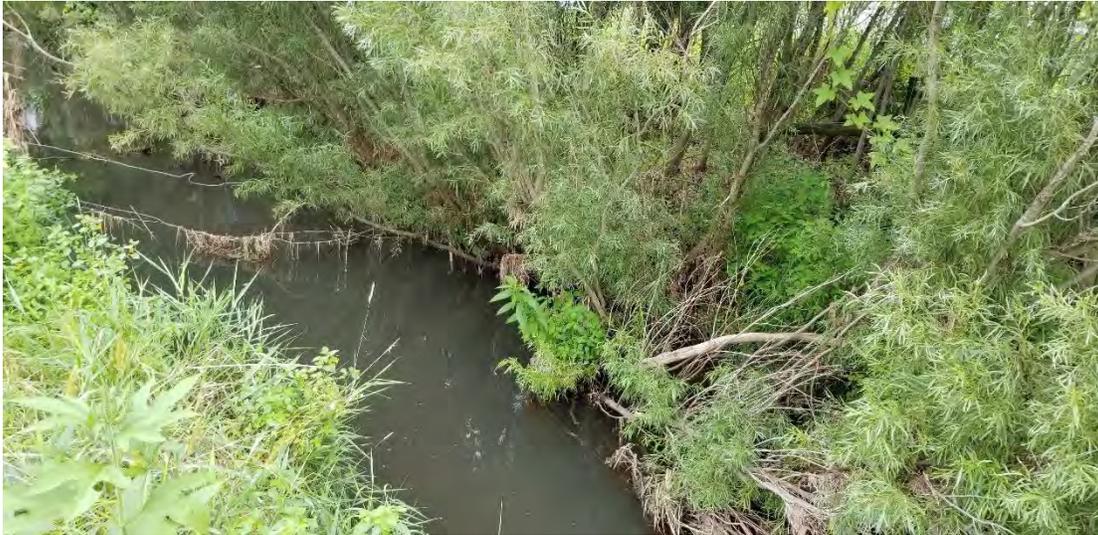
Category-MODERATE

Vegetation overhang, some tree roots within the stream channel

*Figure 3.6: Transition Between 3B/3C*

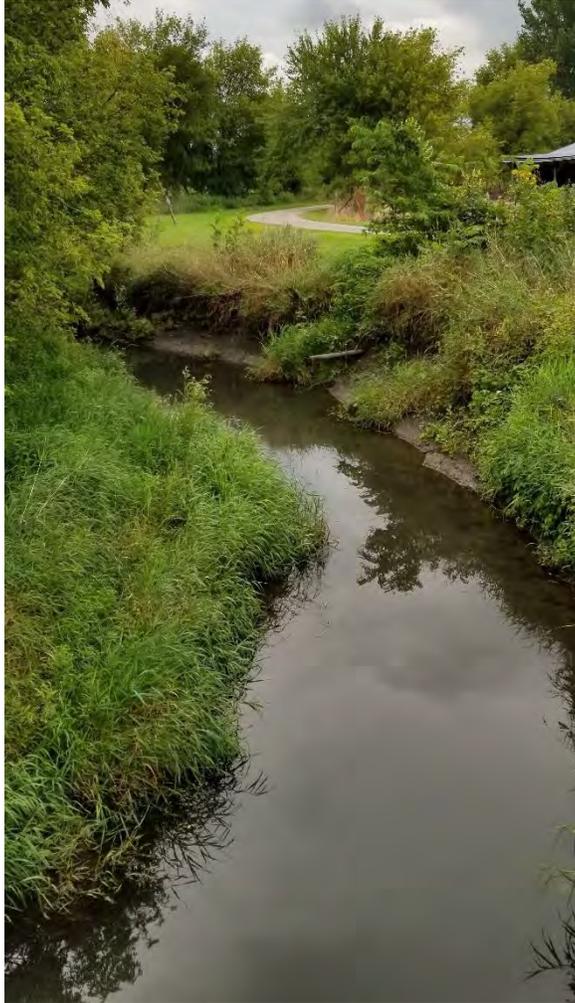
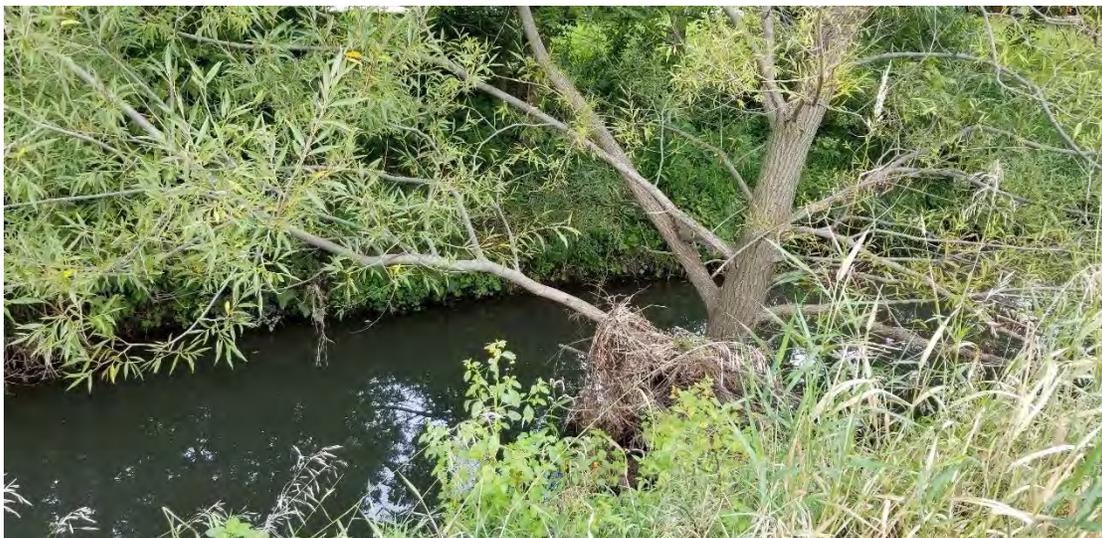
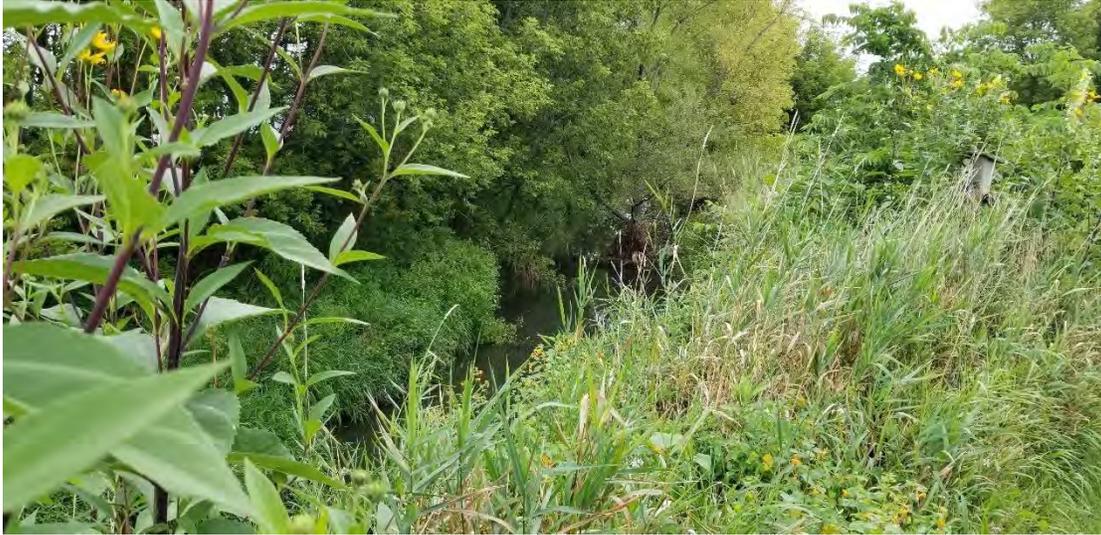
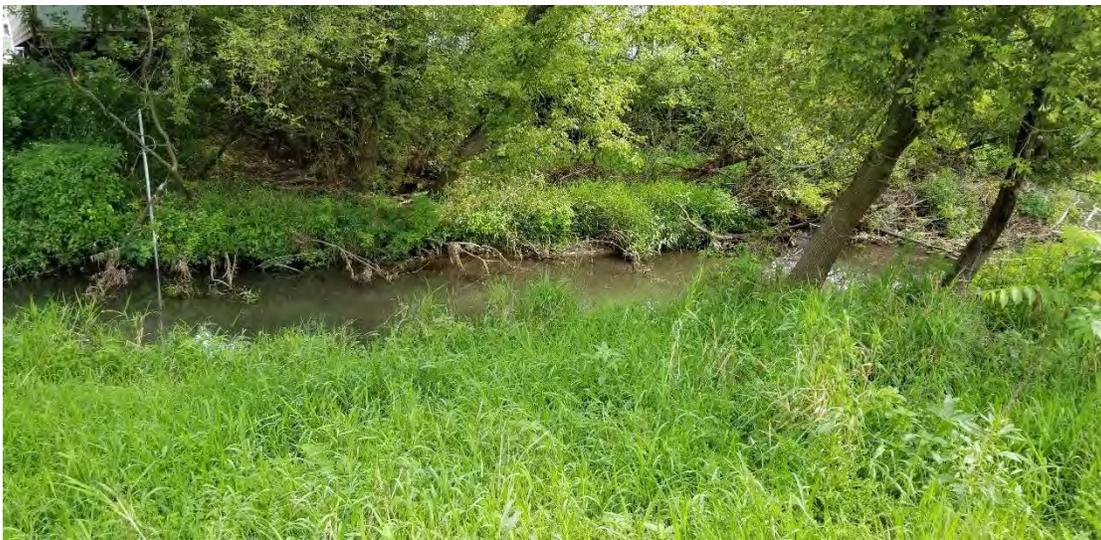
Category-SEVERE

Exposed pipes, u-shaped, vegetation overhang

*Figure 2.7: 3D WDNR Property*

*Figure 3.8: 3D*

*Figure 3.9: 3D*

*Figure 3.10: Transition Between 3C/3D*

In locations where the storm sewer culverts are suspended in the air, the bank will be reconstructed to eliminate the condition and riprap will be installed to protect the bank below the culvert. Any trees that have fallen into the stream or are on the verge of doing so will be removed along with their roots.

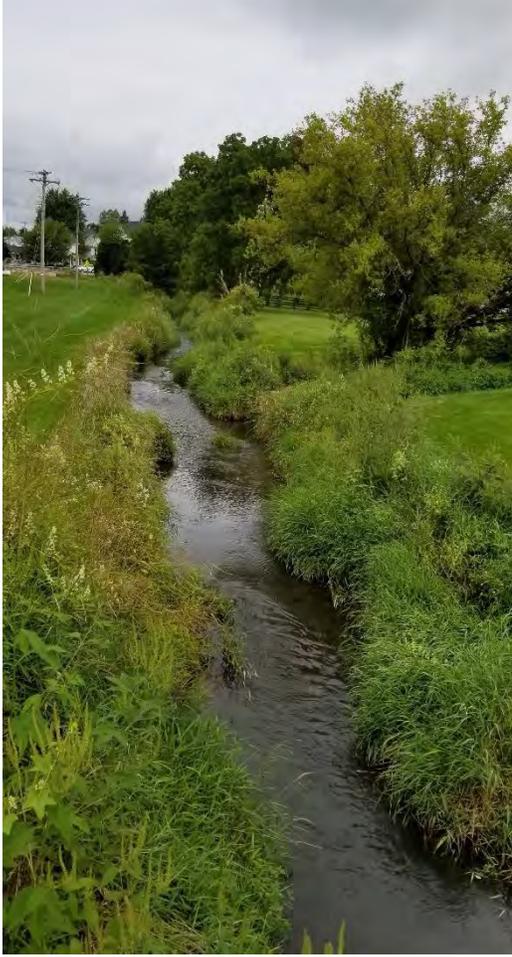
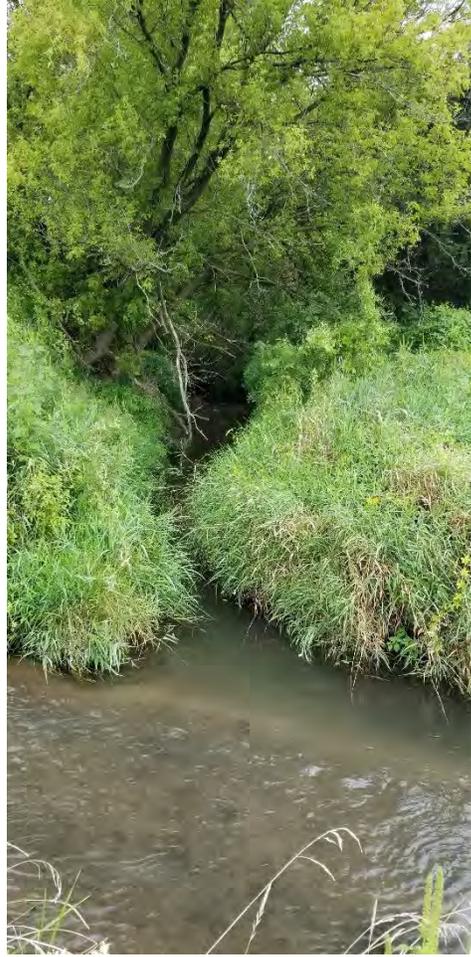
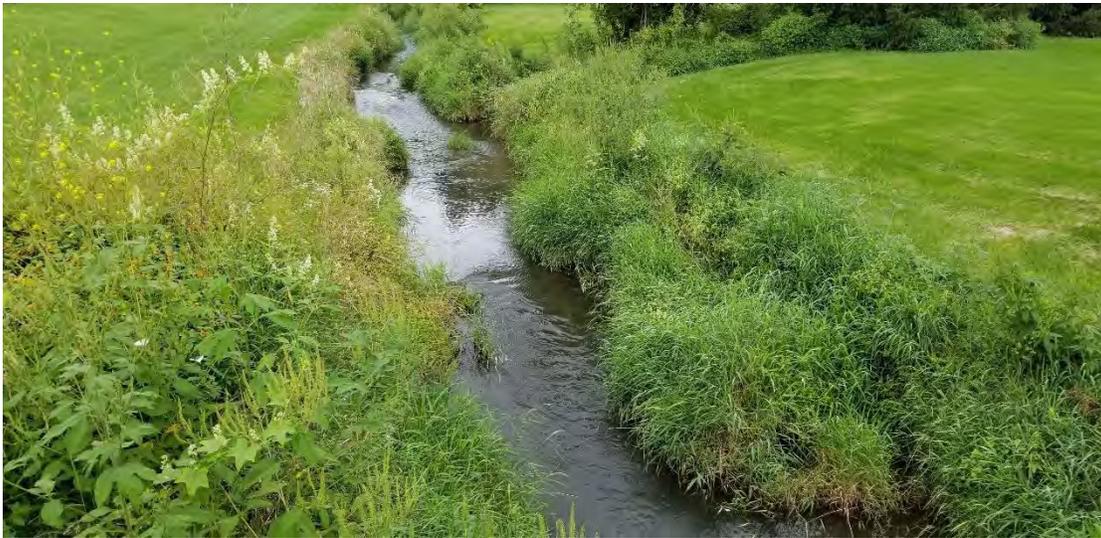
Category-SEVERE

Vegetation overhang, banks slumped

*Figure 3.1: 4E/4W at the Intersection with SE/SW*

*Figure 4.2: 4E/4W from Market Street Bridge*

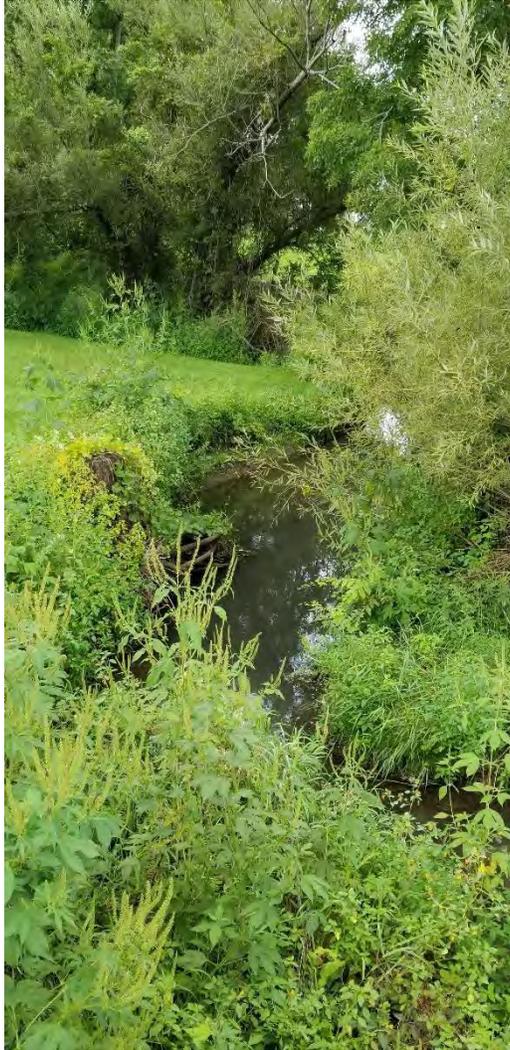
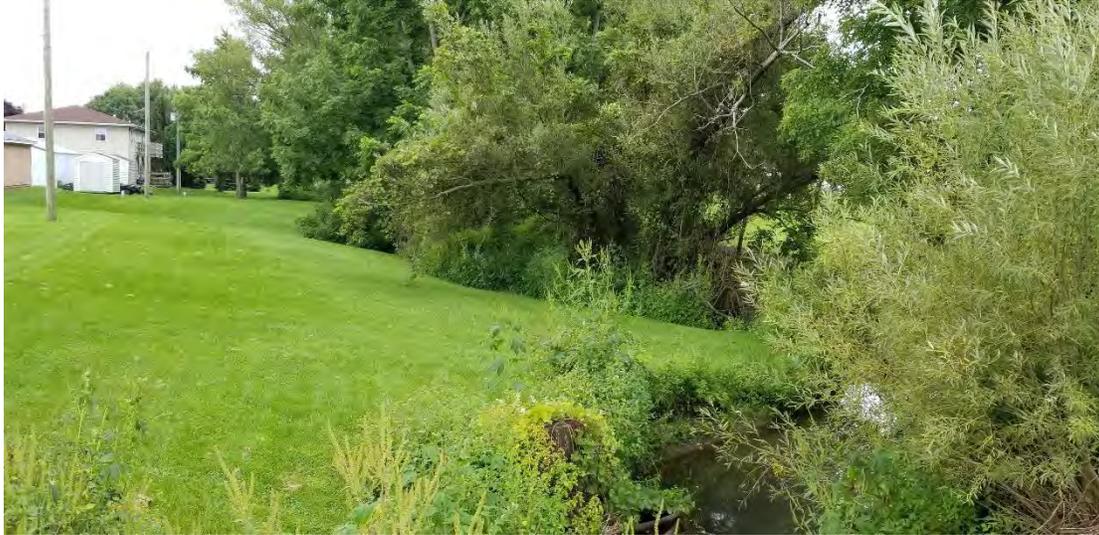
Category-SEVERE

Trees and roots, vegetation overhang

*Figure 4.1: From Liberty Street Bridge*

Figure 5.2: from Liberty Street Bridge

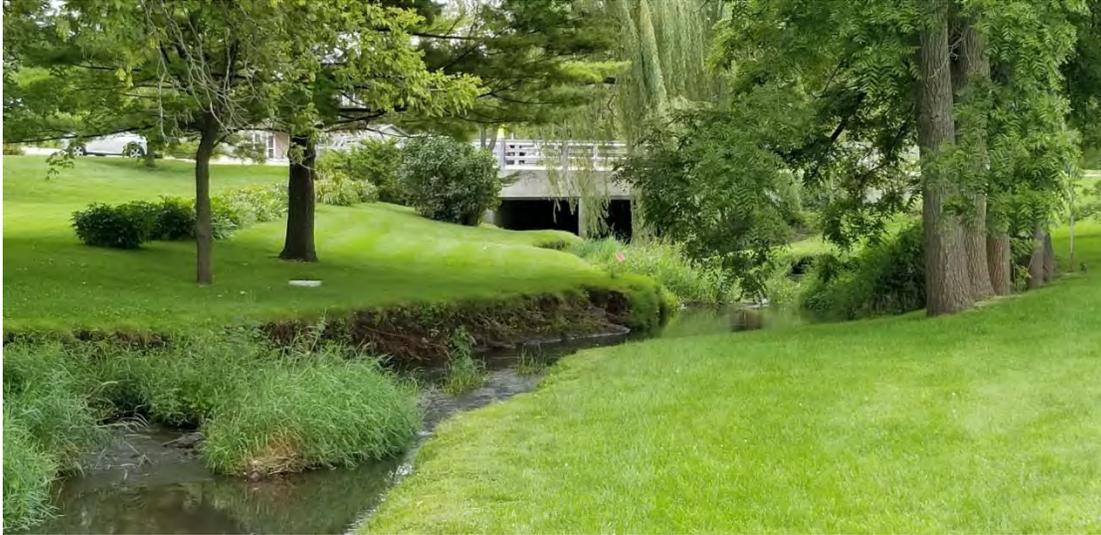
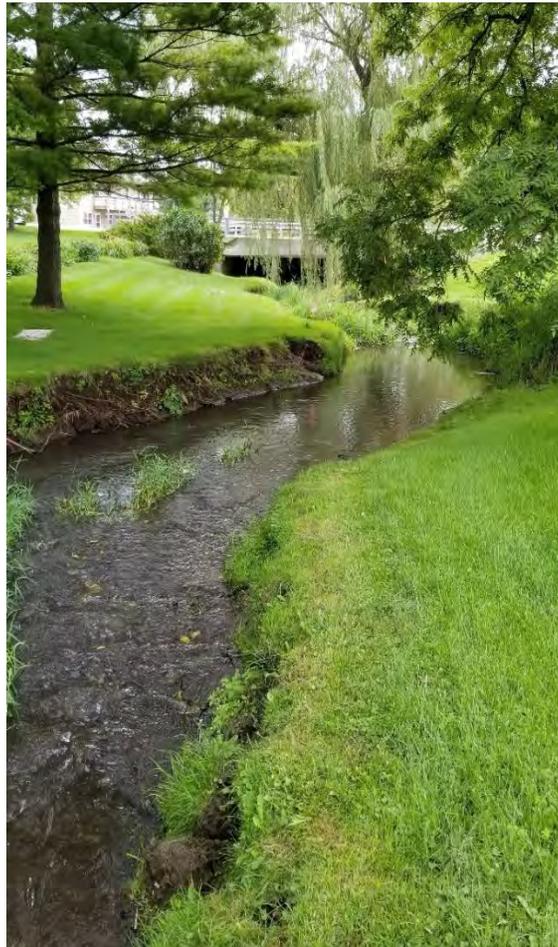
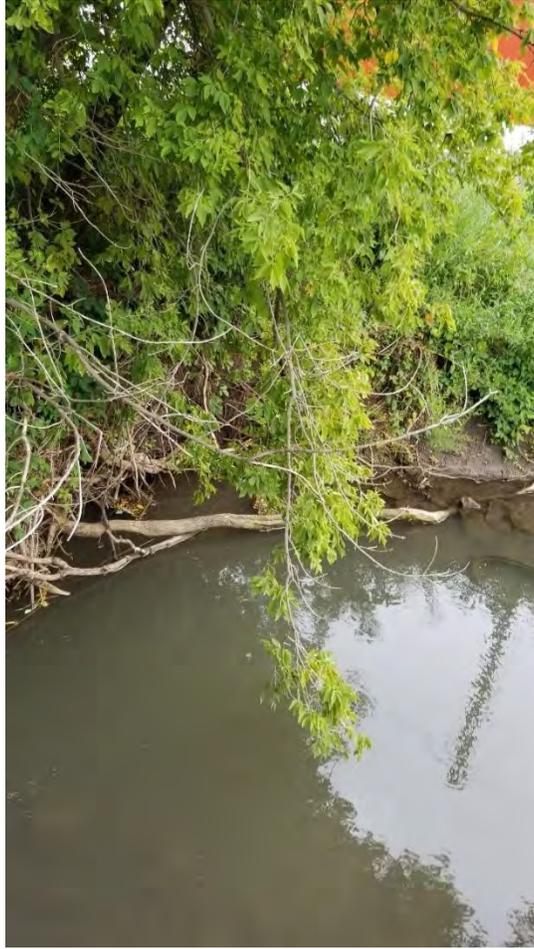
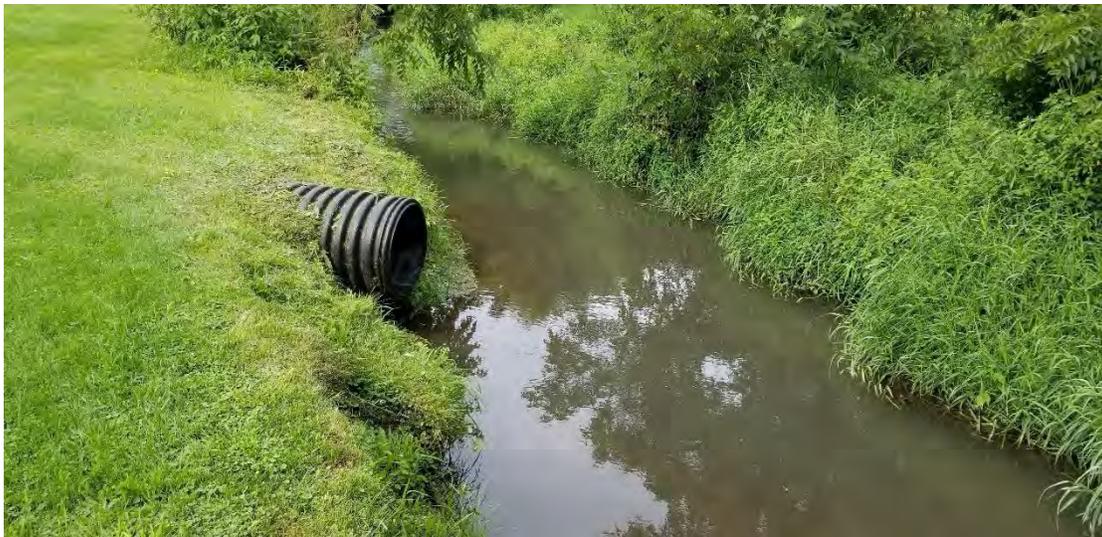
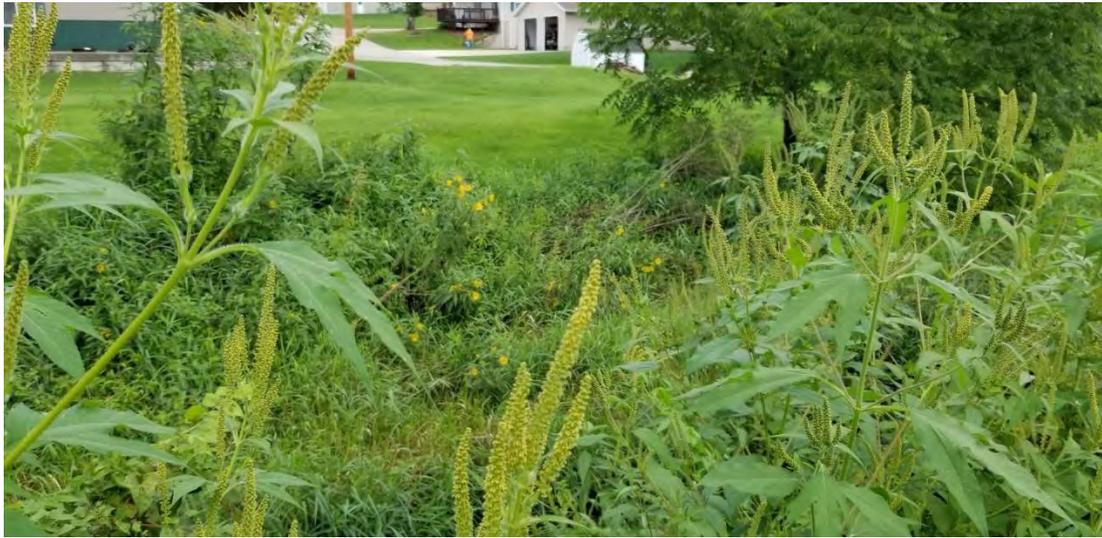
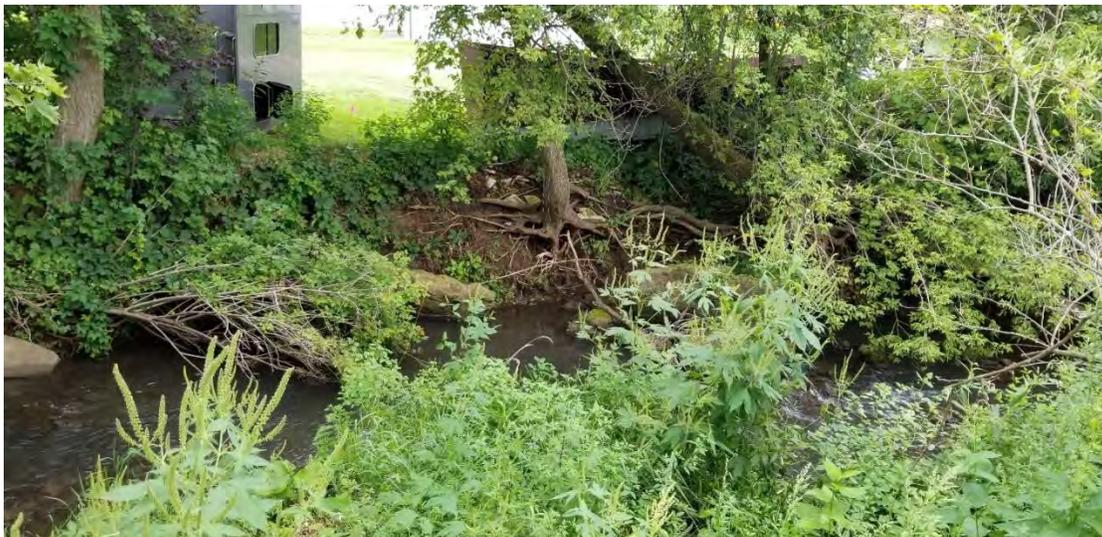
Category-SEVERE

2 culverts exposed, bare banks with drop offs close to the walking trail.

*Figure 8.1: 8E/8W at Sports Page*

*Figure 8.2: 8E/8W at Sports Page*

*Figure 5.3: 8E/8W off Cushman Drive*

*Figure 8.4: 8E/8W off Cushman Drive*

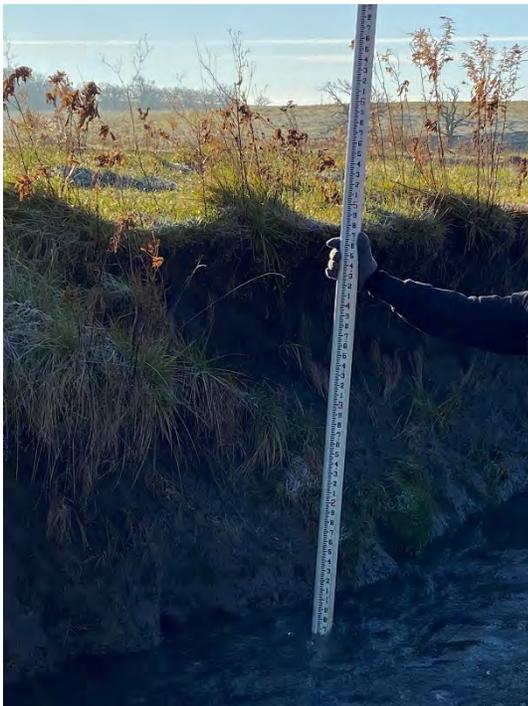
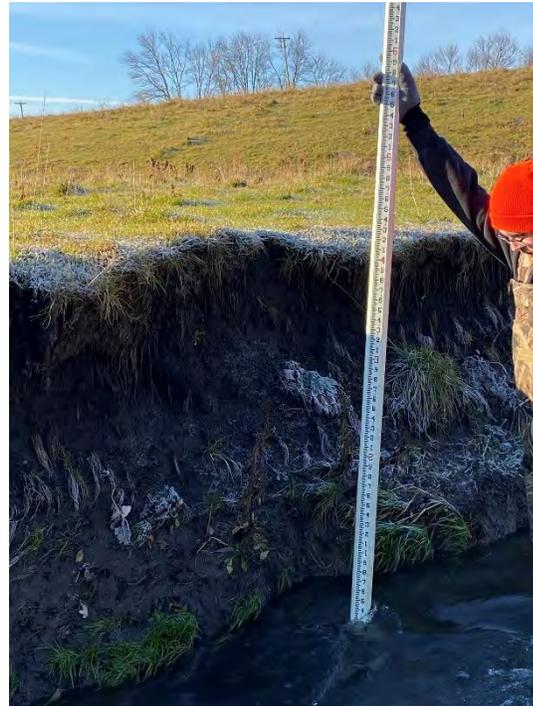
1B:

Figure 4.0: Sta.0+50-3+50 Severe. Bank is bare with severe vegetative overhang.

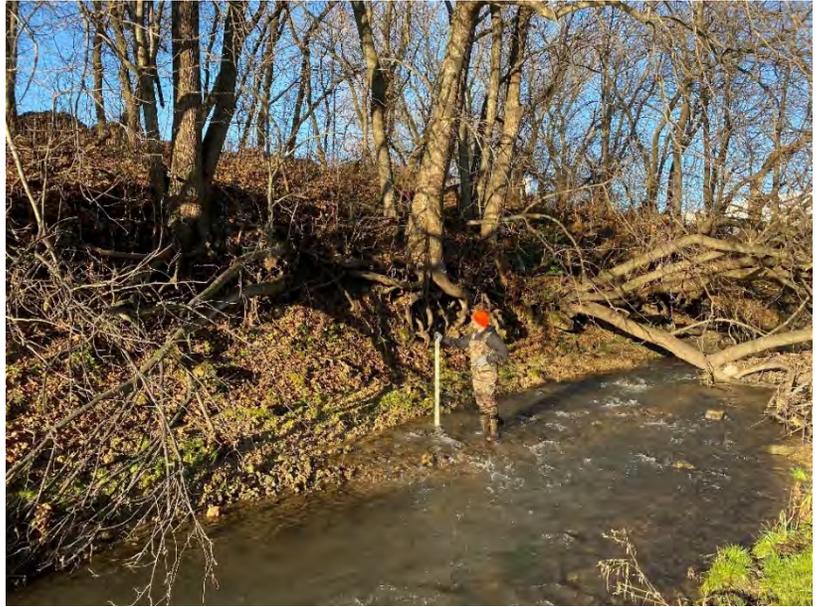
*Figure 6.0: 5+00-6+00 Severe. Bank is bare, washouts, and tree roots exposed.*

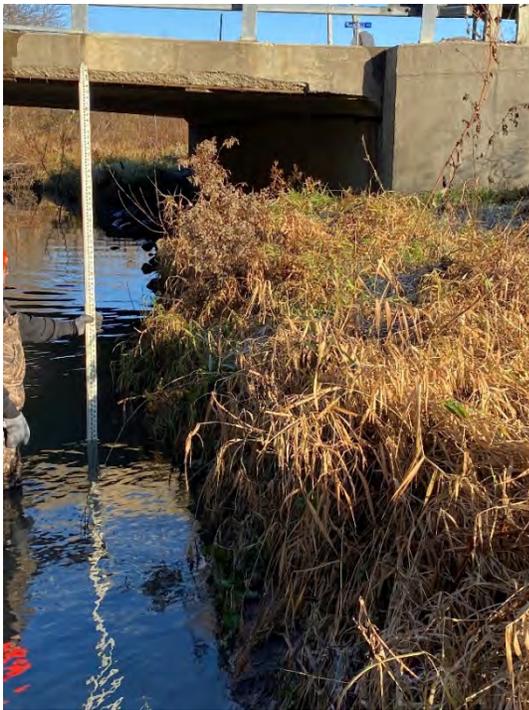
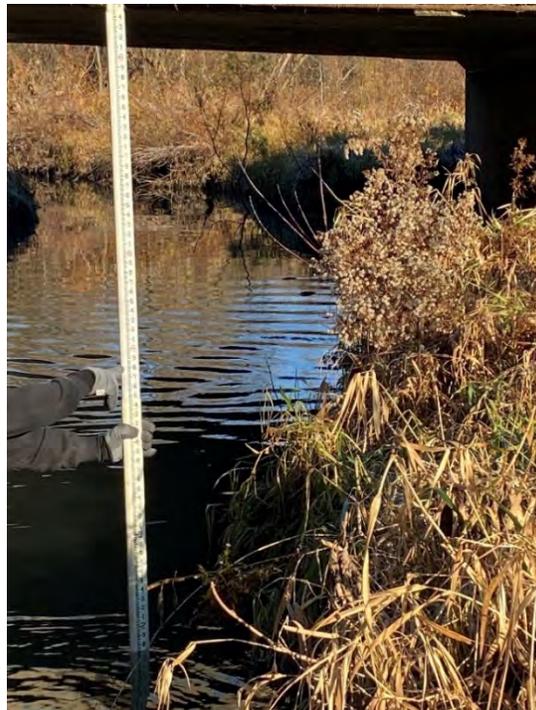
1C:

*Figure 7.0: Sta. 6+00-7+00 Slight/Moderate. Vegetation overhang and slumps present.*

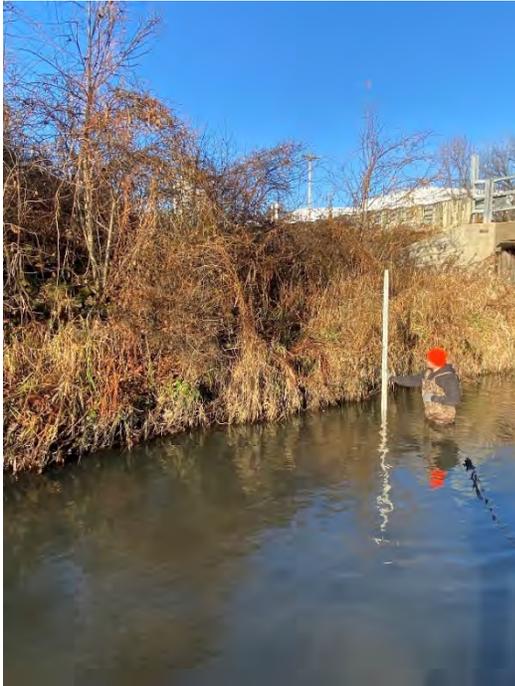
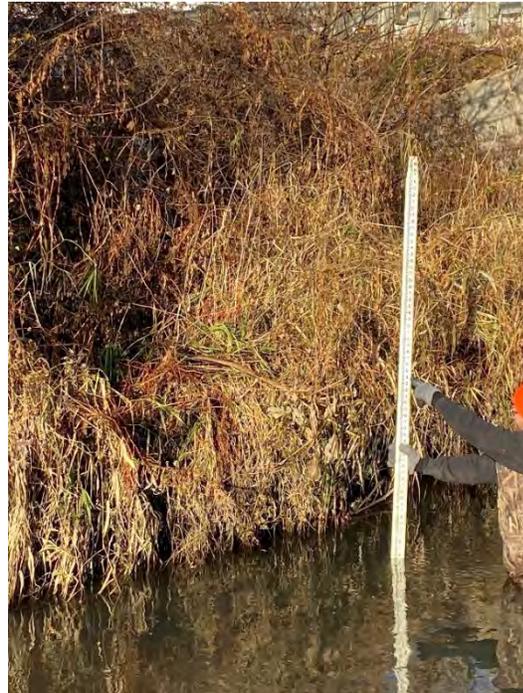
1D:

*Figure 8.0: Sta.6+00-7+00 Moderate/Severe. Bare bank with vegetation overhanging and slumps present.*

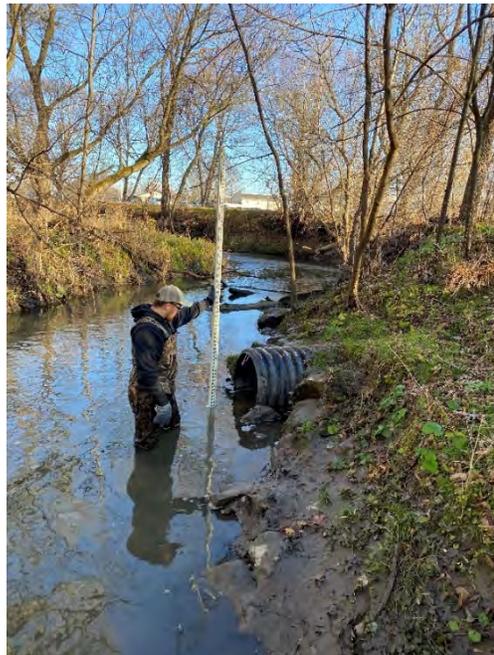
2C:

*Figure 9.0: Sta. 12+00-12+50 Severe. Outfall is eroding, banks bare and channel is U-shaped.*

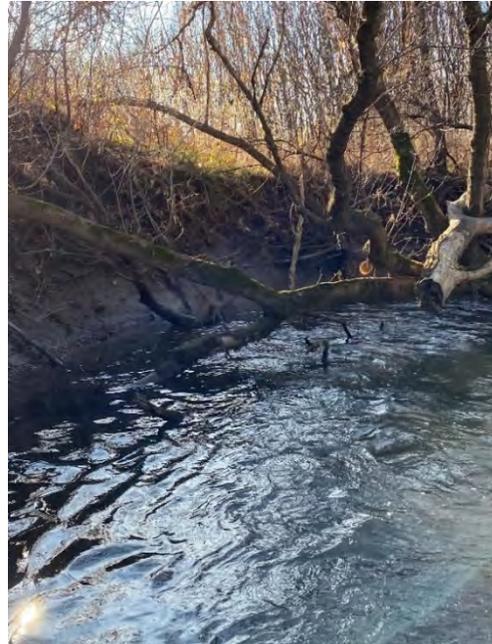
Figure 10.0: 12+50-14+00 Severe. Bank is bare with vegetative overhang and exposed roots.

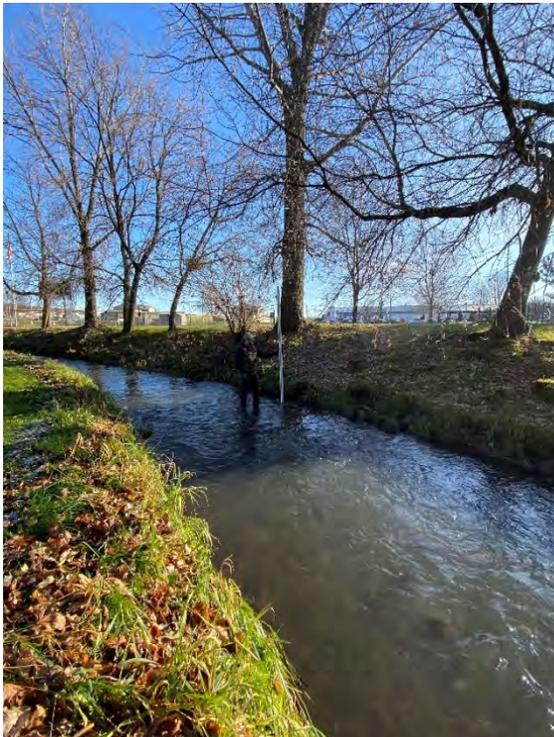
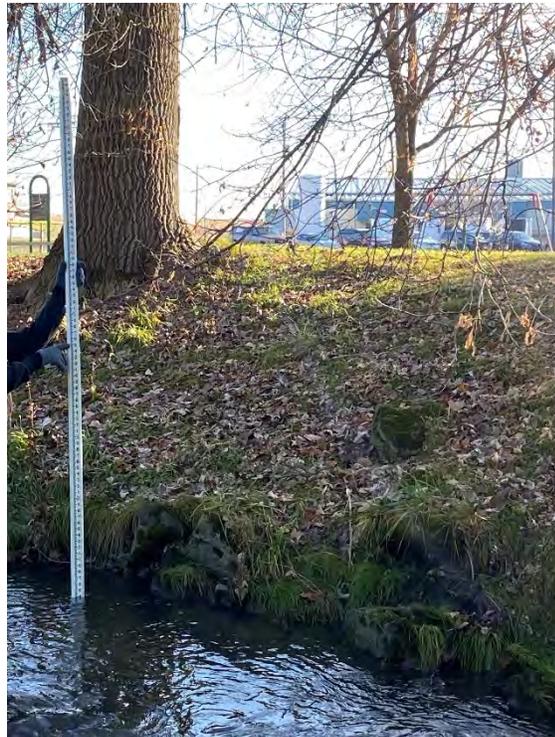
3C:

Figure 11.0: Sta. 19+00-20+00 Slight/Moderate. Vegetative overhang and bank slumps

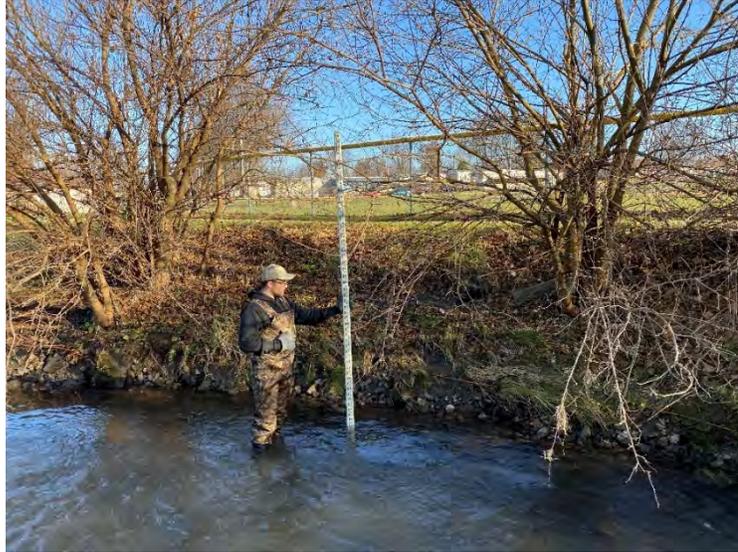
Figure 12.0: Sta. 20+00-21+50 Moderate. Bank is bare in areas, exposed tree roots with some fallen trees.

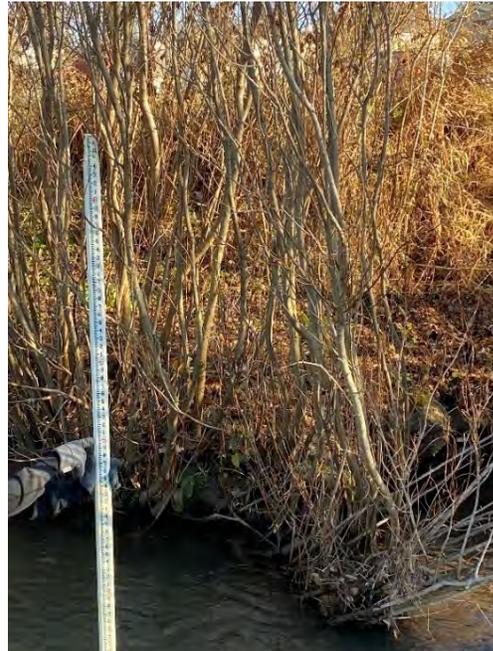
Figure 15.0: Sta. 22+00-23+50 Severe.

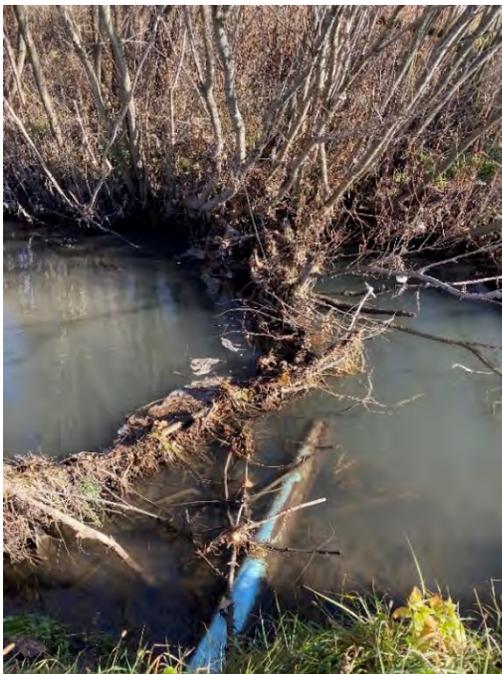
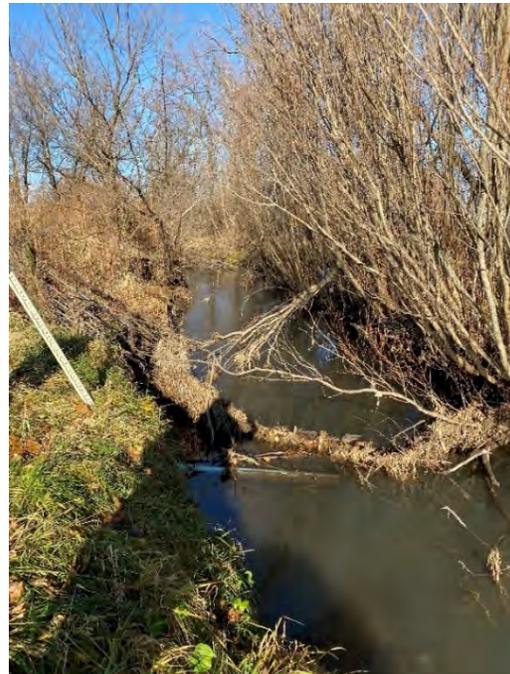
3G/3H:

*Figure 17.0: Sta. 23+50 Exposed water main.*

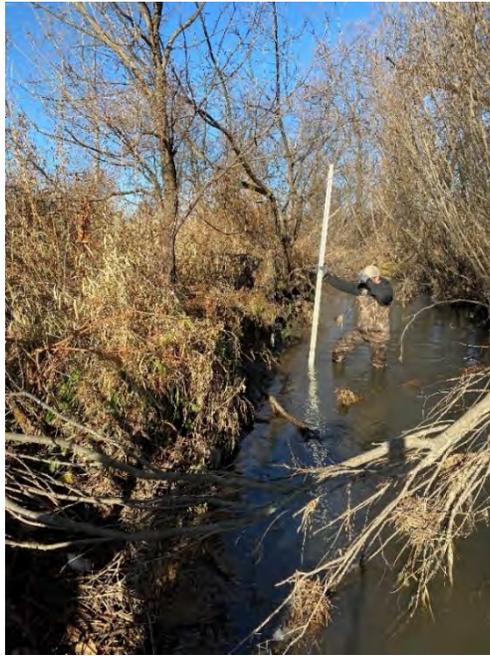
Figure 18.0: Sta. 23+50-24+50 Severe. Exposed roots, vegetative overhang, and some bare banks.

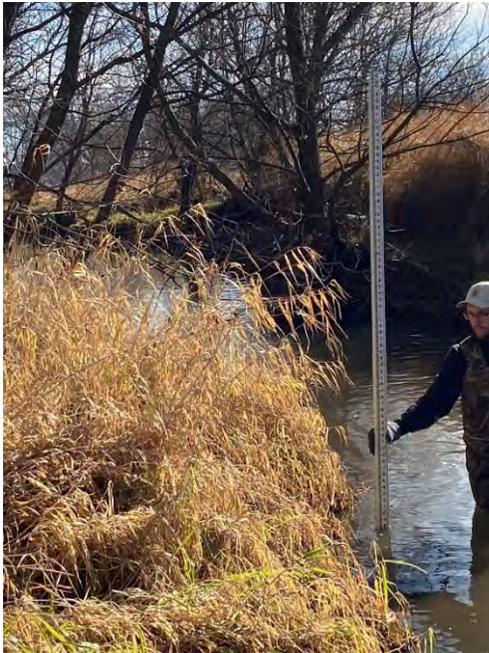
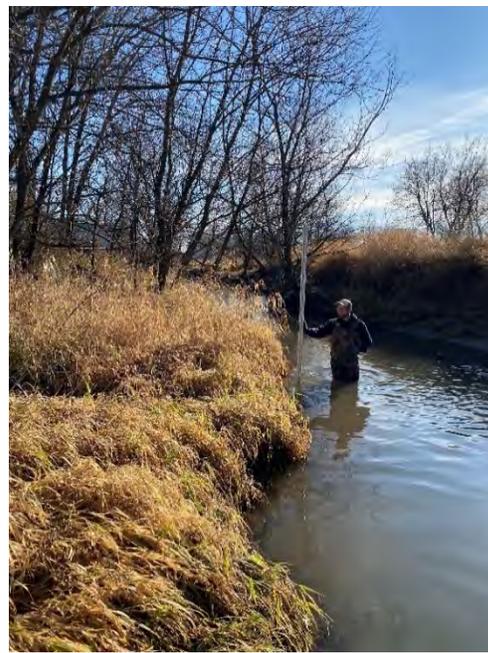
3S:

Figure 19.0: Sta. 32+25-34+22 Slight/Moderate. Some bare banks, vegetative overhang, and bank slumps.

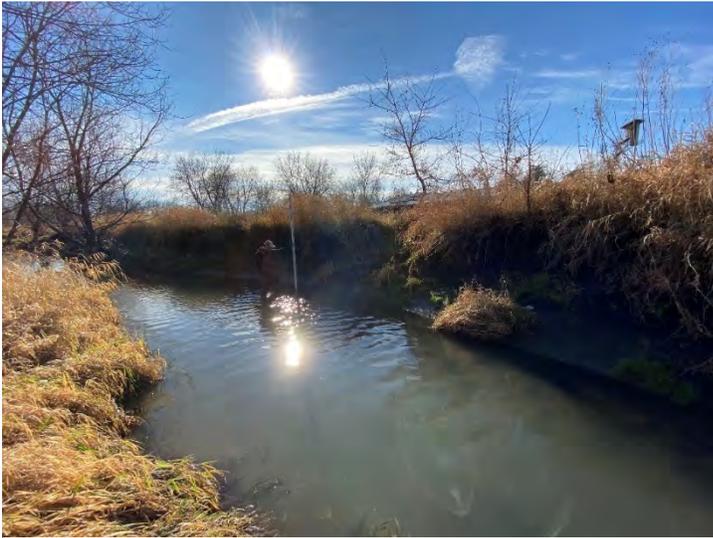
3T:

Figure 20.0: Sta. 32+25-34+22 Severe. Bare banks, vegetative overhang, slumps, and channel cross-section is U-shaped.

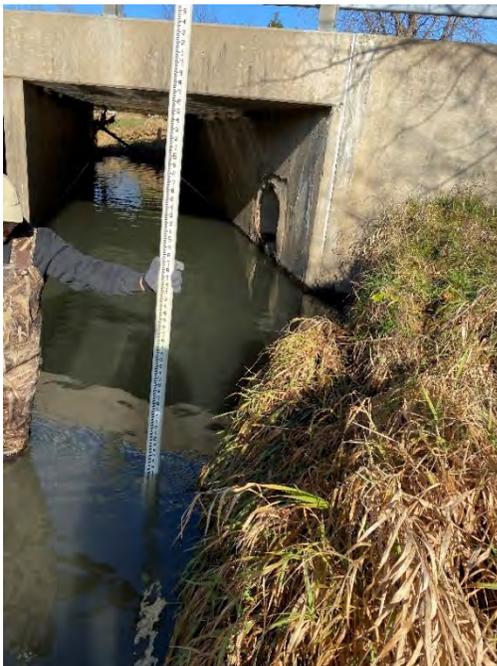
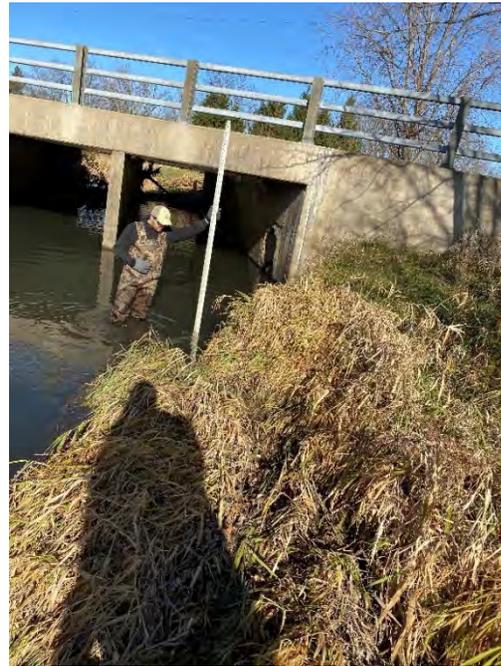
3U:

Figure 21.0: Sta. 34+22-34+50 Slight/Moderate. Some bare banks, slumps, and vegetative overhang.

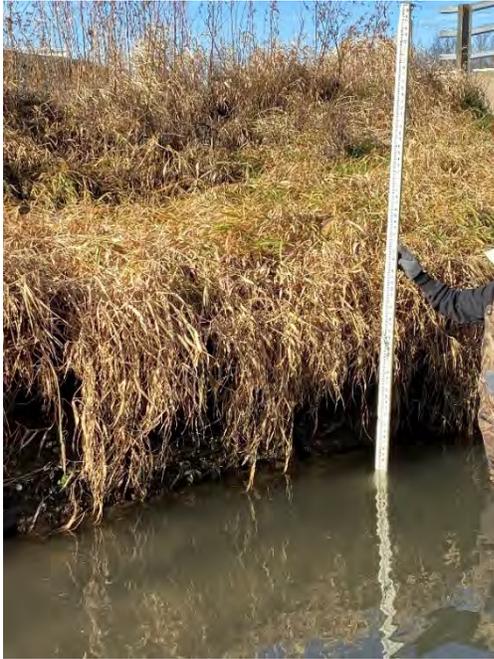
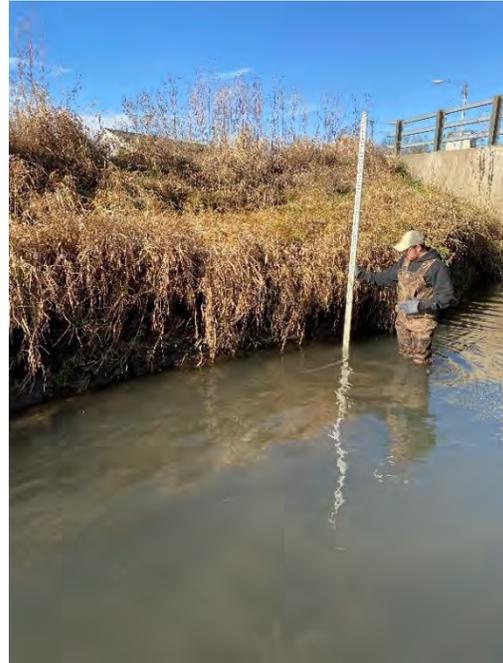
3V:

Figure 22.0: Sta. 34+22-34+50 Moderate/Severe. Bare banks, vegetative overhang, and channel cross-section is U-Shaped
