# Water Quality Trading Plan

## Village of Belmont

Lafayette County, Wisconsin

# **Belmont Water Quality Trading Plan**

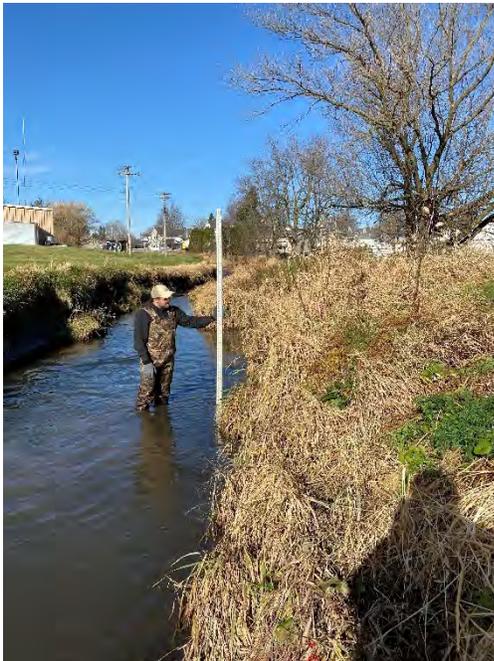
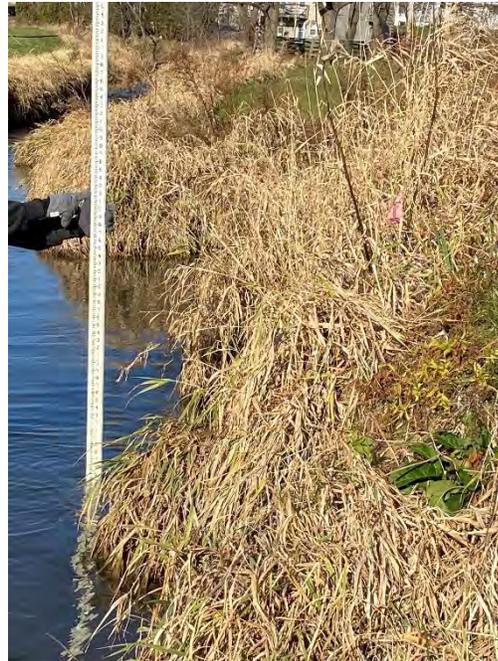
3Y:

Figure 23.0: Sta. 35+00-35+50 Slight/Moderate. Vegetative overhang and bank slumps.

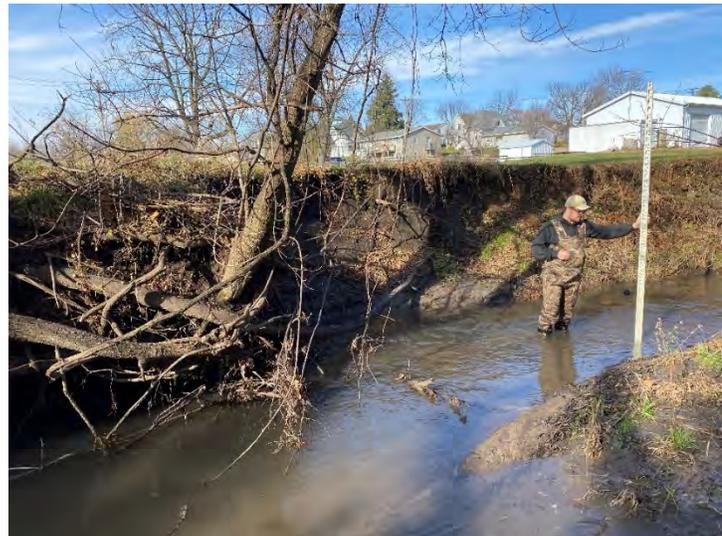
5C:

*Figure 35.0: Sta. 50+20-52+50 Slight/Moderate. Bare banks, exposed roots, trees falling into stream, and channel cross-section U-Shaped.*

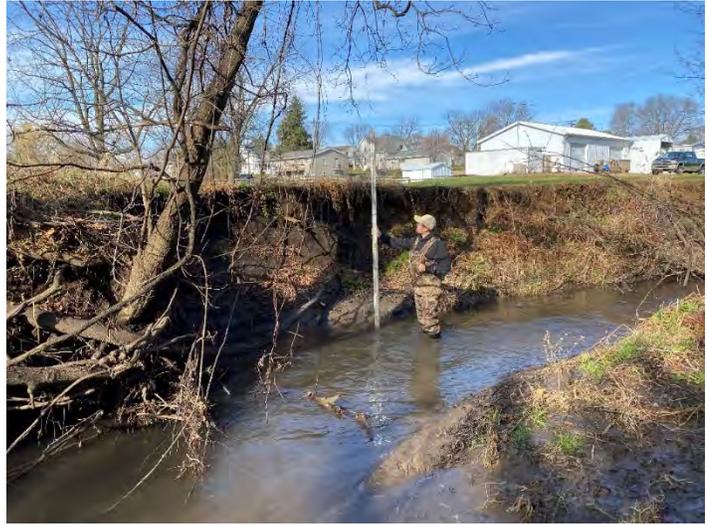
5D:

*Figure 36.0: Sta. 50+20-52+50 Severe. Bare bank and vegetative overhang.*

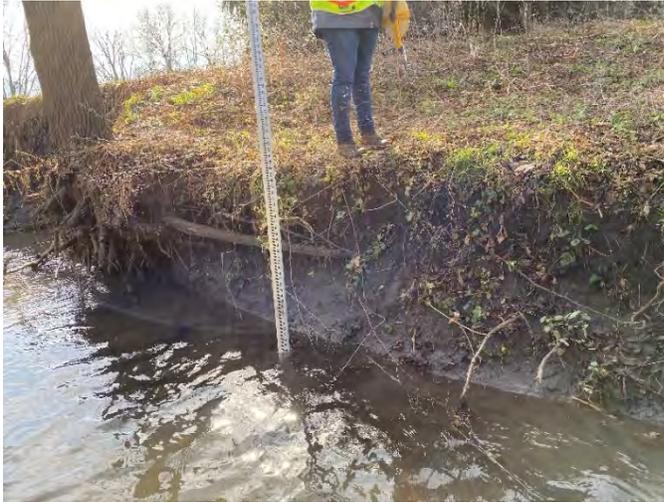
5M:

Figure 38.0: Sta. 54+50-55+50 Severe. Bare banks, exposed roots, slumps, and channel cross-section is U-shaped.

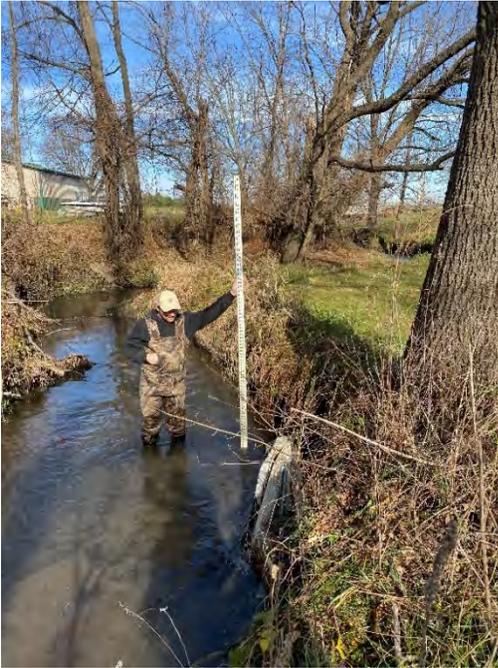
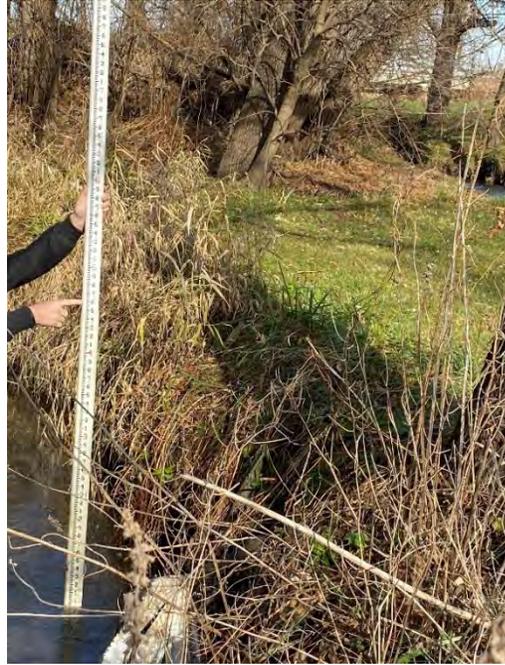
5Q:

*Figure 40.0: Sta.56+00-56+50 Slight/Moderate. Bare banks, vegetative overhang, exposed tree roots, and trees falling into stream.*

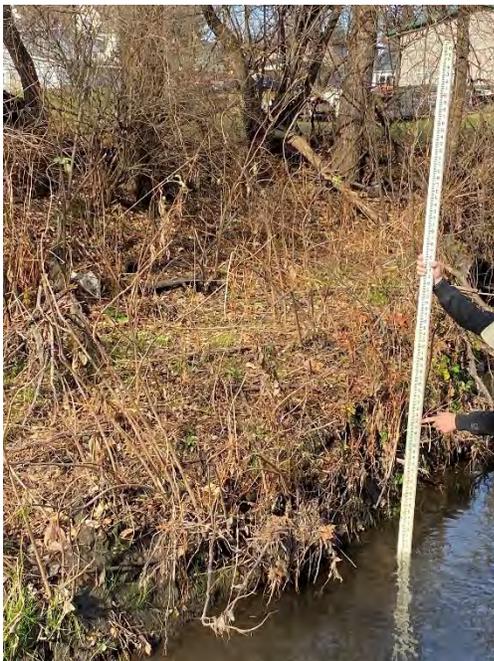
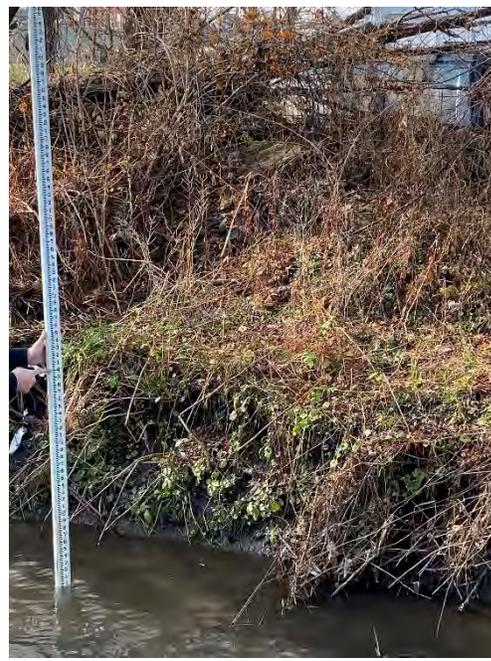
5T:

*Figure 43.0: Sta. 56+50-56+90 Moderate/Severe. Bare banks, exposed roots, slumps, and trees falling into stream.*

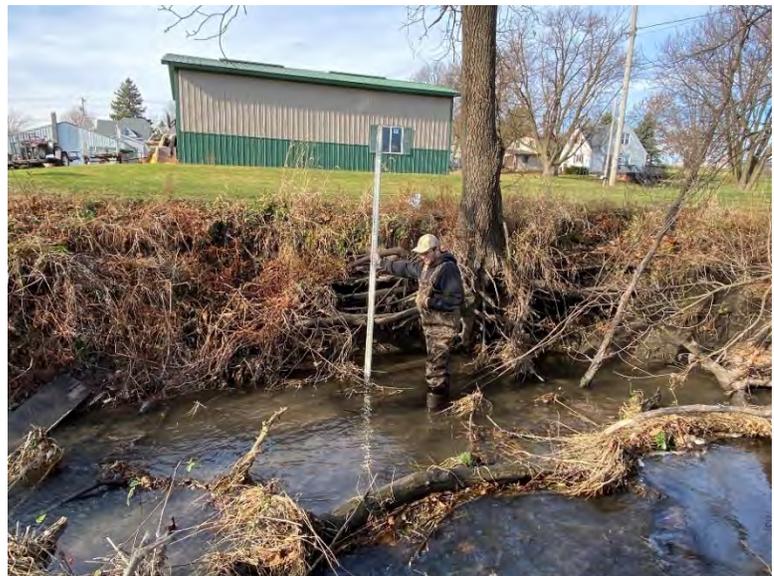
5V:

*Figure 45.0: Sta. 56+90-57+35 Moderate/Severe. Bare banks, exposed roots, slumps, and trees falling into stream.*

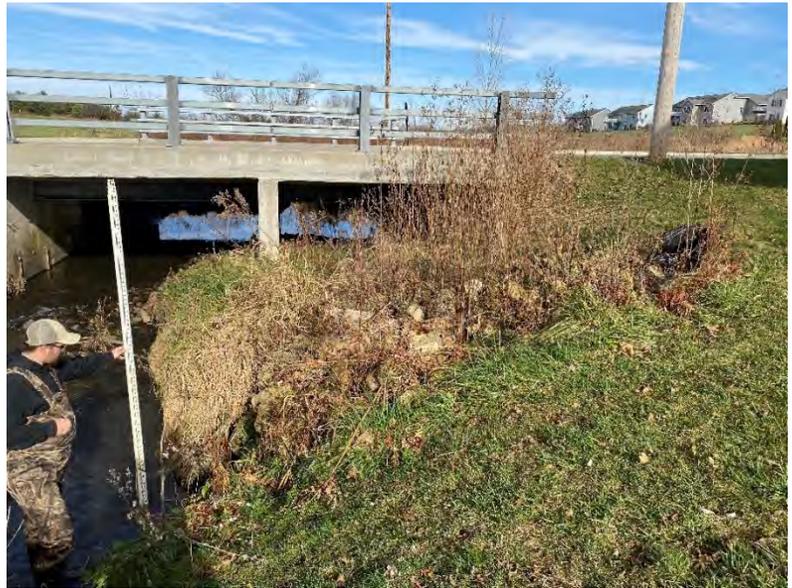
5W:

Figure 46.0: Sta. 57+35-57+75 Slight. Vegetative overhang and outfall exposed.
