ENVIRONMENTAL ASSESSMENT

On the Petition of the
Rock-Koshkonong Lake District
To Amend Order 3-SD-82-809, Regarding the
Indianford Dam and Lake Koshkonong Water Levels

Draft - December 14, 2004
Final March 18, 2005

Wisconsin Department of Natural Resources

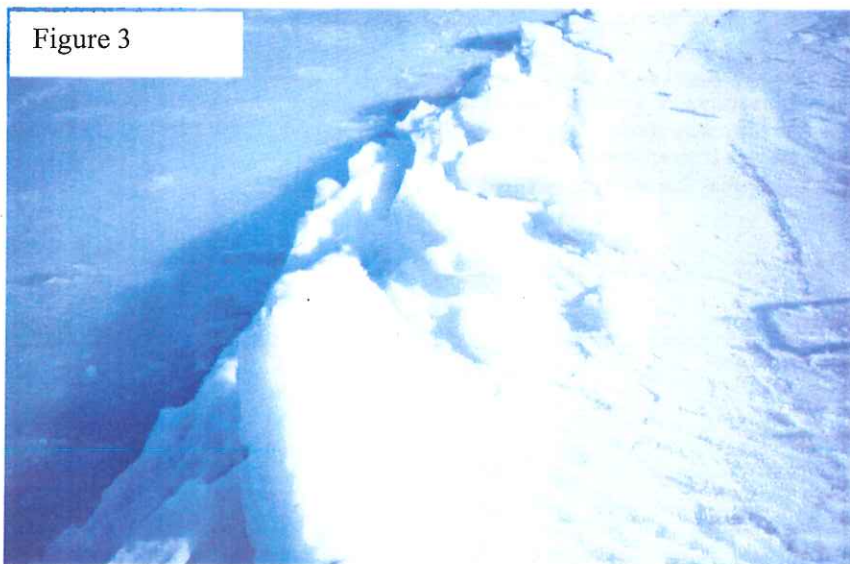
Figure 3

mile long, the change in length would approximate 2.75 feet while the force exerted is probably not less than 30,000 pounds per square foot. If the shore is of such a nature that the ice cannot shove, it may buckle. Buckling is not uncommon, even in very thick ice sheets (see Figure 3). If the ice is weaker than the friction on shore it heaves and cracks near the center of the lake, resulting in ice plates that slide past each other and rest one atop the other, leaving open water. If this occurred now the pressure of the ice on shore would be relieved.

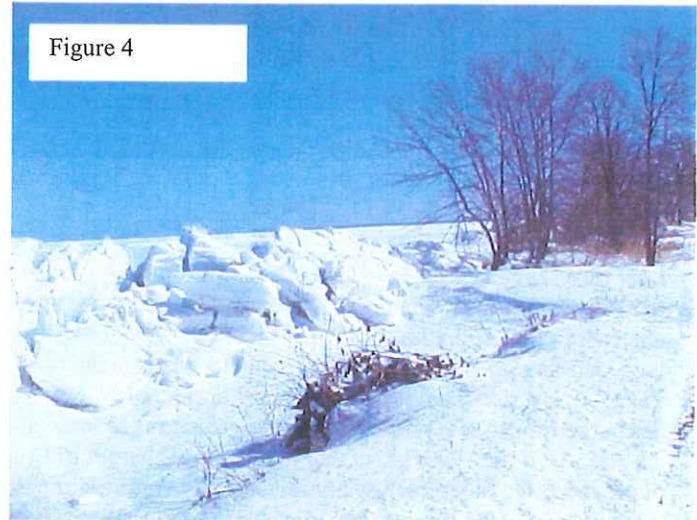
Whether or not expanding ice will push up the shore or buckle (Figure 4) depends on whether weak spots in the ice sheet permit the release of this pressure by the buckling of the sheet or crumbling of its edges, both of these conditions being somewhat dependent on the water depth near the shore. If the shores are gently sloping, the expanding ice overrides them, but if the shore materials are of a yielding sort, an irregular ridge called an ICE RAMPART is likely to be formed by shoving a portion of the marginal material to a higher level, and leaving it in the form of a ridge (Figures 5 and 6). Such ice ramparts may be several feet in height, and may contain large boulders. Where conditions are such that ice ramparts once formed become permanent, successive shoves may build up a considerable accumulation of displaced materials, thus forming an ICE-PUSH TERRACE. Shorelines resist the outward movement of expanding ice.

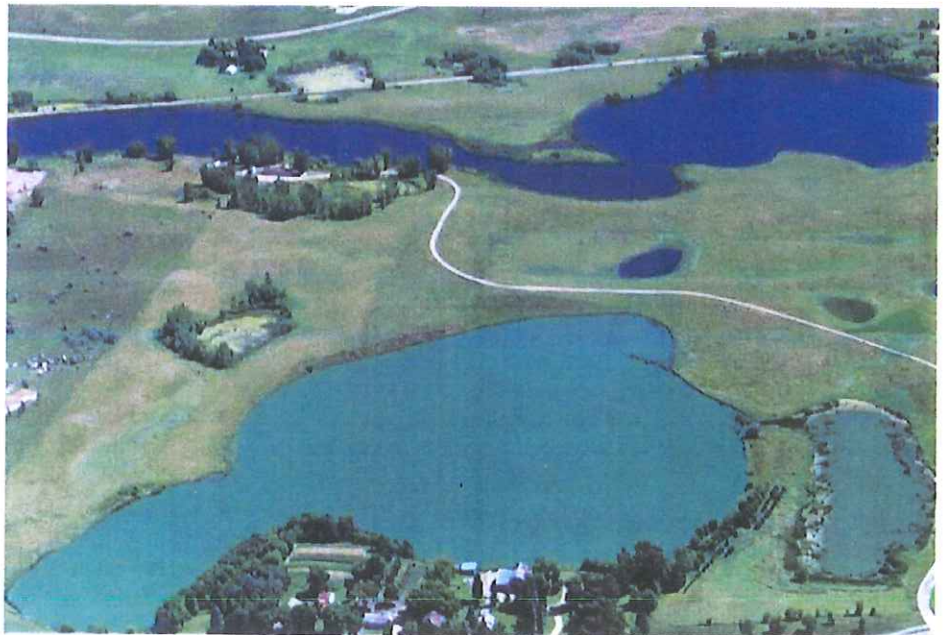
Figure 16

Martin Scheffer (Scheffer 1989) developed an ecological minimal model that describes bi-stability in the ecological properties of shallow lakes (Figure 16). Scientists now recognize that shallow lakes may have two alternative stable conditions, a clear or turbid state. The valleys in the landscape diagram correspond to stable ecological conditions. Each picture shows the stability properties at different nutrient conditions. In the oligotrophic situation a clear state is the only stable condition, and likewise in the hypereutrophic condition the turbid state is the only stable conditions. Continued enrichment gradually causes the stability of the clear state to shrink to nil, where the lake is more vulnerable to perturbations that would shift the equilibrium to the turbid state.

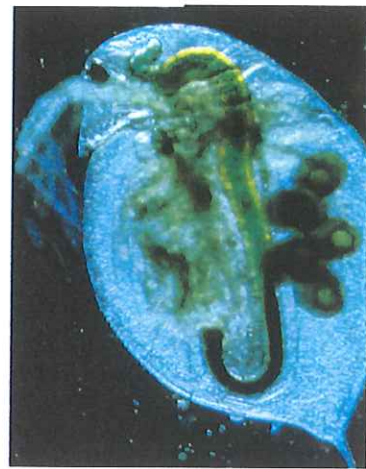
Figure 20

Cladocerans, or water fleas "vacuum" the algae from lake water. When they are abundant, the water is more clear. If conditions are unfavorable, i.e. zooplanktivorous fish abundant, refuge absent, the lake water remains turbid from algae.

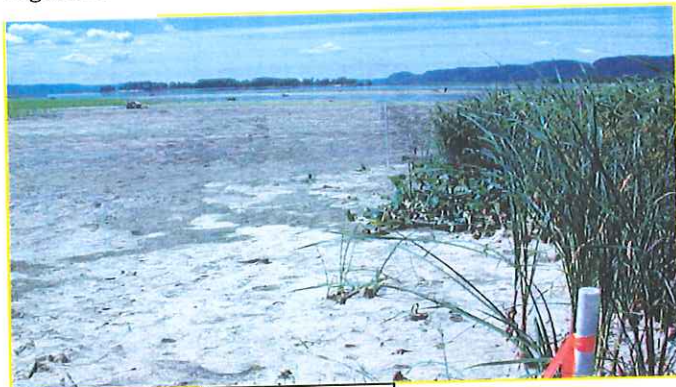
Figure 21

July 12, 2001

Example of vegetation response to drawdown on Pool 8 of the Upper Mississippi River Pool 8. Substrates were exposed between 6-10 July. Plant response dominated by flatsedges, teal lovegrass, rice cut-grass, common arrowhead, and nodding smartweed.

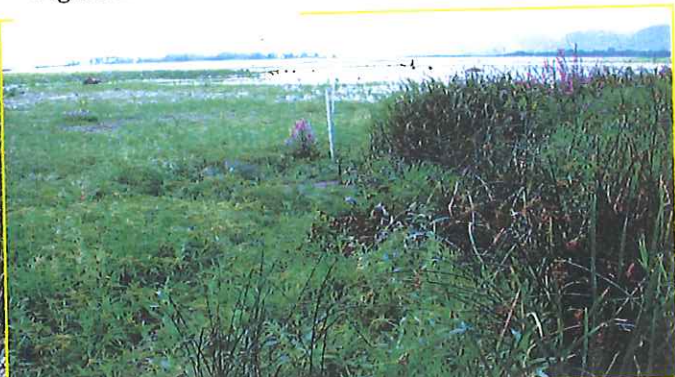
Figure 22

August 27, 2001

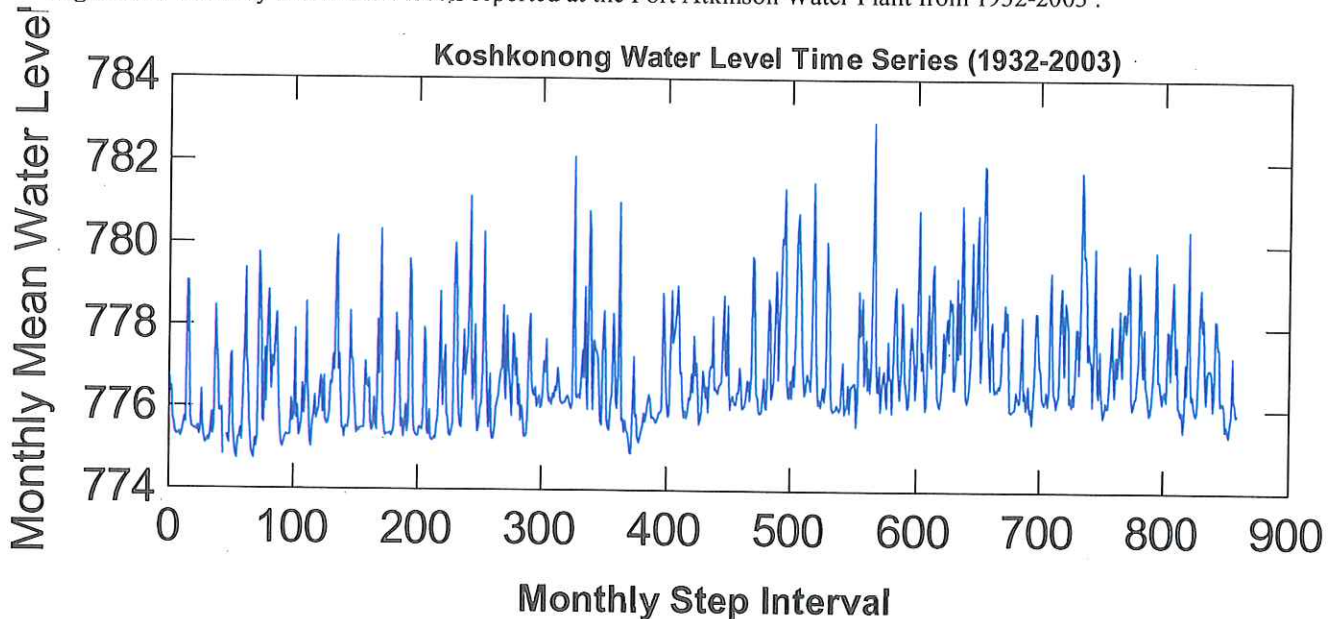
Figure 23. Monthly mean water levels reported at the Fort Atkinson Water Plant from 1932-2003 .

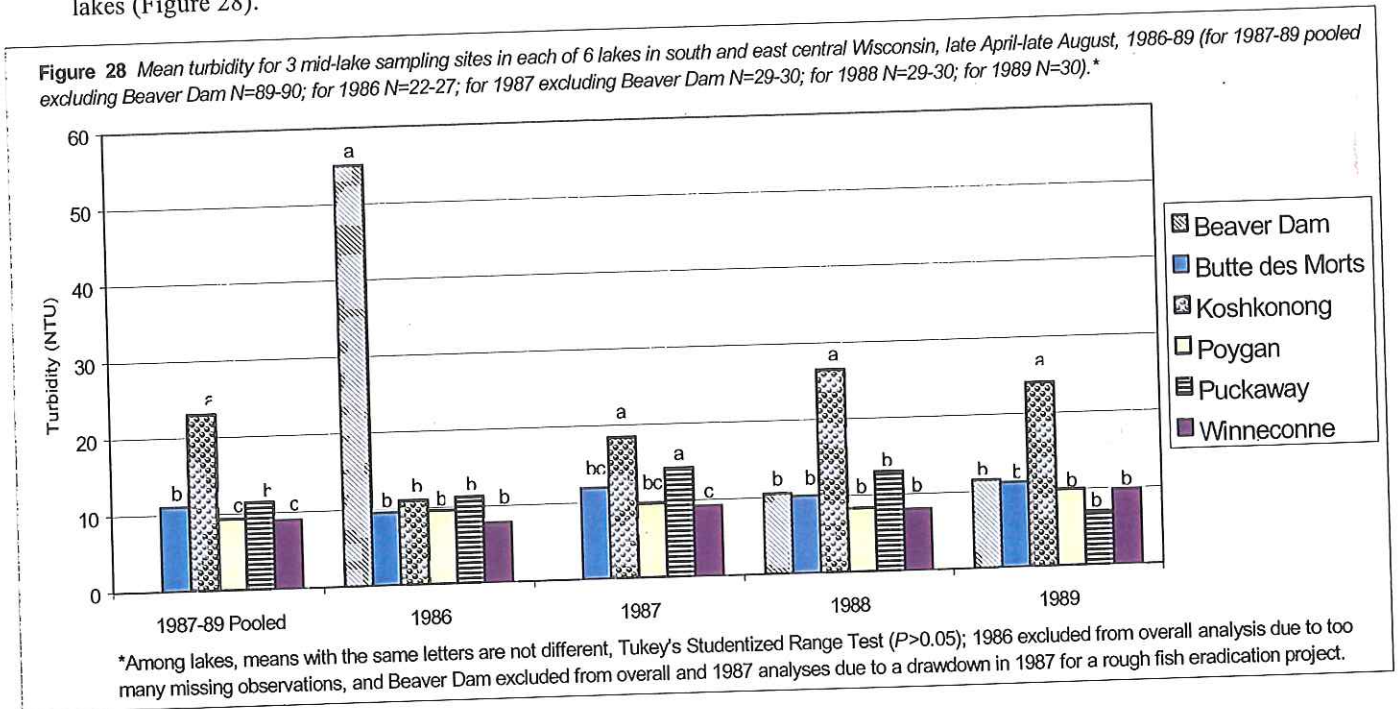
Turbidity is a measure of the cloudiness of water- the cloudier the water, the greater the turbidity. Turbidity is the result of suspended solids in the water, rather than dissolved organic compounds. Suspended particles dissipate light, which affects the depth at which plants can grow. Suspended solids are variable, ranging from clay, silt, and plankton, to industrial wastes and sewage. Lakes receiving runoff from silt or clay soils often possess high turbidities. These values vary widely with the nature of the seasonal runoff. Suspended plants and animals also produce turbidity. Many small organisms have a greater effect than a few large ones. A rough measure of turbidity can be made with a Secchi Disk, but more accurate measurements need to be taken with a turbidimeter, Turbidity is measured in NTUs, the abbreviation for nephelometric turbidity unit. A normal range for turbidity in river water has not been established. High turbidity water will appear to be murky or muddy. Turbidity in excess of five NTUs can be easily detected. Lake Koshkonong is significantly more turbid than other large shallow lakes of the Southeast Glacial Plains. Turbidity values for Lake Koshkonong average 23 NTU's, which is 2 fold higher than other shallow lakes (Figure 28).

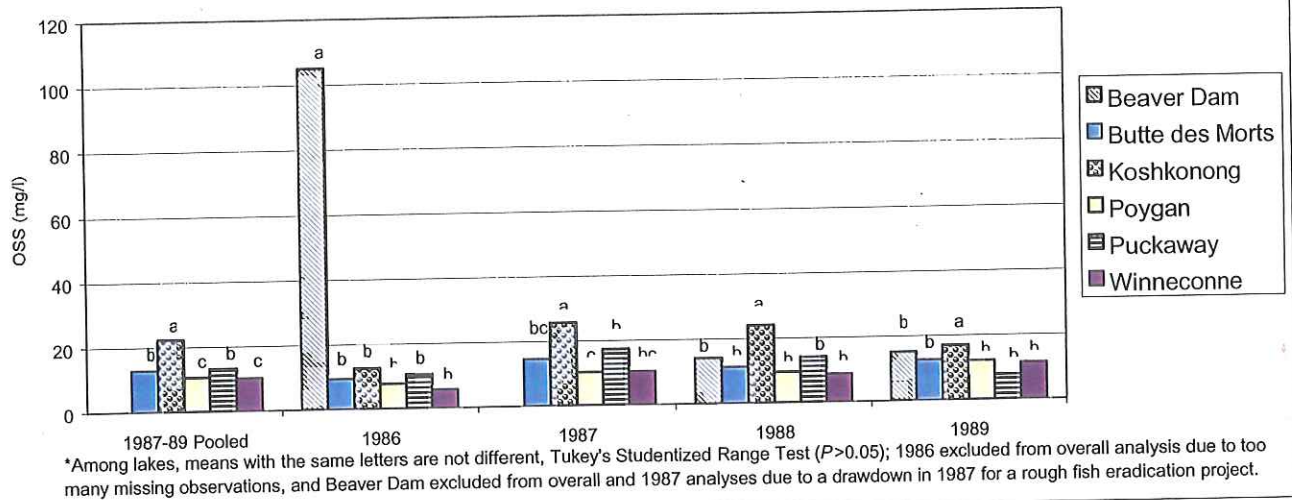
Figure 31. Mean organic suspended solids (OSS) for 3 mid-lake sampling sites in each of 6 lakes in south and east central Wisconsin, late April-late August, 1986-89 (for 1987-89 pooled excluding Beaver Dam N=87-90; for 1986 N=22-27; for 1987 excluding Beaver Dam N=30; for 1988 N=30; for 1989 N=27-30).*

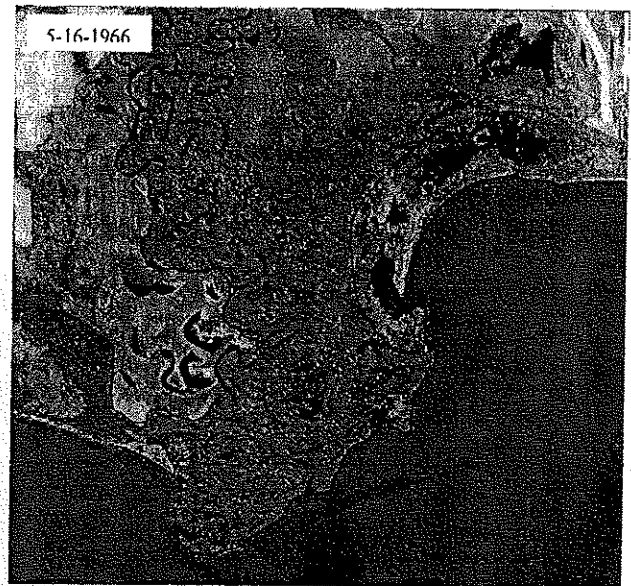
Figure 38. Aerial photos of the Carcajou Wetland Complex

Carcajou (Figure 38) Aerial photo dated 7-19-1937: A large floodplain forest (T3Kw) is present. Large areas of persistent emergent vegetation are also present (E2H). The E2H wetlands buffer the floodplain forest complex from Lake Koshkonong. **Aerial photo dated 5-16-1966:** The E2H wetlands that buffer the floodplain forest complex have decreased in area. They no longer exist at the southern edge of the floodplain forest surrounding Koshkonong Creek and have decreased in size in the bay to the east. **Aerial photo dated 6-25-1979:** The E2H wetlands in the bay have decreased further. **Aerial photo dated 5-31-1986:** The E2H wetlands appear similar in size as to what was present in 1979. **Aerial photo dated 4-28-1992:** The E2H wetlands appear similar in size as to what was present in 1979.

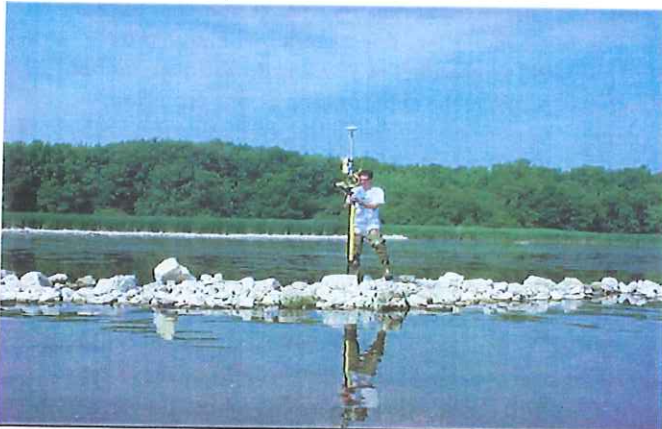
Figure 43. 6/13/03; USGS Gage - 776.31 msl; top of riprap protection at Carcajou Shallow Marsh at outside corner of riprap lakeward from opening behind Carcajou Shallow Marsh. Elevation near top of rock is 777.48 msl.

Due to the combined effects of ever-increasing water levels and the loss of aquatic plants, erosion of the wetlands and some adjacent uplands has been a problem for at least the last 50 years. RKLD and other citizens have recognized this problem and have attempted to deal with this by "armoring" part of the shoreline. The majority of these projects have included riprap armor (Figures 43 and 44) of wetland shoreland areas that have been eroded and lost over time.

They propose to counteract wetland losses by installing additional rock rip rap similar to what has been placed in front of the Carajou marsh (Figures 43 and 44). While this rock may be effective in the short term, based upon similar low elevation installations in the Upper Winnebago pool lakes (UWPL) riprap alone is unlikely to prevent long term erosion of these wetlands. In the UWPL rock and even old cars were placed in front of a cattail marsh over a number of years to prevent erosion. In all cases, erosion continued (R. Kahl, WI Dept of Natural Resources, personal communication). The rock material that has been placed in Lake Koshkonong is smaller than that used in UWPL and would be expected to be less effective over time. Figure 44 shows that this material will largely be flooded at water levels only slightly higher than the maximum proposed target level of 777.0 msl. With the higher level, even minor flood events will overtop these structures and may result in the deterioration of this armoring. While high water levels and waves during storm events are partially responsible for the failure of these structures, even more detrimental to the riprap structures in UWPL was ice jacking. If winter drawdown is eliminated as proposed, the rock riprap would degrade more quickly. The destructive capability of ice shoves is evident during the current water levels with past problems with some boat landings on Lake Koshkonong.

In order for the armoring to have any chance of long term success it must be much larger than shown in Figure 43. In the UWPL (Terrell Island) much larger material was used. The large rocks used extend roughly 4 feet above the water and this type of structure seems to be effective and long lasting in the UWPL but is very expensive to build. In Lake Koshkonong it is important that large rocks to be used and they must extend above the OHWM. If these large rocks are not used, the armoring will be short-lived as the rock dikes will quickly deteriorate during flood events and as a consequence of ice jacking.

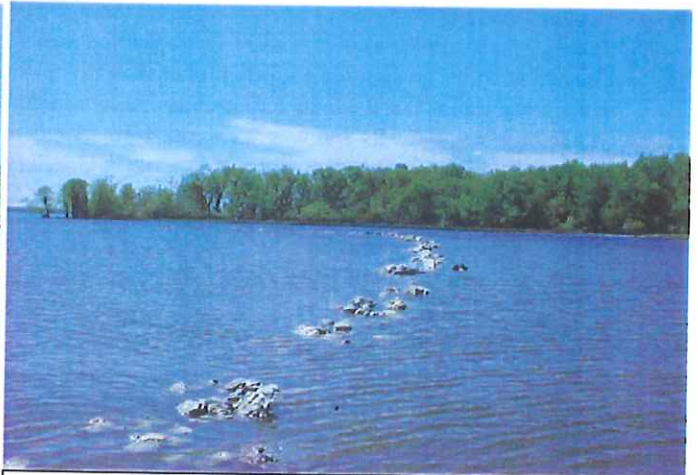
Figure 44. Carcajou Shallow Marsh Date: 5/13/2003 Water Elevation: 777.30 msl.

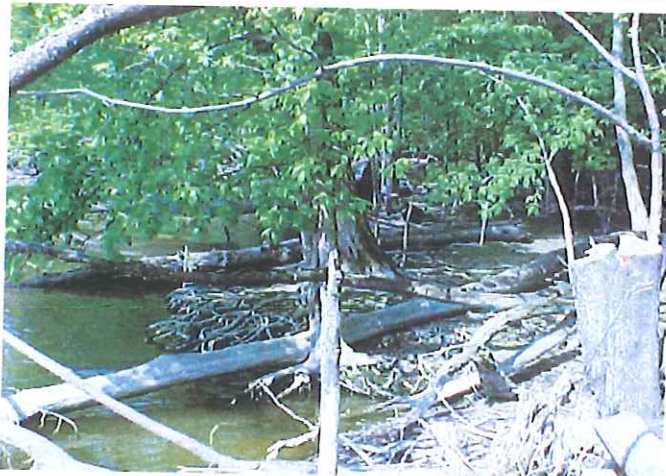
Figure 47 Location: Carcajou Floodplain Forest Date: 5/28/02 WL: 776.81 msl. Evidence of erosional sediment loss in root systems along shore.

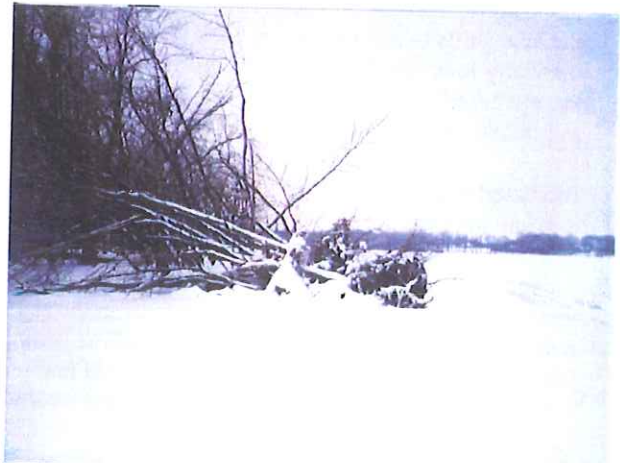
Figure 48. Carajou floodplain forest Jan 02
