WISCONSIN DEPARTMENT OF NATURAL RESOURCES
Fond Du Lac River and Van Dyne Creek Fish
Passage Assessment Report

August 10th, 2023

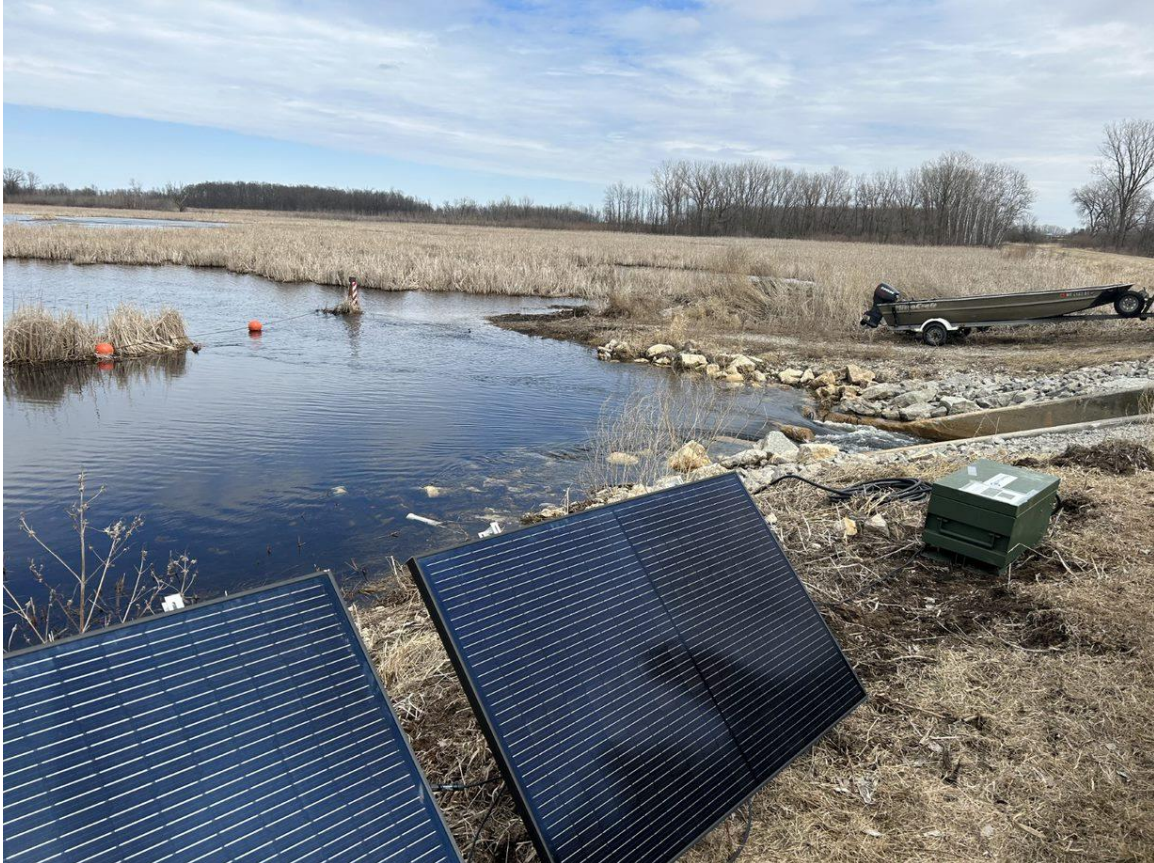
Image 1: LITZ cord solar set up located at the Eldorado Marsh Dam. Photo credit: Wisconsin DNR

The project utilized two types of PIT tag detecting arrays including LITZ cord antenna systems (Image 1) and submersible disc antenna systems (Image 3). Prior to array installation, sites were selected based on probable fish passage routes and suitability for array operation (stream width and depth). LITZ cord array locations included the Howard Litscher Dr crossing near Supples Marsh, the Western Ave crossing on the east branch of the FDLR, the Esterbrook Rd crossing on the west branch of the FDLR, directly above the dam spillway at the Eldorado Marsh Wildlife Area, and the west branch of the FDLR in the town of Eldorado near the CTY RD C crossing (Figure 1). Submersible disc array

Detection data downloads and battery replacement were conducted weekly on LITZ cord arrays and every three weeks on submersible arrays. The LITZ cord arrays located at Esterbrook road and above the Eldorado dam were equipped with solar panels eliminating the need for weekly battery replacement.

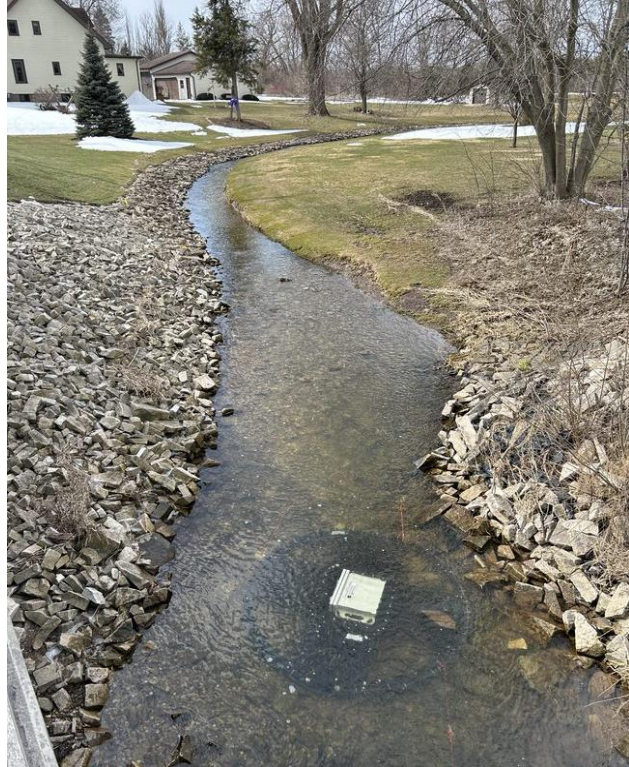
Image 3: Submersible disc array located at Van Dyne Road. Photo credit: Wisconsin DNR.

locations included an unnamed tributary to the FDLR near Adelaide Park at the N Hickory St crossing, the west branch of the FDLR at the HWY 26 crossing, and VDC at the Howlett Rd, Van Dyne Rd, Townline Rd, and Nitschke Rd crossings (Figures 1 and 2). Submersible arrays were installed on March 16th by fisheries staff utilizing paracord, wolf fang anchors, and a hand operated driver. LITZ cord arrays were installed on March 21 and 23 utilizing both fisheries staff as well as contracted divers to anchor antennas with a combination of triangle earth anchors (2-4 inches), paracord or cable depending on substrate, and weighted concrete anchors when driving into substrate was not possible.

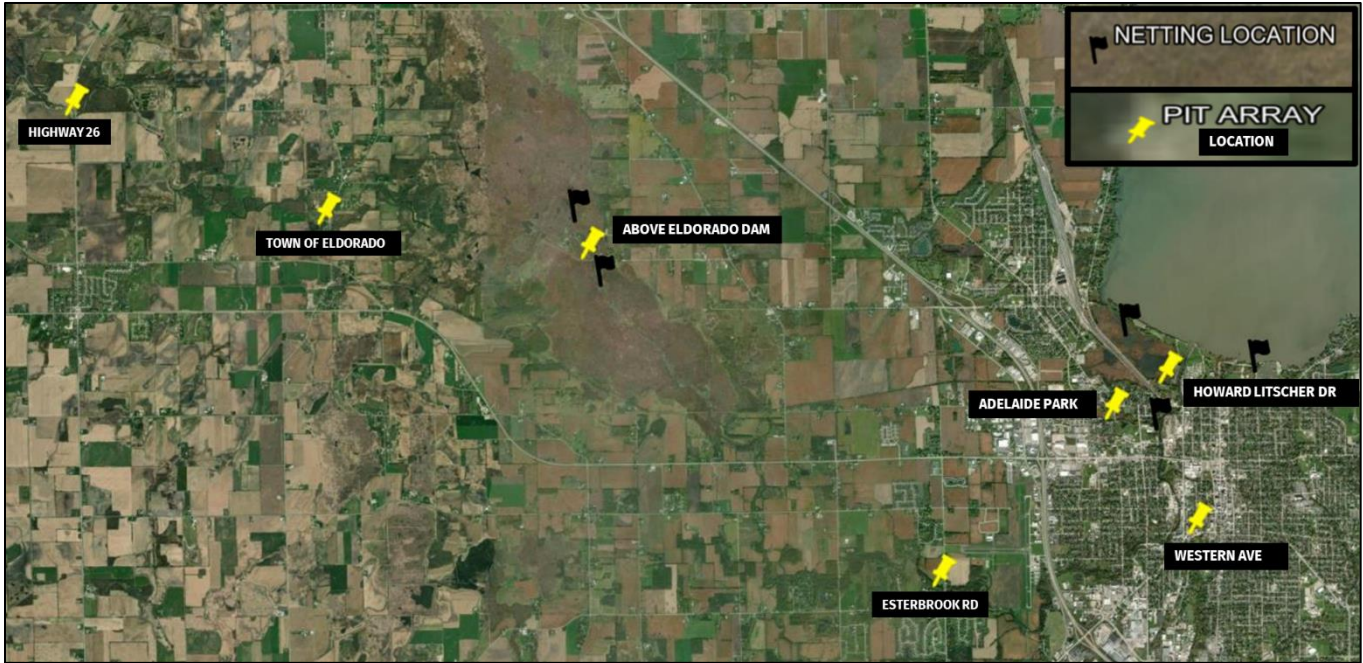
Figure 1: Map of study area on the Fond Du Lac River displaying netting locations and PIT array sites.

Netting locations included rotational comprehensive survey sites (Big Hole and Van Dyne) as well as additional locations in an effort to capture and tag fish entering the area of study (the FDLR, Supples Marsh, below the Eldorado Marsh Dam, and above the Eldorado Marsh Dam (Figures 1 and 2)). Two- and three-foot fyke nets were used depending on conditions at each site. Net set time ranged from one to four days due to catch rates and adverse weather conditions. Number of netting sites at each location were Big Hole (n=2), Supples Marsh (n=3), FDLR (n=9), below the Eldorado Dam (n=2), above the Eldorado Marsh Dam (n=3), and Van Dyne (n=2). The primary target of the netting/tagging effort was northern pike, though other species including white sucker, largemouth bass, walleye, sauger, common carp, and burbot were also tagged. The length and sex (when possible) of all tagged fish was recorded. Panfish species (yellow perch, bluegill, black crappie, and pumpkinseed) were counted and measured. In addition to the fyke netting efforts, dip nets were used to capture white sucker (n= 52) that congregated below the spillway of the Eldorado Marsh Dam on April 12th. The additional dip netting effort was to increase the number of fish tagged directly below the Eldorado Marsh Dam in order to investigate the pass-ability of the spillway.

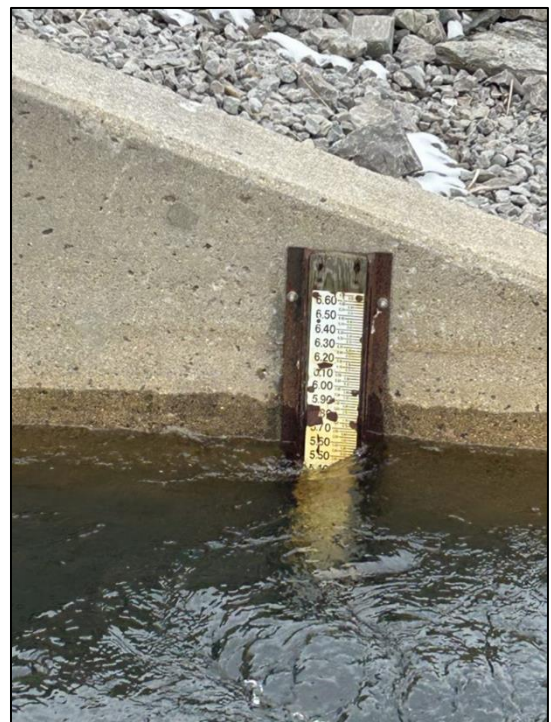
Image 4: Stationary gauge located on the upstream side of the Eldorado Marsh Dam. Photo Credit: Wisconsin DNR.

Water levels at the dam were recorded via the stationary gauge on the upstream side by both fisheries and wildlife staff throughout the study (Image 4). Dam gate operations were also recorded, though gate modifications were limited throughout the study. These values were recorded to provide insight on the relationship between water levels and temporal fish passage through the dam spillway.

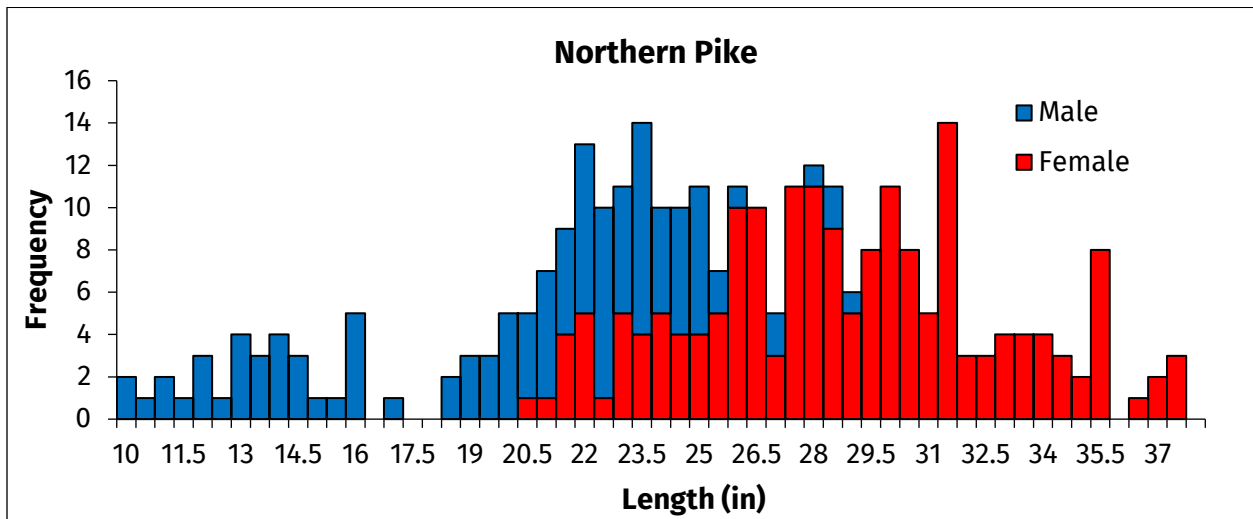
Figure 3: Length Frequency for male and female northern pike captured in all netting locations.

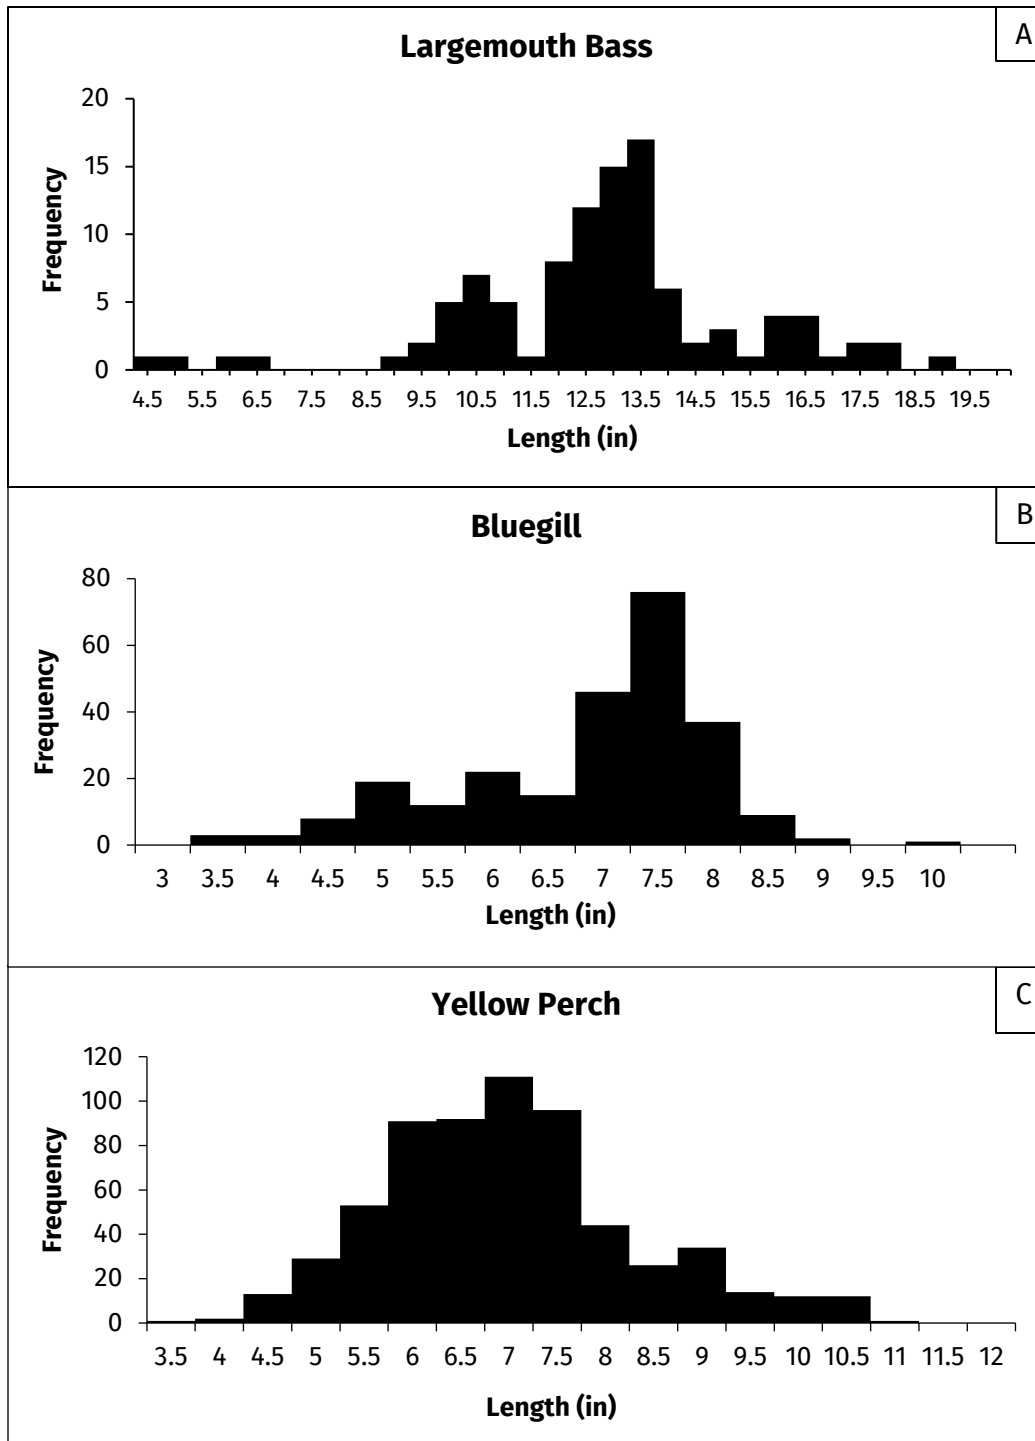
Figure 4: Length frequency for largemouth bass (A), bluegill (B), and yellow perch (C) captured at all netting locations.

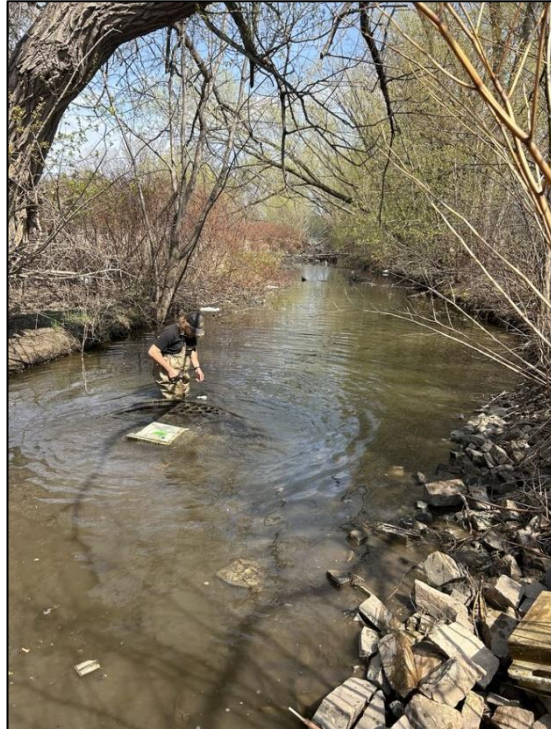
Image 5: Fisheries Staff Nate Schimanski conducting a battery swap on the submersible disc array located near Adelaide Park. Photo Credit: Wisconsin DNR.

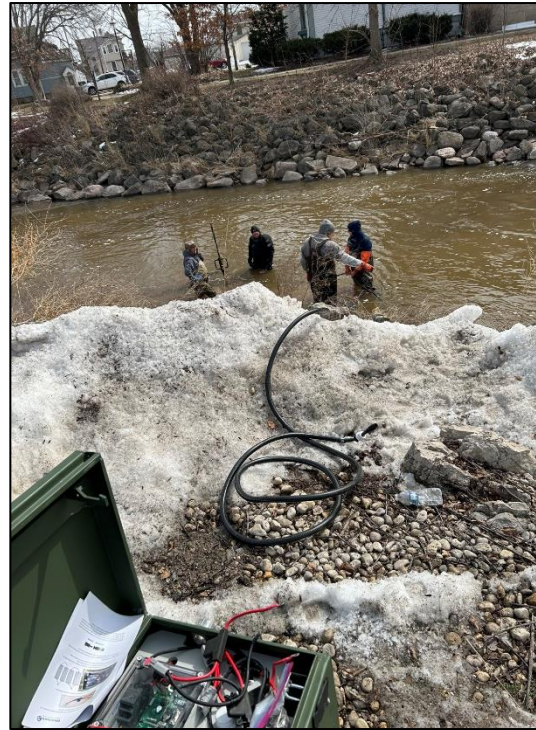
Image 6: Fisheries staff and contracted divers installing the LITZ cord array at Western Ave on the East branch of the Fond Du Lac River. Photo Credit: Wisconsin DNR.

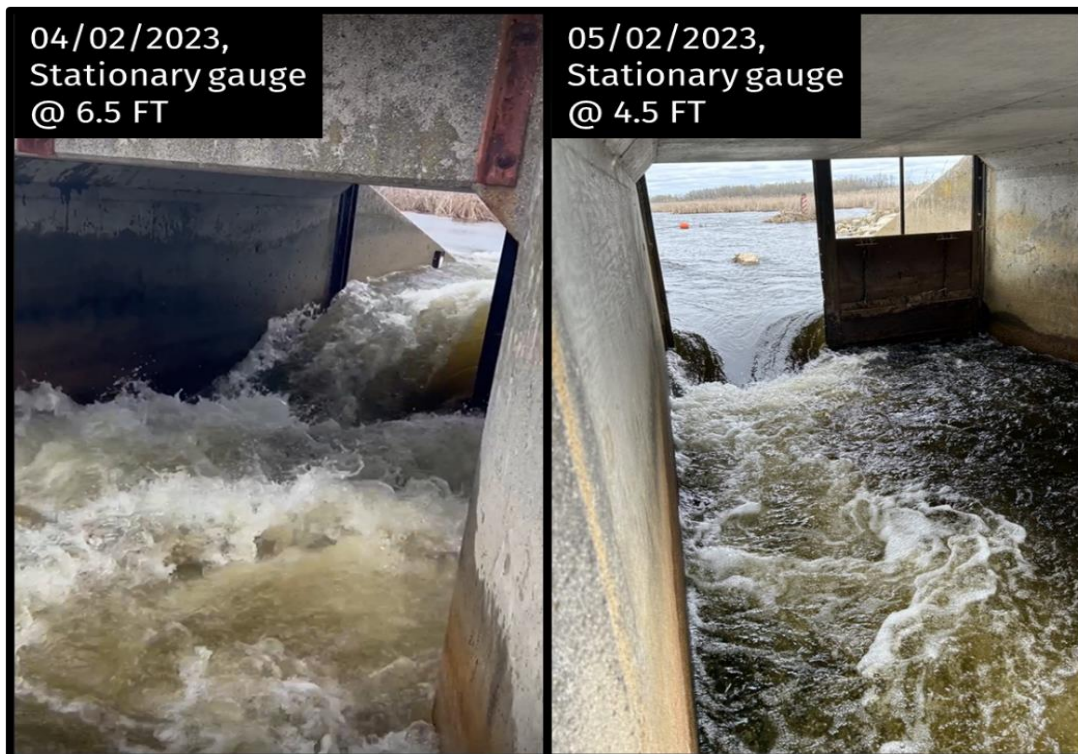
Image 7: View of Eldorado Marsh Dam spillway at different water levels. Photo Credit: Wisconsin DNR.

One of the primary reasons for this study was to evaluate fish passage through the spillway at the Eldorado Marsh dam and whether or not high spring water levels create a barrier to fish passage. The water volume and velocity through the spillway show significant variation, specifically in spring, due to fluctuations in water levels and to a lesser extent dam operations (gate modifications) (Image 7). Northern pike and white sucker from five tagging locations (Below and above the Eldorado Marsh Dam, FDLR, Big Hole, and Van Dyne) were detected above the dam, confirming that the spillway is passable. This study aimed to assess passage on a temporal basis in order to investigate the relationship between water levels and passage through the spillway. The time stamped detection data and recorded water levels at the stationary gauge located at the dam provides evidence that high spring flows create a barrier or at least a deterrence for fish passage.

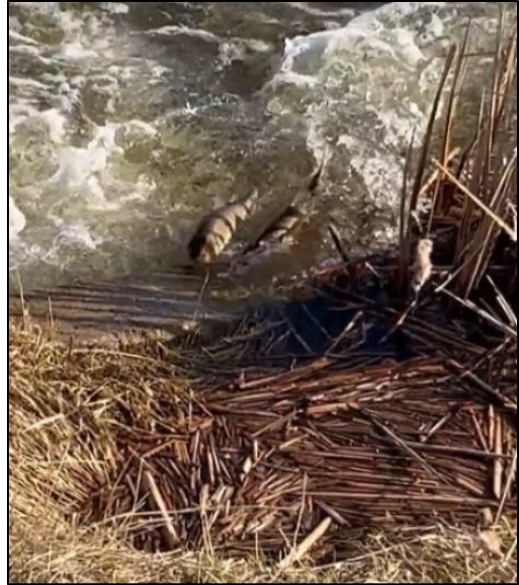
Image 8: White Sucker swimming below the Eldorado Marsh Dam. Photo Credit: Wisconsin DNR.

swimming in the current, occasionally being pushed up on to the concrete wall below the dam (Image 8). In order to increase the number of tagged fish directly below the dam, dip nets were used to capture white sucker (n=52) on April 12th. northern pike were also present, in much lower abundance than white sucker, though dip netting efforts were unsuccessful. The first fish detected above the dam was a white sucker on April 12th. The fish was initially tagged below the dam on April 2nd (Figure 3) indicating it remained in the pool below the dam for 10 days before passing the spillway. On April 13th 12 more white sucker were detected above the dam including fish from all three tagging events below the dam (April 2nd (n=5), April 5th (n=2), and April 12th (n=5)). On April 14th 34 more fish were detected above the dam including 1 northern pike tagged in the FDLR on April 7th and 33 white sucker initially tagged below the dam (n=32) and Big Hole (n=1). April 15th was the last large passing of fish through the spillway with 9 white suckers detected. These observations of temporal passage through the spillway shows that regardless of when fish arrived at the pool below the dam, passage through the spillway was largely concentrated over a span of three days.

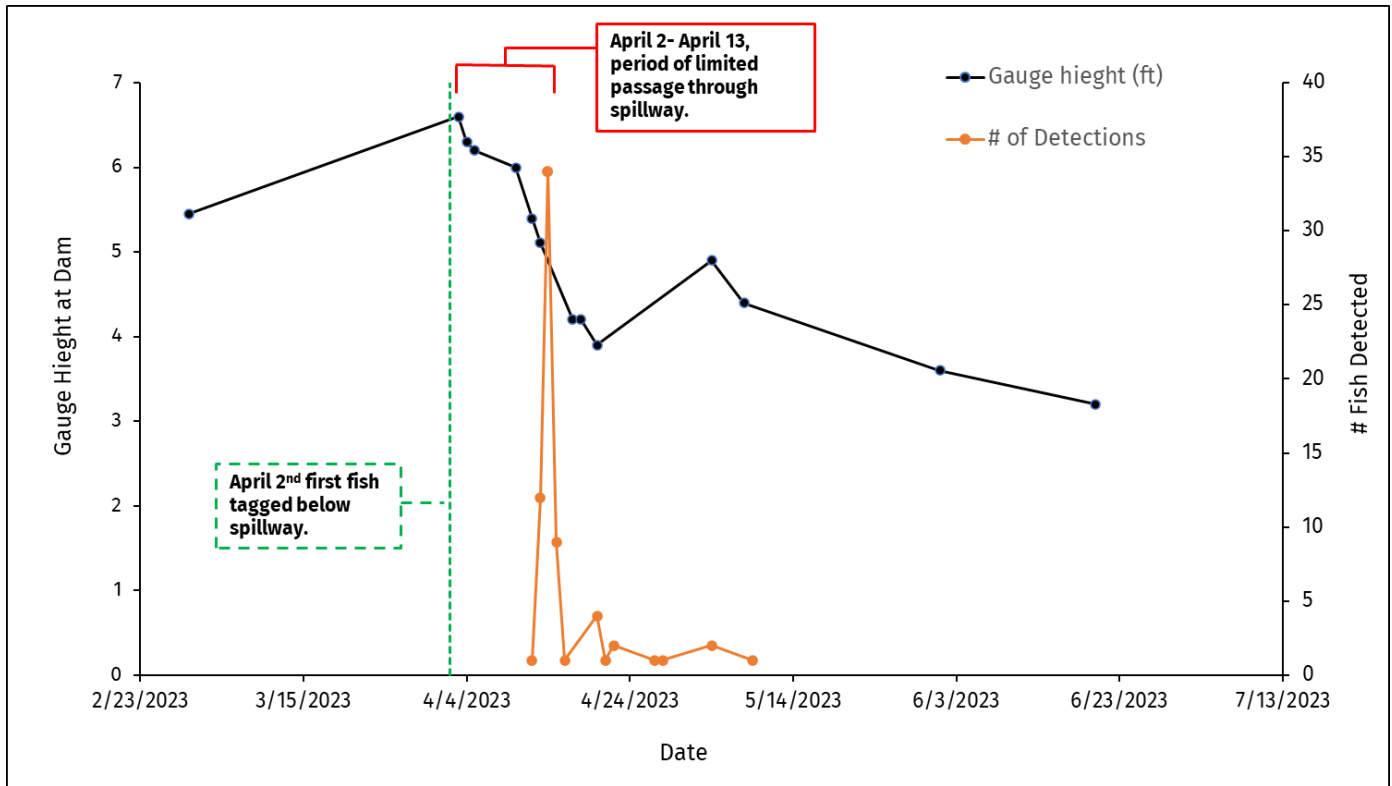
Figure 5. Water Level observations at the stationary gauge located above the Eldorado Marsh Dam spillway and number of detections on the PIT tag array located above the dam over time.

The Water level recordings at the stationary gauge were limited to the times fisheries and wildlife staff were on site to observe the gauge, though there is clear relation between water levels and fish passing the spillway (Figure 5). The highest gauge reading was on April 3rd at 6.6 feet, almost topping the gauge. The water level gradually decreased to 6 feet by April 10th. Following April 10th, the water level at the dam began to decrease more rapidly, hitting 5.4 feet by April 12th, 5.1 feet by April 13th and 4.2 feet by April 17th. Detection data above the dam indicates that fish did not pass through the spillway until the gauge was at 5.4 feet with only a single white sucker detected. While the single fish detection on April 12th shows passage through the spillway is possible at a gauge height around 5.4 feet, the majority of fish were observed to pass on April 13th and 14th when the gauge was around 5 feet. The presence of tagged fish in the area directly below the spillway, the timing of fish detections above the dam, and recorded water levels indicates the spillway creates a barrier when the gauge is above 5.4 feet and remains a deterrence to passage until a gauge height of around 5 feet (Figure 5).
