Wisconsin Water Quality Handout

Lower Plum Creek 2015 (EGAD 3200-2018-68)

Lower Plum Creek 2015

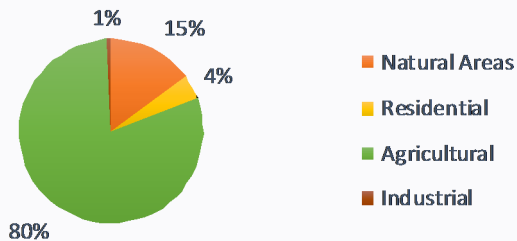
Plum Creek Watershed Land Use

Plum Creek in Brown County is heavily influenced by non-point sources of pollution prior to its confluence of the Fox River in Wrightstown. Plum Creek has been identified as one of the highest contributors of phosphorus and sediment to the Lower Fox River. Overall this watershed is characterized by poor aquatic life and habitat. A Nine Key Element Plan was enacted in the summer of 2015 to continue to address non-point sources of pollution in the watershed.

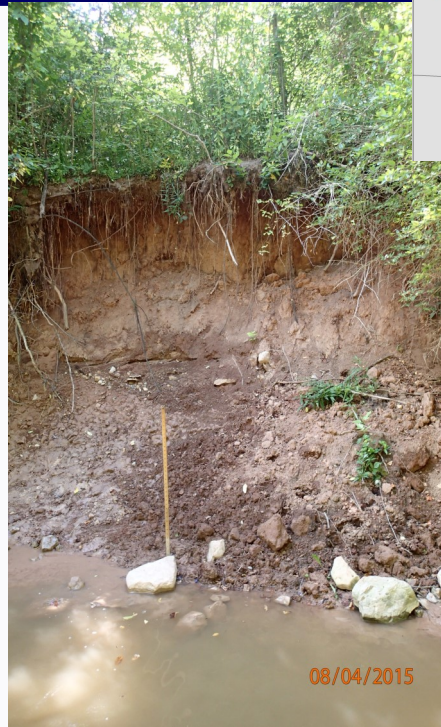
The three survey areas of the Lower Plum have wide forested buffers with lower quality tree species on steep exposed slopes with sparse understory. Habitat ratings ranged from fair to good and scores were better than expected based on undisturbed buffer widths. Habitat ratings in these streams are impacted by fine sediment, bank erosion, and lack of fish cover.

Meter stick along banks on Plum Creek at CTH ZZ.

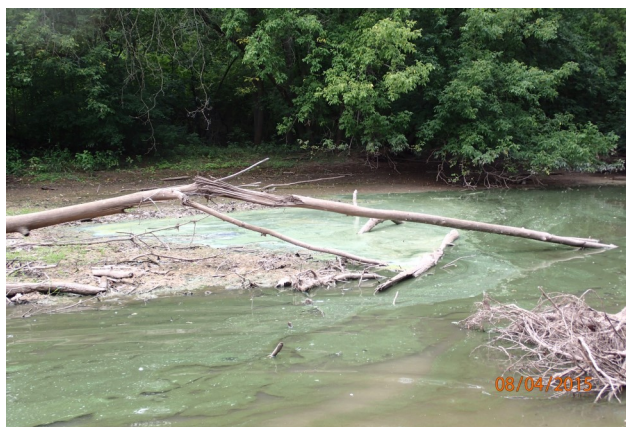
Total Phosphorus concentrations at CTH ZZ were consistently high when compared to Wisconsin's Water Quality Standard of 0.075 mg/L. Future water chemistry monitoring will be conducted slightly upstream to eliminate likely effects from the close proximity of the Fox River.

Top: Algal bloom in Plum Creek at CTH ZZ.

Soil Health principles throughout the watershed should be adopted to improve infiltration along with sediment and nutrient retention on agricultural lands in the watershed. Construction site erosion control needs to be properly planned and maintained to adequately prevent soil loss during storm events. Urban storm water best management practices should continue to properly site treatment ponds and consider infiltration practices to reduce the rate of storm water delivery to streams. Re-establishment of adequate vegetative buffers along stream corridors could include the removal of undesirable species such as box elder and buckthorn allowing for the management of more desirable tree species and a healthy understory. Additionally, vegetative buffer widths should be expanded to prevent soil loss and increase the distances between where nutrient application occurs and the proximity to waterways. Areas of significant bank erosion and failures exist. Focused efforts to stabilize banks through a strategic approach should be enacted to prevent hard armoring in a small parcel by parcel approach.
