**Appendix 14 RCRA Feasibility Investigation (RFI) Report -  
2003**

# Hazardous Waste Facility Investigation

## Task I

**Mercury Waste Solutions, Inc.**  
**Administrative Offices**  
**21211 Durand Avenue**  
**Union Grove, Wisconsin 53182-9711**

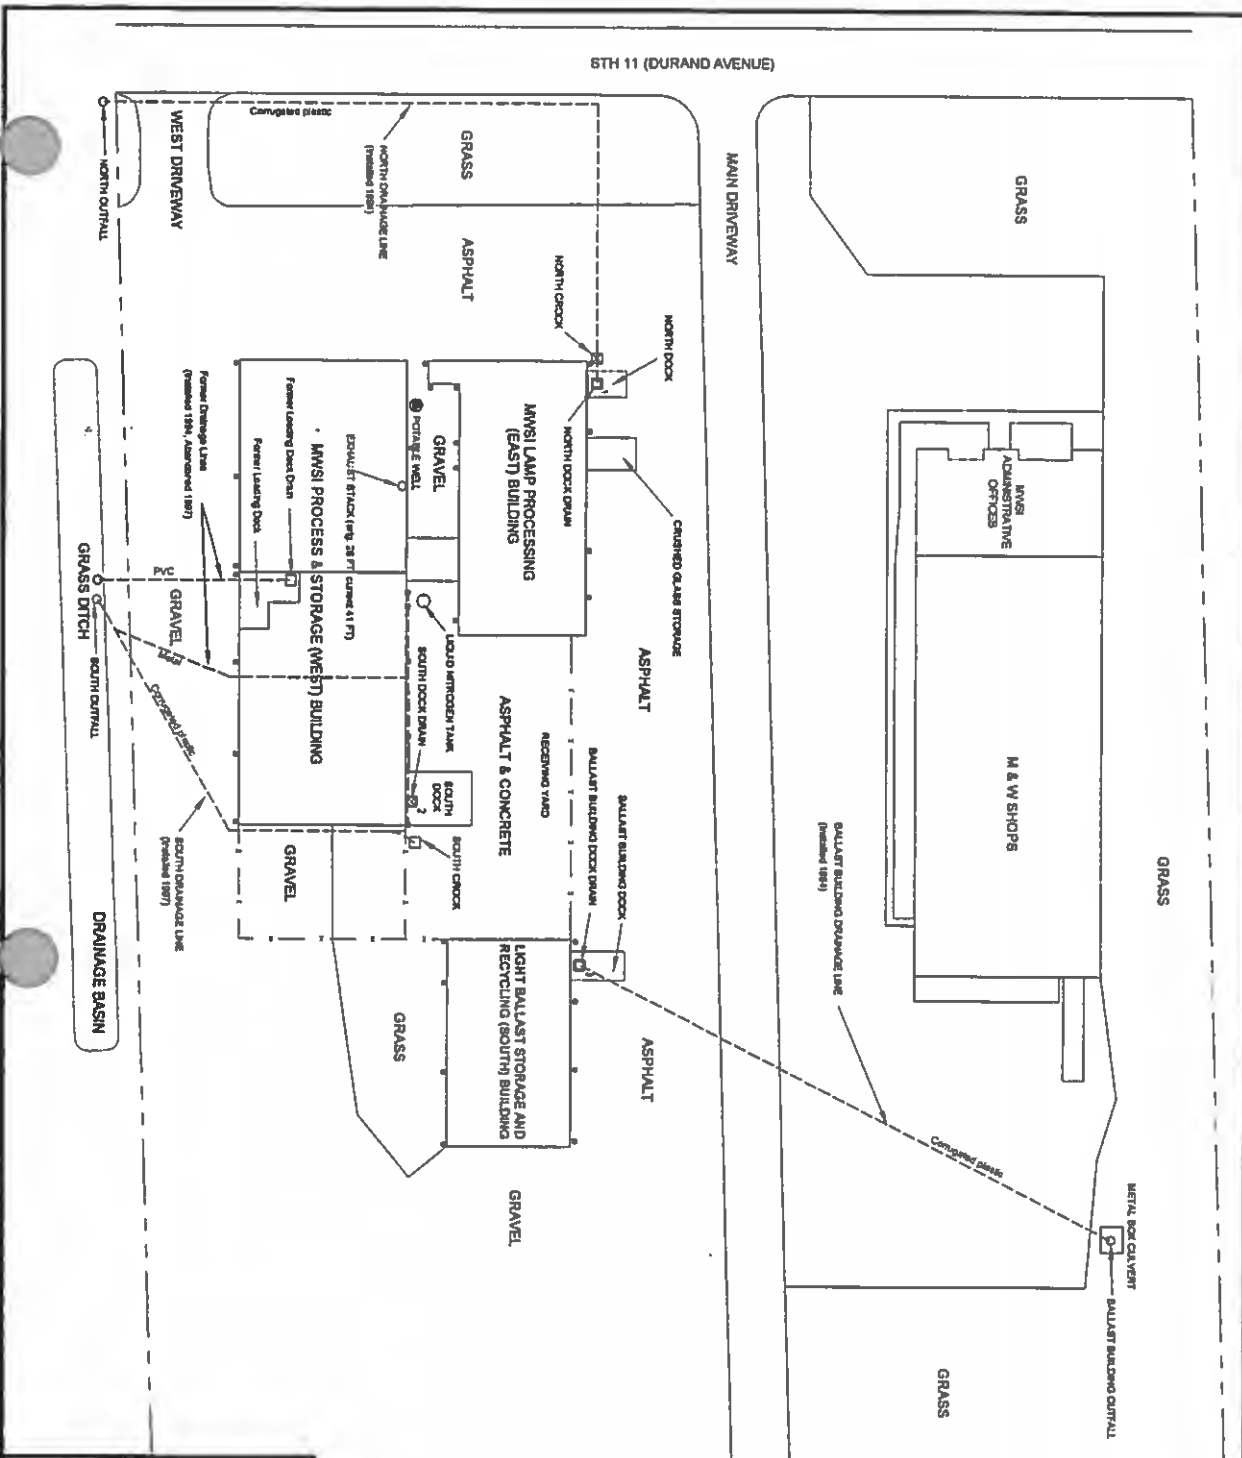
**FIGURE 2A**

Approximate property line location.  
 Chain link fence.

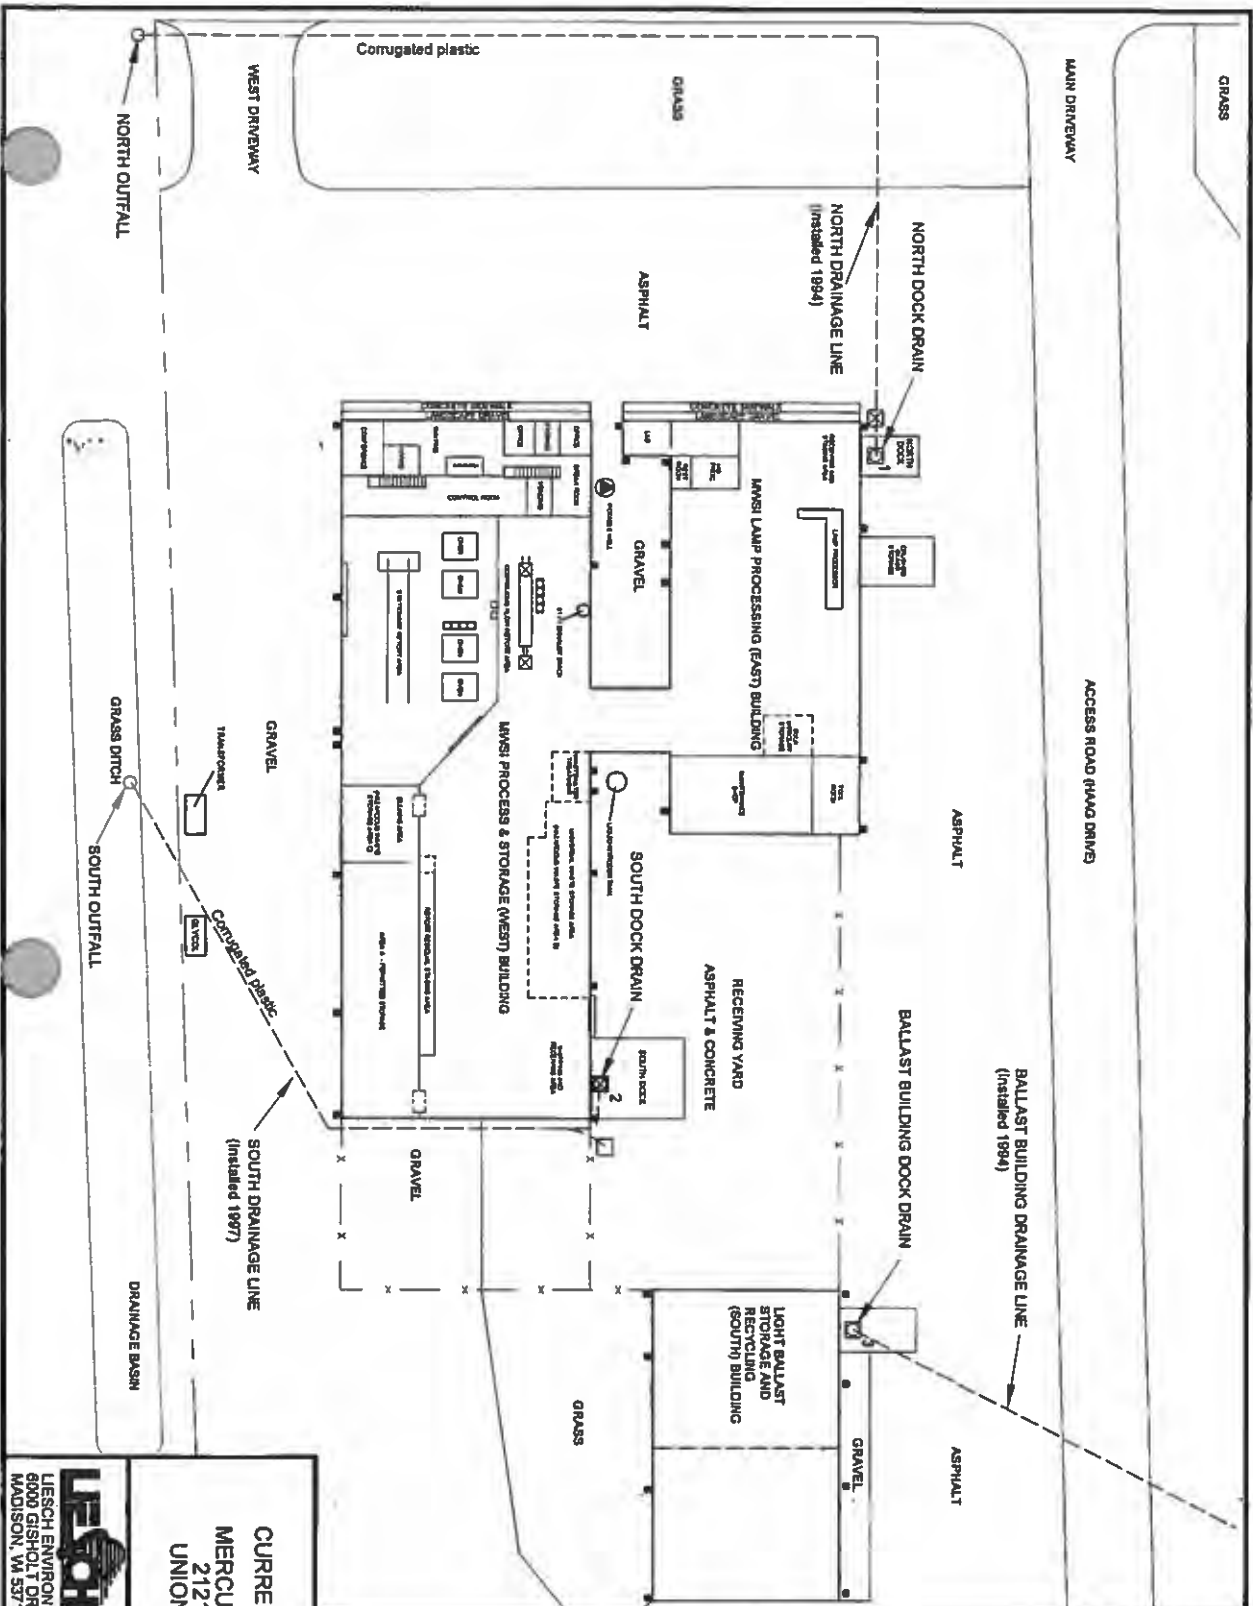
**CURRENT FACILITY SITE PLAN**  
 MERCURY WASTE SOLUTIONS  
 21211 DURAND AVENUE  
 UNION GROVE, WISCONSIN

- 1 Approximate property line location.
- 2 North leading dock drain - manually covered.
- 3 South leading dock drain - covered.
- 4 Ballast building dock drain - manually covered.
- 5 Open drain (fence).
- 6 Covered drain (fence).
- 7 Outside
- 8 Downspout.
- 9 All downspouts disconnected from underground storm sewer lines.
- 10 Current underground stormwater sewer.

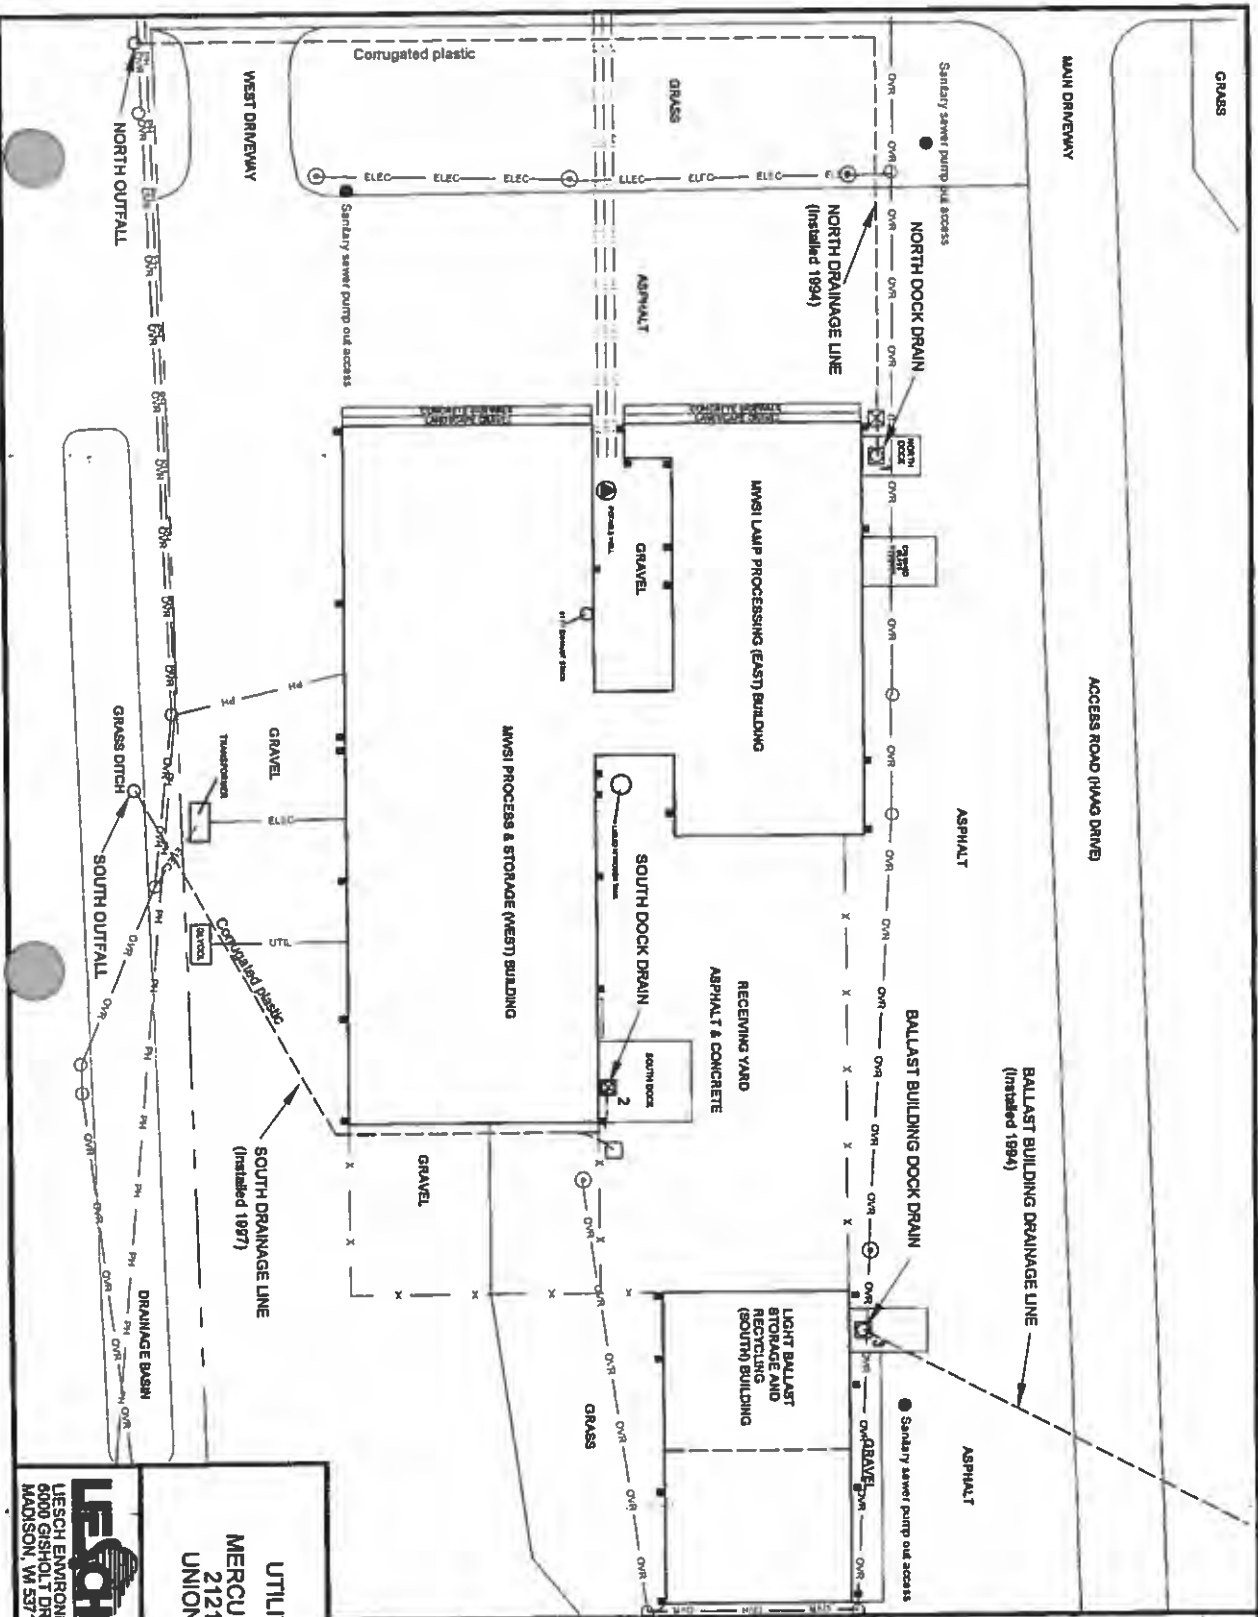
- 1 Approximate property line location.
- 2 Chain link fence.
- 1 North bearing dock drain - manually covered.
- 2 South bearing dock drain - covered.
- 3 Ballast building dock drain - manually covered.
- 4 Open drain (concrete).
- 5 Covered drain (concrete).
- 6 Outfall
- Downspout.
- All disconnections from underground storm sewer line.
- Current underground stormwater sewer.

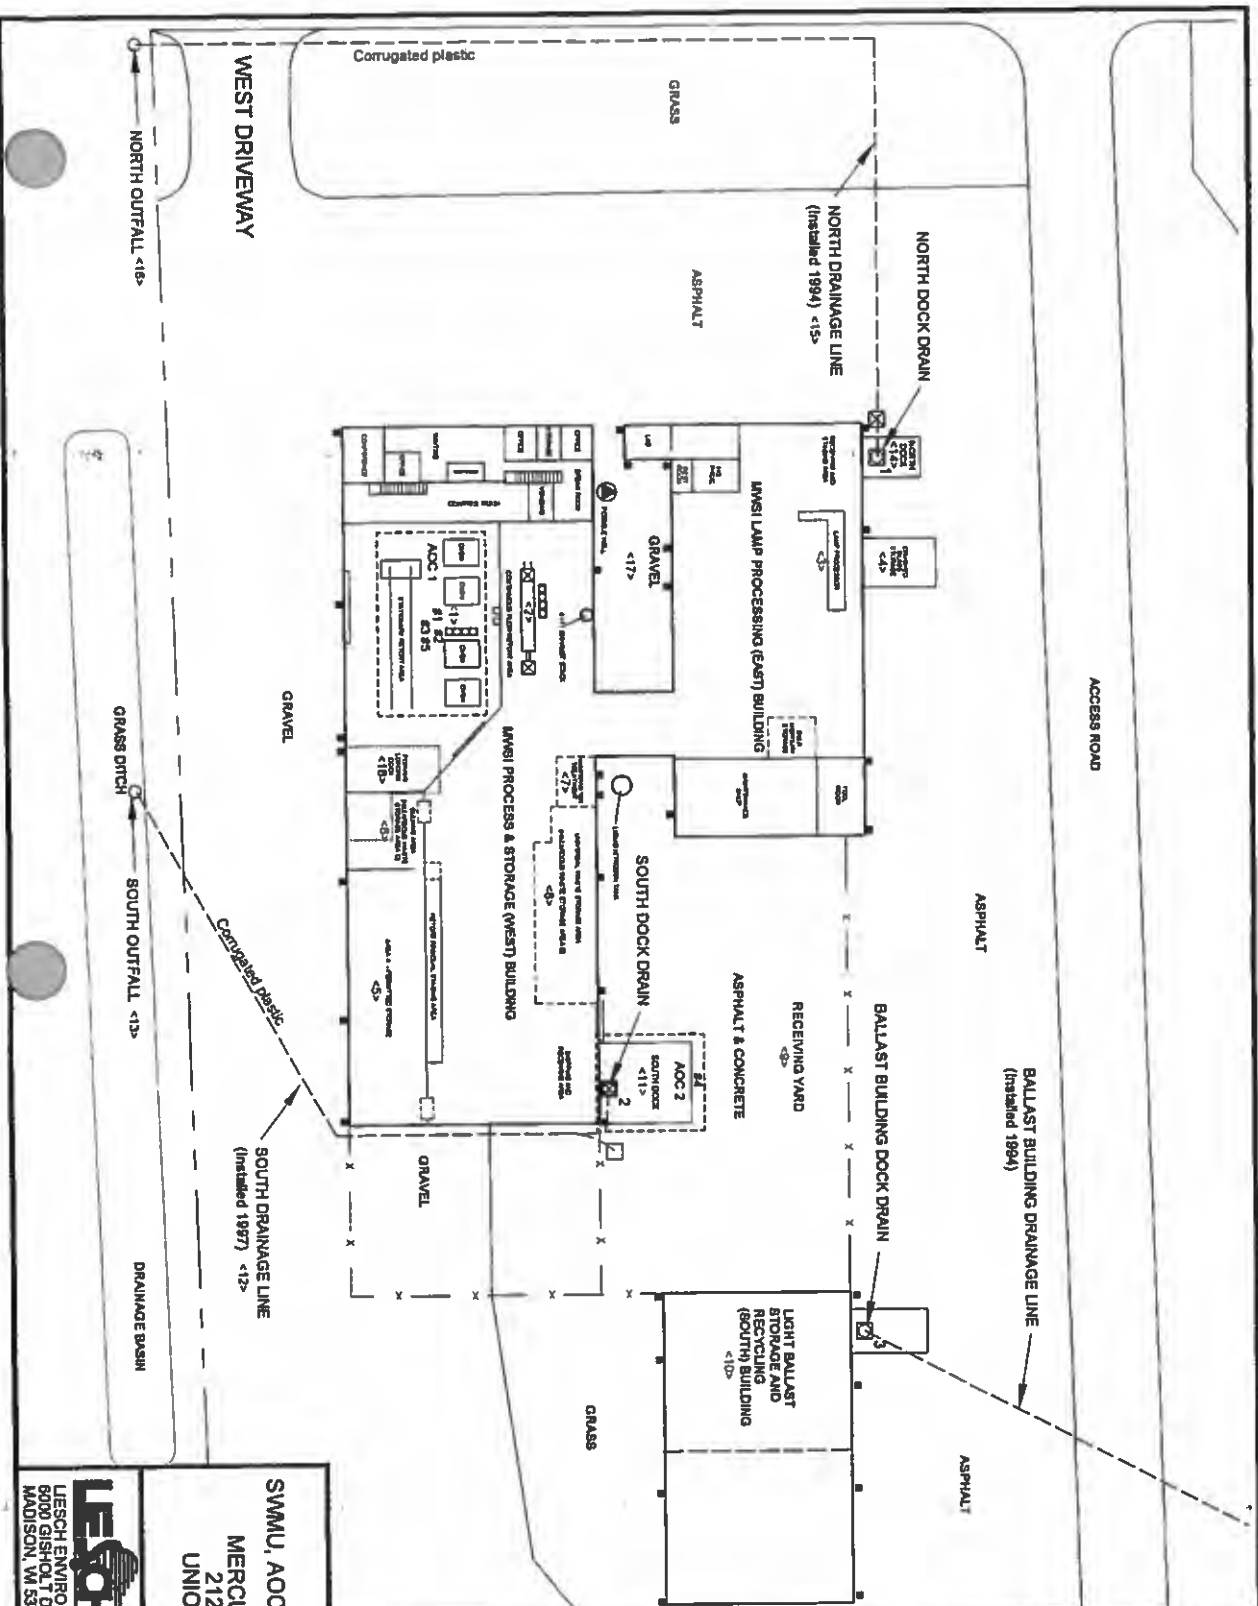
UTILITIES LOCATION MAP  
**MERCURY WASTE SOLUTIONS**  
 2121 DURAND AVENUE  
 UNION GROVE, WISCONSIN

- Approximate property line location.
- Chain link fence.
- North landing dock drain - manually covered.
- South landing dock drain - covered.
- Ballast building dock drain - manually covered.
- Open drain (concrete).
- Covered drain (concrete).
- Outfall.
- Downspout.
- All downspouts disconnected from underground storm sewer lines.
- Current underground stormwater sewer.

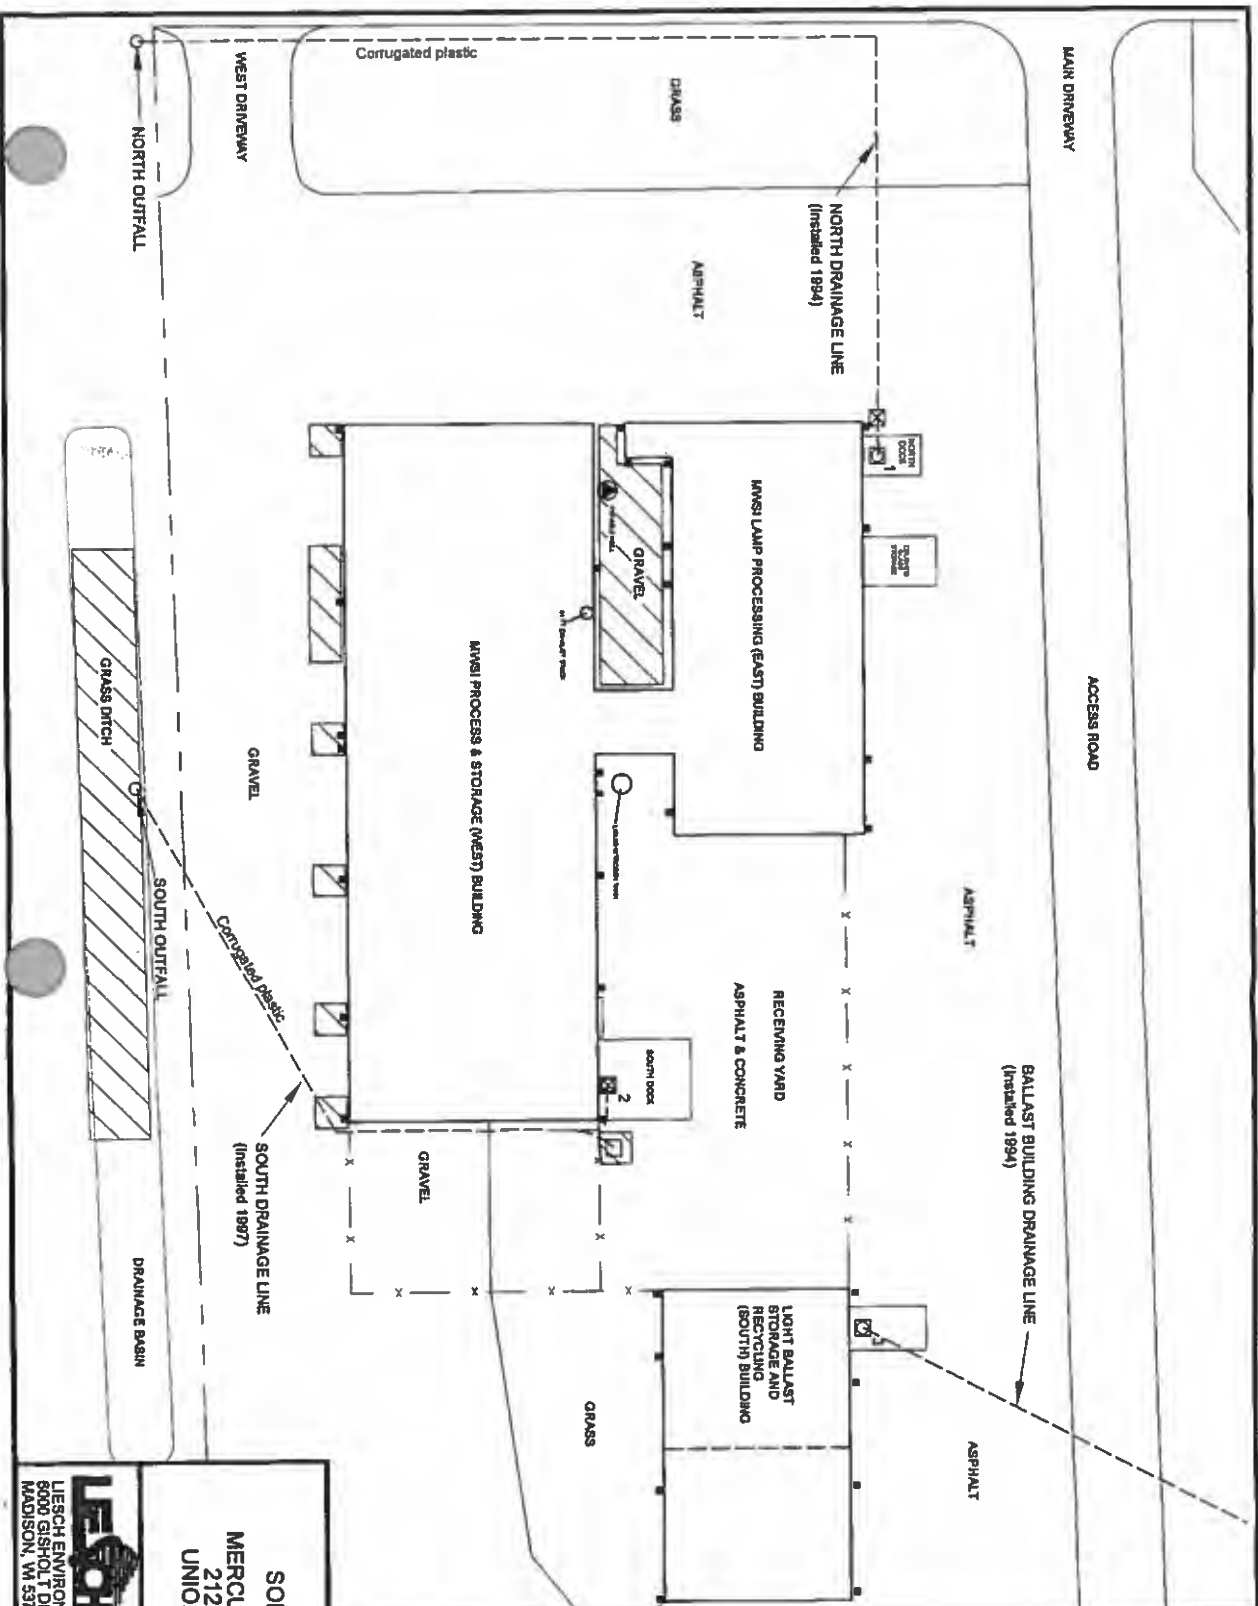
- Approximate property line location.  
Chain link fence.
- 1 North leading dock drain - manually covered
  - 2 South leading dock drain - covered
  - 3 Ballast building dock drain - manually covered
  - Open drain (fence)
  - Covered drain (fence)
  - Outlet
  - Downspout
  - All downspouts disconnected from underground storm sewer line.
  - Current underground stormwater sewer
  - Remediated area.

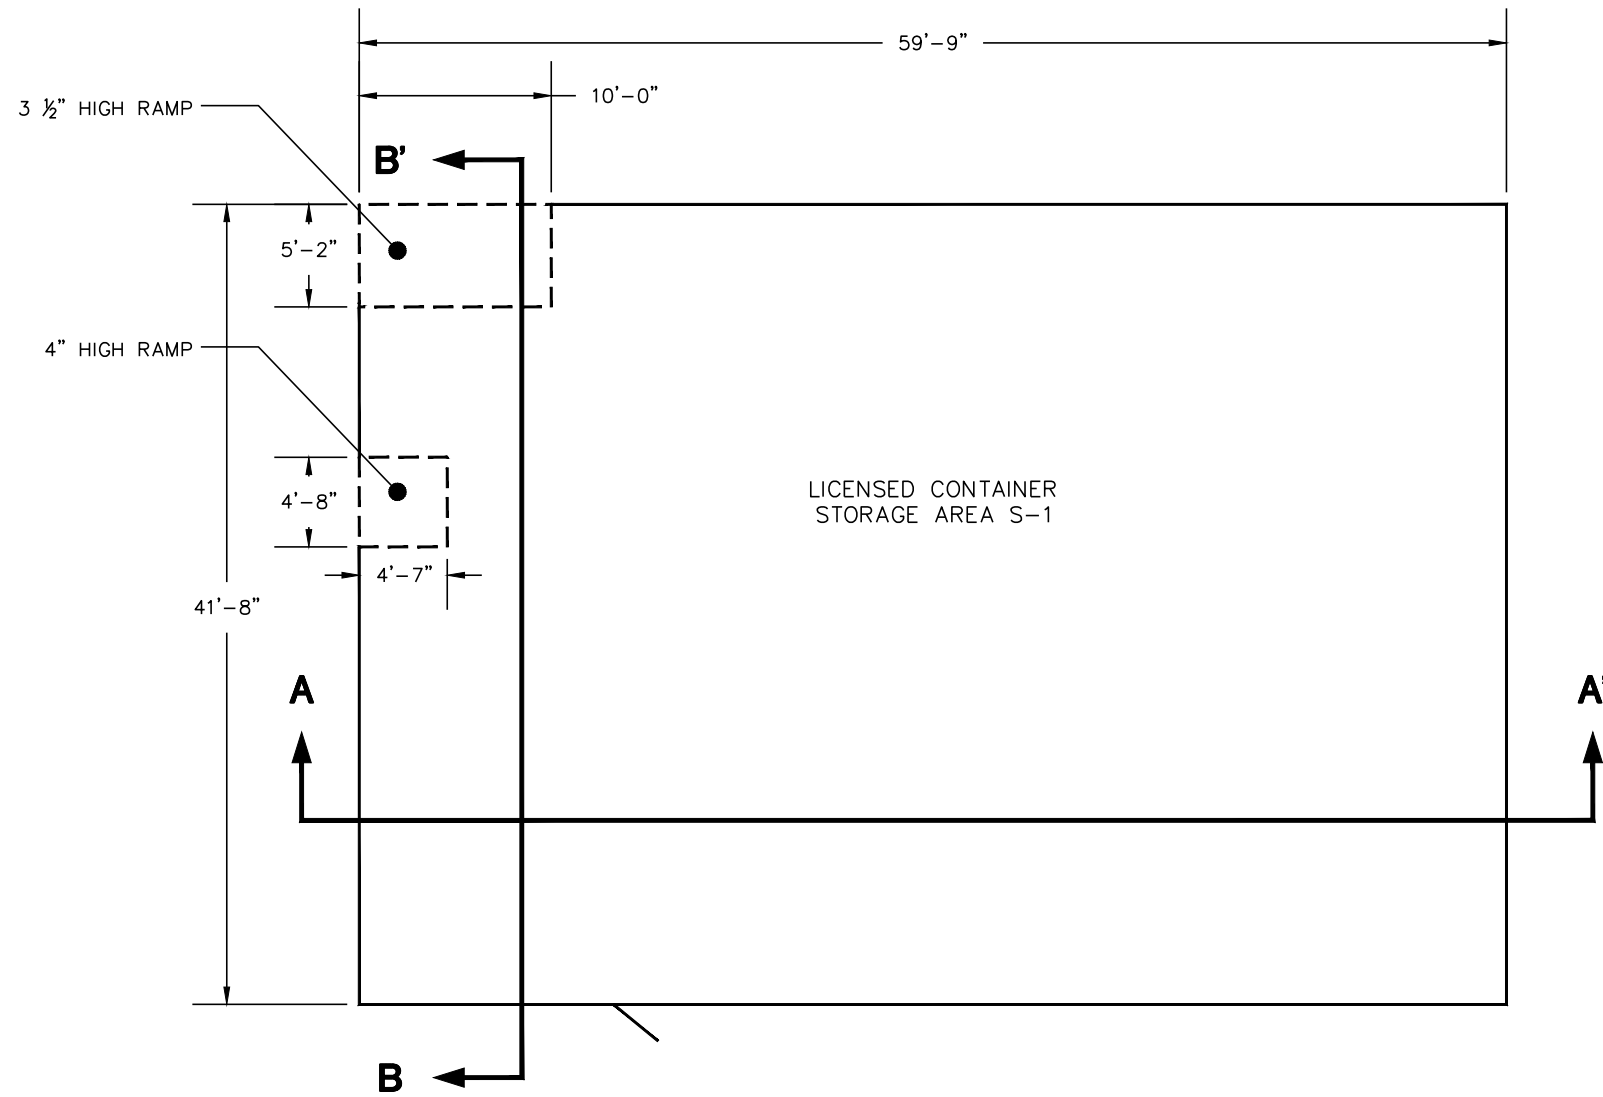
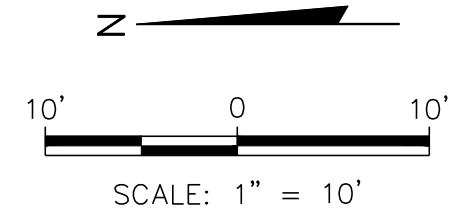
FIGURE	STORAGE AREA S-1
	S-1

SECTION A-A'

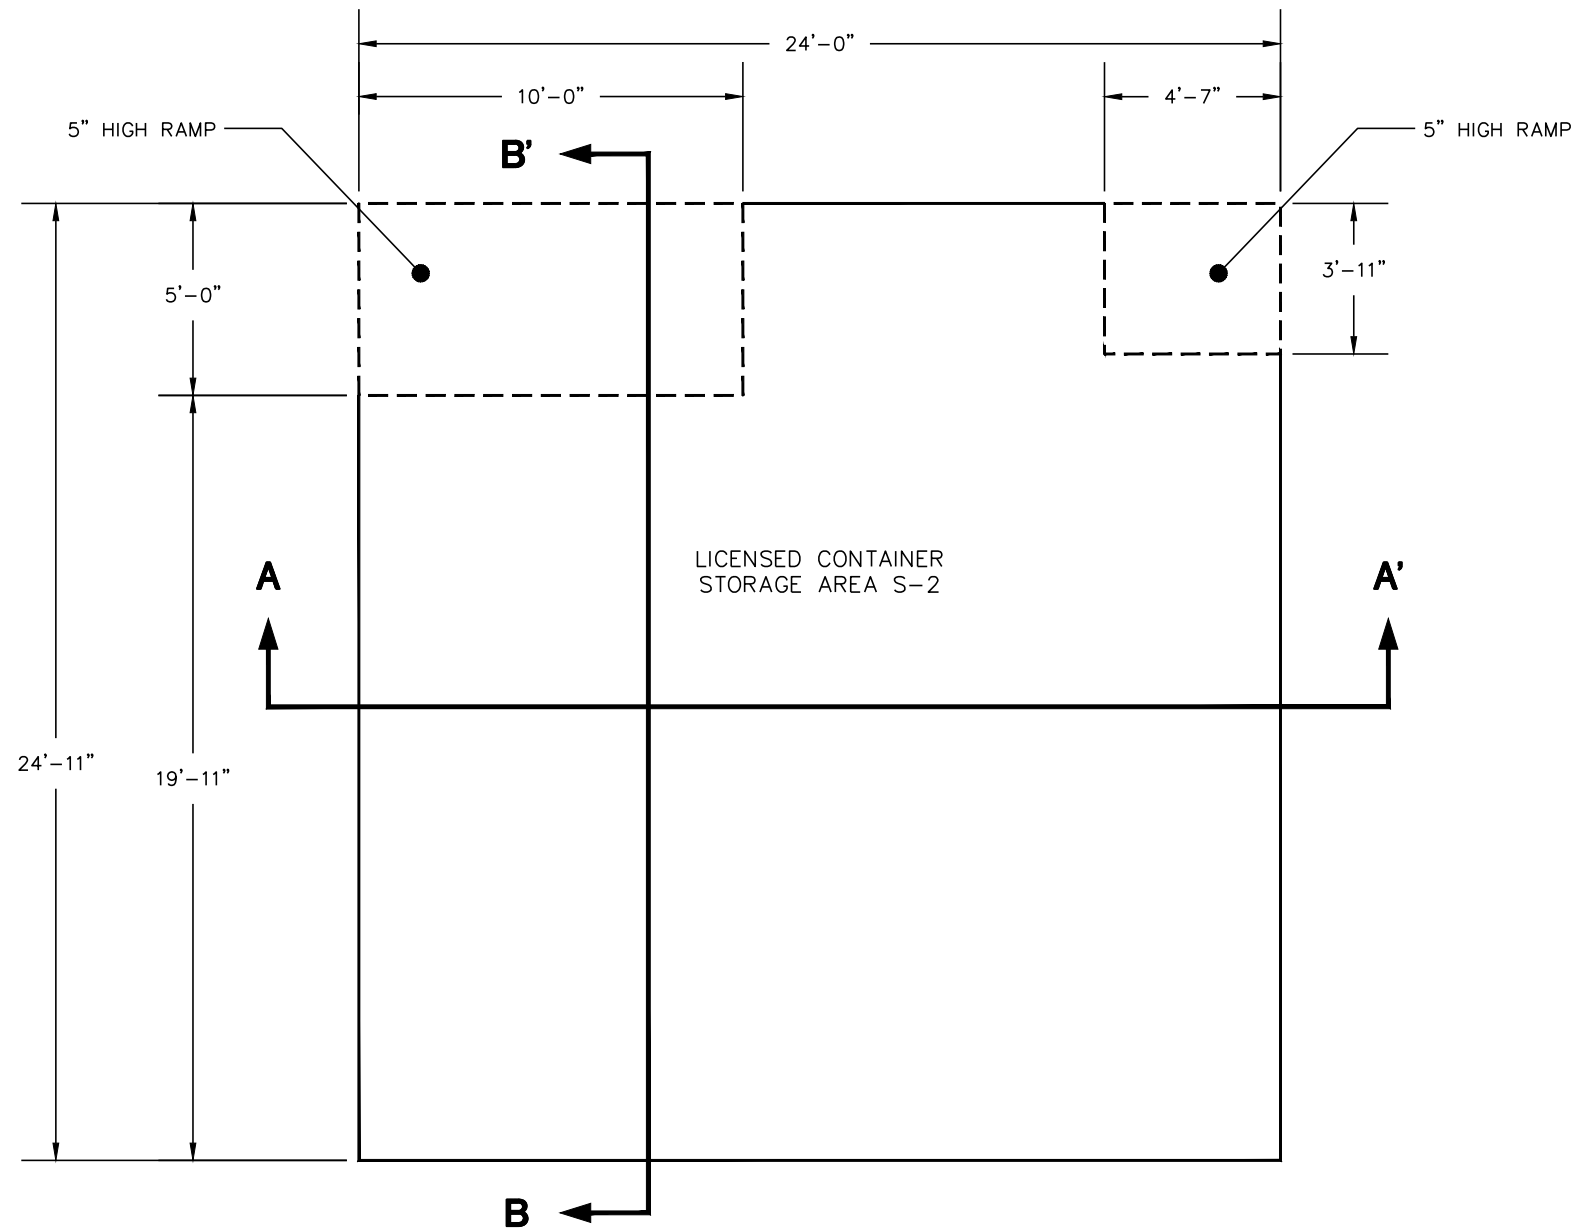
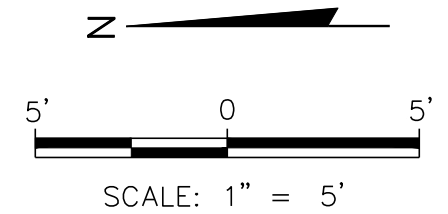
PROJECT NO. 25220201.00	DRAWN BY: JSK	 2830 DAIRY DRIVE MADISON, WI 53718-6751 PHONE: (608) 224-2830	CLIENT WM WASTE, INC.	SITE WM WASTE, INC. 21211 DURAND AVE, UNION GROVE, WI	STORAGE AREA S-2	FIGURE
DRAWN: 12/15/2020	CHECKED BY: MJT					S-2
REVISED: 12/15/2020	APPROVED BY: JMO 12/18/2020

SECTION A-A'

NOTE:  
DIMENSIONS BASED ON FIELD MEASUREMENTS  
COLLECTED BY SCS ENGINEERS ON  
DECEMBER 1, 2020.

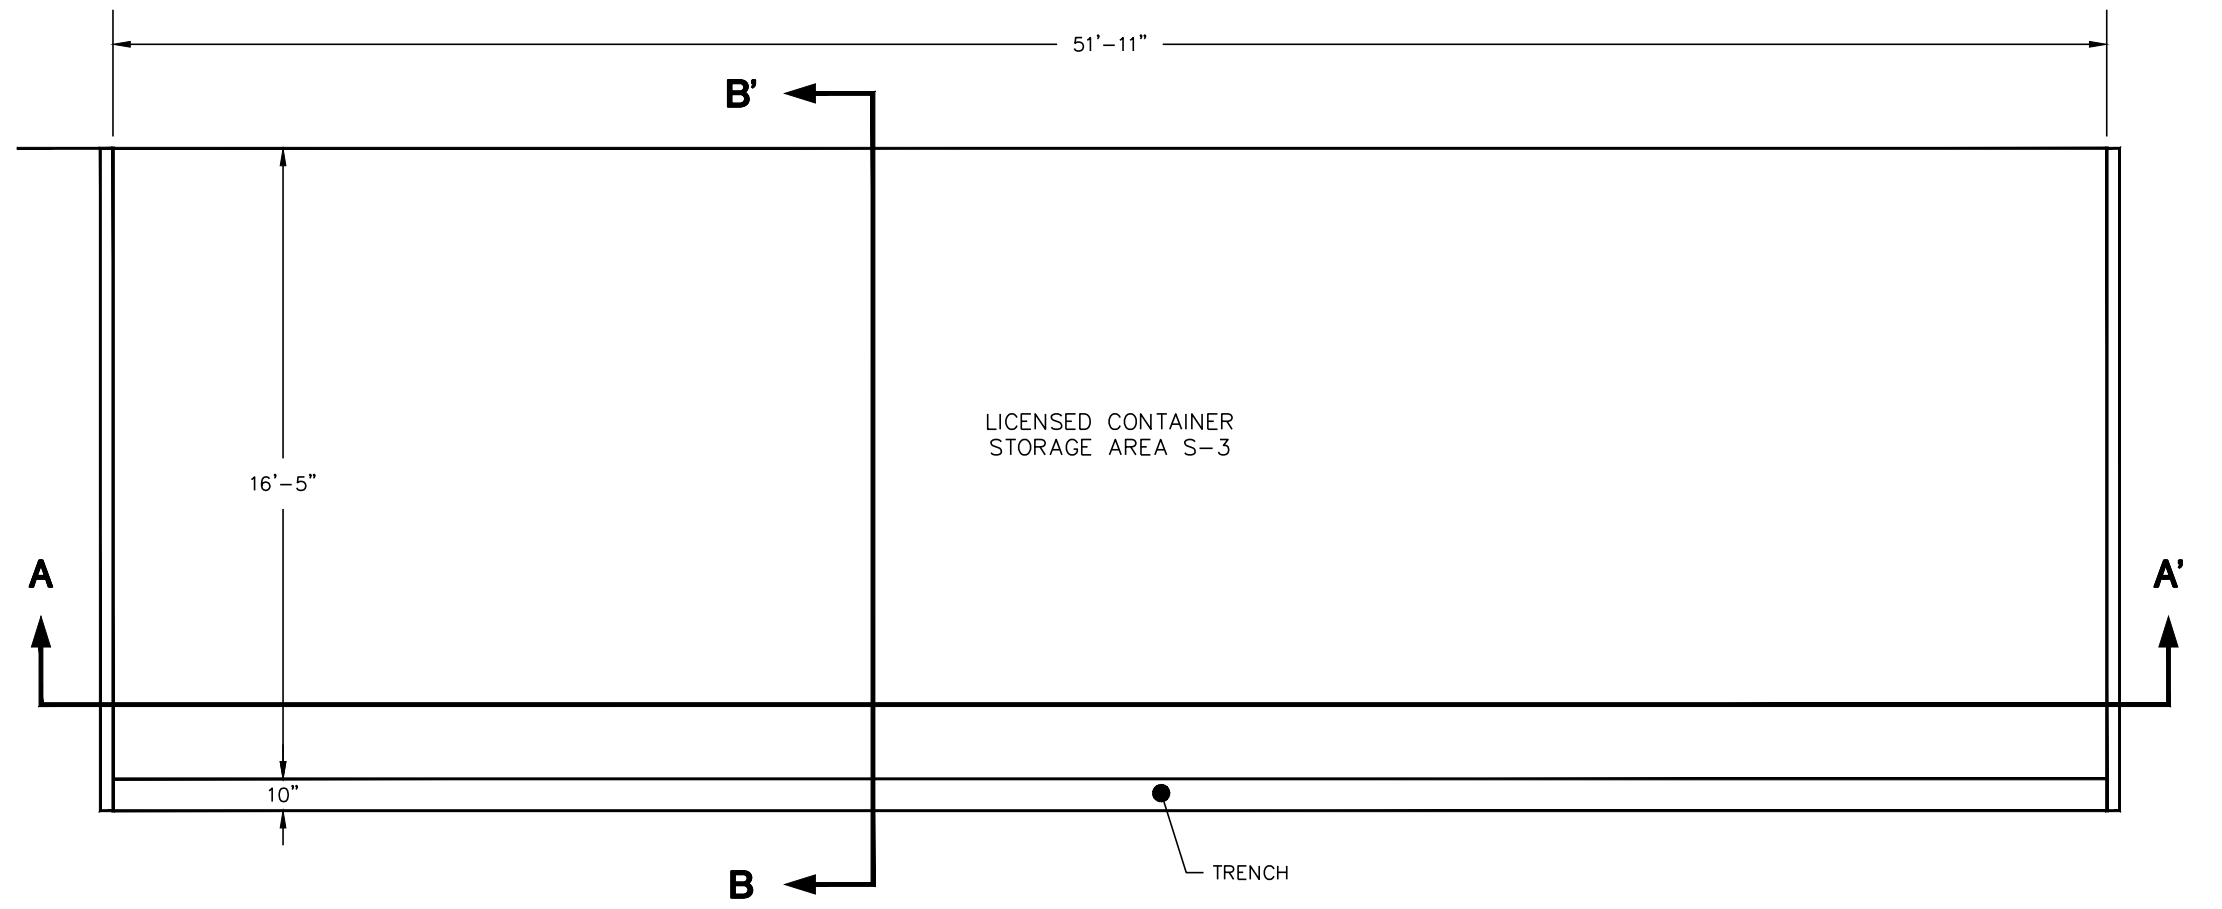
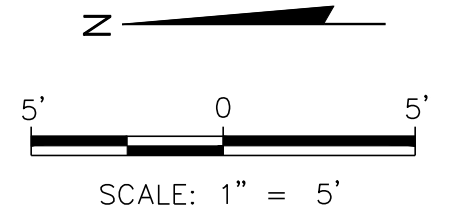
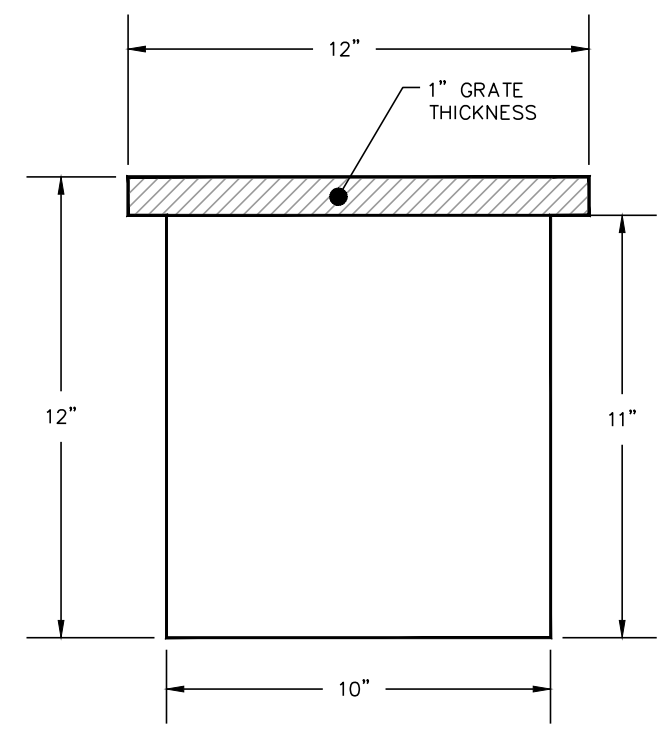
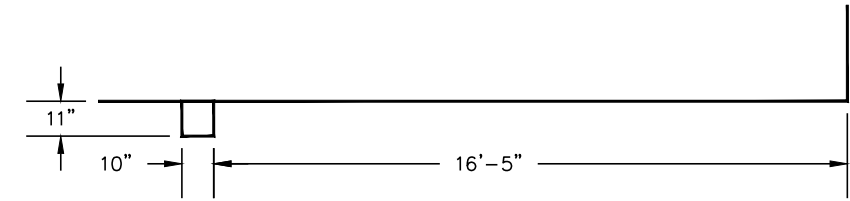
PROJECT NO.	25220201.00	DRAWN BY:	JSK	 2830 DAIRY DRIVE MADISON, WI 53718-6751 PHONE: (608) 224-2830	CLIENT	WM WASTE, INC.	SITE WM WASTE, INC. 21211 DURAND AVE, UNION GROVE, WI	STORAGE AREA S-3	FIGURE	
DRAWN:	12/15/2020	CHECKED BY:	MJT							S-3
REVISED:	12/15/2020	APPROVED BY:	JMO 12/18/2020

TRENCH DETAIL

SECTION A-A'

SECTION B-B'

NOTE:  
DIMENSIONS BASED ON FIELD MEASUREMENTS  
COLLECTED BY SCS ENGINEERS ON  
DECEMBER 1, 2020.

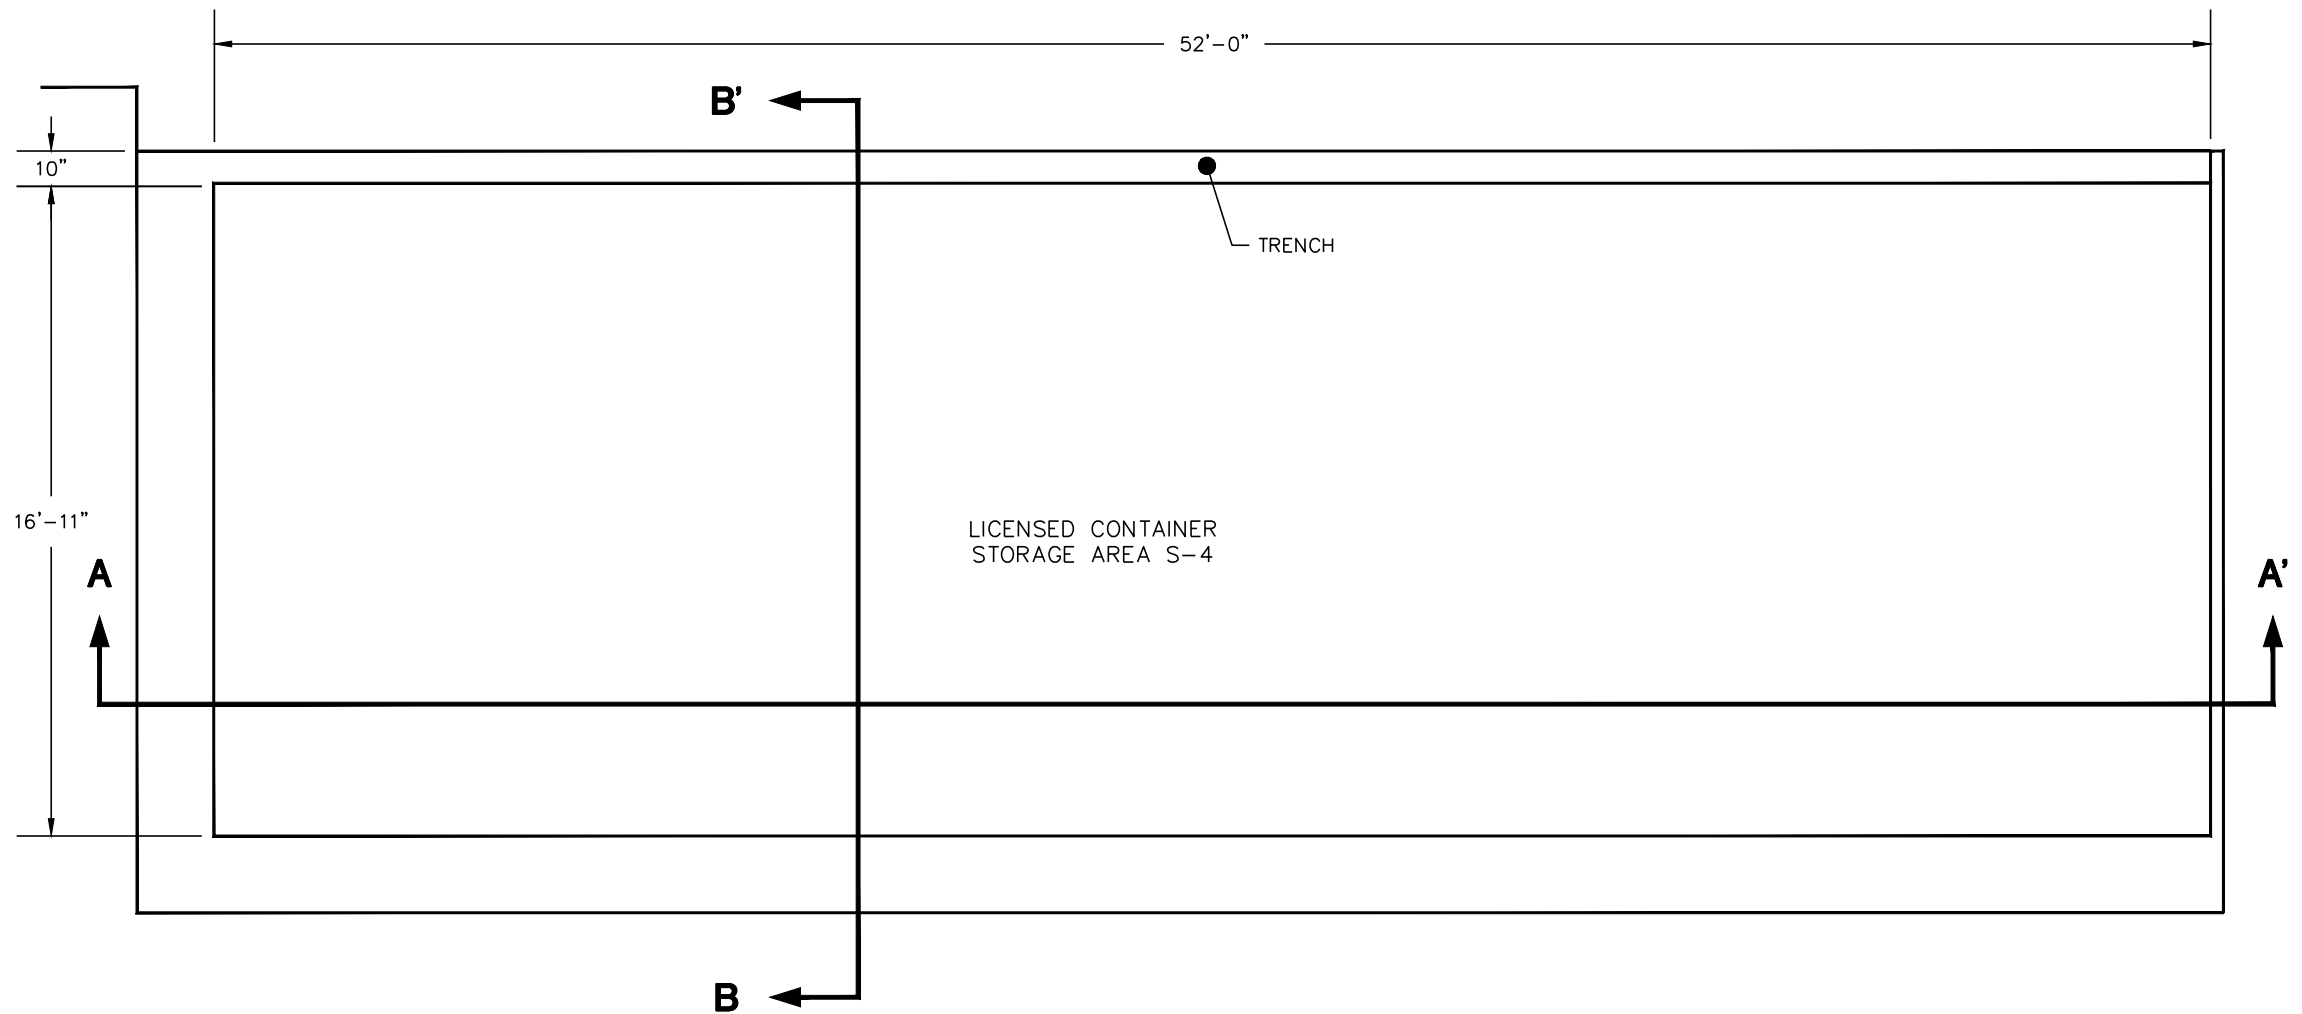
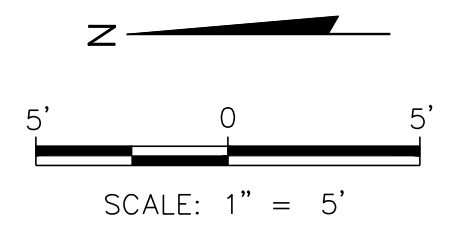
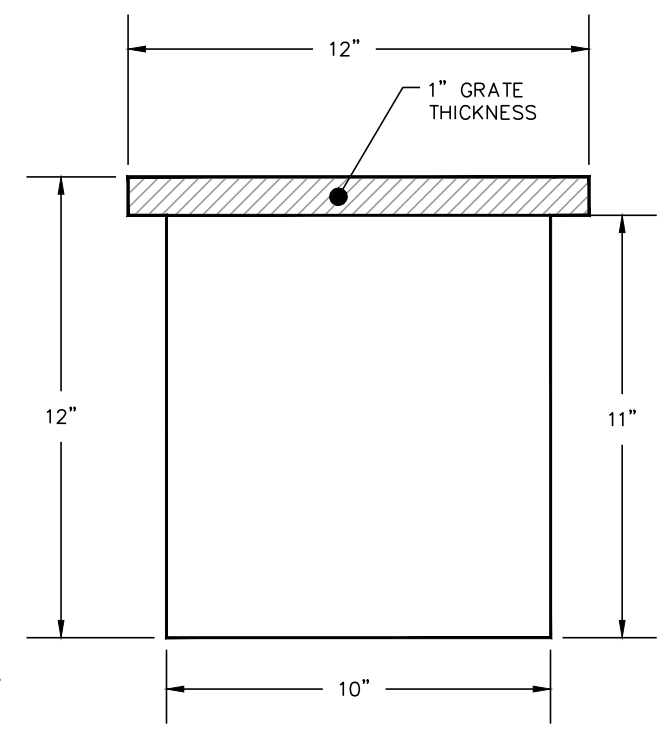
PROJECT NO. 25220201.00	DRAWN BY: JSK	<p>2830 DAIRY DRIVE MADISON, WI 53718-6751 PHONE: (608) 224-2830</p>	CLIENT WM WASTE, INC.	SITE WM WASTE, INC. 21211 DURAND AVE, UNION GROVE, WI	STORAGE AREA S-4	FIGURE
DRAWN: 12/15/2020	CHECKED BY: MJT					S-4
REVISED: 12/15/2020	APPROVED BY: JMO 12/18/2020

**TRENCH DETAIL**

NOTE:  
DIMENSIONS BASED ON FIELD MEASUREMENTS  
COLLECTED BY SCS ENGINEERS ON  
DECEMBER 1, 2020.

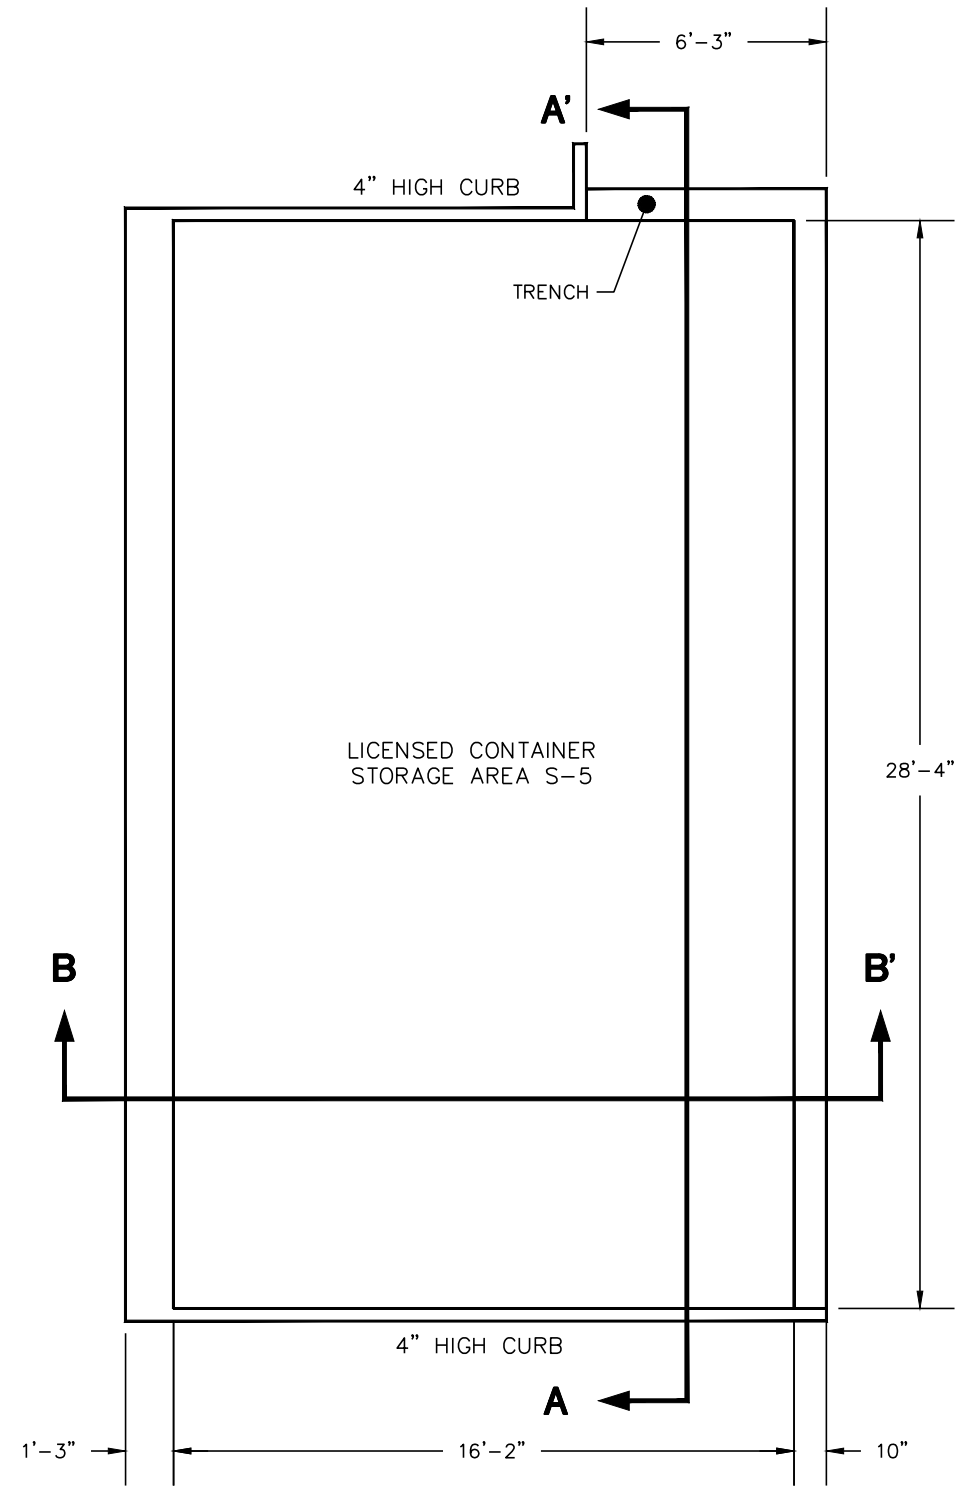
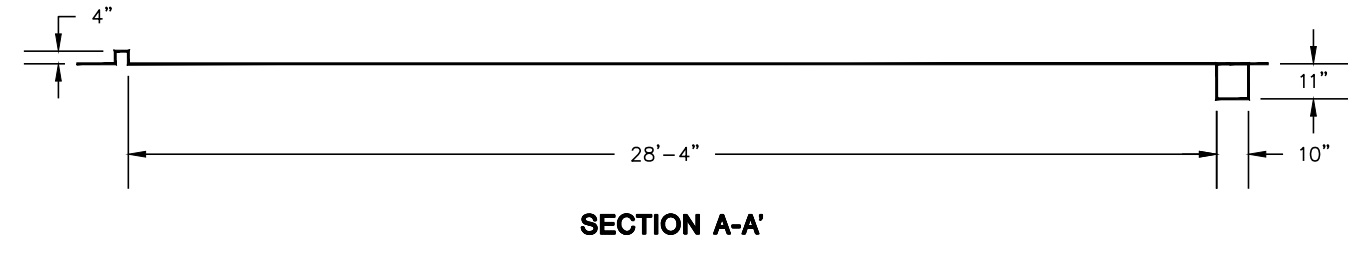
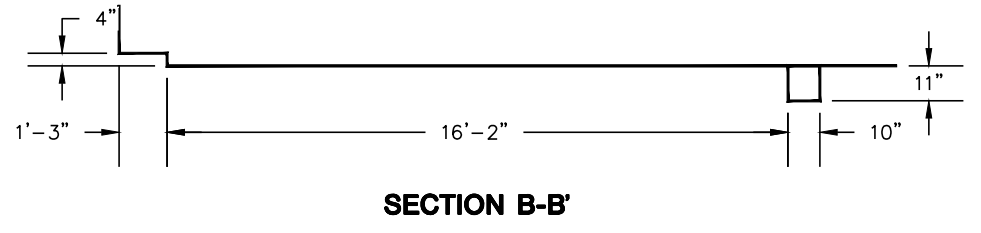
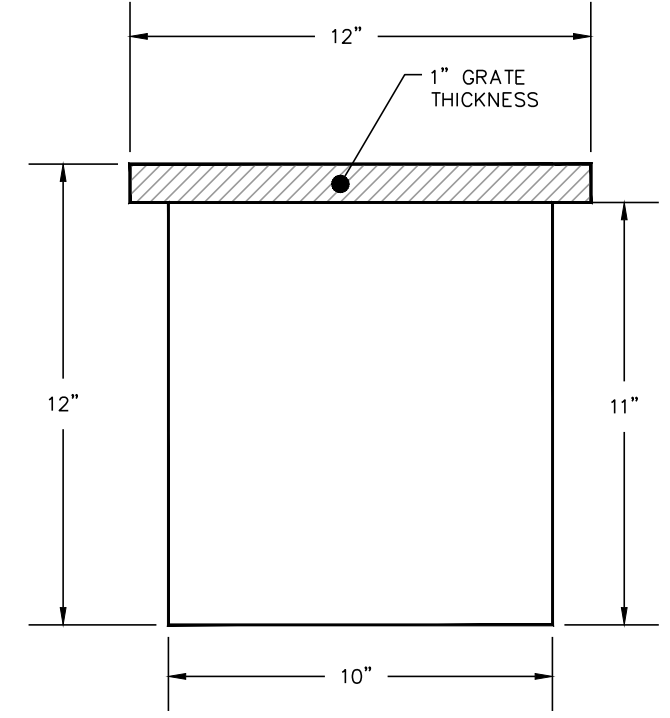
PROJECT NO. 25220201.00	DRAWN BY: JSK	ENGINEER		CLIENT	WM WASTE, INC.	SITE	WM WASTE, INC. 21211 DURAND AVE, UNION GROVE, WI	STORAGE AREA S-5	FIGURE
DRAWN: 12/15/2020	CHECKED BY: MJT								S-5
REVISED: 12/15/2020	APPROVED BY: JMO 12/18/2020

NOTE:  
DIMENSIONS BASED ON FIELD MEASUREMENTS  
COLLECTED BY SCS ENGINEERS ON  
DECEMBER 1, 2020.
