**Appendix 14 RCRA Feasibility Investigation (RFI) Report -  
2003**

# Hazardous Waste Facility Investigation

## Task I

**Mercury Waste Solutions, Inc.**  
**Administrative Offices**  
**21211 Durand Avenue**  
**Union Grove, Wisconsin 53182-9711**

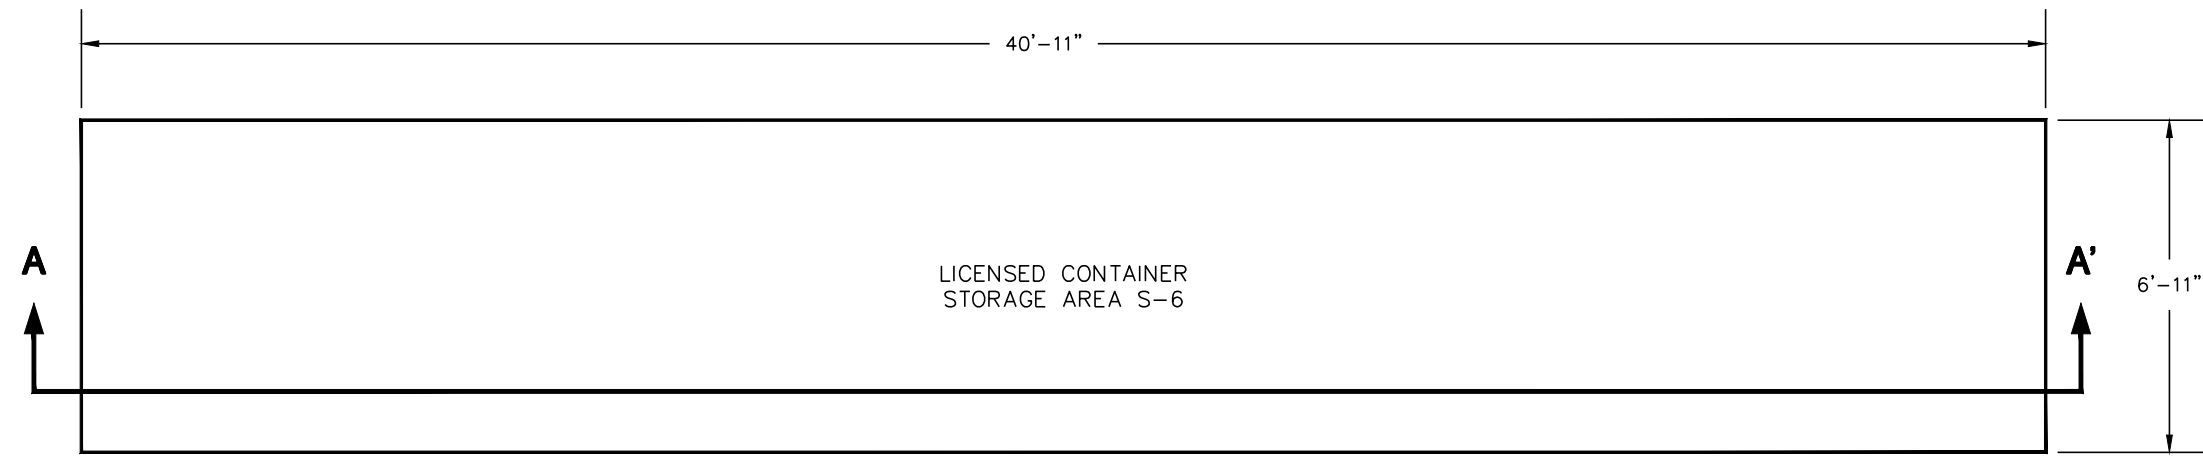
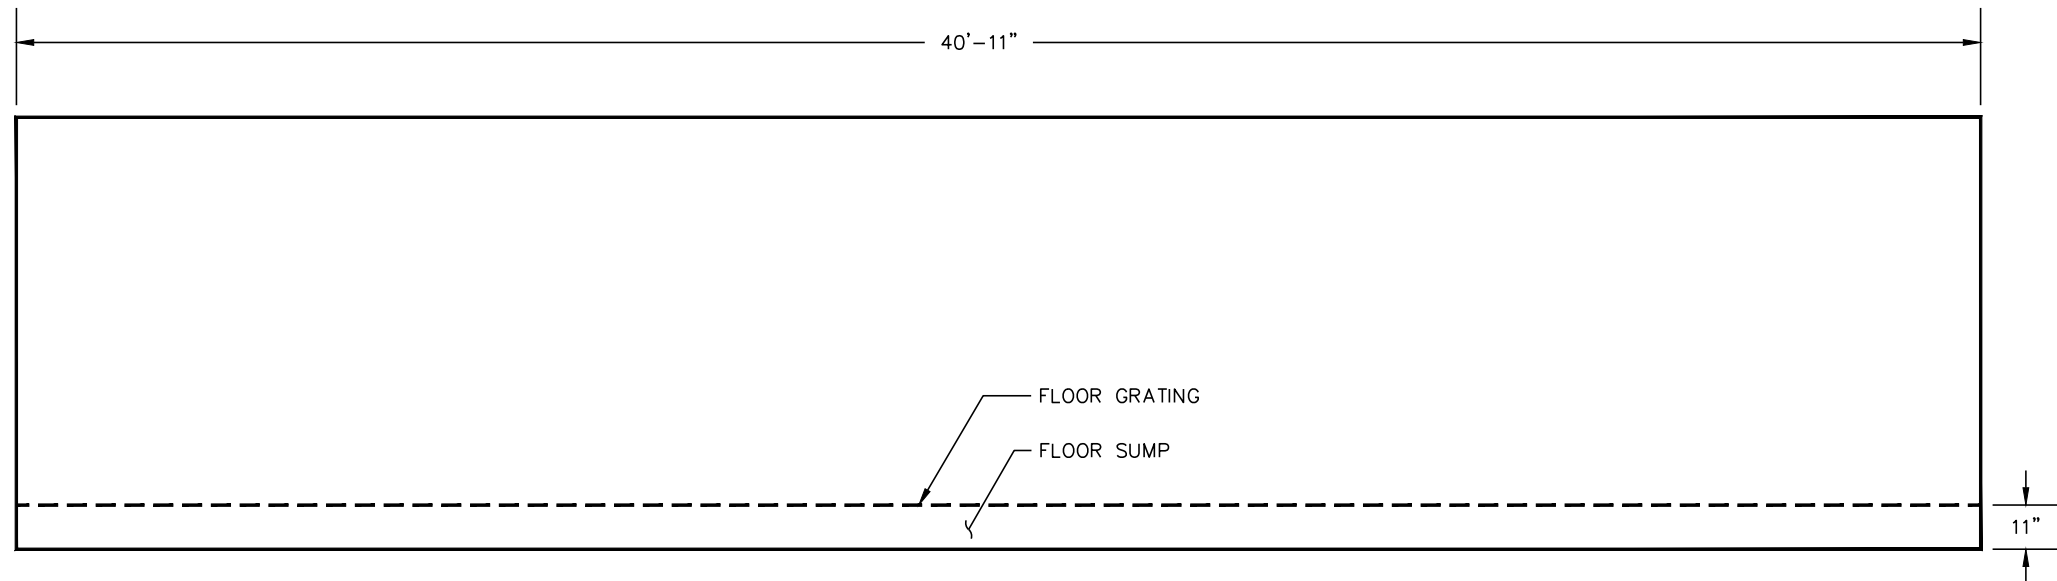
PROJECT NO.	25220201.00	DRAWN BY:	JSK	 2830 DAIRY DRIVE MADISON, WI 53718-6751 PHONE: (608) 224-2830	CLIENT WM WASTE, INC.	SITE WM WASTE, INC. 21211 DURAND AVE, UNION GROVE, WI	STORAGE AREA S-6	FIGURE
DRAWN:	12/15/2020	CHECKED BY:	MJT					S-6
REVISED:	12/15/2020	APPROVED BY:	JMO 12/18/2020

NOTE:  
DIMENSIONS BASED ON FIELD MEASUREMENTS  
COLLECTED BY SCS ENGINEERS ON  
DECEMBER 1, 2020.

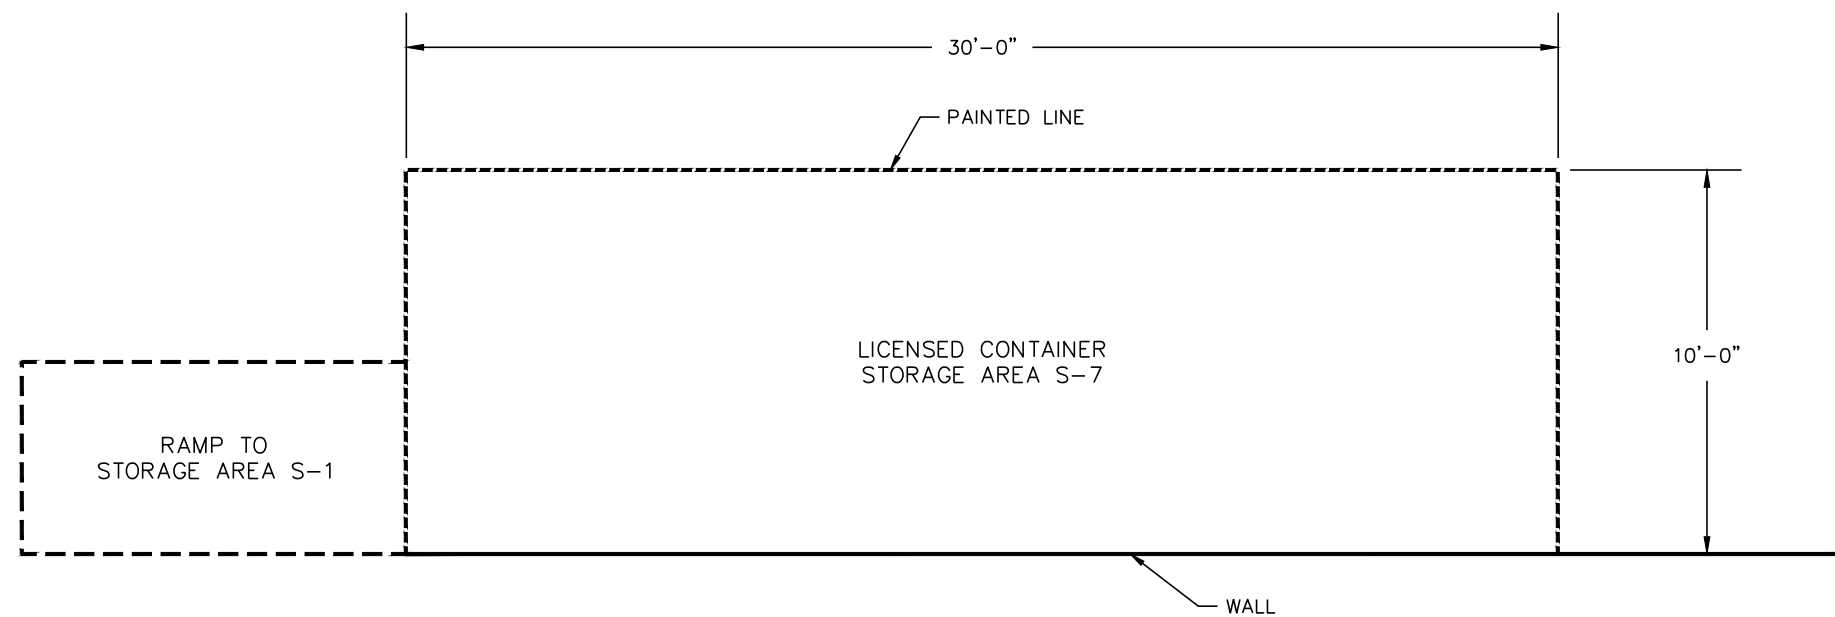
**NOTE:**  
 STORAGE AREA INFORMATION BASED ON FIGURE 16-7, SHEET FPOR-10, DATED 2/24/2011 BY NIELSEN MADSEN & BARBER S.C.

**NOTE:**  
 STORAGE AREA INFORMATION BASED ON FIGURE 16-7, SHEET FPOR-10, DATED 2/24/2011 BY NIELSEN MADSEN & BARBER S.C. EXISTING SECONDARY CONTAINMENT BASED ON FIELD MEASUREMENTS COLLECTED BY SCS ENGINEERS ON DECEMBER 1, 2020, AND DOCUMENTED IN A REPORT DATED DECEMBER 23, 2020. SCS MEASURED THE STORAGE AREA DIMENSIONS WITH A TAPE MEASURE AND A LASER DISTANCE MEASURE, AND MEASURED SLOPED AREAS WITH A LASER LEVEL.

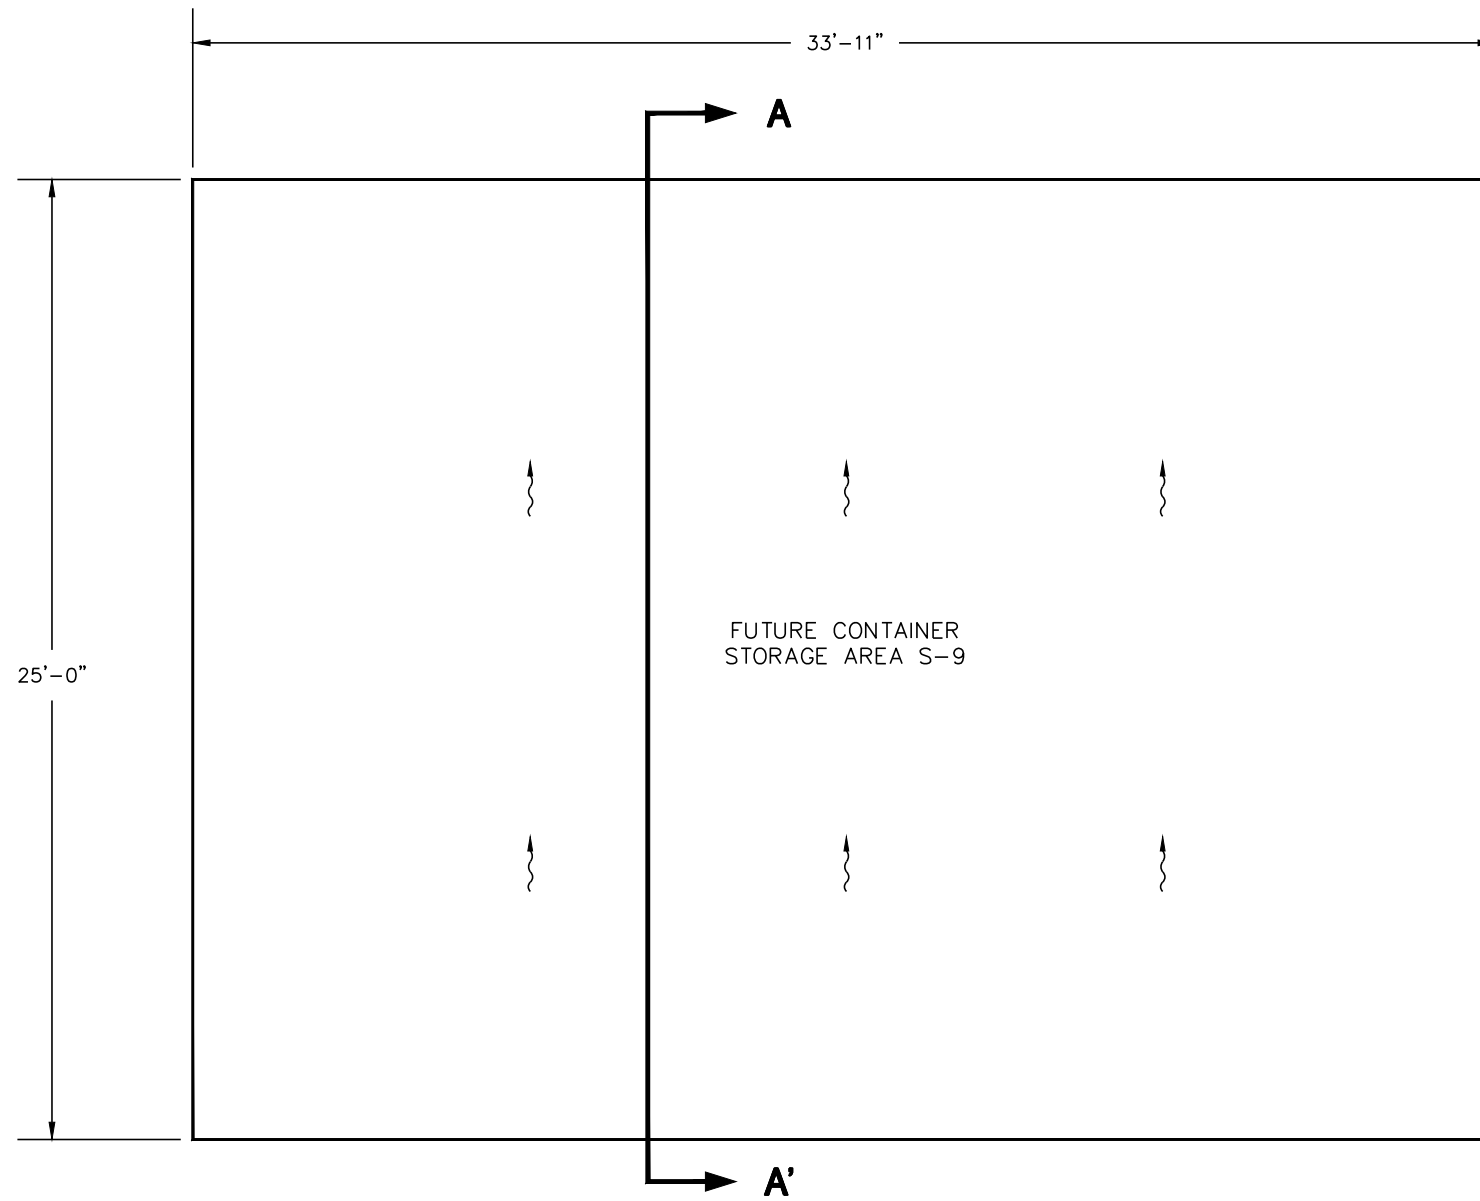
**SECTION A-A'**

- NOTES:
1. STORAGE AREA DIMENSIONS MATCH STORAGE AREA S-12
  2. POSITIVE SLOPE TO THE WEST WAS CONFIRMED IN THE FIELD BY SCS ENGINEERS ON DECEMBER 1, 2020. SLOPE PERCENT IS APPROXIMATE, AND BASED ON RACINE COUNTY LIDAR DATA COLLECTED APRIL-MAY 2017.

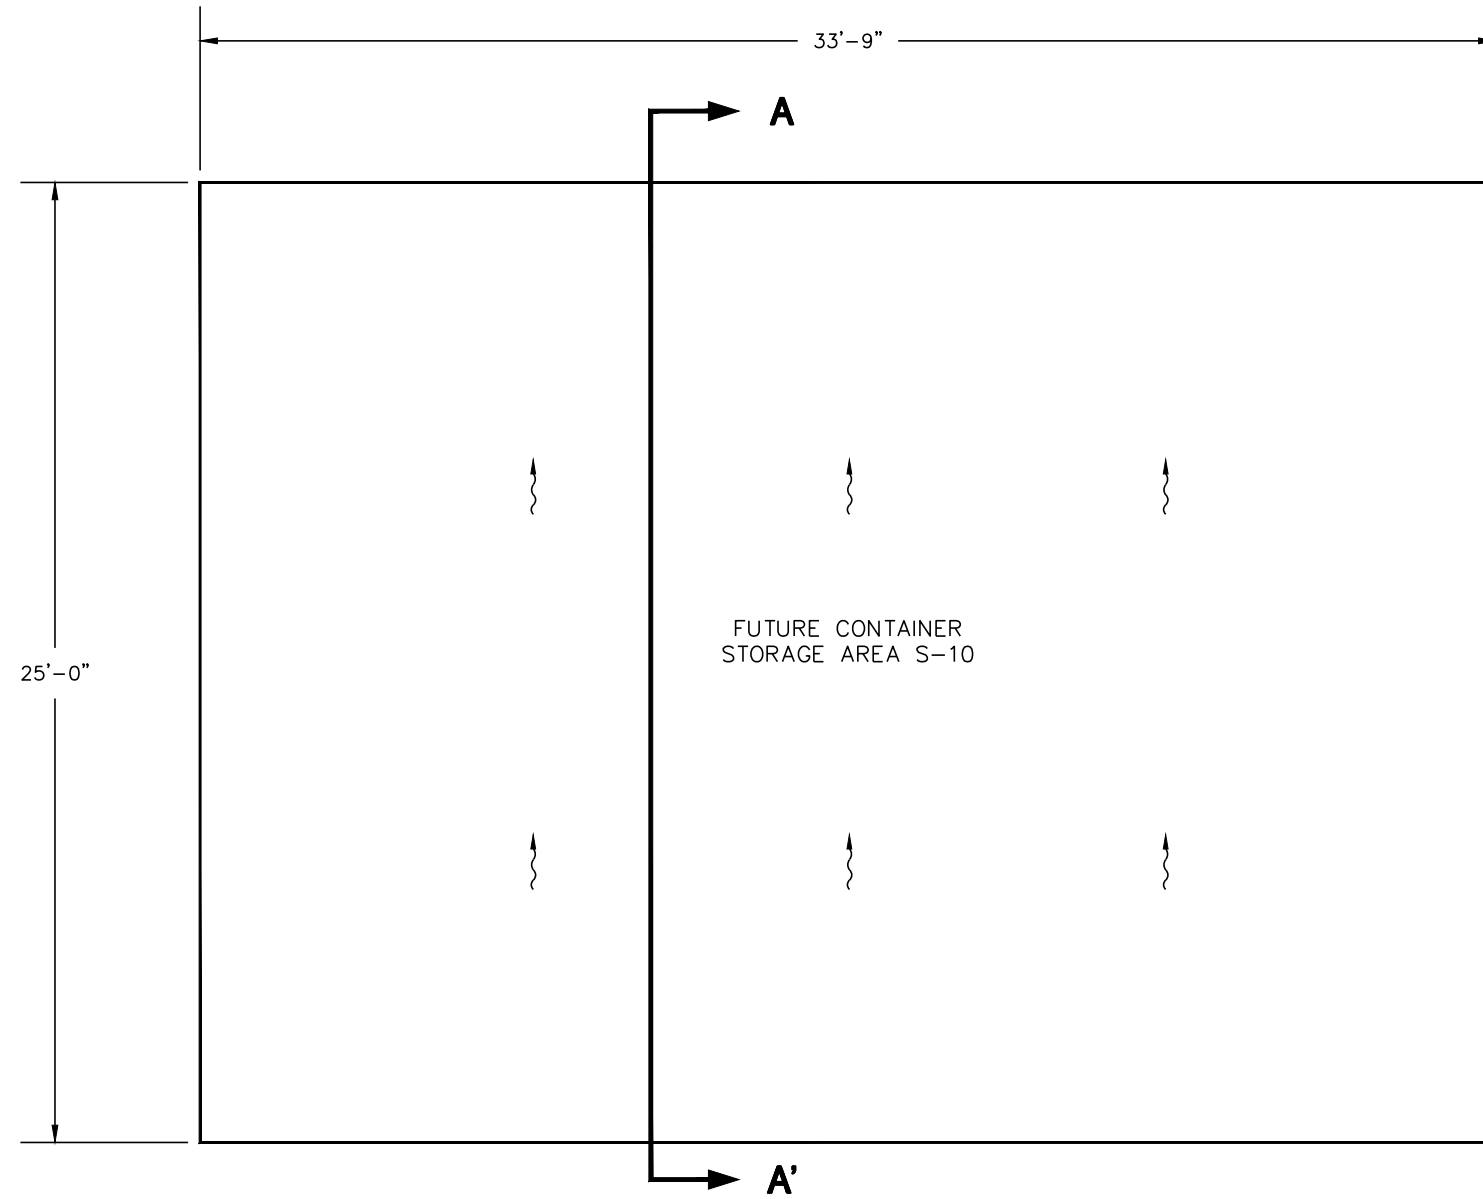
**SECTION A-A'**

- NOTES:
1. STORAGE AREA DIMENSIONS MATCH STORAGE AREA S-13
  2. POSITIVE SLOPE TO THE WEST WAS CONFIRMED IN THE FIELD BY SCS ENGINEERS ON DECEMBER 1, 2020. SLOPE PERCENT IS APPROXIMATE, AND BASED ON RACINE COUNTY LIDAR DATA COLLECTED APRIL-MAY 2017.

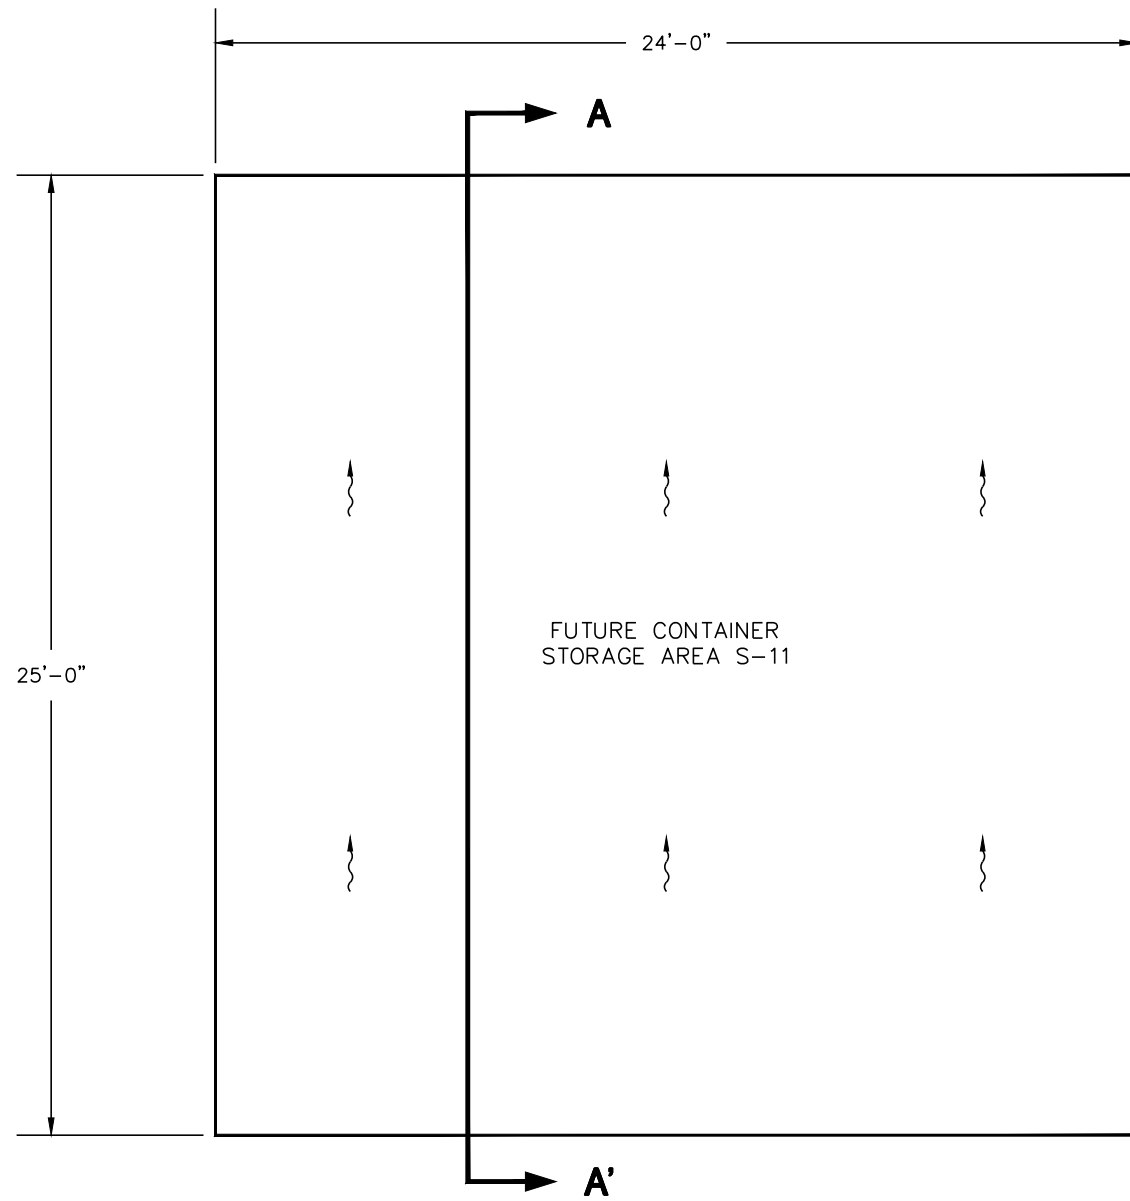
**SECTION A-A'**

- NOTES:
1. STORAGE AREA DIMENSIONS MATCH STORAGE AREA S-14
  2. POSITIVE SLOPE TO THE WEST WAS CONFIRMED IN THE FIELD BY SCS ENGINEERS ON DECEMBER 1, 2020. SLOPE PERCENT IS APPROXIMATE, AND BASED ON RACINE COUNTY LIDAR DATA COLLECTED APRIL-MAY 2017.

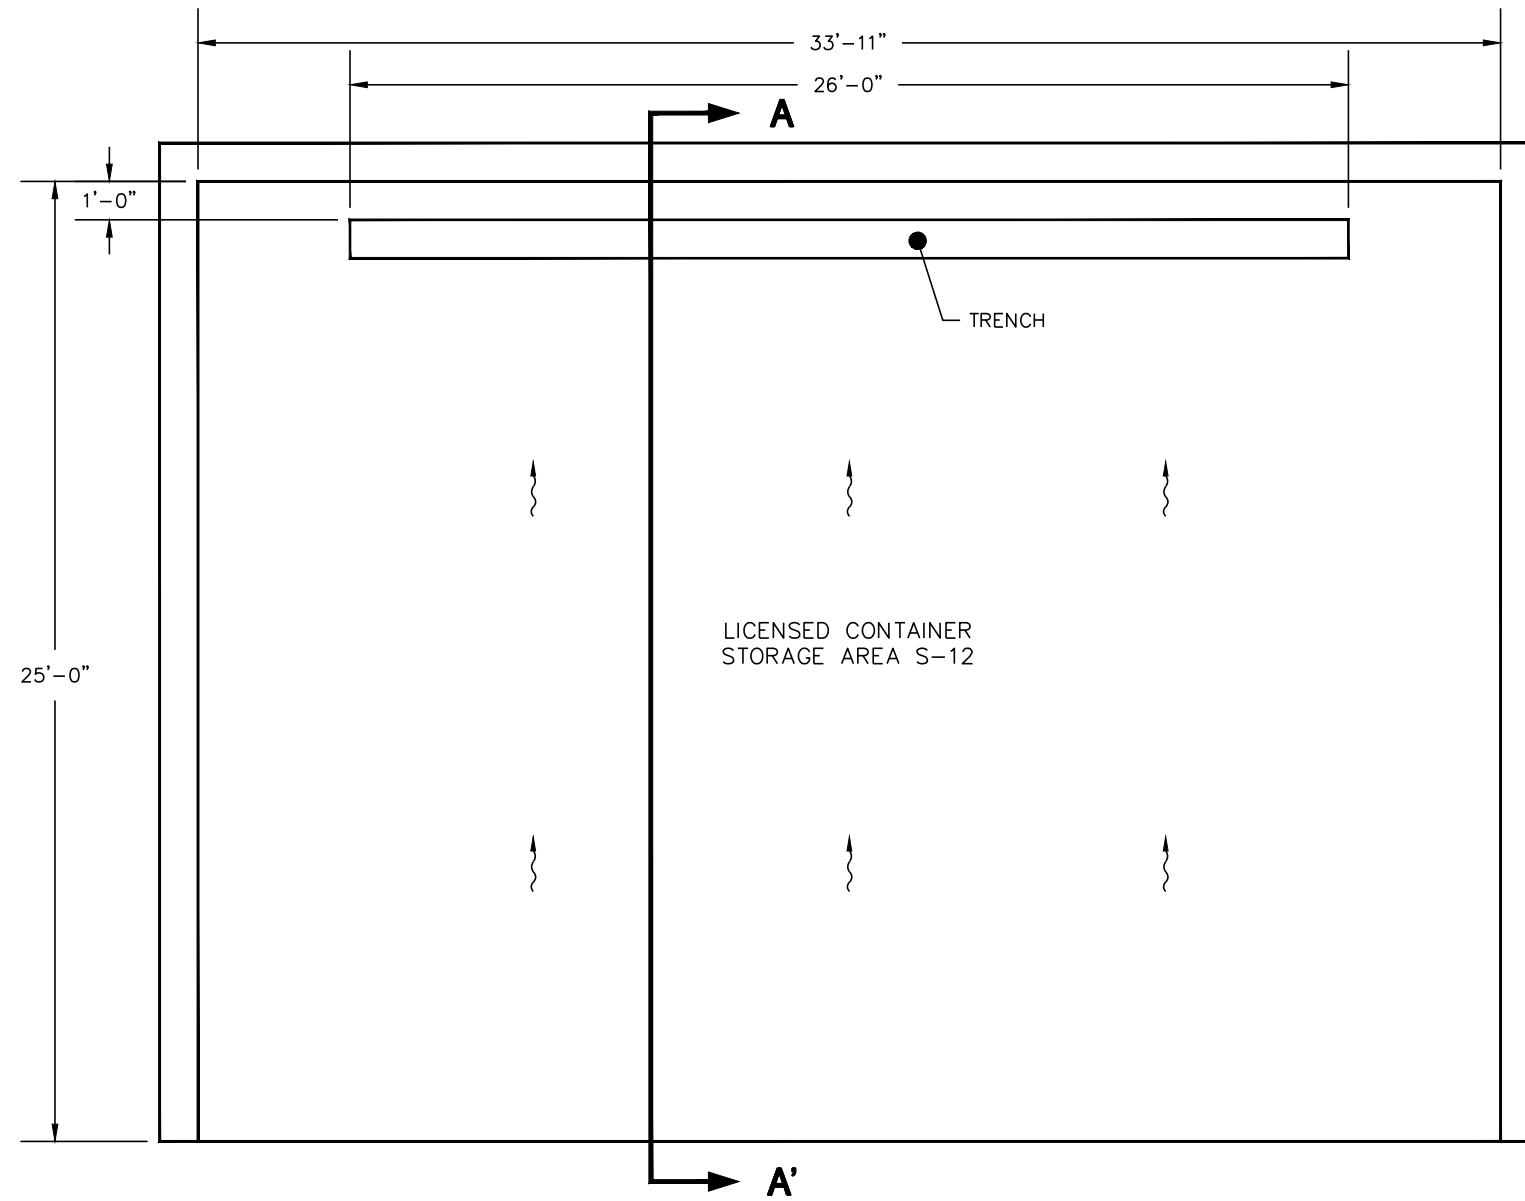
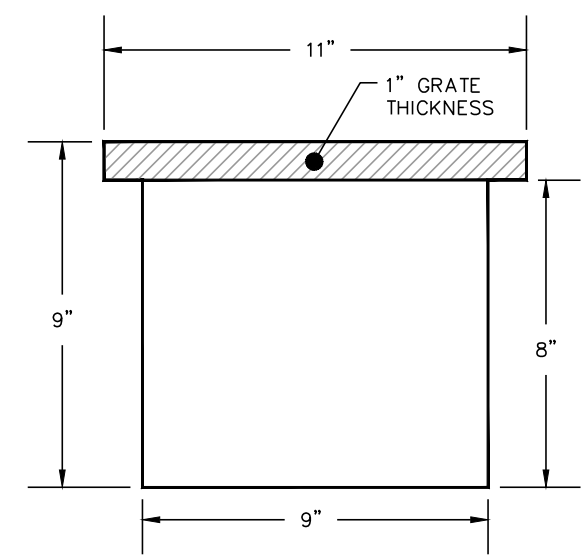
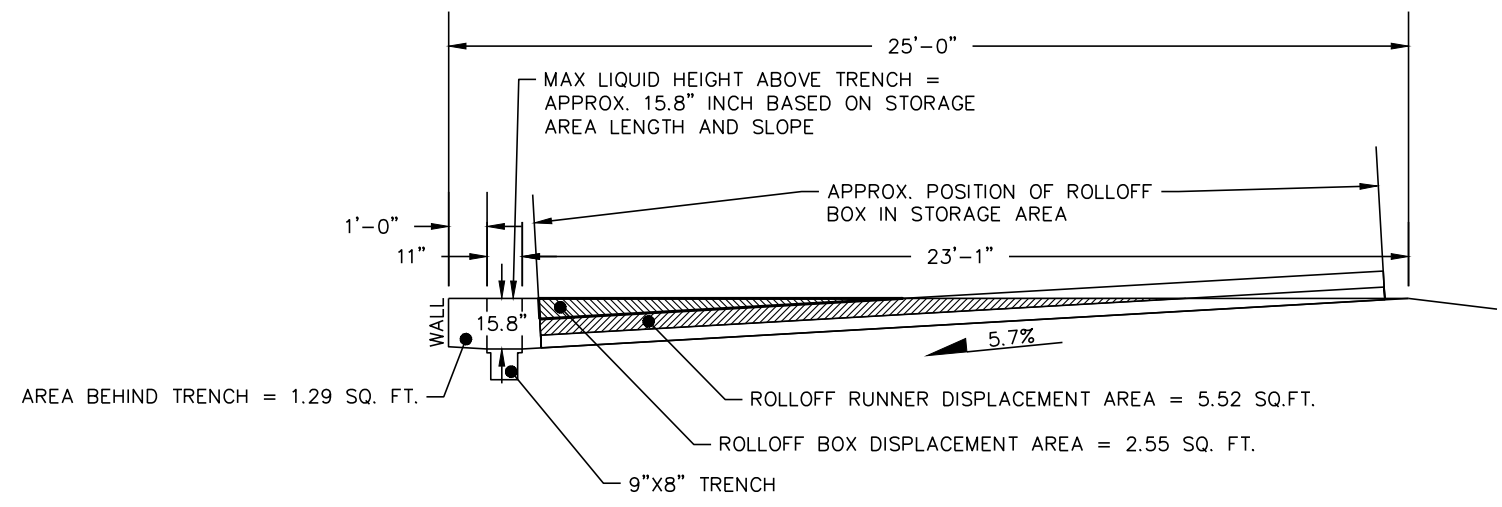
FIGURE  
S-12

**TRENCH DETAIL**

**SECTION A-A'**

NOTE:  
DIMENSIONS BASED ON FIELD MEASUREMENTS  
COLLECTED BY SCS ENGINEERS ON  
DECEMBER 1, 2020.

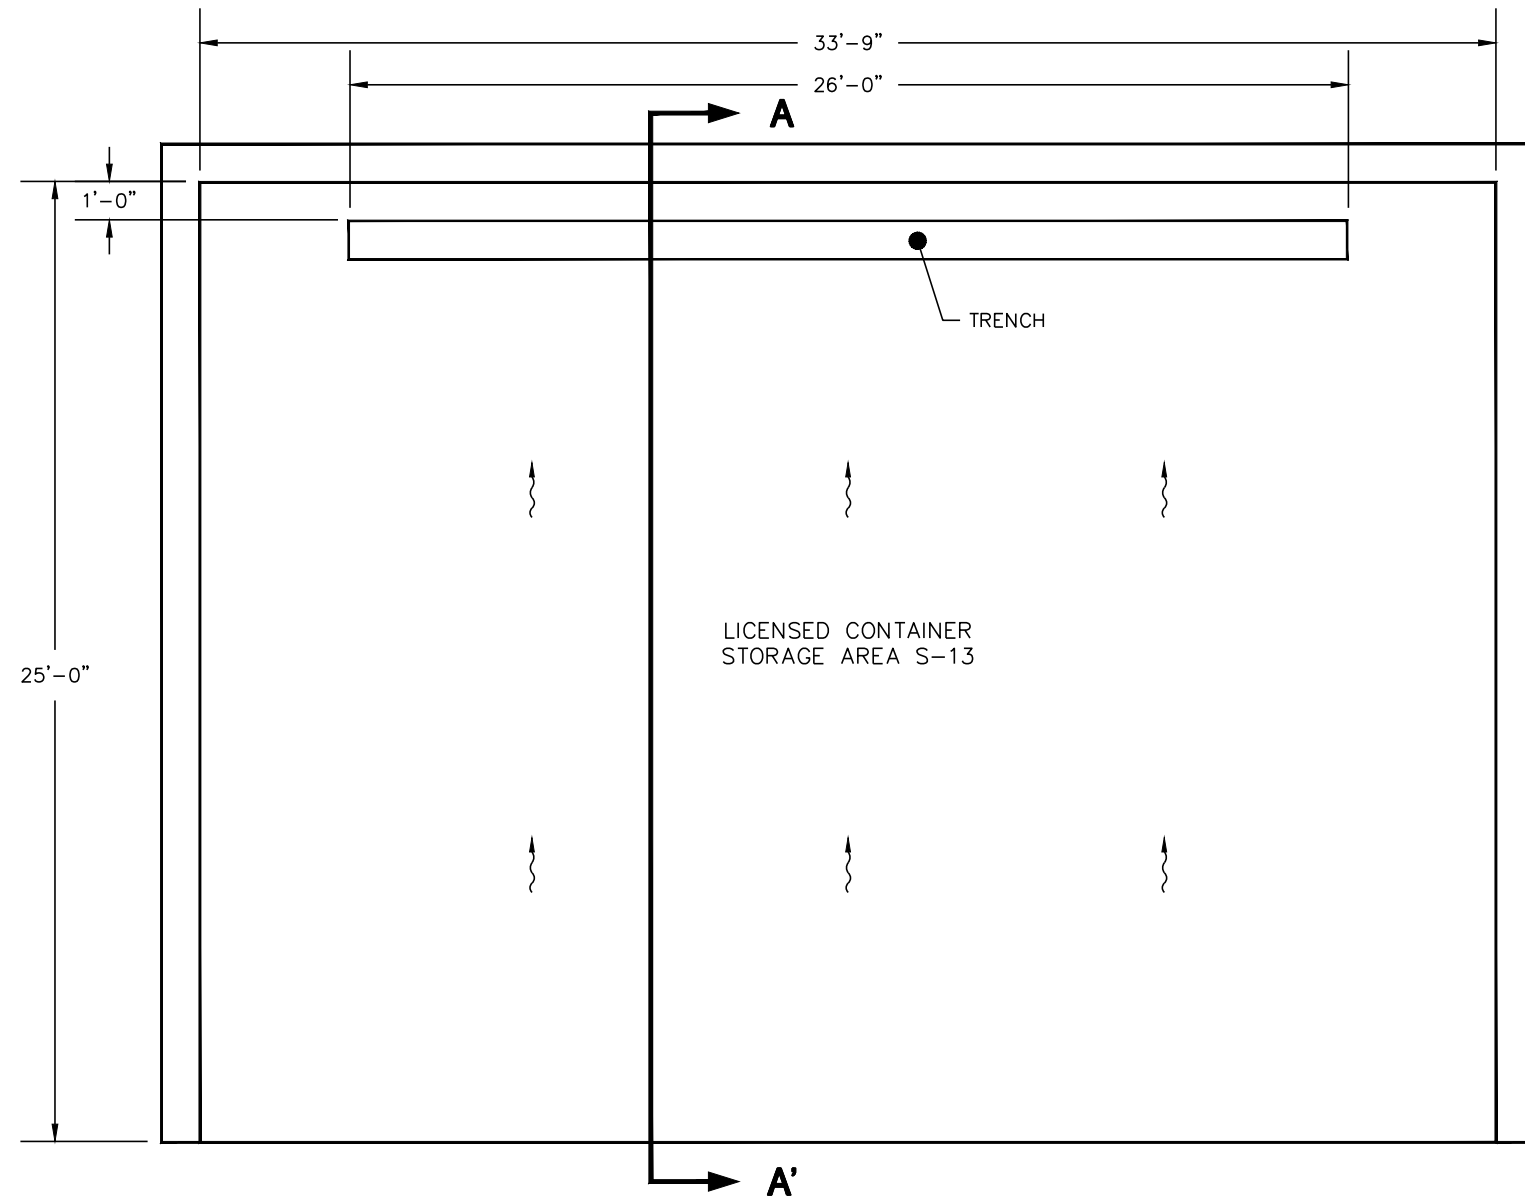
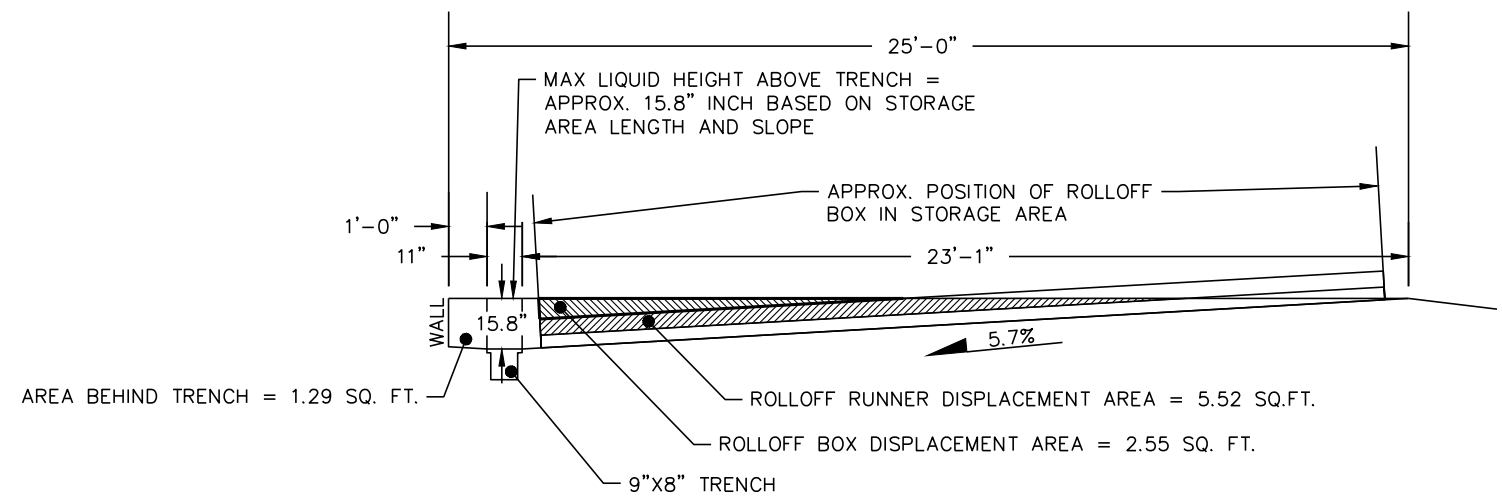
**TRENCH DETAIL**

**SECTION A-A'**

NOTE:  
DIMENSIONS BASED ON FIELD MEASUREMENTS  
COLLECTED BY SCS ENGINEERS ON  
DECEMBER 1, 2020.

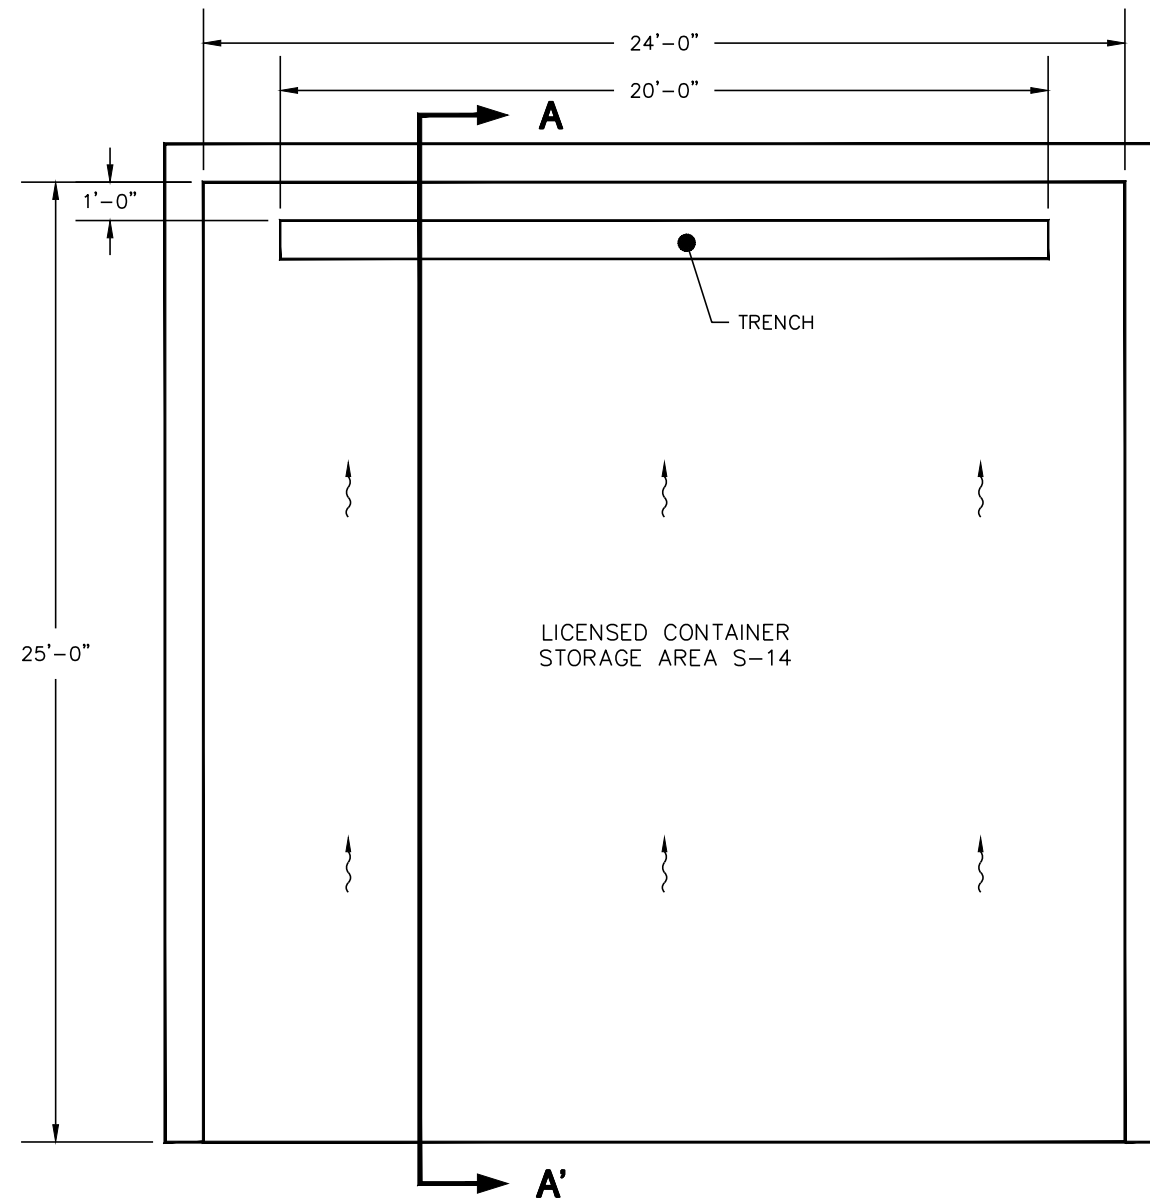
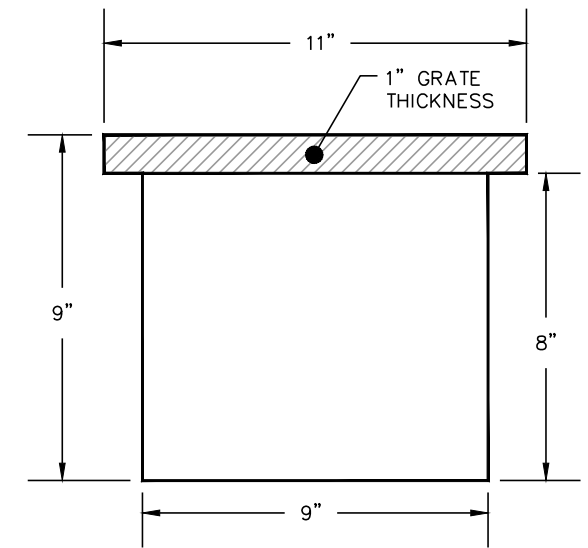
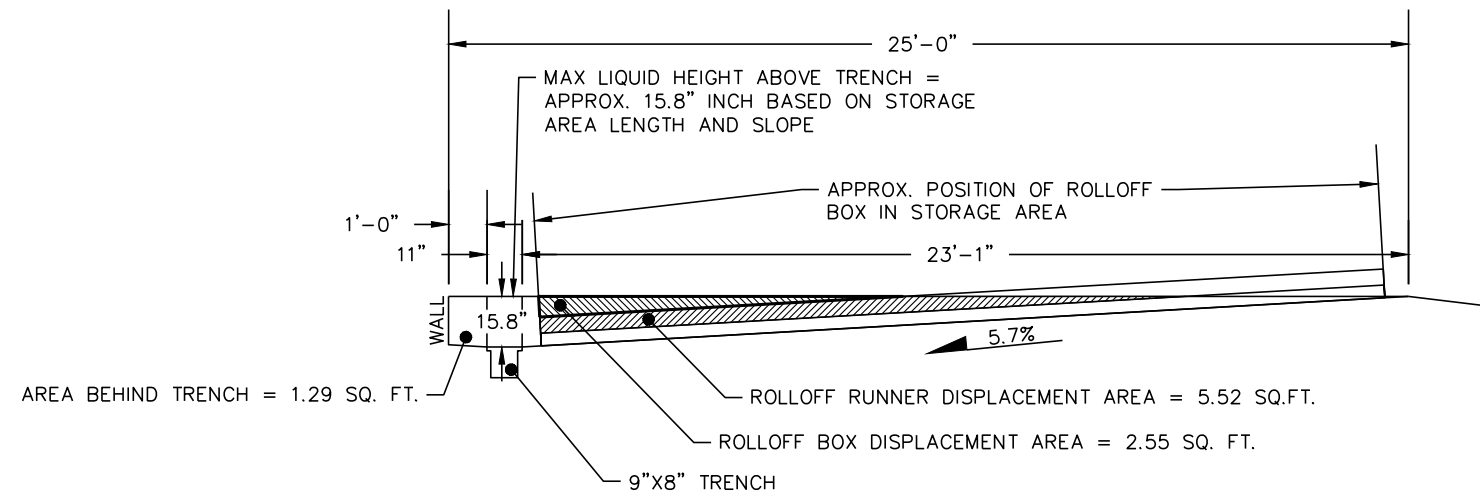
FIGURE  
S-13

TRENCH DETAIL

SECTION A-A'

NOTE:  
DIMENSIONS BASED ON FIELD MEASUREMENTS  
COLLECTED BY SCS ENGINEERS ON  
DECEMBER 1, 2020.

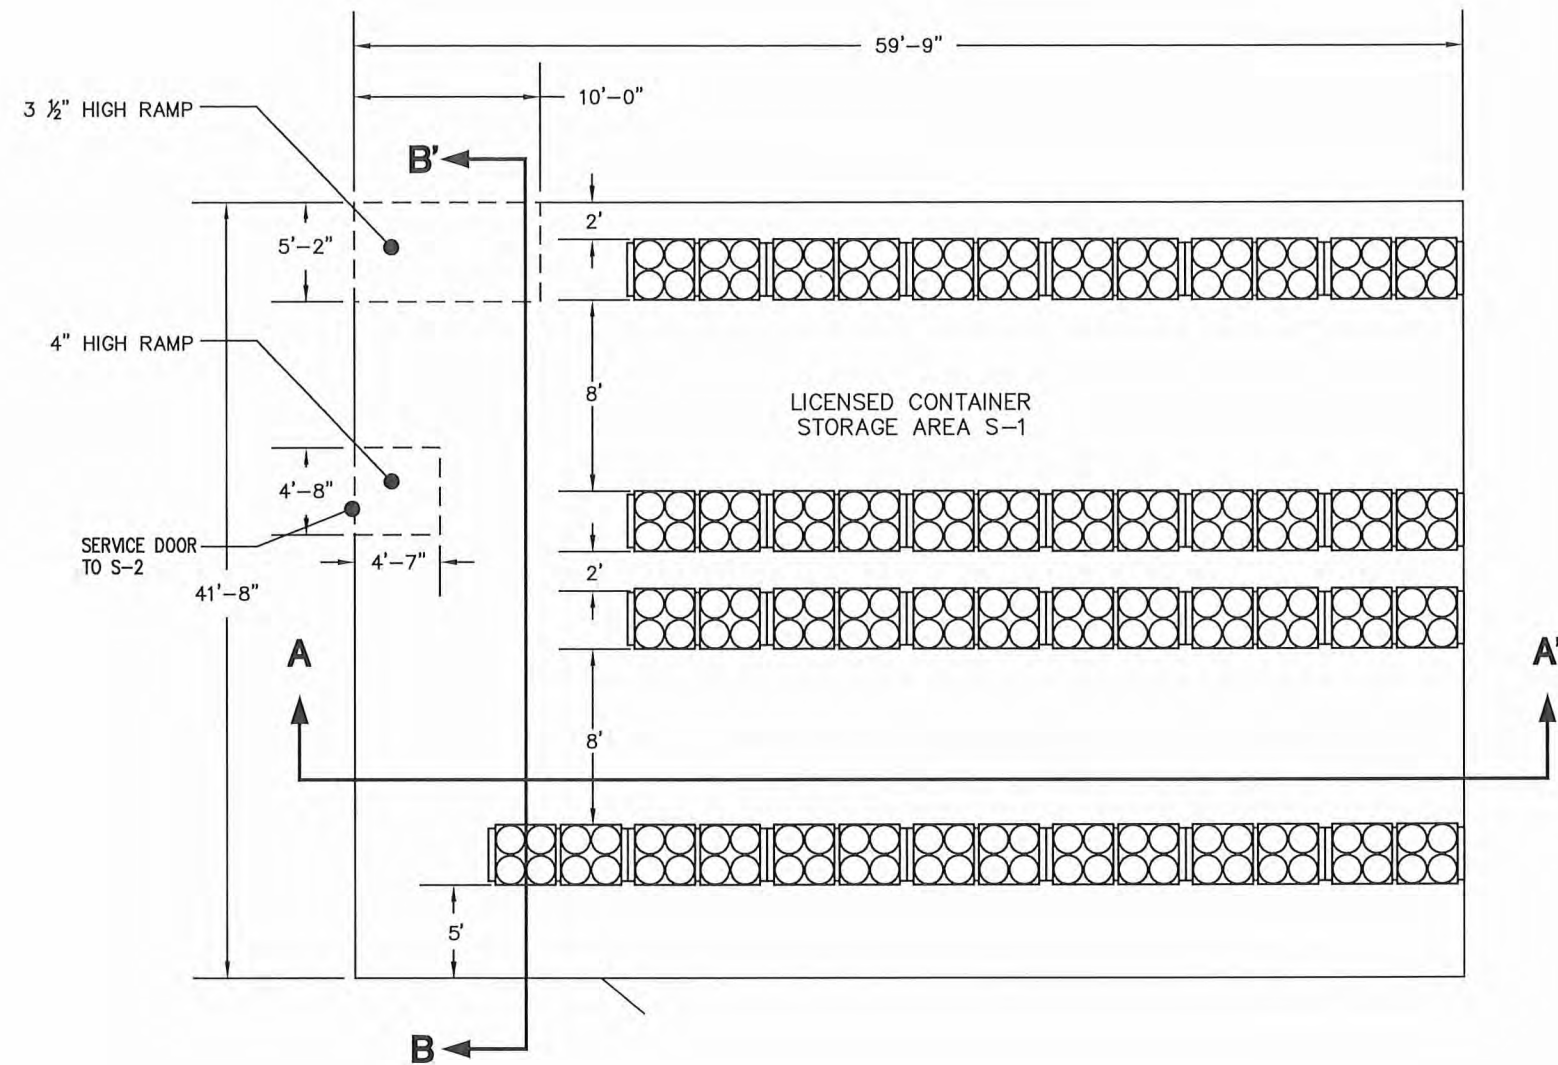
S-1 Containment Area	
Stacking Configuration	3 - Tier Racking System
Container Type	Drum
Maximum Number of Liquid Containers	600
Largest Container (gallons)	55
Proposed Permitted Capacity (Gallons)	33,000
Required Secondary Containment Capacity (greater of 10% of total capacity or largest container)	3,300
Available Secondary Containment (gallons)	3,988
Sufficient Containment?	Yes
Proposed Upgrades	None
Proposed Containment (gallons)	3,988

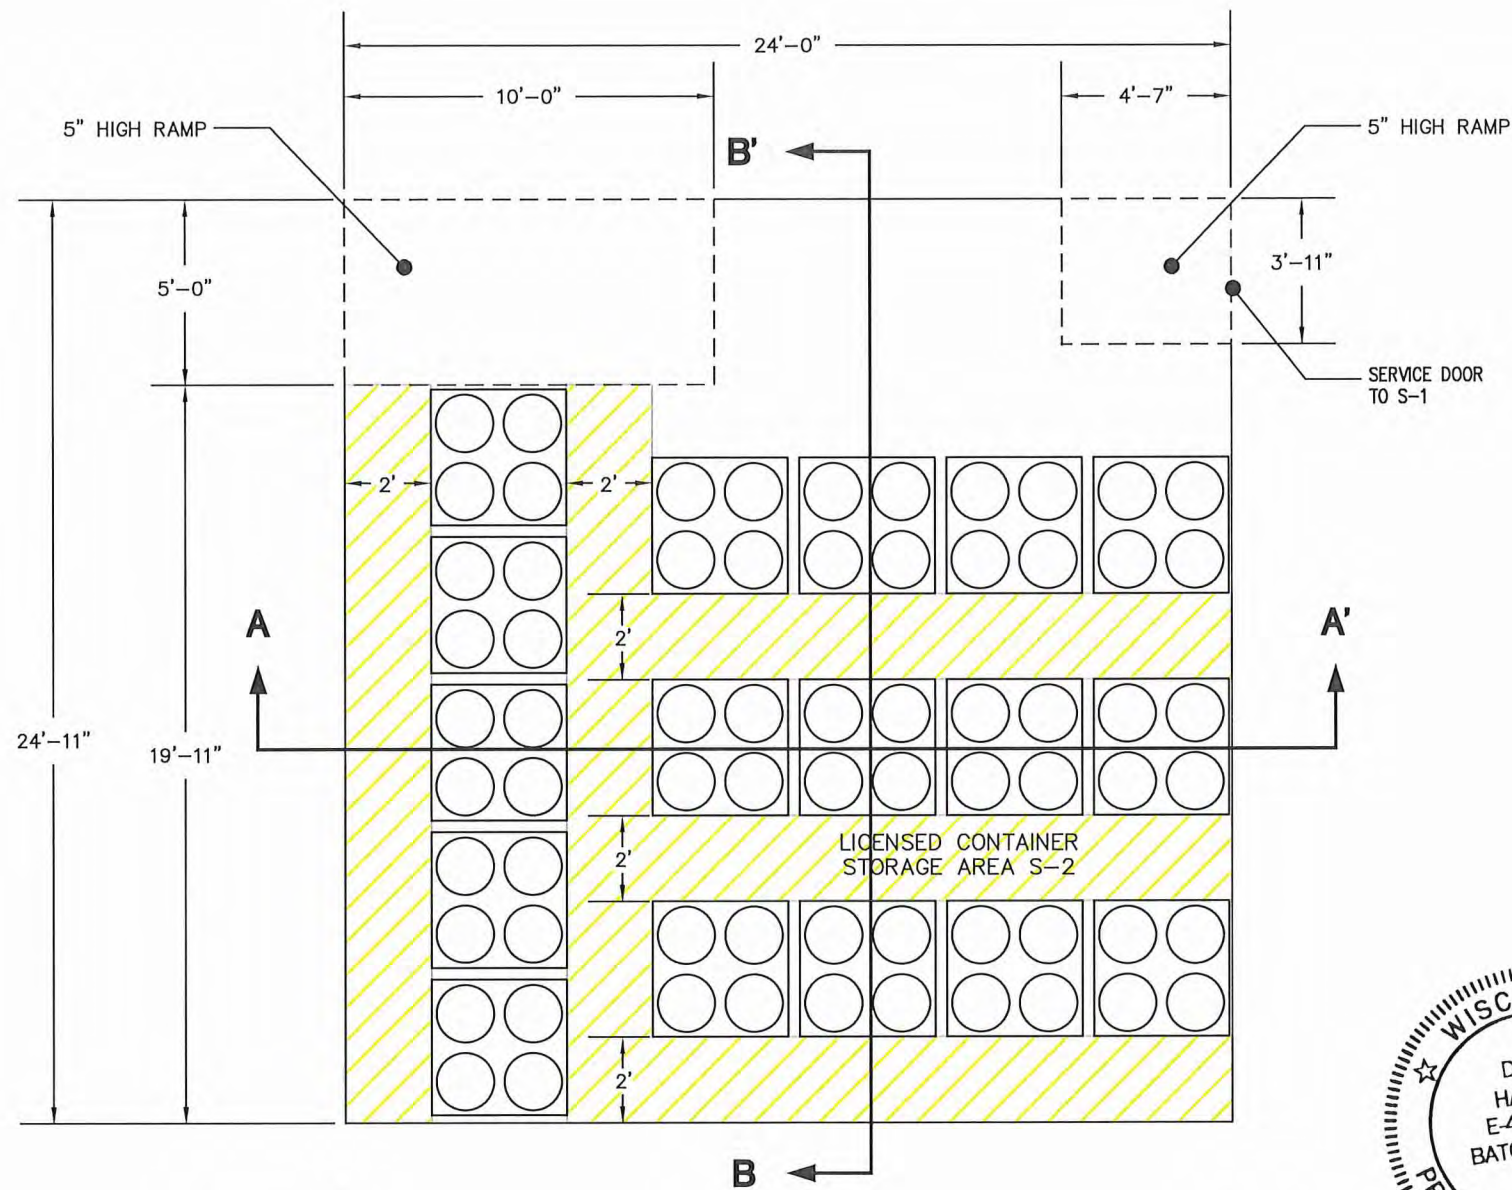
S-2 Containment Area	
Stacking Configuration	2-Tier Stacking
Container Type	Drum
Maximum Number of Liquid Containers (55-gallon drums or DE)	136
largest container (gallons)	55
Proposed Permitted Capacity (Gallons)	7,480
Required Secondary Containment Capacity (greater of 10% of total capacity or largest container)	748
Available Secondary Containment (gallons)	1,102
Sufficient Containment?	Yes
Proposed Upgrades	None
Proposed Containment (gallons)	1,102

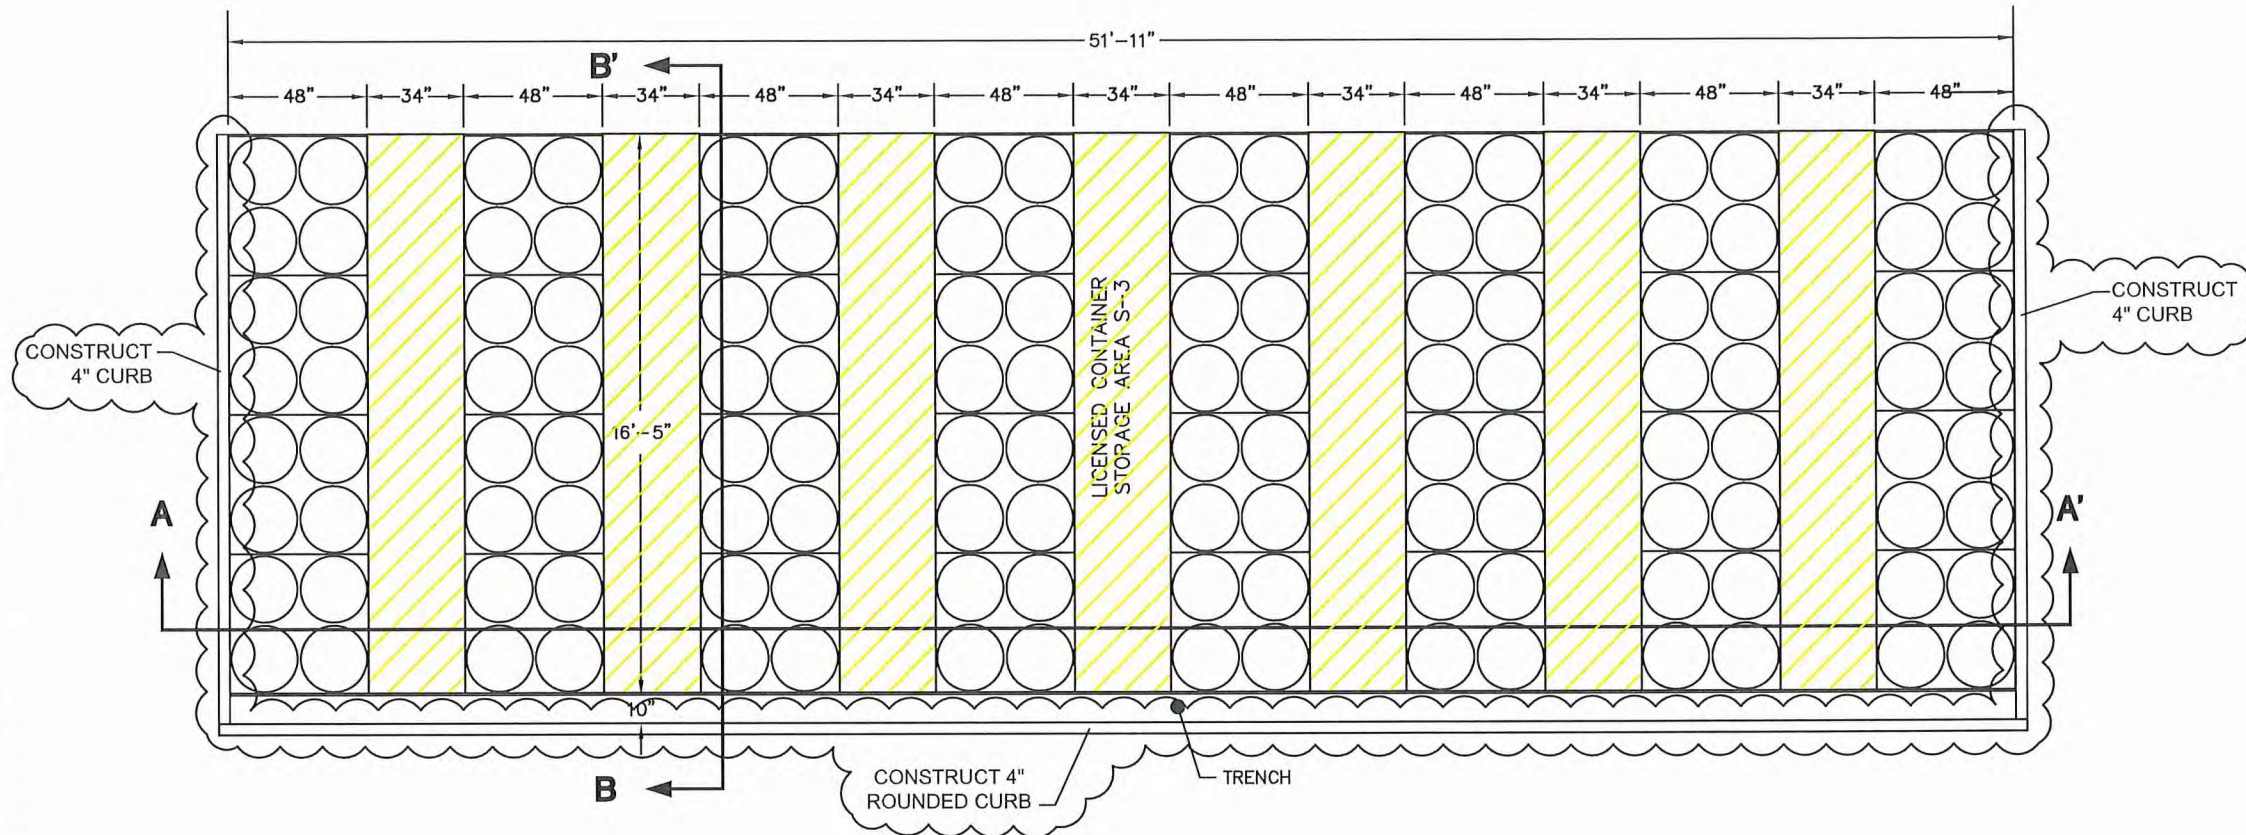
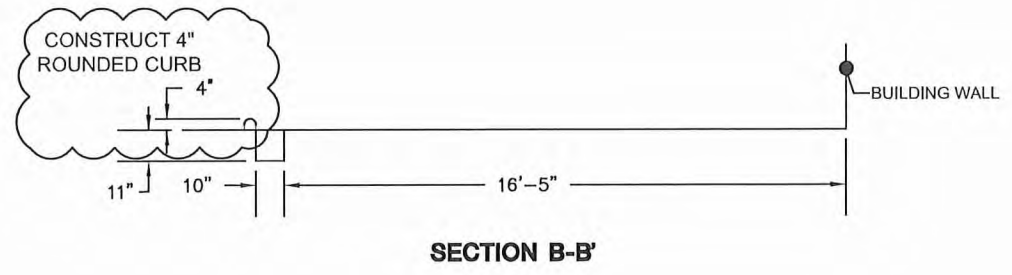
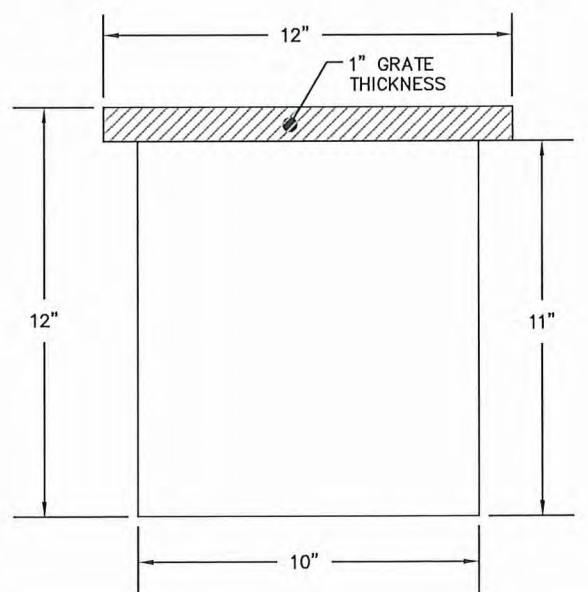
S-3 Containment Area	
Stacking Configuration	2-Tier Stacking
Container Type	Drum
Maximum Number of Liquid Containers (55-gallon drums or DE)	256
Largest container (gallons)	55
Proposed Permitted Capacity (Gallons)	14,080
Required Secondary Containment Capacity (greater of 10% of total capacity or largest container)	1,408
Available Secondary Containment (gallons)	297
Sufficient Containment?	No
Proposed Upgrades	Add 4 inch curbing. See details on drawing.
Proposed Containment (gallons)	1,535
