**Appendix 14 RCRA Feasibility Investigation (RFI) Report -  
2003**

# Hazardous Waste Facility Investigation

## Task I

**Mercury Waste Solutions, Inc.**  
**Administrative Offices**  
**21211 Durand Avenue**  
**Union Grove, Wisconsin 53182-9711**

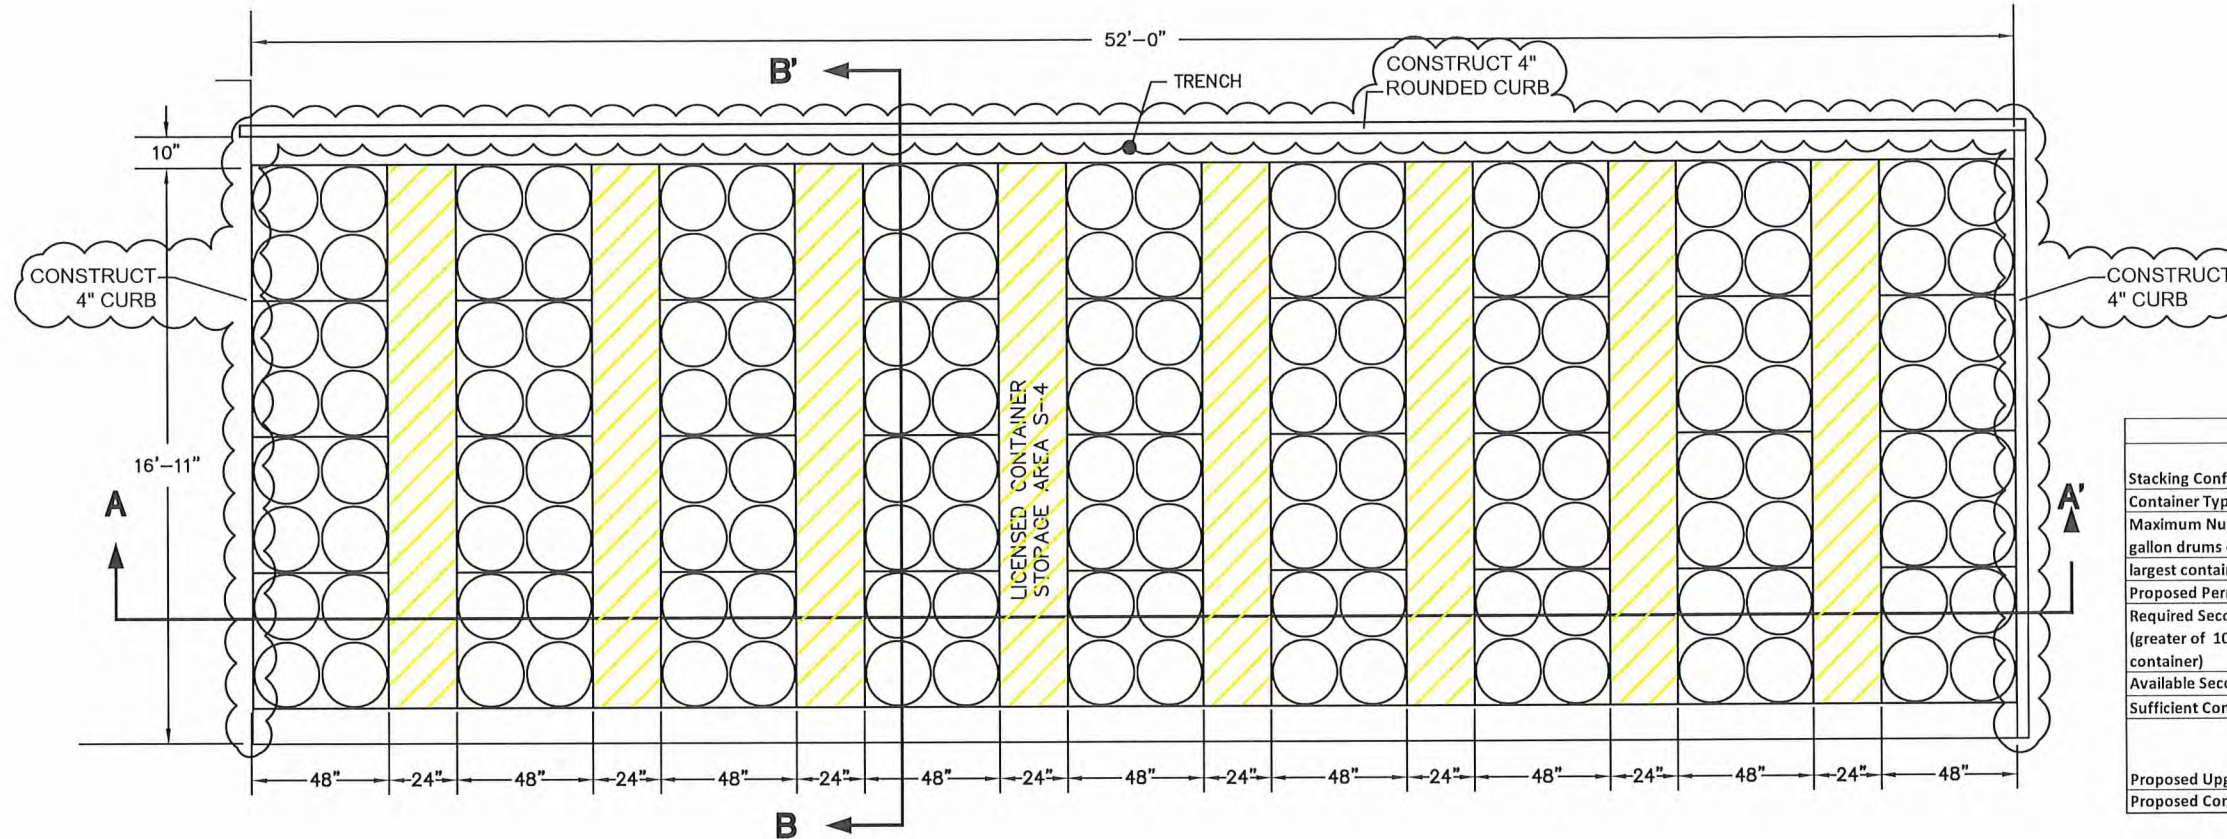
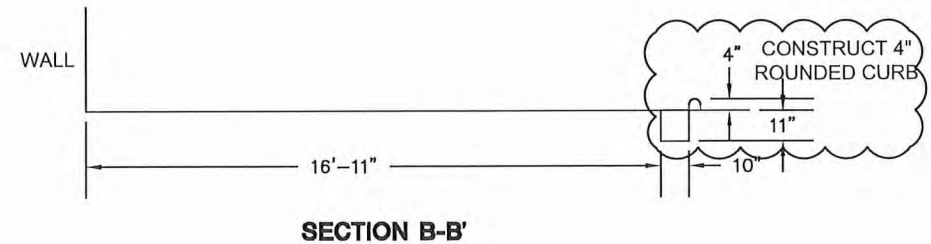
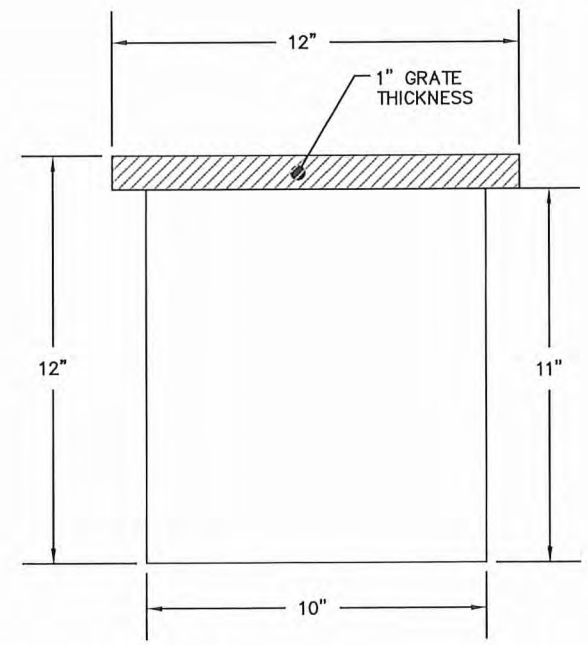
S-4 Containment Area	
Stacking Configuration	2-Tier Stacking
Container Type	Drum
Maximum Number of Liquid Containers (55-gallon drums or DE)	256
Largest container (gallons)	55
Proposed Permitted Capacity (Gallons)	14,080
Required Secondary Containment Capacity (greater of 10% of total capacity or largest container)	1,408
Available Secondary Containment (gallons)	297
Sufficient Containment?	No
Proposed Upgrades	Add 4 inch curbing. See details on drawing.
Proposed Containment (gallons)	1,478

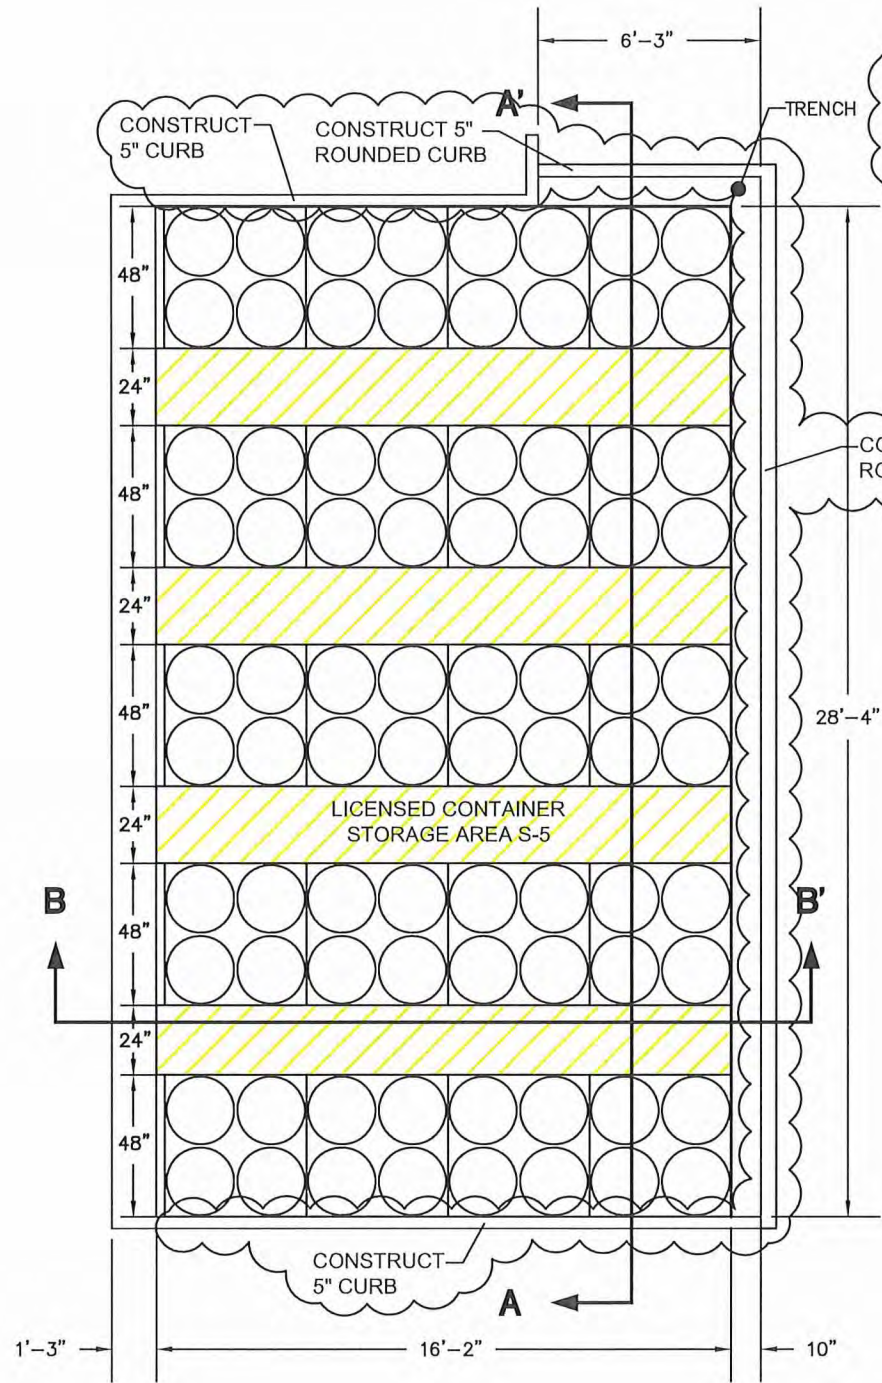
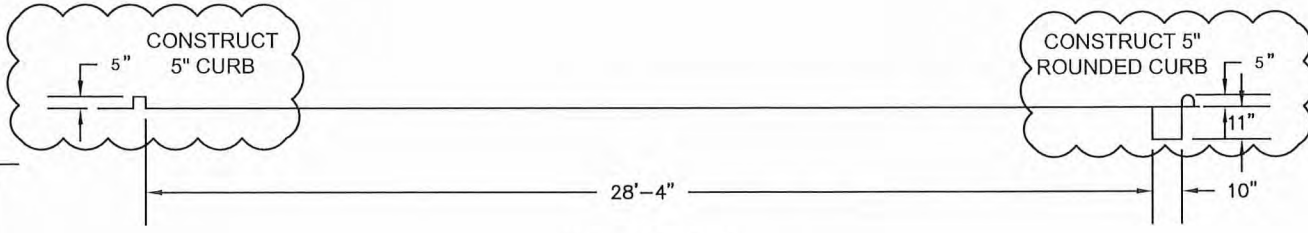
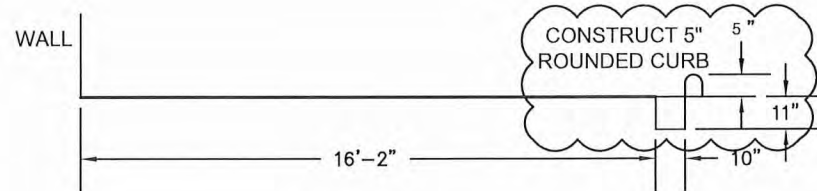
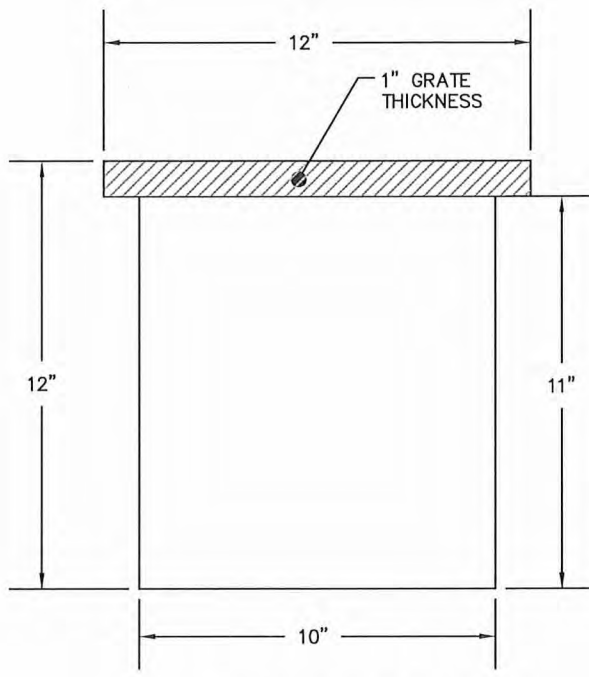
<b>WM Waste, Inc.</b> Union Grove, Wisconsin	
<b>Storage Area S-5          Container Configuration</b>	
Racine County, WI	
	Drawn: CAL/KAC-rev    Checked: BDS Date: 06/03/2022    Approved: BHR Dwg. No.: WA5011-18114-46
<b>Figure 16-5</b>

S-5 Containment Area	
Stacking Configuration	2-Tier Stacking
Container Type	Drum
Maximum Number of Liquid Containers (55-gallon drums or DE)	160
largest container (gallons)	55
Proposed Permitted Capacity (Gallons)	8,800
Required Secondary Containment Capacity (greater of 10% of total capacity or largest container)	880
Available Secondary Containment (gallons)	198
Sufficient Containment?	No
Proposed Upgrades	Add 5 inch curbing. See details on drawing.
Proposed Containment (gallons)	942

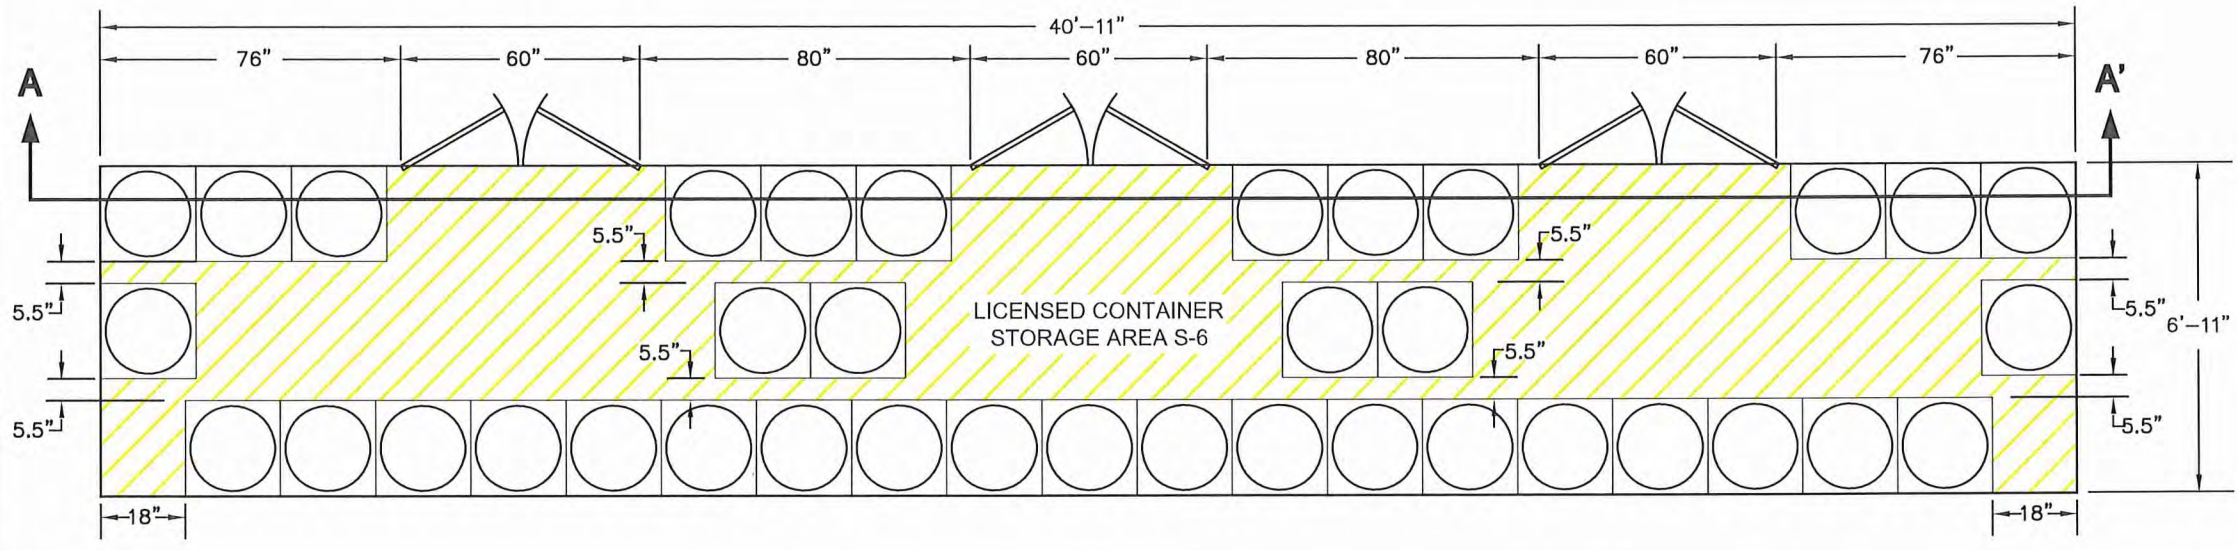
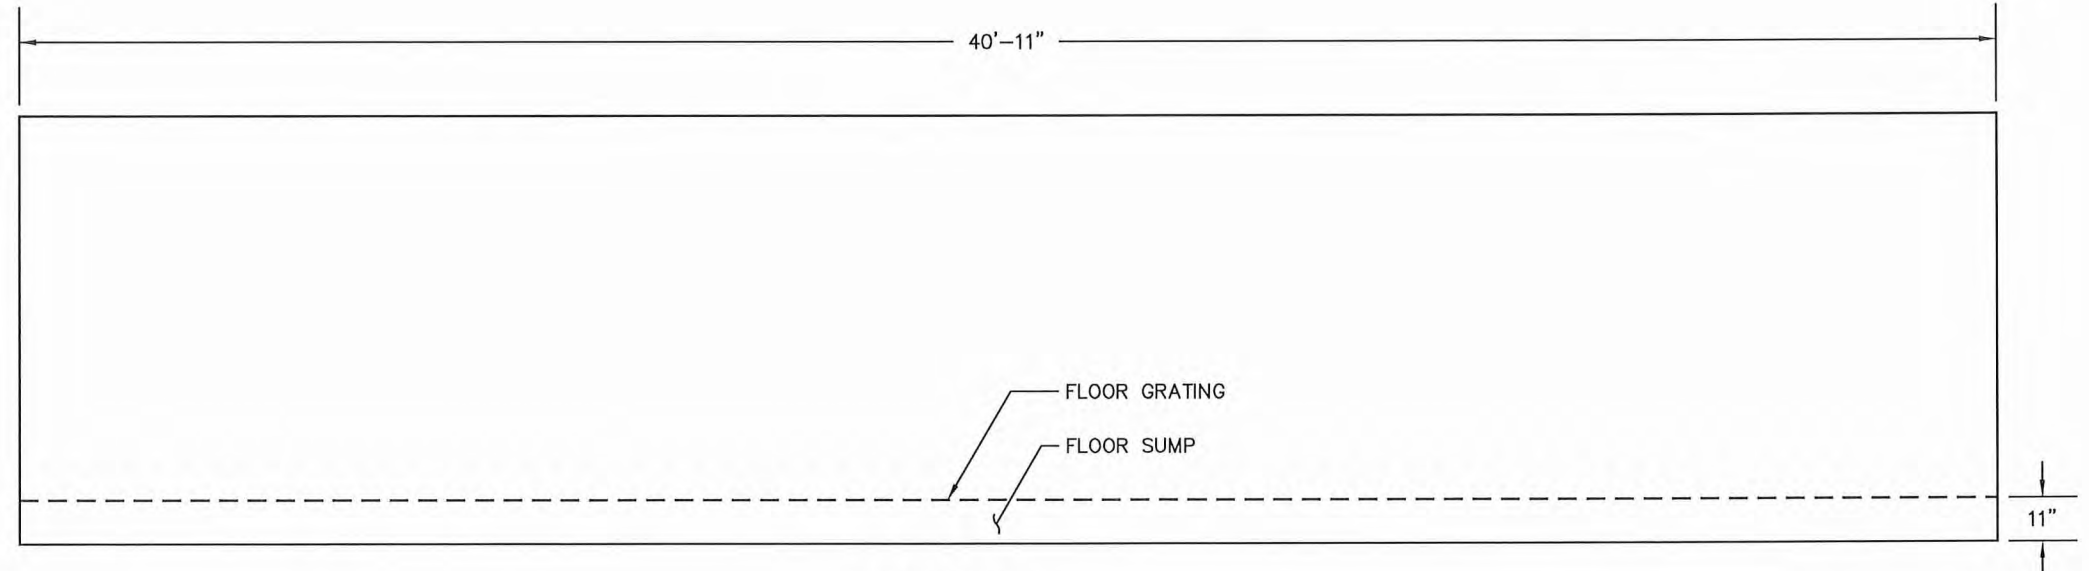
<b>WM Waste, Inc.</b> Union Grove, Wisconsin	
<b>Storage Area S-6</b> <b>Container Configuration</b>	
Racine County, WI	
	Drawn: CAL/KAC-rev    Checked: BDS Date: 06/14/2022    Approved: BHR Dwg. No.: WA5011-18114-47
<b>Figure 16-6</b>

**SECTION A-A'**

S-6 Containment Area	
Stacking Configuration	1-Tier Stacking
Container Type	Drum
Maximum Number of Liquid Containers (55-gallon drums or DE)	37
Largest container (gallons)	55
Proposed Permitted Capacity (Gallons)	2,035
Required Secondary Containment Capacity (greater of 10% of total capacity or largest container)	204
Available Secondary Containment (gallons)	1,941
Sufficient Containment?	Yes
Proposed Upgrades	None
Proposed Containment (gallons)	1,941

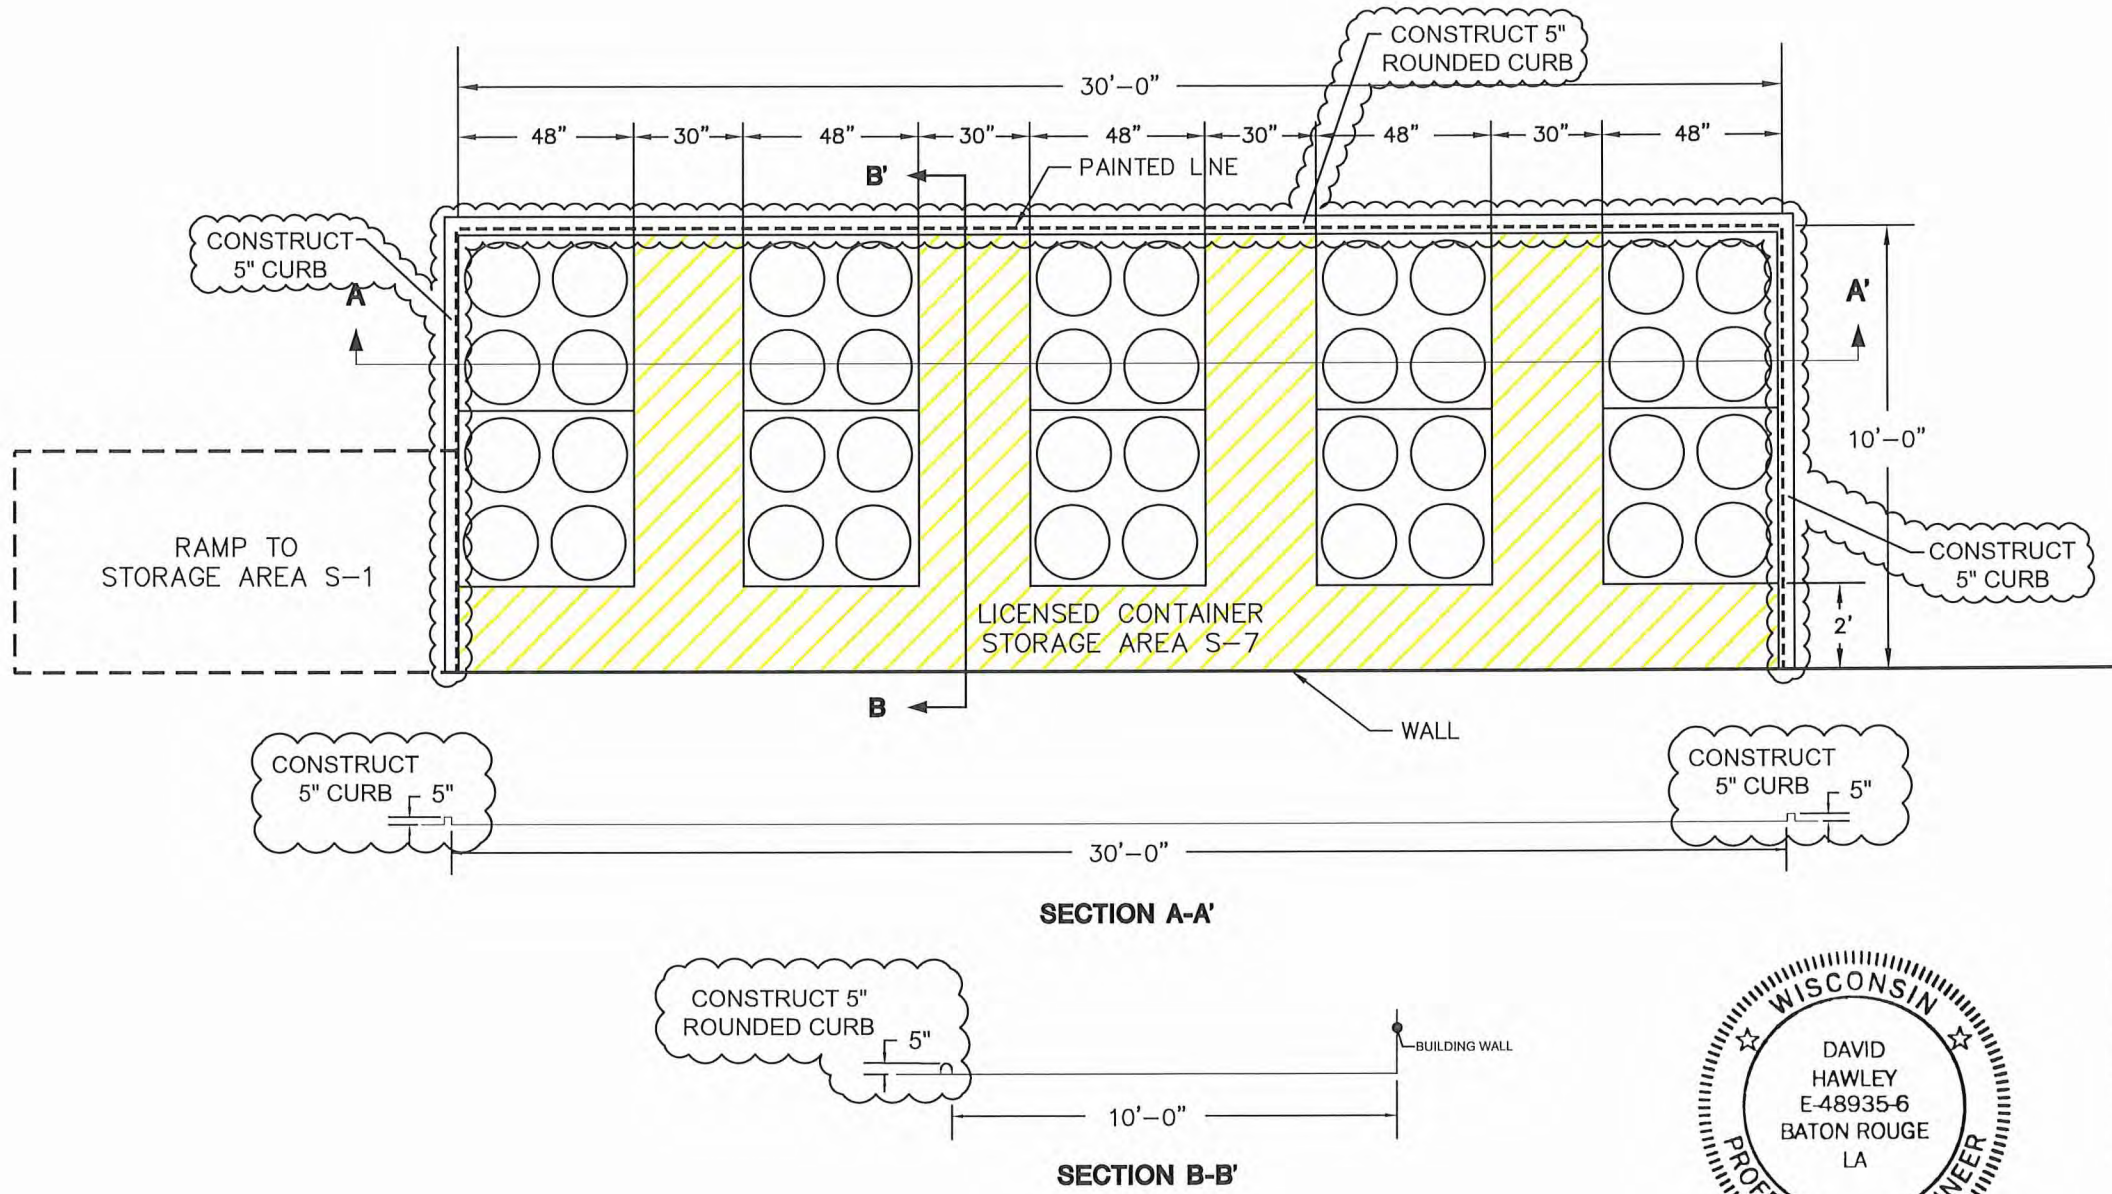
S-7 Containment Area	
Container Configuration	2-Tier Stacking
Container Type	Drum or Tote
Maximum Number of Liquid Containers (55-gallon drums or DE)	80
largest container (gallons)	275
Proposed Permitted Capacity (Gallons)	4,400
Required Secondary Containment Capacity (greater of 10% of total capacity or largest container)	440
Available Secondary Containment (gallons)	0
Sufficient Containment?	No
Proposed Upgrades	Add 5 inch curbing. See details on drawing.
Proposed Containment (gallons)	553

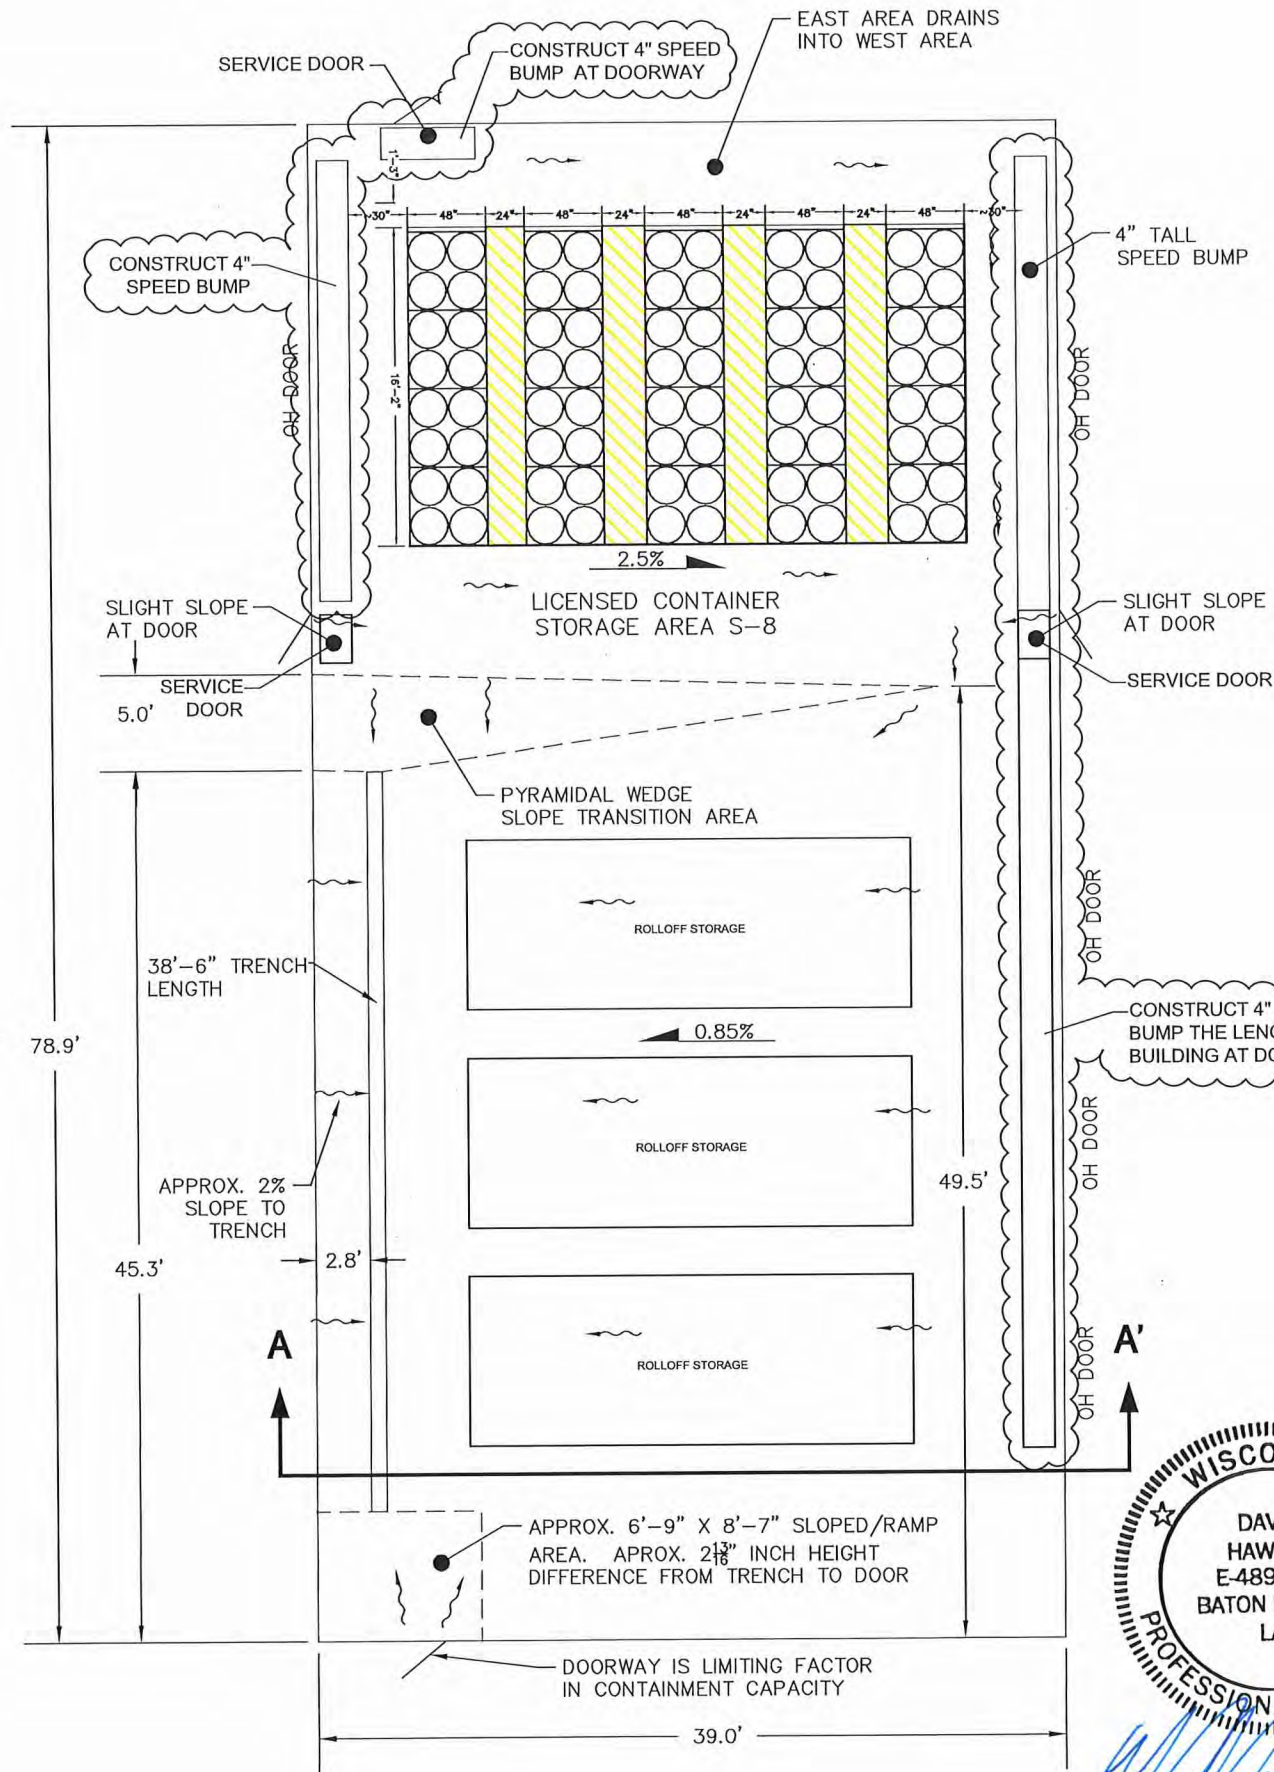
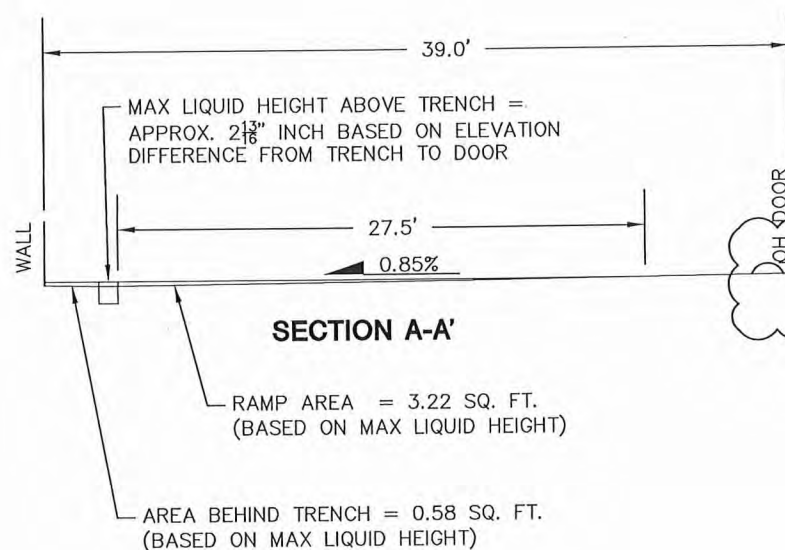
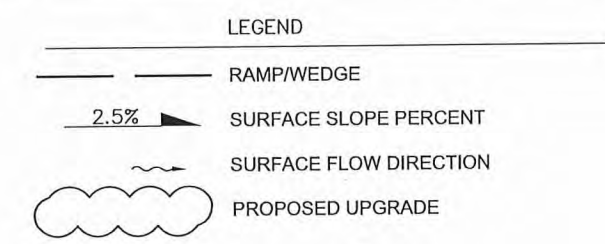
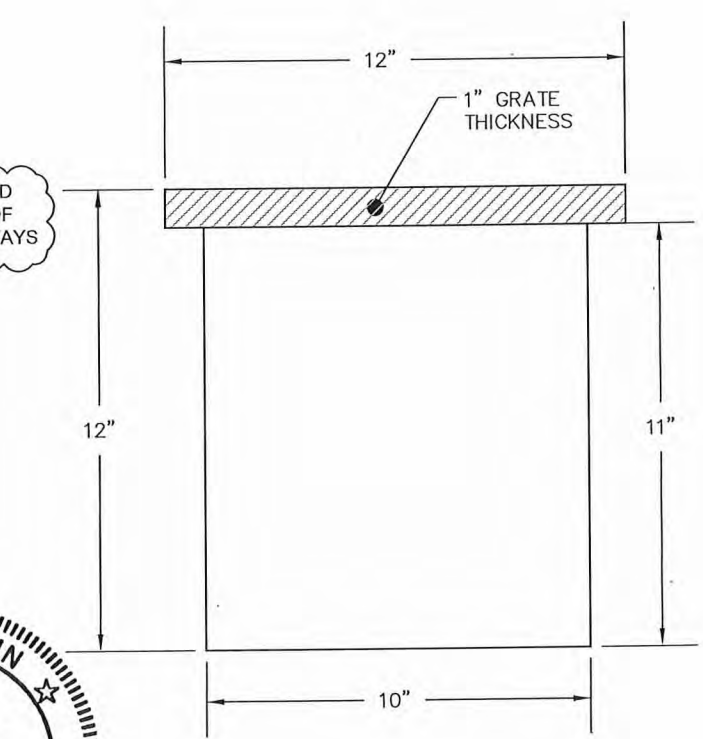
**Storage Area S-8  
Container Configuration**

S-8 Containment Area	
Container Configuration	3 Roll-Off Boxes, 2-Tier Stacking
Container Type	Roll-Off Box, Drum
Maximum Number of Liquid Containers (55-gallon drums or DE)	3 40 yd roll-off boxes, 160 Drums
largest container (gallons)	8,079
Proposed Permitted Capacity (Gallons)	33,037
Required Secondary Containment Capacity (greater of 10% of total capacity or largest container)	8,079
Available Secondary Containment (gallons)	1,545
Sufficient Containment?	No
Proposed Upgrades	Add 4 inch curbing. See details on drawing.
Proposed Containment (gallons)	8,278

**NOTES:**  
 EXISTING SECONDARY CONTAINMENT BASED ON FIELD MEASUREMENTS COLLECTED BY SCS ENGINEERS ON DECEMBER 1, 2020, AND DOCUMENTED IN A REPORT DATED DECEMBER 23, 2020. SCS MEASURED THE STORAGE AREA DIMENSIONS WITH A TAPE MEASURE AND A LASER DISTANCE MEASURE, AND MEASURED SLOPED AREAS WITH A LASER LEVEL.  
 S-8 MAY ALSO BE USED FOR COMPATIBLE HAZARDOUS WASTE DEBRIS CONSOLIDATION.

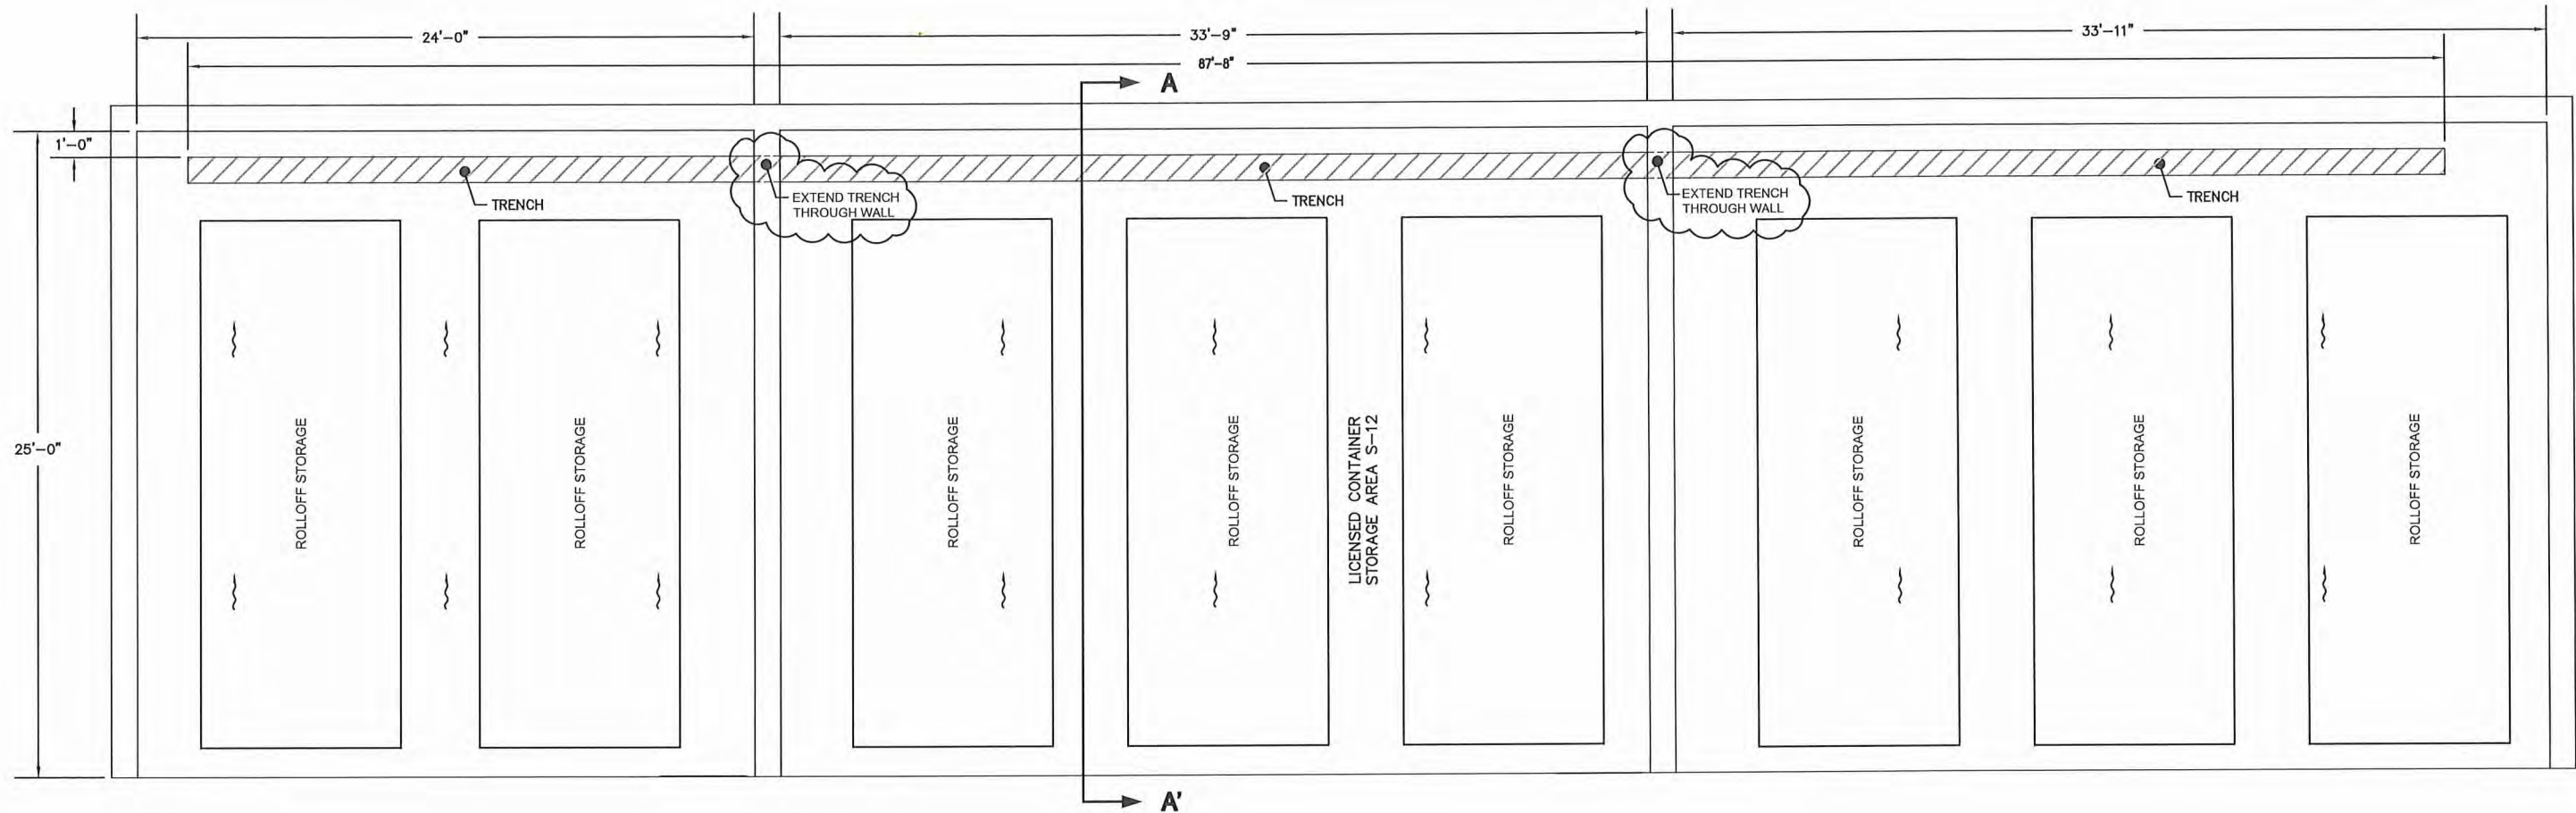
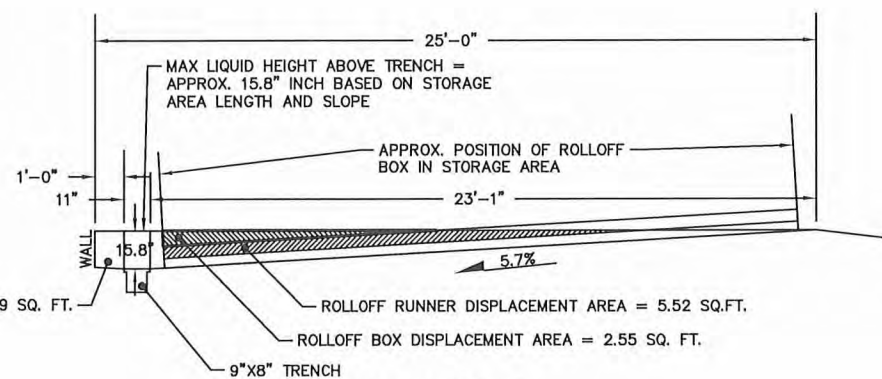
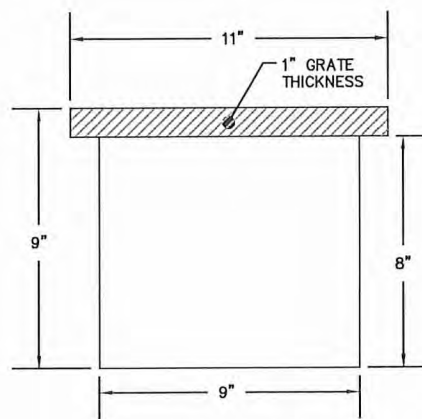
<b>WM Waste, Inc.</b> Union Grove, Wisconsin	
<b>Storage Area S-12          Container Configuration</b>	
Racine County, WI	
	Drawn: CAL/KAC-rev    Checked: BDS Date: 06/14/22    Approved: BHR Dwg. No.: WA5011-18114-50
<b>Figure 16-9</b>

SECTION A-A

TRENCH DETAIL

S-12 Containment Area	
Container Configuration	8 Roll-Off Boxes, spaced as previously in individual units
Container Type	Roll-Off Box
Maximum Number of Liquid Containers (55-gallon drums or DE)	8 40 yd roll-off boxes
largest container (gallons)	8,079
Proposed Permitted Capacity (Gallons)	64,627
Required Secondary Containment Capacity (greater of 10% of total capacity or largest container)	8,079
Available Secondary Containment (gallons)	4,127
Sufficient Containment?	No
Proposed Upgrades	Combine S-12, -13, and -14 into one unit. Extend trench through inner walls. See details on drawing.
Proposed Containment (gallons)	11,234

NOTE:  
 EXISTING SECONDARY CONTAINMENT BASED ON FIELD MEASUREMENTS COLLECTED BY SCS ENGINEERS ON DECEMBER 1, 2020, AND DOCUMENTED IN A REPORT DATED DECEMBER 23, 2020. SCS MEASURED THE STORAGE AREA DIMENSIONS WITH A TAPE MEASURE AND A LASER DISTANCE MEASURE, AND MEASURED SLOPED AREAS WITH A LASER LEVEL.

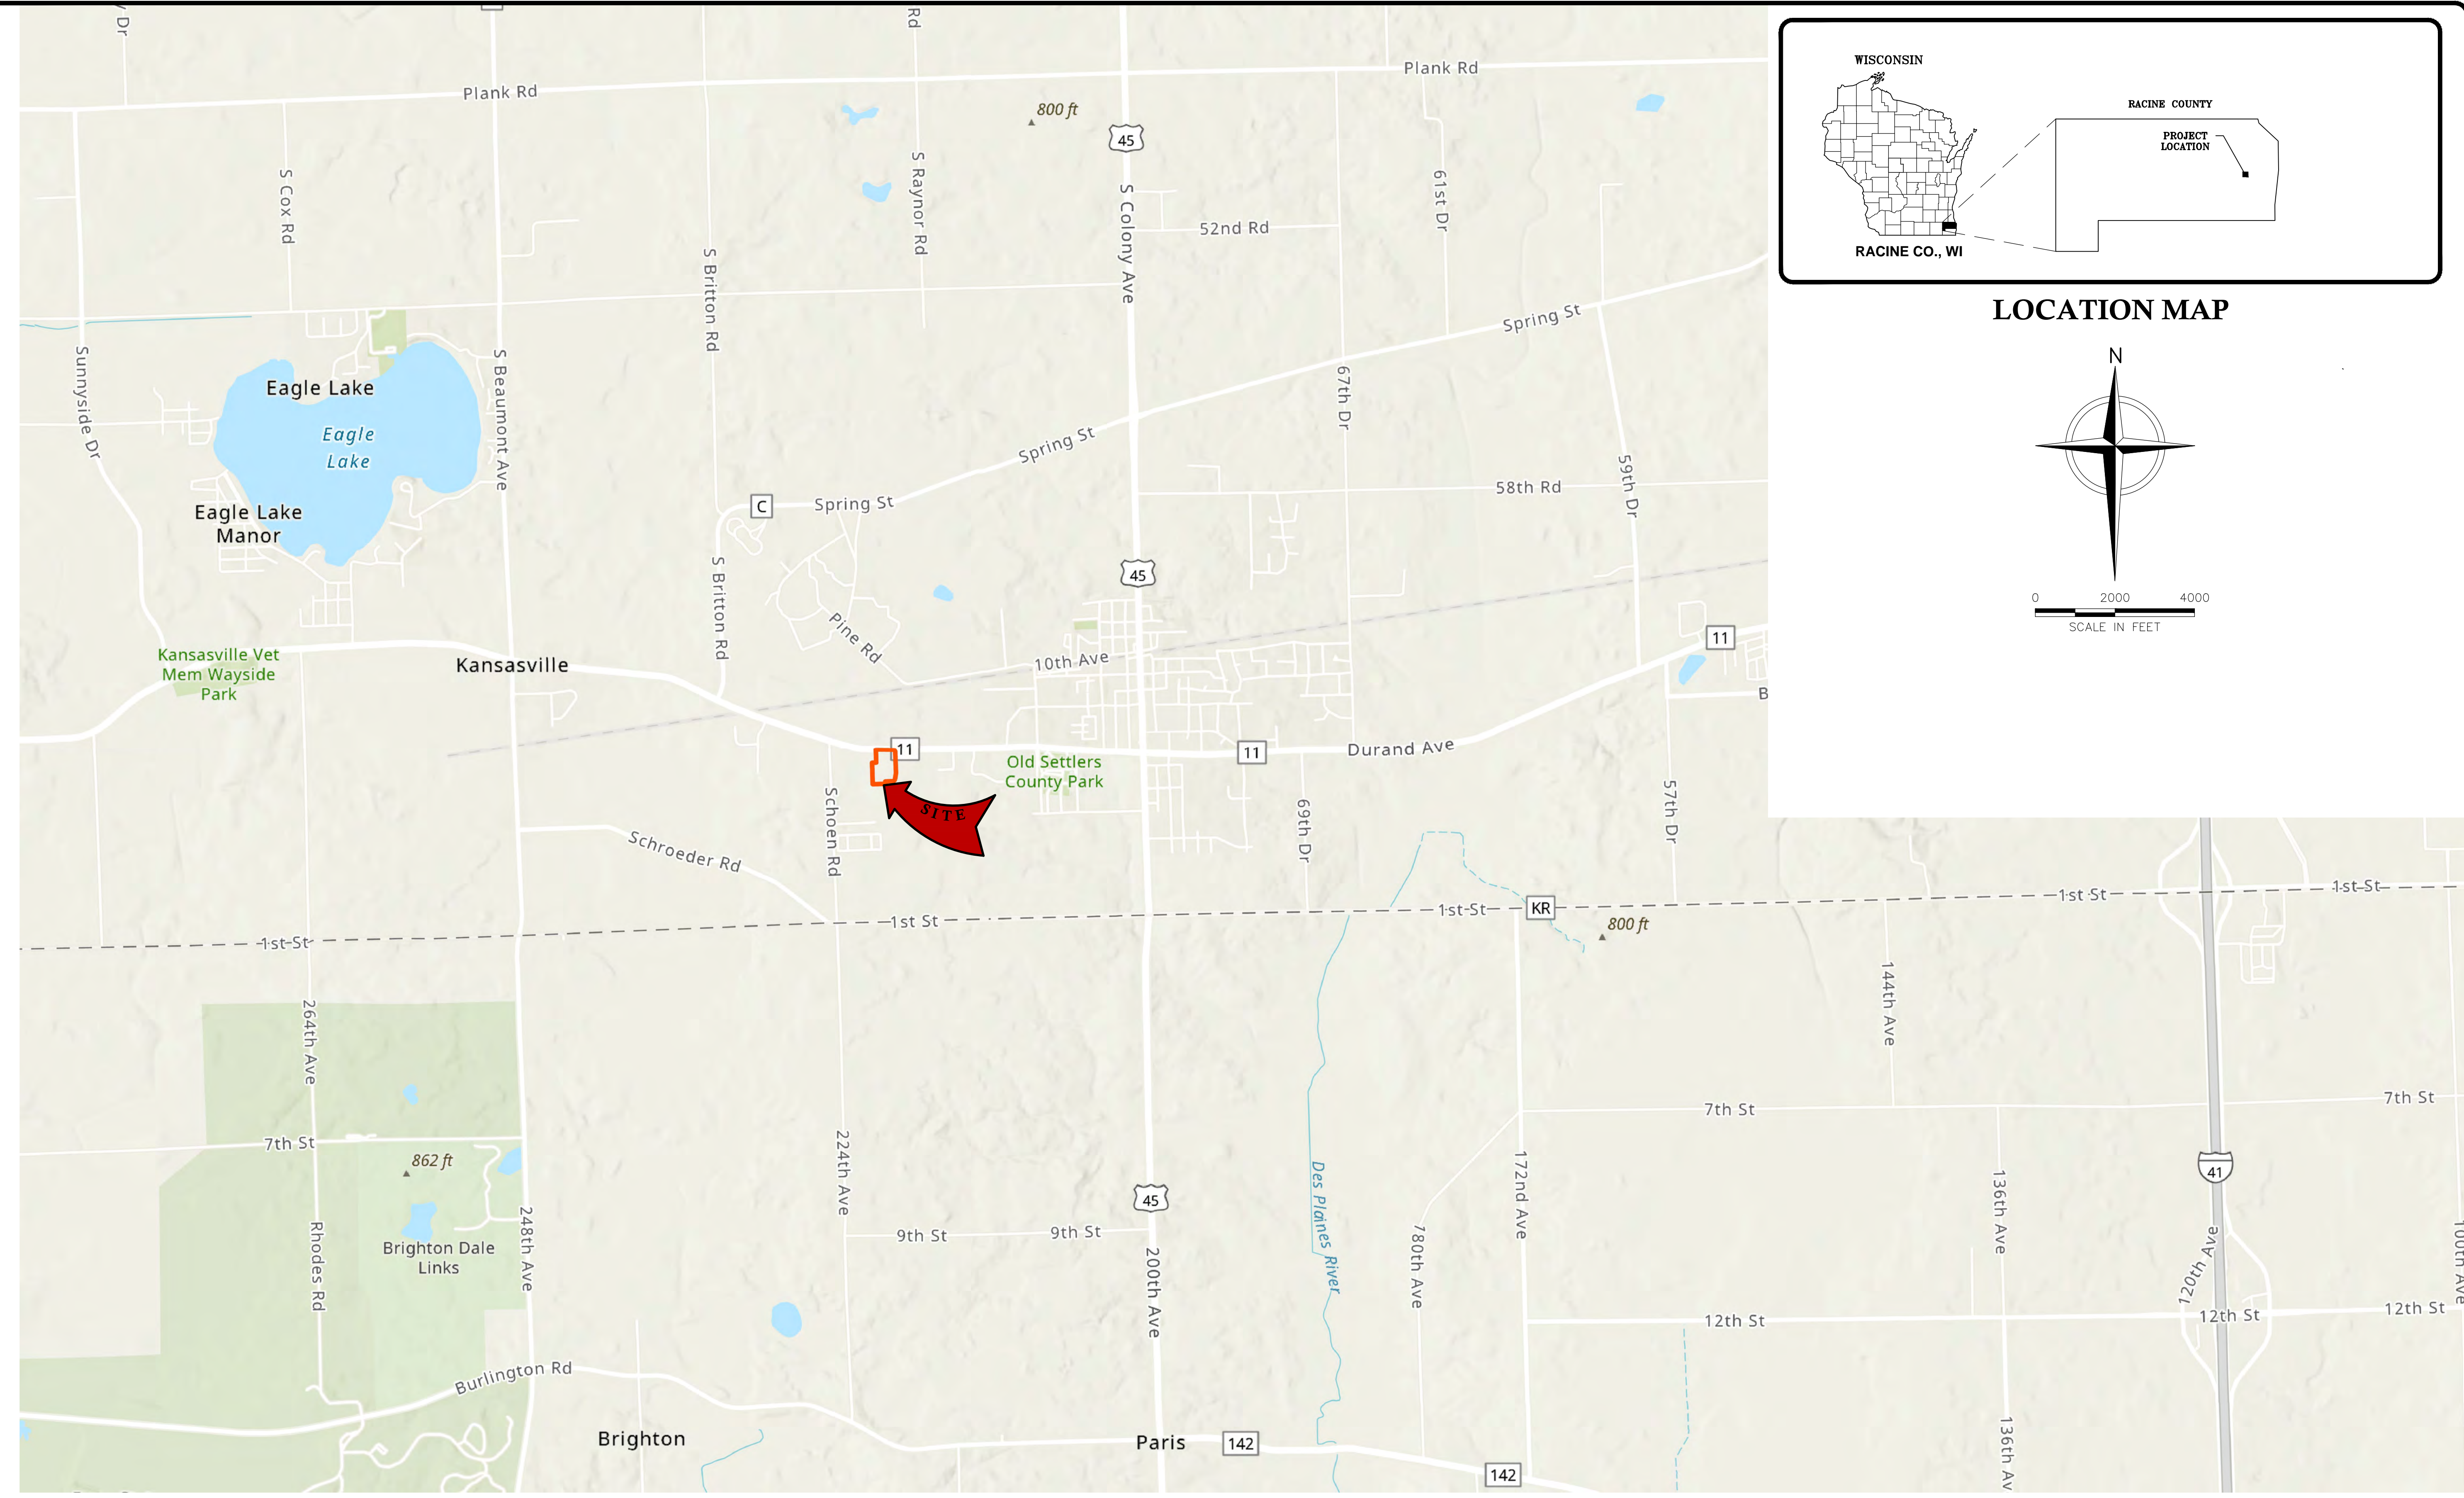
FIGURE NO.  
**2**  
 PROJECT NO.  
 4221563

- NOTES:**
- TETRA TECH COLLECTED SOIL SAMPLES, SURFACE WATER SAMPLES, AND PRIVATE WELL SAMPLES ON 5/24/2022.
  - SAMPLE LOCATIONS WERE SURVEYED IN THE FIELD.
  - TOTAL MERCURY CONCENTRATION RESULTS WERE REPORTED BY PACE ANALYTICAL JUNE 6, 2022 AND JUNE 7, 2022.
  - TOTAL MERCURY CONCENTRATION RESULTS DESIGNATED WITH A "J" QUALIFIER ARE ESTIMATED CONCENTRATIONS GREATER THAN THE LIMIT OF DETECTION AND LESS THAN THE LIMIT OF QUANTIFICATION.
  - THE 2017 EXISTING SURFACE IS TAKEN FROM THE WI STATE CARTOGRAPHER'S OFFICE.

WM WASTE, INC.  
 UNION GROVE, WISCONSIN  
**2022 SITE INVESTIGATION REPORT AND  
 REMEDIAL ACTION PLAN**  
**SITE INVESTIGATION SAMPLING LOCATIONS**
