**Appendix 14 RCRA Feasibility Investigation (RFI) Report -  
2003**

# Hazardous Waste Facility Investigation

## Task I

**Mercury Waste Solutions, Inc.**  
**Administrative Offices**  
**21211 Durand Avenue**  
**Union Grove, Wisconsin 53182-9711**

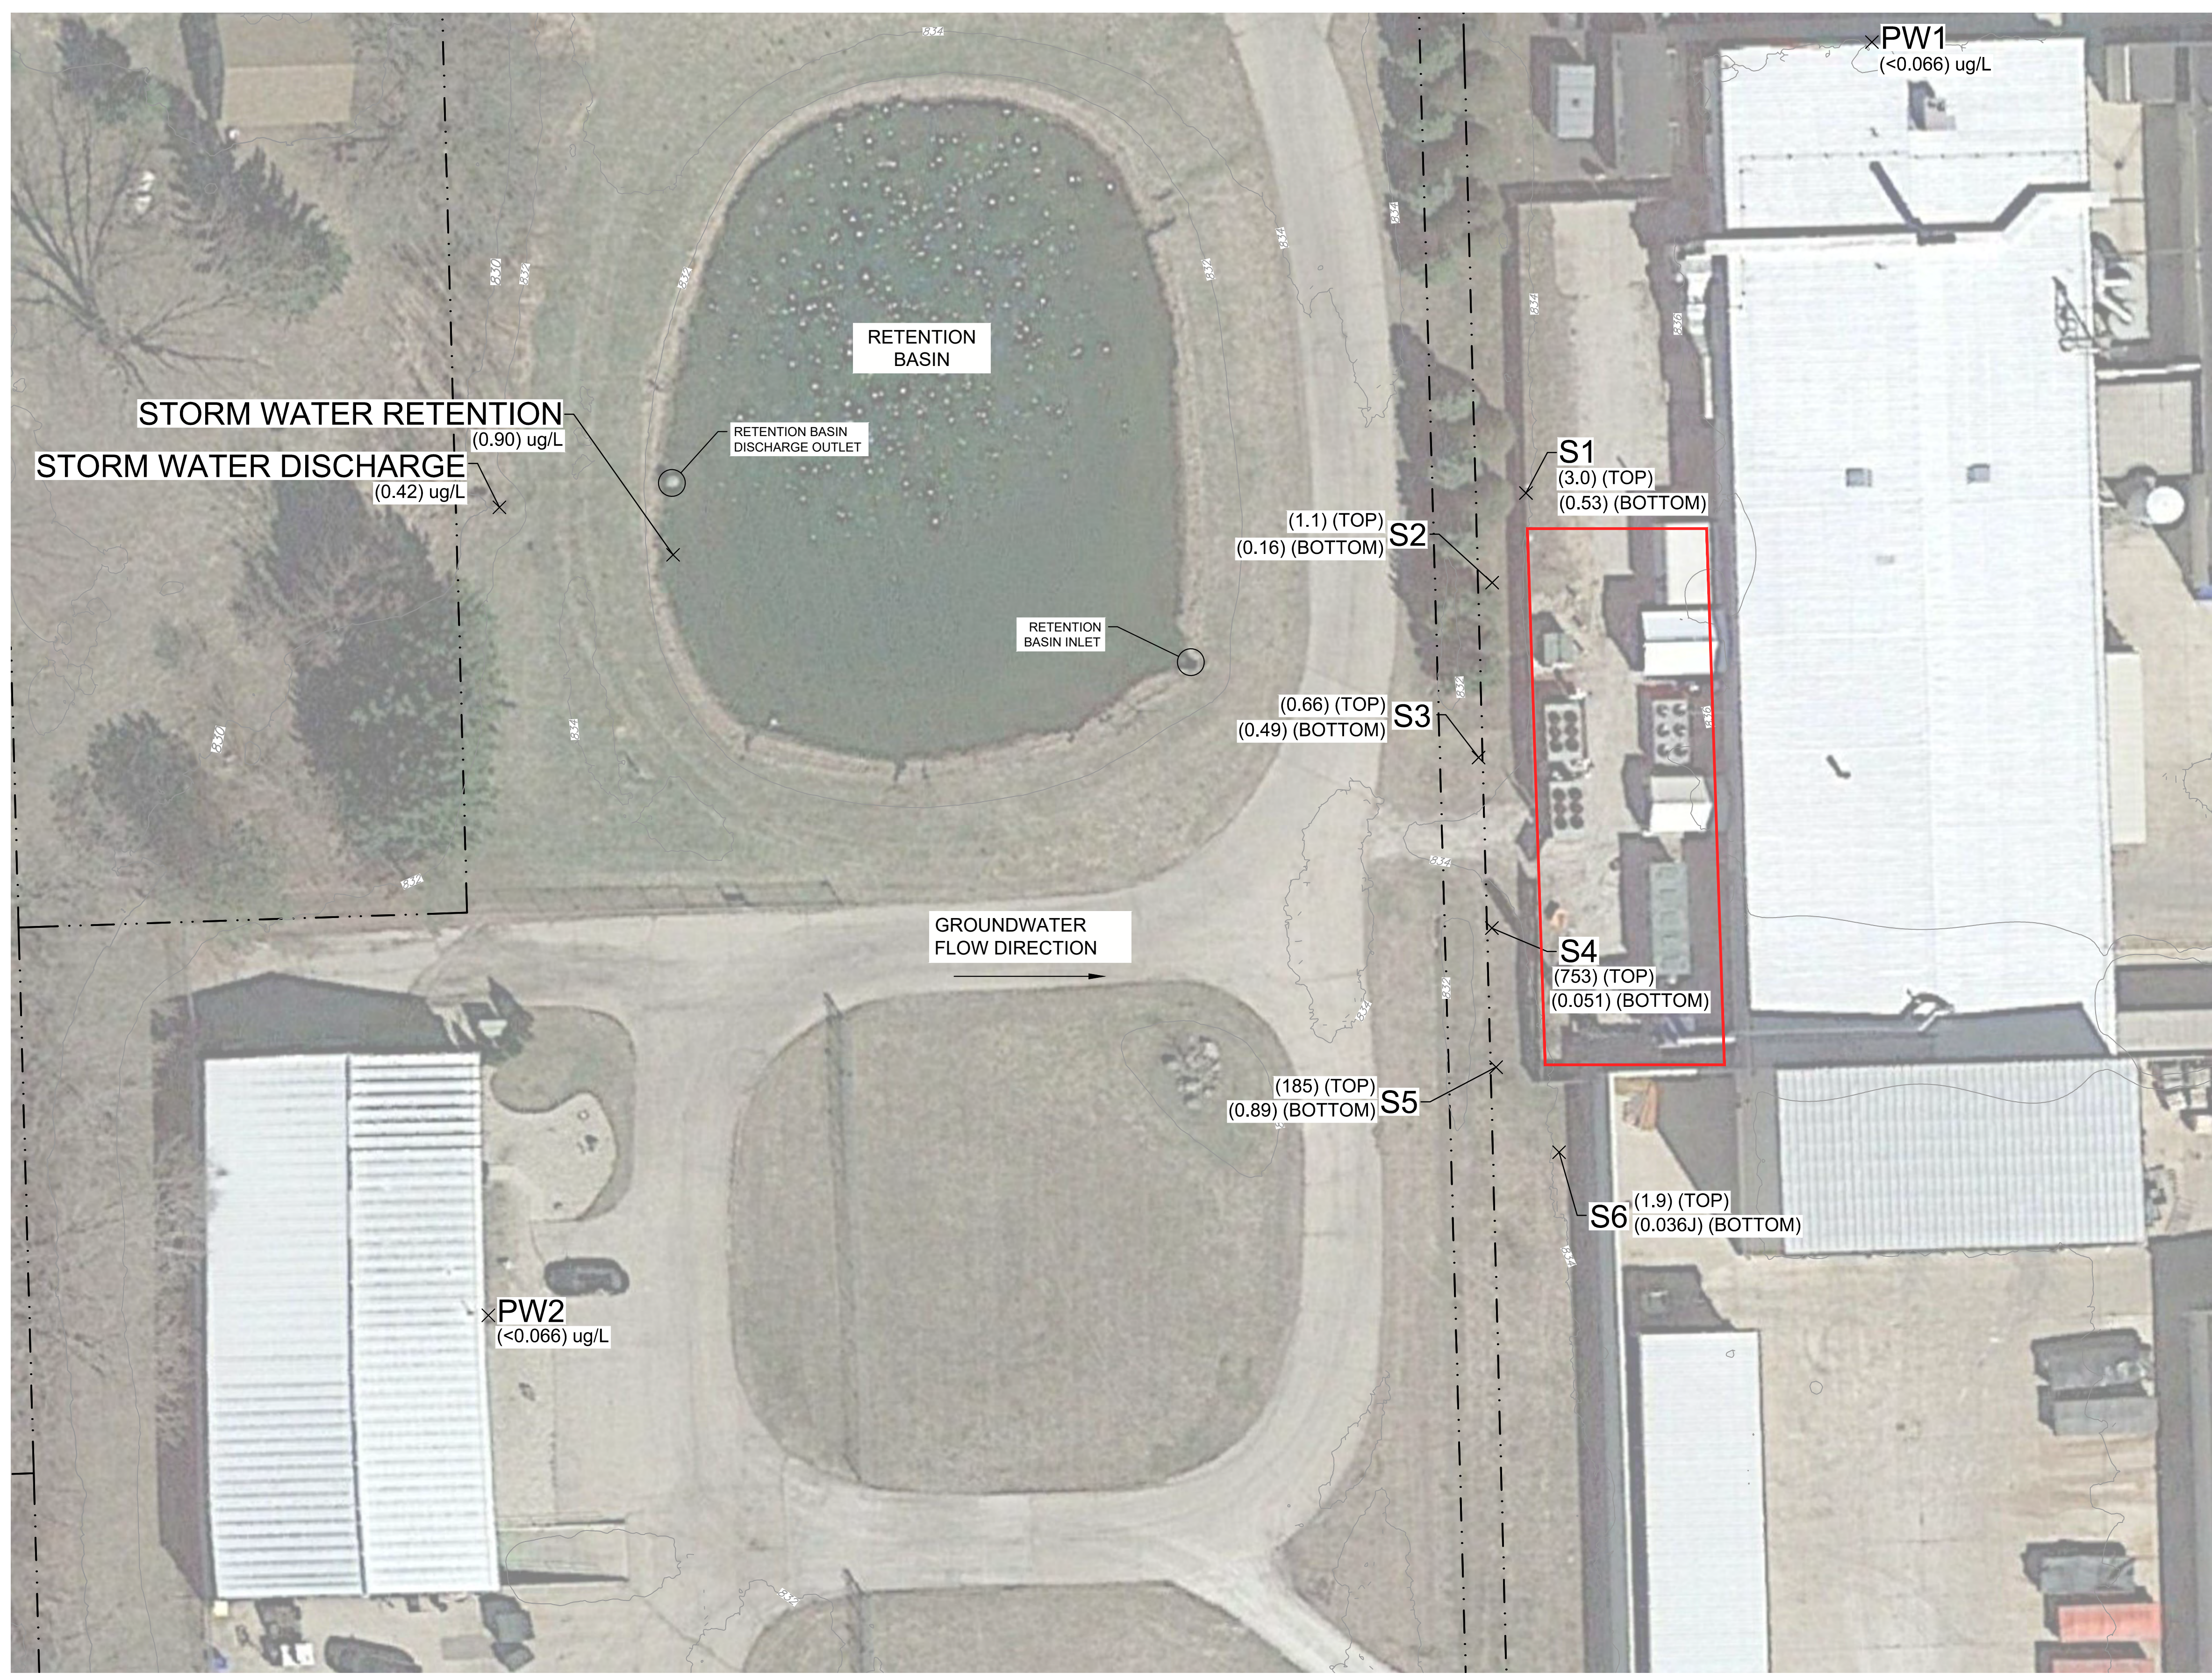
WM WASTE, INC.  
 UNION GROVE, WISCONSIN  
**2022 SITE INVESTIGATION REPORT AND  
 REMEDIAL ACTION PLAN**  
**SITE INVESTIGATION SAMPLING LOCATIONS**

- NOTES:**
- TETRA TECH COLLECTED SOIL SAMPLES, SURFACE WATER SAMPLES, AND PRIVATE WELL SAMPLES ON 5/24/2022.
  - SAMPLE LOCATIONS WERE SURVEYED IN THE FIELD.
  - TOTAL MERCURY CONCENTRATION RESULTS WERE REPORTED BY PACE ANALYTICAL JUNE 6, 2022 AND JUNE 7, 2022.
  - TOTAL MERCURY CONCENTRATION RESULTS DESIGNATED WITH A "J" QUALIFIER ARE ESTIMATED CONCENTRATIONS GREATER THAN THE LIMIT OF DETECTION AND LESS THAN THE LIMIT OF QUANTIFICATION.
  - THE 2017 EXISTING SURFACE IS TAKEN FROM THE WI STATE CARTOGRAPHER'S OFFICE.

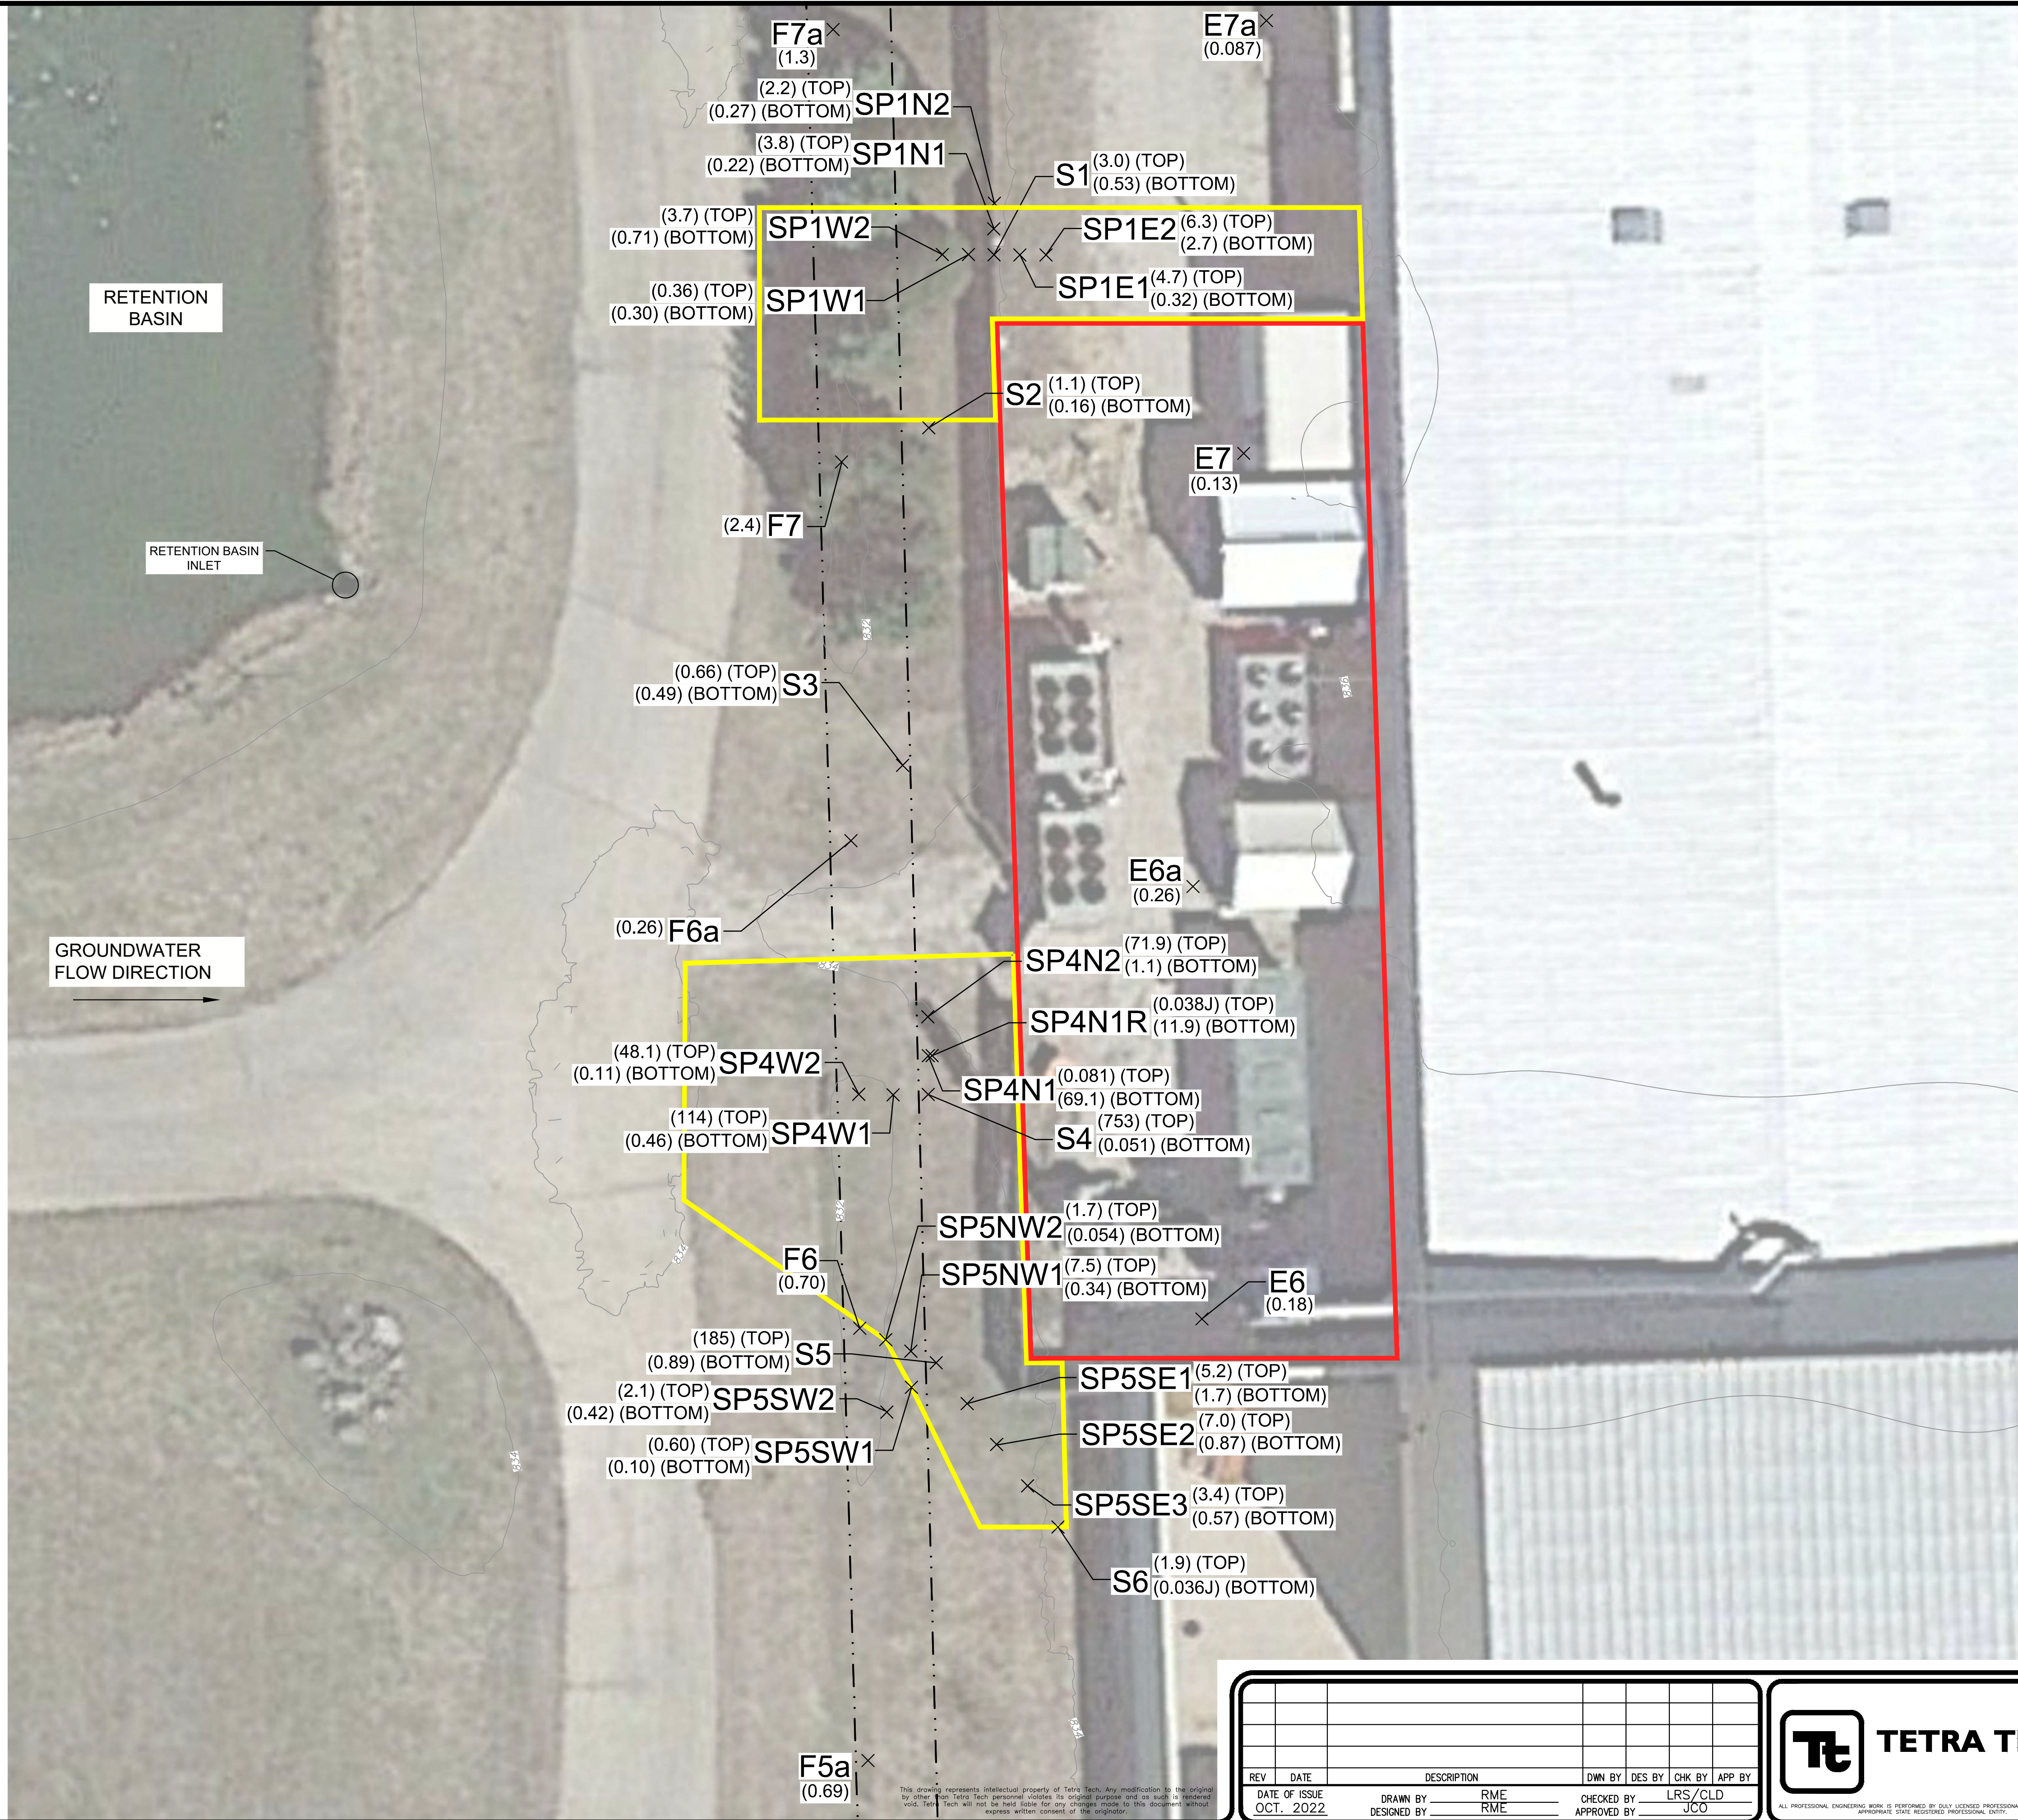
WM WASTE, INC.  
 UNION GROVE, WISCONSIN  
**2022 SITE INVESTIGATION REPORT AND  
 REMEDIAL ACTION PLAN**  
**REMEDIAL EXCAVATION AREA BOUNDARY**

- NOTES: SP4N1 RE-SAMPLE:**
- RE-SAMPLE LOCATION IS DENOTED AS SP4N1R LOCATED 4' TO THE EAST OF SP4N1.
  - TETRA TECH COLLECTED SOIL SAMPLE ON 8/17/2022.
  - SAMPLE LOCATION WAS SURVEYED IN THE FIELD.
  - TOTAL MERCURY CONCENTRATION RESULT WAS REPORTED BY PACE ANALYTICAL AUGUST 22, 2022.
