Permit Fact Sheet

Permit Number:	WI-0063088-04-0
Permittee Name:	Madison Gas & Electric Compensatory Recharge
Address:	P.O. Box 1231
City/State/Zip:	Madison WI 53701-1231
Discharge Location:	NW ¼ of NW ¼ of Section 32, T7N, R9E
Receiving Water:	Groundwaters of the Yahara River and Lake Mendota Watershed
StreamFlow (Q _{7,10}):	N/A
Stream Classification:	N/A
Discharge Type:	Existing Intermittent

SUBJECT: Groundwater Evaluation for Madison Gas and Electric Compensatory Recharge WI-0063088-03

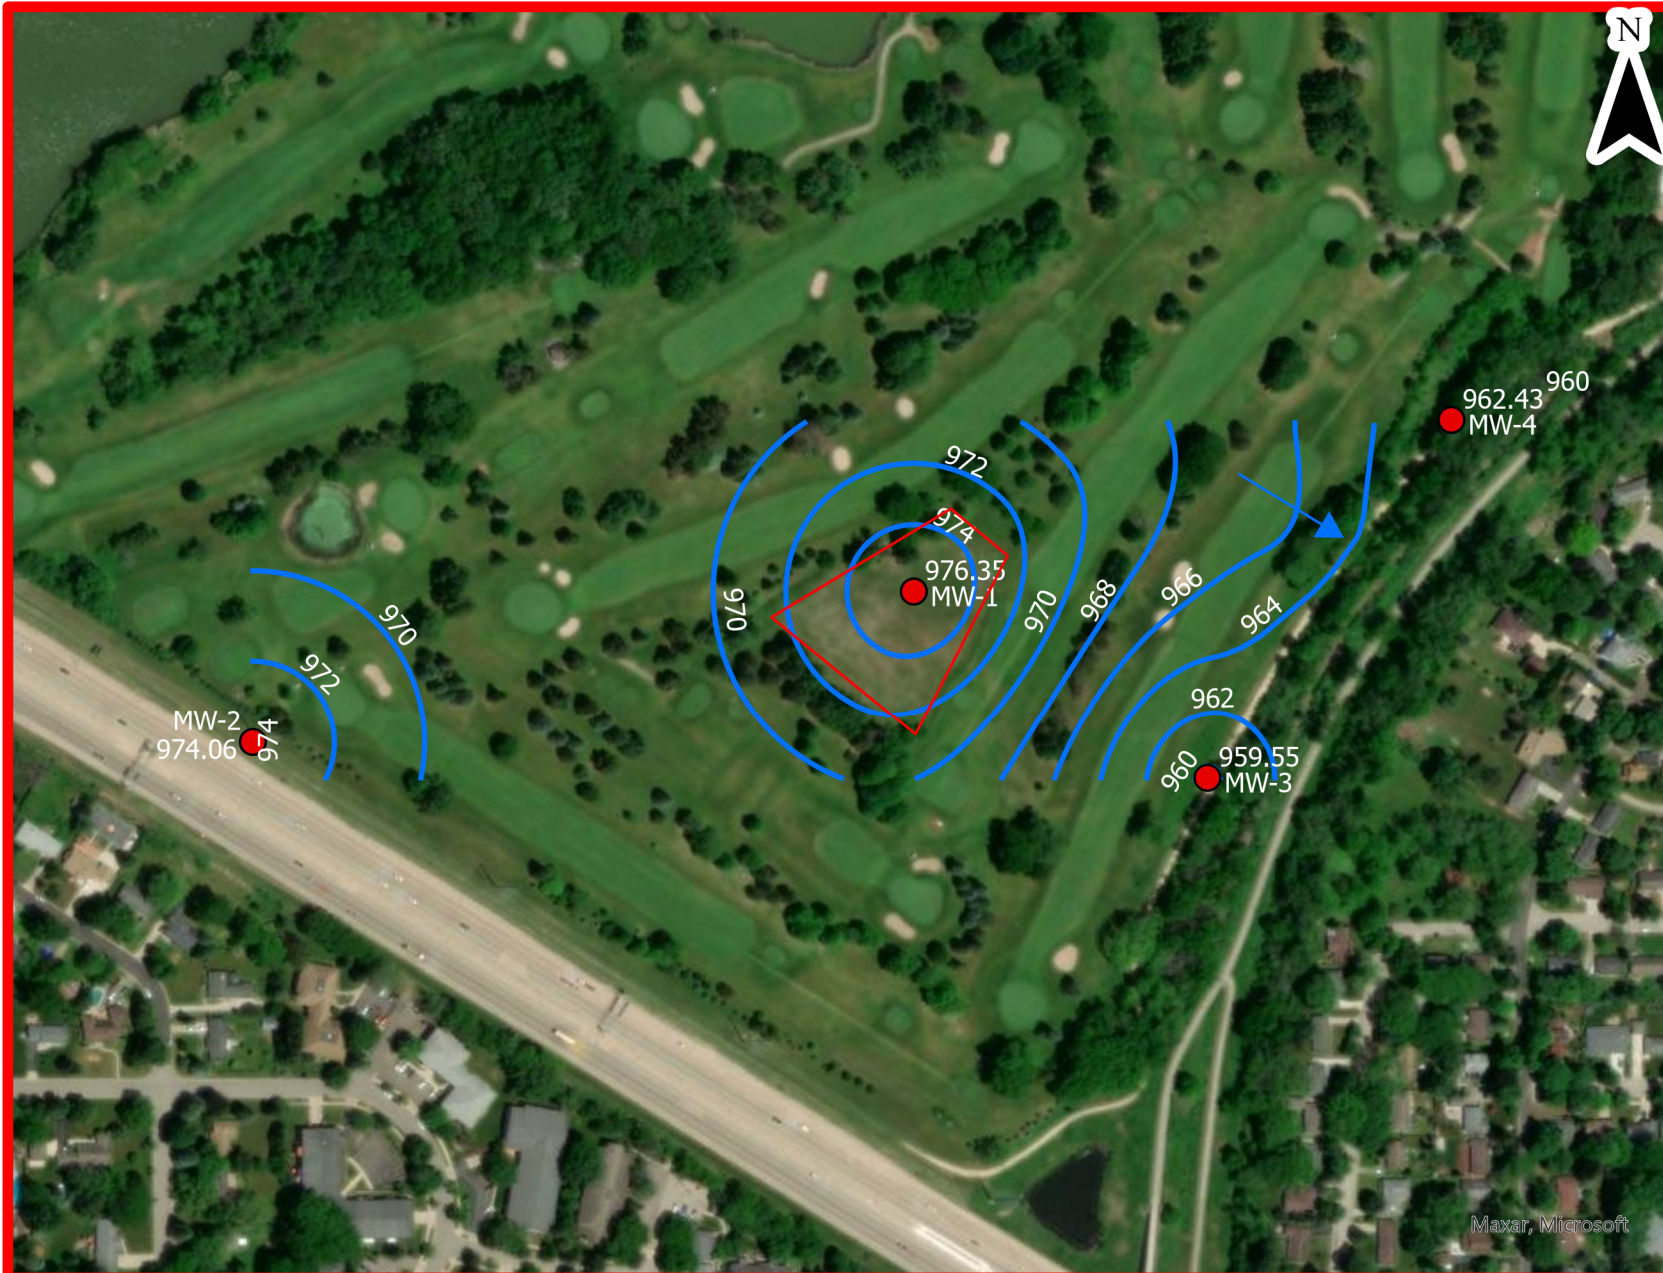
Figure 2 – Infiltration Gallery Groundwater Flow Map – October 3, 2023

Water Table Flow Map

Water table contours generated using elevation data collected on October 3, 2023. Water table elevations and contours are presented in feet above mean sea level.

Interpretation of groundwater flow direction generated in ArcGIS Pro.

Regional groundwater flow is to the northeast towards Lake Mendota and Monona (Water-table elevation
