A-17 Burnett Chases Bents Rd

Project Title Bents Rd Bridge Replacement					Current Funded Miles 264	New Miles (if applicable)
County Burnett	Township 42 N	Range 15	Section 16	¼ ¼ <input type="radio"/> E <input checked="" type="radio"/> W	¼ NW	GPS Coordinates: Lat. 46.128614 Long. -92.2506

BURNETT COUNTY FOREST & PARKS
BRIDGE INSPECTION REPORT
Bents Road Bridge

BURNETT COUNTY FOREST & PARKS DEPT
BENTS ROAD BRIDGE REPLACEMENT
BURNETT COUNTY, WISCONSIN
GENERAL NOTES

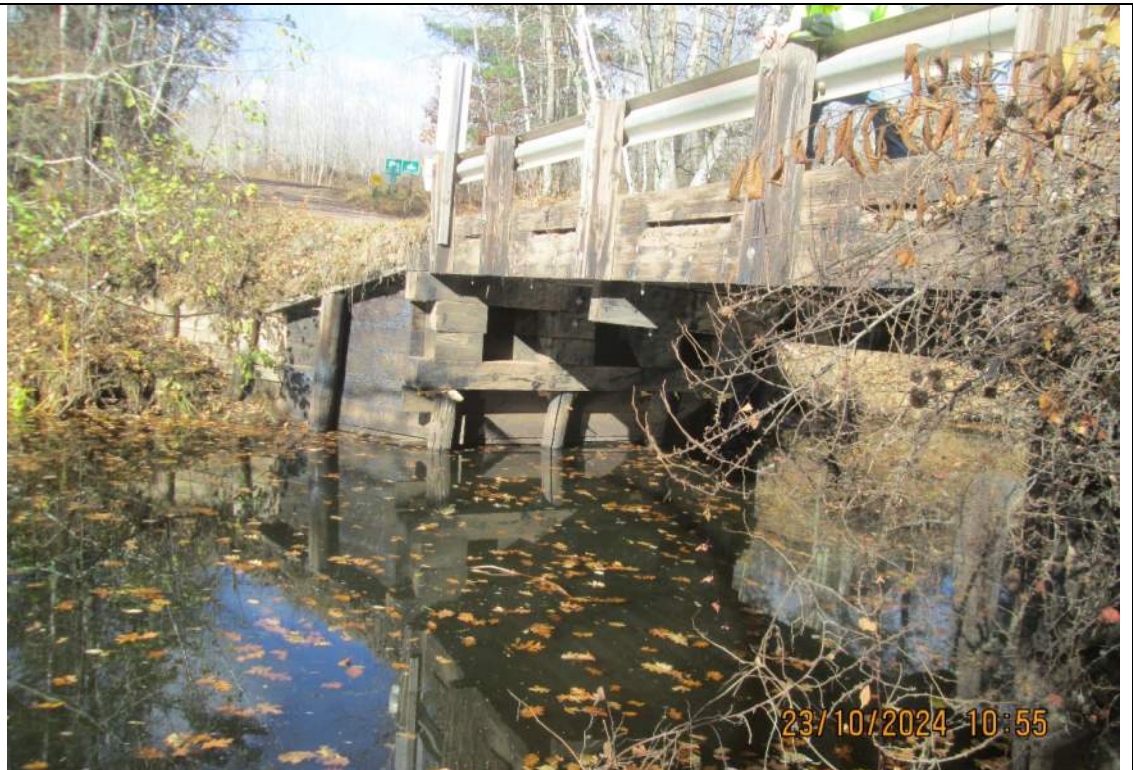
Photo No.
2 **Date:**
10-23-24

Timber Abutments & Wings – The abutments consist of 6 timber piling with timber backing. 4 piling support the bridge structure and the wings each have 1 pile. The piling and backing on the east abutment are in good condition; the west abutment is the same configuration as the east except there is blocking up from the original pile cap (see photo). Two of the piles on the west abutment have vertical cracks and are not plumb. The abutments appear to be stable at this time. The west abutment also have wing extensions that were added at some time in the past.

Fair to Poor Condition.

Bridge Side View
West Abutment –
Uncommon Construction

The timber nail laminated deck is in serious condition and needs to be replaced. It is obvious that there have been heavy loads that have broken some of the timbers and have distorted the nail laminated timber deck. The east abutment appears to be in good condition. The west abutment original construction is unusual with the blocking of the abutment to gain height. The bridge appears to be too short for this crossing and my ultimate recommendation is to replace this bridge in its entirety.

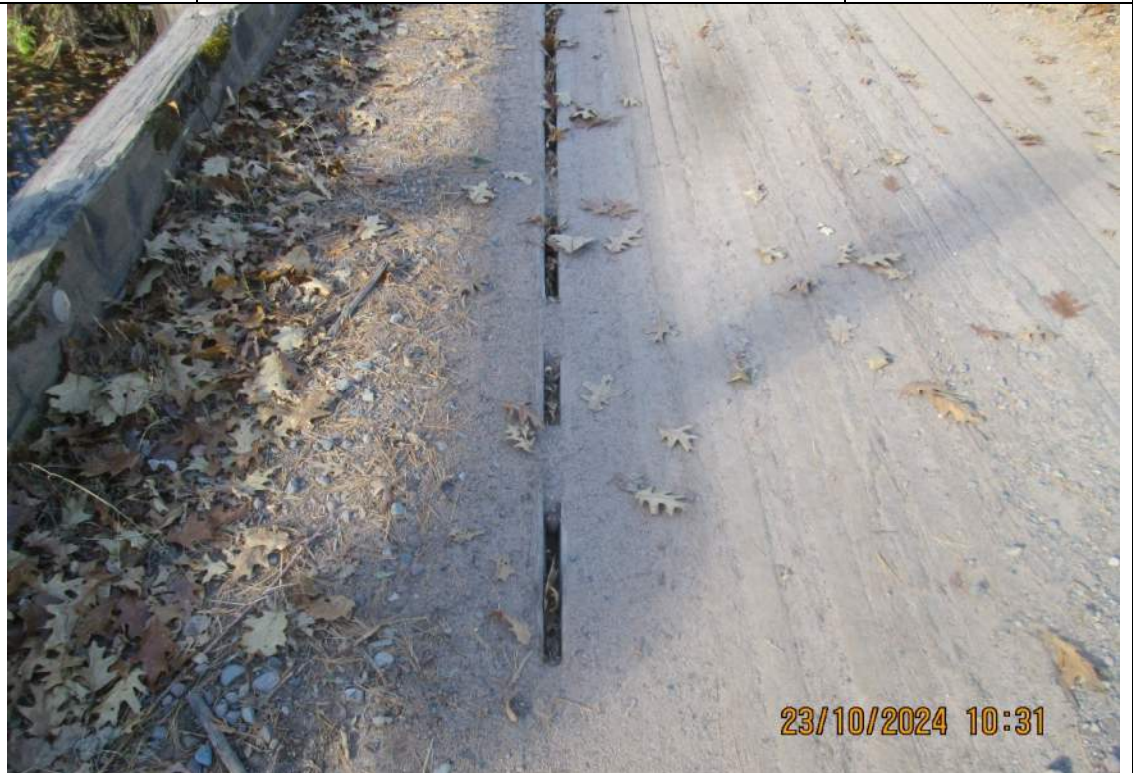
Photo No. 3
Date: 10-23-24

The timber deck has a noticeable dip at each wheel line across the entire structure. There is also a 1 ½” gap in the deck approximately 3.5-feet north of the south curb. From below the bridge, there are at least four of the timbers are broke west of the spreader beam.

Serious condition.

Gap in Nail Laminated Timber Deck

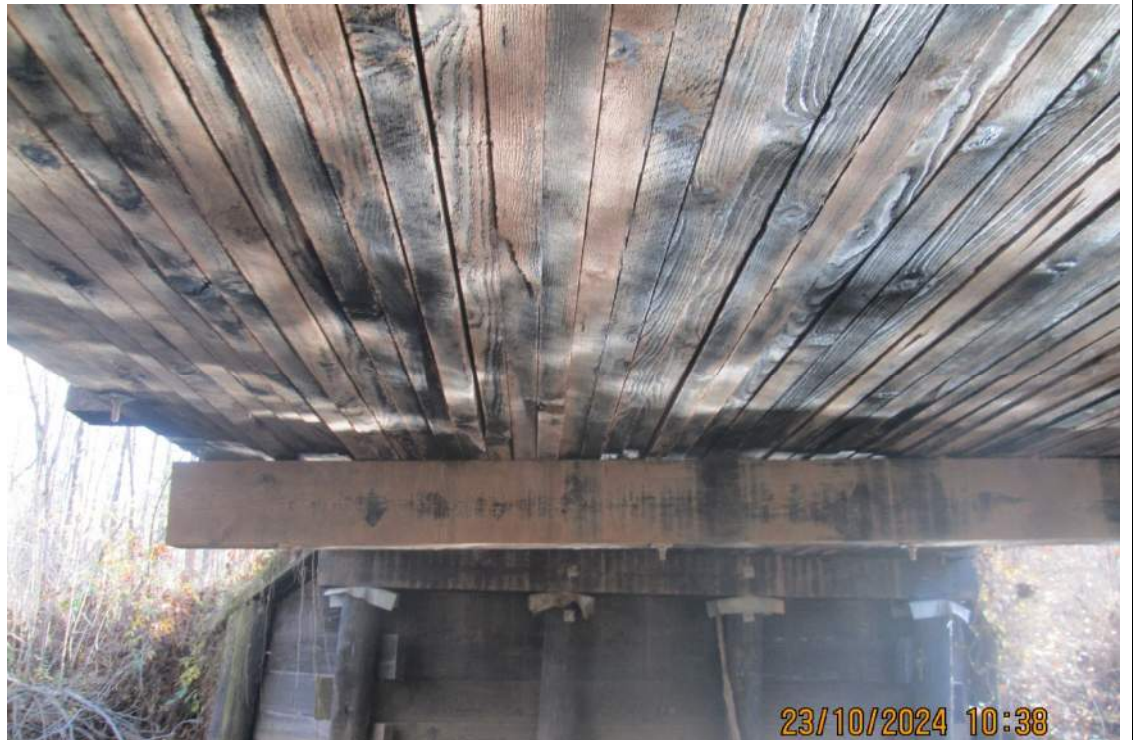
Photo No. 4
Date: 10-23-24

Spreader Beam – The spreader beam is a 12-inch by 12-inch timber that runs transverse to the timber deck to spread the live load to the timber deck. To be effective, the spreader beam has to be in direct contact with the timber deck. This is accomplished with bolt that run thru the deck and also thru the spreader beam. This spreader beam is in good condition but the spreader beam is not in contact with the timber deck along it entire length. With this in mind, I am rating the spreader beam as serious condition.

Serious Condition.

Broken timbers in the nail laminated deck.

Spreader Beam not in full contact with timber deck.

It is my recommendation to close this structure to vehicular traffic. It is also my opinion that the structure can carry snowmobile and ATV traffic at this time. A snowmobile groomer should not be allowed to cross this structure. If the structure is to remain open to snowmobile and ATV traffic, it should be inspected at a 6 month interval.

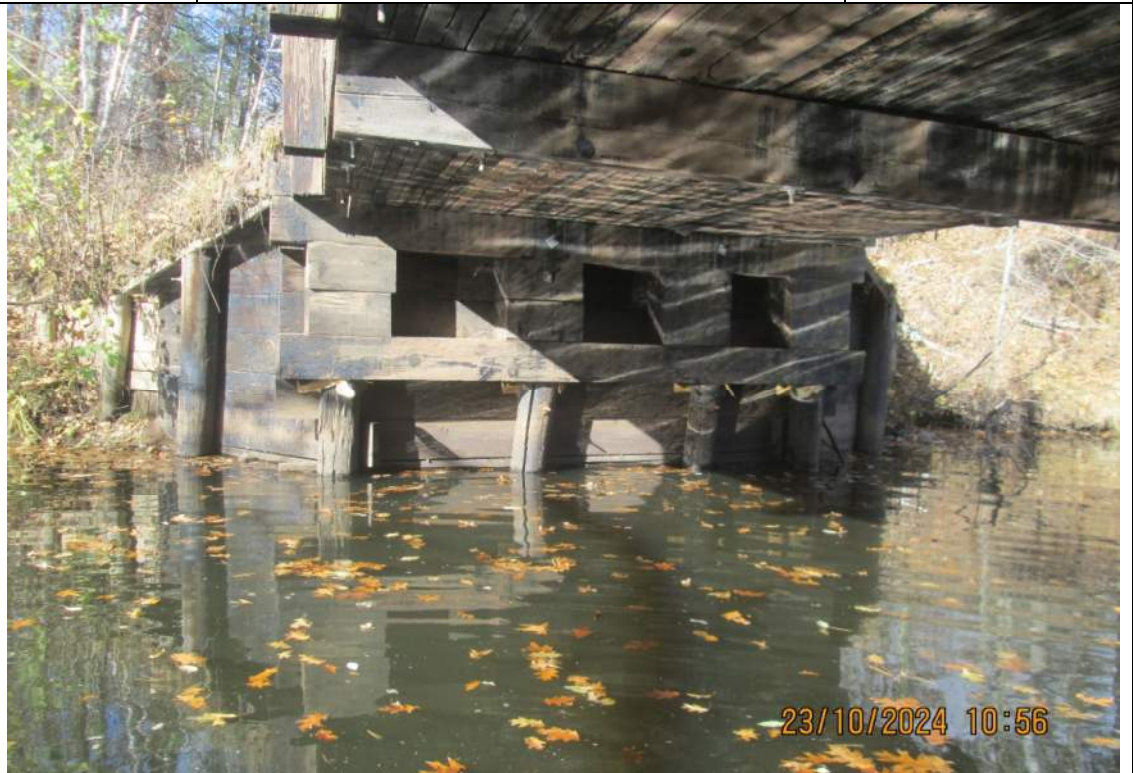
Photo No.
7

West Abutment –
uncommon construction

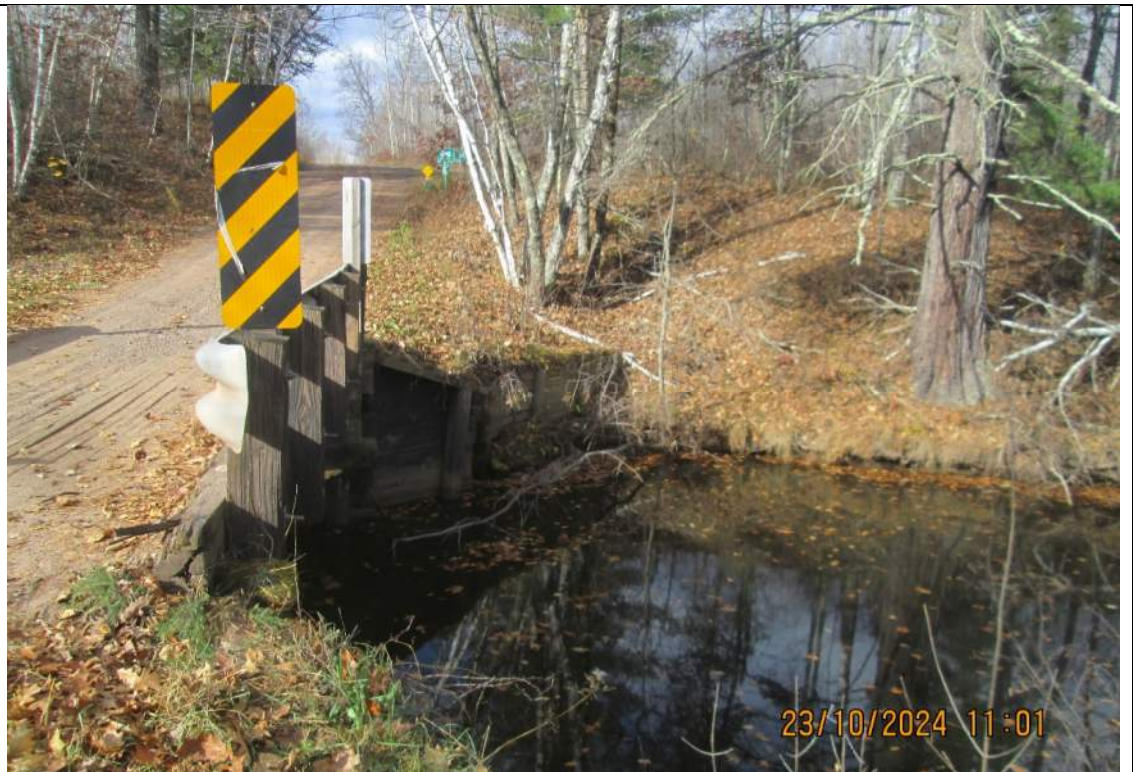
Photo No.
8

Wing extensions at the
west abutment.
