S-4 Tri Co Cheese Country Bridge 3 Rehab

RE: Bridge #3 Rehabilitation Application

# Structure Inspection Cheese Country Trail Bridge # 3

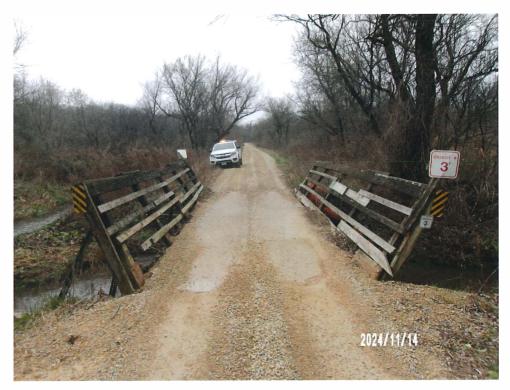
Figure 1 South Approach Looking North

Settlement in wheel paths on both approaches.

- Place gravel at approaches to fill in low areas.
- Clean out edge of deck to allow drainage off of bridge.
- Consider placing riprap along southwest streambank to stop stream migration.
- Consider adding riprap to north abutment.
- Straighten out tiger board signs and consider replacing bridge number sign.
- Remove debris it is blocking flow

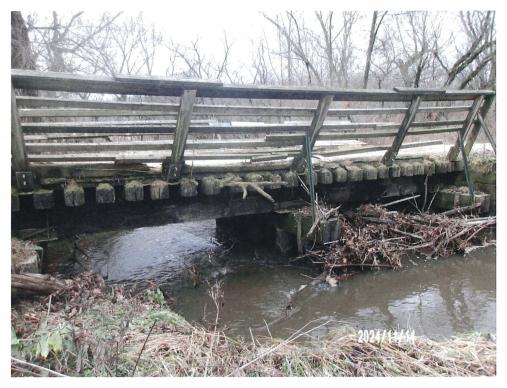
Figure 5: Profile Looking Downstream

Structure is a two span timber girder structure with floor stringers, a concrete deck and supported by timber abutments; it is in overall fair condition.

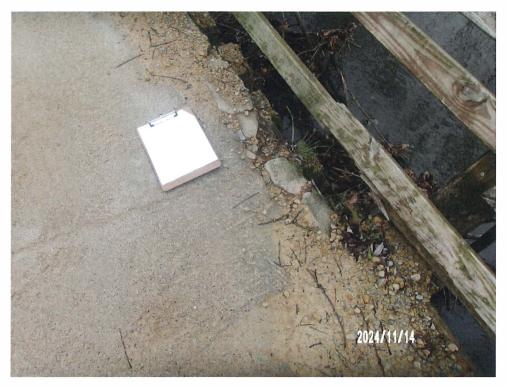
Figure 7: Deck Edge Starting to Spall Off

<u>Reinforced Concrete Deck</u> Fair condition. Some transverse cracking. Solid but edges are spalling off.

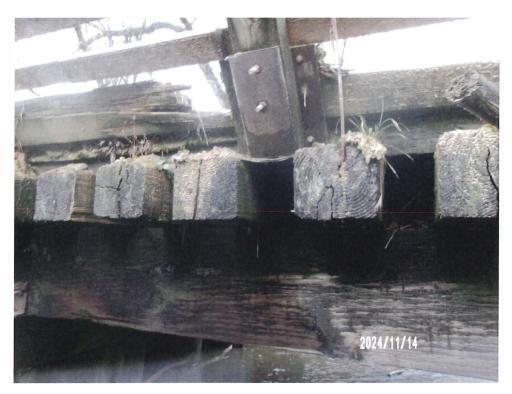
Figure 8: Typical Floor Beam Splitting

<u>Timber Stringer (Transverse rail road ties)</u> Fair condition. Most are splitting but show no signs of distress.

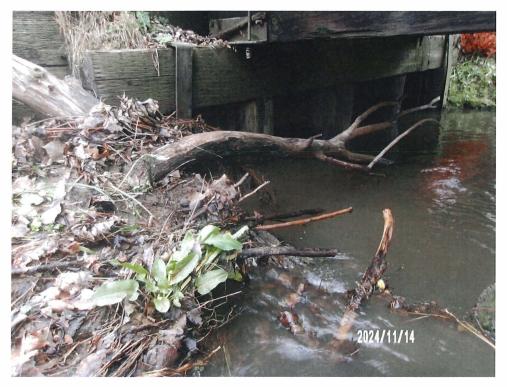
Figure 9: Typical Abutment

<u>Timber Abutment</u> Good condition. Planking is tight.

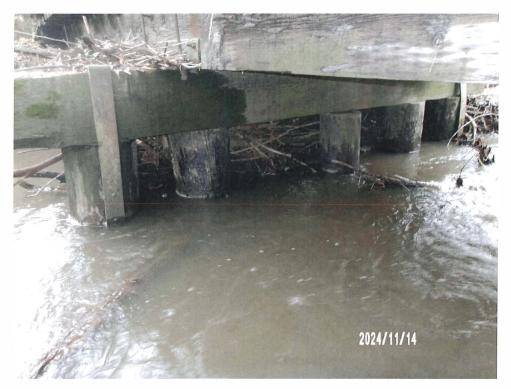
Figure 10: North Face of Pier

The current structure of the bridge has been problematic due to the center piling, which has been causing debris to accumulate and restrict flow through the structure every high-water event. This has also led to erosion to begin forming around the southern abutment as called out in the bridge inspection report. Due to these issues, this causes re-occurring repair costs we would rather spend on other maintenance activities.

It is my belief to effectively address this issue, the bridge deck would need to be removed to facilitate the removal of the center piling. In doing so, the bridge's concrete decking would be ruined, needing a replacement and a proposed new Wheeler decking & railing system which would span the entire channel without the need for a substantial change to the proposed decking system after consultation with an engineer. By eliminating the center piling obstruction, we aim to reduce the recurring debris buildup and improve the overall functionality and safety of the bridge and provide less restricted flow through the bridge structure in high water events.

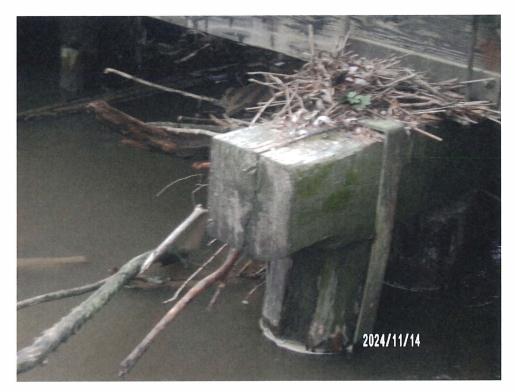
Figure 11: East End of Cap Split

<u>Timber Pier Cap</u> Fair condition. Splitting at ends.

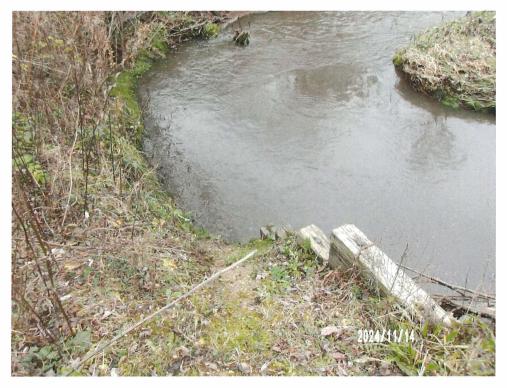
Figure 13: Stream Migrating Behind South Abutment

No slope protection visible. Upstream waterway is laterally migrating to the south; starting to move behind south abutment.
