## #25 Price Co Clover Creek Culvert

### Motorized Recreation Grant Application

Project Title					Current Funded Miles	New Miles (if applicable)
UNT Clover Creek @ Flambeau ATV Culvert Replacement						
County	Township	Range	Section	1/4 1/4	1/4	GPS Coordinates:
Price	39 N	2	2		NE	Lat. 45.893942
						Long. -90.192683

**Site ID - 23934**

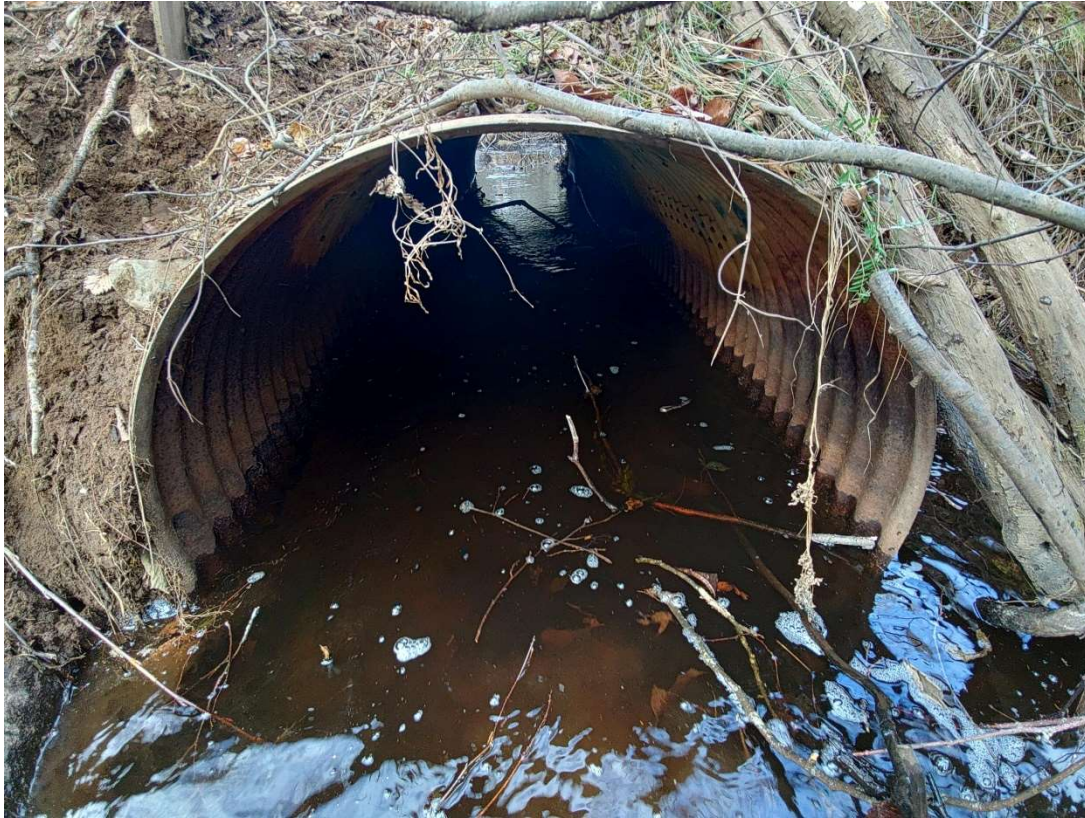
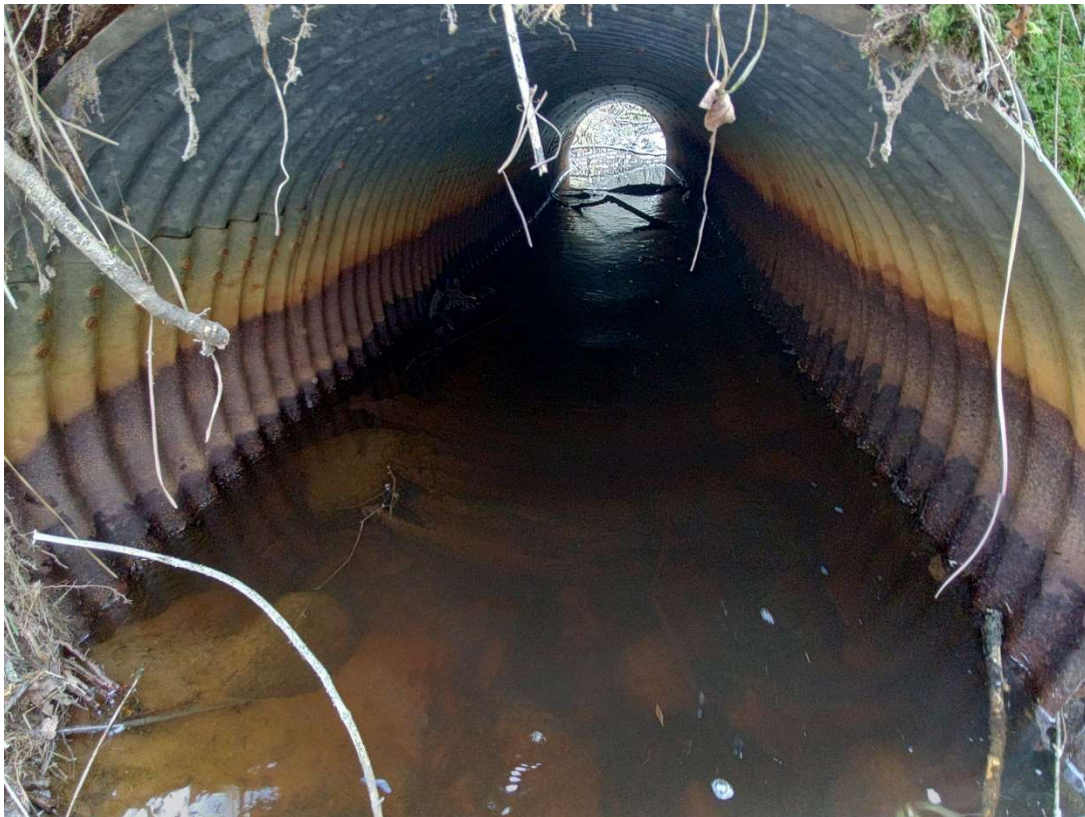
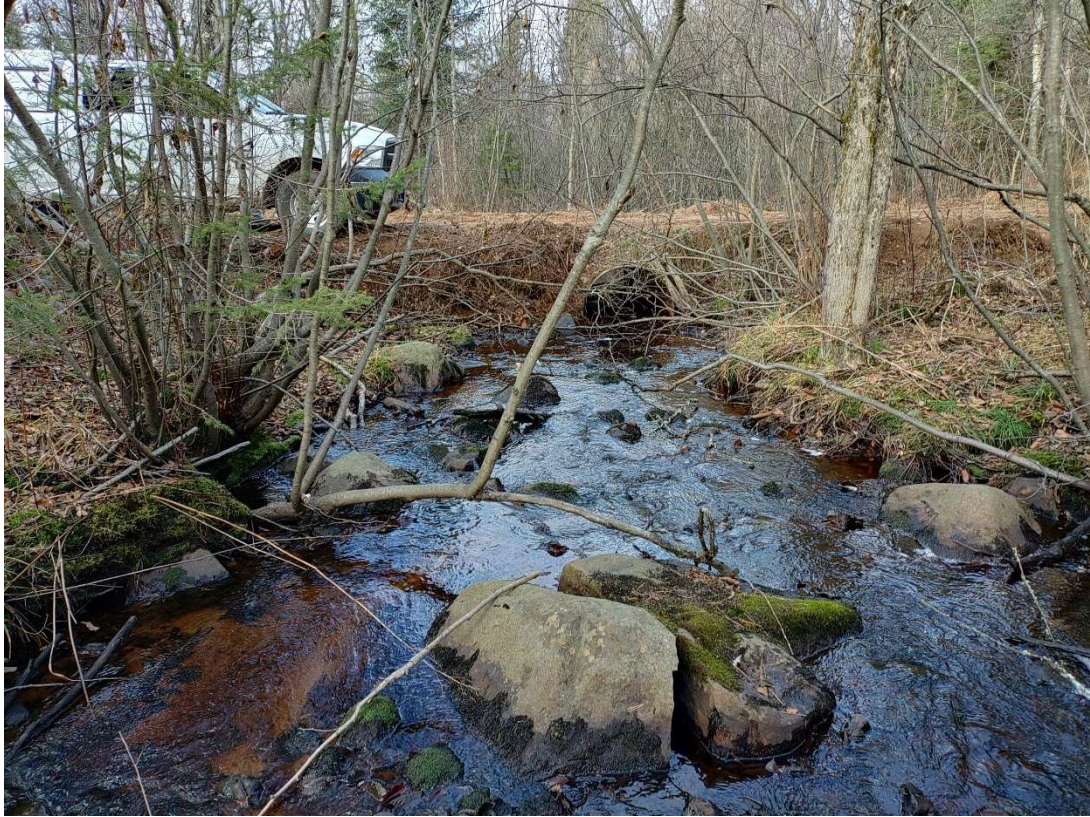
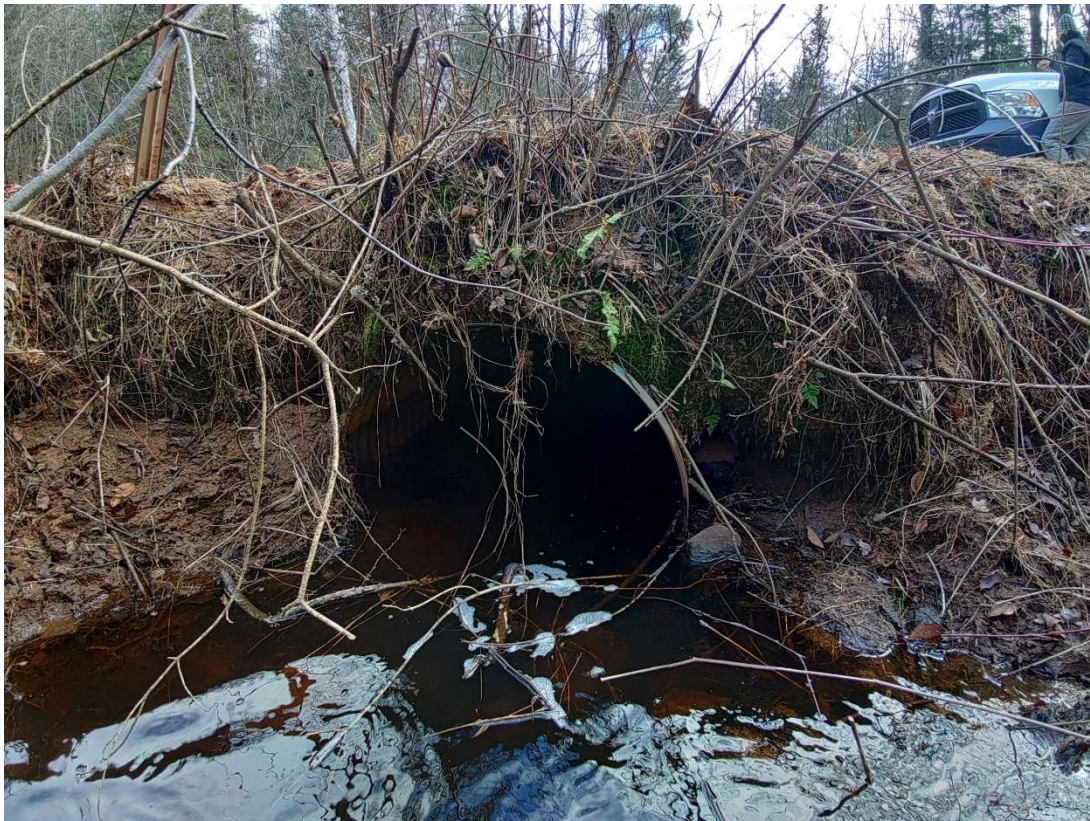
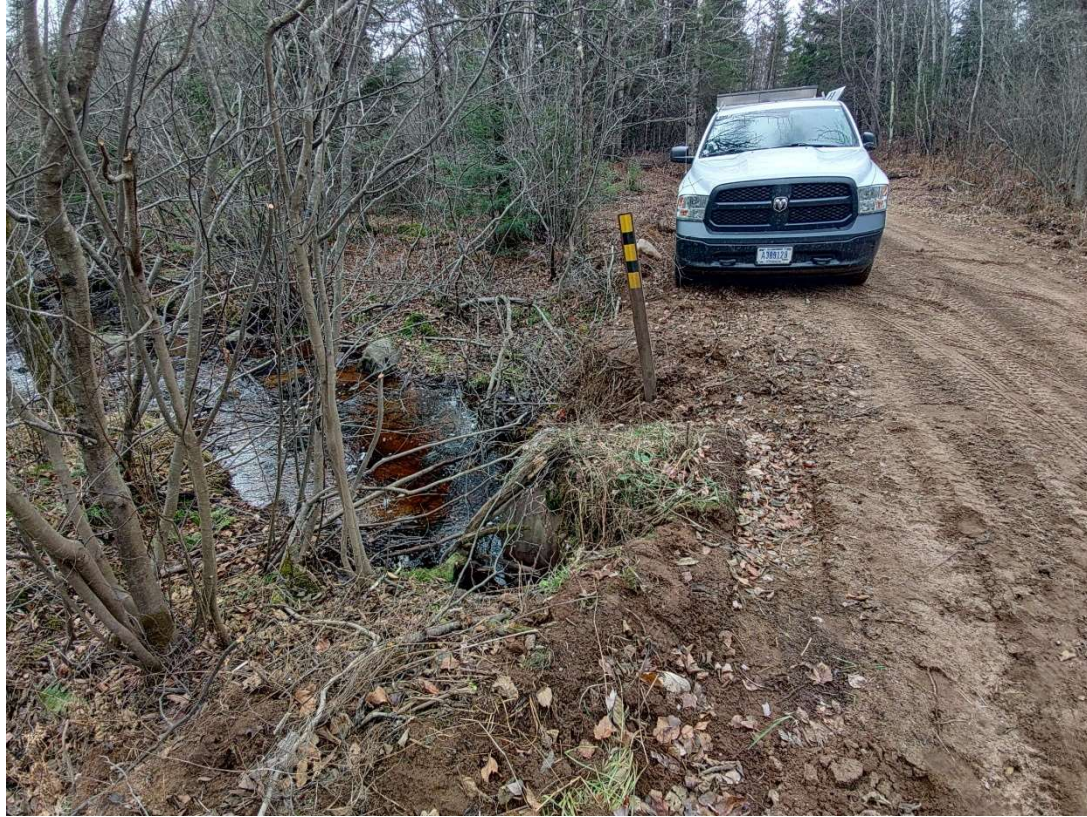
UNT Clover Creek Culvert – Flambeau Trail

The Flambeau Trail is a dual use trail located in Price County. The trail runs over a culvert on an unnamed tributary to Clover Creek that is failing. The pipe bottom is completely gone or detached and there is evidence of fill settling and piping. The current culvert is a 3.5'x2.5'x20' corrugated metal pipe arch. We are proposing to replace it with a 10' 6" x 5' 7" x 40.5' aluminum box culvert that is designed to handle a 100 year flood flow. The US Forest Service has designed the crossing and will work with Price County on implementation of the project.
