# Back to Basics: Applying for Closure

DNR Remediation and Redevelopment Program

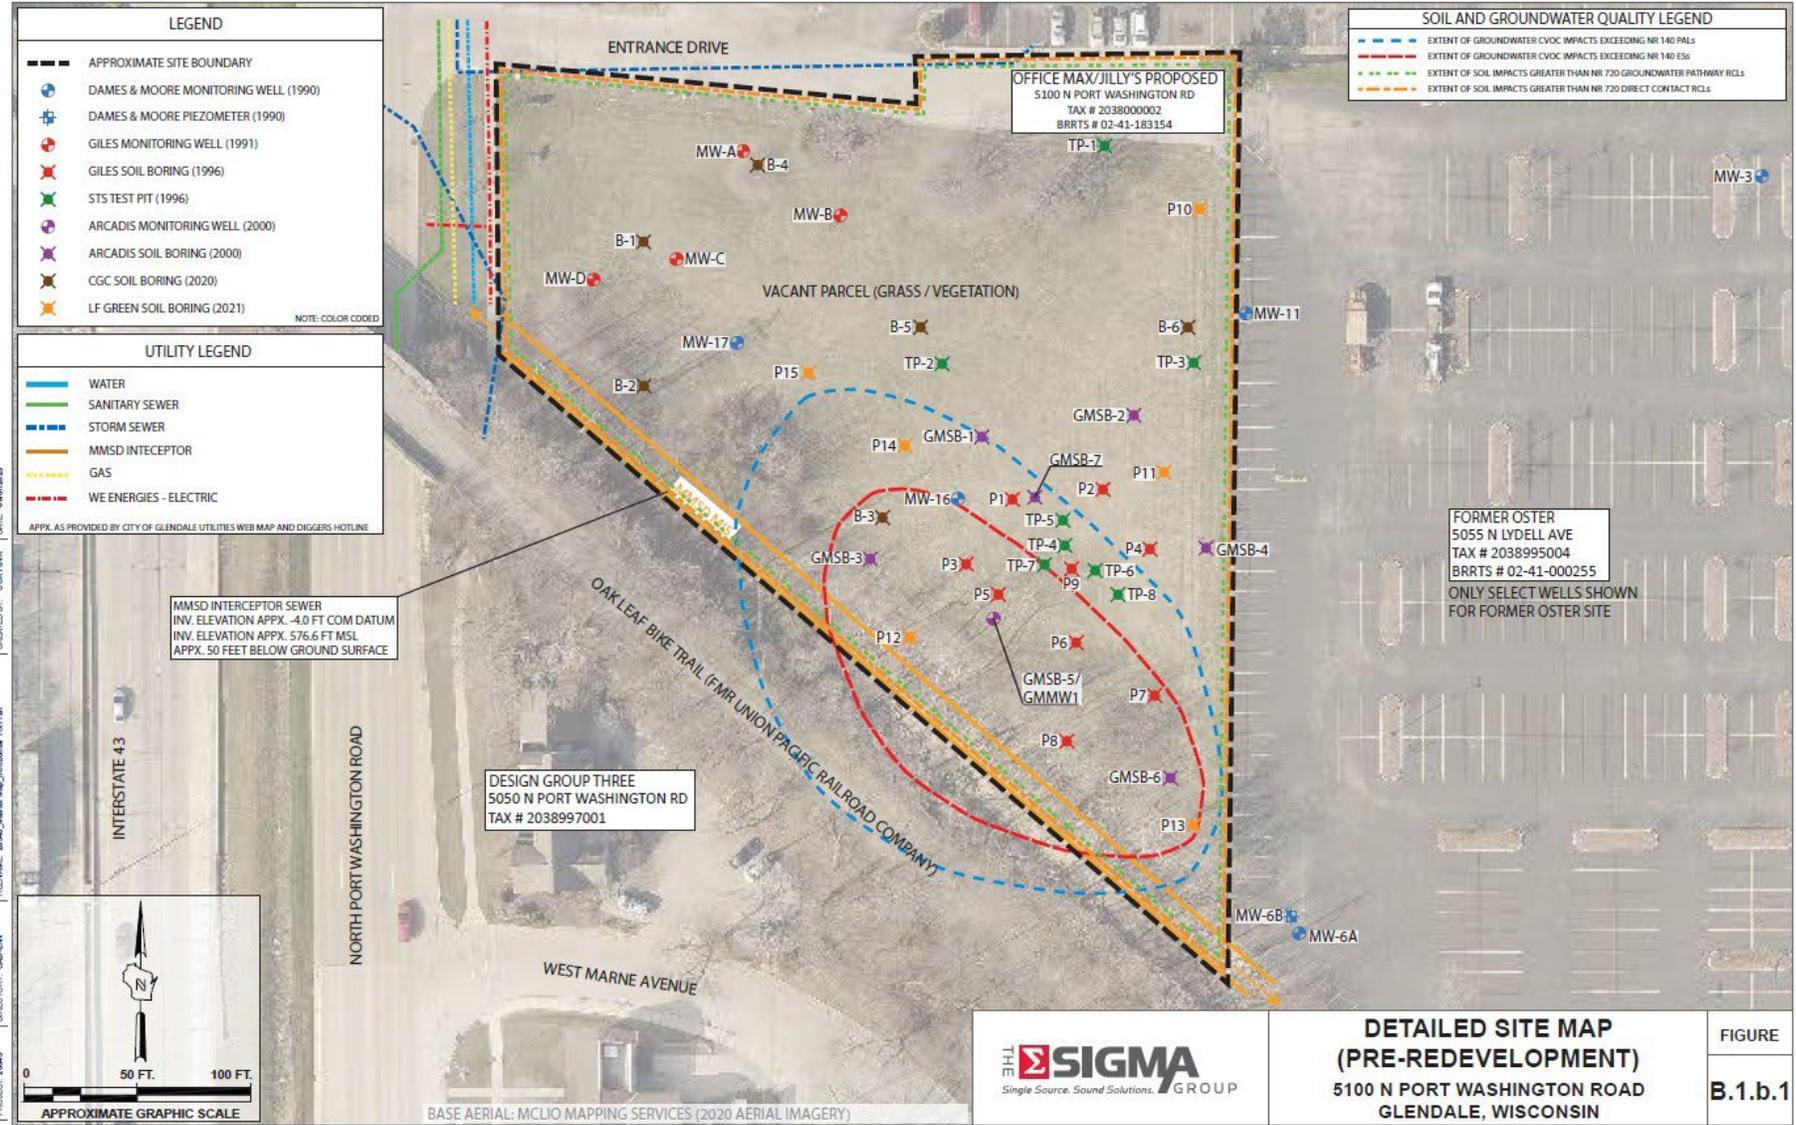
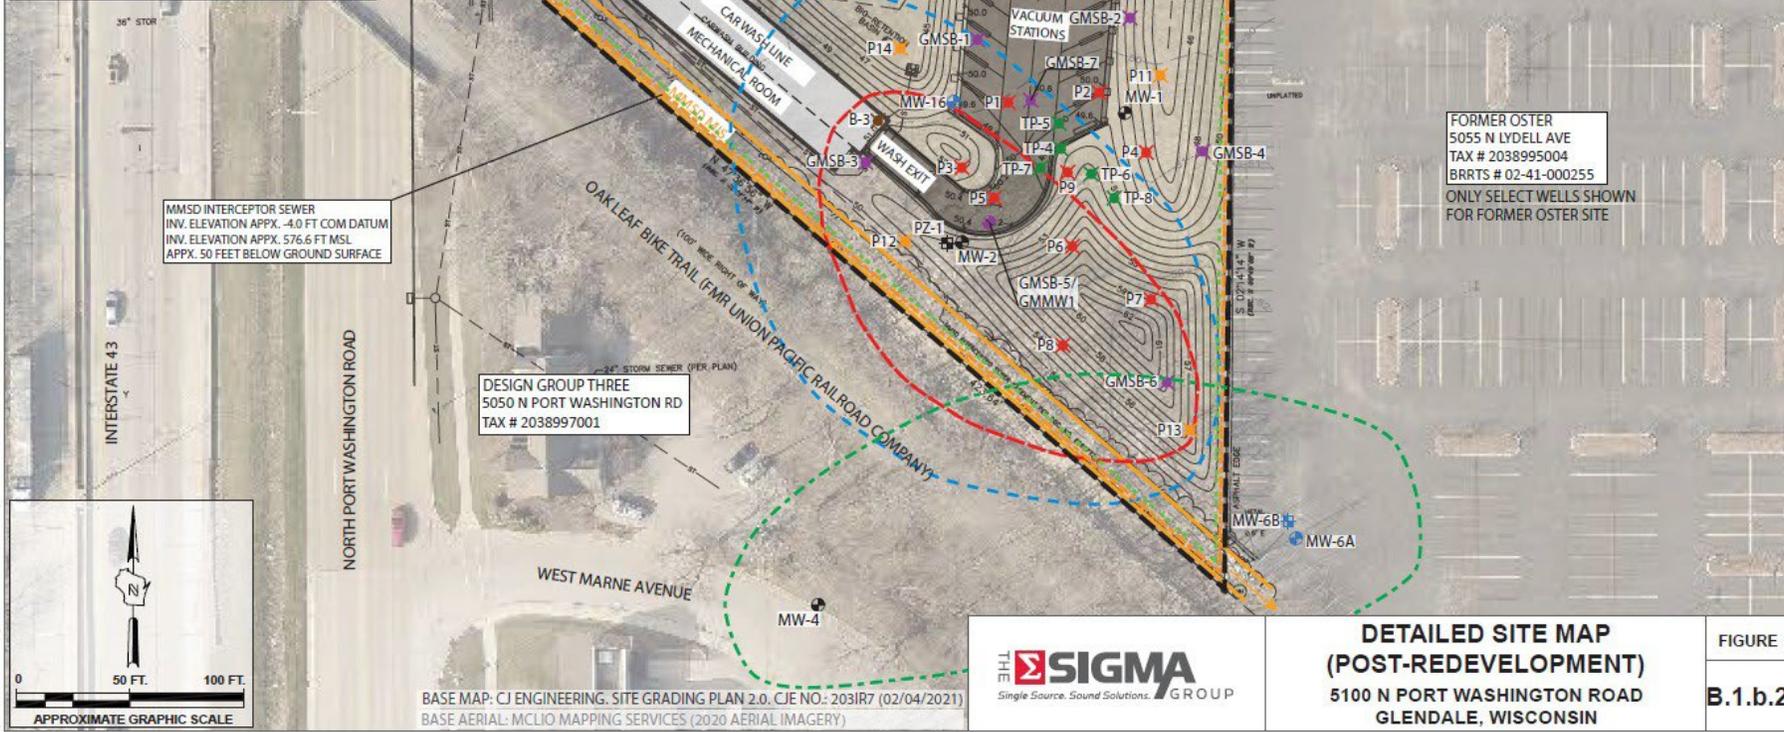
- Historic fill / reworked soil over native sand (plume) and clay (vertical barrier)
- Groundwater 10 to 15 feet below ground, northwest flow
- Soil Impacts
  - Fill-related PAHs, metals – site-wide
  - Waste-related, hotspot chlorinated VOCs – southeast portion of site
- Groundwater Impacts
  - CVOCs – on-site and off-site, and from neighbor
  - Post-Construction RNA selected groundwater remedy
- Vapor Impacts
  - On-site CVOCs, VMS installed, maintenance plan
  - Off-site CVOCs, sealed sump at neighbor to the south
  - Post-construction vapor sampling
- Methane – limited and low-level, but historic detections

MMSD INTERCEPTOR SEWER  
INV. ELEVATION APPX. -4.0 FT COM DATUM  
INV. ELEVATION APPX. 576.6 FT MSL  
APPX. 50 FEET BELOW GROUND SURFACE

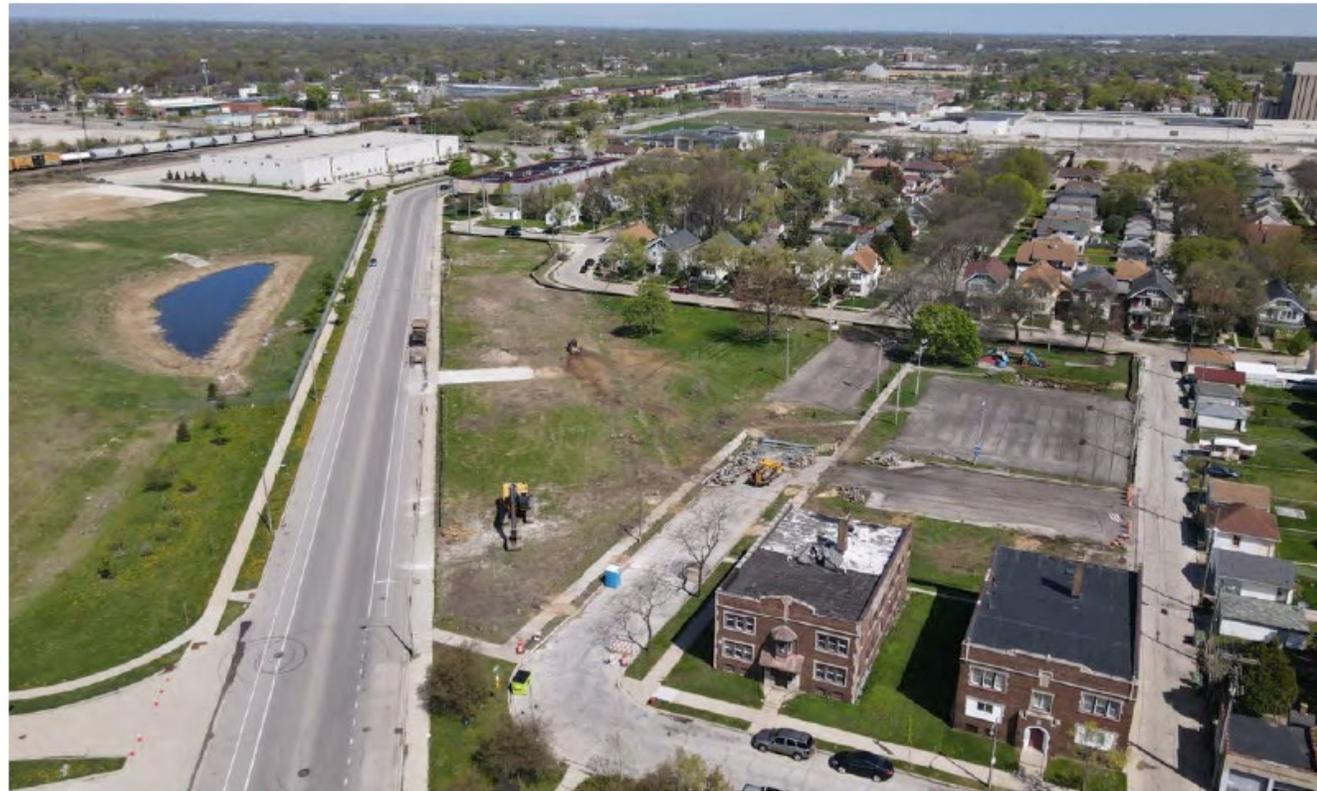
Photo 1: View of site at beginning of construction. View to northwest; photograph taken by drone on May 9, 2023.

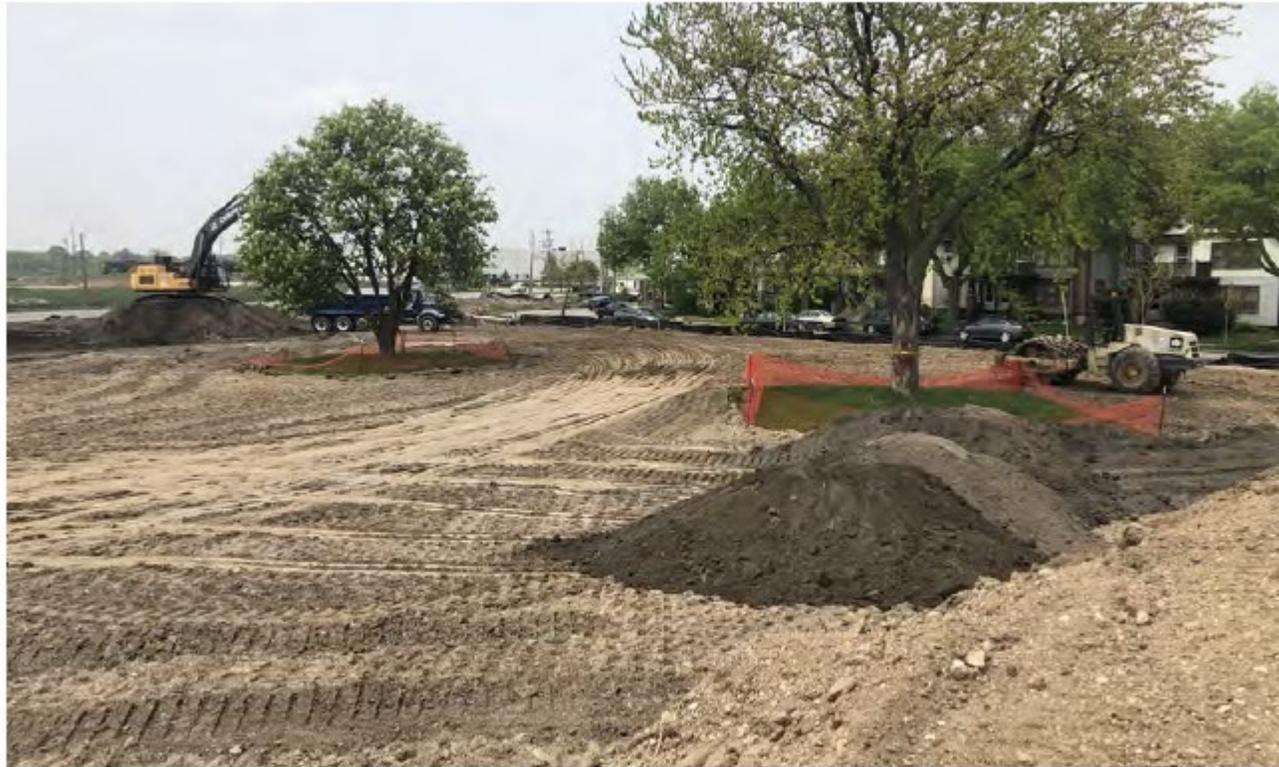
Photo 6: Area with intermediate cap removed in northeastern portion of the Site (Triangle Park). View to northwest; photograph taken on May 19, 2023.

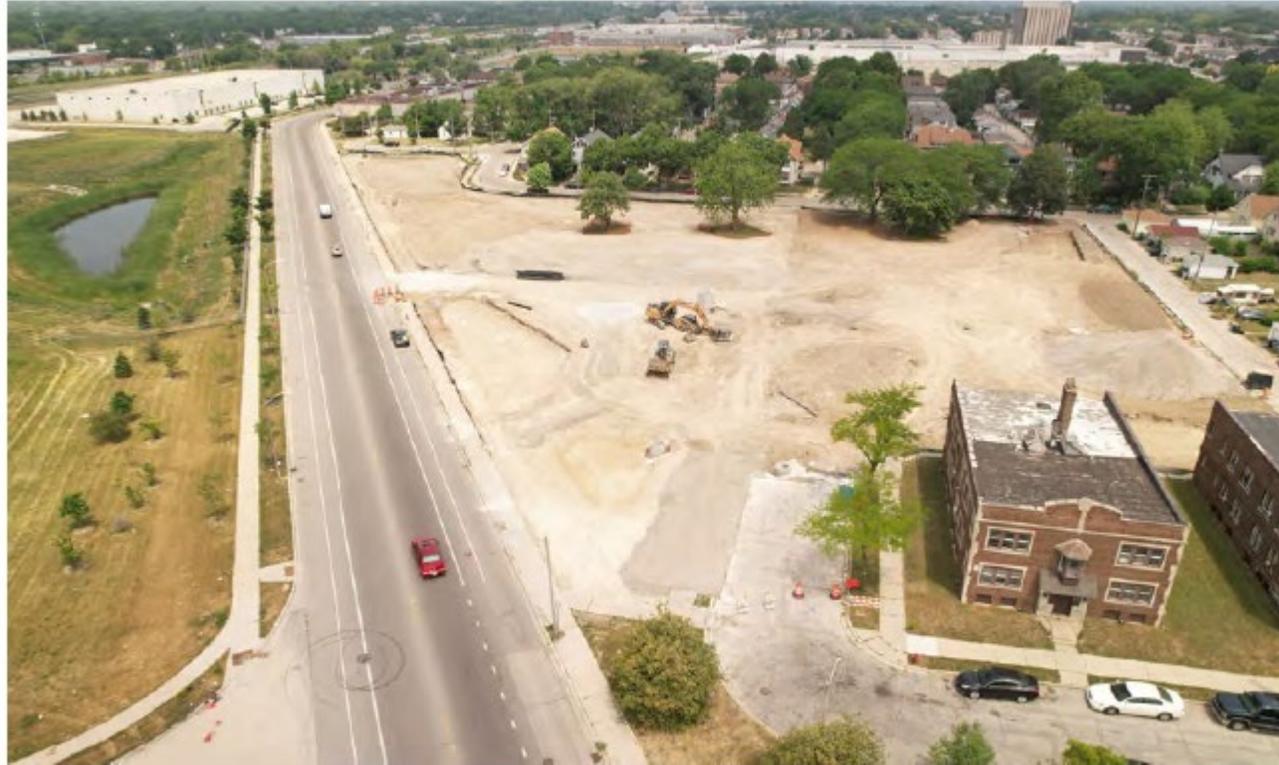
Photo 14: View of southern portion of Site, with bio basins excavated and area partially filled. Trees remained in Triangle Park portion of Site (northeastern portion of Site). View to north; photograph taken by drone on June 23, 2023.

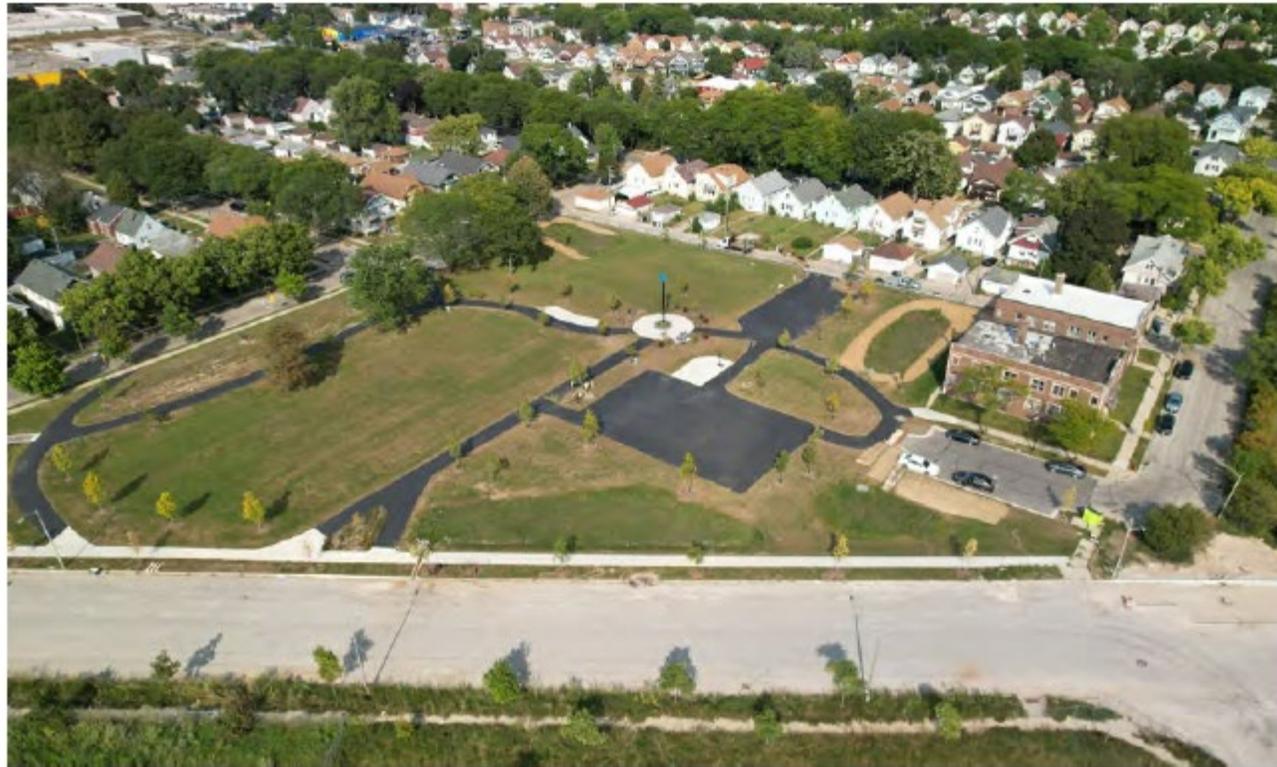
Photo 55: Current conditions. View to east; photograph taken by drone on September 8, 2025.

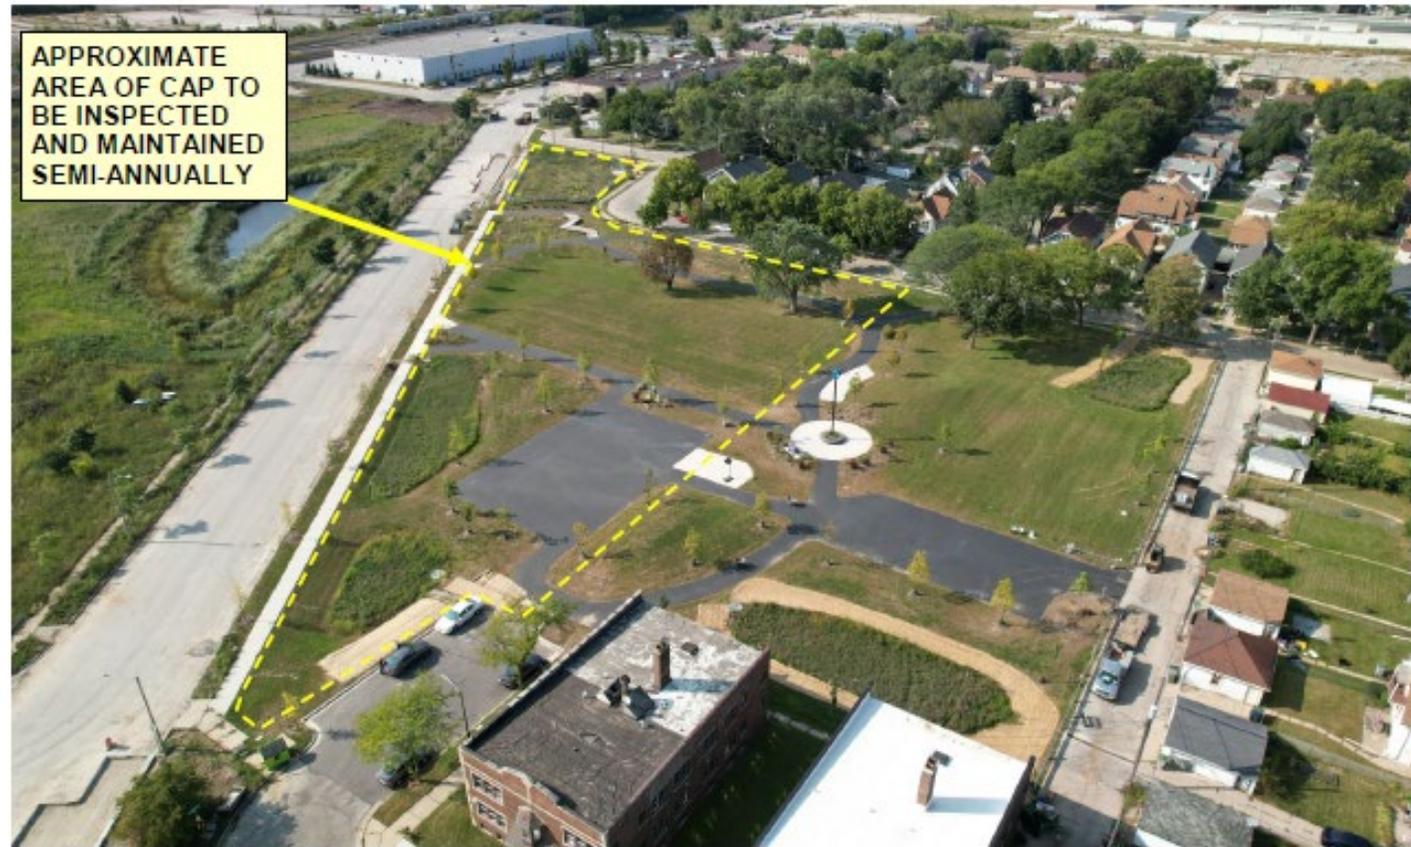
Photo 1: Asphalt pavement, landscaped covers, and biobasins in completed Melvina Park. View to northwest; photograph taken by drone flight on September 8, 2025.
