# **Expenditures of Inland Water Trout Stamp Revenues**Fiscal Years 2011-2012

# TROUT HABITAT IMPROVEMENT PROJECTS FUNDED BY **TROUT STAMP IN 2011-2012**

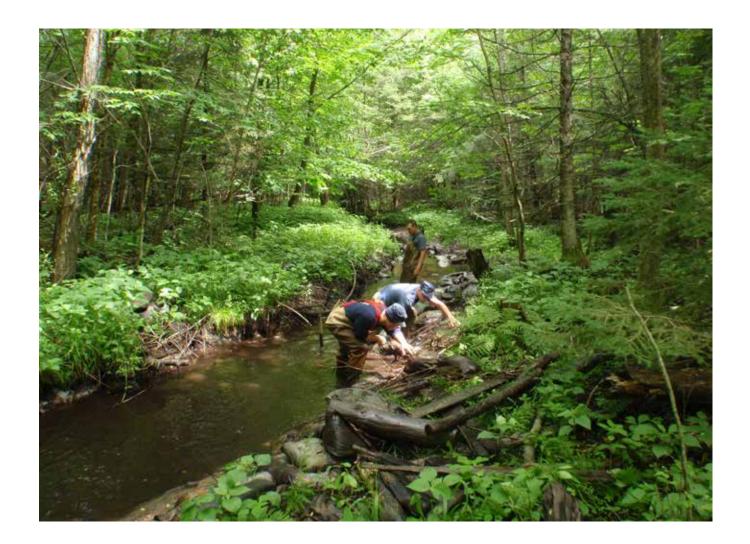
Wilson Creek in Shawano County. The Rawhide Boys Ranch About Face Program volunteers removing polyurethane sand bags from the banks of this brook trout tributary of the Embarrass River.

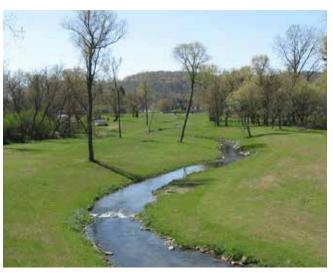
Plum Creek, within the village of Plum City, Pierce County was restored and enhanced after a massive flood severly impacted the creek.

**Justification and Purpose:** This reach of Plum Creek within the Village of Plum City was greatly impacted

by a massive flood that greatly altered the creek within the Village. Federal disaster funds provide for the restoration and enhancement of the creek to return it to a stabile state and enhance the trout habitat of this excellent trout stream.

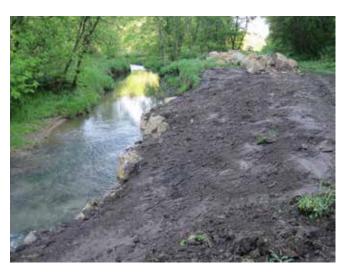
Stabilizing a stream bank using large riprap rock and then sloping the stream bank on the Knapp Creek project located in Crawford County.

Comments and Accomplishments: Restoration work for this project included a section on Knapp Creek where several stream banks have been eroding. Numerous in-stream structures were installed. The stream banks were sloped and stabilized with riprap rock. A major beaver dam and a large log jam were also removed.

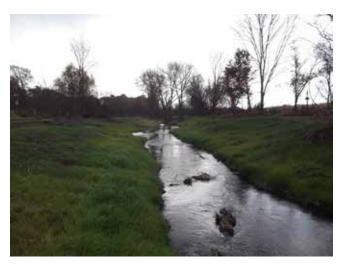
North Branch Trempealeau River, Jackson County. The banks have been sloped, rocked, and planted with grass mix to minimize erosion. Large woody cover (trees) were added to the stream for additional habitat.

Comments and Accomplishments: Removed trees and brush along 1400′ (2800′ both banks) of stream bank. Cut logs for later use as habitat structure. Burned brush and excess trees. Narrowed stream channel an avg. of 2 – 4 ft. Rip rapped and sloped 800′ (1600′ both banks) of stream bank. 12 log clusters installed for cover (avg. 3 logs/cluster). 2 rock weirs constructed w/ associated pools. Planted grass seed on 800′ (1600′ both banks) of sloped stream bank

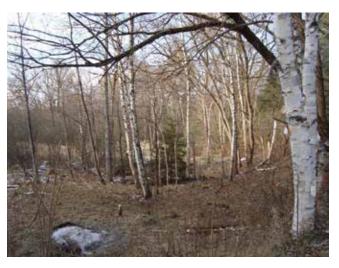
North Branch Trempealeau River, Jackson County. The banks have been sloped, rocked, and planted with grass mix to minimize erosion. Large woody cover (trees) added to the stream for overhead habitat.

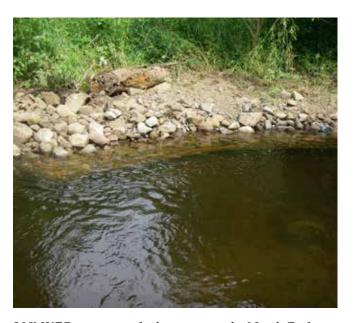
LUNKER structure deployment on the North Fork Clam River, Burnett County.

Comments and Accomplishments: The stretch of the North Fork of the Clam River located at the old Rockaway Farms location in Burnett County was completed in 2012. The work on this stretch included five lunker structures totalling 190 feet in length, four plunge pools varying in depth, riprapped banks to prevent erosion, constricting the channel to increase flows, as well as placing boulders and woody debris to provide fish cover. The Brill River portion of this project was dropped due to lack of interest

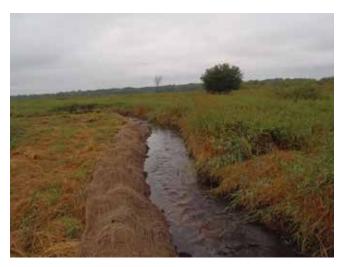
The Scuppernong River project restored a stretch of river to its original channel. Biologs and erosion control mats are used to stabilize the new stream banks.

Comments and Accomplishments: This project is a complete success as the original stream bed was located as indicated by archeological finds of the freshwater mussel the slipper shell, an endangered resource. Although the river is now flowing down the original channel,
