# Milwaukee Harbor Dredged Material Management Facility Fish Removal Effort

Wisconsin Department of  
Natural Resources

August 2025

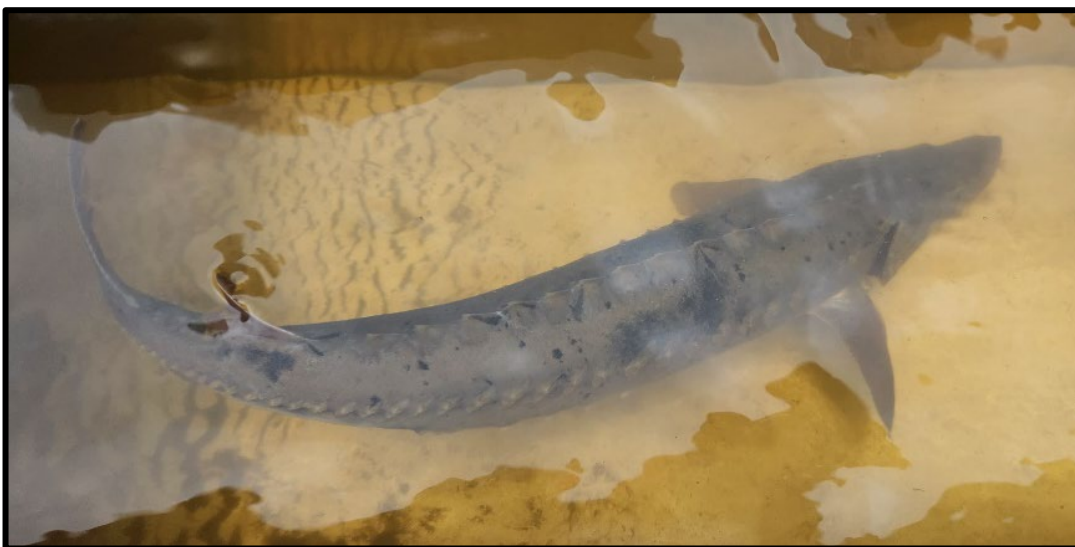
*Image 1. A 686 mm (27 inch) sturgeon in a live well during transport to the north side of the Milwaukee Harbor.*

All fish caught and still alive were marked with a hole punch in the tail and relocated to the north side of the harbor where they were released by a DNR Office of Great Waters (OGW) support boat with a live well (Image 1).

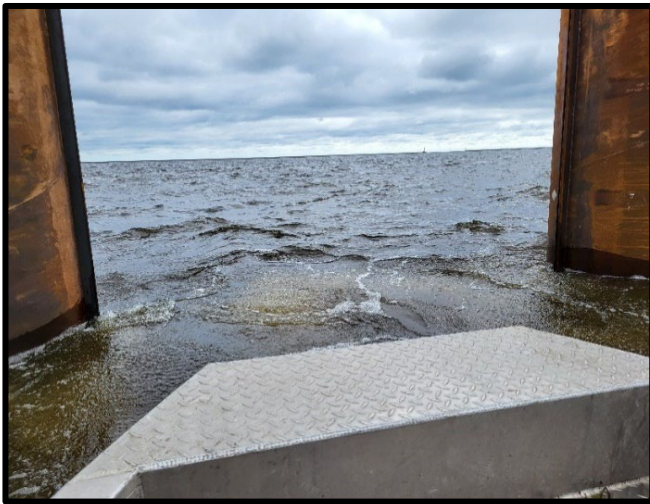
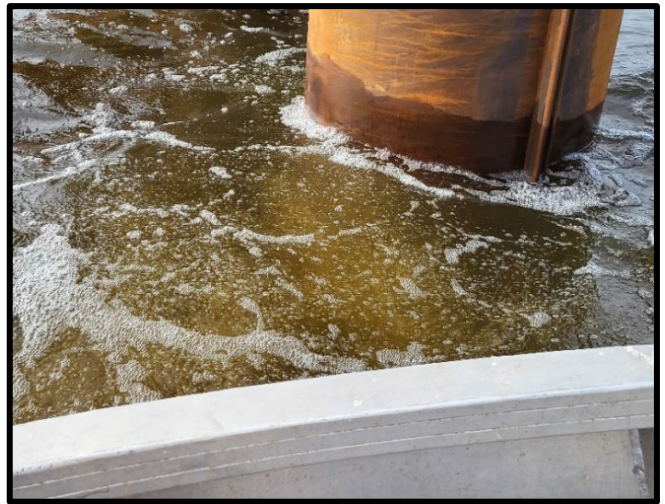
*Image 4. (Left) DNR netting boat approaching the small opening in the wall of the DMMF to exit the facility. (Right) Close up image of the bubbles created by the bubble curtain intended to deter fish from entering the facility during the removal effort.*

Marking each relocated fish with a hole punch allowed for easy identification to determine if that fish was captured inside the facility again. A bubble curtain was installed by the construction contractor, Michels Corporation, and operated 24/7 across the only remaining opening of the DMMF to deter fish from entering the facility (Images 2 and 3).

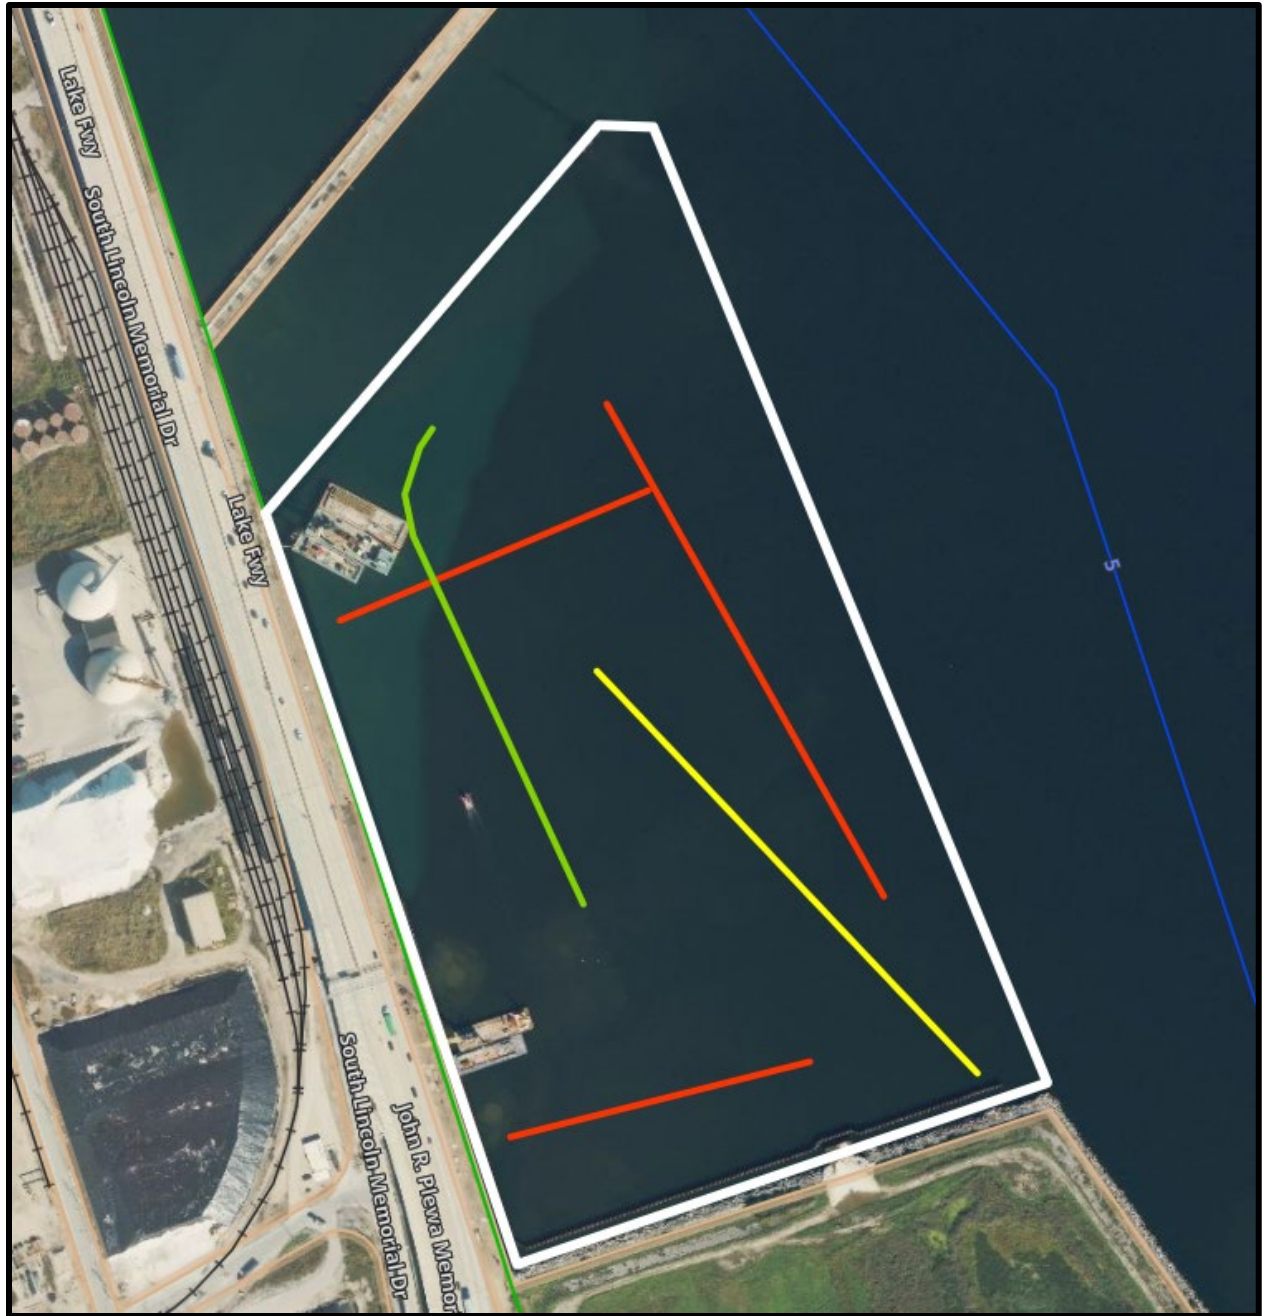
Figure 1. The green line represents the net set Monday morning and lifted Monday afternoon. The yellow line represents the net set Monday morning and fished overnight. The red lines represent nets set Monday afternoon and fished overnight.

The fisheries crew set two 1,000-foot gill nets with the wind from southeast to northwest extending from one corner to the opposite (Figure 1). Surface water temperature was 71.5 degrees Fahrenheit at the start of the gill net set at 8:30 a.m. One of the 1,000-foot gill nets was lifted at 1 p.m. and set again immediately (Green line in Figure 1). In addition, two shorter nets (600 feet) with smaller mesh for a total of 3,200 feet of gill net effort was fished overnight. Only one large drum was caught in the 1,000-foot net lifted on Monday afternoon that was fished for 4.5 hours. The tail was hole punched, and it was released alive in the mouth of the river (Image 4).

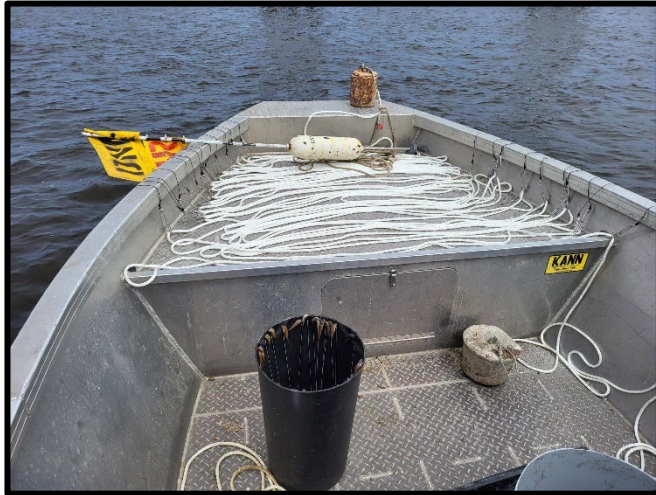
Image 8. A set line rigged on the front of the DNR boat immediately before setting.

The fisheries crew lifted both gill nets Thursday morning. Only five fish were caught in 1,600 feet of gill net (Table 3): two white suckers, one drum, one rock bass and one gizzard shad. The crew also lifted the two set lines that soaked overnight but no fish were captured.

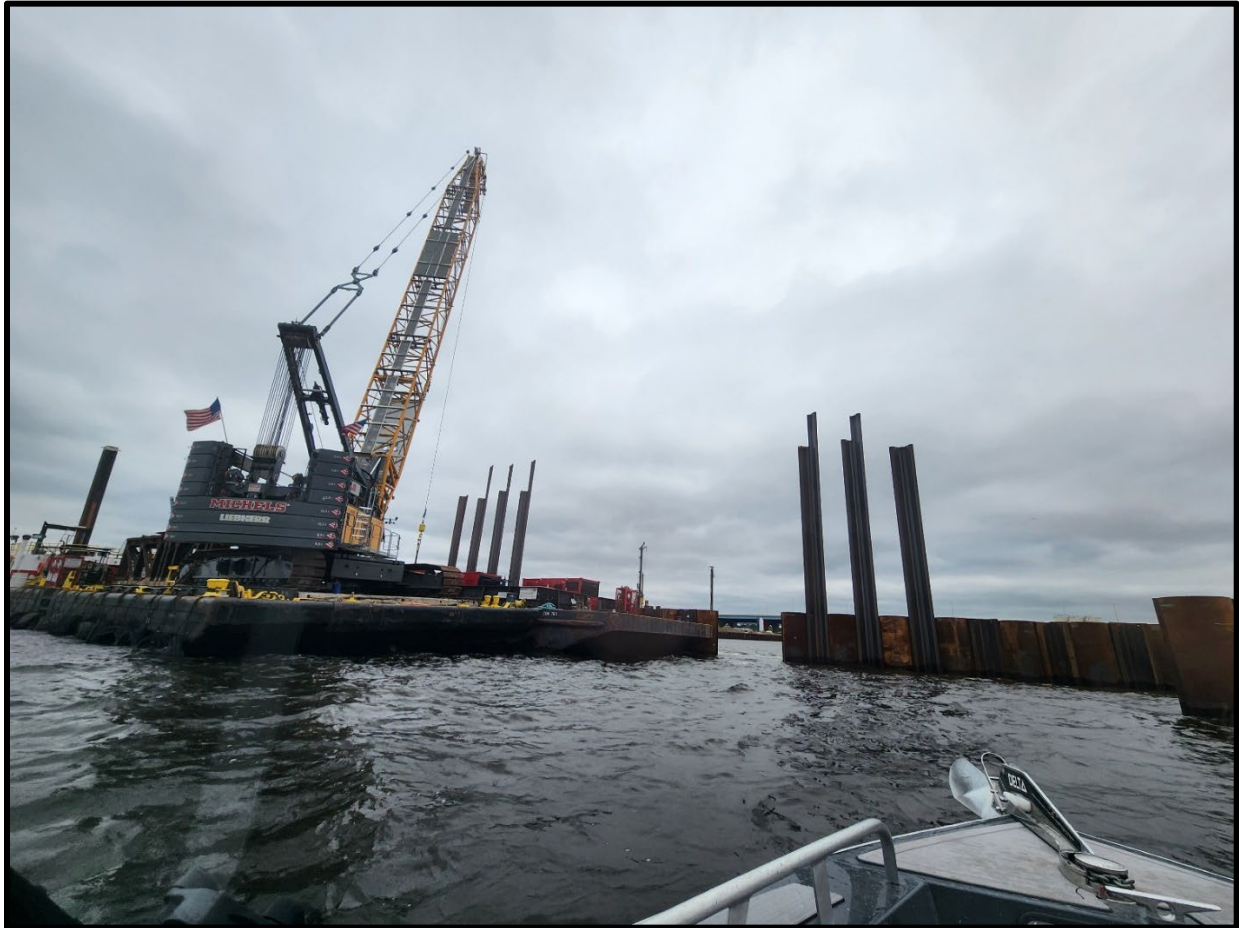
*Image 10. A barge and crane working near the small opening in the wall of the DMMF.*

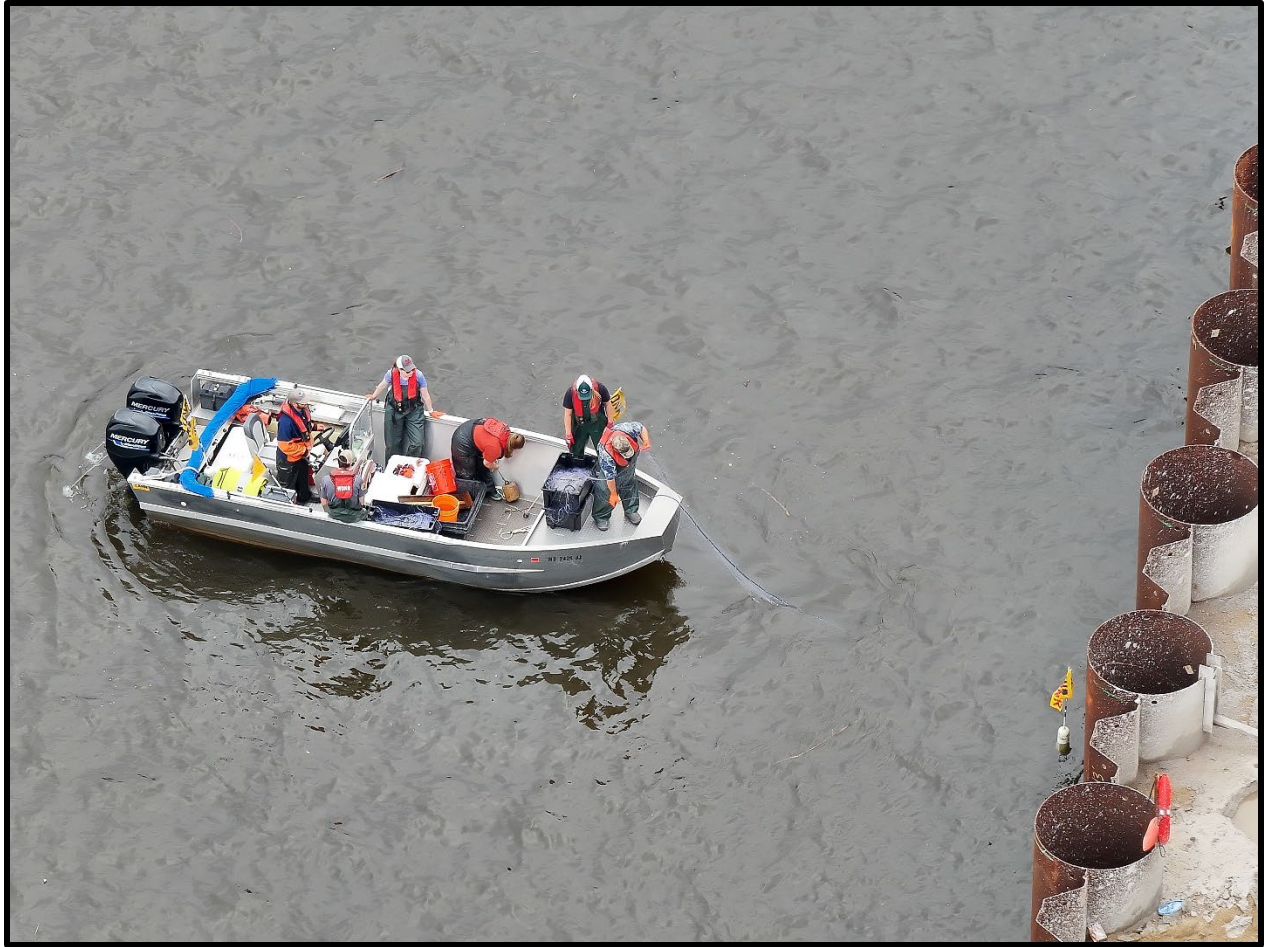
*Image 16. DNR crew sets a gill net that starts tight to the south wall of the DMMF. Photo credit: MMSD.*
