**EXPLORATION LICENSE  
Gogebic Taconite, LLC  
GTAC Exploration No. 2  
December 31, 2013**

Re: Exploration License  
Wisconsin Statutes 295.44

**ATTACHMENT to RESPONSE for s.295.44(2)(a)(11)**  
**WETLAND DELINEATION REPORT**

## **WETLAND DELINEATION REPORT**

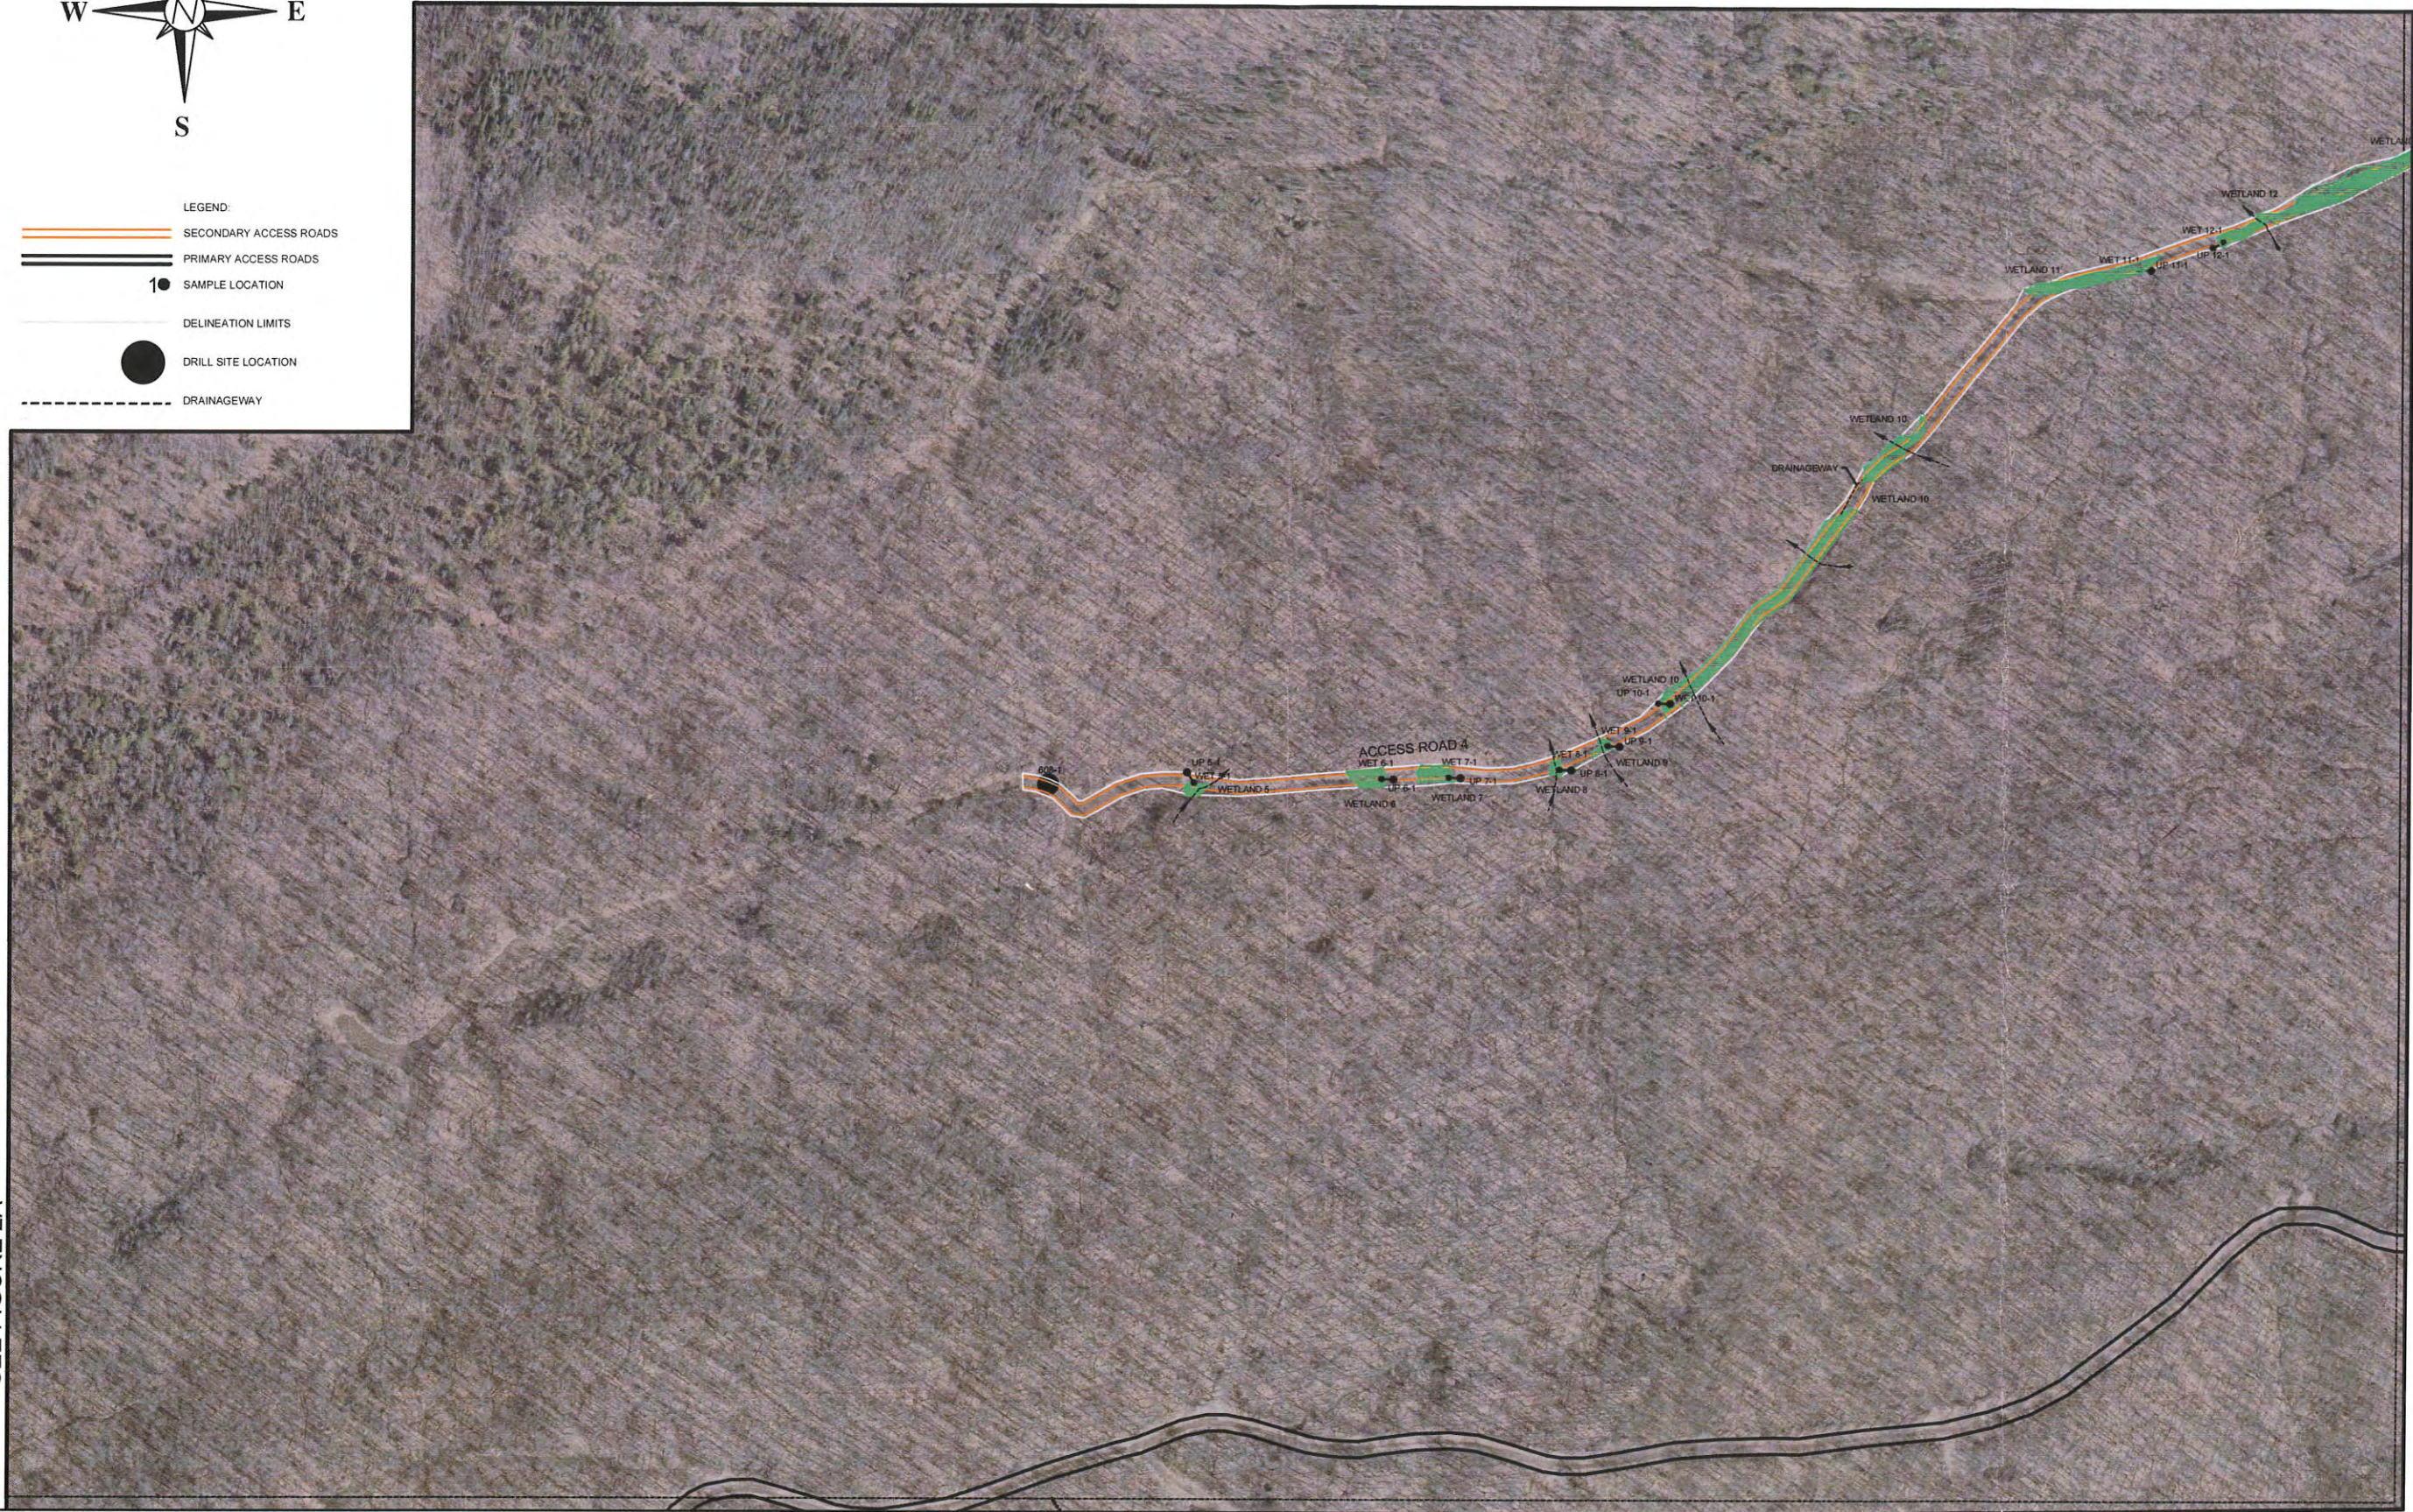
WETLAND LOCATION MAP  
ACCESS ROADS 2, 4 & 5

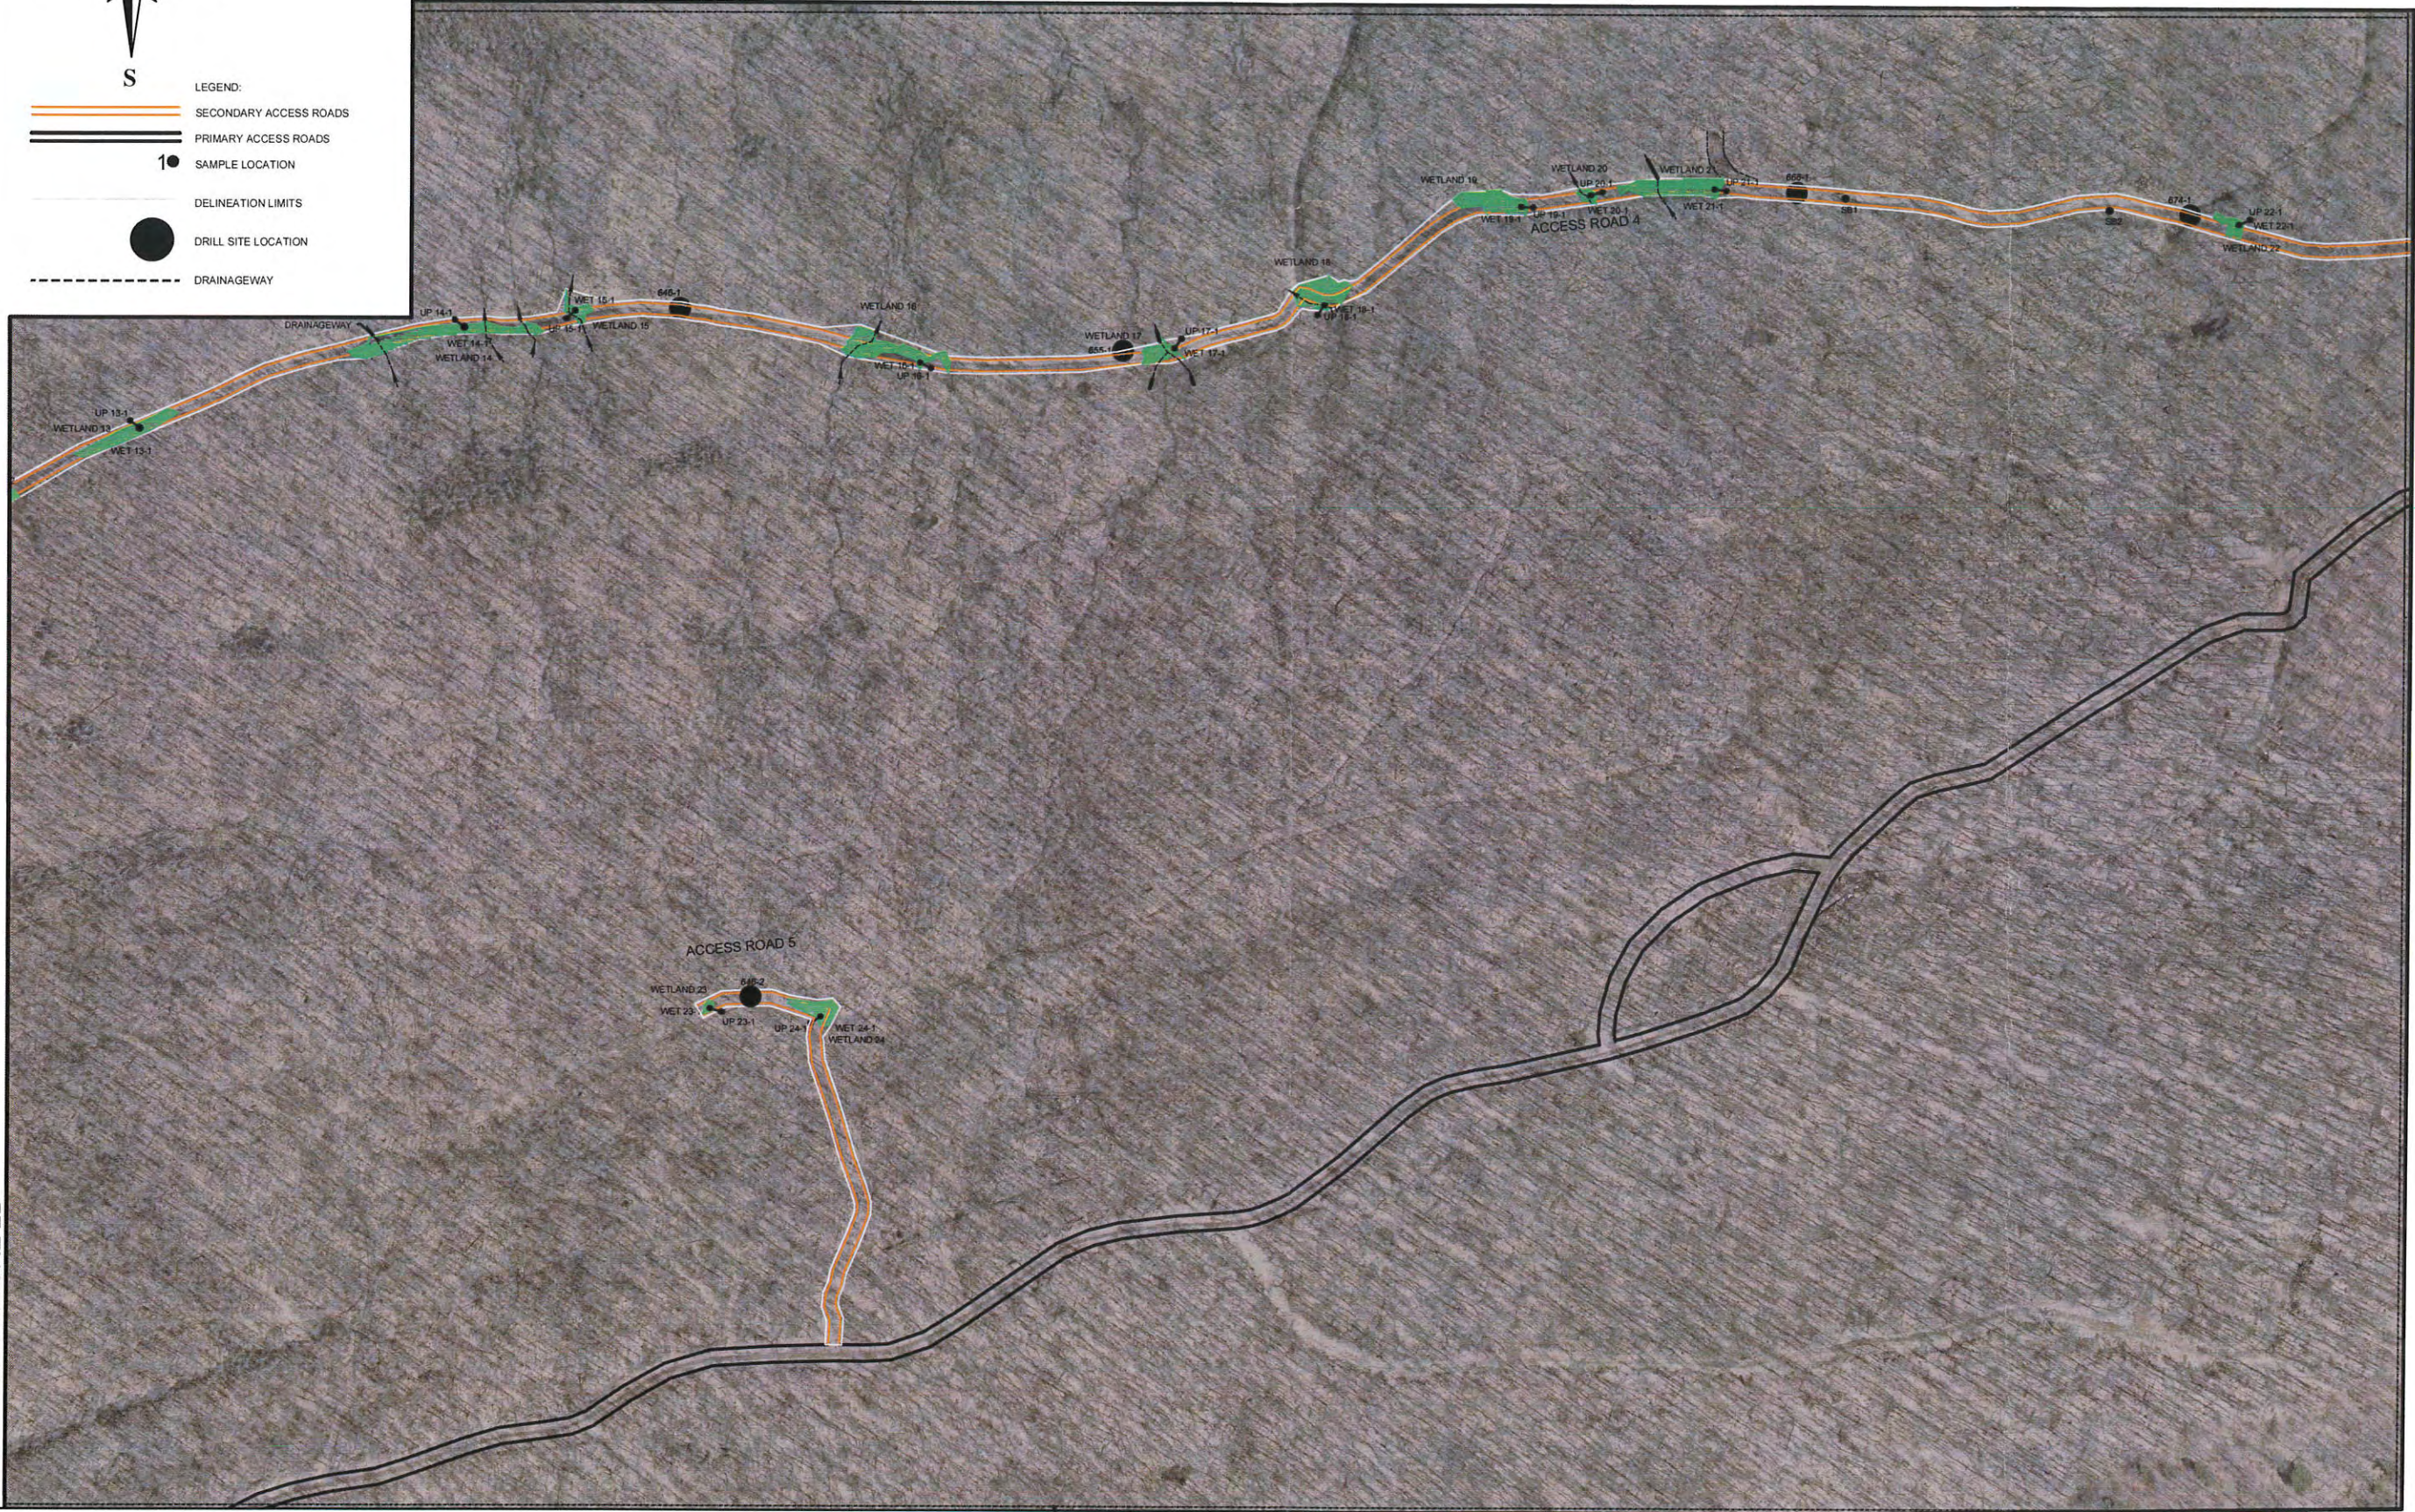
WETLAND LOCATION MAP  
ACCESS ROADS 2, 4 & 5

GOGEBIC TACONITE, LLC  
SEC. 6, 31 & 32, T45N, R1W, TOWN OF ANDERSON,  
IRON COUNTY, WISCONSIN

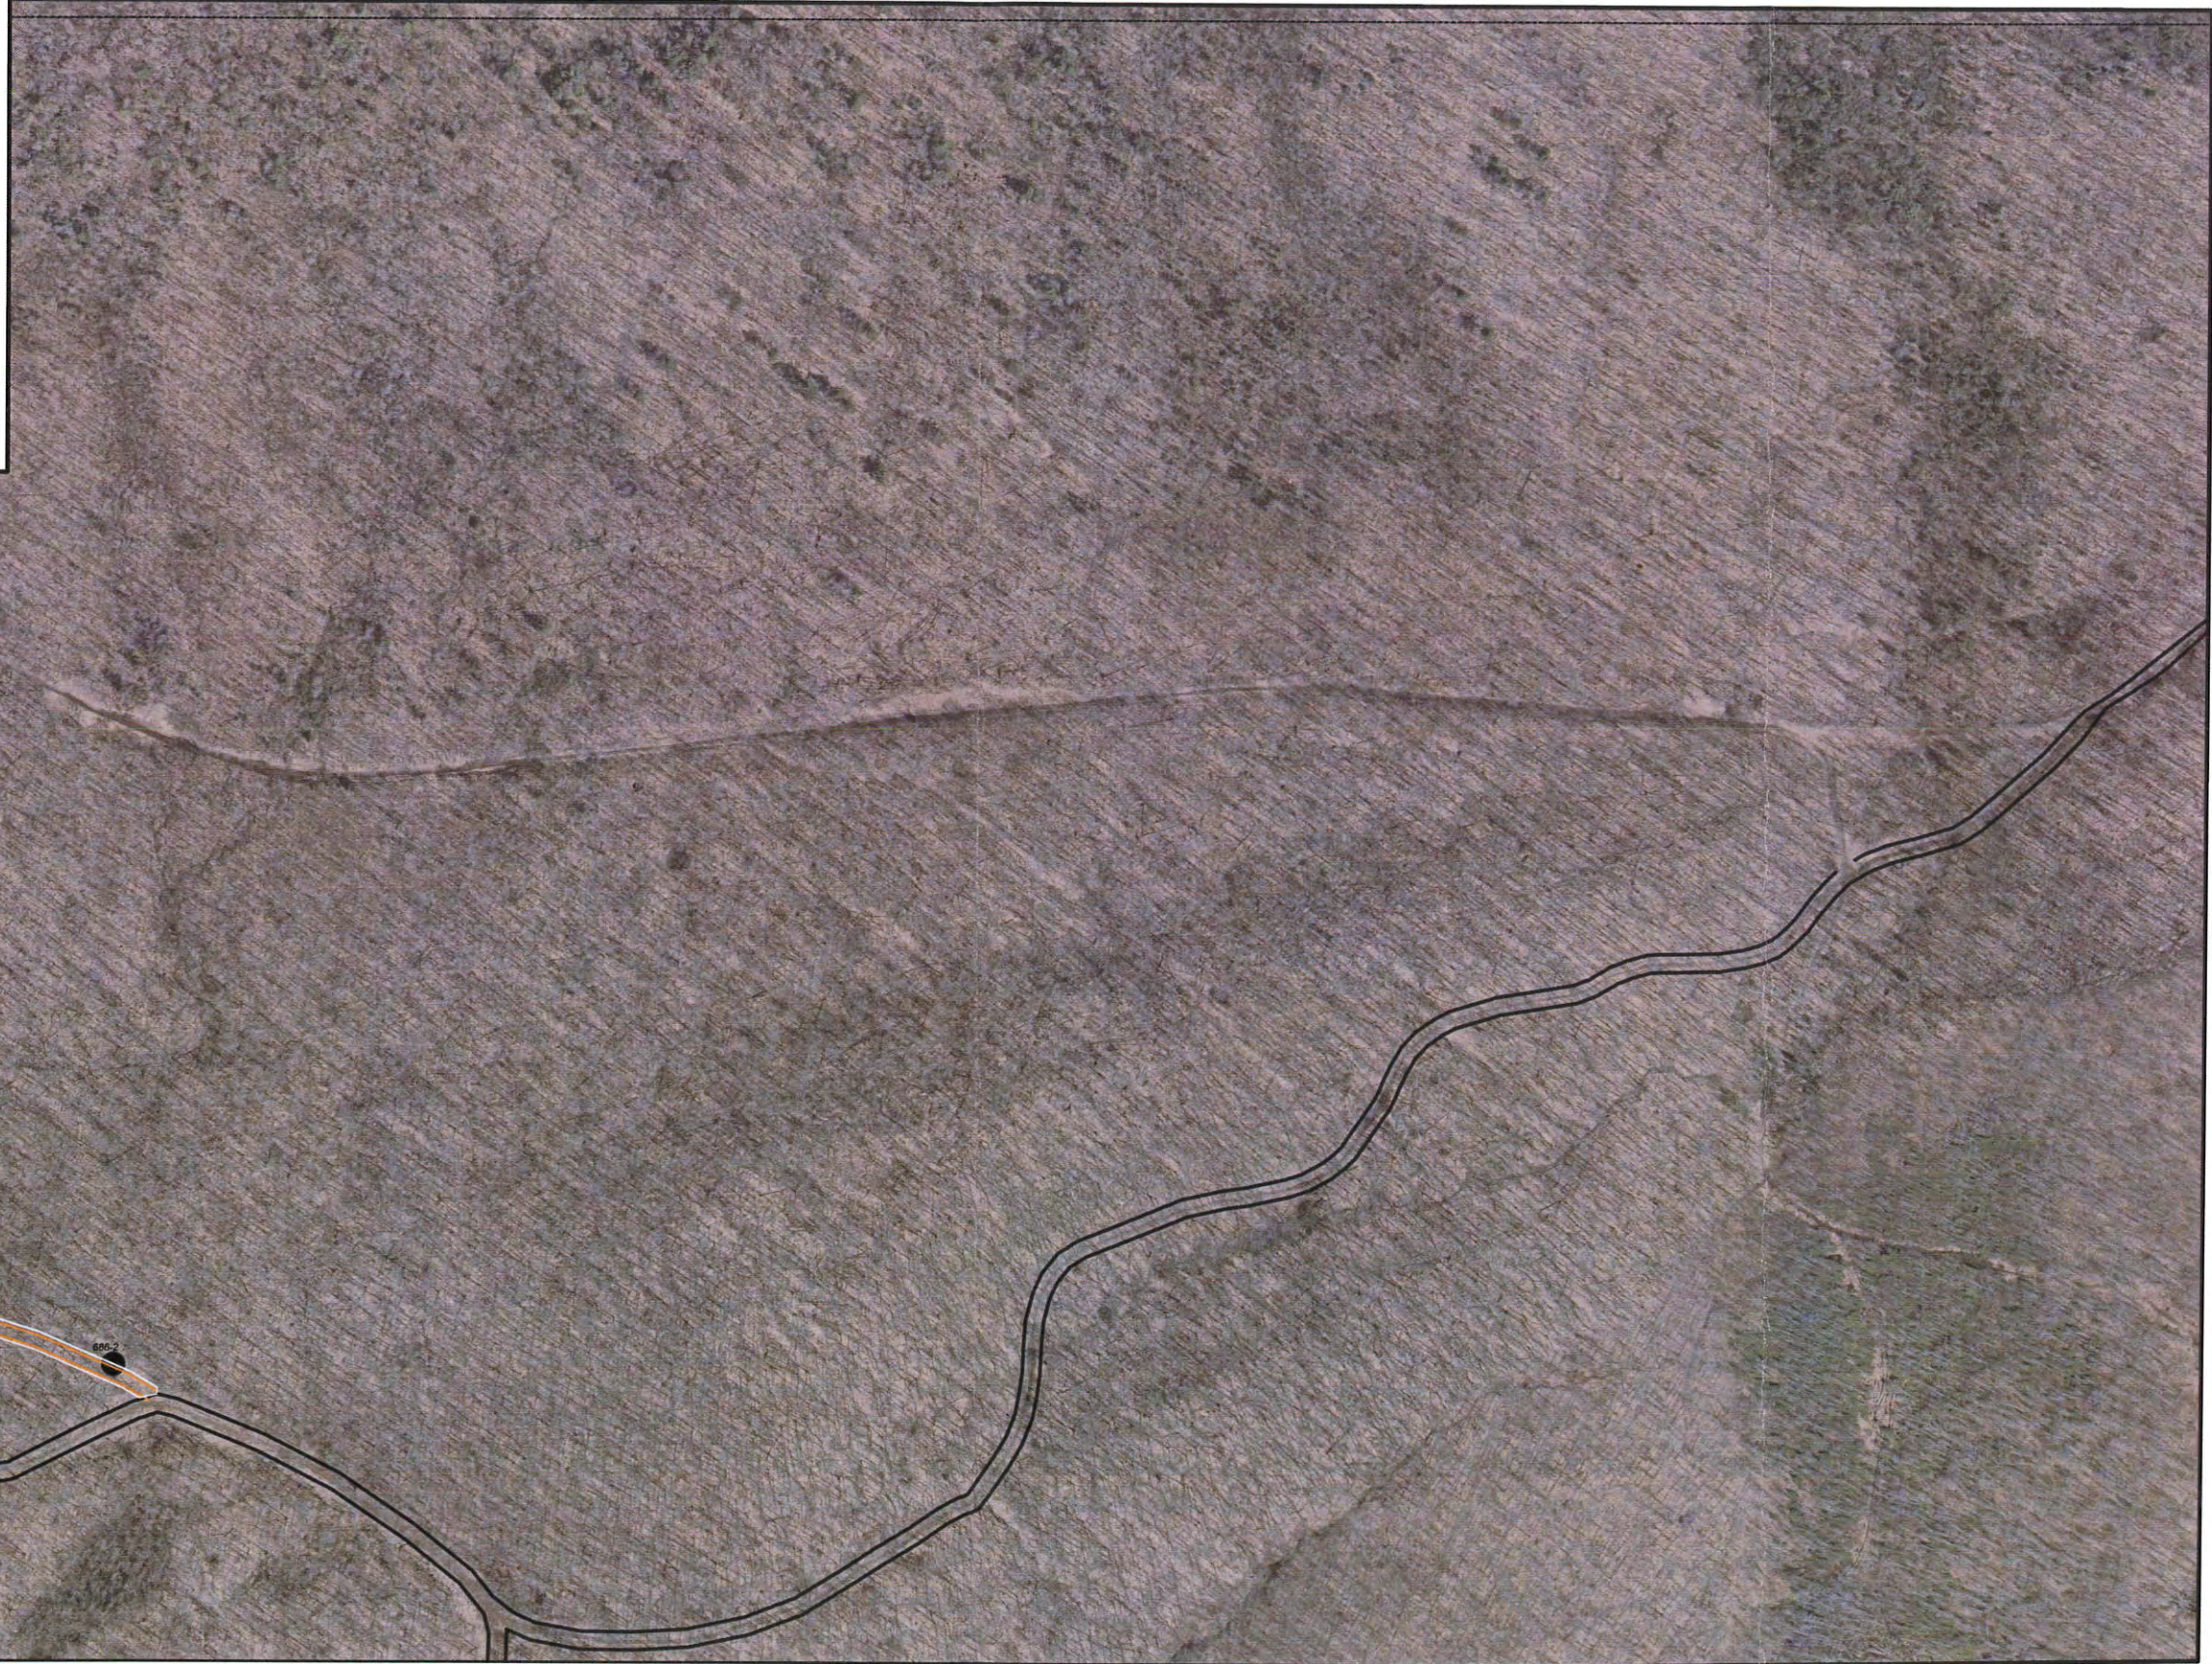
2D

WETLAND LOCATION MAP  
ACCESS ROADS 2, 4 & 5

GOGEBIC TACONITE, LLC  
SEC. 32, T45N, R1W, TOWN OF ANDERSON, IRON  
COUNTY, WISCONSIN
