Re: Bulk Sample Plan
Response to Comments dated August 13, 2013
Wisconsin Statutes 295.45

The Bulk Sample plan has been revised to include a variety of changes, many resulting in a smaller footprint for the project. The revisions include the following:

WETLAND DELINEATION REPORT AMENDMENT

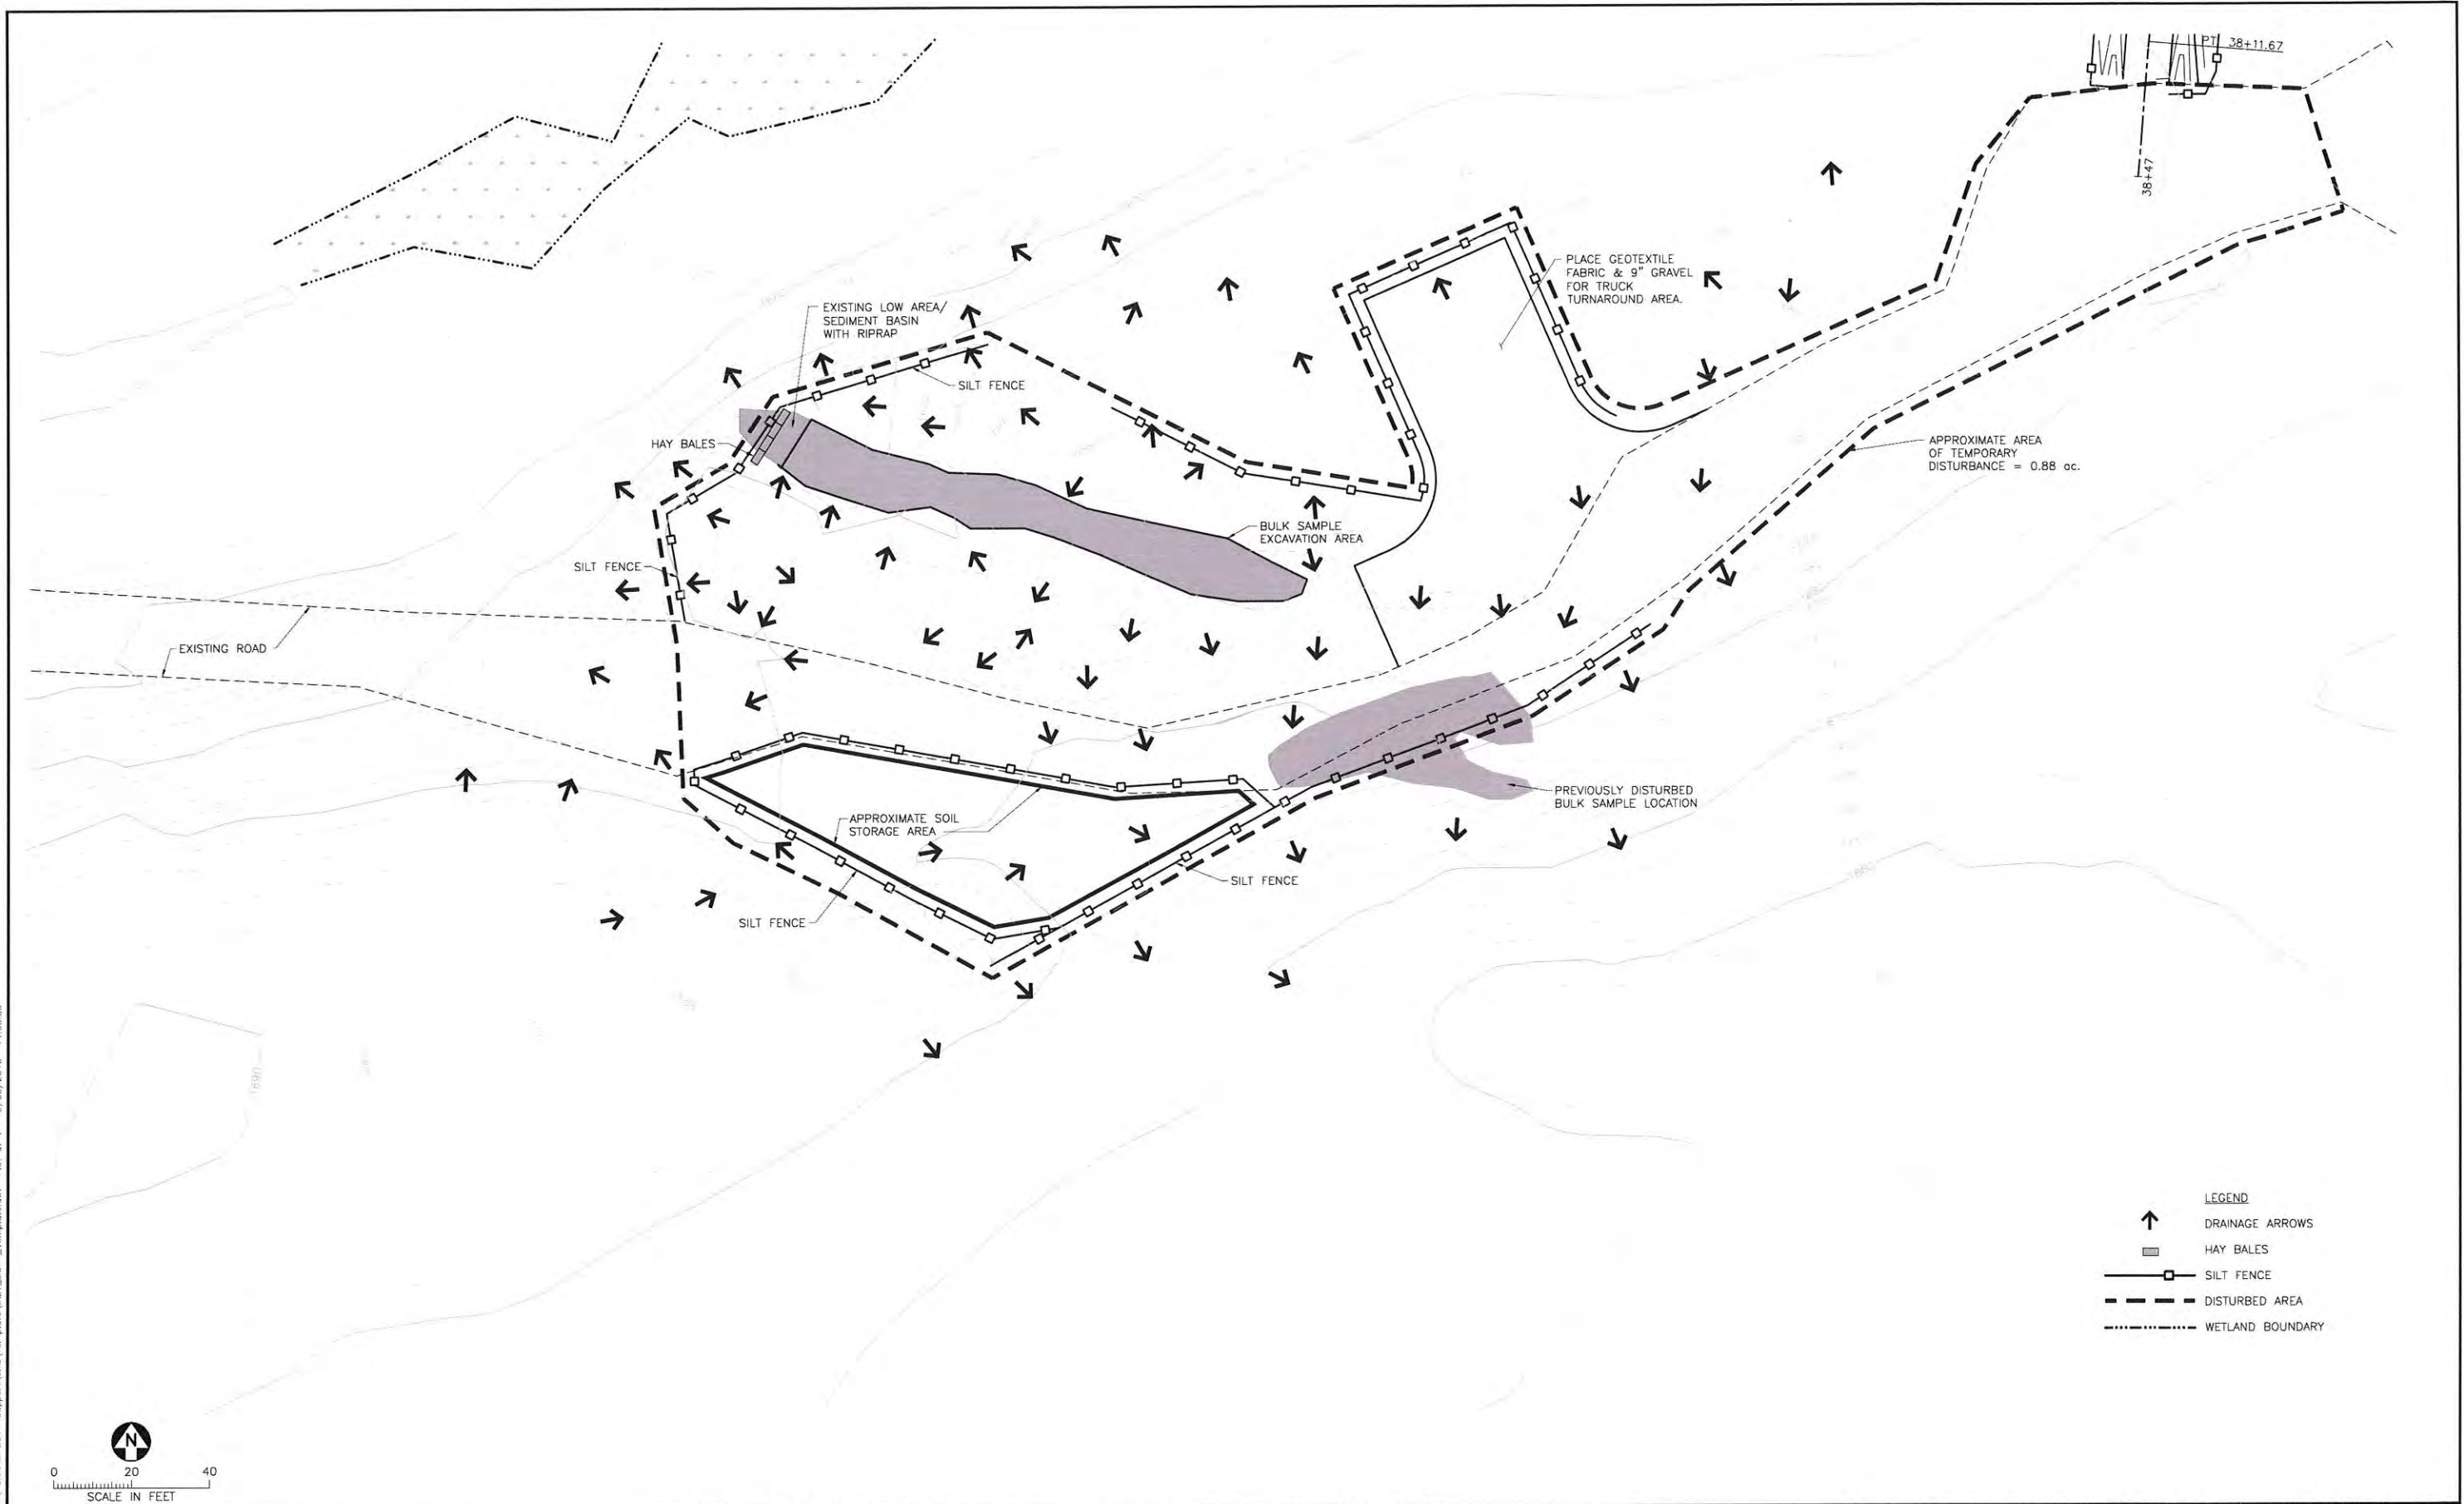
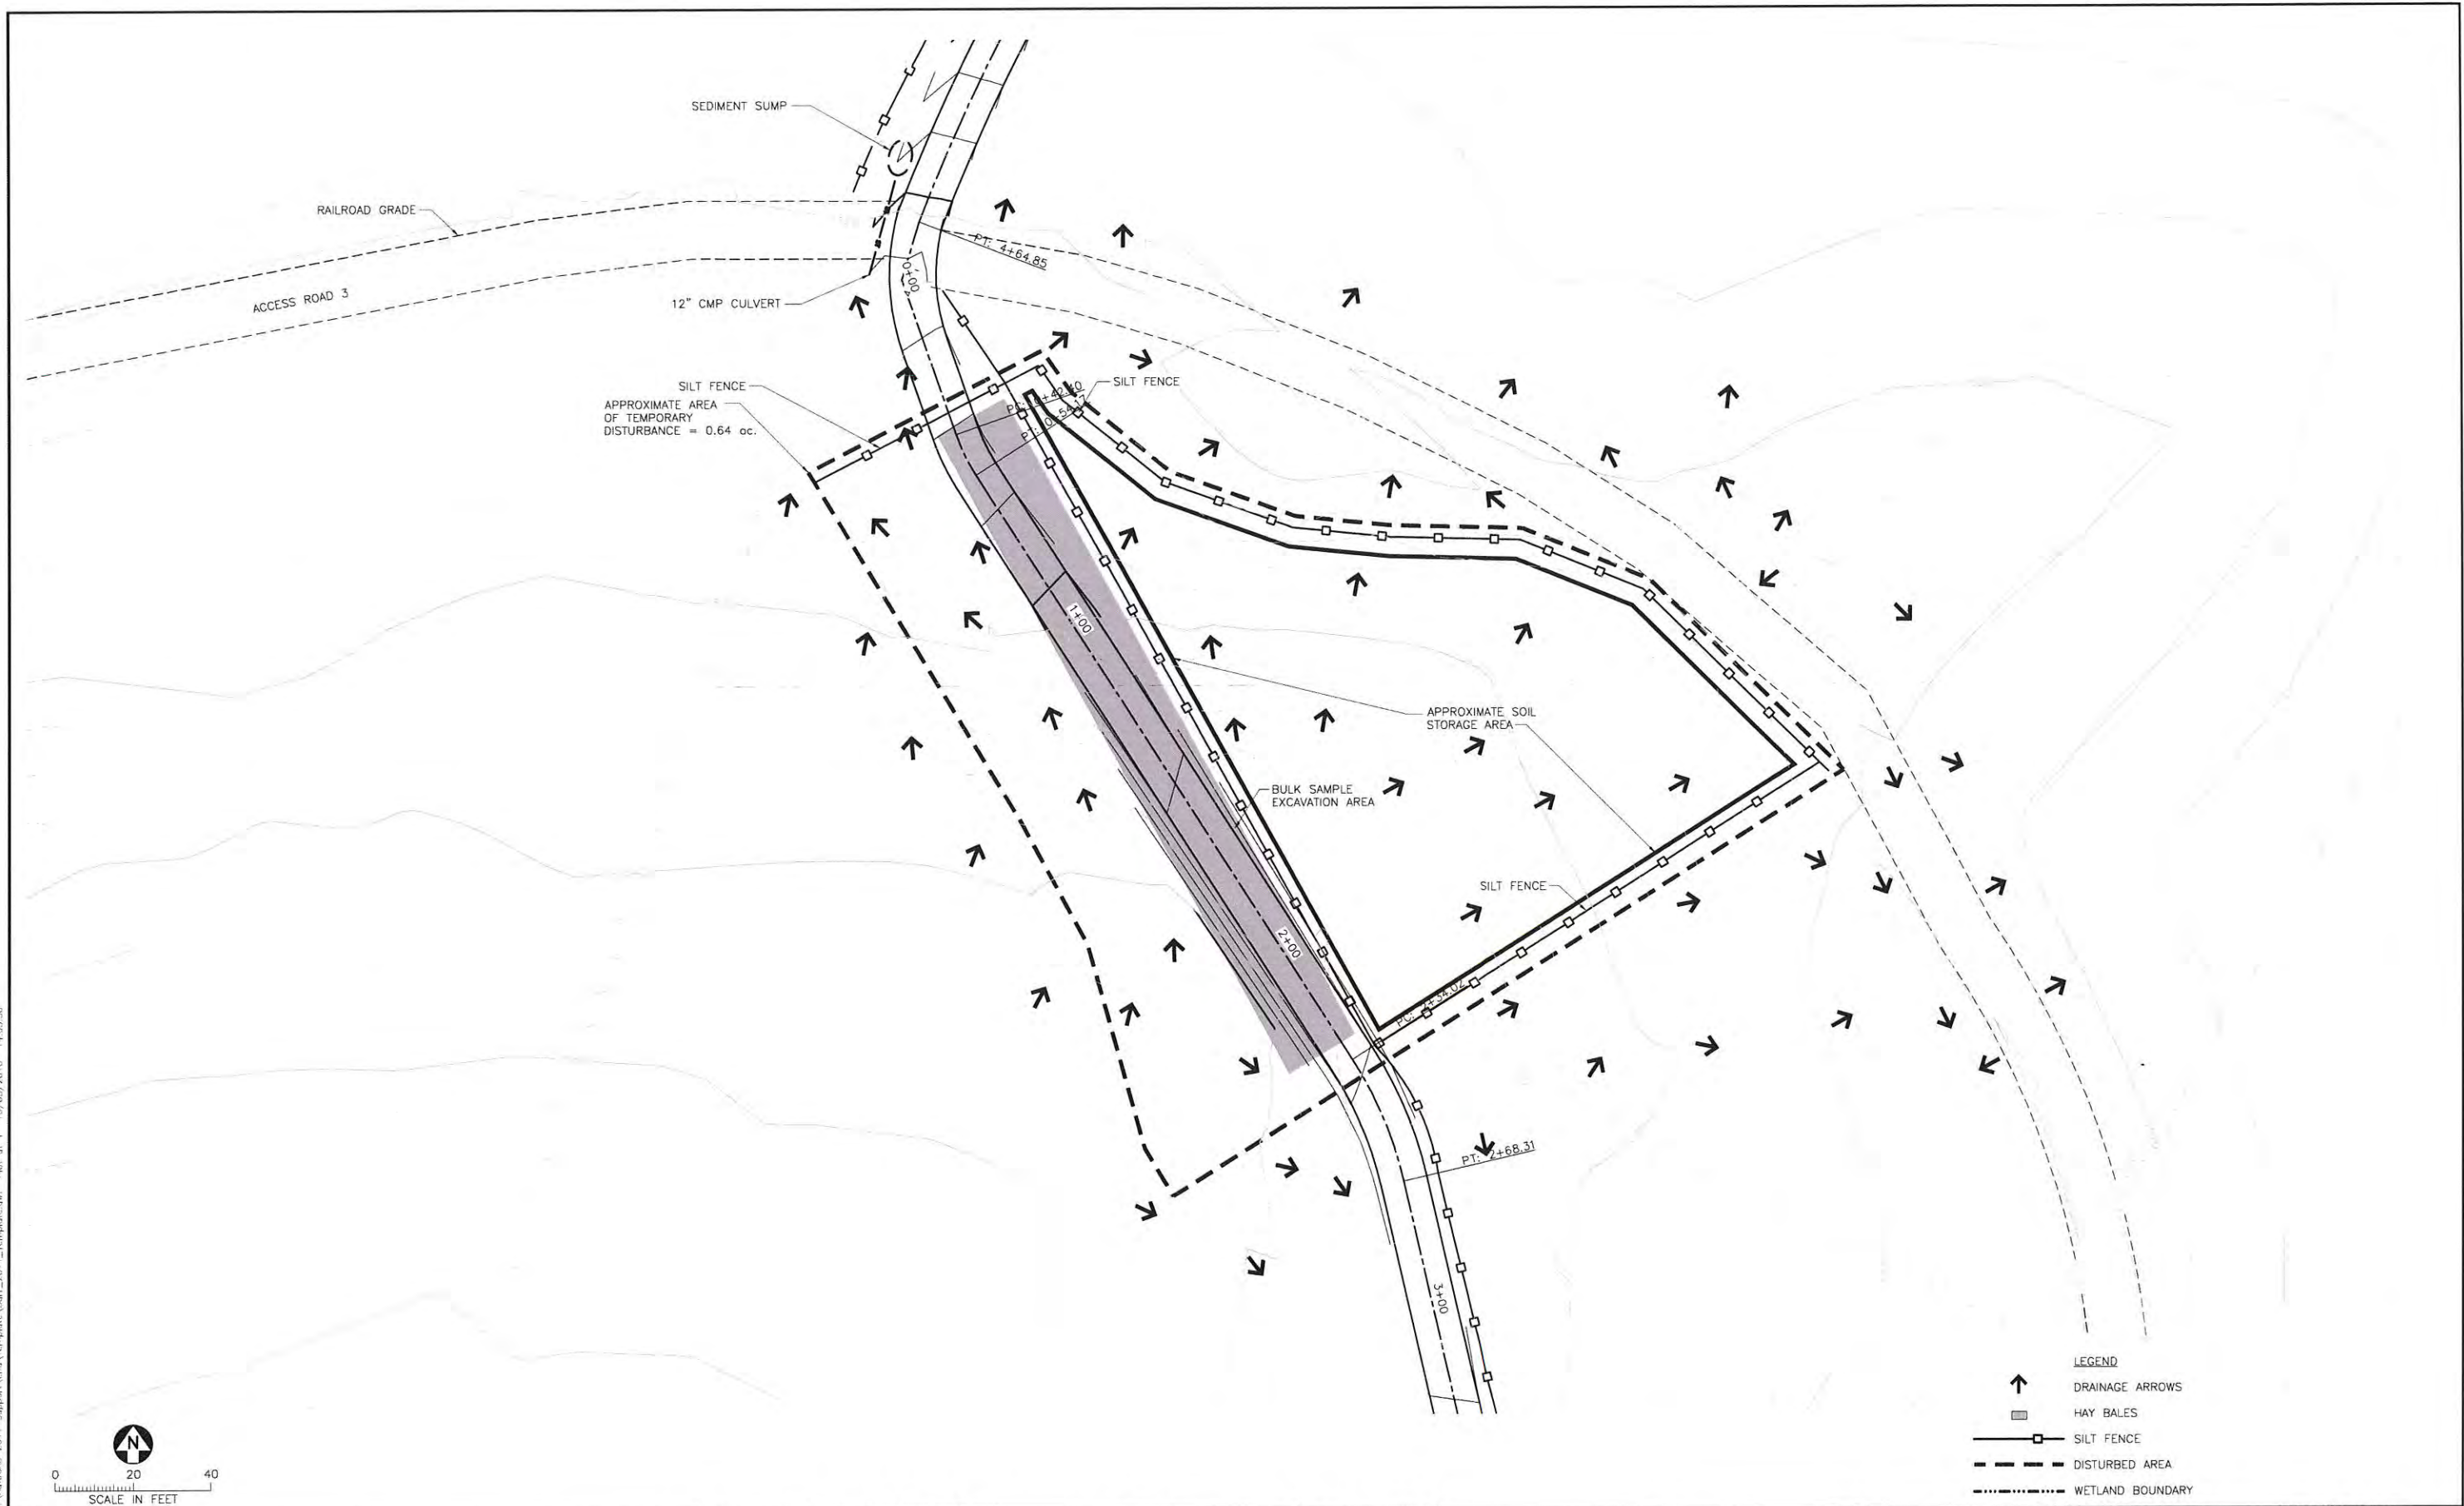
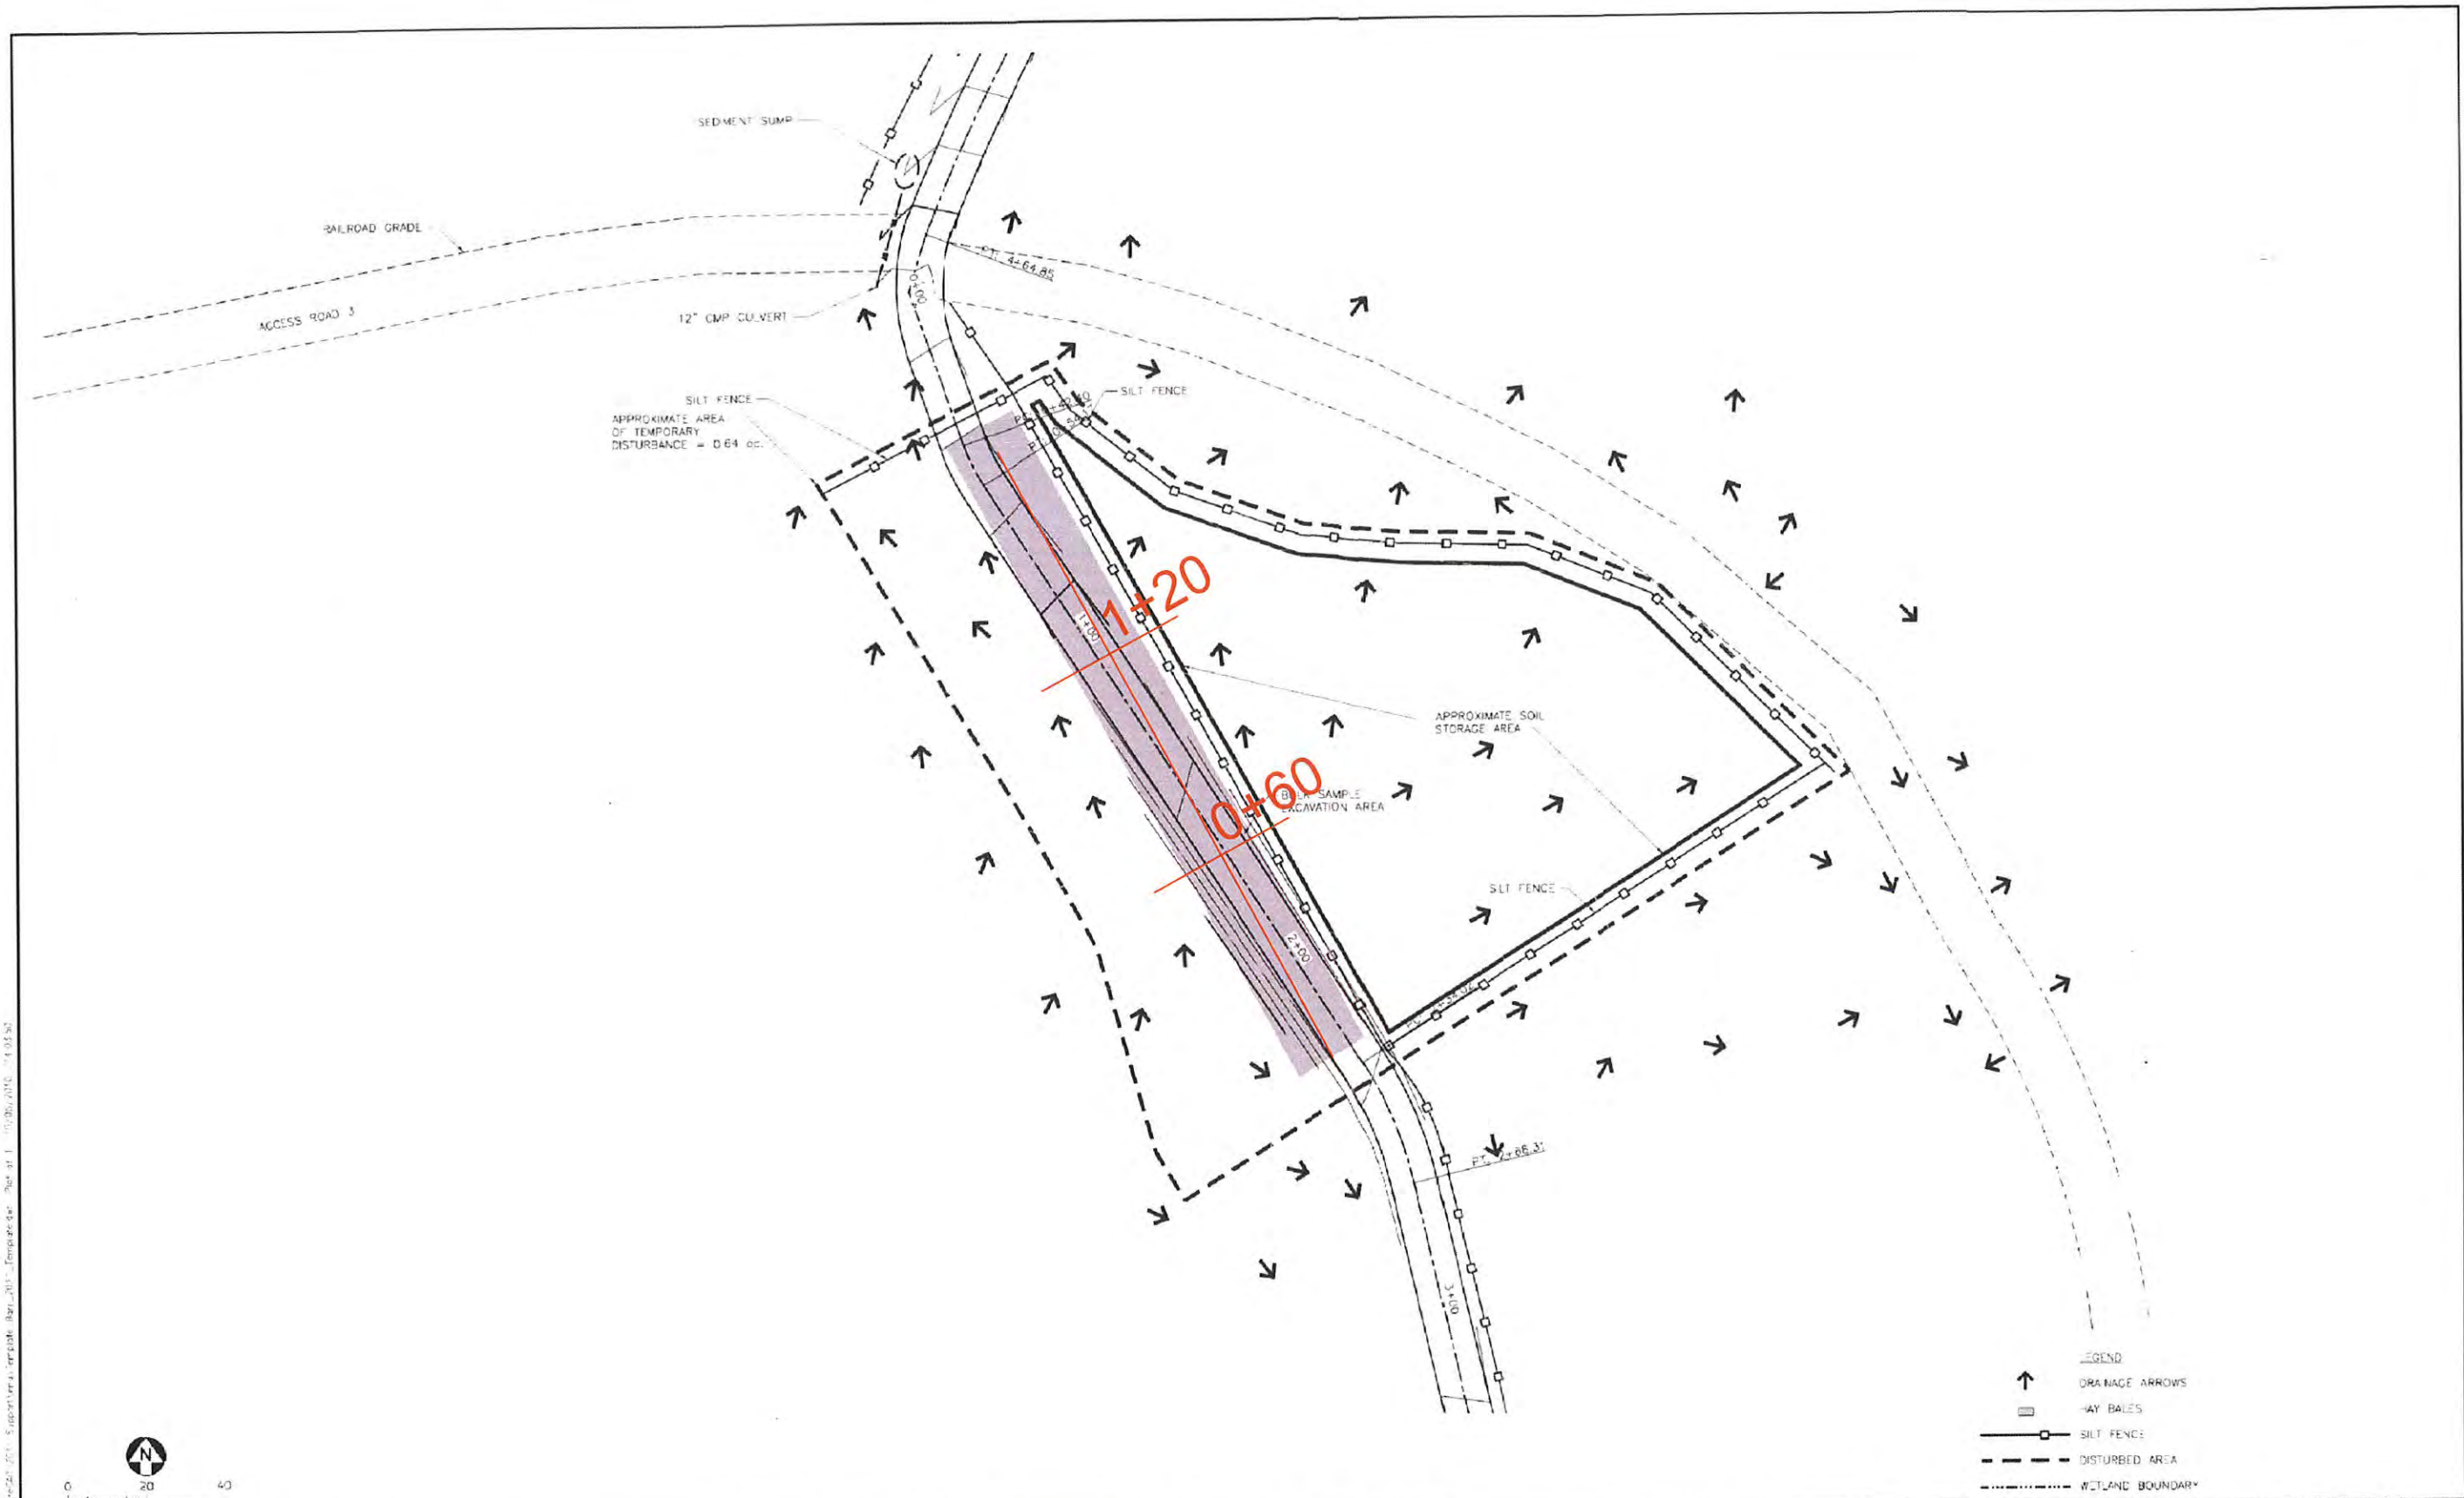
Stormwater drainage control will be established by the utilization of berms, diversion ditches, hay bales, sand bag berms and/or sediment fence. When the conditions allow, up gradient surface runoff may be directed away from the site by diversion ditches or berms. A detailed stormwater drainage plan is provided in a separate submittal.
