RE: Financial Assurance Release - Gogebic Taconite LLC, Ferrous Mineral Exploration Drilling Sites - Ashland and Iron Counties

Completion Report
Exploration License #41002
Vegetation at Exploration Hole 655-1
September 2024

Documentation of site conditions at Exploration Hole 655-1.

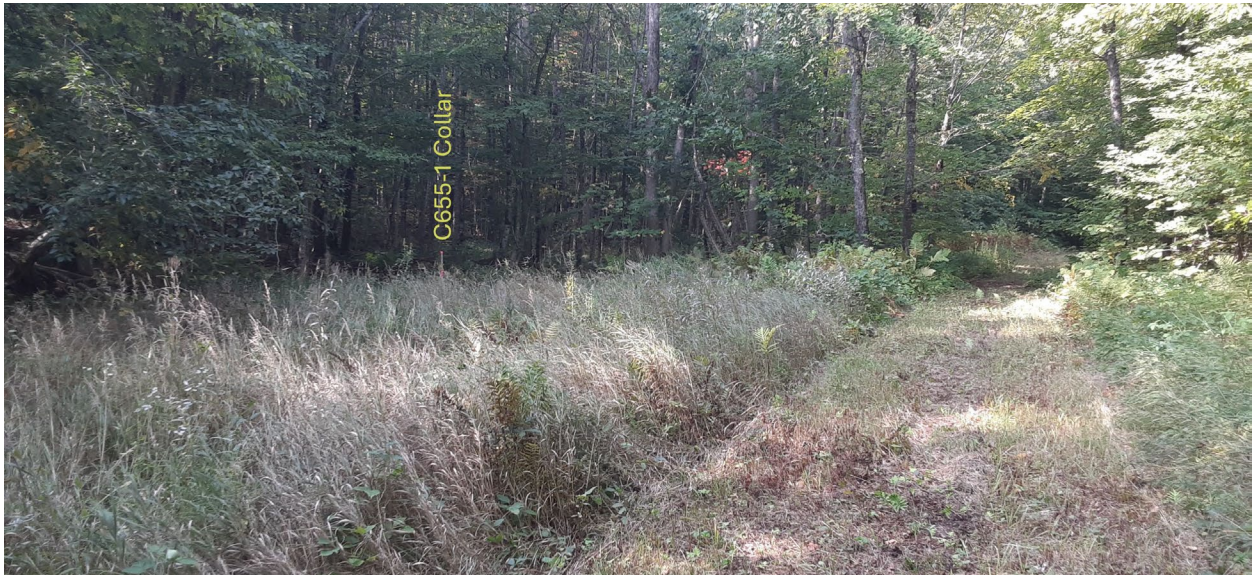
On September 10, 2024, a representative for Gogebic Taconite visited the site. Vegetation approaching the site was thick with the forestry road appearing to have been mowed. A stake with the exploration hole collar has been highlighted in Photo 1.

Photo 1: Site Condition as viewed from existing forestry road.

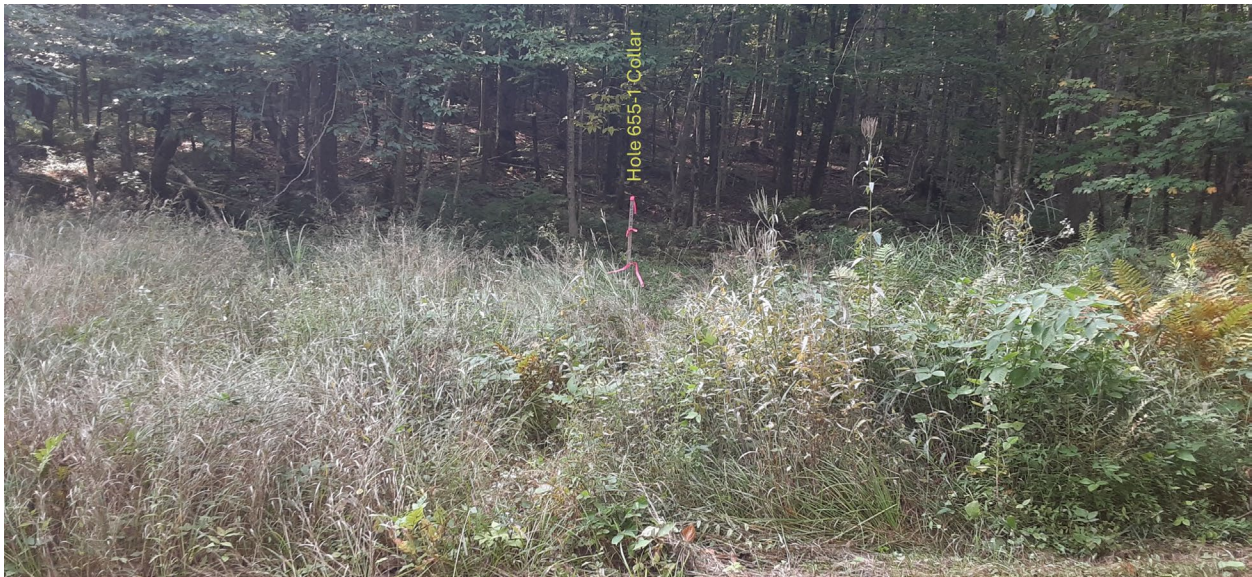
Photo 2 illustrates the vegetation as appearing from the forestry road looking towards the exploration hole 655-1 collar. Vegetation is thick.

Photo 2: Site condition as seen from the forestry road looking towards the exploration hole collar.

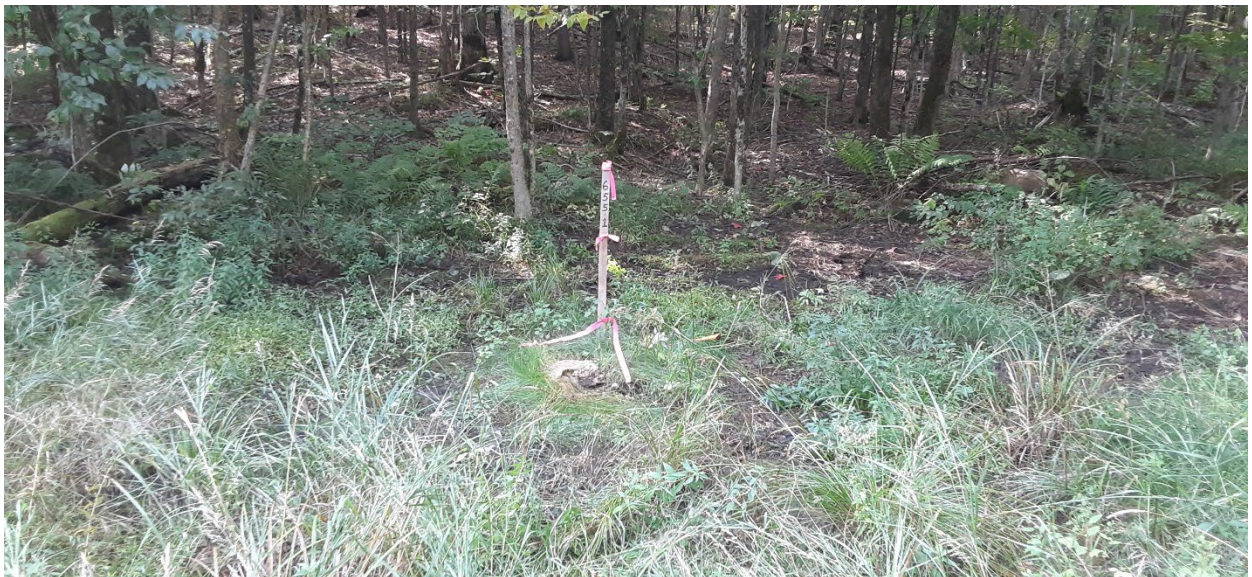
Photo 3 illustrates the general conditions at the collar. Note that the collar is within the shade area of the site.

Photo 3: General Site Condition as viewed at the collar.

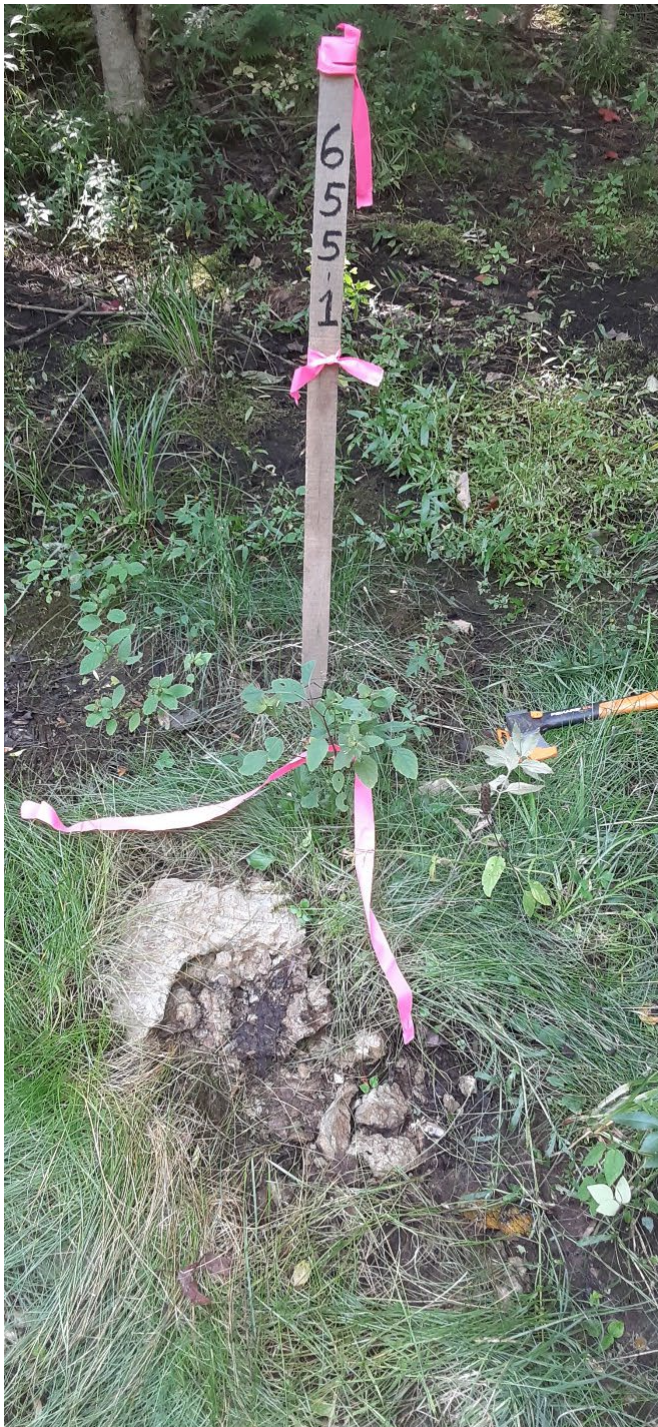
Photo 4 illustrates a close up view of the grout cap located at the collar. The grout cap remains intact and there is no evidence of artesian water flow from the exploration hole.

Photo 4: Close up view of grout cap at Exploration Hole 655-1.

In summary, the secondary grouting activity remains effective and vegetation at the site has been established.
