# Wisconsin Water Quality Handout

## Lower Duck Creek 2015 (EGAD 3200-2018-66)

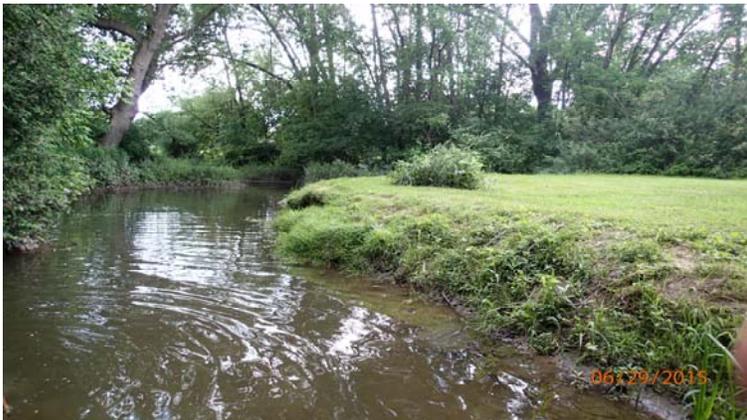
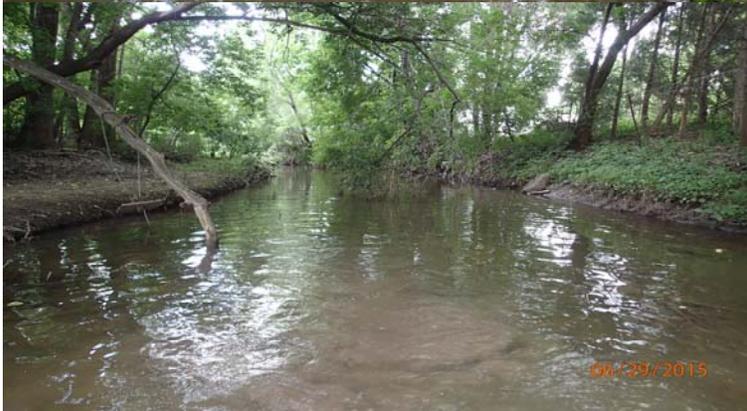
Streams in Lower Duck Creek are located in areas of urban and residential land use. Fine sediments dominate the substrate in most places. Fish cover is lacking at Memorial Drive and STH 54. Habitat scores rated as good at all locations in the Lower Duck Creek.

**Left Top and Bottom:** Beaver Dam Creek at Memorial Drive.

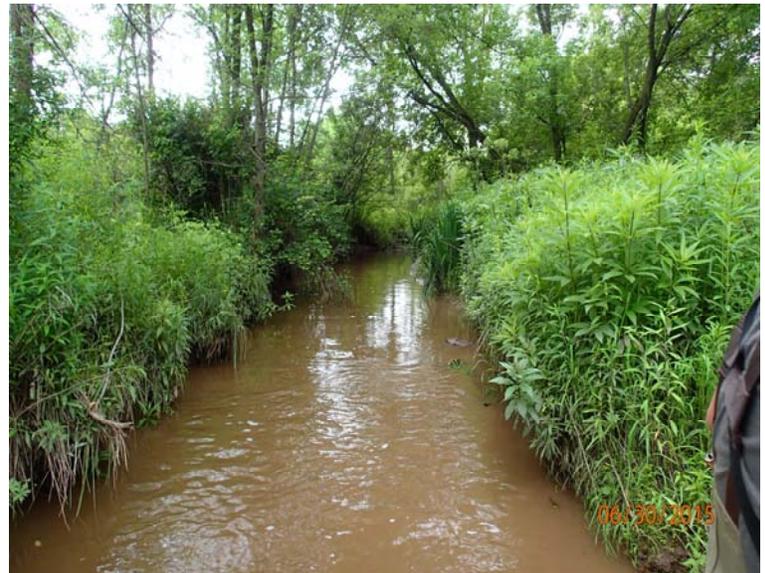
**Above:** Silver Creek above STH 54.
