Wisconsin Water Quality Handout

Upper Plum Creek 2015 (EGAD 3200-2018-77)

Upper Plum Creek 2015

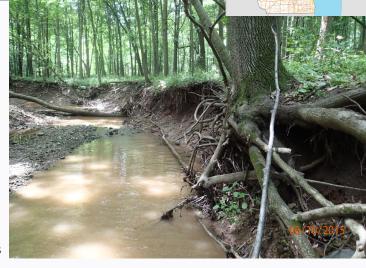
Unnamed tributary to Plum Creek at Holland Road.

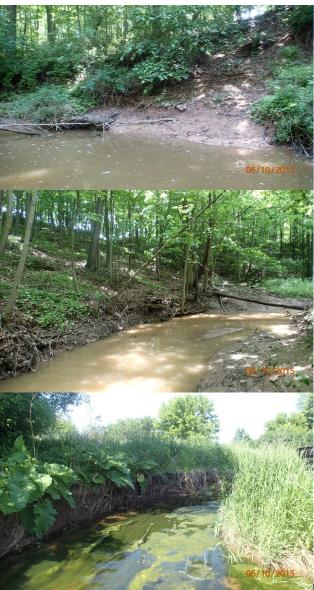
Fish and Habitat Ratings							
Stream Site	Fish IBI	Habitat Rating	Macroinvertebrate IBI				
Plum Creek at CTH Z	Fair	Fair	_				
Plum Creek at Vanderwetting Road	Poor	Fair	_				
Plum Creek at ManCal Road	Poor	Good	Fair				
Unnamed Tributary to Plum Creek at CTH D	Fair	Fair	Fair				
Unnamed Tributary to Plum Creek at Holland Road	Fair	Fair	Fair

Top: Plum Creek at Vanderwetting Road.

Middle: Unnamed tributary to Plum Creek at Holland Road.

Bottom: Unnamed tributary to Plum Creek at CTH D.

Soil Health principles should be adopted to improve infiltration along with sediment and nutrient retention on agricultural lands in the watershed. The re-establishment of adequate vegetative buffers along stream corridors could include the removal of undesirable species such as box elder and buckthorn allowing for the management of more desirable tree species. Additionally, vegetative buffer widths should be expanded to prevent soil loss and to increase distances between nutrient application and waterways. Areas of significant bank erosion and failures exist. Focused efforts to stabilize banks through a strategic approach should be enacted to prevent hard armoring in a small parcel by parcel approach. Permit compliance from permitted facilities must be a high priority to assist in reaching meaningful phosphorous reductions and water quality improvements.
