WETLAND & WATERWAY DELINEATION REPORT

EMERALD PARK LANDFILL – WESTERN EXPANSION
ADVANCED DISPOSAL SERVICES, INC
City OF MUSKEGO, WAUKESHA COUTNY, WI

December 10, 2014

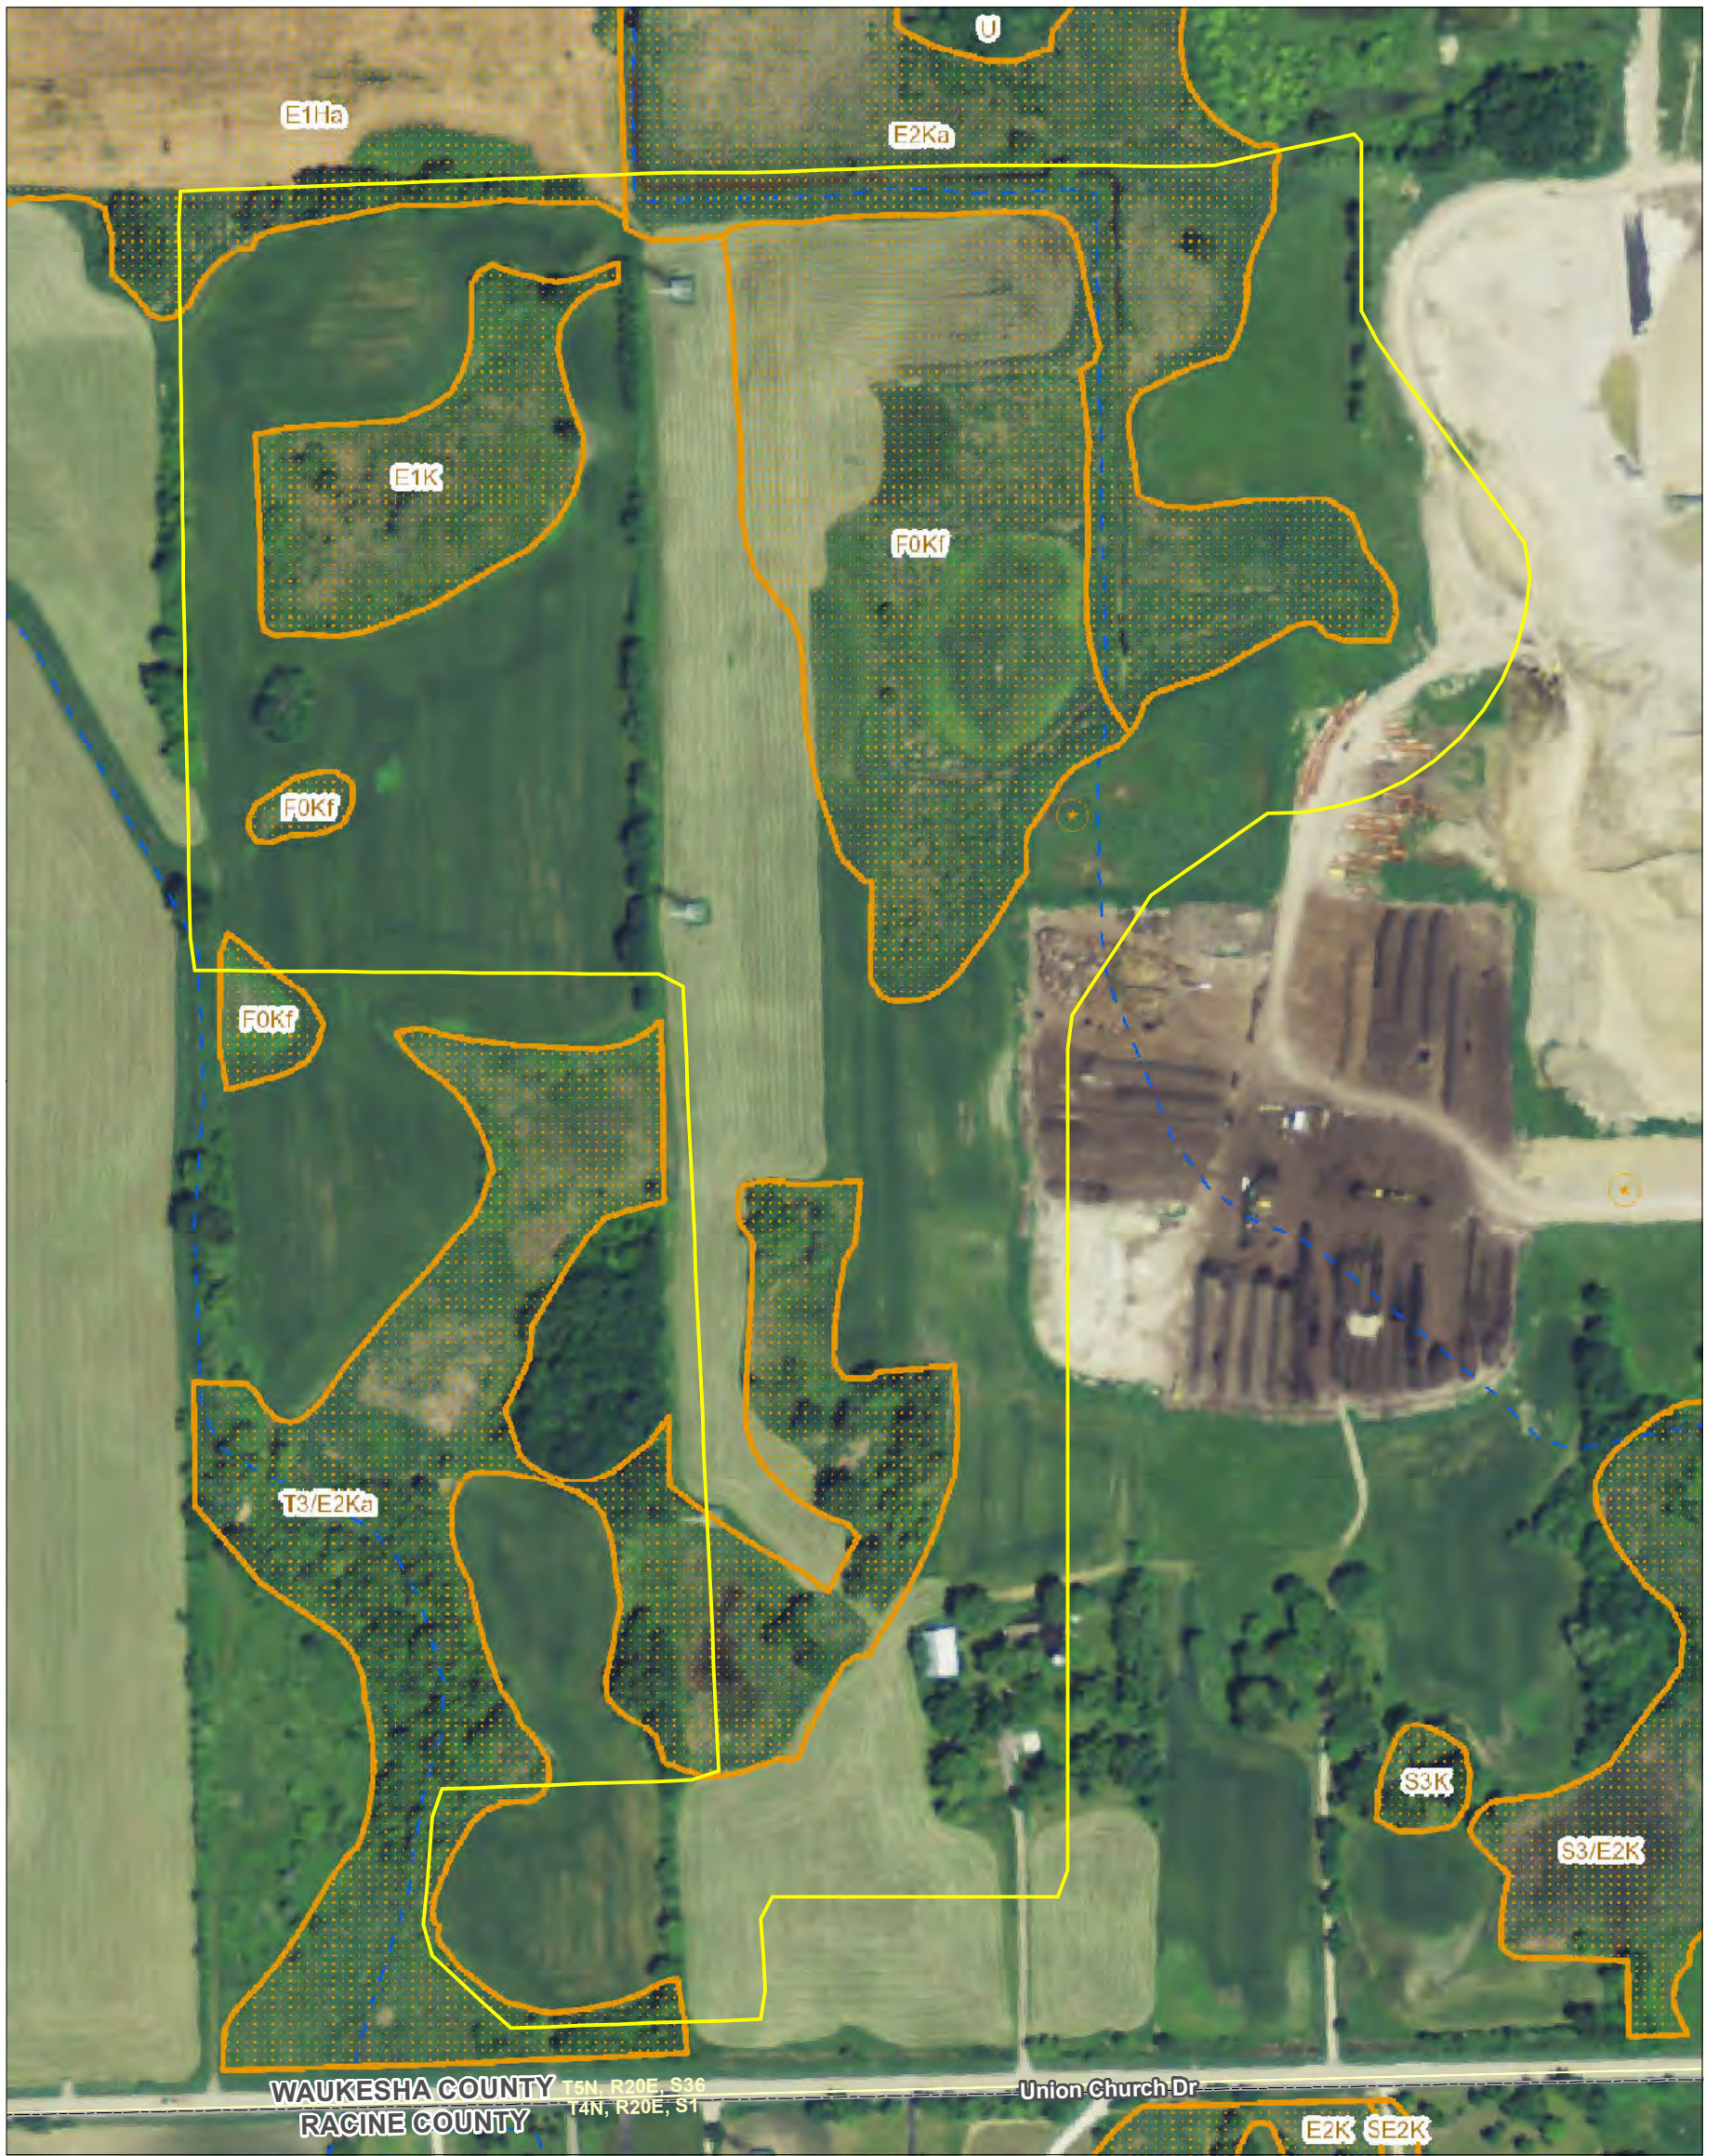
The Wisconsin Wetland Inventory (WWI) map identifies six (6) wetland areas within the Project Area (Figure 3). Two wetlands, predominately comprised of shrub-carr / forested wetland community (T3/E2Ka), are located in the southern portion of the Project Area and generally coincide with field delineated wetlands W-1 and W-11. Four wetlands, predominately comprised of wet meadow and farmed wetland communities (E1K, E1Ha, E2Ka and FOKf), are located in the northern portions of the Project Area. These wetlands generally coincide with field delineated wetlands W-2, W-2A, W-8, W-9, and W-10. Wetlands W-3, W-4, W-5, W-6 and W-7 are not depicted on WWI (Figure 4).
