## TECHNICAL MEMORANDUM

RE: 2021 Expansion Planning – Evaluation for Wetlands  
SEH No. VERSW 157634 14.00

This Memorandum summarizes SEH's site reconnaissance for the proposed expansion of the landfill area at the Vernon County Solid Waste and Recycling Facility, located at S3705 County Road LF, Viroqua, WI. SEH reviewed the natural vegetation and landscape conditions in the landfill expansion area to determine if any areas met the technical criteria of a wetland, as set forth in the U.S. Army Corps of Engineers *Wetlands Delineation Manual* (USACE 1987) and the *Regional Supplement to Wetland Delineation Manual: Midwest Region* (USACE 2010) on May 4, 2021. The field reconnaissance was completed by Renee Wilde, PWS, CFM, Wisconsin Department of Natural Resources (WDNR) Assured Wetland Delineator.

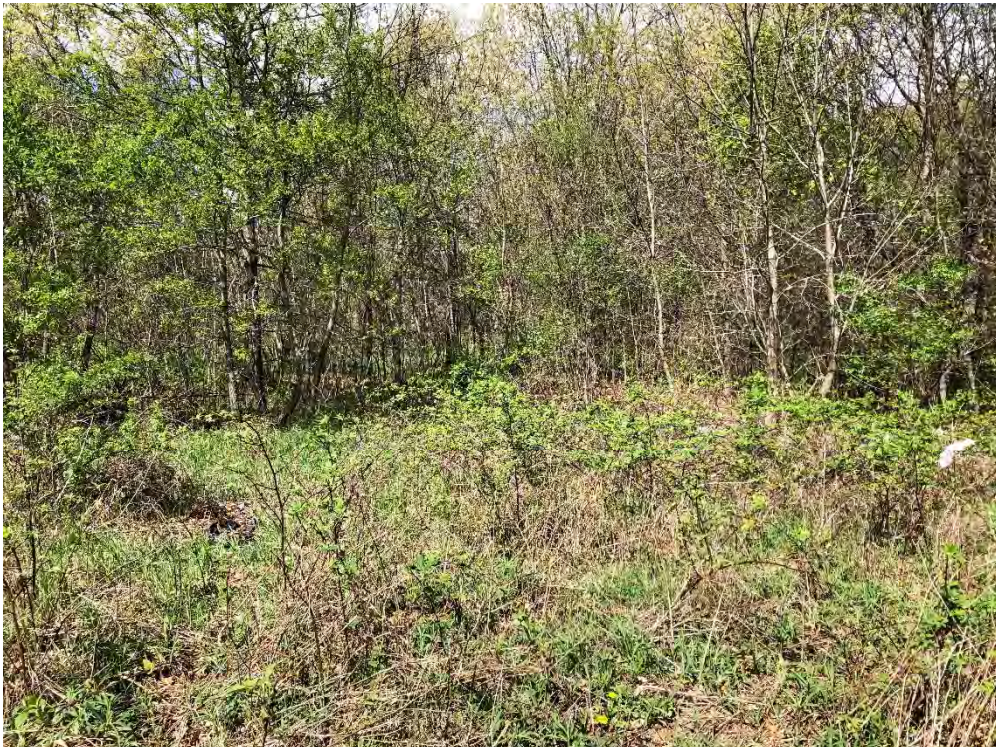
Sample point data (SP1U) was collected to document site conditions. Vegetation was dominated by Kentucky bluegrass (*Poa pratensis* – FAC), Canadian goldenrod (*Solidago canadensis* – FACU), and Allegheny blackberry (*Rhubus allegheniensis* – FACU) in the herbaceous stratum, choke cherry (*Prunus virginiana* – FACU) in the shrub stratum, and black cherry and ash-leaf maple/boxelder (*Acer negundo* – FAC) in the tree stratum. Soils at SP1U are composed of 6 inches of dark yellowish brown (10YR 3/4) silty clay loam, underlain by 4 inches of dark yellowish brown (10YR 4/4) loam. This was followed by 4 inches of yellowish brown (10YR 5/4) loam with 5% redoximorphic concentrations (10YR 4/4), and at least 8 inches of yellowish brown (10YR 5/4) clay loam with 20% redoximorphic concentrations (10YR 4/4). The soil profile does not meet the technical criteria for hydric soils. No primary or secondary hydrology indicators were present. None of the three wetland criteria were met, therefore the area is non-wetland.

**Photo 4** Upland area adjacent to Sample Point 1U; area dominated by species of Kentucky bluegrass, Canada goldenrod, blackberry, and raspberry

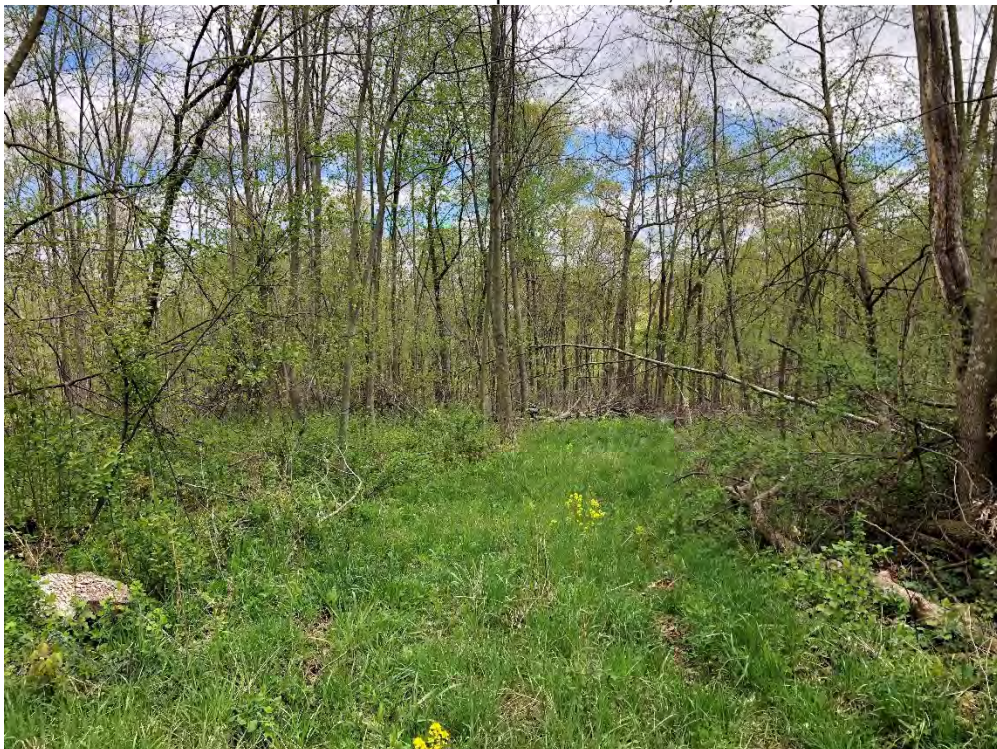
**Photo 6** Old logging road overgrown with grasses; the road slopes towards the northeast

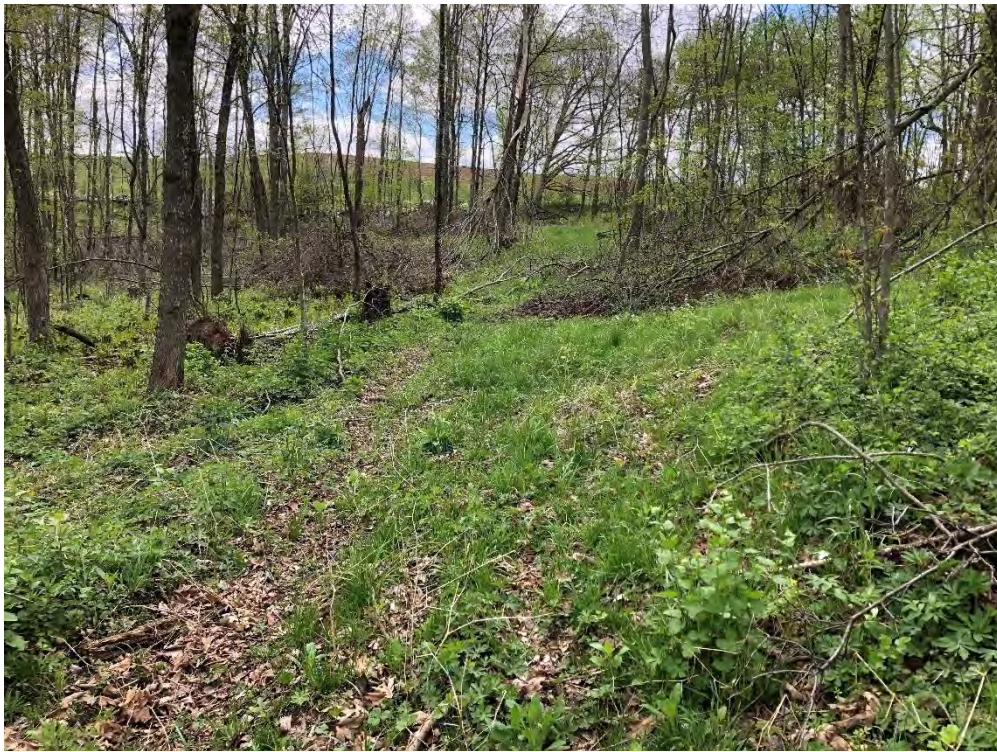
**Photo 7** Intersection of two logging roads within the woods, facing south from the vicinity of Sample Point 2U. The topography slopes towards the northeast, with the landfill seen in the background.

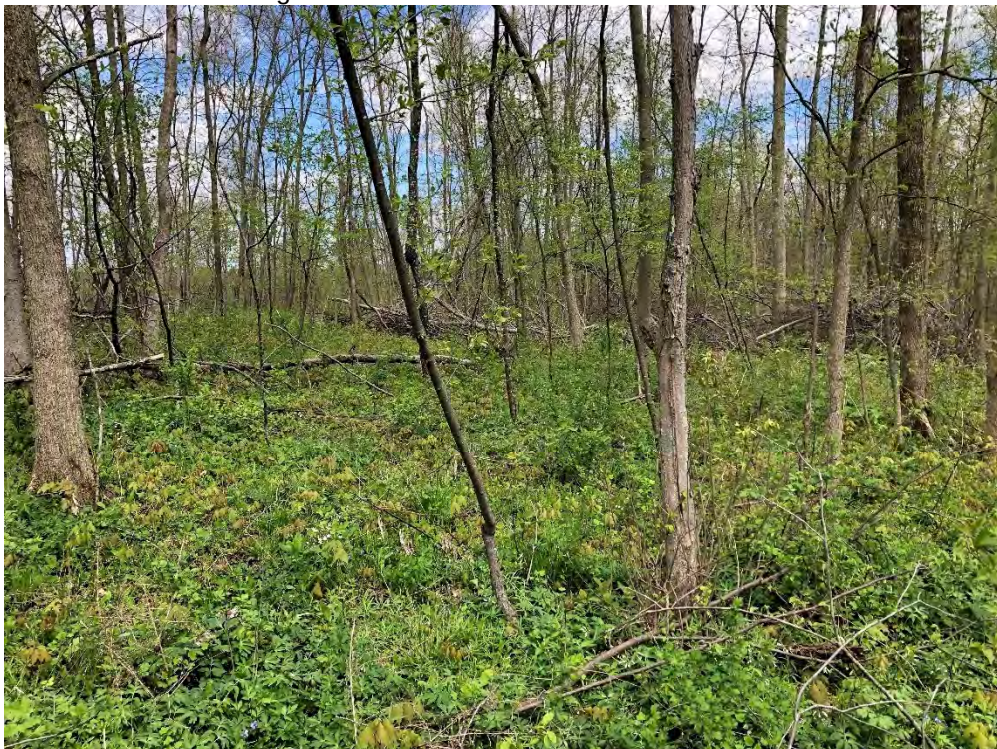
**Photo 8** Typical understory found within the forested area. The forest is high in the landscape and vegetation is dominated by upland species.
