## Appendix C

Local Notifications, Approvals, and Report Submittal to Municipalities

RE: Vernon County Landfill  
Proposed Solid Waste Landfill Expansion

D-5 – WDNR Inspection (8-2023) and Letter of Noncompliance

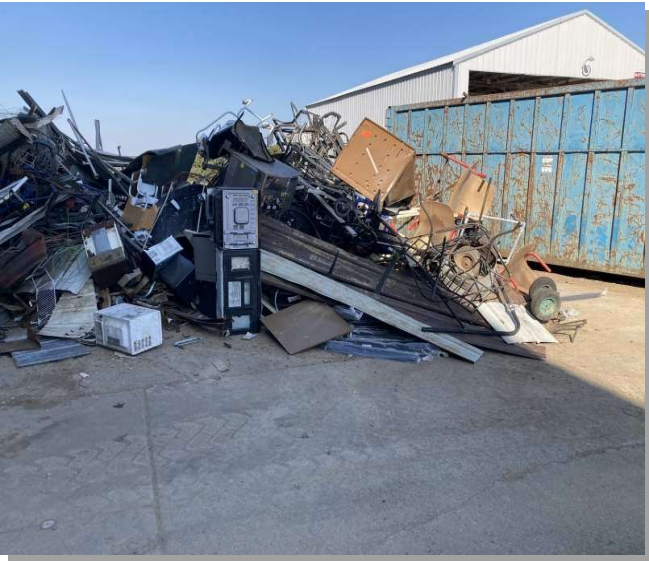
Scrap metal but has some electronics in it

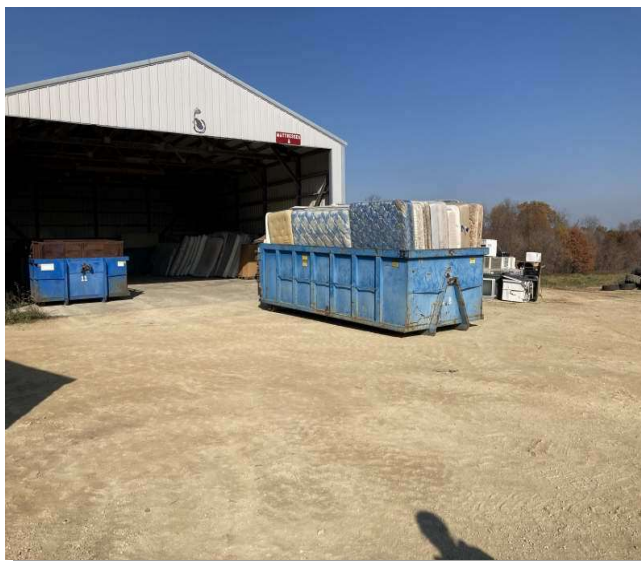
Photo # 83687 Photo 2 of 18

Mattresses ready to be shipped out

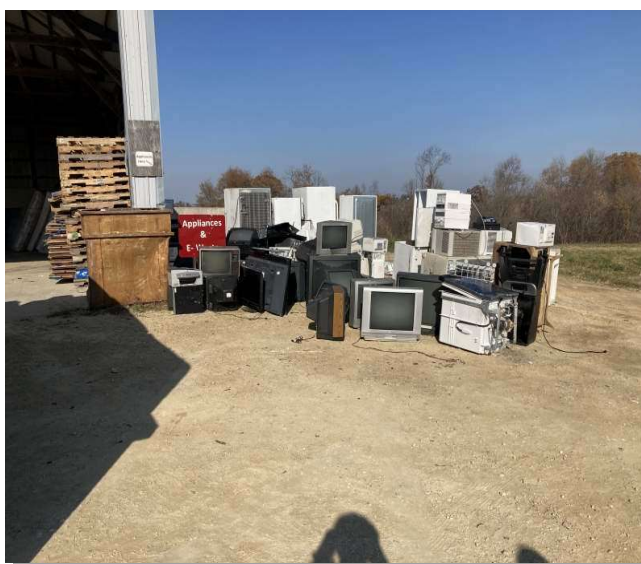
Photo # 83688 Photo 3 of 18

Electronics that need to be stored to prevent contact water

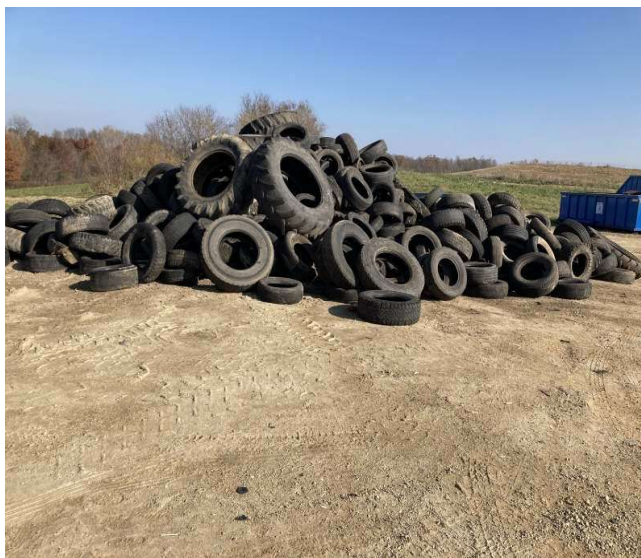
Photo # 83689 Photo 4 of 18

Tire pile is less than a truckload

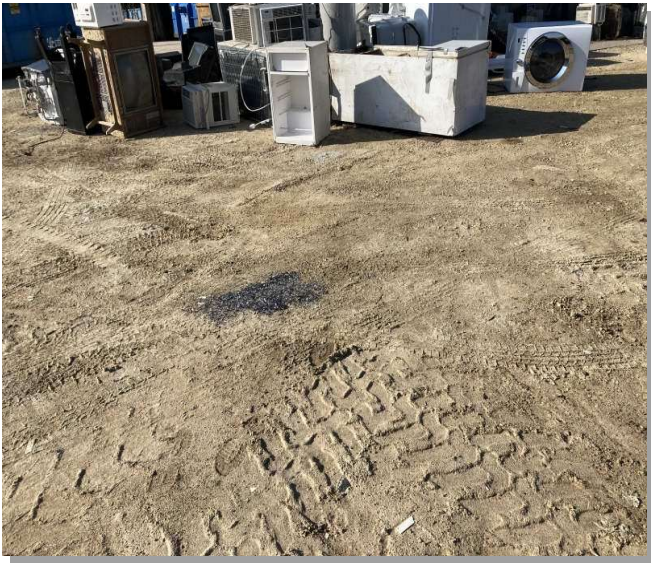
Photo # 83690Photo 5 of 18

Appliances should also be stored to prevent contact water

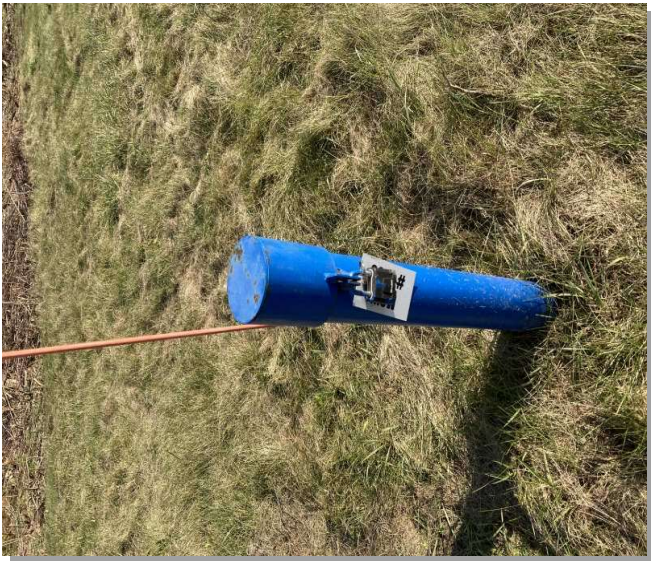
Photo # 83691Photo 6 of 18

example of well labelled and locked

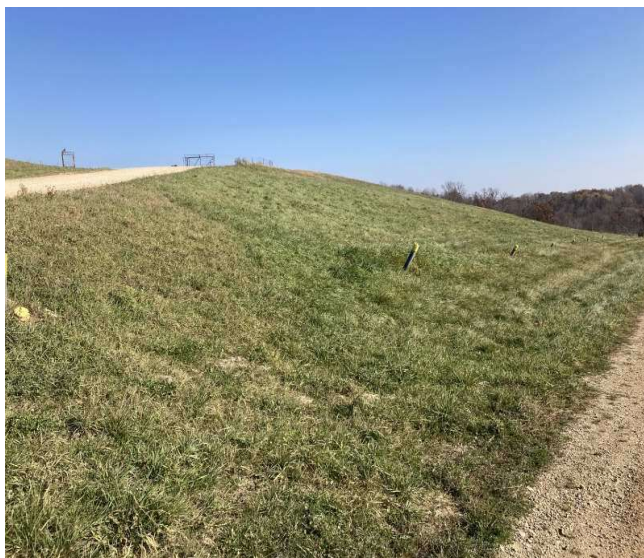
Photo # 83699

Portion of site with final cap installed

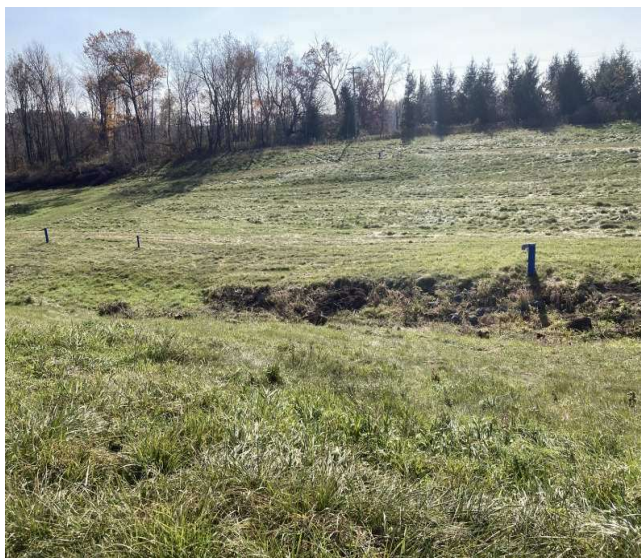
Photo # 83700 Photo 14 of 18

Stormwater conveyance brushed out

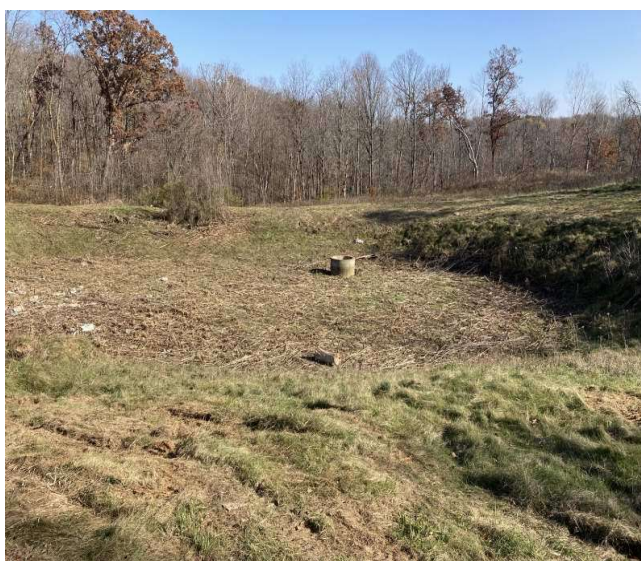
Photo # 83701 Photo 15 of 18

Sed basin brushed out

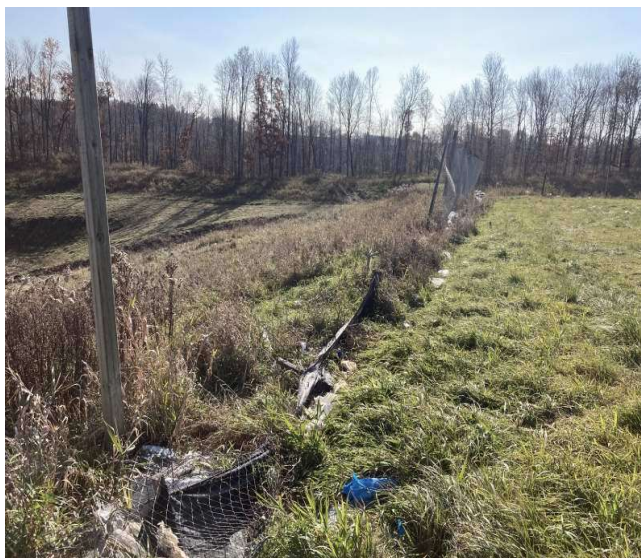
Photo # 83702 Photo 16 of 18

Blown out section of perimeter fence where surface water blows through it. Culvert or energy dissipator structure should be set up.

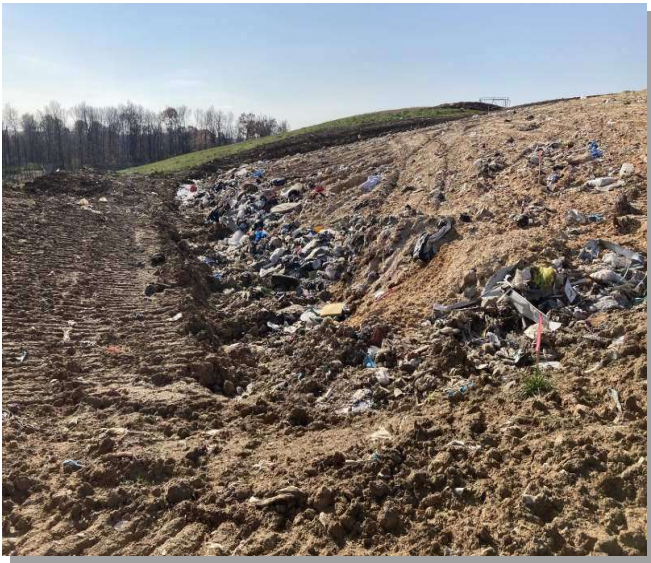
Photo # 83703 Photo 17 of 18

Area where interim cover was ripped off to add extra waste.

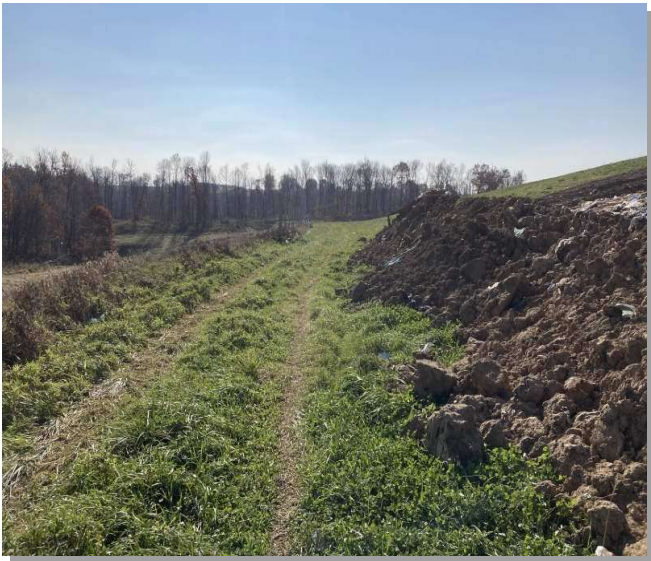
Photo # 83704 Photo 18 of 18

Excess interim cover placed on perimeter

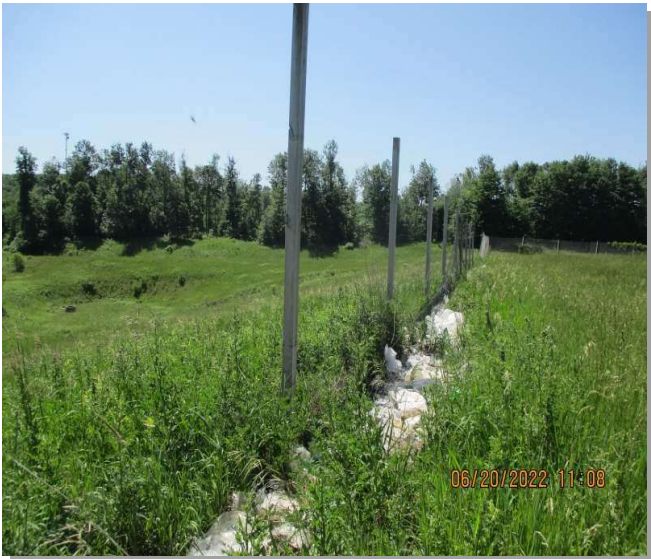
The perimeter litter fence on the eastern side of the landfill was observed down and collected windblown debris was observed in the down litter fencing. Windblown debris was additionally observed on the eastern exterior sideslope of the landfill. The County explained that the County has recently obtained additional telephone poles to extend the perimeter litter fence to the north. The County is waiting to install the additional telephone poles before the litter fence is repaired. The department and County discussed the need to collect windblown debris on the eastern side of the landfill. Collection of windblown debris will be reinspected during the department's next inspection.

| <b>D. Reasonable effort made to collect windblown materials deposited beyond the active area at the end of the day.</b><br>Windblown debris was observed around primarily the northeastern and eastern areas surrounding the landfill, including the eastern exterior sideslope. Concentrated windblown was observed collected where the eastern perimeter litter fence was observed unrepaired from the department's last inspection. The department and County discussed collecting the windblown debris, focusing on areas that may become further windblown and leave the landfill property. | <b>CA</b> | 506.07(1)(c)<br>Photo(s): Y |

Eastern perimeter litter fence observed down with windblown debris collected at the base of the litter fence. The litter fence needs to be repaired and the windblown debris needs to be collected.

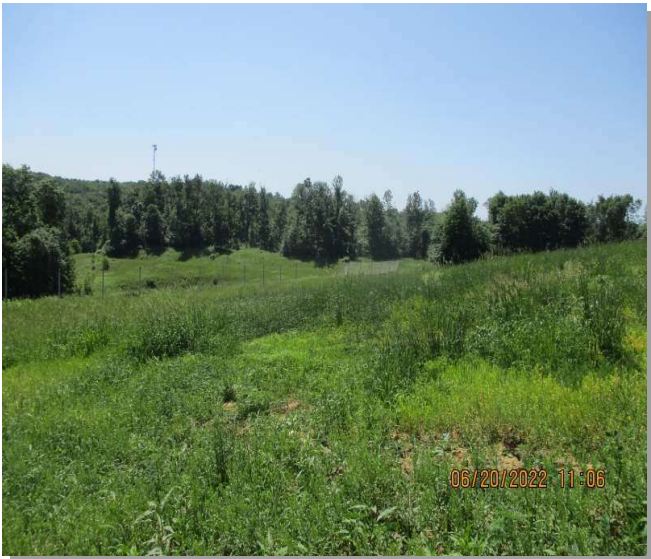
Photo # 88071 Photo 2 of 17

| <b>E. Intermediate cover vegetated, compacted and sloped no less than 5% and no greater than 33%.</b><br>Areas of intermediate cover on the eastern side of the landfill were observed with severe erosion rills. The rills did not appear to be exposing waste. The area will be disturbed later in the week to allow for additional filling in the area. This area will be reinspected during the department's next inspection to check for filling or intermediate cover repair. An area on the northern side of the landfill also had exposed waste that was regraded to allow for filling. The waste is expected to be covered with intermediate cover during the same time the intermediate cover on the eastern side of the landfill is disturbed. This area will additionally be reinspected during the department's next inspection. | CA | 506.06 |

Intermediate cover on the eastern exterior sideslope observed partially vegetated with deep erosion rills. The erosion rills did not appear to be exposing waste. The area is anticipated to be disturbed to be used for filling within the next few days.

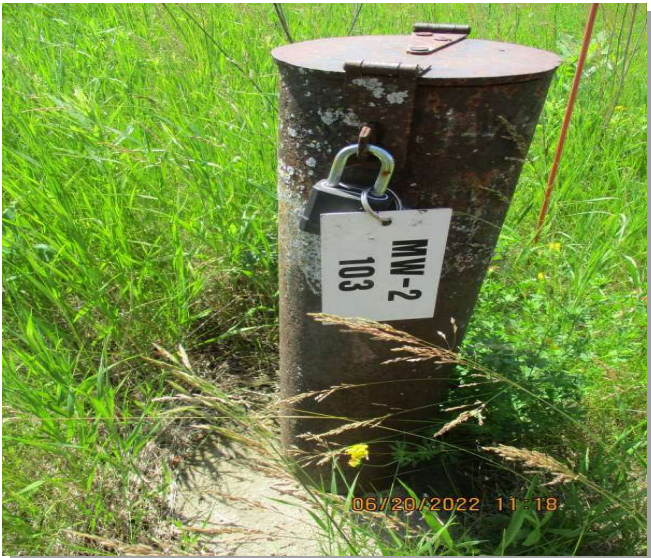
Photo # 88072 Photo 3 of 17

Groundwater monitoring well MW-2 observed locked, labeled, and appeared to be in good condition.

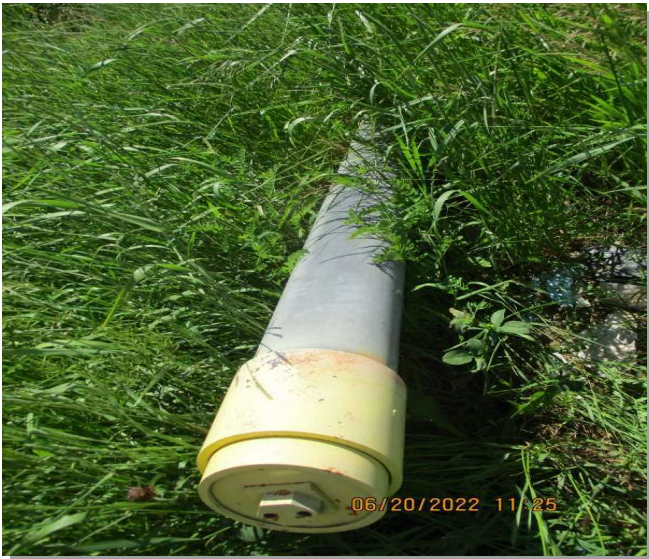
Photo # 88077 Photo 8 of 17

Leachate cleanout on the northern perimeter of the landfill missing a label. Please label the leachate cleanout.

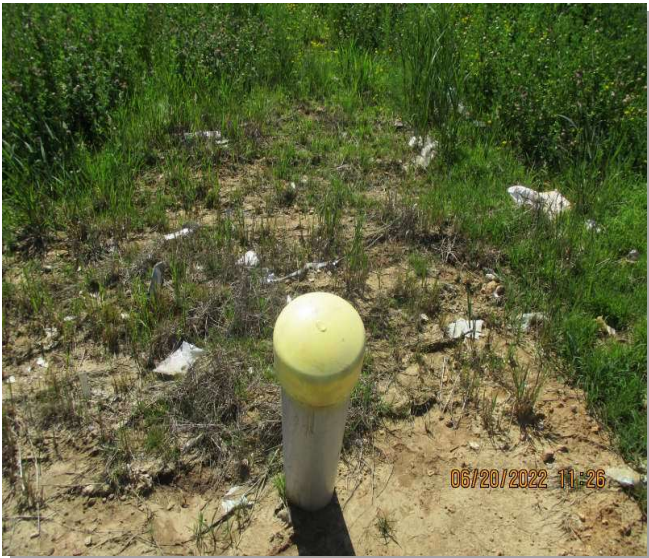
Photo # 88078 Photo 9 of 17

Leachate cleanout on the northern perimeter of the landfill missing a label. Please label the leachate cleanout.

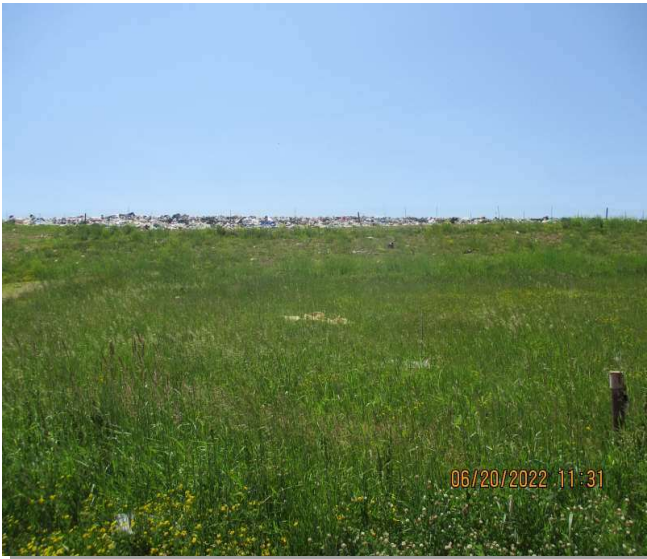
Photo # 88080 Photo 11 of 17

The northern exterior sideslope of the landfill was observed with uncovered waste berm. The County explained that the area had recently been regraded to prepare for future filling sequences. A trench was excavated just north of the waste berm to contain any runoff that may contact the waste pile. A contractor is scheduled to come later in the week to cover the exposed waste. This area will be reinspected during the department's next inspection. Intermediate cover below the northern waste berm was observed with patchy vegetation; however, no erosion rills were observed on the northern exterior sideslope. During the same time the northern waste berm is covered, the contractor will also regrade the eastern exterior sideslope where severe erosion rills were observed. The eastern exterior sideslope is being regraded to allow for filling to continue in the area. This area will additionally be reinspected to ensure that either the erosion rills are repaired, or the area is regraded for filling.

| <b>I. Municipal solid waste and non-high-volume industrial solid waste covered at the end of operating day with at least 6 inches of daily cover. *</b><br>A waste berm area was observed uncovered near the northern exterior sideslope. The County explained that a trench was dug beneath the waste to collect any leachate generated and that a contractor would be on site that week to cover the waste. This area will be reinspected during the department's next inspection for proper coverage of the waste. | <b>CA</b> | 506.05<br>Photo(s): Y |

Intermediate cover on the central portion of the northern exterior sideslope of the landfill observed vegetated. An uncovered waste berm was observed at the top of northern sideslope. A contractor is scheduled to come to the site this week to cover the exposed waste.

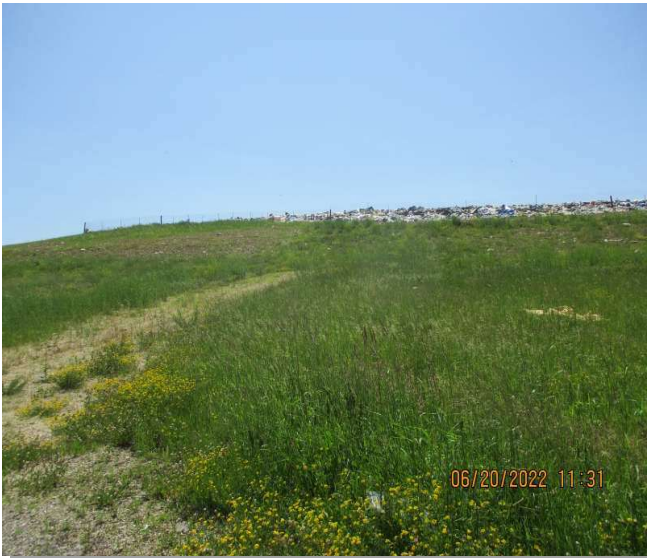
Photo # 88081 Photo 12 of 17

Intermediate cover on the eastern portion of the northern exterior sideslope of the landfill observed vegetated. An uncovered waste berm was observed at the top of northern sideslope. A contractor is scheduled to come to the site this week to cover the exposed waste.

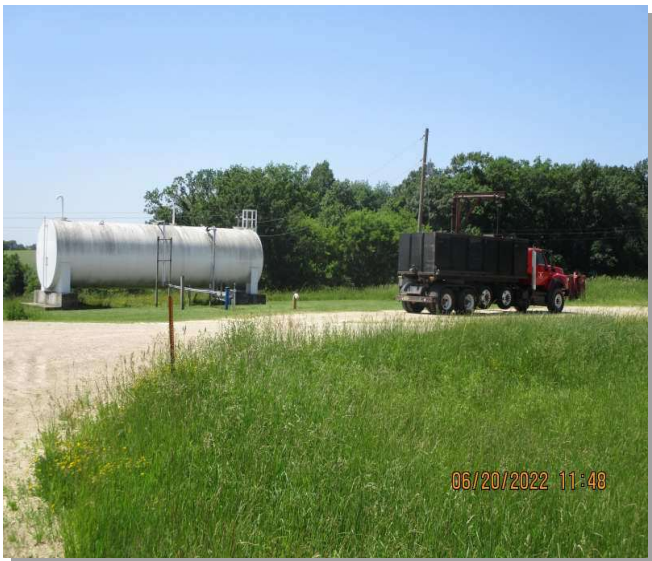
Photo # 88082 Photo 13 of 17

Approximately 30,000-60,000 gallons of leachate is hauled weekly to primarily the Sparta wastewater treatment plant with an on-site haul truck. The truck was observed parked under the above head leachate loadout at the time of the inspection. Backup leachate treatment plants include La Crosse and Viroqua wastewater treatment plants. Leachate collection line jetting has not yet occurred for 2022. The County is anticipating televising leachate collection lines in 2022 to further investigate the blockage report in the 2021 jetting report.

Above ground leachate tank (left) and haul truck under leachate loadout (right).

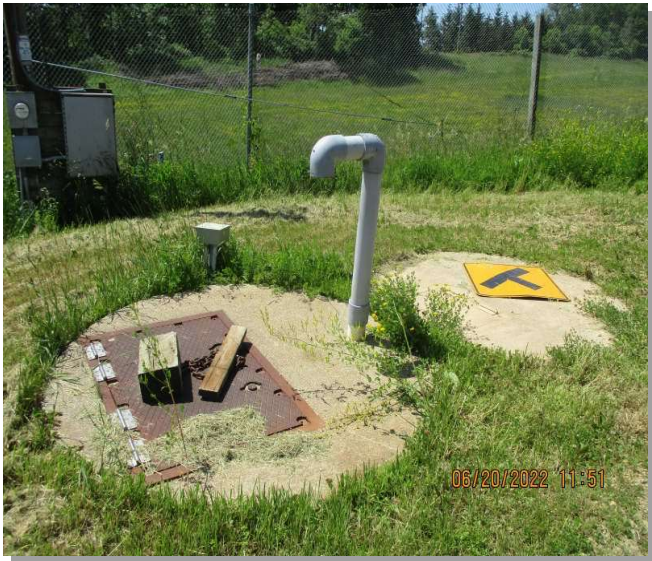
Photo # 88083 Photo 14 of 17

Force main manhole with passive vent.

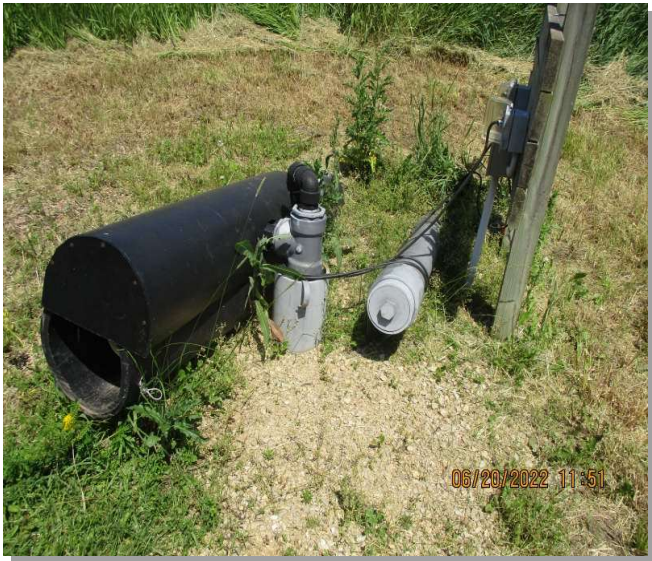
Photo # 88084 Photo 15 of 17

Leachate cleanout and other associated leachate conveyance features. Please label the leachate cleanout.

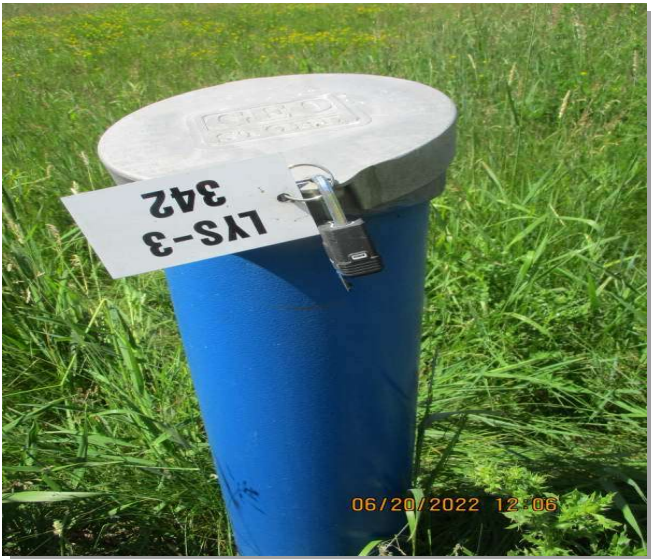
Photo # 88085 Photo 16 of 17

Lysimeter LYS-3 observed with the inner PVC pipe beginning to heave not allowing the cap to properly lock. The PVC pipe should be cut down and the top of well grade surveyed (this information sent to the department).

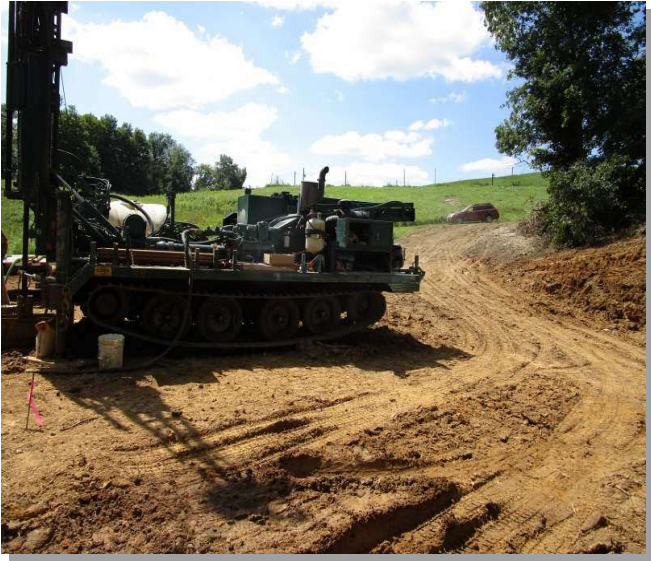
Carolyn Cooper and Joe Lourigan (DNR) met with Stacie Sanborn (Vernon County [County]) and Brian Kent (Short Elliott Hendrickson, Inc. [SEH]) at the Vernon County landfill at approximately 1:00 PM on August 23, 2022 to observe drilling of groundwater monitoring well MW-16. No concerns were observed related to the groundwater monitoring well drilling.

| Photo Description | Drill rig drilling MW-16. | |

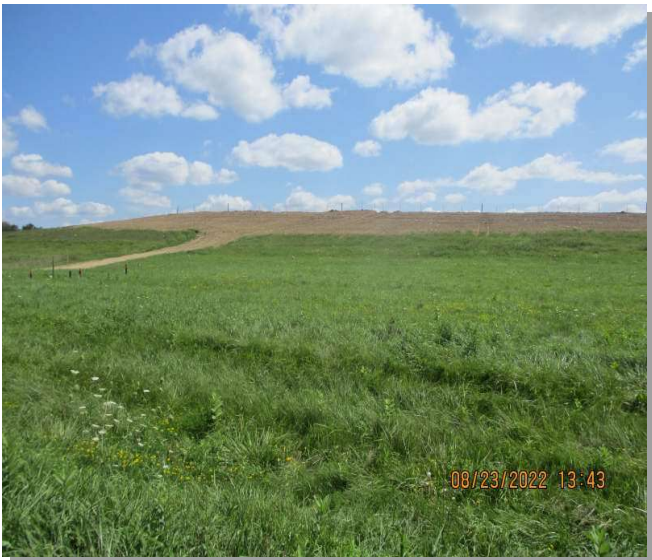
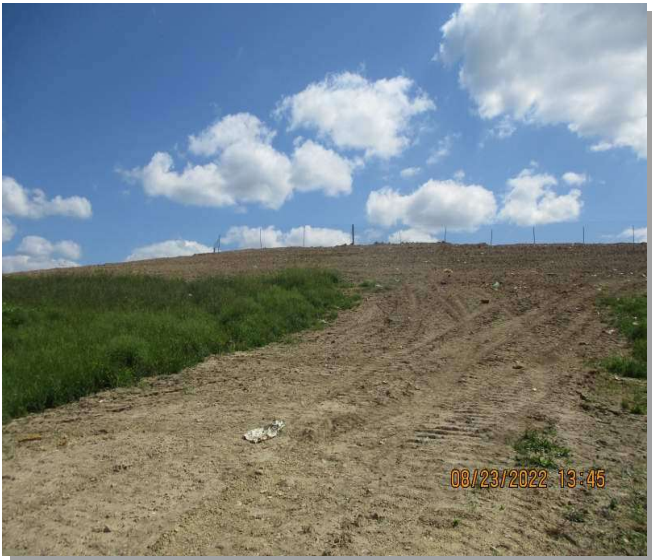
Intermediate cover placed on regraded northern exterior sideslope of the landfill.

- \*Leachate cleanouts have been labeled.
- \*The northern exterior sideslope that had exposed waste has been graded.
- \*The eastern exterior sideslope that had severe erosion rills is now the active area of the landfill.
- \*The eastern permanent litter fence has been repaired and borings for the installation of more litter fence have been completed.
- \*Holes/divots around groundwater monitoring wells have been repaired.
- \*Lysimeter tops have been raised to allow the devices to lock properly.
- \*Groundwater monitoring well MW-8 has been labeled.
- \*Chicken wire has been placed on the sideslope riser to prevent animals from entering the pipe.

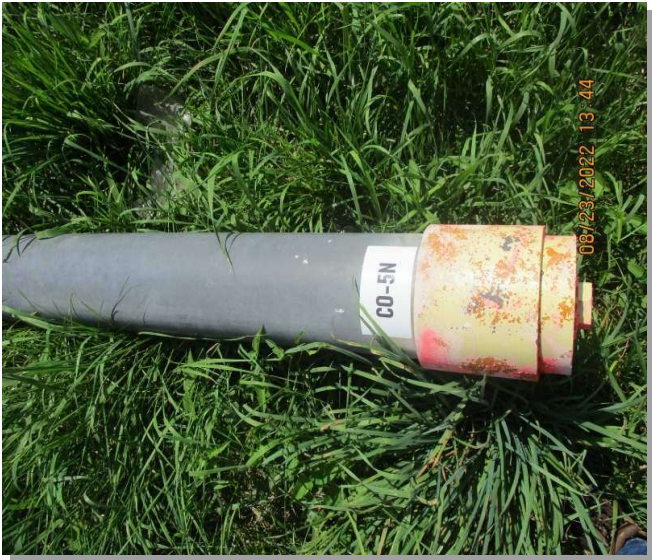
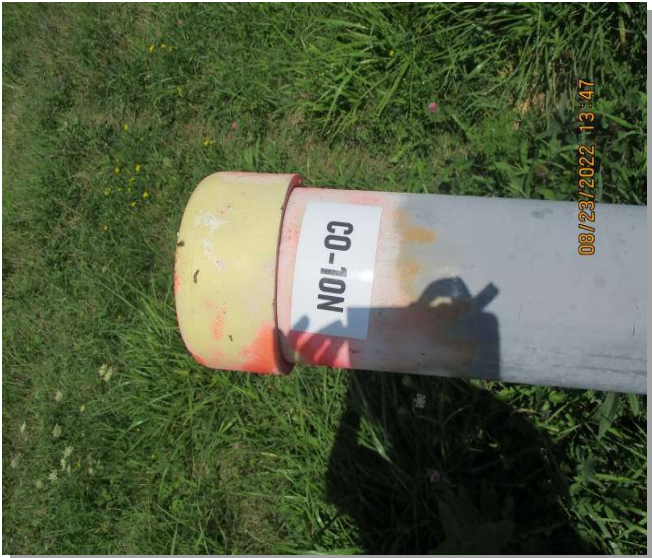
Labeled leachate cleanout.

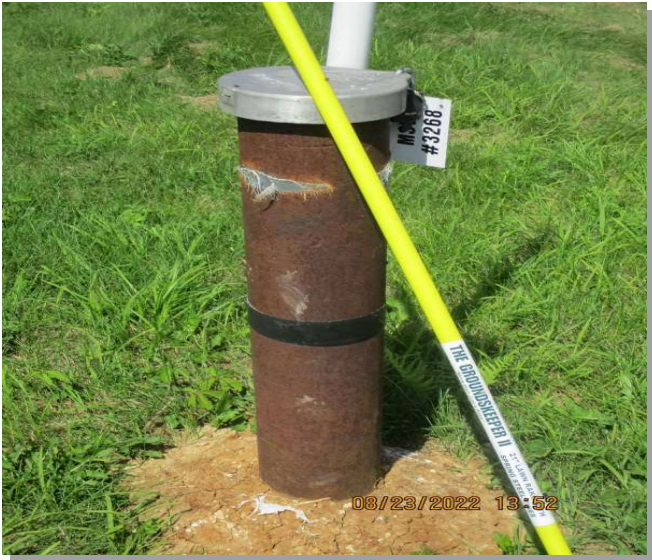
Photo # 89601      Photo 6 of 13

Repair of gap around groundwater monitoring well casing to prevent surface water from entering the well.

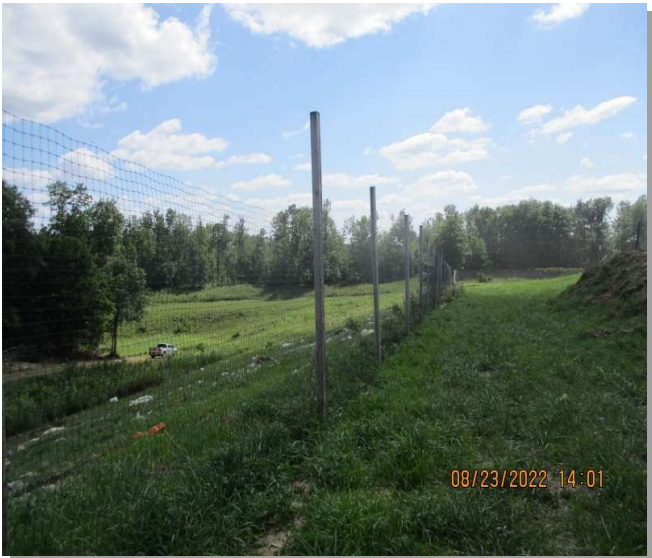
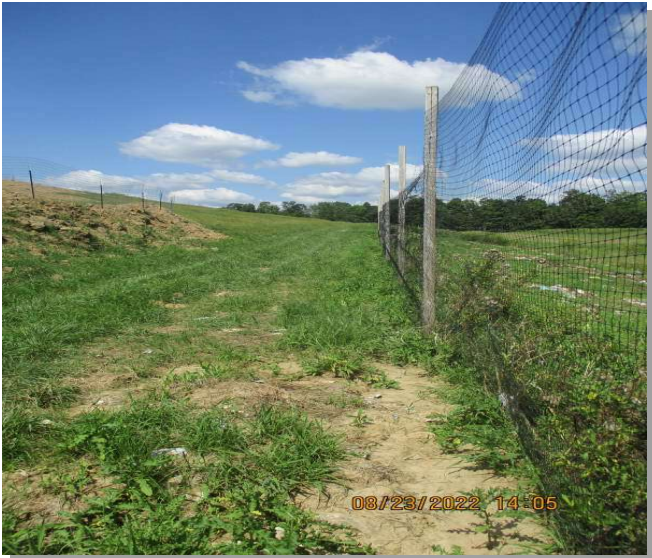
Litter fence on the eastern perimeter of the landfill repaired.

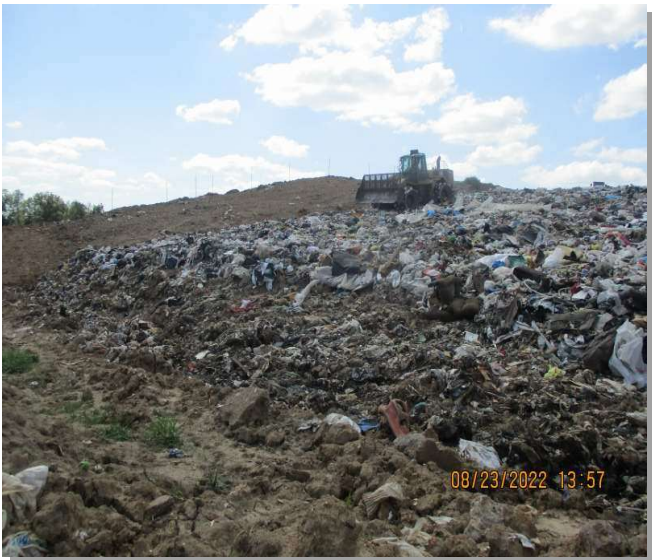
Active area for 'regular' MSW waste on the eastern sideslope with no daily cover.

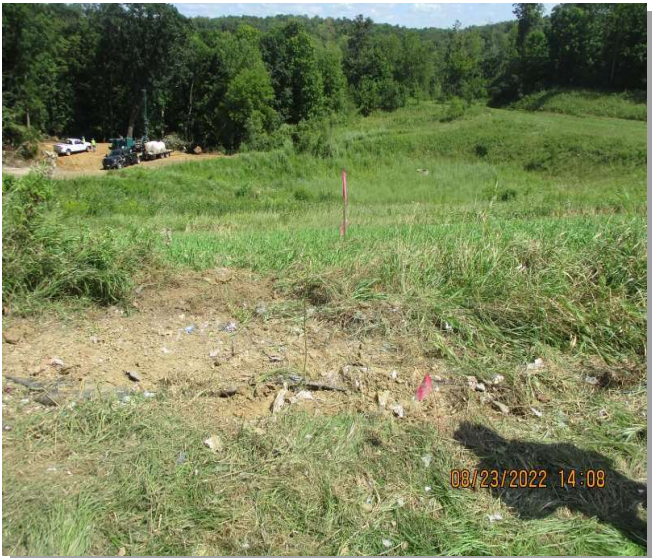
Photo # 89607

Section of litter fence down where new groundwater monitoring well nest will be installed. Litter has been cleaned up in this area.

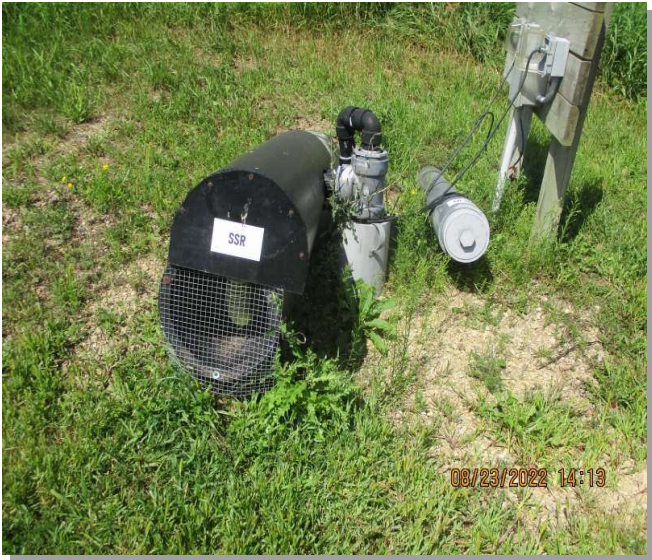
Photo # 89609      Photo 11 of 13

Chicken wire added around sideslope riser to prevent animals from entering the sideslope riser pipe.

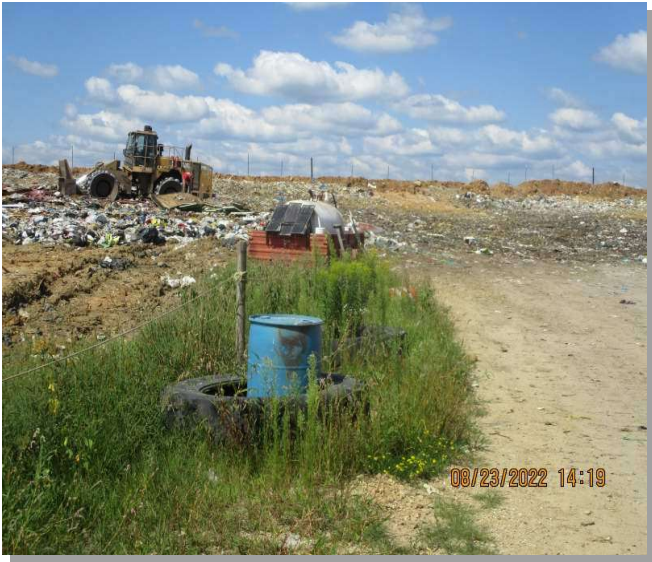
Photo # 89611      Photo 12 of 13

Second active area for bulky waste on the western portion of the landfill with no daily cover.

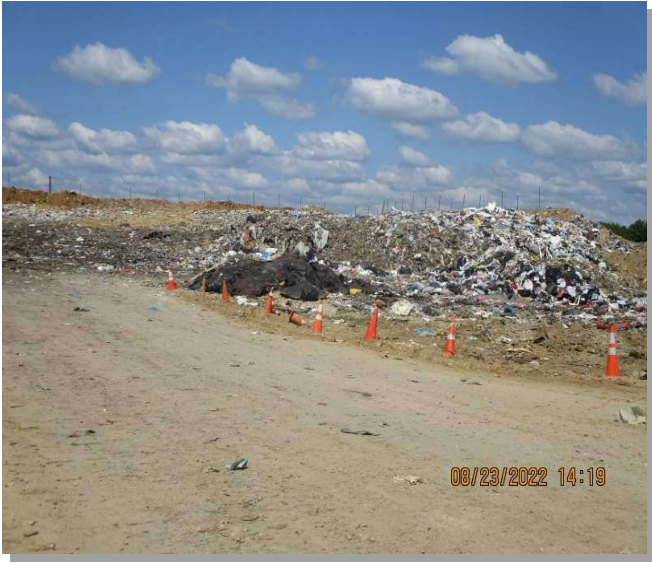
Photo # 89612      Photo 13 of 13

Top of 'regular' MSW waste disposal area with no daily cover.

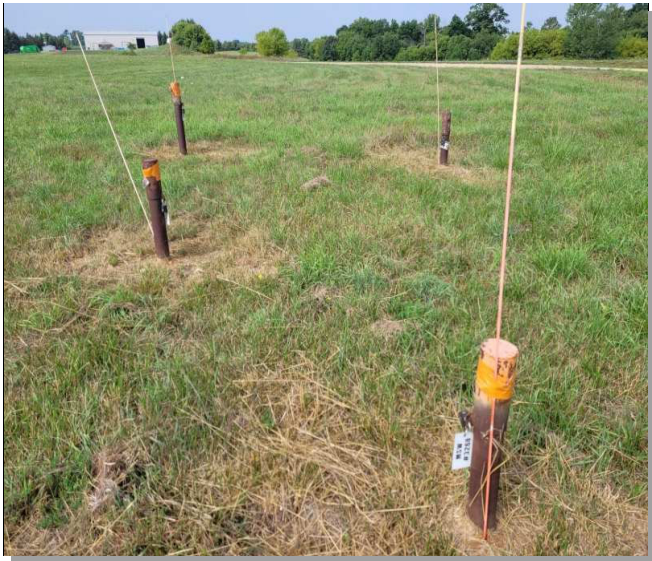
Photo # 98892 Photo 6 of 6

MW-8 well nest locked and labeled
