# Appendix G

## Wetland Evaluation

## TECHNICAL MEMORANDUM

RE: 2021 Expansion Planning – Evaluation for Wetlands  
SEH No. VERSW 157634 14.00

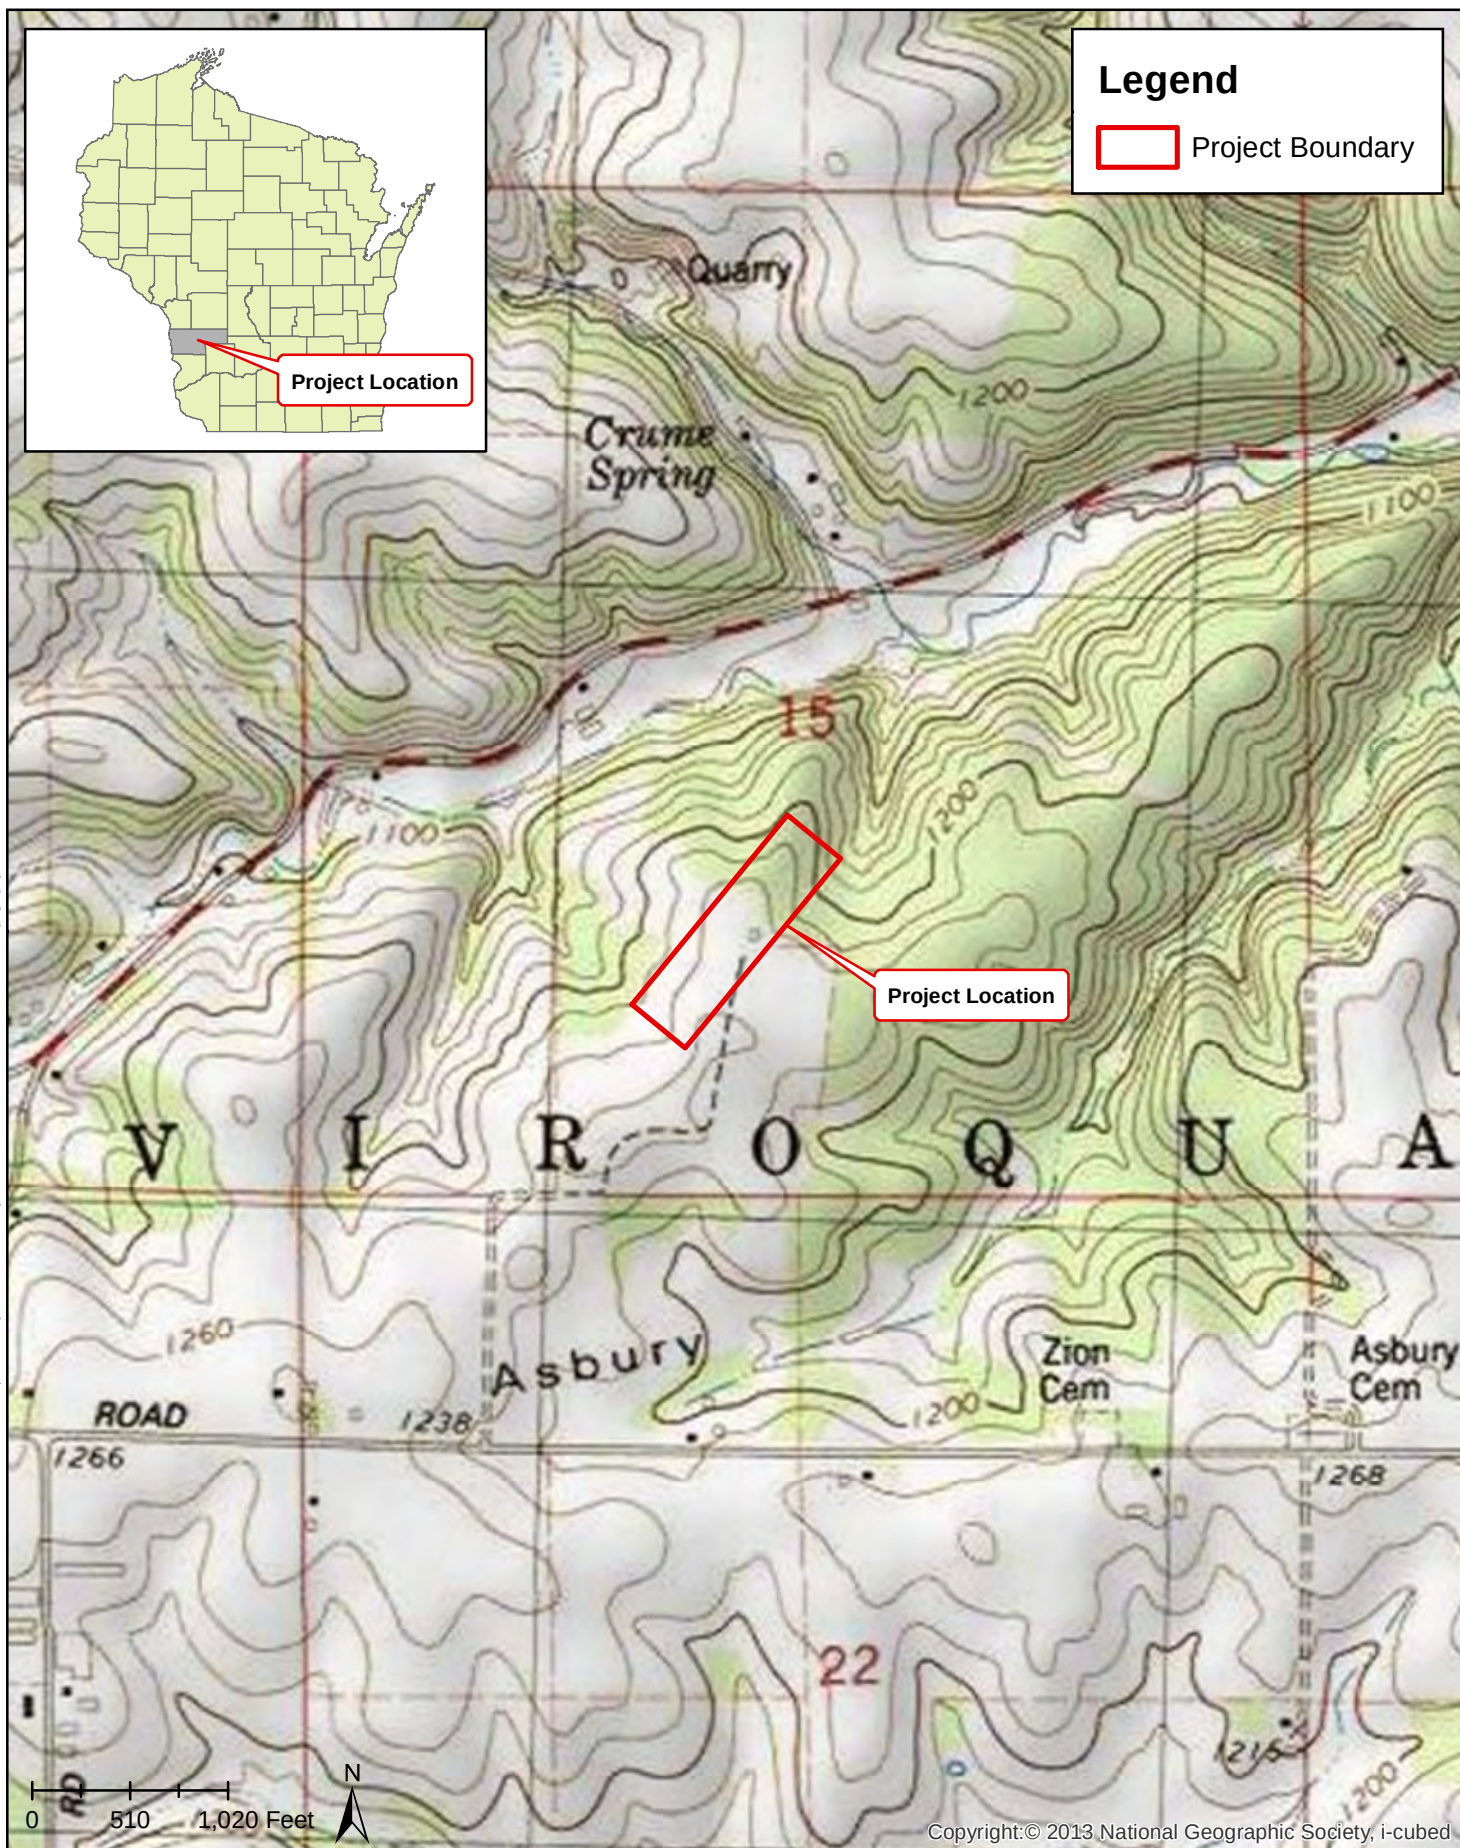
**Figure 1** – Site Location & Topographic Map

The site is located in the southwest 1/4 of Section 15 in Township 13 North, Range 4 West in the Town of Viroqua, Vernon County, Wisconsin (**Figure 1**). In general, the property is located north of County Road LF, east of Bakkom Road, south of County Road Y, and west of Asbury Road.

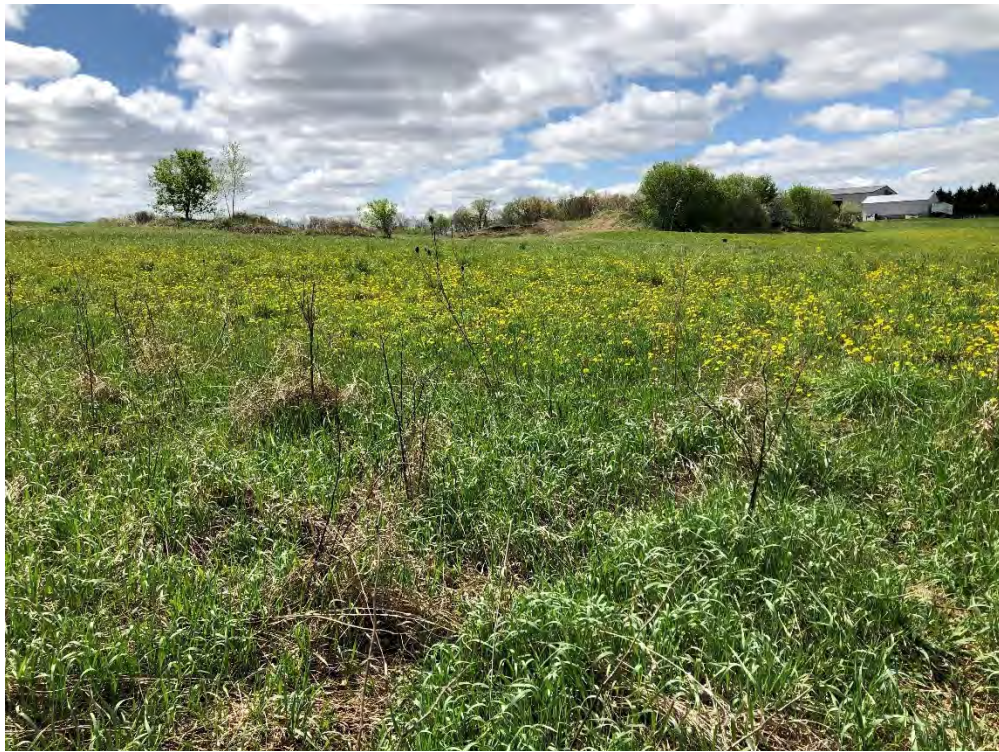
Photo 1 Upland field dominated by dandelion and clover in the southwest corner of the survey limits, facing southwest from the northern edge of the field

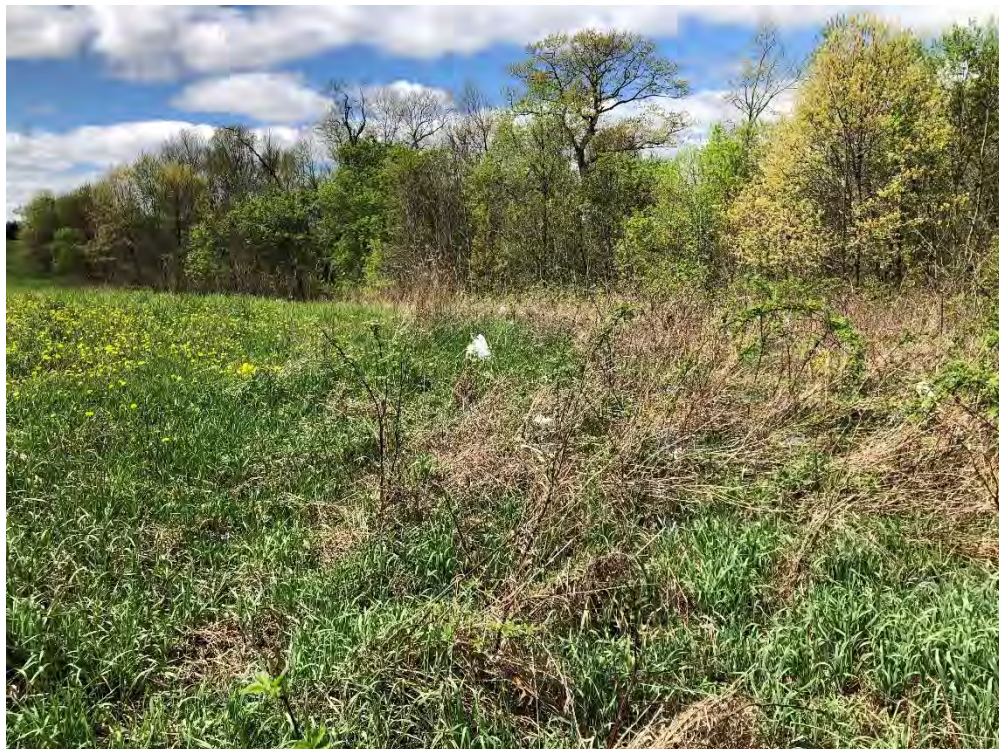
Photo 2 Northern edge of upland field (same as above photo), facing northwest

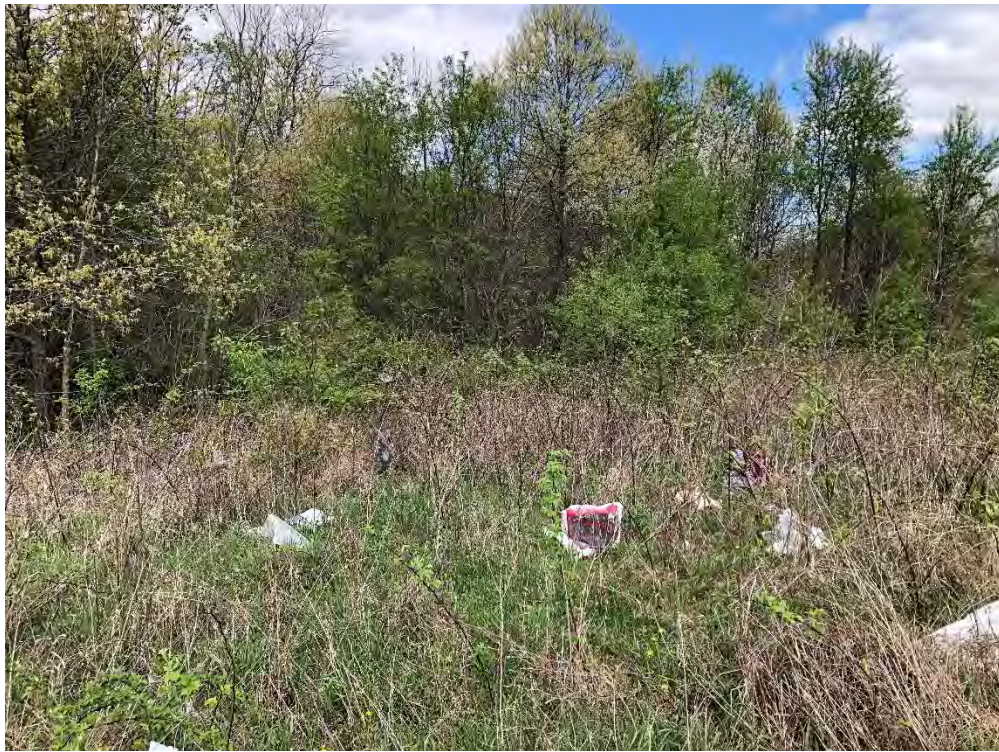
A potential "wet spot" was identified by the NRCS in the southwest portion of the site. At this location, the area is a transition zone between an open field and forested, and the ground elevation slopes towards the northwest.

Photo 3 Transition zone between shrub area and forest located north of the upland field (see Photo 1), facing north towards Sample Point 1U

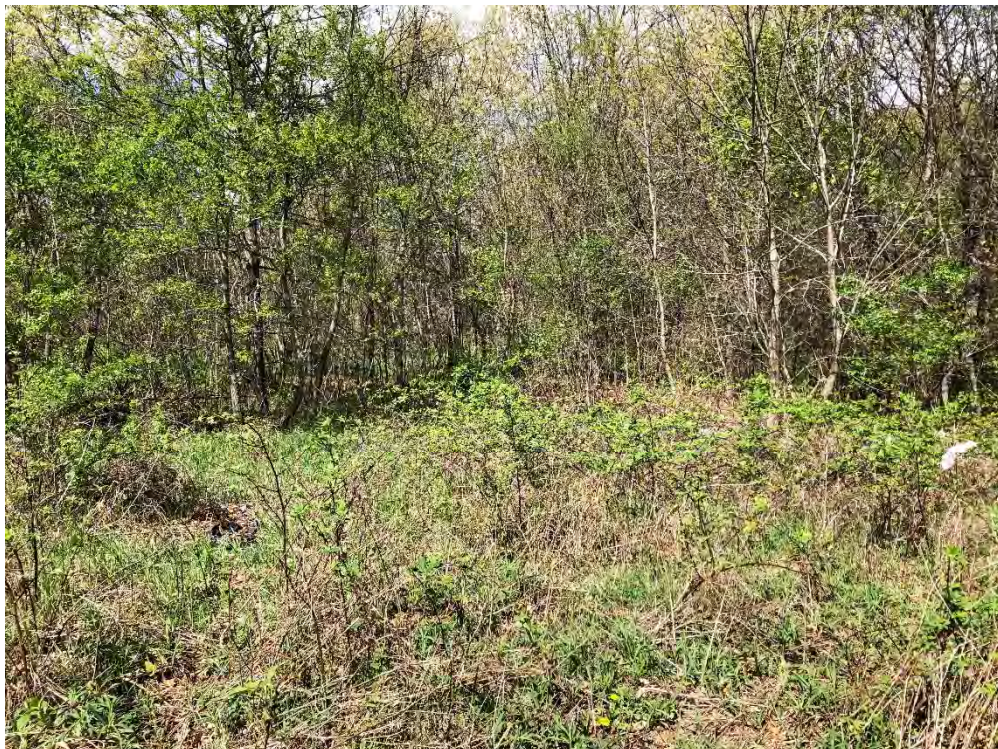
Sample point data (SP1U) was collected to document site conditions. Vegetation was dominated by Kentucky bluegrass (*Poa pratensis* – FAC), Canadian goldenrod (*Solidago canadensis* – FACU), and Allegheny blackberry (*Rhubus allegheniensis* – FACU) in the herbaceous stratum, choke cherry (*Prunus virginiana* – FACU) in the shrub stratum, and black cherry and ash-leaf maple/boxelder (*Acer negundo* – FAC) in the tree stratum. Soils at SP1U are composed of 6 inches of dark yellowish brown (10YR 3/4) silty clay loam, underlain by 4 inches of dark yellowish brown (10YR 4/4) loam. This was followed by 4 inches of yellowish brown (10YR 5/4) loam with 5% redoximorphic concentrations (10YR 4/4), and at least 8 inches of yellowish brown (10YR 5/4) clay loam with 20% redoximorphic concentrations (10YR 4/4). The soil profile does not meet the technical criteria for hydric soils. No primary or secondary hydrology indicators were present. None of the three wetland criteria were met, therefore the area is non-wetland.

Photo 4 Upland area adjacent to Sample Point 1U; area dominated by species of Kentucky bluegrass, Canada goldenrod, blackberry, and raspberry

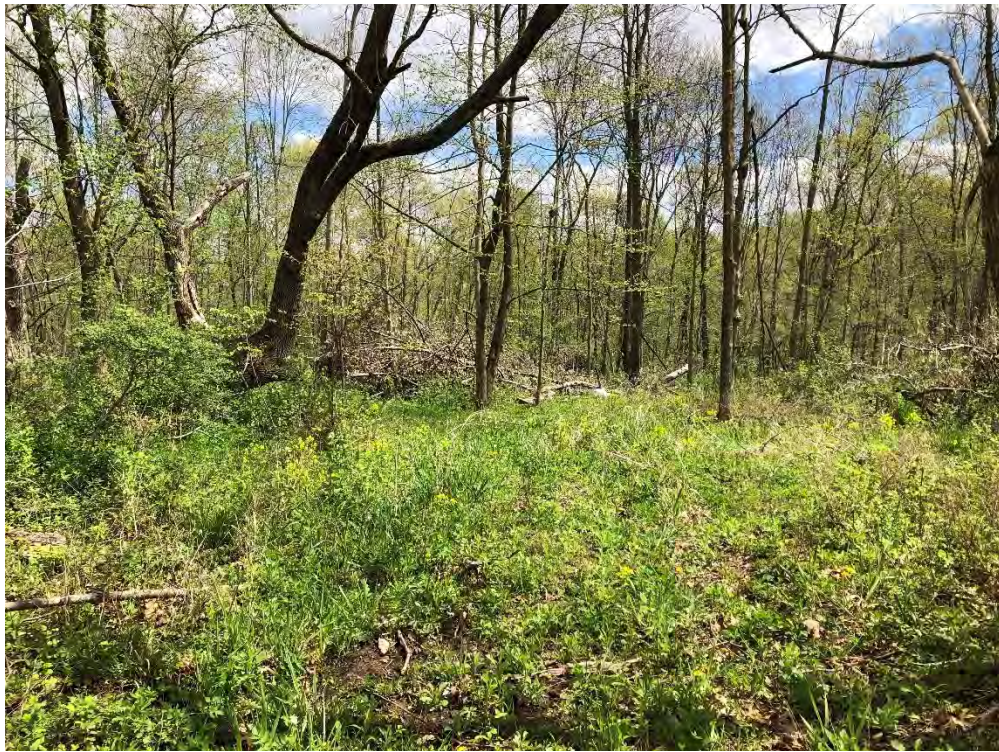
Within the forested area in the northwest portion of the site, multiple NRCS “wet spots” were mapped. The forested appears to have been selectively logged in the past. There are multiple old logging roads in this area that have overgrown with grasses. It is anticipated that these grassed roads appear “greener” on aerial photographs and is likely the reason potential “wet spots” were marked here. Topography in the forest slopes relatively steeply towards the east and northeast. Sample point data (SP2U) was collected in the vicinity of the marked “wet spots.” Vegetation within the forest was dominated by Spotted crane’s bill/wild geranium (*Geranium maculatum* – FACU), Kentucky bluegrass, Pennsylvania sedge (*Carex pensylvanica* – UPL), Virginia spring beauty (*Claytonia virginica* – FACU), creeping buttercup (*Ranunculus repens* – FAC), hooded blue violet (*Viola sororia* – FAC), and Shawnee-salad/Virginia waterleaf (*Hydrophyllum virginianum* – FAC) in the herbaceous stratum; the shrub stratum was dominated by American elm (*Ulmus americana* – FACW) and the tree stratum was dominated by American elm, red maple (*Acer rubrum* – FAC), and northern red oak (*Quercus rubra* – FACU). Soils at SP2U are composed of 3 inches of dark brown (10YR 3/3) silt loam, underlain by 8 inches of dark yellowish brown (10YR 3/4) silt loam. This was followed by 4 inches of dark yellowish brown (10YR 3/6) silt loam, and at least 7 inches of dark yellowish brown (10YR 4/4) silt loam. The soil profile does not meet the technical criteria for hydric soils. No primary or secondary hydrology indicators were present. Although the hydrophytic vegetation criteria was met, hydric soils and hydrology was not present, therefore the area does not meet wetland criteria.

Photo 5 Old logging road within woods that appears to have been selectively cut in the past. In the northern portion of the site, photo taken facing northeast and approximately 50 feet inside the tree line. Trail slopes downward, towards the northeast.

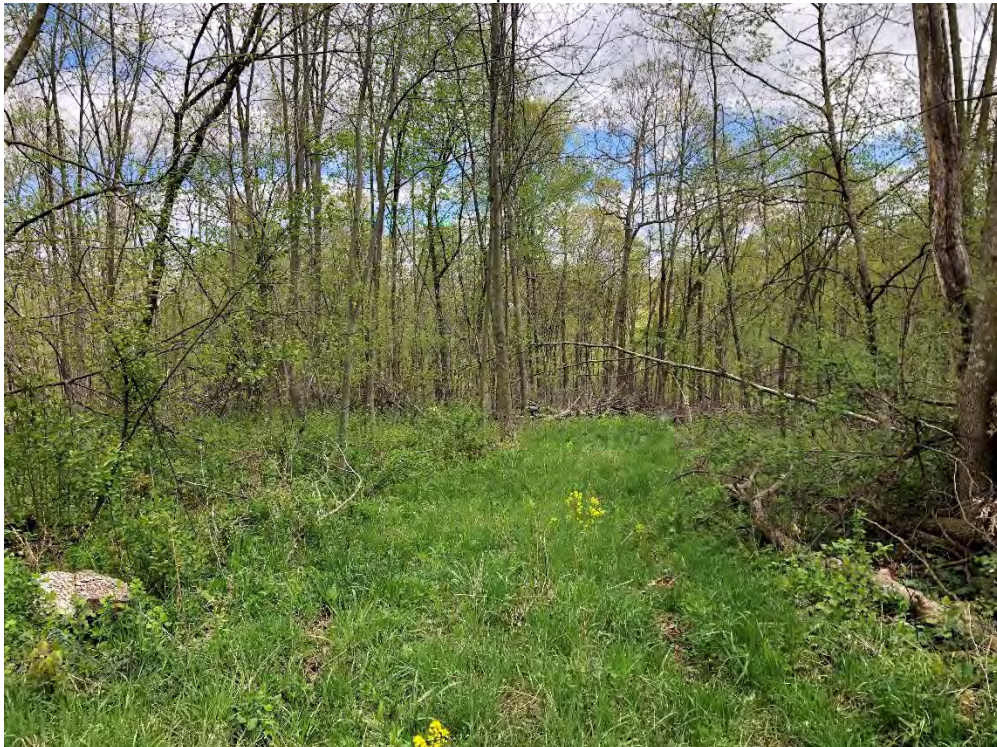
Photo 6 Old logging road overgrown with grasses; the road slopes towards the northeast

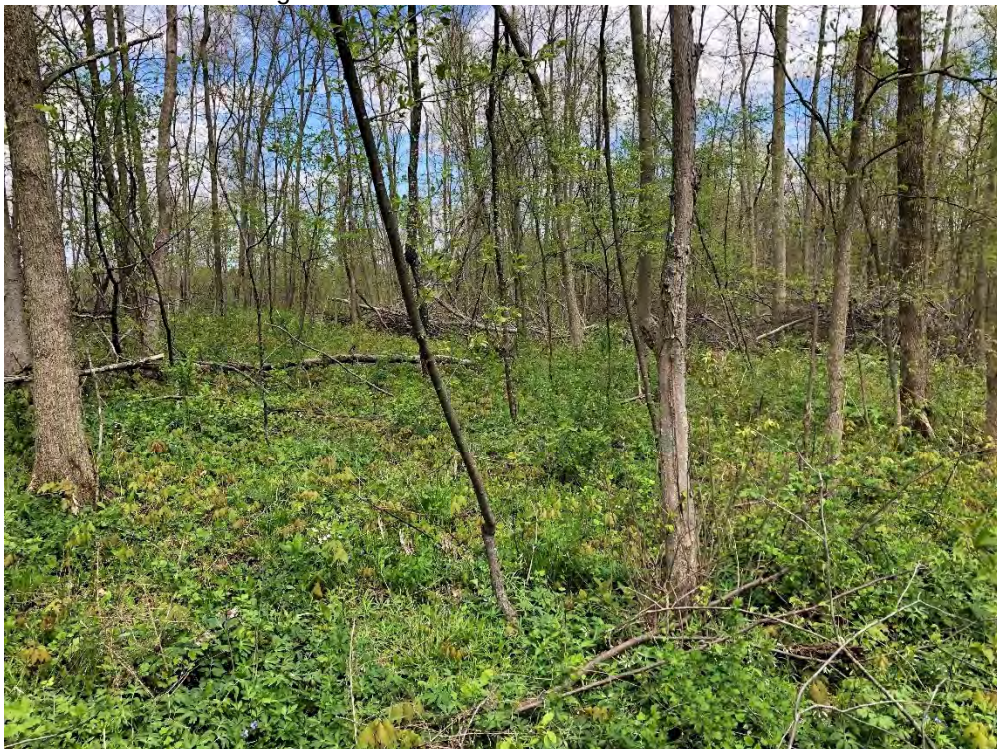
Photo 8 Typical understory found within the forested area. The forest is high in the landscape and vegetation is dominated by upland species.
