WATER QUALITY TRADING PLAN LOGANVILLE WWTF

LOGANVILLE, WI

APRIL 2021

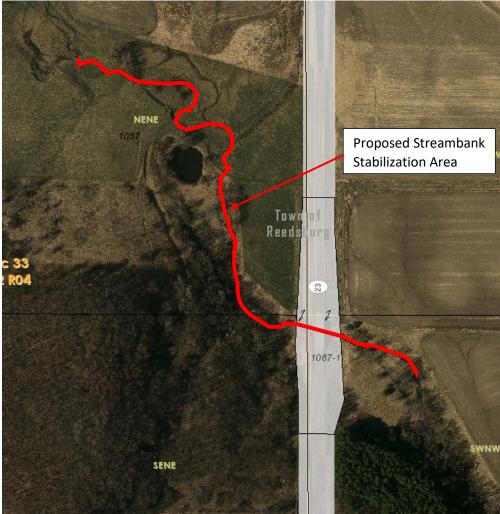
Source: Sauk County GIS. 43°28'45.07"N and 90° 0'54.65"

<u>**County Farm.</u>** The County Farm project site is best described as both banks of the stream along a tributary to Narrows Creek. Approximately 1,900-ft of streambank will be restored in this location. The project would be located off State Highway 23. See the red line along the map below.</u>

The confluence of the tributary where the streambank stabilization project is located the County Farm property and Narrows Creek is located approximately three (3) miles downstream from the Loganville WWTF discharge.

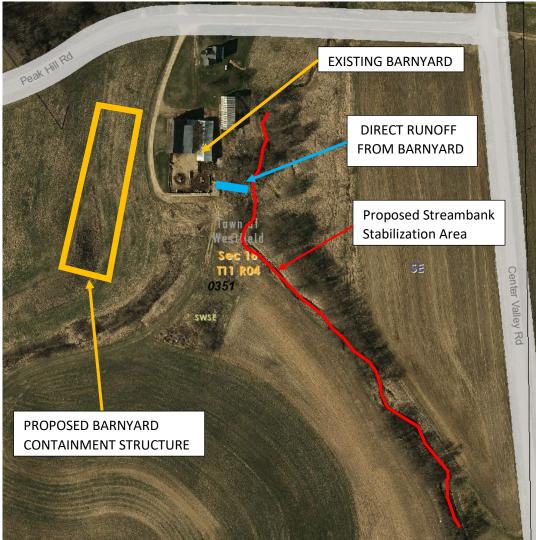
Source: Sauk County GIS. 43°25'35.49"N and 90° 1'16.70"W

The S6111 Peak Hill Farm streambank stabilization project site is best described as both banks of the stream along a tributary to Narrows Creek. Approximately 1,000-ft of streambank will be restored in this location. See the red lines along the following map.

The confluence of the tributary where the barnyard containment project and streambank stabilization project and Narrows Creek is located approximately one (1) mile downstream from the Loganville Wastewater Treatment Facility (WWTF) discharge.

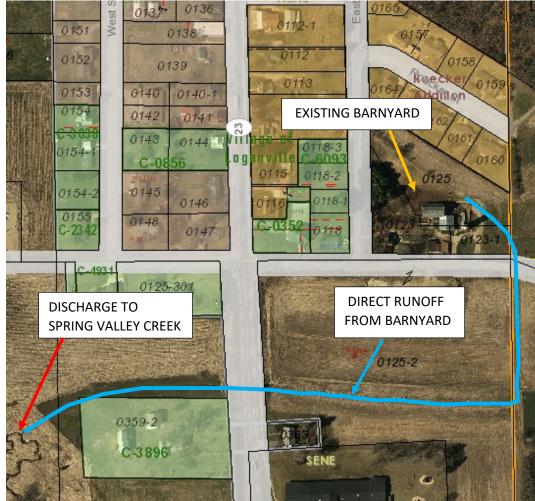
Source: Sauk County GIS. 43°26'6.70"N and 90° 2'4.69"W

<u>265 Peak Hill Farm.</u> The 265 Peakhill Rd Farm barnyard abandonment site is best described as a site that is composed of 21,361 square feet of earthen feed lot, 4,600 square feet of concrete barnyard, 1,671 square feet of roofed area and 0.75 acres of tributary area. The animal numbers average 70 dairy heifers at 400-600 pounds. The barnyard currently discharges runoff to an unnamed tributary to Spring Valley Creek. Spring Valley Creek then discharges to Narrows Creek 0.75 miles downstream. This barnyard would be abandoned, and the existing cattle would be moved to the S6111 Peak Hill Rd Farm.

The confluence of Spring Valley Creek and Narrows Creek is located approximately one and a half (1.5) mile upstream from the Loganville WWTF discharge.

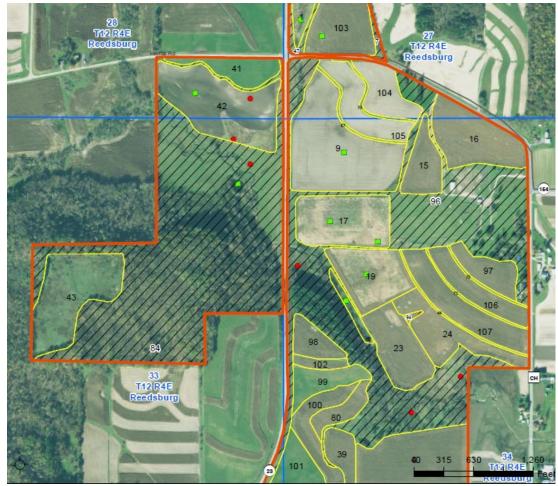
Figure 4-1: Aerial of County Farm - Sauk County, WI

The County farmland is outlined in red in Figure 4-1. This project site has been owned by the County for decades. Based upon aerial imagery through Google Earth, the project site appears to have been a mixture of pasture, crop, and forest land as long as Google Earth has maintained imagery (1992). The crop fields surrounding the proposed streambank stabilization area have been in row crops for several years. Up until 2015, fall tillage was allowed on fields 42, 9, 17, 19, 23, 24 and 40. Since 2015, all of the fields have been no tilled and the crop rotation has been corn, grain, and soybeans, with a year of winter wheat here and there. Prior to 2010, field 23 was a wastewater treatment lagoon for the former Sauk County Health Care center located on the property. In 2010-2011, the buildings along with the treatment lagoon were abandoned and the land reclaimed. The pasture area west of Highway 23 adjacent to the proposed streambank stabilization area has been continuously grazed up until 2018. In 2018, pasture improvements including interior fences and livestock pipeline were installed on the property and the paddocks have been rotationally grazed since.

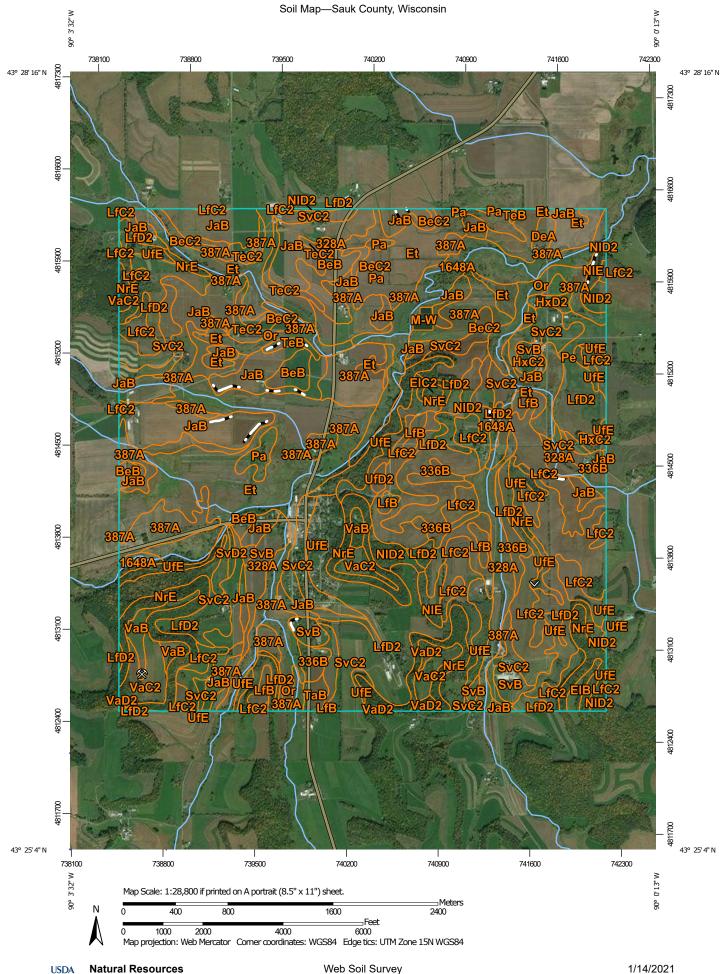
SOIL MAP

The soil type at the project site is identified as Rowley Silt Loam, see **Appendix 4-1** for the Soils Map.

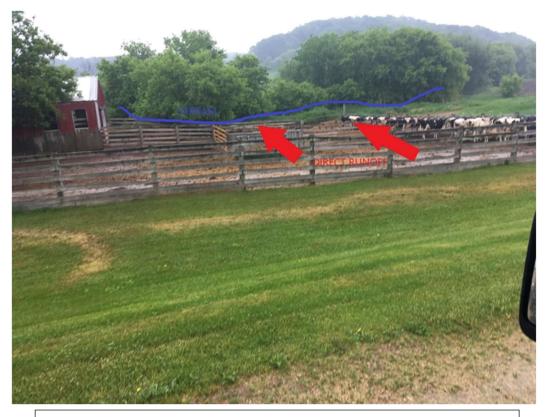
S6111 Peak Hill Farm site photo upslope, depicting topography of site and direct runoff to tributary of Narrows Creek.

Barnyard Containment & Abandonment. A roofed concrete barnyard would be designed and built to be a no runoff system at the S6111 Peak Hill Rd Farm. A roofed manure storage tank will also be installed at the site. The current animals at the S6111 Peak Hill Rd Farm will be moved to this new facility following building completion. The current animals at the 265 Peak Rd Farm will be moved to the new barnyard containment facility at the S6111 Peak Hill Rd Farm as well. The existing facilities will have manure cleaned out and properly land applied according to a Nutrient Management Plan (NMP). The barnyards have been evaluated in the field by the Sauk County Land Resources and Environmental Department. Photos documenting the current state of the barnyards and displaying runoff conditions are provided in **Appendix 5-1**.

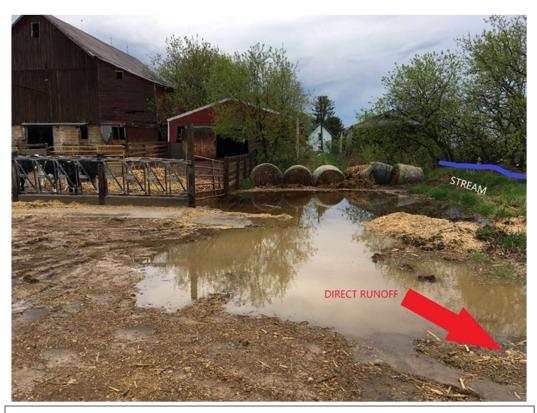
S6111 Peak Hill Farm site photo depicting direct runoff to tributary of Narrows Creek.

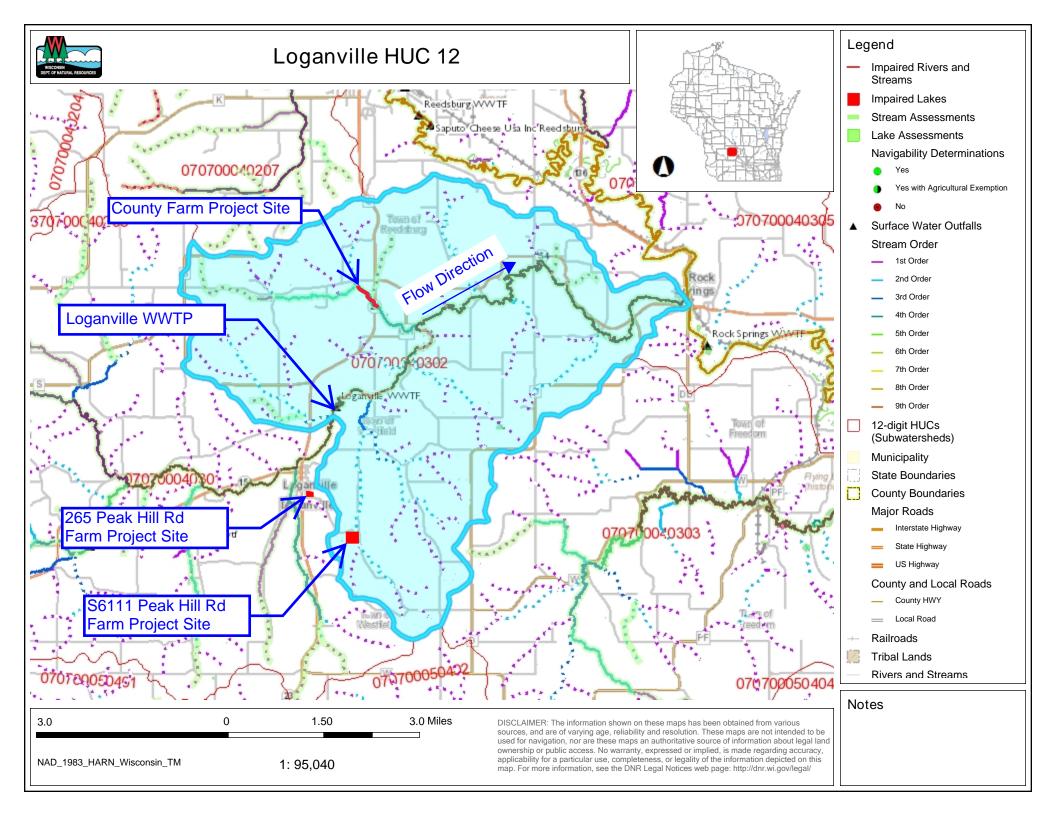
HUC 12 WATERSHED BASIN MAP

Narrows Creek. The credit user and credit generator are in the same HUC 12 basin for the County Farm and S6111 Peak Hill Farm project; however, the credit generators discharge to Narrows Creek downstream of the credit user (WWTF). The distance between the two on Narrows Creek is approximately 0.75 miles apart from the credit generator discharge point to the credit user discharge point on Narrows Creek, which was measured using DNR's Surface Water Data Viewer. Per the *Guidance for Implementing Water Quality Trading in WPDES Permits*, the Delivery Factor in section 2.11.1 states "The delivery factor accounts for the distance between trading partners and the impact that this distance has on the fate and transport of the traded pollutant in surface waters" (pg. 14). The delivery factor is often zero (0) when in the same HUC 12, see **Appendix 7-1** for the HUC 12 Watershed Basin Map.
