Permit Fact Sheet

Permit Number	WI-0067441-01-0
Permittee Name and Address	Augustian Farms LLC E4361 County Road G Kewaunee, WI 54216
Permitted Facility Name and Address	Augustian Farms LLC E4361 County Highway G Kewaunee, WI 54216
Permit Term	August 01, 2026 to July 31, 2031
Receiving Water	Unnamed tributaries within the East Twin River Watershed, Lake Michigan Drainage Basin, and groundwaters of the state
Discharge Type	Existing source CAFO per NR 243.03(23) as the facility has been permitted since 2015.

Augustian Farms, LLC is an existing Concentrated Animal Feeding Operation (CAFO) located in the Township of Carlton in Kewaunee County. Augustian Farms, LLC is owned and operated by Aaron Augustian and family. Augustian Farms, LLC consists of a main production area located E4361 County Rd G, Kewaunee, WI 54216. The production site consists of two waste storage facilities, one feed storage area, one solid stacking area, two barns with outdoor lots, a sand separator, and multiple barns.

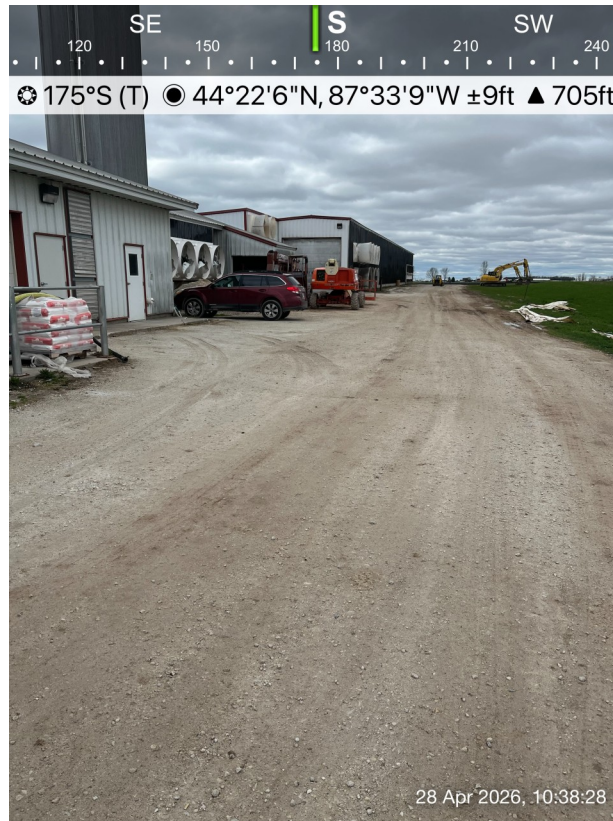
Photo #:	1
Date/Time of Photo:	10:38 am April 28, 2026
Photo By:	Mueller
Photo Location:	Production Site
Photo Description:	
View of the west side of the freestall barns located on the southwest side of the farm. This photo was taken facing south.

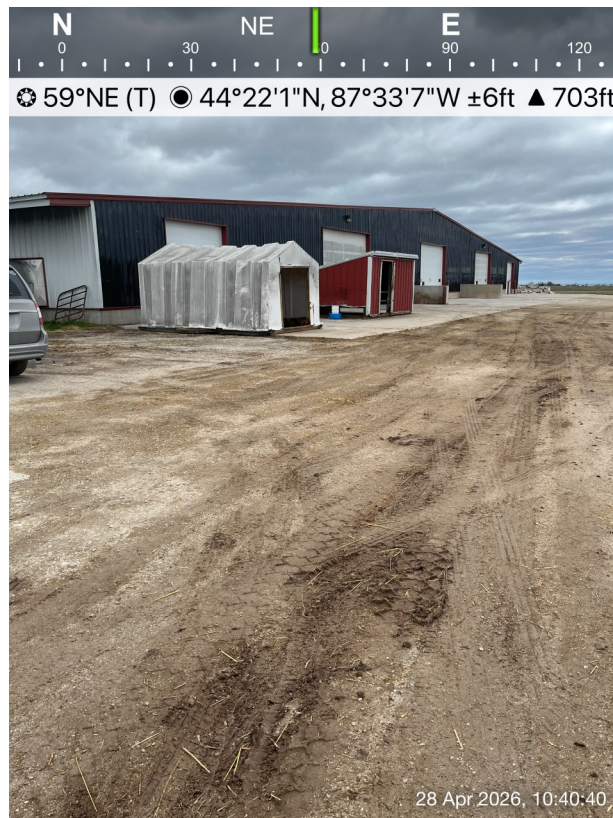
Photo #:	2
Date/Time of Photo:	10:40 am April 28, 2026
Photo By:	Mueller
Photo Location:	Production Site
Photo Description:	
View of the south side of the freestall barns located on the south side of the farm. Minimal tracking of feed/manure outside the freestall barns was observed. This photo was taken facing northeast.

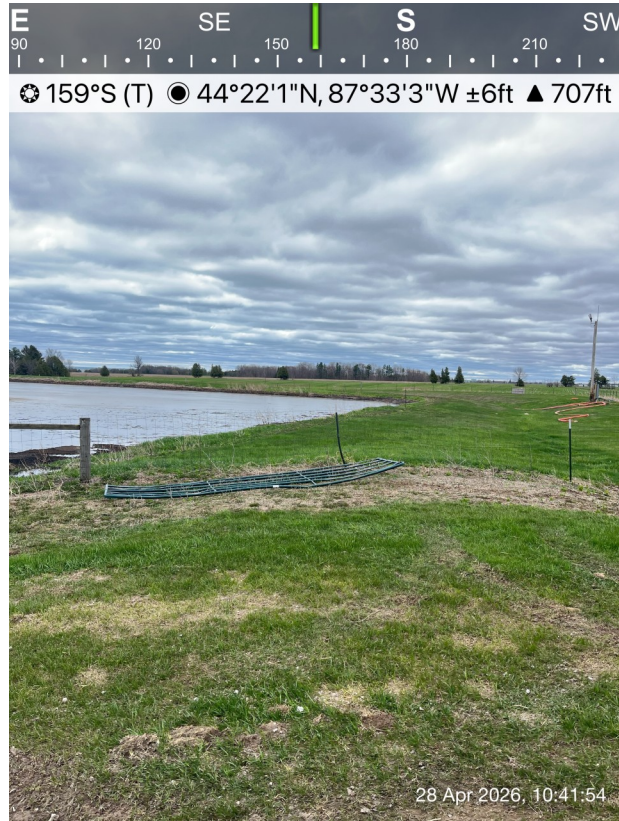
Photo #:	3
Date/Time of Photo:	10:41 am April 28, 2026
Photo By:	Mueller
Photo Location:	Production Site

View of the west and south sides of WSF 1 located on the southeast side of the farm. Proper maintenance of vegetation was observed. This photo was taken facing south.

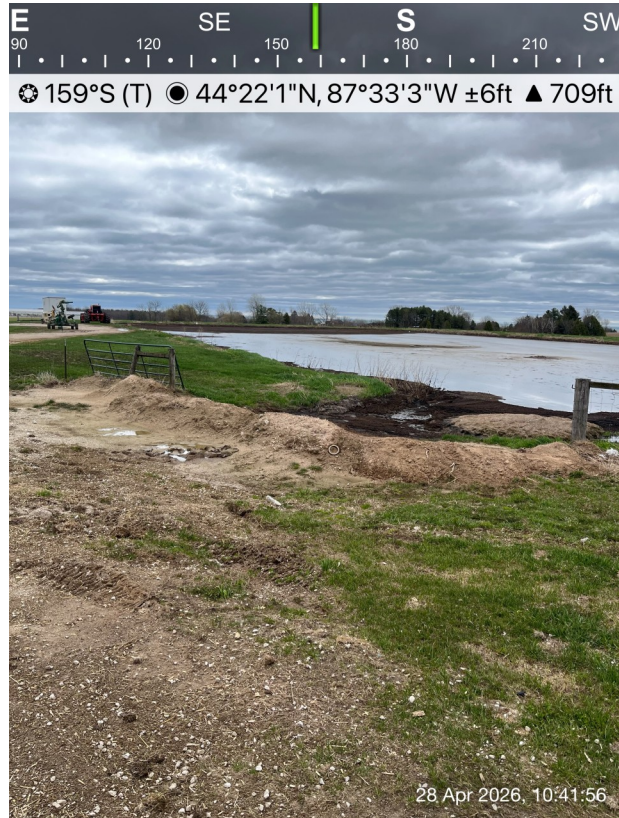
Photo #:	4
Date/Time of Photo:	10:41 am April 28, 2026
Photo By:	Mueller
Photo Location:	Production Site

View of the north and east sides of WSF 1 located on the northeast side of the farm. Proper maintenance of vegetation was observed. This photo was taken facing south.

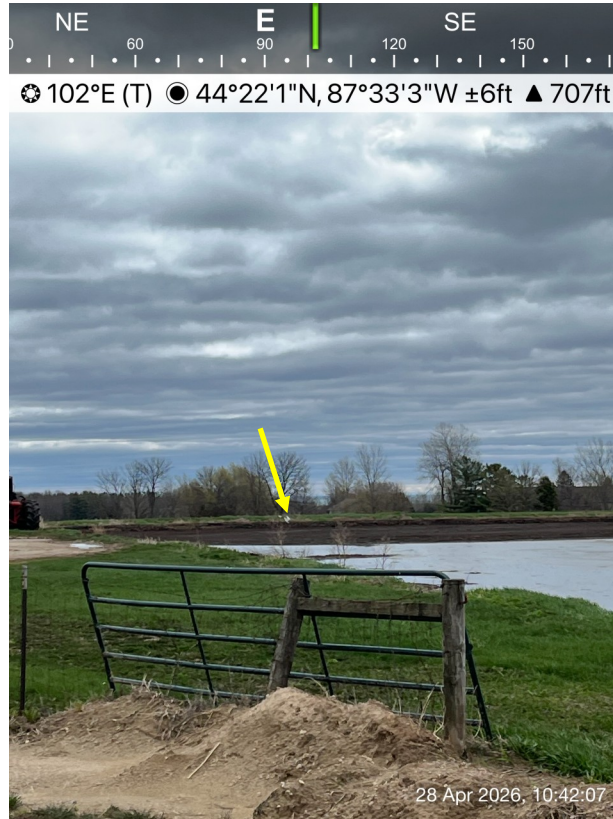
Photo #:	5
Date/Time of Photo:	10:42 am April 28, 2026
Photo By:	Mueller
Photo Location:	Production Site
Photo Description:	
View of the permanent markers located on the east side of WSF 1 located on the northeast side of the farm. The yellow arrow represents the permanent markers. This photo taken facing east.

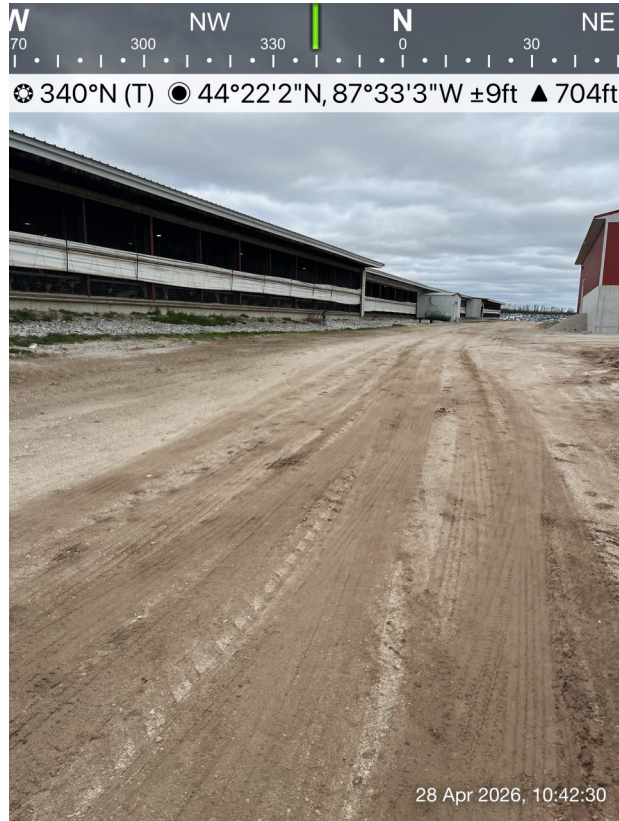
View of the east side of the freestall barns located on the east side of the farm. Minimal bedding leaving freestall barns was observed. This photo was taken facing northwest.

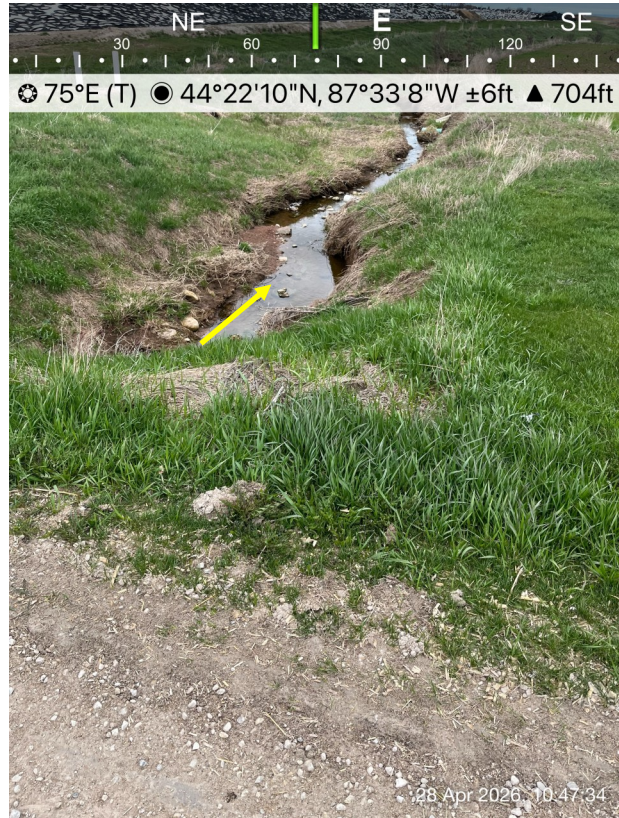
Photo #:	8
Date/Time of Photo:	10:47 am April 28, 2026
Photo By:	Mueller
Photo Location:	Production Site

View of storm water conveyance on the production site located between the feed storage area and the freestall barn on the east side of the farm. The yellow arrow represents the flow path. This photo was taken facing northeast.

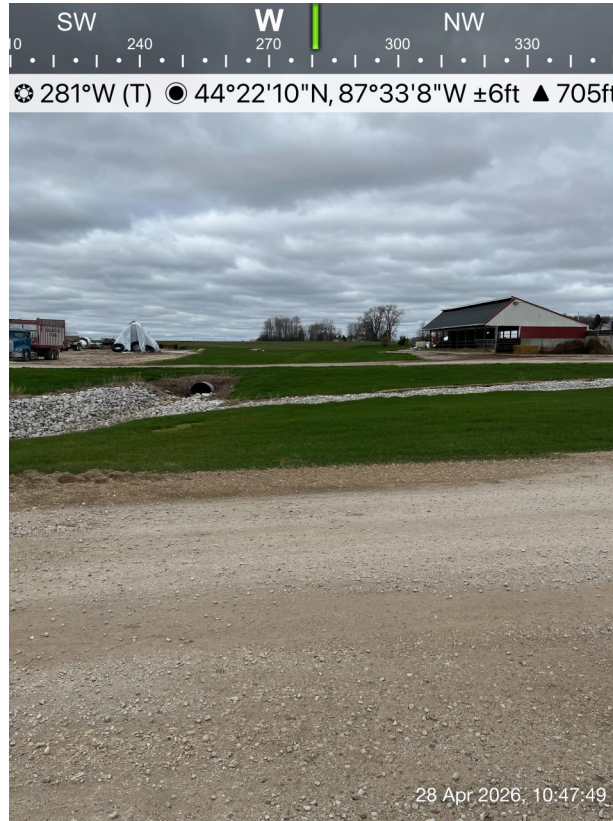
Photo #:	9
Date/Time of Photo:	10:47 am April 28, 2026
Photo By:	Mueller
Photo Location:	Production Site

View of the southeast side of the steer barn located south of the shop. This photo was taken facing west.

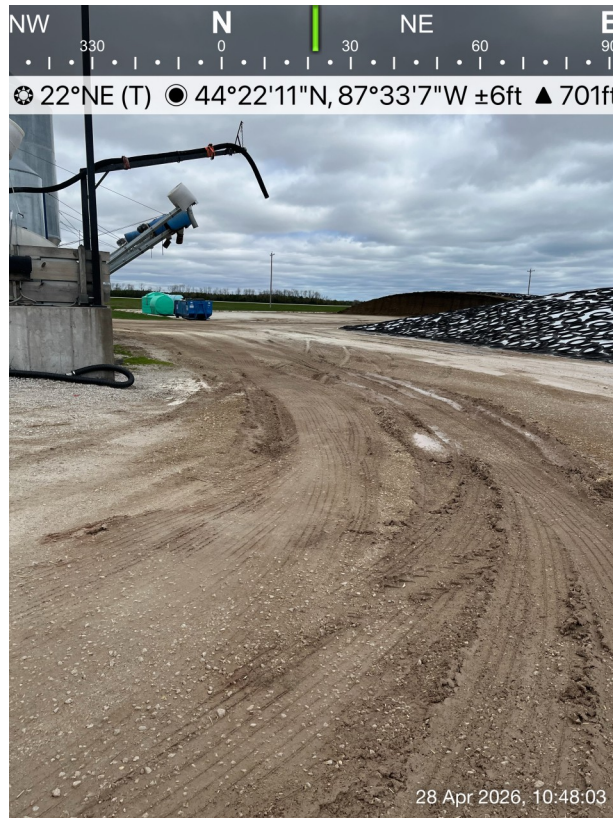
Photo #:	10
Date/Time of Photo:	10:48 am April 28, 2026
Photo By:	Mueller
Photo Location:	Production Site

View of the grain bins and feed storage area located on the north side of the farm. This photo was taken facing north.

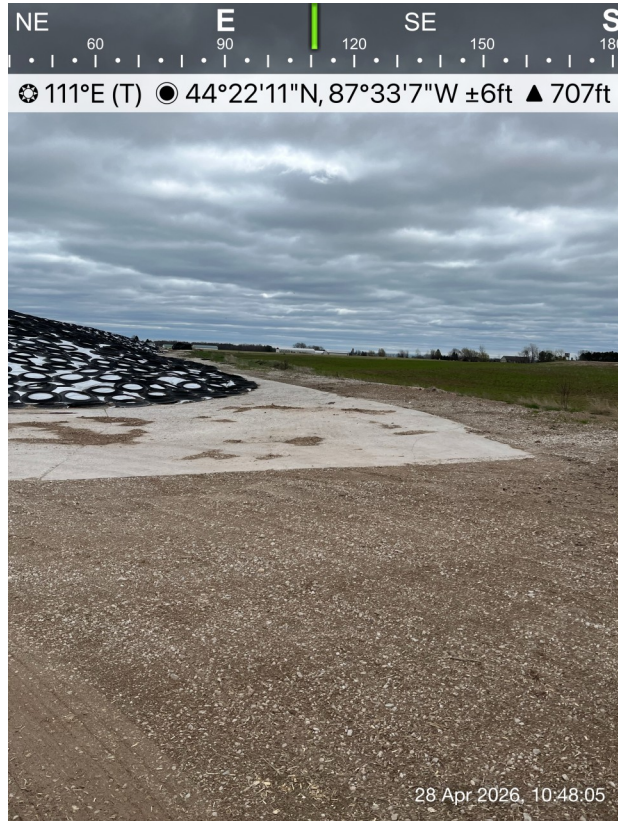
Photo #:	11
Date/Time of Photo:	10:48 am April 28, 2026
Photo By:	Mueller
Photo Location:	Production Site
Photo Description:	
View of the southwest side of the feed storage area located on the northeast side of the farm. This photo was taken facing east.

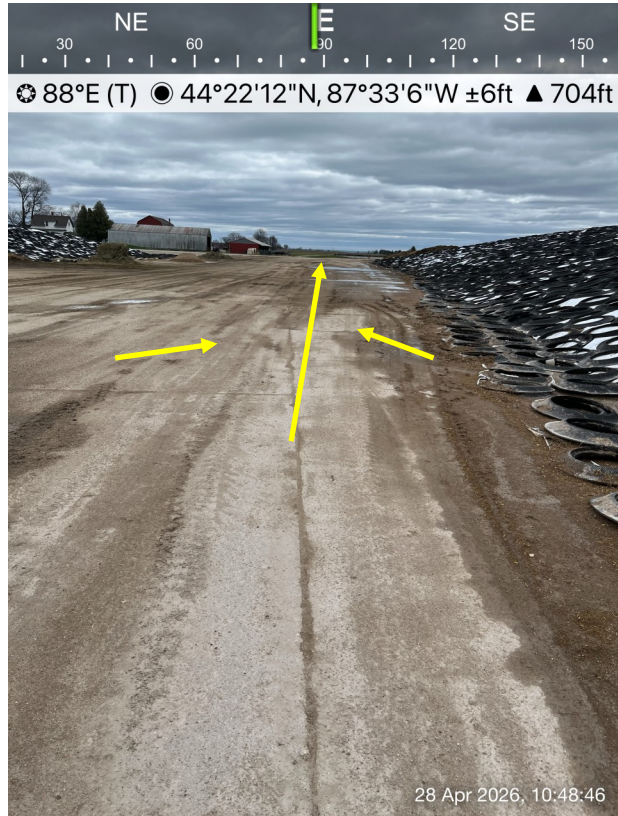
Photo #:	12
Date/Time of Photo:	10:48 am April 28, 2026
Photo By:	Mueller
Photo Location:	Production Site
Photo Description:	
View of the feed storage area located on the northeast side of the farm. The yellow arrows represent the flow path to the WSF 2. This photo was taken facing east.

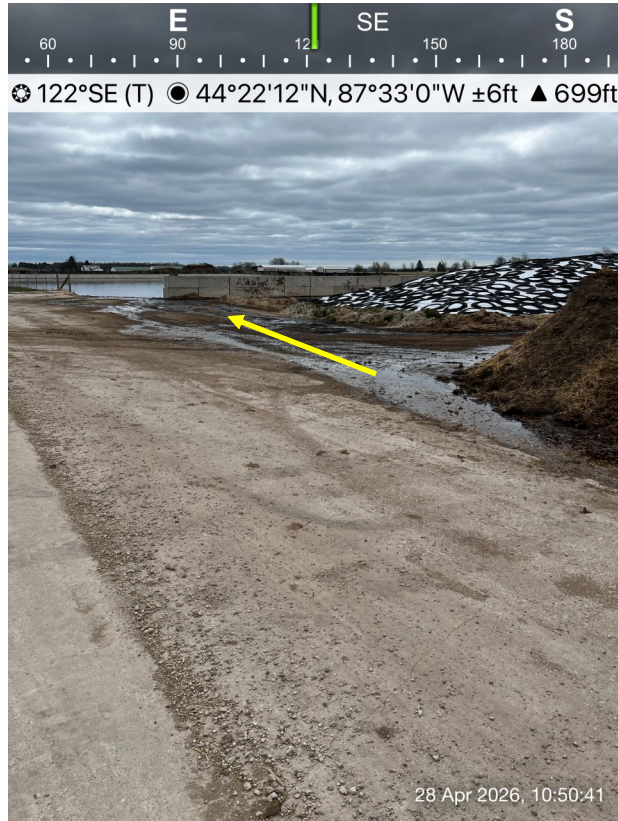
Photo #:	13
Date/Time of Photo:	10:50 am April 28, 2026
Photo By:	Mueller
Photo Location:	Production Site

View of the WSF 2 and the solid manure stacking area on the feed storage area located on the northeast side of the farm. The yellow arrow represents the flow path to WSF 2. This photo was taken facing southeast.

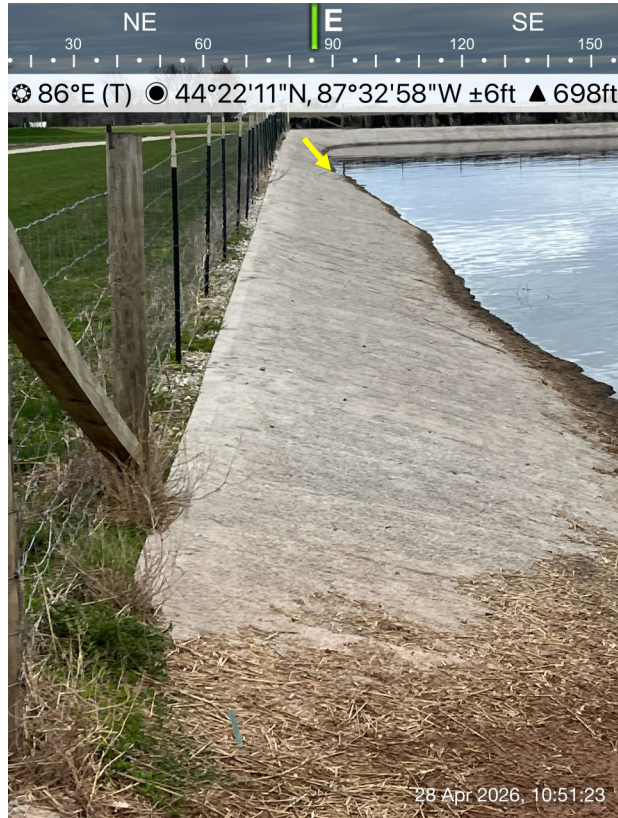
Photo #:	14
Date/Time of Photo:	10:51 am April 28, 2026
Photo By:	Mueller
Photo Location:	Production Site

View of permanent markers on the north side of WSF 2. The yellow arrow represents the permanent markers. This photo was taken facing east.

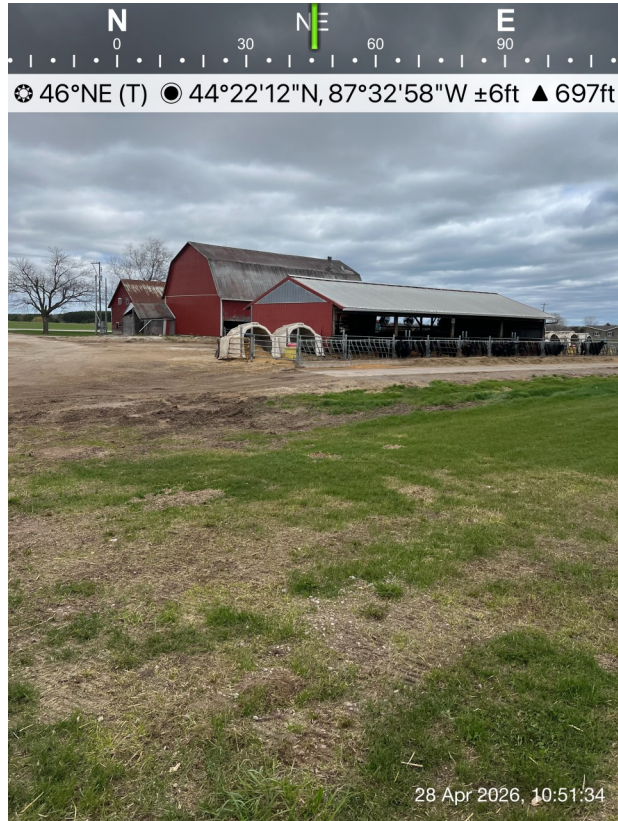
Photo #:	15
Date/Time of Photo:	10:51 am April 28, 2026
Photo By:	Mueller
Photo Location:	Production Site

View of the southwest side of the steer barns and feed lot. This photo was taken facing northeast.

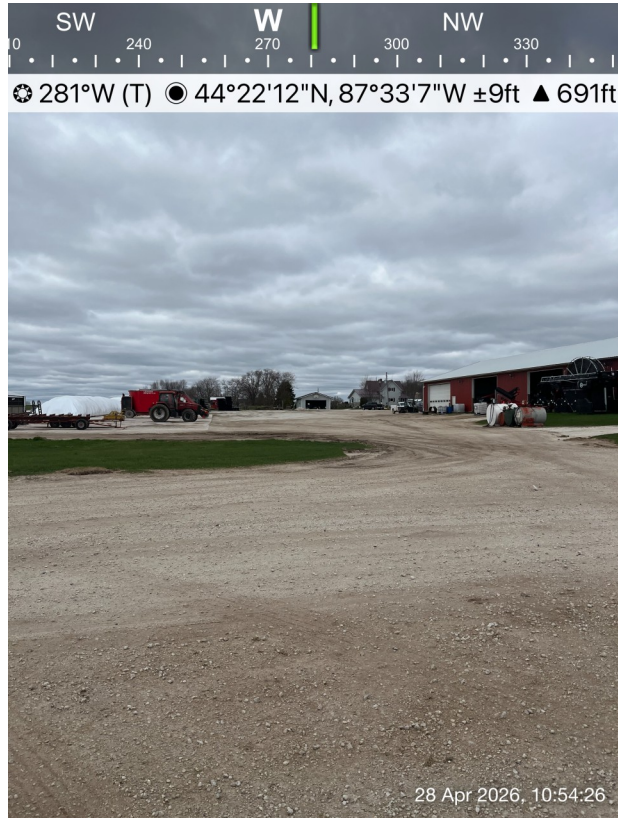
Photo #:	16
Date/Time of Photo:	10:54 am April 28, 2026
Photo By:	Mueller
Photo Location:	Production Site

View of the east side of the parking area and shop. This photo was taken facing west.

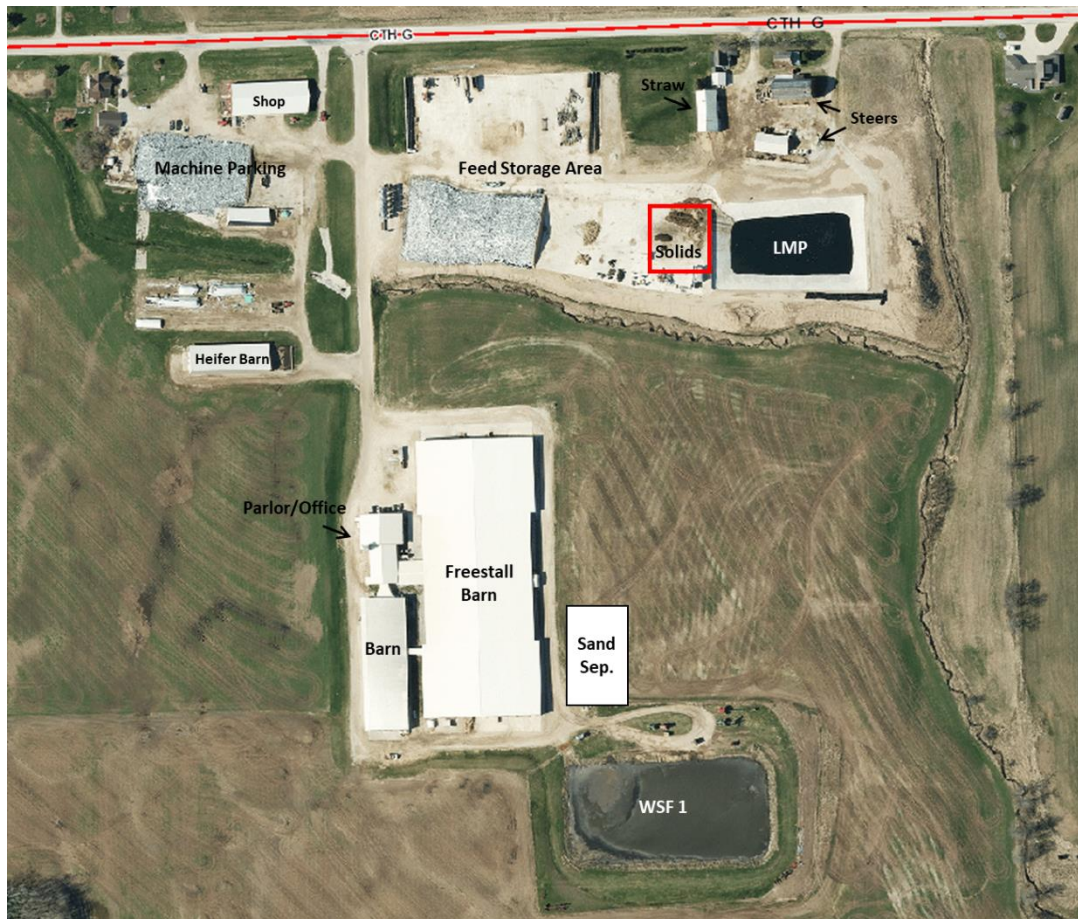
Aerial Map 1. The aerial map above illustrates the production site at Augustian Farms LLC. The production site consists of two liquid storage facilities, one solid stacking area, a sand separation system, several animal barns, and one feed storage area. The aerial image was obtained from Kewaunee County GIS Website.

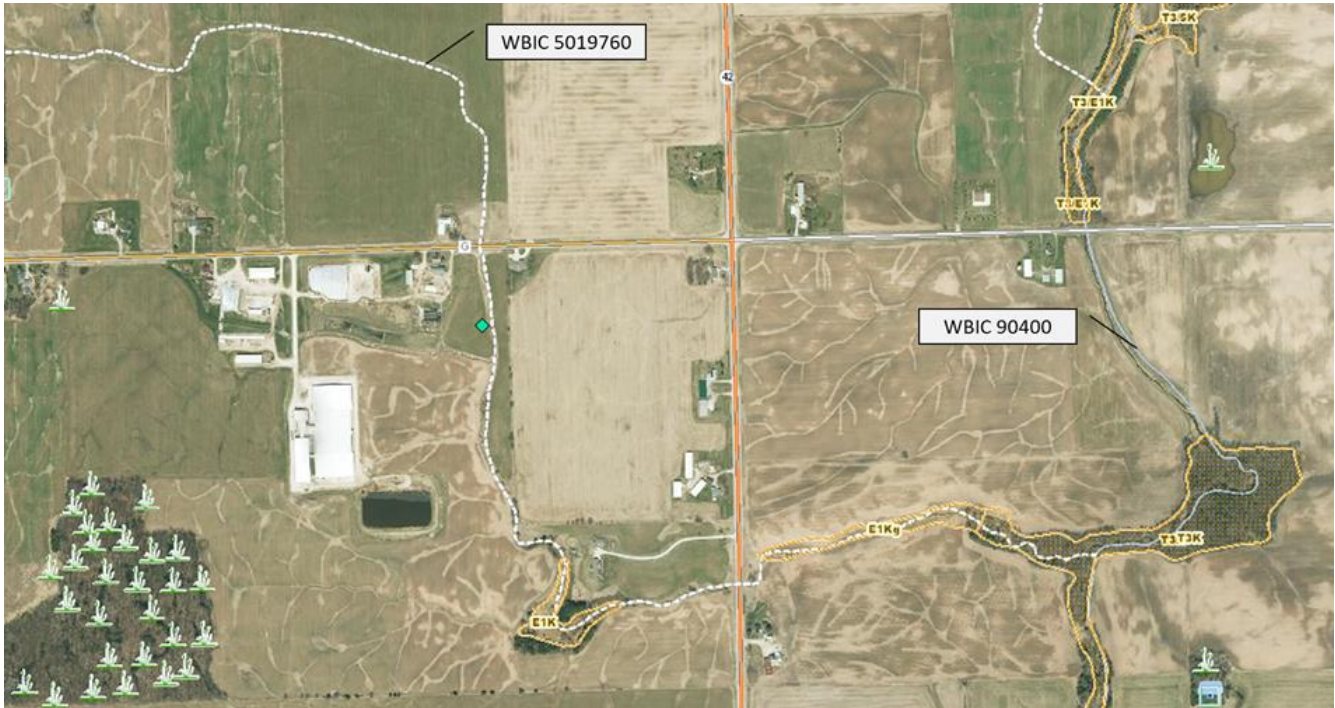
Aerial Map 2. The aerial map above illustrates surface water in relation to the production site at Augustian Farms LLC. A mapped intermittent stream is located east of the production site, identified as WBIC 5019760. The stream is a tributary to Sandy Bay Creek (WBIC 90400), which is a direct tributary to Lake Michigan. The aerial image was obtained from the DNR Surface Water Data Viewer.

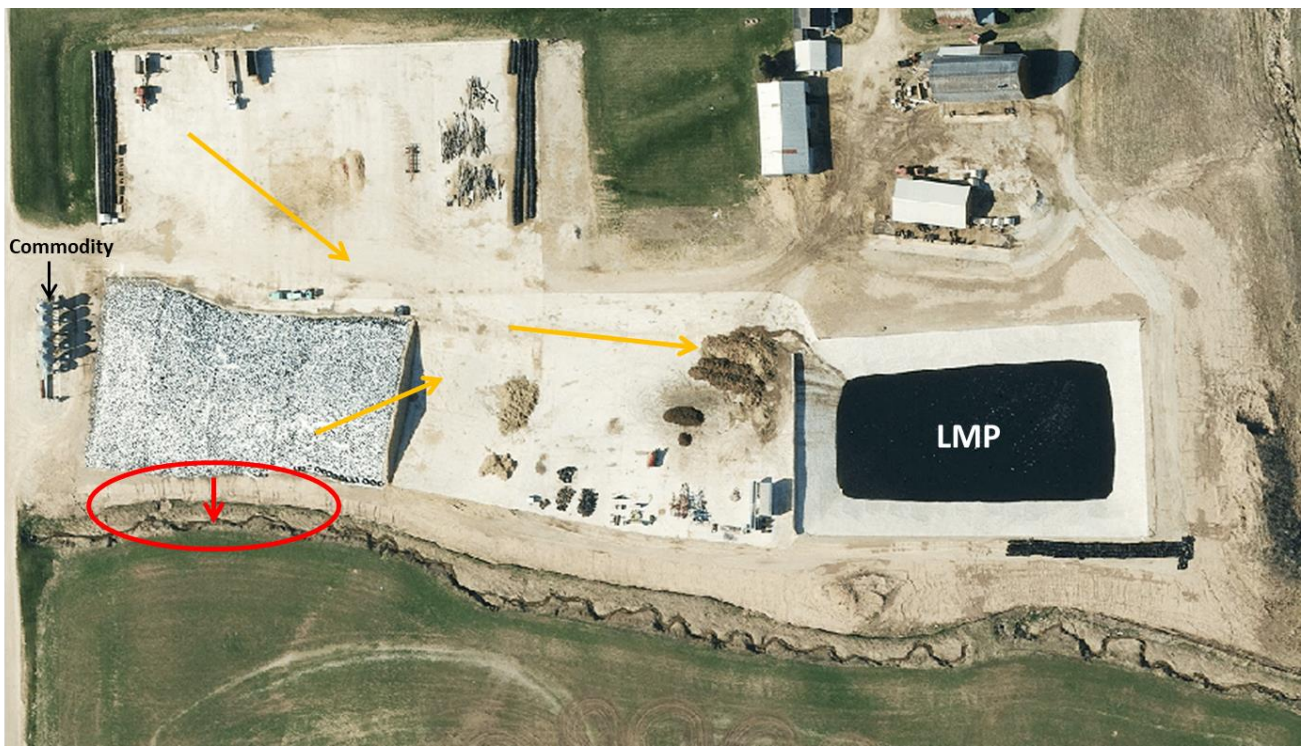
Aerial Map 3. The aerial map above illustrates the flow path of runoff from the feed storage area at Augustian Farms. The yellow arrows represent the flow path of process wastewater towards the leachate management pond. The area circled in red identifies the area where leachate left the concrete feed pad. The aerial photo was obtained from the Kewaunee County GIS Website.

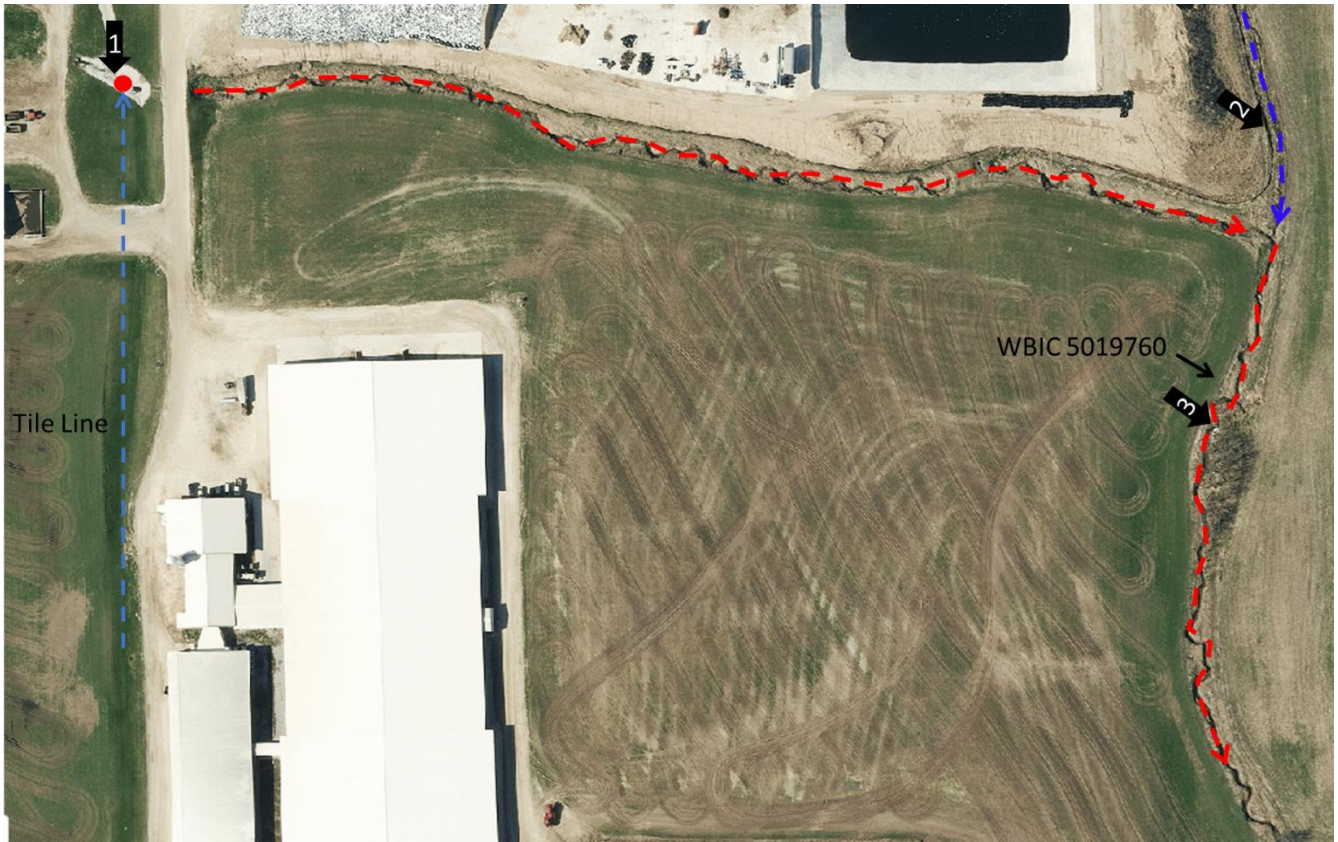
Aerial Map 4. The aerial map above illustrates the flow path of process wastewater that discharged from a tile outlet to the stormwater drainage ditch that runs through the production site. The red dashed arrows represent the flow path of process wastewater through the drainage ditch and through WBIC 5019760. The dashed blue line represented the flow path of WBIC 5019760 before the confluence with the drainage ditch.

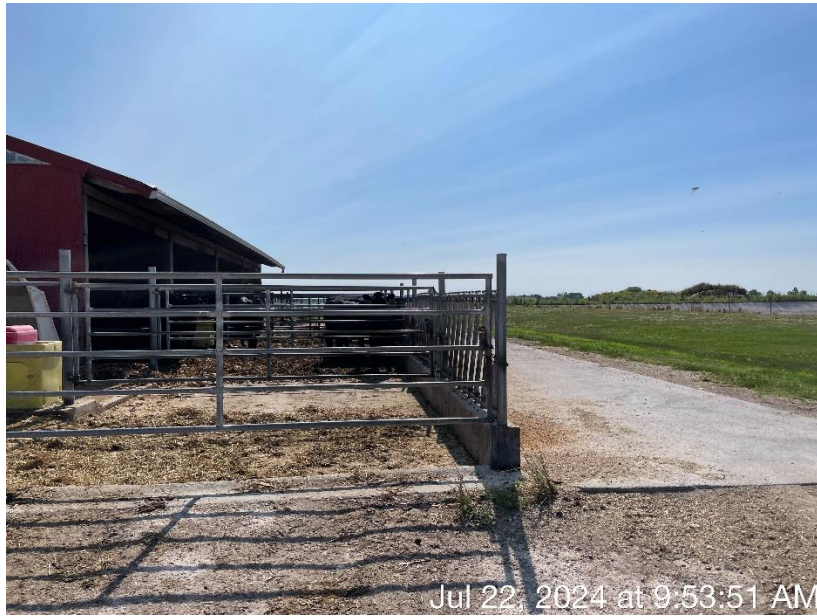
Augustian Farms LLC utilizes two outdoor concrete feedlots that confine beef steers. The feedlots are located on the northeast corner of the production site. A sump is located within the feedlots to collect runoff, which is then manually collected using a PTO-driven VAC tanker. Curbing is present to contain runoff within the concrete lots.

Photo 1. One of the outdoor concrete lots that house beef steers on the northwest corner of the production site. This photo was taken facing east.

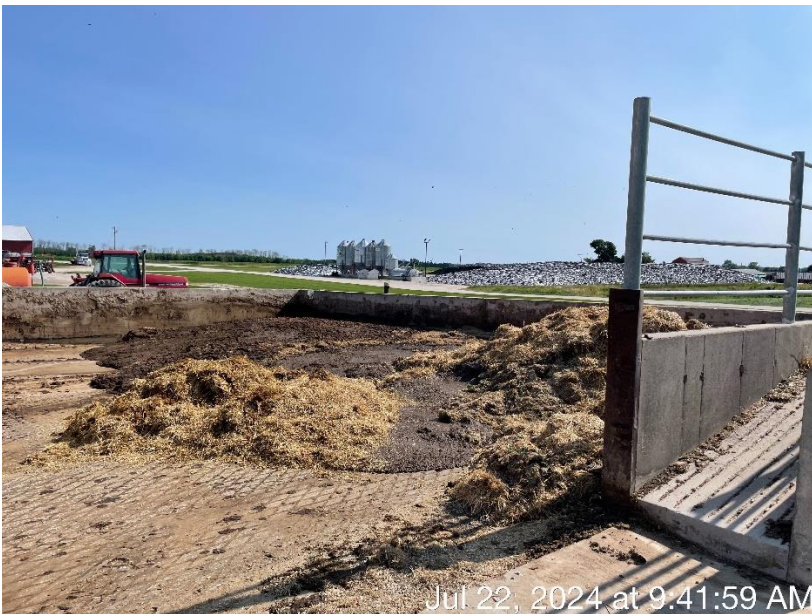
Photo 6. The detention basin that handles manure scrapped from the Heifer Barn on the west side of the production site. This photo was taken facing northeast.

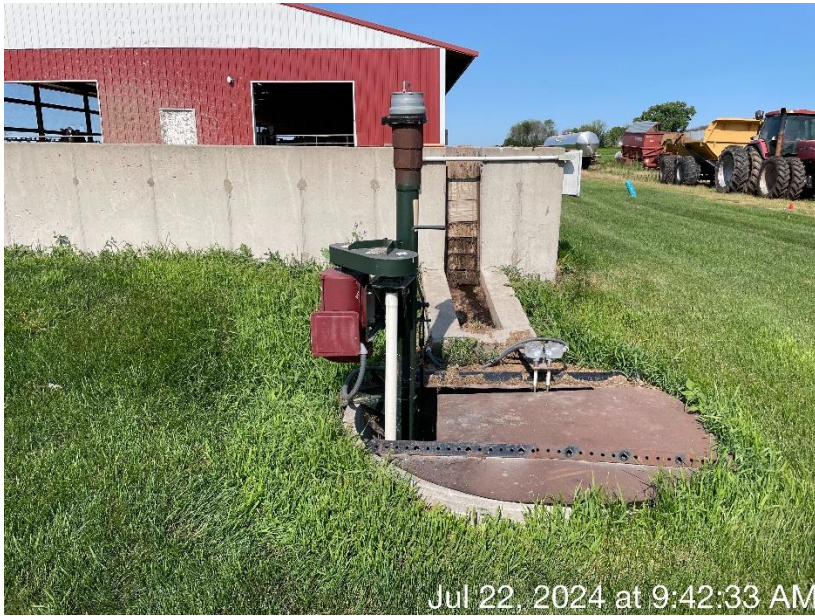
Photo 8. The pump station that captures liquid manure from the detention basin through the picket gate and transfers the waste to the manure transfer system in the freestall barn.

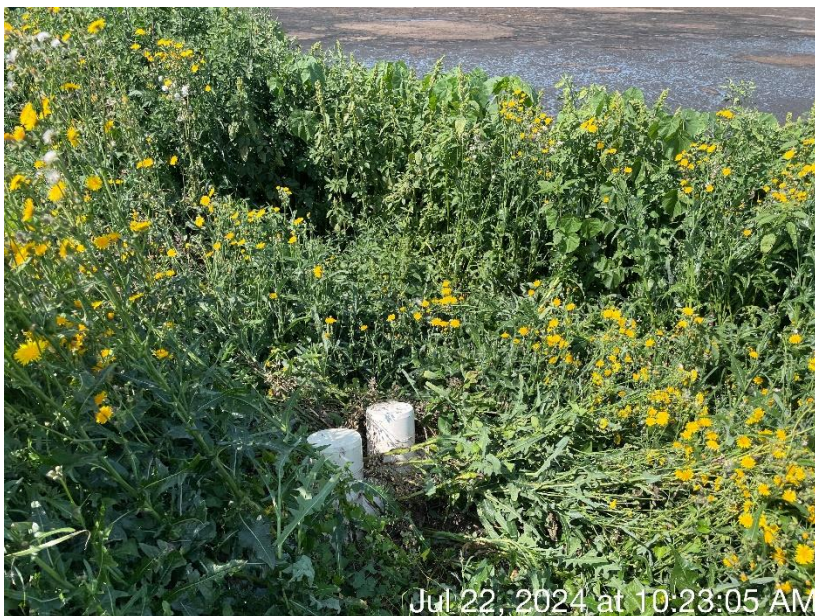
Photo 13. Permanent markers present on the east berm of WSF 1. Salscheider recommended killing off the vegetation so that the markers are more visible.

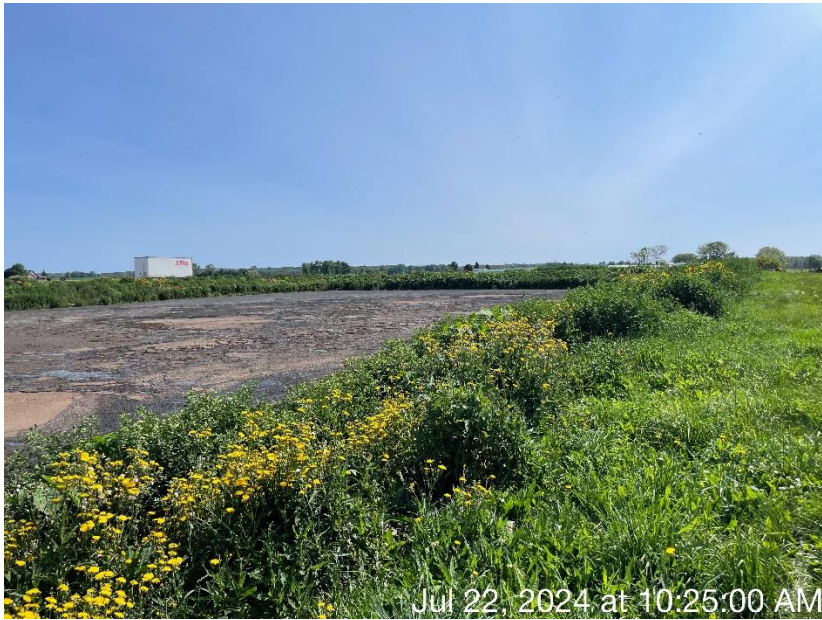
Photo 14. WSF 1 at Augustian Farms LLC, located on the south side of the production site. WSF 1 accepts manure and process wastewater from the freestall barns and milking parlor. This photo was taken facing east.

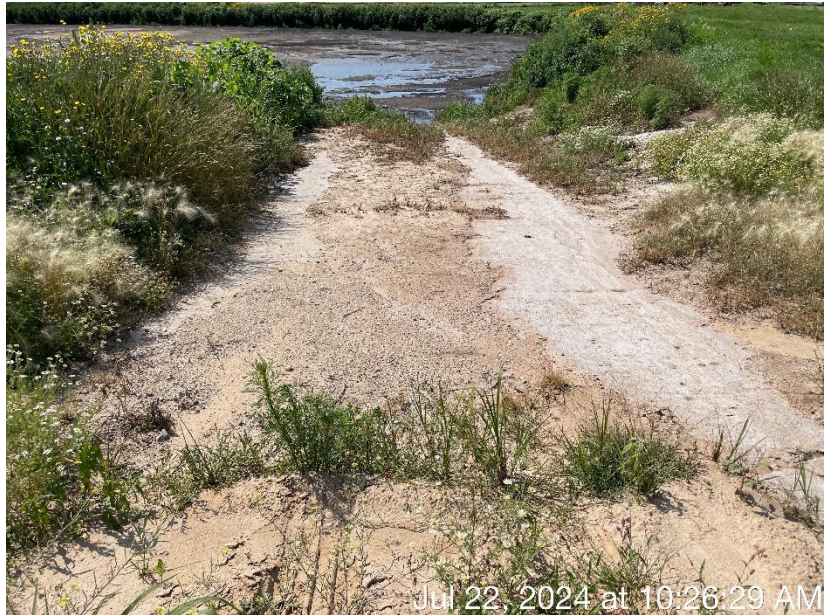
Photo 15. The concrete ramp going into WSF 1 at Augustian Farms LLC.

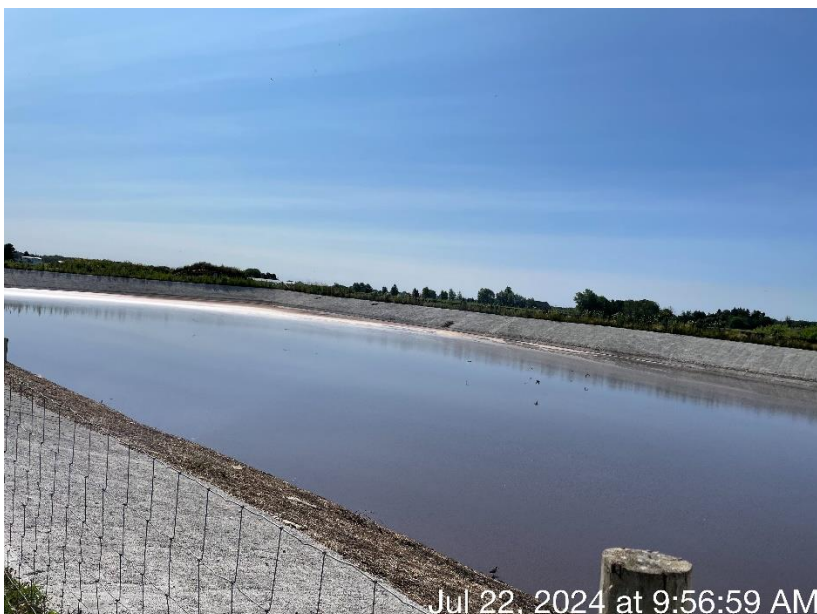
Photo 16. WSF 2 at Augustian Farms LLC located on the northeast portion of the production site. WSF 2 accepts runoff from the feed storage area and manure stacking area. This photo was taken facing southeast.

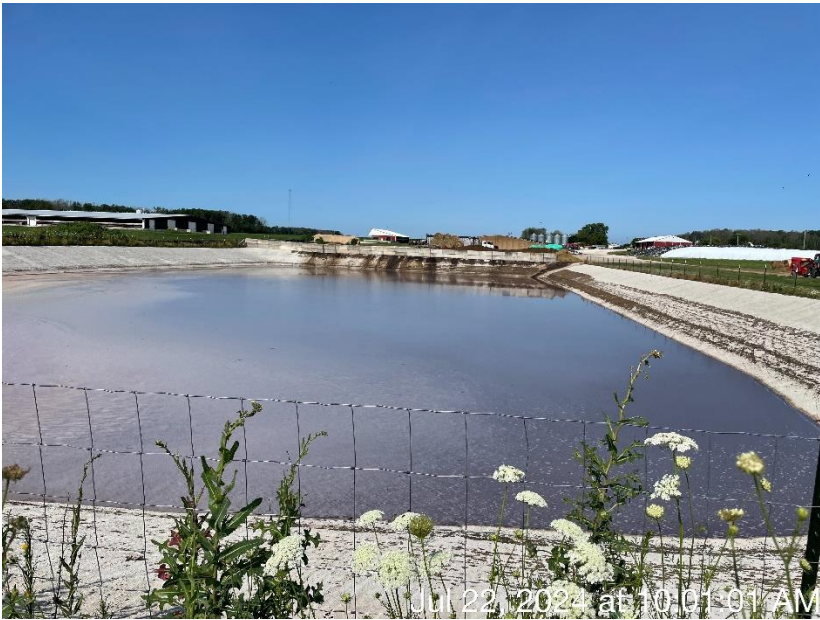
Photo 17. WSF 2 at Augustian Farms LLC located on the northeast portion of the production site. WSF 2 accepts runoff from the feed storage area and manure stacking area. This photo was taken facing west.

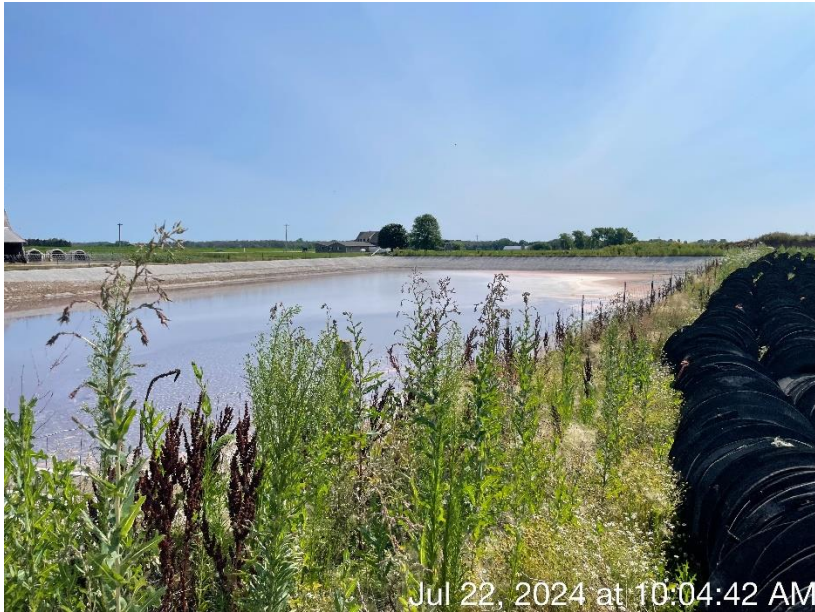
Photo 20. WSF 2 at Augustian Farms LLC located on the northeast portion of the production site. WSF 2 accepts runoff from the feed storage area and manure stacking area. This photo was taken facing northeast.

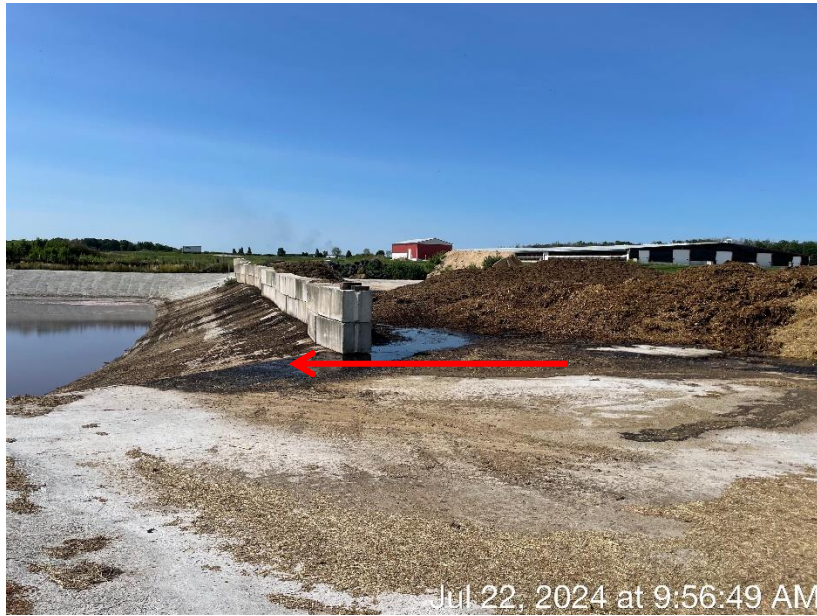
Photo 23. The flow path of runoff from the solid manure stacking area located on the east side of the feed storage area.

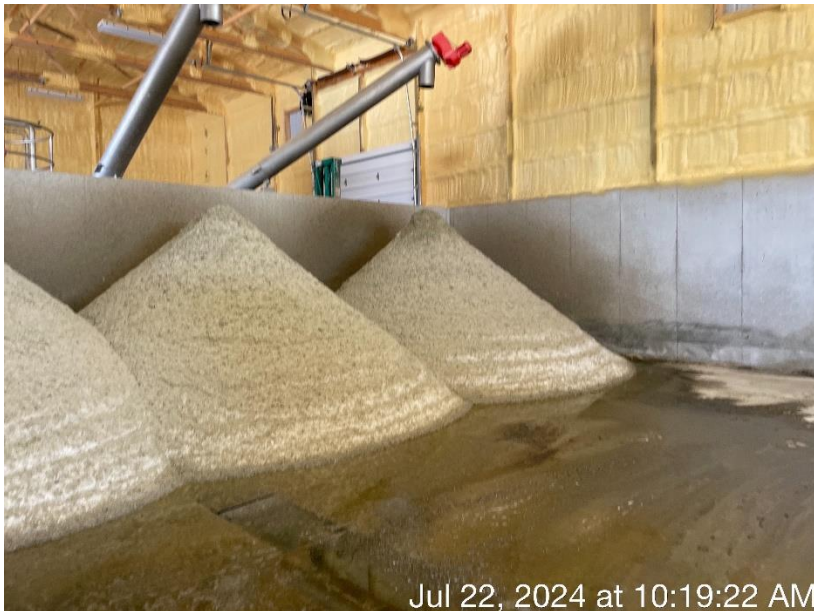
Augustian Farms recently installed a sand separation system that removes sand bedding from the liquid manure generated in the freestall barns. The Stjernholm sand separator is located in the sand separation building. Sand that is removed is conveyed to a stacking location within the building prior. Leachate from the sand stacking piles gravity flows into a collection flume.

Photo 26. The sand stacking area located in the sand separation building. Leaching from the stacking piles gravity flows to a collection system pictured in the foreground of the photo.

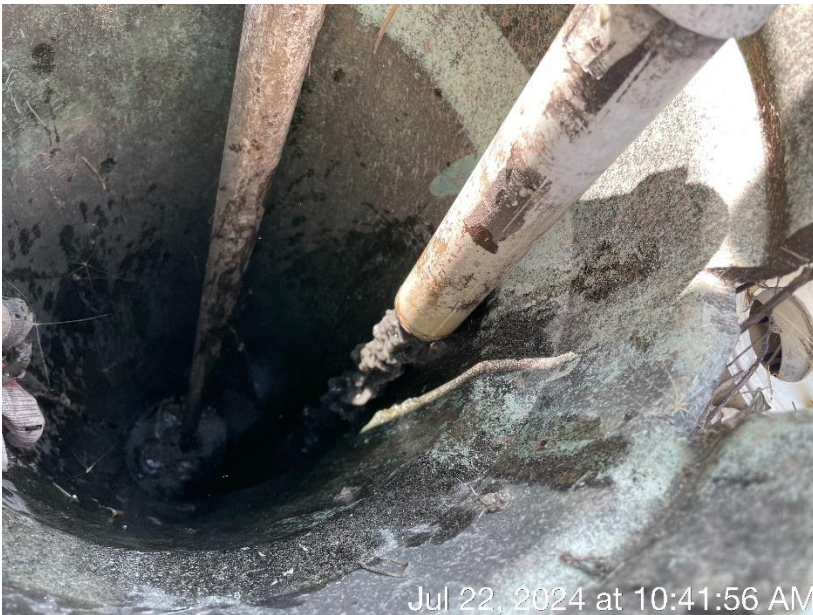
While Salscheider was investigating downstream impacts, Augustian began collection efforts using a PTO-driven VAC tanker. Augustian also began investigating the cause of discharge. Augustian stated that the week prior to the inspection, maintenance was conducted near the transfer line that conveys process wastewater from the milking parlor to the manure transfer system in the freestall barn. Augustian also stated that it could be a sump pump in the milking parlor that failed, causing the sump to fill with process wastewater. After investigation, it was determined that the maintenance work that was completed the week prior to the inspection damaged an old transfer line, causing parlor wastewater to discharge to a gravel layer where water is collected by a sump pump outside of the milking parlor. Maintenance actions were taken to repair the transfer line and prevent parlor wastewater from continuing to discharge.

Photo 28. Contaminated water being pumped from a sump located adjacent to the milking parlor. The water was dark grey, opaque, and had an odor consistent with sewage.

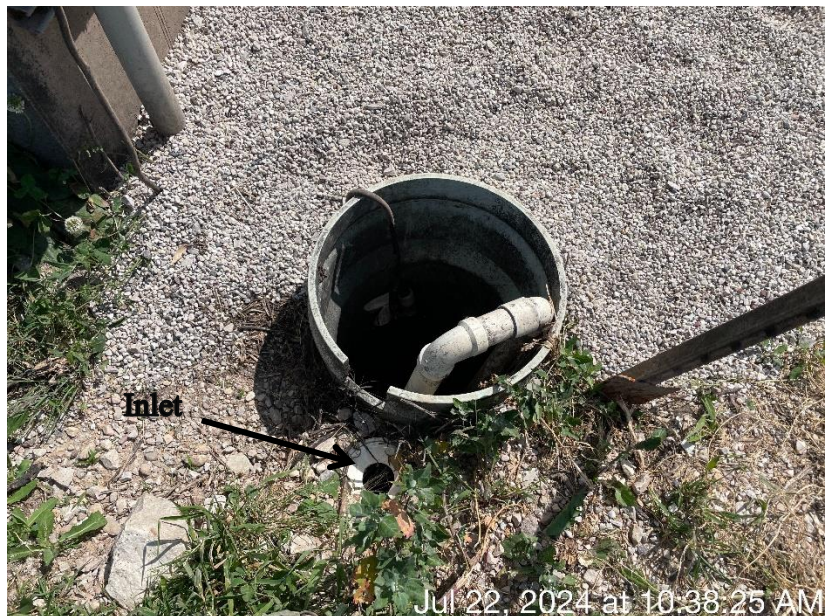
Wastewater from the milking parlor is designed to be collected and comingled with manure generated in the holding area and freestall barns. During the inspection, Salscheider observed grey water discharging to the drainage ditch that runs through the production site from a tile outlet located near the driveway that leads to the farm office and milking parlor. Significant bacteria growth was observed on the tile outlet and on the vegetation in the drainage ditch. Salscheider noticed an odor consistent with sewage. Augustian stated that the tile line conveys subsurface water collected from a sump pump located outside of the milking. Salscheider and Augustian inspected the sump and observed dark grey water being pumped from the sump. Augustian immediately disconnected the pump from the tile line and turned off the pump.

Photo 29. The sump located adjacent to the milking parlor. The sump collects clean water from a gravel layer and pumps the water to a tile line located west of the milking parlor.

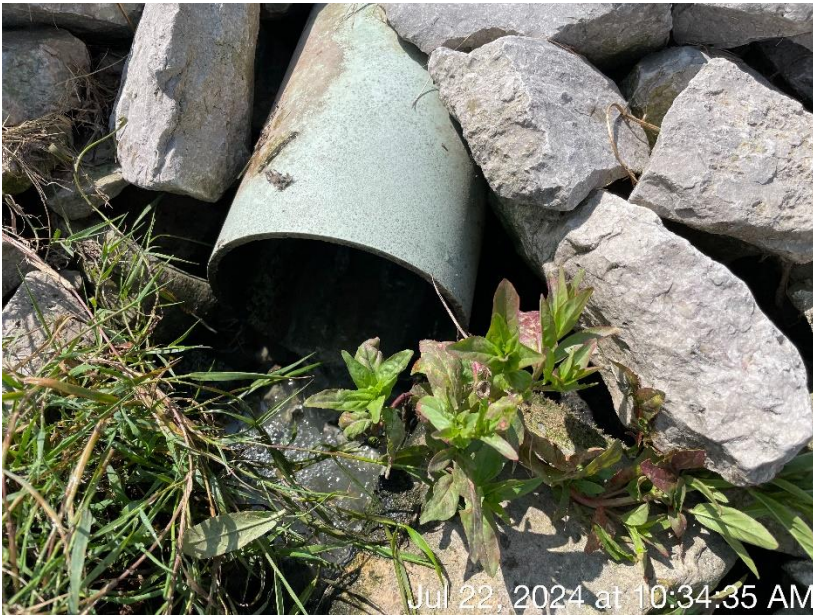
Photo 30. The outlet that discharges water from a tile line located west of the milking parlor. The outlet discharges water collected by the sump pictured in Photo 29. Bacteria was observed within and adjacent to the tile outlet.

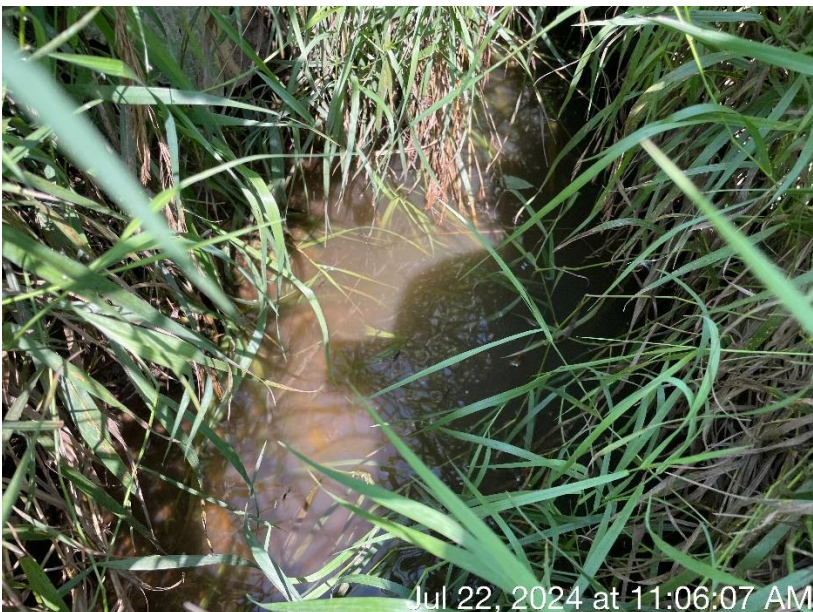
Photo 32. Water within the drainage ditch that flows west to east through the production site at Augustian Farms. The water was cloudy.

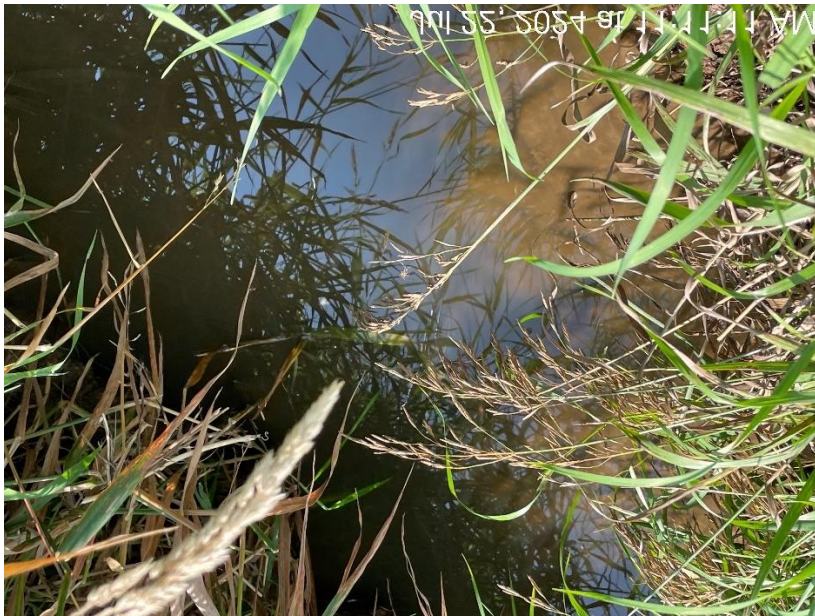
Photo 33. Water within the drainage ditch that flows west to east through the production site at Augustian Farms. The water was cloudy.
