Permit Fact Sheet

Permit Number	WI-0067441-01-0
Permittee Name and Address	Augustian Farms LLC E4361 County Road G Kewaunee, WI 54216
Permitted Facility Name and Address	Augustian Farms LLC E4361 County Highway G Kewaunee, WI 54216
Permit Term	August 01, 2026 to July 31, 2031
Receiving Water	Unnamed tributaries within the East Twin River Watershed, Lake Michigan Drainage Basin, and groundwaters of the state
Discharge Type	Existing source CAFO per NR 243.03(23) as the facility has been permitted since 2015.

Augustian Farms, LLC is an existing Concentrated Animal Feeding Operation (CAFO) located in the Township of Carlton in Kewaunee County. Augustian Farms, LLC is owned and operated by Aaron Augustian and family. Augustian Farms, LLC consists of a main production area located E4361 County Rd G, Kewaunee, WI 54216. The production site consists of two waste storage facilities, one feed storage area, one solid stacking area, two barns with outdoor lots, a sand separator, and multiple barns.

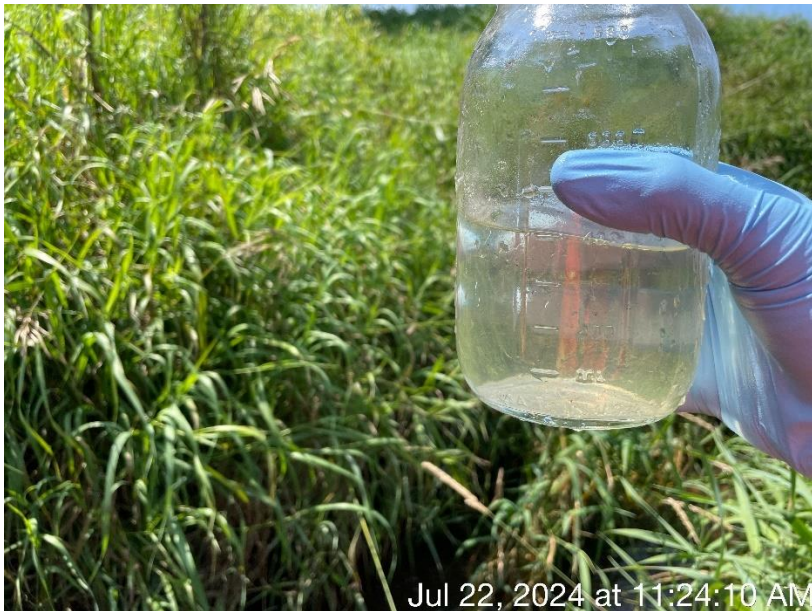
Photo 36. Water within WBIC 5019760, downstream at the Highway 42 road crossing. The water was clear with no visual indications of contamination.

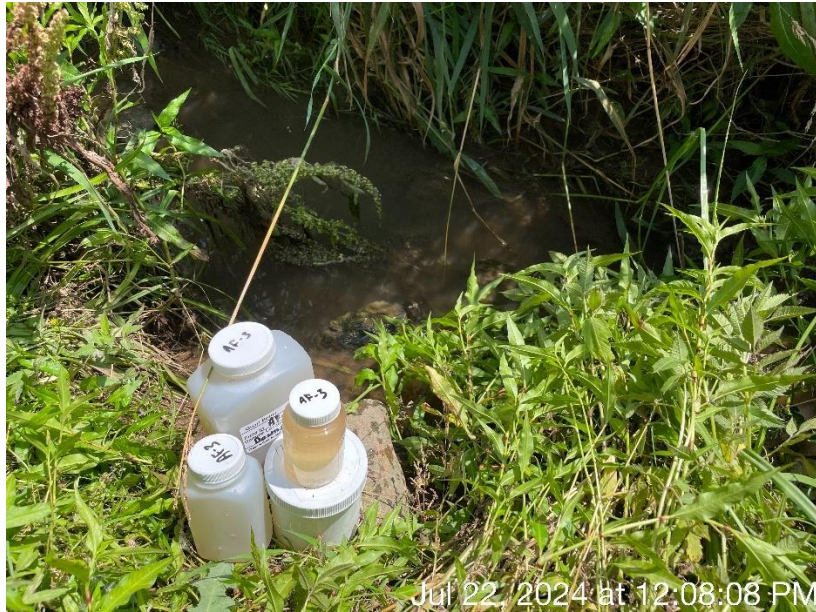
Photo 39. The location where sample AF-2 was collected, from WBIC 5019760 downstream of the confluence with the drainage ditch.

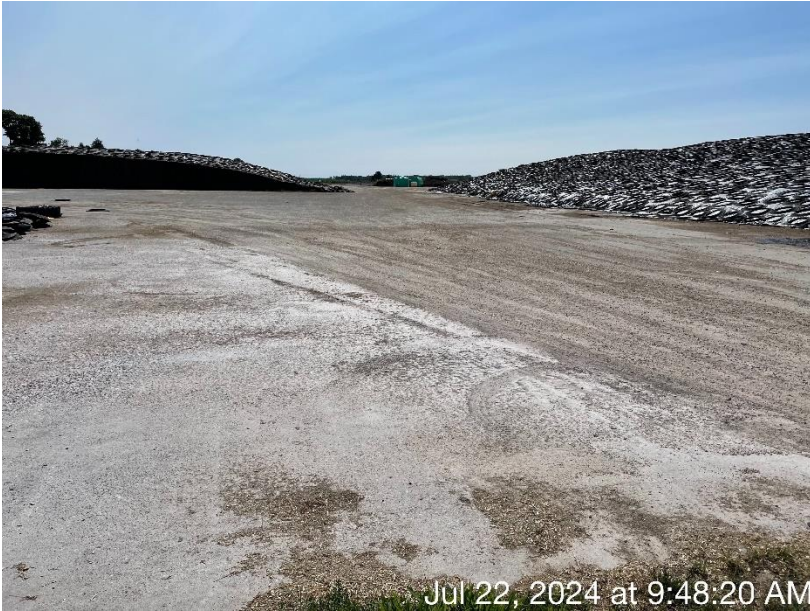
Photo 41. The feed storage area at Augustian Farms LLC, located on the north side of the production site. This photo was taken facing east.

Augustian Farms LLC utilizes one feed storage area located on the north side of the production site. The feed pad is 193,184 ft² in size and stores corn silage and haylage on piles covered in plastic. The feed pad is a concrete-soil composite liner and was expanded in 2021. An 8-inch tall containment curb is present on the north side of the feed pad. An apron is present around that west and south side of the feed pad that is raised 1-foot over 20 feet to prevent leachate and runoff from leaving the feed pad. Runoff from the feed pad flows west-to-east where it gravity flows into WSF 2, where the process wastewater is stored until it can be land applied. Salscheider observed staining on the gravel driveway on the south side of the feed pad, evidence that leachate and process wastewater was leaving the south end of the feed pad. There was no evidence observed to suggest that the runoff was discharging to waters of the state. Salscheider discussed possible solutions with Augustian to prevent discharges of process wastewater from the feed storage area, which included building up the southern edge of the feed storage area or keeping feed off the apron to allow process wastewater to be contained on the concrete feed pad.

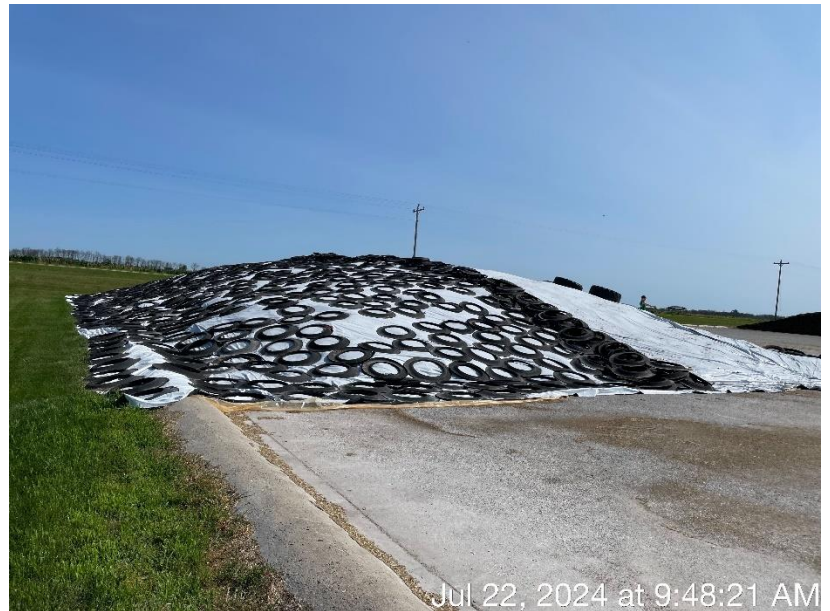
Photo 43. The north side of the feed storage area. Curbing is present around the west and north sides of the feed storage area. This photo was taken facing east.

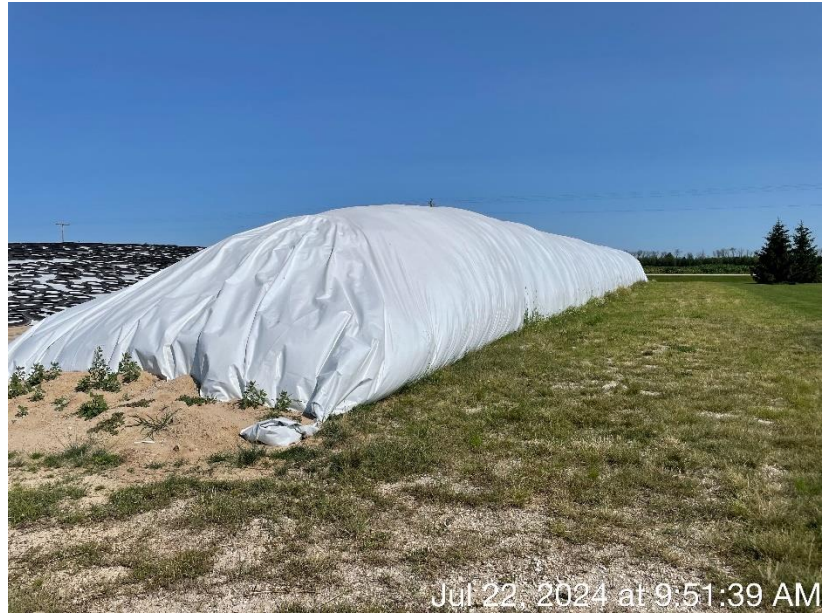
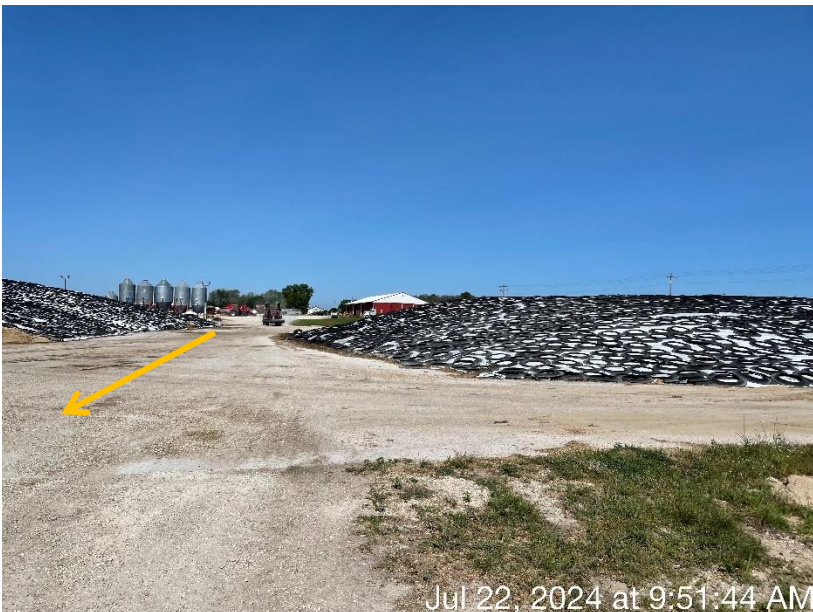
Photo 45. The feed storage area at Augustian Farms LLC, located on the north side of the production site. The orange arrow represents the flow path on the feed pad. This photo was taken facing west.

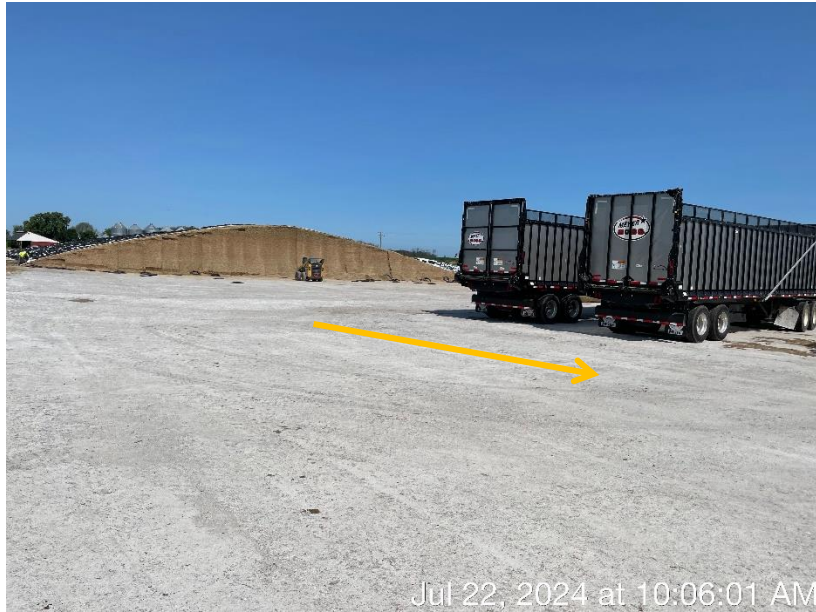
Photo 46. The feed storage area at Augustian Farms LLC, located on the north side of the production site. The orange arrow represents the flow path on the feed pad. This photo was taken facing west.

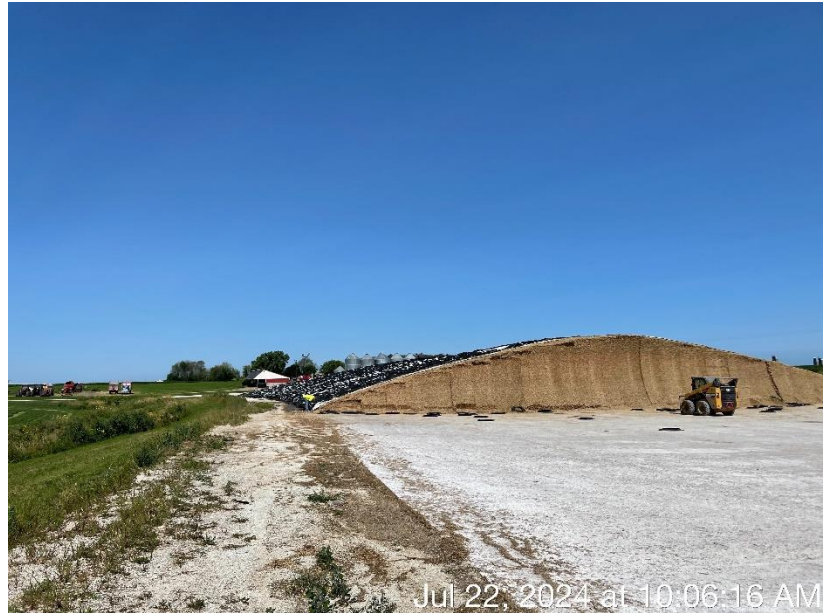
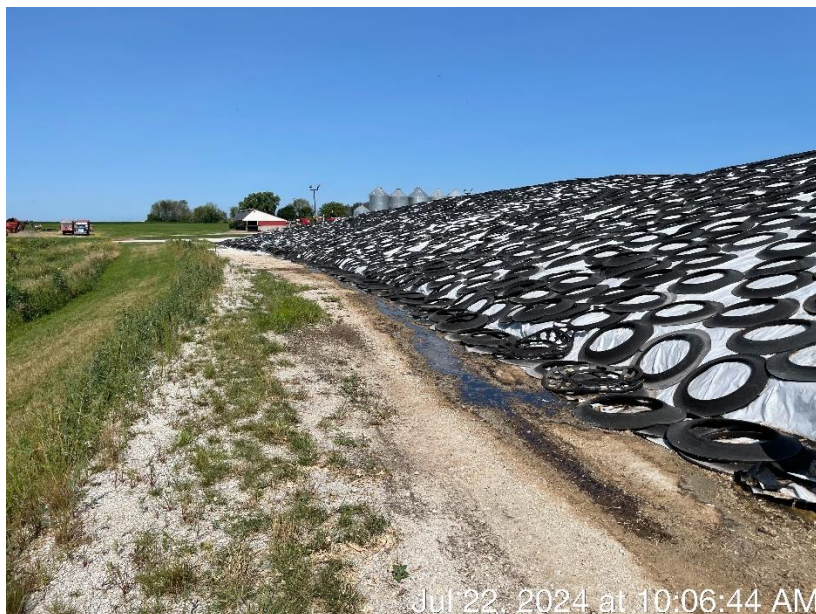
Photo 48. The south side of the feed storage area, where process wastewater had left the concrete feed pad. This photo was taken facing west.

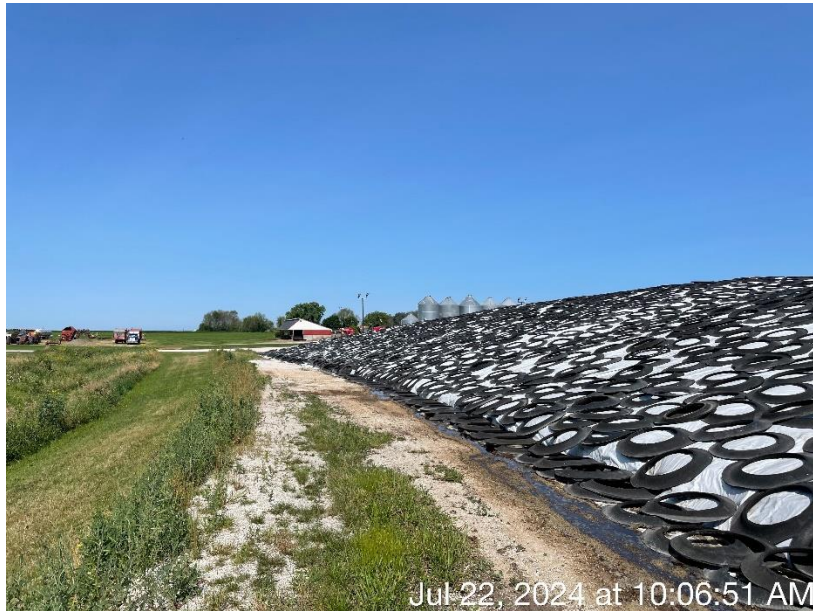
Photo 49. The south side of the feed storage area, where process wastewater had left the concrete feed pad. This photo was taken facing west.

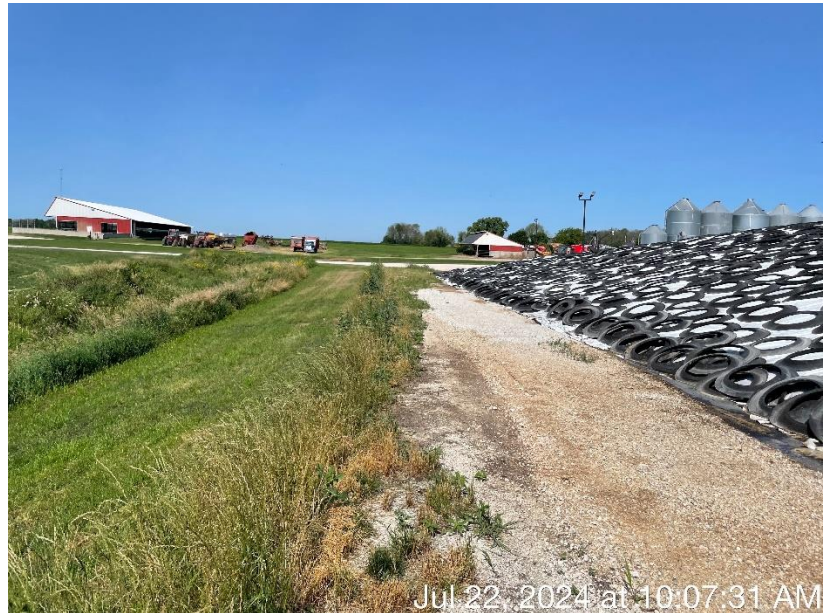
Photo 50. Staining in the gravel along the south side of the feed pad, indicating that leachate and process wastewater had left the concrete apron and flows through the adjacent driveway.

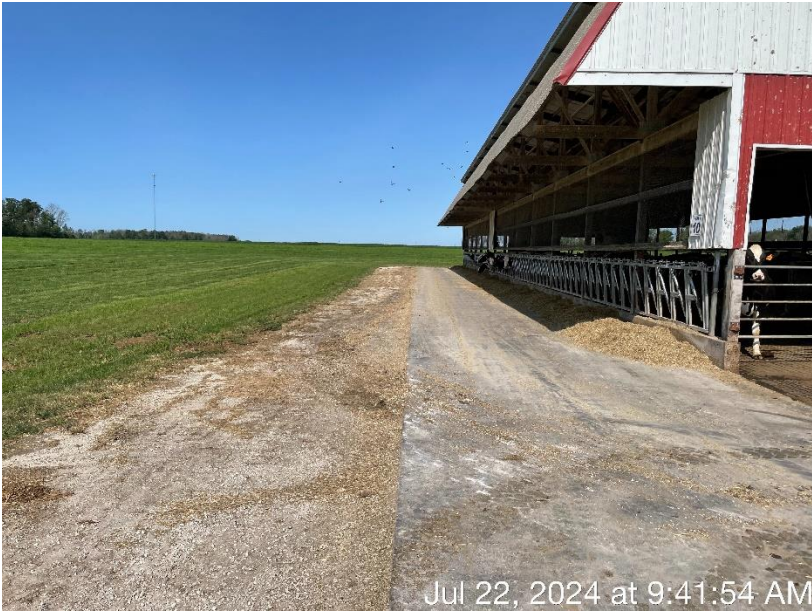
Photo 51. The feed lane outside of the heifer barn on the west side of the production site. No spilled or blown feed was observed during the inspection in this location.

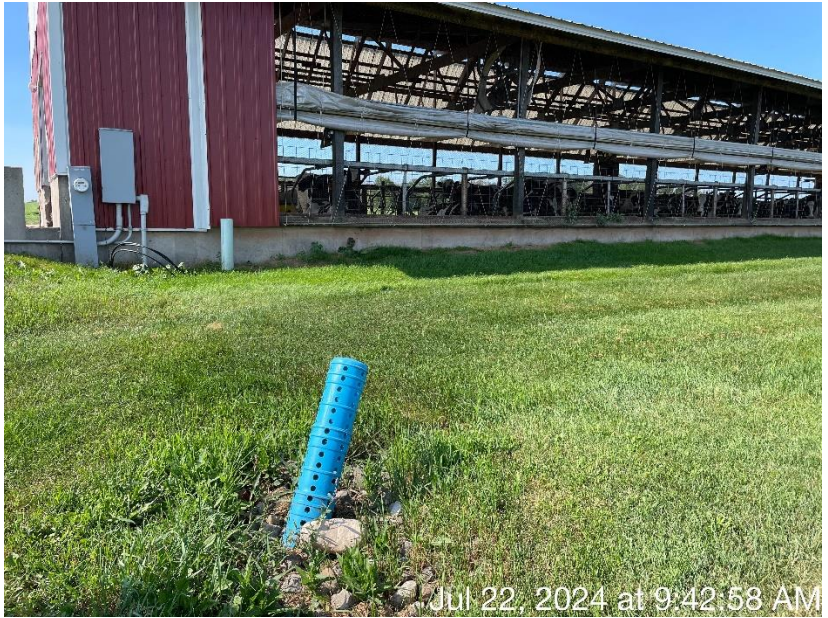
Photo 52. A tile inlet located near the northeast corner of the heifer barn.

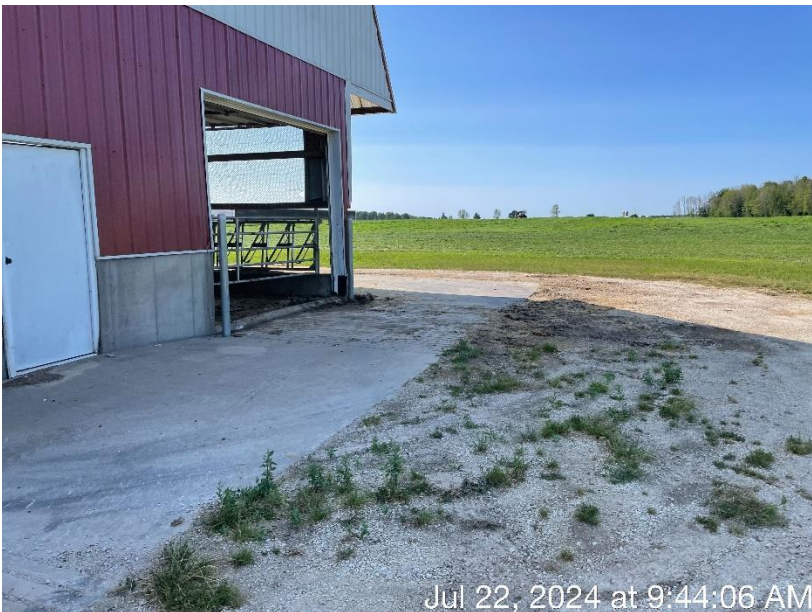
Photo 53. Outside of the heifer barn on the west side of the production site. Minimal manure tracking was observed in this location.

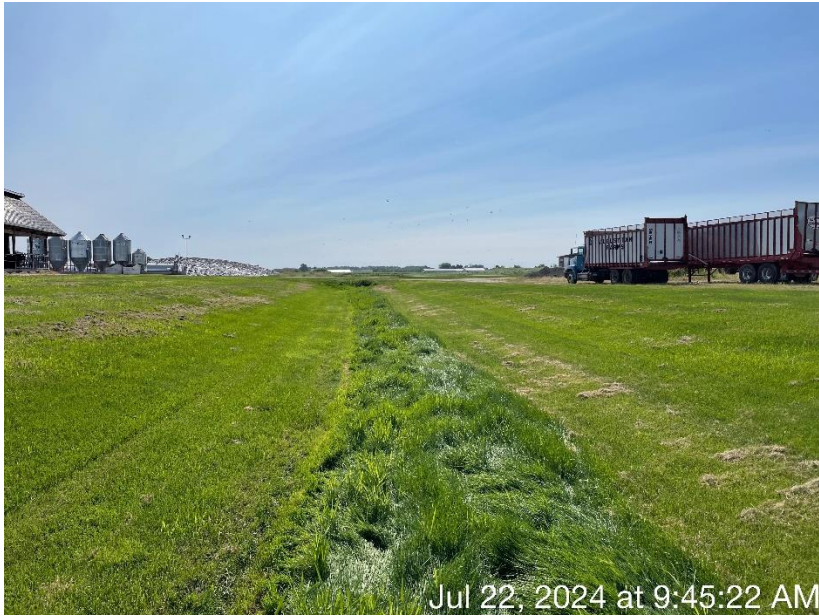
Photo 54. A grassed waterway that conveys stormwater to the drainage ditch that flows through the production site. This photo was taken on the west side of the production site facing east.

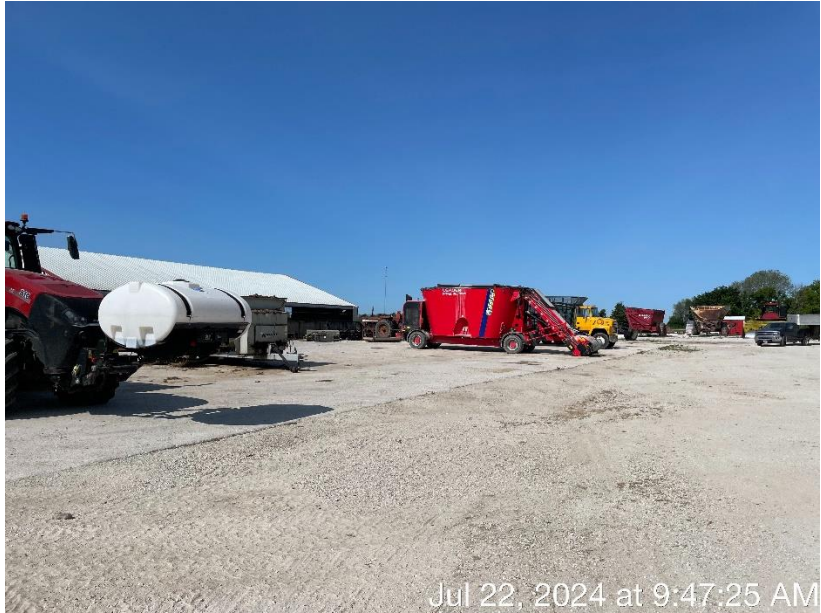
Photo 55. The west feed storage area, which has since been abandoned and turned into equipment parking.

Augustian Farms used a second feed storage area for haylage in the past, located on the west side of the production site. There were no runoff controls in-place for the feed storage area. Augustian Farms have since stopped using that feed storage area and now use the area for equipment parking.

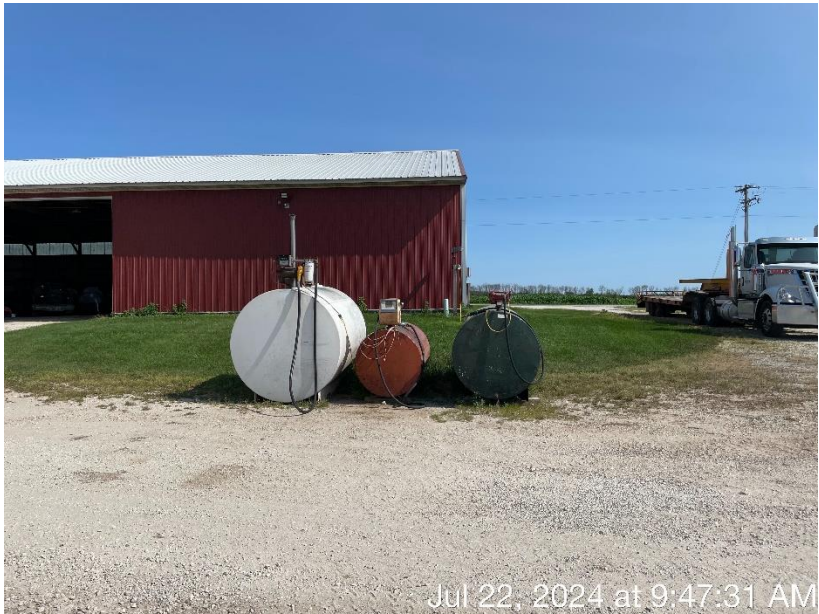
Photo 56. Fuel storage located near the machine shed on the northwest corner of the production site.

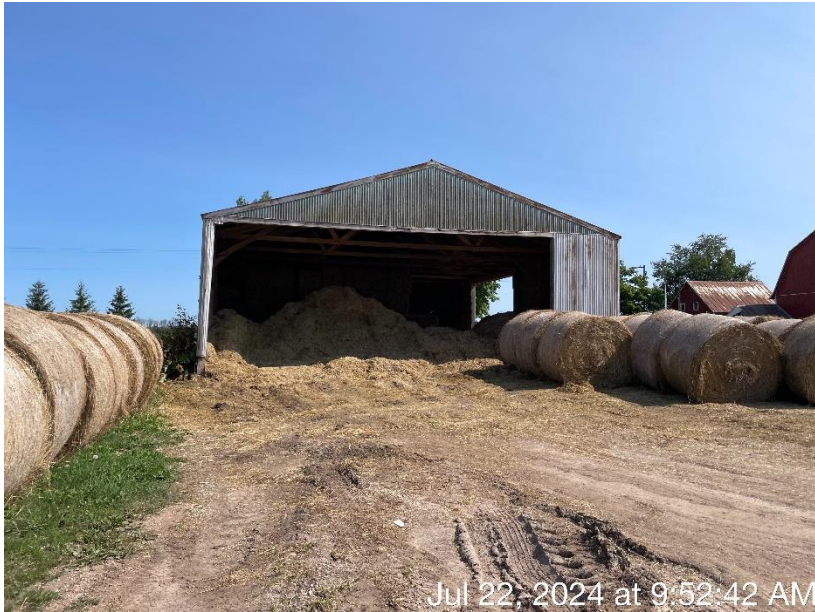
Photo 57. Straw bedding storage located near the steer barns on the northeast corner of the production site. A significant amount of spilled bedding material was observed.

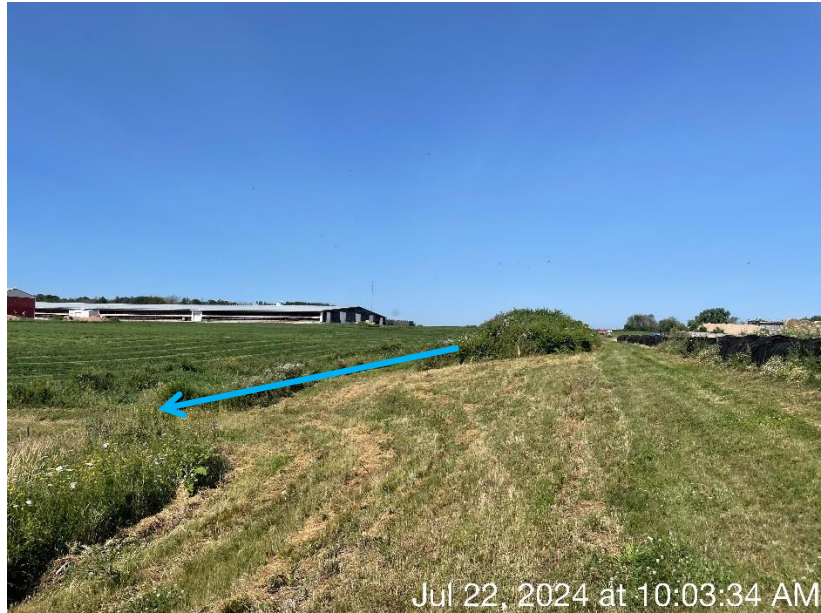
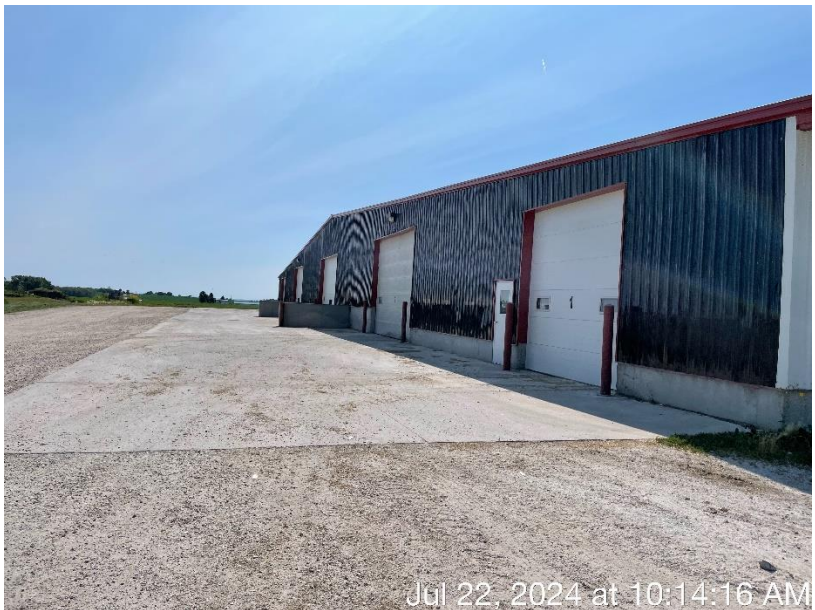
Photo 59. The driveways adjacent to the large freestall barn. Minimal manure tracking was observed on the north side of the freestall barn.

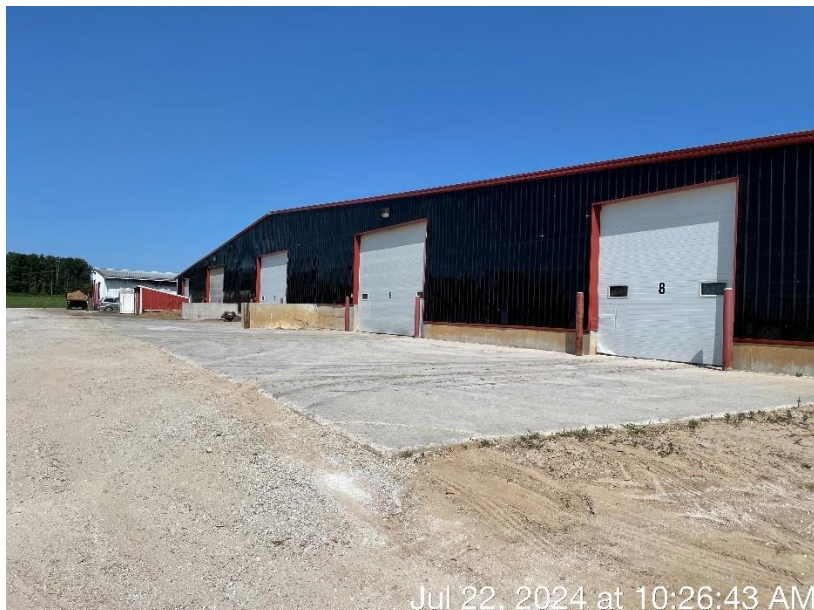
Photo 62. The driveways adjacent to the large freestall barn. Minimal manure tracking was observed on the south side of the freestall barn.
