# Permit Fact Sheet

Permit Number:	WI-0061794-05-0
Permittee Name:	B&D Dairy Farm LLC
Address:	4304 N 5th Road
City/State/Zip:	Pound WI 54161
Discharge Location:	<b>Main Farm</b> – W7251 E. 6 <sup>th</sup> Rd. Pound, WI 54161 ; SW ¼ of SW ¼ Section 36 T31N R20E <b>Heifer Facility</b> – W7276 E. 6 <sup>th</sup> Rd., Pound, WI 54161 ; Section 25 T31N R20E <b>Little River Site</b> – 7651 Hillcrest Road, Oconto, WI 54153 NE ¼ of NE ¼ Section 34 T29N R21E & 3267 County Road A, Oconto, WI 54153 NW ¼ of NW ¼ Section 35 T29N R21E
Receiving Water:	Surface Waters of the Little Peshtigo River, Lower Peshtigo River, Little River, and Middle Peshtigo River Watersheds. Lake Michigan Basin, & groundwaters of the state.
Discharge Type:	Existing

On Tuesday July 18, 2023 Hanson & Brenny met with Lepianka, Lepianka, Coady, Paulson & Hodkiewicz at 13:00 at B&D Dairy Farm LLC site to conduct a permit reissuance walkover inspection. All 3 sites in the permit were inspected. A heavy downpour occurred at the beginning of the inspection but for the remainder of the inspection temperatures were in the 80's and cloudy. No permit violations were observed, and no water samples were collected. Hanson & Brenny

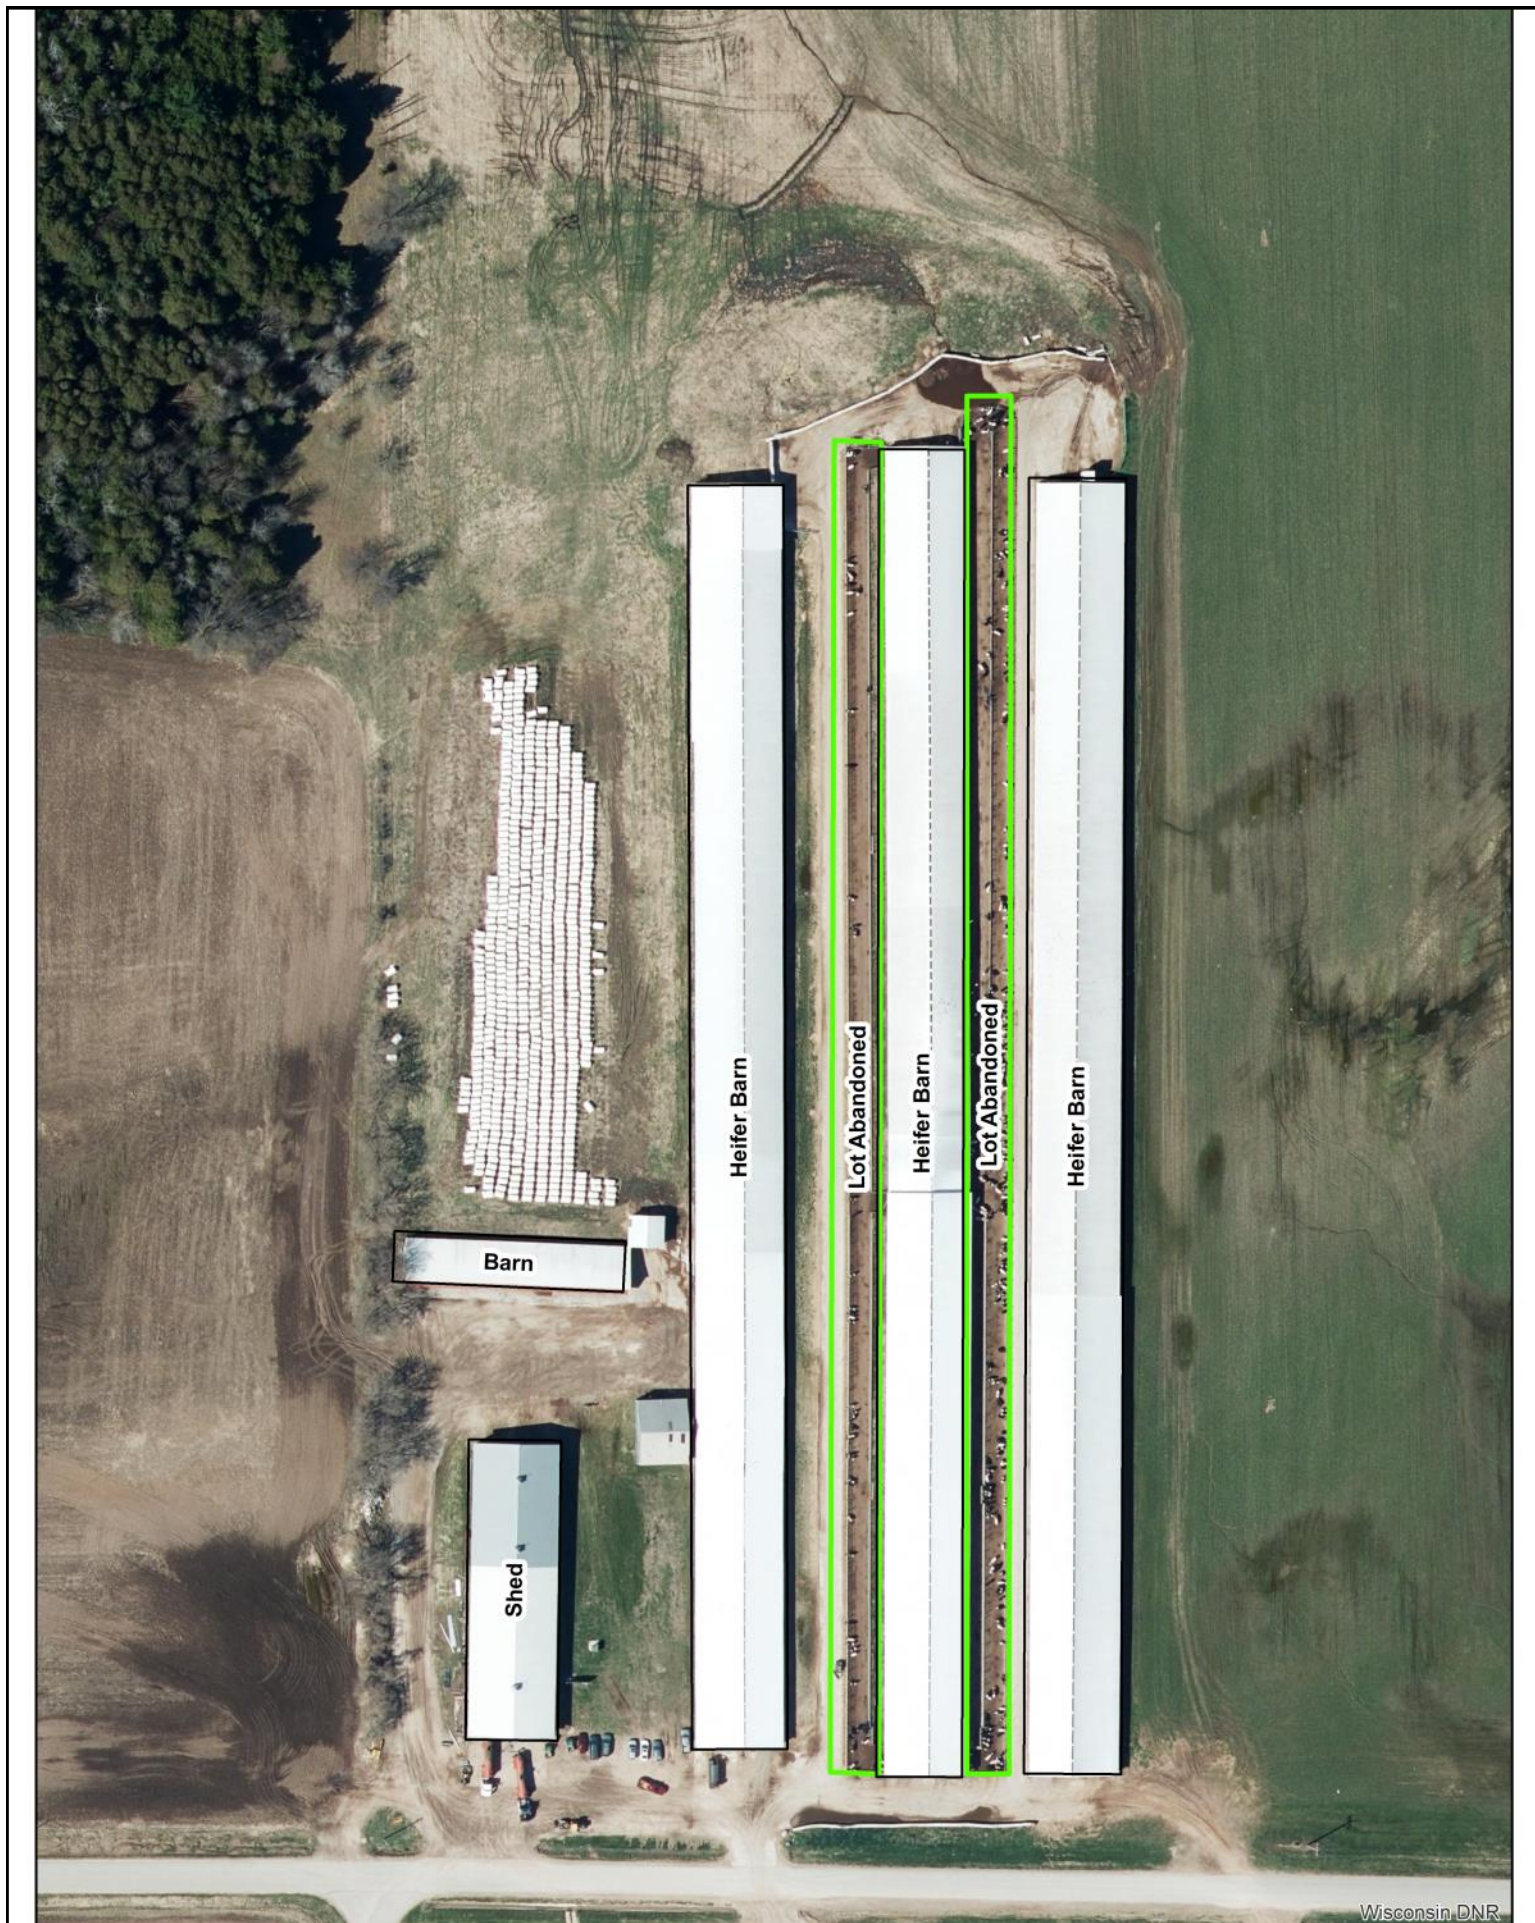
Site Overview Diagram (Heifer Farm: orange lines = potential runoff flow patterns, blue lines = stormwater flow, pink lines = waste transfer system)

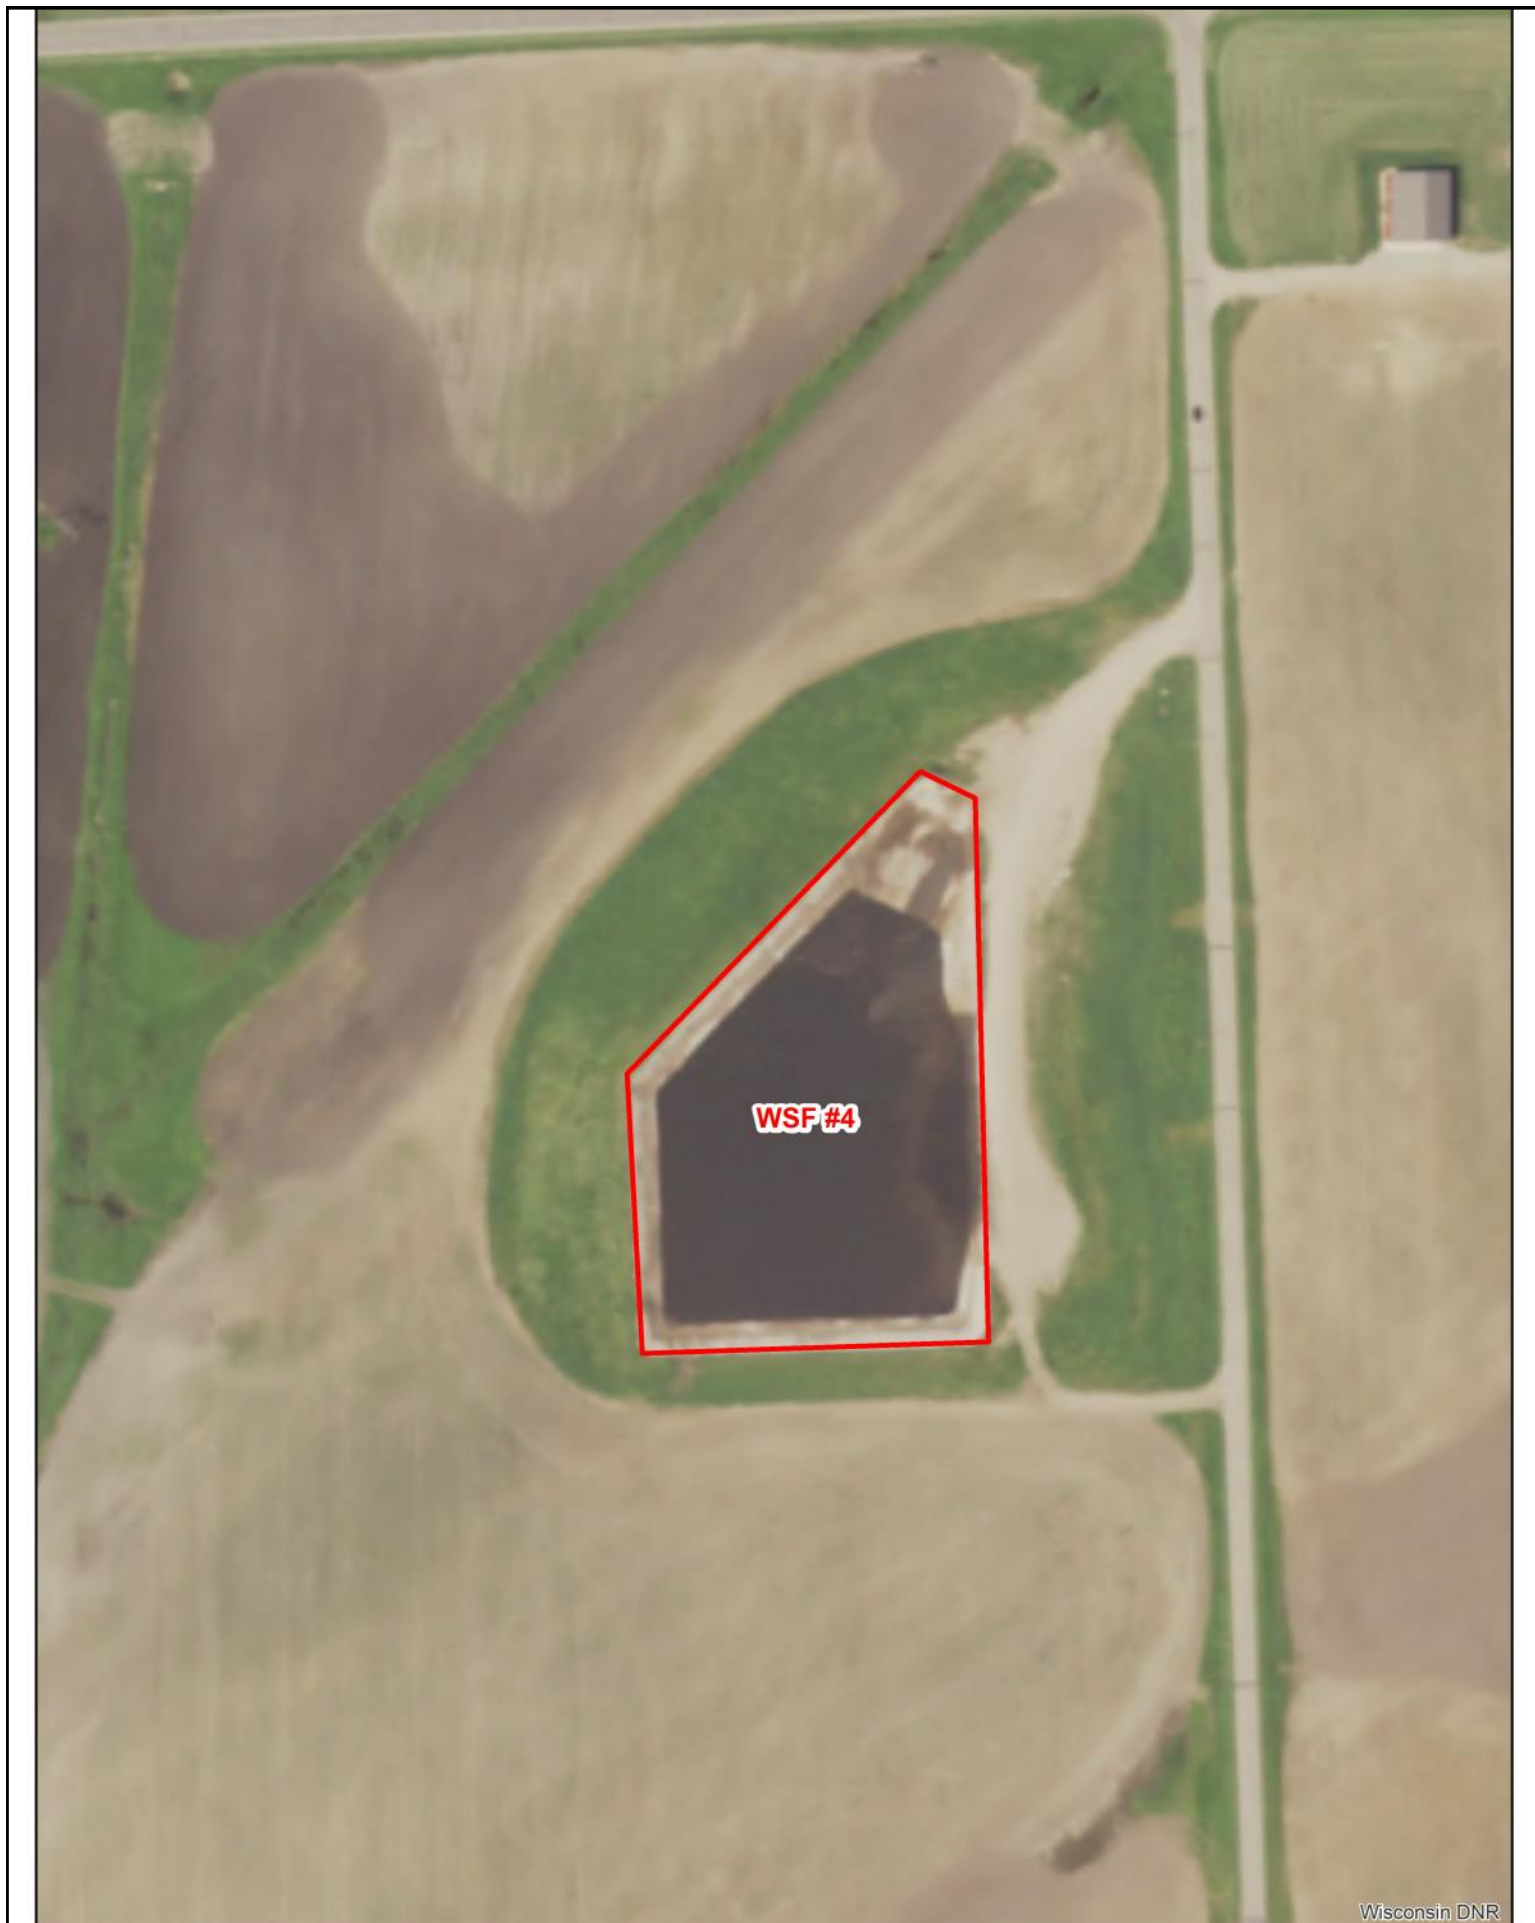
**Site Overview Diagram** (Little River WSF: orange lines =potential runoff flow patterns, blue lines = stormwater flow, pink lines = waste transfer system,)

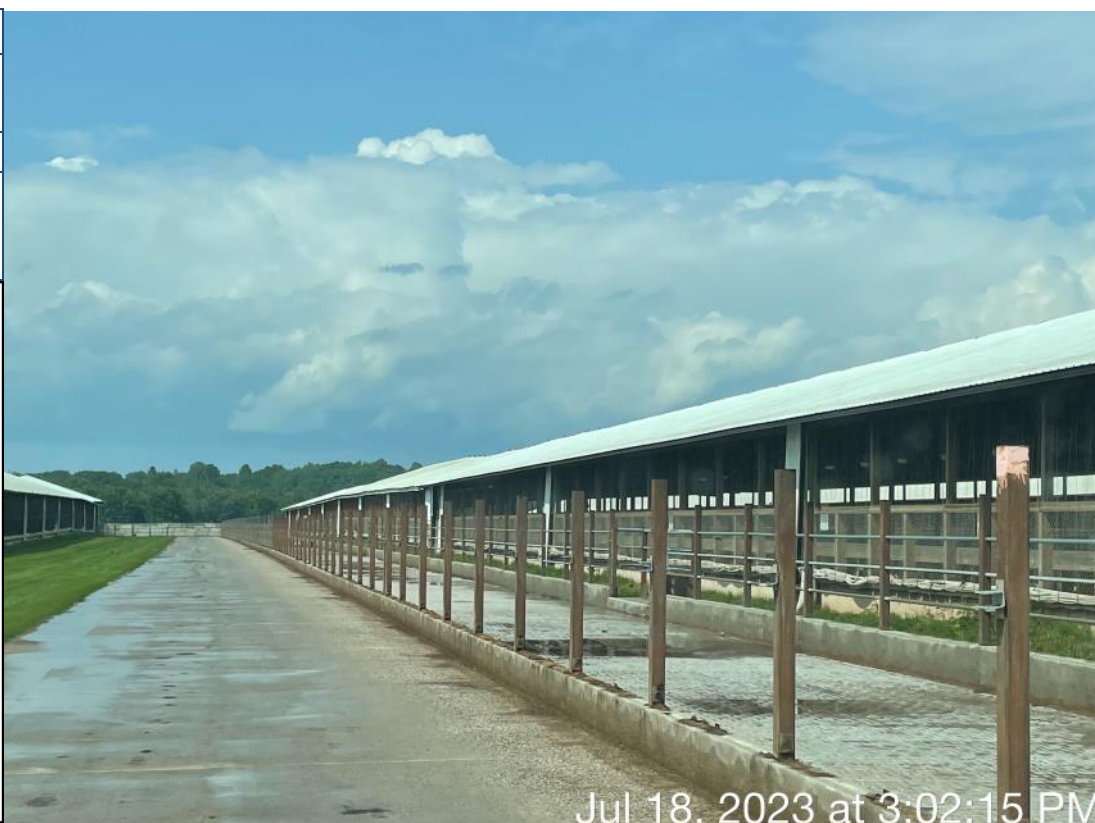
<b>Photo #:</b>	7514
<b>Date/Time of Photo:</b>	7/18/2023 15:02
<b>Photo By:</b>	Brian Hanson
<b>Photo Location:</b>	Heifer Farm Outdoor Lot

Standing on the south end of the west lot looking north: View of the west outdoor lot that has been abandoned.

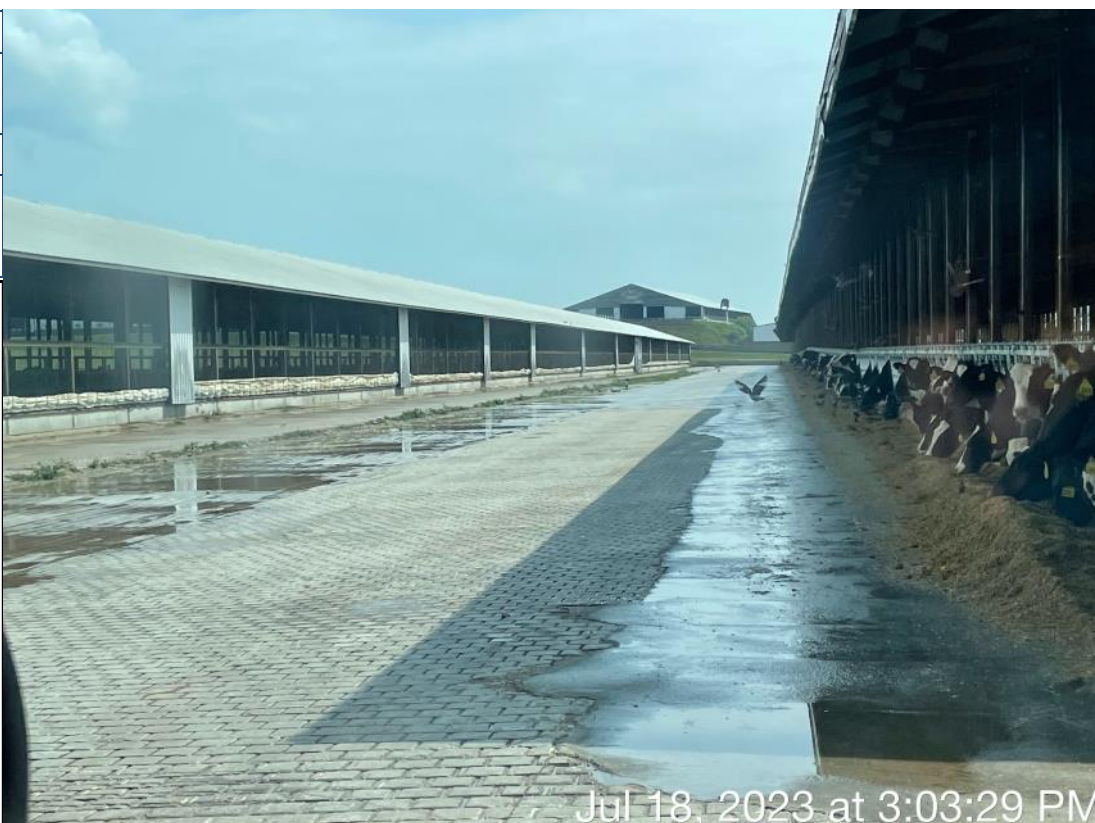
<b>Photo #:</b>	7518
<b>Date/Time of Photo:</b>	7/18/2023 15:03
<b>Photo By:</b>	Brian Hanson
<b>Photo Location:</b>	Heifer Farm Outdoor Lot

Standing on the north end of the east lot looking south: View of abandoned east lot. Notice all post and headlocks have been removed.

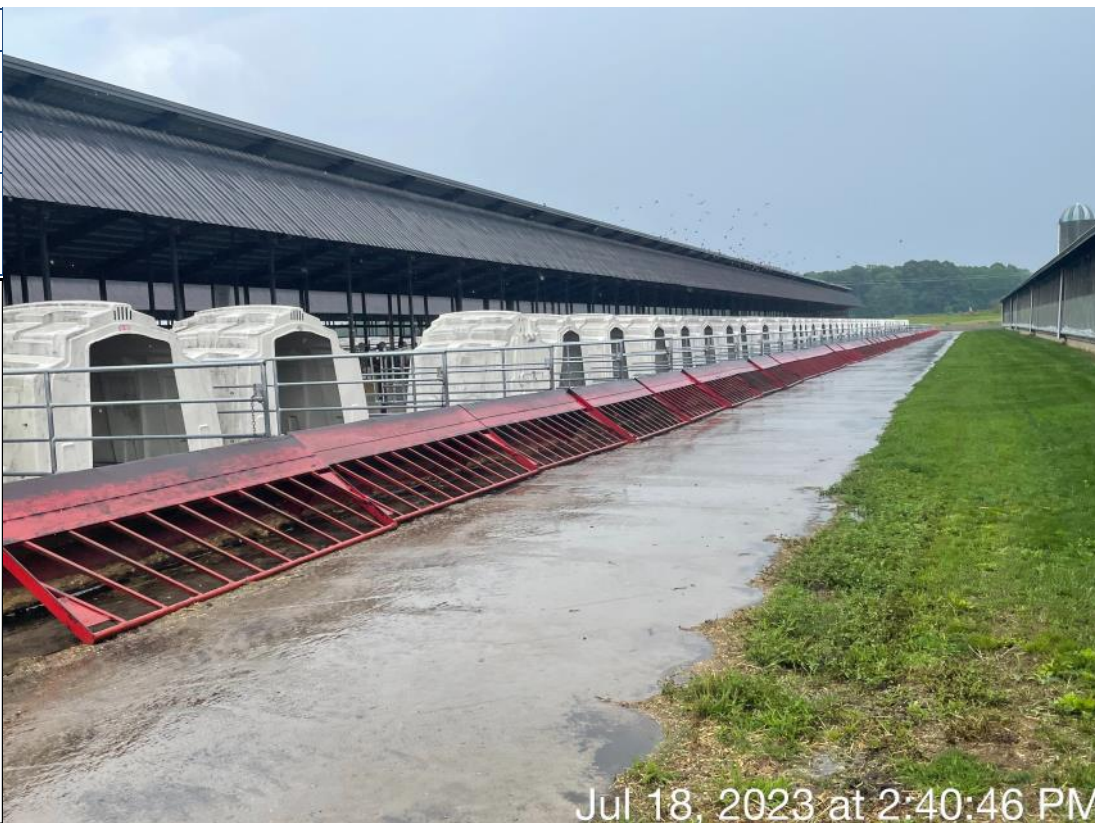
<b>Photo #:</b>	7429
<b>Date/Time of Photo:</b>	7/18/2023 14:40
<b>Photo By:</b>	Brian Hanson
<b>Photo Location:</b>	Main Dairy NE Calf Hutch Area

**Photo Description:**  
Standing on the west side of calf barns looking east: View of abandoned calf hutches in-between north 2 calf barns.

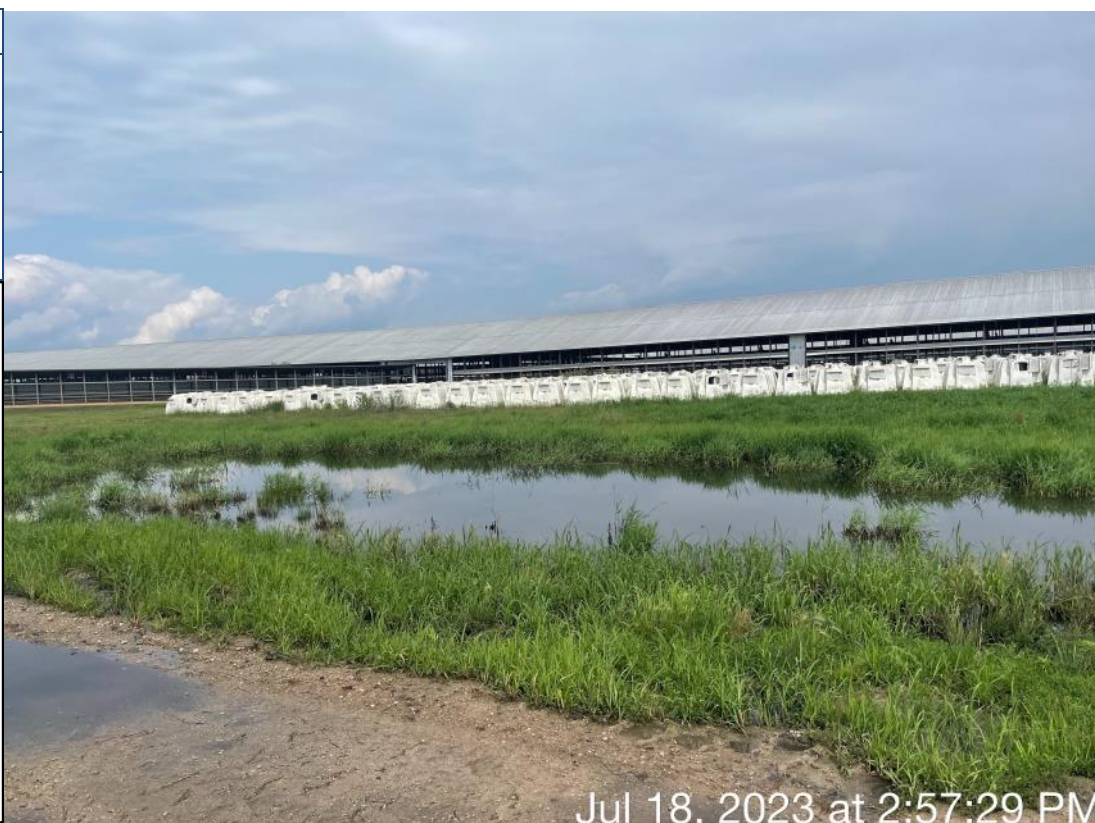
<b>Photo #:</b>	7505
<b>Date/Time of Photo:</b>	7/18/2023 14:57
<b>Photo By:</b>	Brian Hanson
<b>Photo Location:</b>	Main Dairy Calf Hutch Storage

**Photo Description:**  
Standing on the east side of WSF #3 looking northeast: View of calf hutch storage area in between WSF's & freestall barn. No animals present at time of inspection.

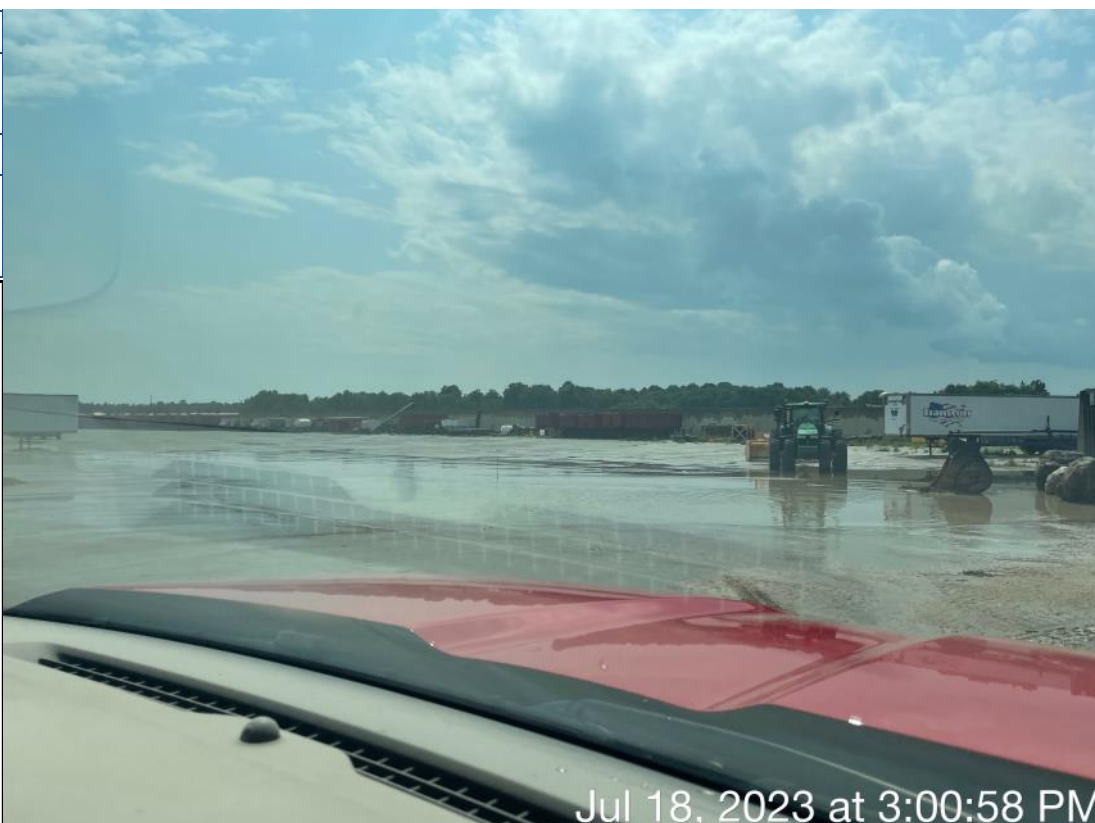
<b>Photo #:</b>	7508
<b>Date/Time of Photo:</b>	7/18/2023 15:00
<b>Photo By:</b>	Brian Hanson
<b>Photo Location:</b>	Main Dairy NW Calf Hutch Area

**Photo Description:**  
Standing on north side of NW Feed Storage/Calf Hutch Area looking south. View of concrete pad previously used to store feed & calf hutches during previous permit terms. Area is currently being used as an equipment storage area.

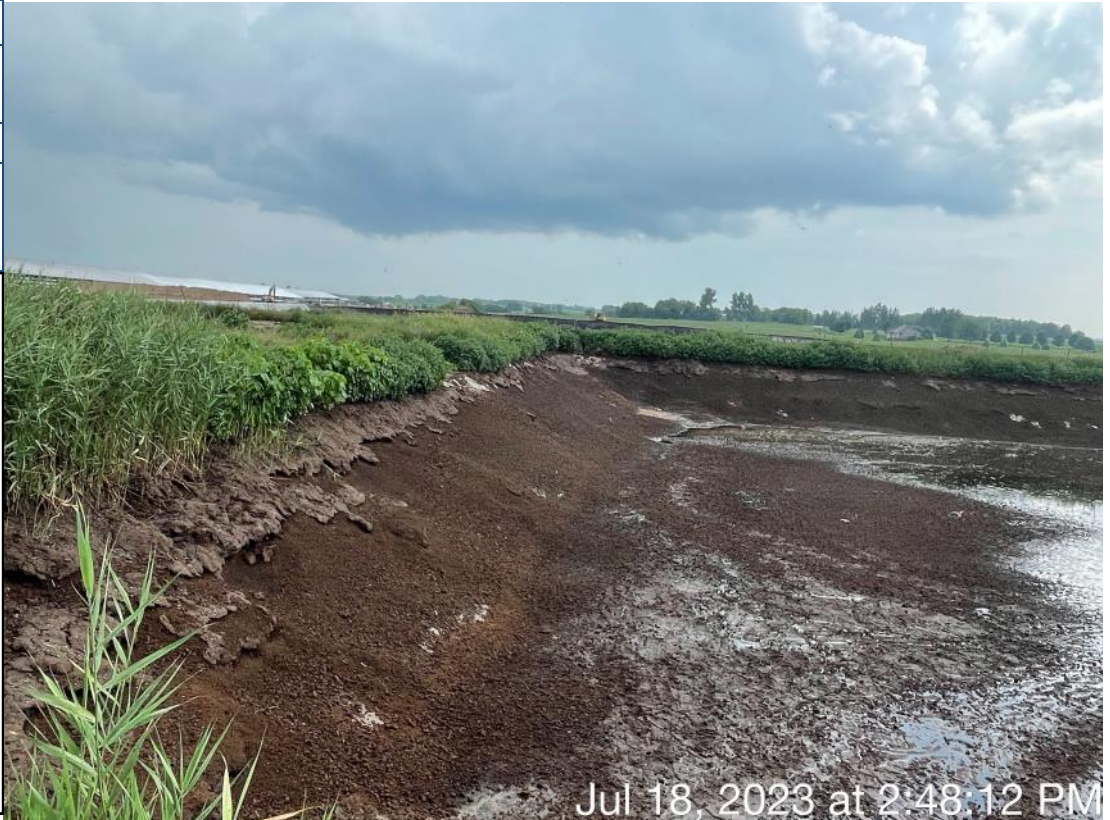
<b>Photo #:</b>	7449
<b>Date/Time of Photo:</b>	7/18/2023 14:48
<b>Photo By:</b>	Brian Hanson
<b>Photo Location:</b>	Main Dairy WSF #1

**Photo Description:**  
Standing at the northeast corner of WSF #1 looking south: View of east edge of WSF #1.

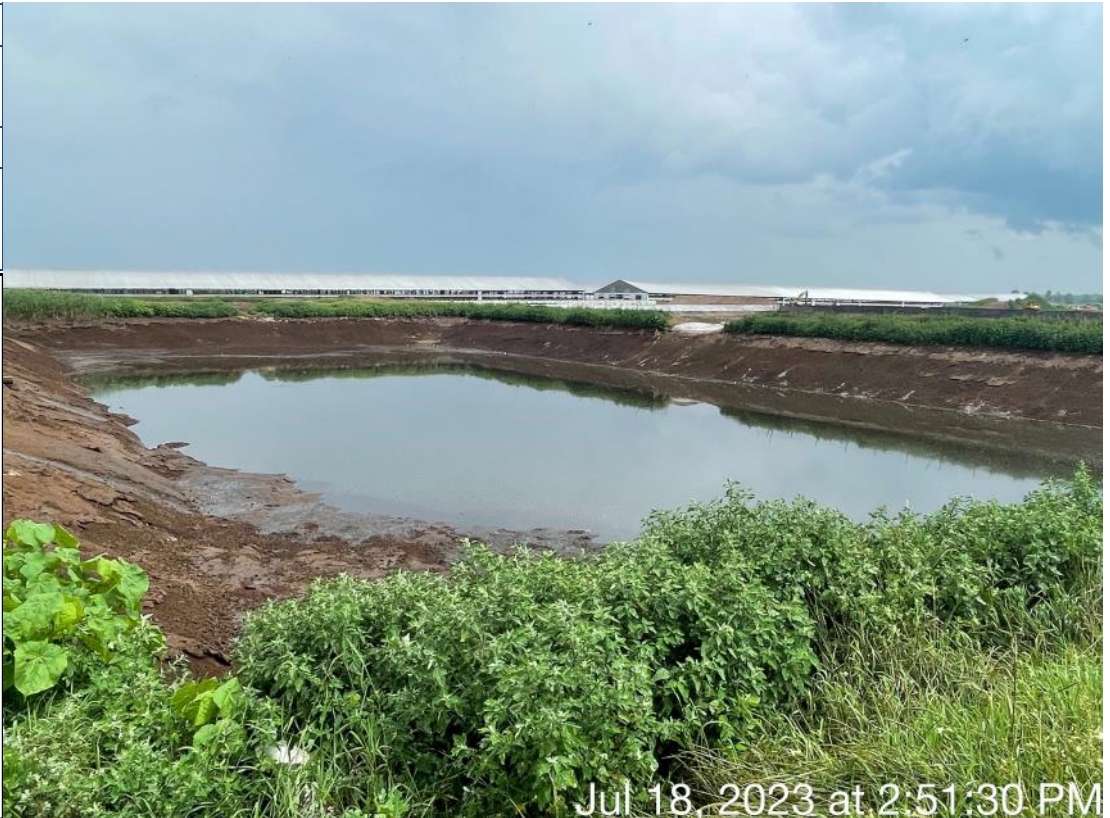
<b>Photo #:</b>	7460
<b>Date/Time of Photo:</b>	7/18/2023 14:51
<b>Photo By:</b>	Brian Hanson
<b>Photo Location:</b>	Main Dairy WSF #1

**Photo Description:**  
Standing at the northwest corner of WSF #1 looking southeast: View of WSF #1.

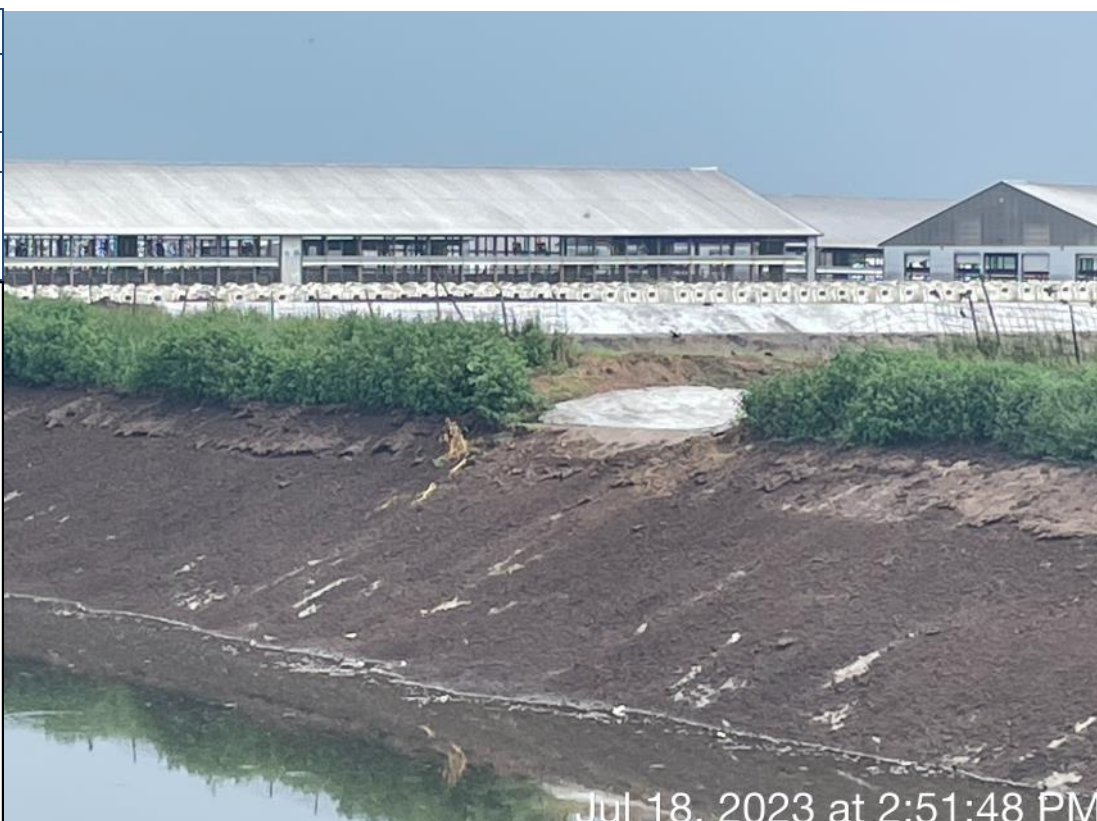
<b>Photo #:</b>	7462
<b>Date/Time of Photo:</b>	7/18/2023 14:51
<b>Photo By:</b>	Brian Hanson
<b>Photo Location:</b>	Main Dairy WSF #1
<b>Photo Description:</b>  Standing on the northwest corner of WSF #1 looking southeast: Zoomed in view of south edge of WSF #1. A new concrete overflow channel has been constructed to connect WSF #1 & WSF #3.

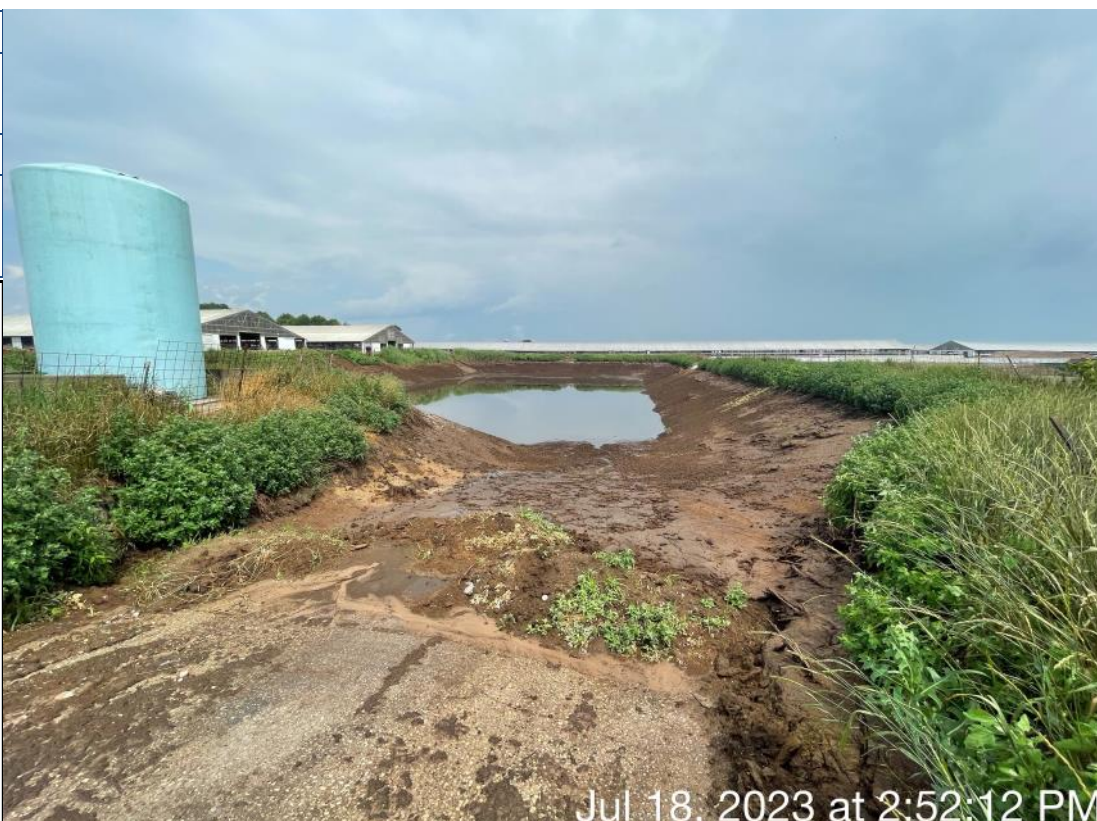
<b>Photo #:</b>	7465
<b>Date/Time of Photo:</b>	7/18/2023 14:52
<b>Photo By:</b>	Brian Hanson
<b>Photo Location:</b>	Main Dairy WSF #1
<b>Photo Description:</b>  Standing at southwest corner of WSF #1 looking east: View of concrete access ramp into WSF #1

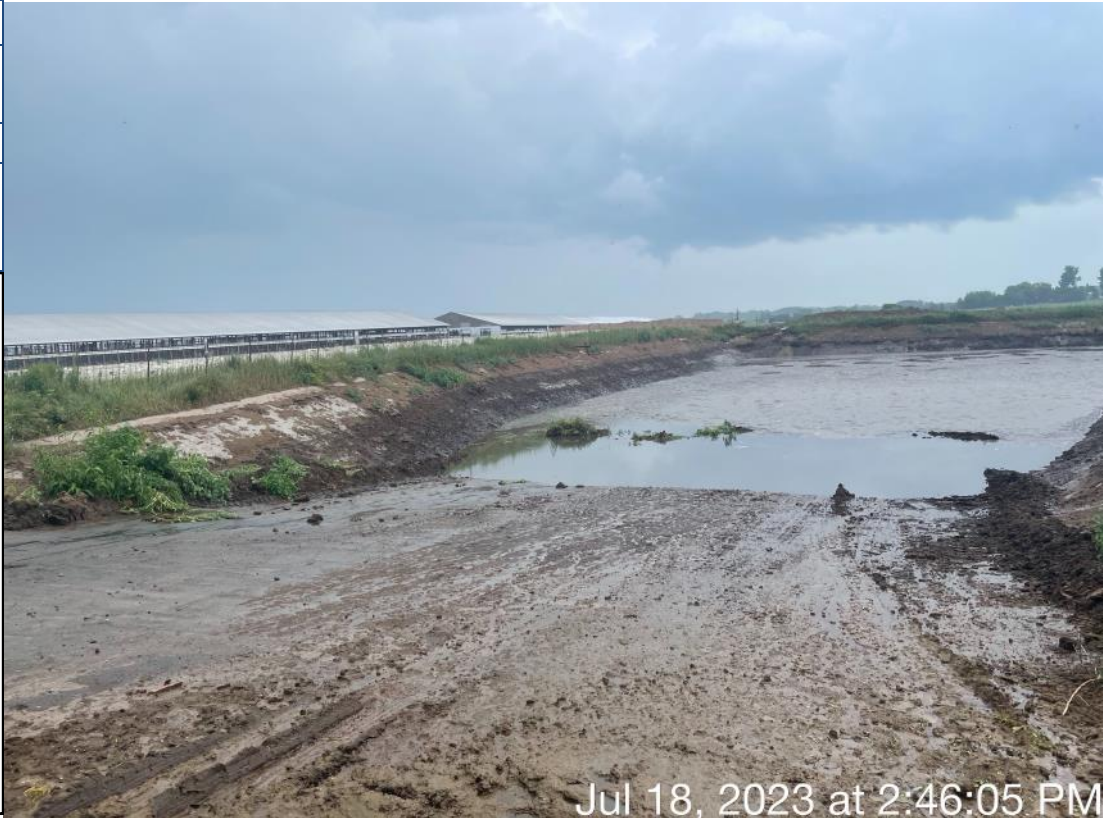
<b>Photo #:</b>	7436
<b>Date/Time of Photo:</b>	7/18/2023 14:46
<b>Photo By:</b>	Brian Hanson
<b>Photo Location:</b>	Main Dairy WSF #2

**Photo Description:**  
Standing on the northeast corner of WSF #2 looking south: View of access ramp located in northeast corner of WSF #2

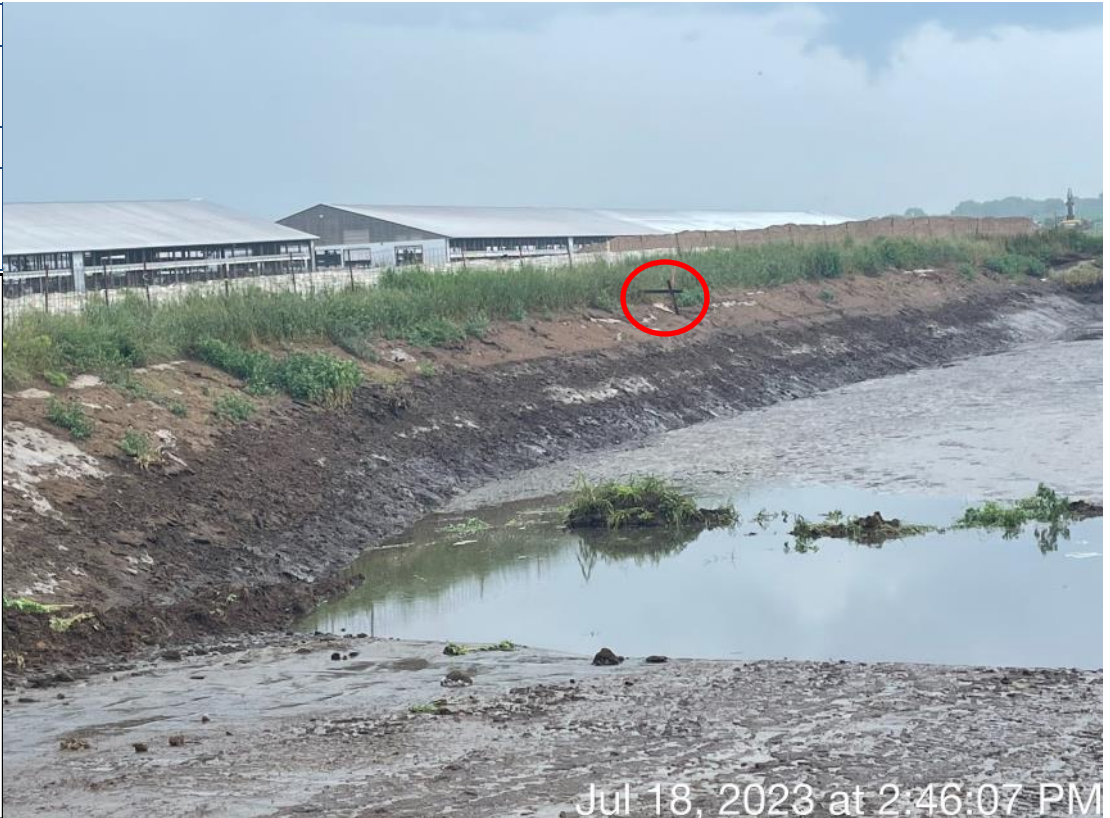
<b>Photo #:</b>	7437
<b>Date/Time of Photo:</b>	7/18/2023 14:46
<b>Photo By:</b>	Brian Hanson
<b>Photo Location:</b>	Main Dairy WSF #2

**Photo Description:**  
Standing at the northeast corner of WSF #2 looking southeast: View of permanent marker on east side of WSF #2.

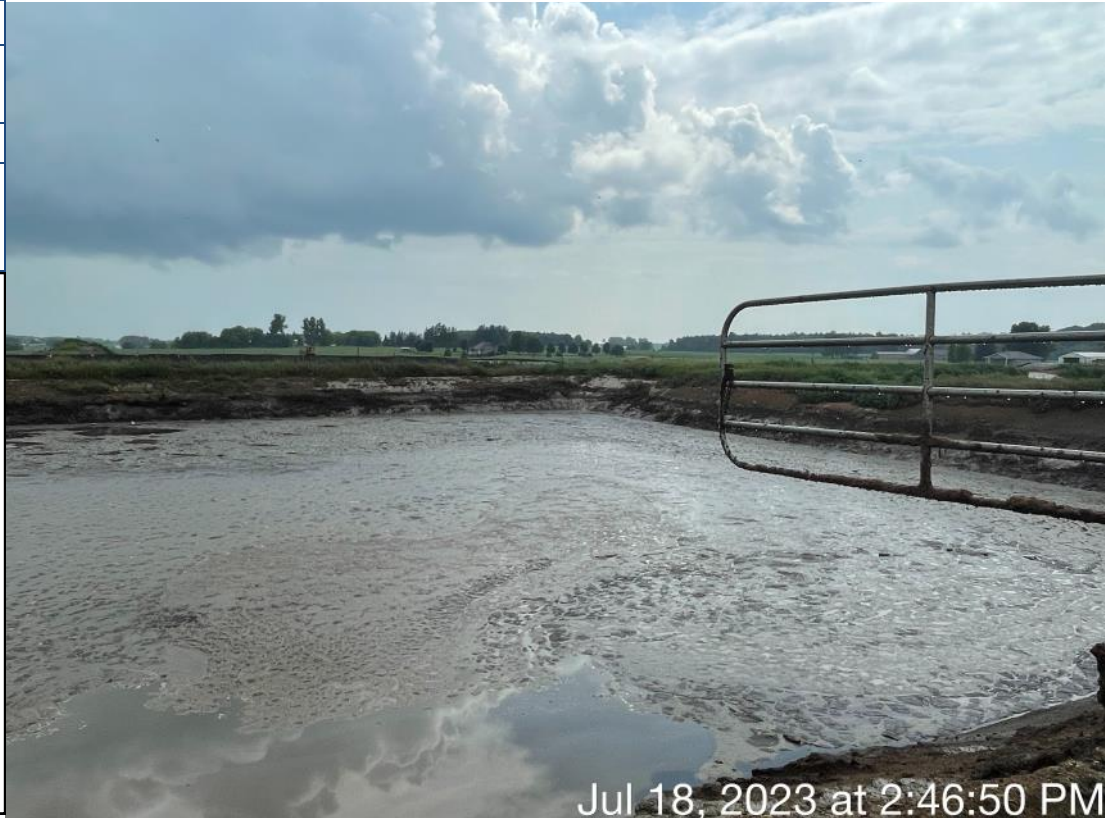
<b>Photo #:</b>	7444
<b>Date/Time of Photo:</b>	7/18/2023 14:46
<b>Photo By:</b>	Brian Hanson
<b>Photo Location:</b>	Main Dairy WSF #2

**Photo Description:**  
Standing on the north side of WSF #2 looking south: View of western 1/2 of WSF #2.

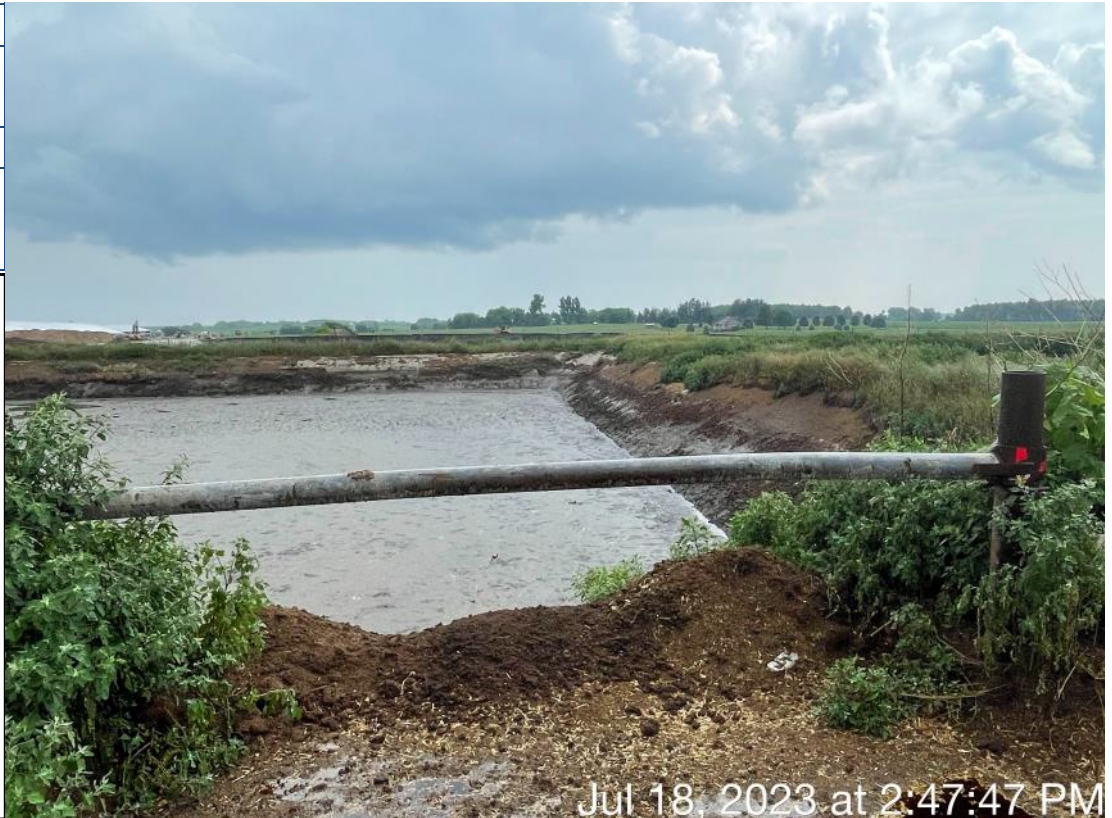
<b>Photo #:</b>	7446
<b>Date/Time of Photo:</b>	7/18/2023 14:47
<b>Photo By:</b>	Brian Hanson
<b>Photo Location:</b>	Main Dairy WSF #2

**Photo Description:**  
Standing at the northwest corner of WSF #2 looking south: View of the west edge of WSF #2.

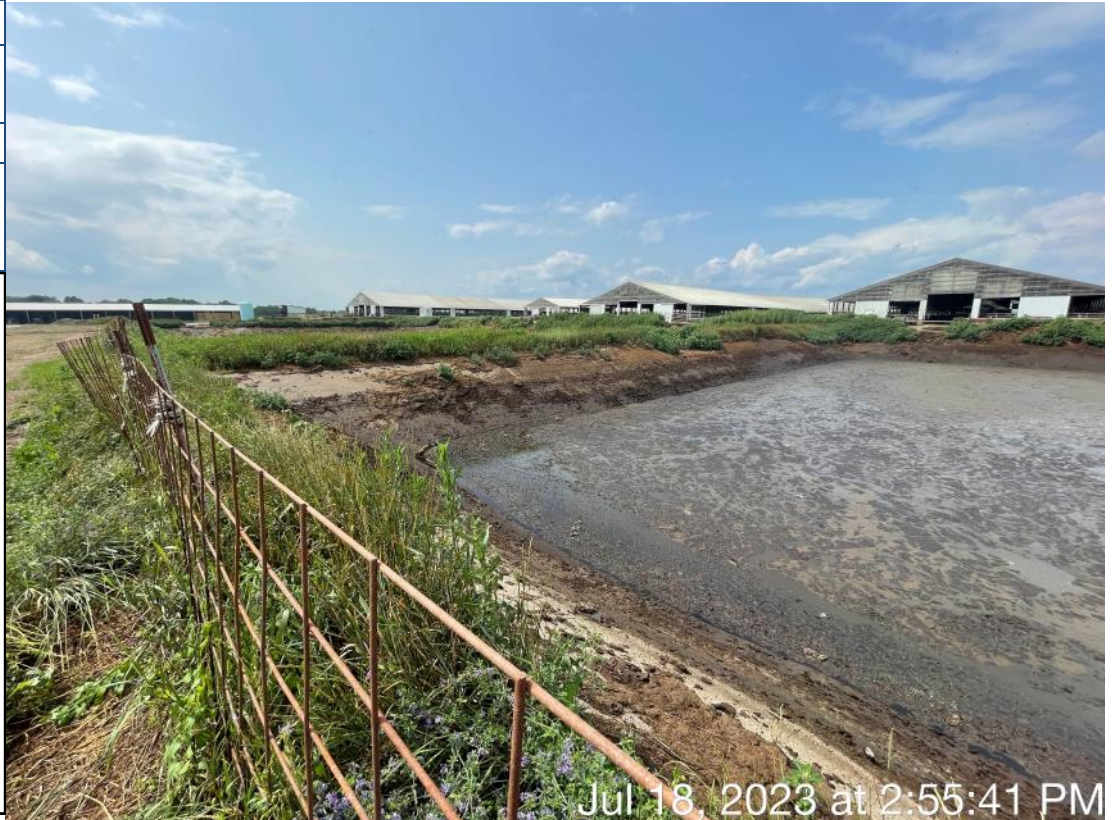
<b>Photo #:</b>	7486
<b>Date/Time of Photo:</b>	7/18/2023 14:55
<b>Photo By:</b>	Brian Hanson
<b>Photo Location:</b>	Main Dairy WSF #2

**Photo Description:**  
Standing on the south side of WSF #2 looking northwest: View of southwest corner of WSF #2

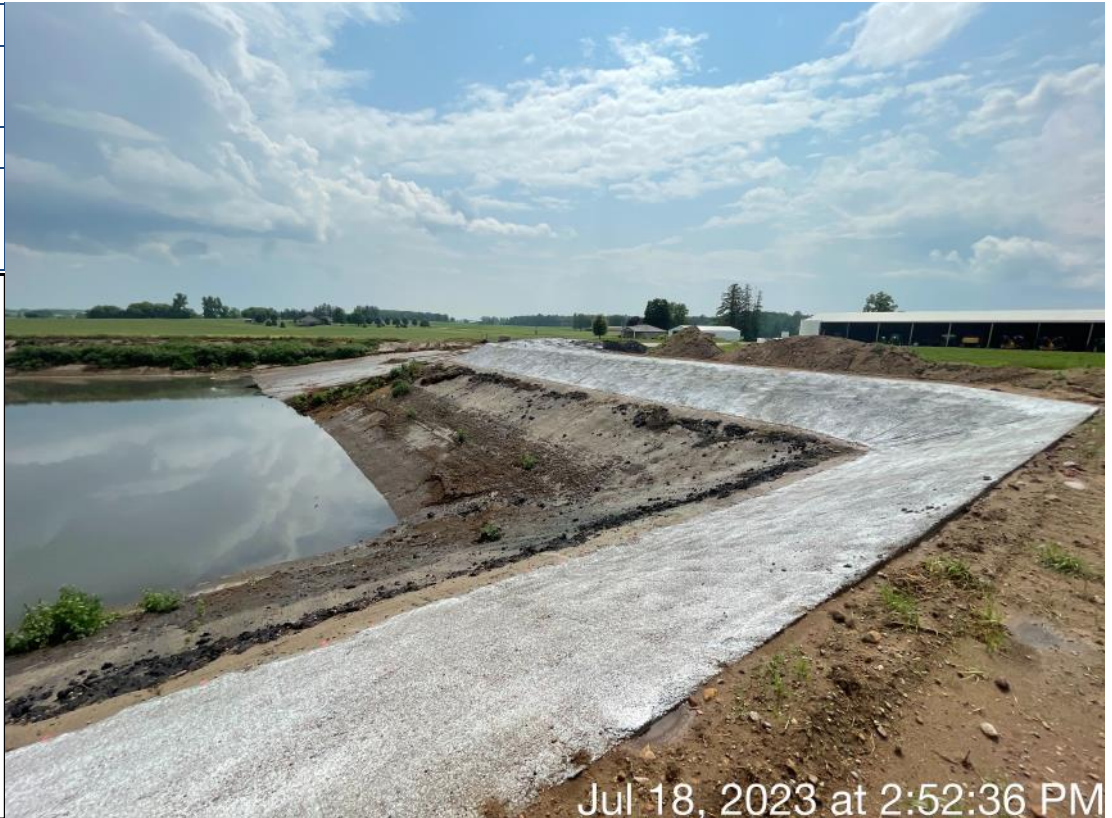
<b>Photo #:</b>	7466
<b>Date/Time of Photo:</b>	7/18/2023 14:52
<b>Photo By:</b>	Brian Hanson
<b>Photo Location:</b>	Main Dairy WSF #3

**Photo Description:**  
Standing at the northwest corner of WSF #3 looking southwest: View of northwest corner of WSF #3. Notice new concrete placed as part of ongoing expansion project.

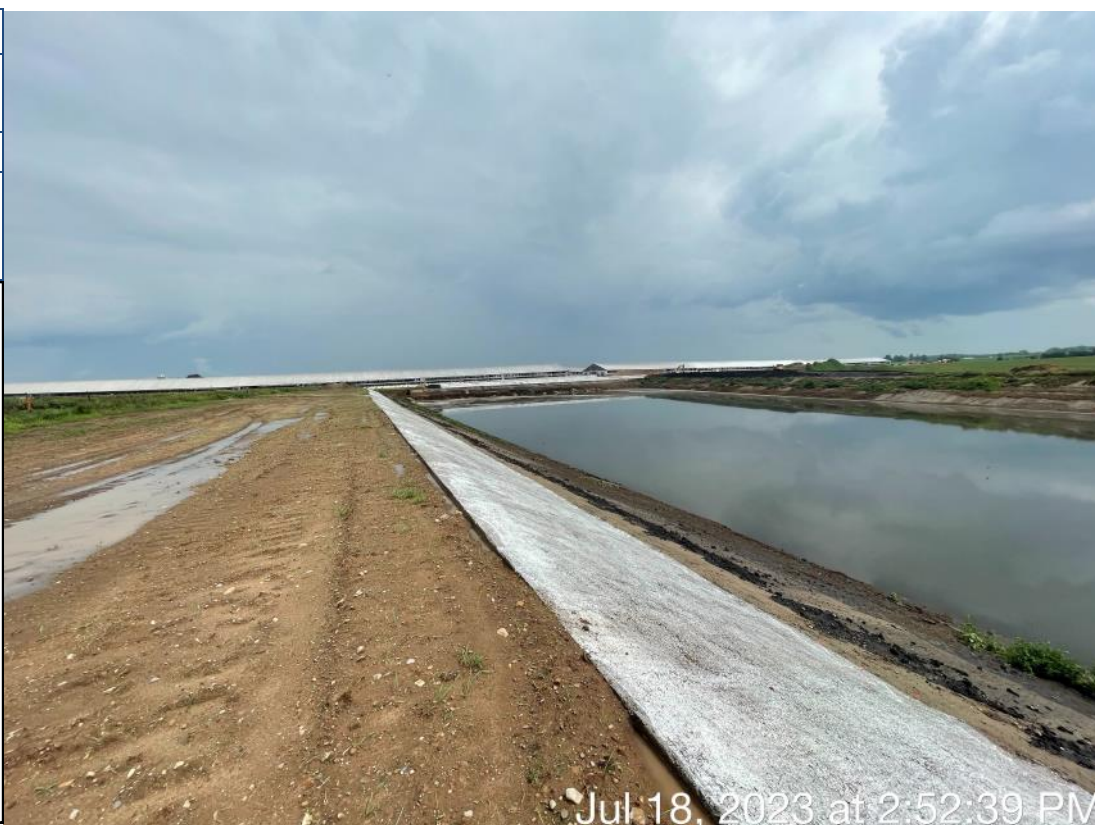
<b>Photo #:</b>	7468
<b>Date/Time of Photo:</b>	7/18/2023 14:52
<b>Photo By:</b>	Brian Hanson
<b>Photo Location:</b>	Main Dairy WSF #3

**Photo Description:**  
Standing on the north side of WSF #3 looking east: View of north edge of WSF #3.

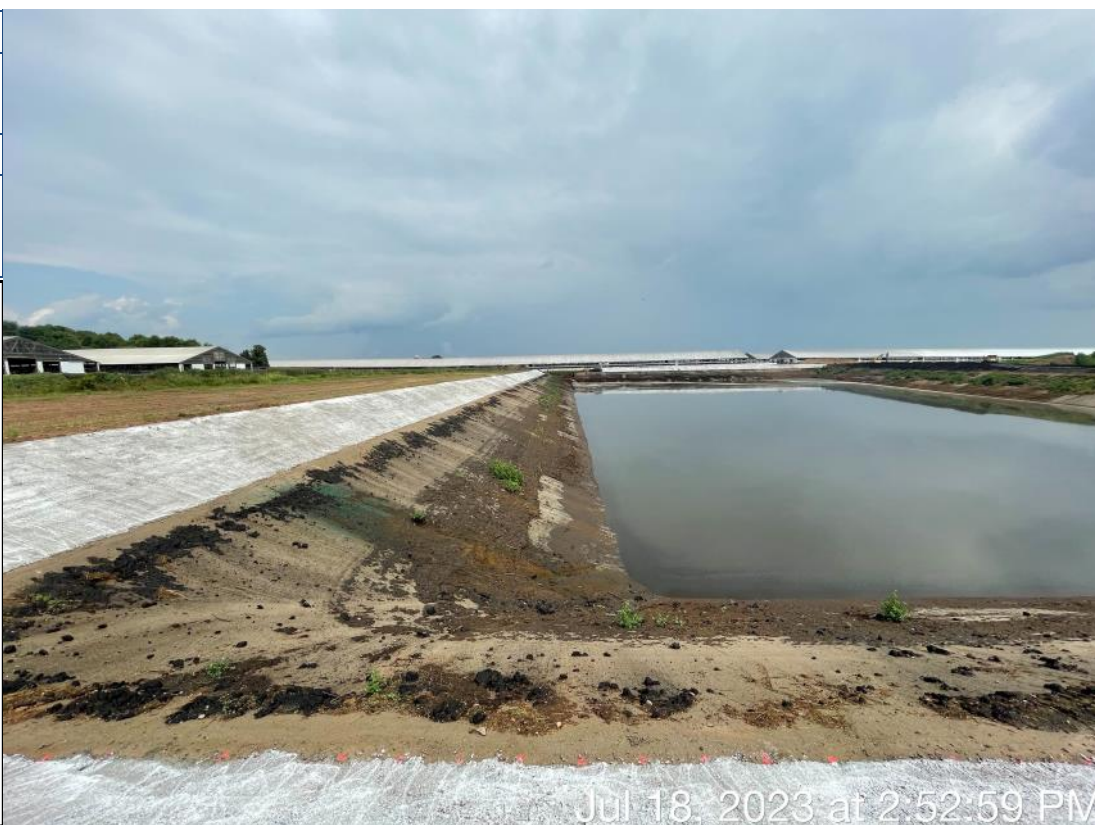
**Photo Description:**  
Standing on west side of WSF #3 looking east: View of northwest corner of WSF #3. Notice new concrete placed as part of ongoing expansion project.
