# Permit Fact Sheet

Permit Number:	WI-0061794-05-0
Permittee Name:	B&D Dairy Farm LLC
Address:	4304 N 5th Road
City/State/Zip:	Pound WI 54161
Discharge Location:	<b>Main Farm</b> – W7251 E. 6 <sup>th</sup> Rd. Pound, WI 54161 ; SW ¼ of SW ¼ Section 36 T31N R20E <b>Heifer Facility</b> – W7276 E. 6 <sup>th</sup> Rd., Pound, WI 54161 ; Section 25 T31N R20E <b>Little River Site</b> – 7651 Hillcrest Road, Oconto, WI 54153 NE ¼ of NE ¼ Section 34 T29N R21E & 3267 County Road A, Oconto, WI 54153 NW ¼ of NW ¼ Section 35 T29N R21E
Receiving Water:	Surface Waters of the Little Peshtigo River, Lower Peshtigo River, Little River, and Middle Peshtigo River Watersheds. Lake Michigan Basin, & groundwaters of the state.
Discharge Type:	Existing

On Tuesday July 18, 2023 Hanson & Brenny met with Lepianka, Lepianka, Coady, Paulson & Hodkiewicz at 13:00 at B&D Dairy Farm LLC site to conduct a permit reissuance walkover inspection. All 3 sites in the permit were inspected. A heavy downpour occurred at the beginning of the inspection but for the remainder of the inspection temperatures were in the 80's and cloudy. No permit violations were observed, and no water samples were collected. Hanson & Brenny

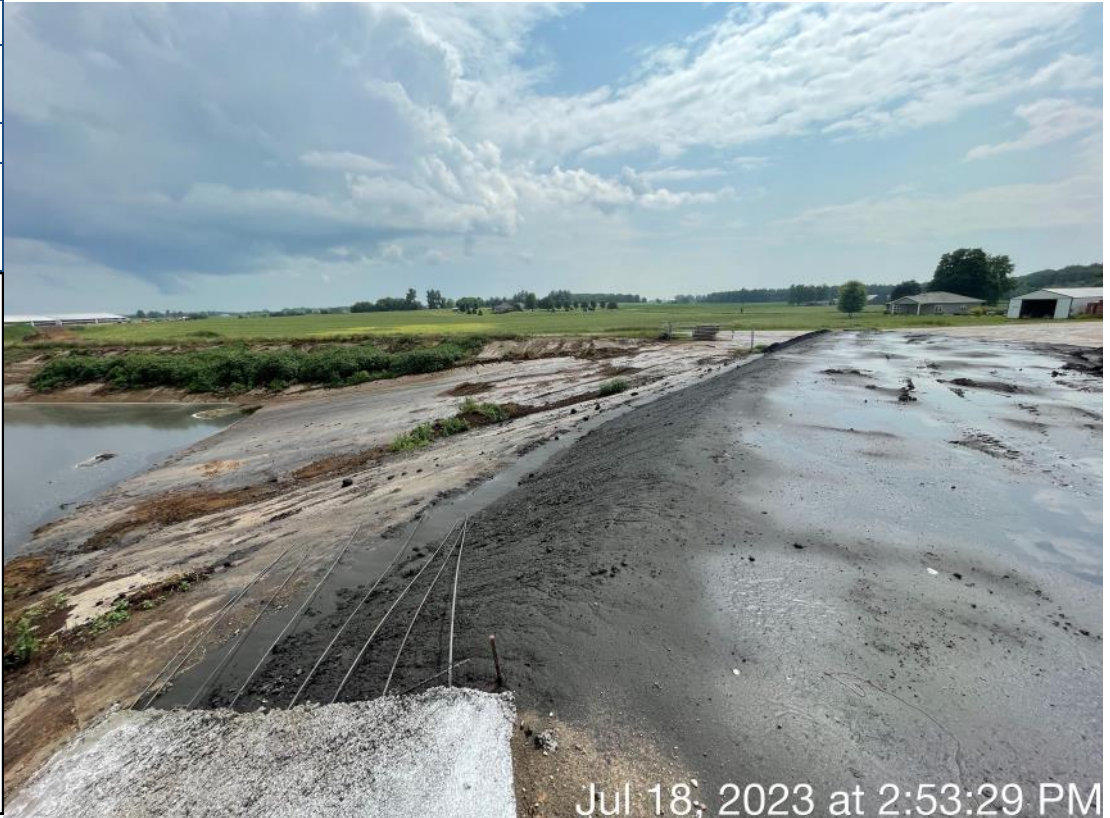
**Photo Description:**  
Standing on the west side of WSF #3 looking south: View of west edge of WSF #3. Notice edge of new concrete with rebar protruding and foundry sand being used as sub liner. Construction ongoing in this corner of WSF.

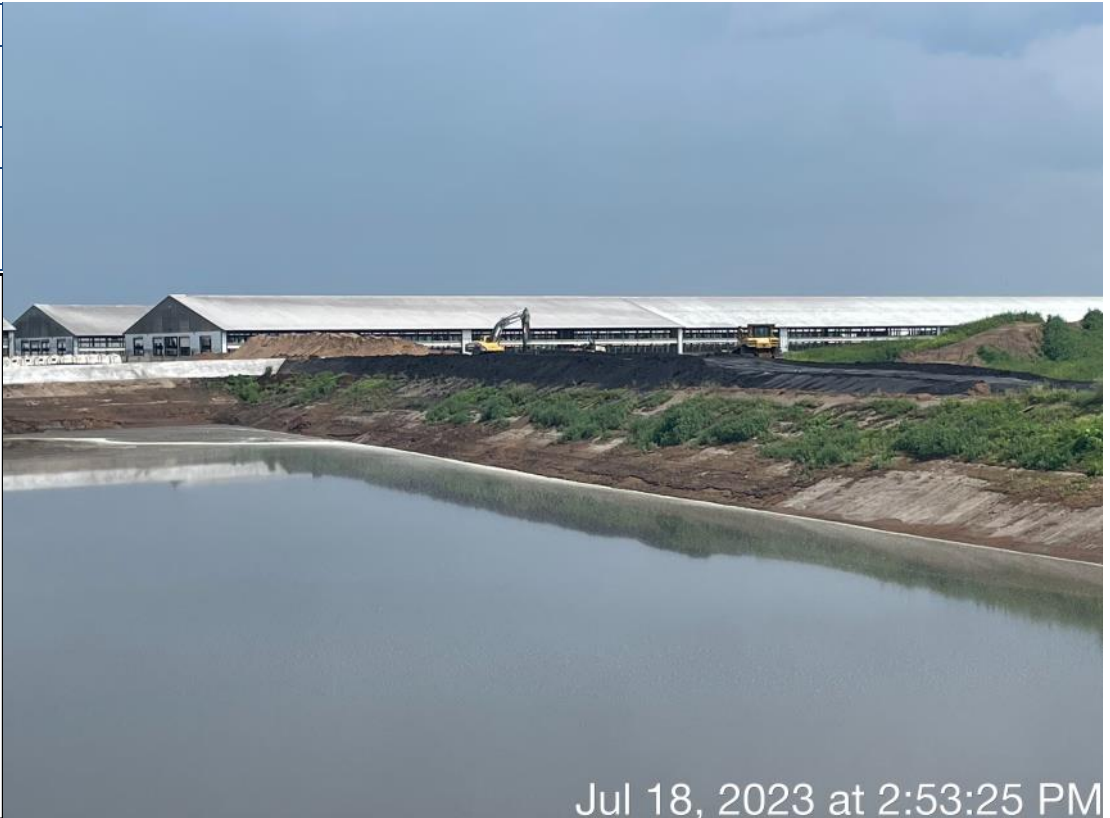
**Photo Description:**  
Standing on west side of WSF #3 looking southeast: View of southern berm of WSF #3. Notice construction of WSF expansion is underway. Foundry sand is being place as a sub liner below the concrete.

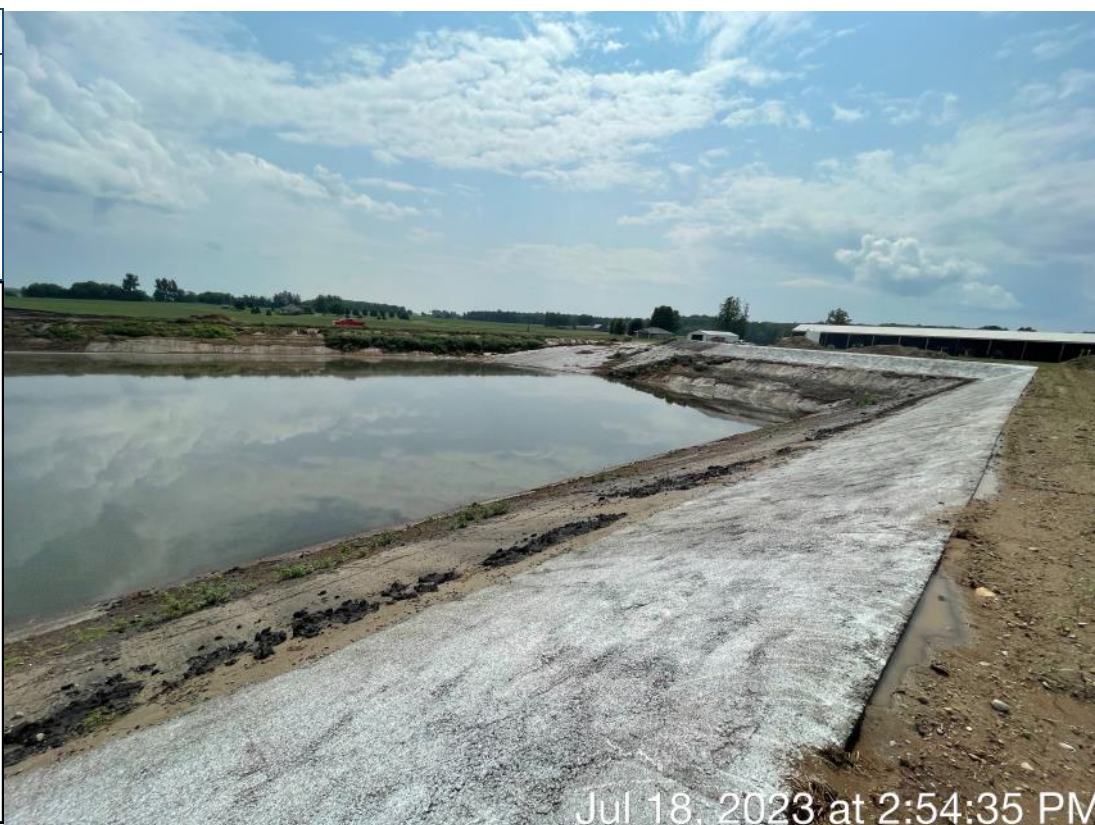
**Photo Description:**  
Standing on the north side of WSF #3 Looking west: View of northwest corner of WSF #3

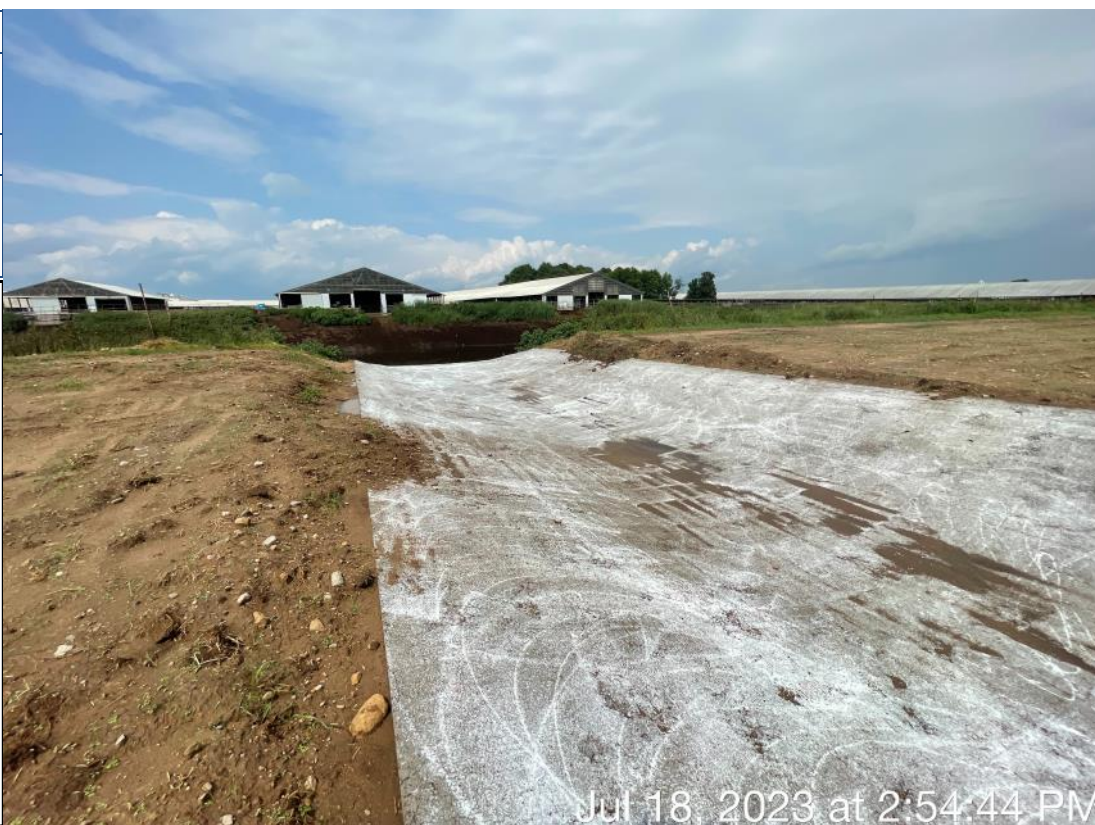
**Photo Description:**  
Standing on the north side of WSF #3 looking north: View of newly constructed concrete overflow channel connected WSF #1 to WSF #3.

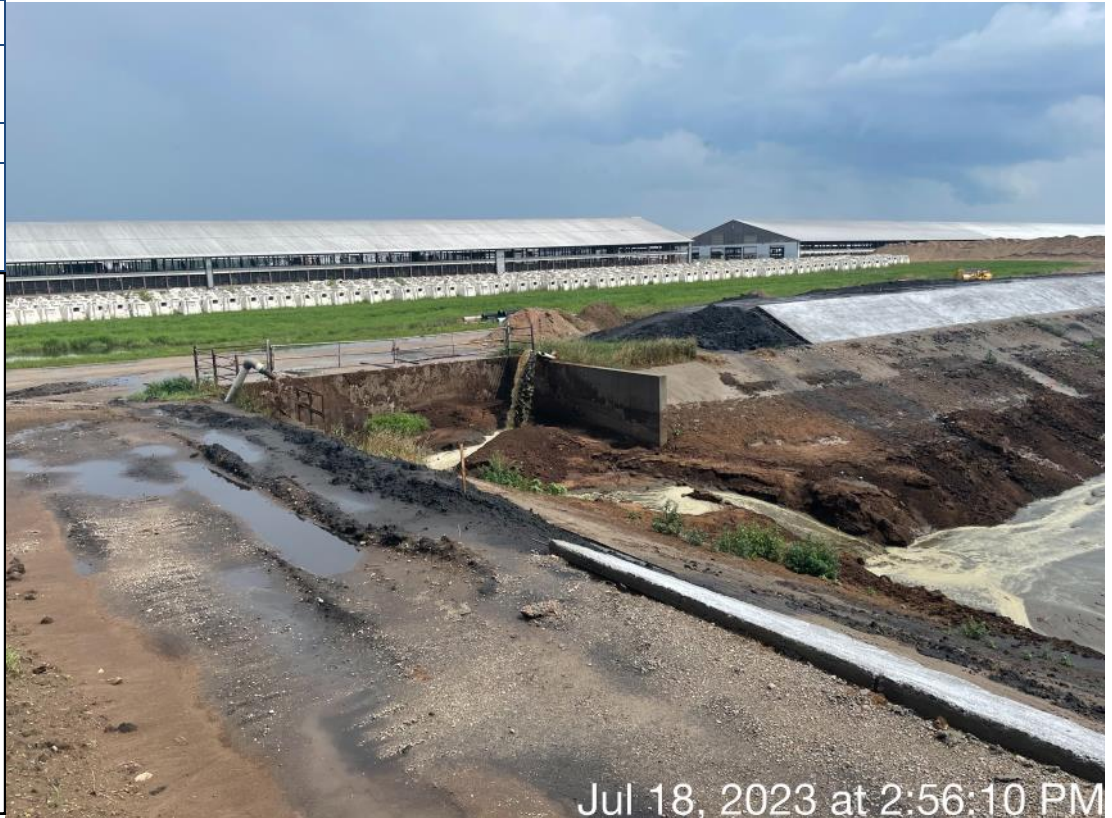
<b>Photo #:</b>	7494
<b>Date/Time of Photo:</b>	7/18/2023 14:56
<b>Photo By:</b>	Brian Hanson
<b>Photo Location:</b>	Main Dairy WSF #3
<b>Photo Description:</b>	
<p>Standing at the northeast corner of WSF #3 looking southeast: View of northeast corner of WSF #3 that has vertical concrete wall. Notice WSF expansion not yet completed in this corner.</p>

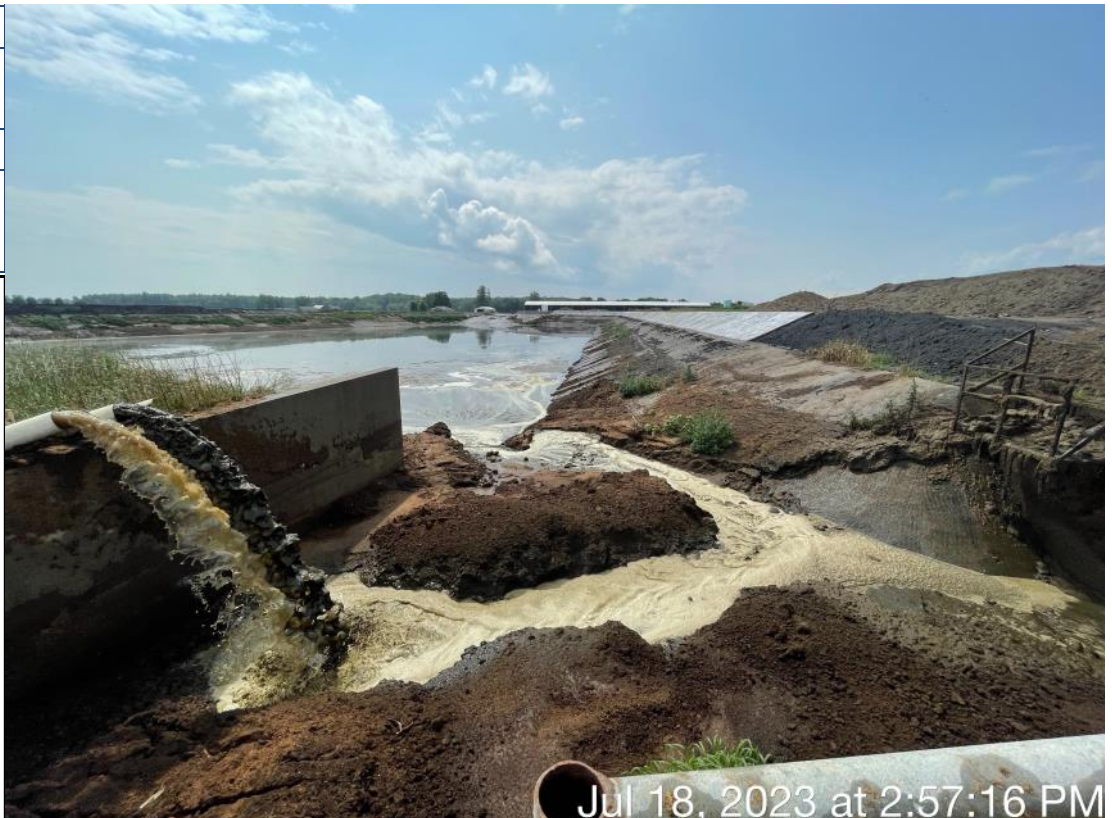
<b>Photo #:</b>	7504
<b>Date/Time of Photo:</b>	7/18/2023 14:57
<b>Photo By:</b>	Brian Hanson
<b>Photo Location:</b>	Main Dairy WSF #3
<b>Photo Description:</b>	
<p>Standing on the east side of WSF #3 looking west: View of northeast corner of WSF #3. Notice outlet pipes on left side of photo. One pipe is discharge of Feed Storage Area runoff controls &amp; the other is from the east freestall barns.</p>

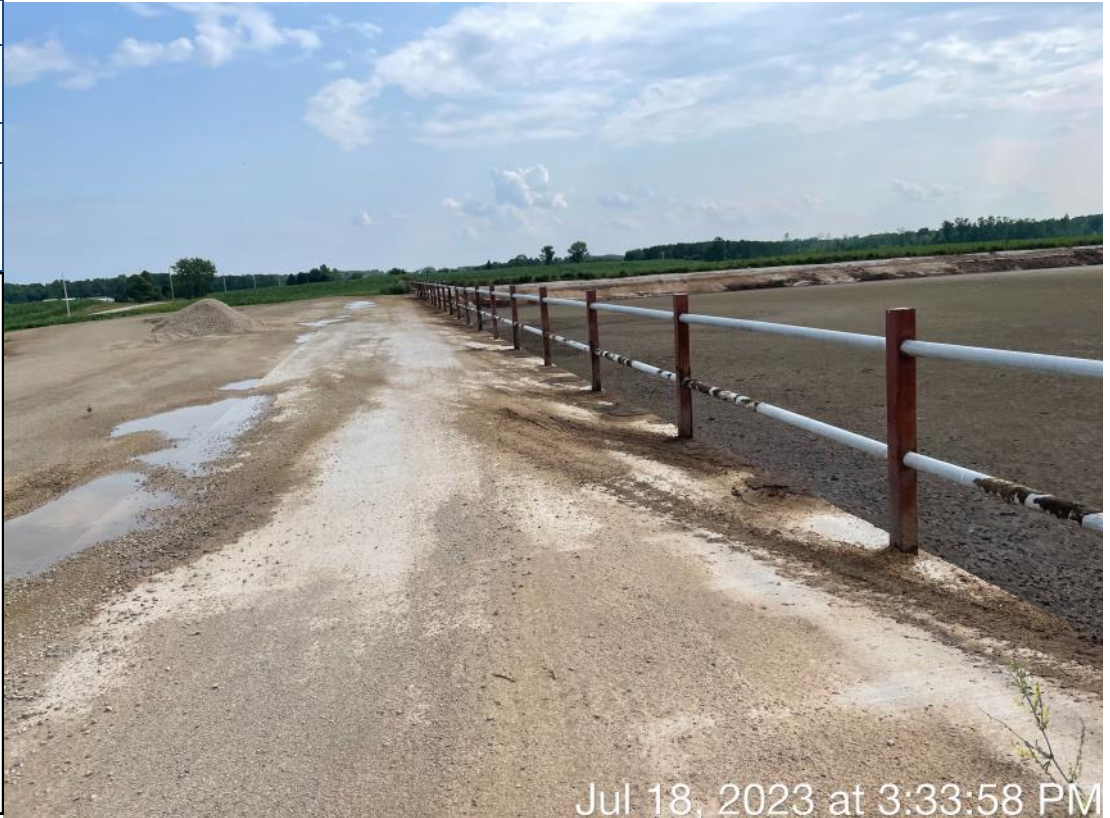
<b>Photo #:</b>	7526
<b>Date/Time of Photo:</b>	7/18/2023 15:33
<b>Photo By:</b>	Brian Hanson
<b>Photo Location:</b>	Little River Pit WSF # 4

**Photo Description:**  
Standing on the east side of WSF #4 looking south: View of the east edge of WSF #4 near the truck unloading area.

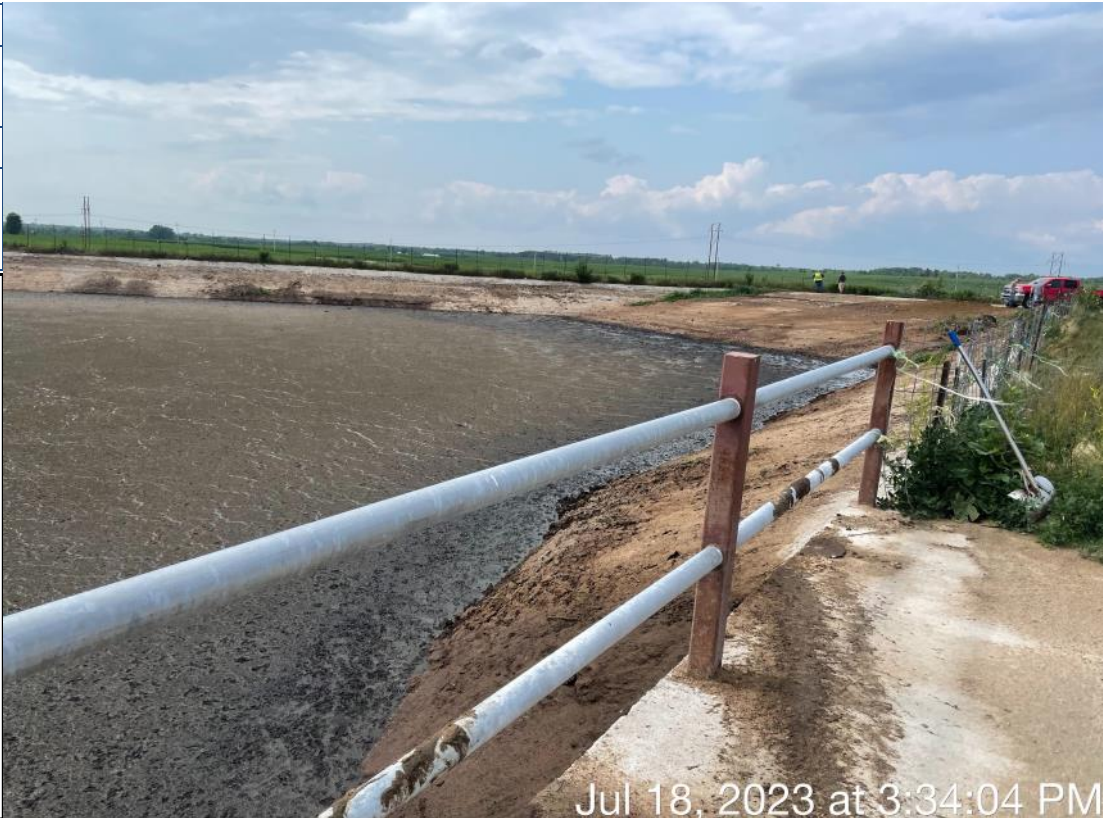
**Photo Description:**  
Standing on the east side of WSF #4 looking northwest: View of the northeast corner of WSF #4.

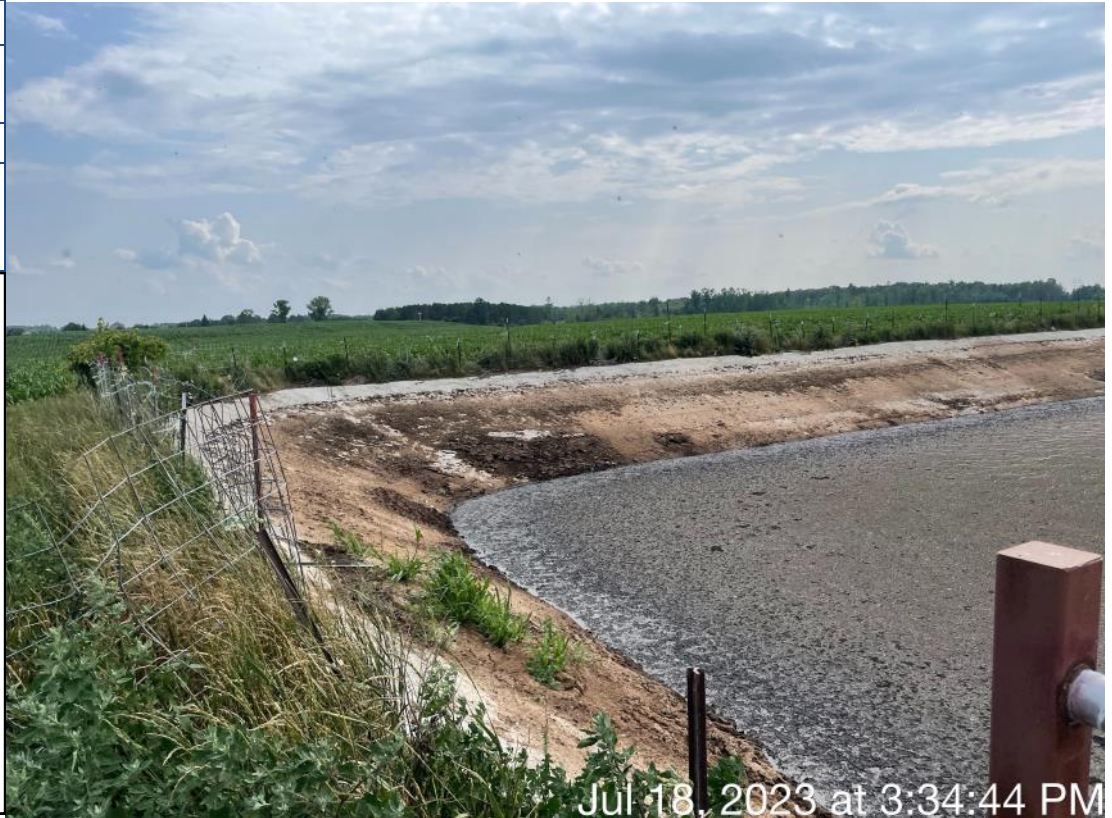
**Photo Description:**  
Standing on the east side of WSF #4 looking southwest: View of southeast corner of WSF #4.

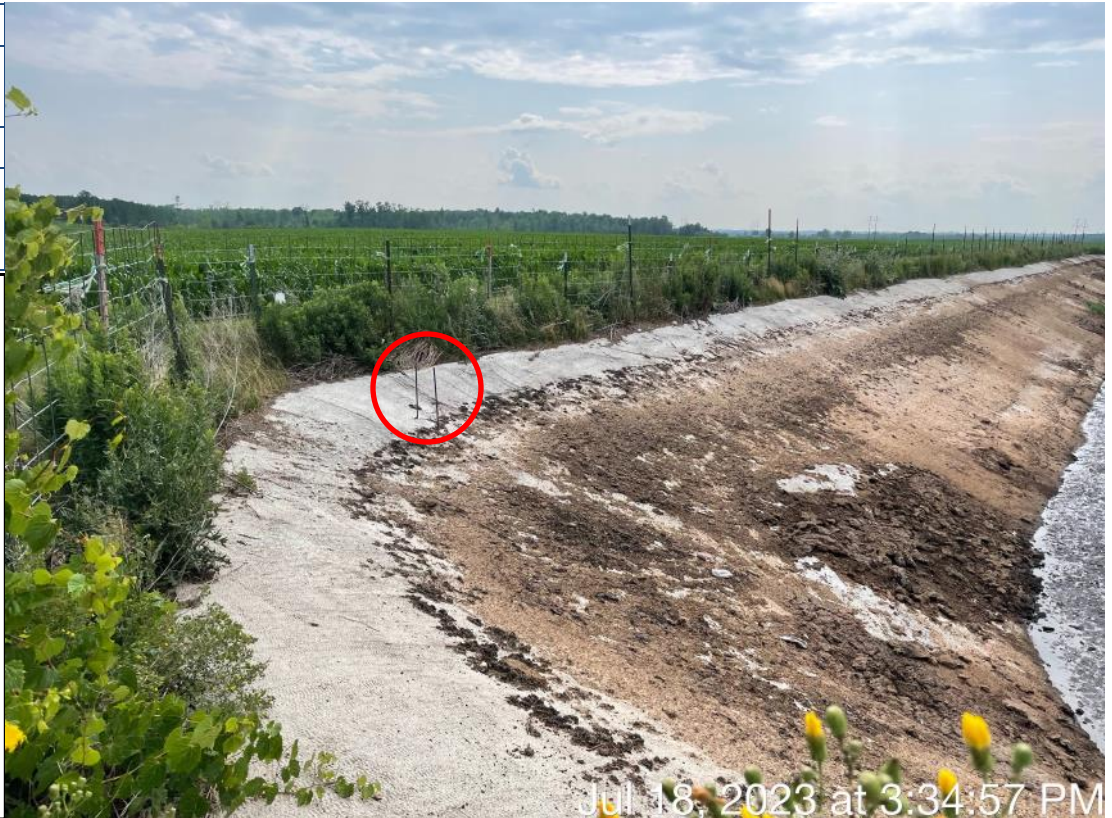
**Photo Description:**  
Standing at the southeast corner of WSF #4 looking southwest: View of permanent markers in southeast corner of WSF #4.

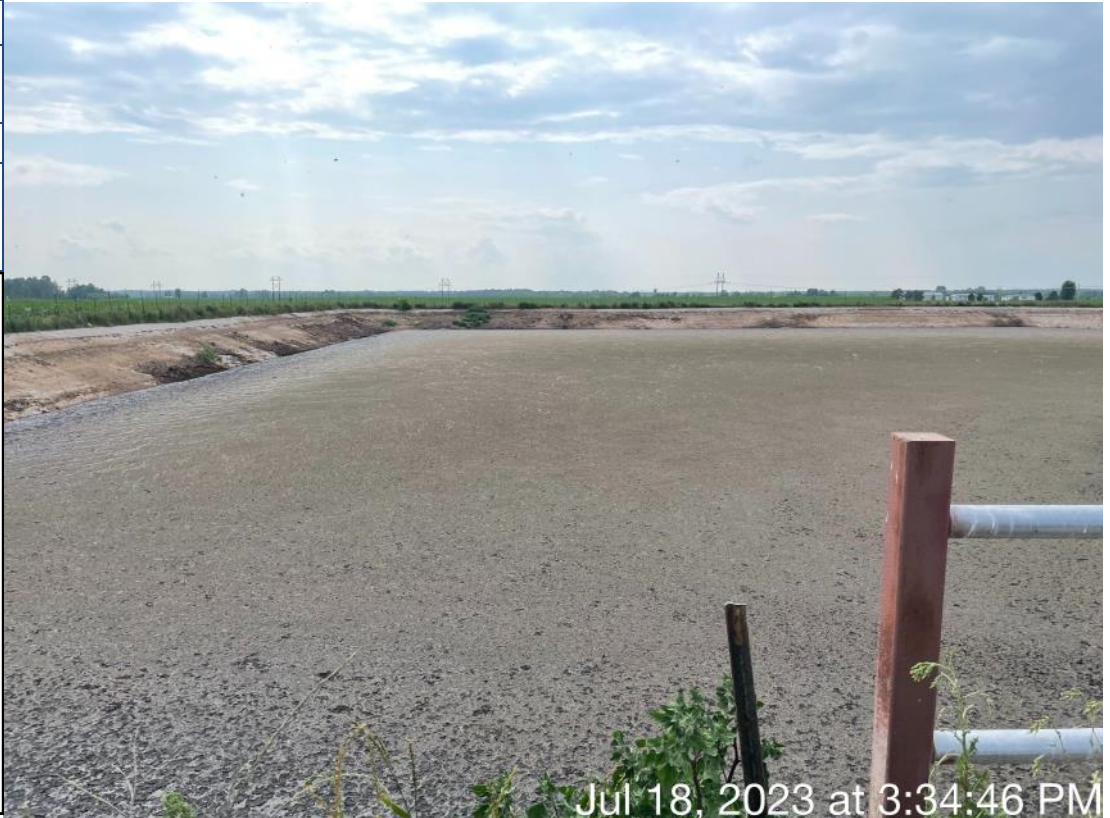
**Photo Description:**  
Standing on the east side of WSF #4 looking west: View of the south 1/2 of WSF #4.

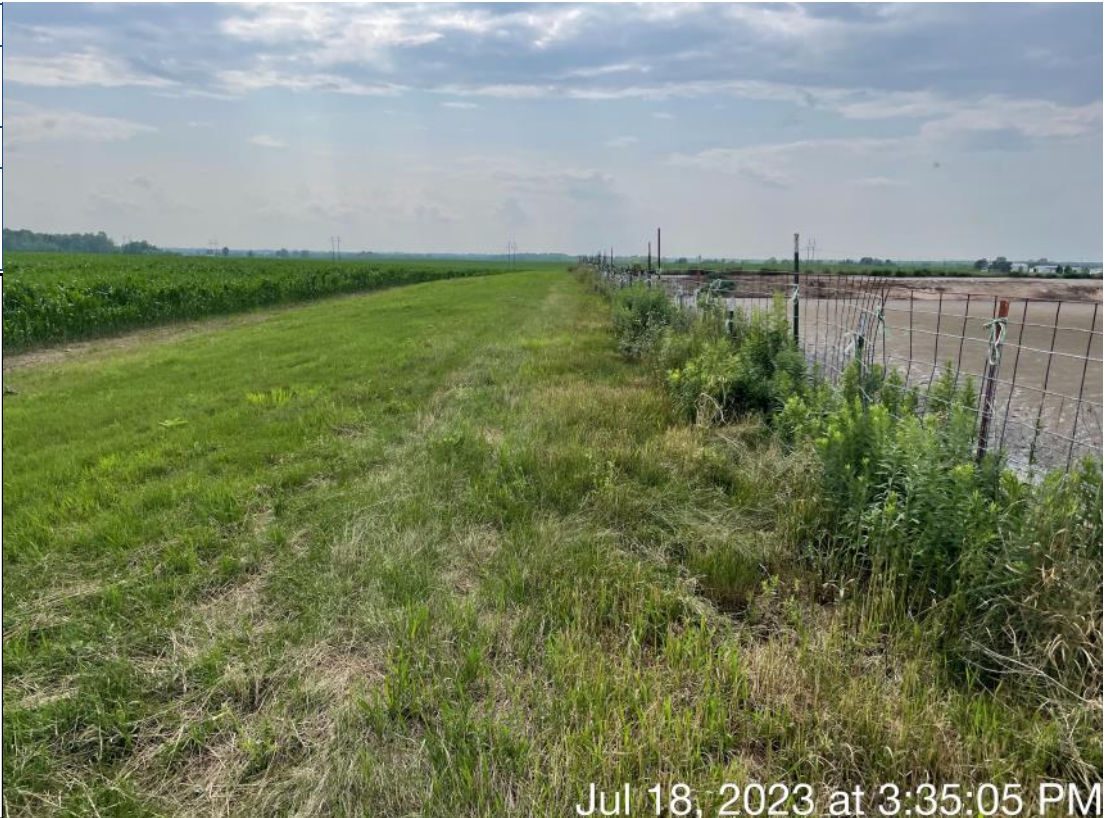
**Photo Description:**  
Standing on the south side of WSF #4 looking west: View of south berm of WSF #4.

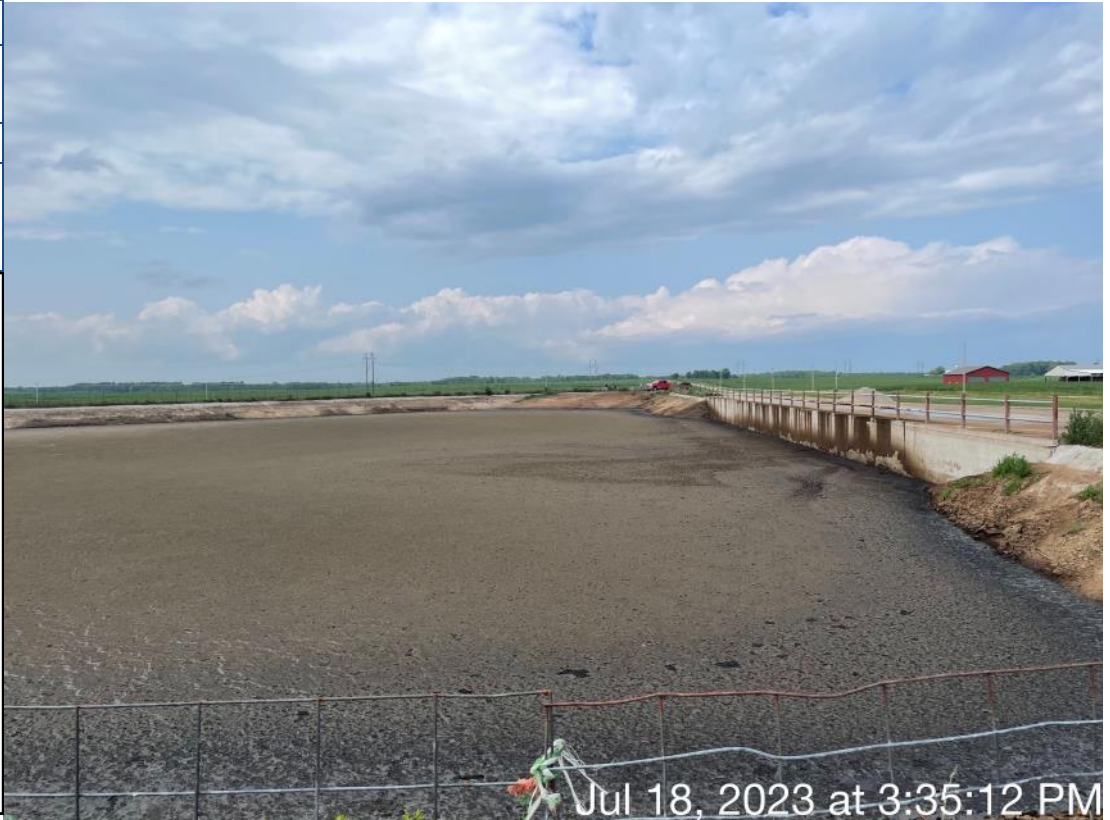
**Photo Description:**  
Standing on the south side of WSF #4 looking north: View of east 1/2 of WSF #4.

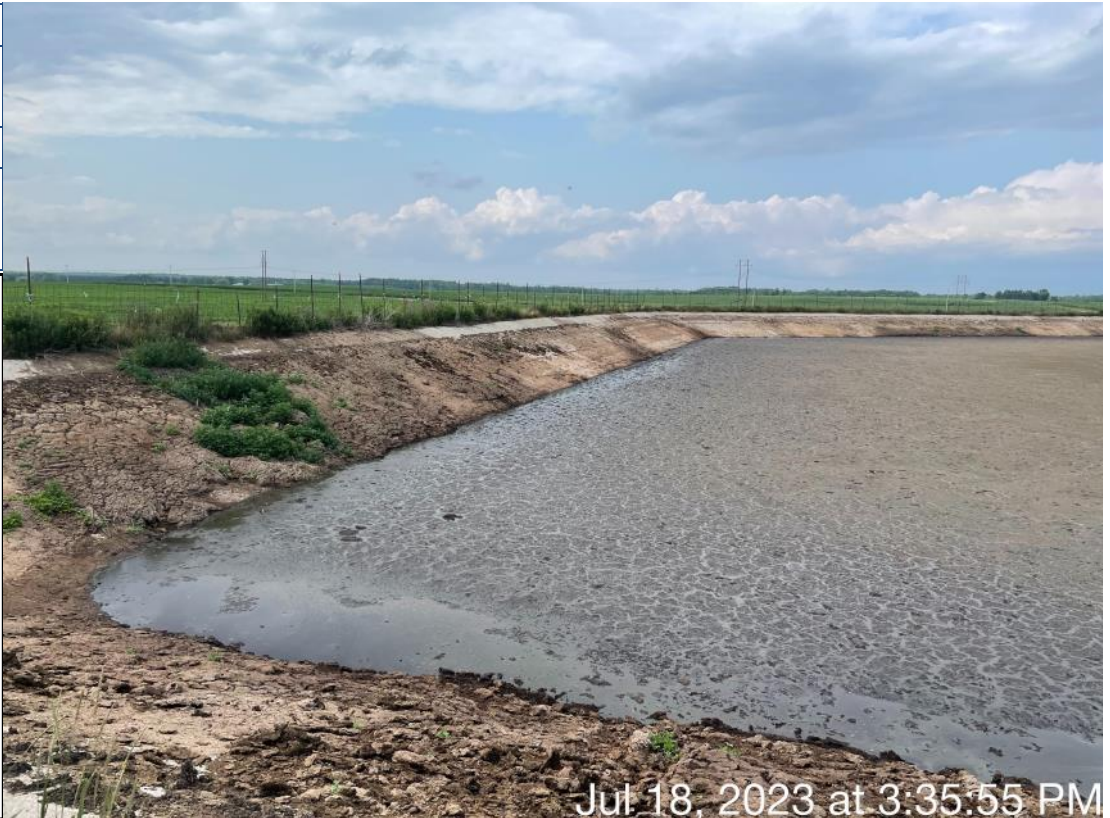
**Photo Description:**  
Standing on the south side of WSF #4 looking north: View of the western edge of WSF #4.

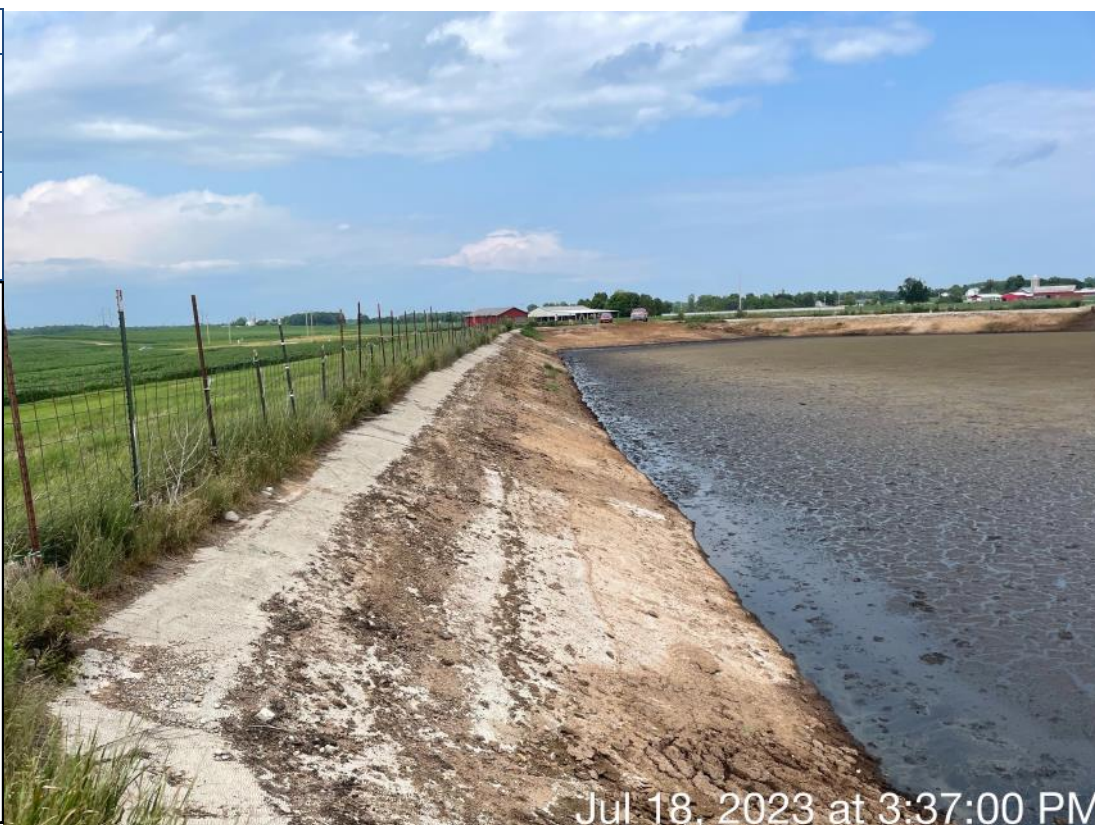
**Photo Description:**  
Standing on the west side of WSF #4 looking northeast: View of northwest edge of WSF #4.

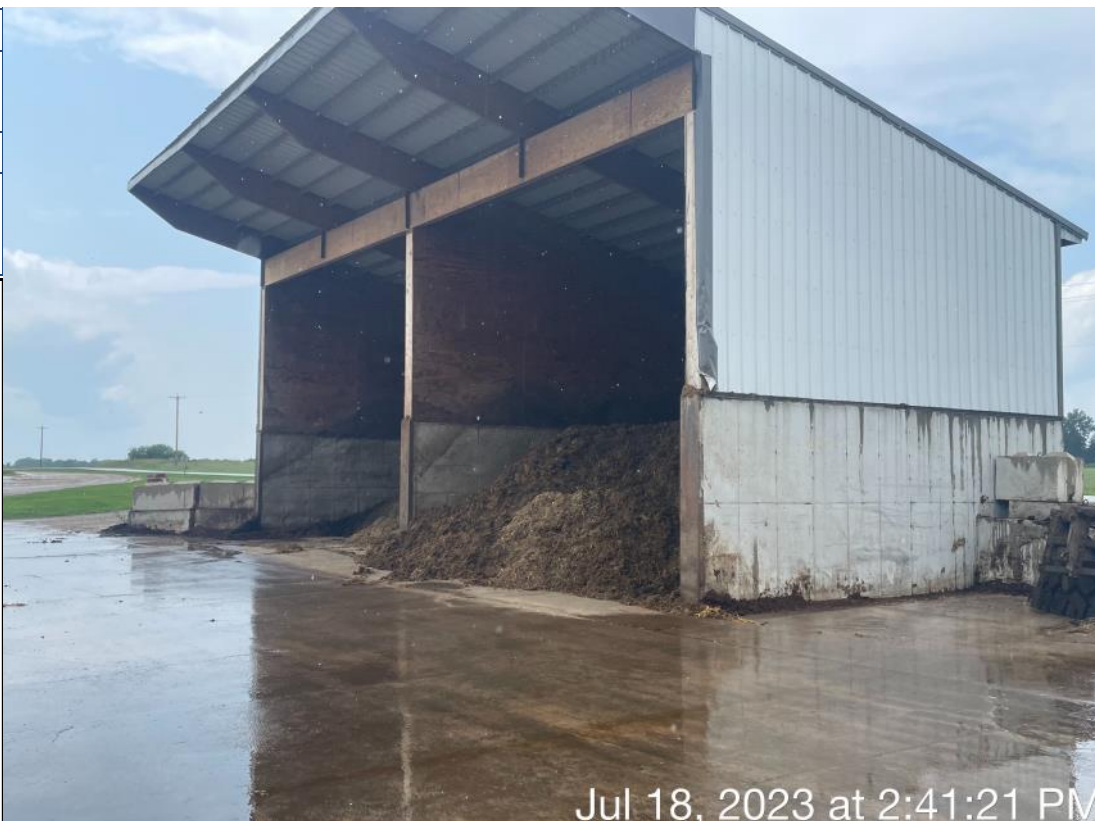
**Photo Description:**  
Standing on the west side of the calf barns looking northwest: View of roofed solid stacking area on the west side of calf barns.

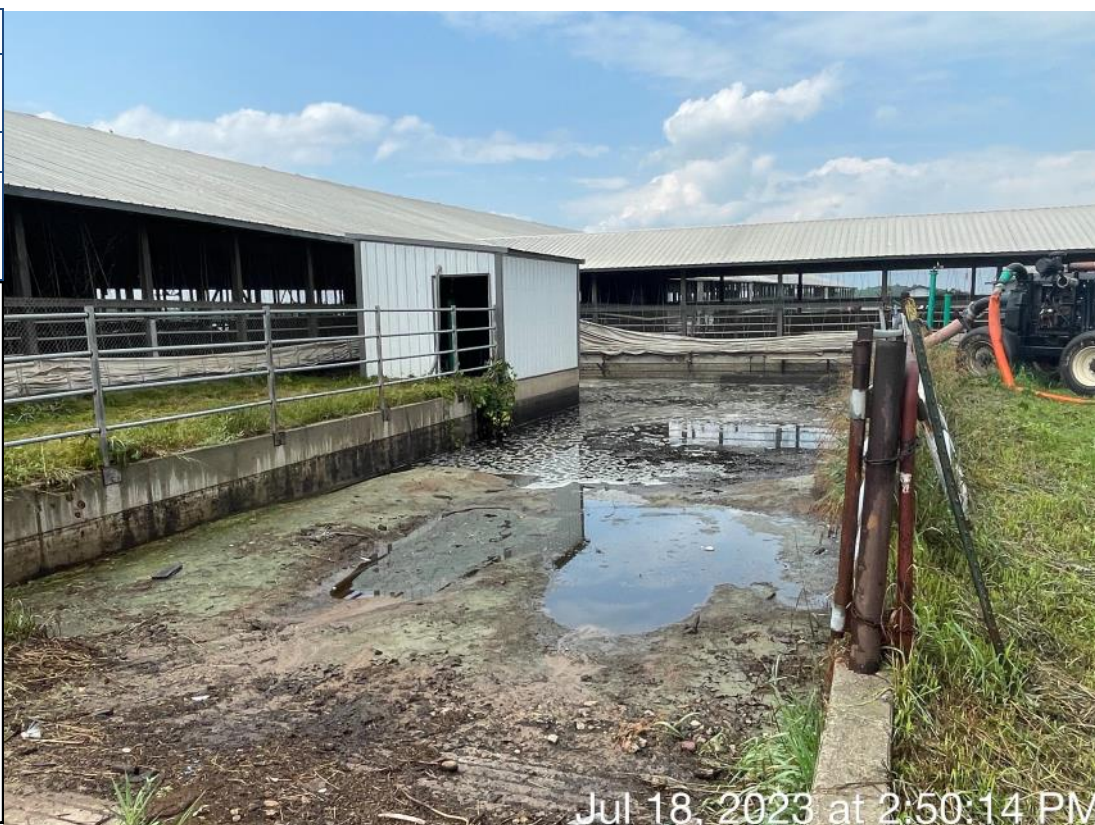
**Photo Description:**  
Standing north of WSF #1 near freestall barn looking northwest: View of manure reception structure located on east side of building. Manure is pumped to WSF #1 from this structure.

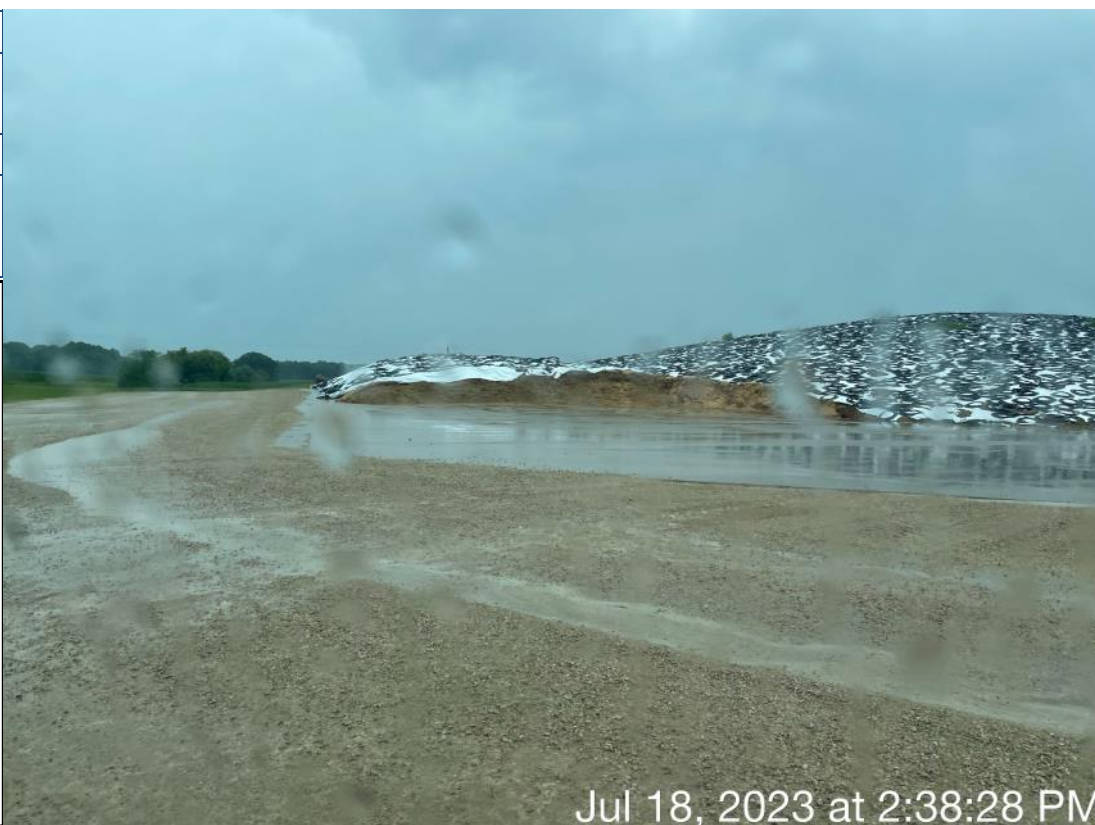
**Photo Description:**  
Standing on the north side of FSA looking east: View of the northern edge of FSA.

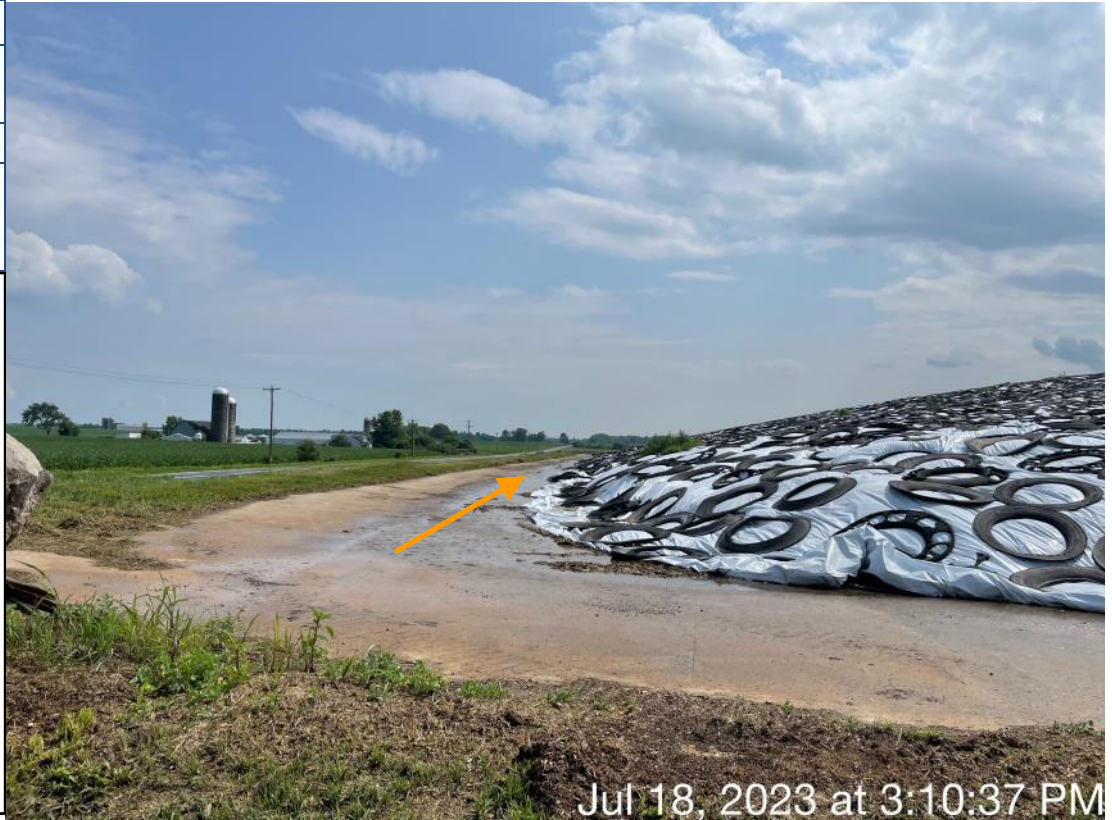
<b>Photo #:</b>	7520
<b>Date/Time of Photo:</b>	7/18/2023 15:10
<b>Photo By:</b>	Brian Hanson
<b>Photo Location:</b>	Main Dairy Feed Storage

Standing on north side of FSA looking west: View of north edge of FSA.

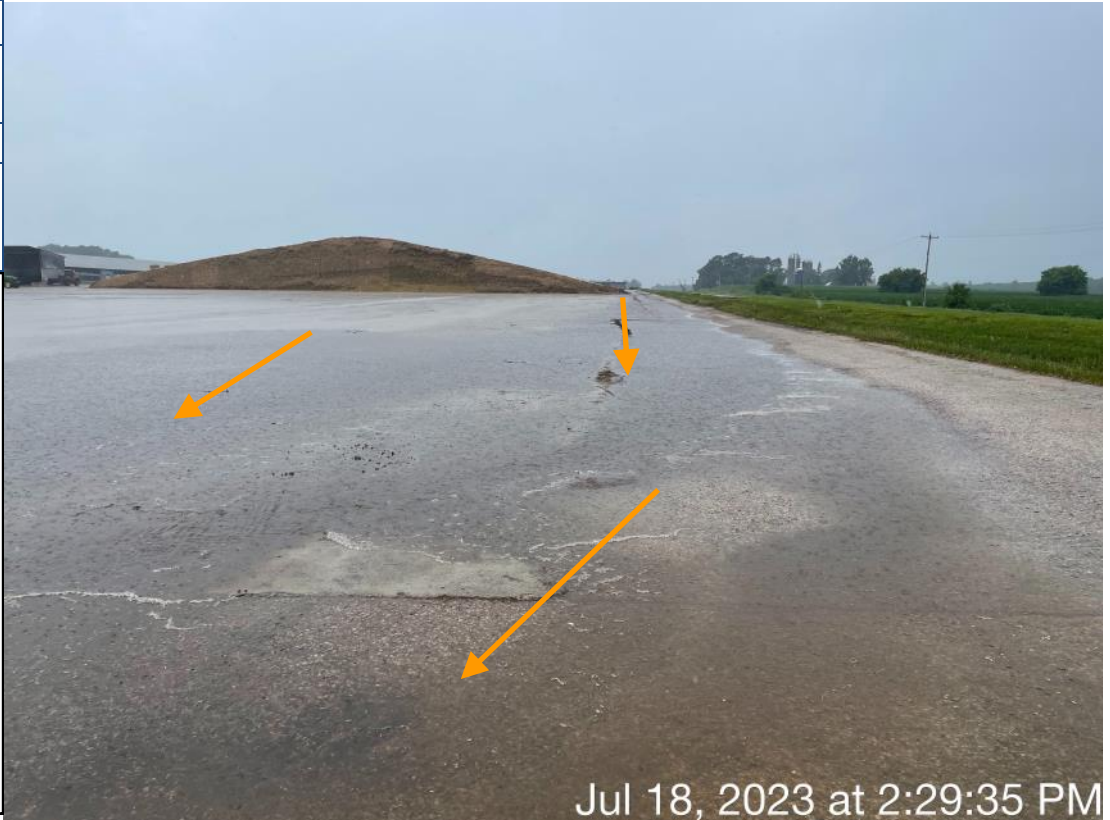
<b>Photo #:</b>	7374
<b>Date/Time of Photo:</b>	7/18/2023 14:29
<b>Photo By:</b>	Brian Hanson
<b>Photo Location:</b>	Main Dairy Feed Storage

**Photo Description:**  
Standing on the east side of FSA looking north: View of east edge of FSA. Arrows indicate direction of runoff flow.

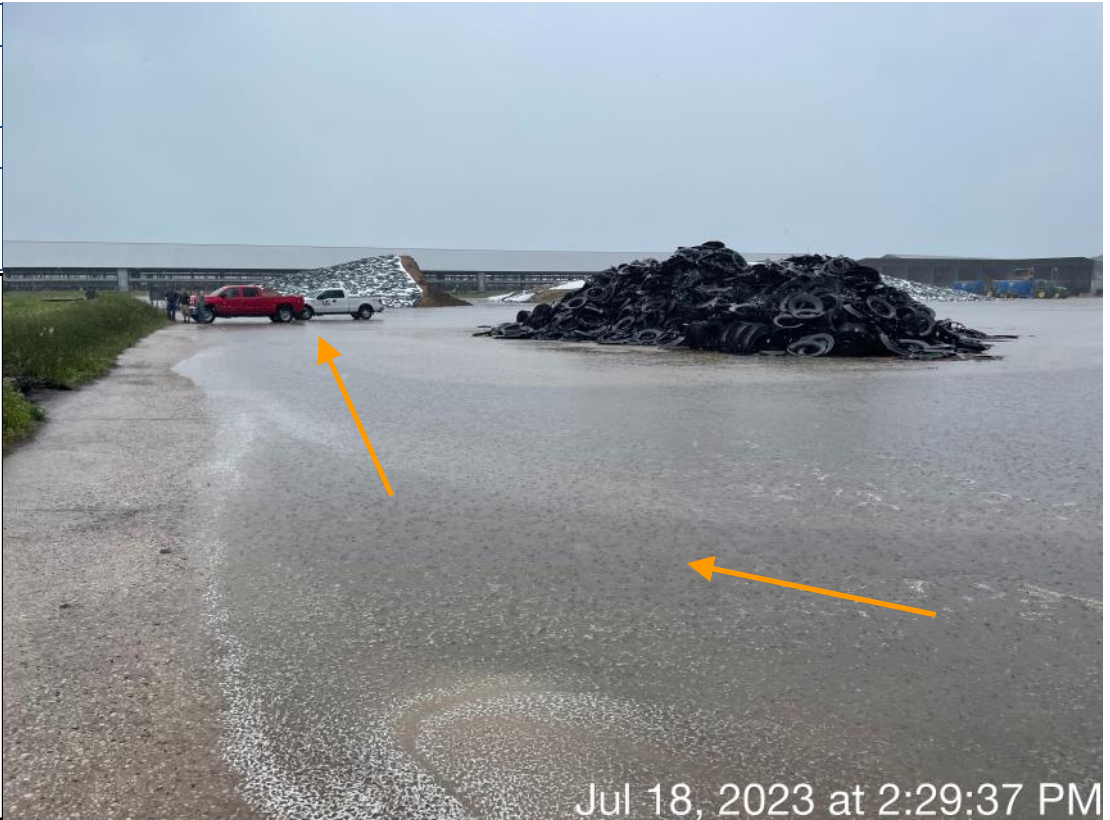
<b>Photo #:</b>	7375
<b>Date/Time of Photo:</b>	7/18/2023 14:29
<b>Photo By:</b>	Brian Hanson
<b>Photo Location:</b>	Main Dairy Feed Storage

**Photo Description:**  
Standing on the south side of FSA looking west: View of southeast corner of FSA. Arrows indicate direction of runoff flow.

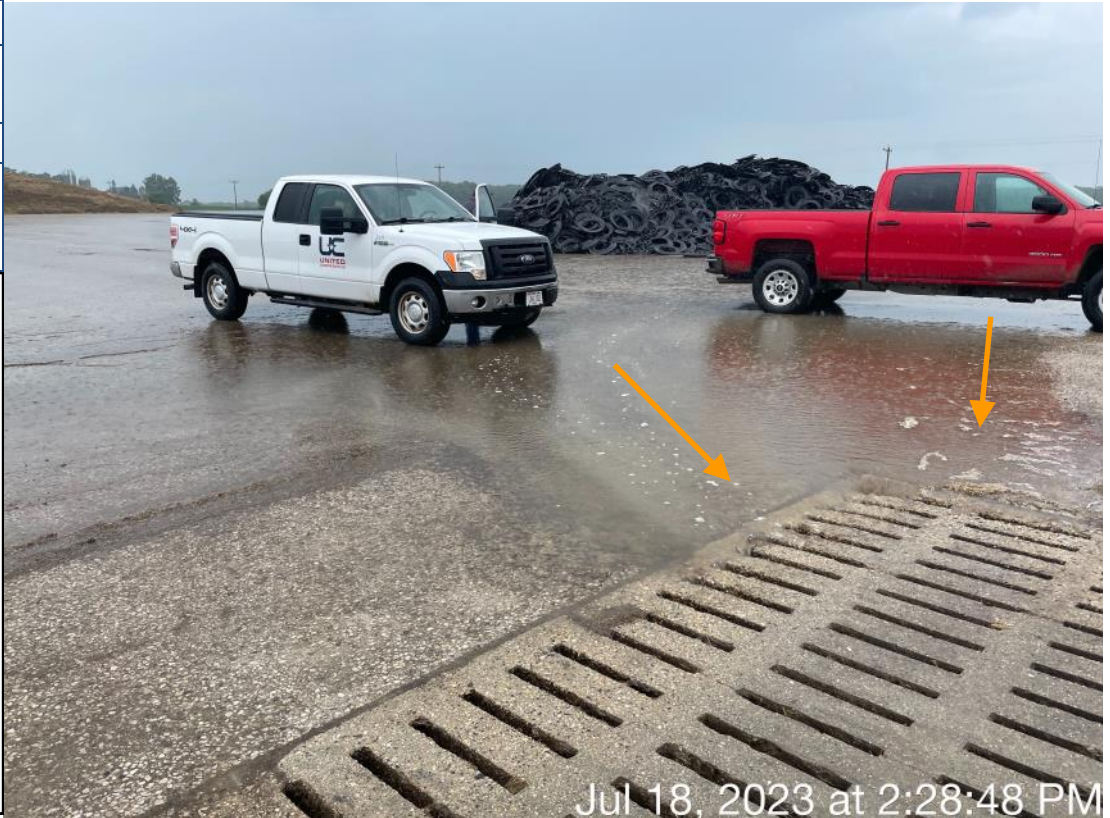
<b>Photo #:</b>	7367
<b>Date/Time of Photo:</b>	7/18/2023 14:28
<b>Photo By:</b>	Brian Hanson
<b>Photo Location:</b>	Main Dairy Feed Storage
<b>Photo Description:</b>	
<p>Standing on the south side of the FSA looking northeast: View of south edge of FSA at runoff collection tank. Arrows indicate direction of runoff flow.</p>

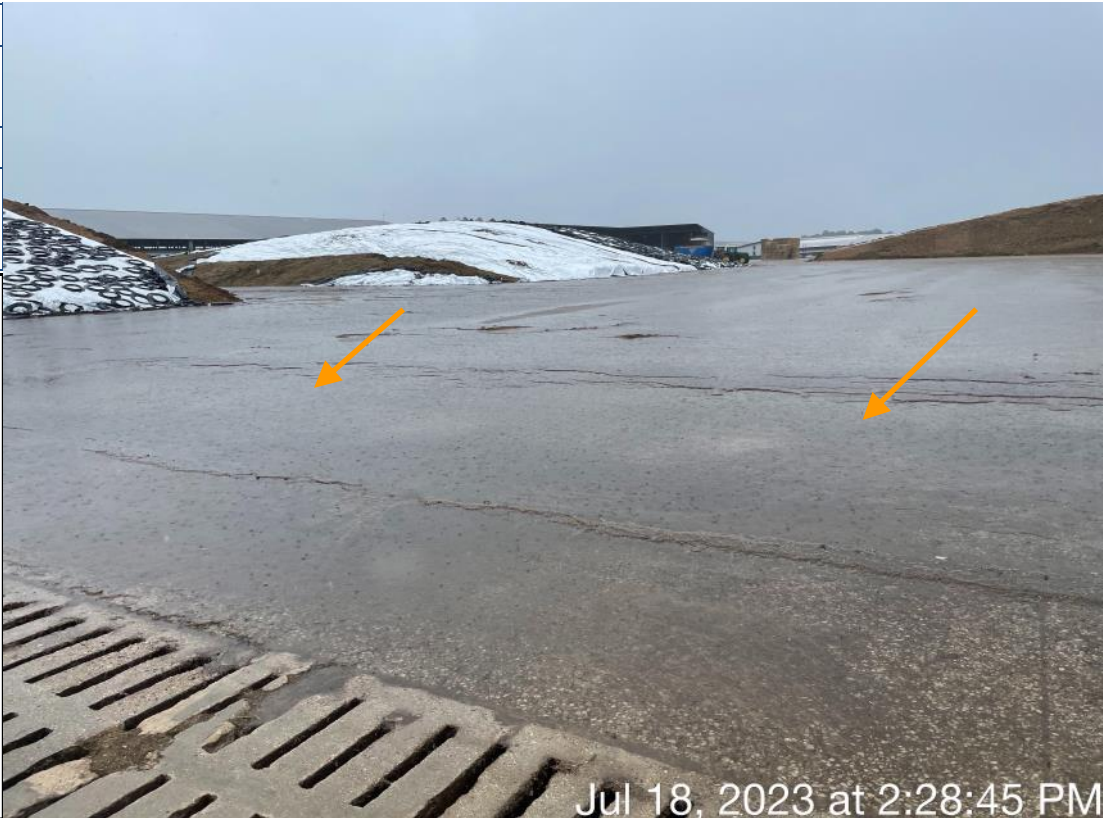
<b>Photo #:</b>	7366
<b>Date/Time of Photo:</b>	7/18/2023 14:28
<b>Photo By:</b>	Brian Hanson
<b>Photo Location:</b>	Main Dairy Feed Storage
<b>Photo Description:</b>	
<p>Standing on the south side of the FSA looking northwest: View of south edge of FSA at runoff collection tank. Arrows indicate direction of runoff flow.</p>
