# Permit Fact Sheet

Permit Number:	WI-0061794-05-0
Permittee Name:	B&D Dairy Farm LLC
Address:	4304 N 5th Road
City/State/Zip:	Pound WI 54161
Discharge Location:	<b>Main Farm</b> – W7251 E. 6 <sup>th</sup> Rd. Pound, WI 54161 ; SW ¼ of SW ¼ Section 36 T31N R20E <b>Heifer Facility</b> – W7276 E. 6 <sup>th</sup> Rd., Pound, WI 54161 ; Section 25 T31N R20E <b>Little River Site</b> – 7651 Hillcrest Road, Oconto, WI 54153 NE ¼ of NE ¼ Section 34 T29N R21E & 3267 County Road A, Oconto, WI 54153 NW ¼ of NW ¼ Section 35 T29N R21E
Receiving Water:	Surface Waters of the Little Peshtigo River, Lower Peshtigo River, Little River, and Middle Peshtigo River Watersheds. Lake Michigan Basin, & groundwaters of the state.
Discharge Type:	Existing

On Tuesday July 18, 2023 Hanson & Brenny met with Lepianka, Lepianka, Coady, Paulson & Hodkiewicz at 13:00 at B&D Dairy Farm LLC site to conduct a permit reissuance walkover inspection. All 3 sites in the permit were inspected. A heavy downpour occurred at the beginning of the inspection but for the remainder of the inspection temperatures were in the 80's and cloudy. No permit violations were observed, and no water samples were collected. Hanson & Brenny

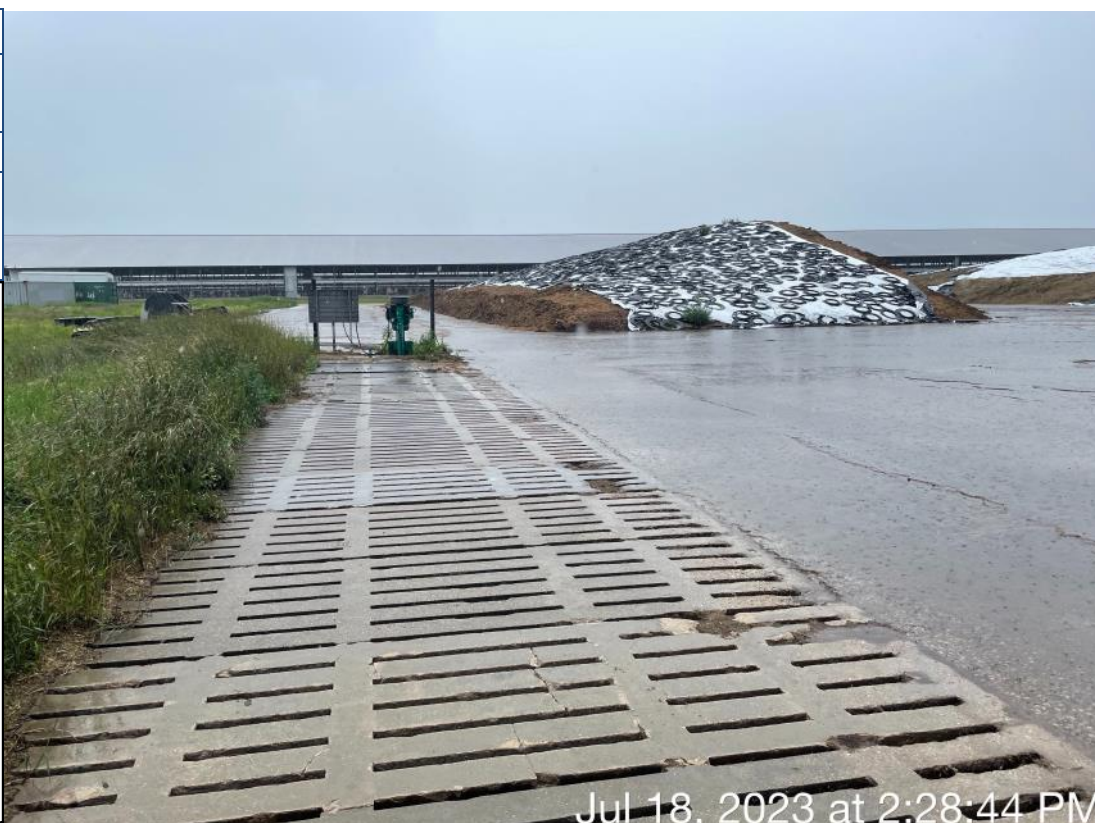
<b>Photo #:</b>	7365
<b>Date/Time of Photo:</b>	7/18/2023 14:28
<b>Photo By:</b>	Brian Hanson
<b>Photo Location:</b>	Main Dairy Feed Storage

Standing on the south side of the FSA looking west: View of the south edge of FSA at runoff collection tank. Notice pump & controls at west edge of tank.

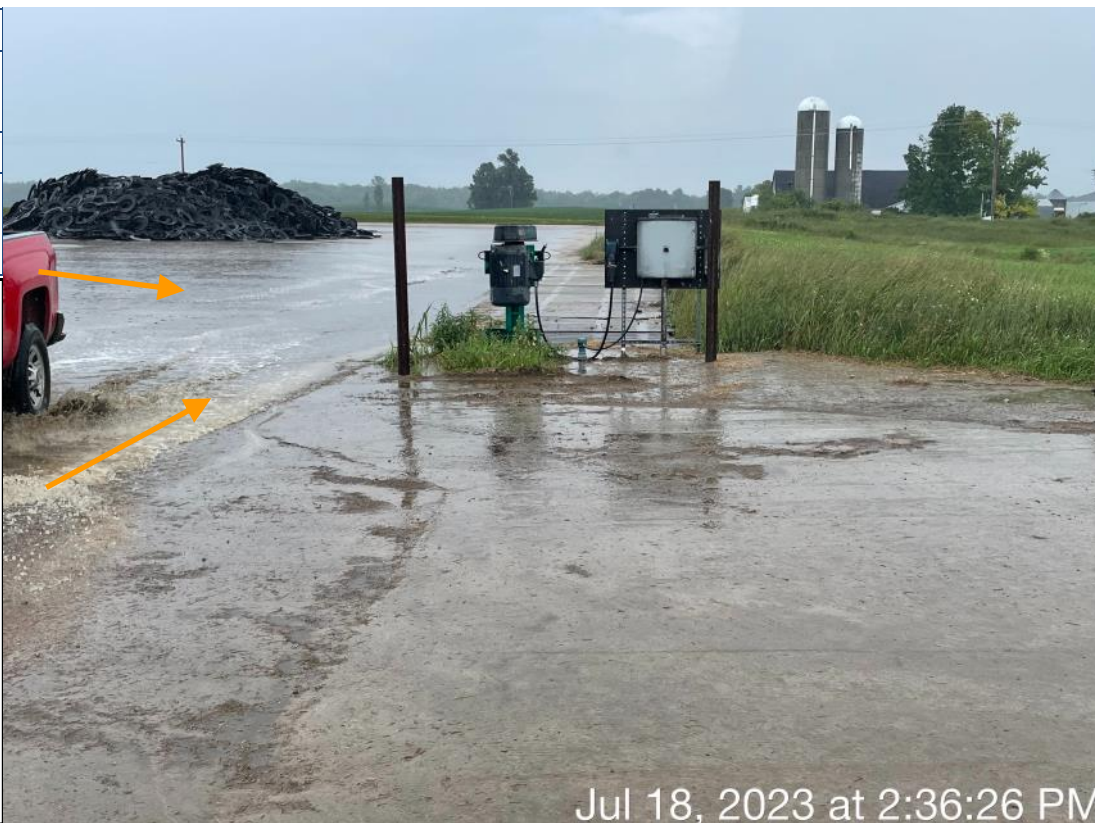
<b>Photo #:</b>	7415
<b>Date/Time of Photo:</b>	7/18/2023 14:36
<b>Photo By:</b>	Brian Hanson
<b>Photo Location:</b>	Main Dairy Feed Storage

Standing on the south side of FSA looking east: View of south edge of FSA on west side of runoff collection tank. Arrows indicate direction of runoff flow.

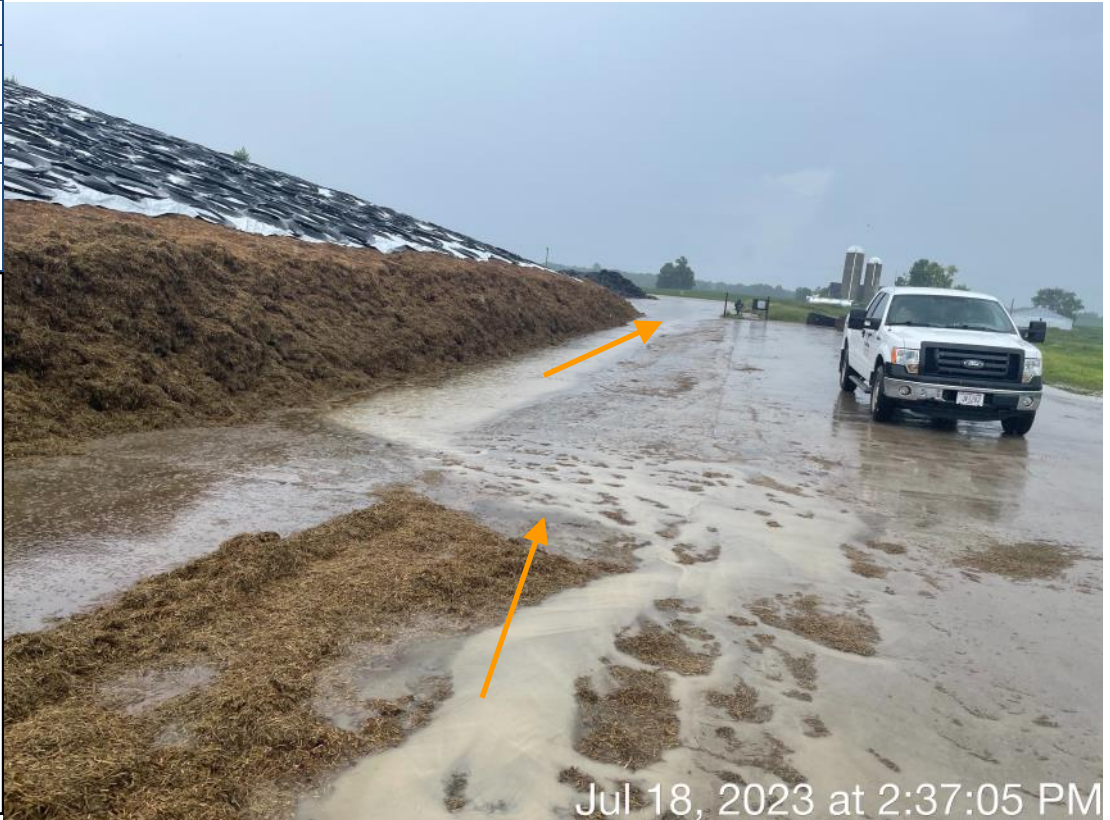
<b>Photo #:</b>	7417
<b>Date/Time of Photo:</b>	7/18/2023 14:37
<b>Photo By:</b>	Brian Hanson
<b>Photo Location:</b>	Main Dairy Feed Storage

**Photo Description:**  
Standing at the southwest corner of the FSA looking east: View of south edge of FSA. Arrows indicate direction of runoff flow.

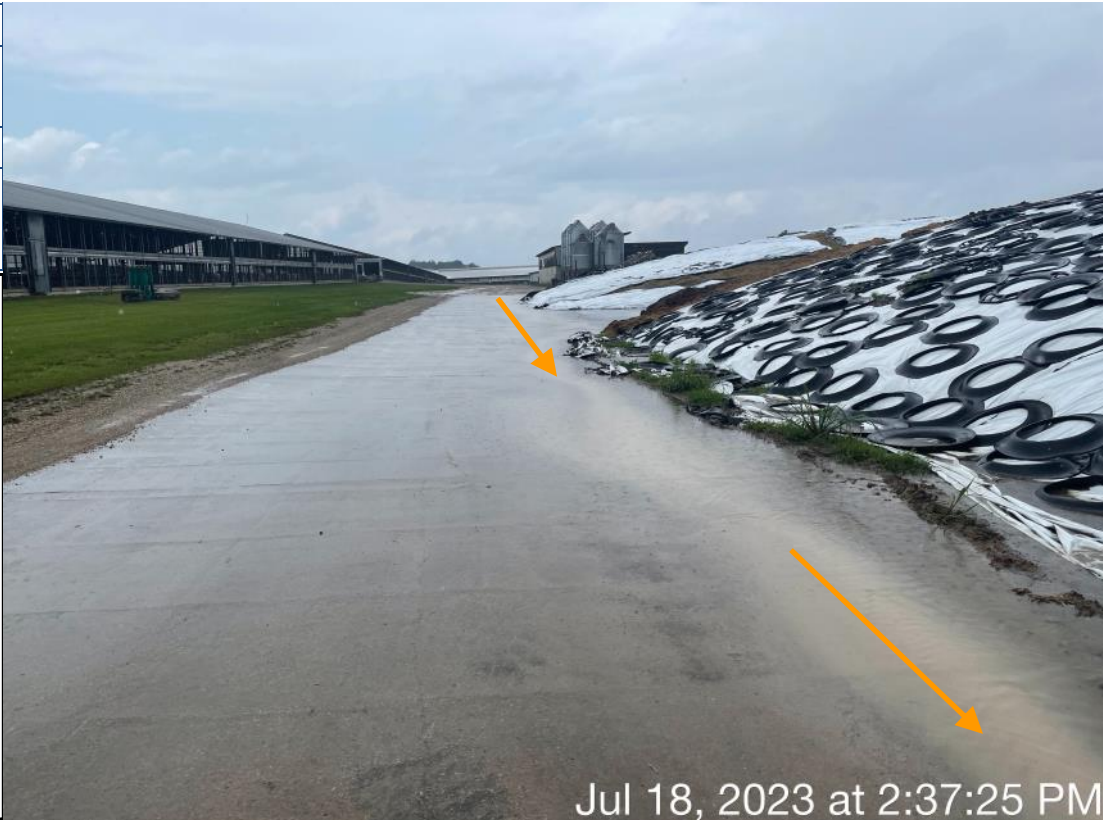
<b>Photo #:</b>	7419
<b>Date/Time of Photo:</b>	7/18/2023 14:37
<b>Photo By:</b>	Brian Hanson
<b>Photo Location:</b>	Main Dairy Feed Storage

**Photo Description:**  
Standing on the west side of FSA looking north: View of west edge of FSA. Arrows indicate direction of runoff flow.

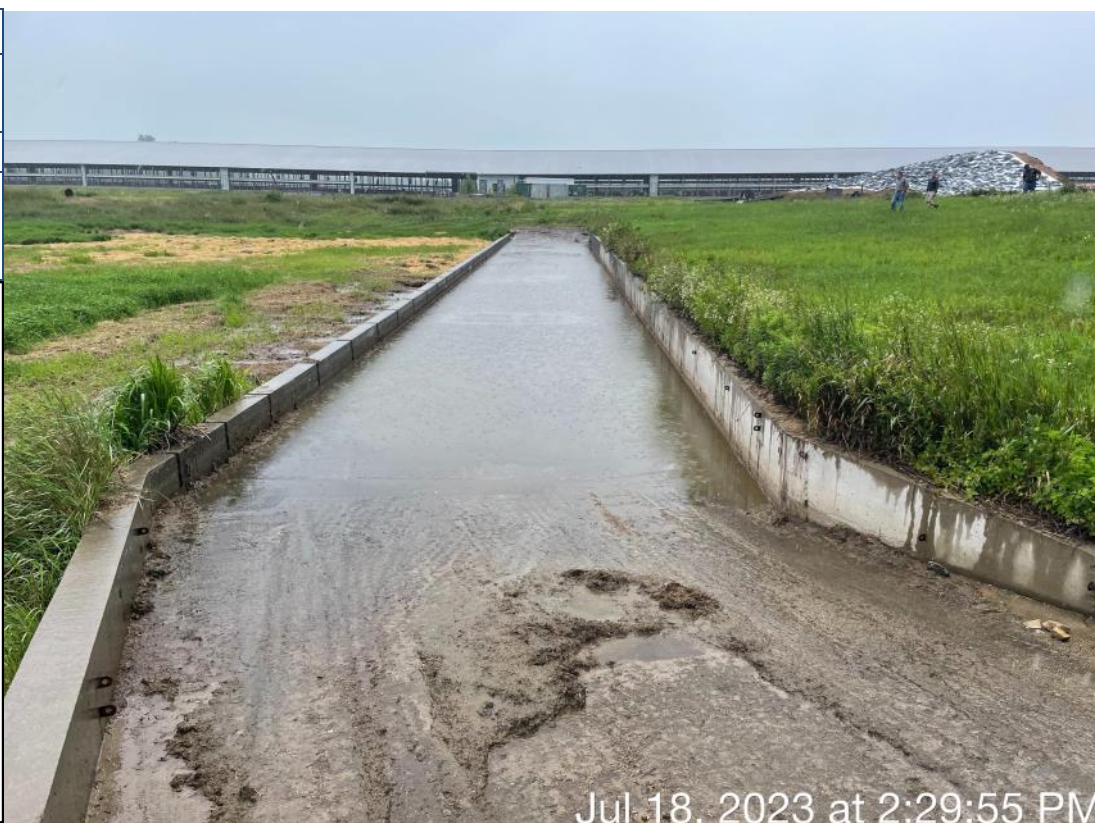
<b>Photo #:</b>	7376
<b>Date/Time of Photo:</b>	7/18/2023 14:29
<b>Photo By:</b>	Brian Hanson
<b>Photo Location:</b>	Main Dairy FSA VTA

**Photo Description:**  
Standing off the south side of the FSA looking west: View of concrete spreader bar on north edge of Vegetated Treatment Area (VTA).

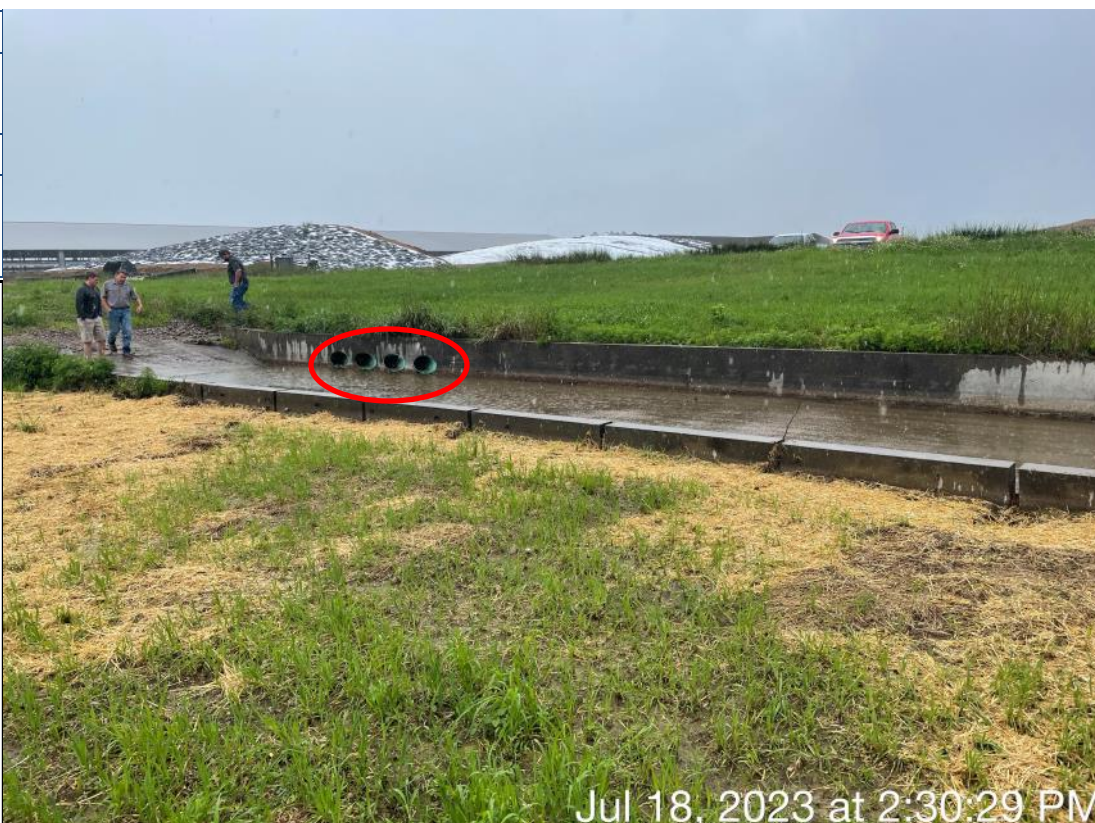
**Photo Description:**  
Standing on the south side of concrete spreader pad looking northwest: View of west end of spreader pad. Outlet pipes from runoff collection tank highlighted.

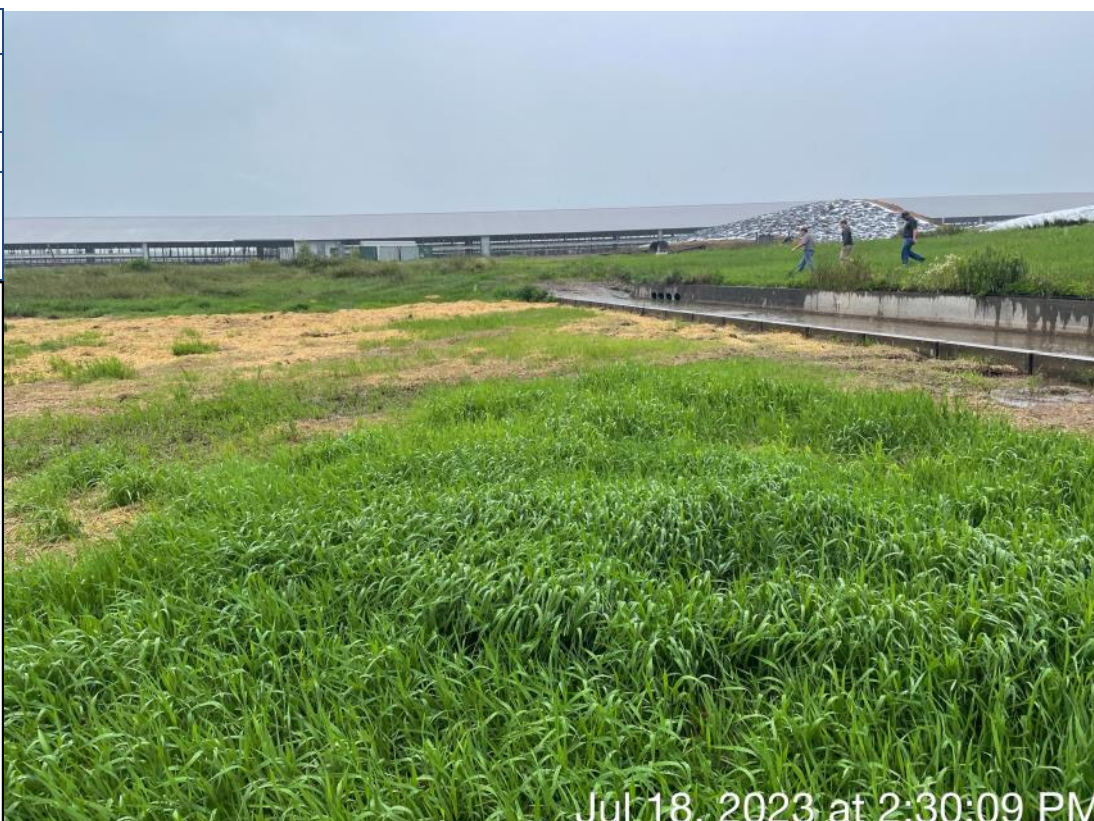
<b>Photo #:</b>	7381
<b>Date/Time of Photo:</b>	7/18/2023 14:30
<b>Photo By:</b>	Brian Hanson
<b>Photo Location:</b>	Main Dairy FSA VTA
<b>Photo Description:</b>  Standing on north end of VTA looking west: View of north end of VTA. Area had been recently reseeded. Notice straw in some areas used to cover the seed.

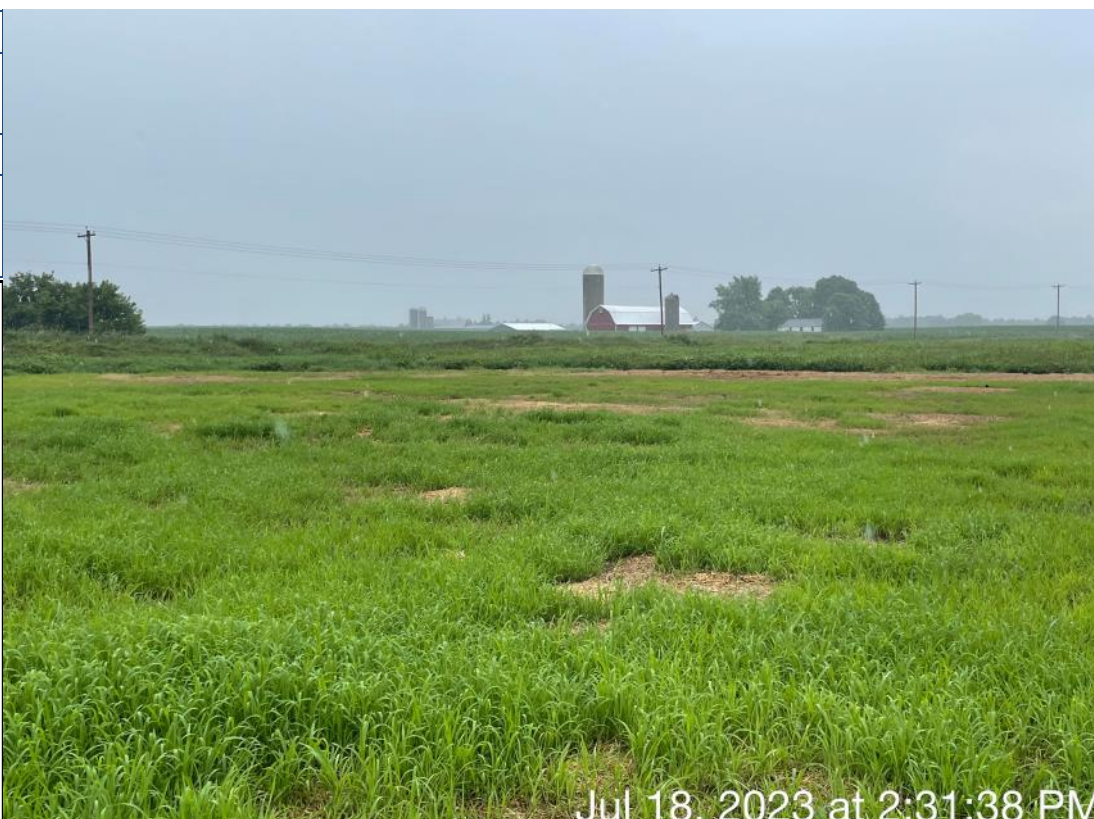
<b>Photo #:</b>	7389
<b>Date/Time of Photo:</b>	7/18/2023 14:31
<b>Photo By:</b>	Brian Hanson
<b>Photo Location:</b>	Main Dairy FSA VTA
<b>Photo Description:</b>  Standing on the north end of VTA looking south: View of northern end of VTA. Area had recently been reseeded.

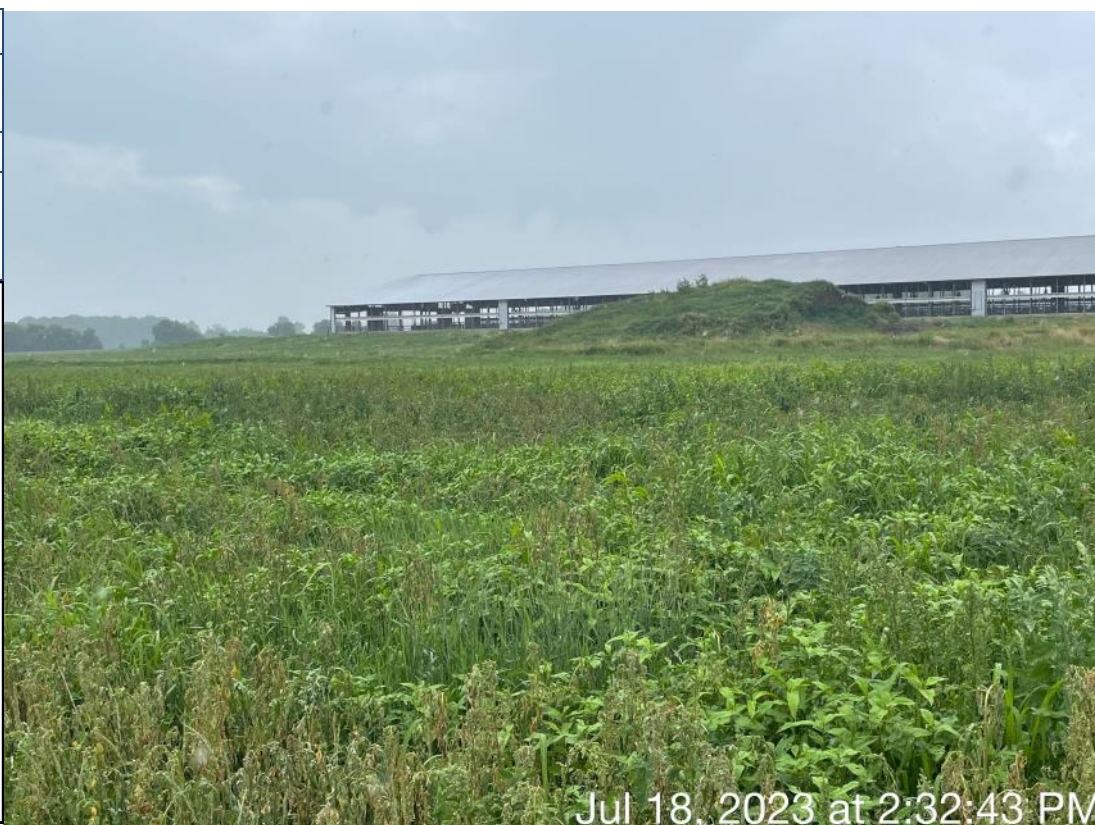
<b>Photo #:</b>	7395
<b>Date/Time of Photo:</b>	7/18/2023 14:32
<b>Photo By:</b>	Brian Hanson
<b>Photo Location:</b>	Main Dairy FSA VTA

**Photo Description:**  
Standing in the center of VTA looking southwest: View of center section of VTA. Area is well vegetated.

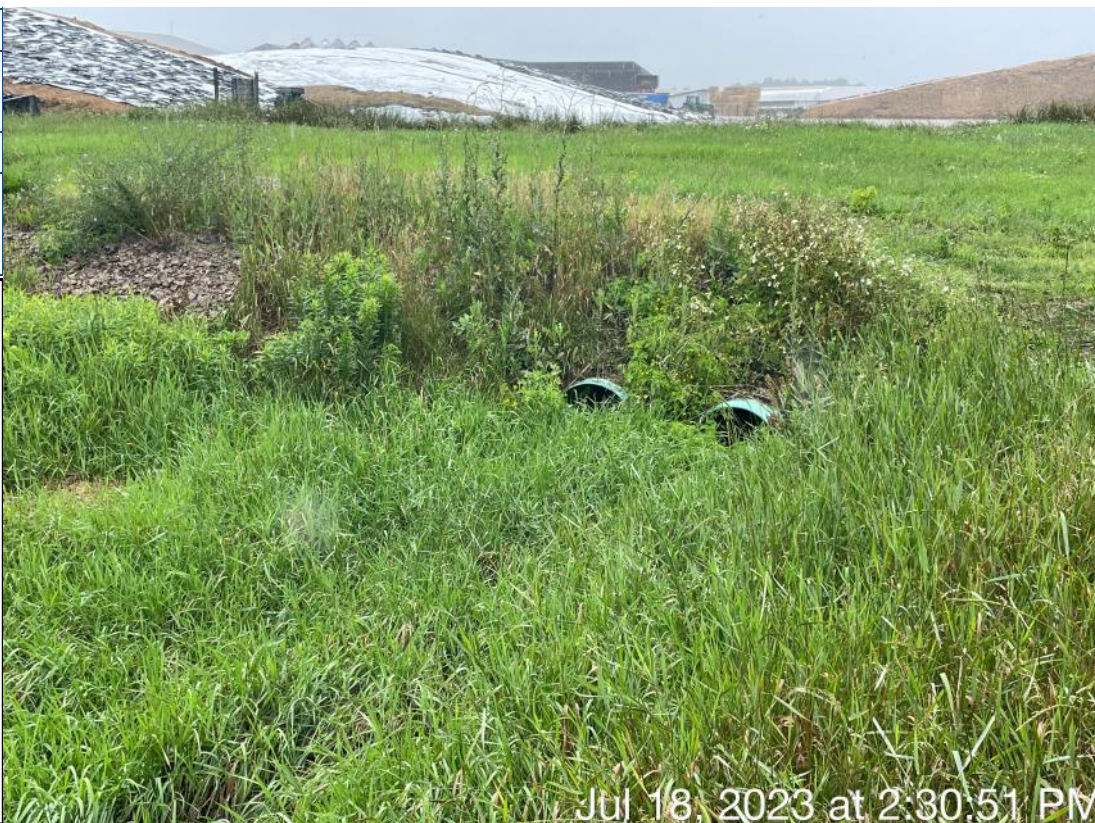
**Photo Description:**  
Standing on the west side of VTA looking north: View of runoff collection system overflow pipes.

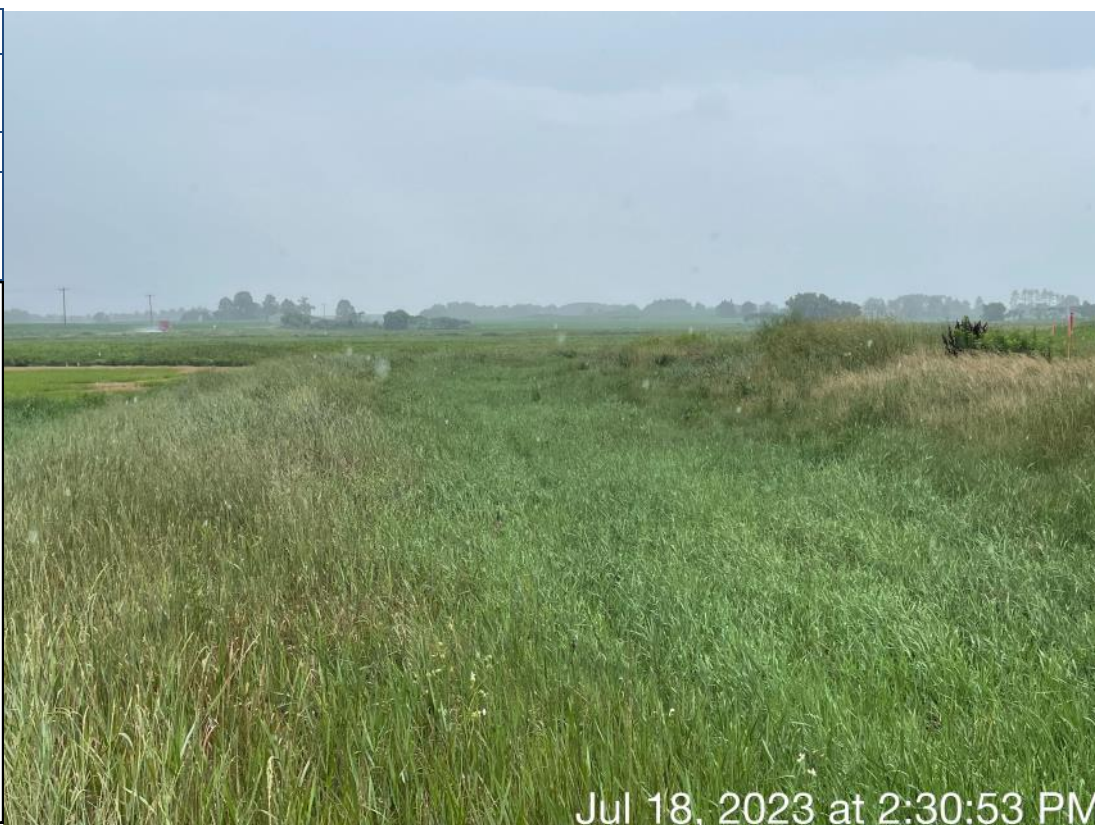
**Photo Description:**  
 Standing on the west side of VTA looking south: View of secondary VTA for runoff collection system overflow pipes shown in photo 7385. Area is well vegetated.

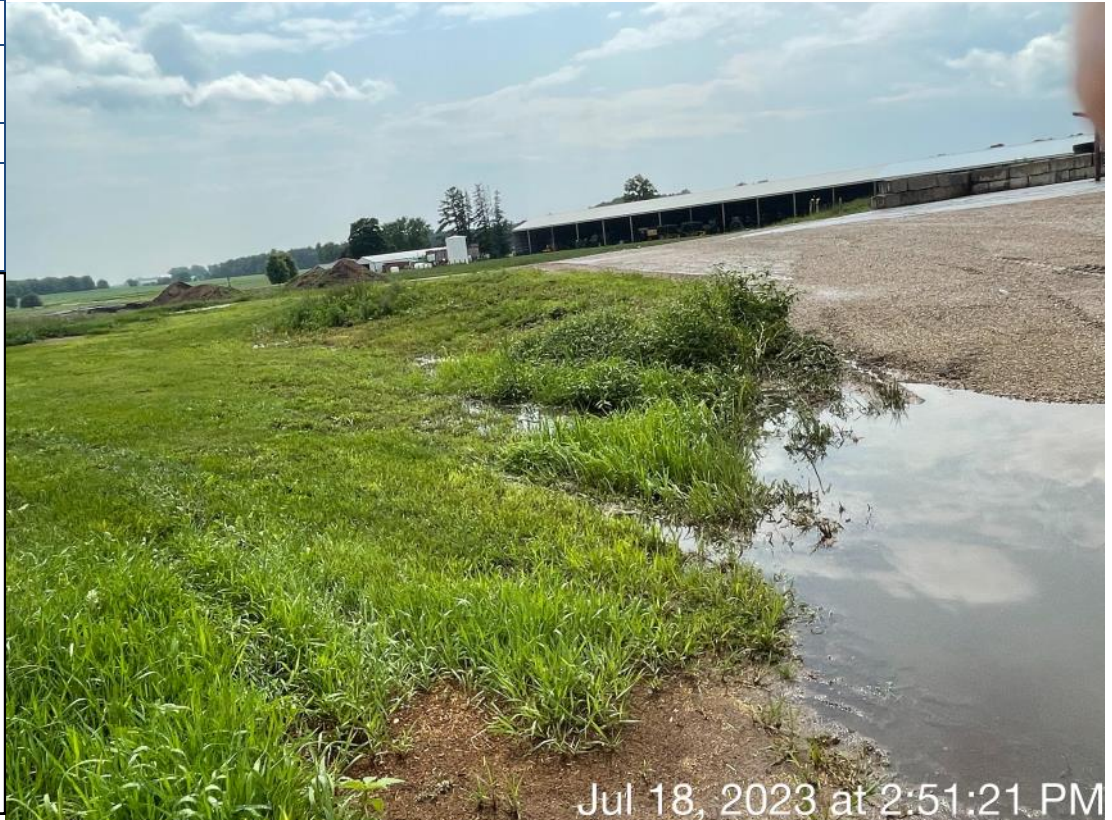
<b>Photo #:</b>	7458
<b>Date/Time of Photo:</b>	7/18/2023 14:51
<b>Photo By:</b>	Brian Hanson
<b>Photo Location:</b>	Main Dairy Stormwater
<b>Photo Description:</b>	
Standing on the west side of WSF #1 looking south: View of stormwater surface flow along west side of WSF #1 & WSF #3
