Permit Fact Sheet

Permit Number	WI-0067617-01-0
Permittee Name and Address	Bakake Acres LLC E8885 Worm Rd, New London, WI 54961
Permitted Facility Name and Address	Bakake Acres LLC E8865 County Road T, New London, WI 54961
Permit Term	March 01, 2026 to February 28, 2031
Receiving Water	Unnamed tributary within the Partridge Lake - Wolf River Watershed, and groundwaters of the state
Discharge Type	Existing source CAFO per NR 243.03(23) as the animal feeding operation was in existence on the site prior to April 14, 2003.

Brief Facility Description: Bakake Acres LLC is a proposed Concentrated Animal Feeding Operation (CAFO) that is owned & operated by Grady Auer. The department is required Bakake Acres LLC to apply for a WPDES permit per s. NR 243.25 (2) Wis. Admin. Code. for failing to implement corrective measures of a previously issued Notice of Discharge. Bakake Acres LLC consists of 1 site located at E8865 County Road T, New London, WI 54961. . Bakake Acres LLC currently in herd size consists of 504 animal units (303 milking & dry cows, 80 heifers & 60 calves) and is not proposing to expand during the upcoming permit term. Bakake Acres LLC currently produces approximately 5.3 m

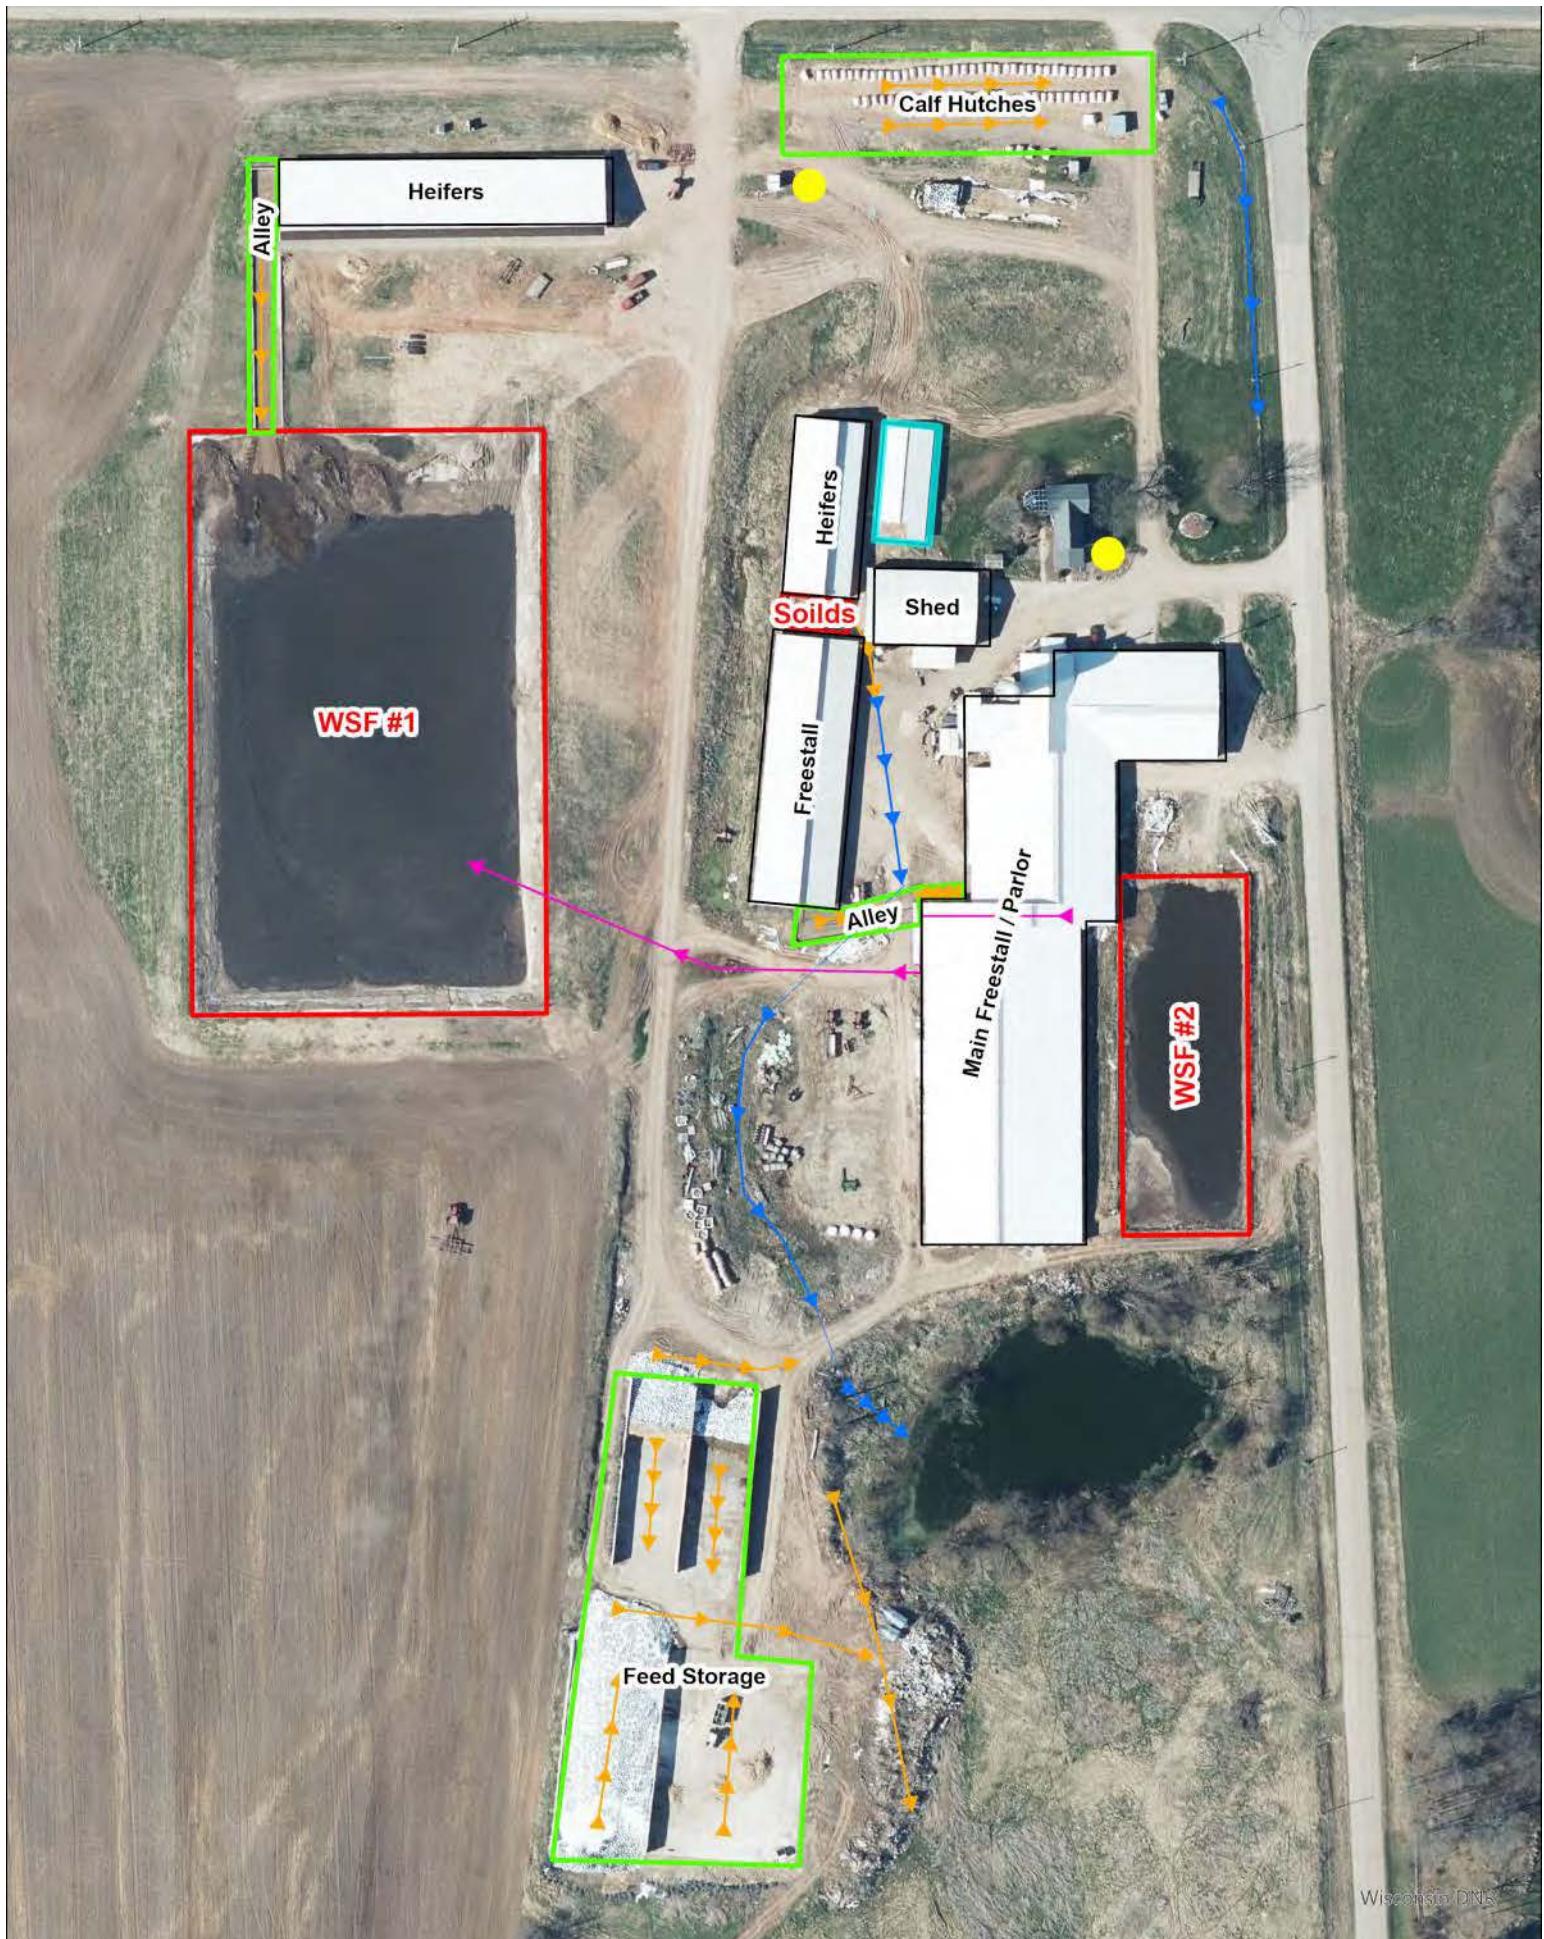
Site Overview Diagram (Main Dairy: orange lines = potential contaminated runoff, blue lines = stormwater flow, pink lines = waste transfer system, yellow circles = well locations)

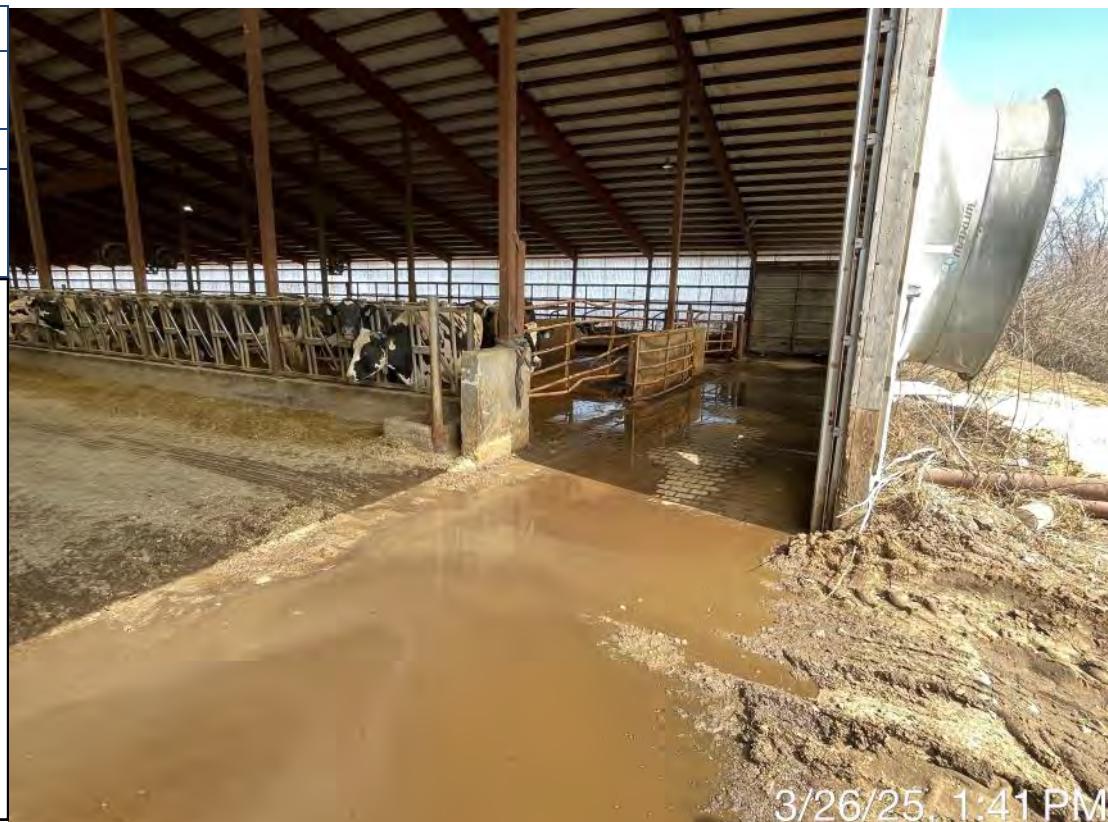
Standing on the south end of the main freestall barn looking east: View of concrete alley on south end of barn. Litter alleys slope to the south and liquids accumulate in this alleyway. Farm should inspect this area often to make sure liquids do not leave the barn.

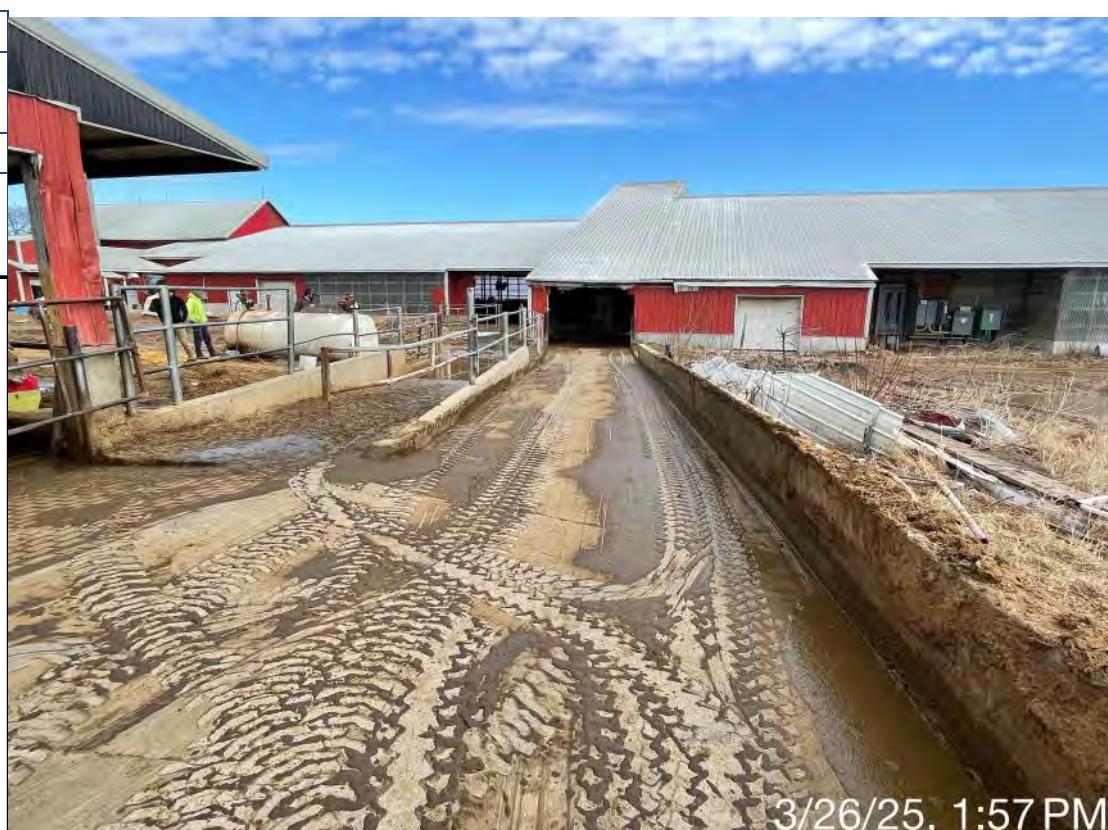
Photo #:	2
Date/Time of Photo:	3/26/2025 13:57
Photo By:	Brian Hanson
Photo Location:	West Freestall Barn

Standing on the south end of the west freestall barn looking east: View of concrete alley used to scrape manure from the west freestall barn to the transfer system in the main freestall barn. Scrape alley has concrete curbs and slopes to the east.

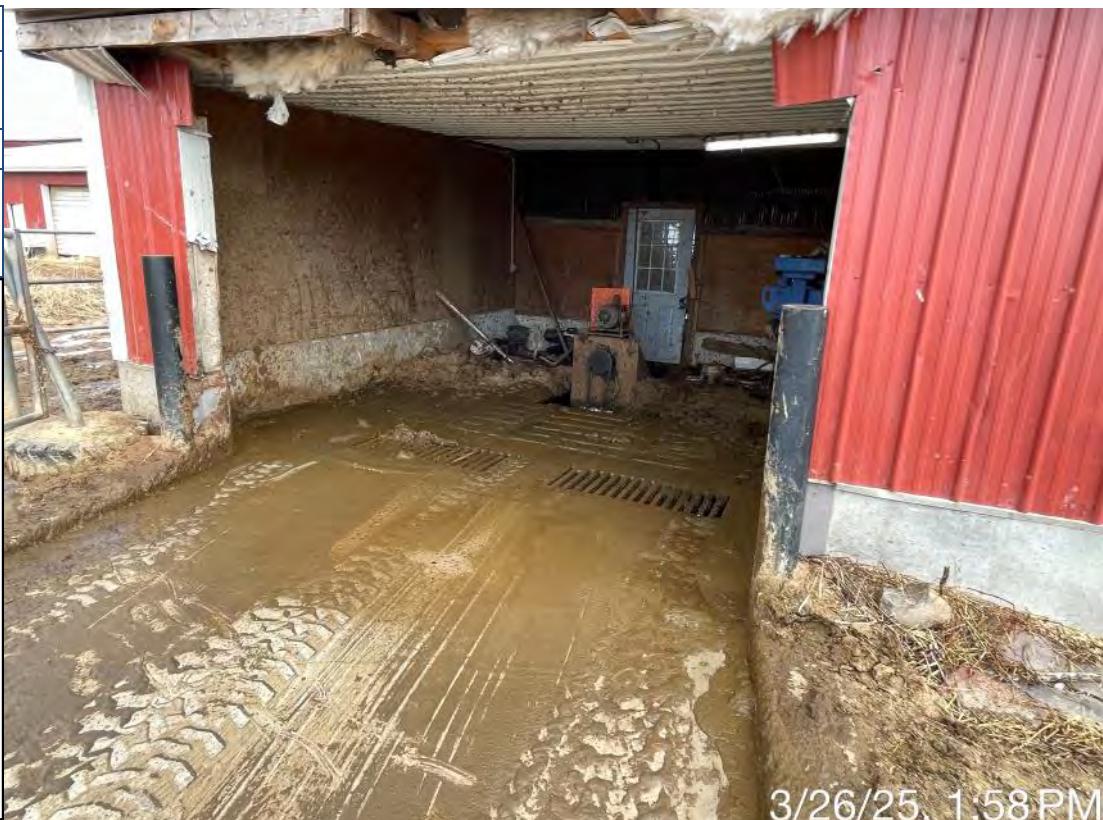
Photo #:	3
Date/Time of Photo:	3/26/2025 13:58
Photo By:	Brian Hanson
Photo Location:	Main Freestall Barn
Photo Description:	
<p>Standing on the west side of main freestall barn looking east: View of east end of scrape ally shown in photo #2 where manure is scraped into reception tank of the manure transfer system.</p>

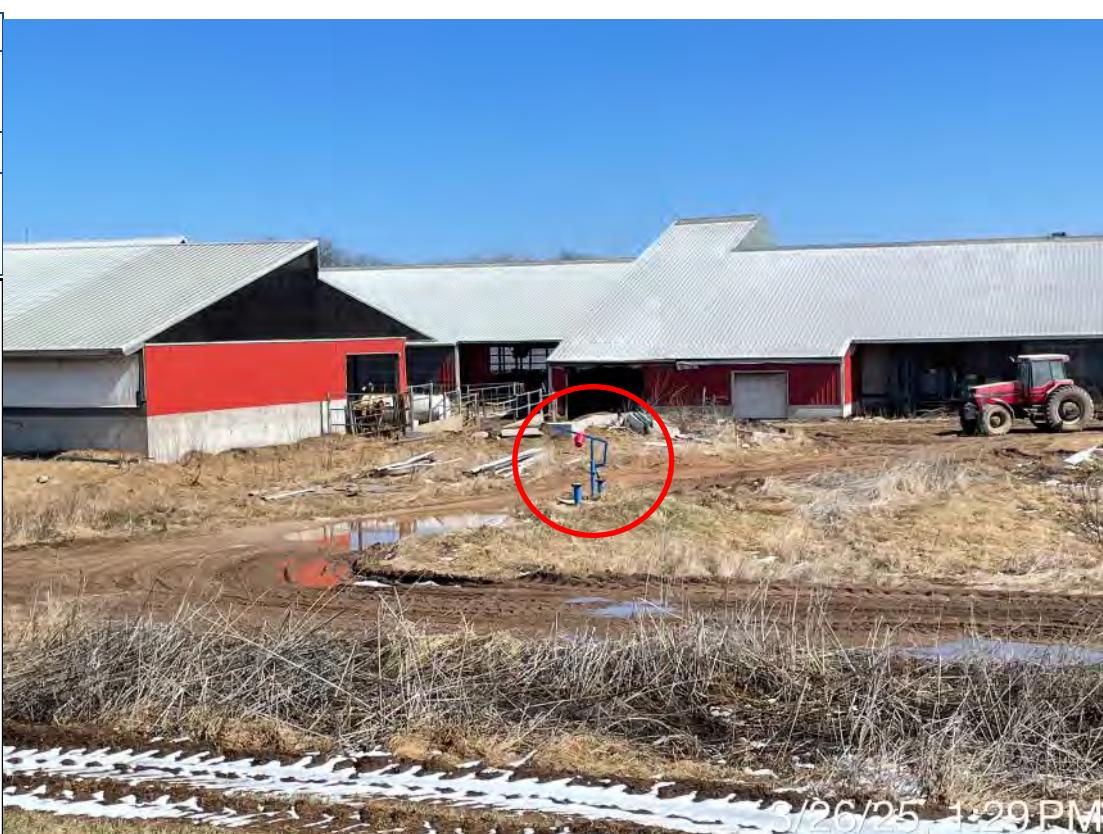
Photo #:	4
Date/Time of Photo:	3/26/2025 13:29
Photo By:	Brian Hanson
Photo Location:	Waste Transfer System
Photo Description:	
<p>Standing on the east side of WSF # 1 looking east: View of inline transfer pipe valve and cleanouts located between manure pump & WSF #1.</p>

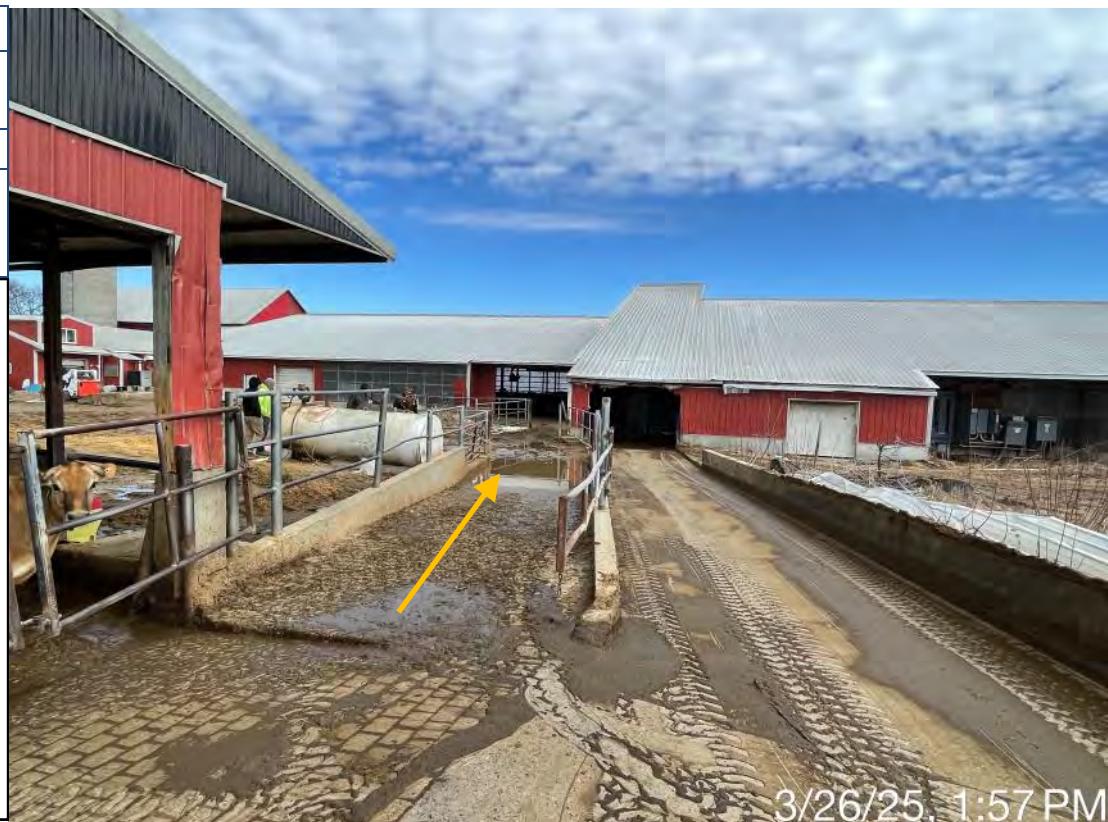
Photo #:	5
Date/Time of Photo:	3/26/2025 13:57
Photo By:	Brian Hanson
Photo Location:	Cattle Walkway

Standing on the south end of the west freestall barn looking east: View of concrete walkway used to transfer cows from the west freestall barn to the parlor to be milked. Arrow indicates direction of runoff flow.

- Waste Storage Facilities show signs of past overtopping. Continue to monitor manure levels in both pits to prevent future overtopping events.
- The concrete cattle walkway between the small freestall barn & the main freestall barn does not have engineered runoff controls. Manure laden runoff was observed leaving the concrete area and entering the stormwater culvert. The farm should continue to monitor the cattle walkway area to look for areas of possible discharge. Where discharge is occurring , the farm should install interim best management practices to prevent a discharge to waters of the state until permanent controls are installed.

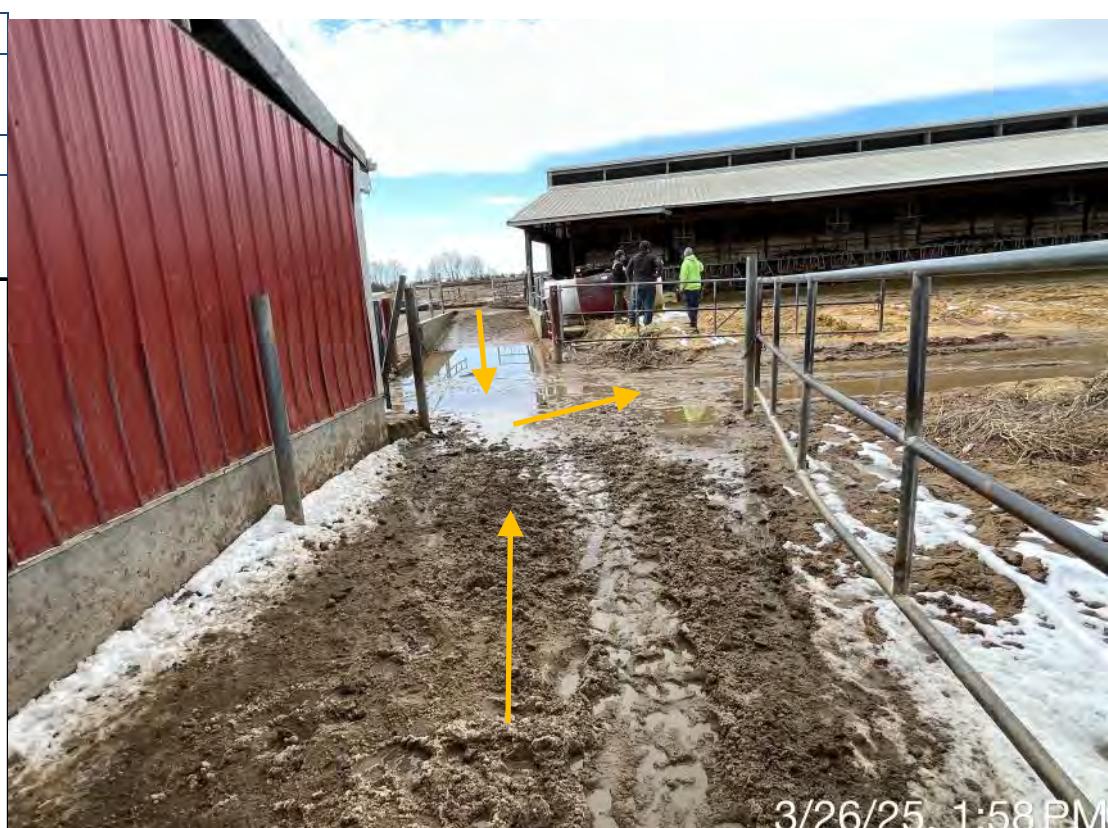
Photo #:	6
Date/Time of Photo:	3/26/2025 13:58
Photo By:	Brian Hanson
Photo Location:	Cattle Walkway

Standing on the west side of the main freestall barn looking west: View of the cattle walkway near the main freestall barn. Arrows indicate direction of runoff flow.

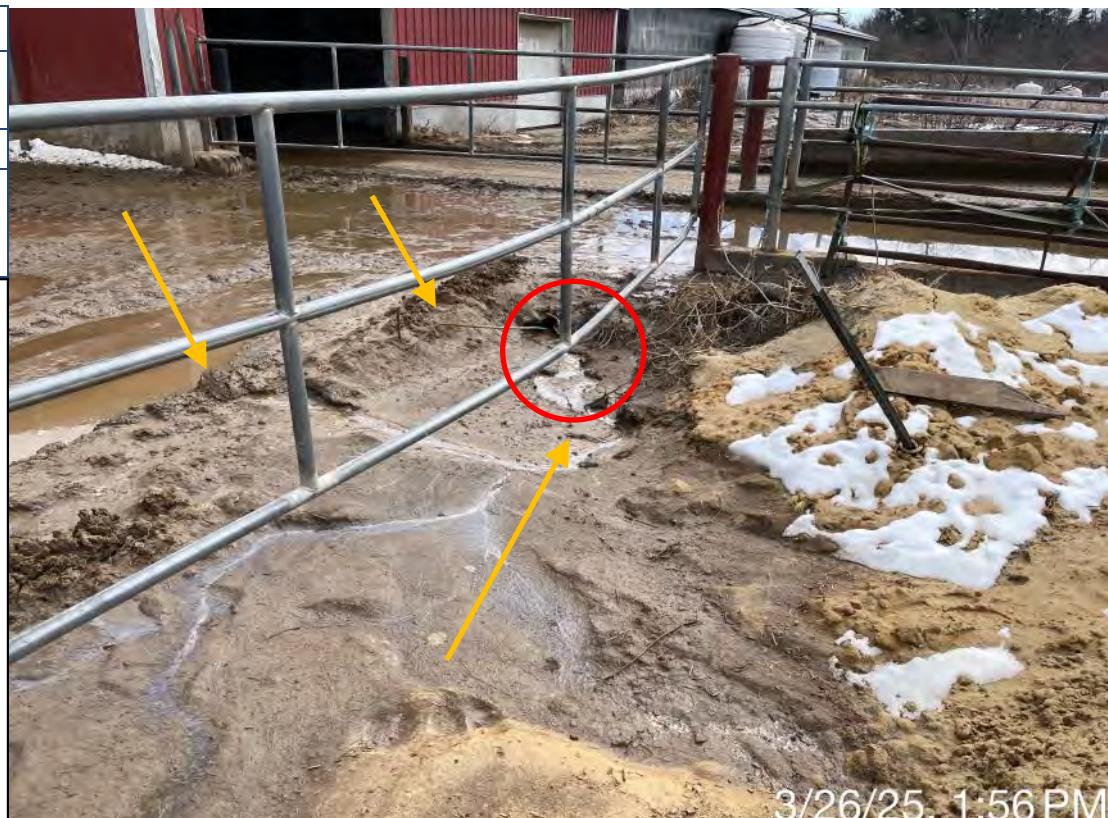
Photo #:	7
Date/Time of Photo:	3/26/2025 13:56
Photo By:	Brian Hanson
Photo Location:	Cattle Walkway
Photo Description:	
Standing on the north side of the cattle walkway looking south: View of runoff from the concrete walkway entering the stormwater channel. Arrows indicate direction of runoff flow. Red circle shows location of stormwater culvert under cattle walkway.

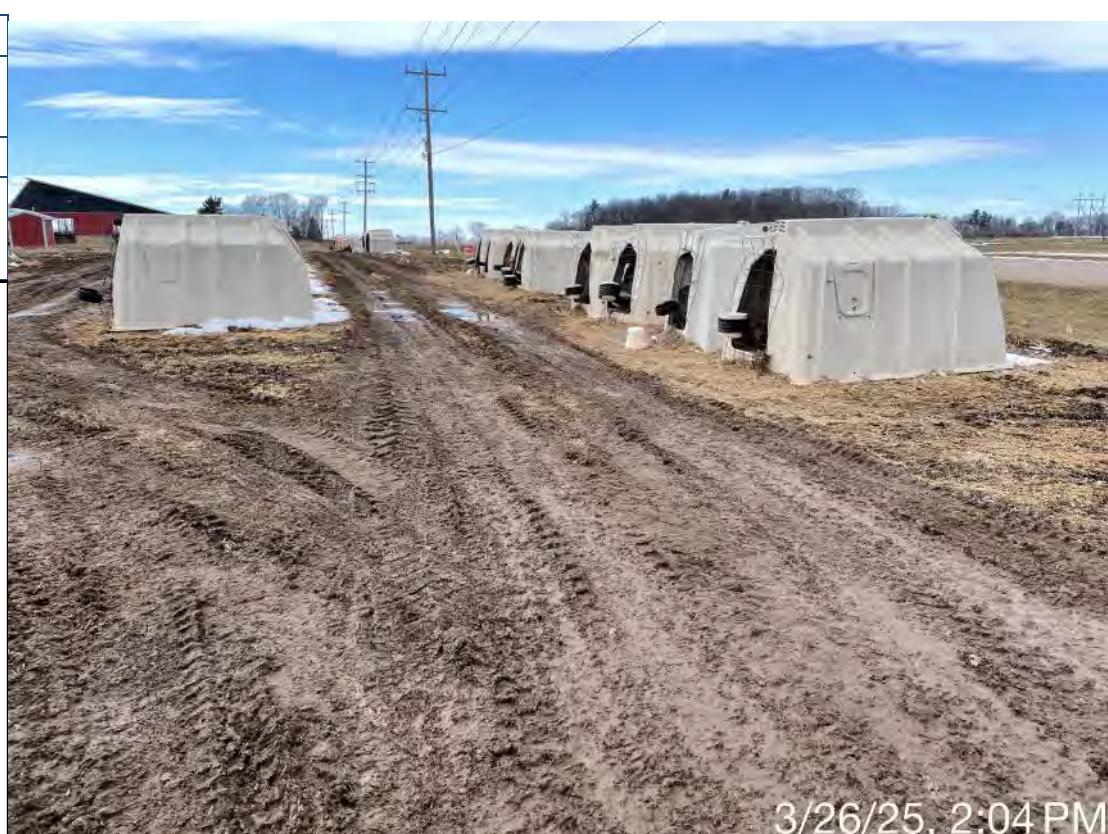
Photo #:	8
Date/Time of Photo:	3/26/2025 14:04
Photo By:	Brian Hanson
Photo Location:	Calf Hutch Area
Photo Description:	
Standing on the east side of the calf hutch area looking west: View of the north edge of the calf hutch area.

During an inspection that occurred on March 26, 2025, the department observed the Calf Hutch Area and concluded that engineered runoff controls were not present. Engineering Plans & Specs of Calf Hutch Area Runoff Controls (Sample Point 007) has been included per s. NR 243.15(2) Wis. Admin. Code to ensure the Calf Hutch Area complies with the applicable production area requirements in s. NR 243.13 Wis. Admin. Code.

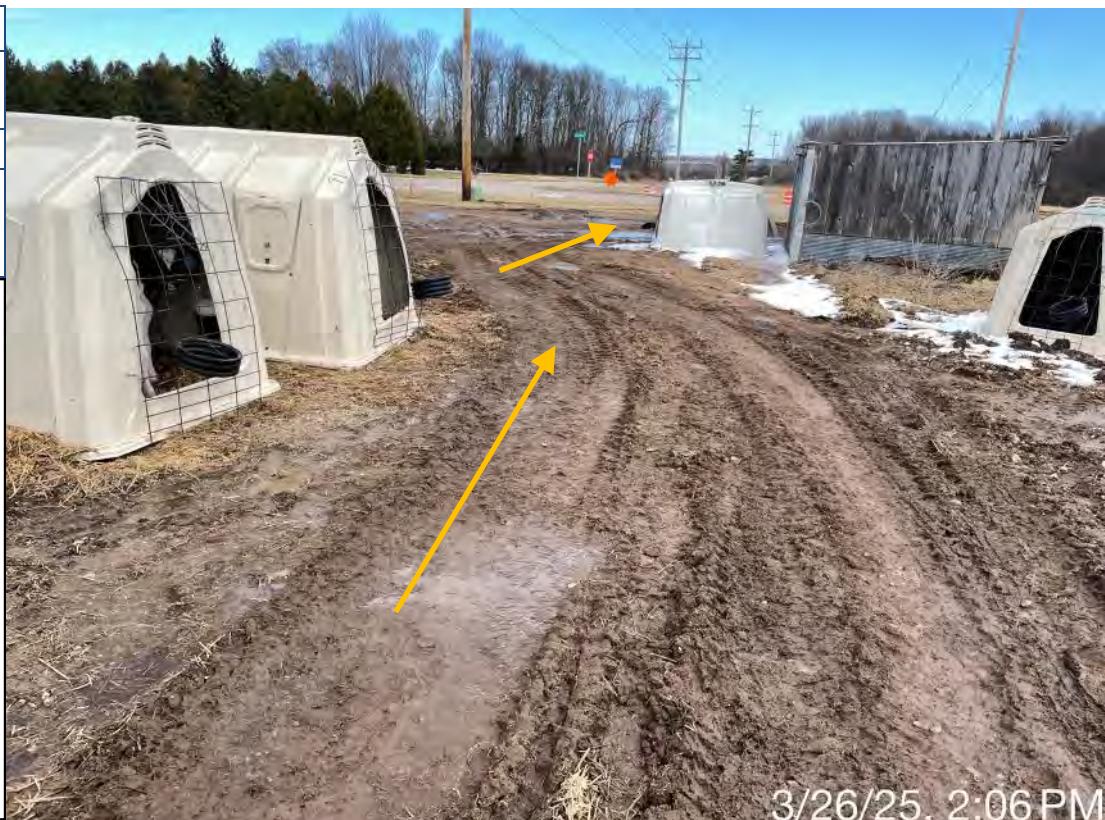
Photo #:	11
Date/Time of Photo:	3/26/2025 14:06
Photo By:	Brian Hanson
Photo Location:	Calf Hutch Area

Standing in the middle of the calf hutch area looking east: View of east end of calf hutch area. Arrows indicate direction of runoff flow. Runoff flows east towards Madden Road ditch.

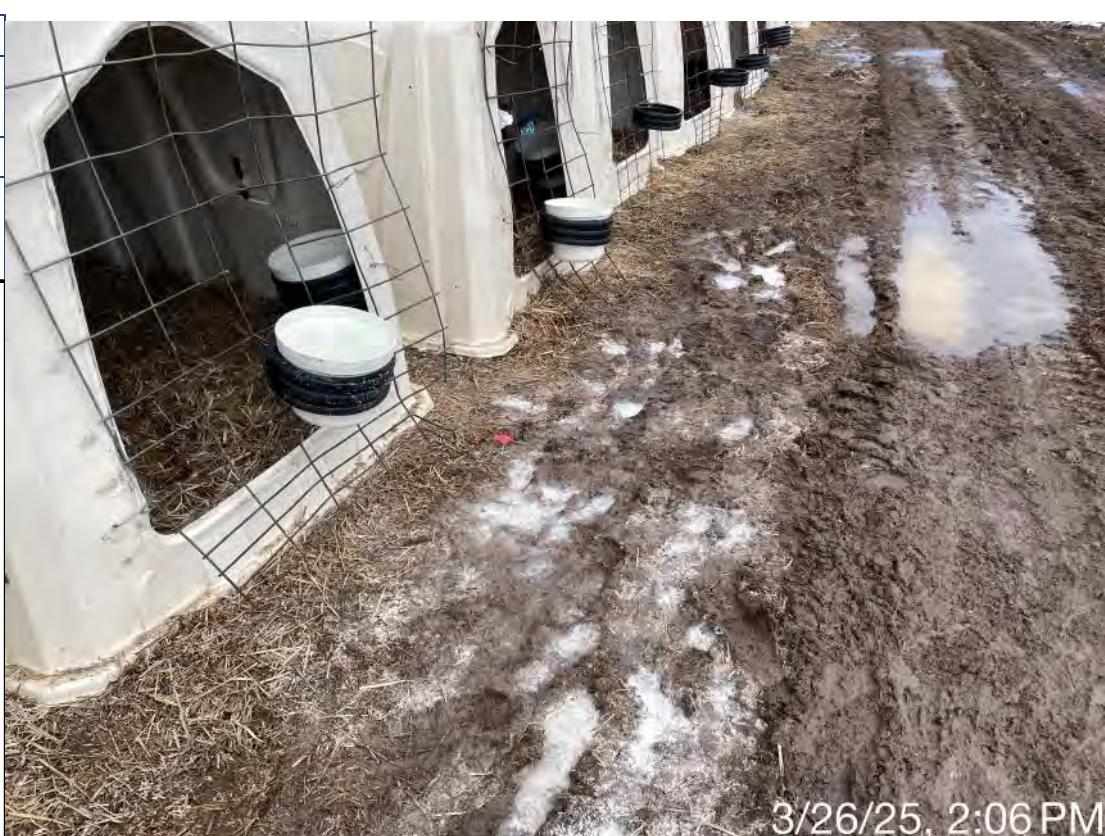
Standing in the middle of the calf hutch area looking east & down: View of spilled milk in front of a few calf huts.

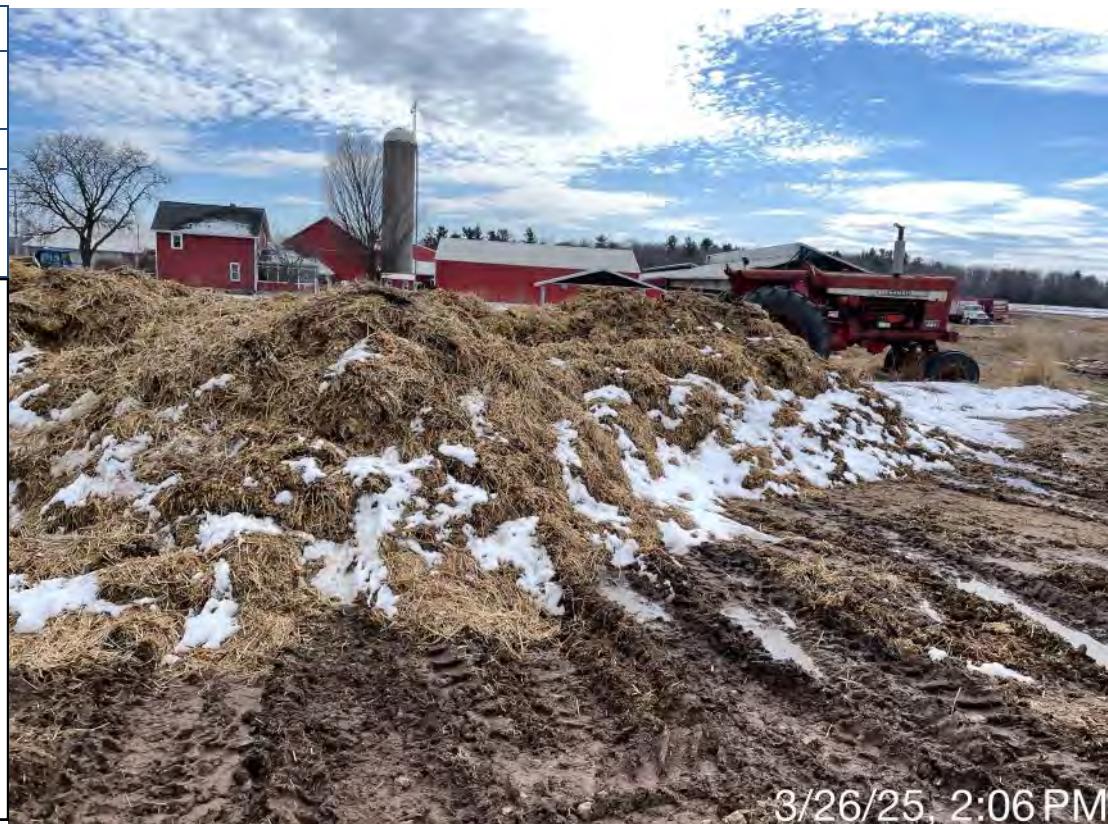
Standing on the west side of the calf hutch area looking south: View of used calf hutch bedding piled on the south side of the calf hutches.

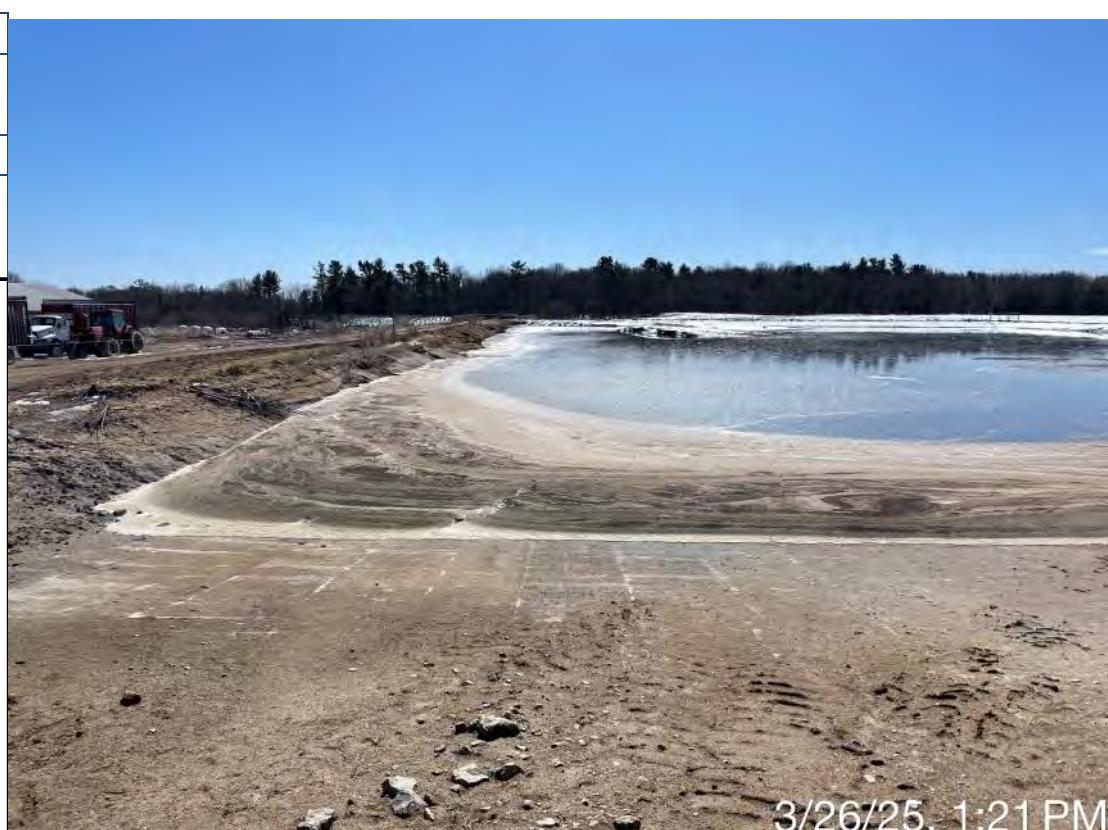
Standing on the north side of WSF #1: View of the northeast corner of WSF #1.

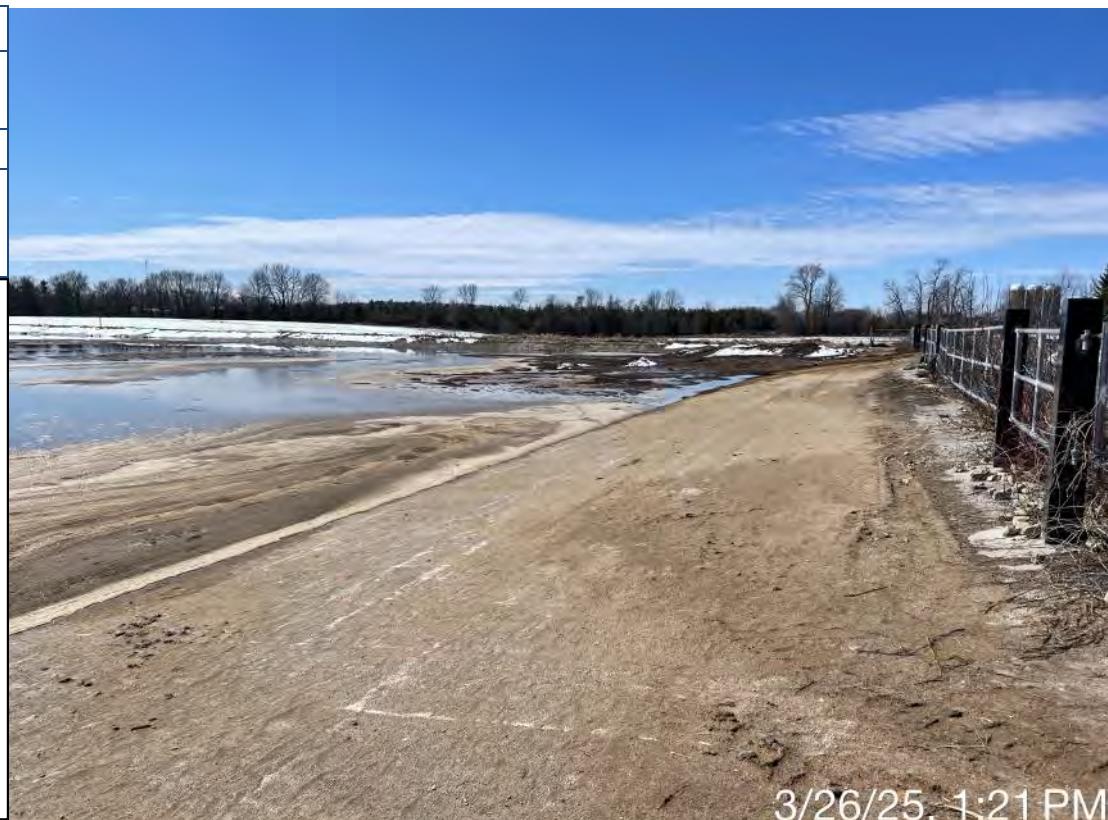
Photo #:	15
Date/Time of Photo:	3/26/2025 13:21
Photo By:	Brian Hanson
Photo Location:	WSF #1
Photo Description:	
Standing on the north side of WSF #1 looking west: View of north end of WSF #1. Notice entire north side slope can be used as a ramp to enter the facility.

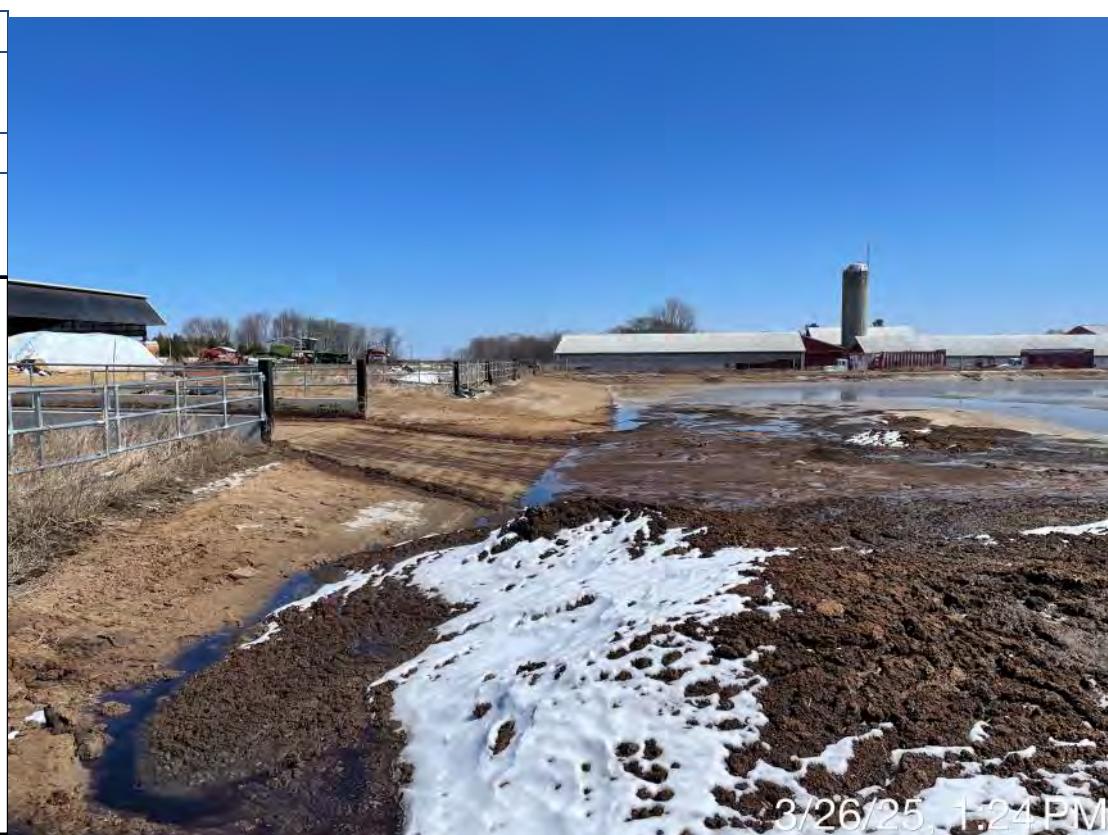
Photo #:	16
Date/Time of Photo:	3/26/2025 13:21
Photo By:	Brian Hanson
Photo Location:	WSF #1
Photo Description:	
Standing on the west side of WSF #1 looking east: Alternate view of the north end of WSF #1. Notice heifer barn push off alley on left side of photo.

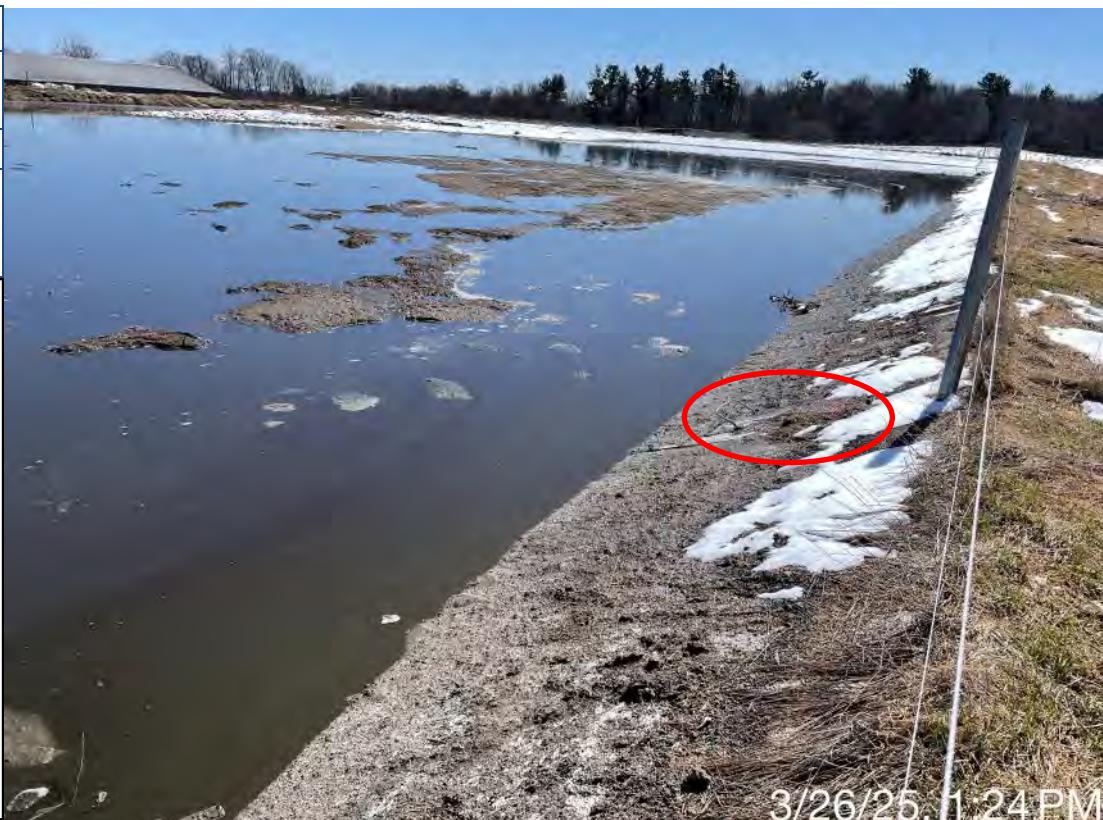
Photo #:	17
Date/Time of Photo:	3/26/2025 13:24
Photo By:	Brian Hanson
Photo Location:	WSF #1
Photo Description:	
Standing on the west side of WSF #1 looking south: View of the west side of WSF #1. Highlighted area shows location of markers in photo #18

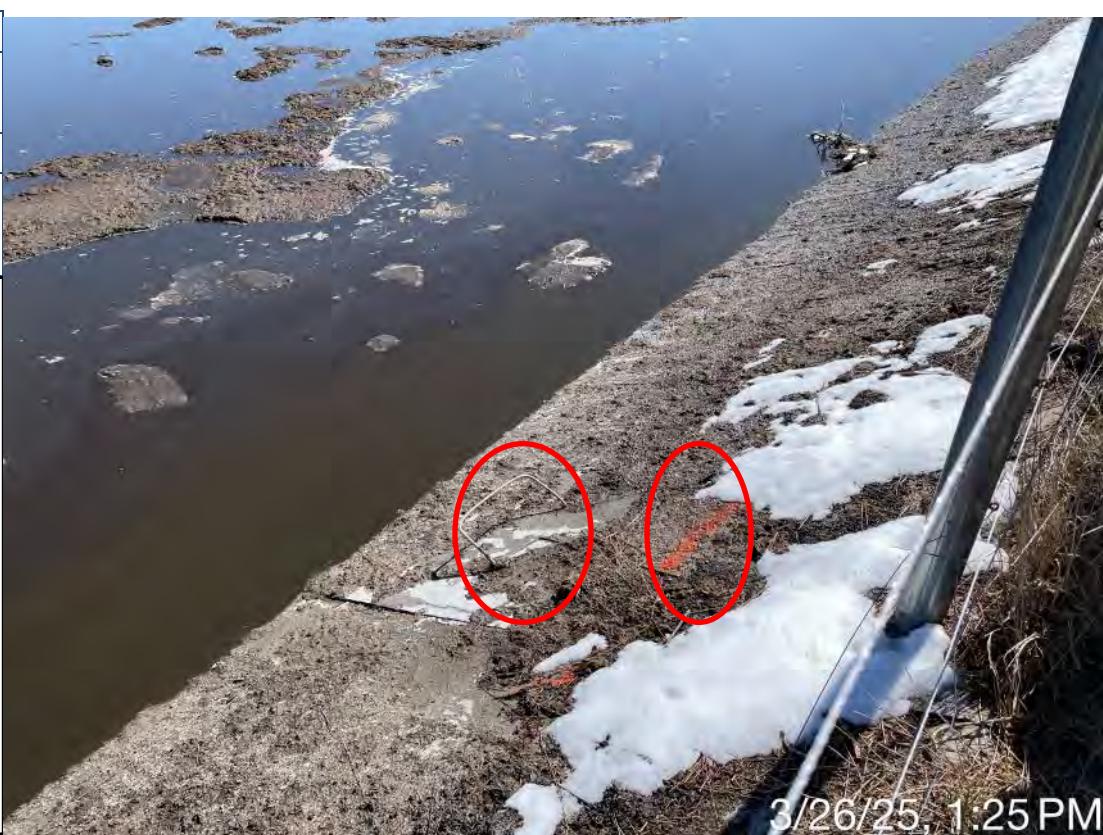
WSF #1 appears to be in good repair, but evidence implies that it may have been operating over the maximum operating level or may have overtopped in the recent past.

Photo #:	18
Date/Time of Photo:	3/26/2025 13:25
Photo By:	Brian Hanson
Photo Location:	WSF #1
Photo Description:	
Standing on the west side of WSF #1 looking south & down: View of MOL & MOS markers. Base of rebar meant to be MOL and orange line meant to be MOS.

During an inspection that occurred on March 26, 2025, the department observed WSF #1 and concluded that Margin of Safety & Maximum Operating Level markers were not present. Installation of these markers has been included to ensure the WSF #1 complies with the applicable design requirements in s. NR 243.15 (3) (e).

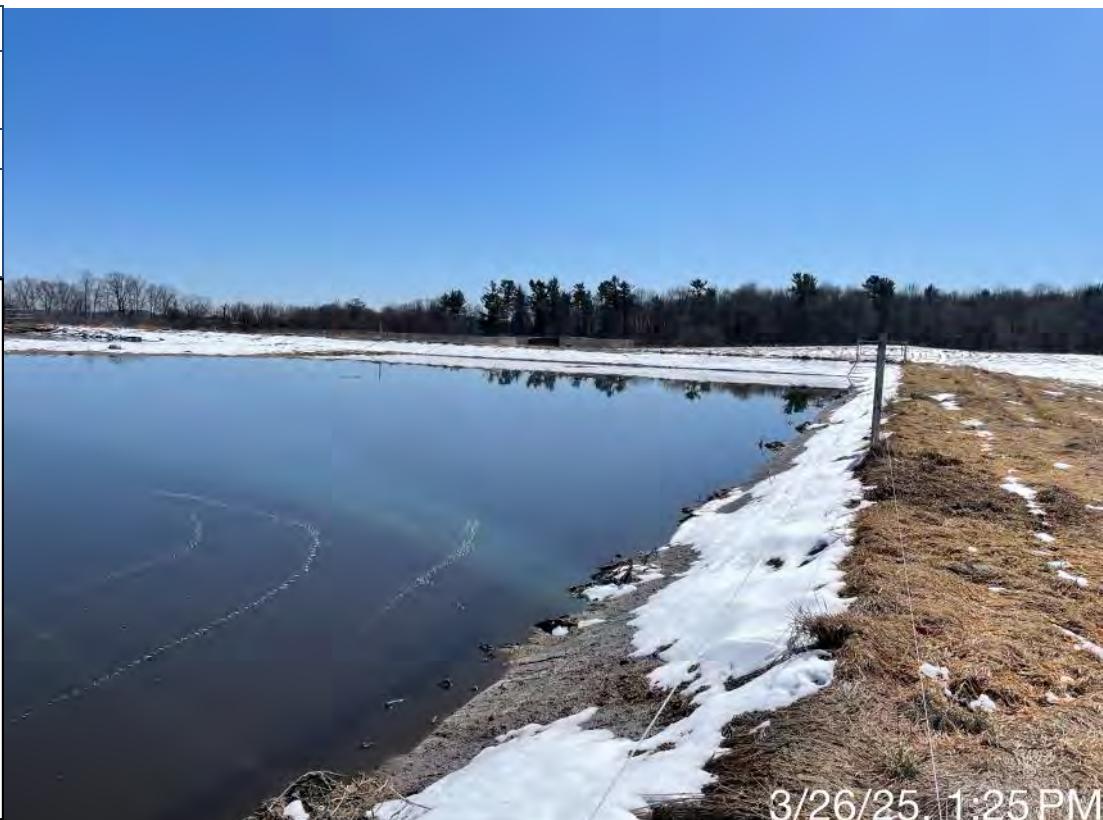
Photo #:	19
Date/Time of Photo:	3/26/2025 13:25
Photo By:	Brian Hanson
Photo Location:	WSF #1
Photo Description:	
Standing on the west side of WSF #1 looking south: View of southwest corner of WSF #1

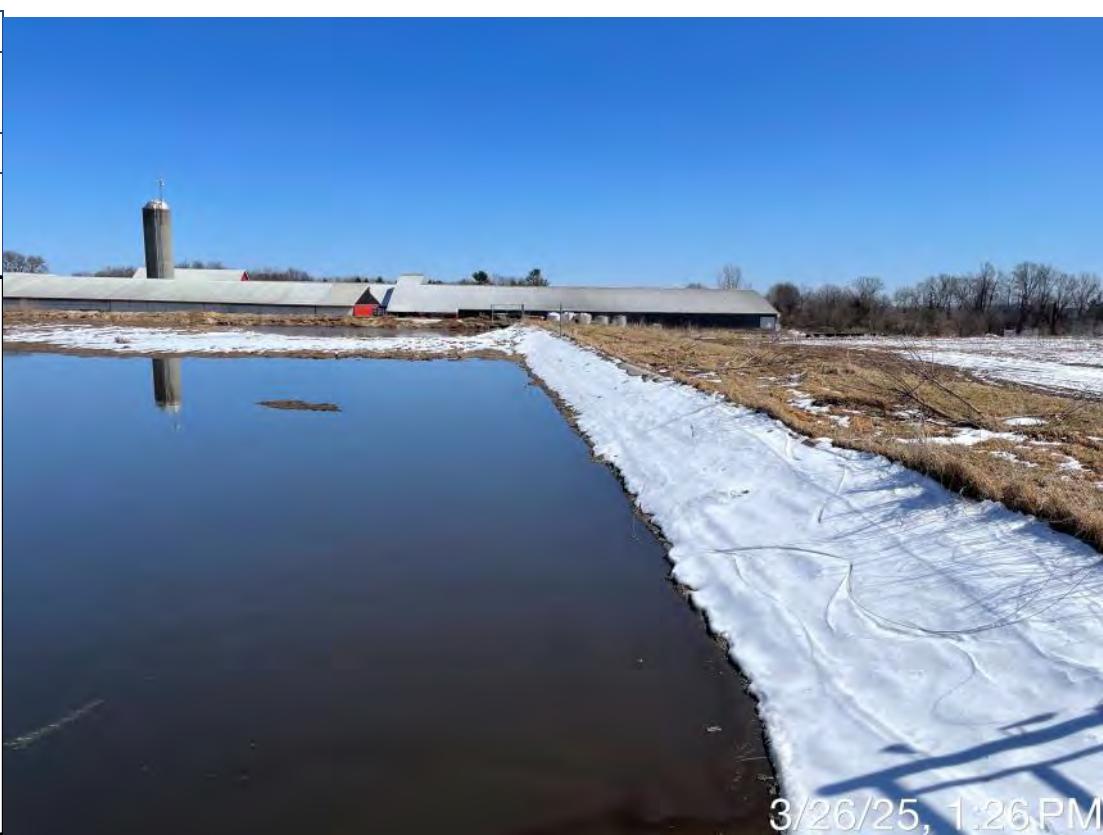
Photo #:	20
Date/Time of Photo:	3/26/2025 13:26
Photo By:	Brian Hanson
Photo Location:	WSF #1
Photo Description:	
Standing on west side of WSF #1 looking east: View of south edge of WSF #1

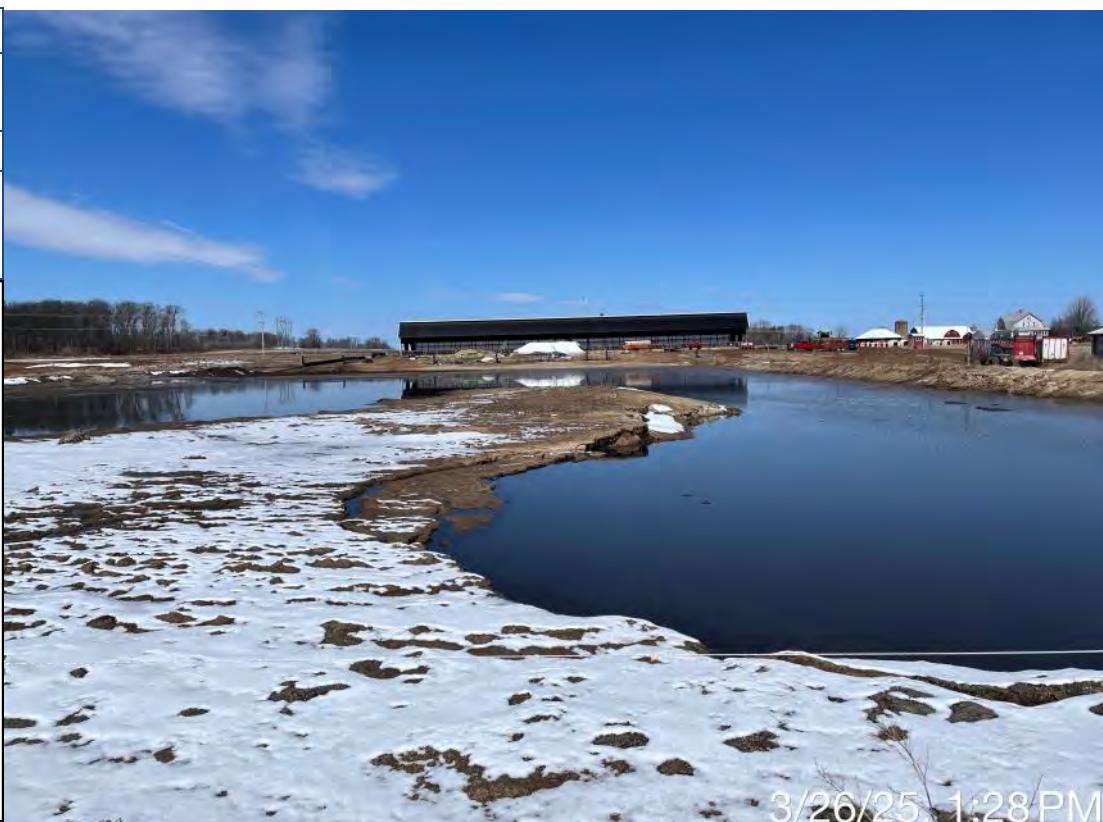
Photo #:	21
Date/Time of Photo:	3/26/2025 13:28
Photo By:	Brian Hanson
Photo Location:	WSF #1
Photo Description:	
Standing on the south side of WSF #1 looking north: View of south end of WSF #1 near transfer pipe outlet. Notice sand berm in south end of WSF #1 that was not removed last fall.
