Permit Fact Sheet

Permit Number	WI-0067617-01-0
Permittee Name and Address	Bakake Acres LLC E8885 Worm Rd, New London, WI 54961
Permitted Facility Name and Address	Bakake Acres LLC E8865 County Road T, New London, WI 54961
Permit Term	March 01, 2026 to February 28, 2031
Receiving Water	Unnamed tributary within the Partridge Lake - Wolf River Watershed, and groundwaters of the state
Discharge Type	Existing source CAFO per NR 243.03(23) as the animal feeding operation was in existence on the site prior to April 14, 2003.

Brief Facility Description: Bakake Acres LLC is a proposed Concentrated Animal Feeding Operation (CAFO) that is owned & operated by Grady Auer. The department is required Bakake Acres LLC to apply for a WPDES permit per s. NR 243.25 (2) Wis. Admin. Code. for failing to implement corrective measures of a previously issued Notice of Discharge. Bakake Acres LLC consists of 1 site located at E8865 County Road T, New London, WI 54961. . Bakake Acres LLC currently in herd size consists of 504 animal units (303 milking & dry cows, 80 heifers & 60 calves) and is not proposing to expand during the upcoming permit term. Bakake Acres LLC currently produces approximately 5.3 m

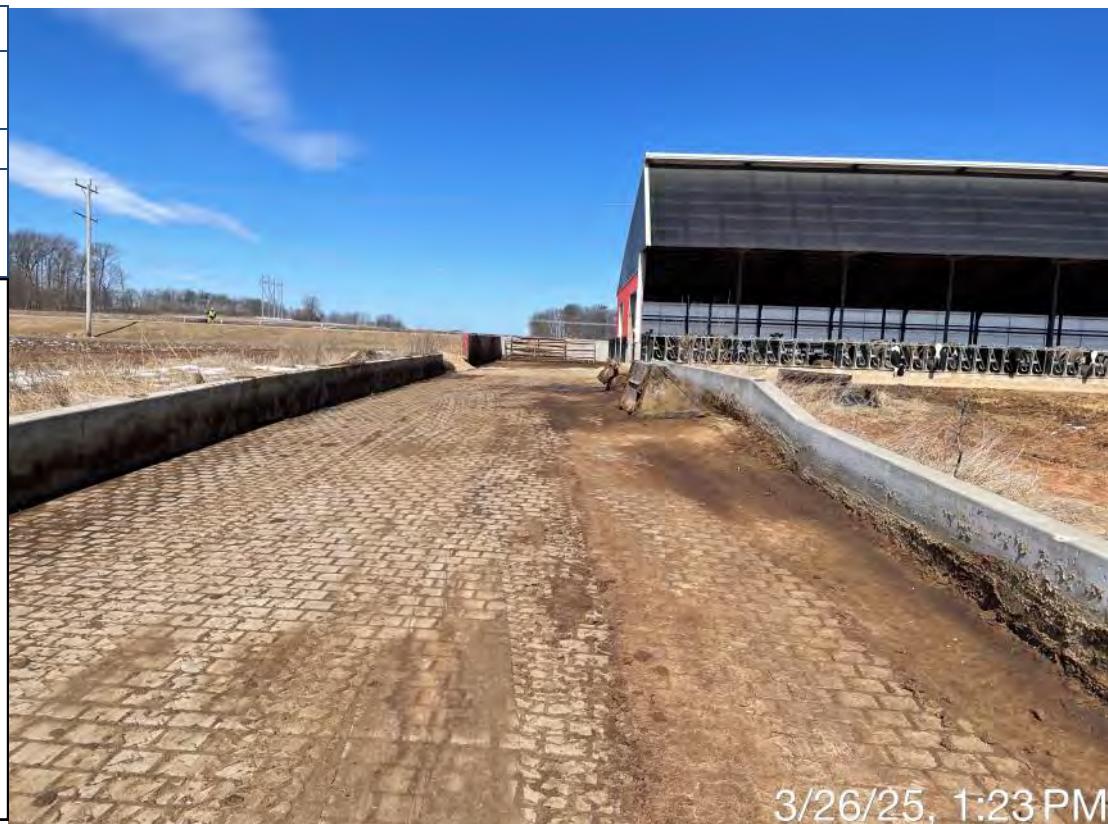
Photo #:	23
Date/Time of Photo:	3/26/2025 13:23
Photo By:	Brian Hanson
Photo Location:	Heifer Barn Scrape Alley

Standing on the north side of WSF #1 looking north: View of concrete scrape ally used to transfer manure from the heifer barn to WSF 1.

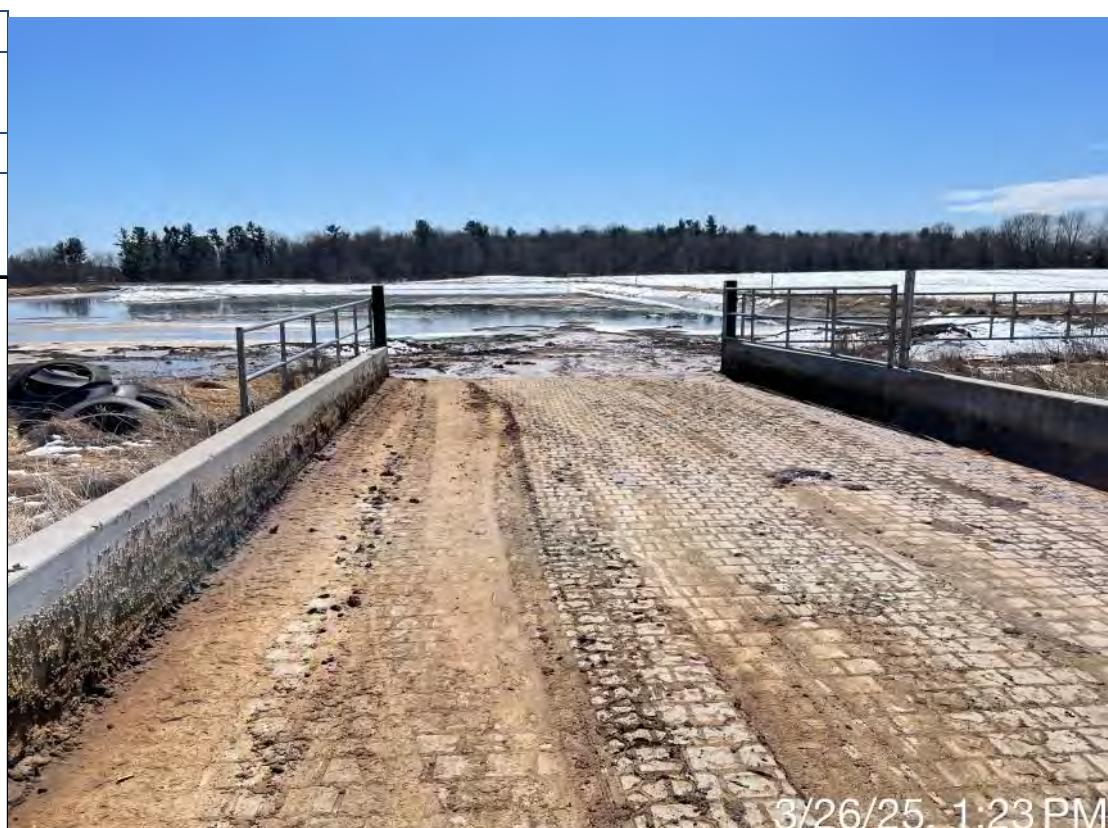
Same location as photo #23 looking south: View of scrape alley as it enters WSF #1

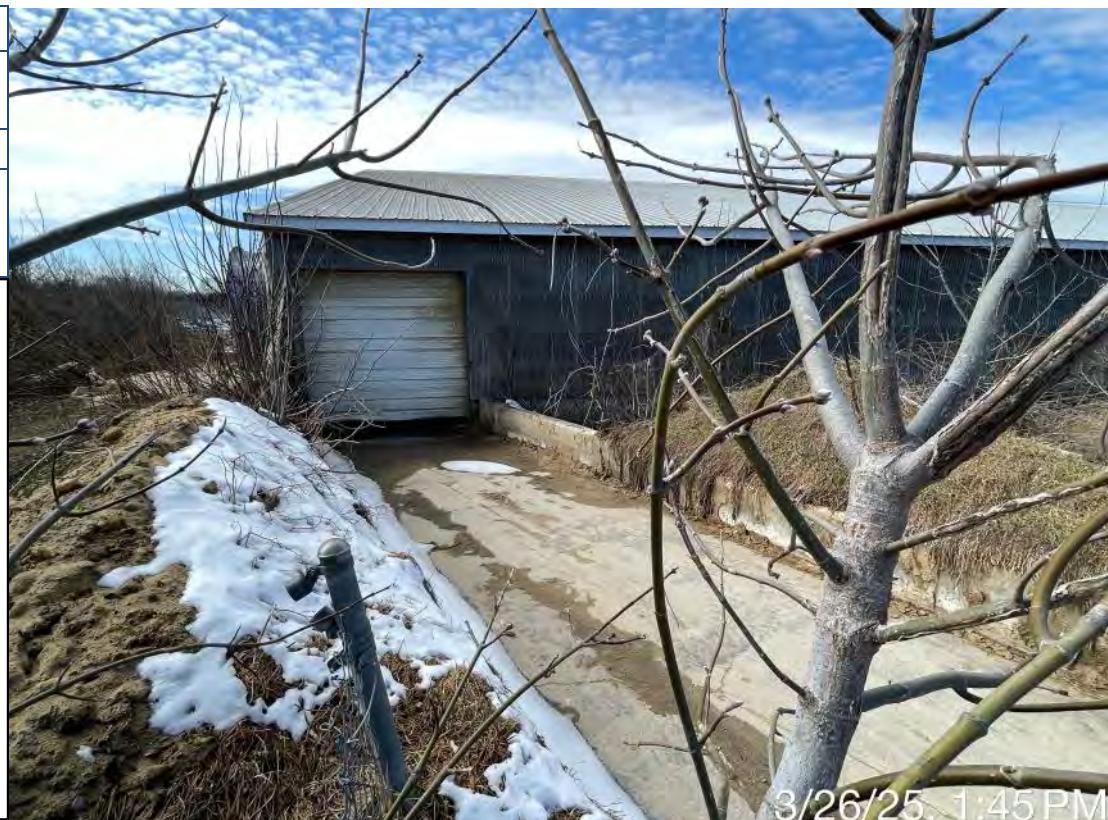
Standing on the south side of WSF #2 looking west: View of manure push in channel from main freestall barn. This is an extension of the alley shown in photo #1. Farm no longer uses this channel as all manure is now pumped to WSF #1.

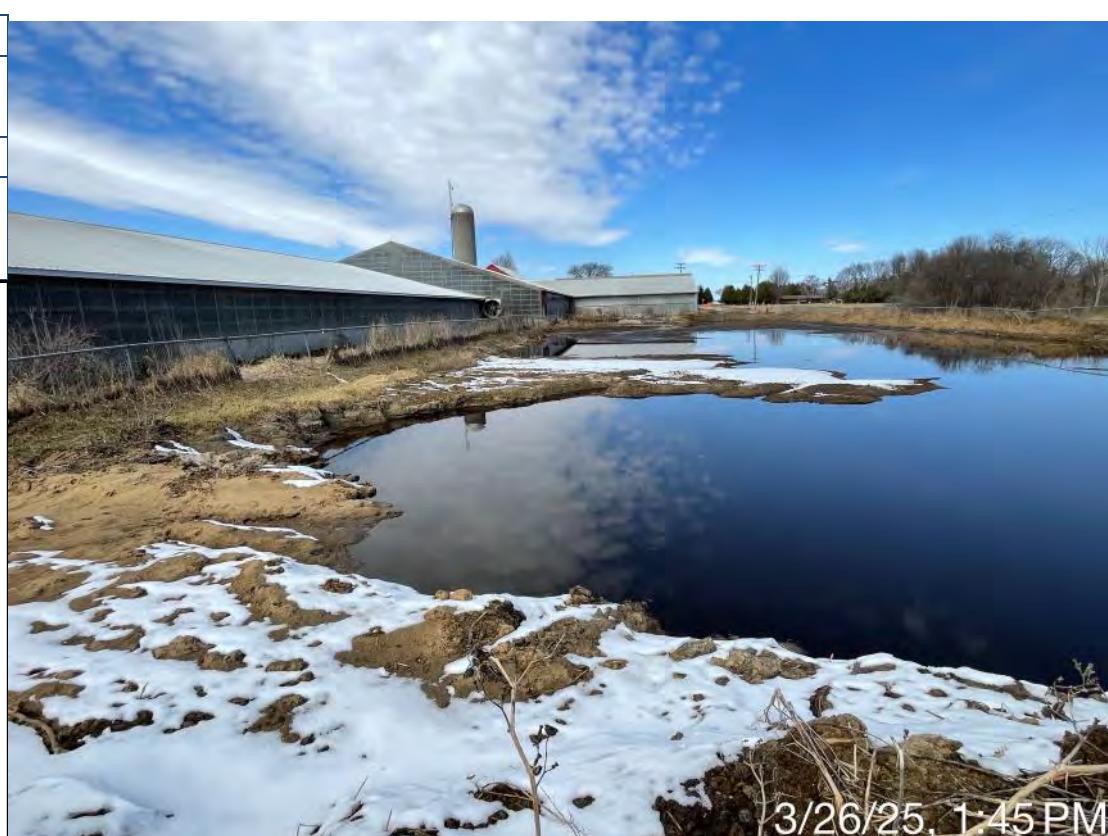
Photo #:	26
Date/Time of Photo:	3/26/2025 13:45
Photo By:	Brian Hanson
Photo Location:	WSF #2

Standing on the south side of WSF #2 looking north: View of south west corner of WSF #2. Notice solids accumulation along south & west sides of WSF #2.

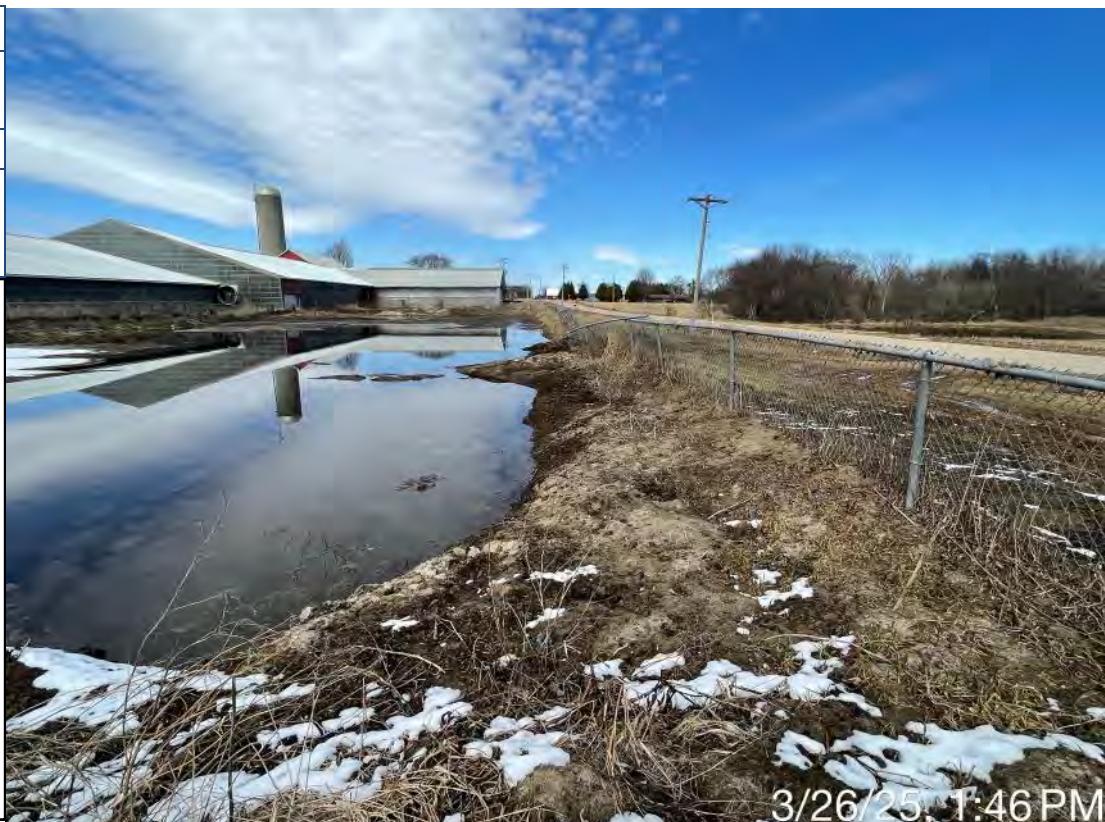
WSF #2 appears to be in good repair, but evidence implies that it may have been operating over the maximum operating level or may have overtopped in the recent past.

Photo #:	27
Date/Time of Photo:	3/26/2025 13:46
Photo By:	Brian Hanson
Photo Location:	WSF #2
Photo Description:	Standing on the south side of WSF #2 looking north: View of southeast corner of WSF #2. Notice manure solids up against the wire fence above the top of the WSF.

- Waste Storage Facilities show signs of past overtopping. Continue to monitor manure levels in both pits to prevent future overtopping events.
- The concrete cattle walkway between the small freestall barn & the main freestall barn does not have engineered runoff controls. Manure laden runoff was observed leaving the concrete area and entering the stormwater culvert. The farm should continue to monitor the cattle walkway area to look for areas of possible discharge. Where discharge is occurring , the farm should install interim best management practices to prevent a discharge to waters of the state until permanent controls are installed.

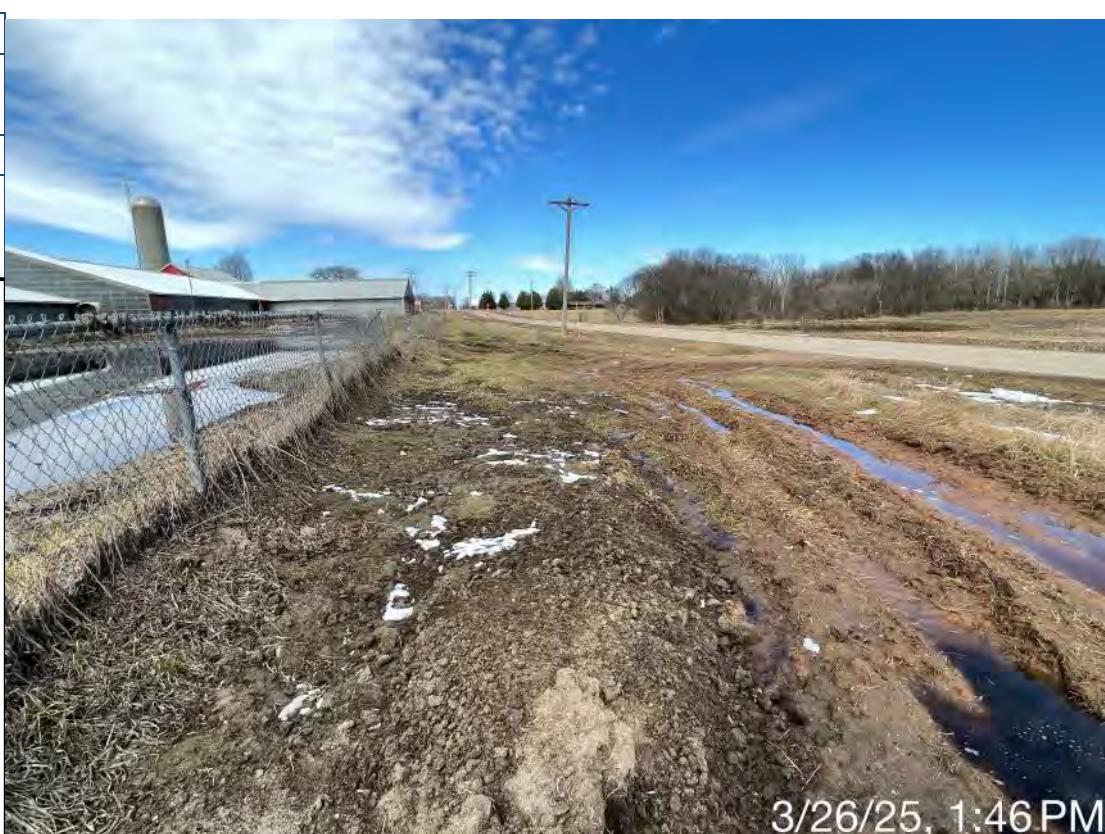
Photo #:	28
Date/Time of Photo:	3/26/2025 13:46
Photo By:	Brian Hanson
Photo Location:	WSF #2
Photo Description:	Standing on the east side of WSF #2 looking north: View of exterior side slope of WSF #2 at same location as photo #27. Notice manure solids and ponded runoff present outside of WSF.

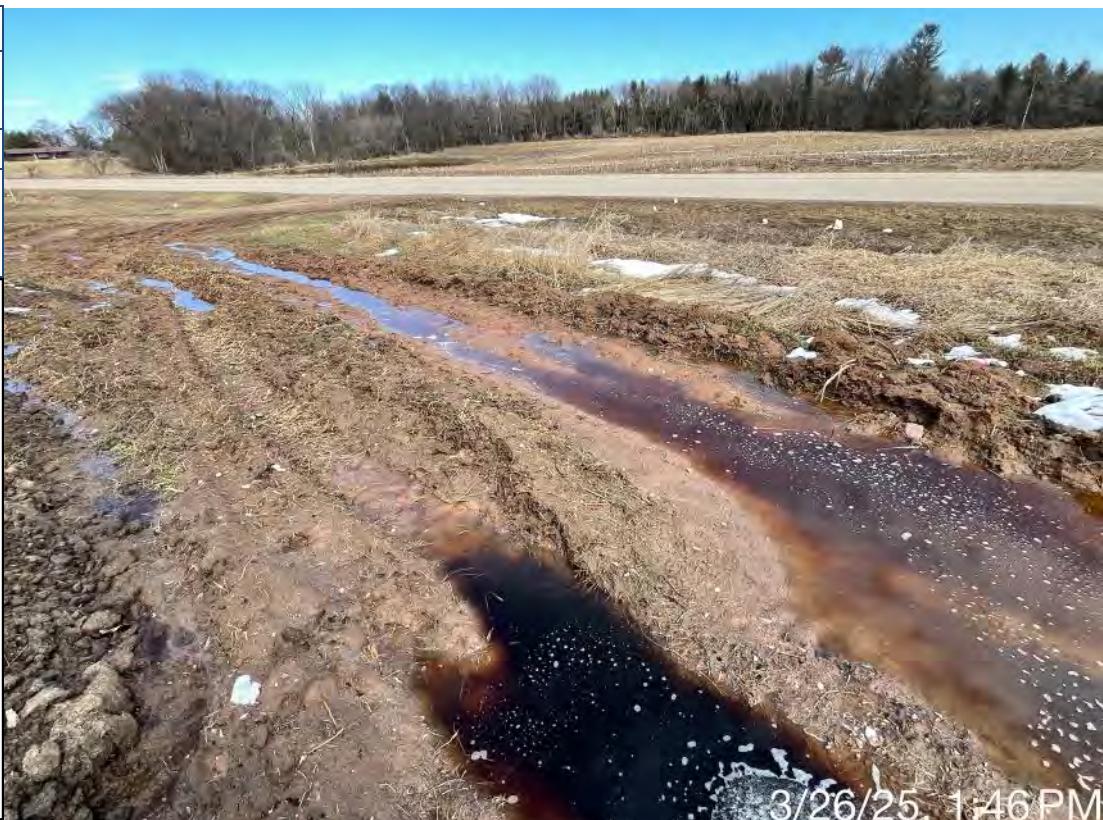
Photo #:	29
Date/Time of Photo:	3/26/2025 13:46
Photo By:	Brian Hanson
Photo Location:	WSF #2
Photo Description:	
Standing on the east side of WSF #2 looking northeast: Close up view of ponded runoff in photo #28. Notice very dark color consistent with manure runoff.

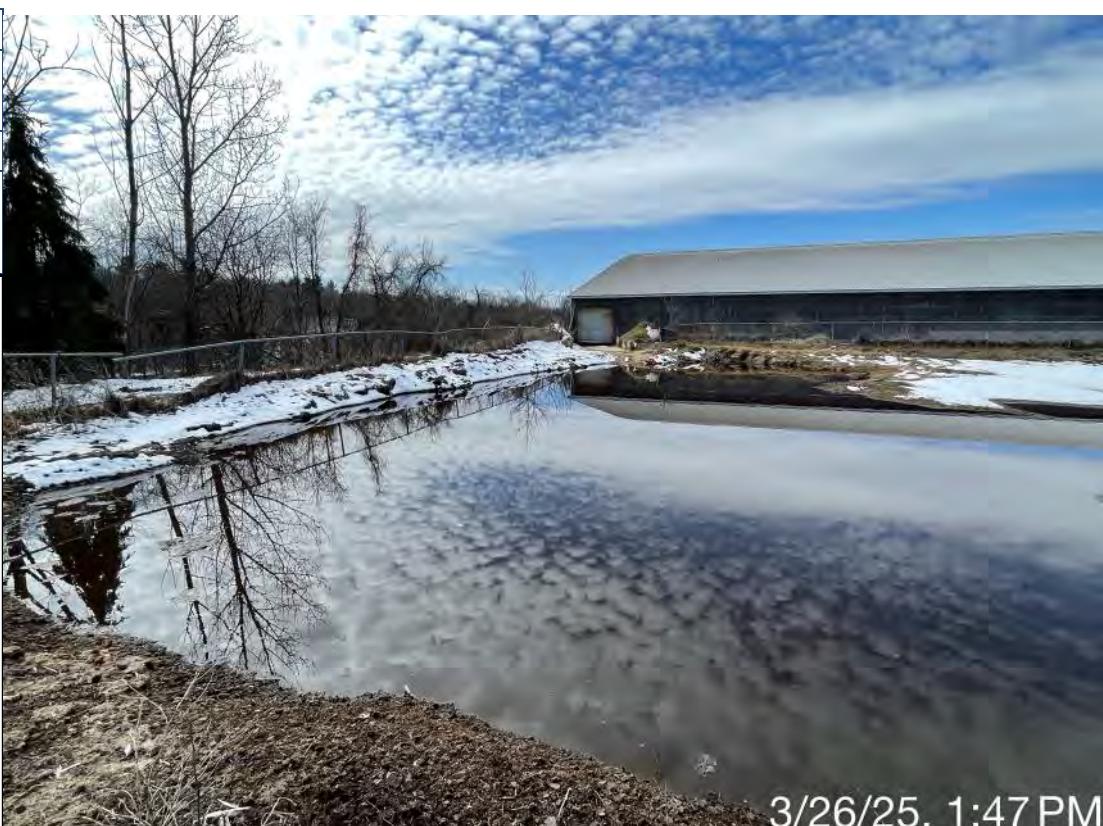
Photo #:	30
Date/Time of Photo:	3/26/2025 13:47
Photo By:	Brian Hanson
Photo Location:	WSF #2
Photo Description:	
Standing on the east side of WSF #2 looking southwest: View of south edge of WSF #2. Notice push in ramp shown in photo #25.

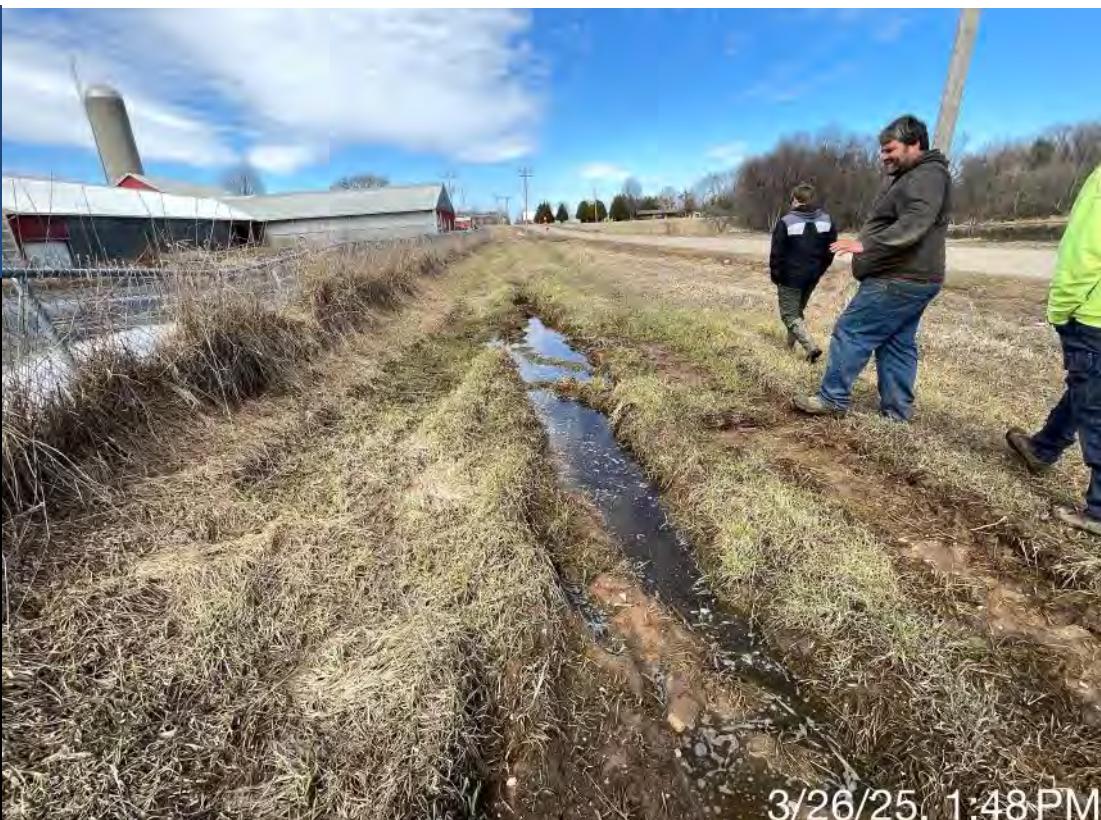
Photo #:	31
Date/Time of Photo:	3/26/2025 13:48
Photo By:	Brian Hanson
Photo Location:	WSF #2
Photo Description:	Standing on the east side of WSF #2 looking north: View of more ponded runoff on east side of WSF #2. Notice dark color consistent with manure runoff.

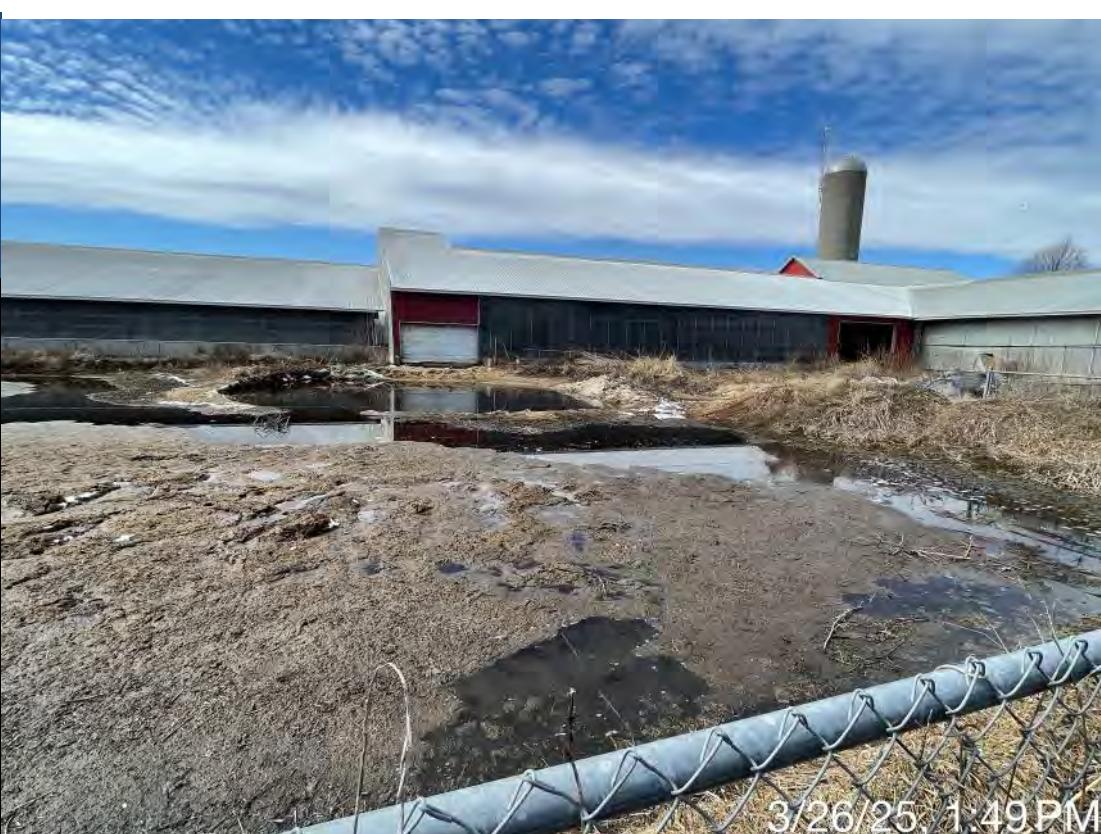
Photo #:	32
Date/Time of Photo:	3/26/2025 13:49
Photo By:	Brian Hanson
Photo Location:	WSF #2
Photo Description:	Standing on east side of WSF #2 looking west: View of north edge of WSF #2.

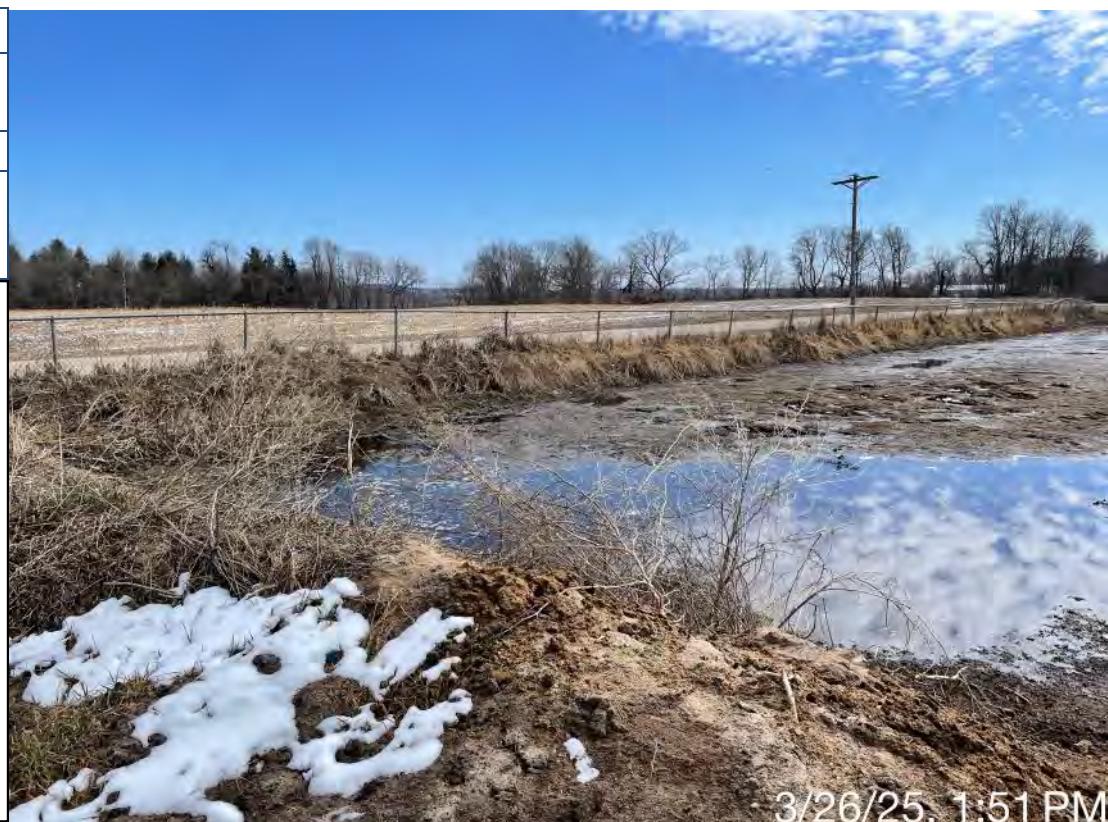
Photo #:	33
Date/Time of Photo:	3/26/2025 13:51
Photo By:	Brian Hanson
Photo Location:	WSF #2
Photo Description:	Standing on the north side of WSF #2 looking southeast: View of northeast corner of WSF #2.

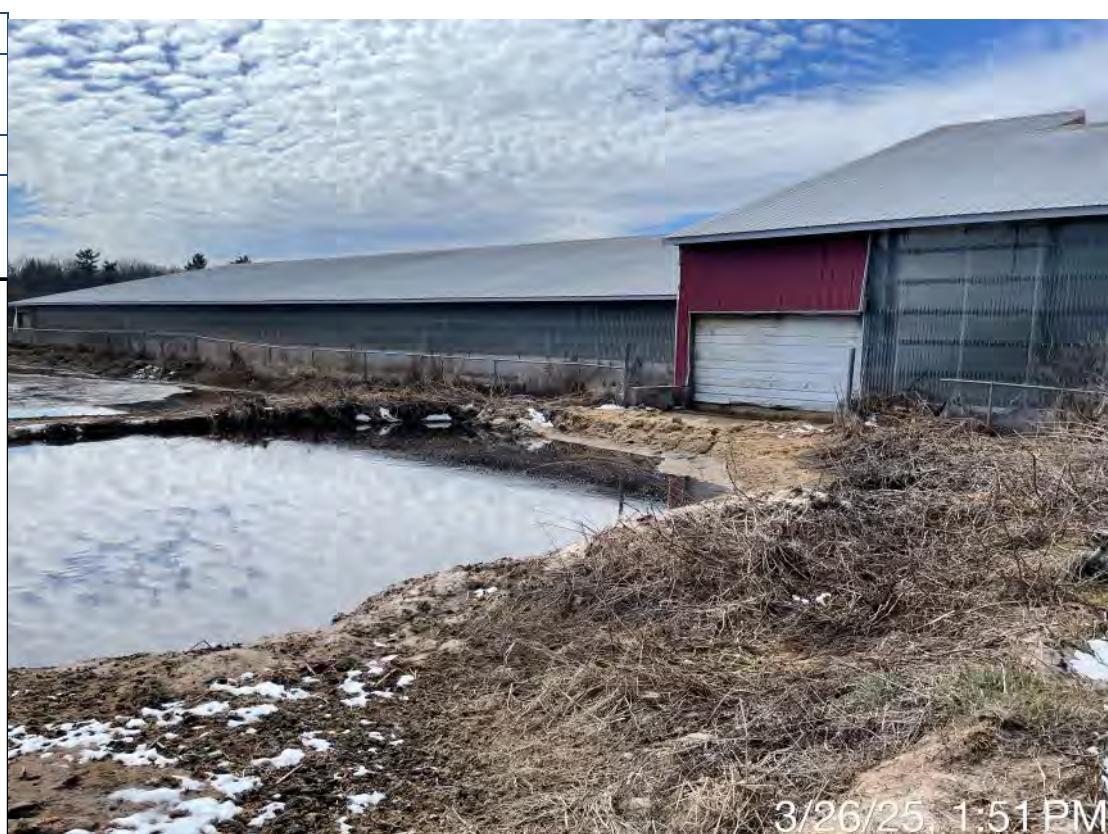
Photo #:	34
Date/Time of Photo:	3/26/2025 13:51
Photo By:	Brian Hanson
Photo Location:	WSF #2
Photo Description:	Standing on the north side of WSF #2 looking southwest: View of northwest corner of WSF #2.

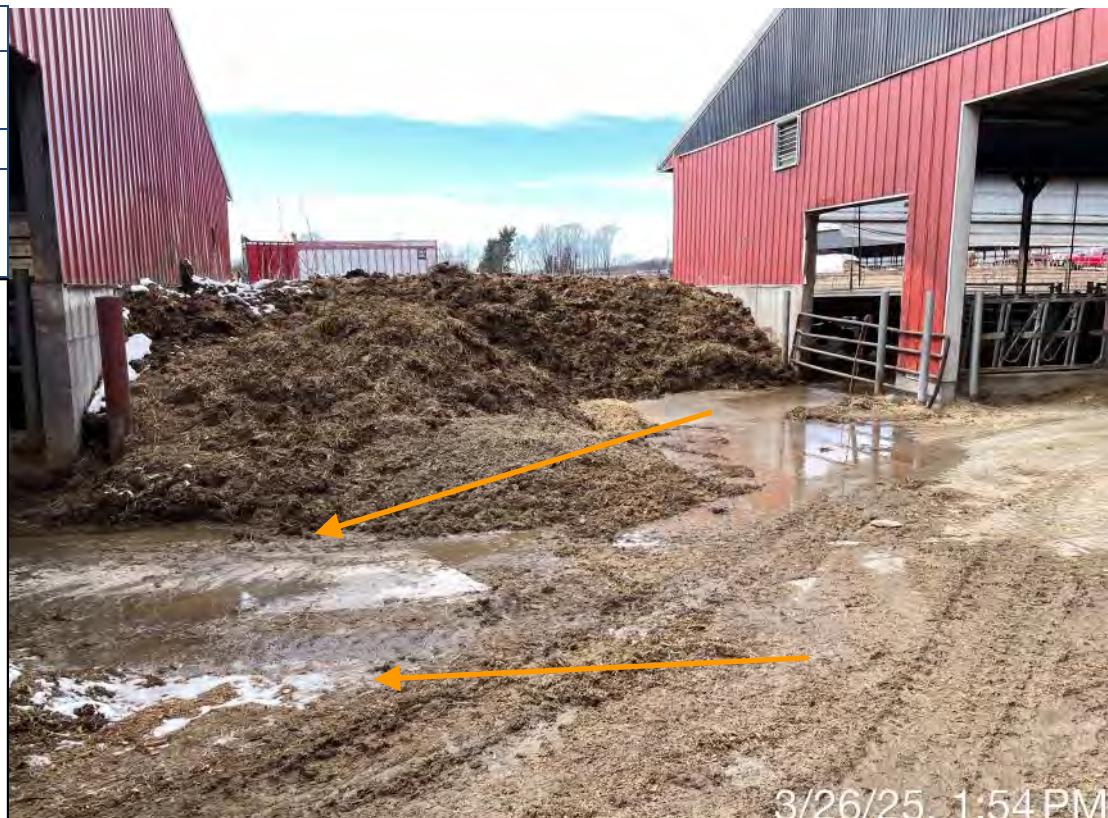
Photo #:	35
Date/Time of Photo:	3/26/2025 13:54
Photo By:	Brian Hanson
Photo Location:	Solids Stacking

Standing on the west side of machine shed looking west: View of concrete area between small freestall barn & heifer barn used to store solid manure. Arrows indicate direction of runoff flow.

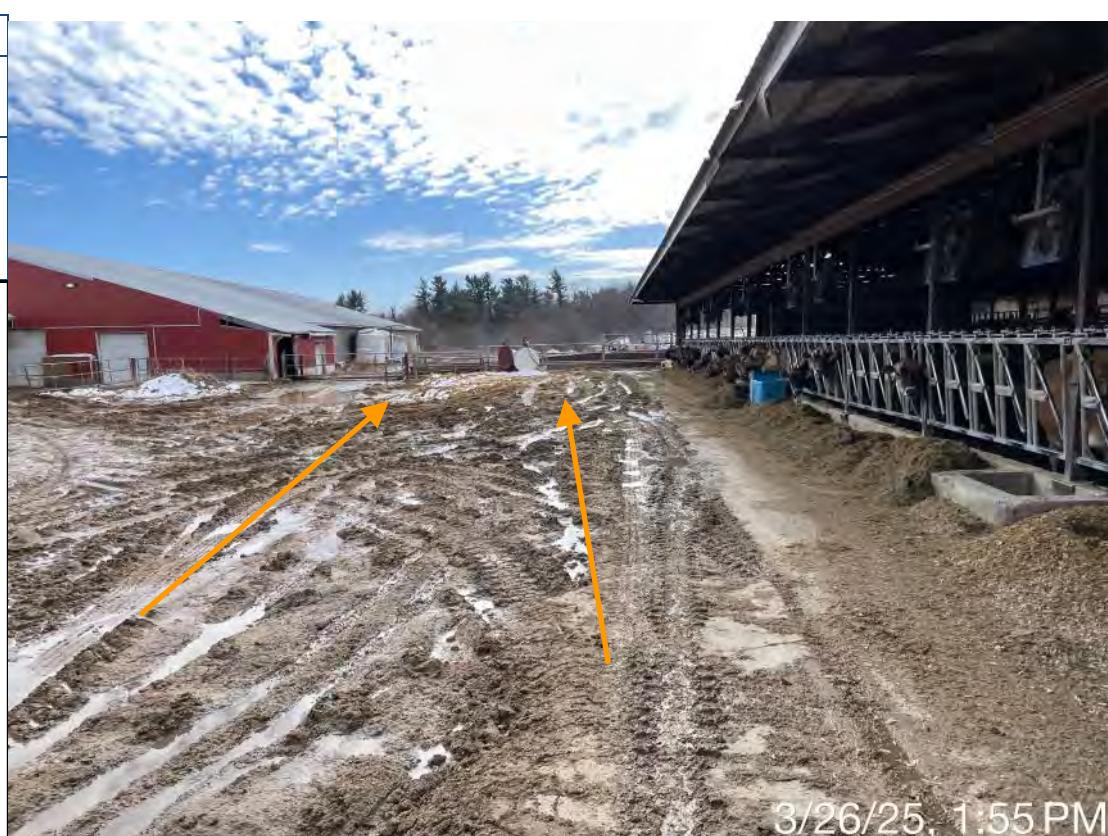
Photo #:	36
Date/Time of Photo:	3/26/2025 13:55
Photo By:	Brian Hanson
Photo Location:	Solids Stacking

Standing on east side of solids stacking area looking south: View of runoff flow path from solids stacking area. Arrows indicate direction of runoff flow. Runoff flows to culvert shown in photo #7.

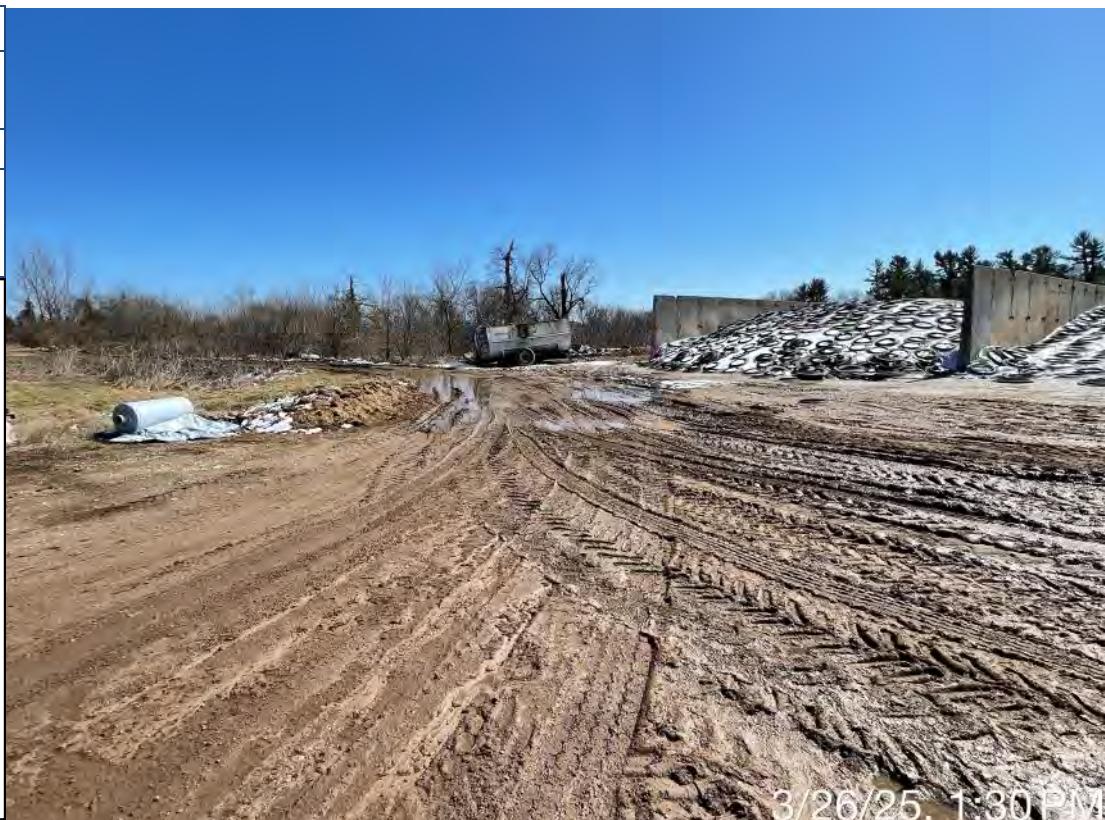
Photo #:	37
Date/Time of Photo:	3/26/2025 13:30
Photo By:	Brian Hanson
Photo Location:	Feed Storage Area
Photo Description:	
Standing on the north side of FSA looking east: View of north side of FSA. Notice lack of runoff controls.

During an inspection that occurred on March 26, 2025, the department observed the Feed Storage Area and concluded that engineered runoff controls were not present. Engineering Plans & Specs of Feed Storage Area Runoff Controls (Sample Point 006) has been included per s. NR 243.15(9) Wis. Admin. Code to ensure the Feed Storage Area complies with the applicable production area requirements in s. NR 243.13 Wis. Admin. Code.

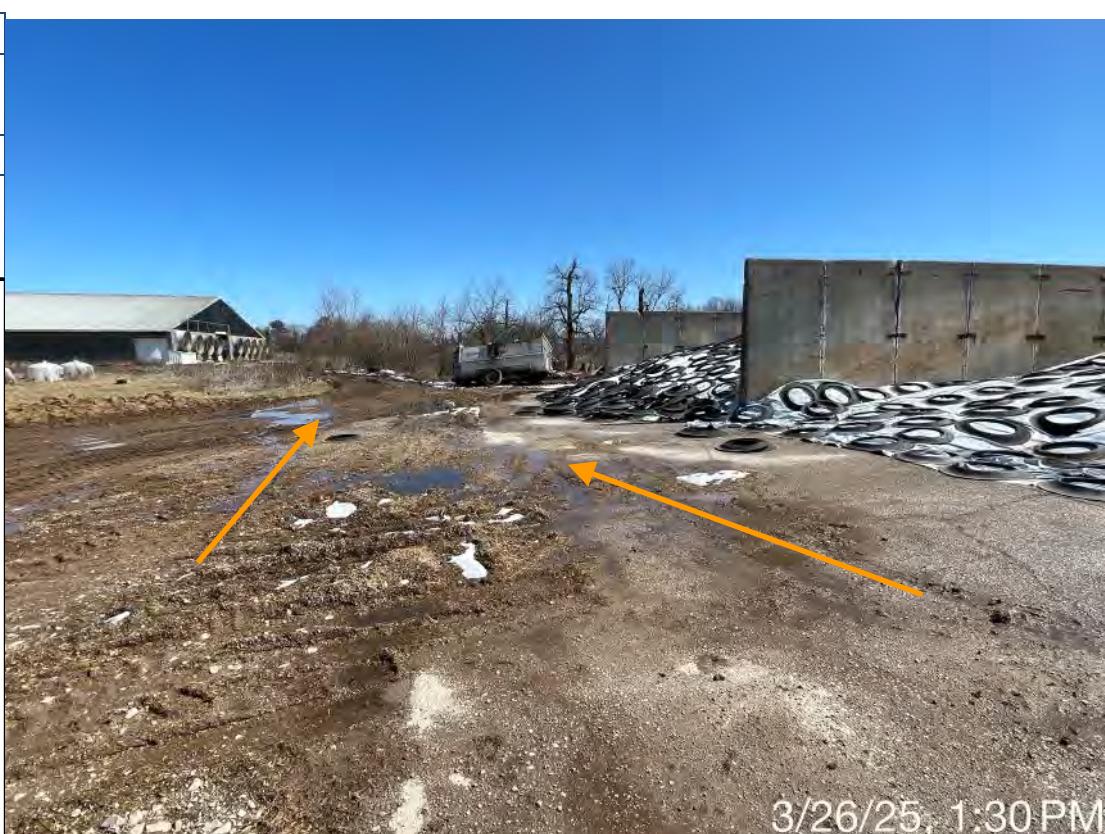
Photo #:	38
Date/Time of Photo:	3/26/2025 13:30
Photo By:	Brian Hanson
Photo Location:	Feed Storage Area
Photo Description:	
Standing on the north side of feed storage area looking east: View of north edge of FSA where runoff enters gravel driveway. Notice dark colored ponded runoff consistent with feed leachate. Arrows indicate direction of runoff flow.

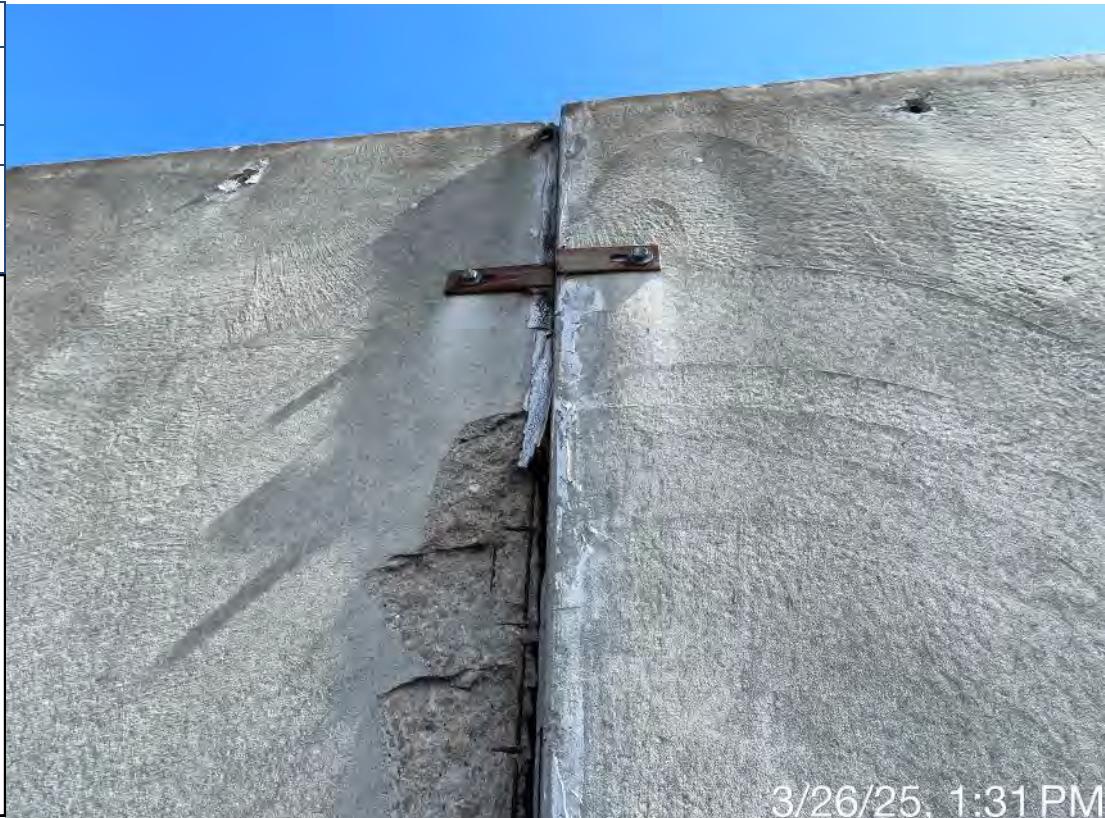
Photo #:	39
Date/Time of Photo:	3/26/2025 13:31
Photo By:	Brian Hanson
Photo Location:	Feed Storage Area

The north 1/2 of the FSA is a set of 2 concrete bunkers. These bunkers are generally sloped to the south towards the center drive alley, but due to feed being stored beyond the bunker walls on the north end, leachate and runoff was visible running off the FSA and to the east towards the stormwater channel. The bunker walls on this section looked quite old and had multiple areas where the concrete was cracked and the straps holding them together were broken.

Standing on the west side of FSA north bunkers looking east & up: View of bunker wall connection. Notice bunker walls are deteriorating and connection straps are broken.

Required Action	Due Date
Retain Qualified Expert: The permittee shall retain a qualified expert to complete an engineering evaluation for the permanent feed storage area and report the name of the expert to the Department.	06/30/2026
Written Description of Existing System: Submit an engineering evaluation that includes a written description of the existing feed storage area and its adequacy to meet the conditions found in the Production Area Discharge Limitations subsection and NR 243.15, Wis. Adm. Code.	12/31/2026
Plans and Specifications: Submit plans and specifications for Department review and approval to	09/30/2027

permanently correct any adverse conditions identified as part of the engineering evaluation for the feed storage area in accordance with Chapter 281.41, Wis. Stats., and Chapter NR 243, Wis. Adm. Code.	
Corrections and Post Construction Documentation: Complete construction of improvements to permanently correct any adverse conditions in concurrence with and approval by the Department, by the specified Date Due. Submit post construction documentation within 60 days of completion of the project.	06/30/2028

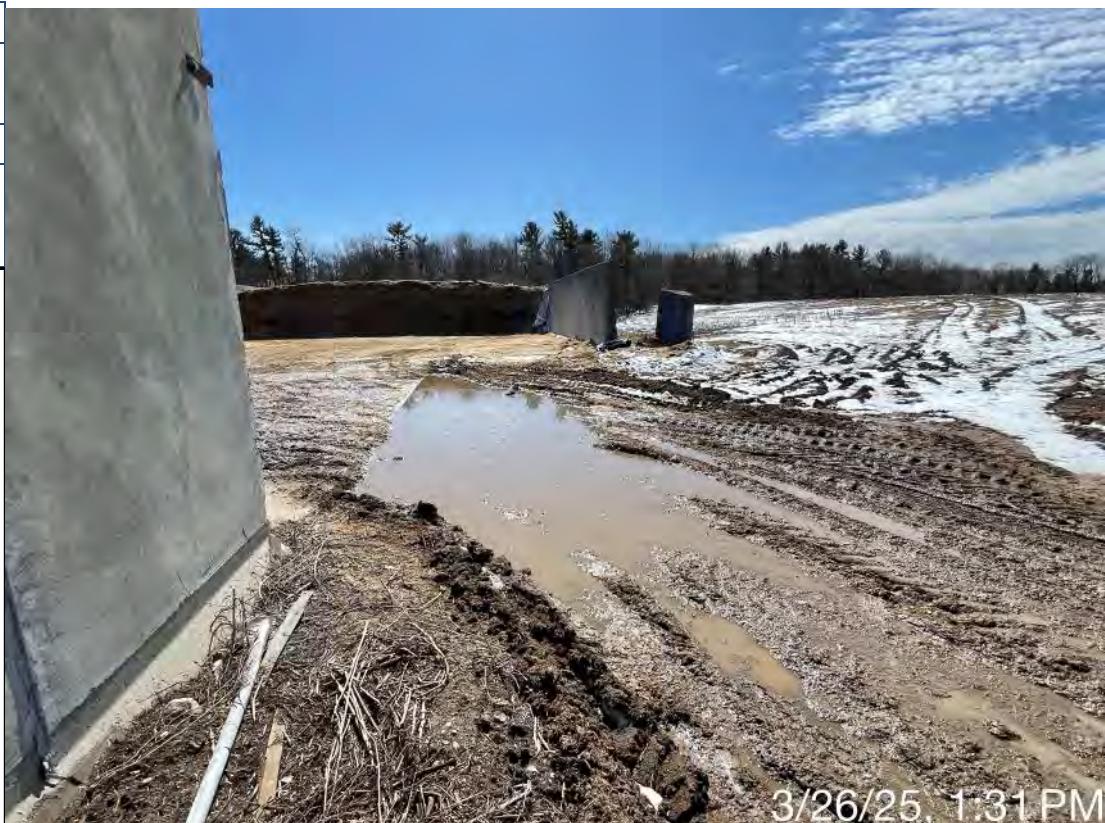
Standing on the west side of FSA looking south: View of west edge of FSA between the 2 sets of bunker walls.

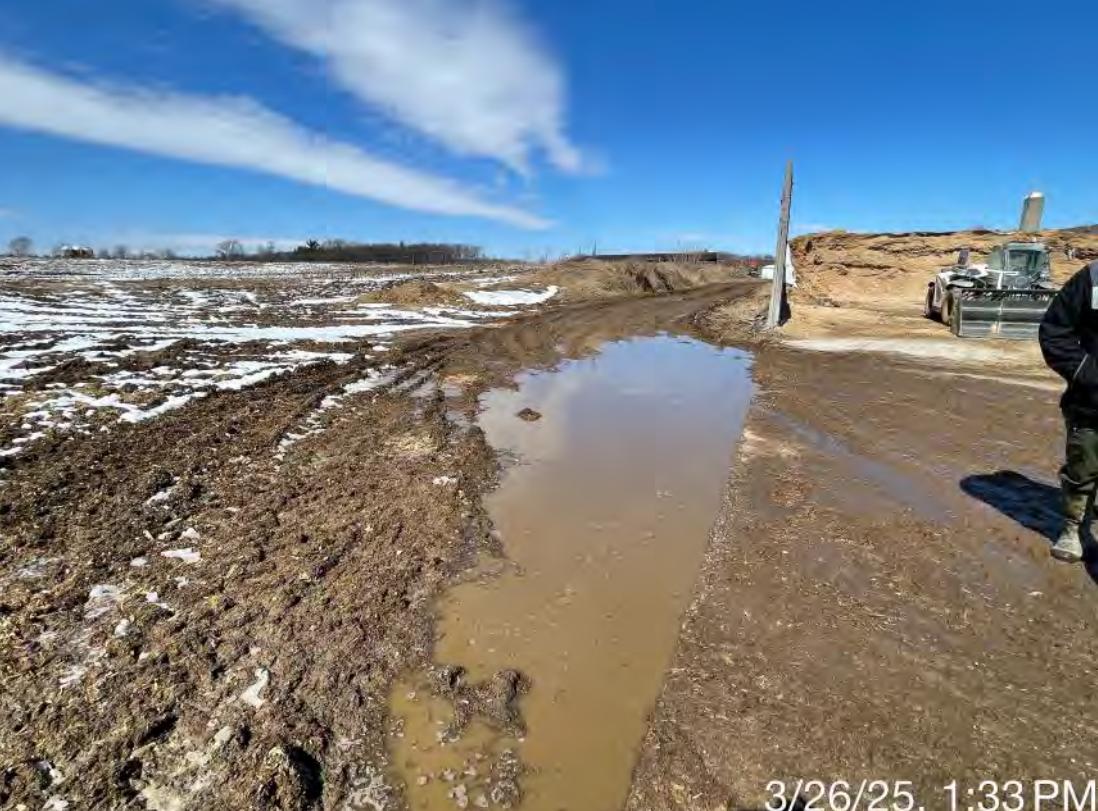
Photo #:	43
Date/Time of Photo:	3/26/2025 13:33
Photo By:	Brian Hanson
Photo Location:	Feed Storage Area
Photo Description: Standing on the west side of FSA looking north: View of west edge of FSA & north bunker.

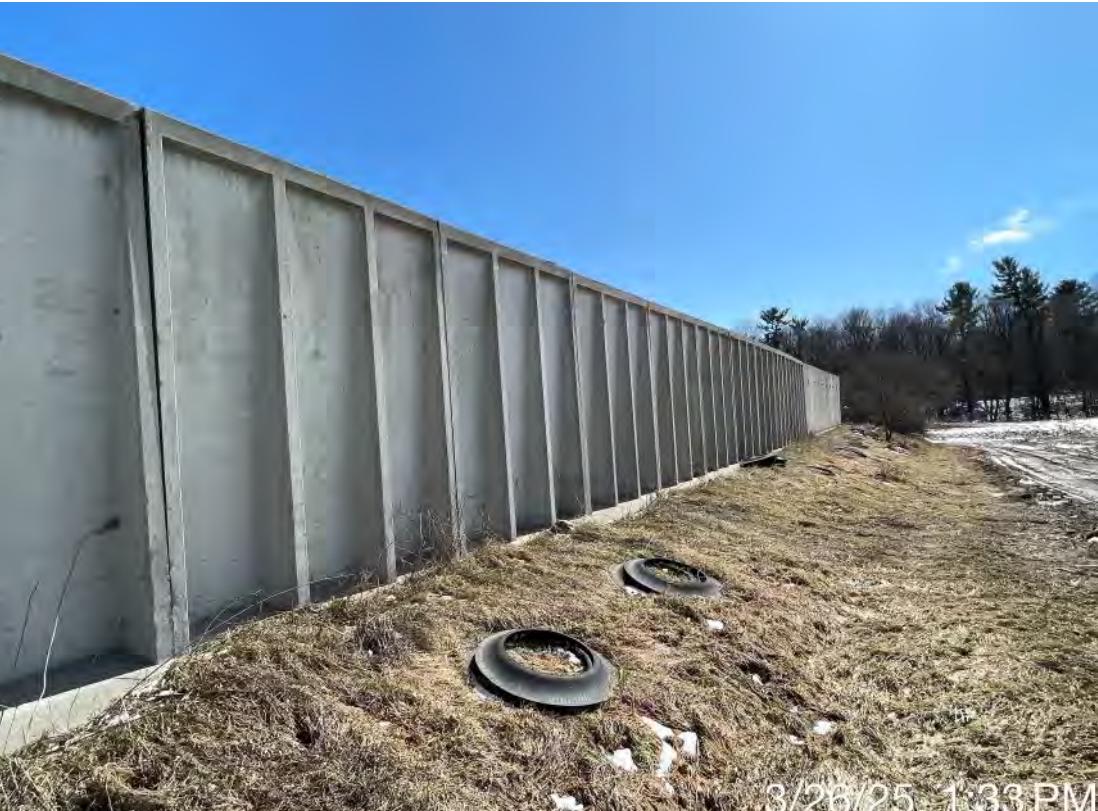
Photo #:	44
Date/Time of Photo:	3/26/2025 13:33
Photo By:	Brian Hanson
Photo Location:	Feed Storage Area
Photo Description: Standing on west side of FSA looking south: View of west wall of south bunker. These bunker walls in much better shape than north bunkers.

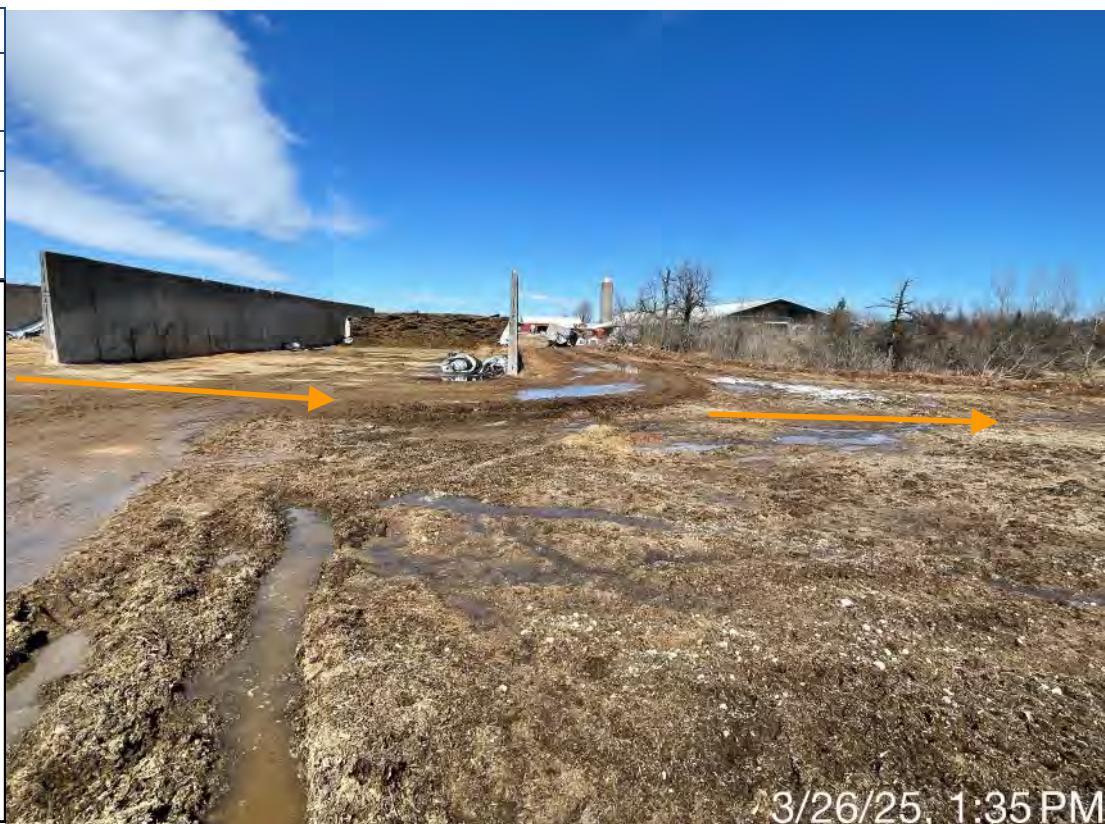
Photo #:	49
Date/Time of Photo:	3/26/2025 13:35
Photo By:	Brian Hanson
Photo Location:	Feed Storage Area

Standing on the east side of FSA looking north: View of east edge of FSA. Notice areas of ponded runoff. Arrows indicate direction of runoff flow.

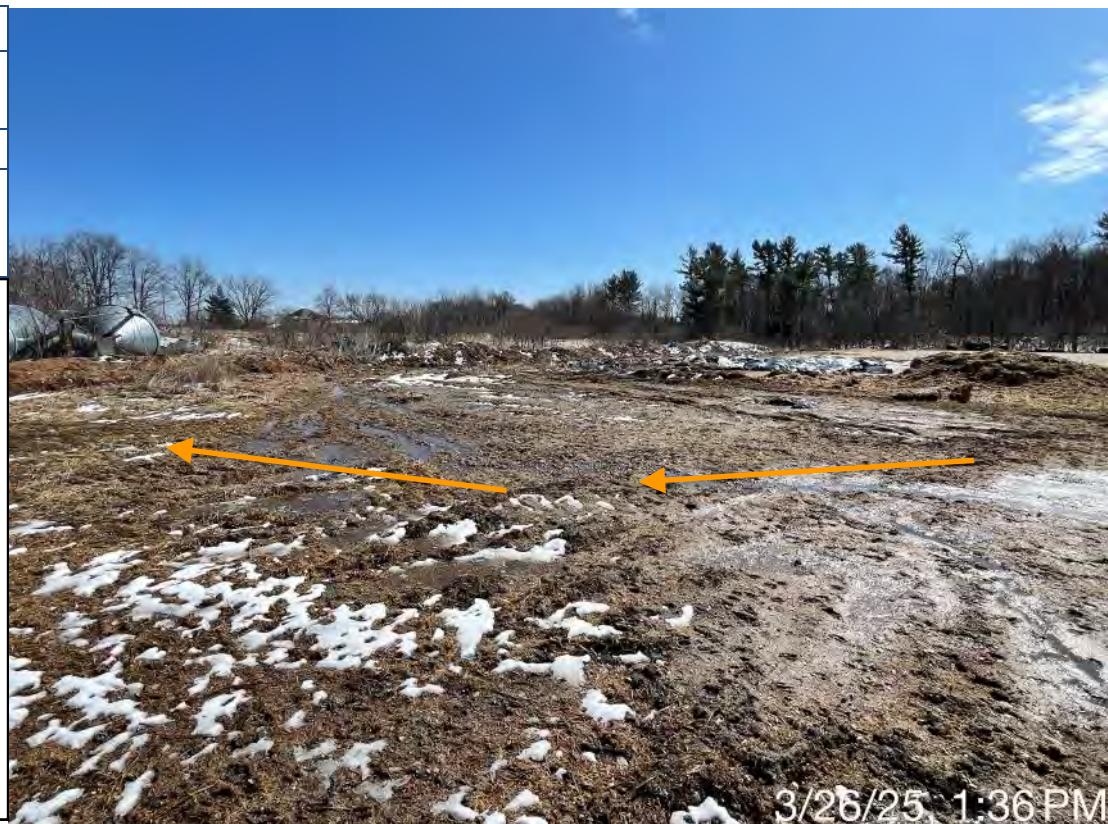
Standing on east side of FSA looking south: View of earthen area east of FSA. Arrows indicate direction of runoff flow.
