Permit Fact Sheet

Permit Number	WI-0067617-01-0
Permittee Name and Address	Bakake Acres LLC E8885 Worm Rd, New London, WI 54961
Permitted Facility Name and Address	Bakake Acres LLC E8865 County Road T, New London, WI 54961
Permit Term	March 01, 2026 to February 28, 2031
Receiving Water	Unnamed tributary within the Partridge Lake - Wolf River Watershed, and groundwaters of the state
Discharge Type	Existing source CAFO per NR 243.03(23) as the animal feeding operation was in existence on the site prior to April 14, 2003.

Brief Facility Description: Bakake Acres LLC is a proposed Concentrated Animal Feeding Operation (CAFO) that is owned & operated by Grady Auer. The department is required Bakake Acres LLC to apply for a WPDES permit per s. NR 243.25 (2) Wis. Admin. Code. for failing to implement corrective measures of a previously issued Notice of Discharge. Bakake Acres LLC consists of 1 site located at E8865 County Road T, New London, WI 54961. . Bakake Acres LLC currently in herd size consists of 504 animal units (303 milking & dry cows, 80 heifers & 60 calves) and is not proposing to expand during the upcoming permit term. Bakake Acres LLC currently produces approximately 5.3 m

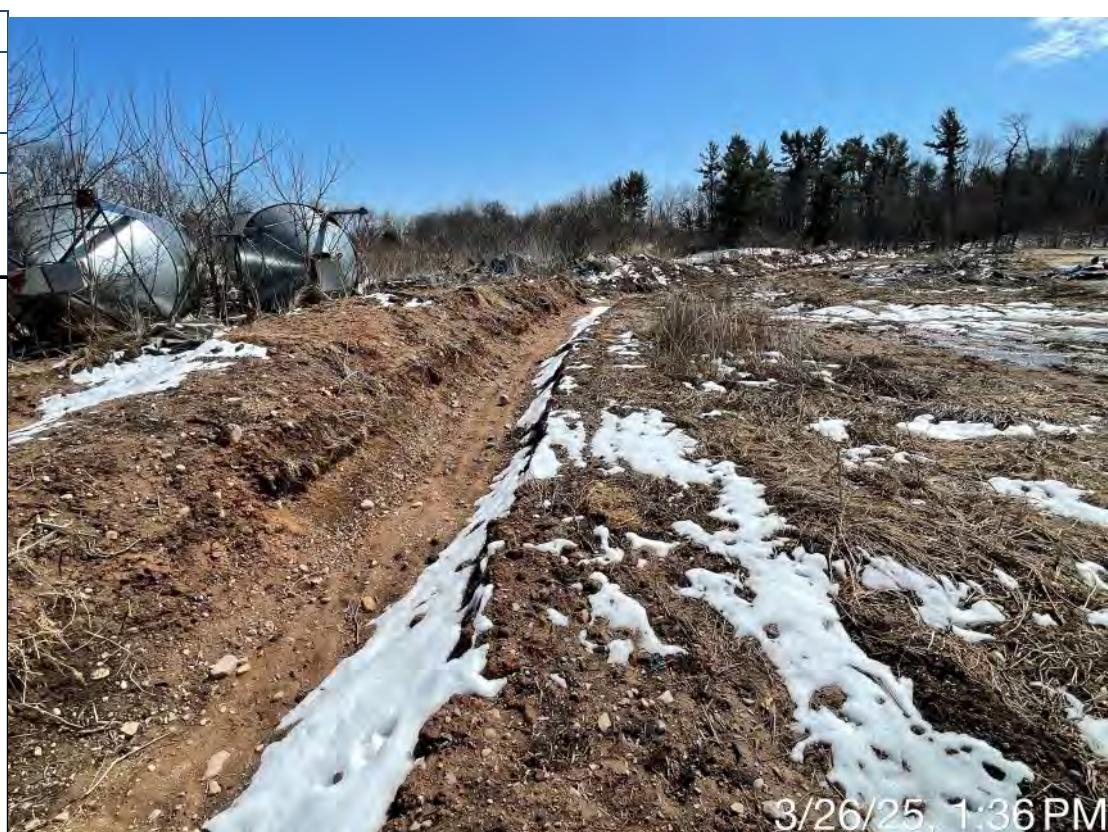
Photo #:	52
Date/Time of Photo:	3/26/2025 13:36
Photo By:	Brian Hanson
Photo Location:	Feed Storage Area

Standing east of FSA looking south: View of earthen trench dug in 2024 to divert FSA runoff from entering adjacent pond.

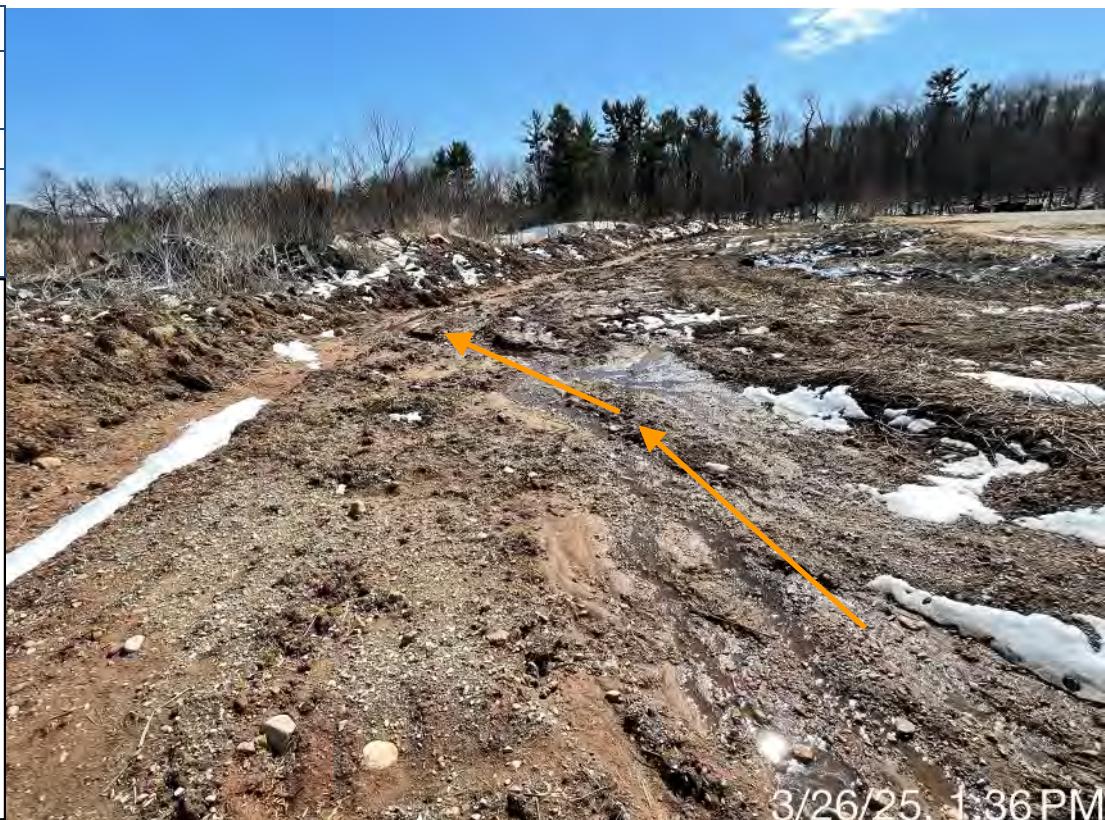
Photo #:	53
Date/Time of Photo:	3/26/2025 13:36
Photo By:	Brian Hanson
Photo Location:	Feed Storage Area

Standing on east side of FSA looking south: View of area where runoff from FSA is flowing towards trench. Arrows indicate direction of runoff flow.

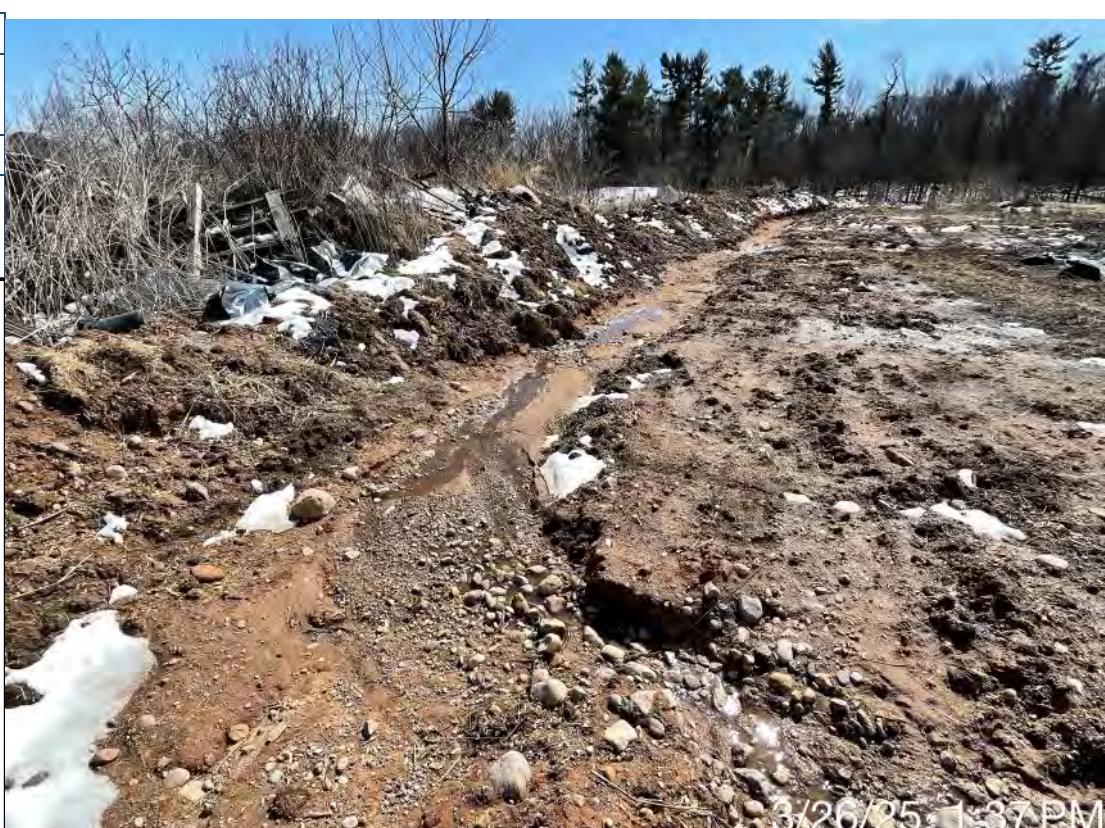
Photo #:	54
Date/Time of Photo:	3/26/2025 13:37
Photo By:	Brian Hanson
Photo Location:	Feed Storage Area

Close up view of photo #53. Notice dark colored runoff consistent with leachate flowing into trench and flowing to the south.

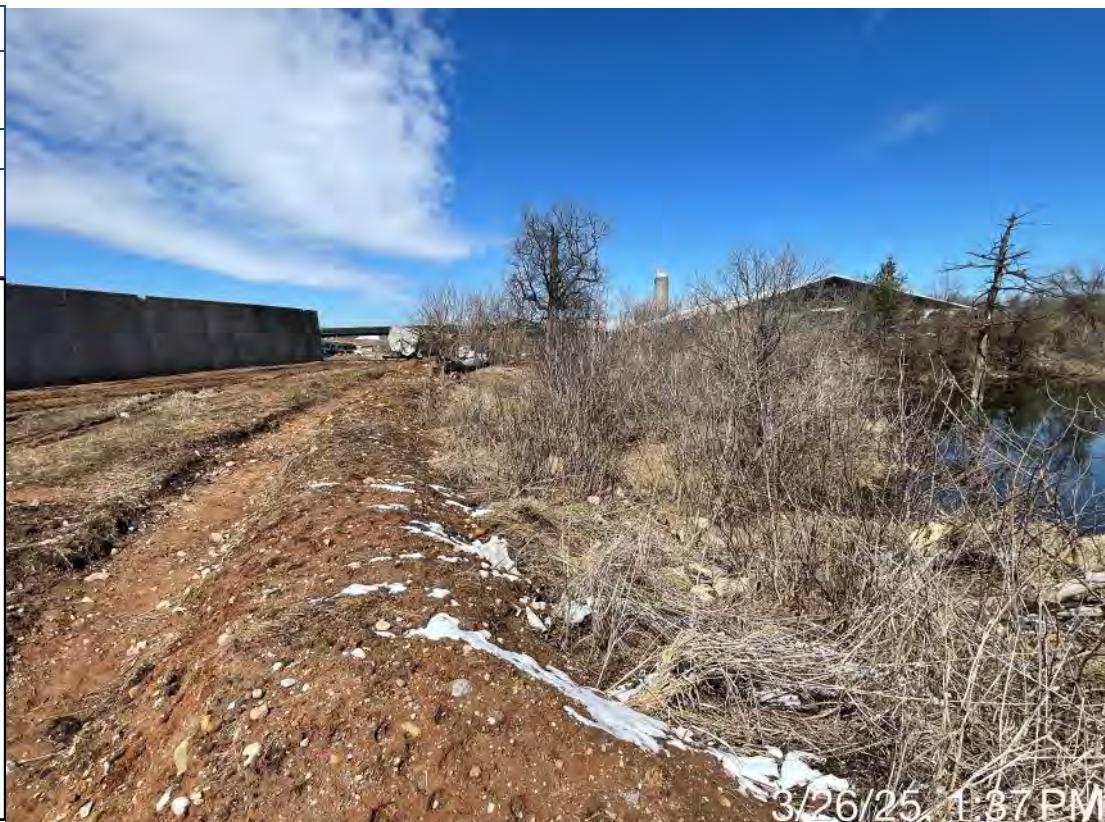
Photo #:	55
Date/Time of Photo:	3/26/2025 13:37
Photo By:	Brian Hanson
Photo Location:	Feed Storage Area

Standing on east side of FSA looking north: View of trench dug to divert FSA runoff. Notice proximity to depressional pond on right side of photo.

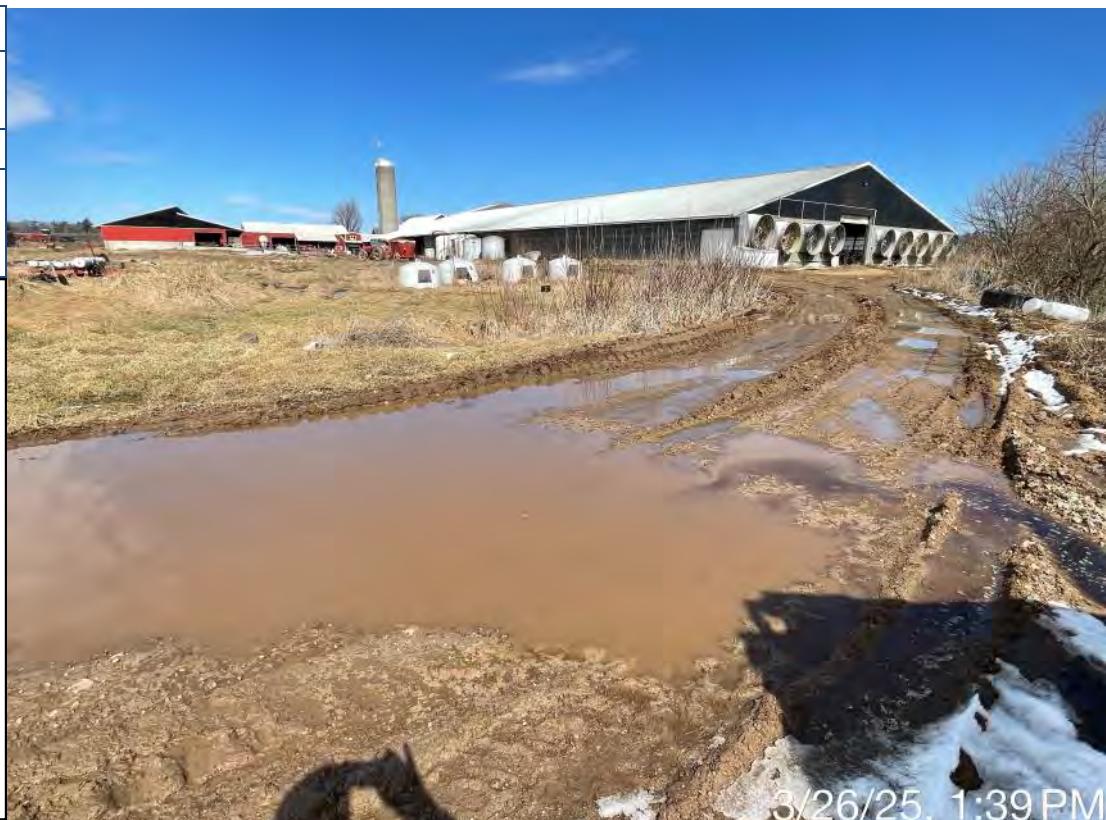
Photo #:	57
Date/Time of Photo:	3/26/2025 13:39
Photo By:	Brian Hanson
Photo Location:	Feed Storage Area

Standing on the north side of FSA looking northeast: View of gravel drive off the northeast corner of FSA.

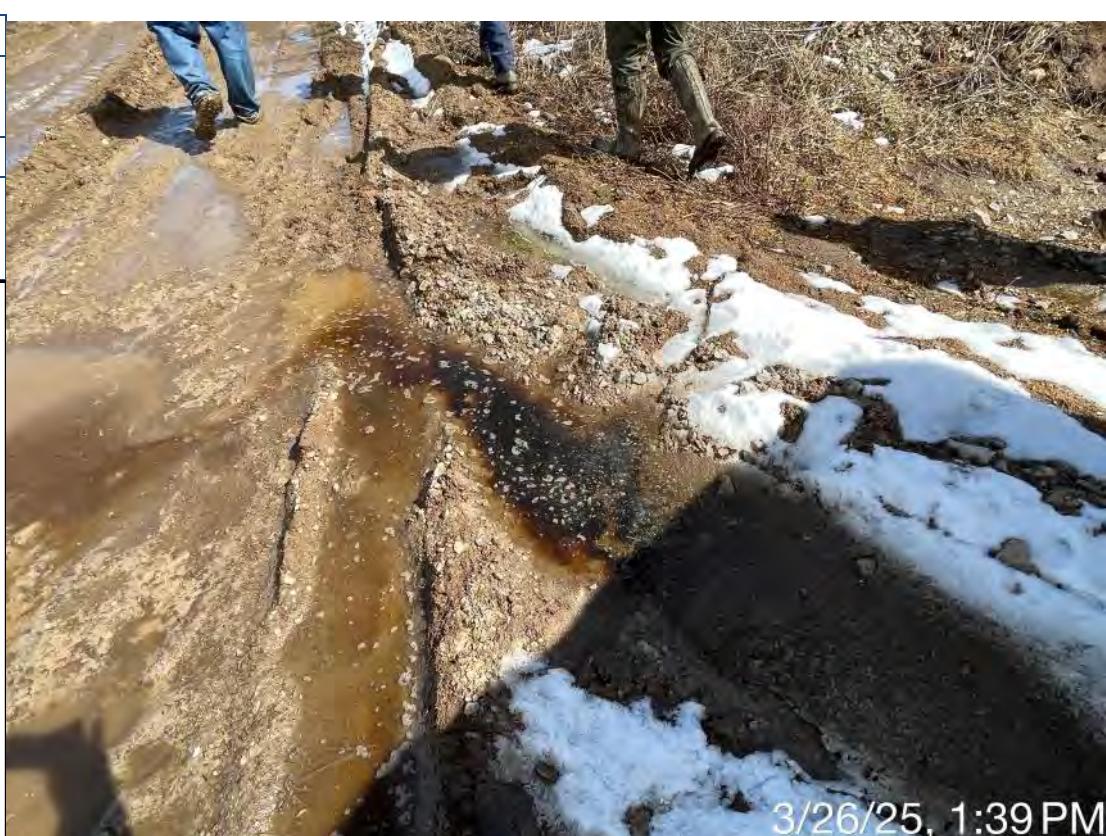
Photo #:	58
Date/Time of Photo:	3/26/2025 13:39
Photo By:	Brian Hanson
Photo Location:	Feed Storage Area

Close up view of the right side of photo 57: View of FSA runoff mixing with ponded stormwater runoff in gravel driveway.

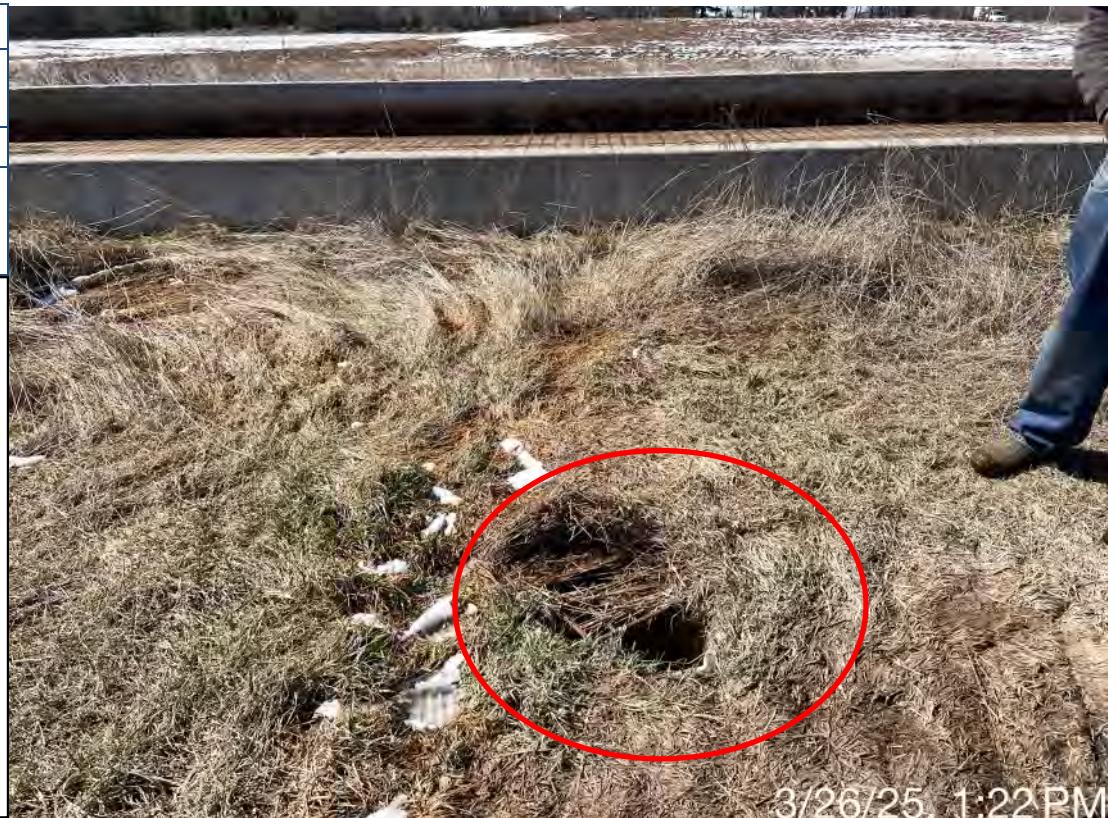
Photo #:	59
Date/Time of Photo:	3/26/2025 13:22
Photo By:	Brian Hanson
Photo Location:	Stormwater Runoff
Photo Description:	
Standing on north side of WSF #1 looking west & down: View of stormwater inlet used to convey stormwater underneath concrete scrape alley from heifer barn.

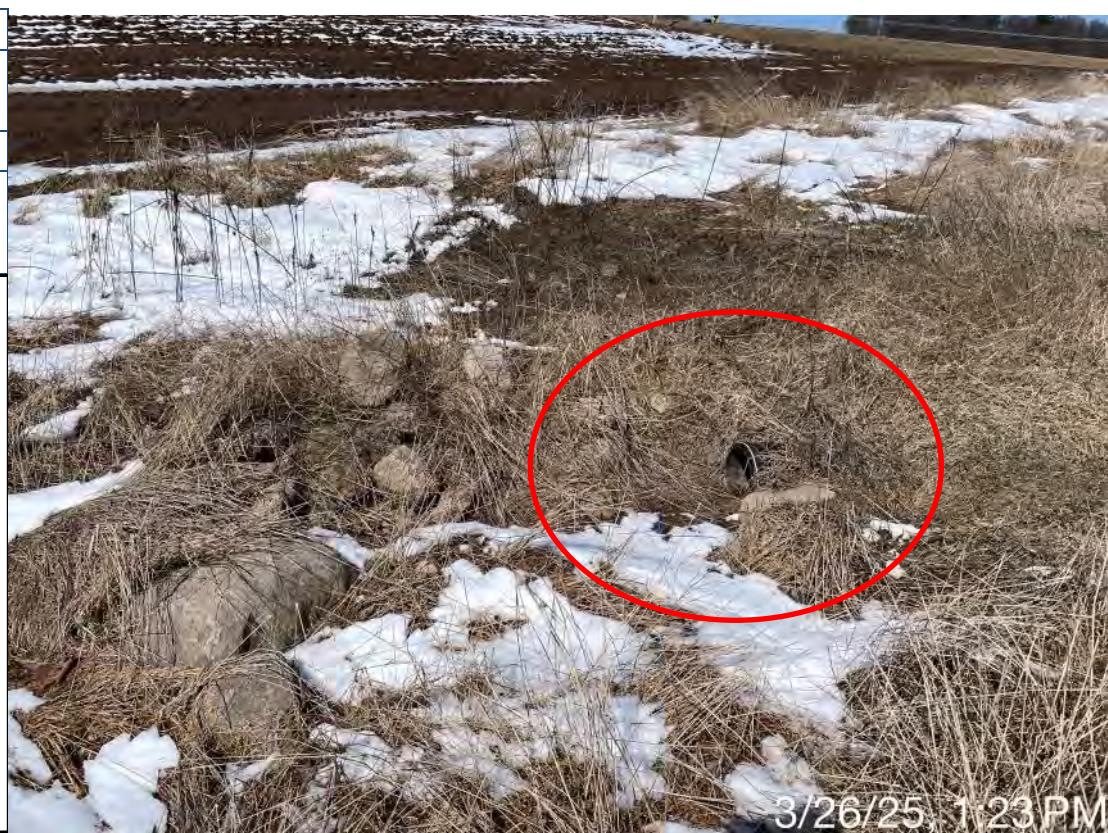
Photo #:	60
Date/Time of Photo:	3/26/2025 13:23
Photo By:	Brian Hanson
Photo Location:	Stormwater Runoff
Photo Description:	
View of outlet pipe for inlet in photo #59 on west side of heifer barn scrape alley.

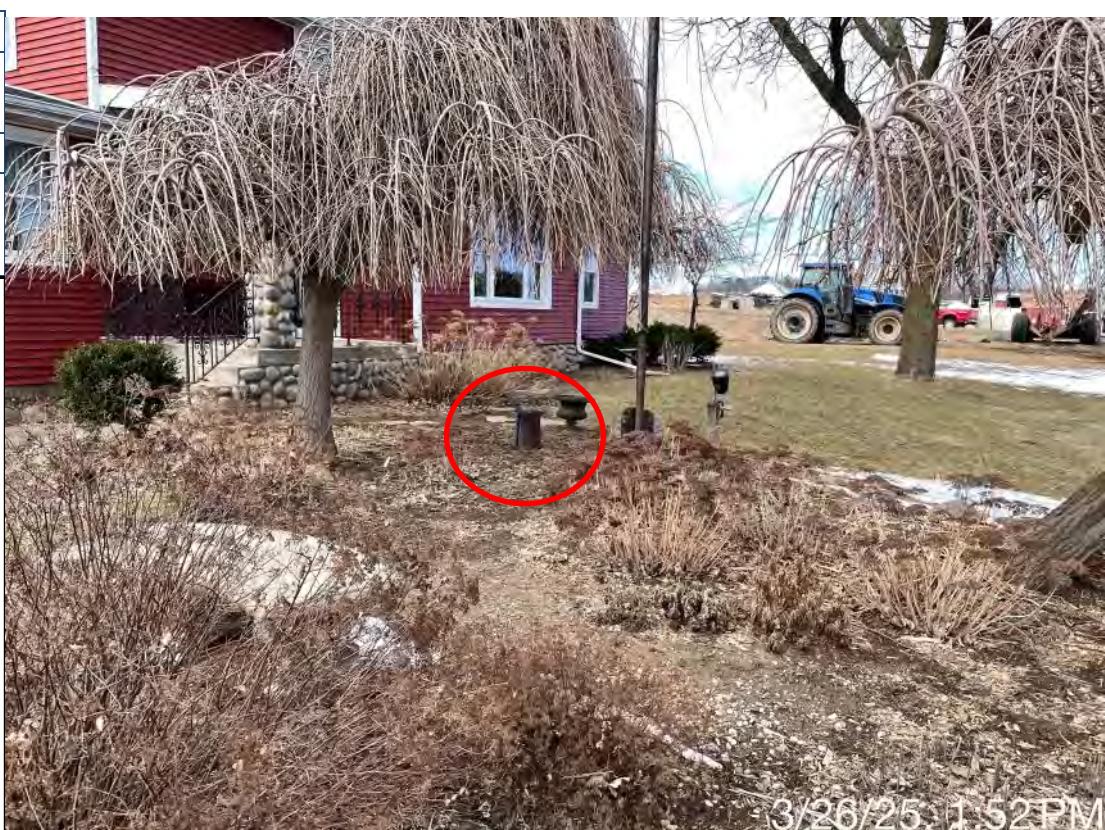
Standing on the east side of the house looking northwest: View of water supply well. Unique Well # 8HP085.

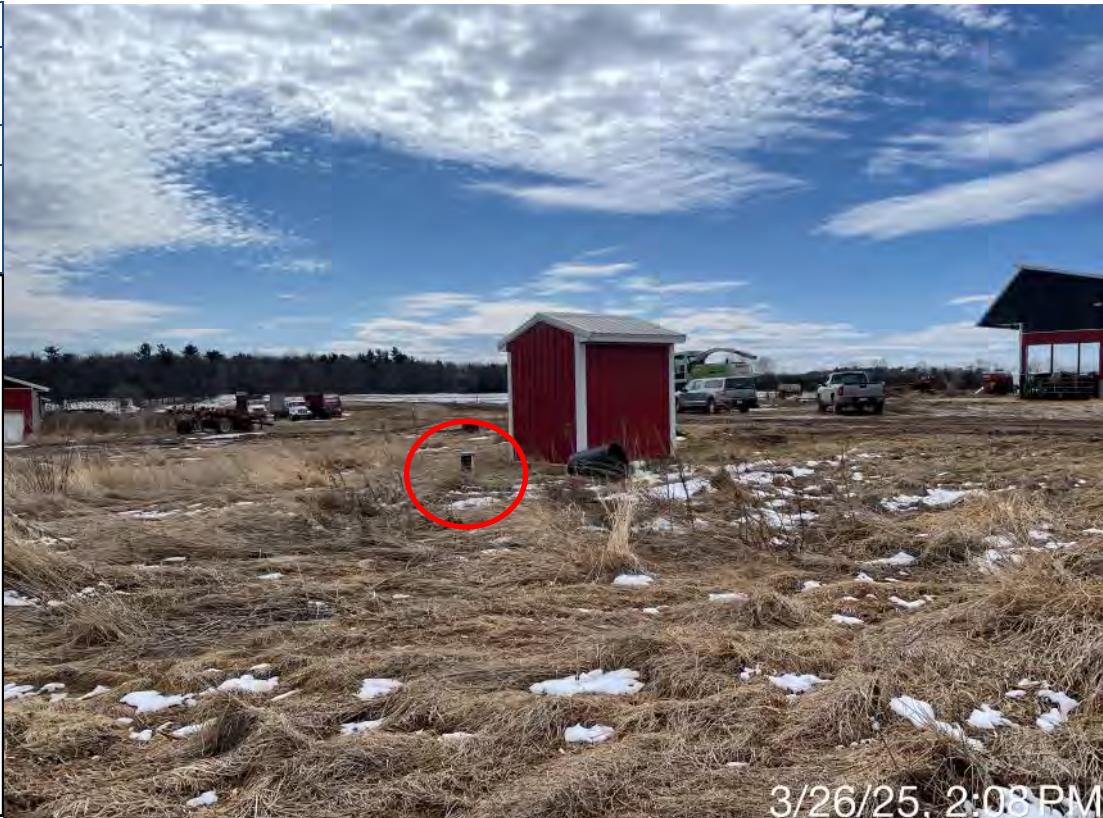
Photo #:	63
Date/Time of Photo:	3/26/2025 14:08
Photo By:	Brian Hanson
Photo Location:	Well Location
Photo Description:	
Standing on west side of calf hutch area looking southwest: View of water supply well. Unique Well # YS599.
