## Permit Fact Sheet

| Permit Number | WI-0064254-04-0 |
| Permittee Name and Address | Birlings Bovines LLC<br>Main Site: N8212 Town Hall Rd, Black Creek, WI 54106<br>Satellite Site (Meyer): W5429 Meyer Rd Black Creek, WI |

On October 29, 2024, the Department of Natural Resources (department) conducted a reissuance walkover inspection of Birling Bovines LLC. Results and photos are included in the enclosed report. The department has noted follow up action items on page 28 in the enclosed report.

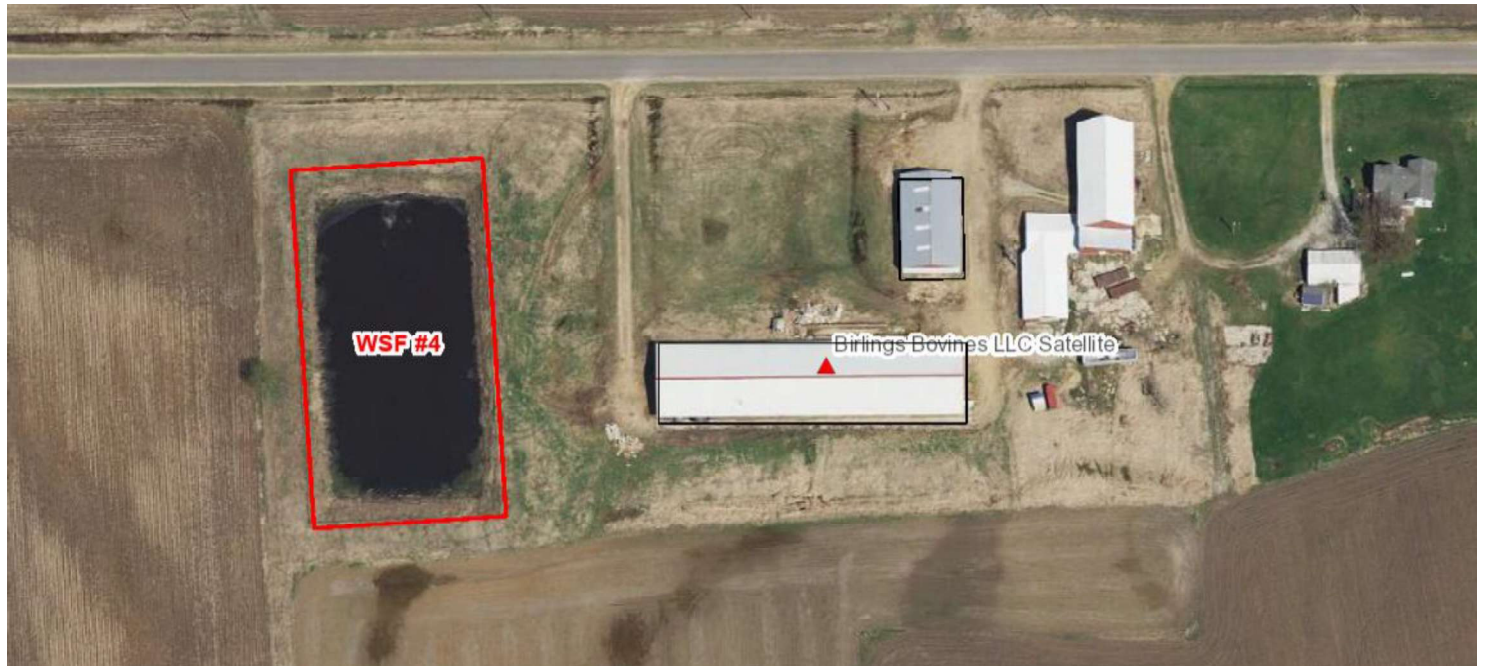
**Site Overview Diagram** (Satellite Site: orange lines =potential runoff flow patterns, blue lines = stormwater flow, pink lines = waste transfer system, yellow circles indicate water supply well locations)

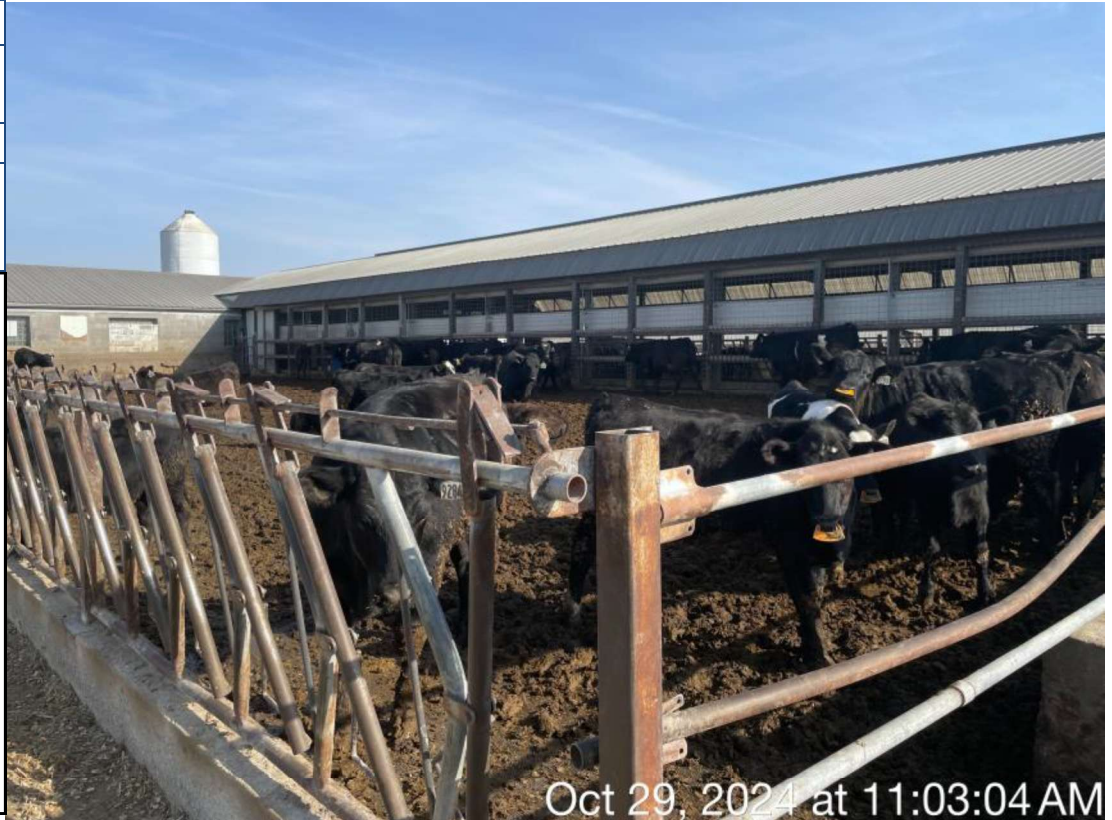
| <b>Photo Description:</b><br><br>Standing at the East side of the outdoor feed lot looking Northeast. View of outdoor feedlot area. | |

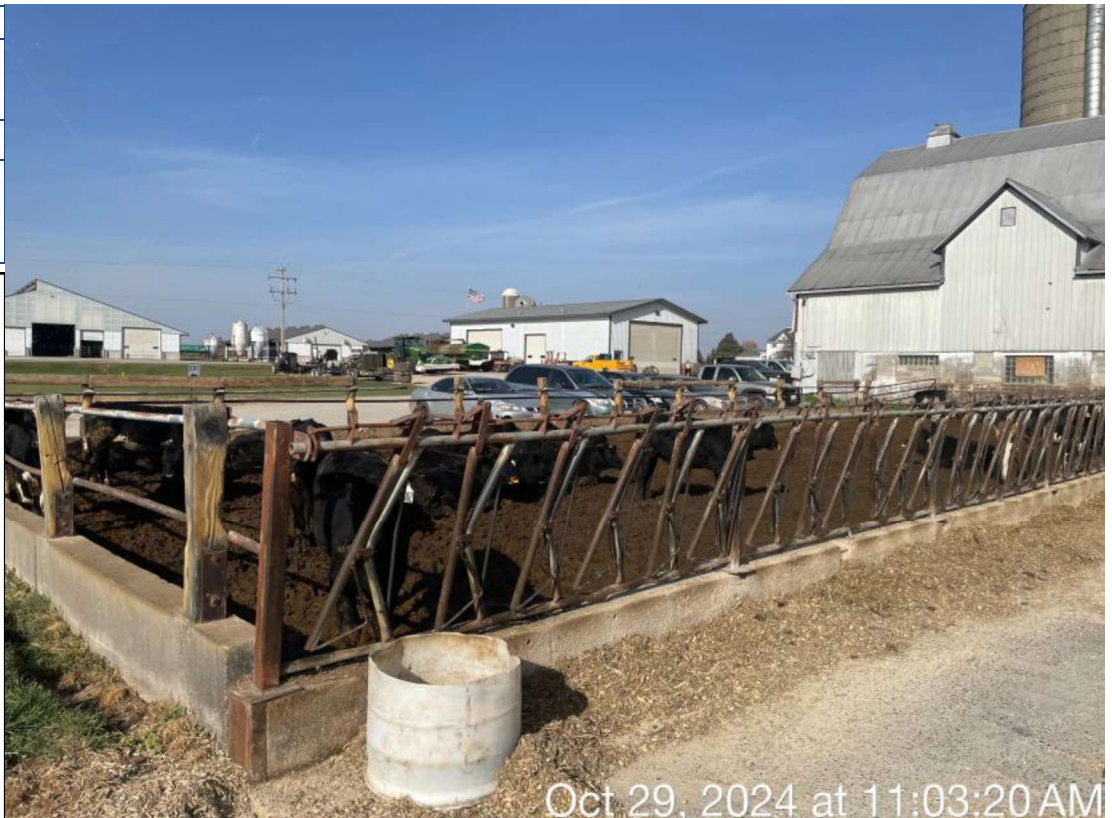
| <b>Photo Description:</b><br><br>Standing at the East side of the outdoor feed lot looking Northwest. View of outdoor feedlot area. | |

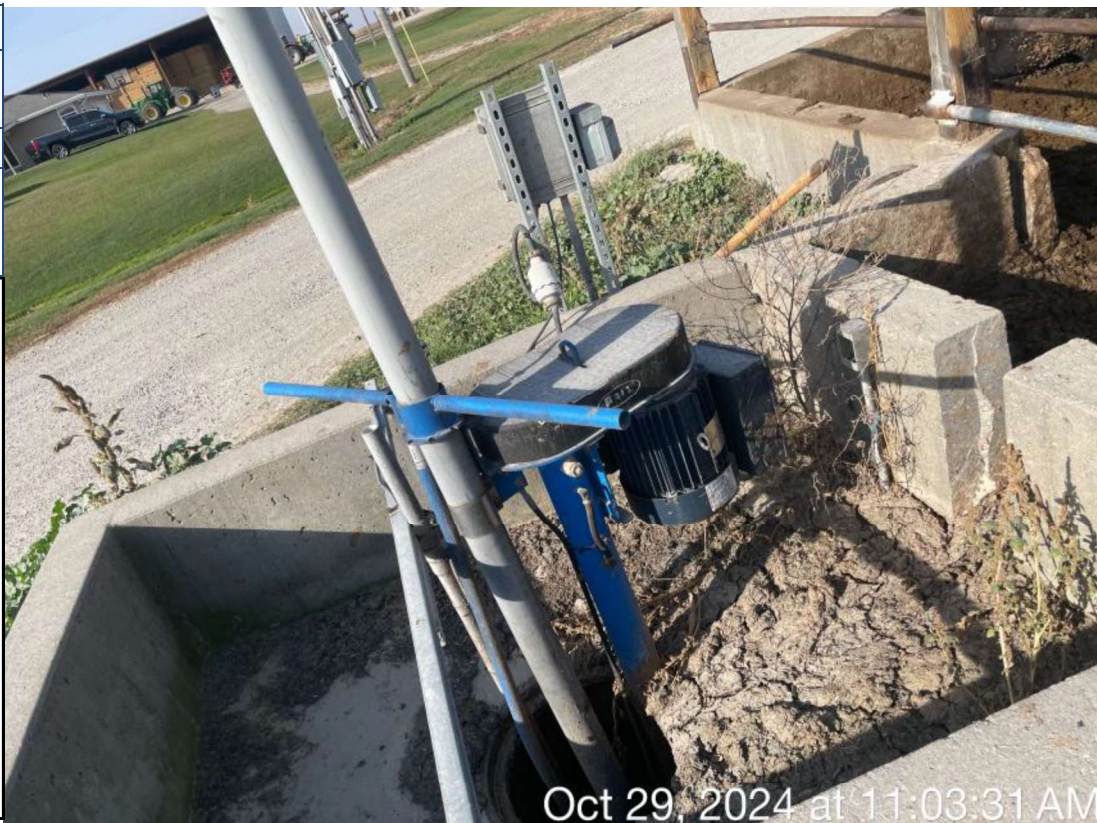
Standing at the East end of the feed lot looking West. View of outdoor feed lot pump that goes to WSF 2.

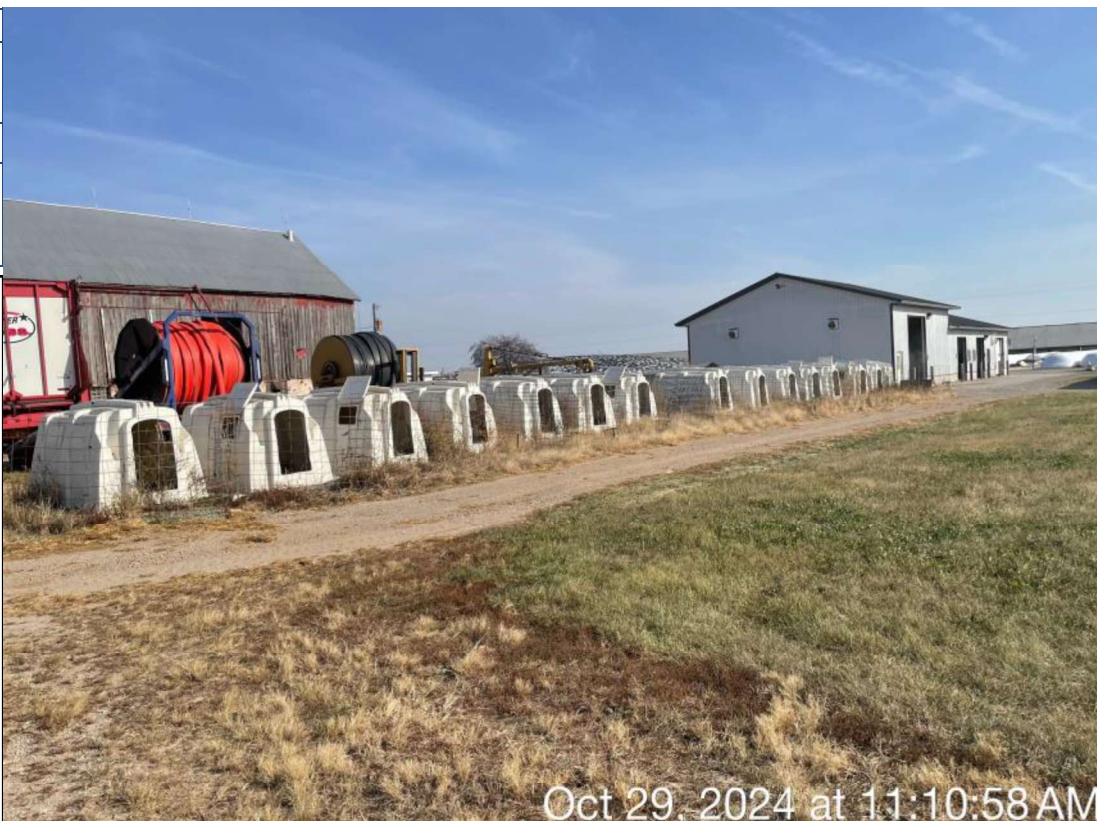
Standing at the West end of the calf hutch area looking Northeast. Calf hutches haven't been used in 8 months.

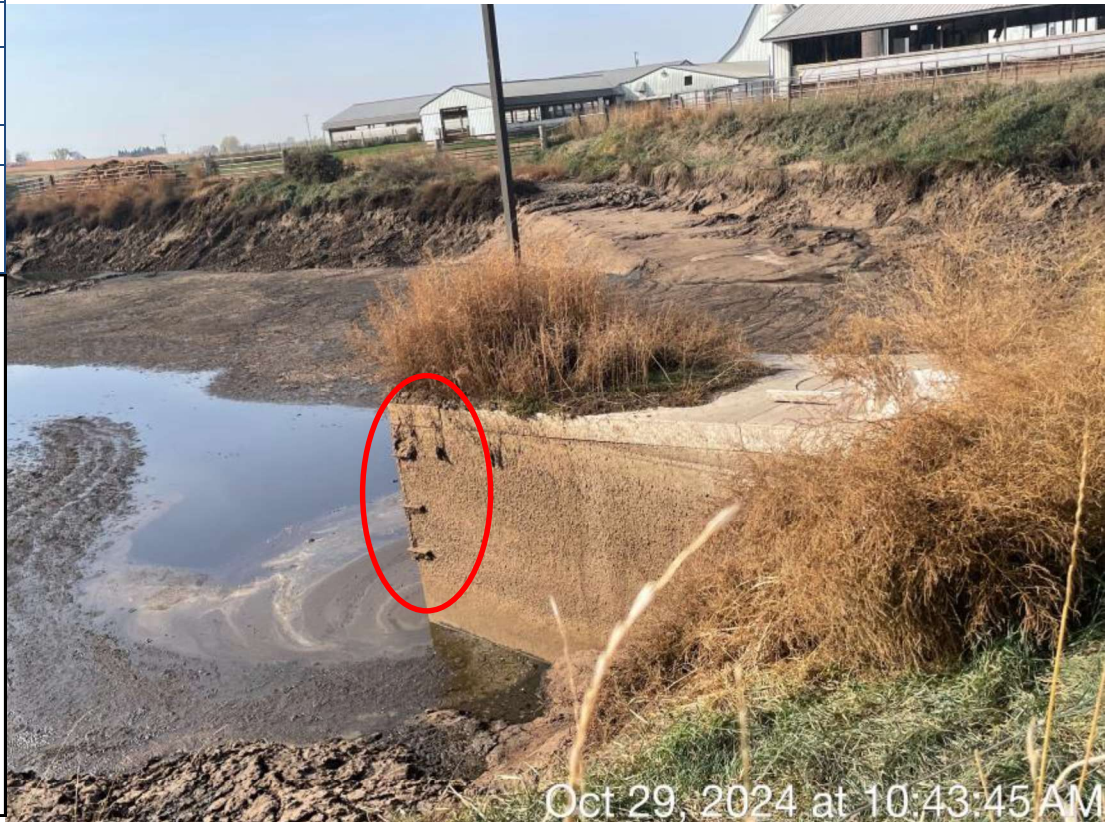
- WSF 1 is an earthen lined storage with concrete floor and armoring located at the Main Farm north of WSF 2 and to the east of the outdoor concrete lot. This storage serves as the sand settling cell of a two celled storage system. WSF 1 was constructed in 1995. A permanent markers were observed.

Standing at the North side of WSF 1 looking Southwest. View of Markers circled in red.

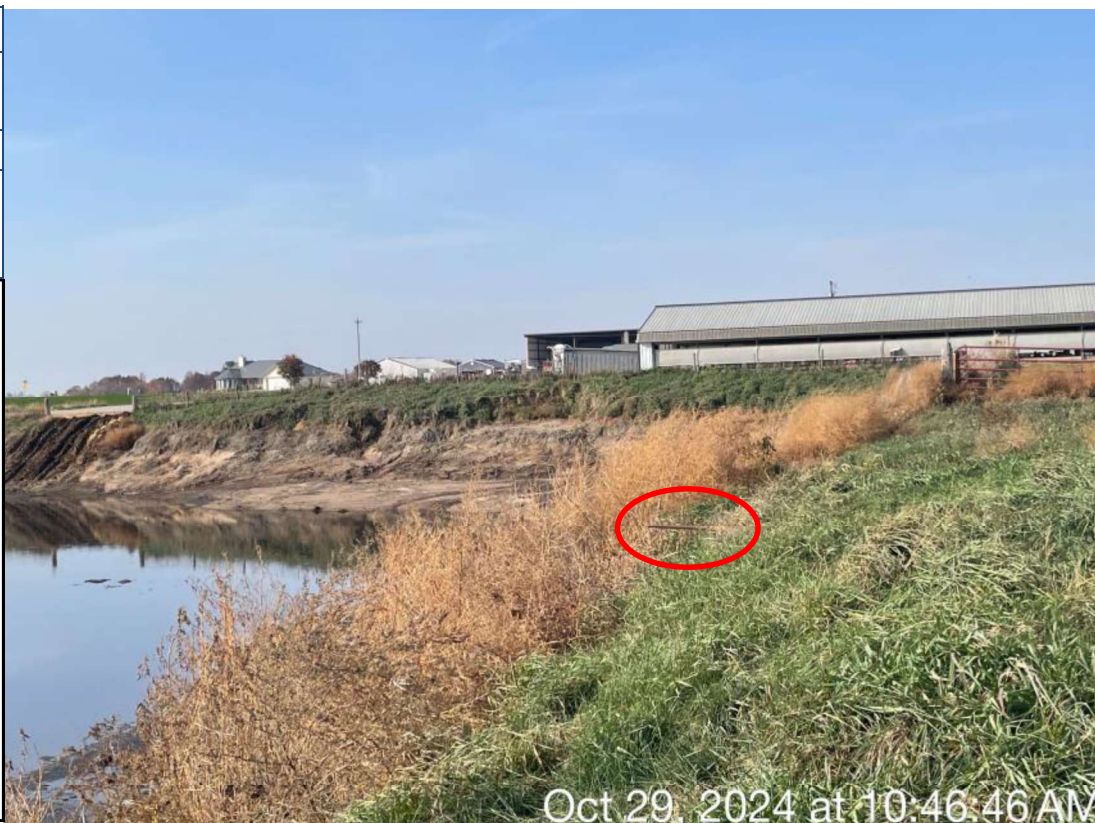
Standing on the North side of WSF 2 looking West. Circled in red is the marker.

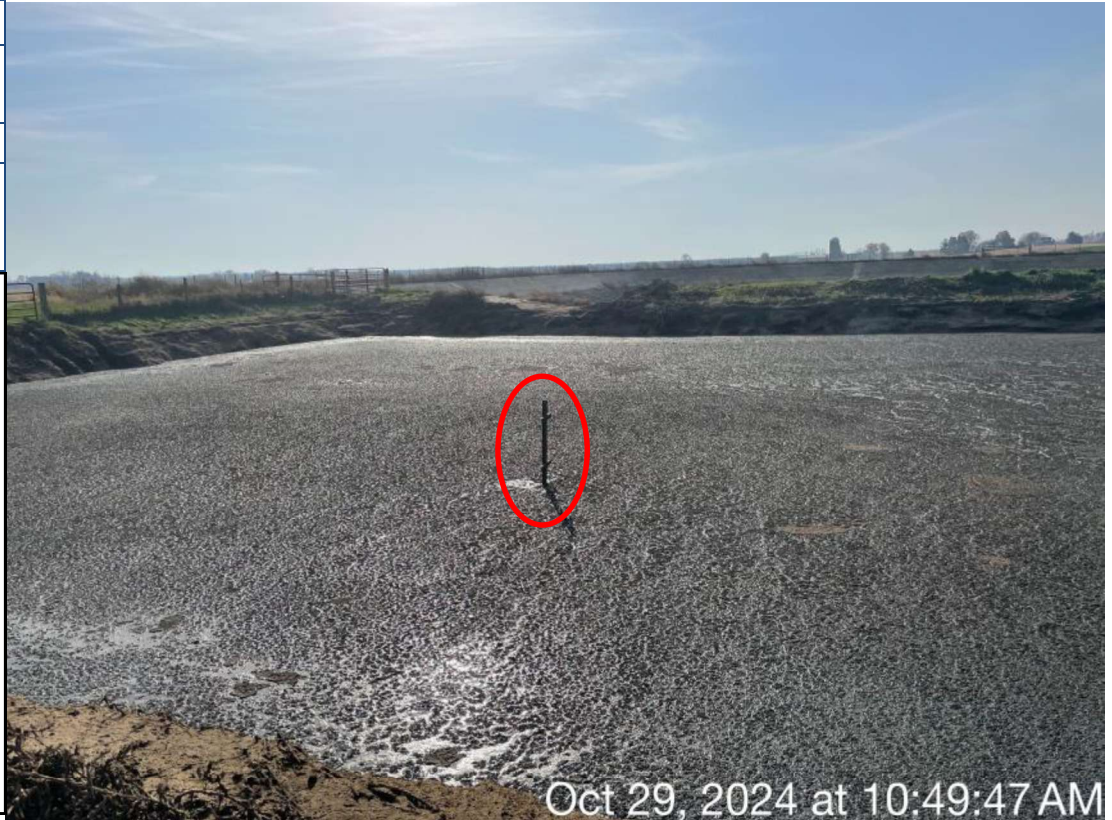
- WSF 3 is an earthen lined storage with concrete floor and armoring located at the Main Farm north of WSF 6 and to the east of WSF 1. This storage serves as the sand settling cell of a two-celled storage system. WSF 3 was constructed in 2012. A permanent marker was observed.

Standing on the North side of WSF 3 looking South. Circled in red are the markers.

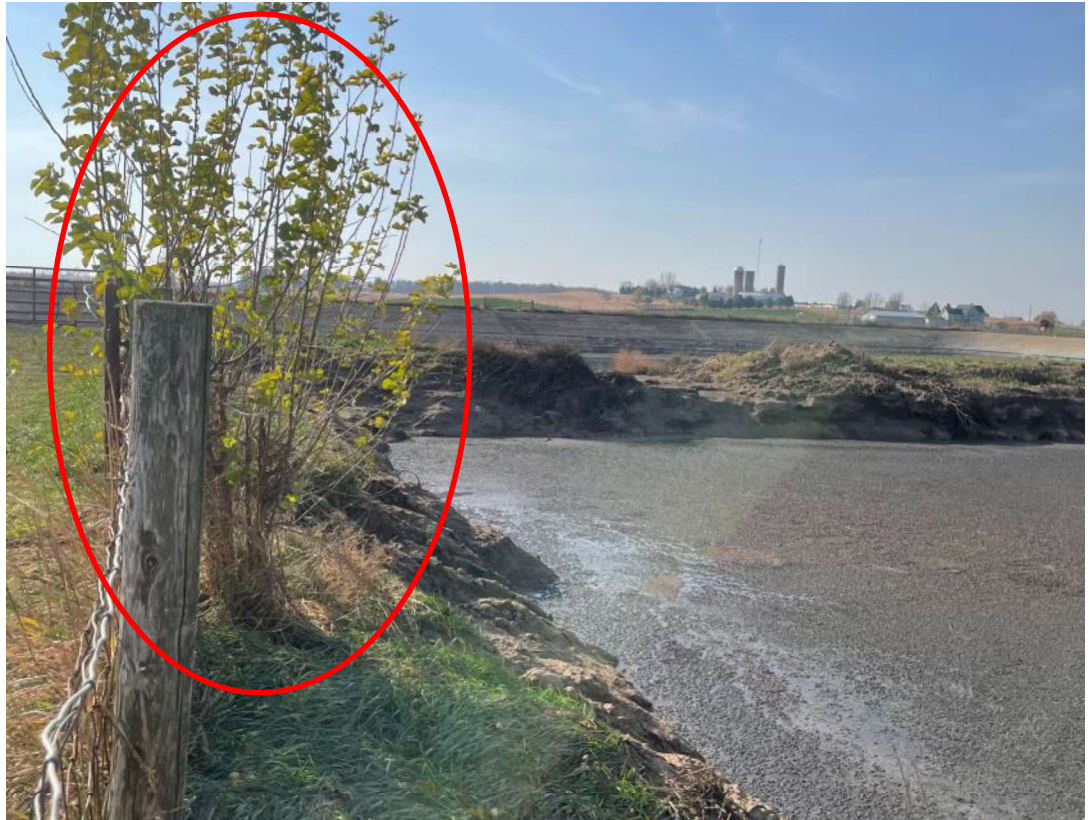
| <b>Photo Description:</b><br><br>Standing on the East side of WSF 3 looking South. Circled in red if a view of wooded vegetation. | |

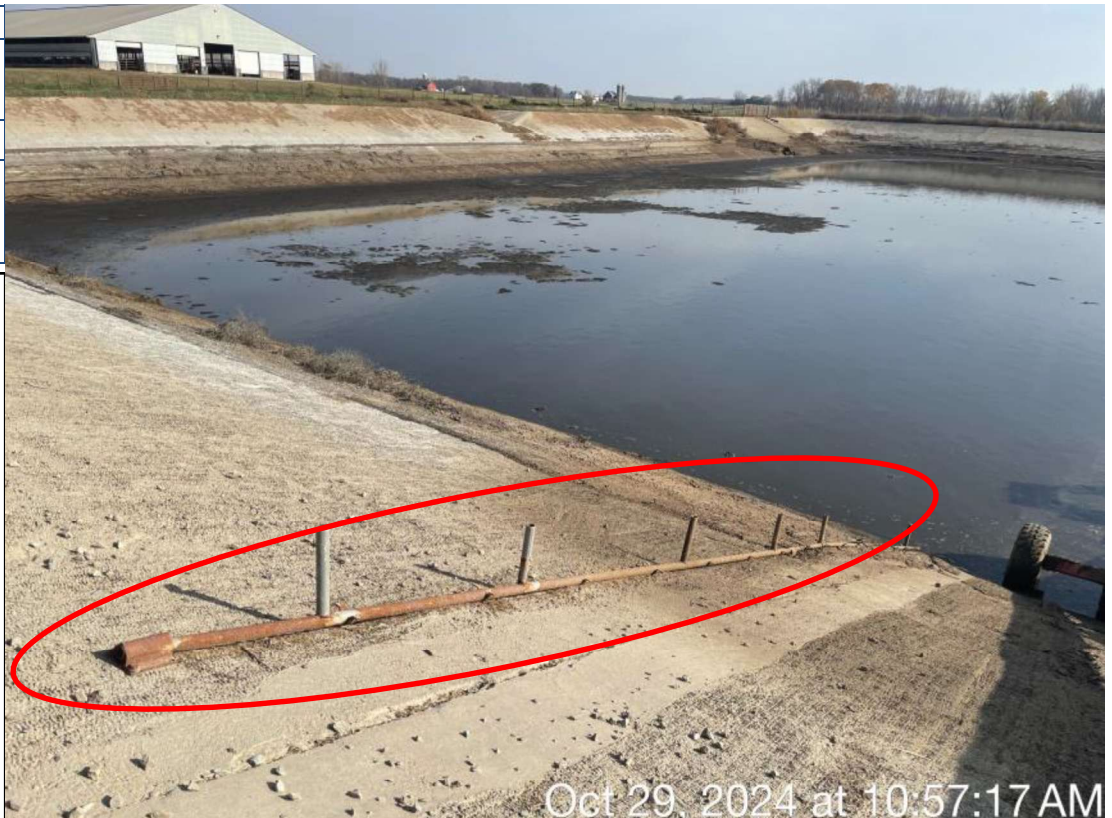
- WSF 6 earthen lined storage located at the Main Farm south of WSF 3. This storage serves as the second cell of a two-celled storage system. This storage accepts manure and process wastewater from WSF 3. A permanent marker was observed. WSF 6 was constructed in 2017.

Standing on the west side of WSF 6 looking Northeast. Circled in red are the markers.

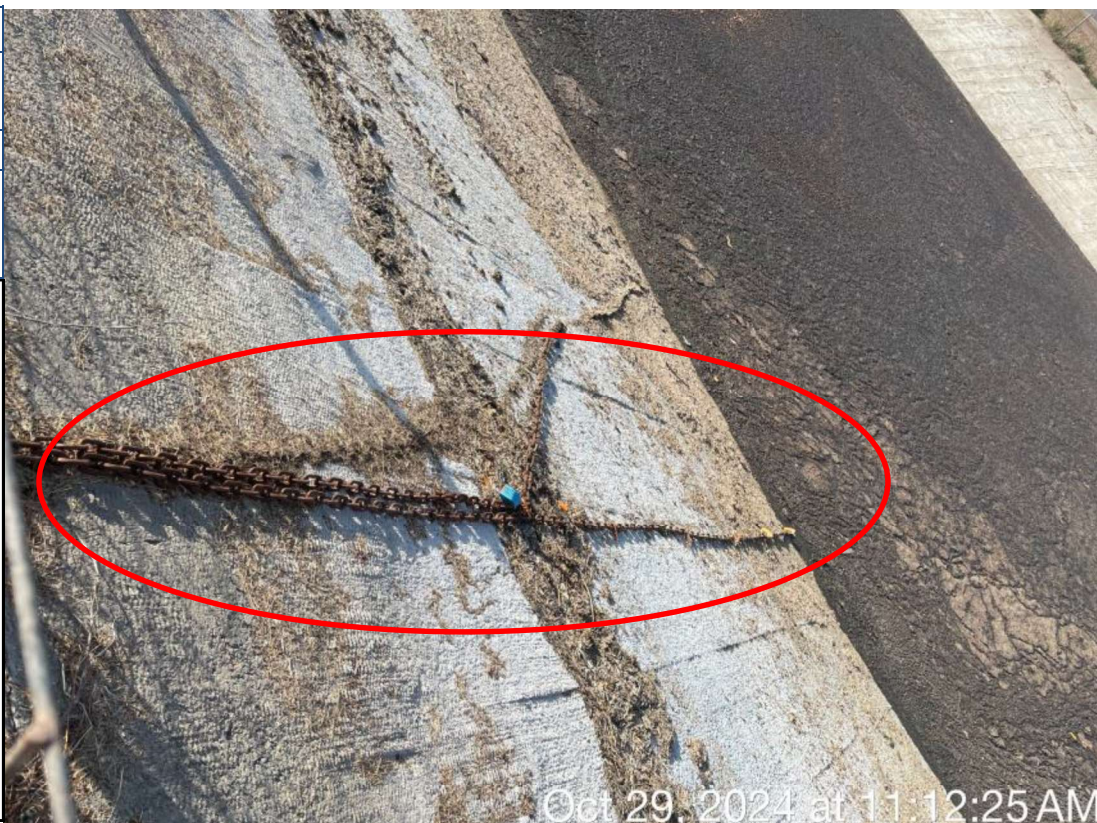
Standing on the East side of WSF 5 looking into the pit. Circled in red are the markers.

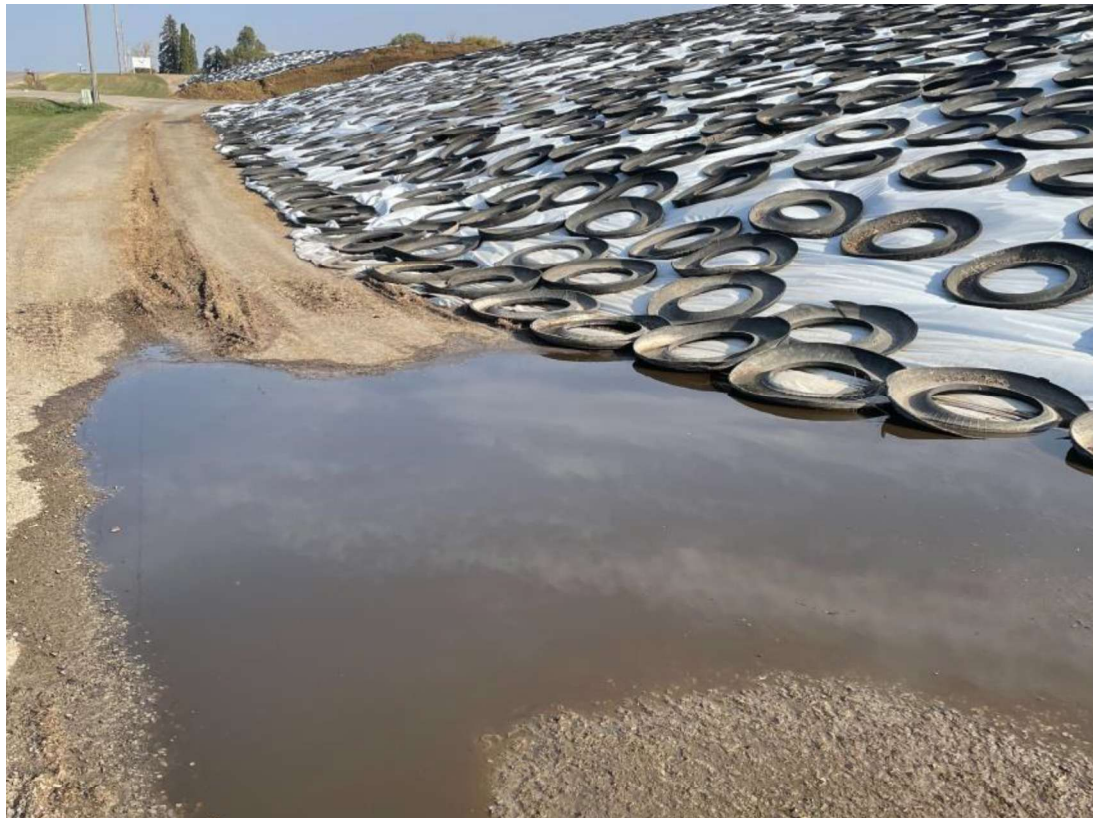
- Corn silage is stored and kept covered on concrete south of the Haylage pad. Runoff from the feed pad flows southeast to the runoff collection system, which consists of a collection tank, vegetated treatment area (VTA) and biofilter. Feed leachate is also collected via tile lines located to the west and south of the feed storage pad then transferred to the runoff collection system. First flush (0.5 inches) is collected and transferred from the collection tank into WSF 1. Additional runoff is directed east to a VTA and biofilter. The material present in biofilter is replaced yearly. Runoff from the biofilter flows to a grassed swale that runs south along Town Hall Rd, then southeast across the production area to a storm water retention basin then leaves the production area. According to the farm, the FSA runoff control system plans will be submitted to the department by the end of 2024.

| <b>Photo Description:</b><br><br>Standing at the Southwest corner of the silage pad looking North. View of ponding leachate on the Southwest corner. | |

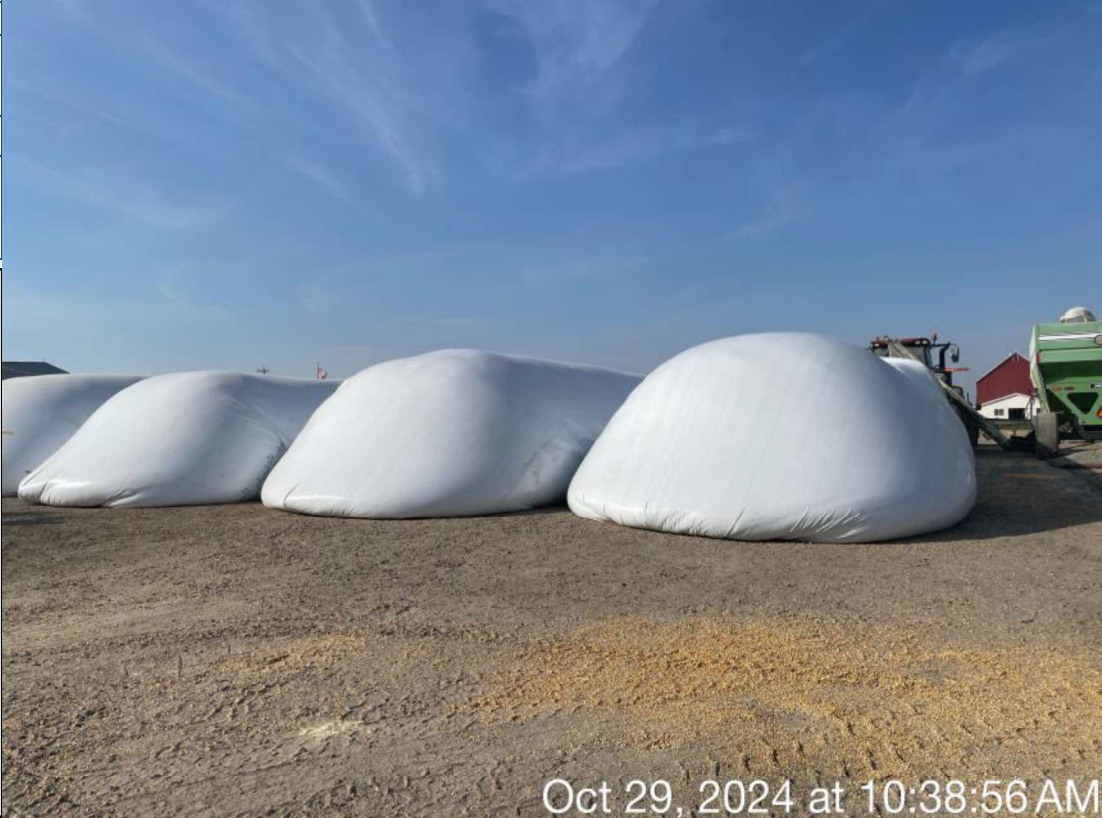
- High moisture corn is kept in bags on gravel south of the Corn Silage Feed Pad. No runoff controls are in place but are not required as long as the farm follows their operation and maintenance plan. An evaluation was submitted in 2019, no further actions were required (R-2019-0219).

| Photo Description:<br><br>Standing at the East side of the High Moisture corn bags looking west. View of HM corn bags. | |

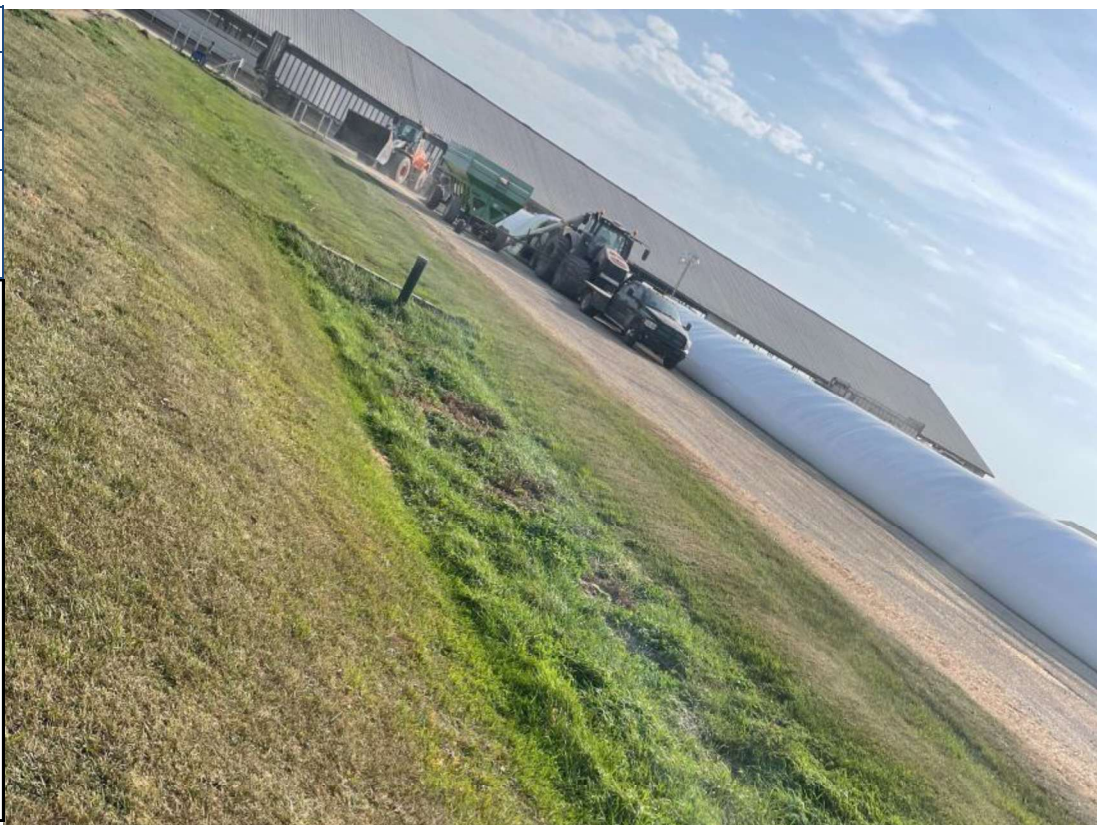
Standing at the west end of the Bio Filter looking east. View of Bio Filter.

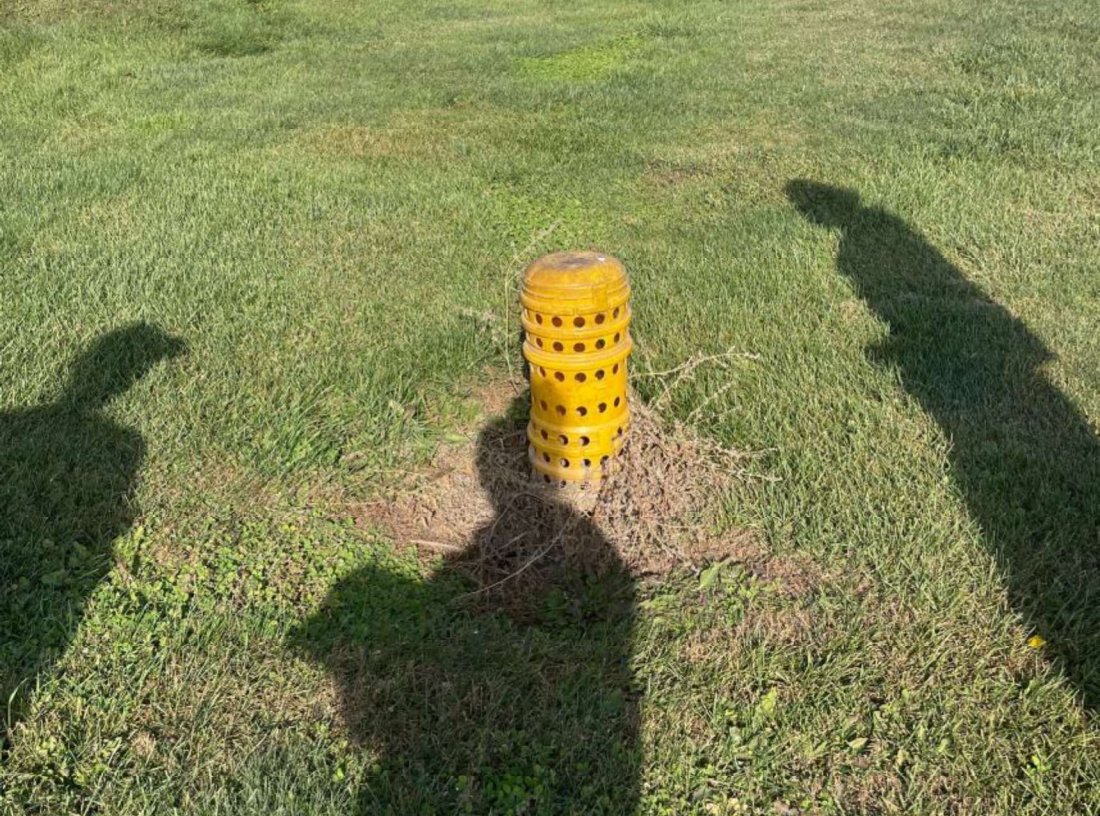
Standing at the Bio Filter outlet.
