Permit Fact Sheet

Permit Number:	WI-0064246-03-0
Permittee Name:	Blaser Farms Inc
Address:	9267 State Hwy 22 E
City/State/Zip:	Gillett WI 54124
Discharge Location:	9267 Hwy 22 E, Gillett, WI 54124 ; NW ¼ of NW ¼ Section 20, T28N, R19E
Receiving Water:	Unnamed tributaries within the Oconto River Watershed, and groundwaters of the state
Discharge Type:	Existing

Site Overview Diagram (Blaser Farms Inc.)

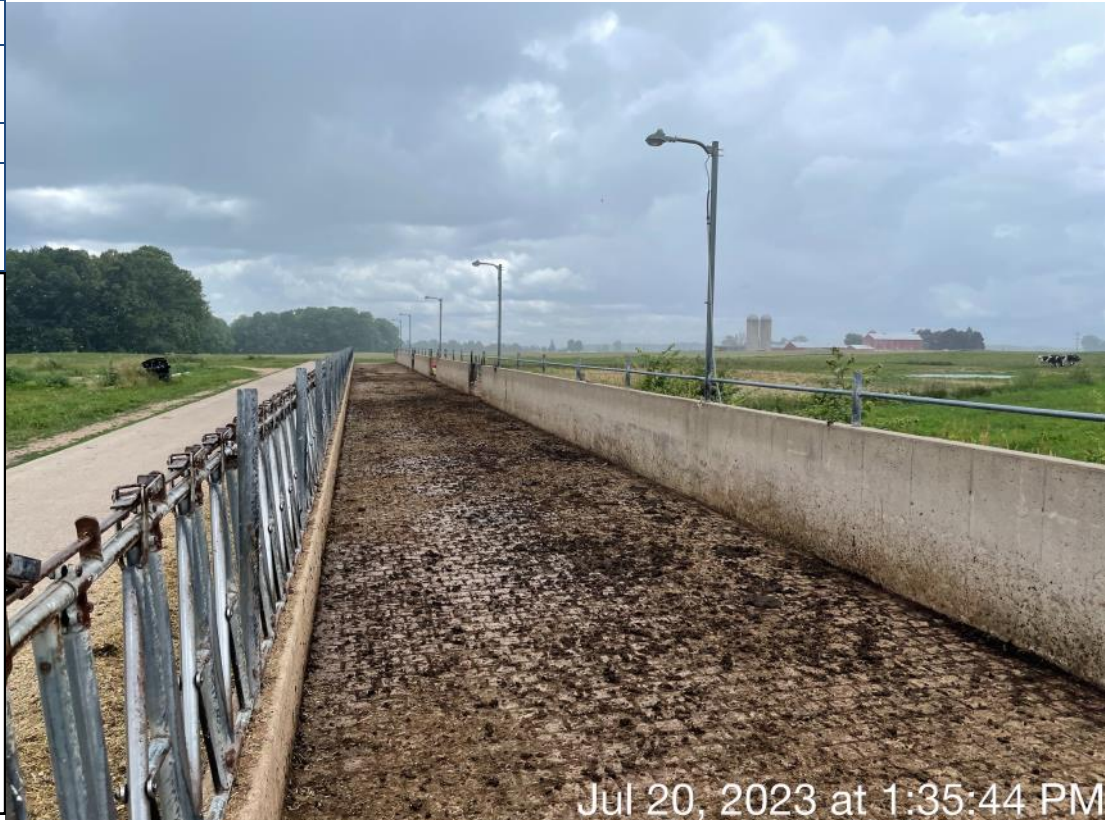
Standing on the east side of feed rail looking west: View of litter alley of concrete feed rail.

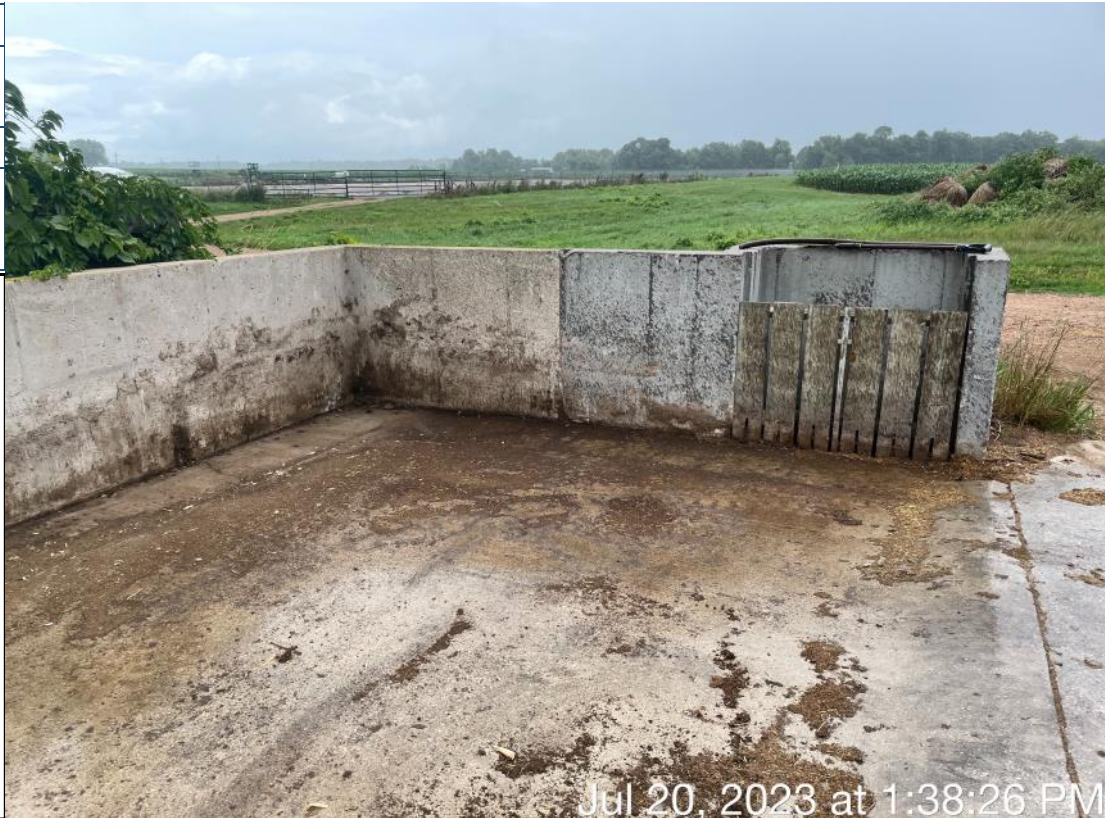
Photo #:	7803
Date/Time of Photo:	7/20/2023 13:38
Photo By:	Brian Hanson
Photo Location:	Pasture Feed Rail

Standing on east end of feed rail looking east: View of manure push up area on east end of feed rail. Notice wooden screen on right side of wall. Runoff inlet to VTA is behind this screen.

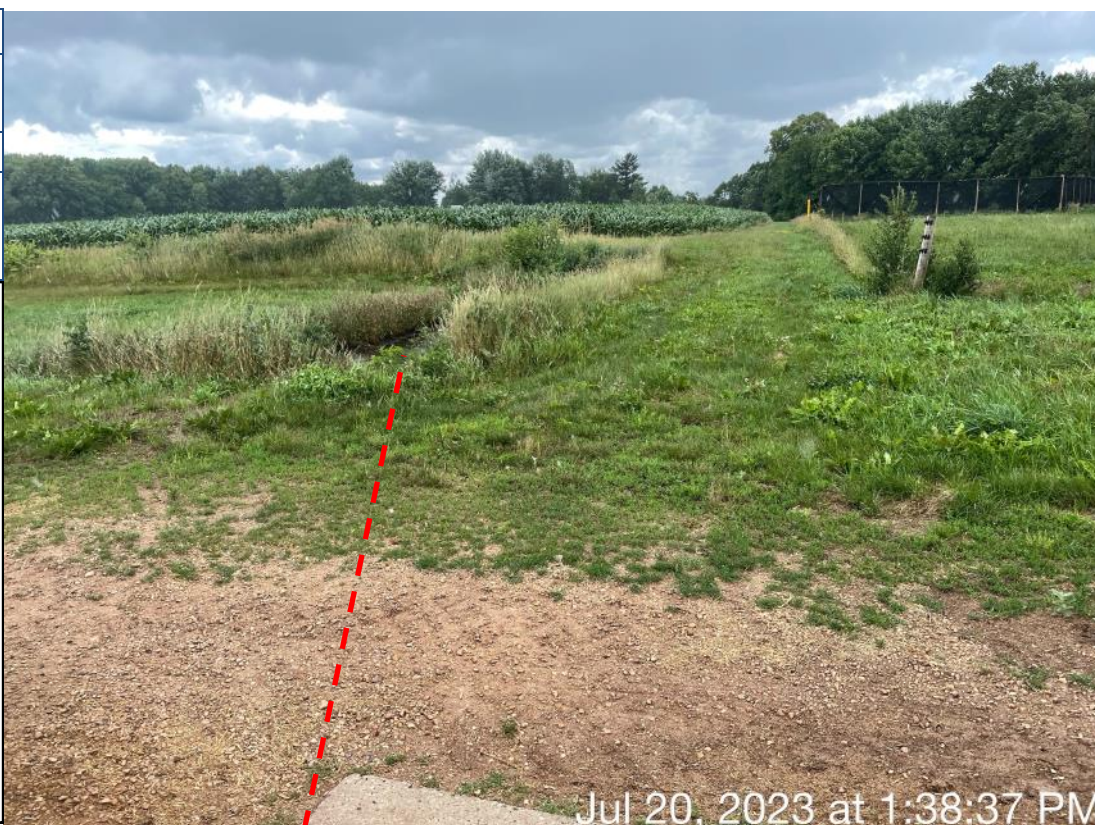
Photo #:	7804
Date/Time of Photo:	7/20/2023 13:38
Photo By:	Brian Hanson
Photo Location:	Pasture Feed Rail

Photo Description:
Standing on the east end of feed rail looking southeast: View of concrete spreader pad from edge of feed rail. Dotted line indicates underground pipe that conveys runoff to spreader pad.

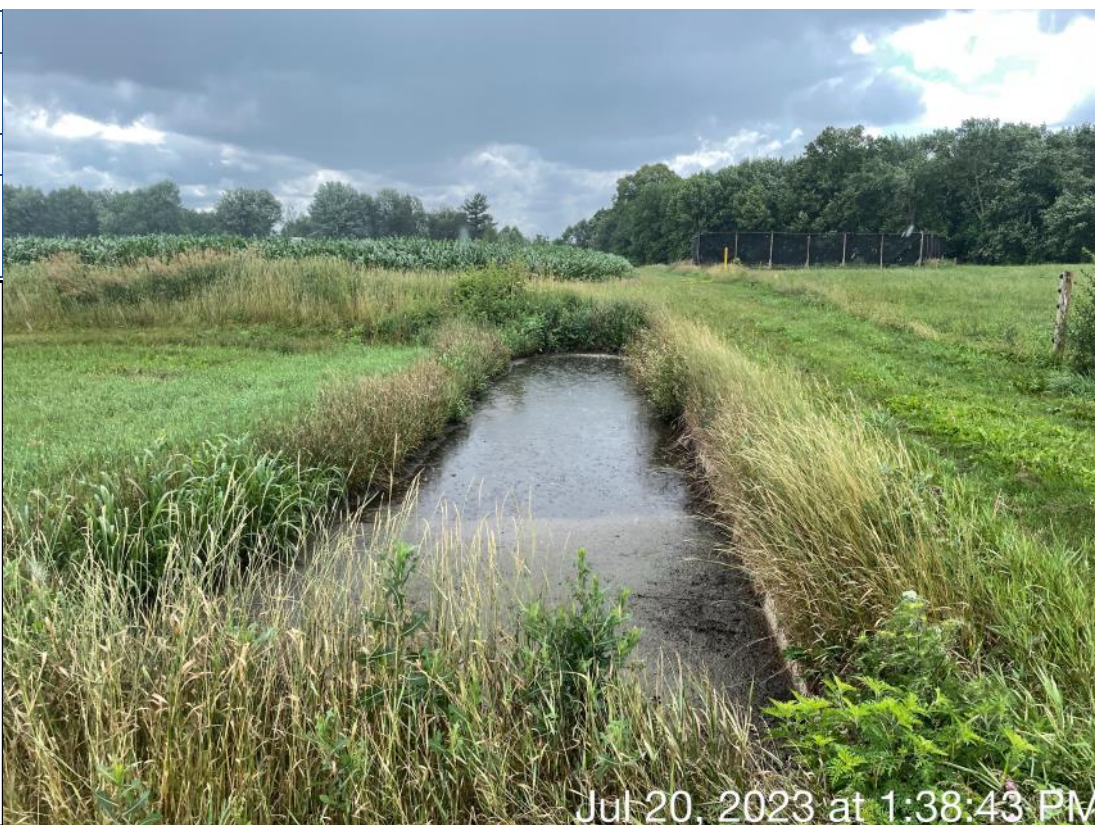
Photo #:	7805
Date/Time of Photo:	7/20/2023 13:38
Photo By:	Brian Hanson
Photo Location:	Pasture Feed Rail

Photo Description:
Standing on north side of spreader pad looking south: View of concrete spreader pad on west end of VTA. Notice runoff is ponding on pad prior to entering VTA.

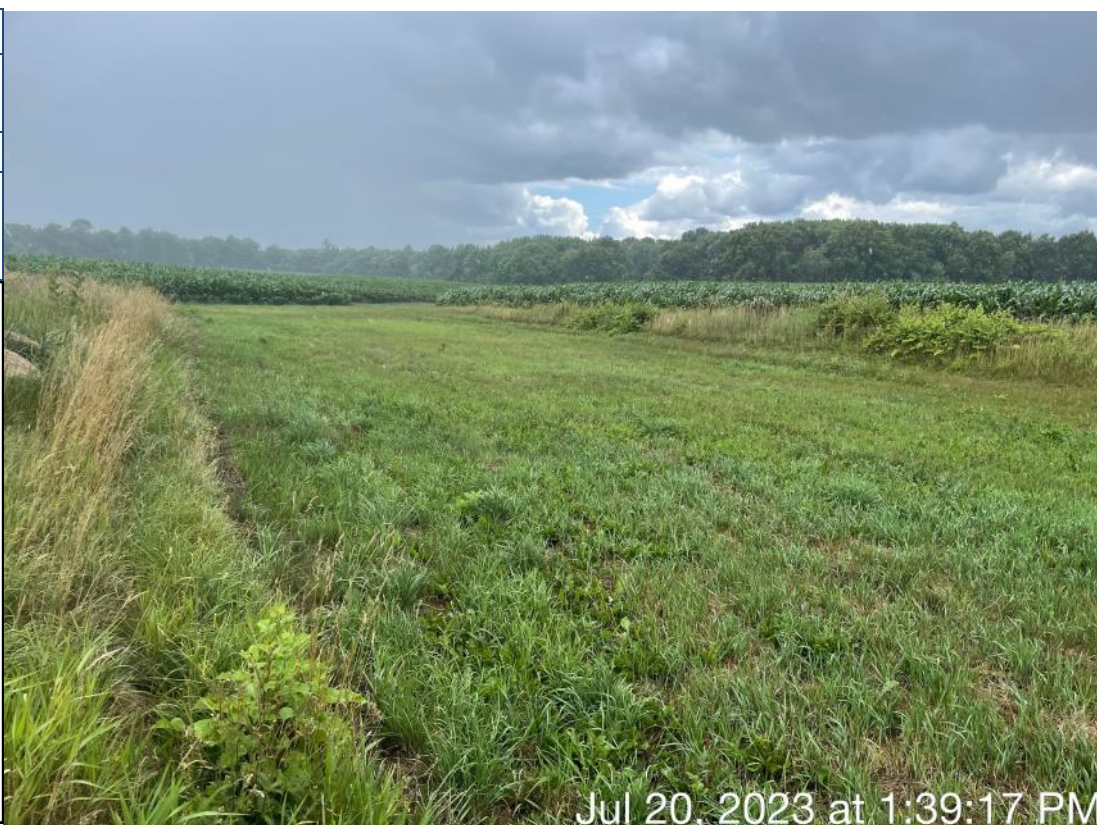
Photo #:	7807
Date/Time of Photo:	7/20/2023 13:39
Photo By:	Brian Hanson
Photo Location:	Pasture Feed Rail VTA
Photo Description:	Standing on the east side of concrete spreader pad looking east: View of vegetated treatment are from feed rail. Area is well-vegetated & maintained.

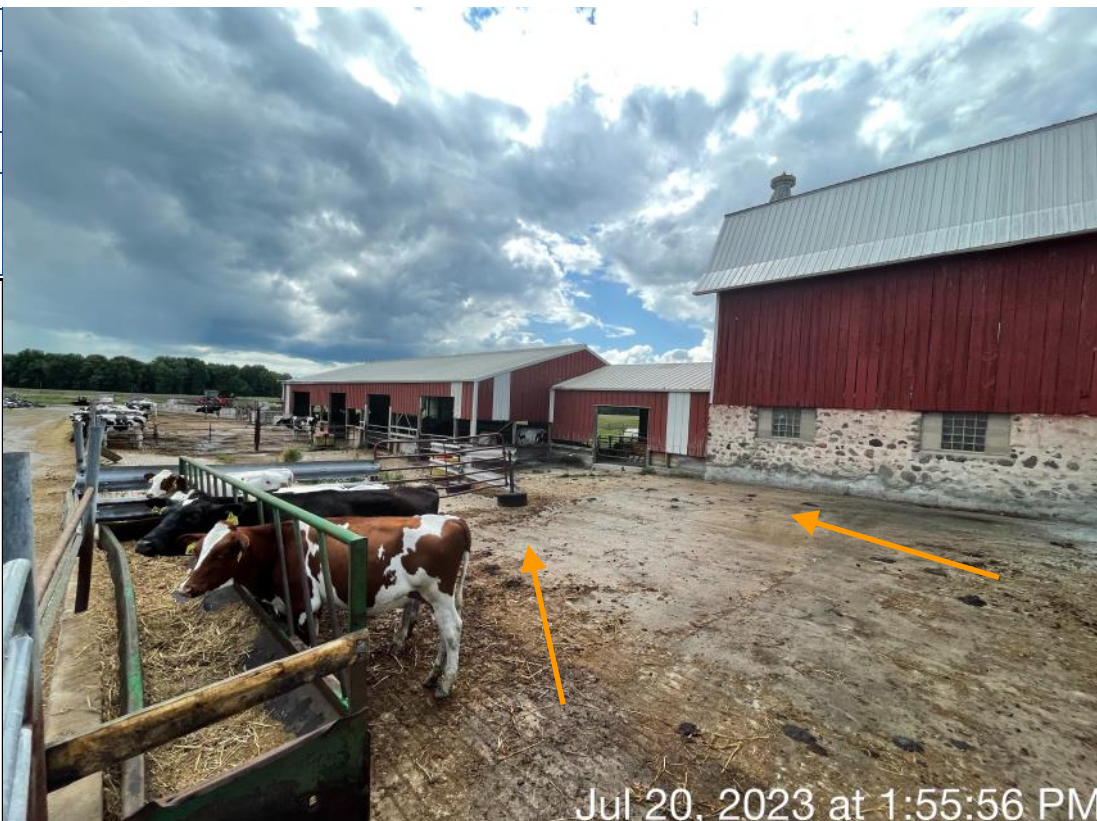
Photo #:	7893
Date/Time of Photo:	7/20/2023 13:55
Photo By:	Brian Hanson
Photo Location:	Dry Cow Lot
Photo Description:	Standing on the north end of dry cow lot looking south: View of north end of dry cow lot. Arrows indicate direction of runoff flow.

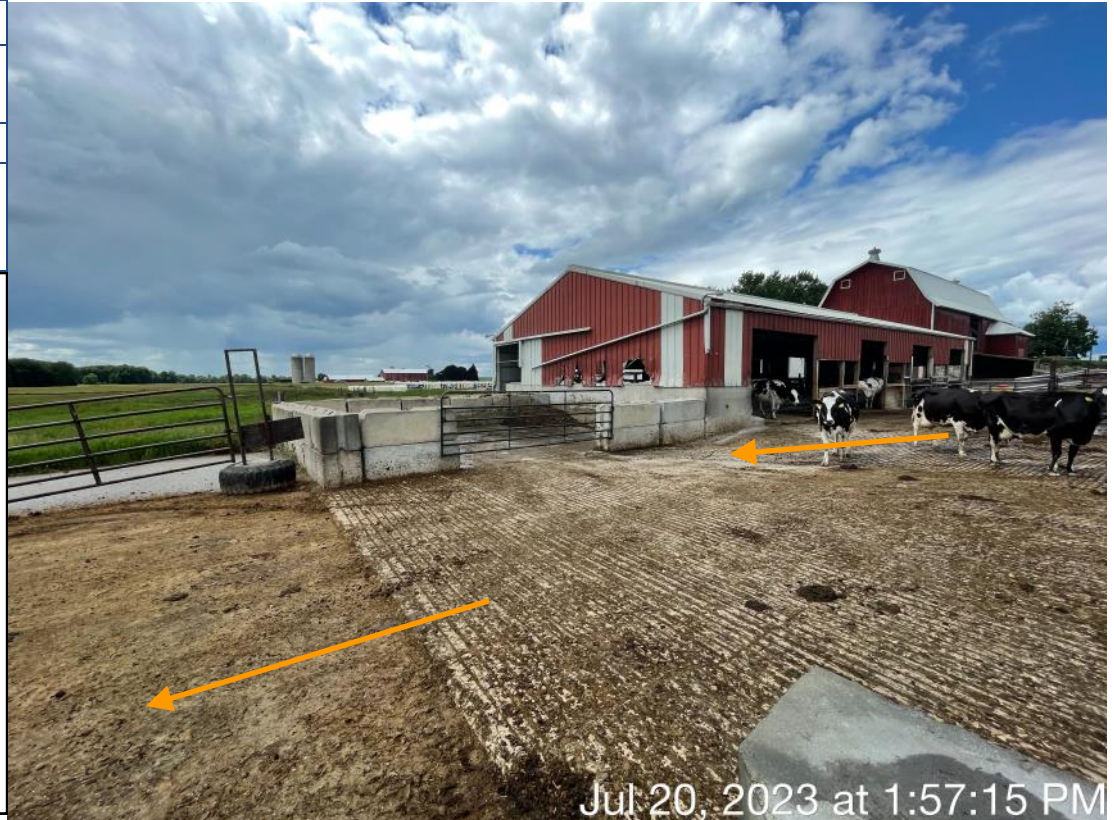
Photo #:	7904
Date/Time of Photo:	7/20/2023 13:57
Photo By:	Brian Hanson
Photo Location:	Dry Cow Lot

Photo Description:
Standing in the middle of dry cow lot looking west: View of middle of dry cow lot . Notice manure stacking area on west side of lot. Arrows indicate direction of runoff flow.

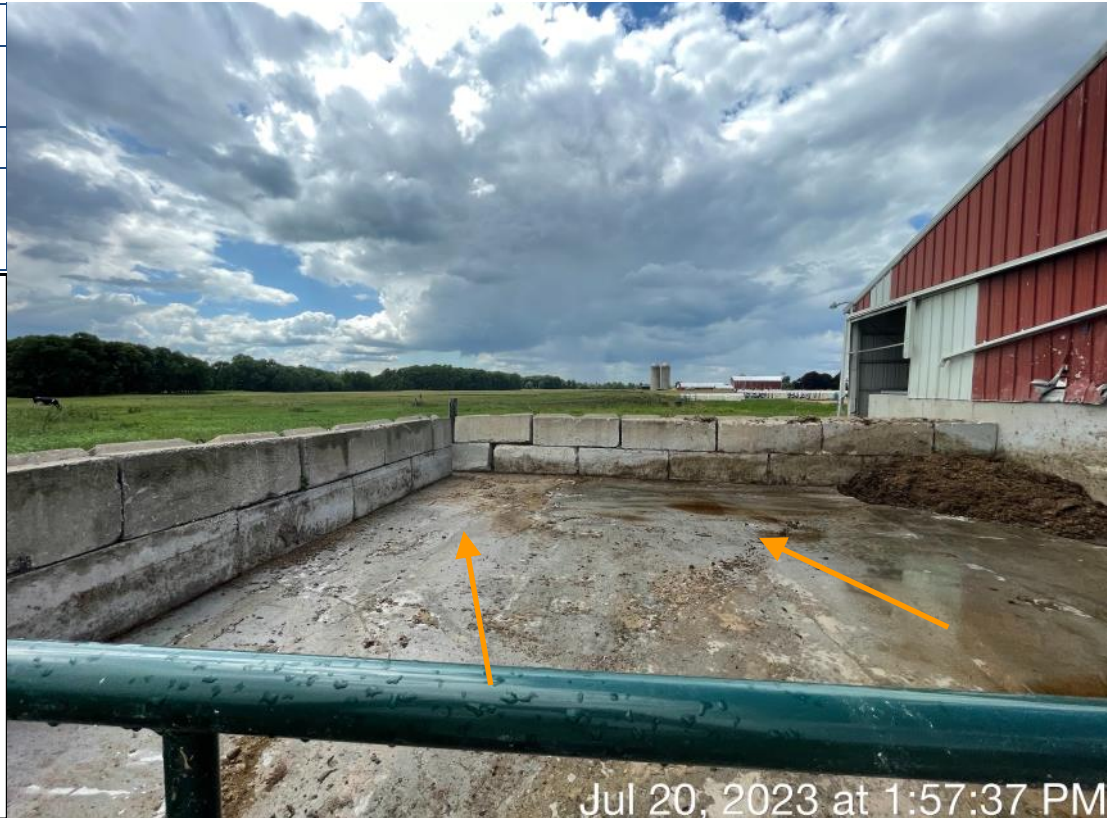
Photo #:	7909
Date/Time of Photo:	7/20/2023 13:57
Photo By:	Brian Hanson
Photo Location:	Dry Cow Lot

Photo Description:
Standing in middle of dry cow lot looking west: Close up view of manure stacking area. Notice walls made of Texas blocks. Arrows indicate direction of runoff flow.

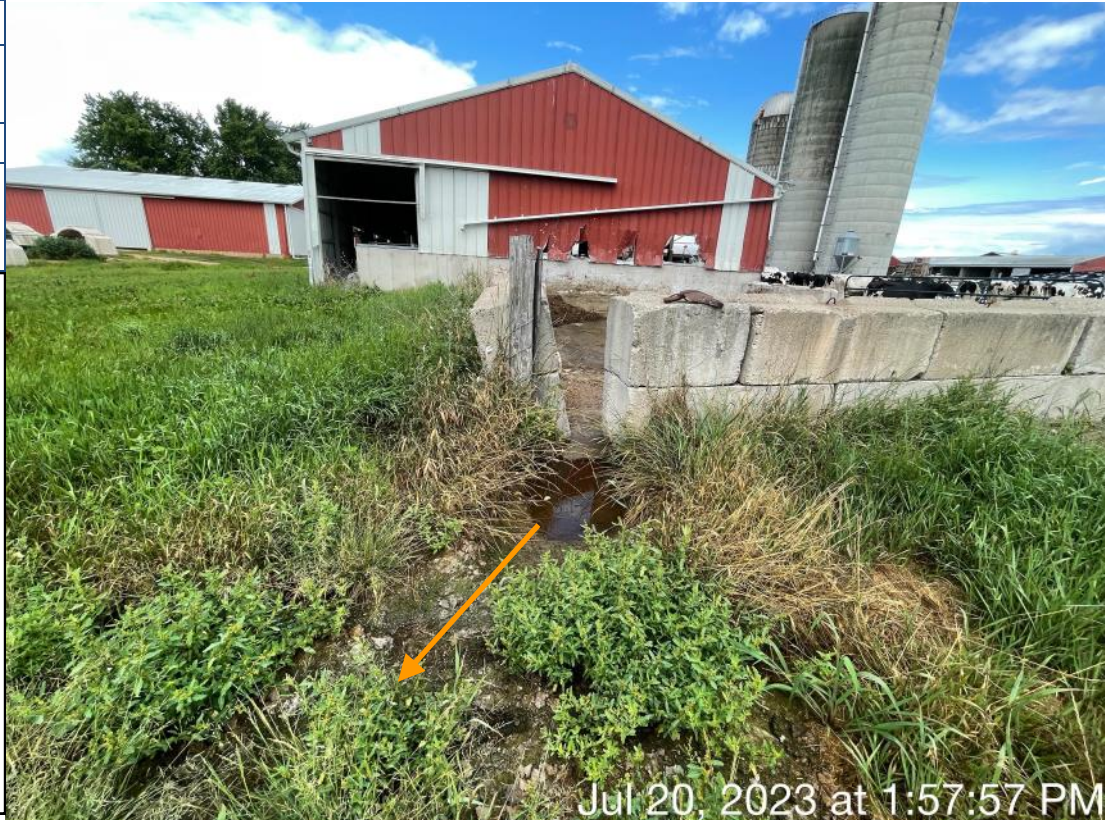
Photo #:	7910
Date/Time of Photo:	7/20/2023 13:57
Photo By:	Brian Hanson
Photo Location:	Dry Cow Lot

Photo Description:
Standing on west side of dry cow lot looking northeast: View of south west corner of manure stacking pad. Notice gap in wall and ponded runoff outside of blocks. Arrow indicated direction of runoff flow.

Feedlot runoff control system for the Feed Rail Area is well-maintained and in good repair, however according to the 2021 evaluation further actions are required which have not yet been completed. At the time of the inspection, the Dry Cow Lot & the Cattle Walkway did not have any runoff controls present.

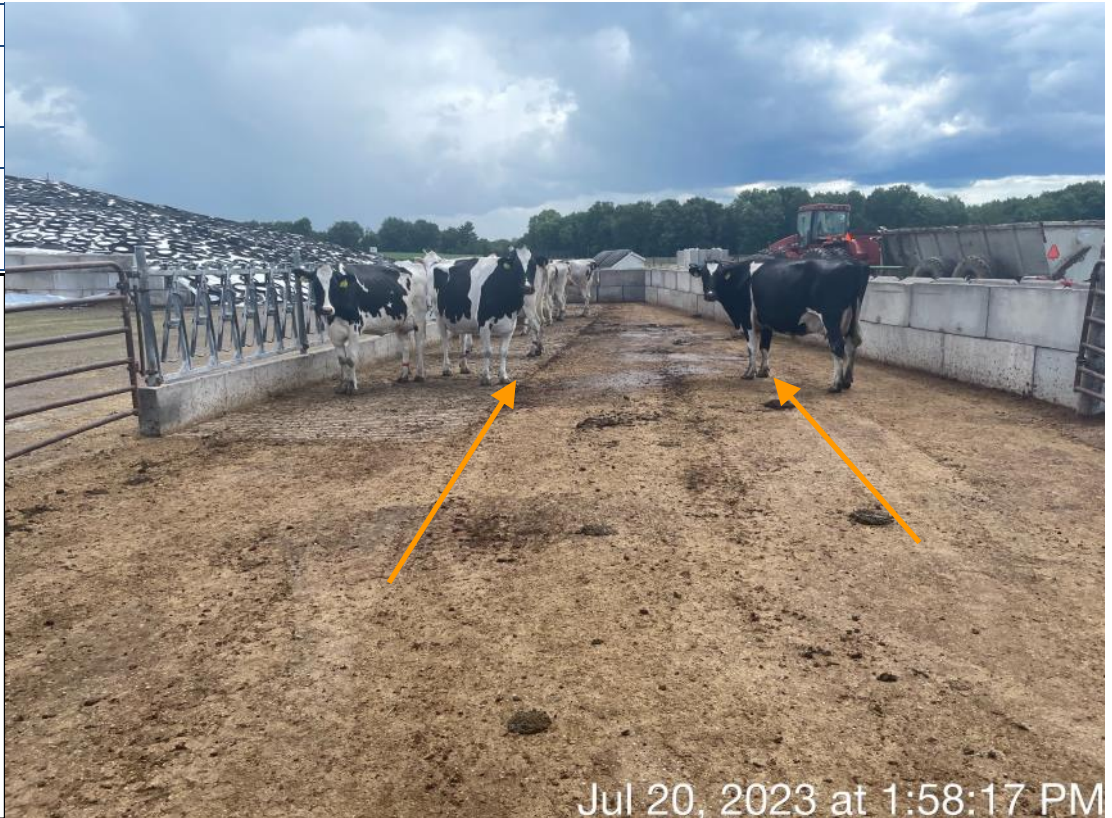
Photo #:	7912
Date/Time of Photo:	7/20/2023 13:58
Photo By:	Brian Hanson
Photo Location:	Dry Cow Lot

Photo Description:
Standing in middle of dry cow lot looking south: View of south 1/2 of dry cow lot. Arrows indicate direction of runoff flow.

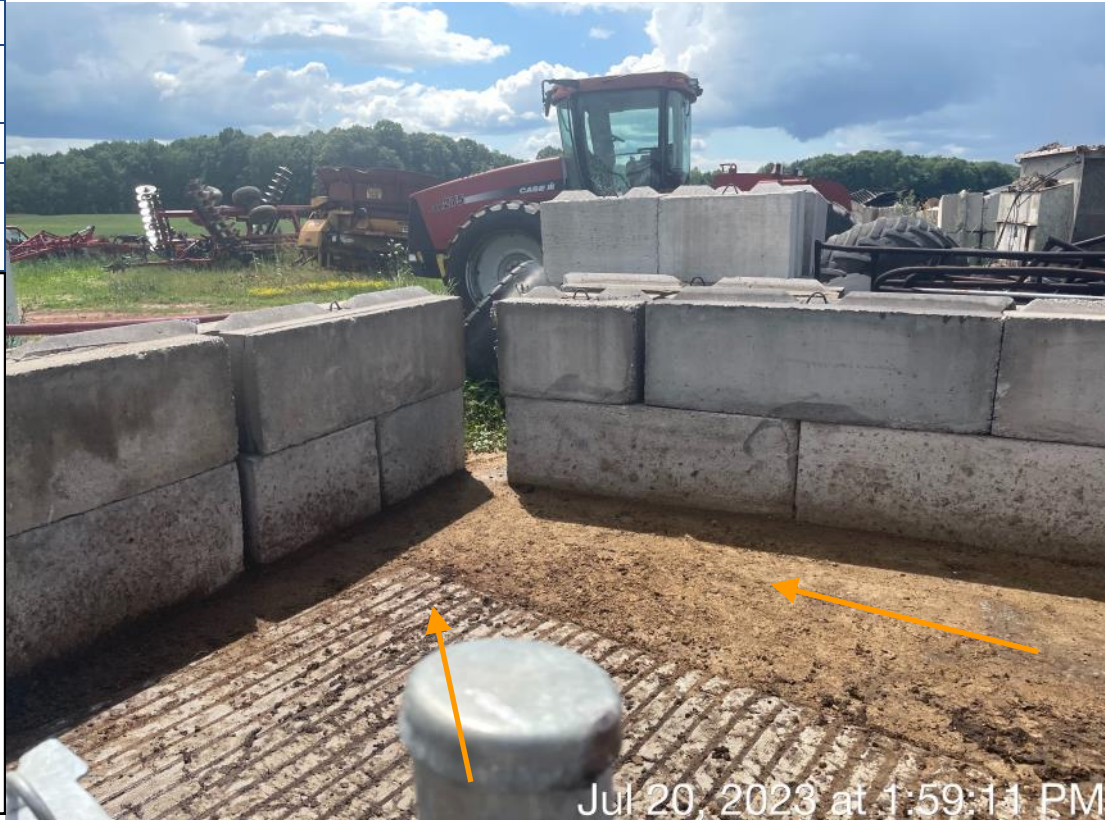
Standing at south end of dry cow lot looking southwest: View of south end of dry cow lot. Notice Texas blocks again used to form edge of lot. Also notice gap in wall. Arrows indicate direction of runoff flow.

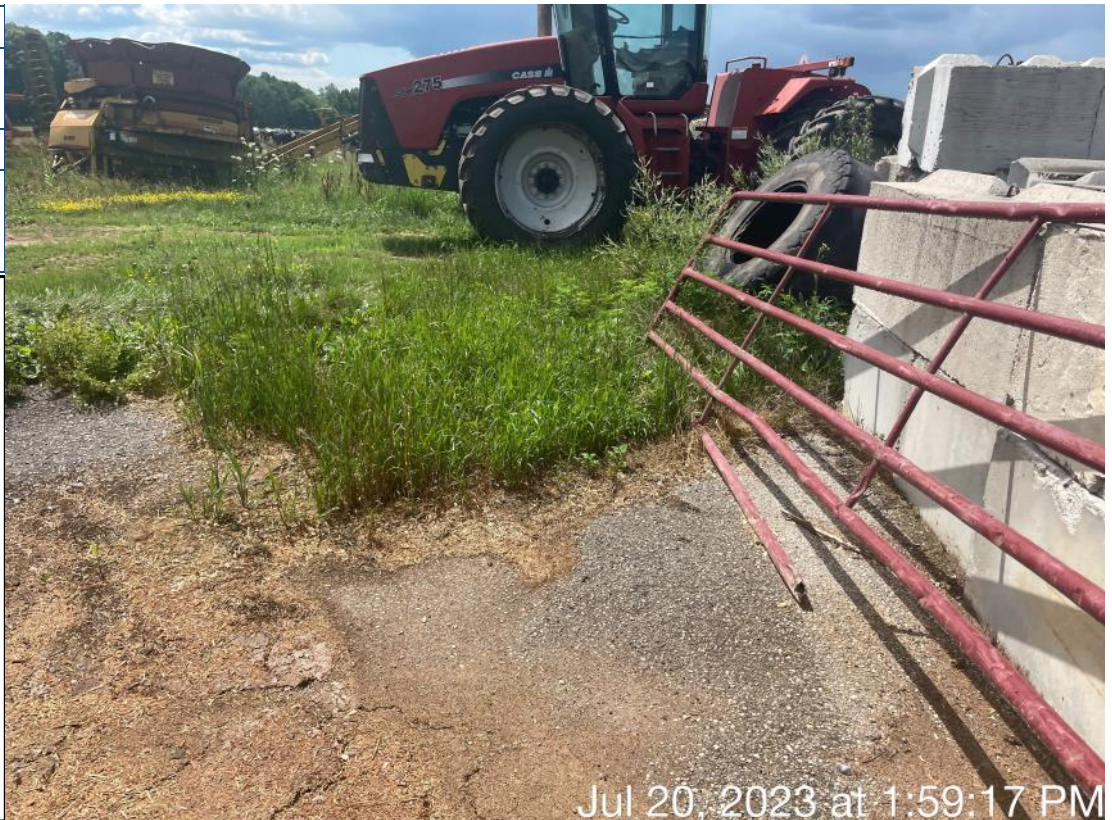
Photo #:	7916
Date/Time of Photo:	7/20/2023 13:59
Photo By:	Brian Hanson
Photo Location:	Dry Cow Lot

Standing off south end of dry cow lot looking west: View of area south of dry cow lot wall. Notice manure solids & ponded runoff visible on exterior of lot.

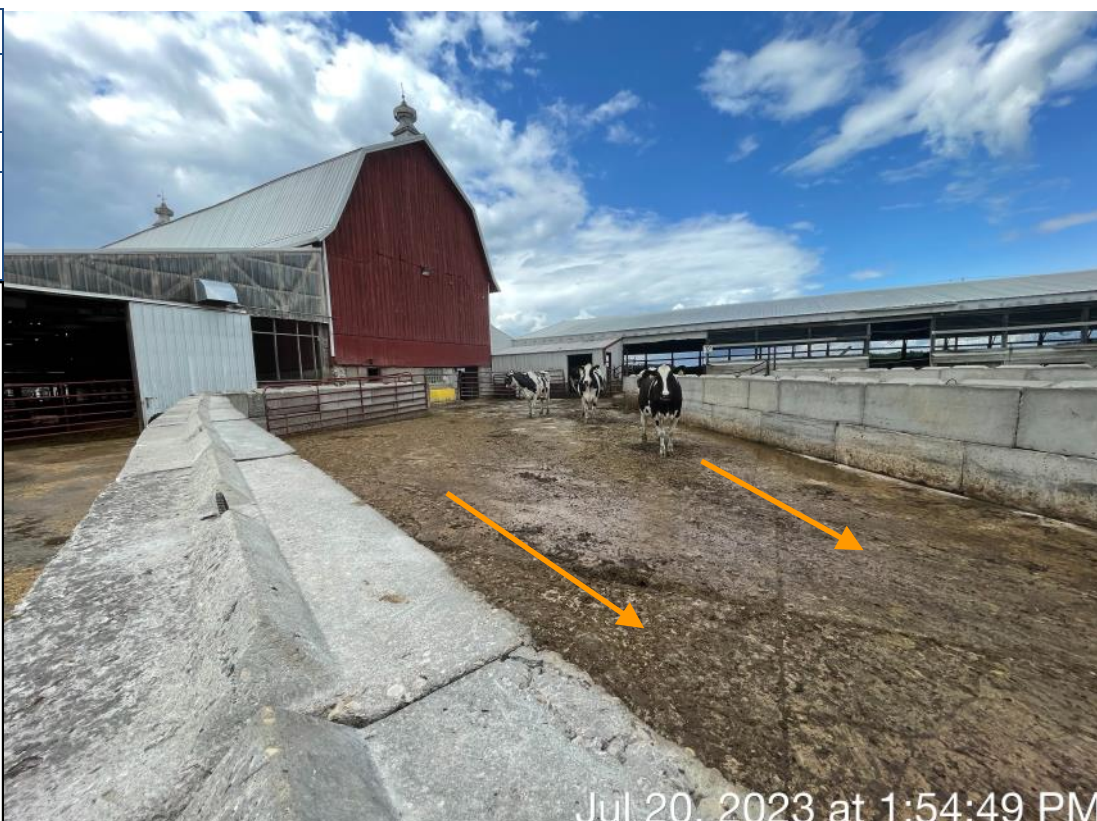
Photo #:	7878
Date/Time of Photo:	7/20/2023 13:54
Photo By:	Brian Hanson
Photo Location:	Cattle Walkway

Photo Description:
 Standing north of the feed storage area looking north: View of the cattle walkway connecting the freestall barns & parlor. Arrows indicate direction of runoff flow.

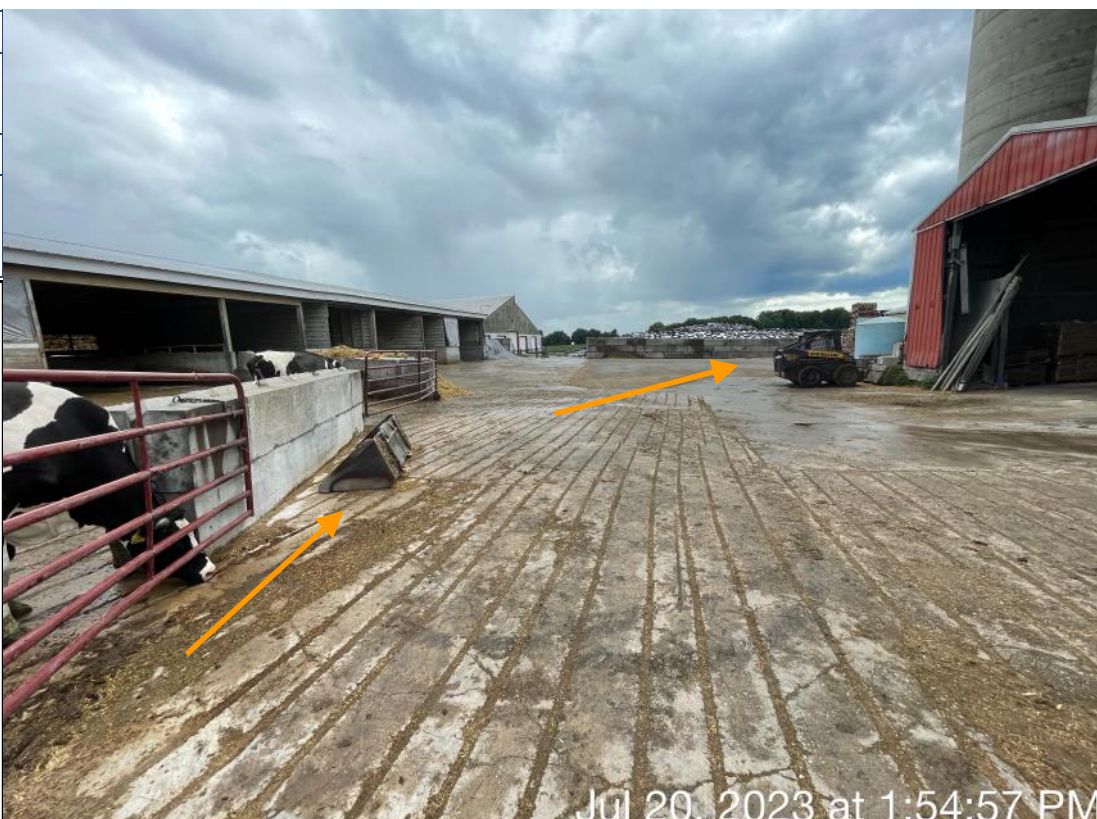
Photo #:	7881
Date/Time of Photo:	7/20/2023 13:54
Photo By:	Brian Hanson
Photo Location:	Cattle Walkway

Photo Description:
 Standing on the north side of feed storage area looking south: View of edge of cattle walkway. Notice gaps in block wall where runoff exits the lot. Arrows indicate direction of runoff flow.

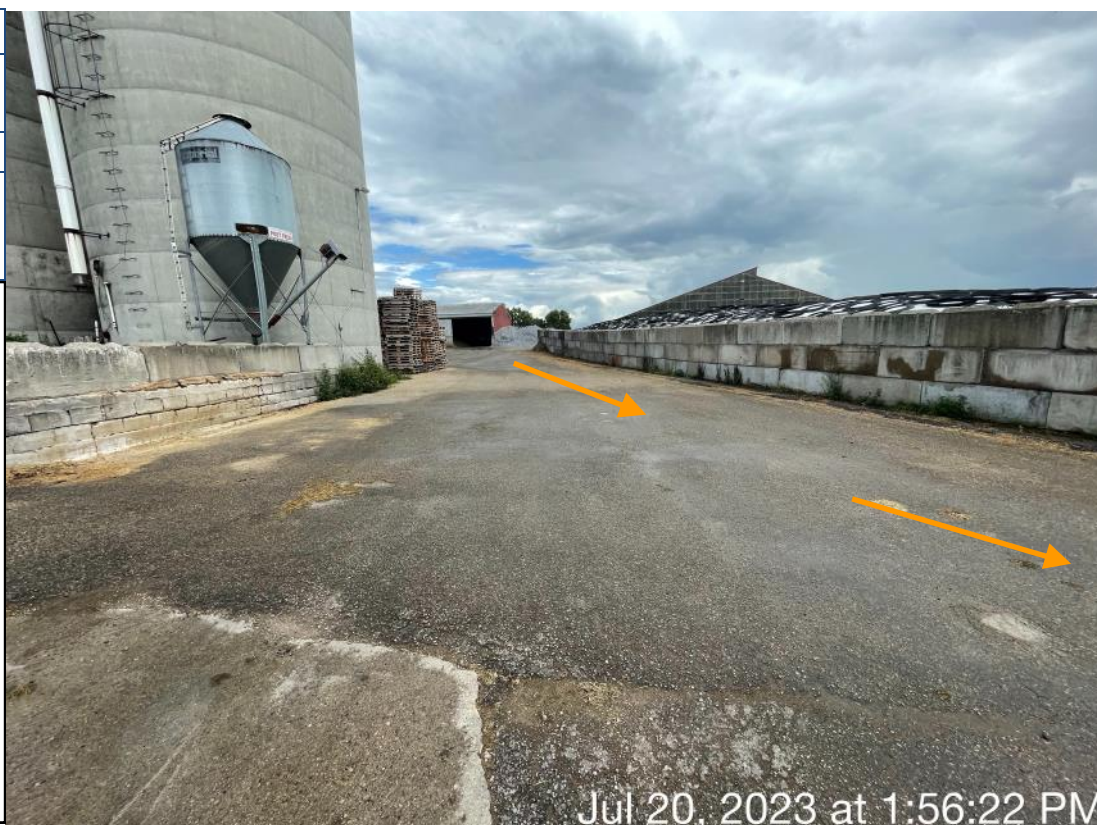
Photo #:	7898
Date/Time of Photo:	7/20/2023 13:56
Photo By:	Brian Hanson
Photo Location:	Cattle Walkway Runoff Flow

Photo Description:
Standing on the north side of feed storage area looking east: View of north edge of FSA where runoff from cattle walkway flows around FSA. Arrows indicate direction of runoff flow.

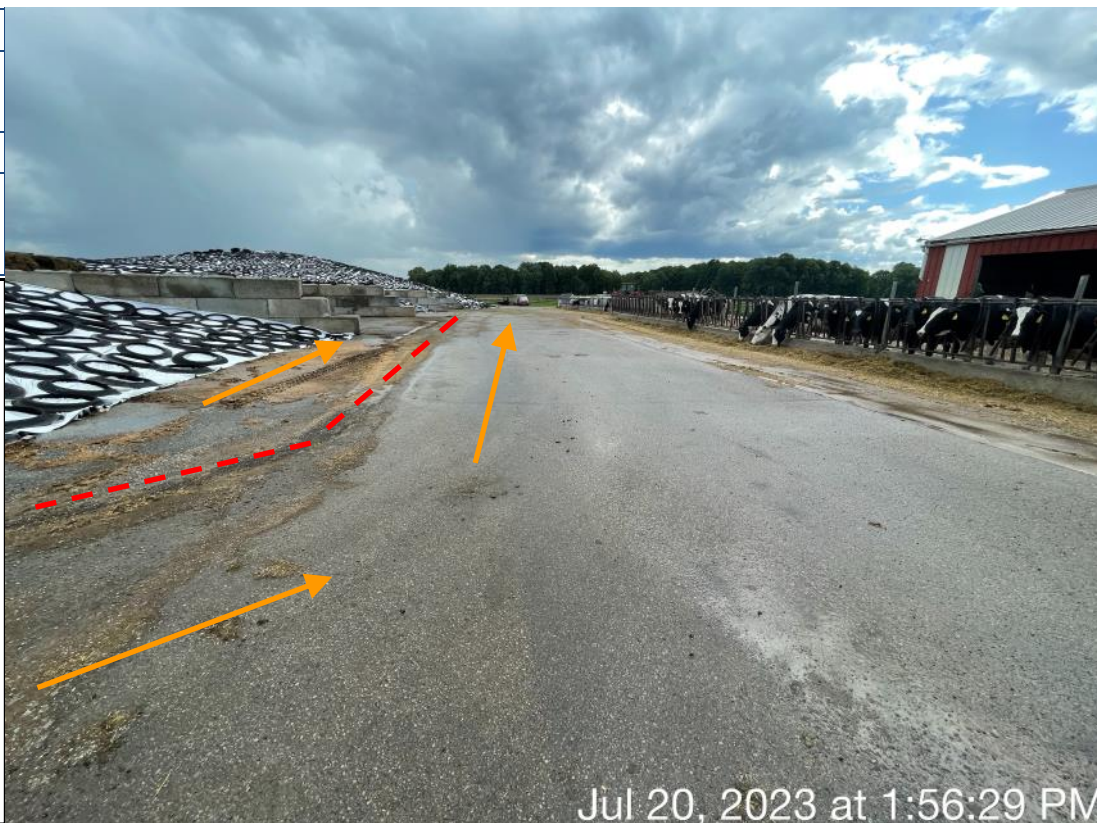
Photo #:	7899
Date/Time of Photo:	7/20/2023 13:56
Photo By:	Brian Hanson
Photo Location:	Cattle Walkway Runoff Flow

Photo Description:
Standin at northwest corner of FSA looking south: View of west edge of FSA. Red line indicates curb used to keep FSA runoff separate from other runoff. Arrows indicate direction of runoff flow.

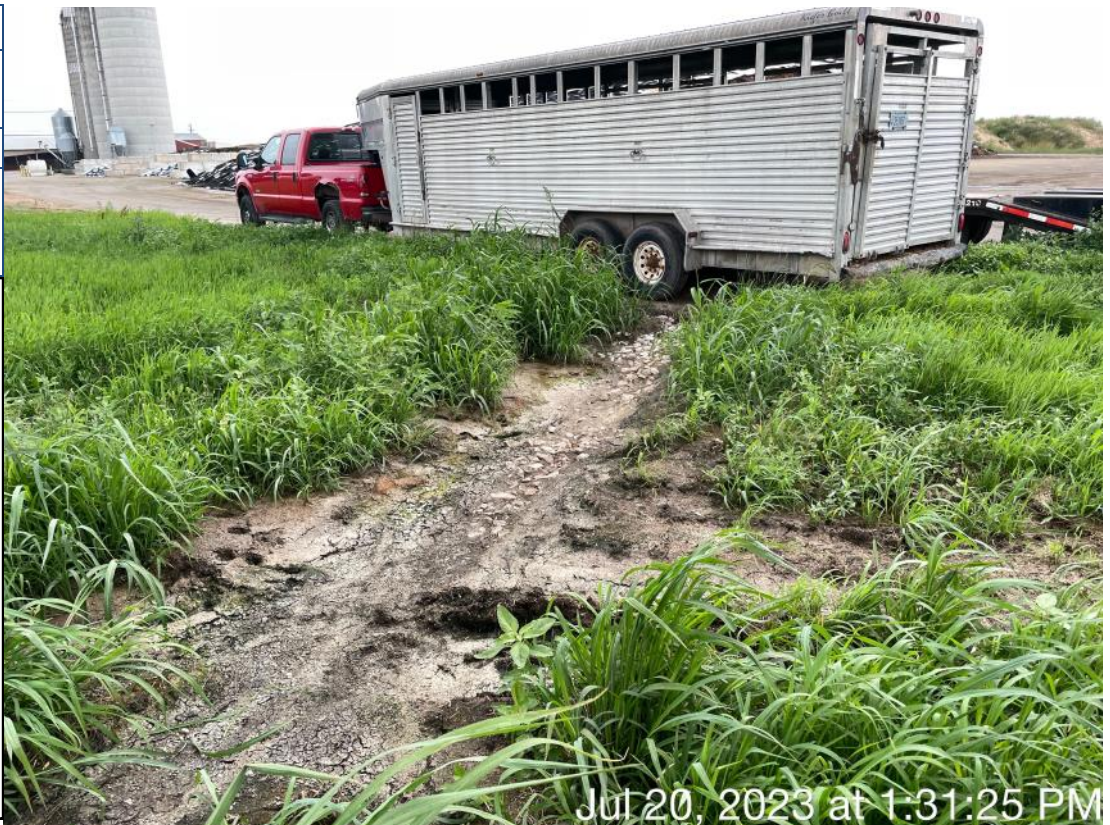
Photo #:	7772
Date/Time of Photo:	7/20/2023 13:31
Photo By:	Brian Hanson
Photo Location:	Cattle Walkway Runoff Flow

Photo Description:
Standing off the southwest corner of FSA looking northeast: View of stormwater runoff channel the collects runoff from farmstead & cattle walkway. Noticed channelized flow with organic solids & lack of vegetation.

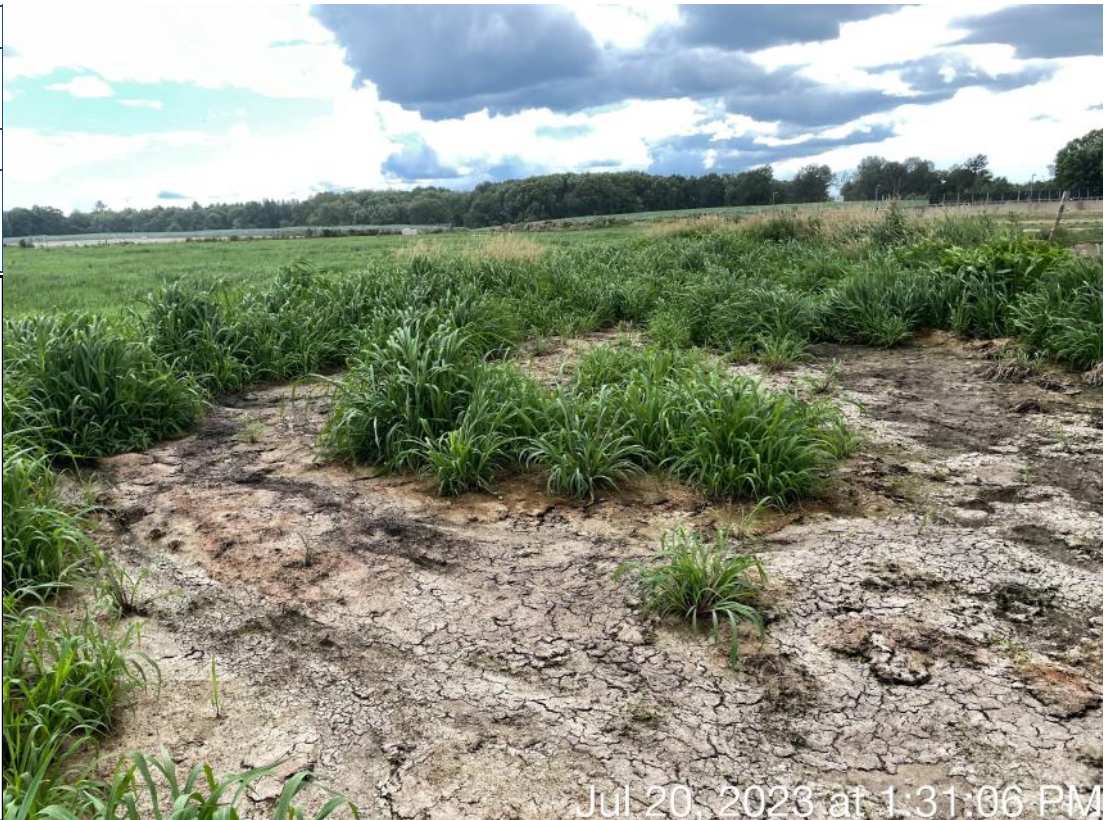
Photo #:	7771
Date/Time of Photo:	7/20/2023 13:31
Photo By:	Brian Hanson
Photo Location:	Cattle Walkway Runoff Flow

Photo Description:
Standing off the southwest corner of FSA looking southwest: View of stormwater runoff channel the collects runoff from farmstead & cattle walkway. Noticed area where runoff ponds. Organic solids & lack of vegetation present indicating signs of previous discharges.

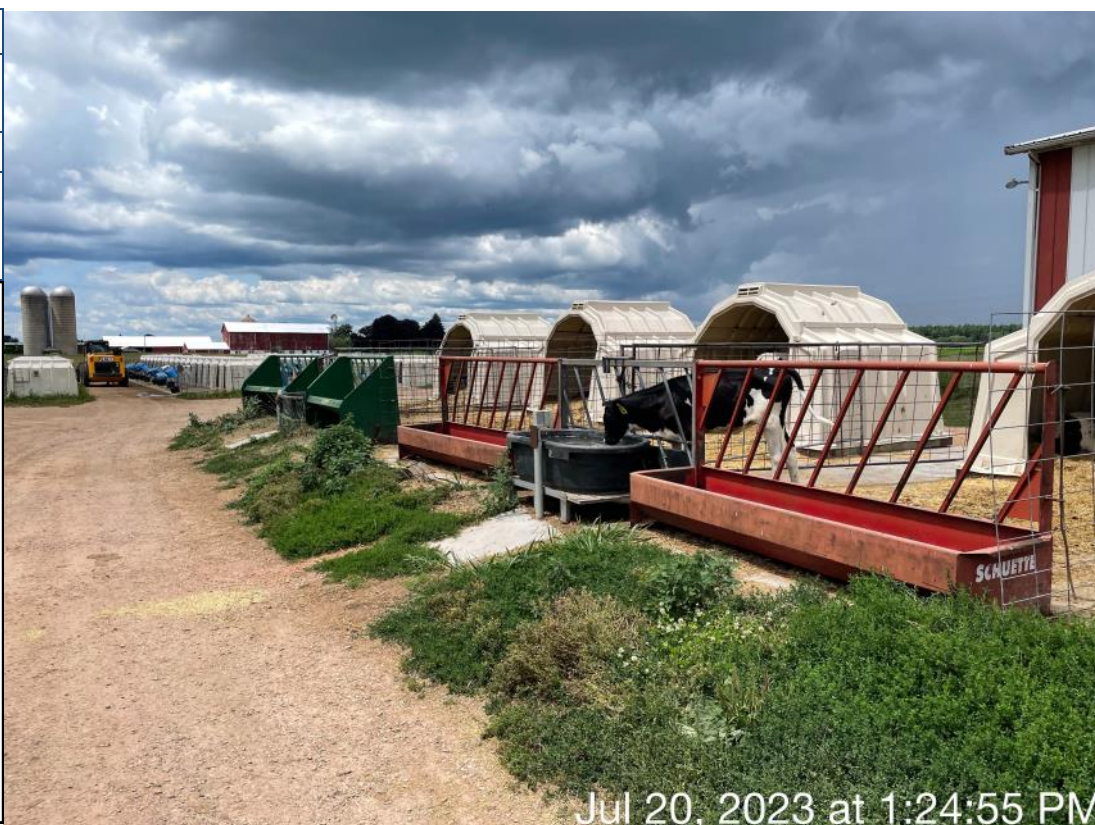
Photo #:	7742
Date/Time of Photo:	7/20/2023 13:24
Photo By:	Brian Hanson
Photo Location:	Calf Hutch Area

Photo Description:
Standing on the south side of calf hutch area looking west: View of super hutch area on east end of calf hutch area.

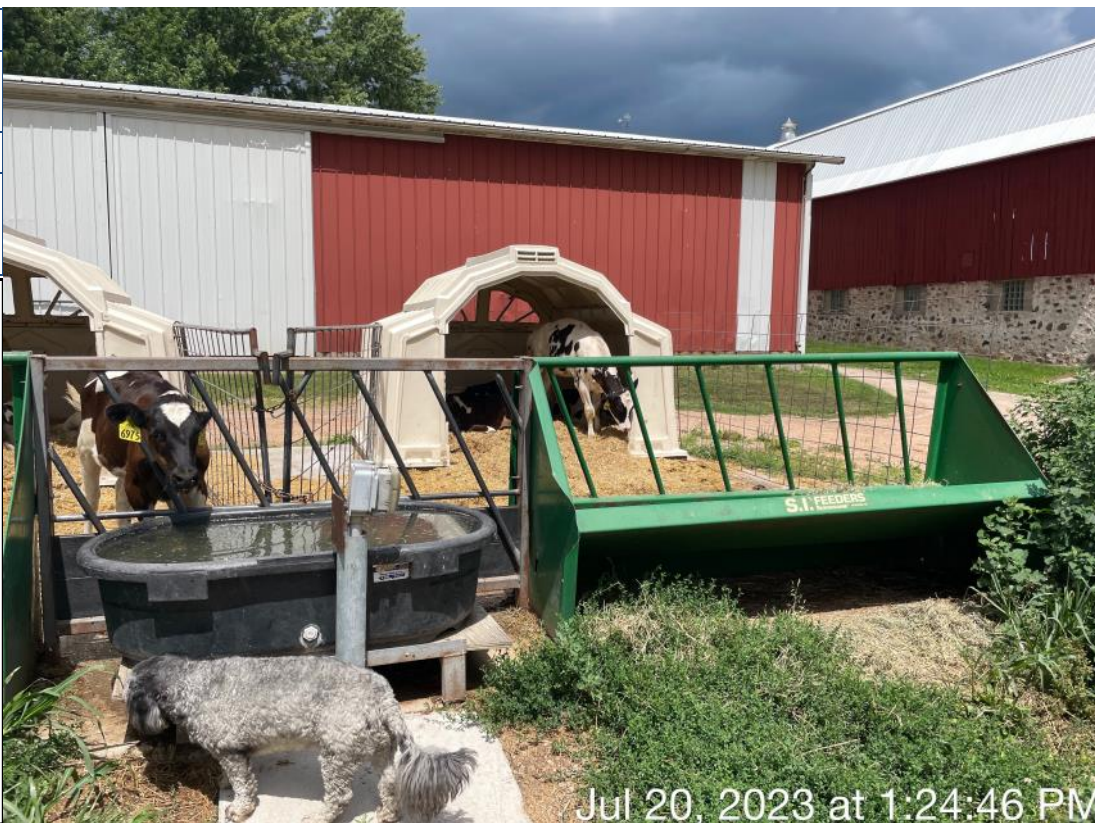
Photo #:	7739
Date/Time of Photo:	7/20/2023 13:24
Photo By:	Brian Hanson
Photo Location:	Calf Hutch Area

Photo Description:
Standing on south side of calf hutch area looking north: View of super hutch. Notice calves have access to bedded outdoor area and feed rail system.

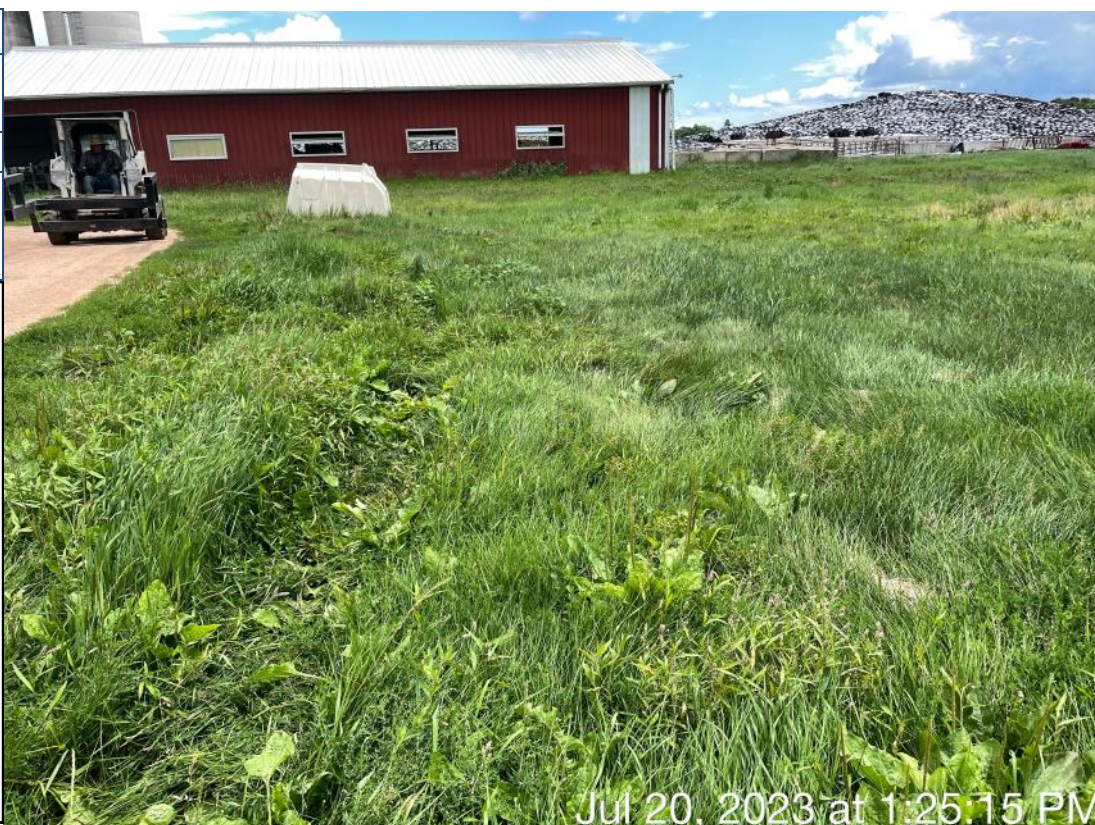
Photo #:	7745
Date/Time of Photo:	7/20/2023 13:26
Photo By:	Brian Hanson
Photo Location:	Calf Hutch Area

Standing on south side of calf hutch area looking east: View of grassed area on south side of calf hutch area where runoff would flow. No signs of current or past discharges in this area.

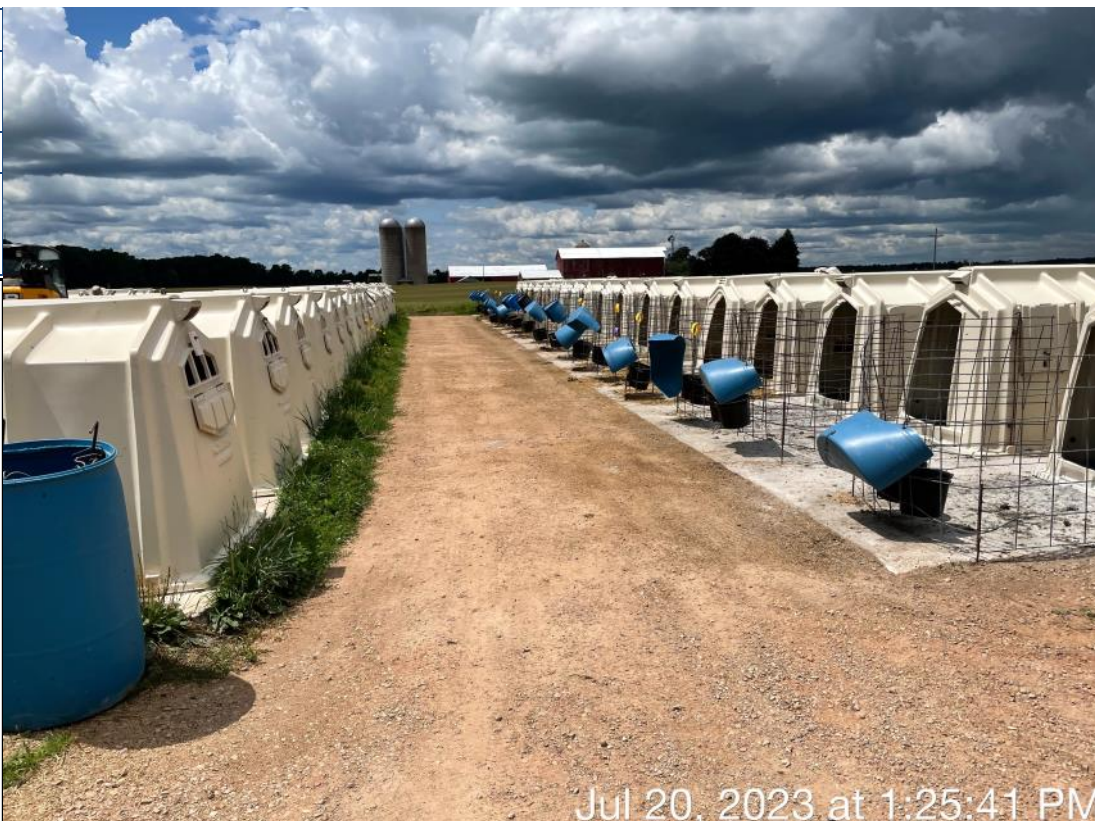
Photo #:	7748
Date/Time of Photo:	7/20/2023 13:25
Photo By:	Brian Hanson
Photo Location:	Calf Hutch Area

Standing on the east side of the calf hutch area looking west: View of the west 1/2 of lot that has individual hutches. Notice hutches are placed on concrete slabs.

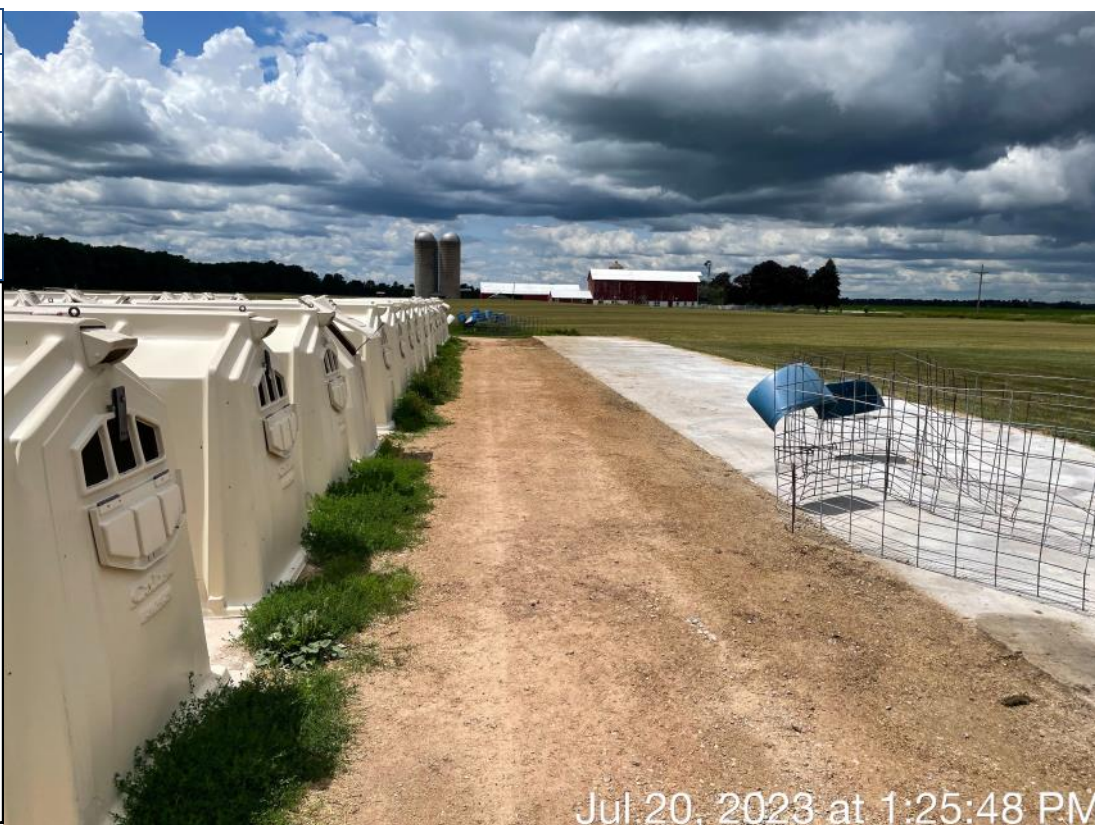
Photo Description:
Standing on the side of calf hutch area looking west: View of the northern row of calf hutch area. Notice hutches are rotated when calves are moved. When not in use, hutches are removed and area is cleaned.
