Permit Fact Sheet

Permit Number:	WI-0064246-03-0
Permittee Name:	Blaser Farms Inc
Address:	9267 State Hwy 22 E
City/State/Zip:	Gillett WI 54124
Discharge Location:	9267 Hwy 22 E, Gillett, WI 54124 ; NW ¼ of NW ¼ Section 20, T28N, R19E
Receiving Water:	Unnamed tributaries within the Oconto River Watershed, and groundwaters of the state
Discharge Type:	Existing

Site Overview Diagram (Blaser Farms Inc.)

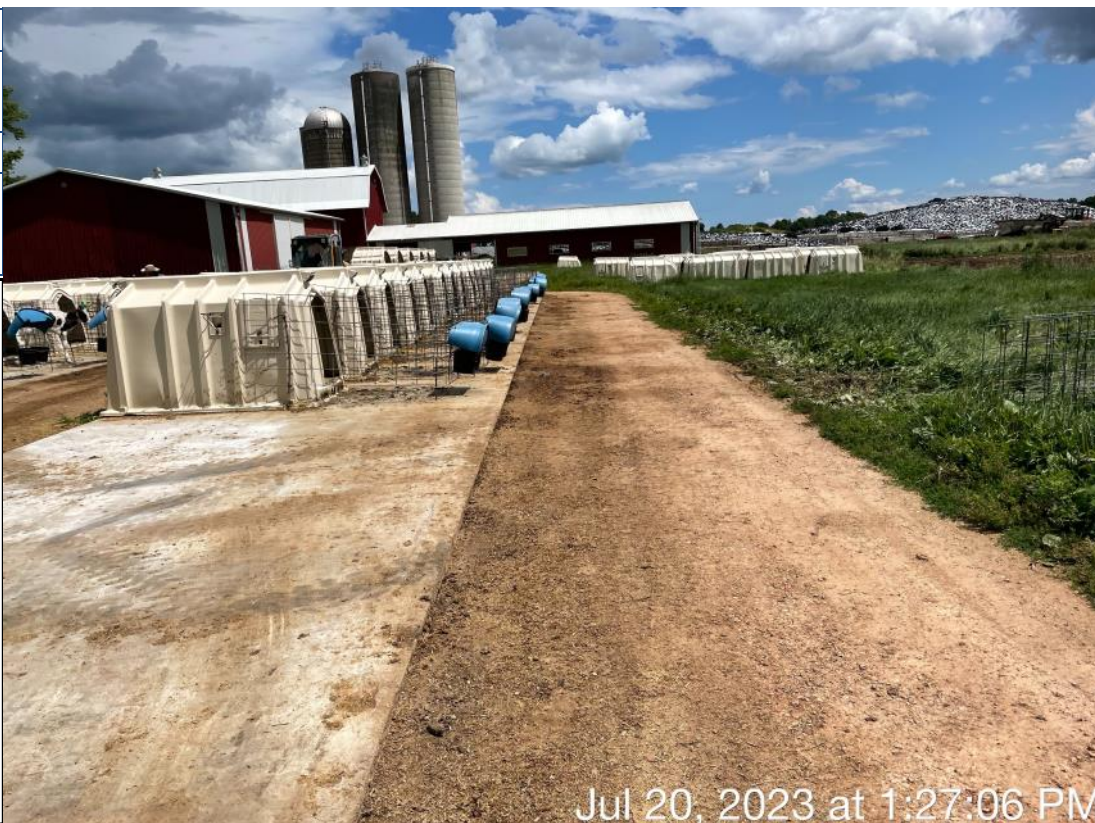
Photo Description:
Standing on west side of calf hutch area looking east: View of south row of calf hutch area. Notice a small amount of solids & runoff at edge of gravel.

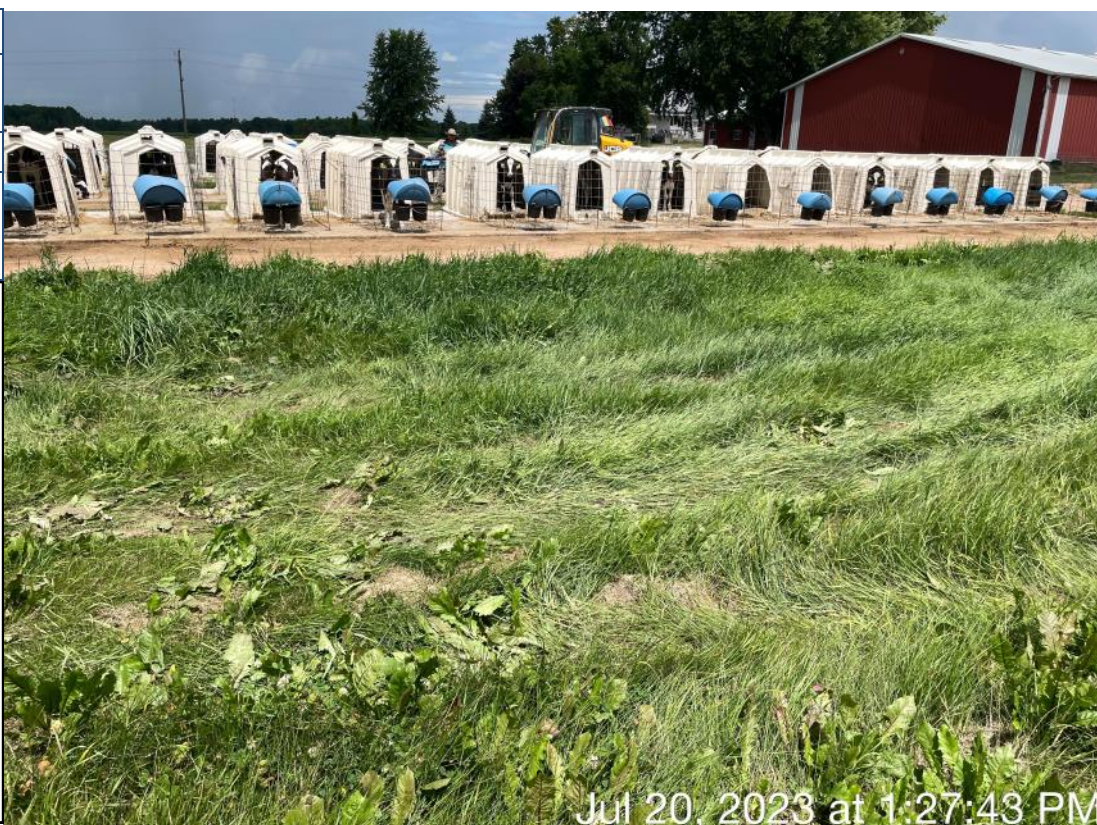
Photo #:	7812
Date/Time of Photo:	7/20/2023 13:40
Photo By:	Brian Hanson
Photo Location:	WSF #1
Photo Description:	Standing at the southwest corner of WSF #1 looking north: View of west edge of WSF #1

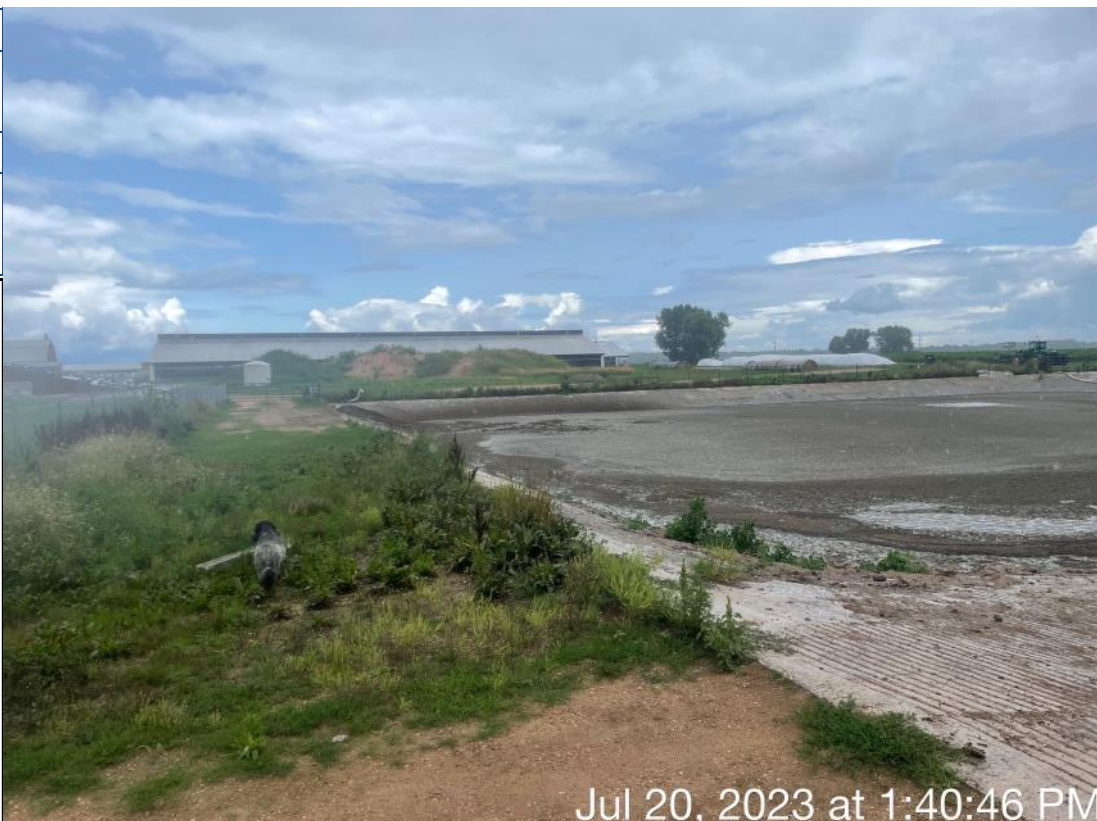
Photo #:	7817
Date/Time of Photo:	7/20/2023 13:41
Photo By:	Brian Hanson
Photo Location:	WSF #1
Photo Description:	
<p>Standing on south side of WSF #1 looking northeast: View of east 1/2 of WSF #1. Notice diving berm on right side of photo.</p>

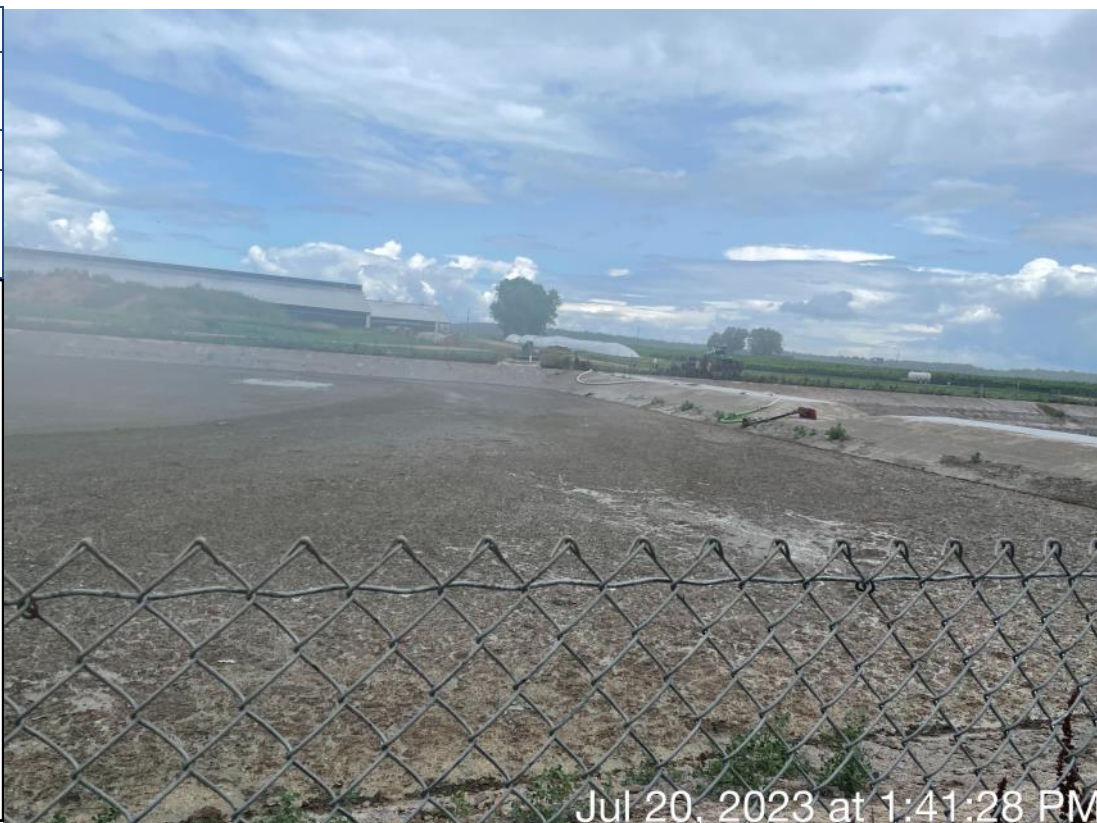
Photo #:	7842
Date/Time of Photo:	7/20/2023 13:47
Photo By:	Brian Hanson
Photo Location:	WSF #1
Photo Description:	
<p>Standing at northeast corner of WSF #1 looking north: View of recirculation tank. Notice concrete channel that slopes into WSF #1 in case of pump failure and tank overflow.</p>

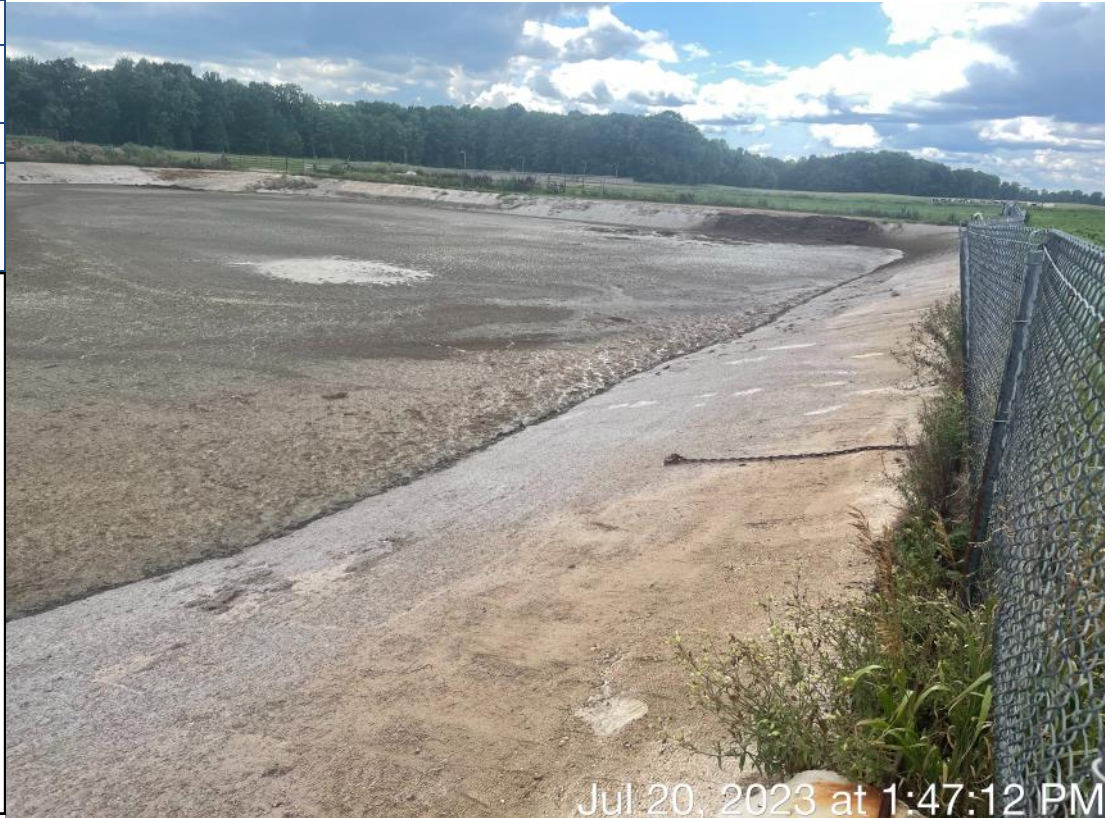
Photo #:	7821
Date/Time of Photo:	7/20/2023 13:42
Photo By:	Brian Hanson
Photo Location:	WSF #2
Photo Description:	Standing on south side of WSF #2 looking north: View of west edge of WSF #2

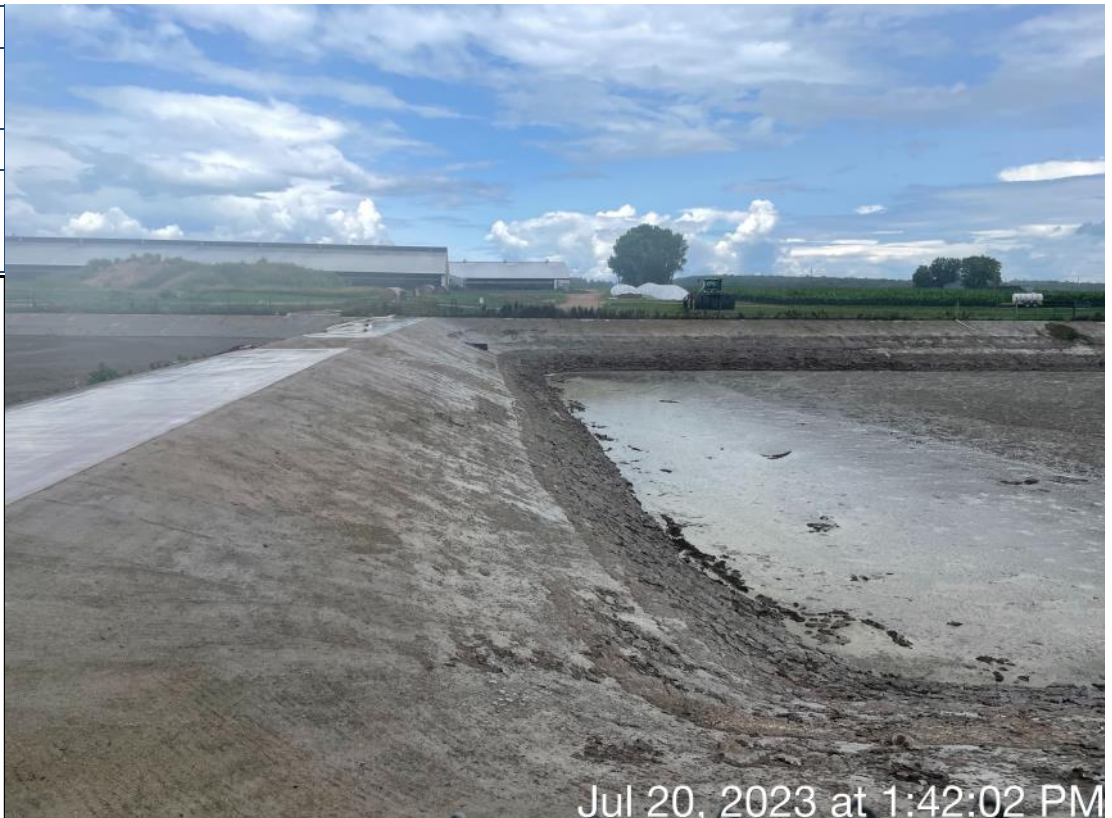
Photo #:	7825
Date/Time of Photo:	7/20/2023 13:42
Photo By:	Brian Hanson
Photo Location:	WSF #2
Photo Description:	Standing on south side of WSF #2 looking east: View of south edge of WSF #2.

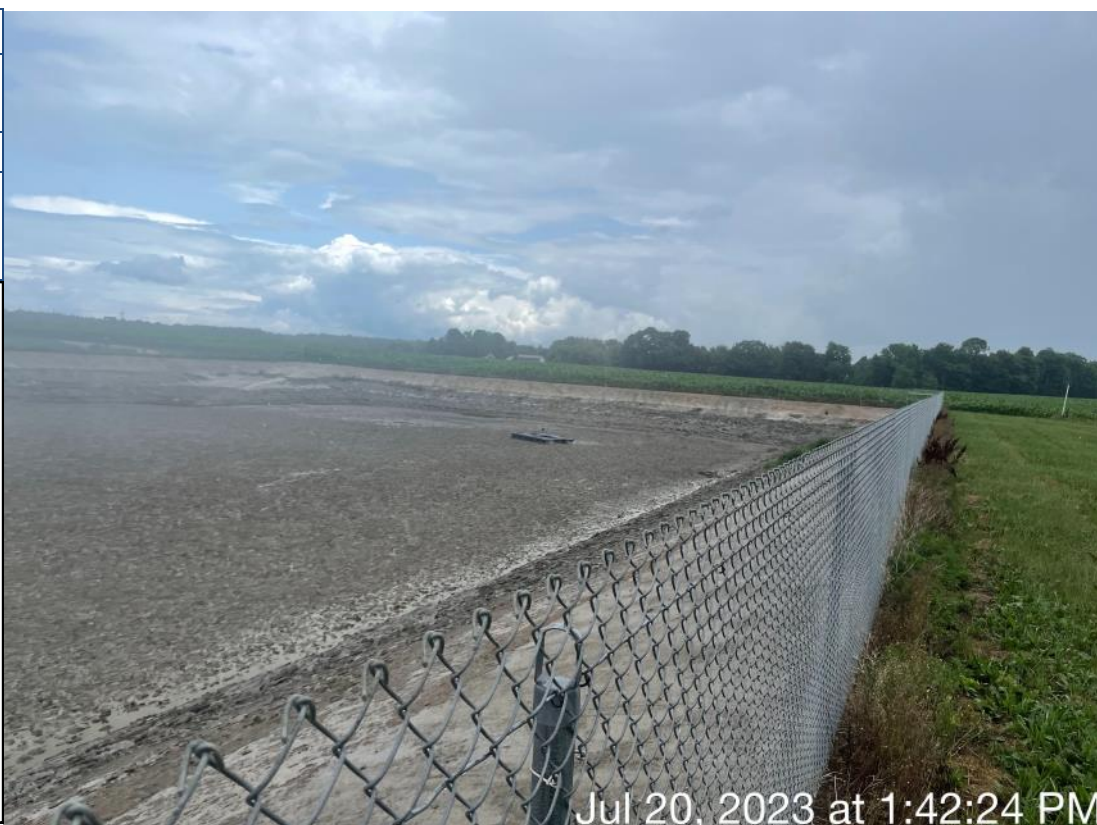
Photo #:	7827
Date/Time of Photo:	7/20/2023 13:44
Photo By:	Brian Hanson
Photo Location:	WSF #2
Photo Description:	Standing on the east side of WSF #2 looking west: View of center section of WSF #2. Notice floating inlet in idle of pit used to supply recirculation water.

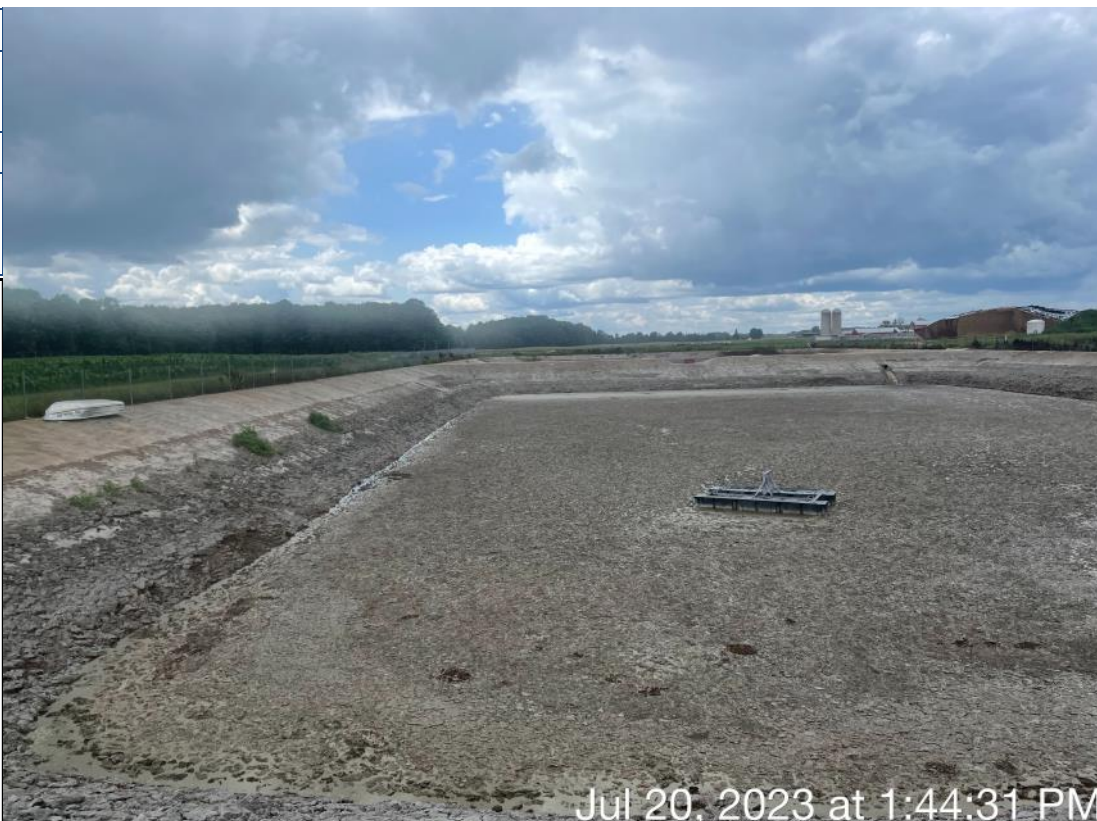
Photo #:	7833
Date/Time of Photo:	7/20/2023 13:45
Photo By:	Brian Hanson
Photo Location:	WSF #2
Photo Description:	Standing at the northeast corner of WSF #2 looking west: View of northeast corner of WSF #2. Notice concrete access ramp in northeast corner of WSF #2.

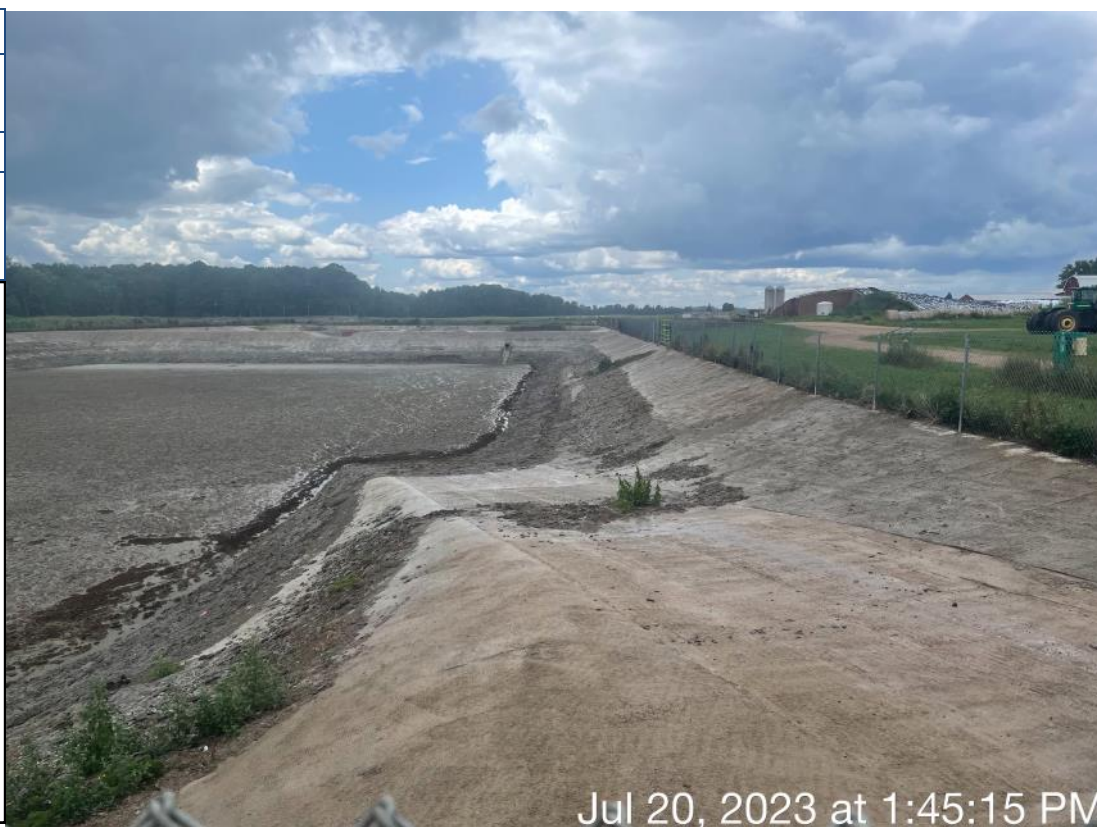
Photo #:	7838
Date/Time of Photo:	7/20/2023 13:46
Photo By:	Brian Hanson
Photo Location:	WSF #2
Photo Description:	Standing on north side of WSF #2 looking west: View of northwest corner of WSF #2. Notice chain pinned to top of liner used as permanent marker.

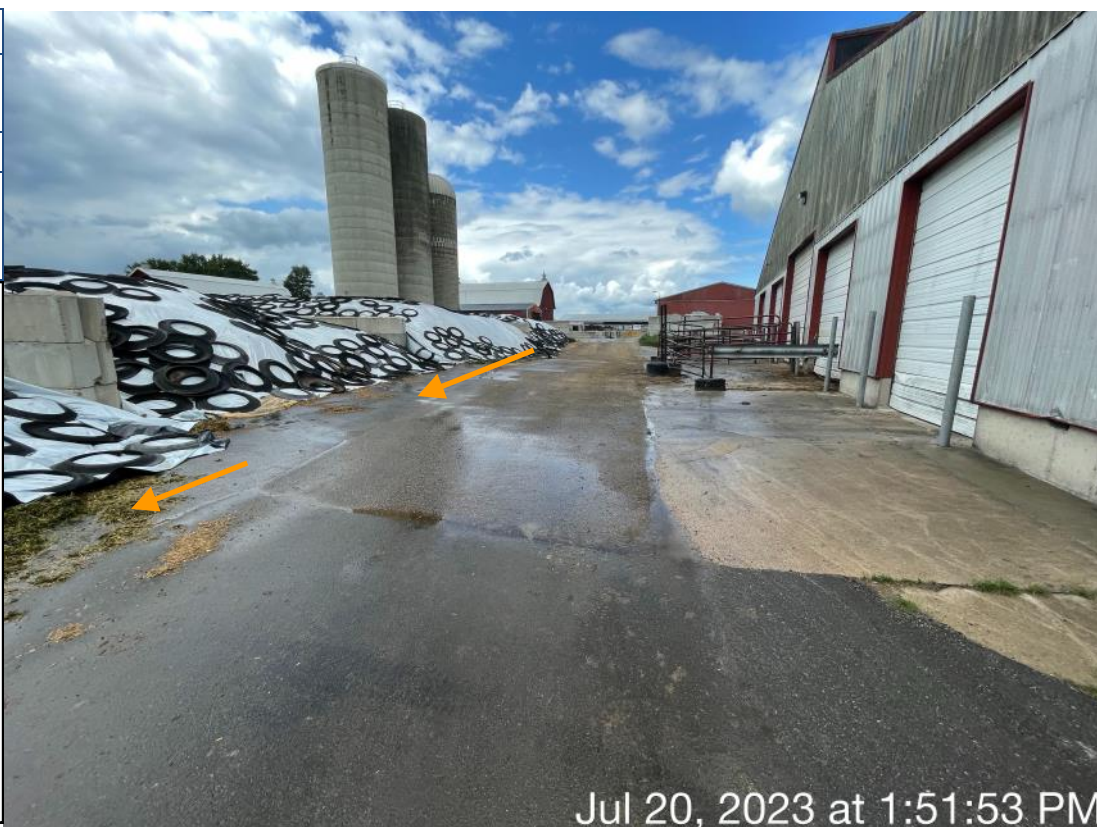
Photo #:	7866
Date/Time of Photo:	7/20/2023 13:51
Photo By:	Brian Hanson
Photo Location:	Feed Storage Area

Photo Description:
Standing on the east side of FSA looking north: View of east side of FSA. Arrows indicate direction of runoff flow.

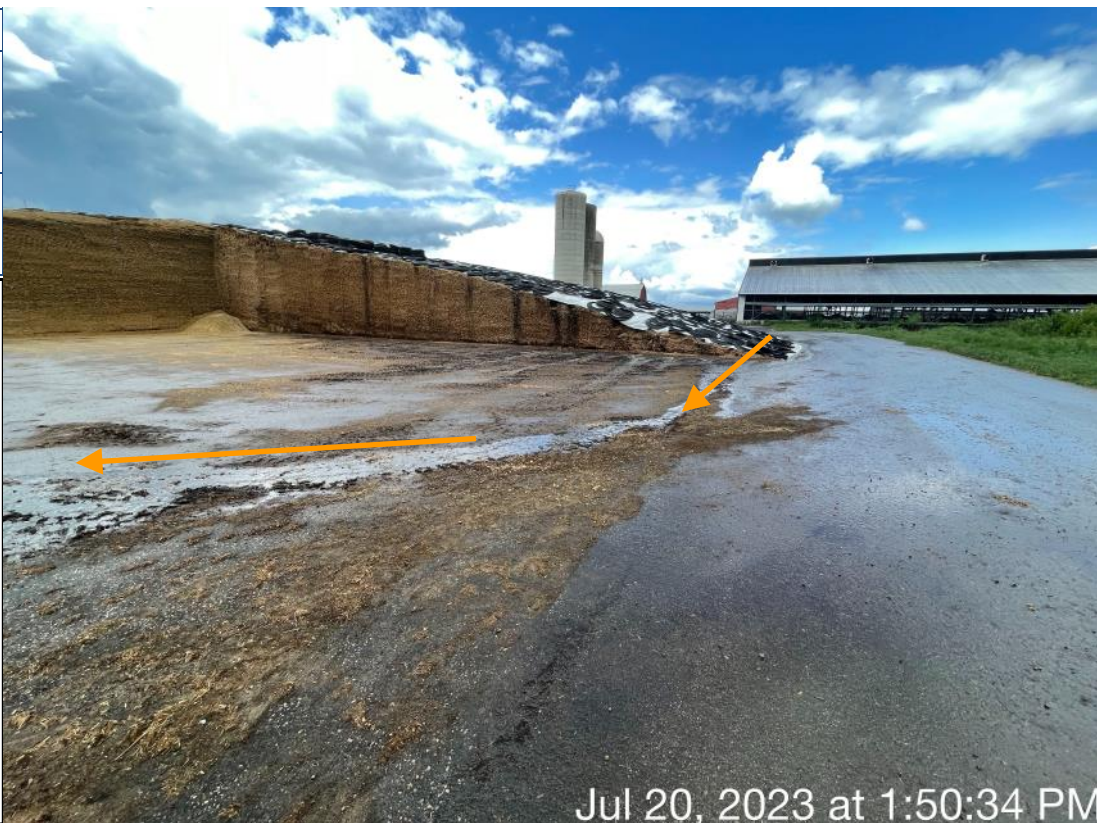
Photo #:	7864
Date/Time of Photo:	7/20/2023 13:51
Photo By:	Brian Hanson
Photo Location:	Feed Storage Area
Photo Description:	Standing on east side of FSA looking southwest: View of southeast corner of FSA. Arrows indicate direction of runoff flow.

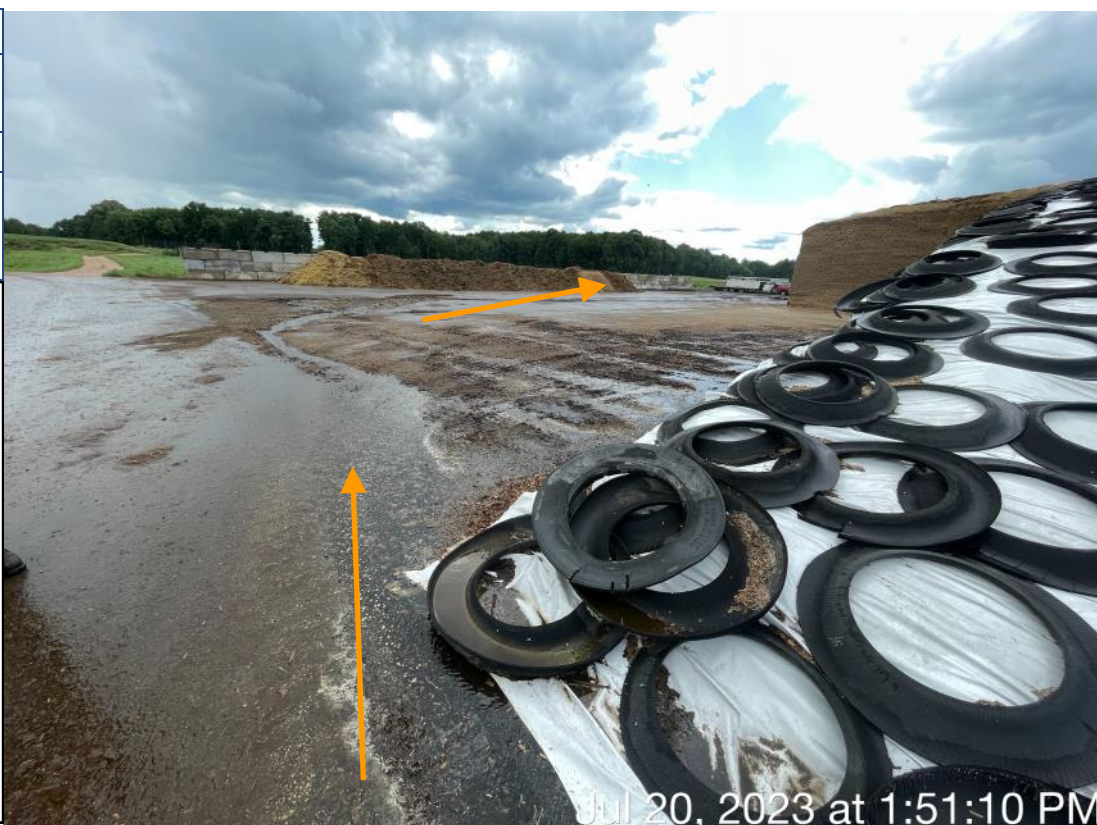
Photo #:	7861
Date/Time of Photo:	7/20/2023 13:50
Photo By:	Brian Hanson
Photo Location:	Feed Storage Area
Photo Description:	Standing at southeast corner of FSA looking west: View of south end of FSA. Arrows indicated direction of runoff flow.

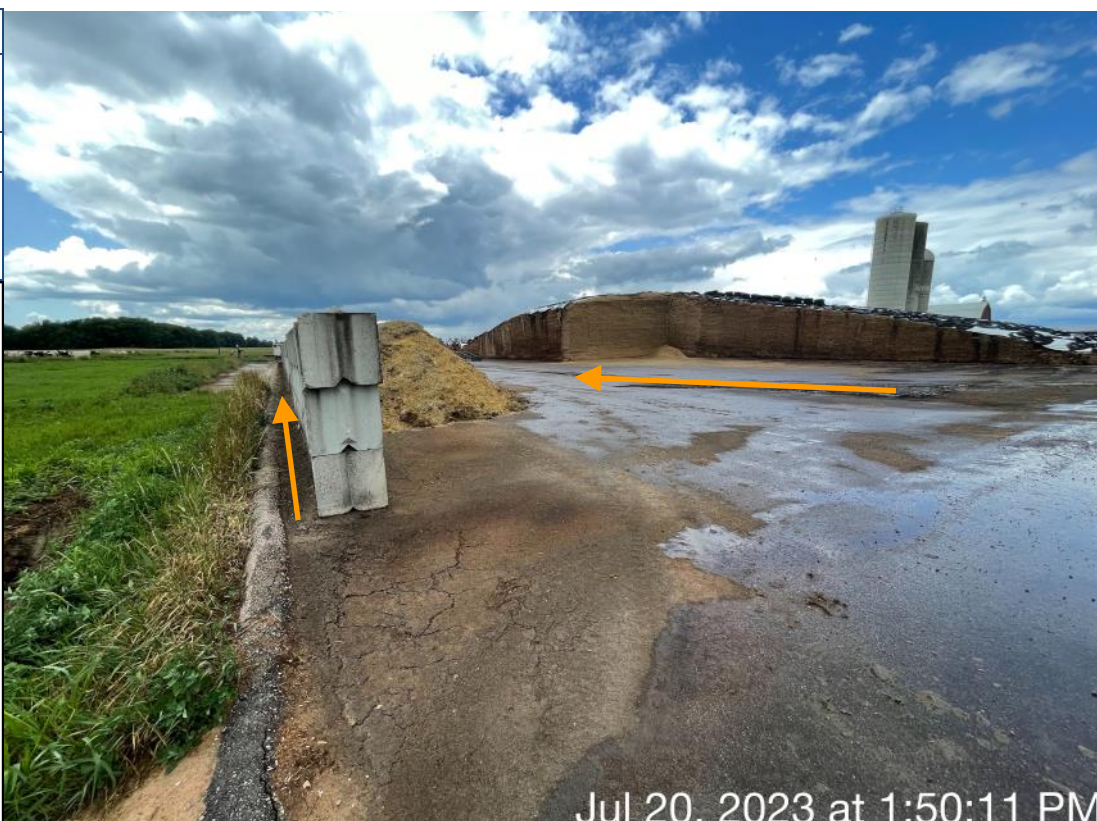
Photo #:	7856
Date/Time of Photo:	7/20/2023 13:50
Photo By:	Brian Hanson
Photo Location:	Feed Storage Area

Photo Description:
 Standing at southeast corner of FSA looking west: View of south edge of FSA. Notice curb on south end used to divert any runoff to reception tank in southwest corner. Arrows indicate direction of runoff flow.

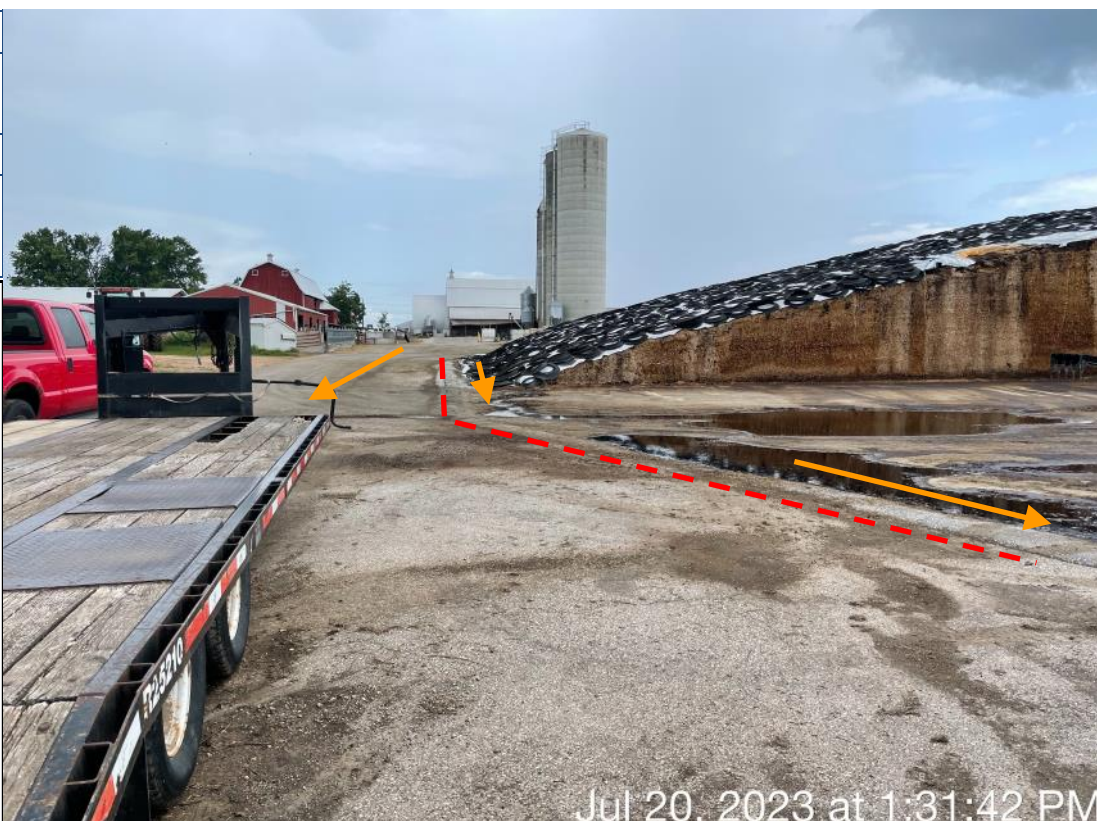
Photo #:	7774
Date/Time of Photo:	7/20/2023 13:31
Photo By:	Brian Hanson
Photo Location:	Feed Storage Area

Photo Description:
 Standing on west side of FSA looking north: View of west edge of FSA. Red line indicates curb used to separate FSA runoff from other runoff.

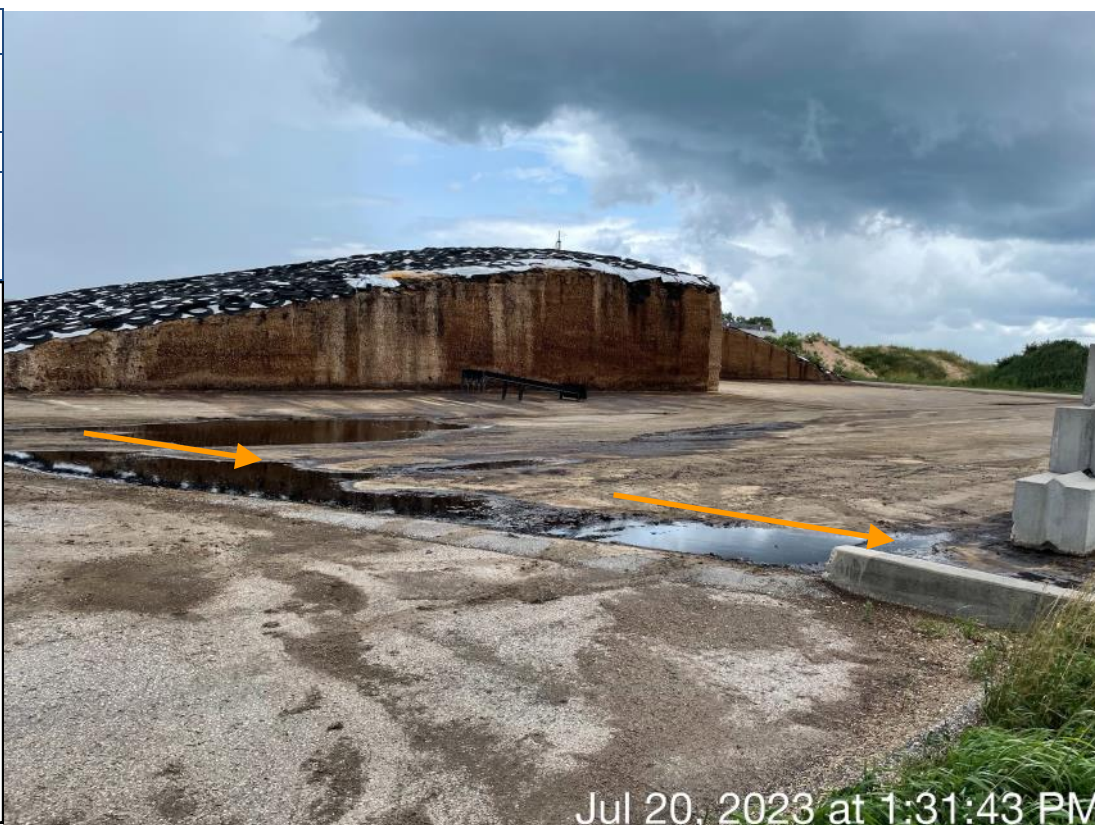
Photo Description:
Standing at the southwest corner of FSA looking northeast: View of southwest corner of FSA. Arrows indicate direction of runoff flow.

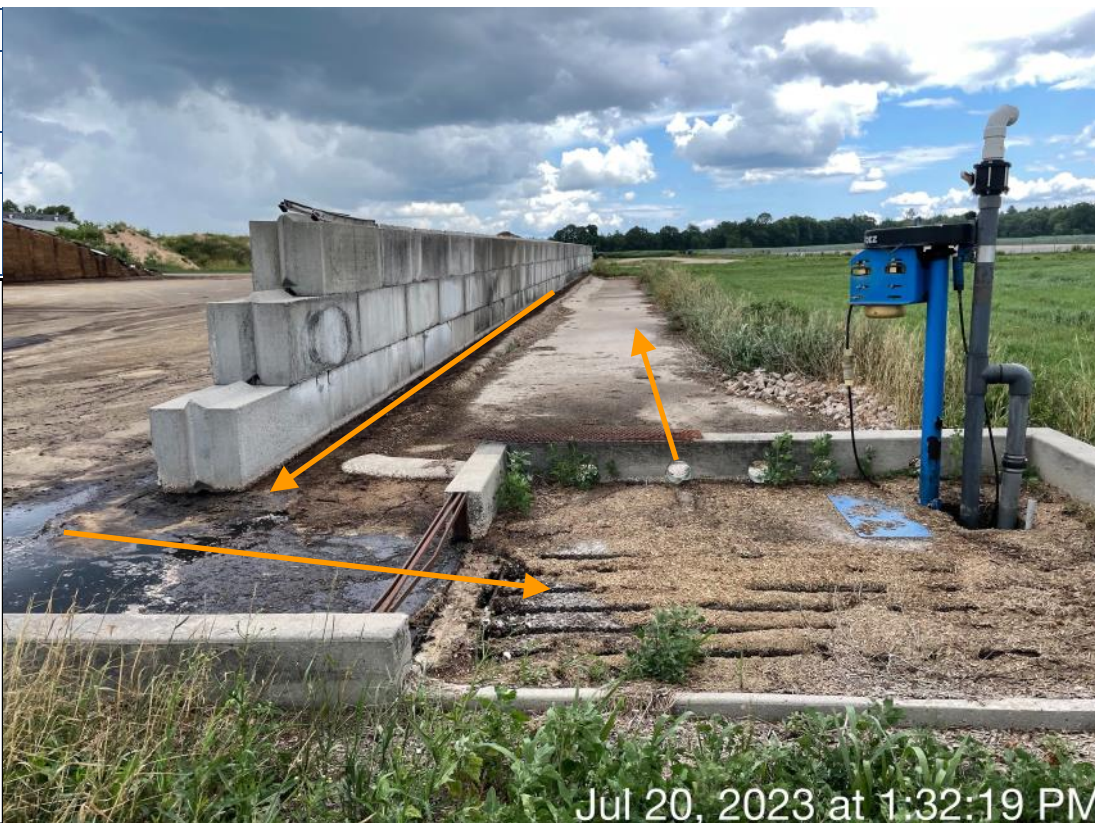
Photo Description:
Standing at the southwest corner of FSA looking east: View of runoff collection system in southwest corner. Leachate & first flush runoff enter reception tank & are pumped to WSF #1. Additional runoff overflows onto concrete spreader pad & VTA

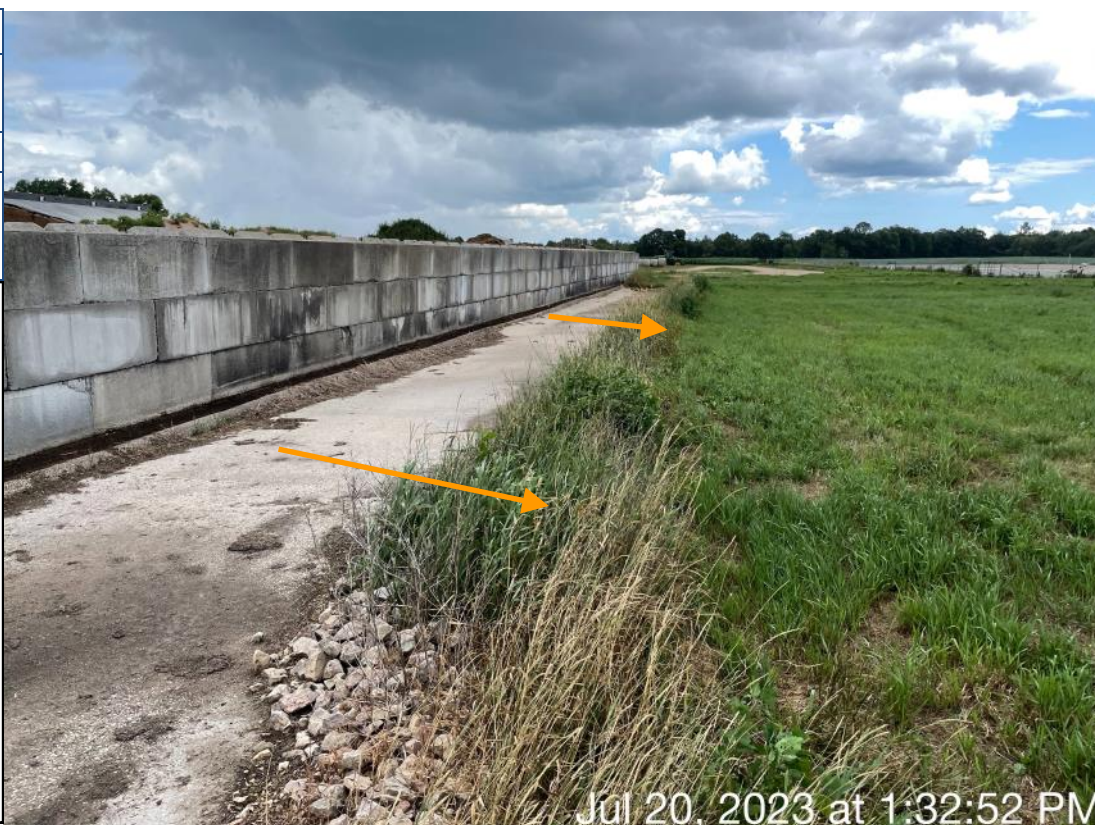
Photo #:	7780
Date/Time of Photo:	7/20/2023 13:32
Photo By:	Brian Hanson
Photo Location:	Feed storage VTA

Standing at the northwest corner of VTA looking east: View of north edge of VTA where runoff flows off concrete spreader pad onto VTA. No concentrated flow channels or ponded runoff areas visible.

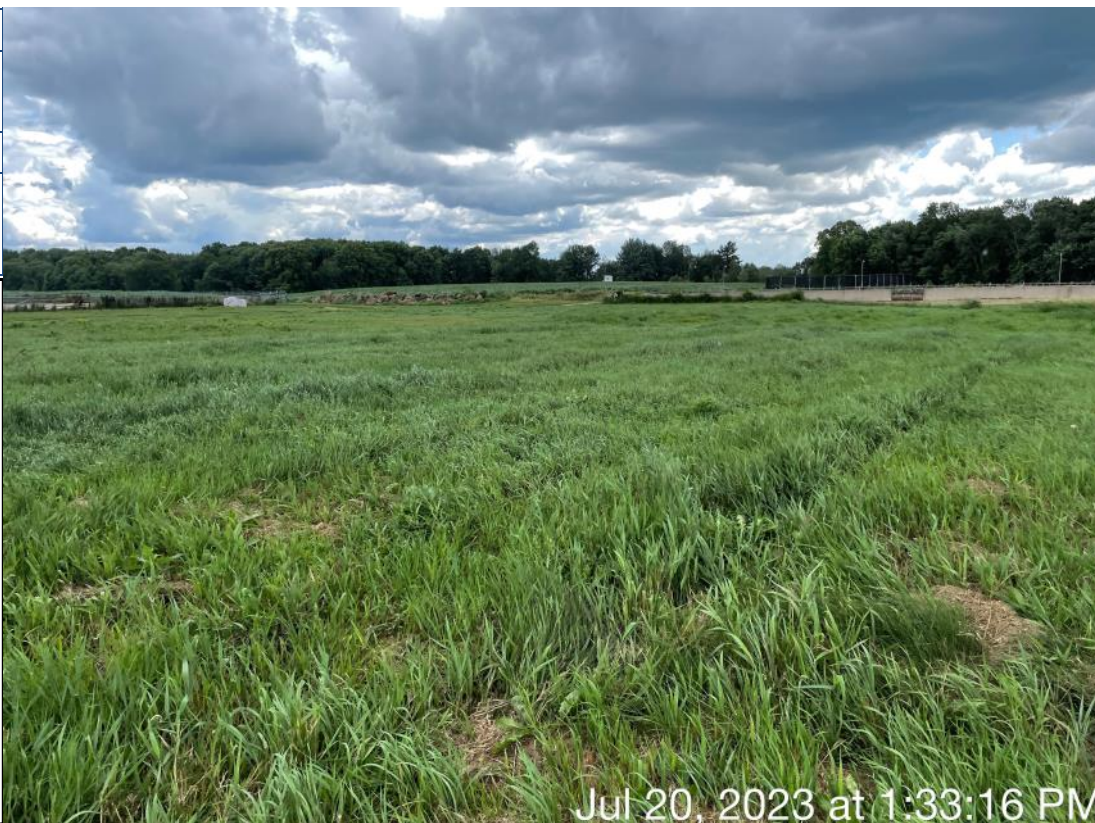
Photo #:	7783
Date/Time of Photo:	7/20/2023 13:33
Photo By:	Brian Hanson
Photo Location:	Feed Storage VTA

Standing in the middle of the VTA looking southwest: View of the south end of VTA. Area is well-vegetated.

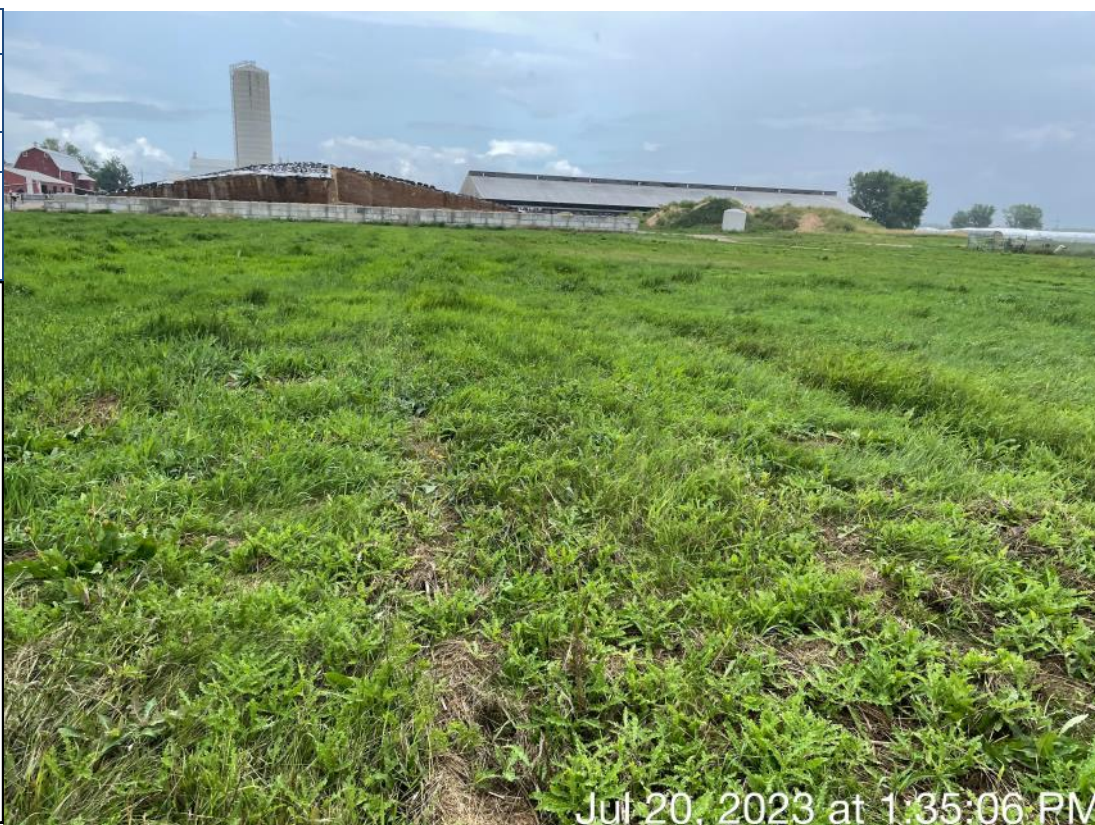
Photo Description:
Standing on the south end of VTA looking north: View of south end of VTA. Area is well-vegetated.

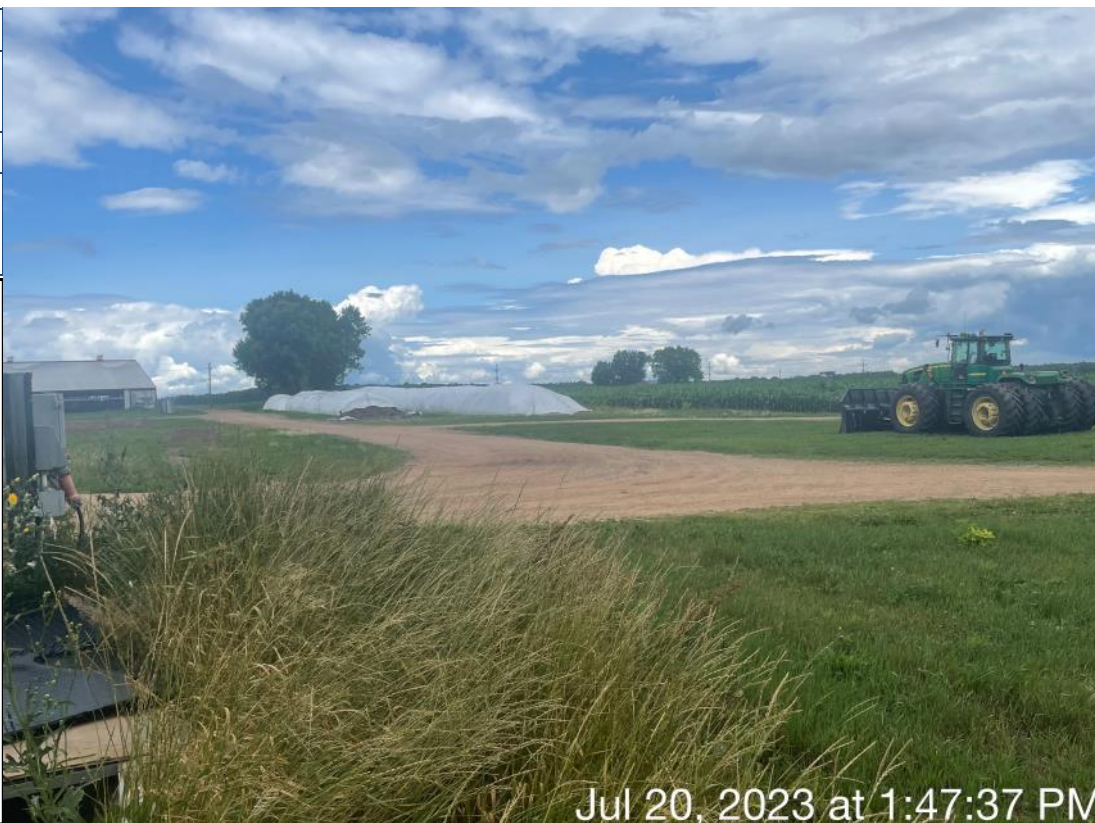
Photo Description:
Standing on the north side of WSF #1 looking north: View of temporary feed bags along driveway. Temporary use was approved by the department.

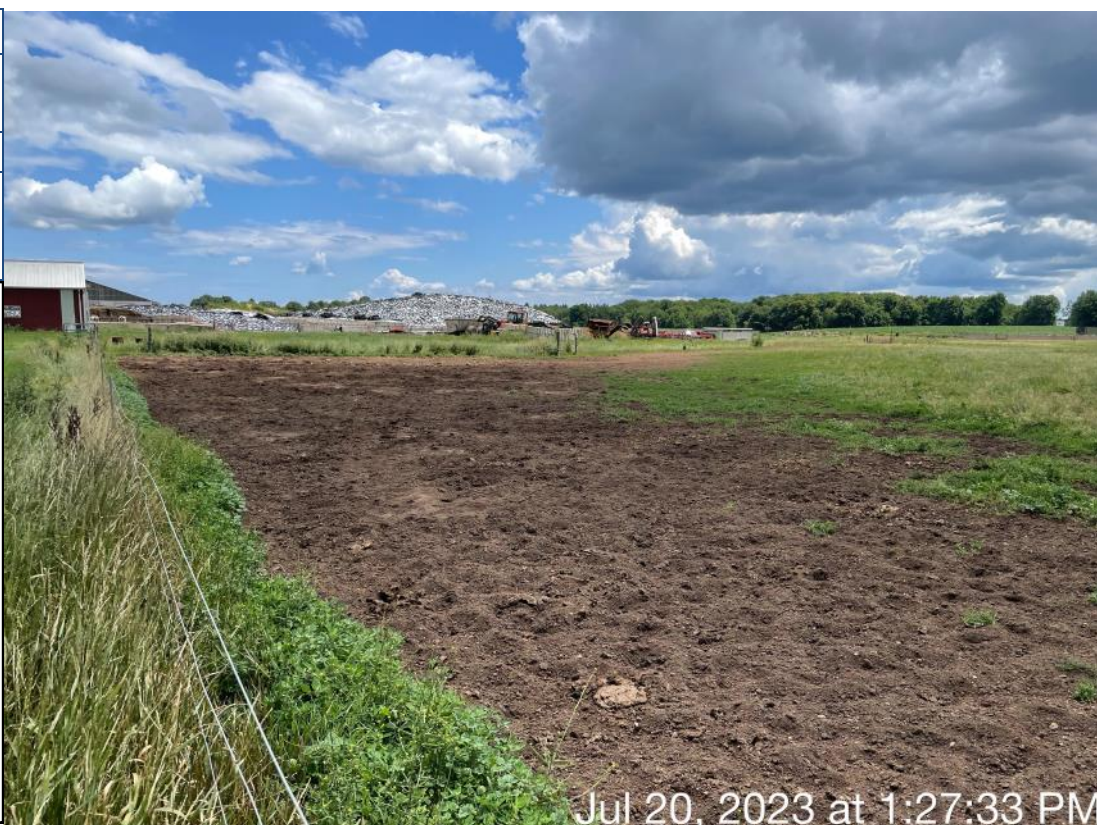
Photo #:	7763
Date/Time of Photo:	7/20/2023 13:27
Photo By:	Brian Hanson
Photo Location:	Pasture
Photo Description:	Standing on the south side of calf hutch area looking south: View of the northern edge of pasture. Notice small area of earthen lot present along fence. The rest of the area is well-vegetated.

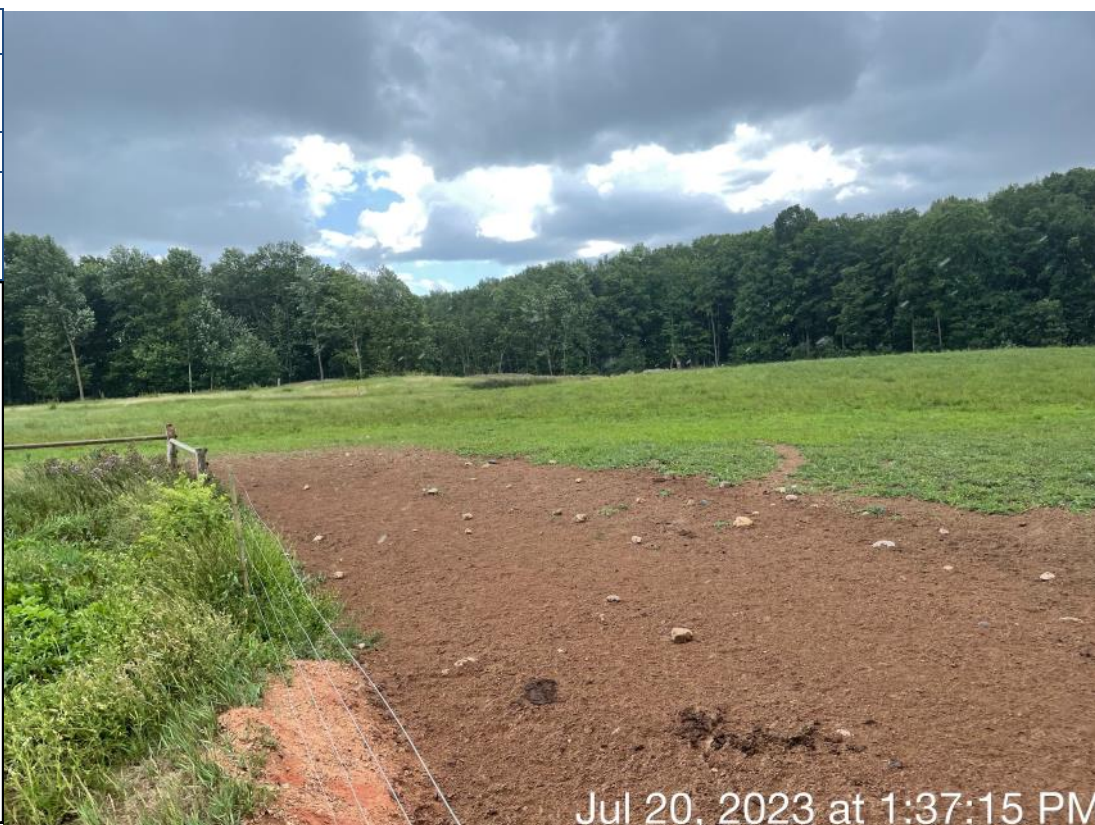
Photo Description:
Standing on the west side of feed rail looking south: View of east edge of pasture. Notice small area of earthen lot next to fence,. The rest of the area is well-vegetated.

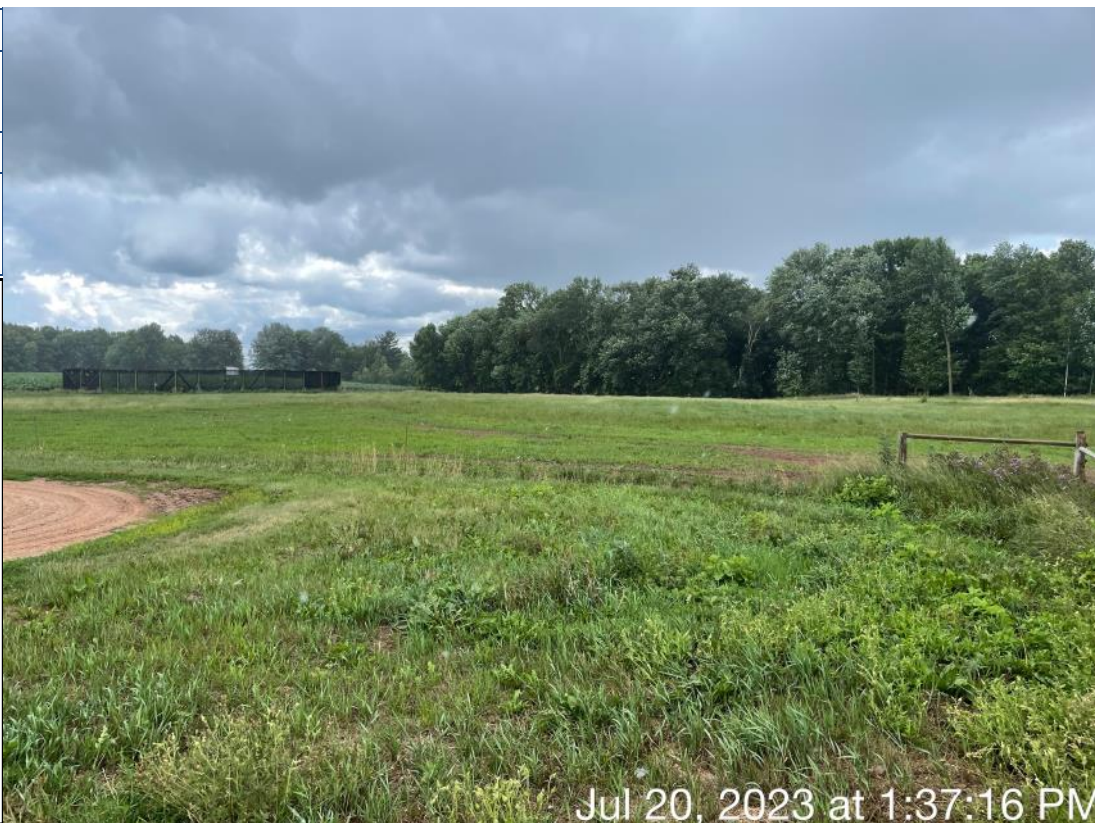
Photo Description:
Standing on the west side of feed rail looking southwest: View of east edge of pasture. Pasture in this area is well-vegetated.
