Permit Fact Sheet

Permit Number:	WI-0064246-03-0
Permittee Name:	Blaser Farms Inc
Address:	9267 State Hwy 22 E
City/State/Zip:	Gillett WI 54124
Discharge Location:	9267 Hwy 22 E, Gillett, WI 54124 ; NW ¼ of NW ¼ Section 20, T28N, R19E
Receiving Water:	Unnamed tributaries within the Oconto River Watershed, and groundwaters of the state
Discharge Type:	Existing

Site Overview Diagram (Blaser Farms Inc.)

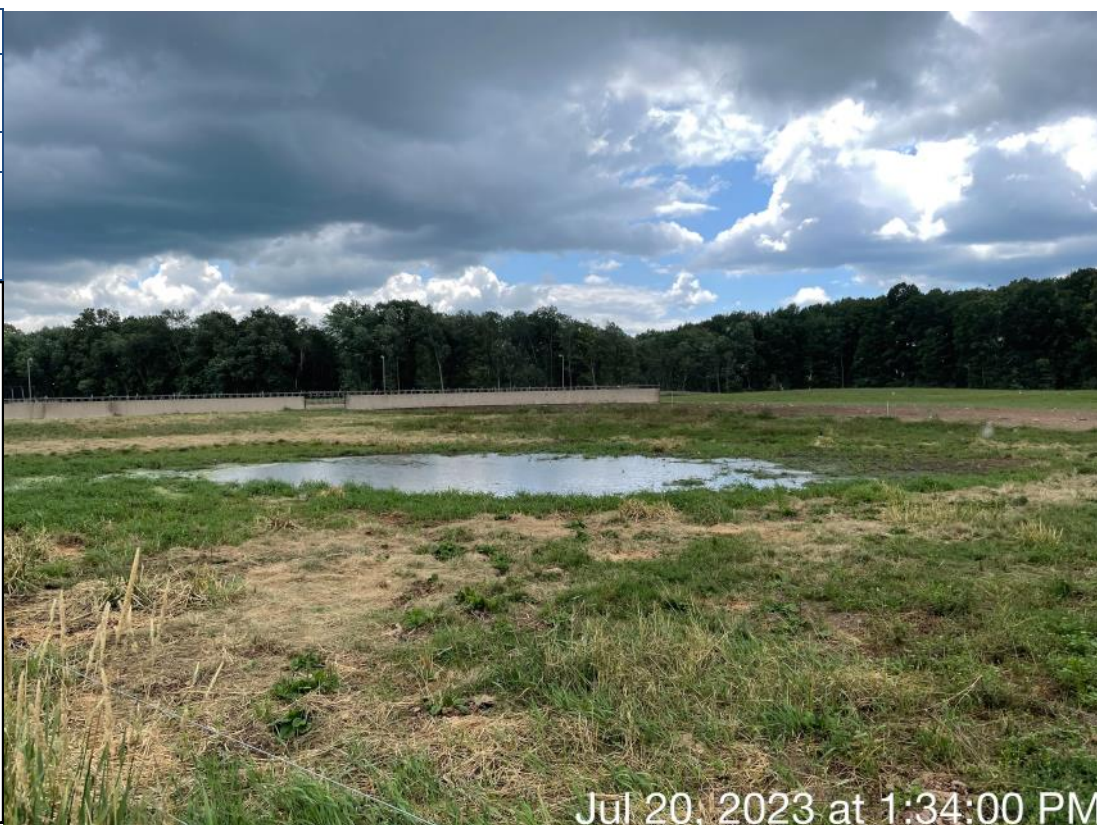
Photo #:	7786
Date/Time of Photo:	7/20/2023 13:34
Photo By:	Brian Hanson
Photo Location:	Pasture/ Storm Water

Standing on the west side of the VTA looking south: View of low spot on the north side of the pasture feed rail. Area has been fenced off to exclude animals. Runoff from dry cow lot and cattle walkway flow to this area

Feedlot runoff control system for the Feed Rail Area is well-maintained and in good repair, however according to the 2021 evaluation further actions are required which have not yet been completed. At the time of the inspection, the Dry Cow Lot & the Cattle Walkway did not have any runoff controls present.

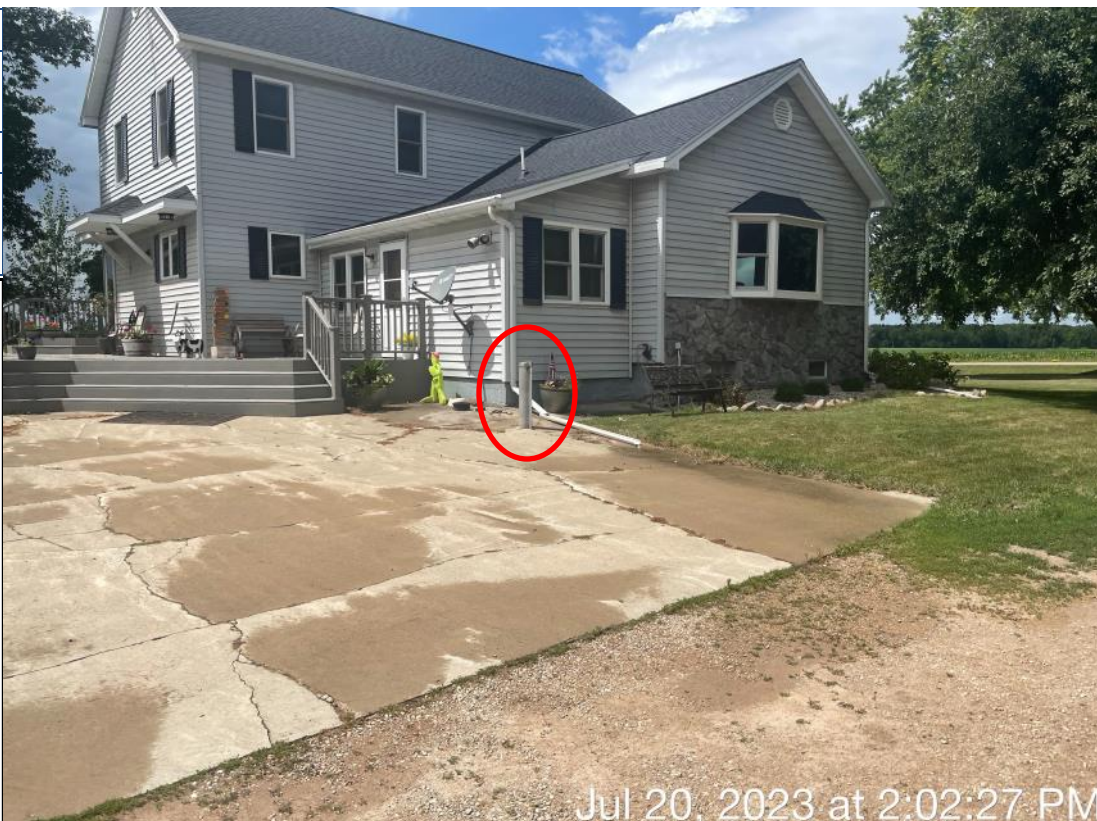
Photo #:	7923
Date/Time of Photo:	7/20/2023 14:02
Photo By:	Brian Hanson
Photo Location:	Water Supply Well

Standing on the east side of the farmhouse looking northwest: View of 1 of 2 wells on the property. Identified as ID# 8BX828

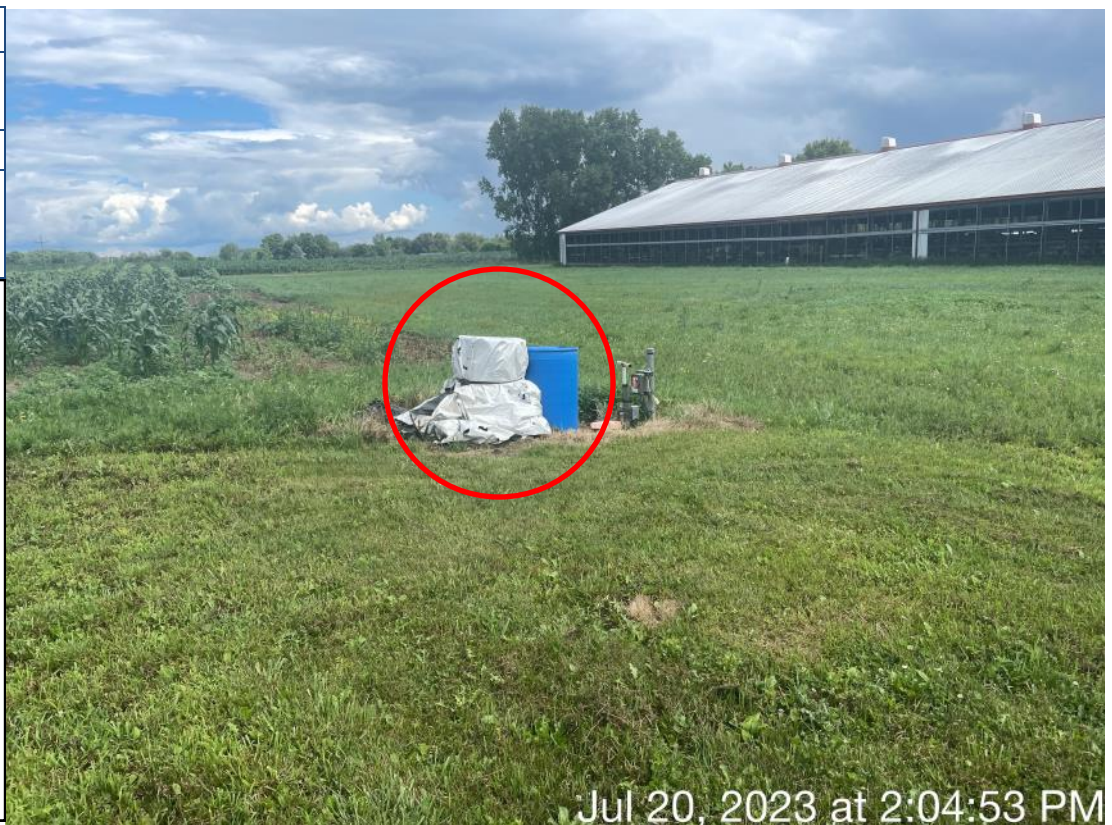
Photo #:	7924
Date/Time of Photo:	7/20/2023 04:04
Photo By:	Brian Hanson
Photo Location:	Water Supply Well Locations
Photo Description: Standing on the north side of the freestall barns looking east: View of water supply well location. Well is located underneath plastic barrel. Identified as : ID# : MR407
