# Permit Fact Sheet

Permit Number:	WI-0061697-05-0
Permittee Name:	Calf Source LLC
Address:	N3569 Vanden Bosch Rd
City/State/Zip:	Kaukauna WI 54130
Receiving Water:	Unnamed tributaries of the Branch River within the Branch River Watershed, and groundwaters of the state.

SUBJECT: Calf Source LLC – Assessment of groundwater quality, potential contaminate sources and need for groundwater monitoring at the production site.

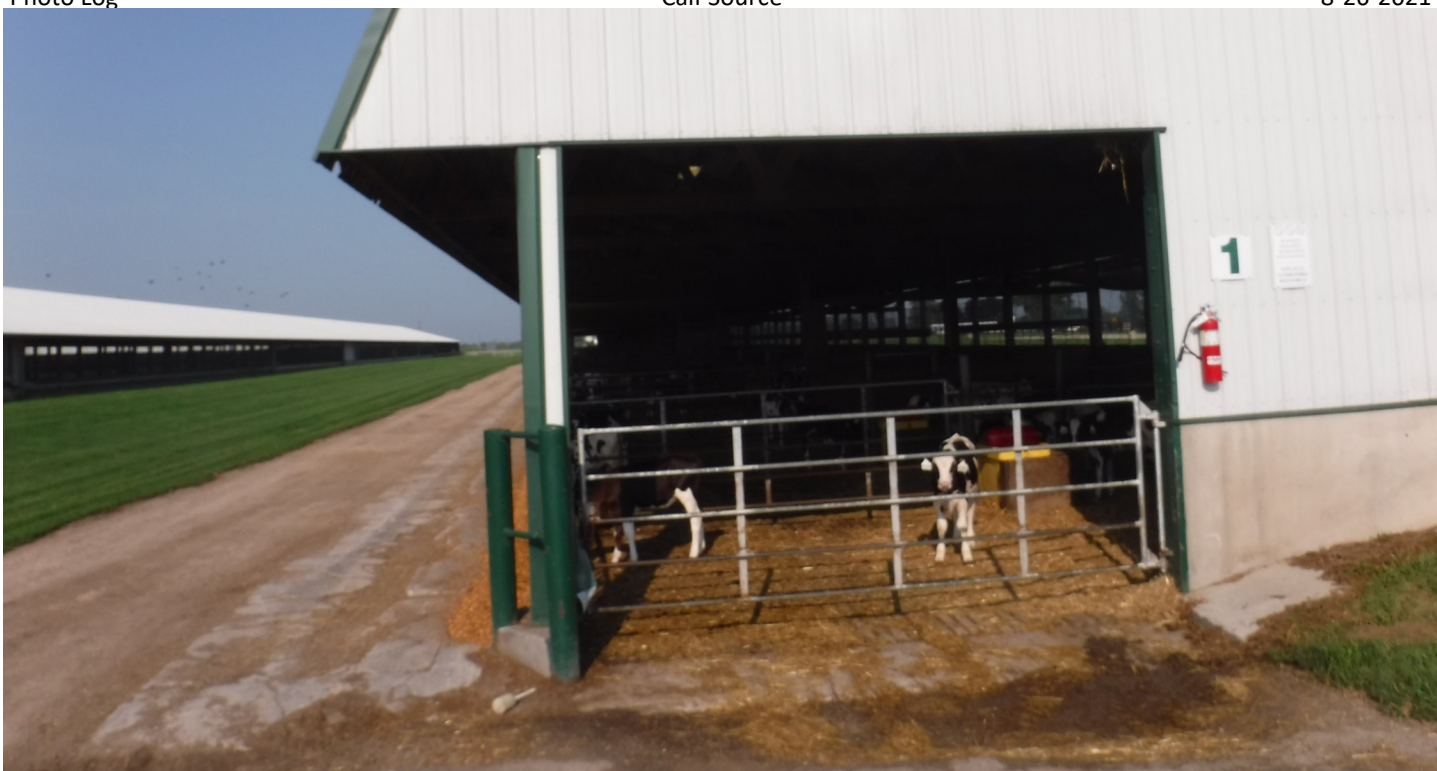
<b>Photo #:</b>	5756	<b>Photo Description:</b> Calf Barn 1, a three-sided barn with an open face for drive by feeding. Note, roof extends over feed lane.
<b>Date/Time of Photo:</b>	8-26-21 / AM	
<b>Photo Location:</b>	Calf Source	
<b>Photo By:</b>	Uvaas

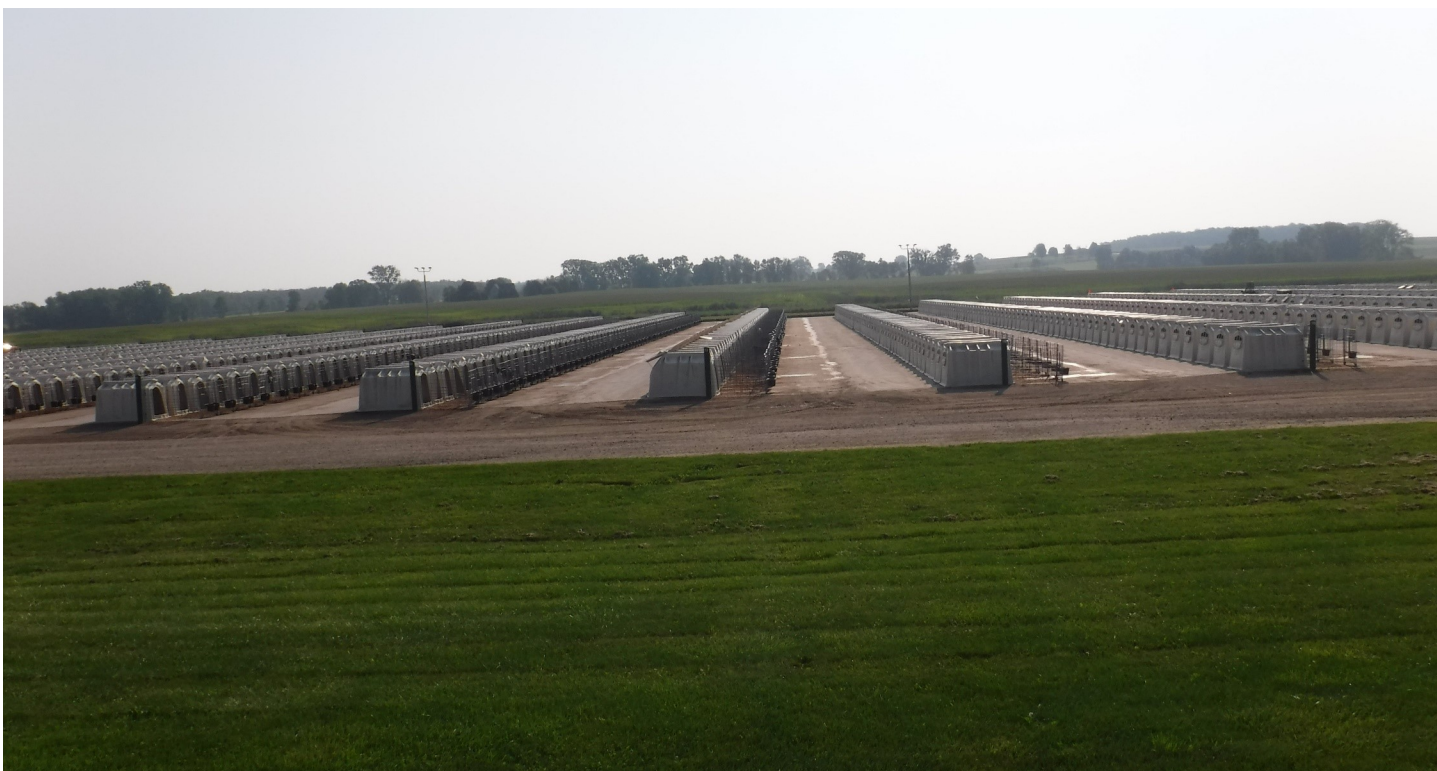
<b>Photo #:</b>	5768	<b>Photo Description:</b> Overview of calf hutch area, facing east
<b>Date/Time of Photo:</b>	8-26-21 / AM	
<b>Photo Location:</b>	Calf Source	
<b>Photo By:</b>	Uvaas

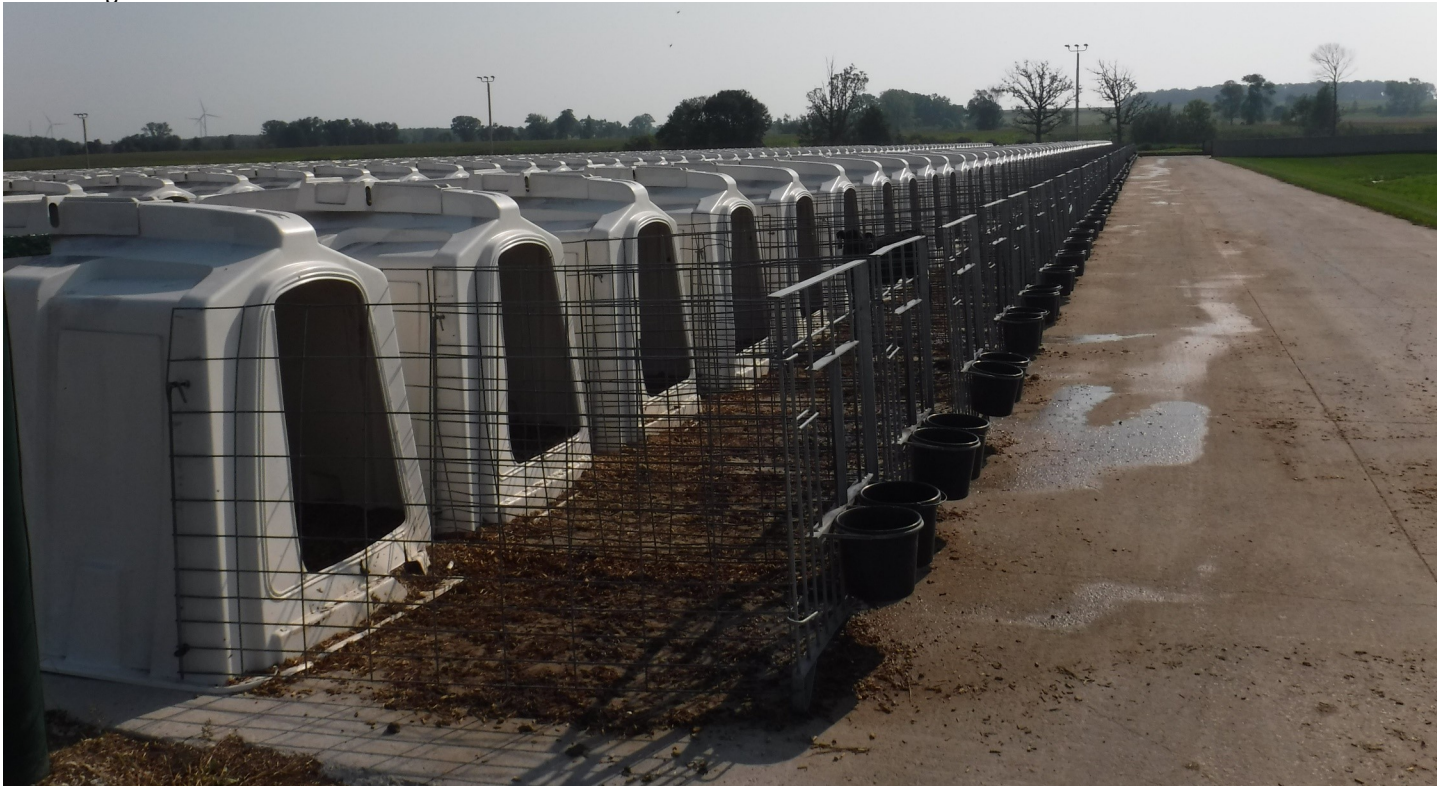
<b>Photo #:</b>	5795	<b>Photo Description:</b> Calf hutch area, facing east
<b>Date/Time of Photo:</b>	8-26-21 / AM	
<b>Photo Location:</b>	Calf Source	
<b>Photo By:</b>	Uvaas

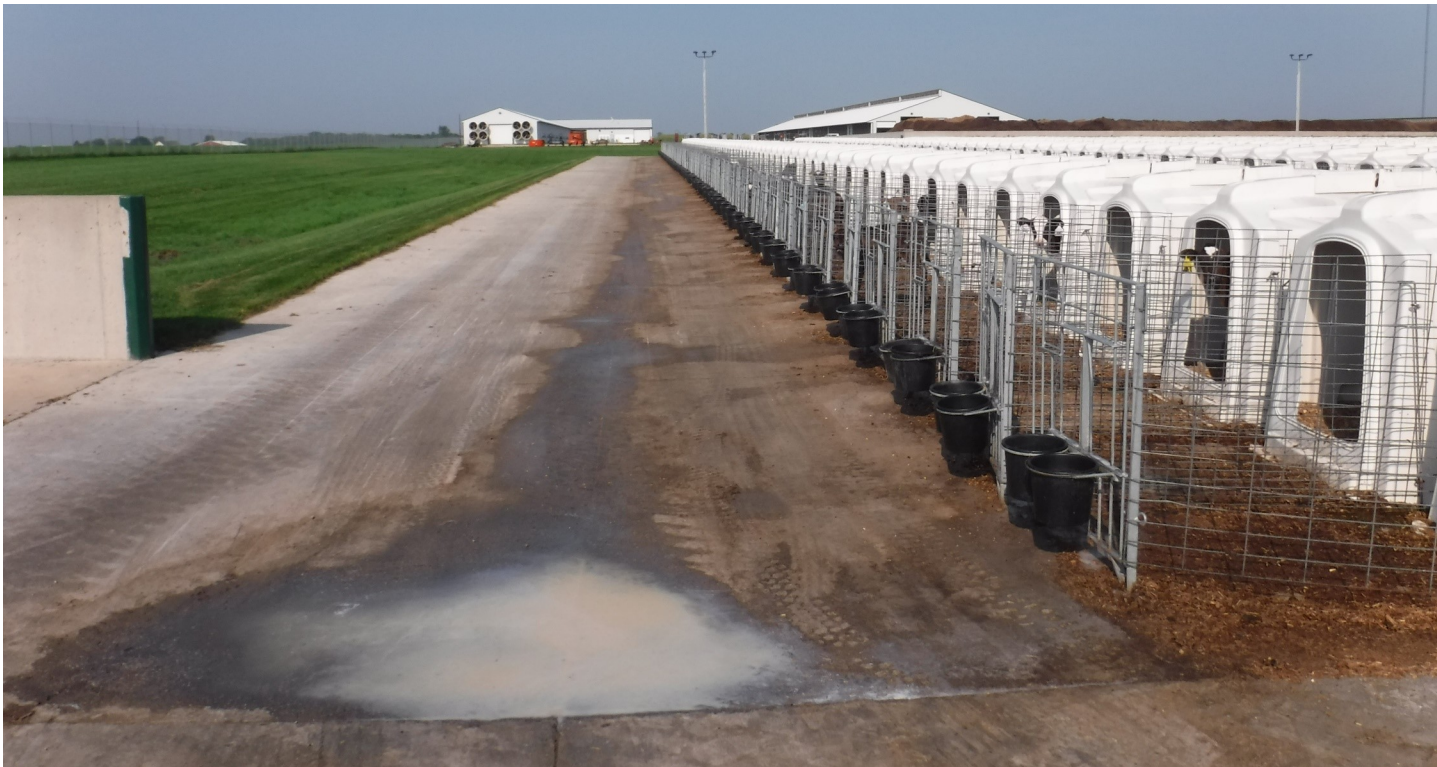
<b>Photo #:</b>	5798	<b>Photo Description:</b> Overview of calf hutch area, facing west
<b>Date/Time of Photo:</b>	8-26-21 / AM	
<b>Photo Location:</b>	Calf Source	
<b>Photo By:</b>	Uvaas

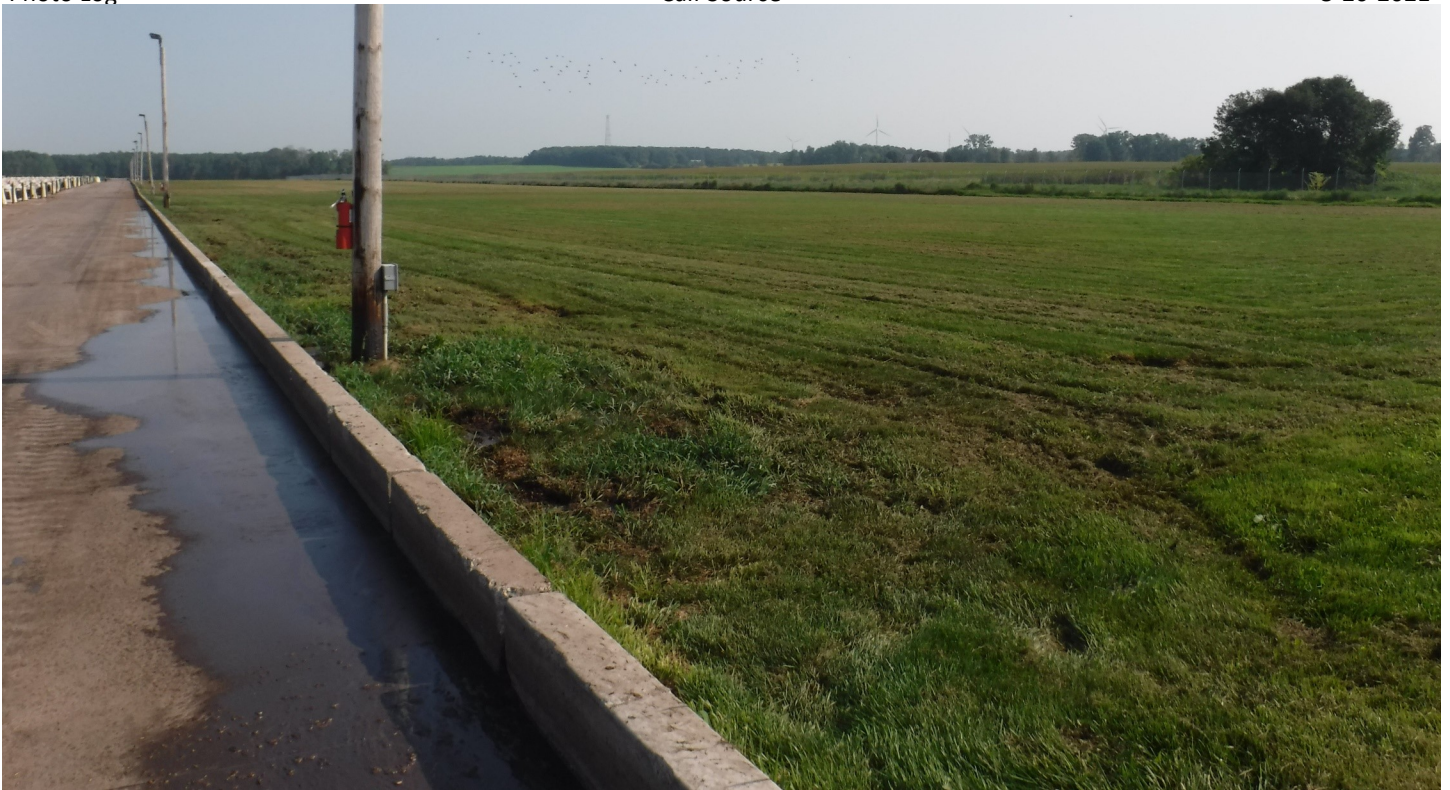
<b>Photo #:</b>	5800	<b>Photo Description: Calf hutch area runoff controls and VTA at its spreader bar</b>
<b>Date/Time of Photo:</b>	8-26-21 / AM	
<b>Photo Location:</b>	Calf Source	
<b>Photo By:</b>	Uvaas

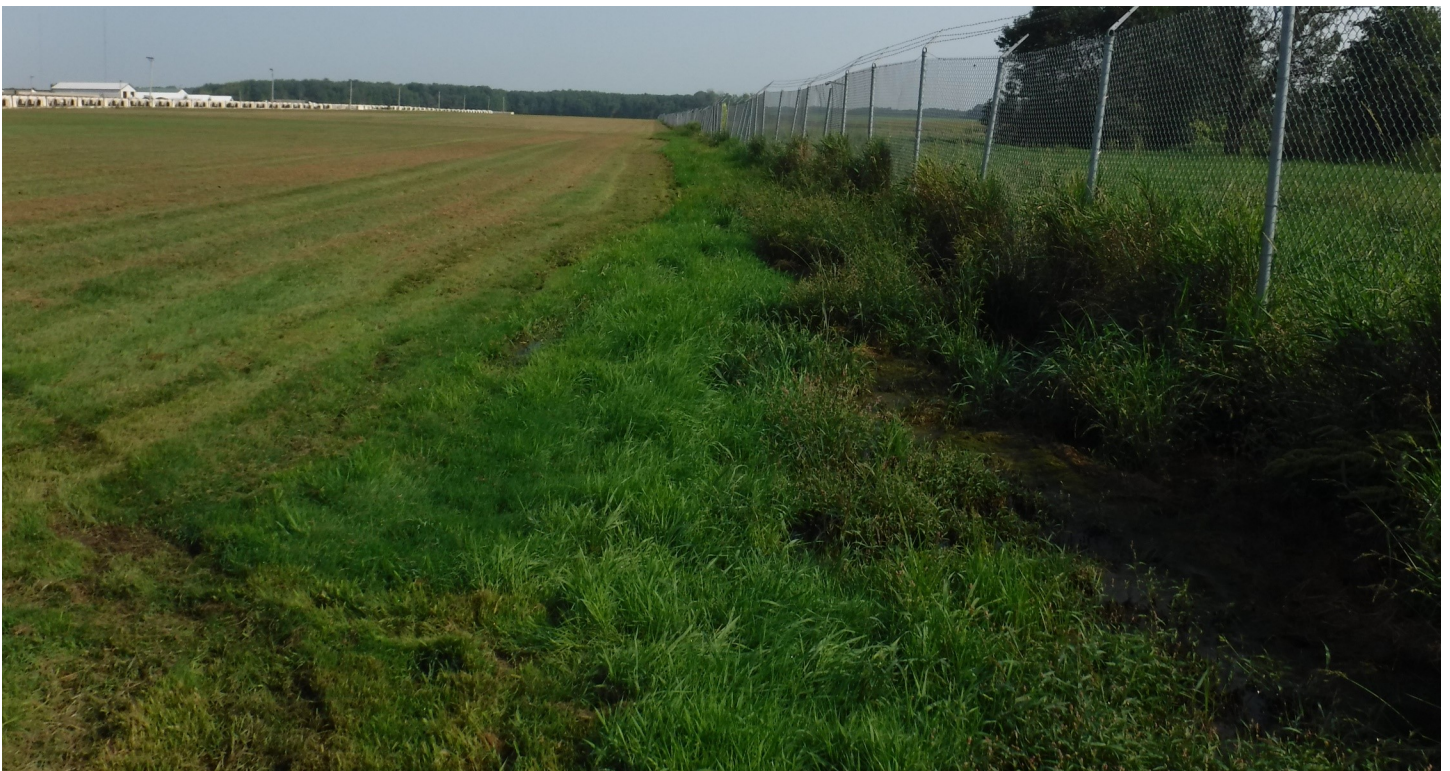
<b>Photo #:</b>	5803	<b>Photo Description: VTA near its southeast corner</b>
<b>Date/Time of Photo:</b>	8-26-21 / AM	
<b>Photo Location:</b>	Calf Source	
<b>Photo By:</b>	Uvaas

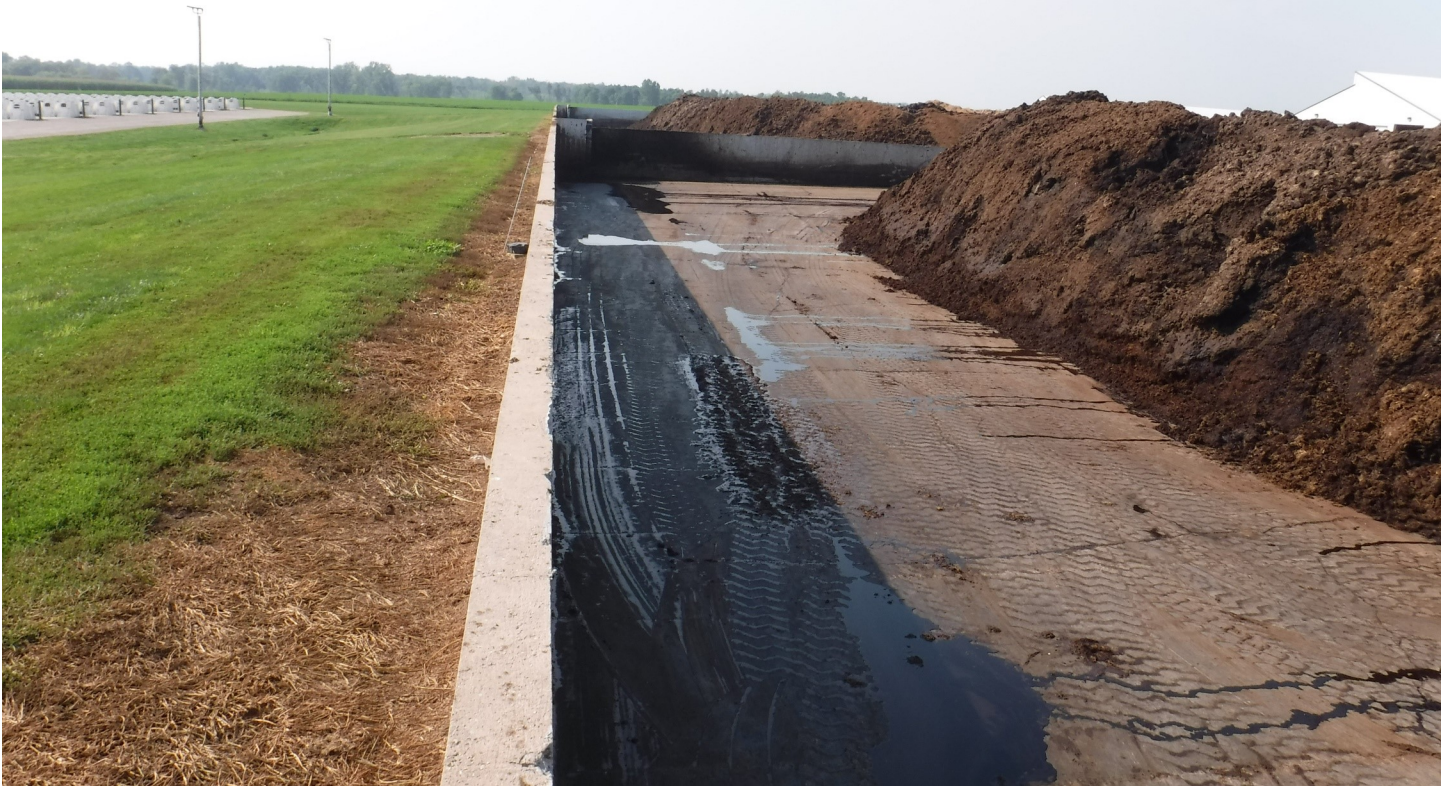
<b>Photo #:</b>	5807	<b>Photo Description: Solid manure storage, facing south</b>
<b>Date/Time of Photo:</b>	8-26-21 / AM	
<b>Photo Location:</b>	Calf Source	
<b>Photo By:</b>	Uvaas

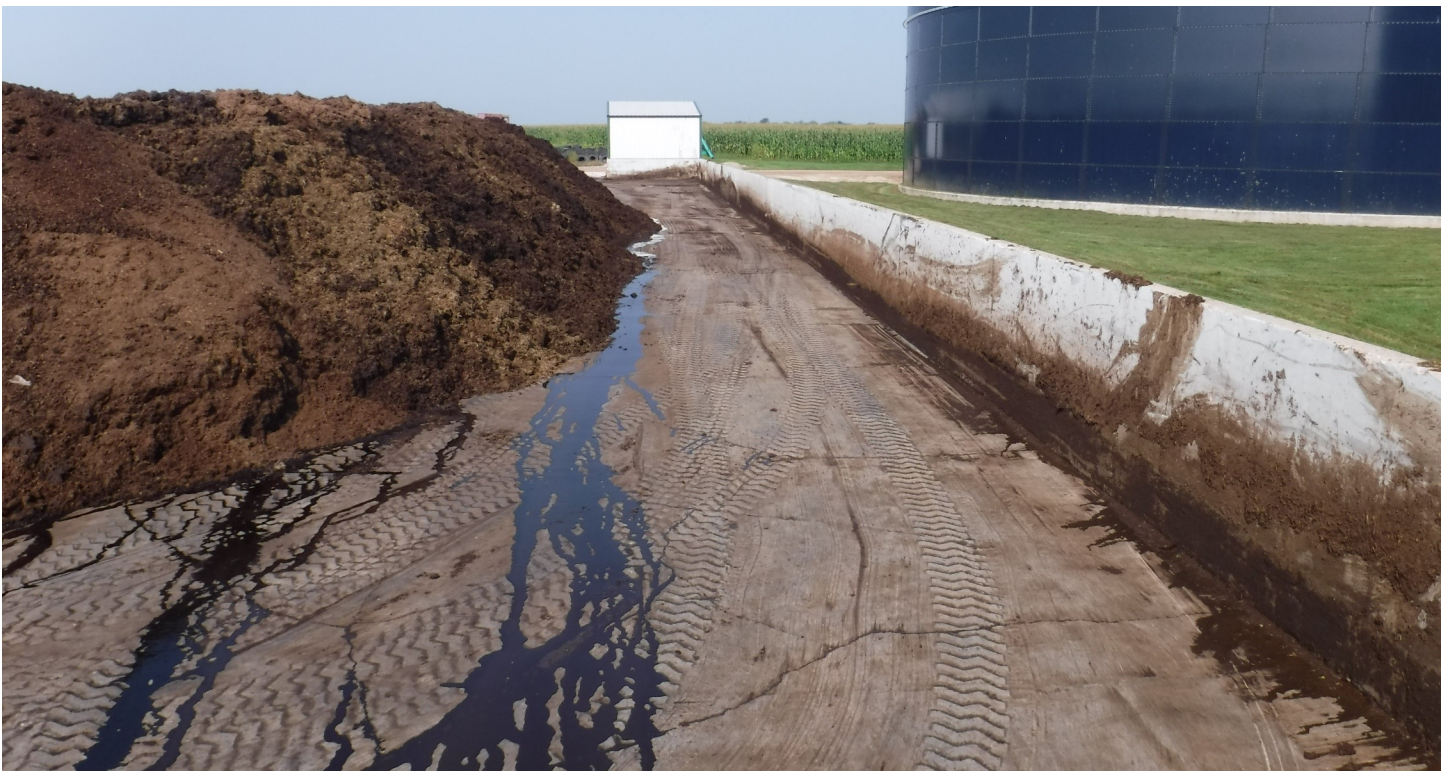
<b>Photo #:</b>	5808	<b>Photo Description: Solid manure storage, facing west</b>
<b>Date/Time of Photo:</b>	8-26-21 / AM	
<b>Photo Location:</b>	Calf Source	
<b>Photo By:</b>	Uvaas

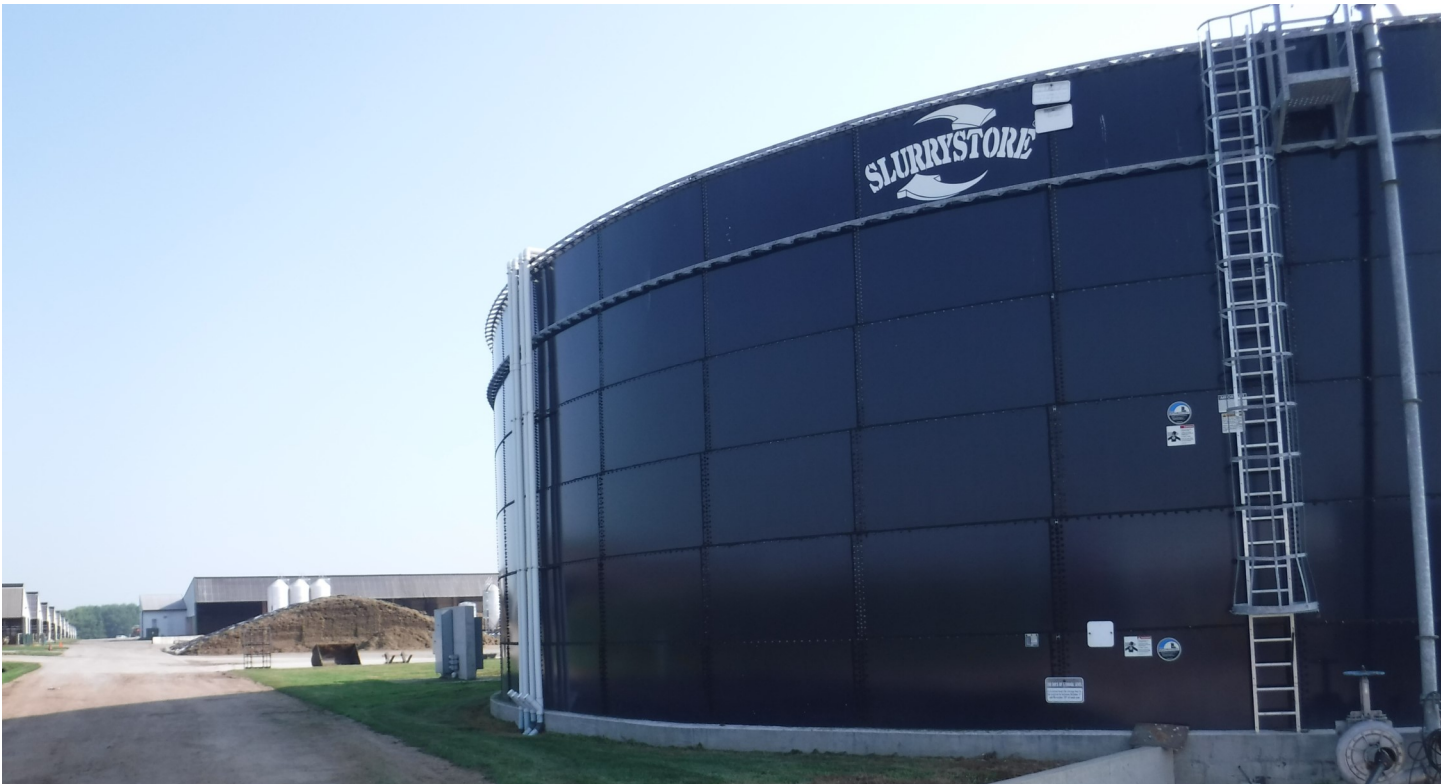
<b>Photo #:</b>	5781	<b>Photo Description: West Slurrystore structure</b>
<b>Date/Time of Photo:</b>	8-26-21 / AM	
<b>Photo Location:</b>	Calf Source	
<b>Photo By:</b>	Uvaas

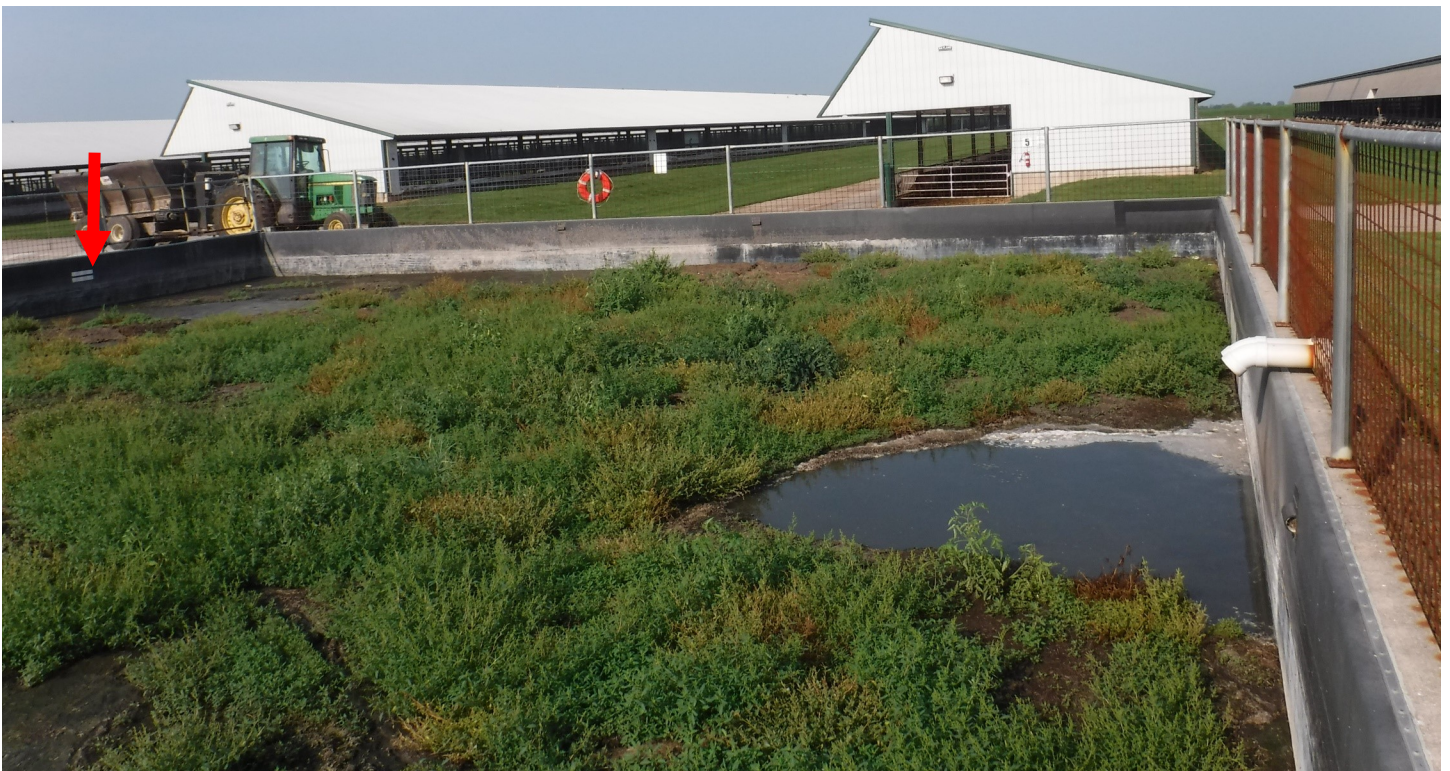
<b>Photo #:</b>	5760	<b>Photo Description: HPDE lined concrete waste storage structure, markers at red arrow</b>
<b>Date/Time of Photo:</b>	8-26-21 / AM	
<b>Photo Location:</b>	Calf Source	
<b>Photo By:</b>	Uvaas

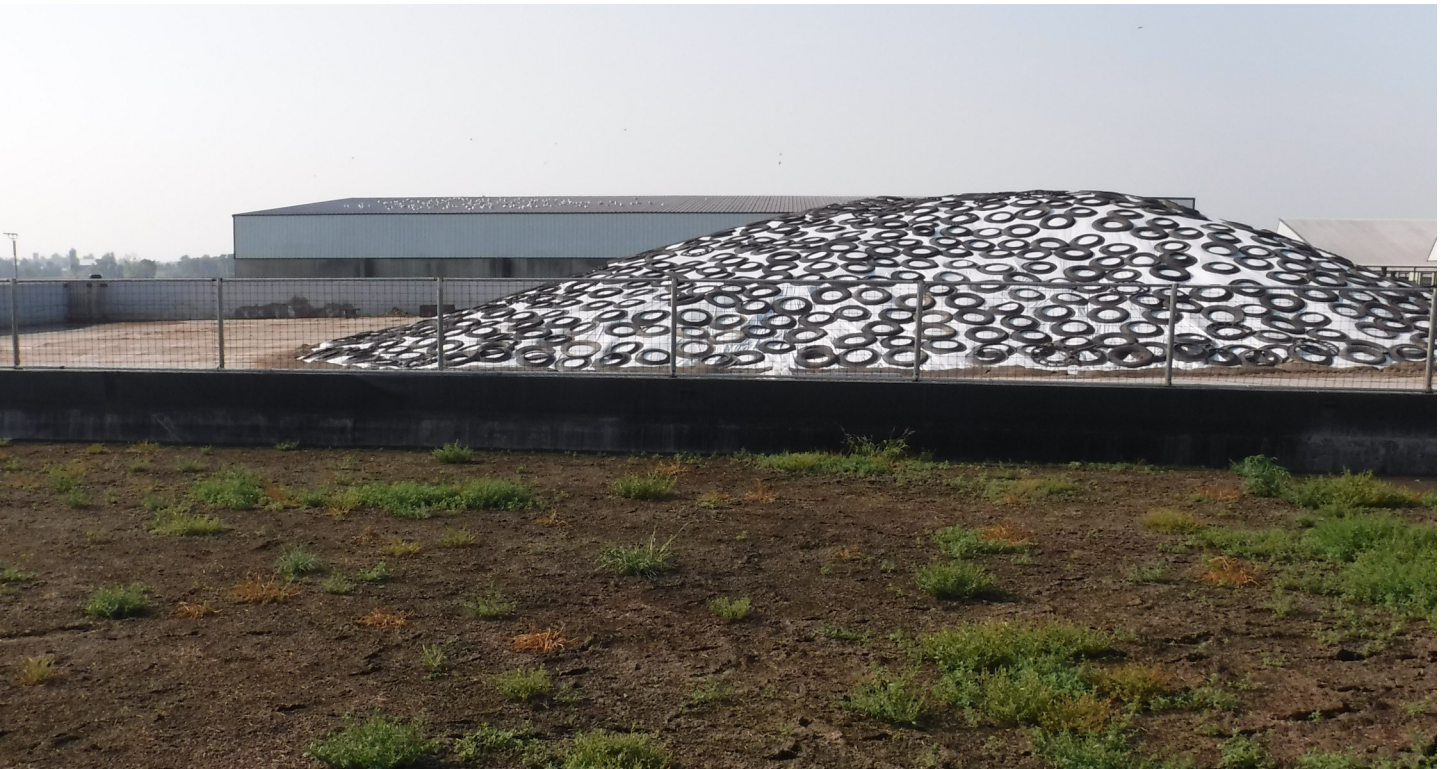
<b>Photo #:</b>	5759	<b>Photo Description:</b> North feed storage area (photo background)
<b>Date/Time of Photo:</b>	8-26-21 / AM	
<b>Photo Location:</b>	Calf Source	
<b>Photo By:</b>	Uvaas

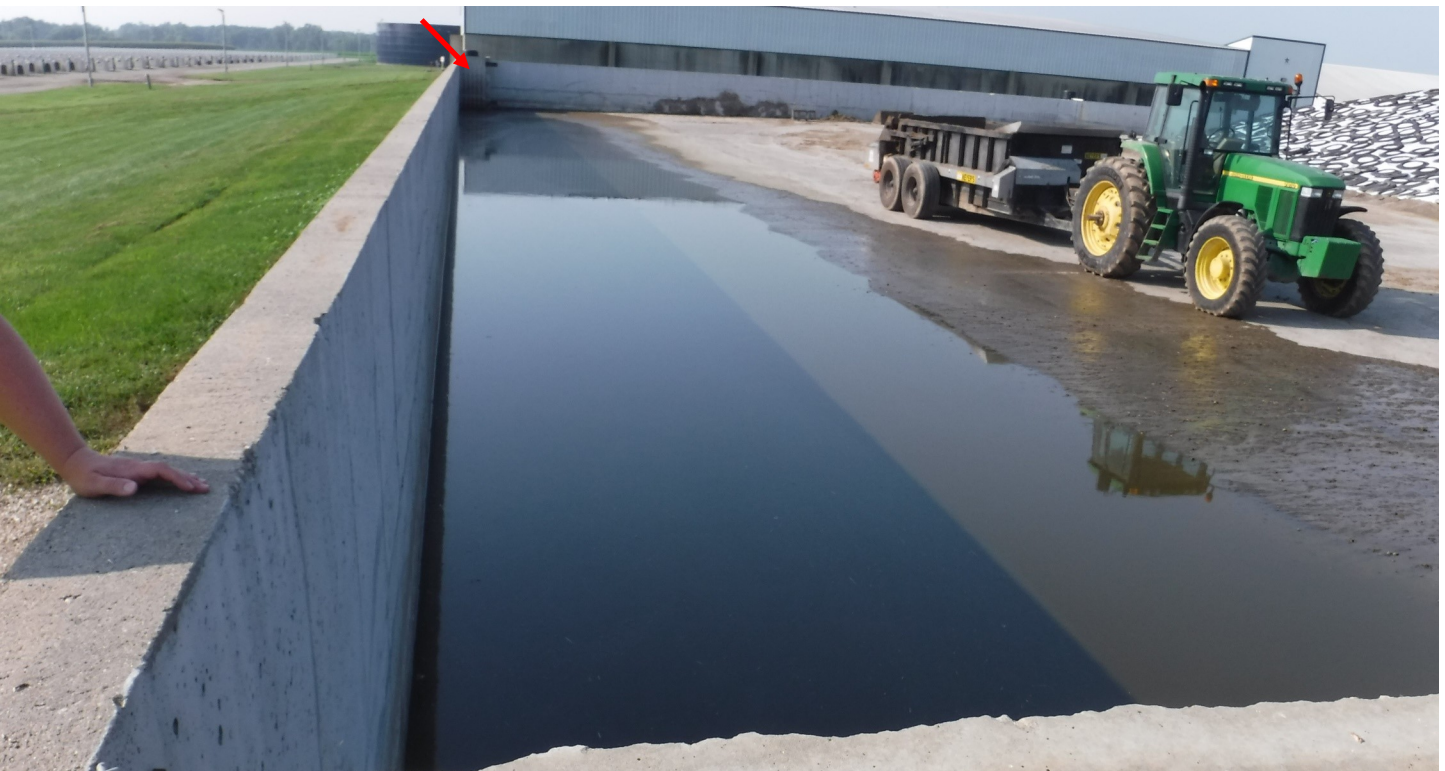
<b>Photo #:</b>	5767	<b>Photo Description:</b> North feed storage area runoff collection, red arrow at its southeast collection sump
<b>Date/Time of Photo:</b>	8-26-21 / AM	
<b>Photo Location:</b>	Calf Source	
<b>Photo By:</b>	Uvaas

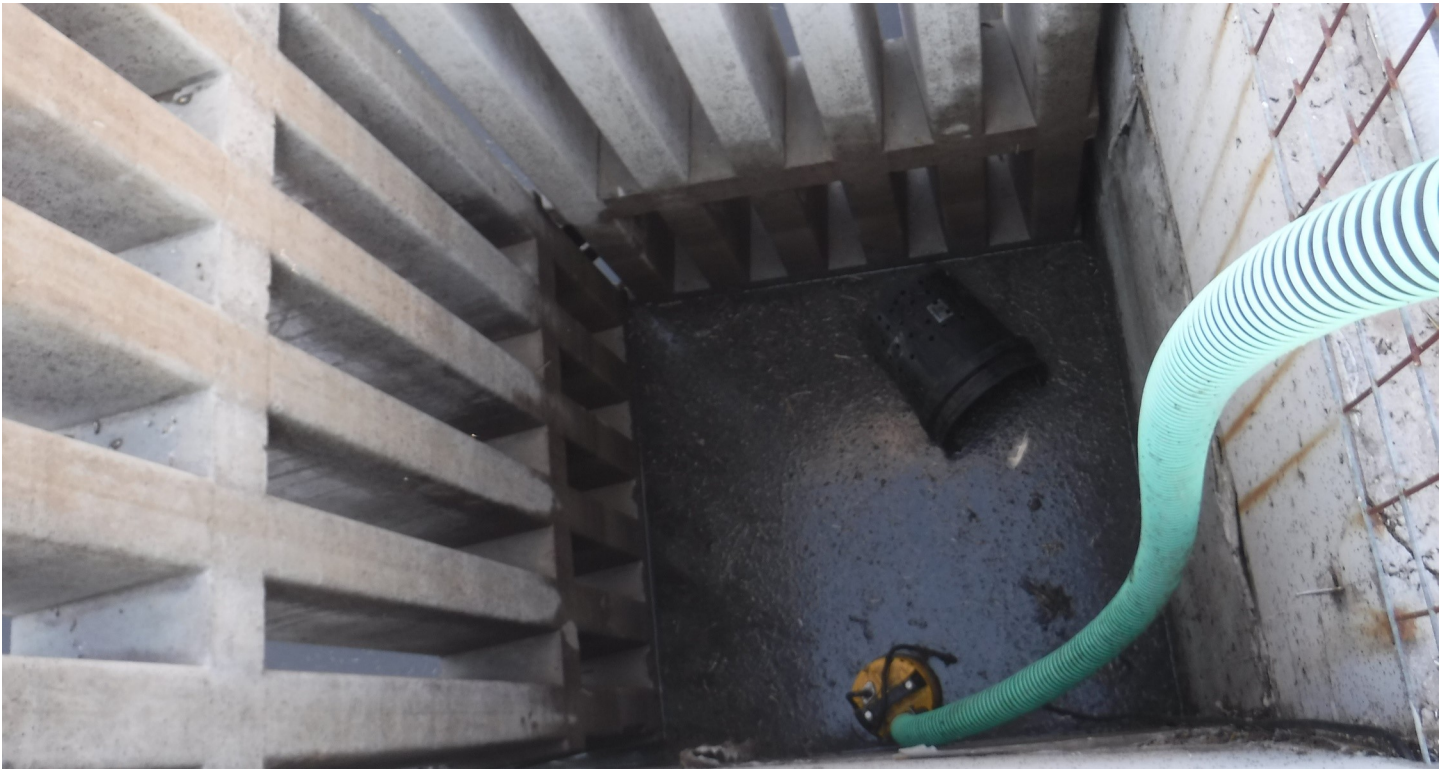
<b>Photo #:</b>	5765	<b>Photo Description:</b> North feed storage area northeast runoff collection sump utilizing portable pump and transfer line
<b>Date/Time of Photo:</b>	8-26-21 / AM	
<b>Photo Location:</b>	Calf Source	
<b>Photo By:</b>	Uvaas

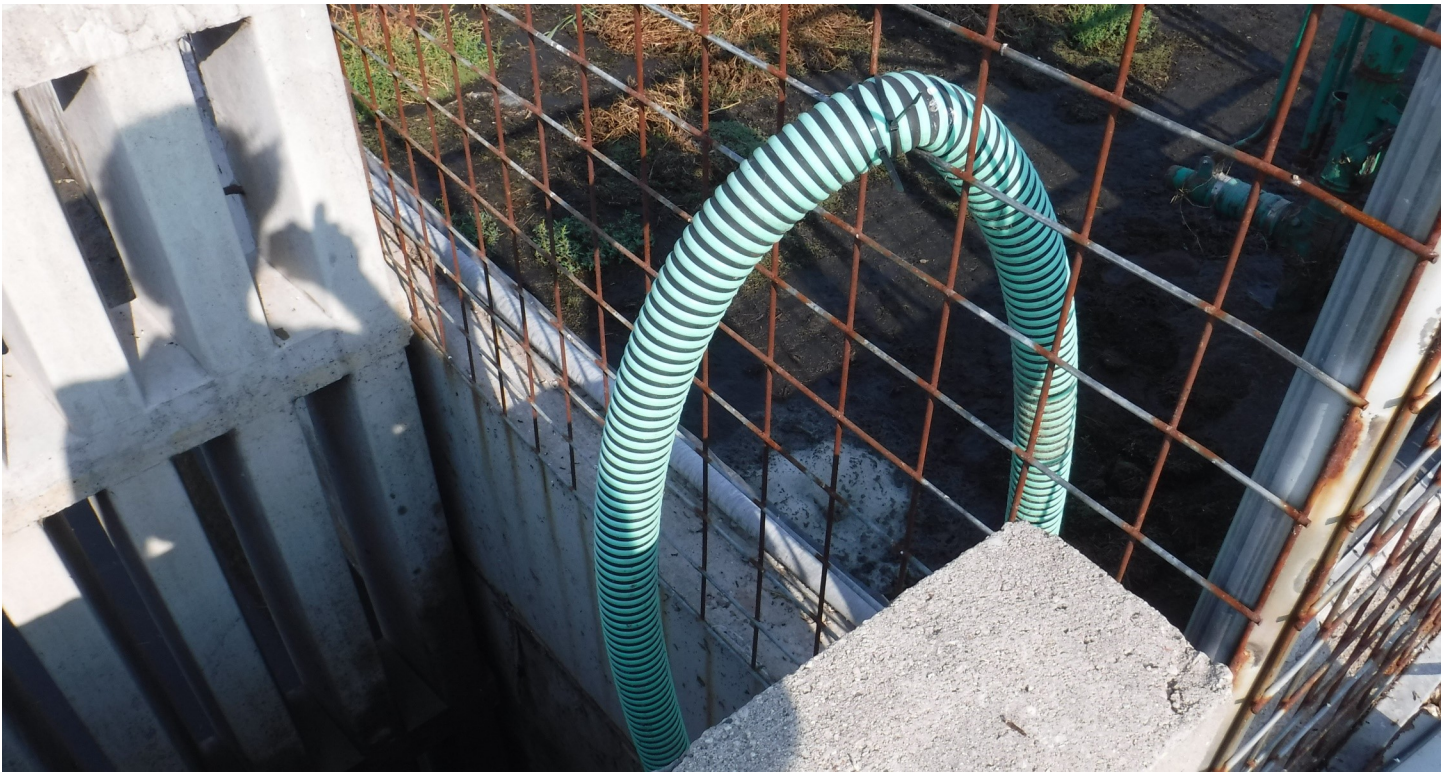
<b>Photo #:</b>	5766	<b>Photo Description:</b> Close-up transfer line in Photo 5765 and its outlet to the concrete liquid manure storage
<b>Date/Time of Photo:</b>	8-26-21 / AM	
<b>Photo Location:</b>	Calf Source	
<b>Photo By:</b>	Uvaas

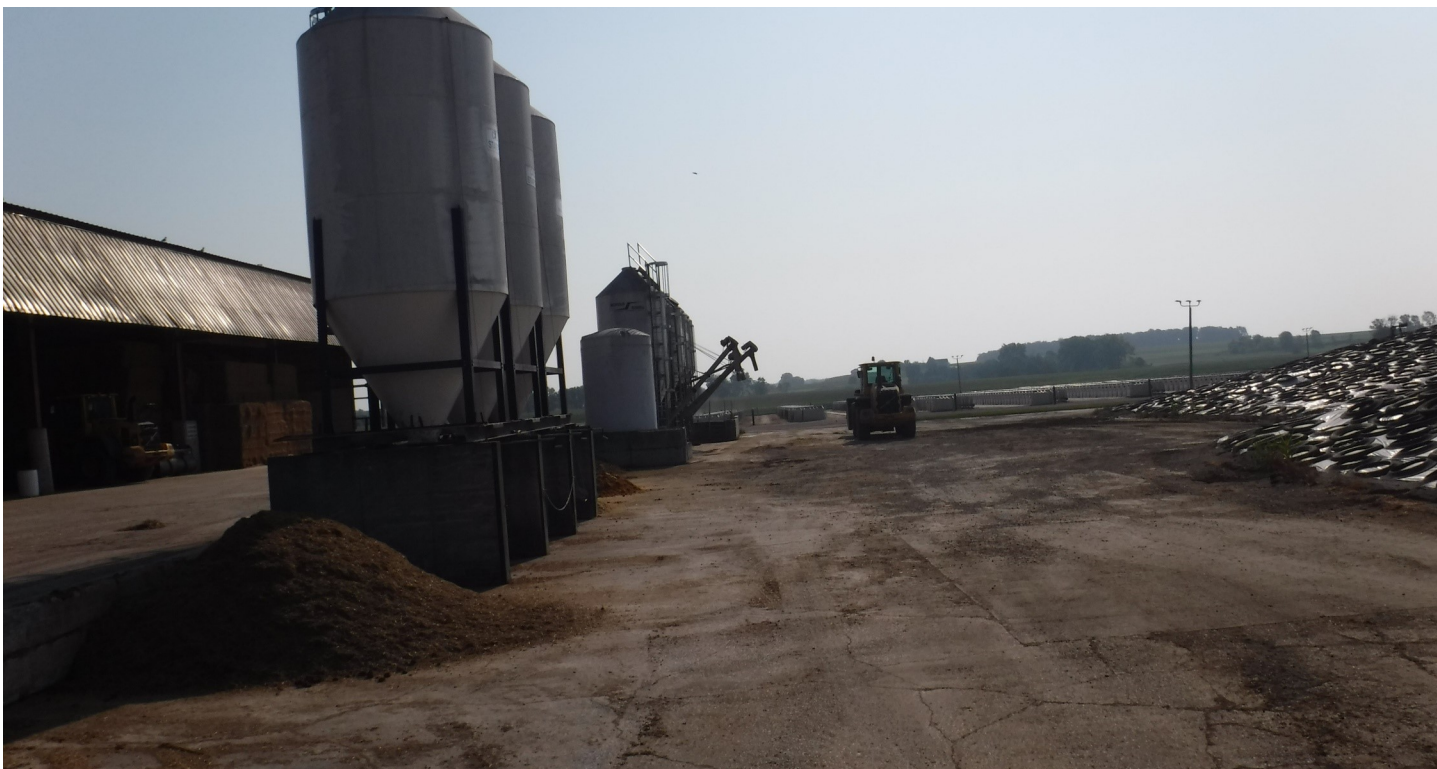
<b>Photo #:</b>	5776	<b>Photo Description: South feed storage area and upright bins</b>
<b>Date/Time of Photo:</b>	8-26-21 / AM	
<b>Photo Location:</b>	Calf Source	
<b>Photo By:</b>	Uvaas

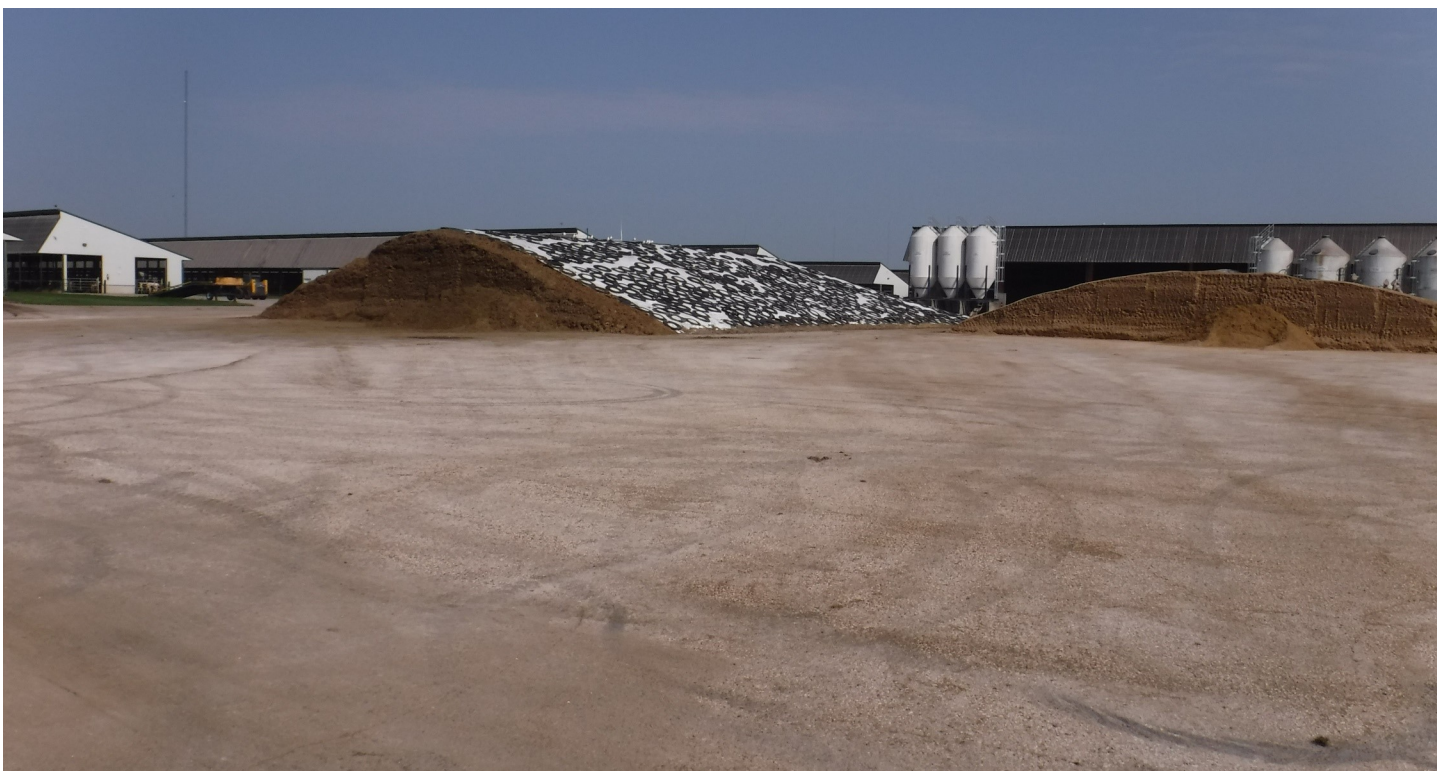
<b>Photo #:</b>	5810	<b>Photo Description: South feed storage area</b>
<b>Date/Time of Photo:</b>	8-26-21 / AM	
<b>Photo Location:</b>	Calf Source	
<b>Photo By:</b>	Uvaas

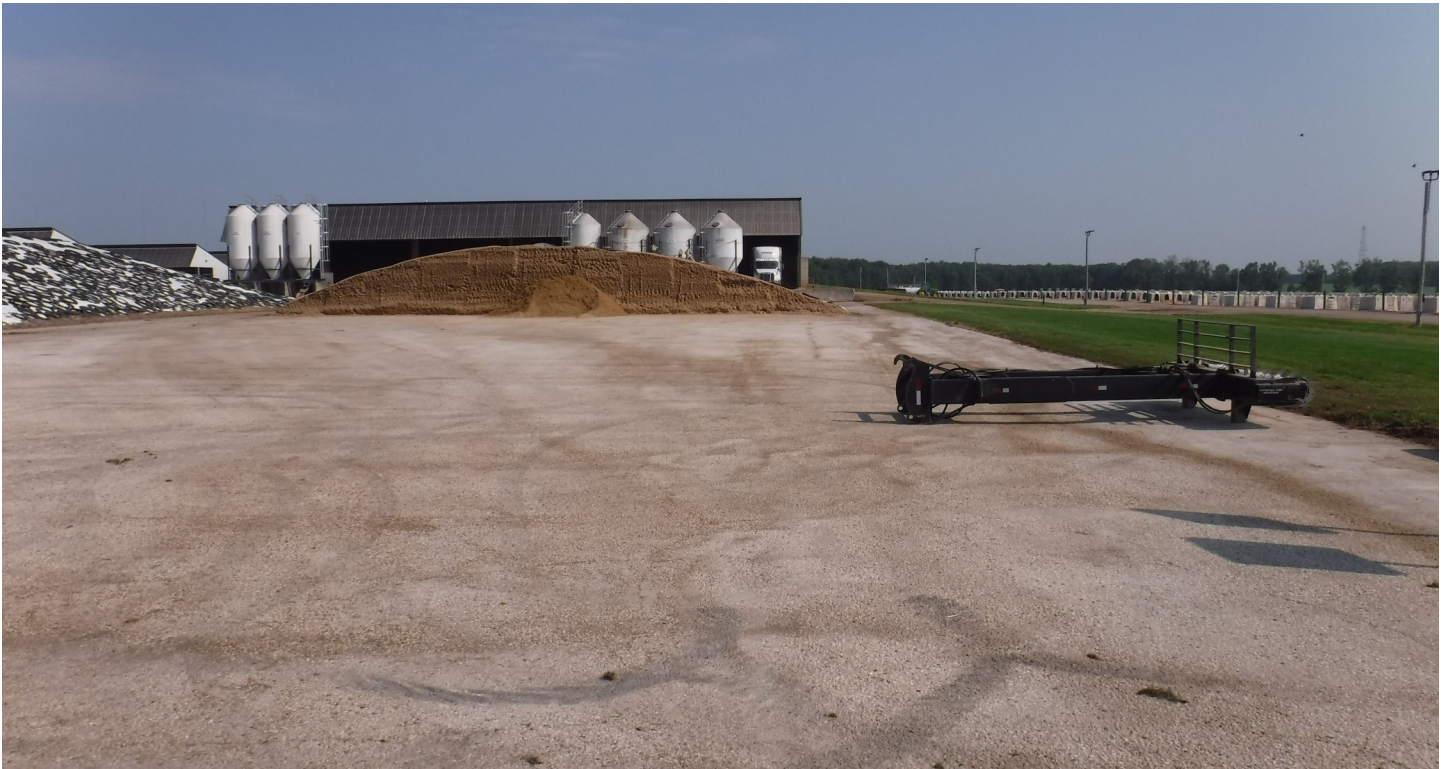
<b>Photo #:</b>	5811	<b>Photo Description: South feed storage area from its southeast corner and runoff control system</b>
<b>Date/Time of Photo:</b>	8-26-21 / AM	
<b>Photo Location:</b>	Calf Source	
<b>Photo By:</b>	Uvaas

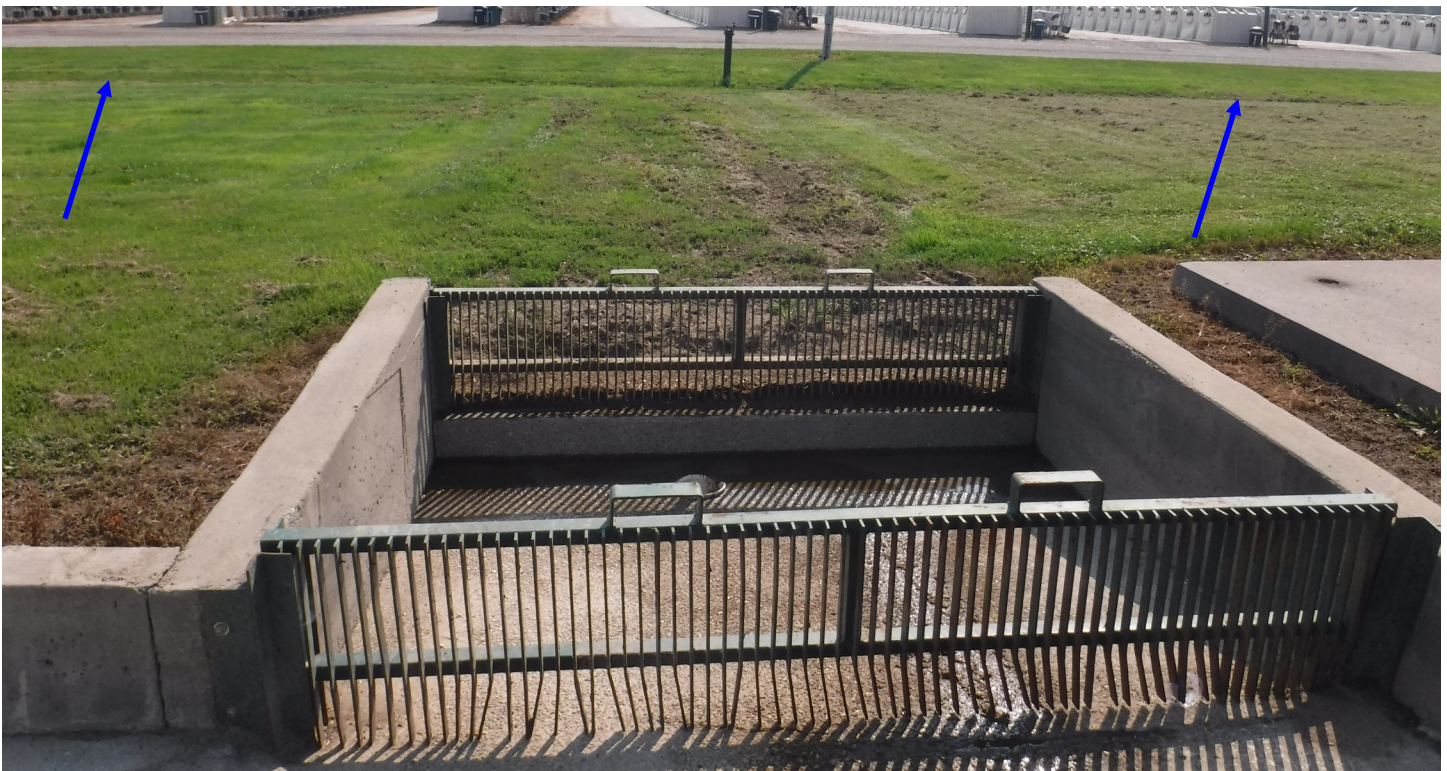
<b>Photo #:</b>	5813	<b>Photo Description: South feed storage area runoff control system, stormwater swale at blue arrows</b>
<b>Date/Time of Photo:</b>	8-26-21 / AM	
<b>Photo Location:</b>	Calf Source	
<b>Photo By:</b>	Uvaas

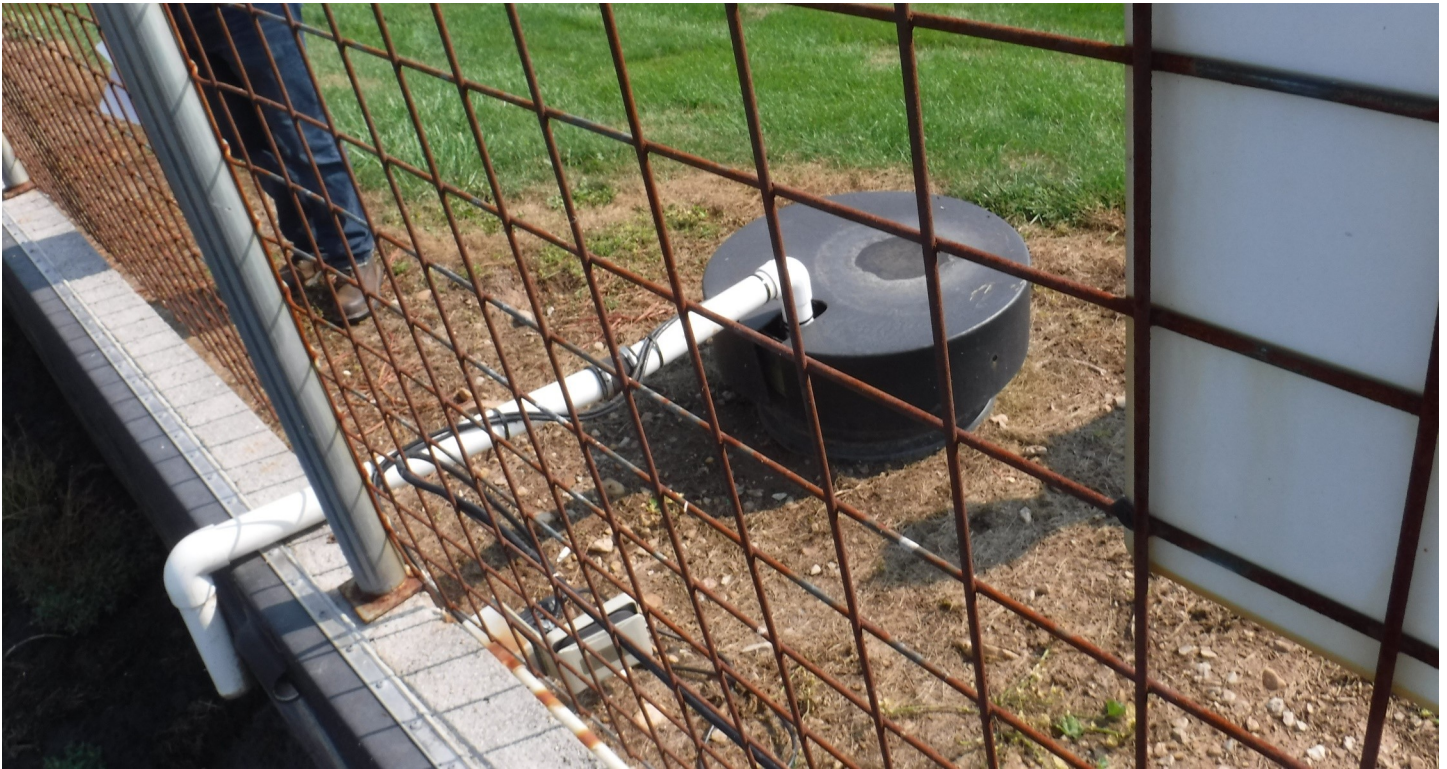
<b>Photo #:</b>	5823	<b>Photo Description:</b> SP-4 and its transfer system
<b>Date/Time of Photo:</b>	8-26-21 / AM	
<b>Photo Location:</b>	Calf Source	
<b>Photo By:</b>	Uvaas
