# Permit Fact Sheet

Permit Number:	WI-0061697-05-0
Permittee Name:	Calf Source LLC
Address:	N3569 Vanden Bosch Rd
City/State/Zip:	Kaukauna WI 54130
Receiving Water:	Unnamed tributaries of the Branch River within the Branch River Watershed, and groundwaters of the state.

SUBJECT: Calf Source LLC – Assessment of groundwater quality, potential contaminate sources and need for groundwater monitoring at the production site.

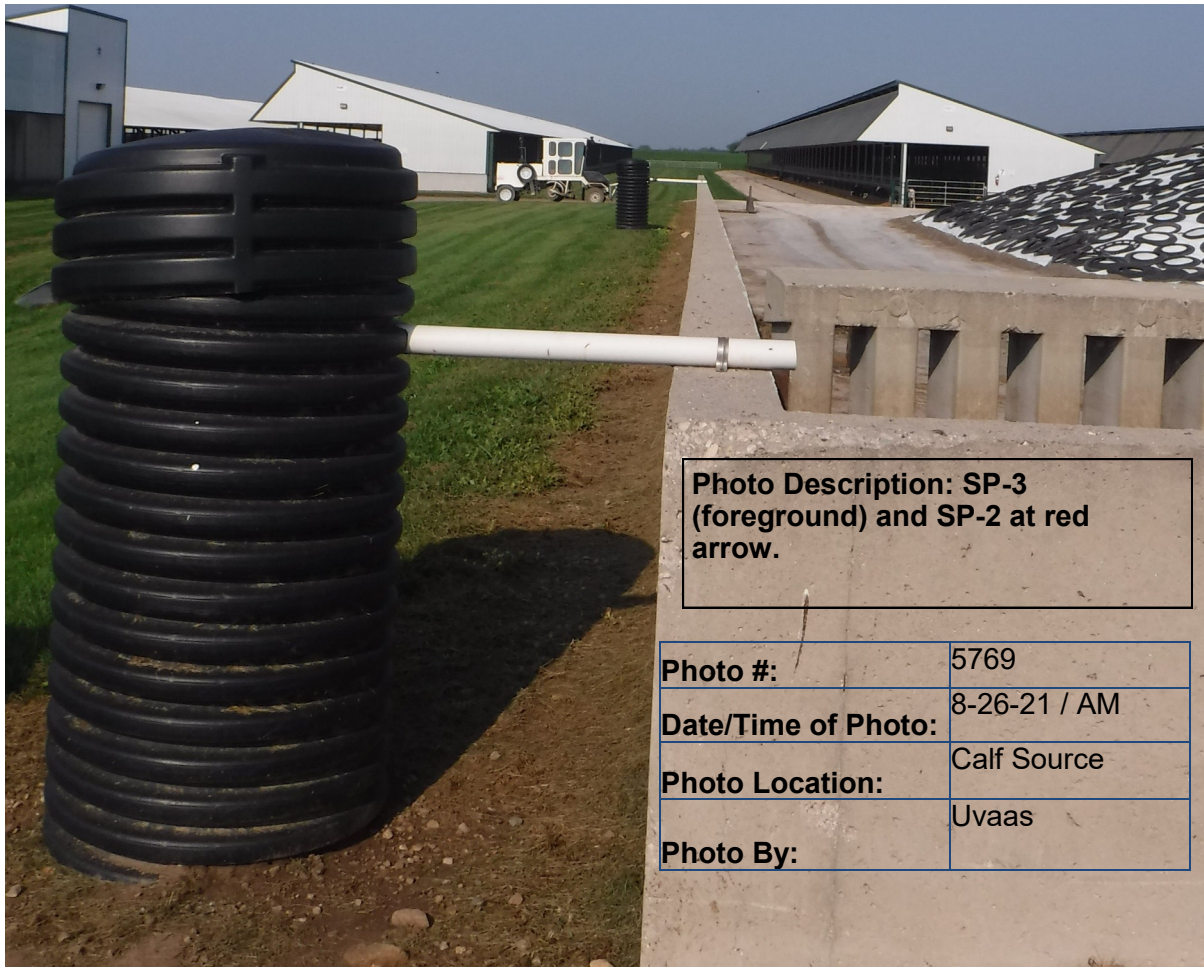
<b>Photo #:</b>	5769
<b>Date/Time of Photo:</b>	8-26-21 / AM
<b>Photo Location:</b>	Calf Source
<b>Photo By:</b>	Uvaas

**Photo Description:** SP-3 (foreground) and SP-2 at red arrow.

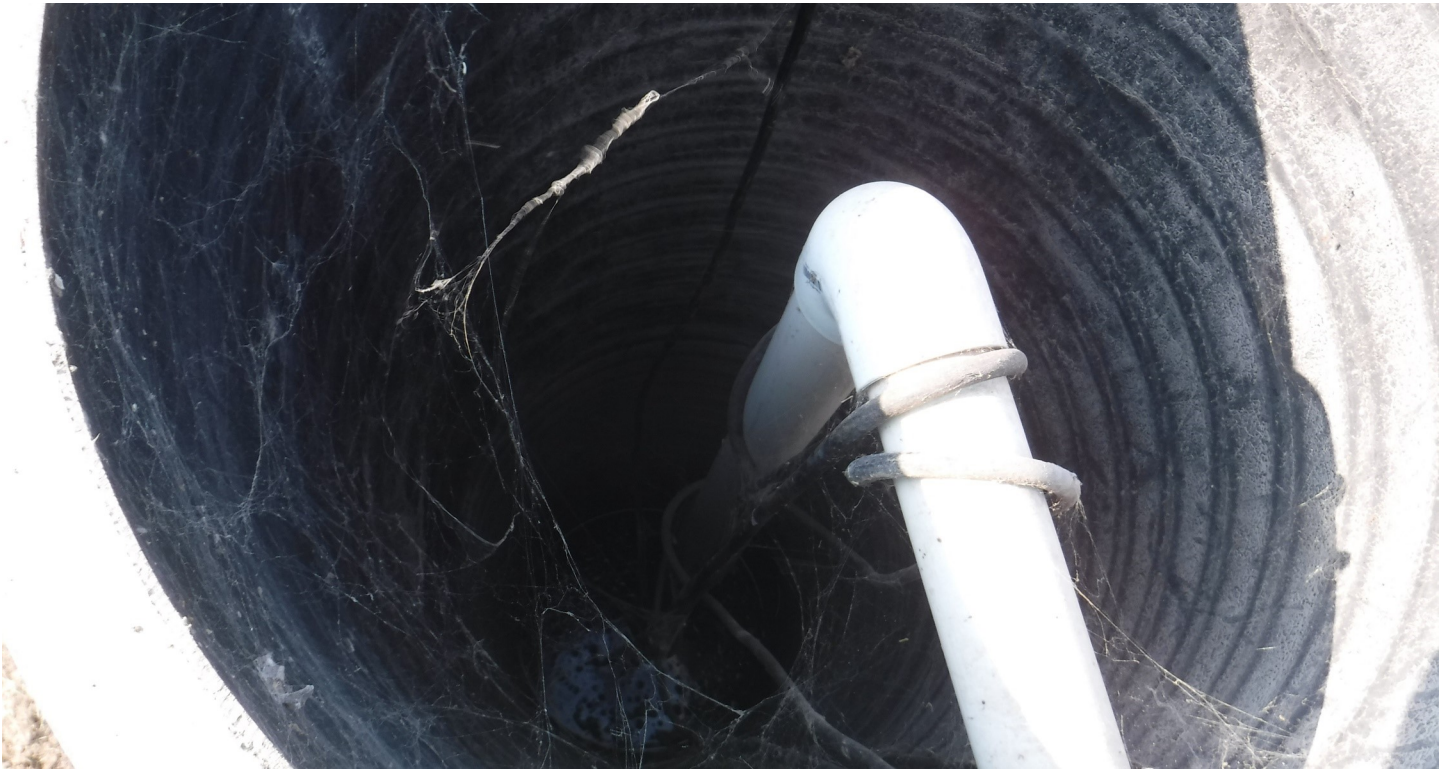
<b>Photo #:</b>	5771	<b>Photo Description:</b> View inside SP-3
<b>Date/Time of Photo:</b>	8-26-21 / AM	
<b>Photo Location:</b>	Calf Source	
<b>Photo By:</b>	Uvaas

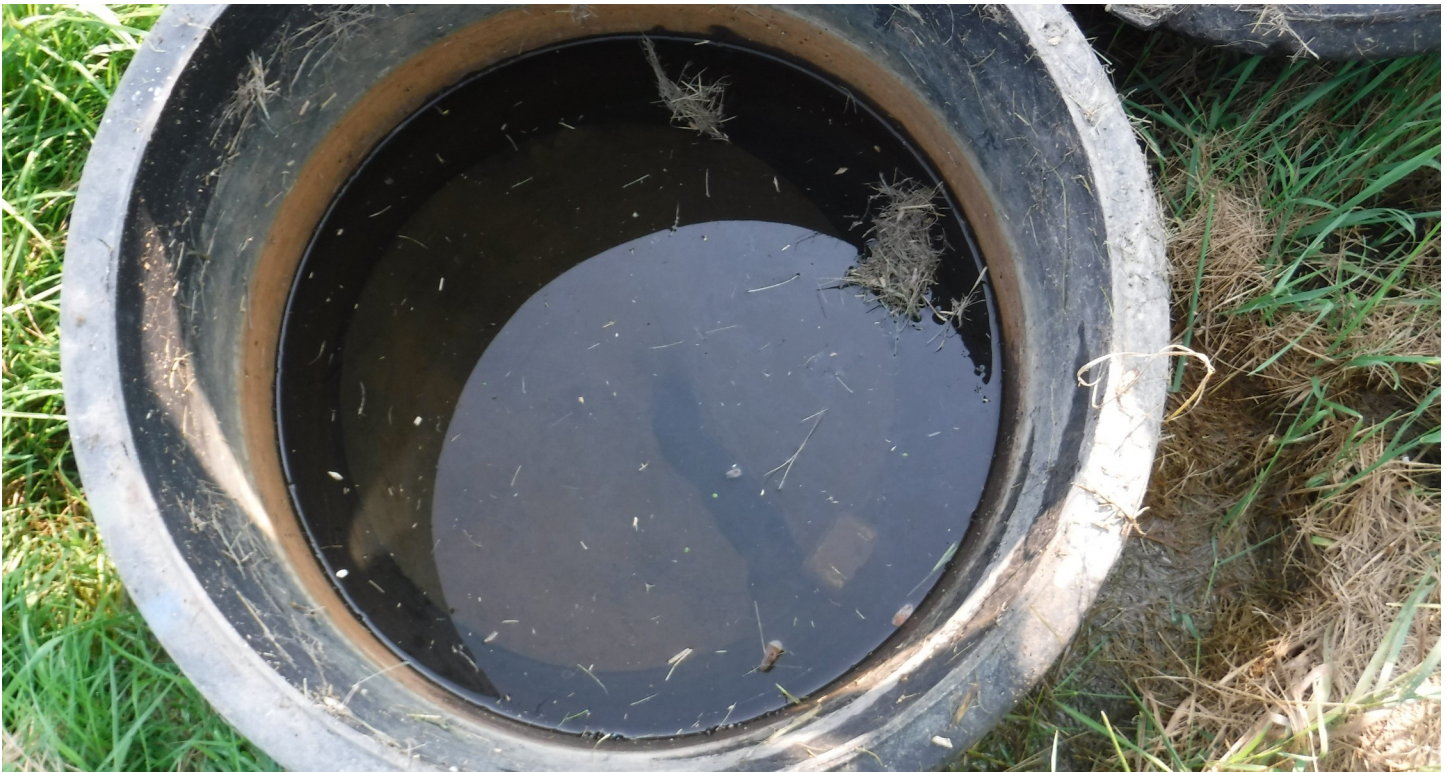
<b>Photo #:</b>	5789	<b>Photo Description:</b> View inside SP-1
<b>Date/Time of Photo:</b>	8-26-21 / AM	
<b>Photo Location:</b>	Calf Source	
<b>Photo By:</b>	Uvaas

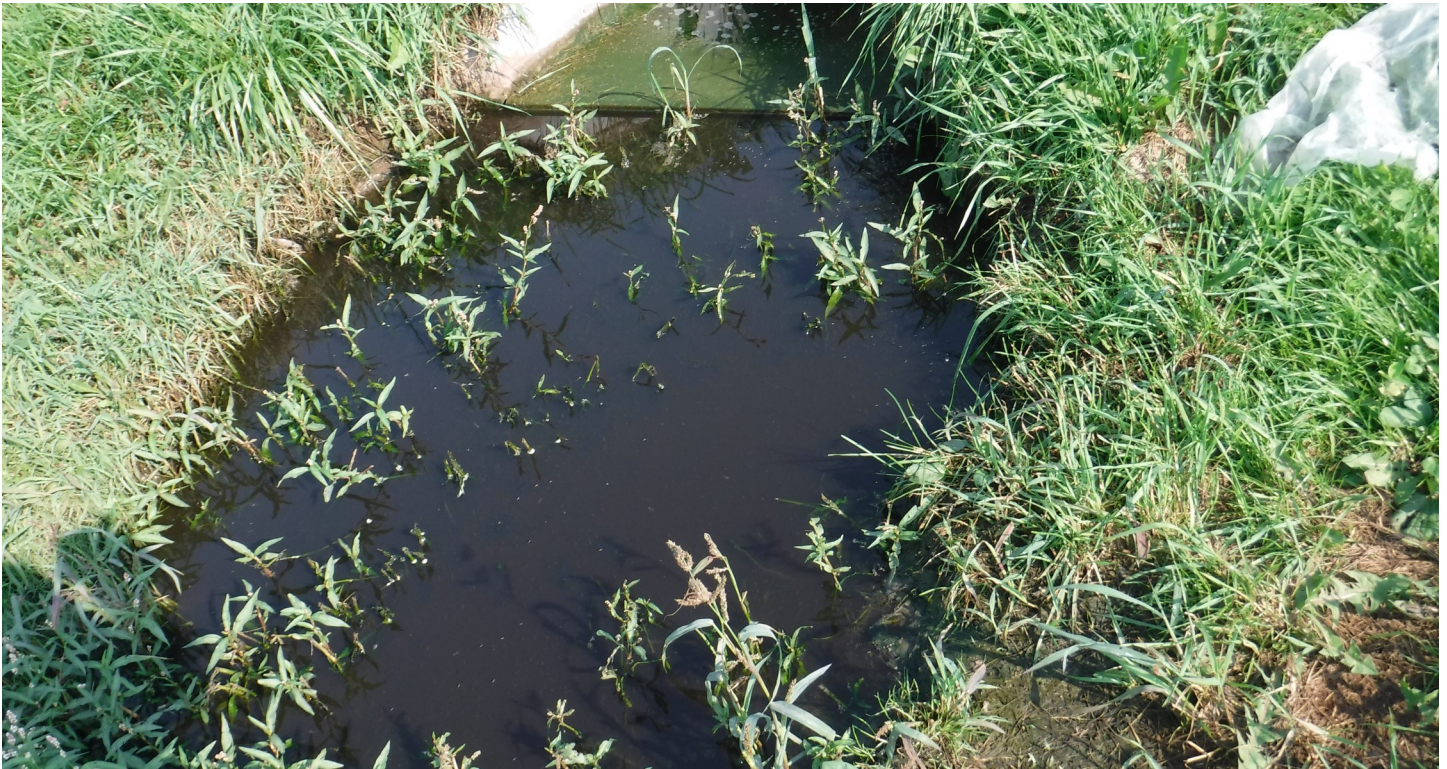
<b>Photo #:</b>	5805	<b>Photo Description: South stormwater swale near calf hutch pad's southern border</b>
<b>Date/Time of Photo:</b>	8-26-21 / AM	
<b>Photo Location:</b>	Calf Source	
<b>Photo By:</b>	Uvaas

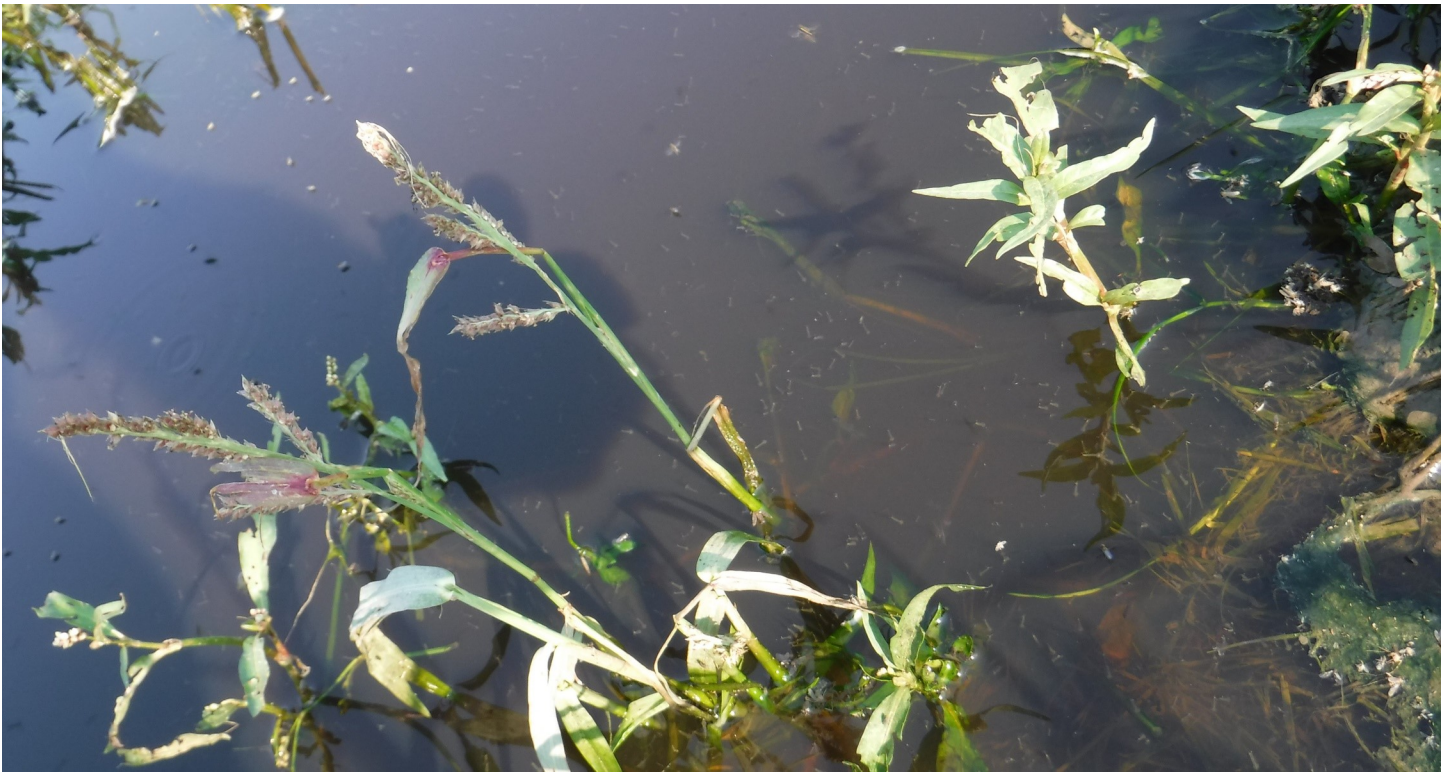
<b>Photo #:</b>	5806	<b>Photo Description: Close-up of liquid in photo 5805</b>
<b>Date/Time of Photo:</b>	8-26-21 / AM	
<b>Photo Location:</b>	Calf Source	
<b>Photo By:</b>	Uvaas
