# Permit Fact Sheet

| Permittee Name: | Drumlin Dairy, LLC |

On August 30 – September 1, 2021 Chambers and Holly Stegemann (DNR Agricultural Runoff Management Specialist) met with Brent Cousins, Authorized Representative & several farm staff to conduct a permit reissuance inspection of the Holsum Dairy facilities. Inspections were conducted at all sites currently covered under the WPDES Permit: Holsum Irish, Holsum Elm, Drumlin Dairy, and the Ditter Farm Satellite Pit. Holsum Dairies intends to add the Schneider Farm main site to their permit during the reissuance process. This location was not inspected due to a recent DNR reissuance inspection for the Schneider Farms permit conducted on October 7, 2020, a copy of that report has been included. No precipitation had fallen 24 hours prior to the inspection, conditions during the inspection were warm and dry. Follow up items are requested on page 24.

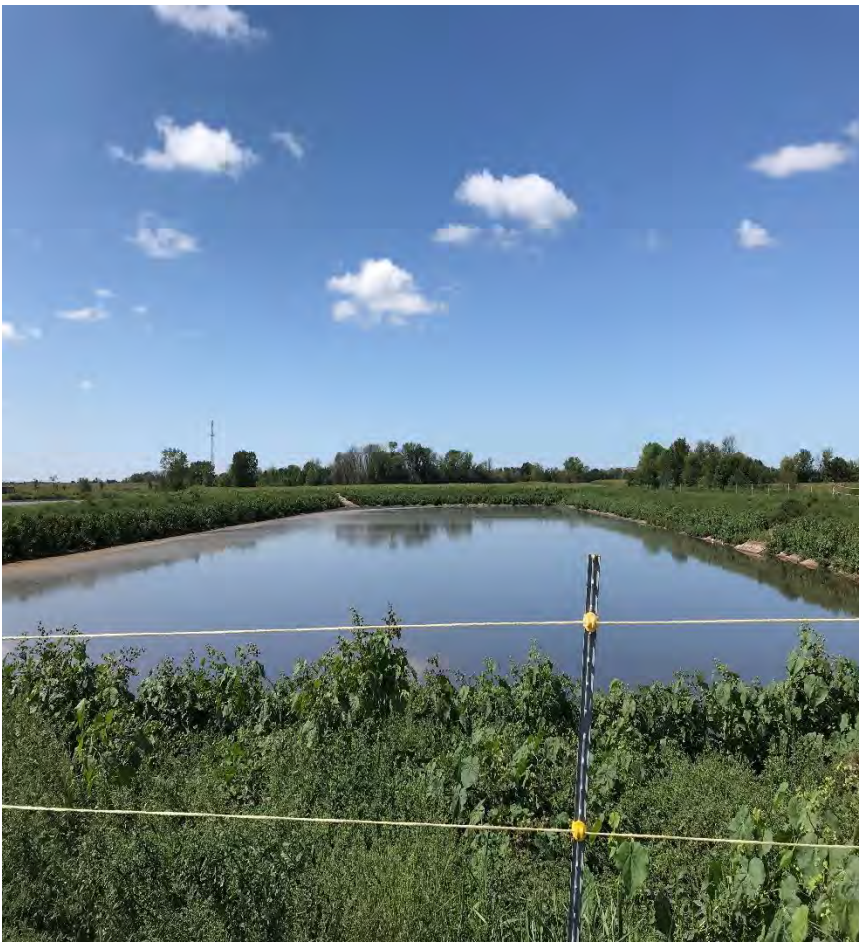
| Photo #: | 001 |

- WSF 1: North Pit is an earthen lined storage facility constructed in 2001 and serves as the second cell of a two-celled system. WSF 1 is located to the north side of the facility. WSF 1 accepts post-digester liquids and process wastewater. At the time of inspection, required fencing and permanent markers were in place. Concrete ramps were also observed.

Photo Description: View of WSF 1, North Pit. Concrete ramps present.

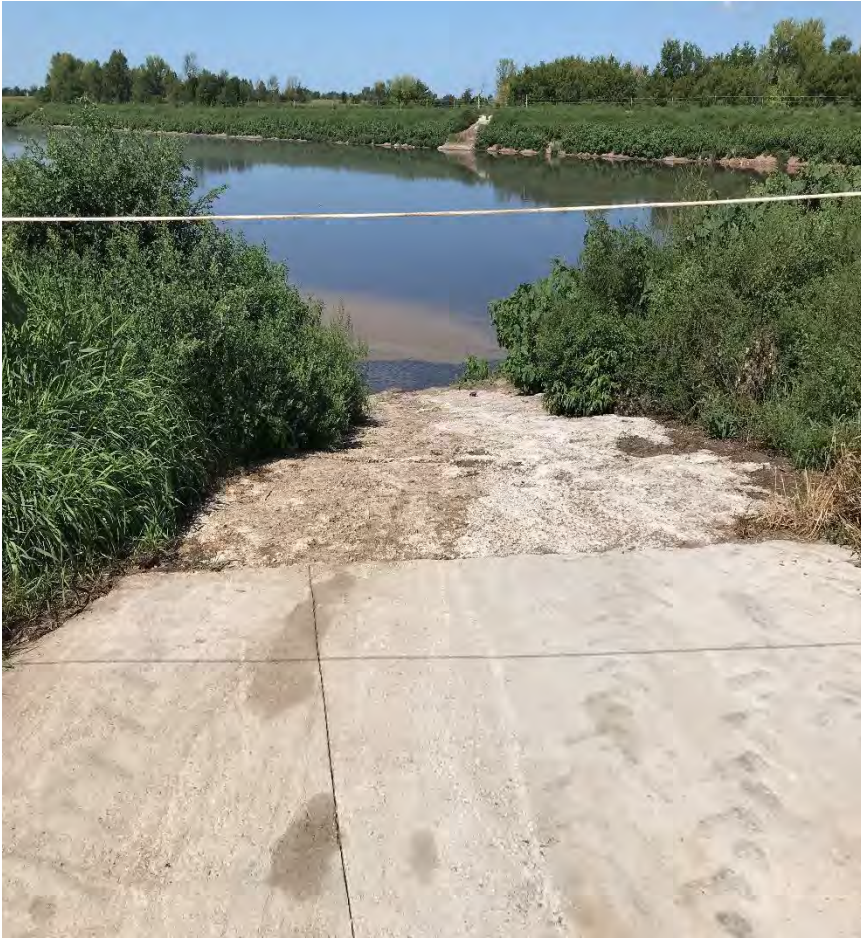
| Photo #: | 002 |

- WSF 2: South Pit is an earthen lined storage facility constructed in 2001 and serves as the first cell of a two-celled system. WSF 2 is located to the south of WSF 1. WSF 2 accepts overflow from WSF 1. At the time of inspection, required fencing and permanent markers were in place. Concrete ramps were also observed.

Photo Description: View of WSF 2, South Pit. Concrete ramps were observed.

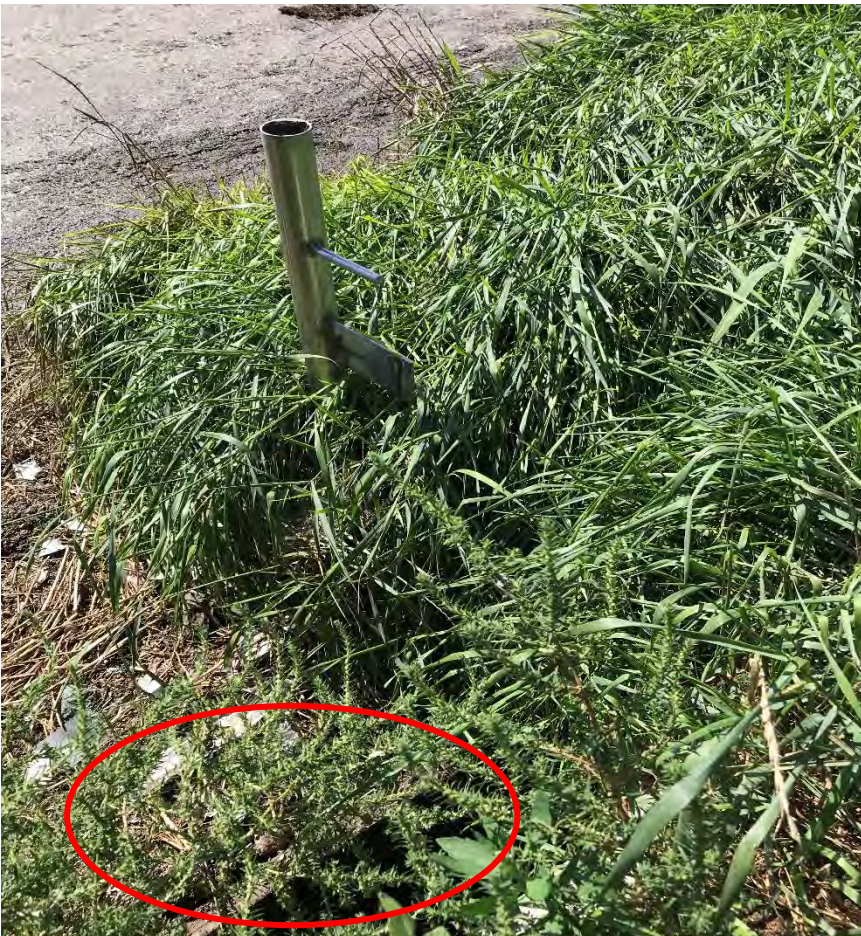
| Photo #: | 003 |

Photo Description: View of permanent markers for WSF 1-2, located on the berm between the storages. An overflow weir is designated by the red circle.

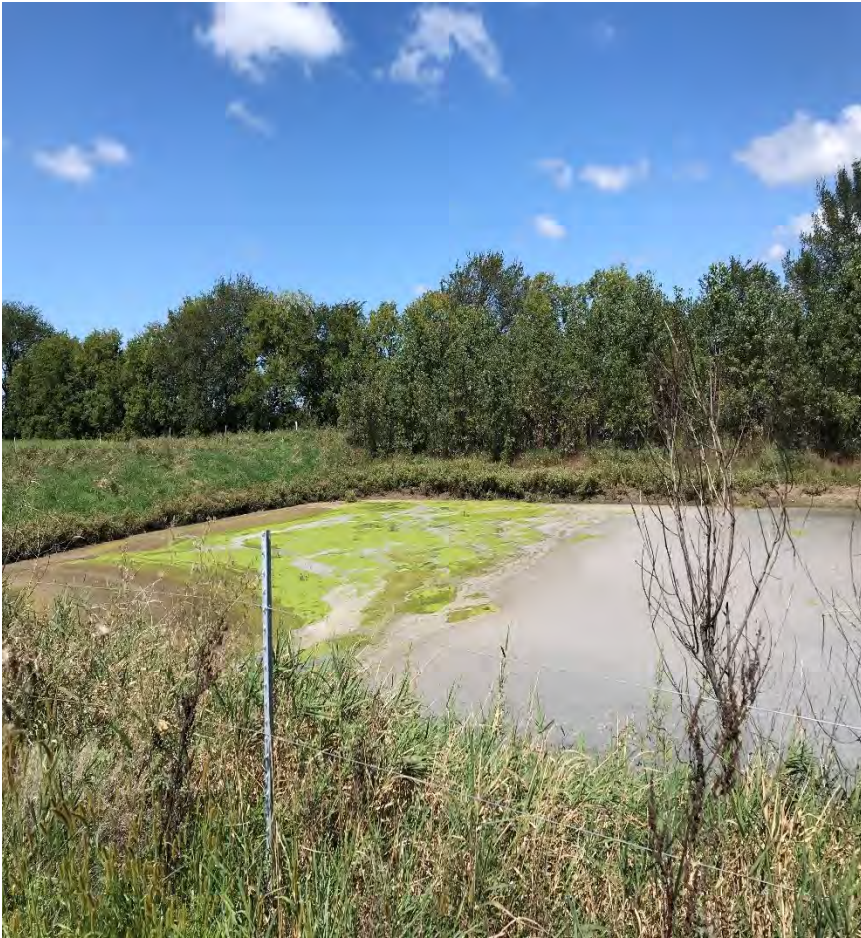
| Photo #: | 004 |

- WSF 8 Leachate: The leachate pit is an earthen lined storage constructed in 2013 and is used to store additional runoff from the feed storage area, after the first flush collection. At the time of the inspection, fencing was observed, permanent markers were not installed

Photo Description: WSF 8, used to storage overflow leachate.

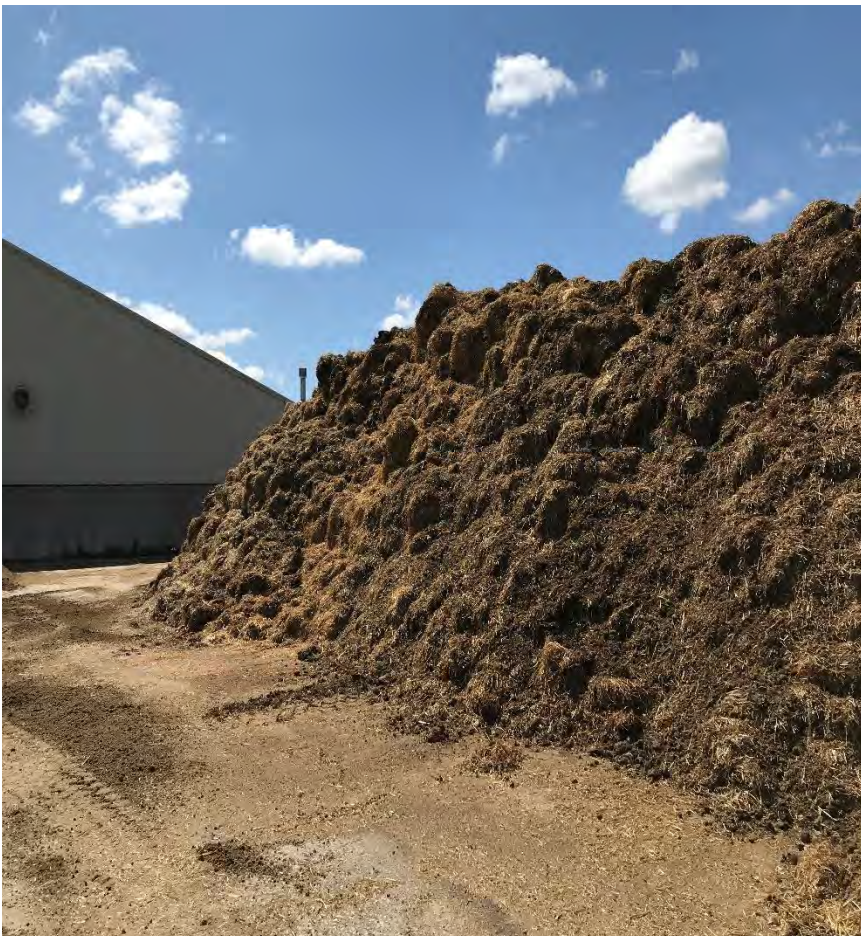
| Photo #: | 005 |

Photo Description: Solid manure stacked on concrete at the Irish site

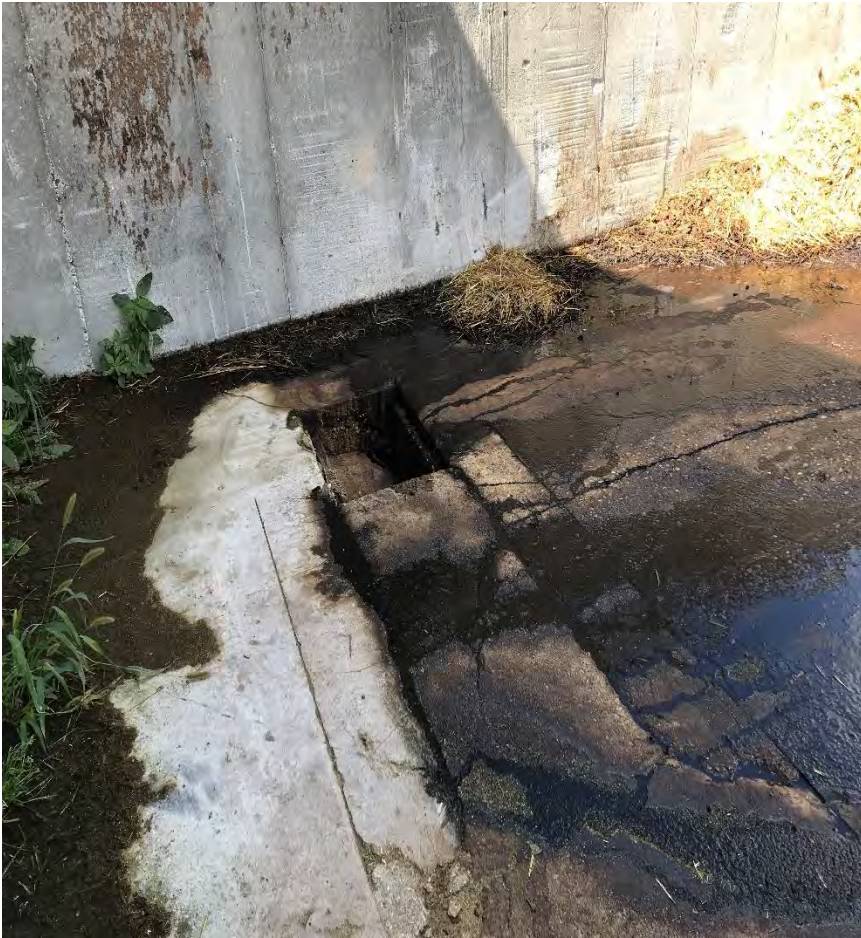
| Photo #: | 006 |

Photo Description: Drain located in the solid storage area used to convey runoff to permanent storage

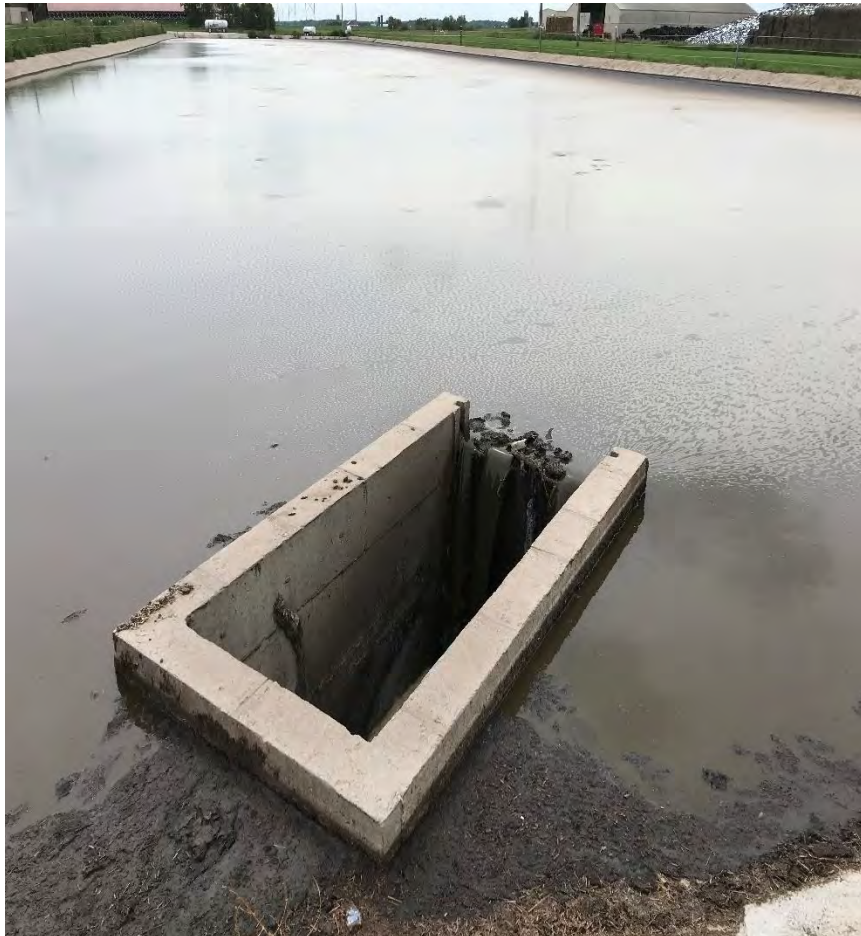
| Photo #: | 007 |

Photo Description: View of WSF 3, Pond 1 and overflow weir used to convey manure and process wastewater to WSF 4. Serves as initial cell.

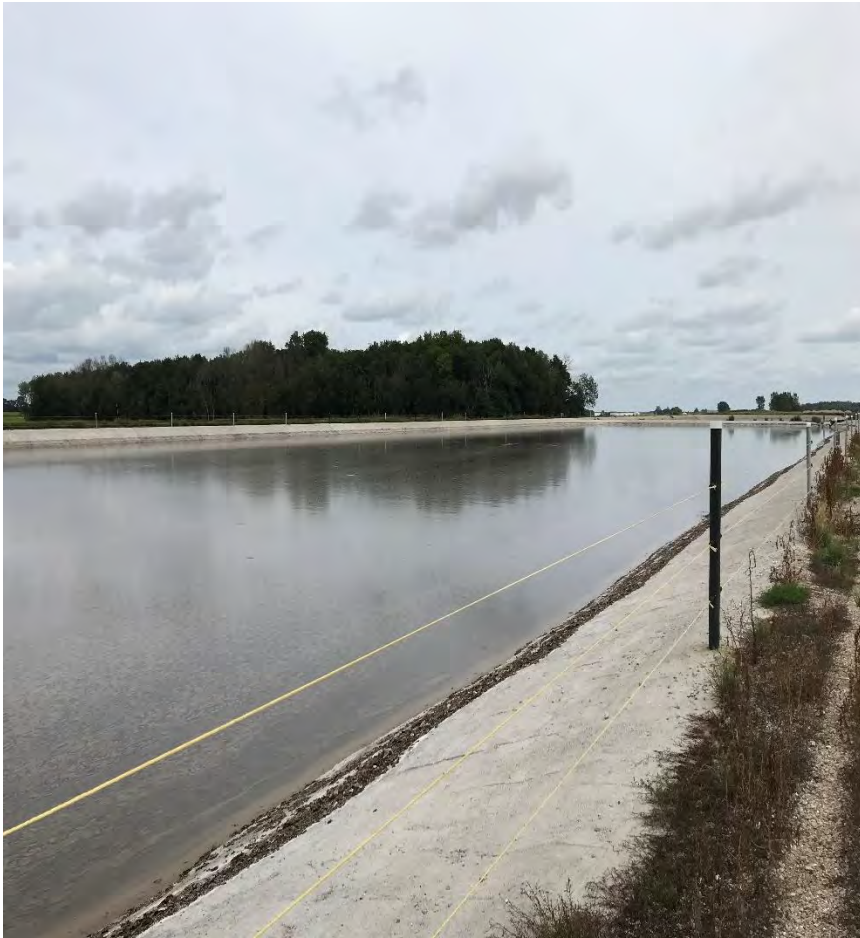
| Photo #: | 008 |

Photo Description: View of WSF 4, Pond 2. Serves as the second cell.

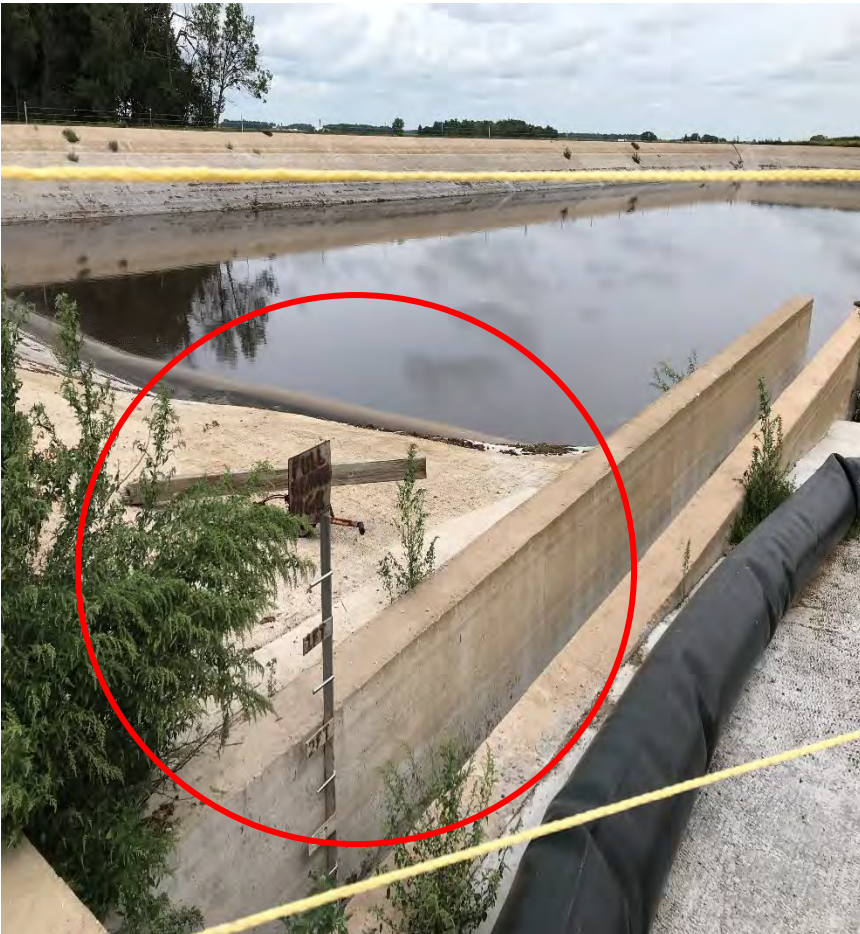
| Photo #: | 009 |

- WSF 5: Pond 3 is a concrete lined storage facility upgraded in 2016. This storage serves as the final cell of a three-celled system. WSF 5 is located to the east of WSF 4. WSF 5 accepts overflow from WSF 4. At the time of inspection, required fencing and permanent markers were in place. Concrete ramps were also observed.

Photo Description: View of WSF 5 Pond 3. Serves as third cell. Permanent markers designated by red circle.

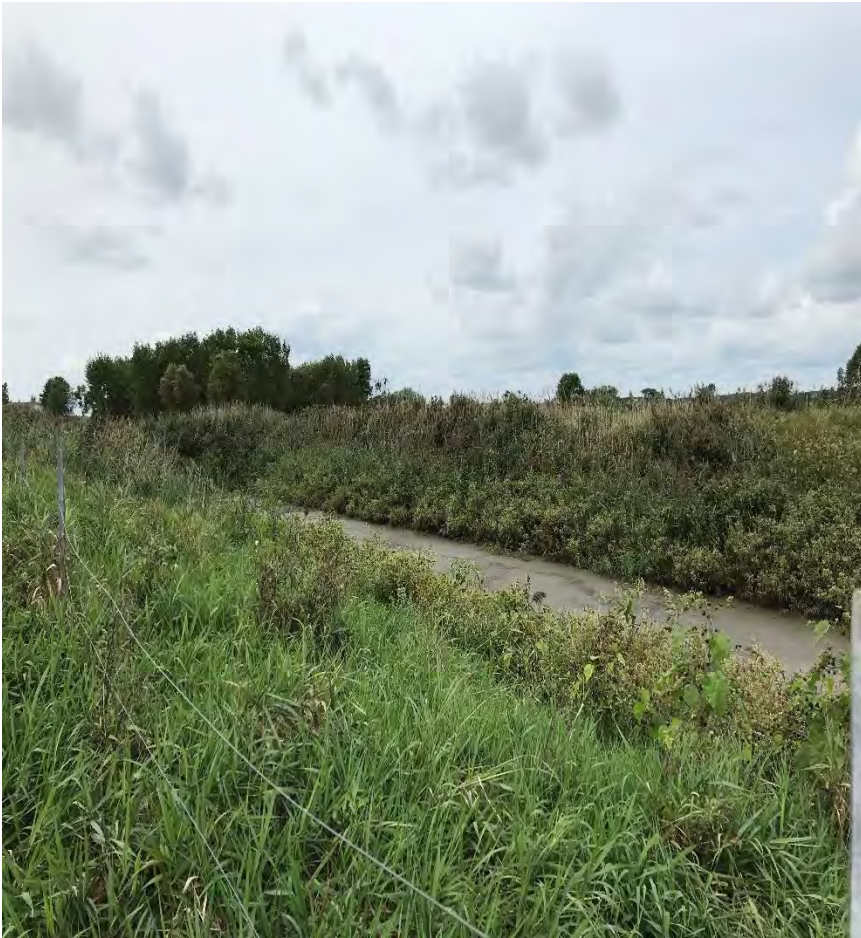
| Photo #: | 010 |

- WSF 7 Leachate: The leachate pit is an earthen lined storage constructed in 2013 and is used to store additional runoff from the feed storage area, after the first flush collection. At the time of the inspection, fencing was observed.

Photo Description: WSF 7, used to storage overflow leachate.

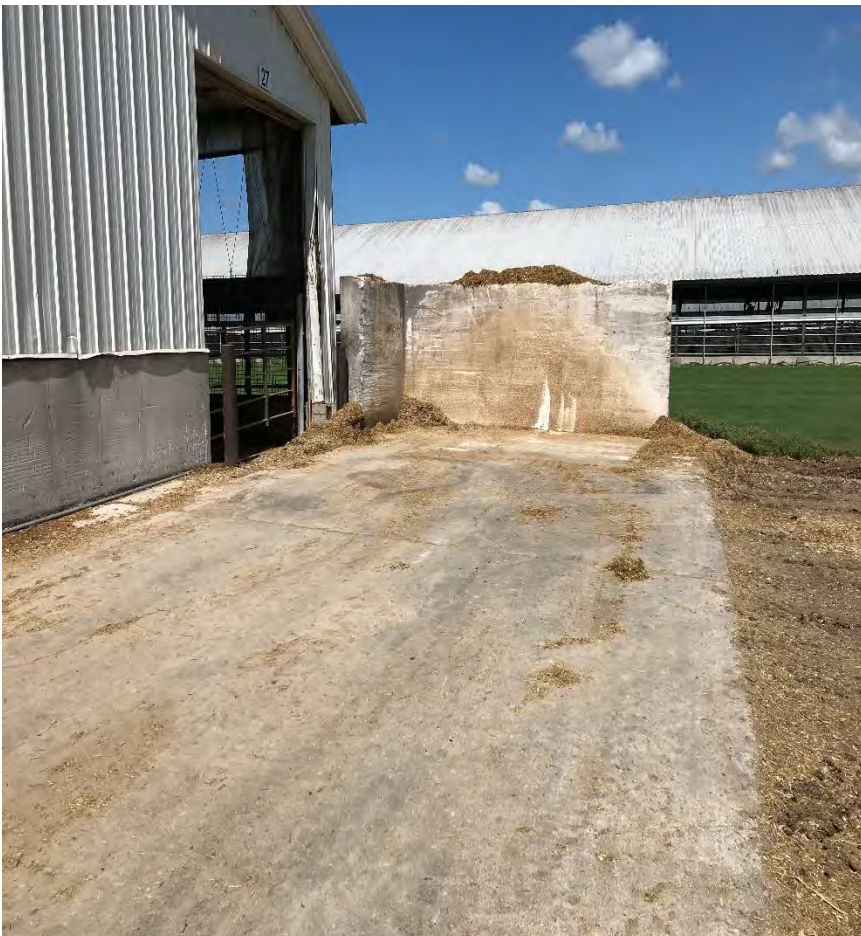
| Photo #: | 011 |

Photo Description: Pushout area at the Irish site. Some manure observed outside boundaries, but no runoff risk was observed.

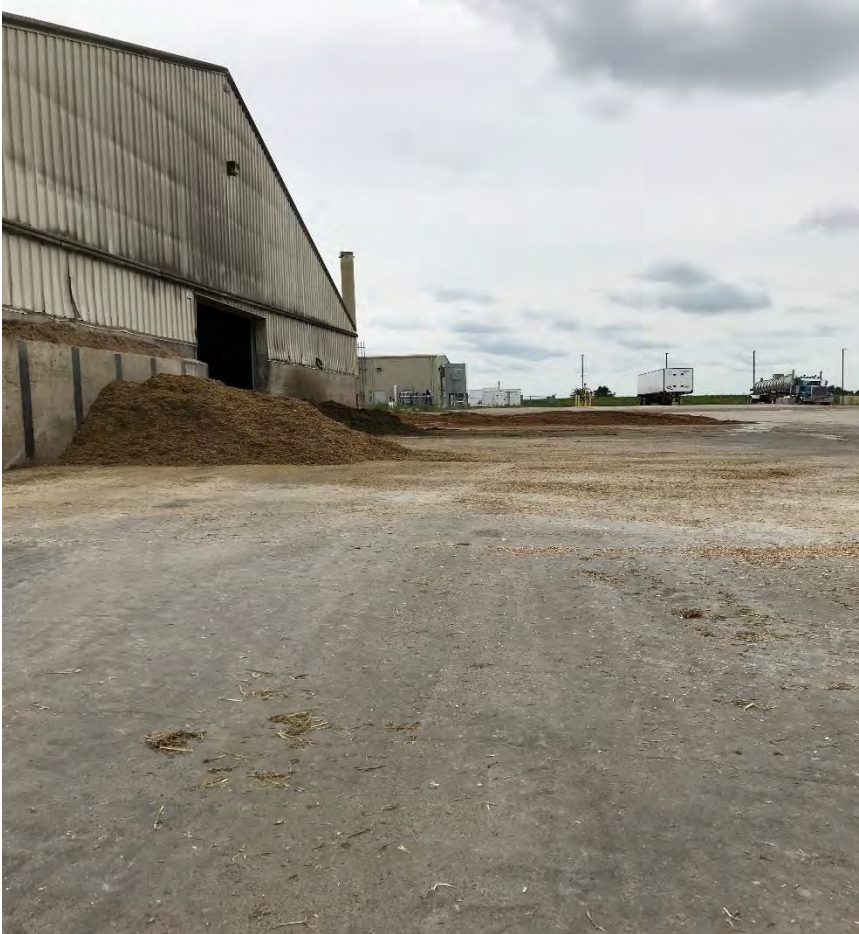
| Photo #: | 012 |

Photo Description: Pushout area used at the Elm site. Solids stored on concrete.

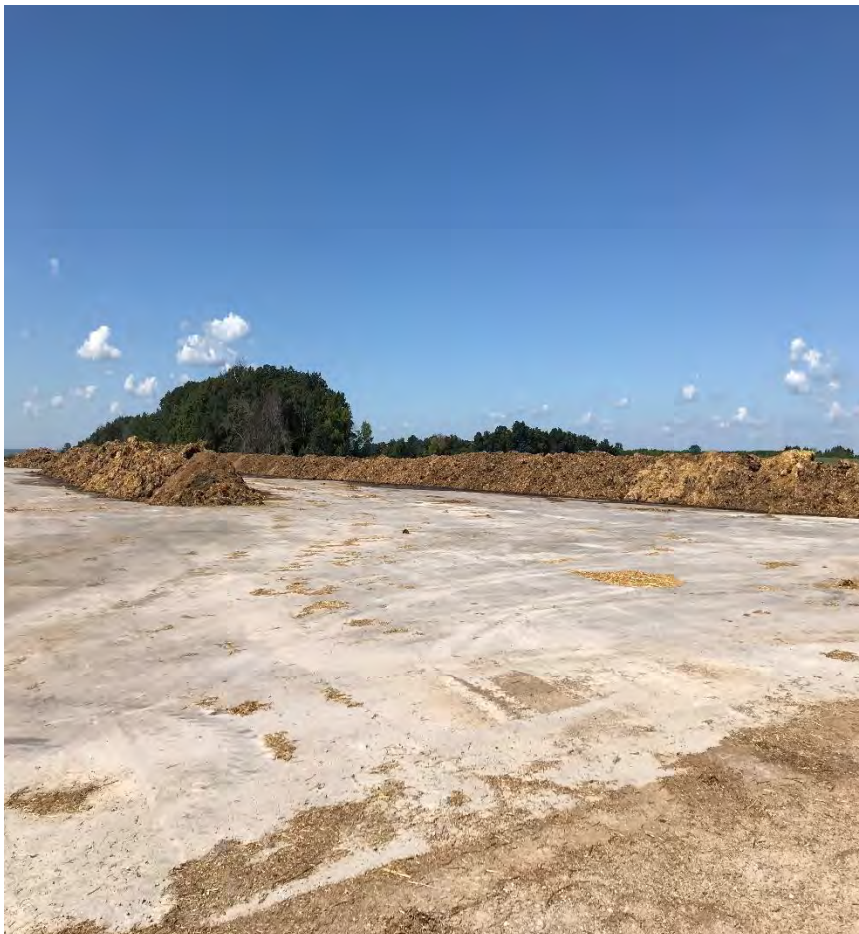
| Photo #: | 013 |

Photo Description: Solid manure composting site located at the Drumlin site. Runoff is conveyed towards permanent storage.

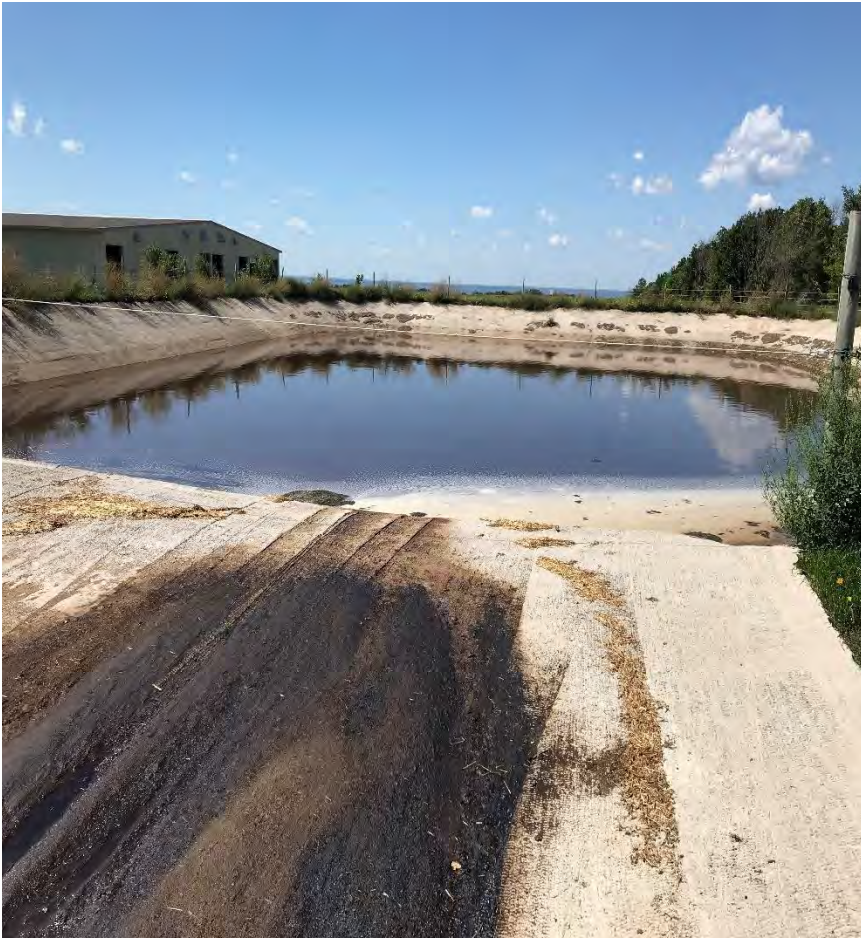
| Photo #: | 014 |

Photo Description: View of WSF 6, Runoff storage facility. Used to store liquids from the composting pad and other process wastewaters from the Drumlin site.

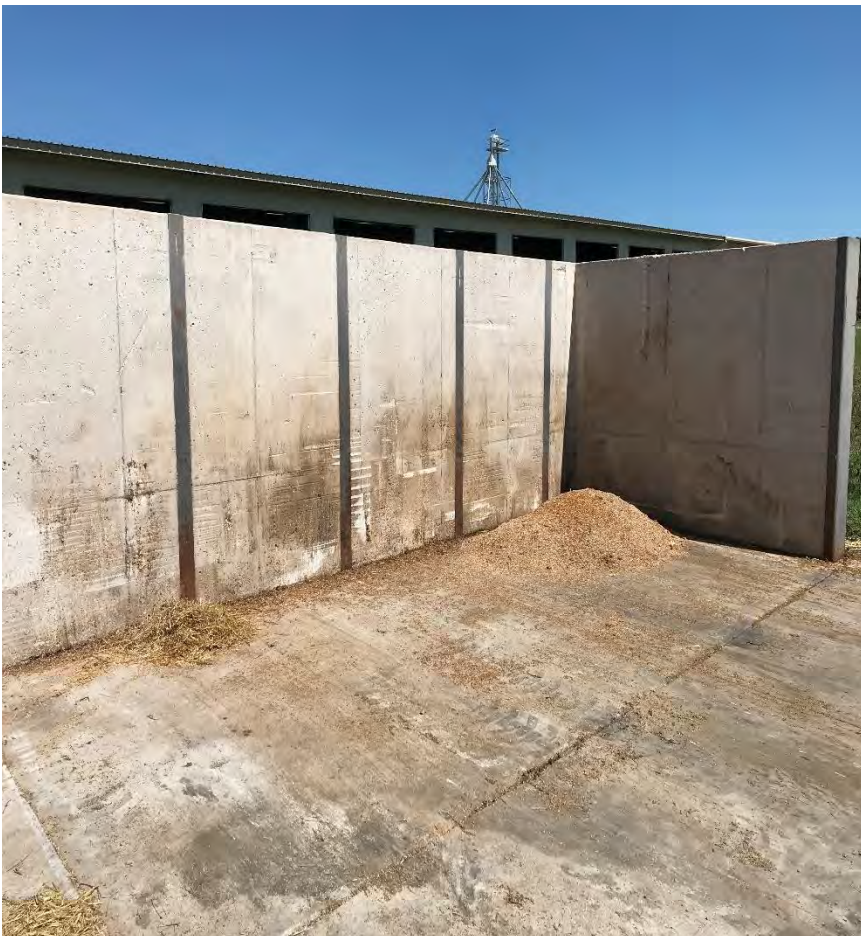
| Photo #: | 015 |

Photo Description: Pushout area used at the Drumlin site.

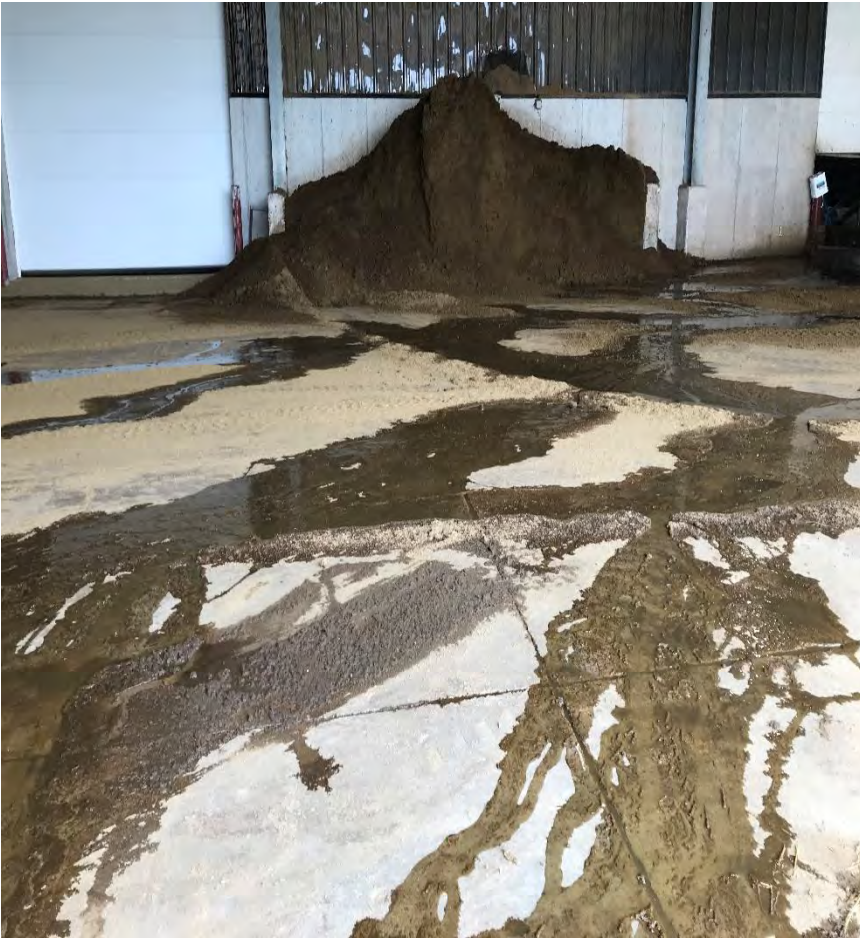
| Photo #: | 017 |

Photo Description: Separated solids used for animal bedding stored under roof at the Elm site.

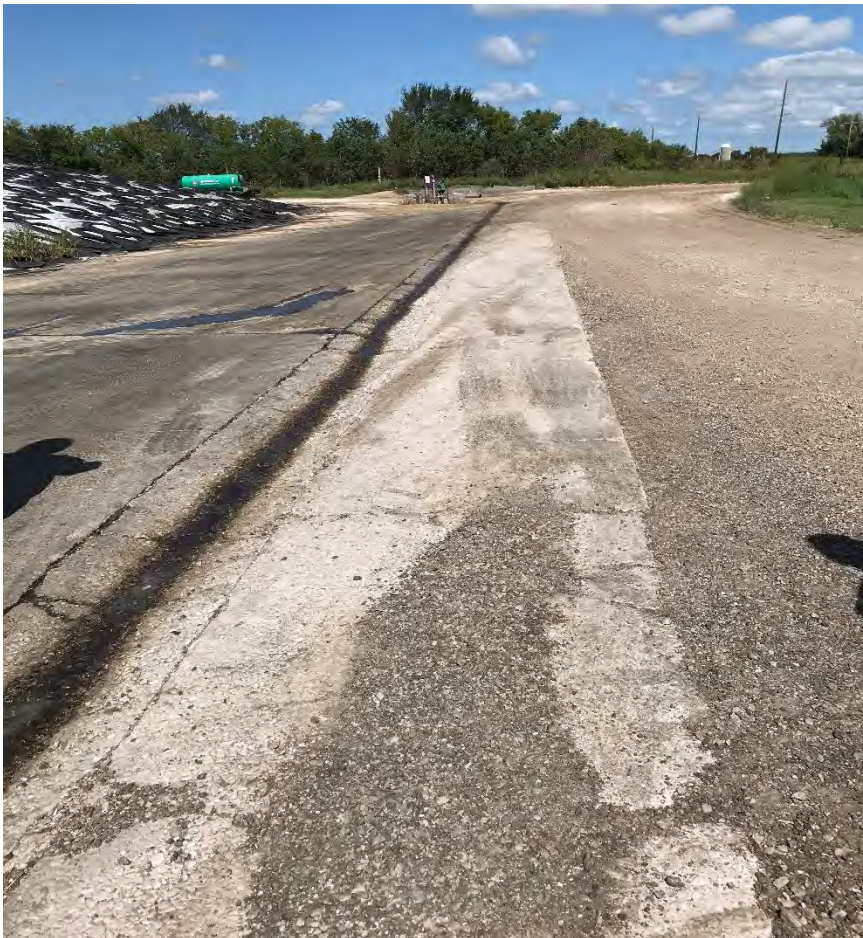
| Photo #: | 019 |

Photo Description: Curbing observed at the Irish site feed pad, conveying runoff towards a collection point.

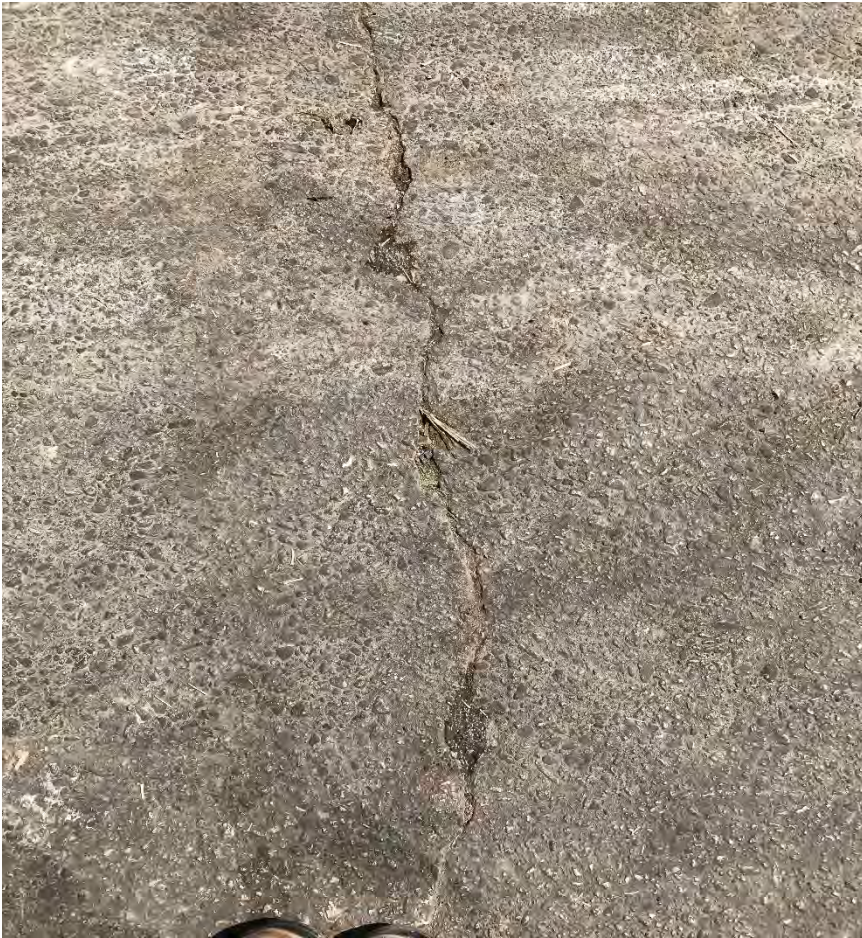
| Photo #: | 020 |

Photo Description: Cracks observed at the Irish site feed storage area.

- Cracks and rebar from wear were observed in the concrete at both locations

- a. Submit to the department by 11/30/2021 a detailed timeline for the repair to the feed storage area concrete. Pending any major repairs needed, plans and specifications may be required during the next permit term.

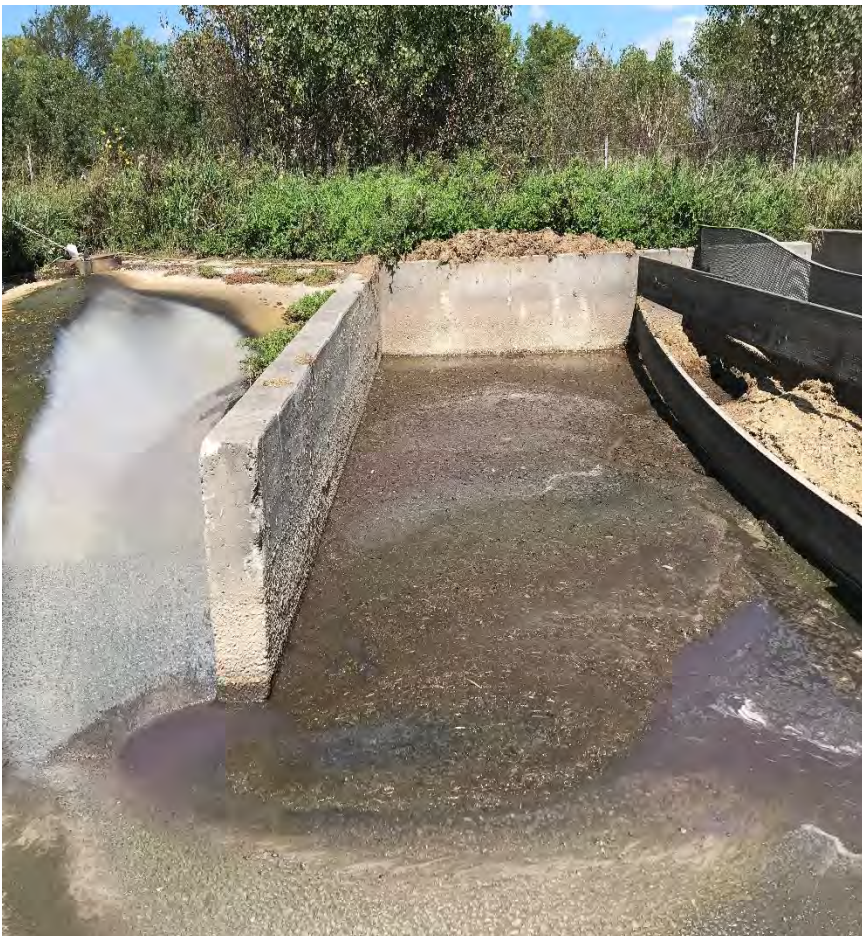
| Photo #: | 021 |

Photo Description: View of runoff controls for the Irish feed storage area. Screens cleaned as needed.

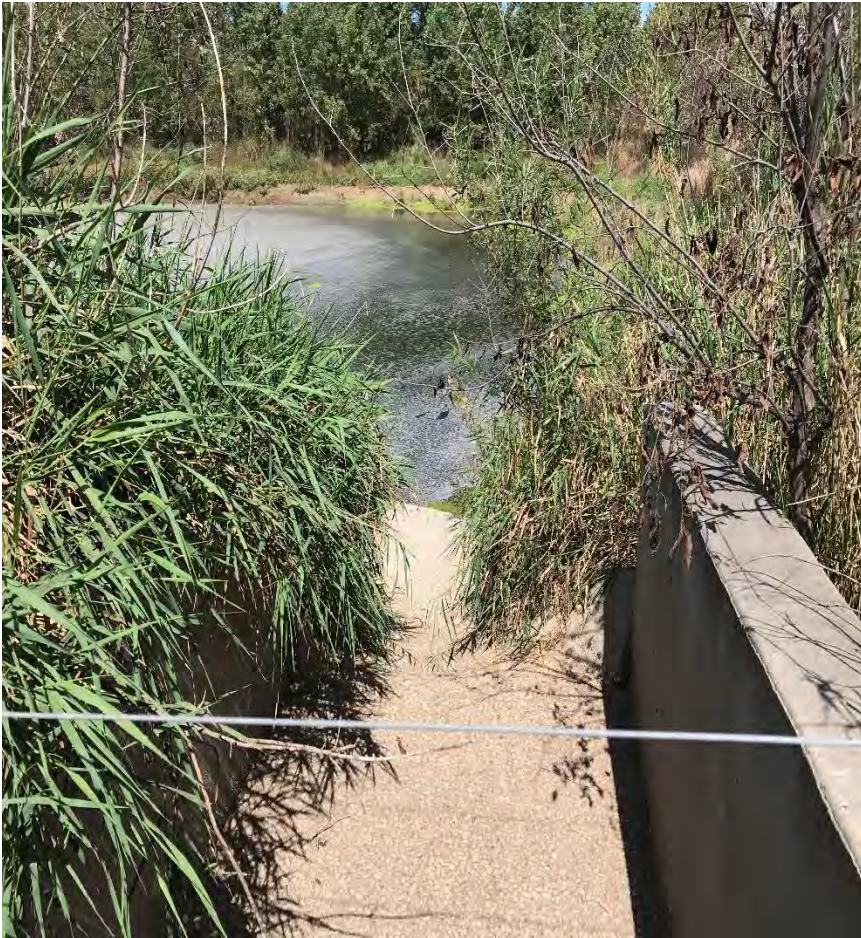
| Photo #: | 022 |

Photo Description: View of concrete conveyance towards leachate pond.

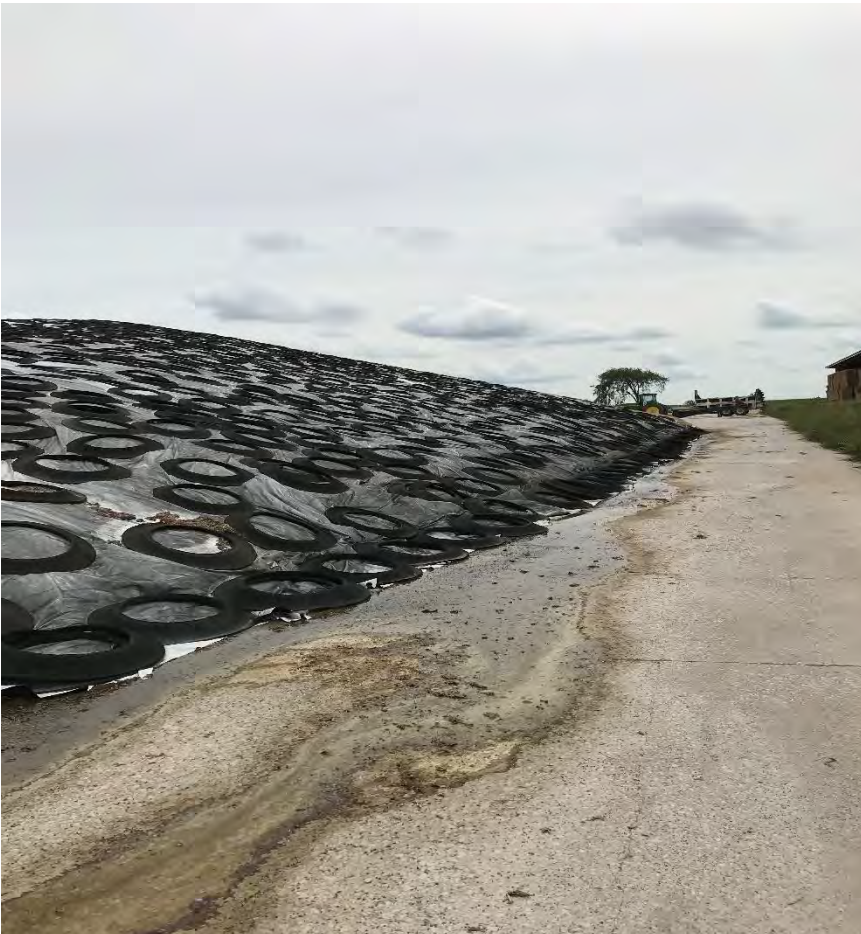
| Photo #: | 023 |

Photo Description: Curbing observed at the Elm site feed storage, feed kept under plastic.

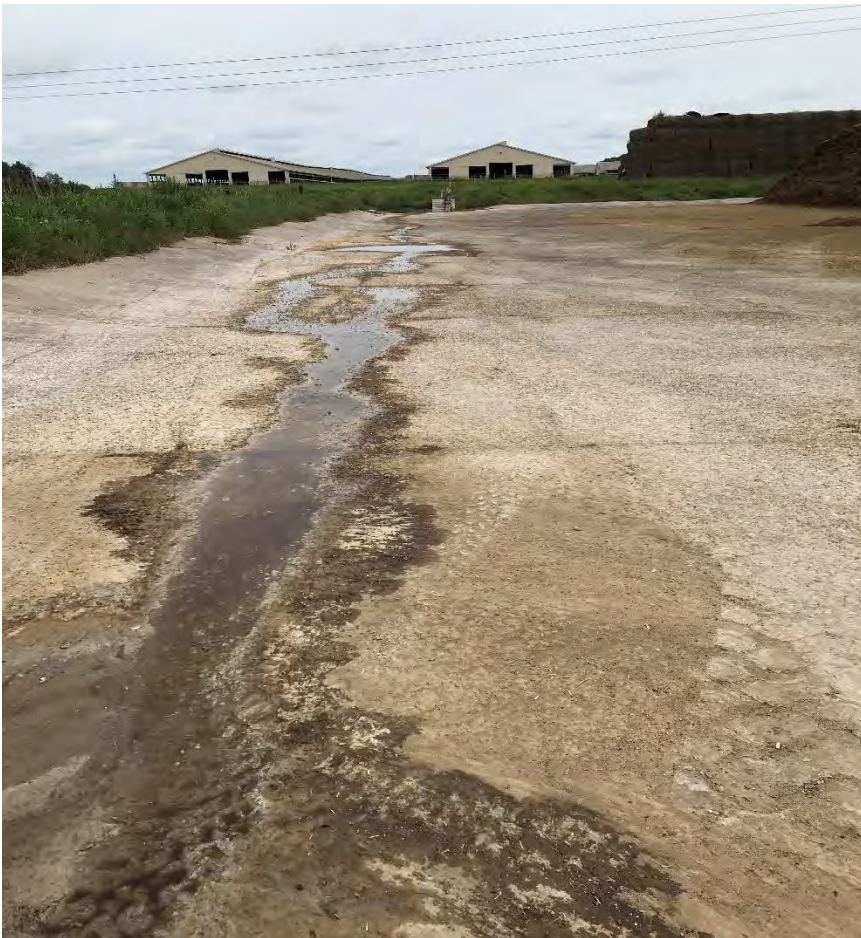
| Photo #: | 024 |

Photo Description: Runoff is conveyed towards runoff controls at the Elm site feed storage area.

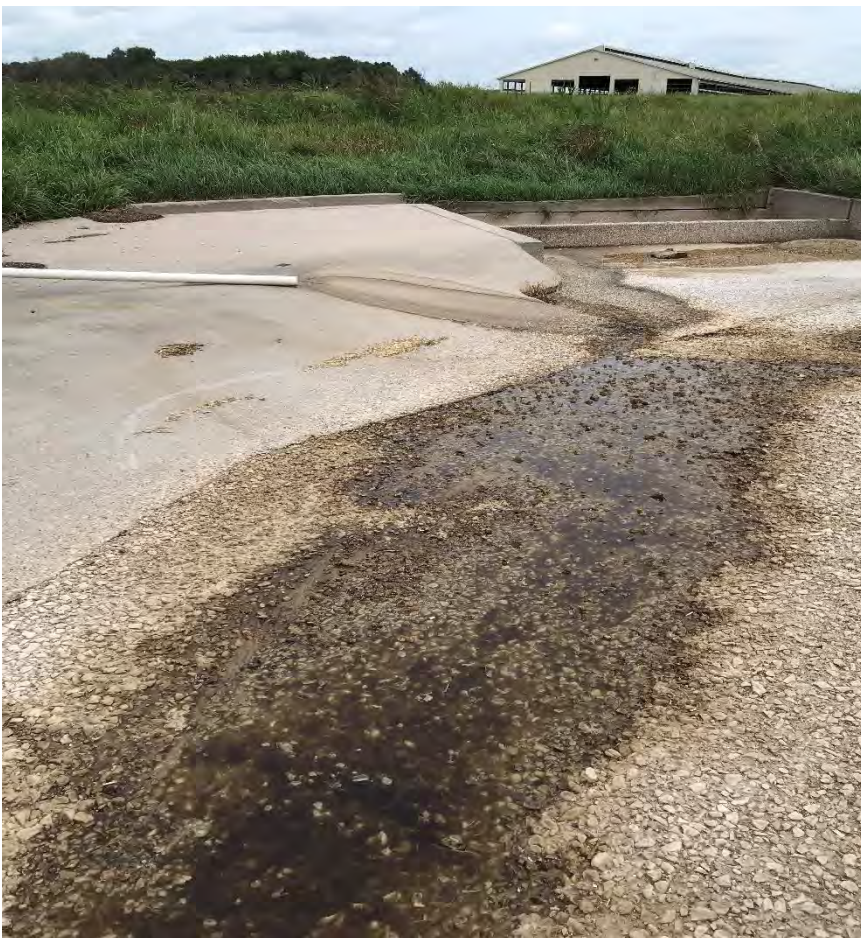
| Photo #: | 025 |

Photo Description: View of Elm site runoff controls.

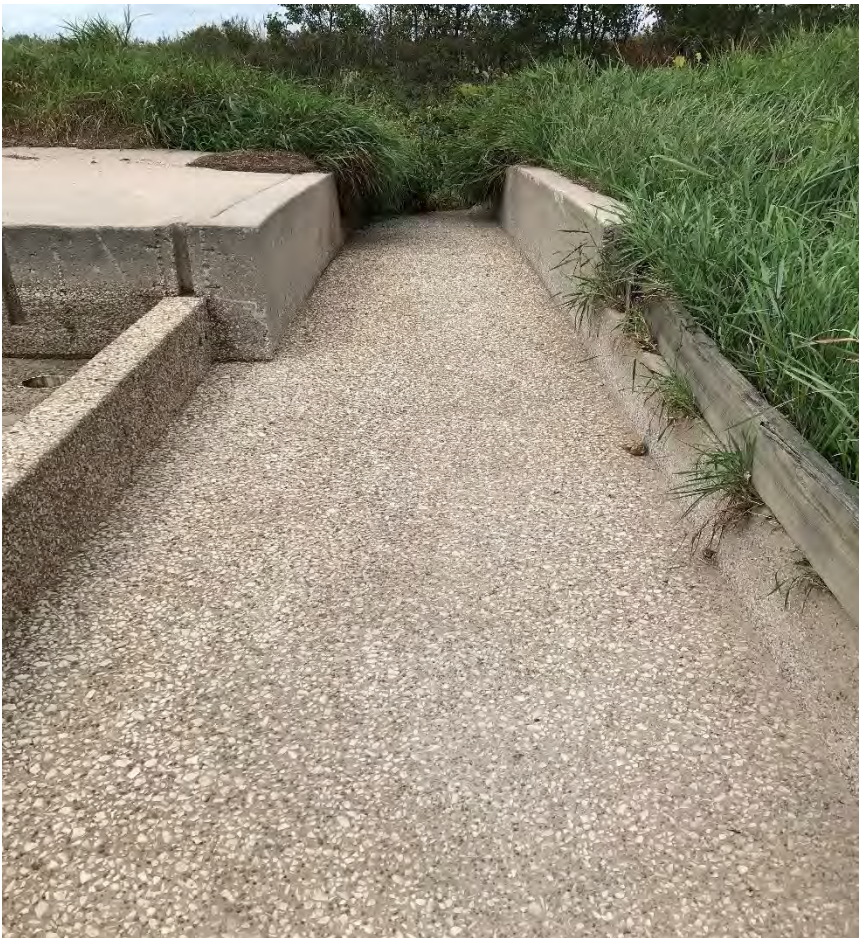
| Photo #: | 026 |

Photo Description: View of concrete conveyance towards leachate pond.

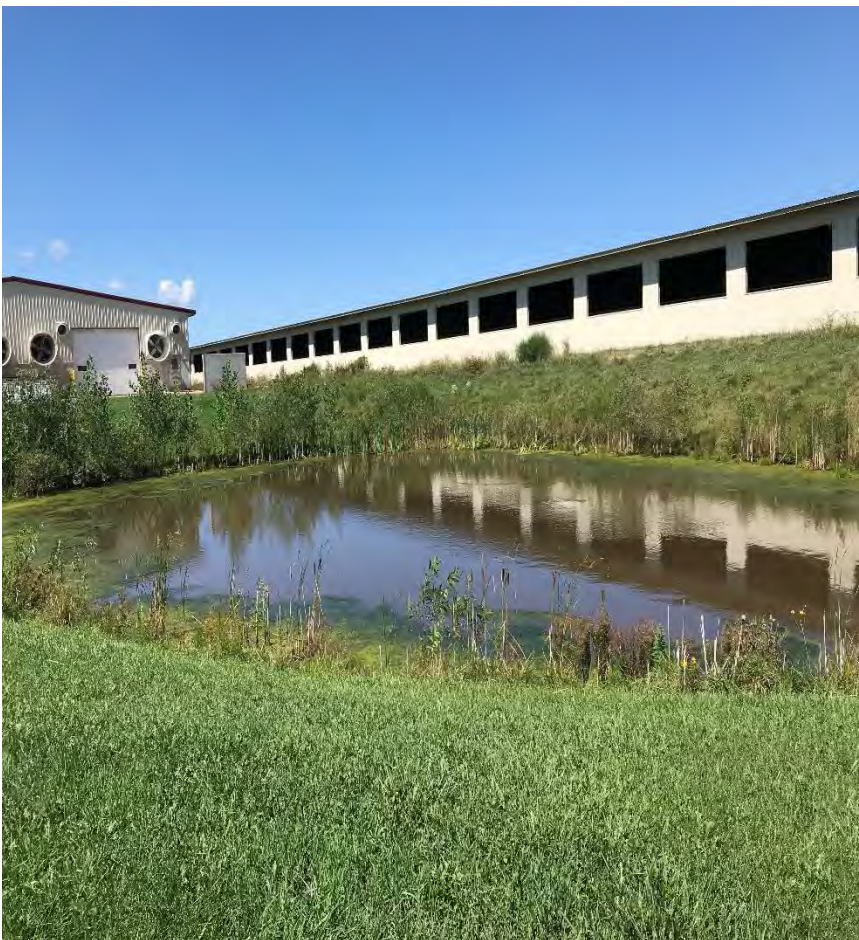
| Photo #: | 028 |

Photo Description: Stormwater pond at the Drumlin site. No indications of nutrient pollution observed.

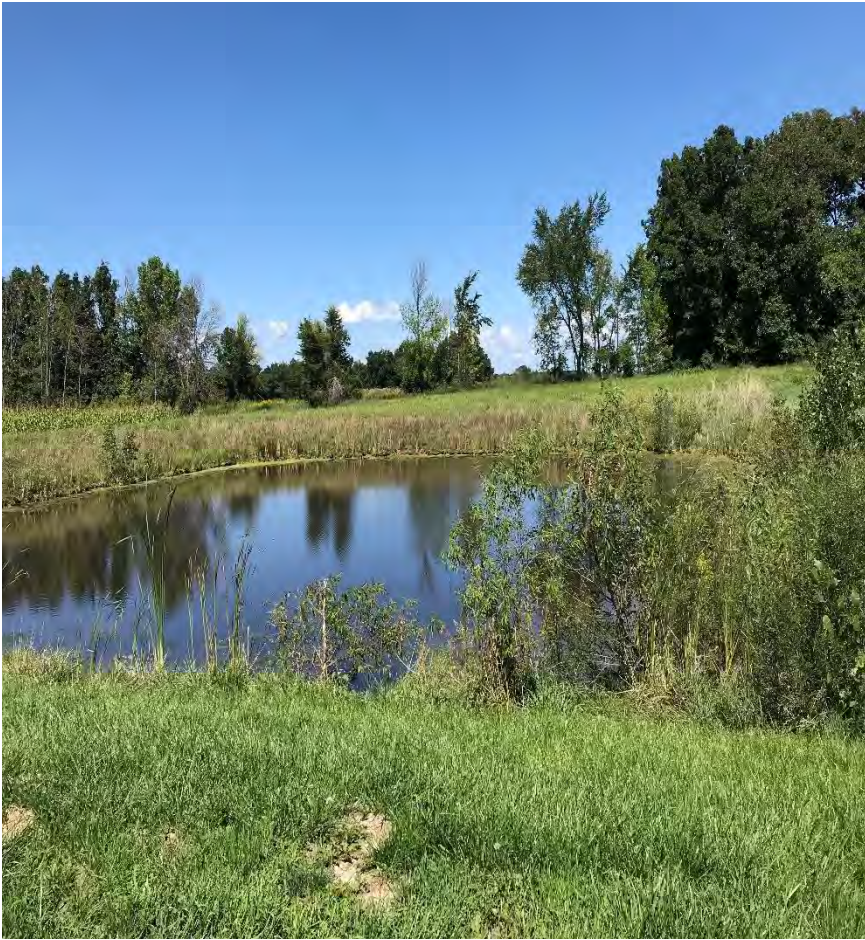
| Photo #: | 029 |

Photo Description: No indications of nutrient pollution observed.

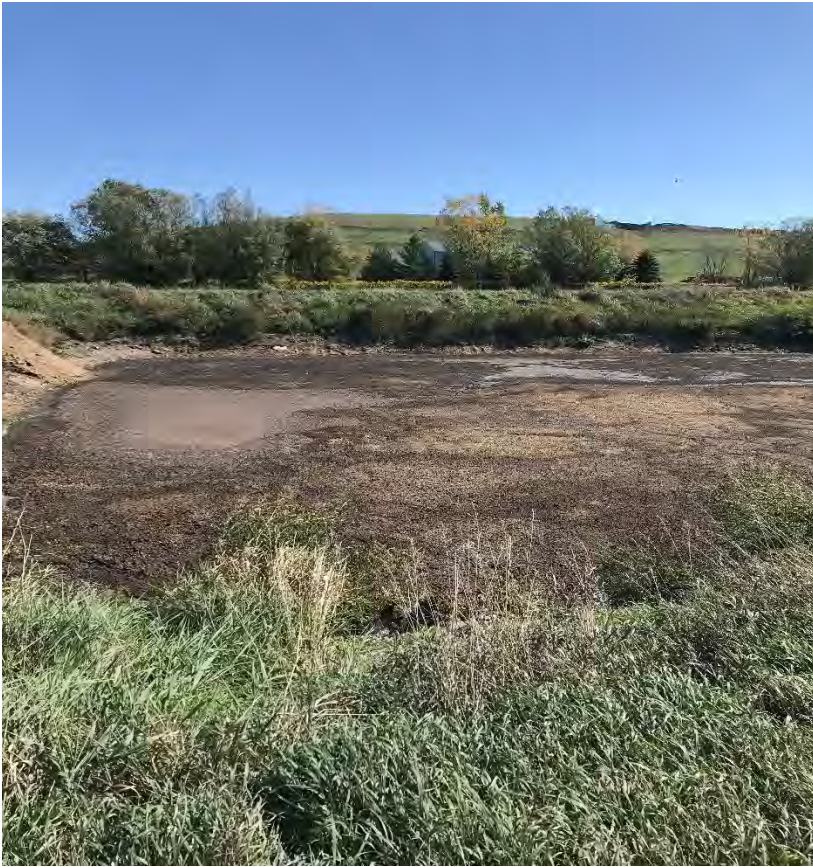
| Photo #: | 001 |

Photo Description: Overview of WSF 1. Fencing and markers missing
