# Permit Fact Sheet

| Permittee Name: | Drumlin Dairy, LLC |

On August 30 – September 1, 2021 Chambers and Holly Stegemann (DNR Agricultural Runoff Management Specialist) met with Brent Cousins, Authorized Representative & several farm staff to conduct a permit reissuance inspection of the Holsum Dairy facilities. Inspections were conducted at all sites currently covered under the WPDES Permit: Holsum Irish, Holsum Elm, Drumlin Dairy, and the Ditter Farm Satellite Pit. Holsum Dairies intends to add the Schneider Farm main site to their permit during the reissuance process. This location was not inspected due to a recent DNR reissuance inspection for the Schneider Farms permit conducted on October 7, 2020, a copy of that report has been included. No precipitation had fallen 24 hours prior to the inspection, conditions during the inspection were warm and dry. Follow up items are requested on page 24.

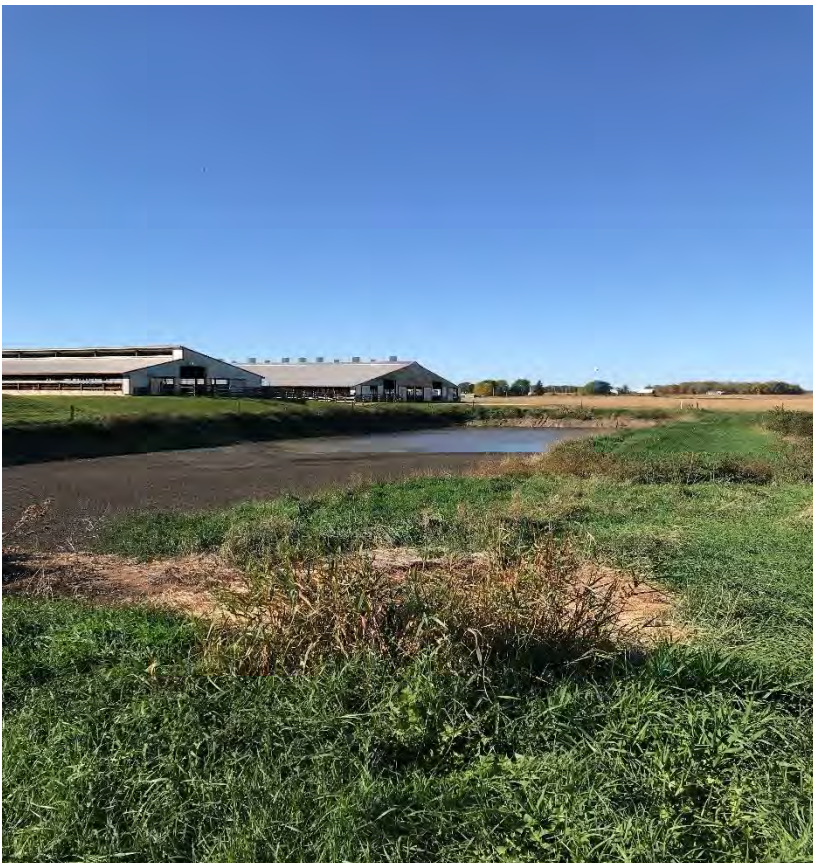
| Photo #: | 002 |

Photo Description: View of the first cell of WSF 2. Fencing present

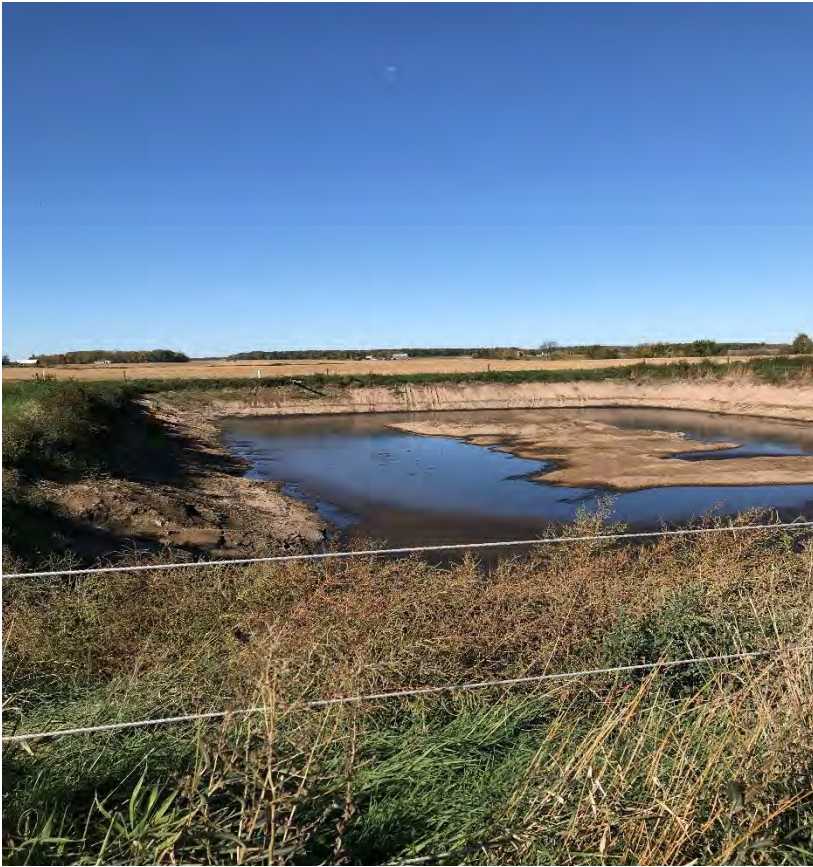
| Photo #: | 003 |

Photo Description: View of the second cell of WSF 2. Fencing present

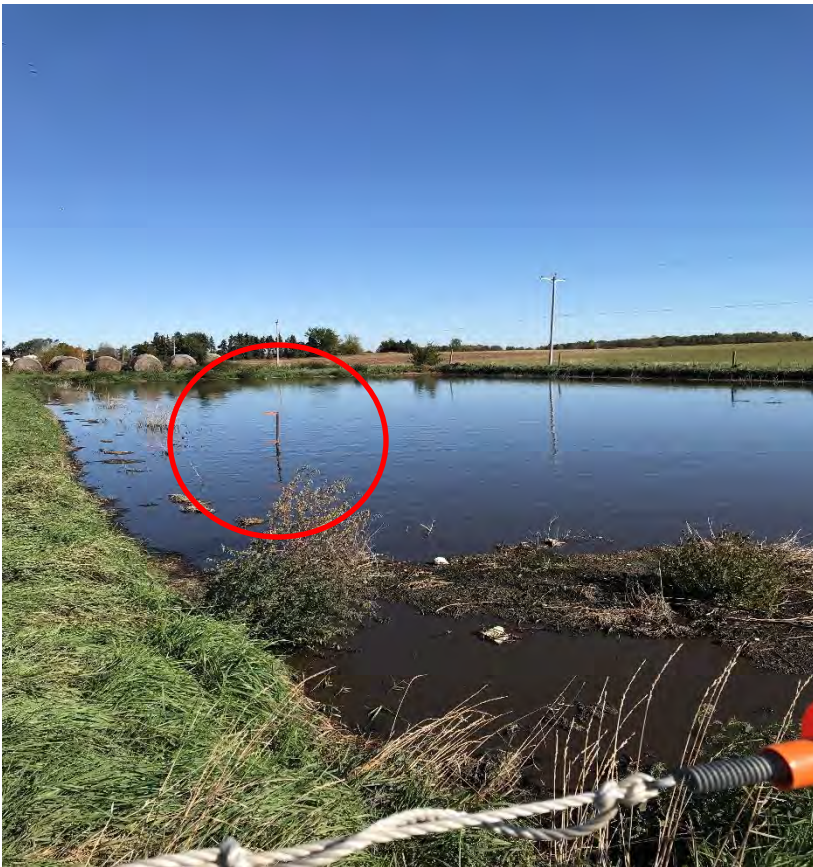
| Photo #: | 004 |

WSF 3 is an earthen lined pit constructed in 1977 and accepts manure and process wastewater and runoff from the adjacent animal barns. At the time of inspection, required fencing and permanent markers were in place. WSF 3 was last evaluated in 2017 and was found to be in compliance.

Photo Description: WSF 3, permanent markers circled in red

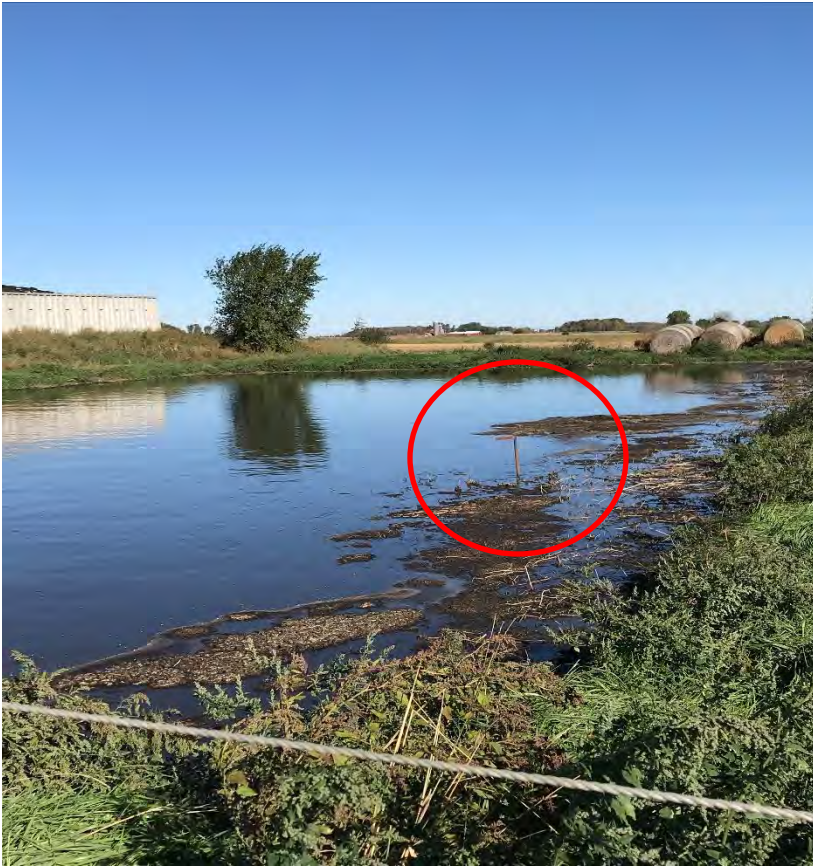
| Photo #: | 005 |

WSF 4 is an earthen lined pit constructed in 1977 and accepts manure and process wastewater and runoff from the adjacent animal barns. At the time of inspection, required fencing and permanent markers were in place. WSF 4 was last evaluated in 2017 and was found to be in compliance.

Photo Description: WSF 4,  
permanent markers circled in red

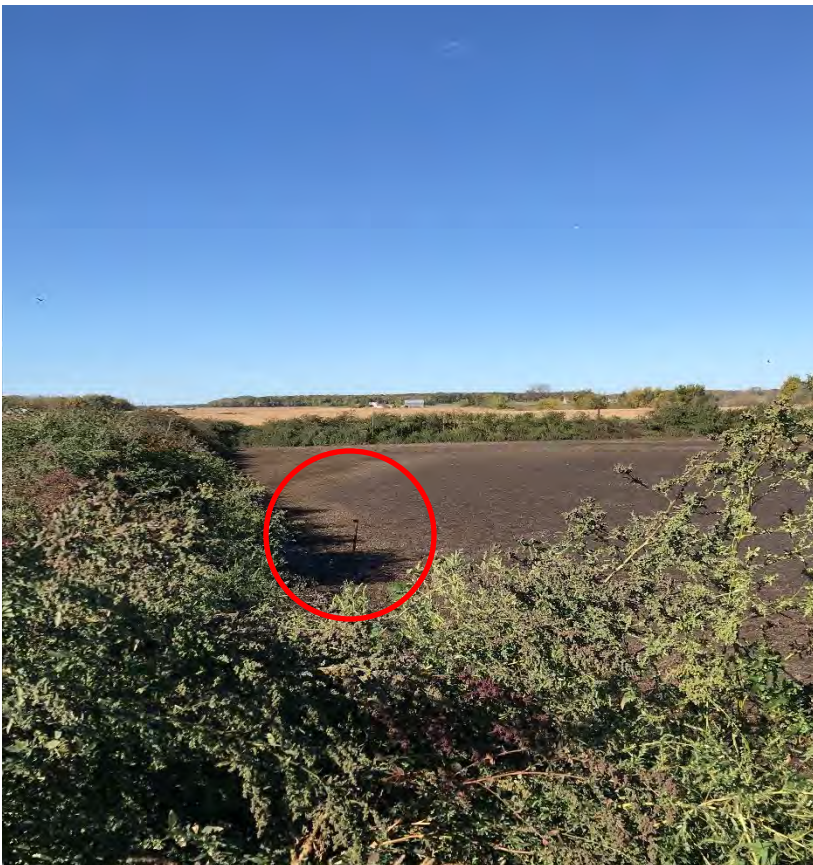
| Photo #: | 006 |

Photo Description: WSF 5,  
permanent markers circled in red

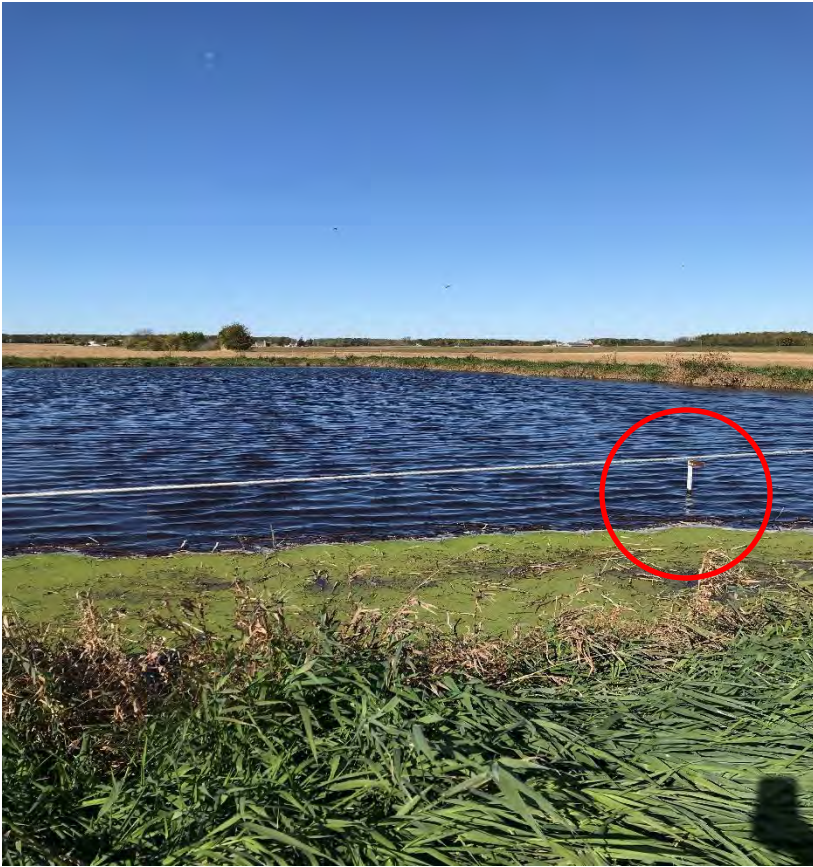
| Photo #: | 007 |

Photo Description: WSF 6,  
permanent markers circled in red

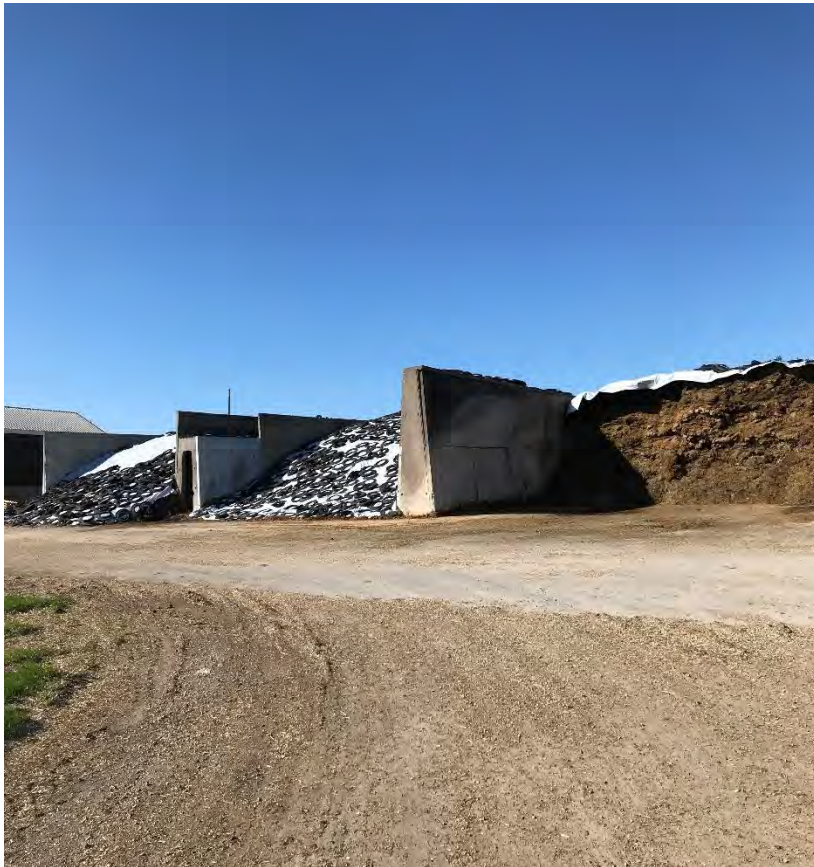
| Photo #: | 009 |

Photo Description: Overview of North feed storage area

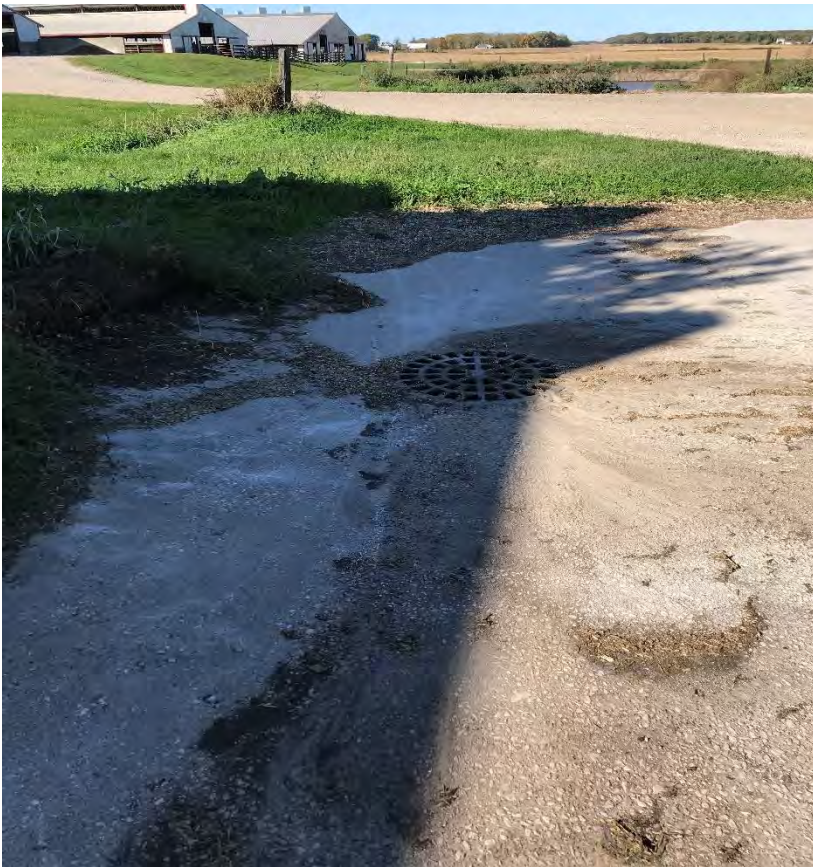
| Photo #: | 010 |

Photo Description: View of inlet for feed storage runoff. Windblown feed present outside feed storage area boundaries. No indications of discharges or overflow present
