Permit Fact Sheet

Permit Number	WI-0062235-05-0
Permittee Name and Address	Ebert Enterprises LLC N6939 Cty Hwy D Algoma, WI 54201
Permitted Facility Name and Address	Home Farm- N6939 County Road D, Algoma, WI 54201 Tonet Dairy- N7521 Tonet Rd, Luxemburg, WI 54217 Tonet Dairy- N7518 Tonet Rd, Luxemburg, WI 54217 Longfellow Farm- N6388 Longfellow Road, Algoma, WI 54201 K Farm- 5083 County Road K, Algoma, WI 54201 S Farm- E5639 County Rd S, Algoma, WI 54201
Permit Term	August 01, 2026 to July 31, 2031
Receiving Water	Unnamed tributaries within the Ahnapee River Watershed, and groundwaters of the state.
Discharge Type	Existing source CAFO per NR 243.03(23) as the facility has been permitted since 2002.

CAFO Compliance Report (1/31/2025)

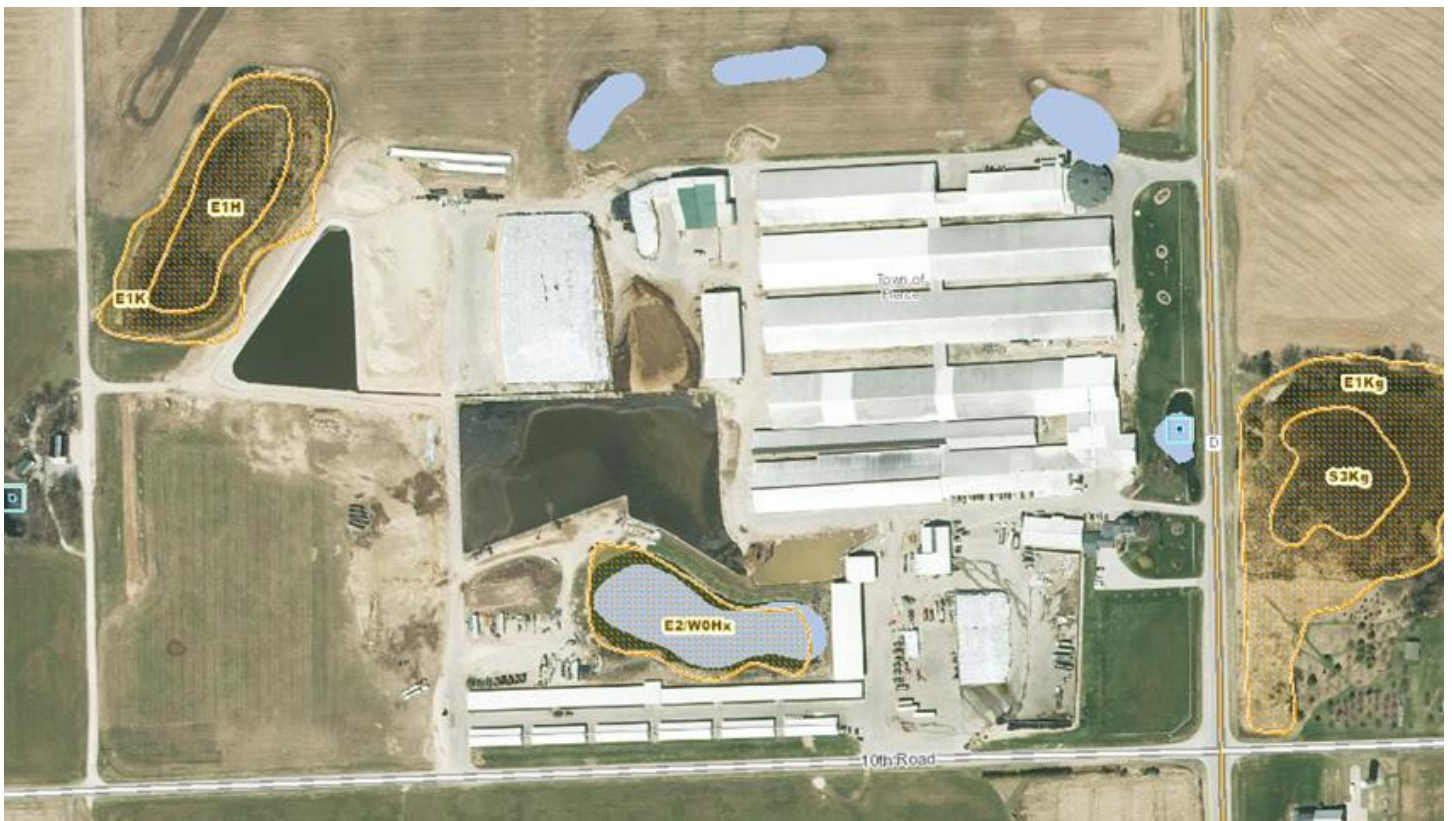
Aerial Map 2. The aerial map above illustrates surface water in relation to the Main Site at Ebert Enterprises LLC. Wetlands are identified by the yellow shaded areas. Ponds are identified by the blue shaded areas. The aerial image was obtained from the DNR Surface Water Data Viewer.

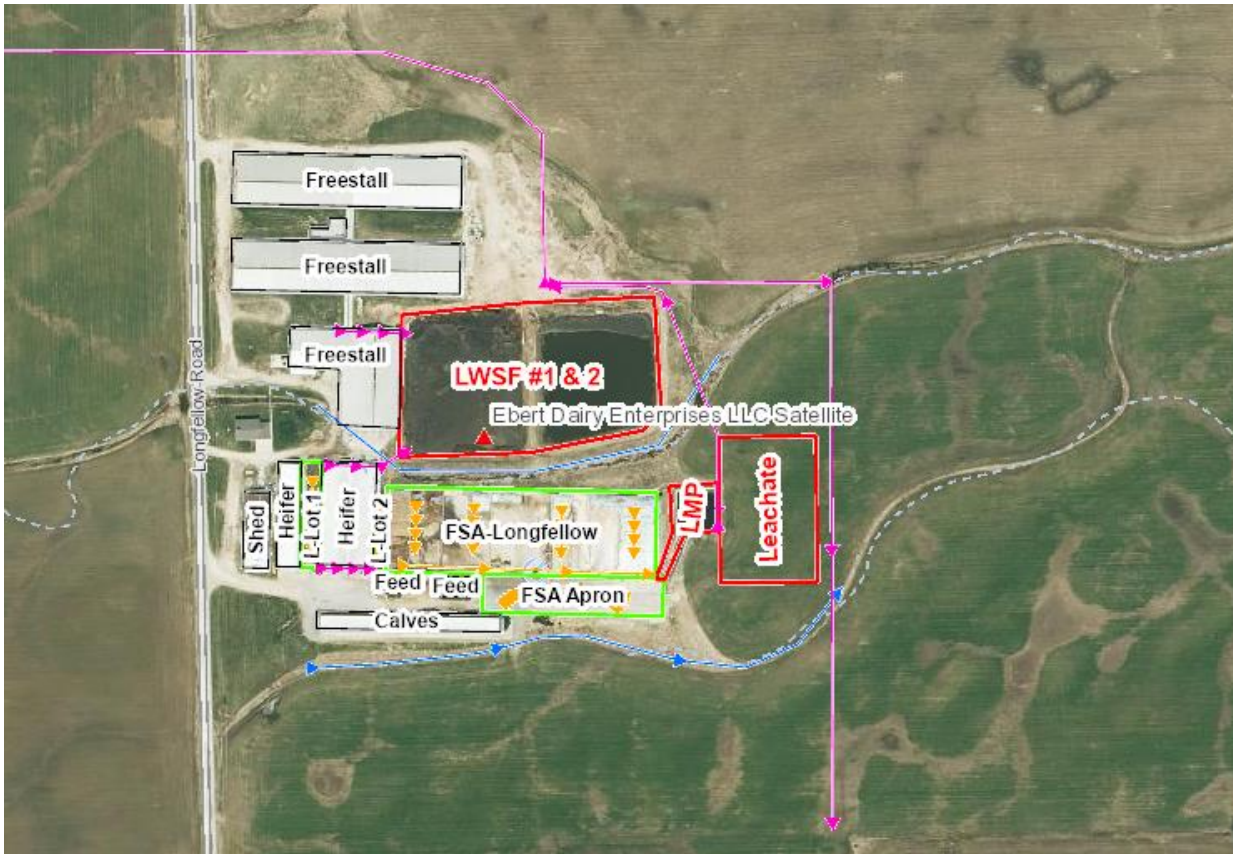
Aerial Map 3. The aerial map above illustrates the production site at the Longfellow Farm at Ebert Enterprises LLC. The purple lines represent permanent manure transfer lines. Yellow arrows represent the flow path of process wastewater on the production site.

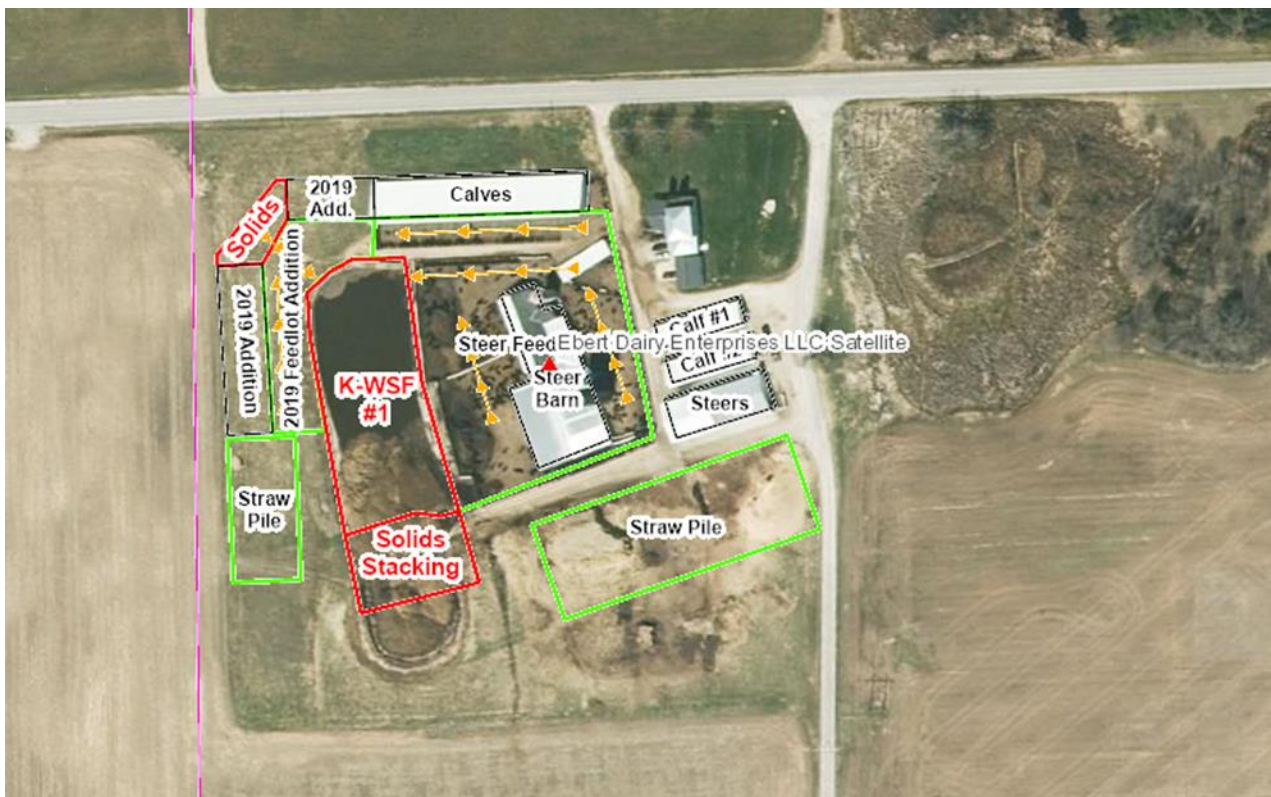
Aerial Map 4. The aerial map above illustrates the production site at the K Farm at Ebert Enterprises LLC. The purple lines represent permanent manure transfer lines. Yellow arrows represent the flow path of process wastewater on the production site.

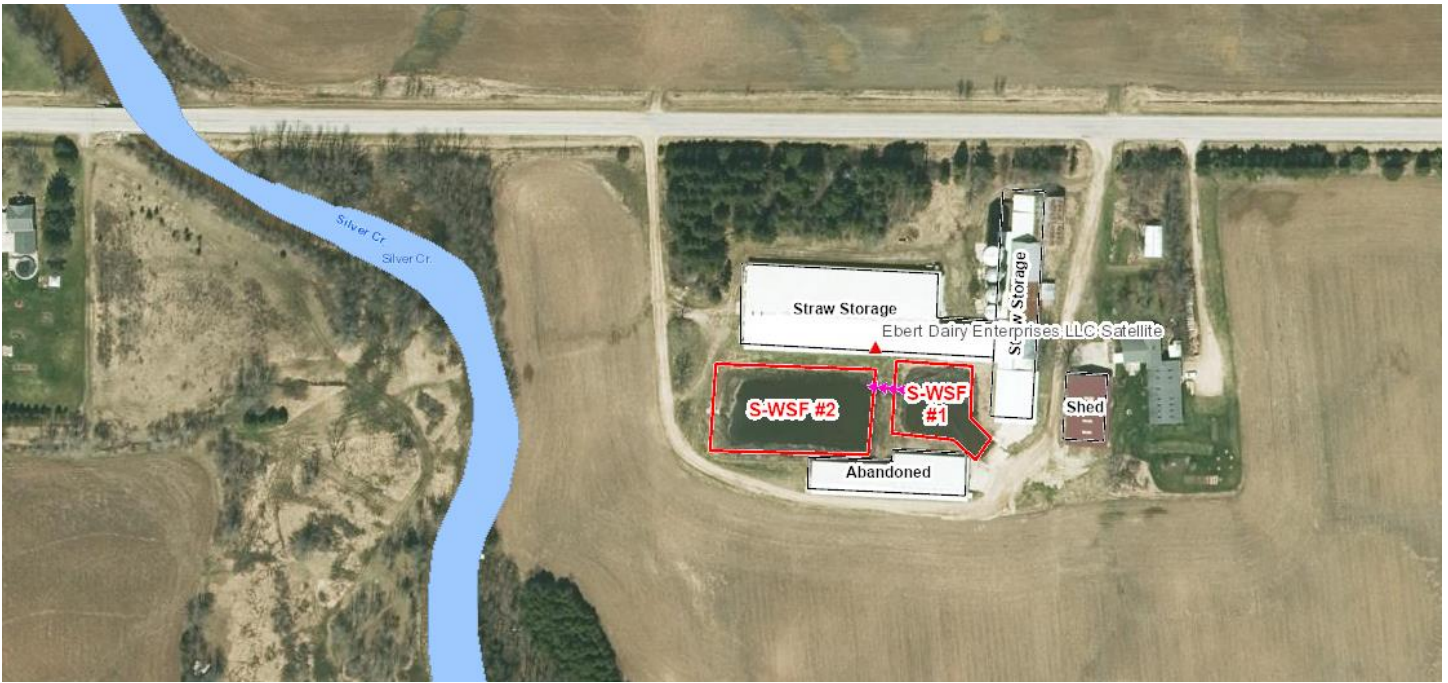
Aerial Map 5. The aerial map above illustrates the production site at the S Farm at Ebert Enterprises LLC, which consists of two liquid waste storage facilities. Silver Creek (WBIC 94900) flows north to south, directly west of the production site.

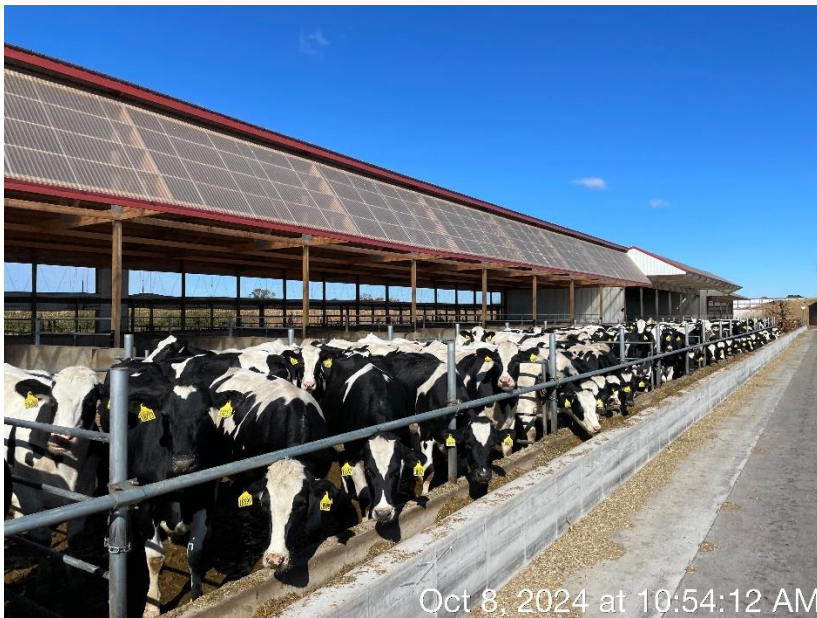
Photo 1. The western outdoor concrete feed lot at the K Farm. Runoff flows north where it then flows into the northwest corner of the liquid waste storage facility at the K Farm.

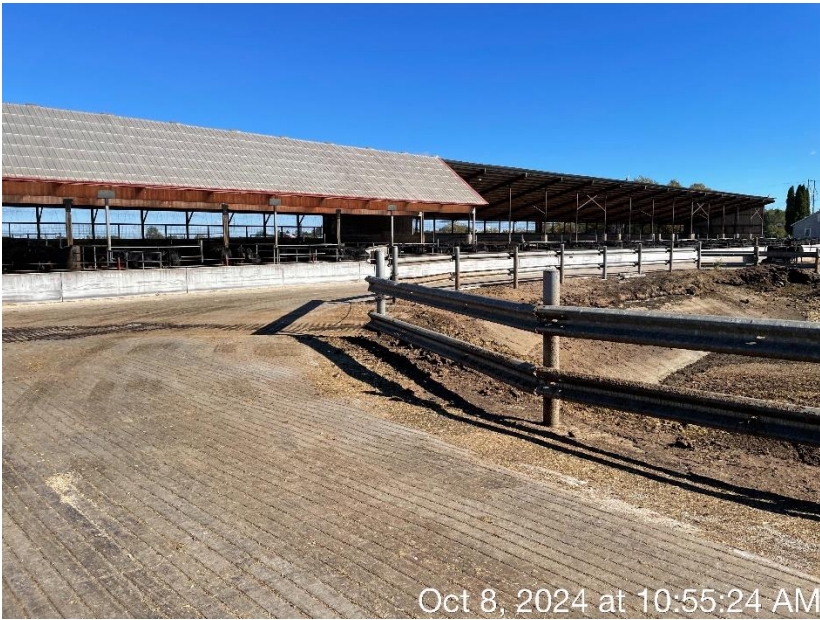
Photo 2. The western outdoor concrete feed lot at the K Farm. Runoff flows north where it then flows into the northwest corner of the liquid waste storage facility at the K Farm.

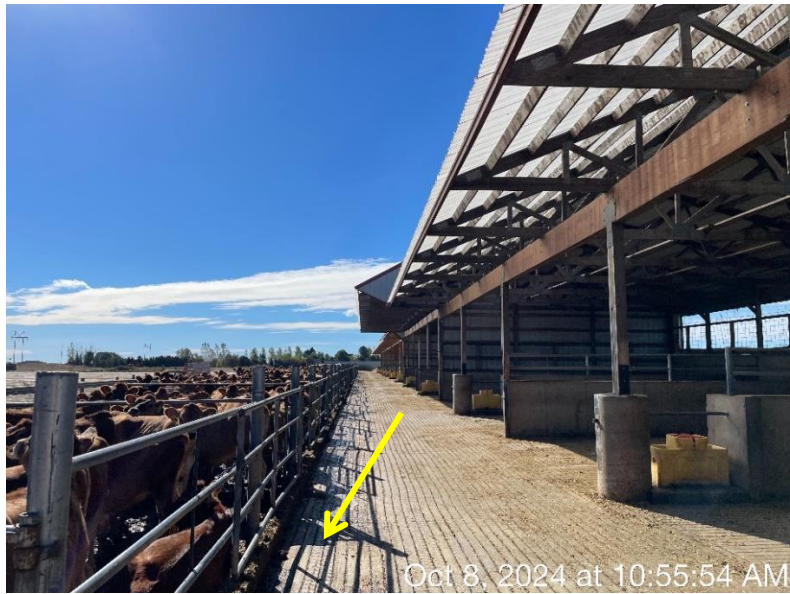
Photo 3. The northwest corner of the storage facility at the K Farm, where runoff from the western feed lots gravity flows into the storage. This photo was taken facing northeast.

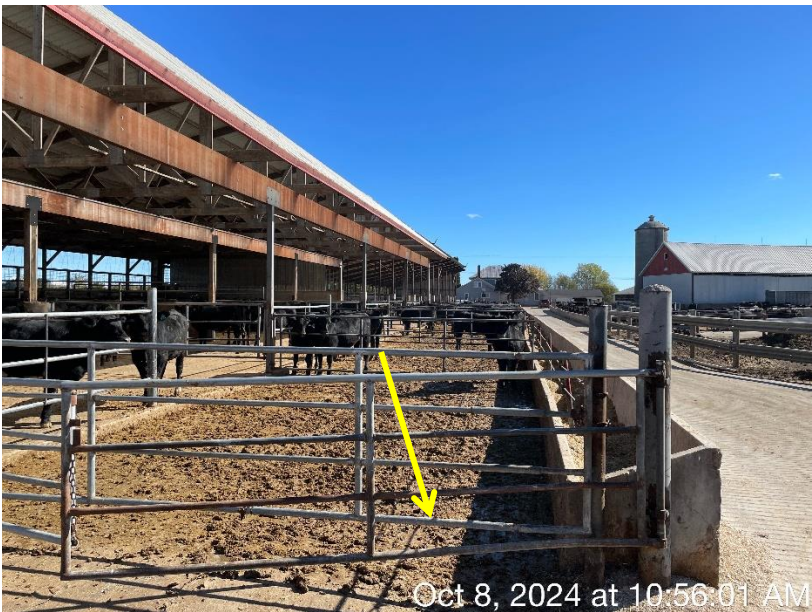
Photo 4. The western feed lots at the K Farm. Runoff gravity flows north, represented by the yellow arrow. This photo was taken facing south.

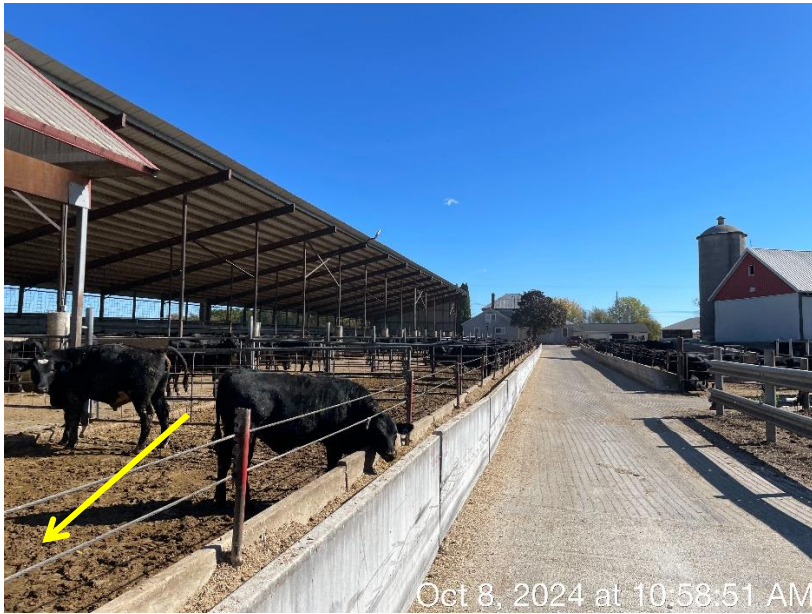
Photo 5. The northern feed lots at the K Farm. Runoff gravity flows west, represented by the yellow arrow. This photo was taken facing east.

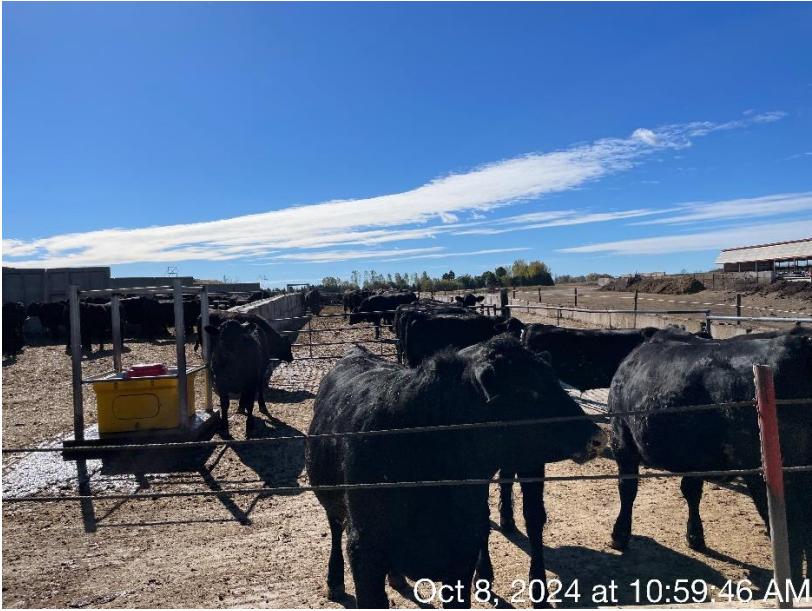
Photo 6. The northern feed lots at the K Farm. Runoff gravity flows west, represented by the yellow arrow. This photo was taken facing east.

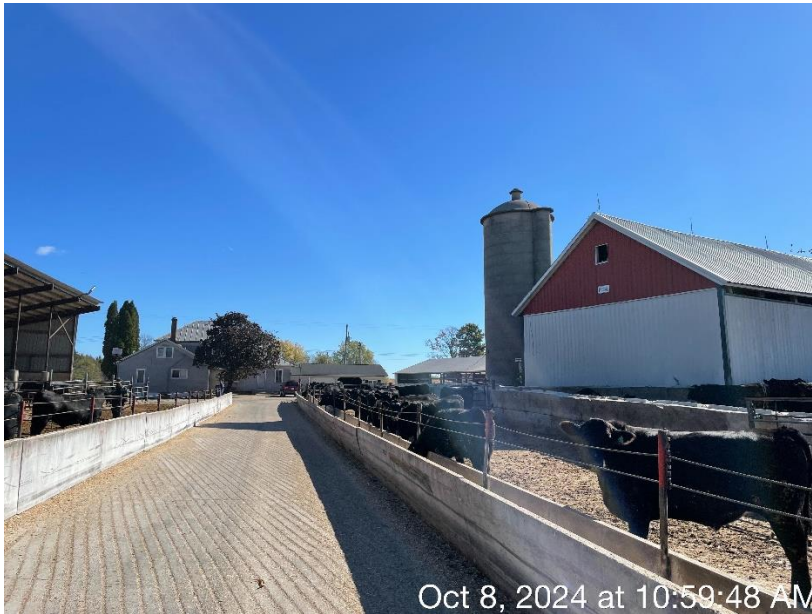
Photo 7. The eastern feed lots at the K Farm. Runoff gravity flows west into the existing waste storage facility. This photo was taken facing south.

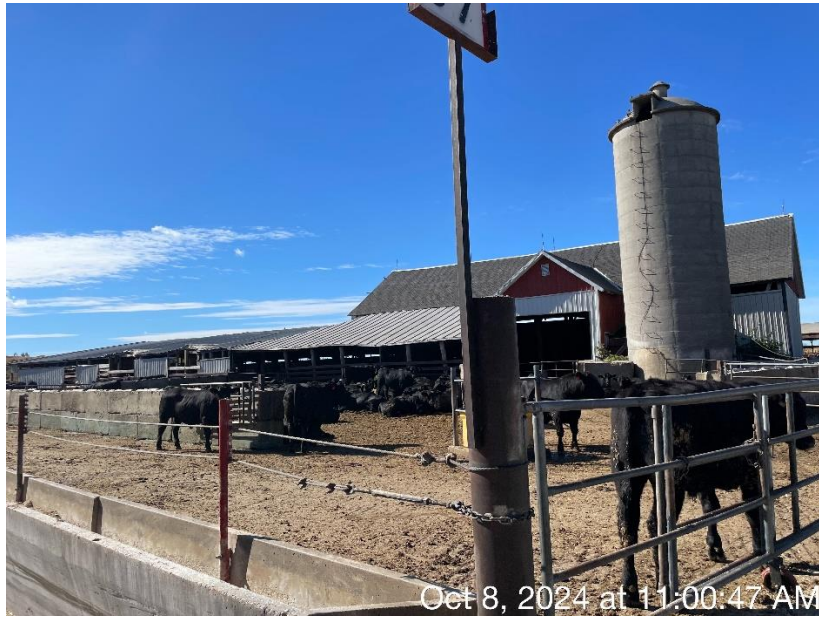
Photo 8. The eastern feed lots at the K Farm. Runoff gravity flows west into the existing waste storage facility. This photo was taken facing east.

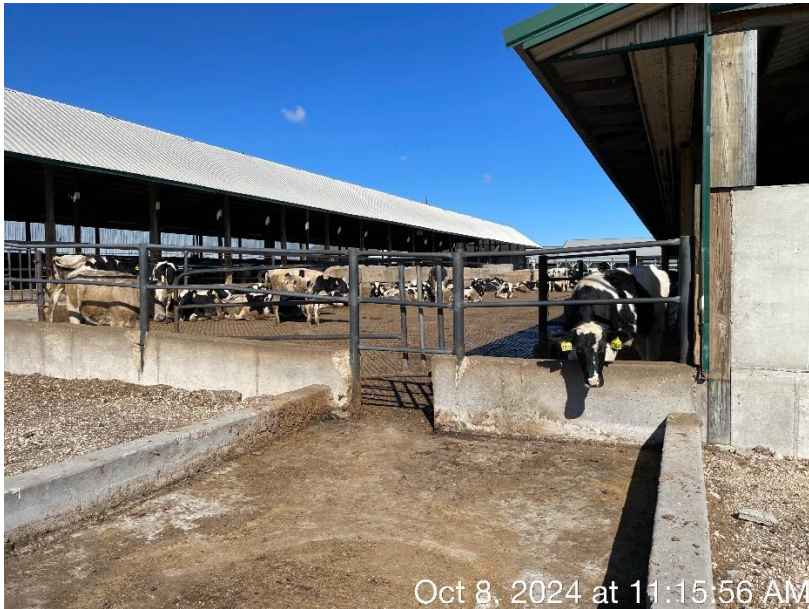
Photo 11. The concrete barnyard at the Longfellow Farm. This photo was taken facing north.

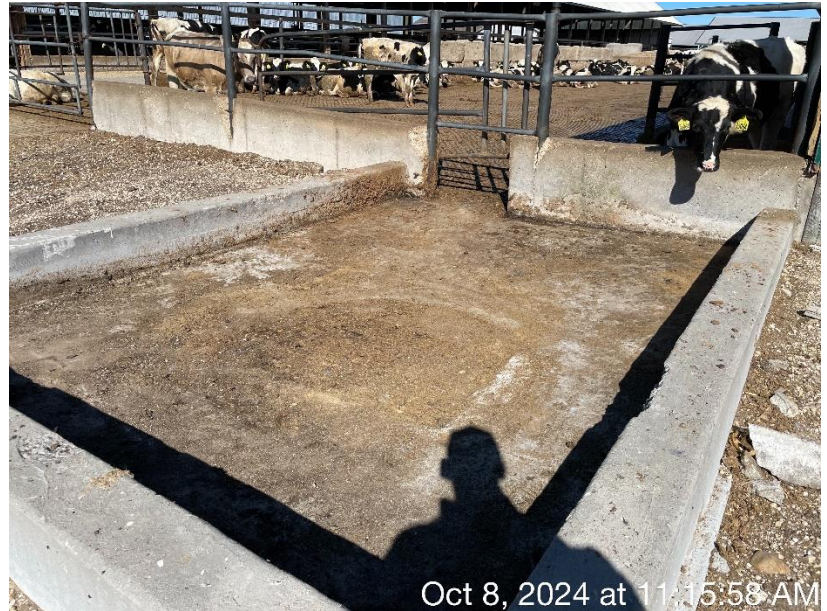
Photo 12. The flow path of runoff towards the collection inlet on the south side of the feed lot at the Longfellow Farm.

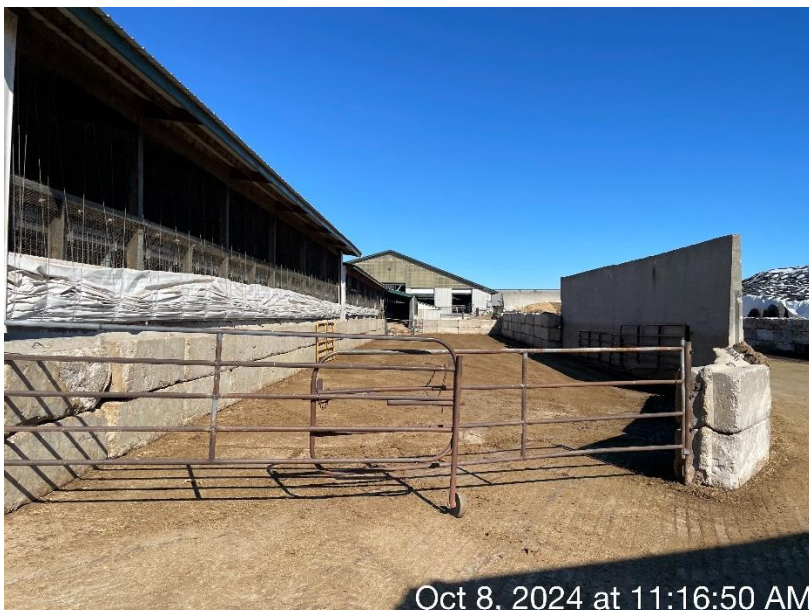
Photo 13. The collection inlet located on the south side of the feed lot at the Longfellow Farm.

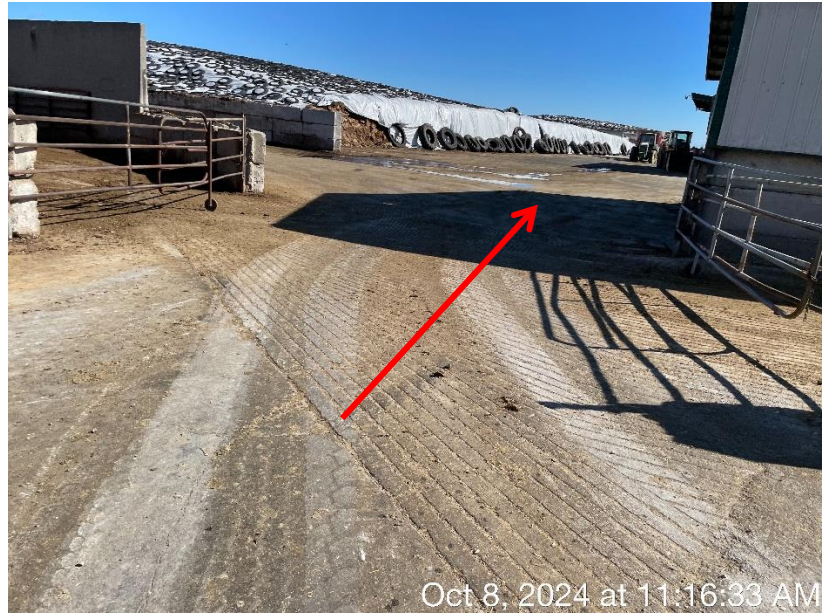
Photo 16. The flow path of runoff from the barnyard towards the feed storage area. This photo was taken facing east.

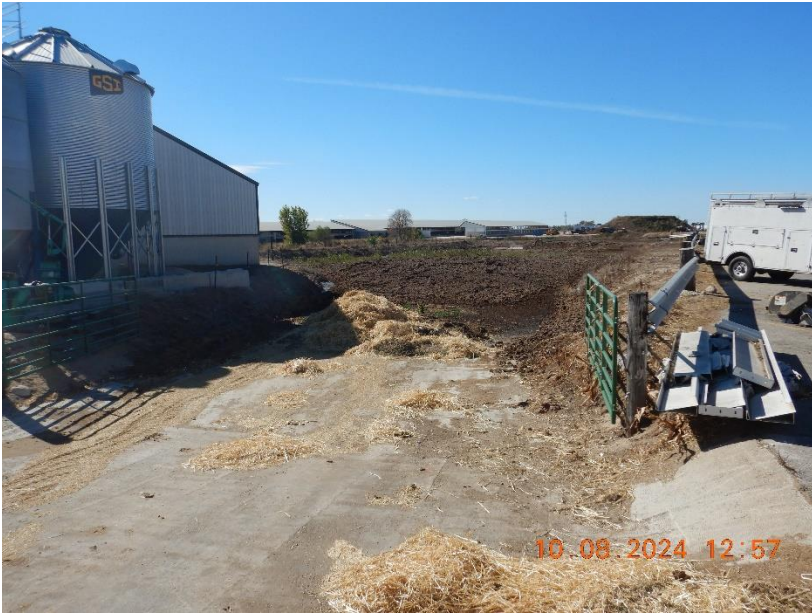
Photo 19. The ramp leading into WSF 1 at the Main Site. This photo was taken facing southwest.

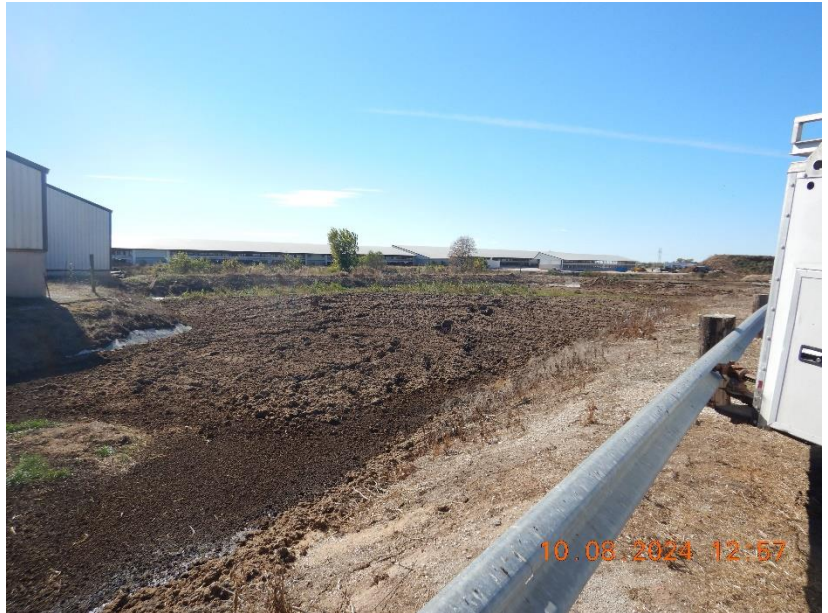
Photo 20. WSF 1 at the Main Site. This photo was taken facing southwest.

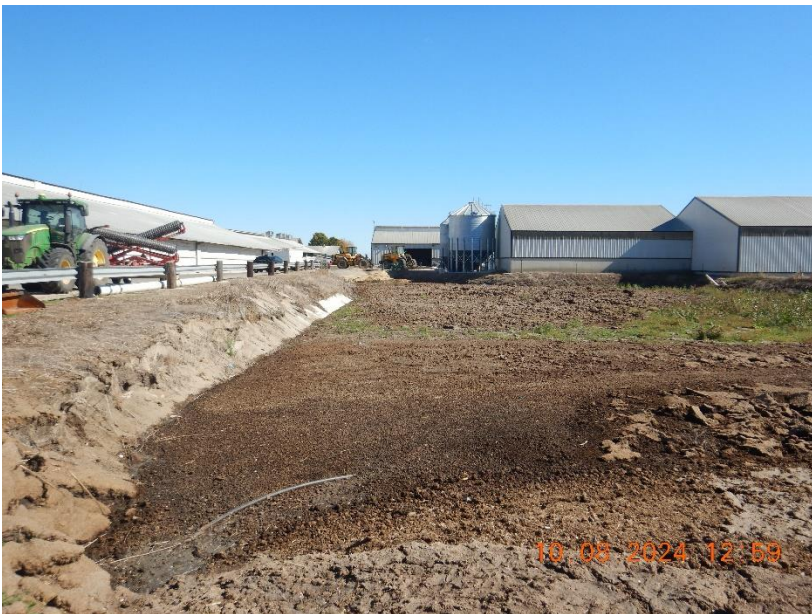
Photo 21. WSF 1 at the Main Site. This photo was taken facing east.

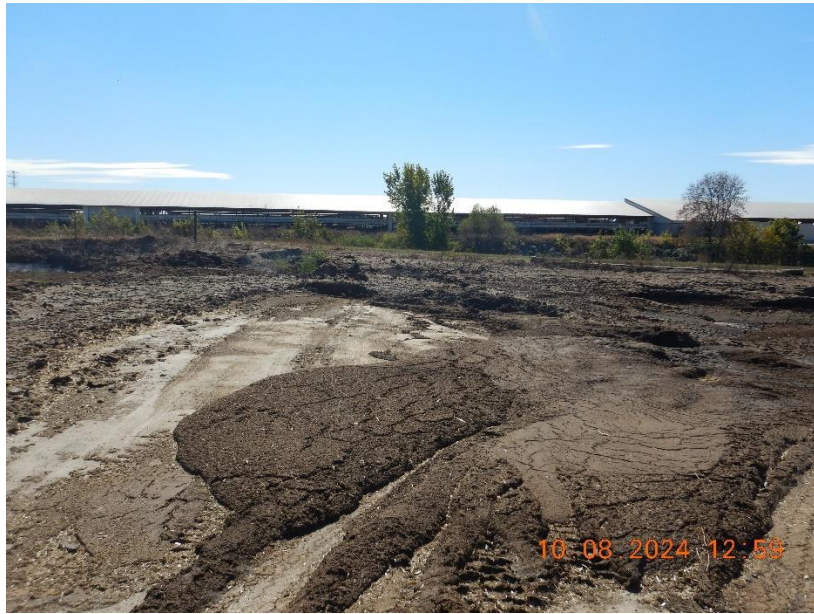
Photo 22. The concrete berm that separates WSF 1 and WSF 2. This photo was taken facing south.

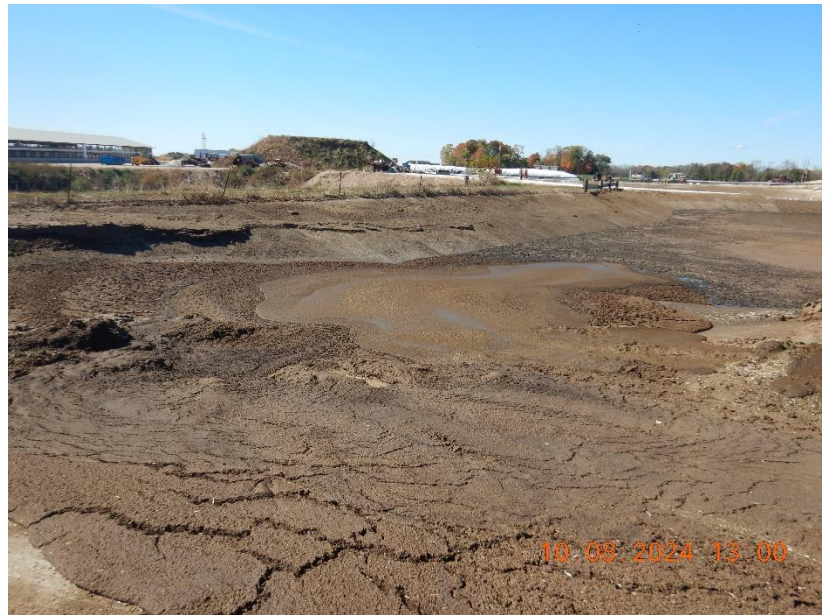
Photo 23. WSF 2 at the Main Site. This photo was taken from the east side of the storage facing southwest.

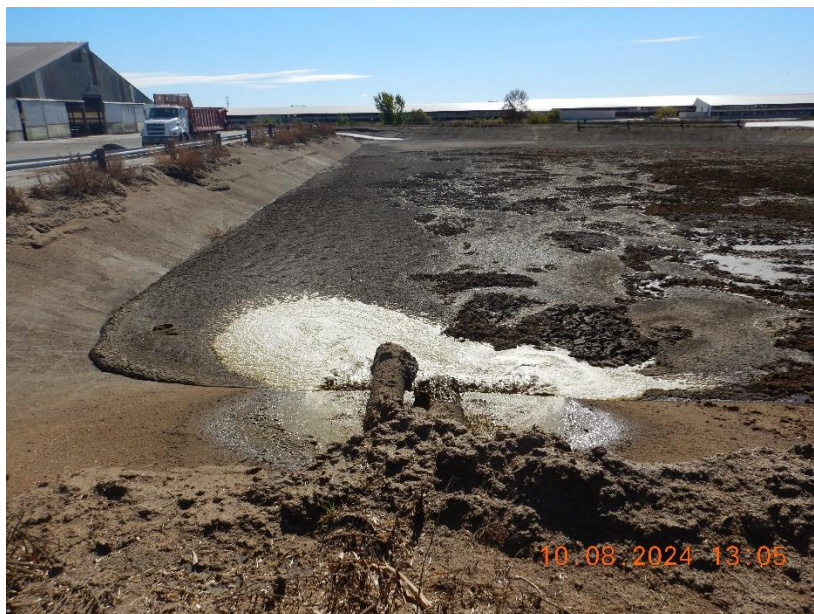
Photo 24. The outlet that discharges manure from the solid separation building into the three-stage manure storage system, located on the northeast corner of WSF 2. This photo was taken facing south.

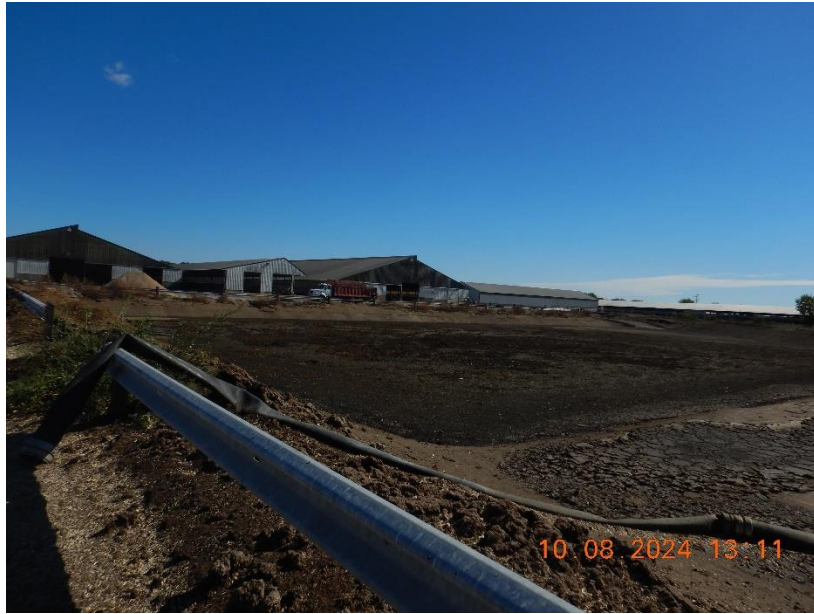
Photo 25. WSF 2 at the Main Site.
This photo was taken from the north side of the storage facing southeast.

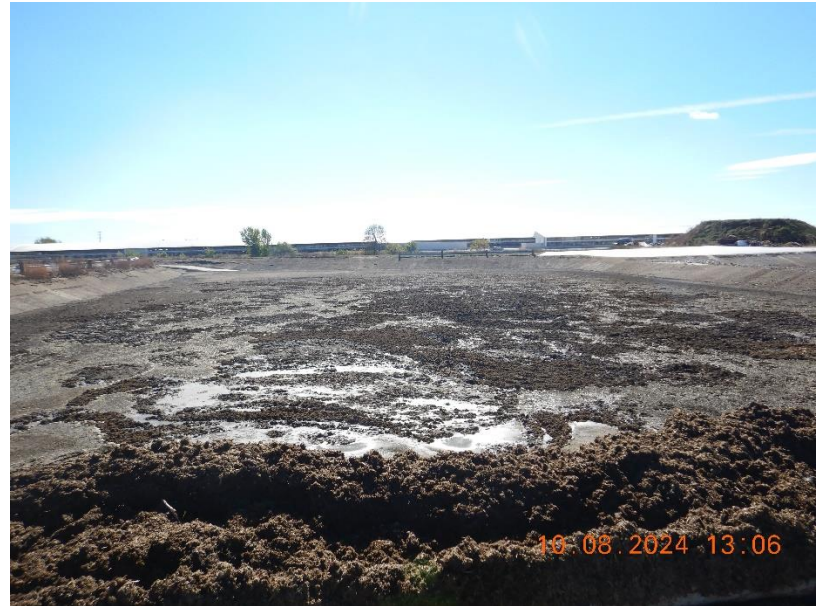
Photo 26. WSF 2 at the Main Site.
This photo was taken from the north side of the storage facing south.

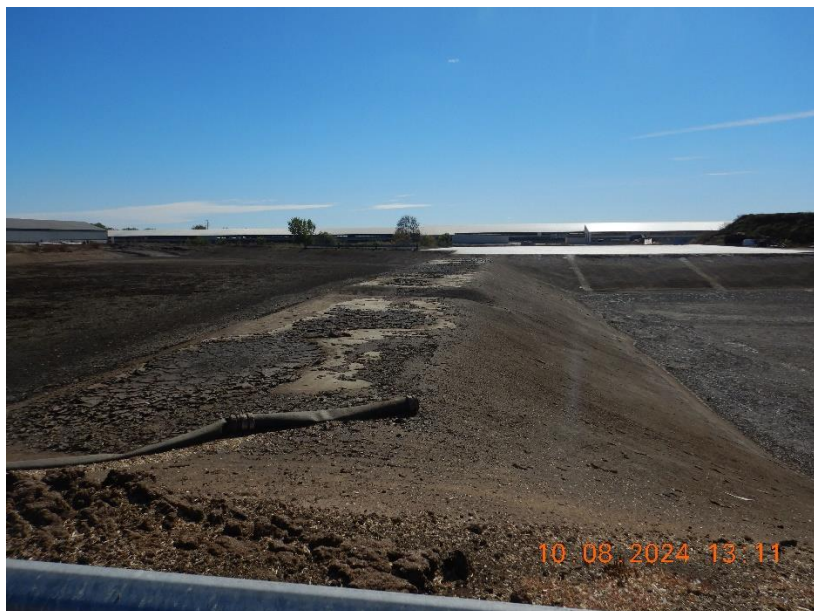
Photo 27. The berm located between WSF 2 and WSF 3 at the Main Site.
This photo was taken facing south.
The solid stacking pad can be seen in the background, located on the southern side of WSF 3.

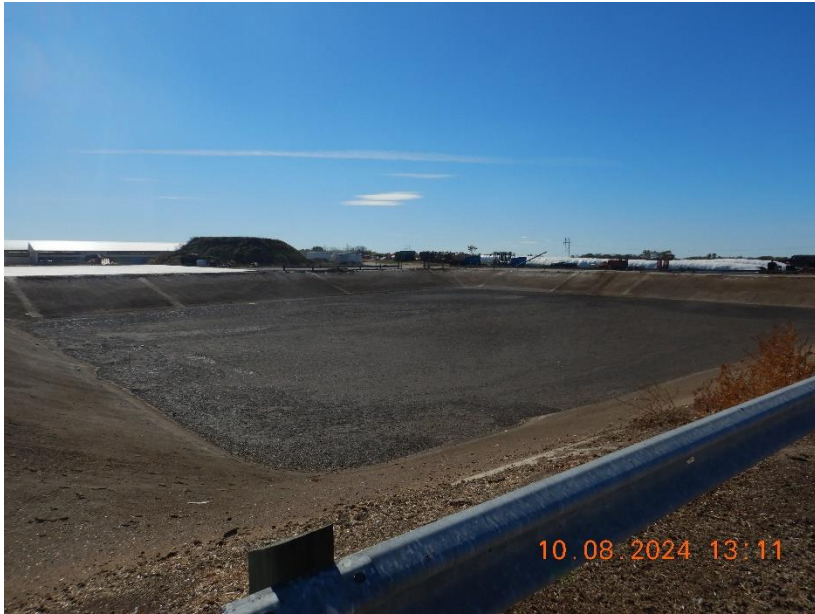
Photo 28. WSF 3 at the Main Site. This photo was taken facing southeast. The solid stacking pad can be seen in the background, located on the southern side of WSF 3.

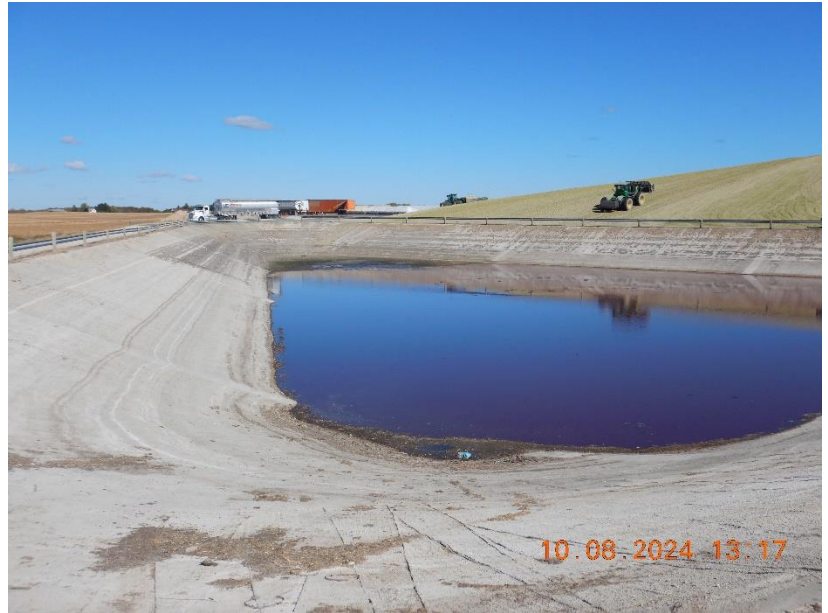
Photo 29. WSF 4 at the Main Site, which accepts runoff from the northern feed storage area. This photo was taken facing north.

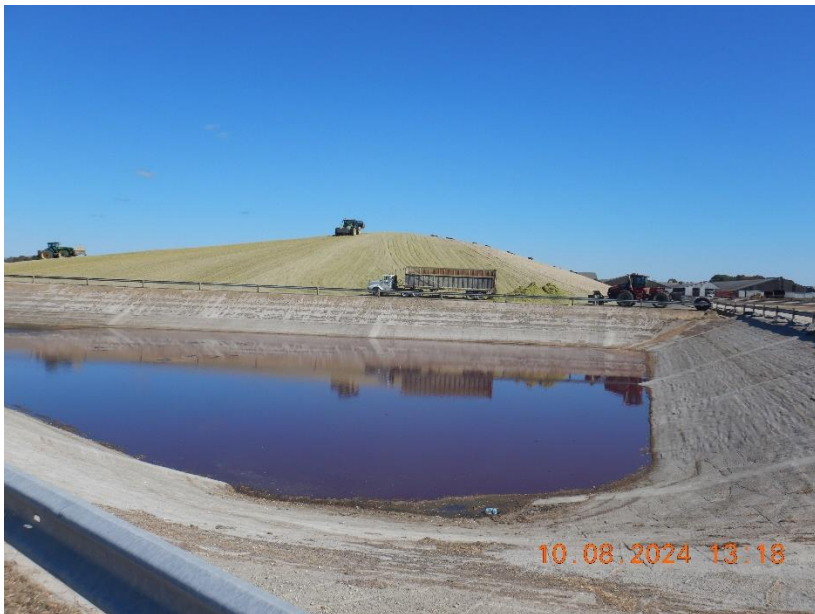
Photo 30. WSF 4 at the Main Site, which accepts runoff from the northern feed storage area. This photo was taken facing east.

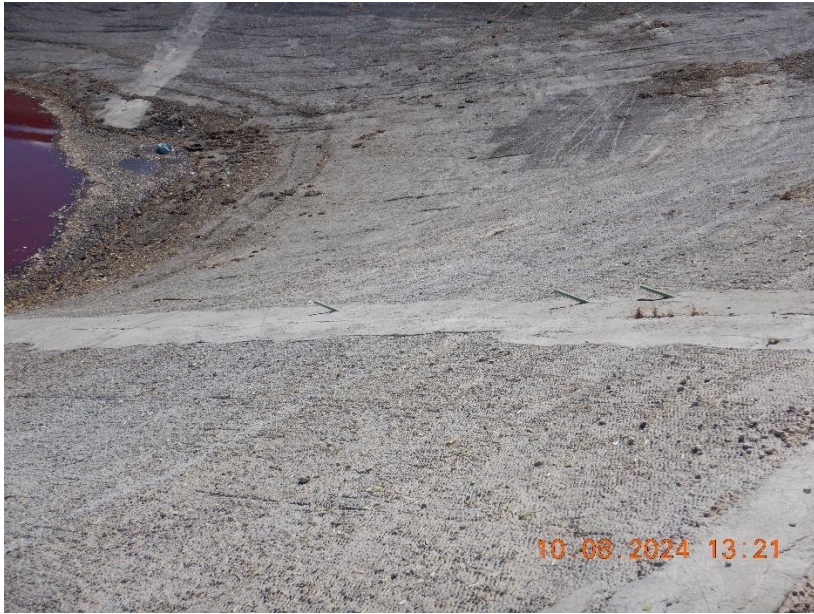
Photo 31. Permanent markers within WSF 4, located on the berm along the west side of the storage.

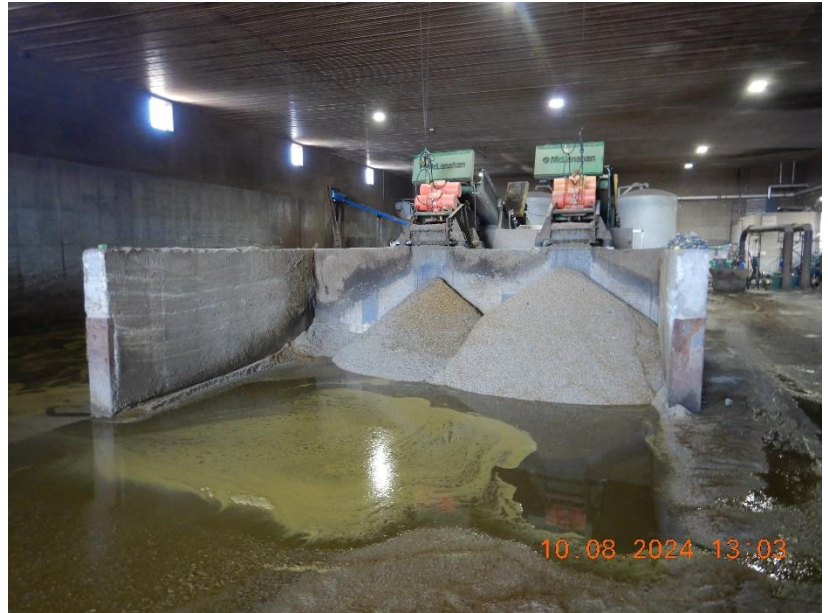
Photo 32. The sand separation system that handles all manure generated in the freestall barns at the Main Site.

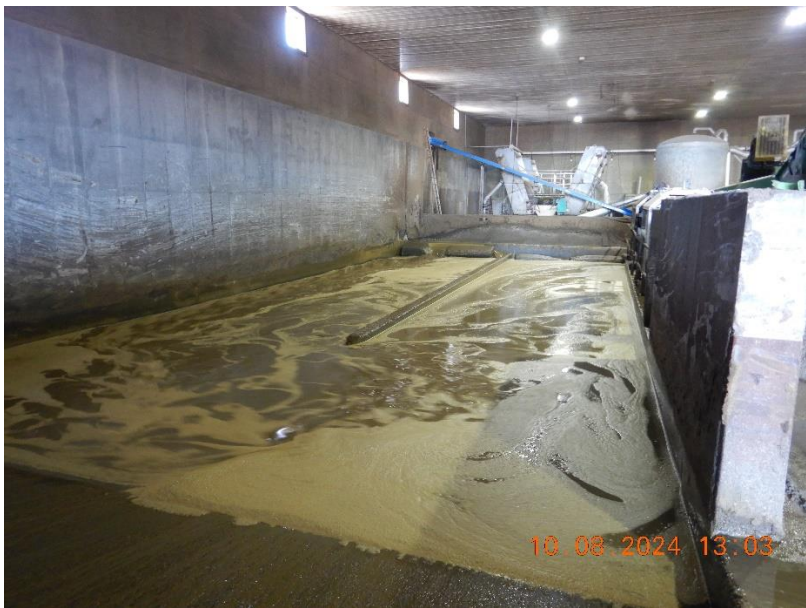
Photo 33. The sand separation system that handles all manure generated in the freestall barns at the Main Site.

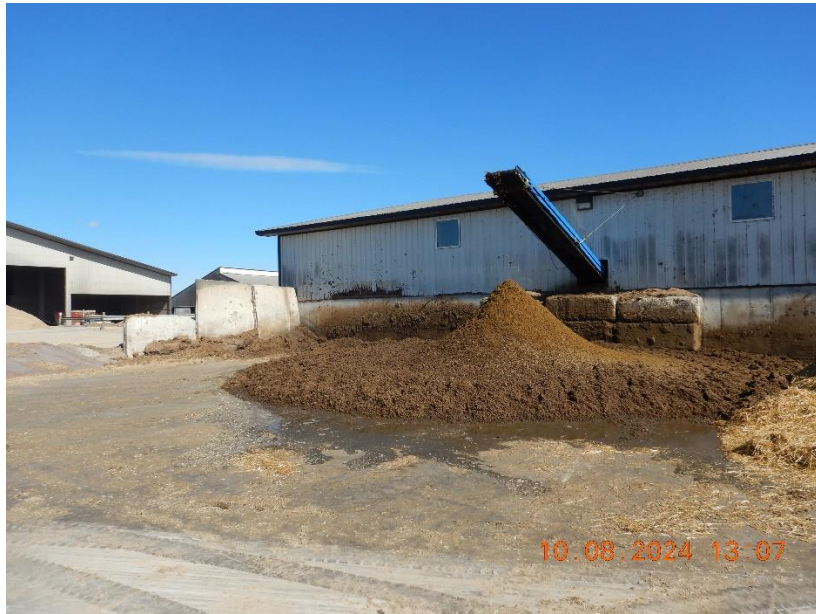
Photo 34. Solid fiber removed from the liquid manure in the solid separation building located east of the northern feed storage area at the Main Site.

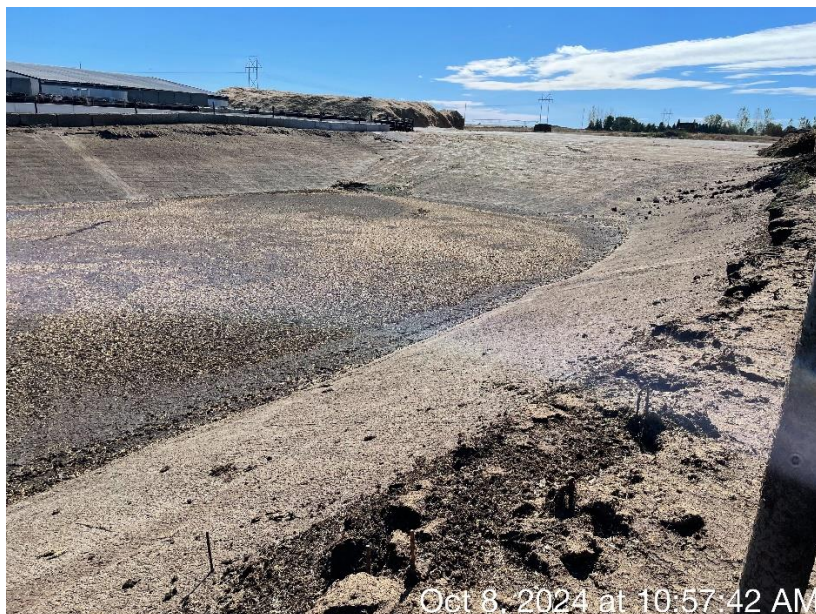
Photo 36. WSF 1 at the K Farm, which accepts runoff from the barnyards and solid stacking area. This photo was taken facing southeast.

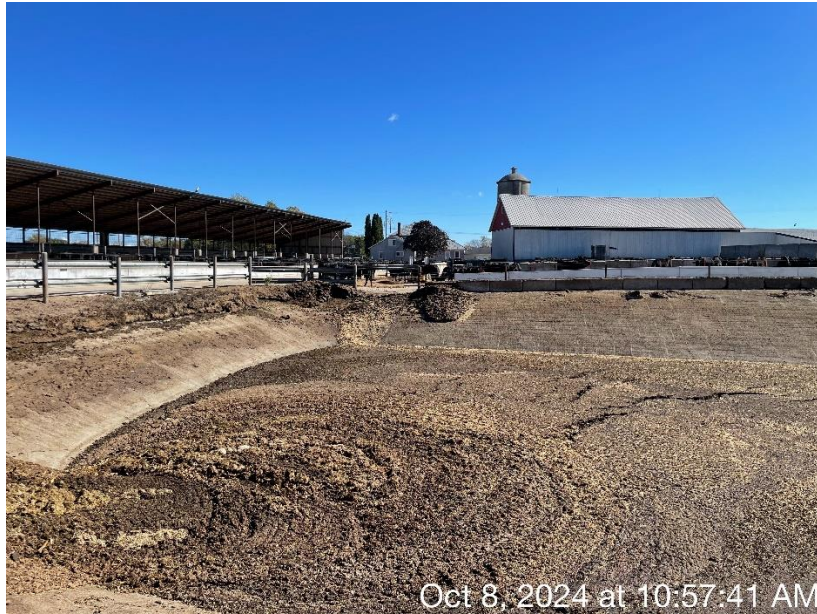
Photo 37. WSF 1 at the K Farm, which accepts runoff from the barnyards and solid stacking area. This photo was taken facing east.

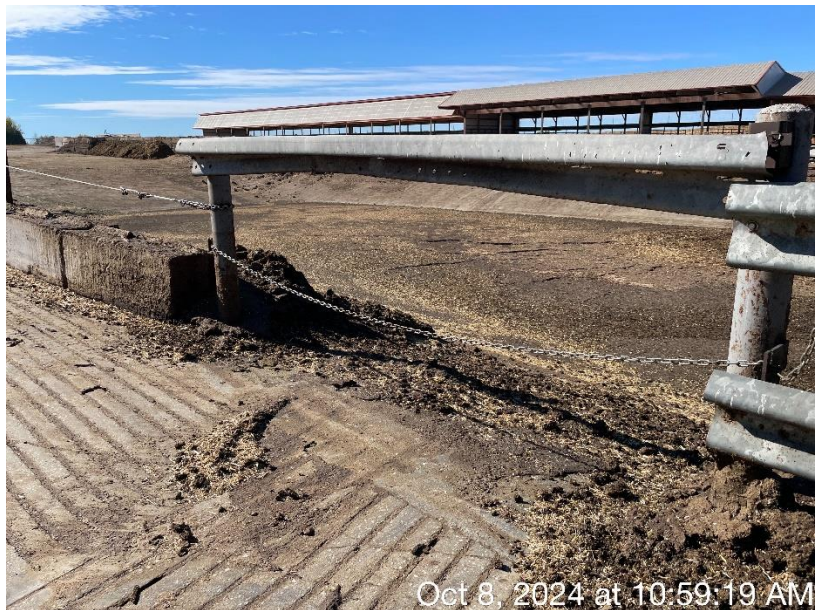
At the K Farm, Ebert Enterprises utilizes one liquid WSF and one solid manure stacking pad. WSF 1 at the K Farm is a concrete liquid storage that has a capacity of 751,311 gallons. WSF 1 was constructed in 2013 and accepts runoff from the concrete barnyards and solid manure stacking area at the K Farm. The storage appeared to be in good condition. Permanent markers were not present during the inspection. Solid manure generated at the K Farm is stacked on a concrete pad that is sloped into WSF 1. Runoff from the pad gravity flows directly into WSF 1.

Photo 38. Permanent markers within WSF 1 at the K Farm, located on the west berm within the storage facility.

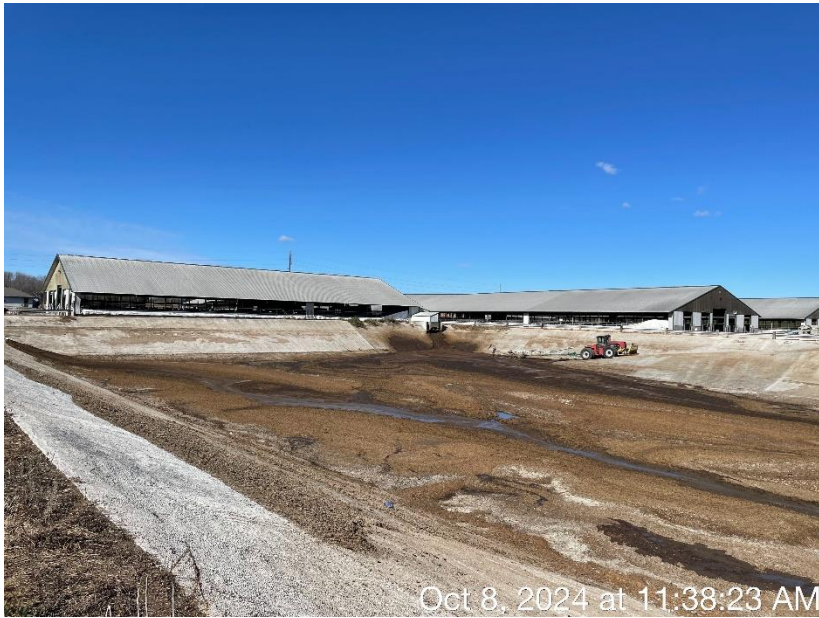
Photo 39. WSF 1 at the K Farm, which accepts runoff from the barnyards and solid stacking area. This photo was taken facing west.

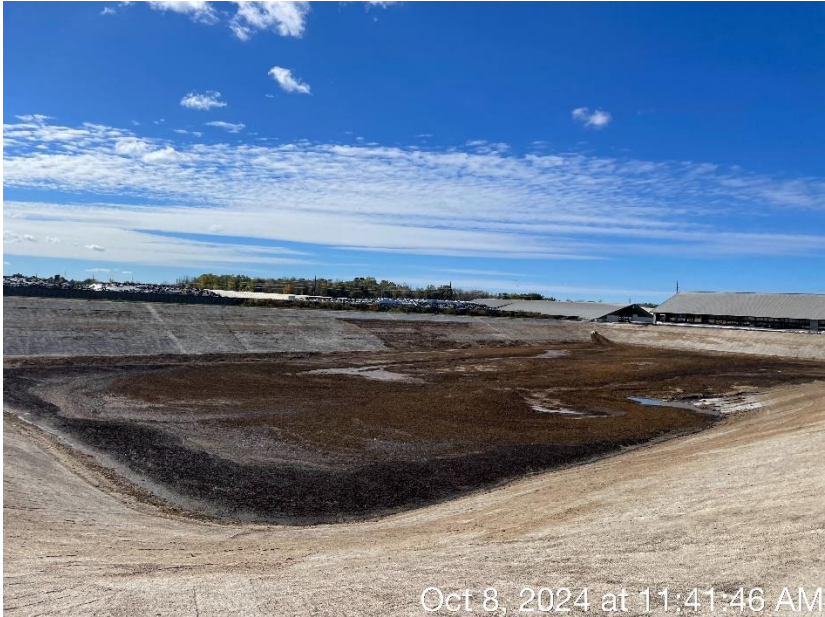
Photo 40. WSF 1 at the Longfellow Site. This photo was taken facing northwest.

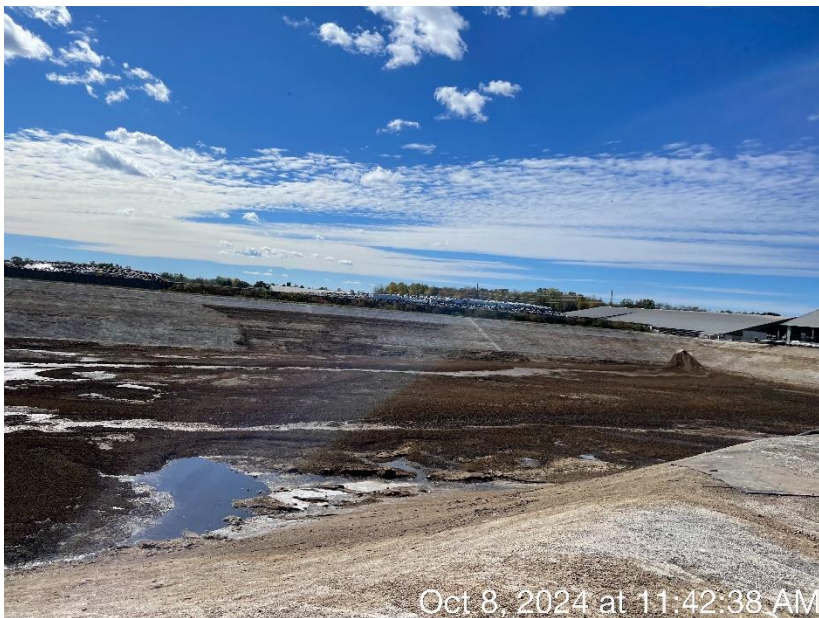
Photo 41. WSF 1 at the Longfellow Site. This photo was taken facing southwest.
