Permit Fact Sheet

Permit Number	WI-0062235-05-0
Permittee Name and Address	Ebert Enterprises LLC N6939 Cty Hwy D Algoma, WI 54201
Permitted Facility Name and Address	Home Farm- N6939 County Road D, Algoma, WI 54201 Tonet Dairy- N7521 Tonet Rd, Luxemburg, WI 54217 Tonet Dairy- N7518 Tonet Rd, Luxemburg, WI 54217 Longfellow Farm- N6388 Longfellow Road, Algoma, WI 54201 K Farm- 5083 County Road K, Algoma, WI 54201 S Farm- E5639 County Rd S, Algoma, WI 54201
Permit Term	August 01, 2026 to July 31, 2031
Receiving Water	Unnamed tributaries within the Ahnapee River Watershed, and groundwaters of the state.
Discharge Type	Existing source CAFO per NR 243.03(23) as the facility has been permitted since 2002.

CAFO Compliance Report (1/31/2025)

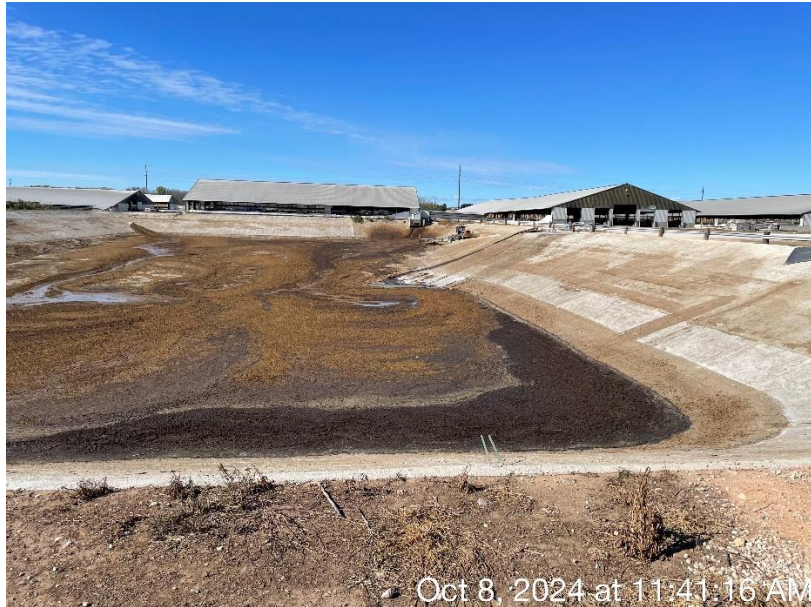
Photo 42. WSF 1 at the Longfellow Site. This photo was taken facing south.

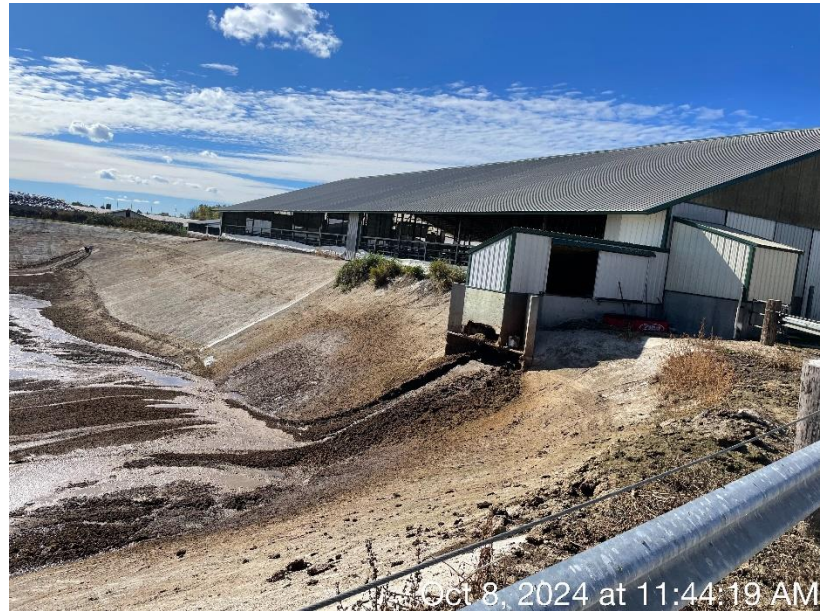
Photo 43. WSF 1 at the Longfellow Site. This photo was taken facing west.

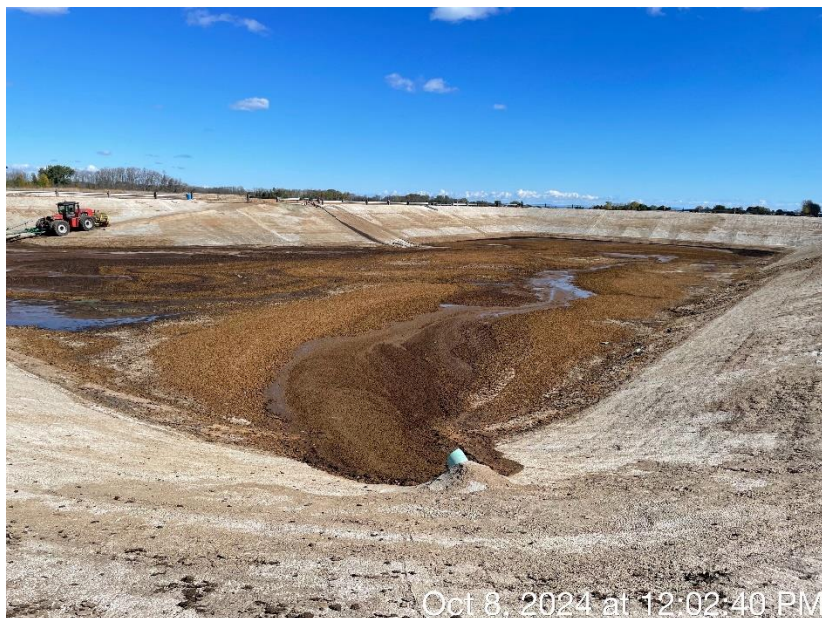
Photo 44. One of the outlets that discharges manure into WSF 1 at the Longfellow Site. This outlet is located in the northwest corner of the storage facility.

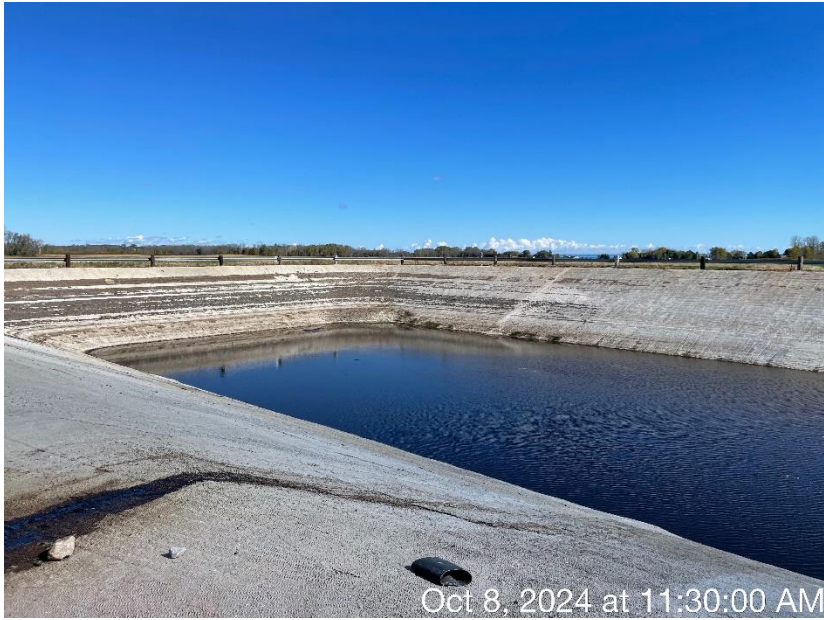
Photo 45. The second outlet that discharges manure into WSF 1 at the Longfellow Site. This outlet is located in the southwest corner of the storage facility.

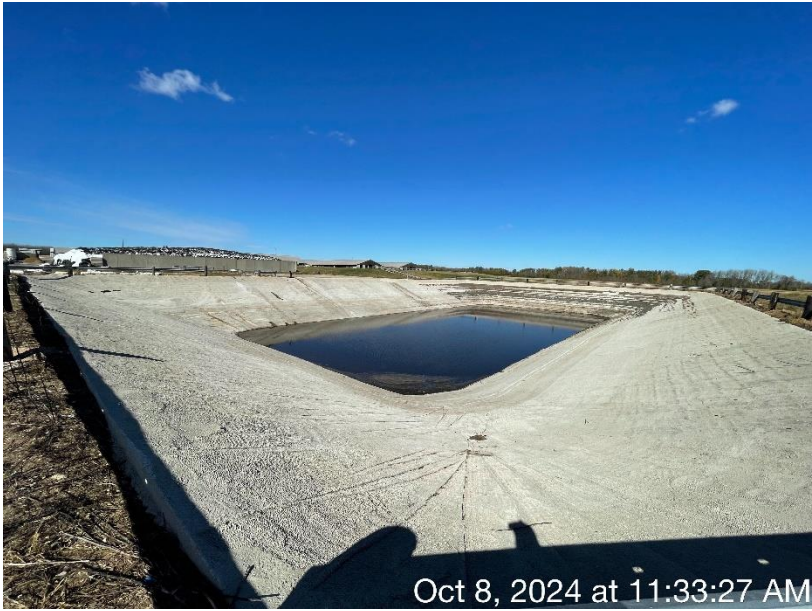
Photo 46. WSF 2 at the Longfellow Site, which accepts runoff from the feed storage area at the Longfellow Site. This photo was taken facing northeast.

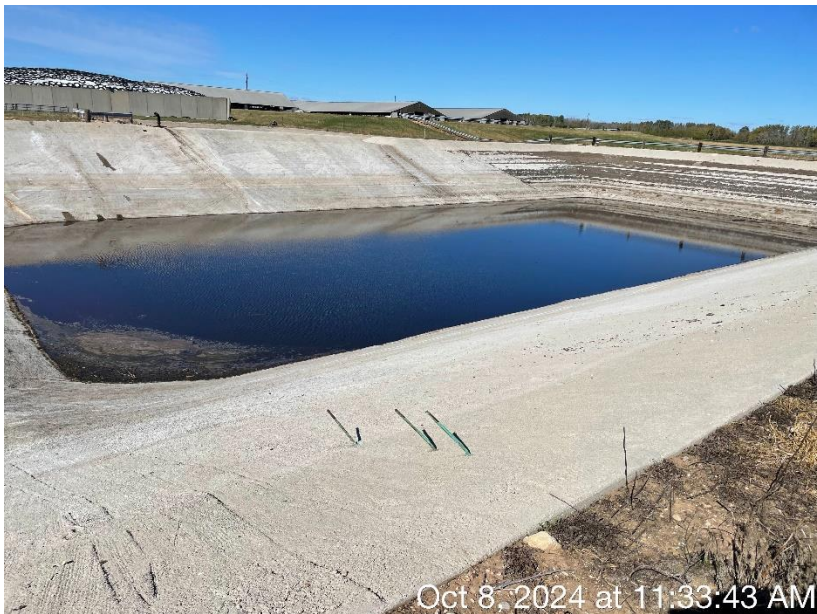
Photo 47. WSF 2 at the Longfellow Site, which accepts runoff from the feed storage area at the Longfellow Site. This photo was taken facing northeast.

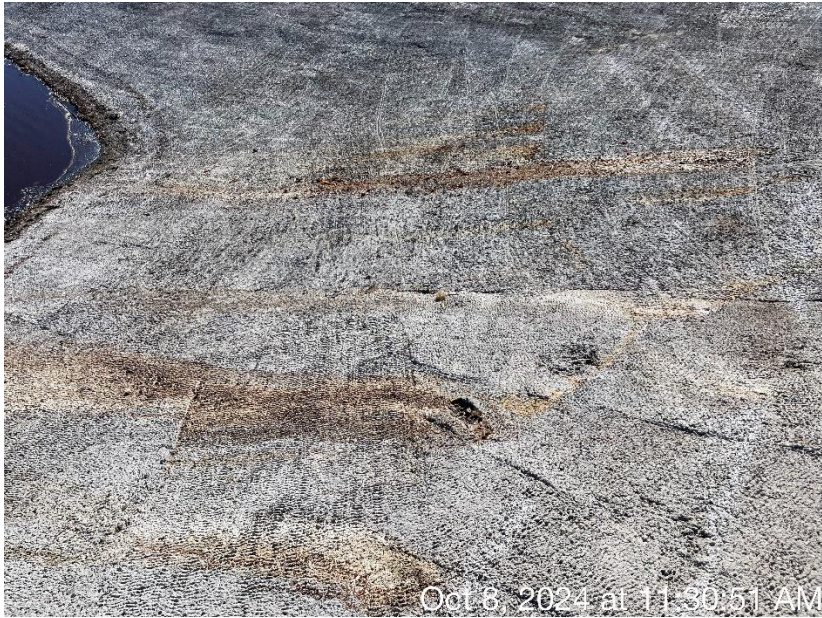
Photo 49. Cracks and evidence of seepage within WSF 2 at the Longfellow Site.

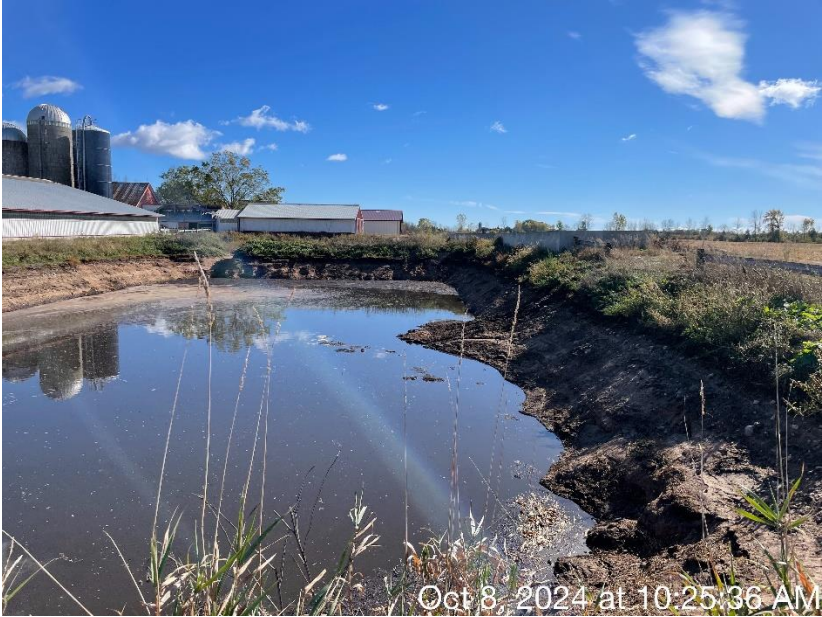
Photo 50. WSF 2 at the S Farm. This photo was taken facing east.

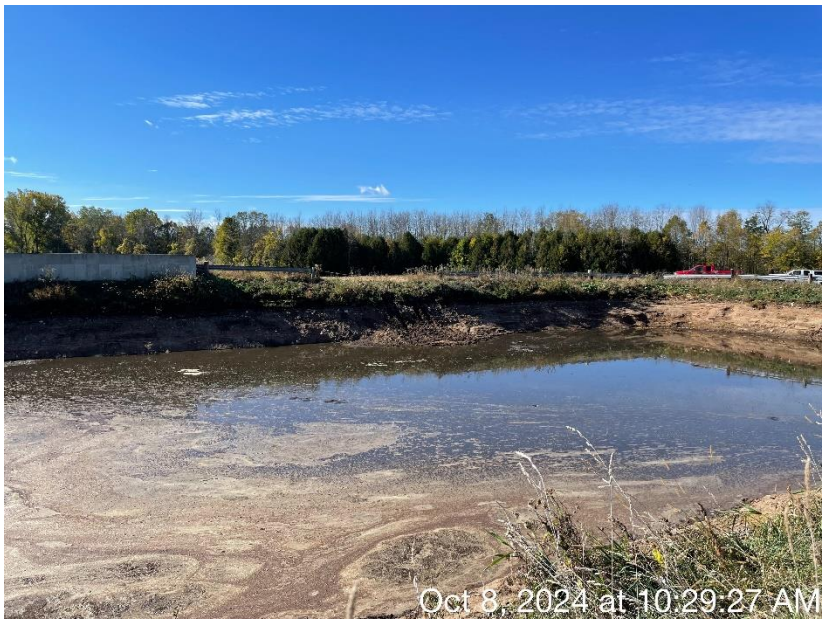
Photo 51. WSF 2 at the S Farm. This photo was taken facing south.

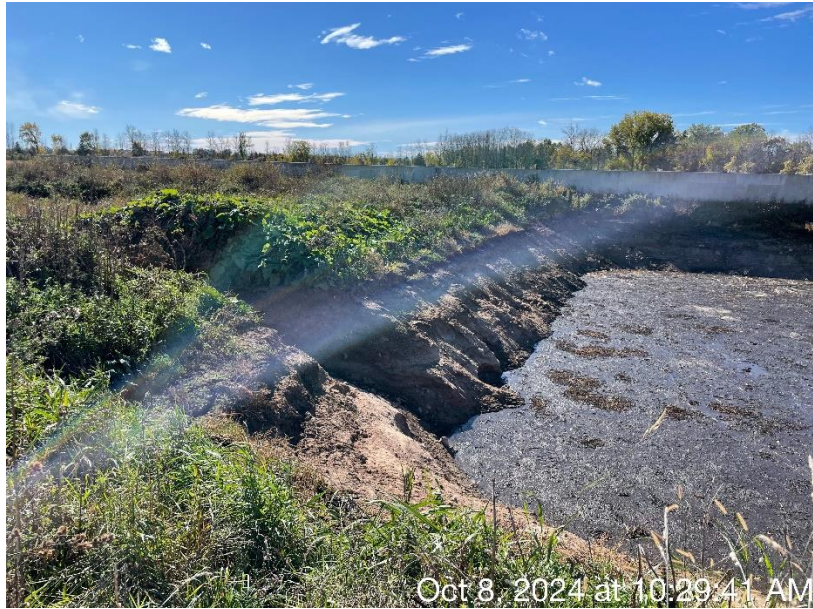
Photo 52. The berm that separates WSF 1 and WSF 2 at the S Farm. Significant erosion was present in the weir.

- Seepage of leachate from the perimeter tile line around the southern feed storage area at the Main Site
- Lack of permanent markers within the manure storage facilities at the S Farm
- Erosion within the storage facilities at the S Farm
- Bedding and feed materials present within the driveway between the calf barns at the Main Site
- Blown bedding material at the K Farm
- Small amount of burnout on the VTA at the Main Site

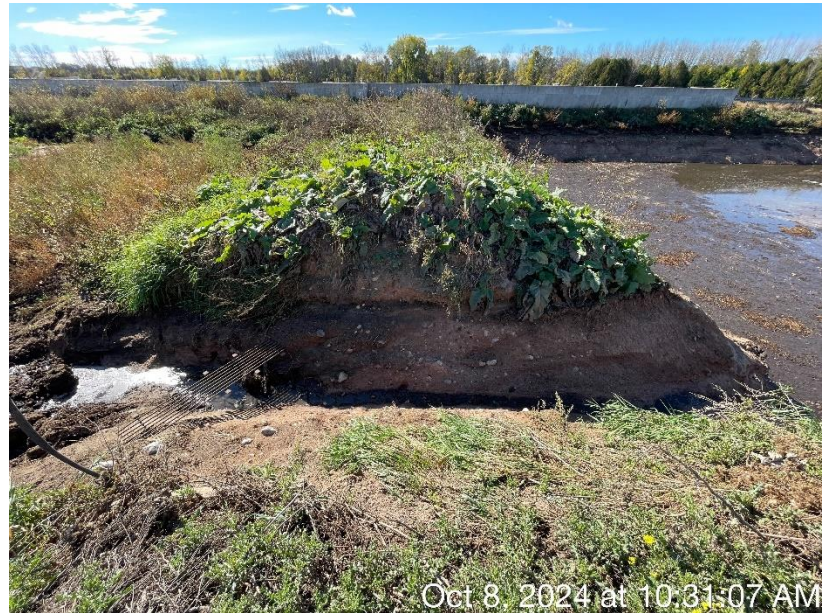
Photo 53. The weir that allows manure to flow from WSF 1 to WSF 2 at the S Farm. Significant erosion was present in the weir.

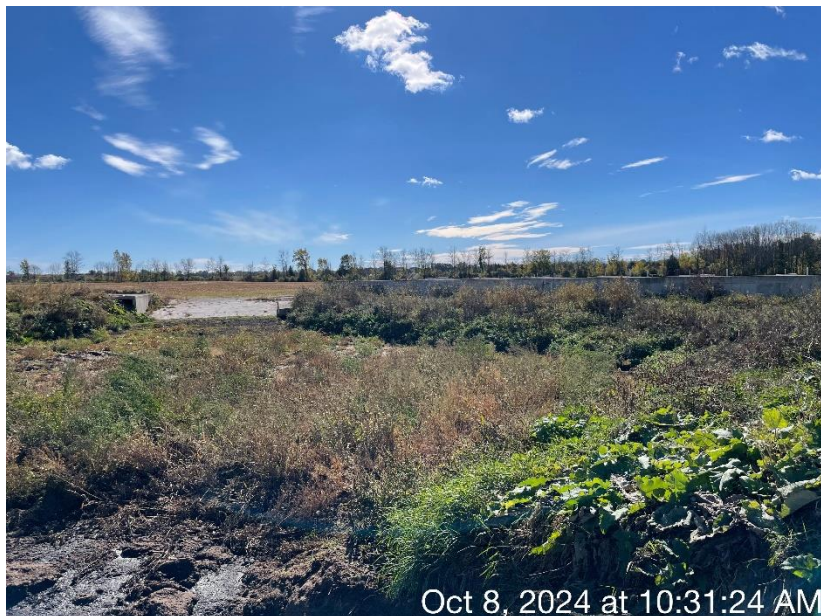
Photo 54. WSF 1 at the S Farm. This photo was taken facing southeast.

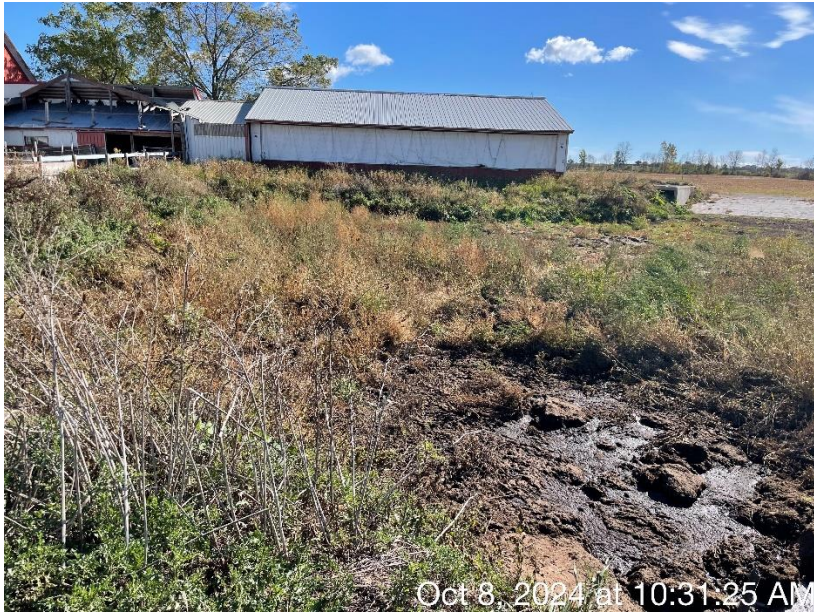
Photo 55. WSF 1 at the S Farm. This photo was taken facing east.

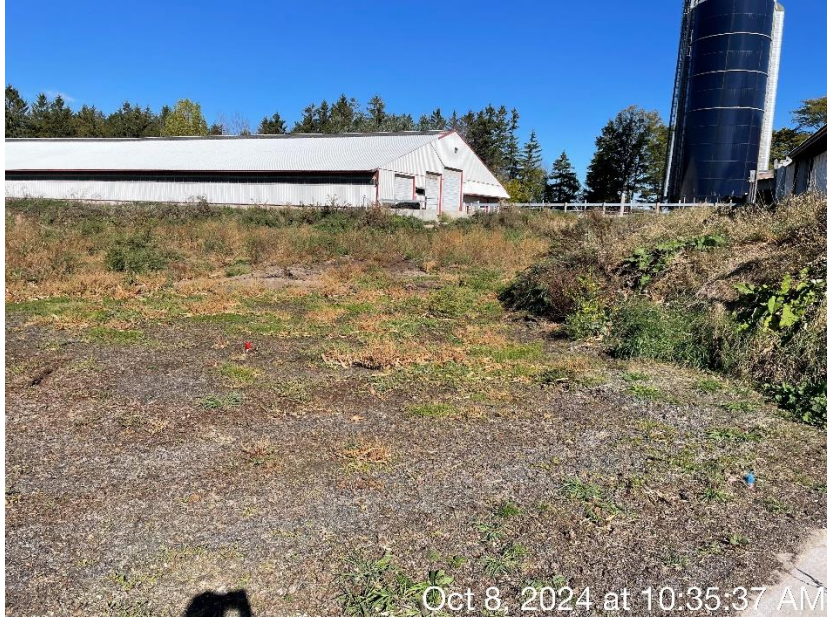
Photo 56. WSF 1 at the S Farm. This photo was taken facing north.

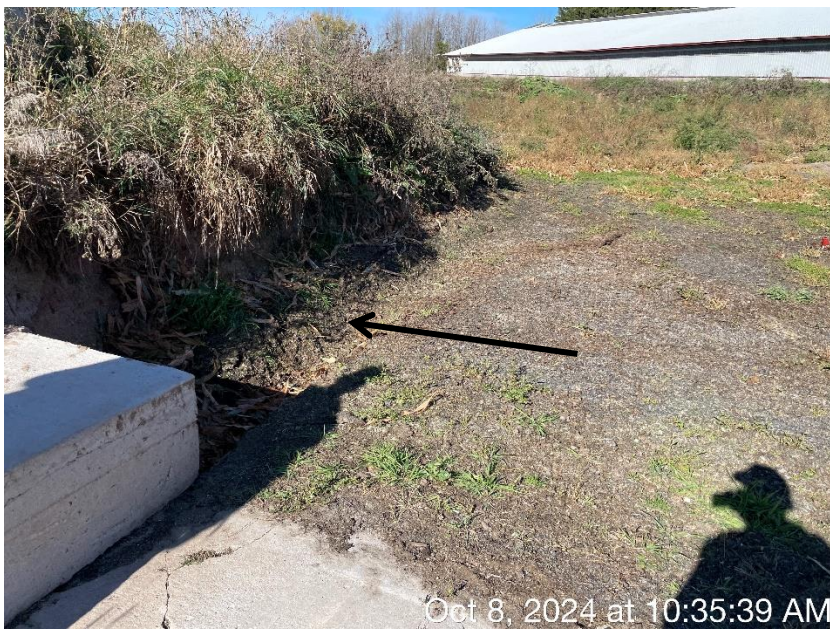
Photo 57. Erosion present along the concrete ramp leading into WSF 1 at the S Farm, identified by the black arrow.

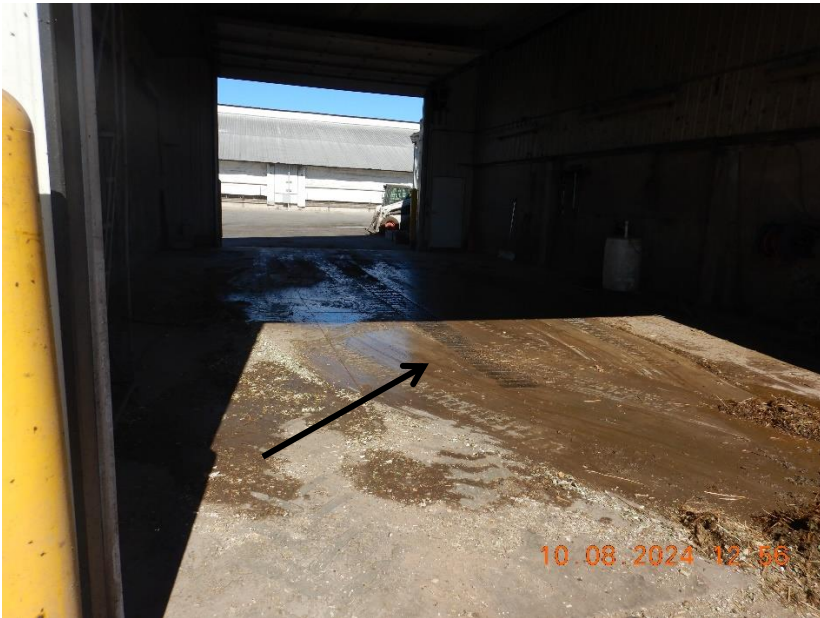
Photo 58. The machinery washing area, located within a shop located on the north side of the southern feed storage area at the Main Site. Runoff is collected by a flume, identified by the black arrow.

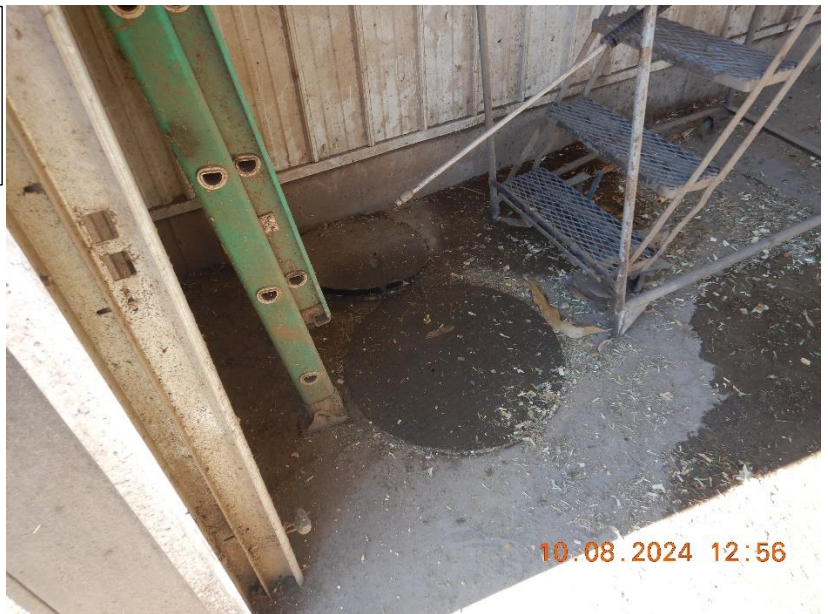
Photo 59. The manhole/pump station associated with the machinery washing center. Wastewater is transferred to WSF 1.

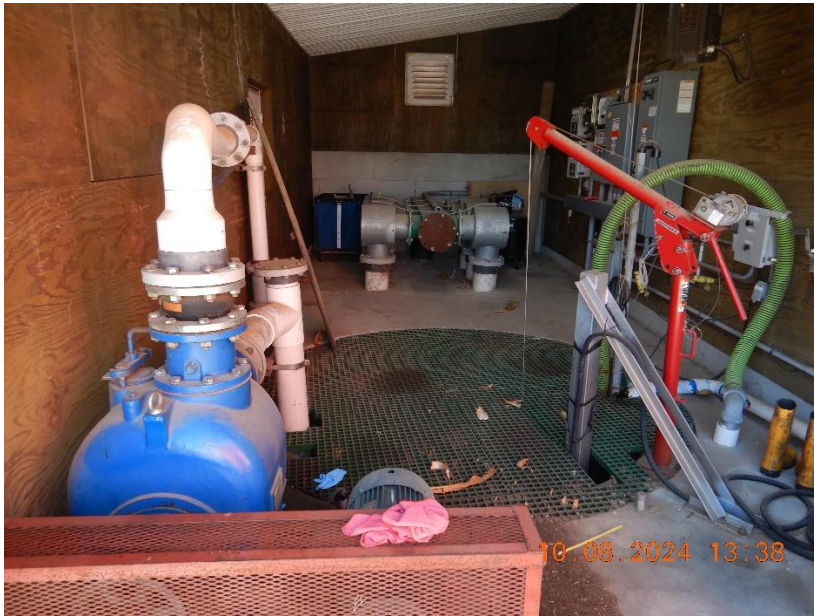
Photo 60. The pump station associated manure transfer system for the milking parlor at the Main Site.

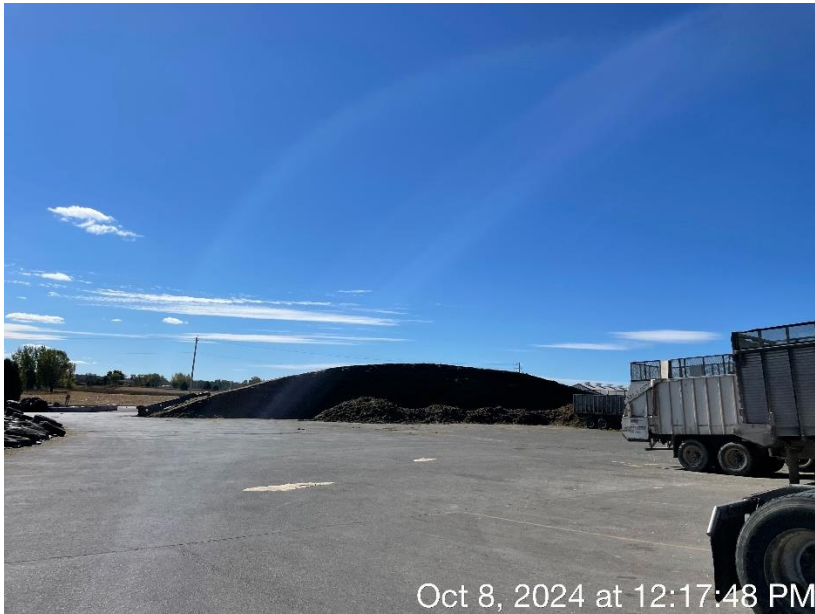
Photo 61. The southern feed storage area at the Main Site, which consists of piles of haylage covered in plastic.

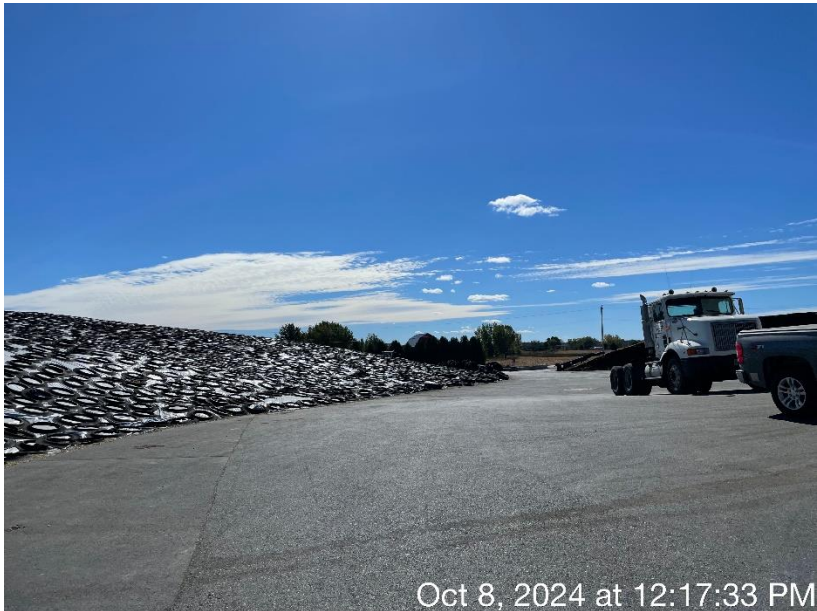
Photo 62. The southern feed storage area at the Main Site, which consists of piles of haylage covered in plastic.

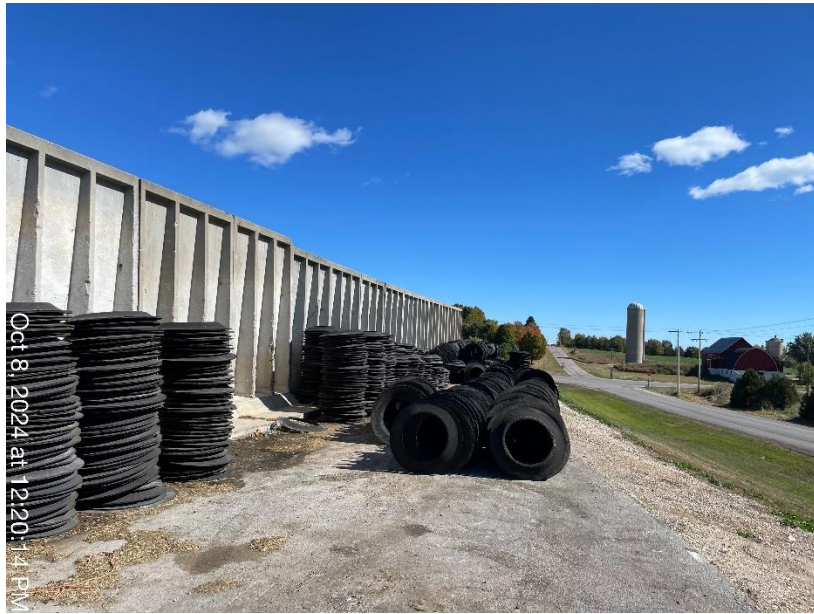
Photo 64. The wall along the southern feed storage area at the Main Site. This photo was taken on the south side of the feed storage area, facing east.

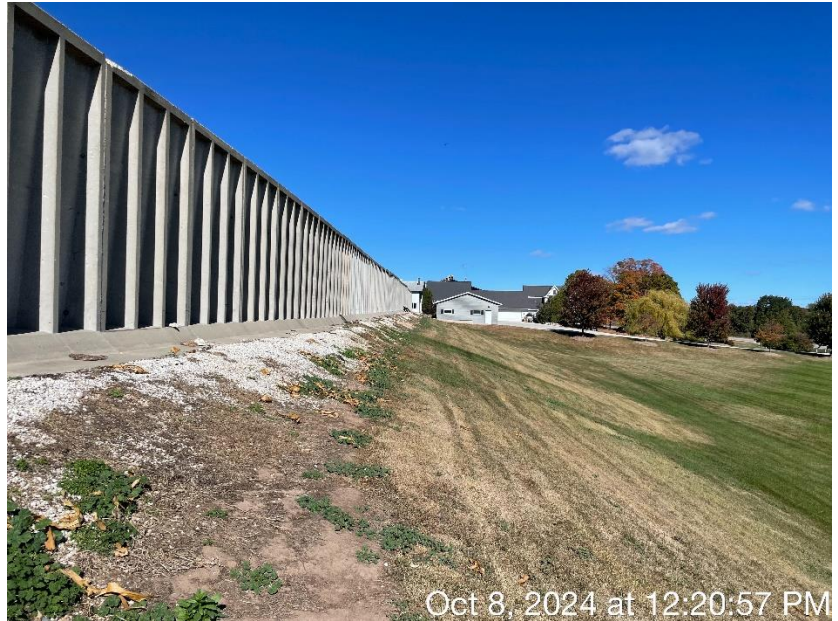
Photo 66. Evidence of seepage of leachate from the perimeter tile line around the southern feed storage area.

- Better housekeeping around the ancillary areas to clean up spilled bedding and feed materials
- Repair broken perimeter tile line around the southern feed storage area at the Main Site
 - o Submit documentation of actions taken to repair the tile line to the department by **March 31, 2025**
- Install permanent markers within the waste storage facilities at the S Farm
 - o This has been completed by Ebert Enterprises LLC. No further actions are required for this.
- Conduct maintenance actions to repair erosion present with the storage facilities at the S Farm
 - o Submit documentation of actions taken to repair the erosion within the storage facilities at the S Farm by **June 30, 2025**
- **Submit a complete permit reissuance application by March 31, 2025.**

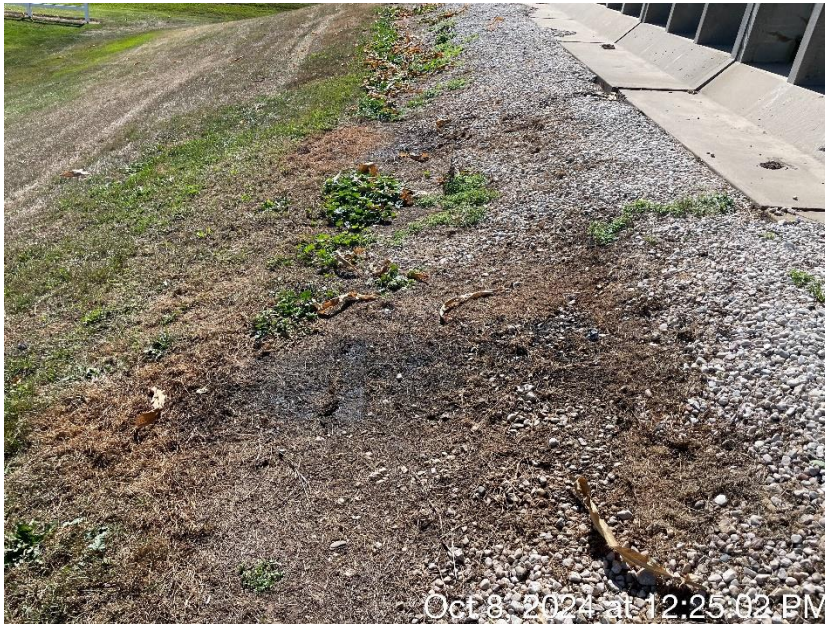
Photo 67. Evidence of seepage of leachate from the perimeter tile line around the southern feed storage area.

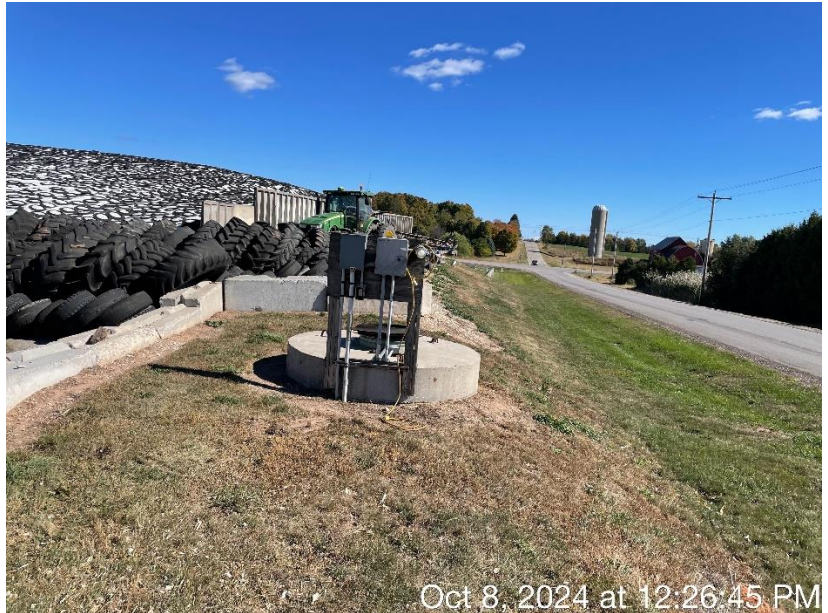
Photo 68. The pump station associated with the runoff controls for the southern feed storage area.

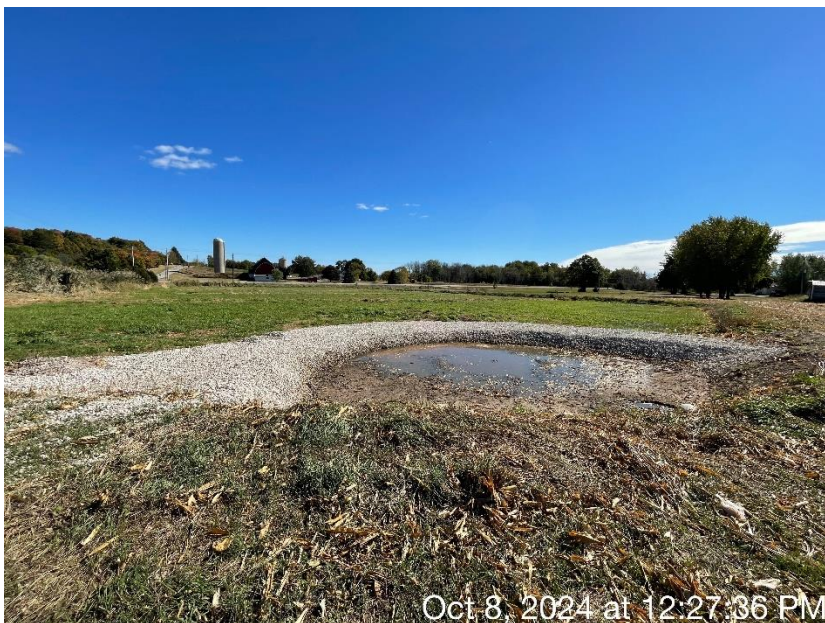
Photo 69. The VTA associated with the runoff controls for the southern feed storage area, located on the southeast corner of the production site at the Main Site.

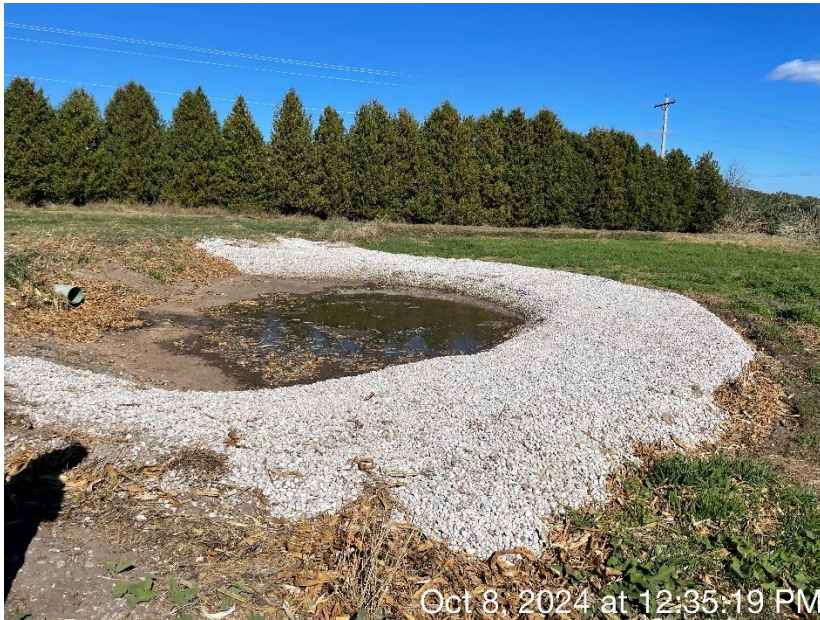
Photo 70. The gravel spreader bar associated with the VTA at the Main Site. The spreader bar appeared to be well maintained.

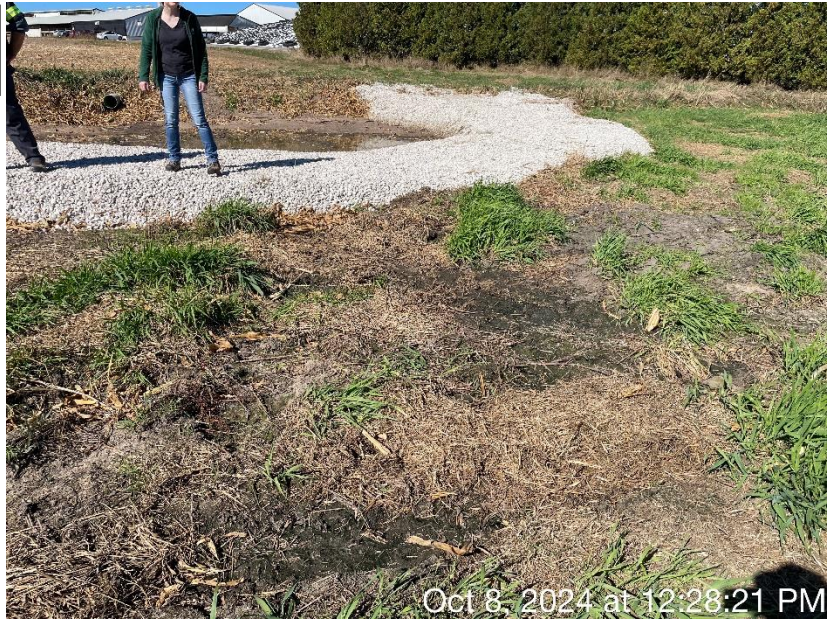
Photo 71. Burnout present adjacent to the gravel spreader bar.

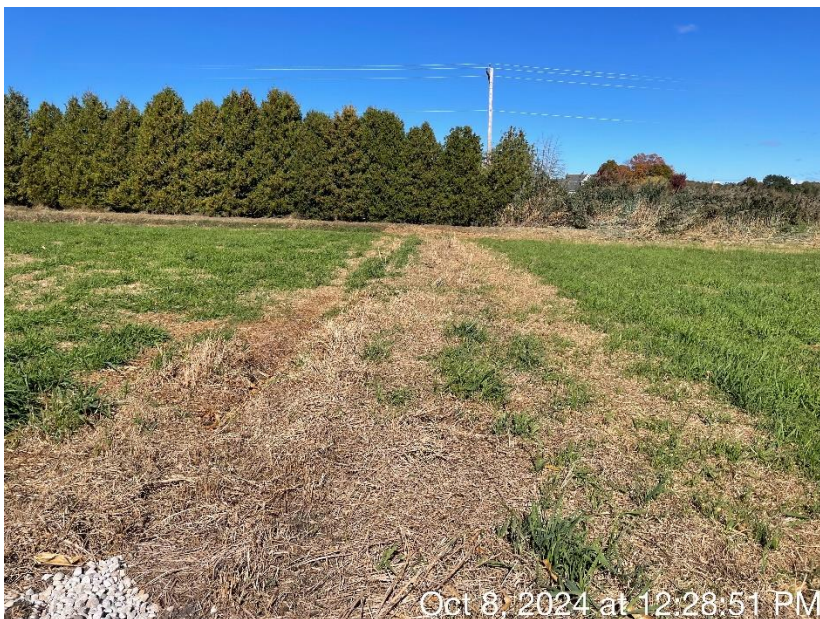
Photo 72. A gravel spreader bar located downslope of the initial gravel spreader bar. Herbicide was used to kill vegetation on the gravel spreader bar.

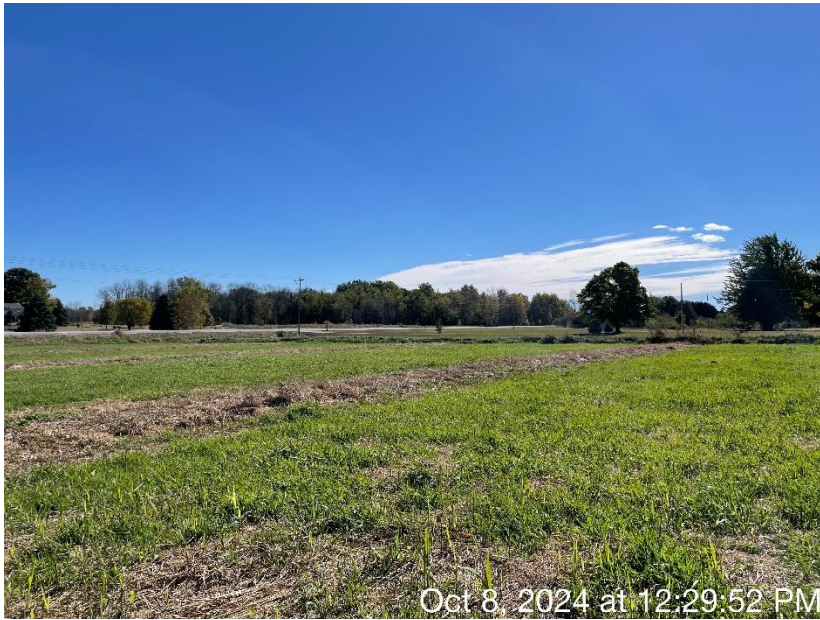
Photo 73. The VTA used to treat excess process wastewater captured from the southern feed storage area at the Main Site.

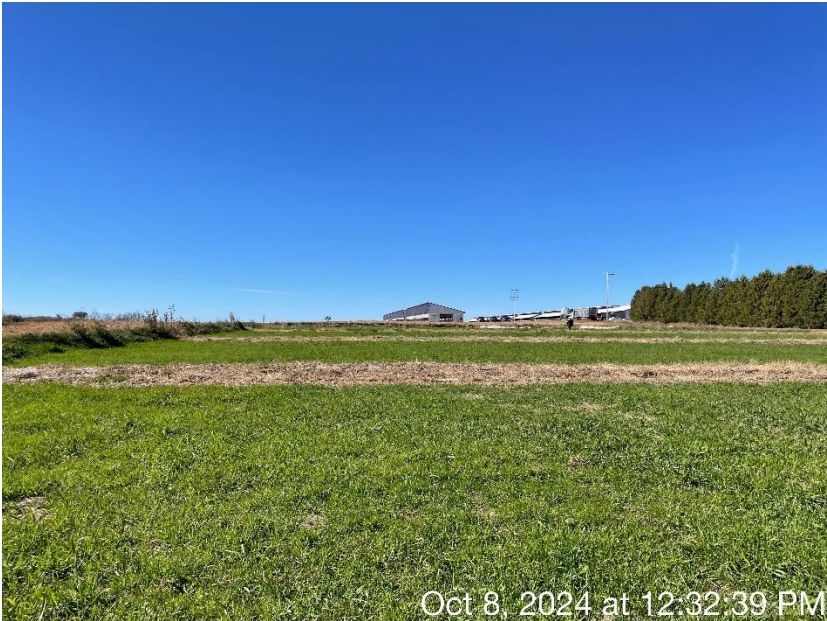
Photo 74. The VTA used to treat excess process wastewater captured from the southern feed storage area at the Main Site.

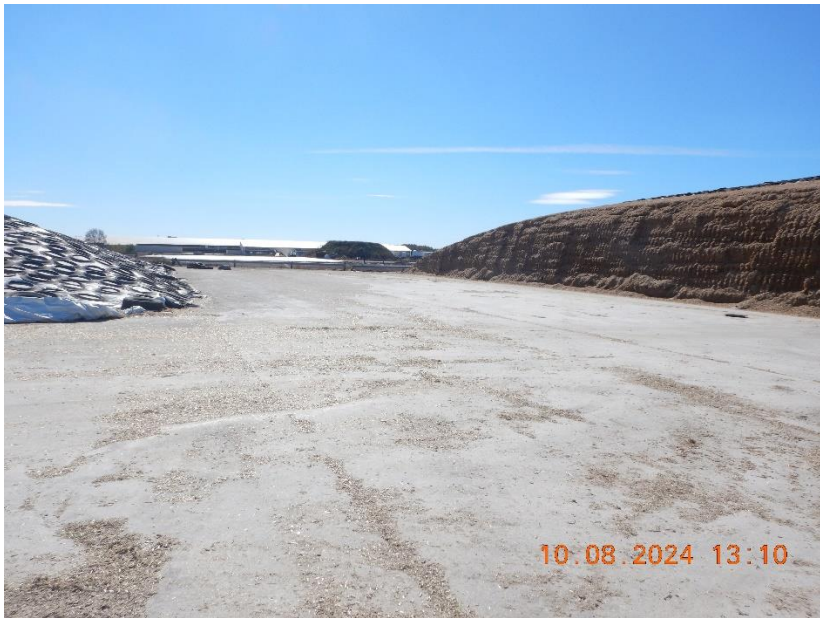
Photo 75. The northern feed storage area at the Main Site, where corn silage and haylage area stored in piles covered in plastic.

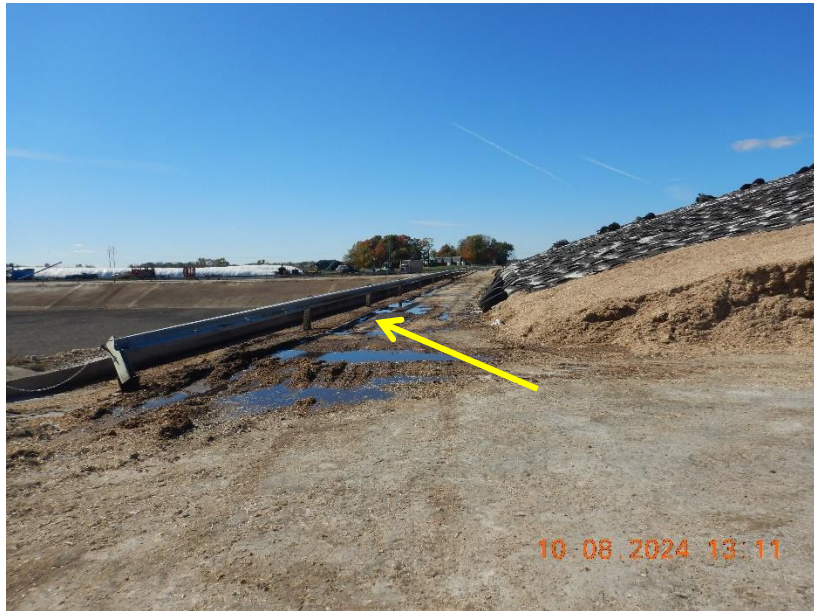
Photo 76. The flow path of runoff towards the collection system, located on the south side of the feed storage area.

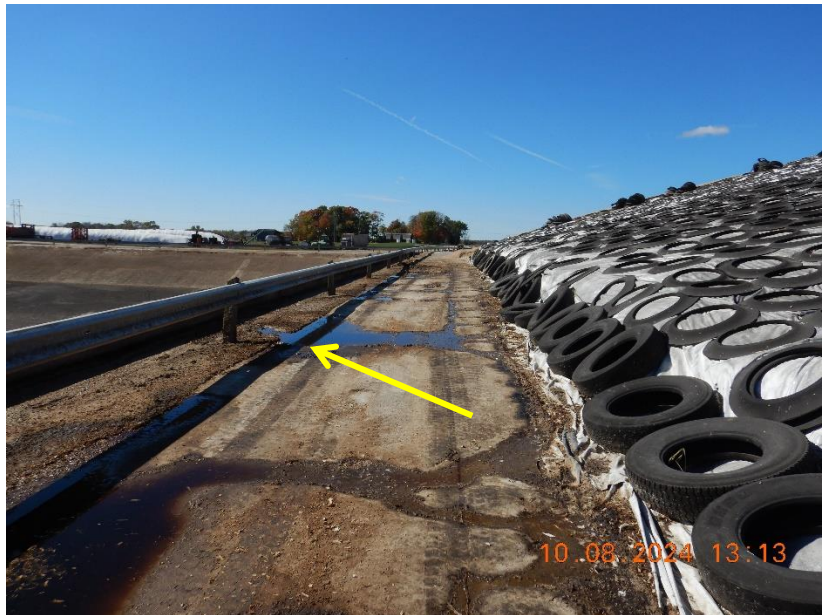
Photo 77. The flow path of runoff towards the collection system, located on the south side of the feed storage area.

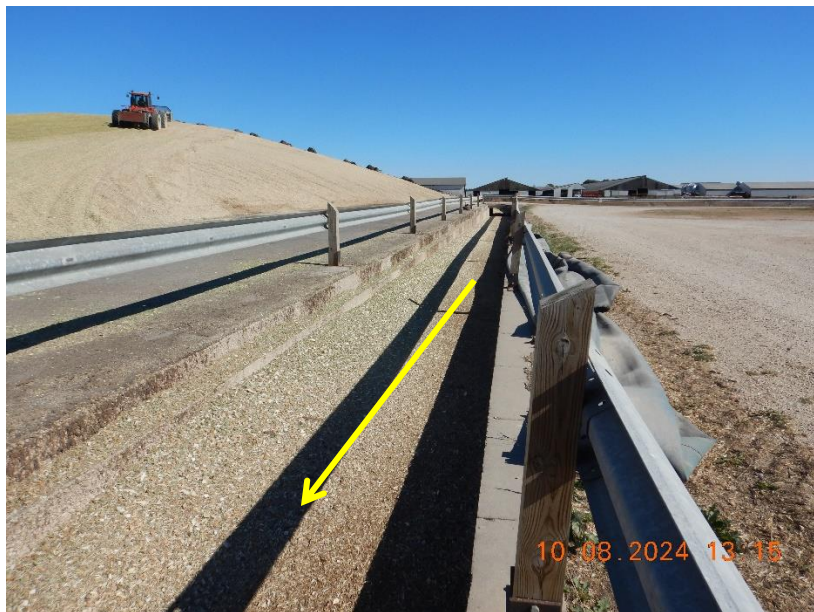
Photo 78. The flow path of runoff within the concrete conveyance channel towards WSF 4.

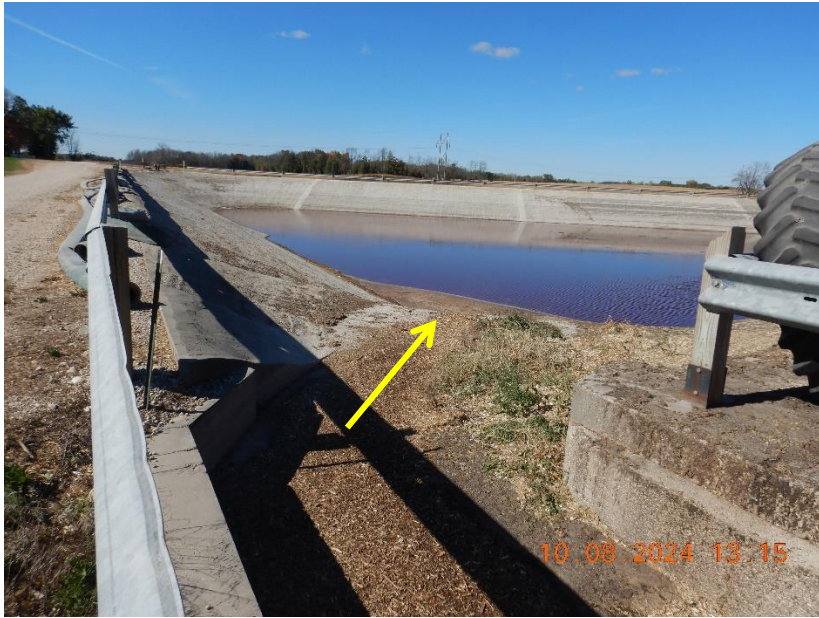
Photo 79. The flow path of runoff from the concrete conveyance channel into the southeast corner of WSF 4.

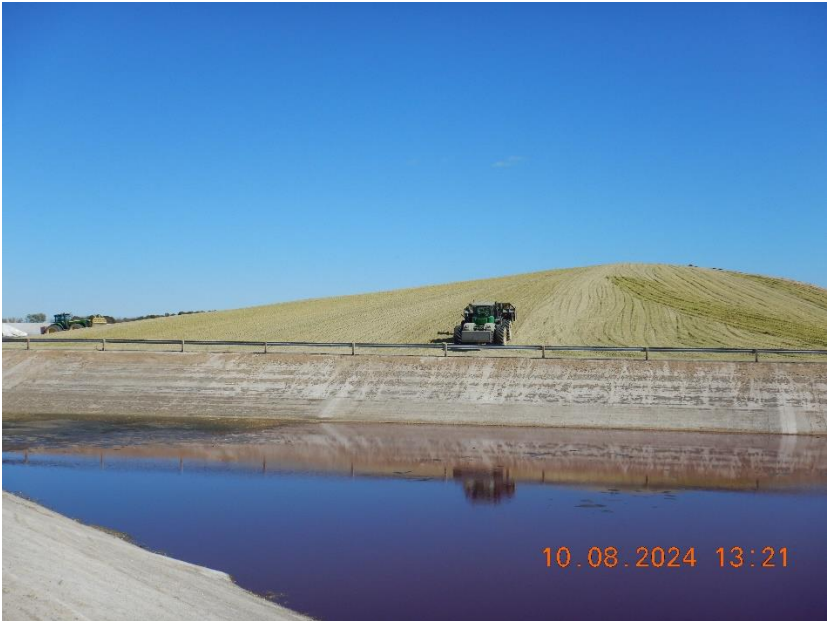
Photo 80. Corn silage being packed on the feed storage area just north of WSF 4, seen in the foreground.

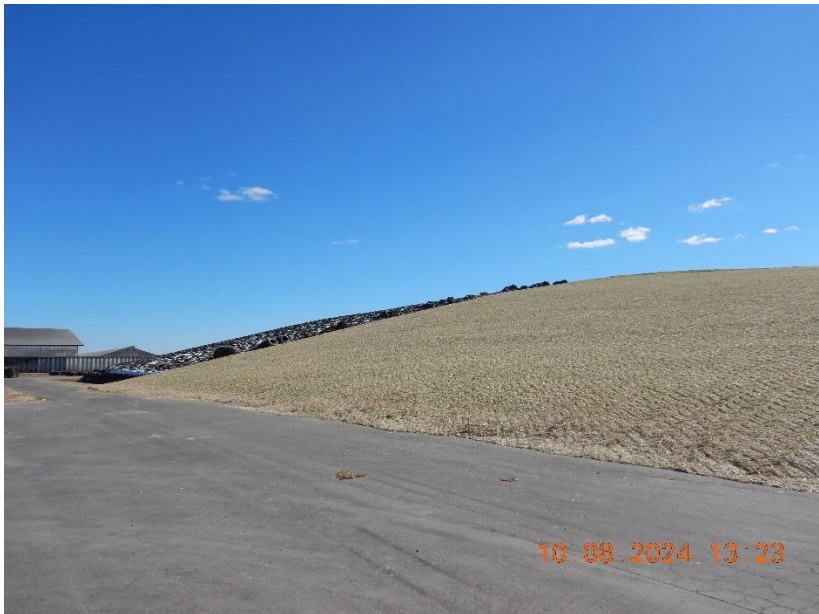
Photo 81. Corn silage being packed on the northern feed storage area at the Main Site.

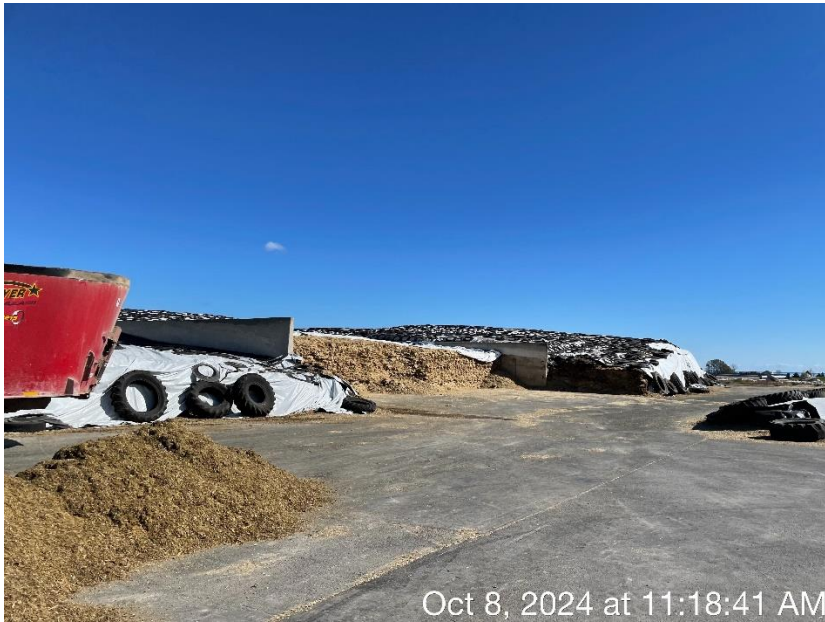
Photo 82. The feed storage area at the Longfellow Site, where corn silage is stored in feed bunkers.

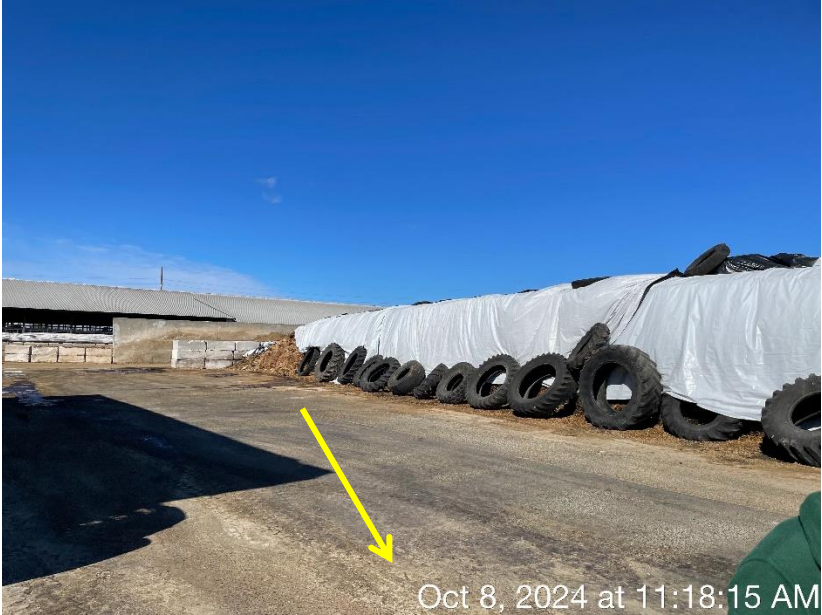
Photo 83. The feed storage area at the Longfellow Site, where corn silage is stored in feed bunkers.

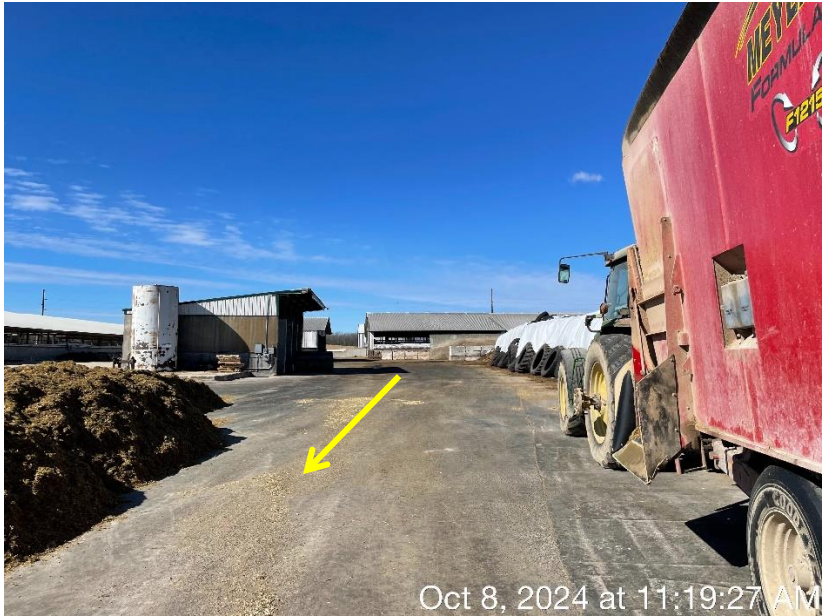
Photo 84. The flow path of runoff on the feed storage area at the Longfellow Site. Runoff gravity flows east towards the collection system.

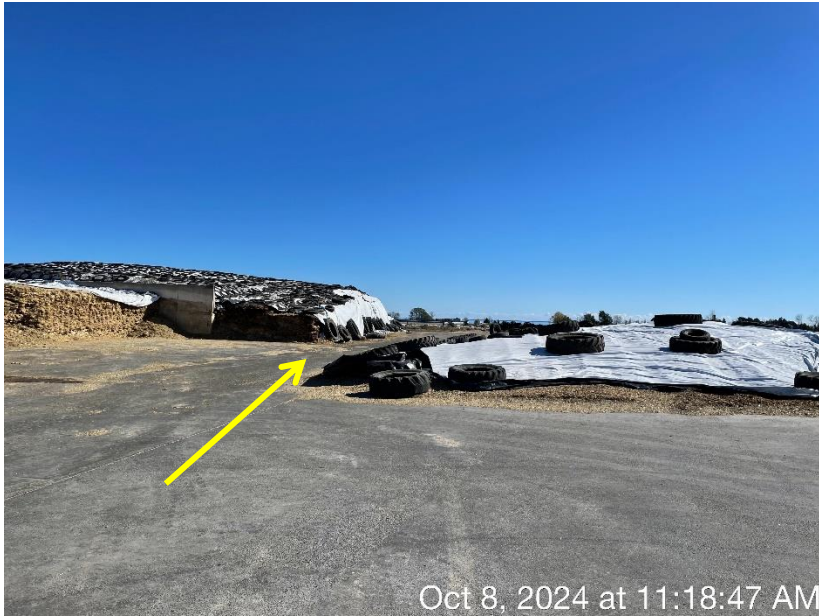
Photo 85. The flow path of runoff on the feed storage area at the Longfellow Site. Runoff gravity flows east towards the collection system.

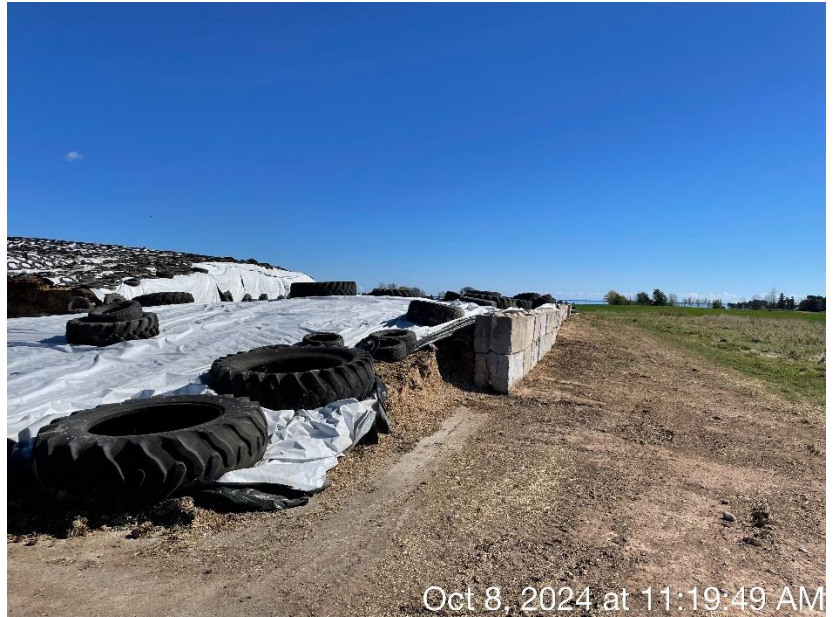
Photo 86. The south side of the feed storage area at the Longfellow Site. This photo was taken facing east.
