Permit Fact Sheet

Permit Number	WI-0062235-05-0
Permittee Name and Address	Ebert Enterprises LLC N6939 Cty Hwy D Algoma, WI 54201
Permitted Facility Name and Address	Home Farm- N6939 County Road D, Algoma, WI 54201 Tonet Dairy- N7521 Tonet Rd, Luxemburg, WI 54217 Tonet Dairy- N7518 Tonet Rd, Luxemburg, WI 54217 Longfellow Farm- N6388 Longfellow Road, Algoma, WI 54201 K Farm- 5083 County Road K, Algoma, WI 54201 S Farm- E5639 County Rd S, Algoma, WI 54201
Permit Term	August 01, 2026 to July 31, 2031
Receiving Water	Unnamed tributaries within the Ahnapee River Watershed, and groundwaters of the state.
Discharge Type	Existing source CAFO per NR 243.03(23) as the facility has been permitted since 2002.

CAFO Compliance Report (1/31/2025)

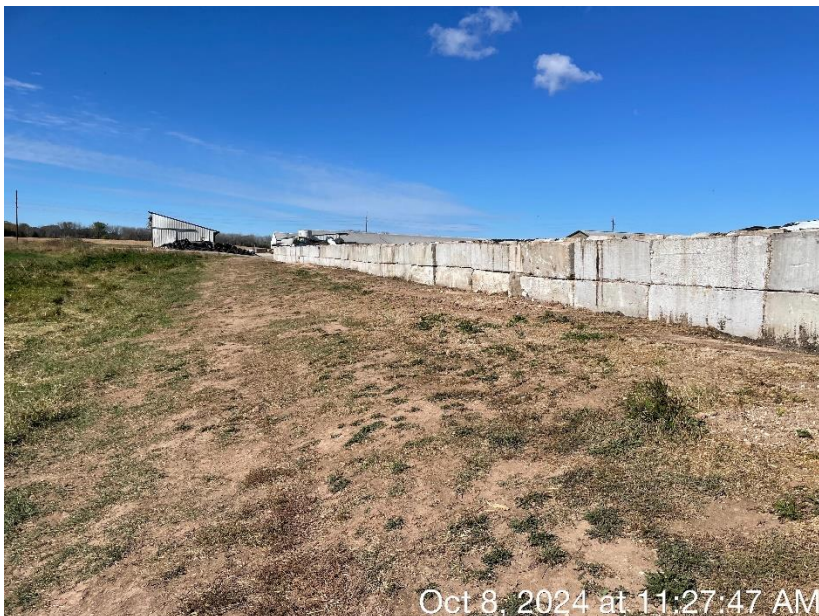
Photo 87. The south side of the feed storage area at the Longfellow Site. This photo was taken facing west.

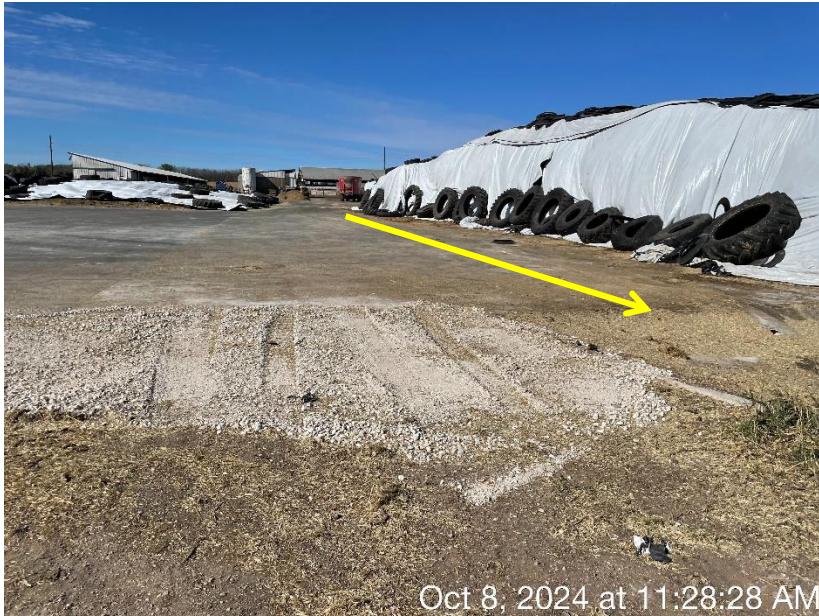
Photo 88. The flow path of runoff from the feed storage area at the Longfellow Site towards the collection system located on the east side of the feed storage area.

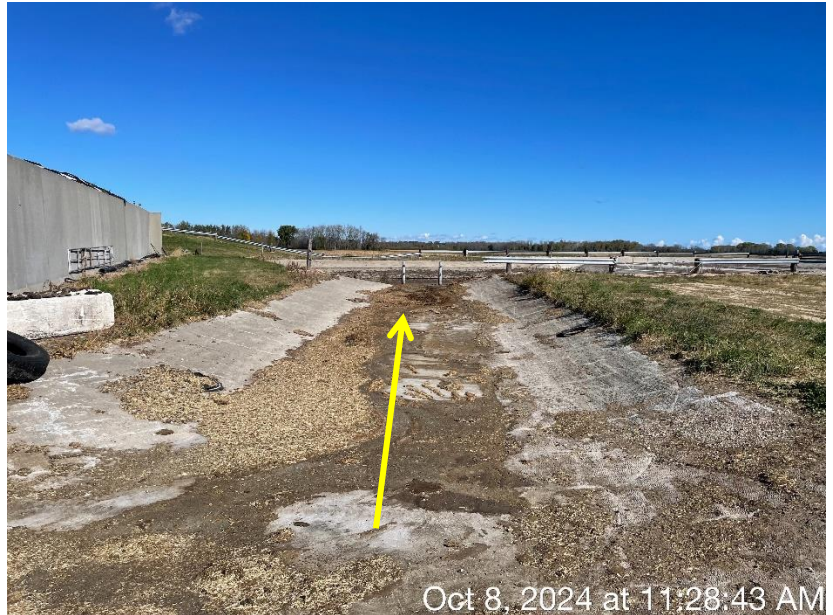
Photo 89. The concrete conveyance channel that conveys runoff from the feed storage area at the Longfellow Site towards the collection system.

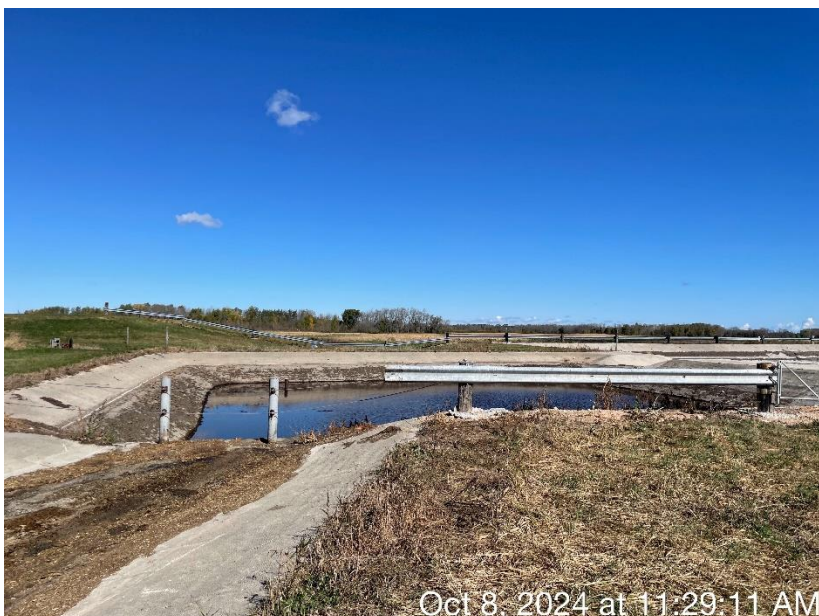
Photo 90. The detention basin that accepts runoff from the feed storage area, located west of WSF 2 at the Longfellow Site. This photo was taken facing north.

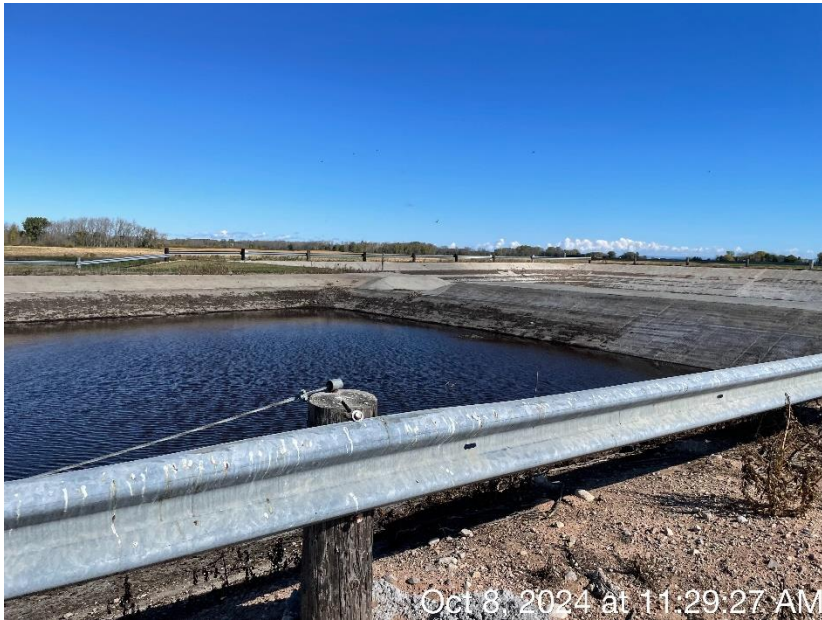
Photo 91. The detention basin that accepts runoff from the feed storage area, located west of WSF 2 at the Longfellow Site. This photo was taken facing northeast.

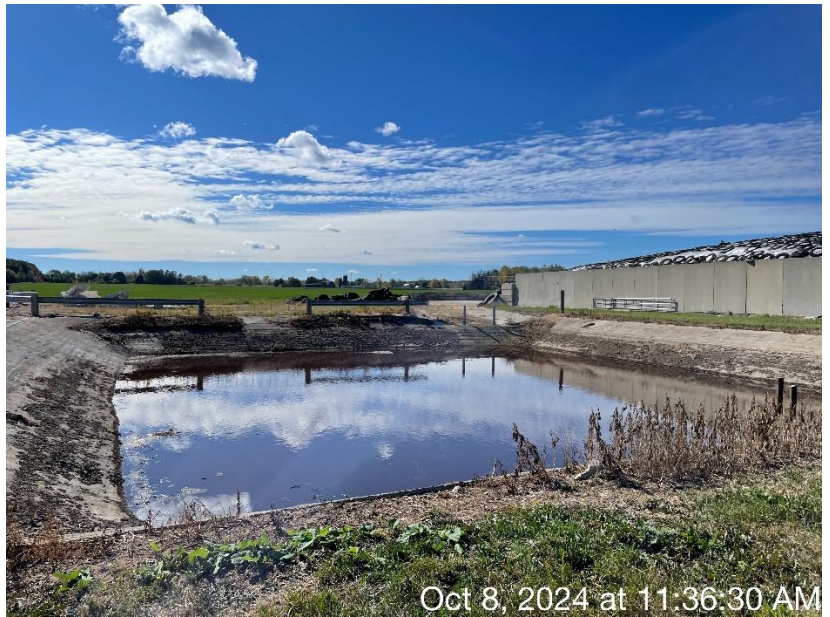
Photo 92. The detention basin that accepts runoff from the feed storage area, located west of WSF 2 at the Longfellow Site. This photo was taken facing south.

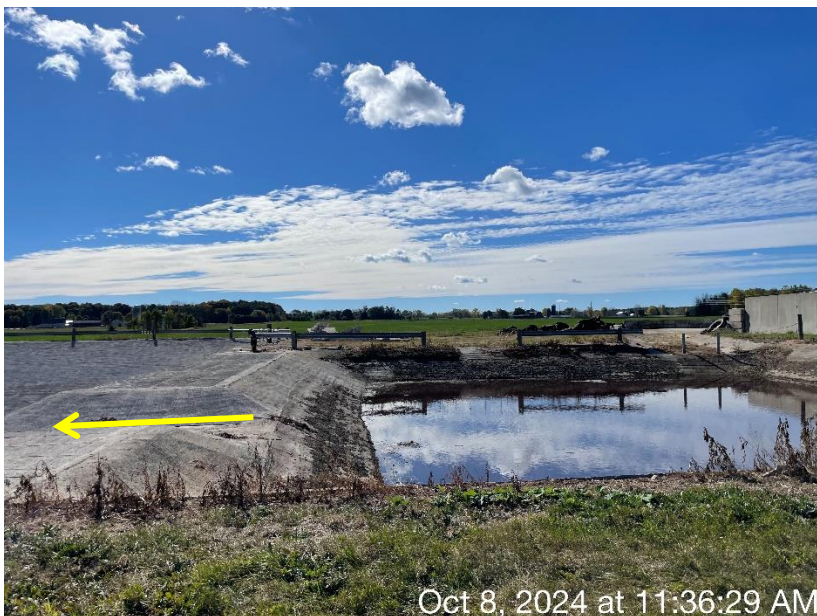
Photo 93. The concrete berm and weir that conveys runoff from the detention basin to WSF 2 at the Longfellow Site. The yellow arrow represents the flow path of process wastewater through the weir.

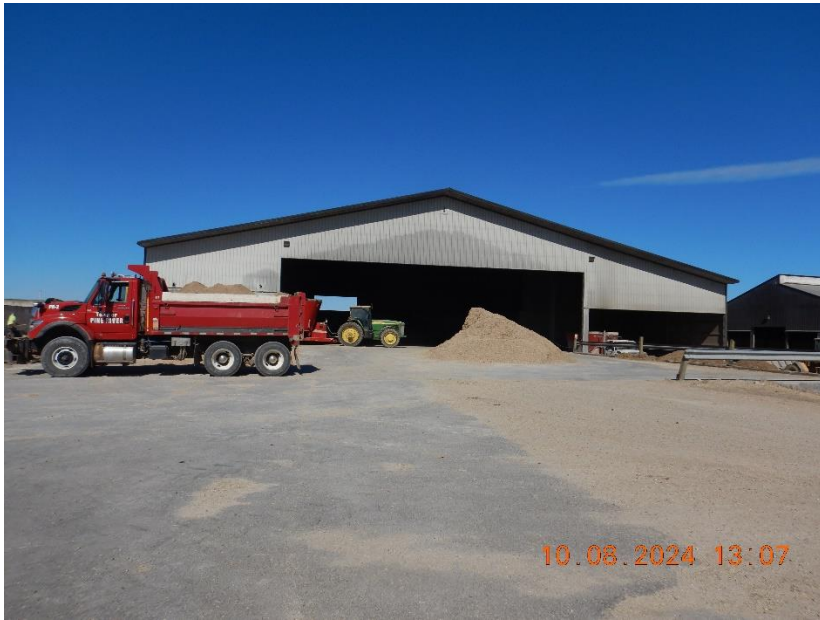
Photo 94. The commodity feed storage shed at the Main Site, located on the north side of the production site and east of the feed storage area.

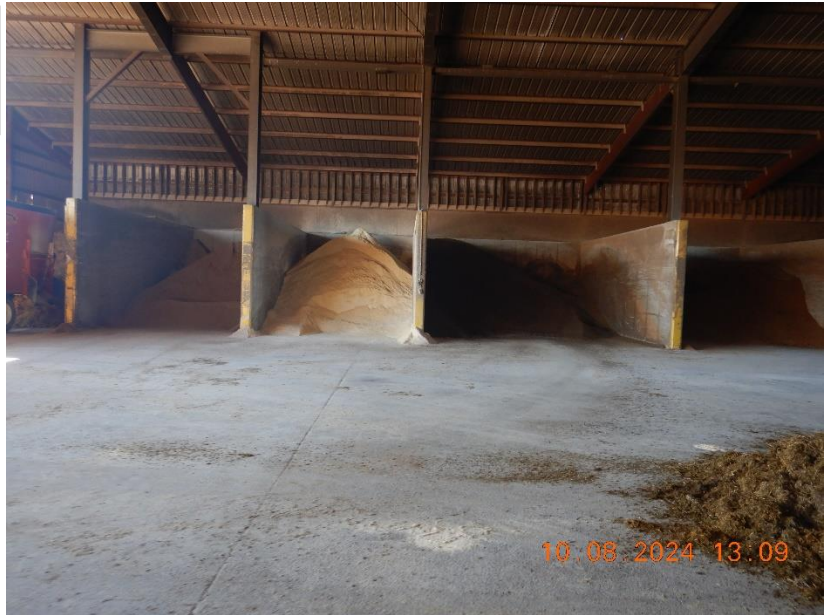
Photo 95. The commodity feed being stored in bunkers within the shed at the Main Site.

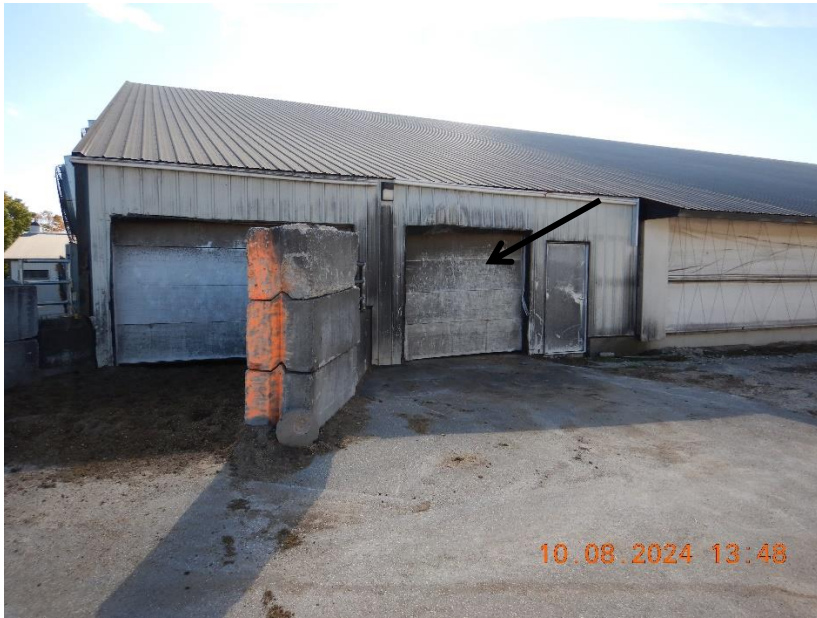
Photo 96. The animal mortality holding area at the Main Site, where carcasses are stored until they are picked up by Sandy bay Mink Ranch.

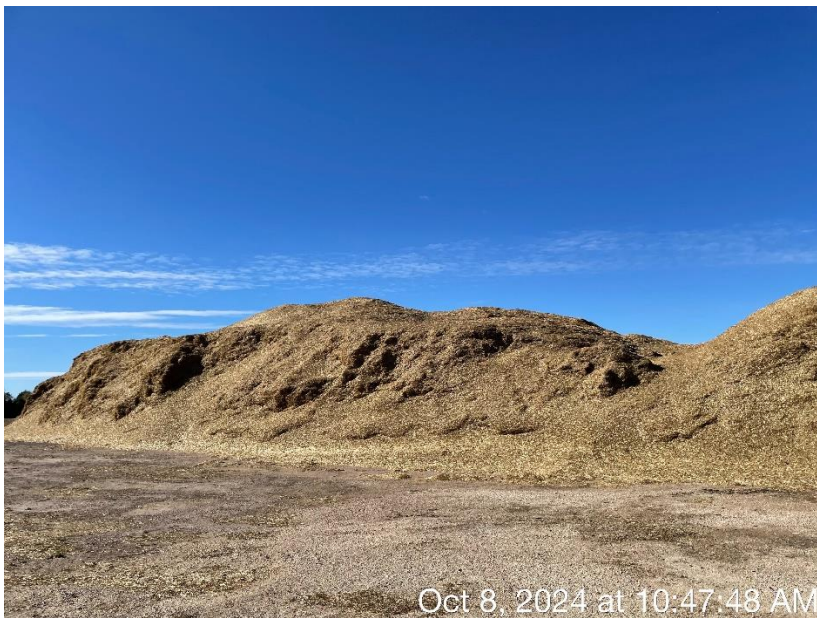
Photo 97. The chopped straw pile at the K Farm, located on the south side of the production site.

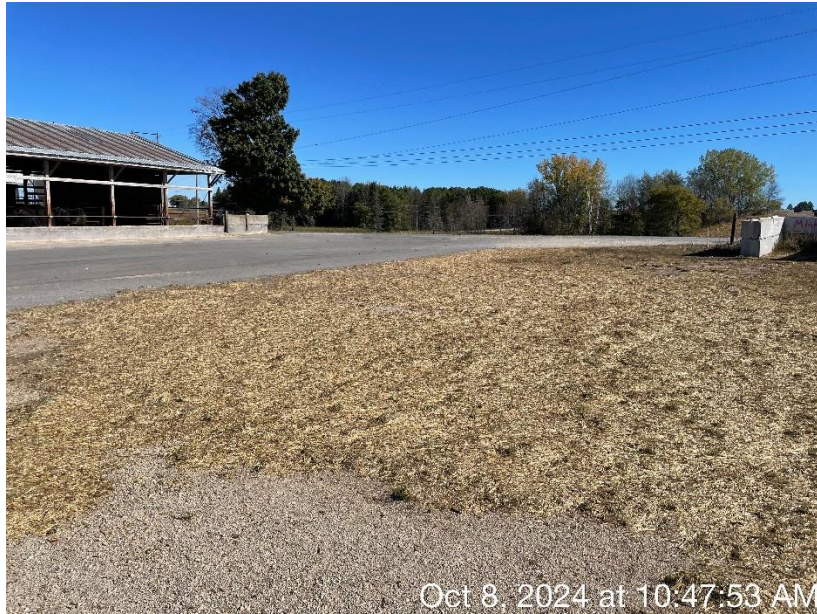
Photo 98. Blown straw from the pile at the K Farm. This photo was taken facing east.

- Better housekeeping around the ancillary areas to clean up spilled bedding and feed materials
- Repair broken perimeter tile line around the southern feed storage area at the Main Site
 - o Submit documentation of actions taken to repair the tile line to the department by **March 31, 2025**
- Install permanent markers within the waste storage facilities at the S Farm
 - o This has been completed by Ebert Enterprises LLC. No further actions are required for this.
- Conduct maintenance actions to repair erosion present with the storage facilities at the S Farm
 - o Submit documentation of actions taken to repair the erosion within the storage facilities at the S Farm by **June 30, 2025**
- **Submit a complete permit reissuance application by March 31, 2025.**

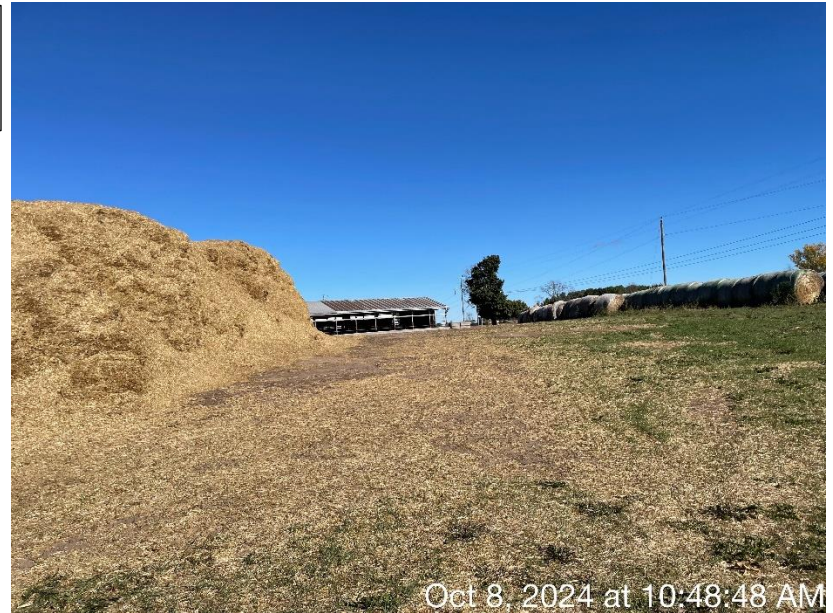
Photo 99. Blown straw from the pile at the K Farm. This photo was taken facing north.

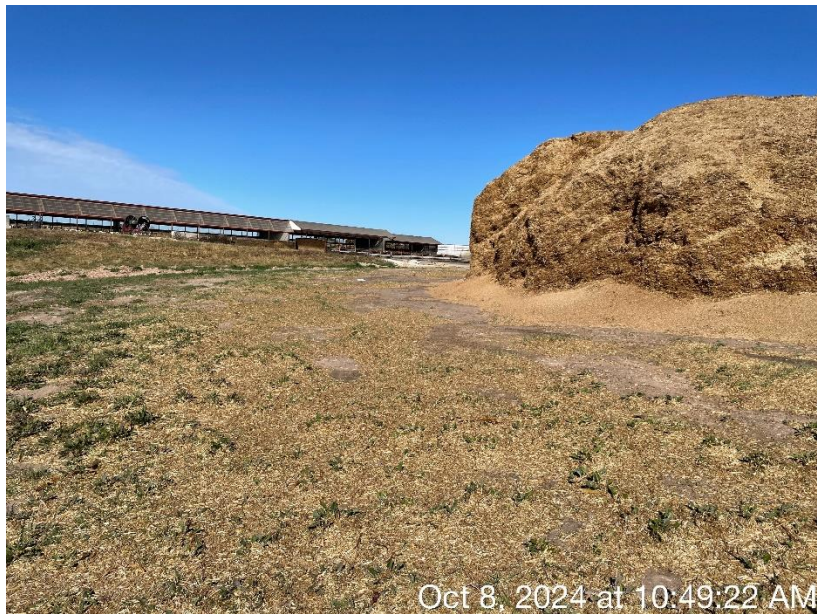
Photo 100. Blown straw from the pile at the K Farm. This photo was taken facing west.

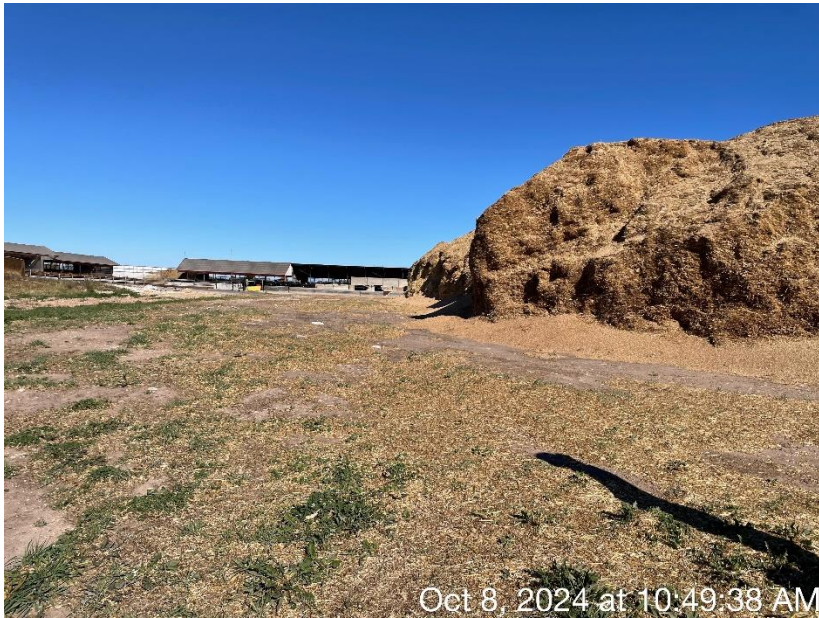
Photo 101. Blown straw from the pile at the K Farm. This photo was taken facing north.

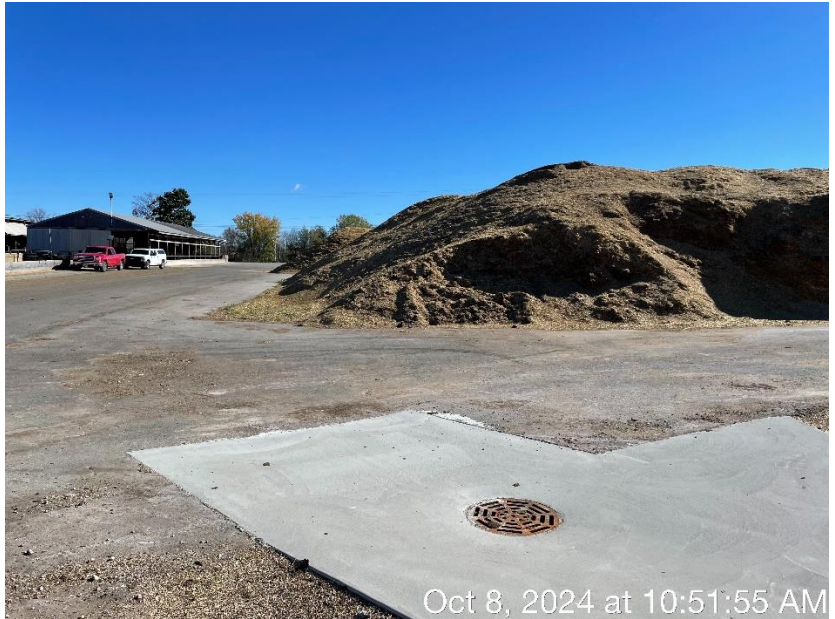
Photo 102. A surface inlet that accepts runoff from the driveway and straw pile at the K Farm.

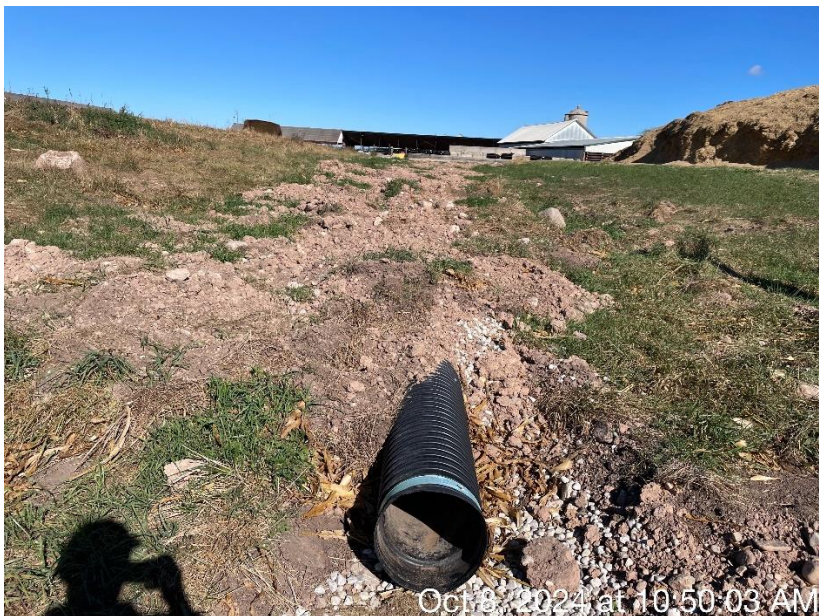
Photo 103. The outlet associated with the inlet pictured in Photo 101.

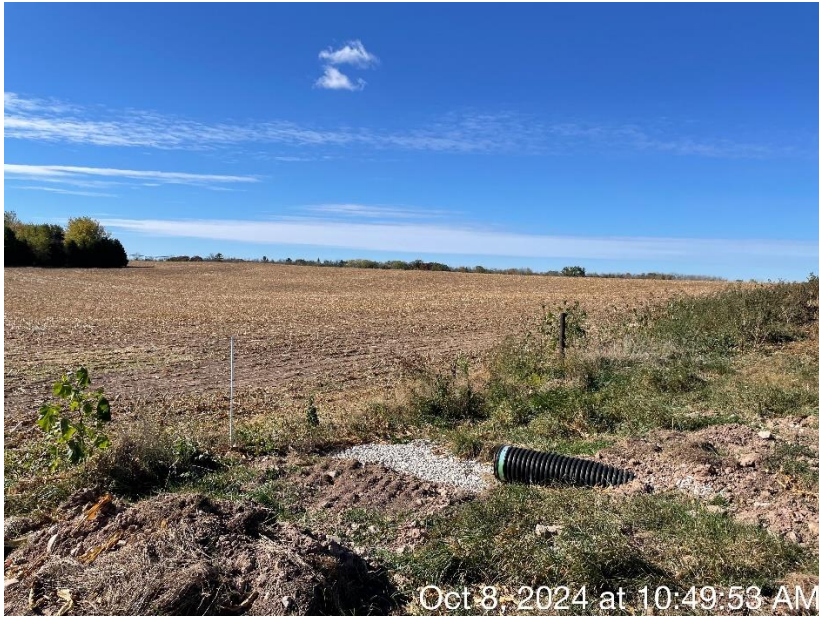
Photo 104. The outlet associated with the inlet pictured in Photo 101. Runoff flows south into the adjacent field, where the flow path terminates.

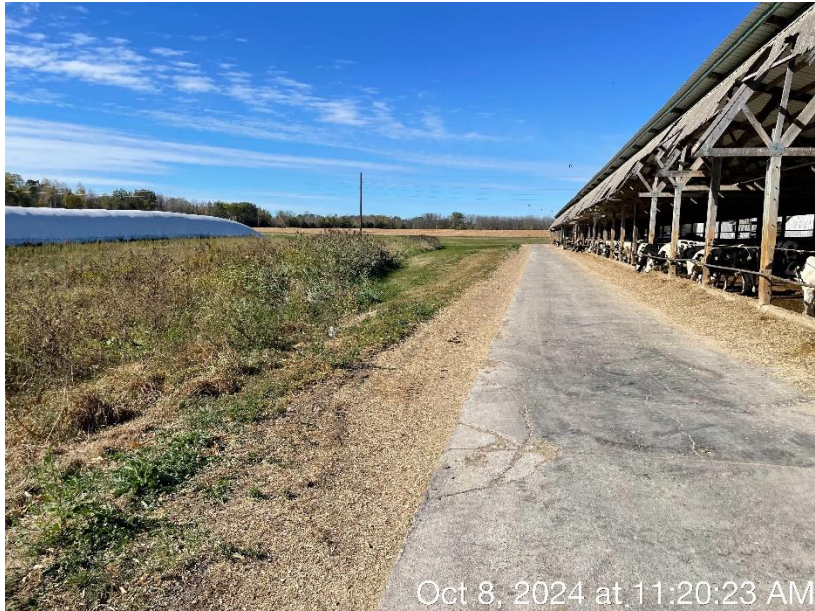
Photo 105. The feed lane for the southernmost barn at the Longfellow Site. Blown feed was present adjacent to the lane. This photo was taken facing west.

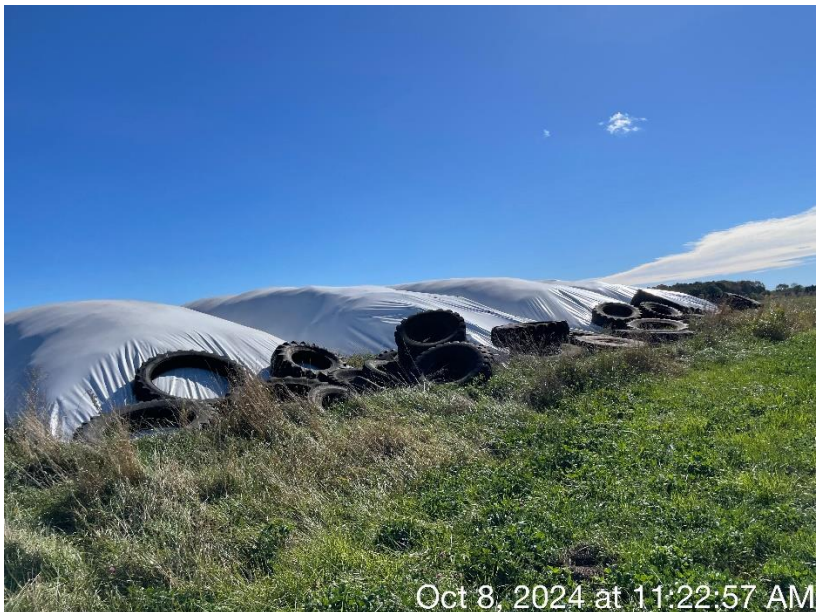
Photo 106. Chopped straw being stored in AgBags on the south side of the production site at the Longfellow Site.

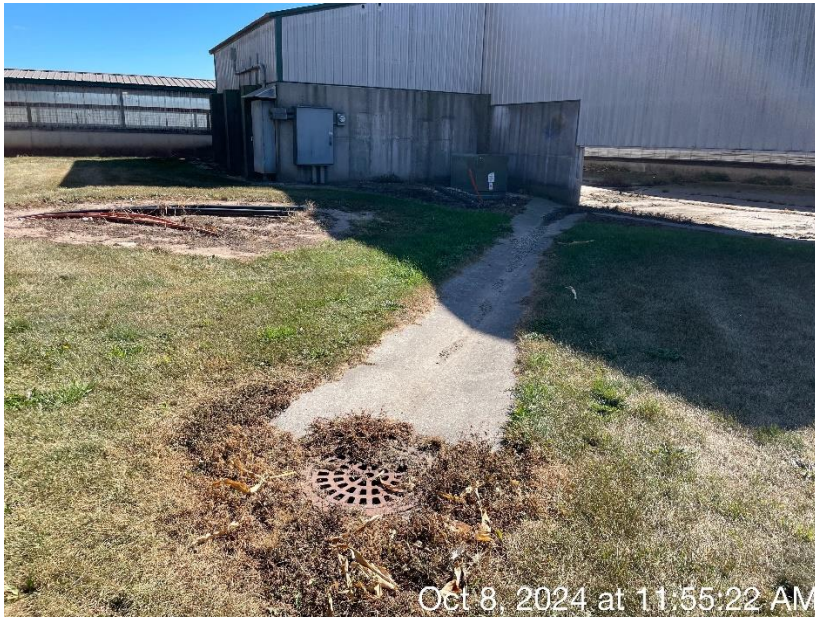
Photo 107. A stormwater surface inlet located between barns at the Longfellow Site. The inlet was clear of debris, with no indications of discharge observed.

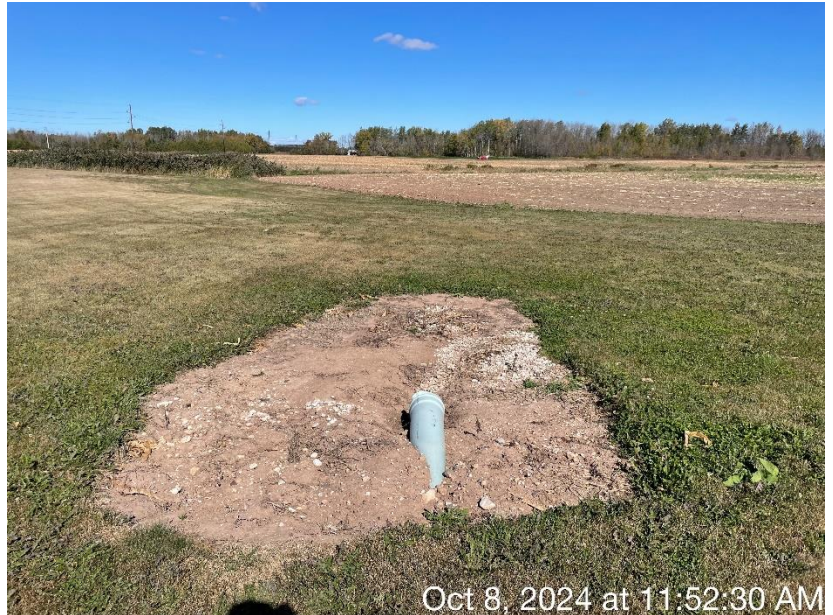
Photo 108. A stormwater outlet located on the north side of the production site at the Longfellow Site.

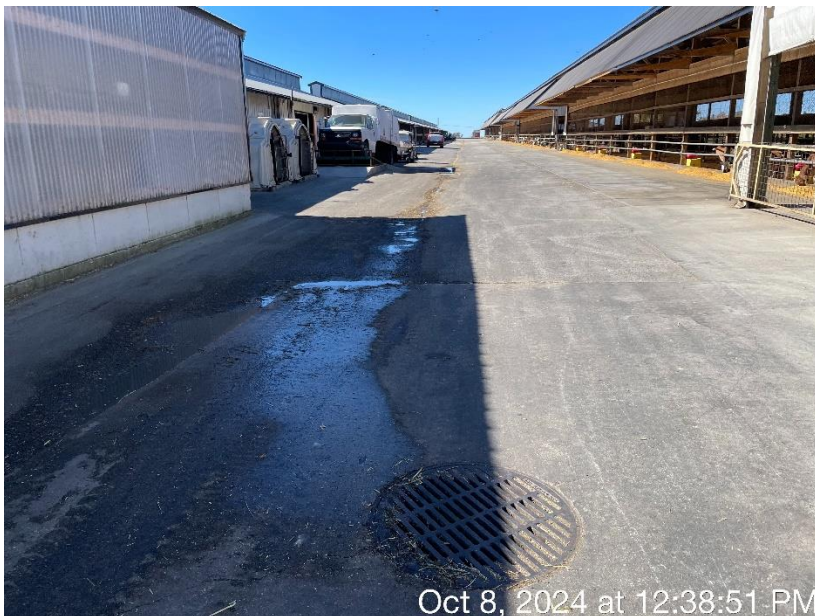
Photo 109. A stormwater outlet located between the calf barns on the south side of the production site at the Main Site. The inlet accepts runoff from the driveway and barn roofs and conveys the runoff to the southern stormwater pond.

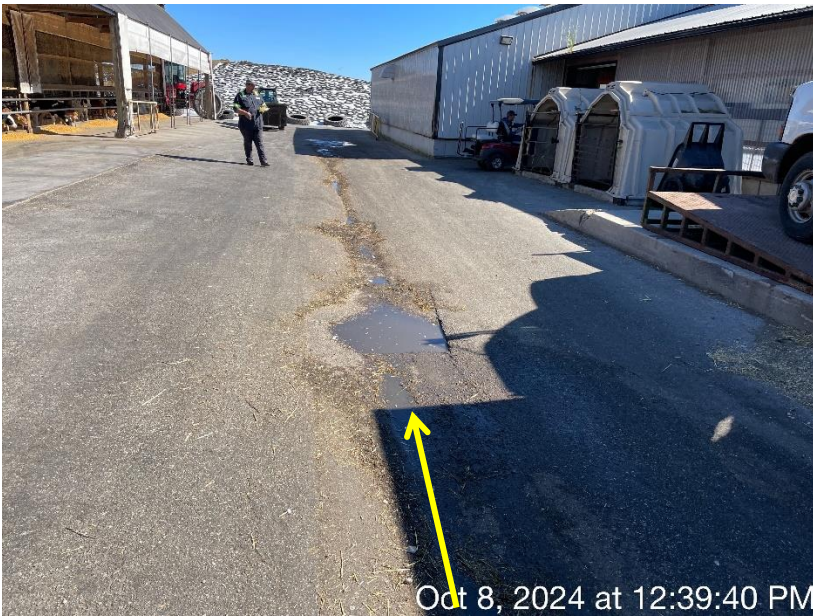
Photo 110. The flow path of stormwater on the driveway between the calf barns at the Main Site. Some feed and bedding debris was present within the flow path. This photo was taken facing east.

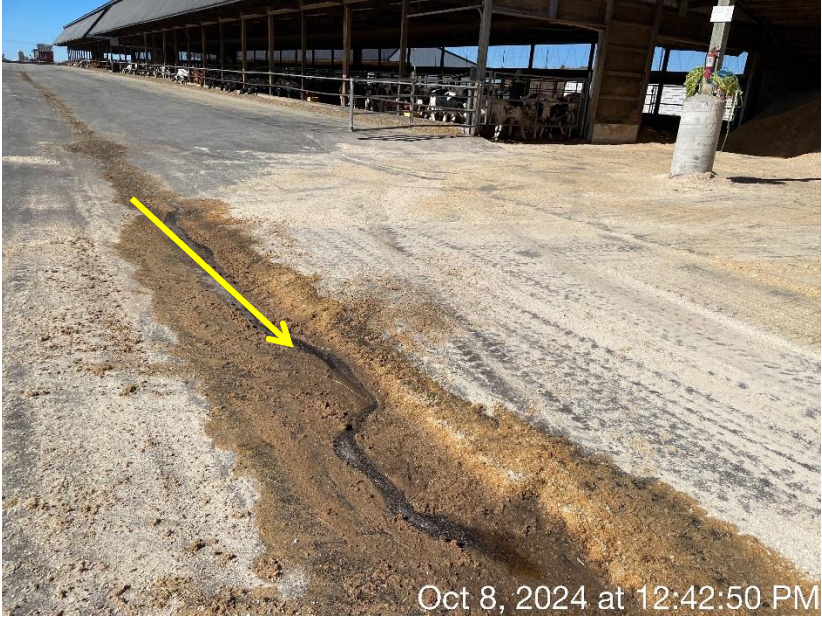
Photo 111. The flow path of stormwater through bedding debris (sawdust) on the driveway between the calf barns.

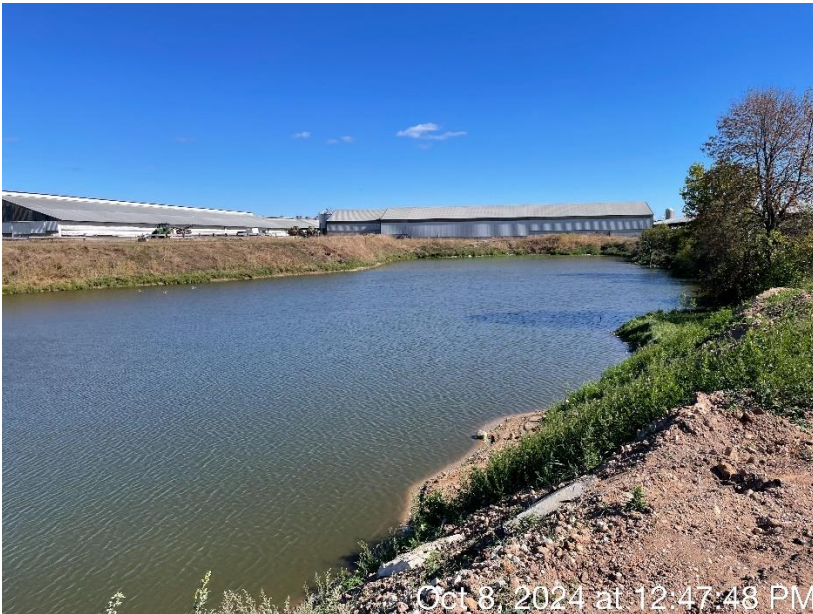
Photo 112. The large stormwater pond located north of the calf barns and south of the waste storage facilities at the Main Site. This photo was taken facing east.

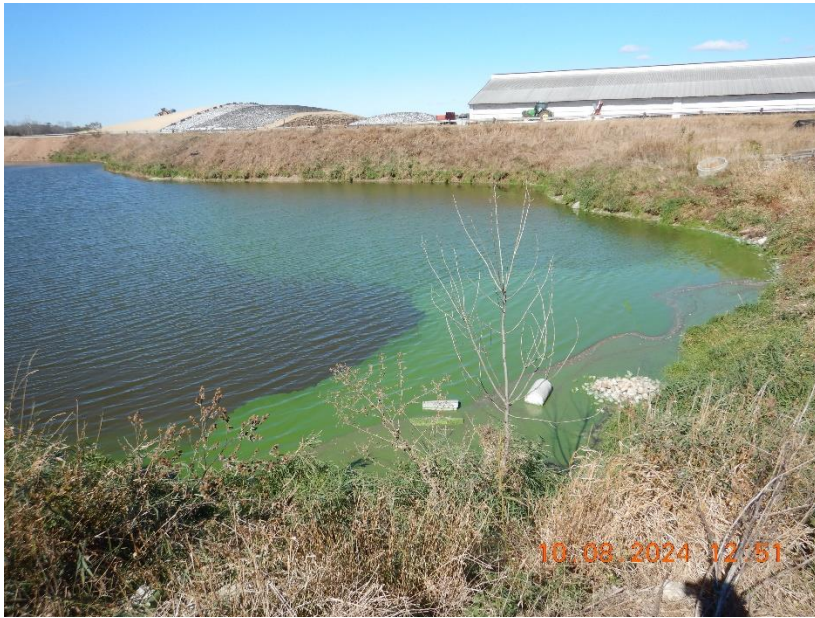
Photo 113. An algal bloom present within the large stormwater pond at the Main Site. This photo was taken facing northwest.

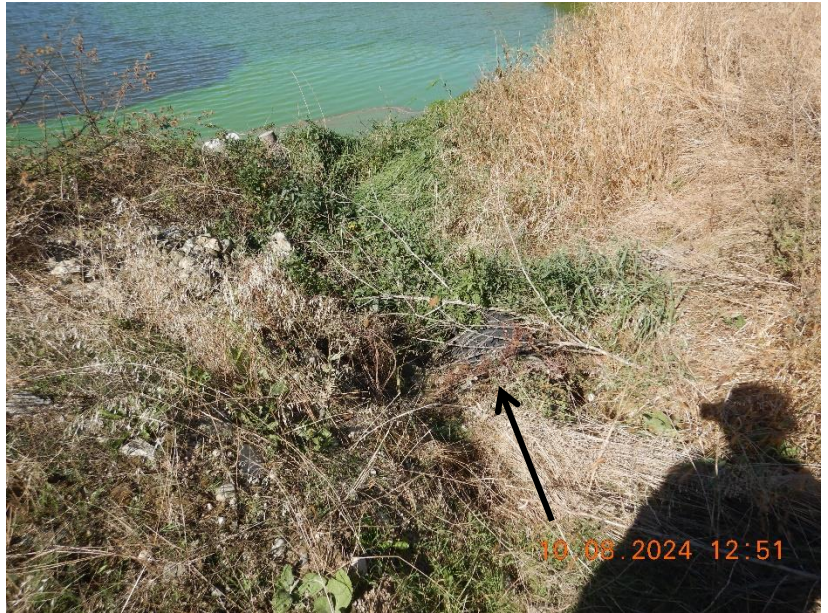
Photo 114. The outlet associated with the stormwater inlet pictured in Photo 108. The outlet discharges stormwater in the southeast corner of the large stormwater pond.

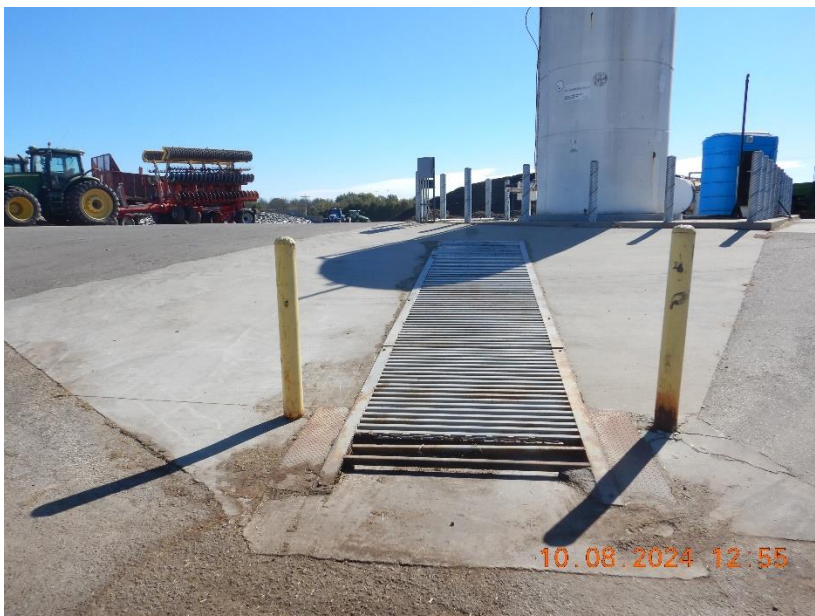
Photo 115. A stormwater collection inlet located near the fuel storage area at the Main Site.

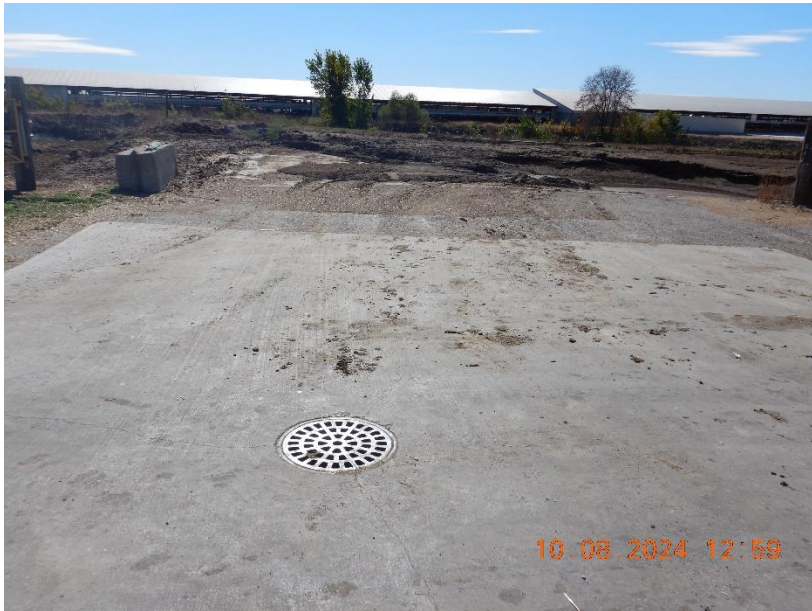
Photo 116. A surface inlet located near WSF 1 and WSF 2 at the Main Site. This photo was taken facing south.

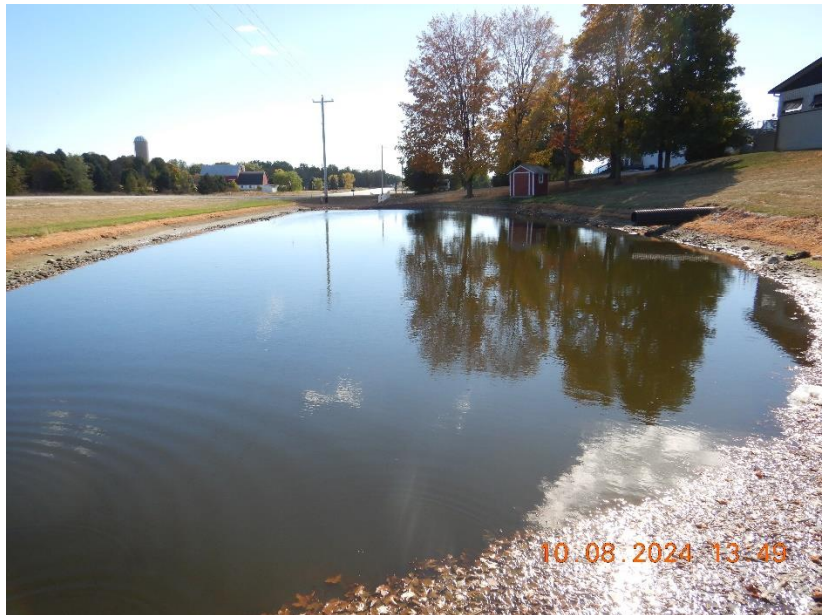
Photo 117. The small stormwater pond located on the east side of the production site, adjacent to County Rd D.

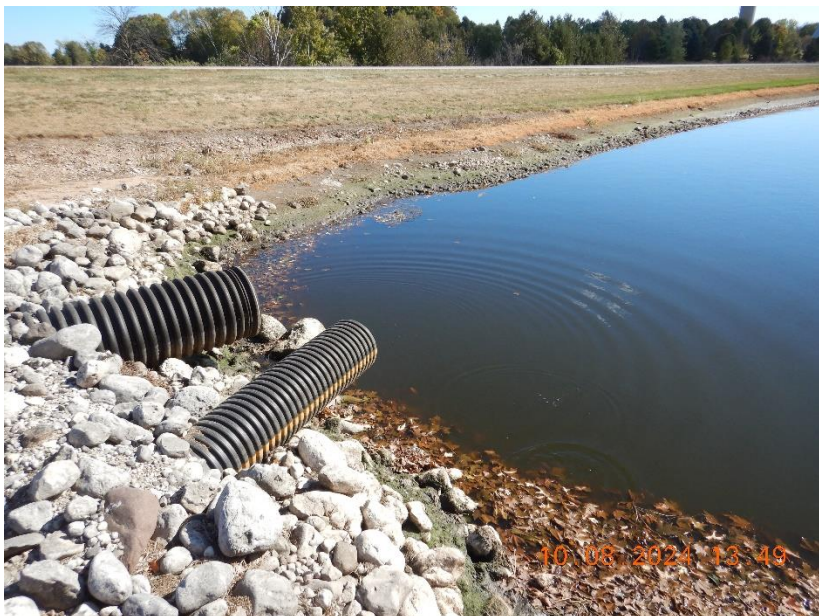
Photo 118. The small stormwater pond located on the east side of the production site, adjacent to County Rd D.

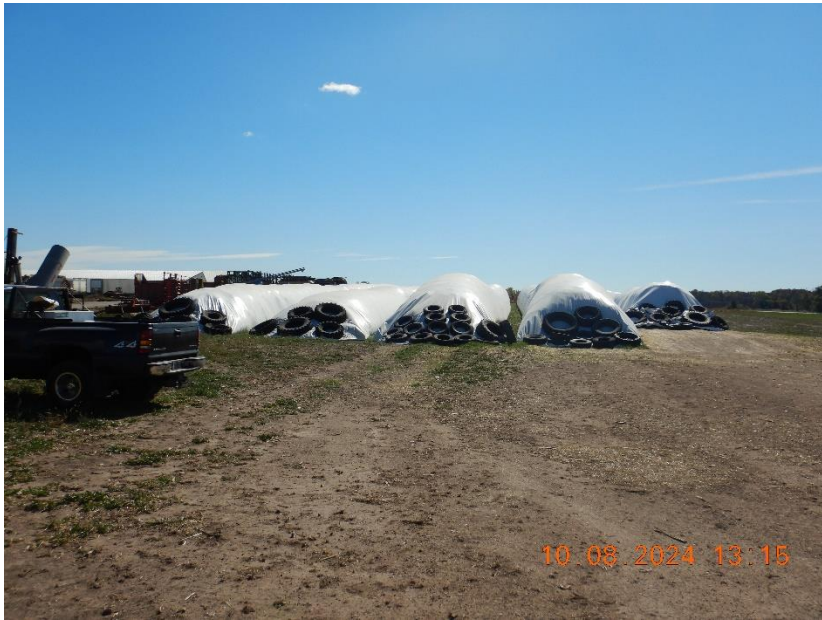
Photo 119. Chopped straw stored in AgBags, located on the west side of the production site at the Main Site.

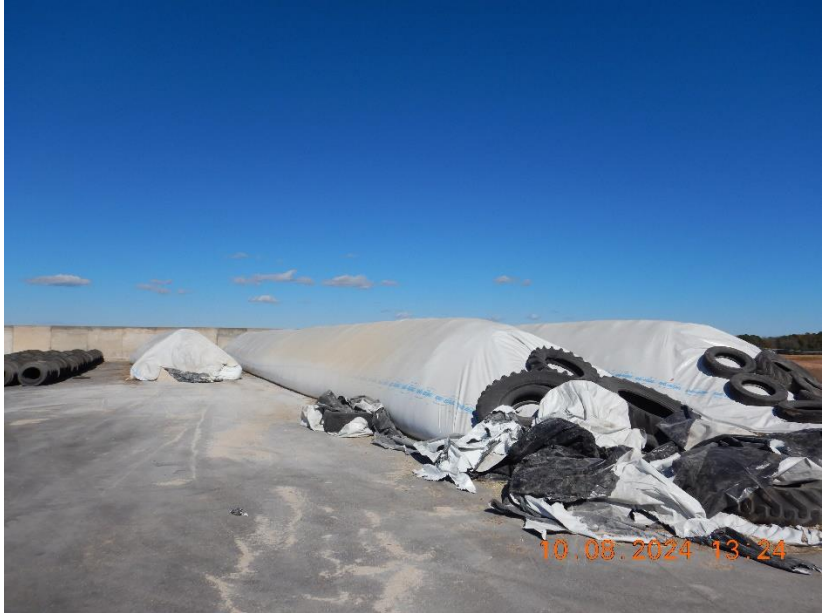
Photo 120. Chopped rye stored in AgBags on an asphalt pad located on the north side of the production site.

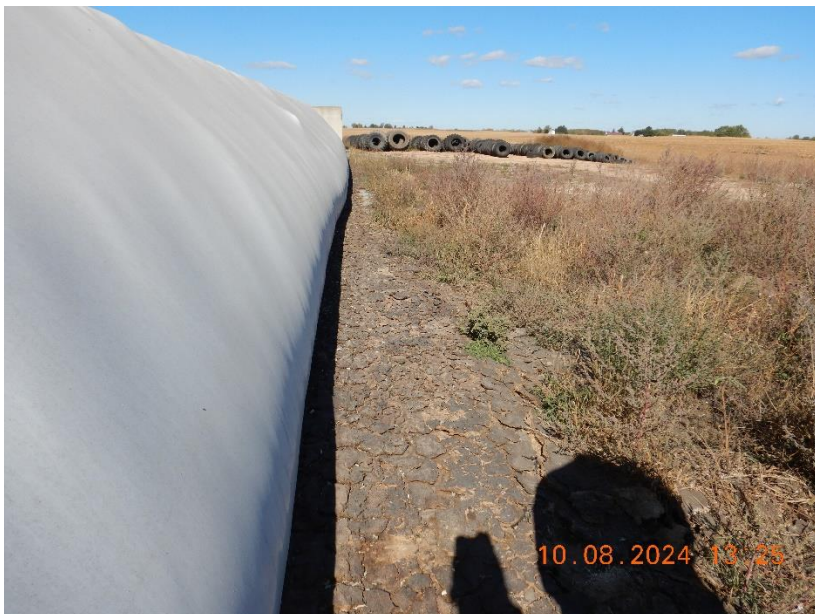
Photo 121. Dried organic matter present adjacent to the chopped rye bags pictured in Photo 118. The dried material appeared to be black, consistent with leachate.

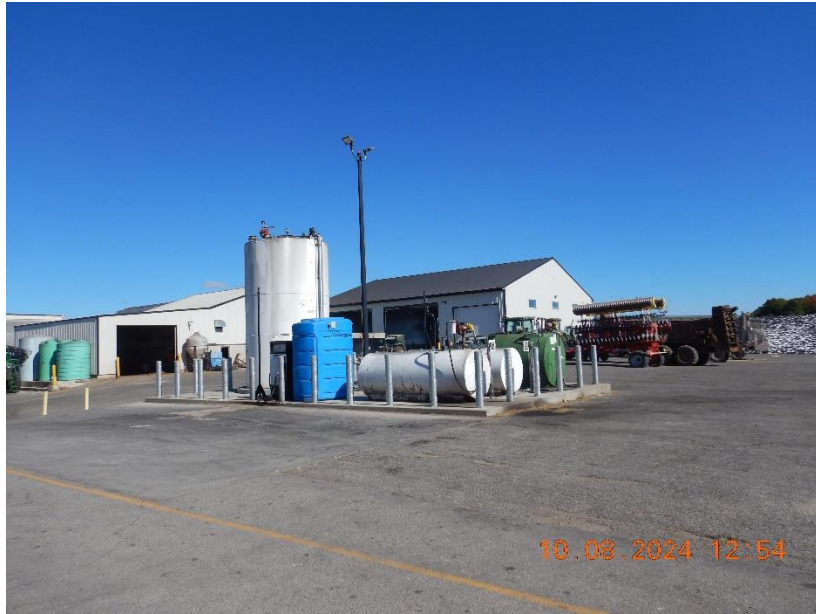
Photo 122. Fuel storage at the Main Site, located near the southern feed storage area.

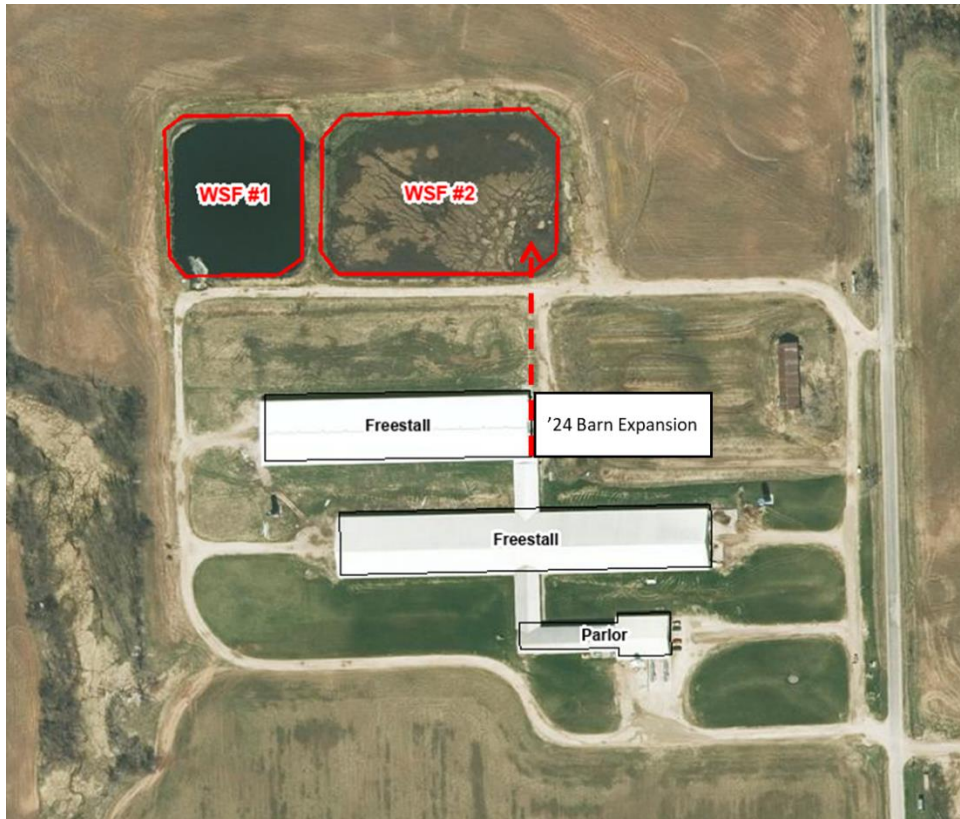
Aerial Map 2. The aerial map above illustrates the west production site at Tonet Dairy. The site consists of two animal barns, a milking parlor, and two liquid waste storage facilities.

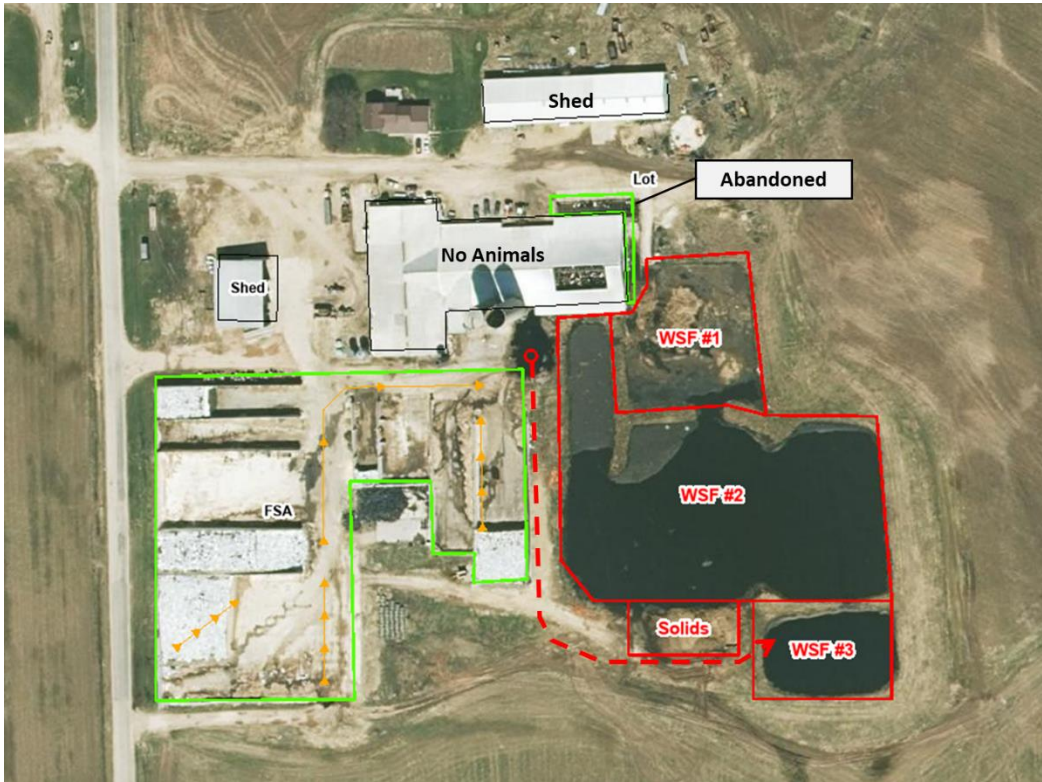
Aerial Map 3. The aerial map above illustrates the east production site at Tonet Dairy. The site consists of a feed storage area, commodity sheds, machine sheds, a solid stacking area, and three liquid waste storage facilities. Animals are no longer housed at the east site.

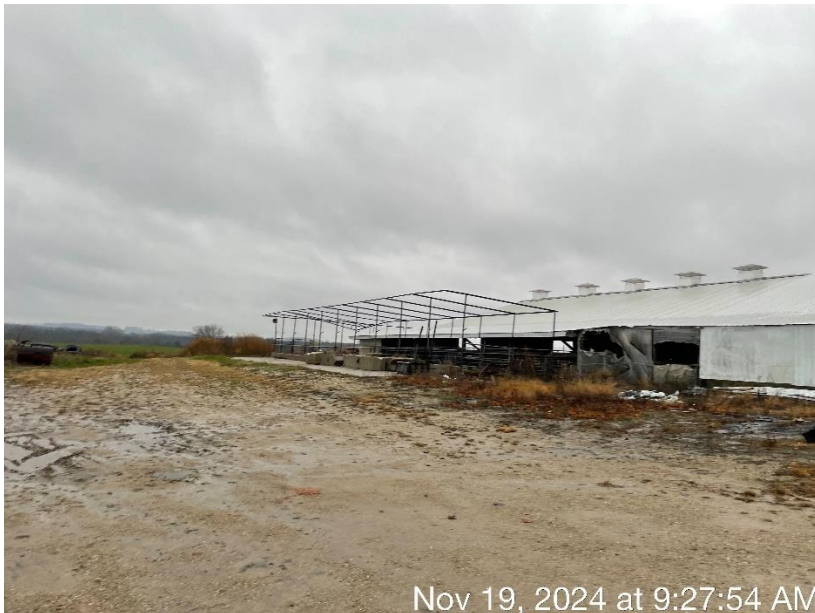
Tonet Dairy no longer utilizes outdoor feedlots. All animals at Tonet Dairy are housed under roof. An abandoned feed lot is present at the east site, which no longer has animals.

Photo 1. The abandoned feedlot located at the East Site. Animals are no longer housed at the East Site.

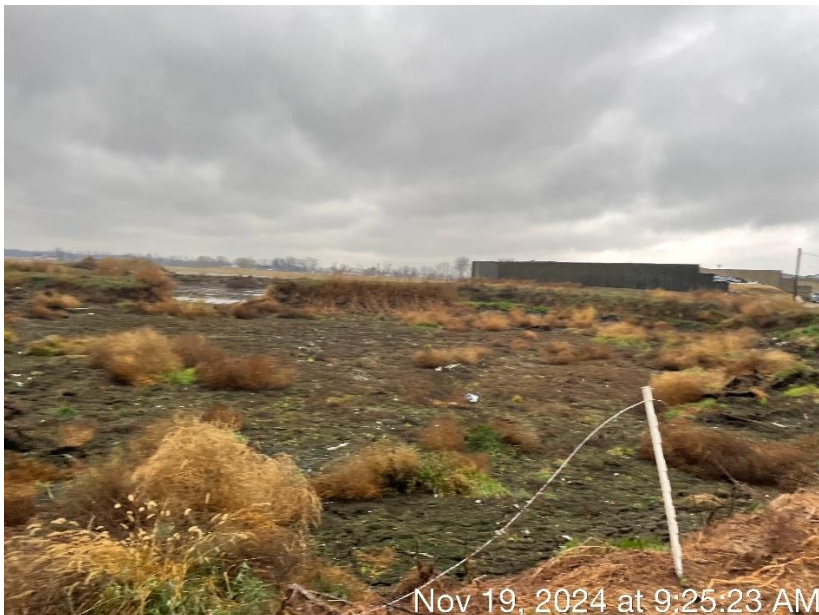
Photo 2. WSF 1, located at the East Site. WSF 1 is located on the east side of the production area, north of WSF 2. Fencing around the storage was in poor repair.
