Permit Fact Sheet

Permit Number	WI-0062235-05-0
Permittee Name and Address	Ebert Enterprises LLC N6939 Cty Hwy D Algoma, WI 54201
Permitted Facility Name and Address	Home Farm- N6939 County Road D, Algoma, WI 54201 Tonet Dairy- N7521 Tonet Rd, Luxemburg, WI 54217 Tonet Dairy- N7518 Tonet Rd, Luxemburg, WI 54217 Longfellow Farm- N6388 Longfellow Road, Algoma, WI 54201 K Farm- 5083 County Road K, Algoma, WI 54201 S Farm- E5639 County Rd S, Algoma, WI 54201
Permit Term	August 01, 2026 to July 31, 2031
Receiving Water	Unnamed tributaries within the Ahnapee River Watershed, and groundwaters of the state.
Discharge Type	Existing source CAFO per NR 243.03(23) as the facility has been permitted since 2002.

CAFO Compliance Report (1/31/2025)

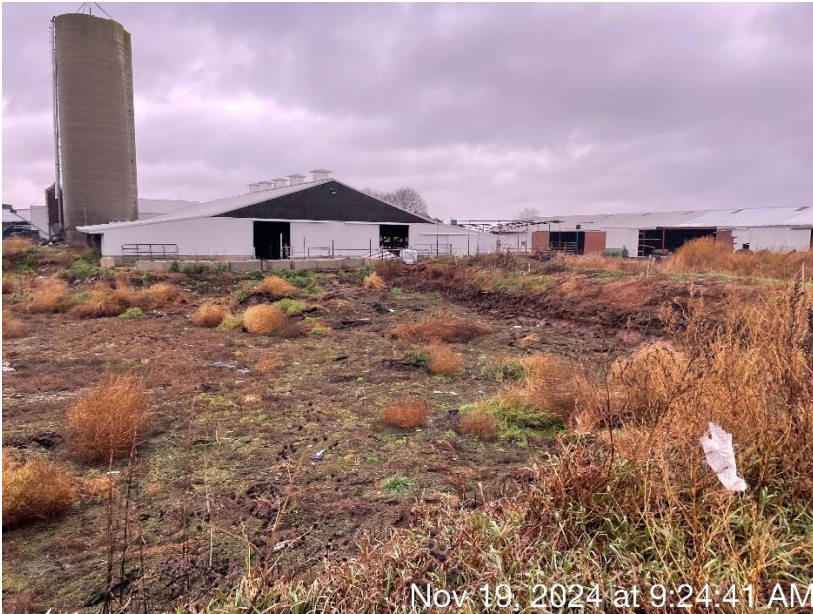
Photo 3. WSF 1, located at the East Site. WSF 1 is located on the east side of the production area, north of WSF 2. Fencing around the storage was in poor repair. This photo was taken facing west.

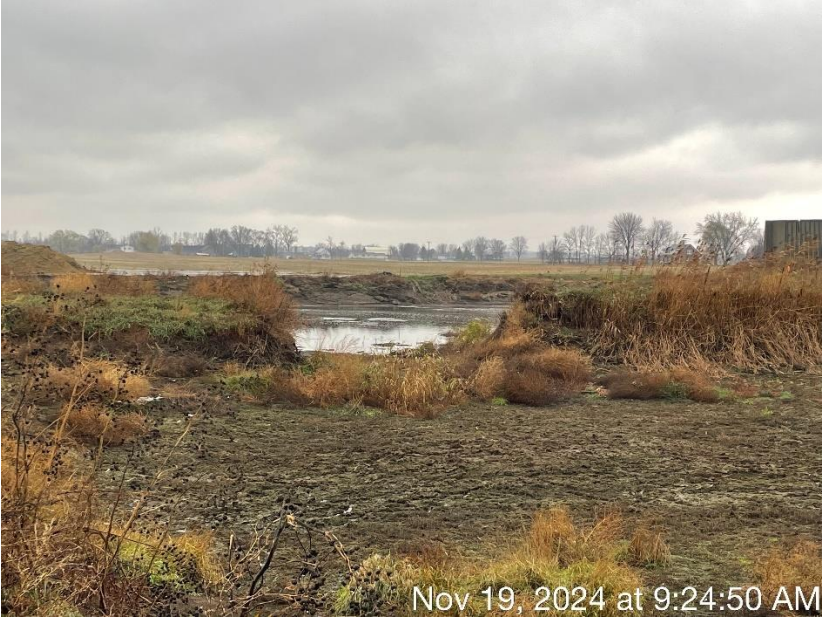
Photo 4. The weir that connects WSF 1 and WSF 2 at the East Site. This photo was taken facing south.

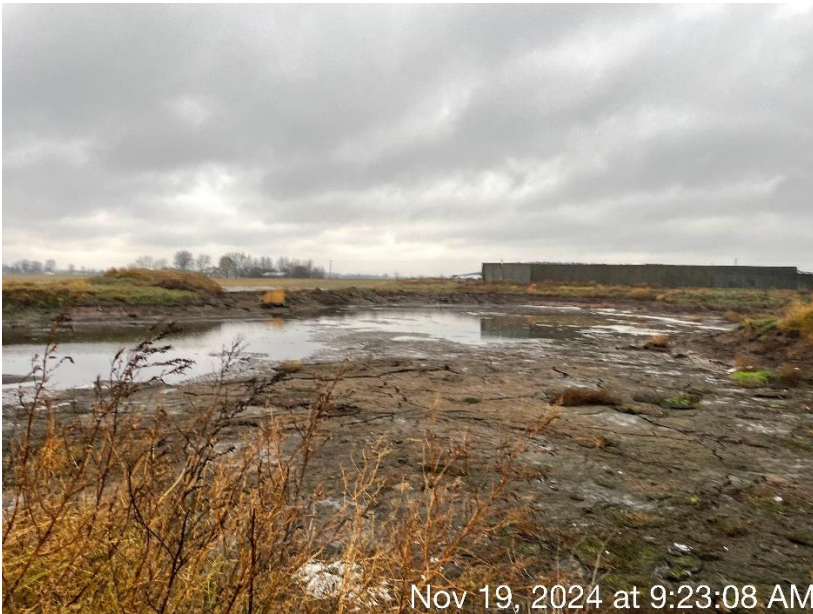
Photo 5. WSF 2, located at the East Site. WSF 2 is located south of WSF 1 and north of WSF 3. This photo was taken facing west.

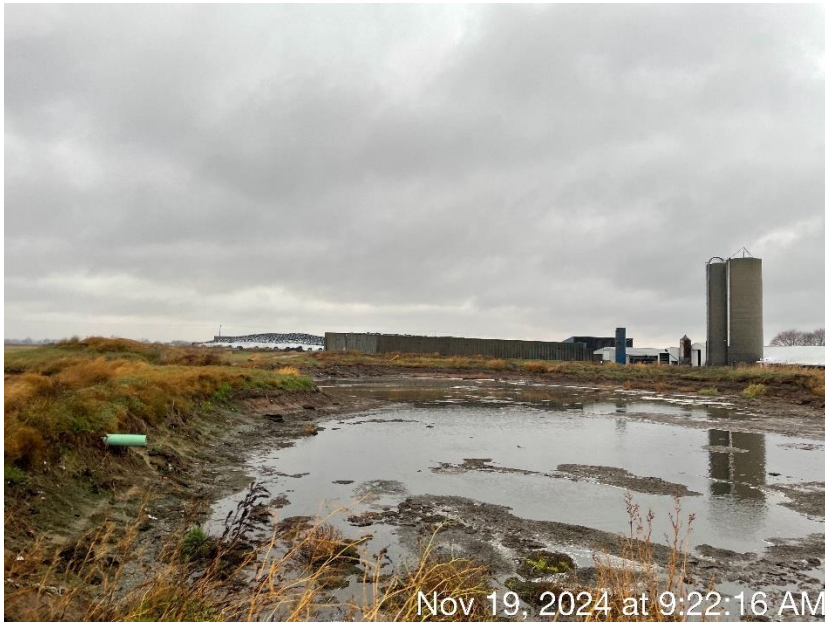
Photo 6. WSF 2, located at the East Site. WSF 2 is located south of WSF 1 and north of WSF 3. The PVC pipe pictured in the photo conveys manure to WSF 3. This photo was taken facing west.

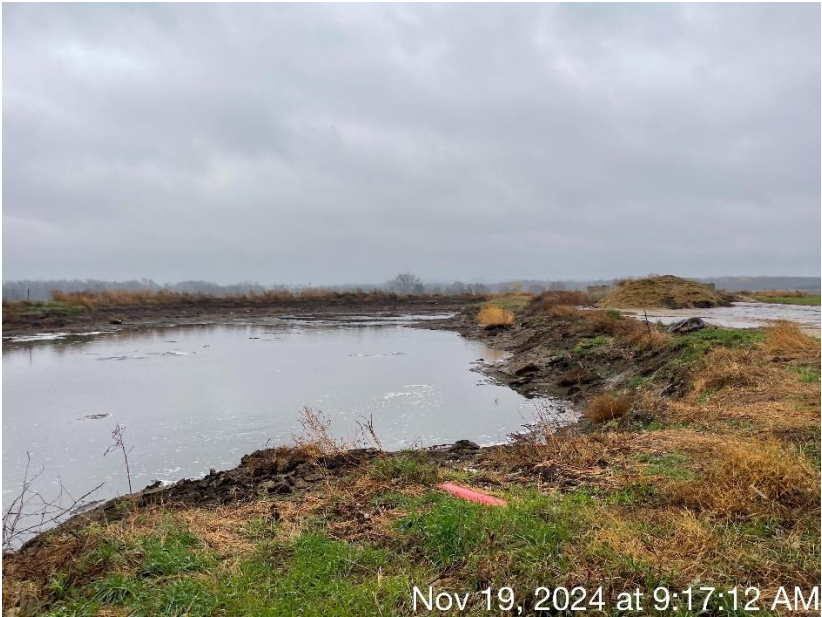
Photo 7. WSF 2, located at the East Site. WSF 2 is located south of WSF 1 and north of WSF 3. This photo was taken from the west side of the storage, facing east.

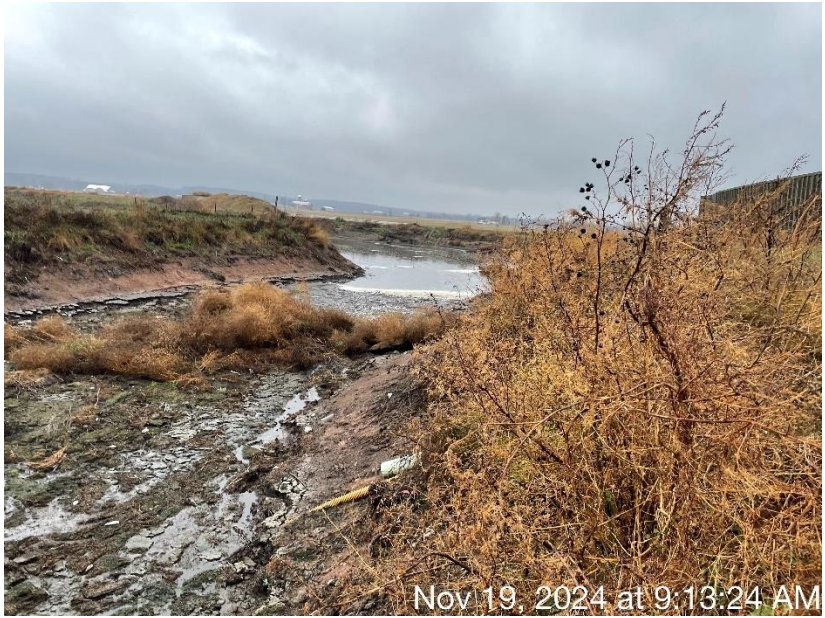
Photo 8. The west side of WSF 2, which has an irregular shape. This photo was taken facing south.

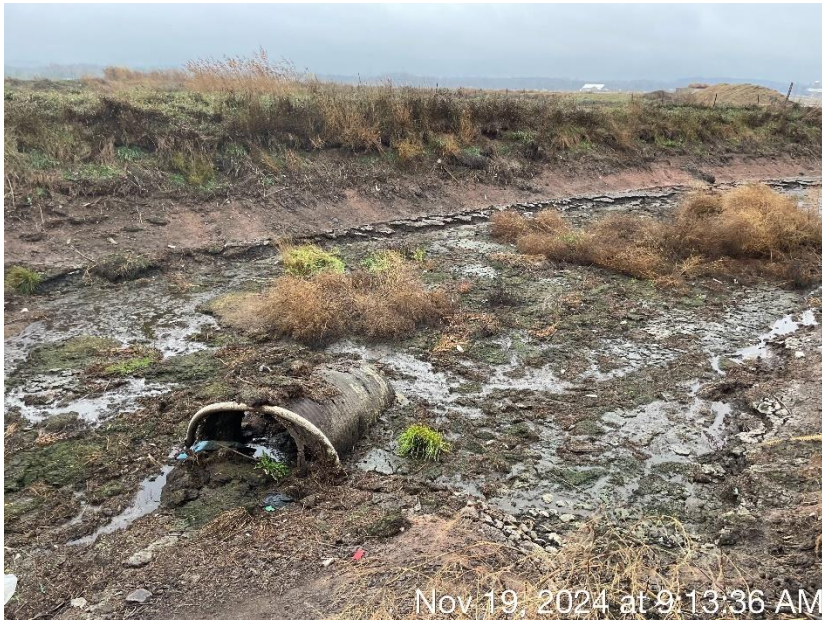
Photo 9. The west side of WSF 2, which has an irregular shape.

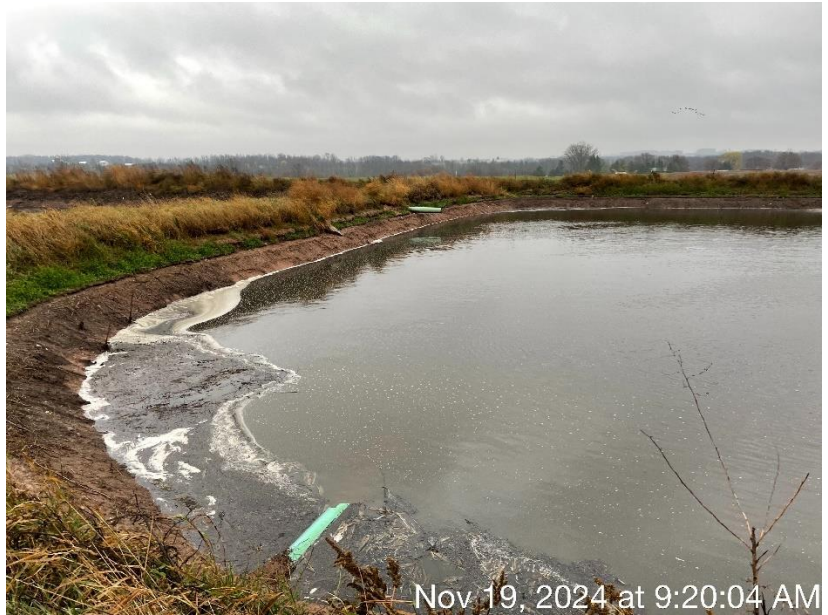
Photo 10. WSF 3, located at the East Site. WSF 3 is located south of WSF 2 and accepts runoff from the feed storage area. This photo was taken facing east.

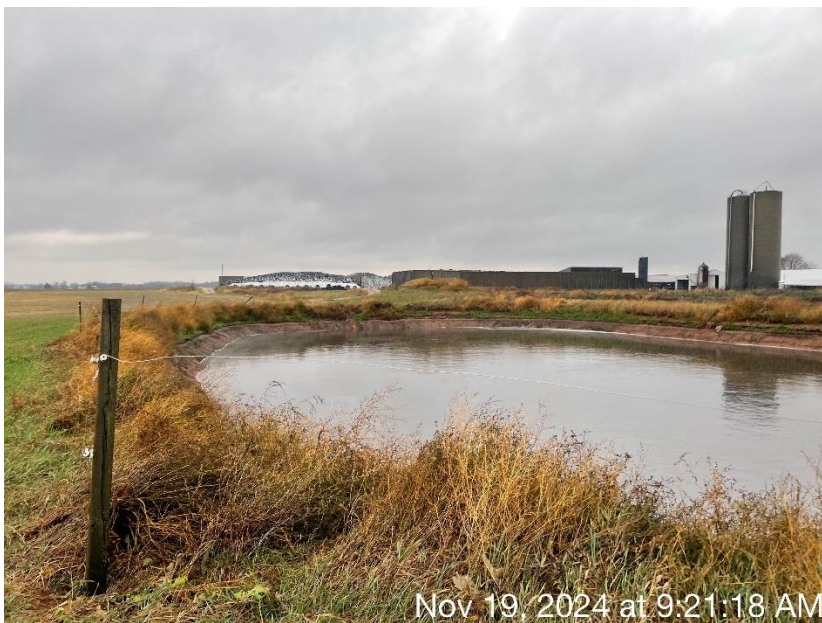
Photo 11. WSF 3, located at the East Site. WSF 3 is located south of WSF 2 and accepts runoff from the feed storage area. This photo was taken facing west.

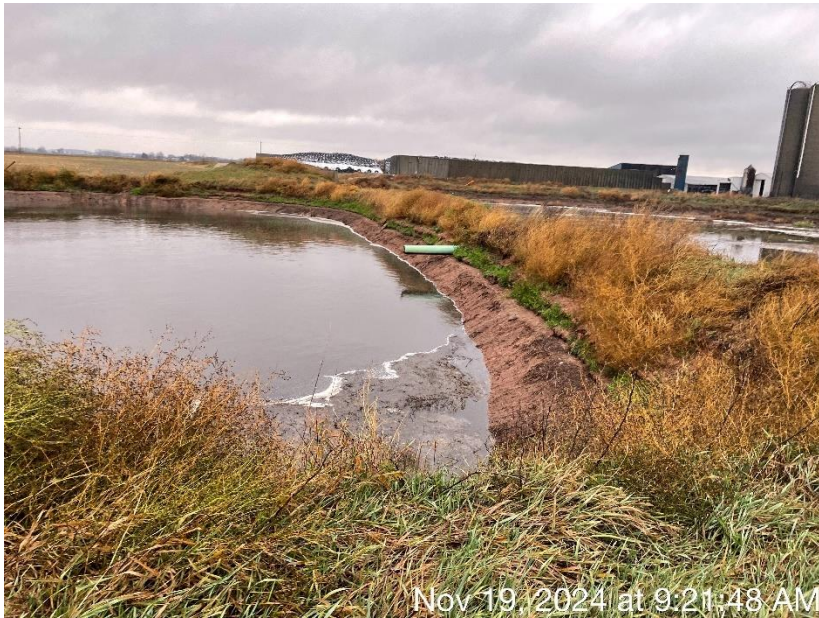
Photo 12. WSF 3, located at the East Site. The pipe that conveys manure between WSF 2 and WSF 3 can be seen in the photo. This photo was taken facing west.

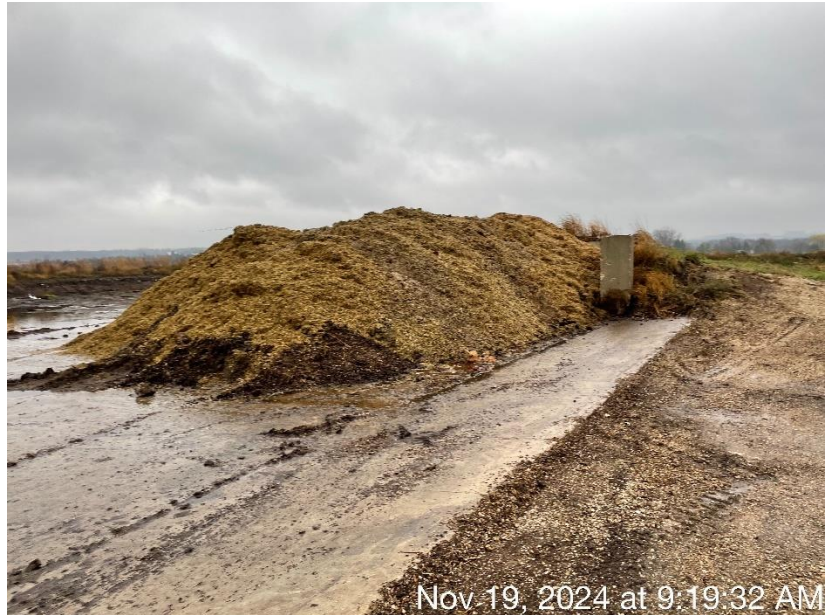
Photo 13. The solid stacking area located on the south side of WSF 2 at the East Site. Runoff from the stacking area gravity flows into WSF 2.

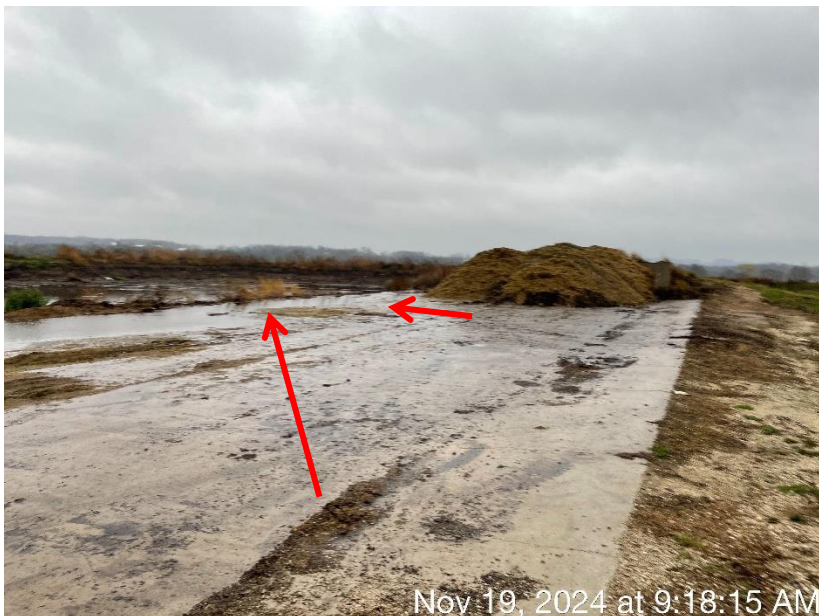
Photo 14. The flow path of runoff from the stacking area into WSF 2. This photo was taken facing east.

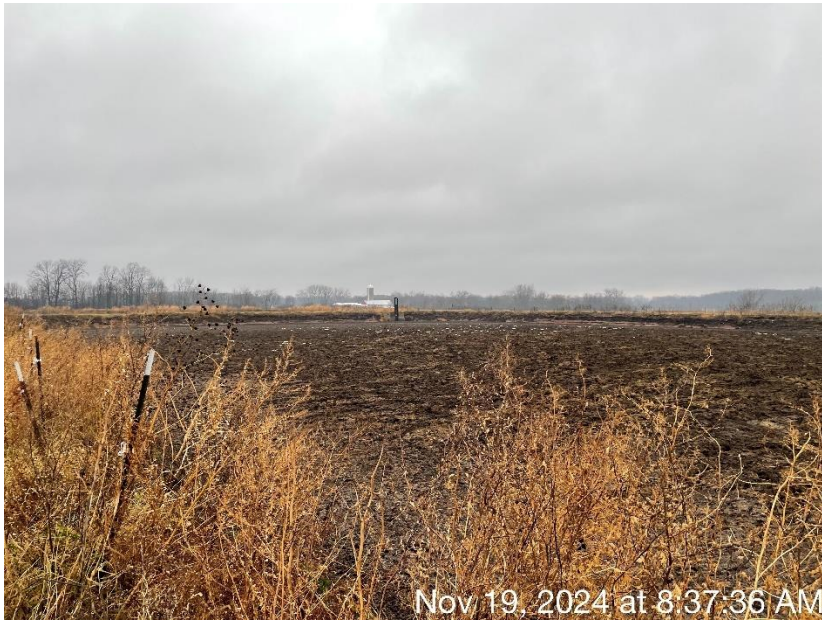
Photo 15. WSF 4 located at the West Site. WSF 4 accepts manure from the freestall barns at the West Site and is located east of WSF 5. This photo was taken facing northwest.

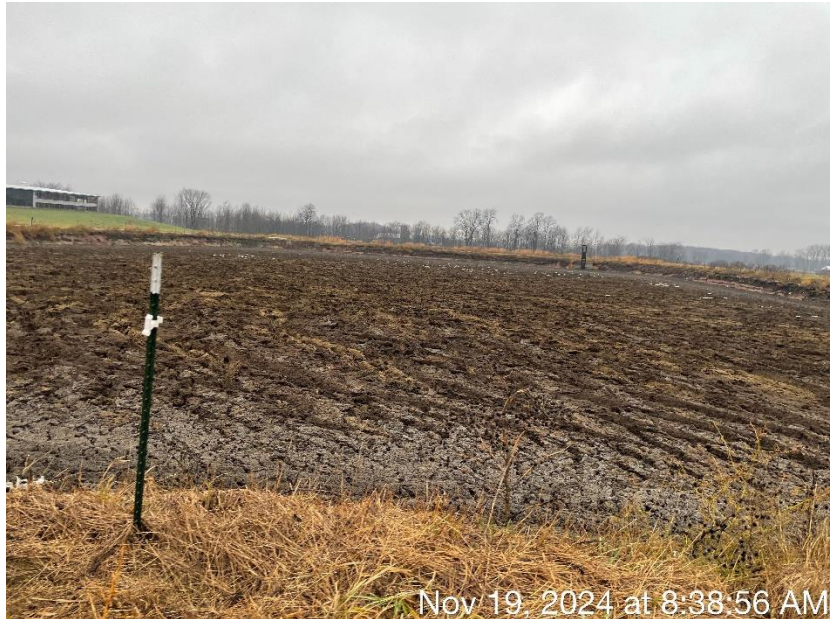
Photo 16. WSF 4 located at the West Site. WSF 4 accepts manure from the freestall barns at the West Site and is located east of WSF 5. This photo was taken facing west.

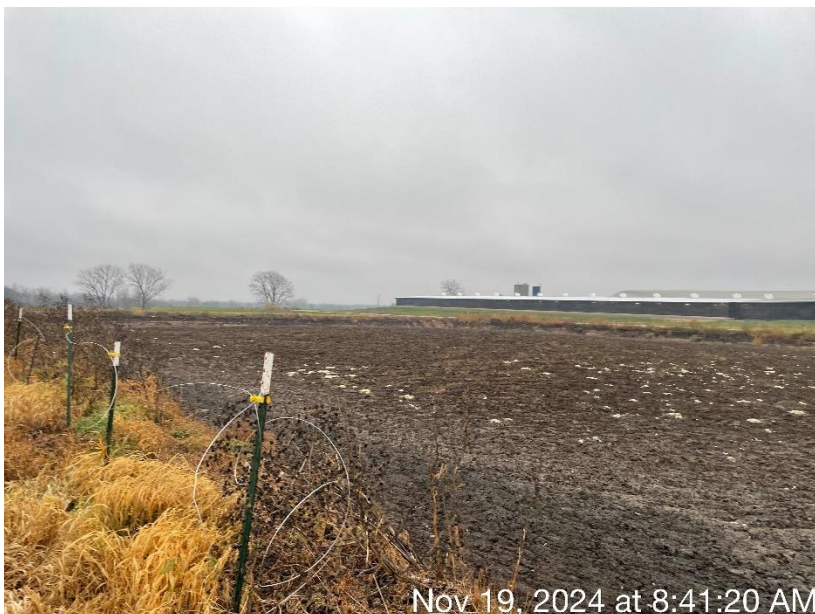
Photo 17. WSF 4 located at the West Site. WSF 4 accepts manure from the freestall barns at the West Site and is located east of WSF 5. This photo was taken facing southeast.

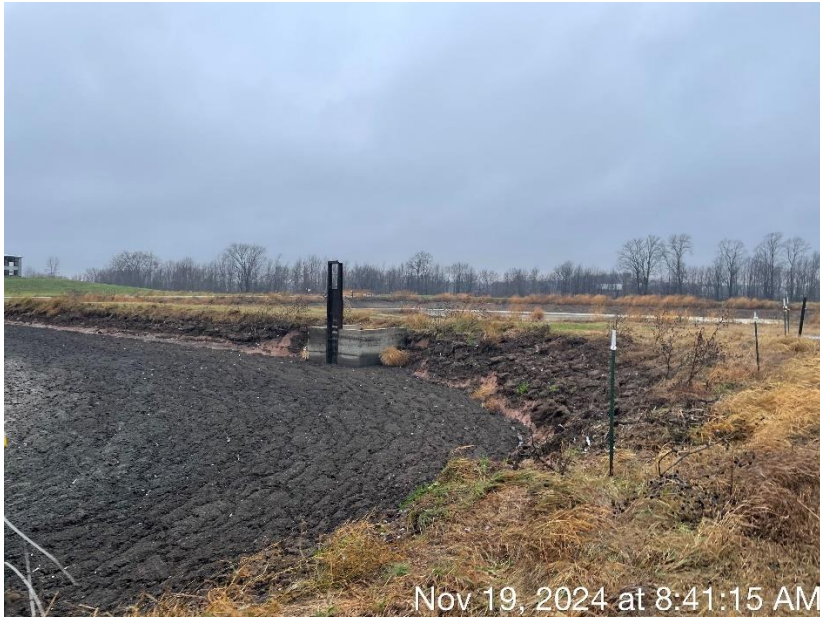
Photo 18. The berm between WSF 4 and WSF 5 at the West Site. Manure flows through the concrete ladder weir, pictured in the photo. This photo was taken facing southwest.

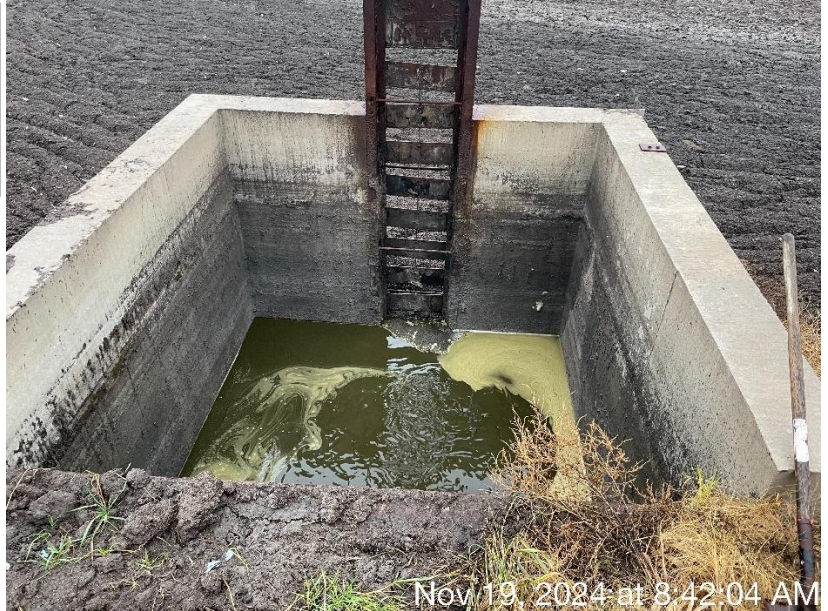
Photo 19. The concrete ladder weir that conveys manure from WSF 4 to WSF 5. The weir is located on the west side of WSF 4.

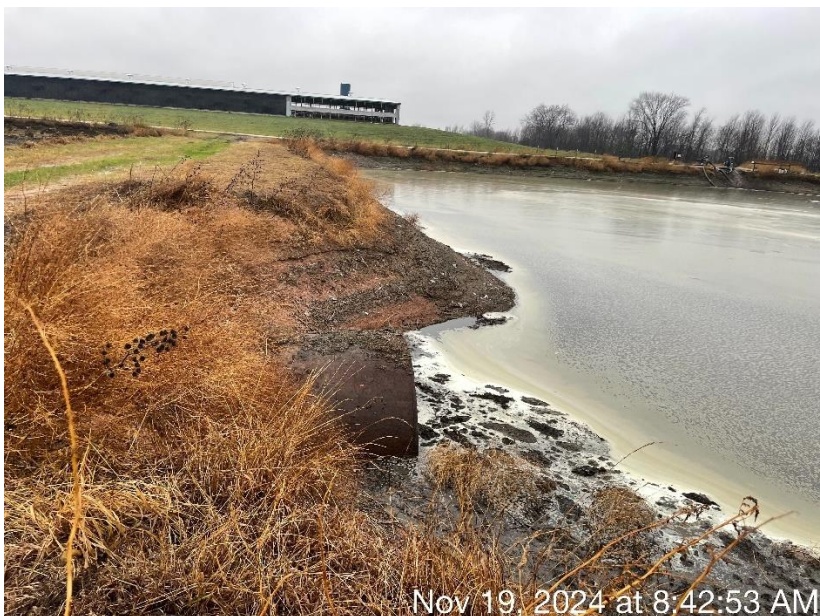
Photo 20. The outfall from the ladder weir into WSF 5. Significant erosion was present around the outfall on the east side of WSF 5.

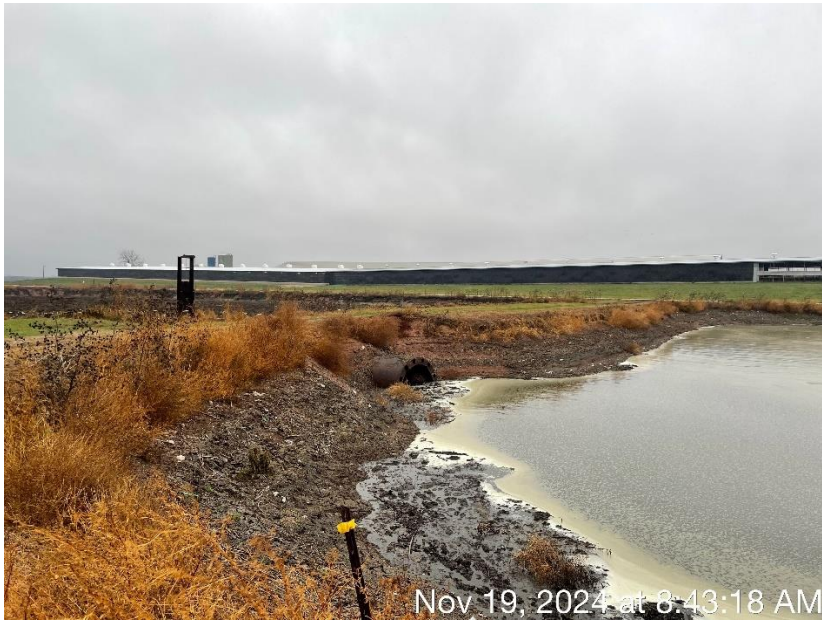
Photo 21. The outfall from the ladder weir into WSF 5. Significant erosion was present around the outfall on the east side of WSF 5. This photo was taken facing south.

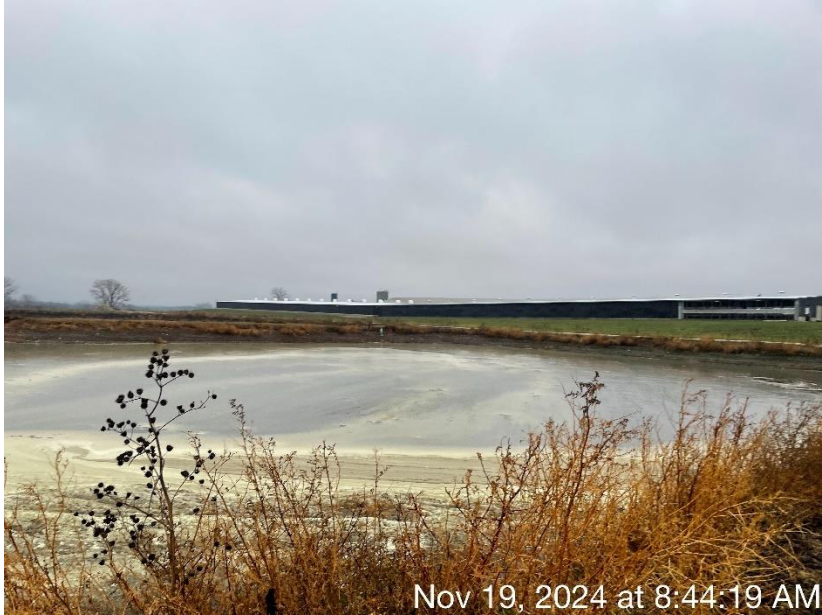
Photo 22. WSF 5 located at the West Site. WSF 5 accepts manure from WSF 4 and is located west of WSF 4. This photo was taken facing southeast.

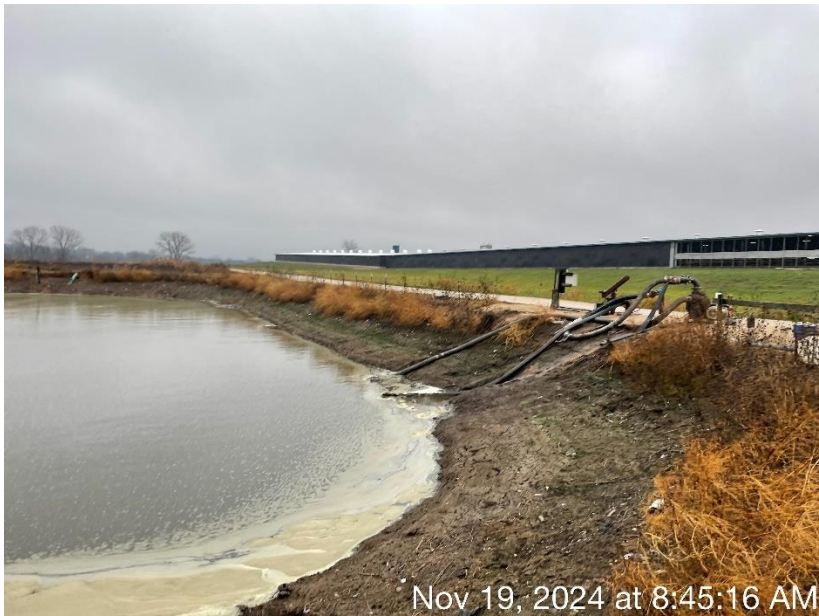
Photo 23. The south side of WSF 5 at the West Site, where the intake and pump for the flush system is located. This photo was taken facing east.

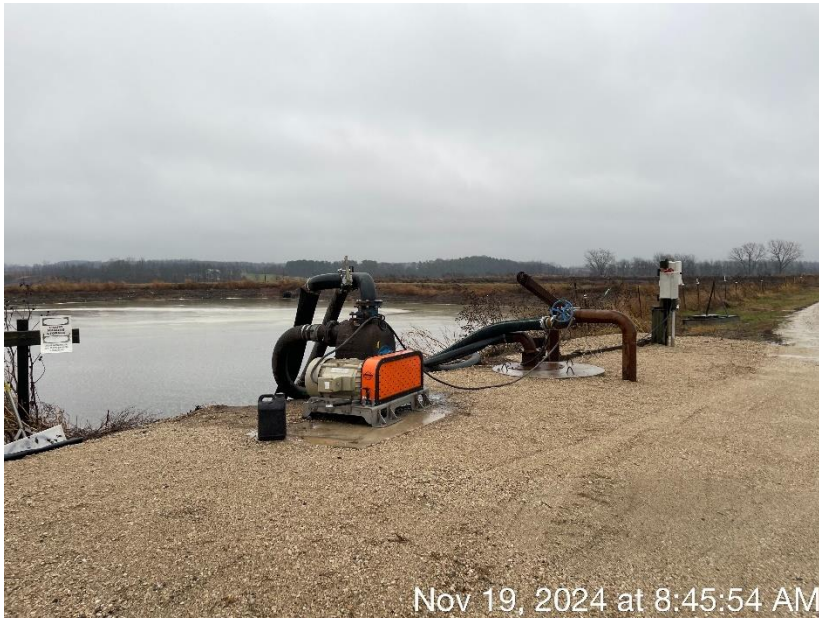
Photo 24. The pump station that collects liquid manure from WSF 5 for the flush system in the freestall barns at the West Site.

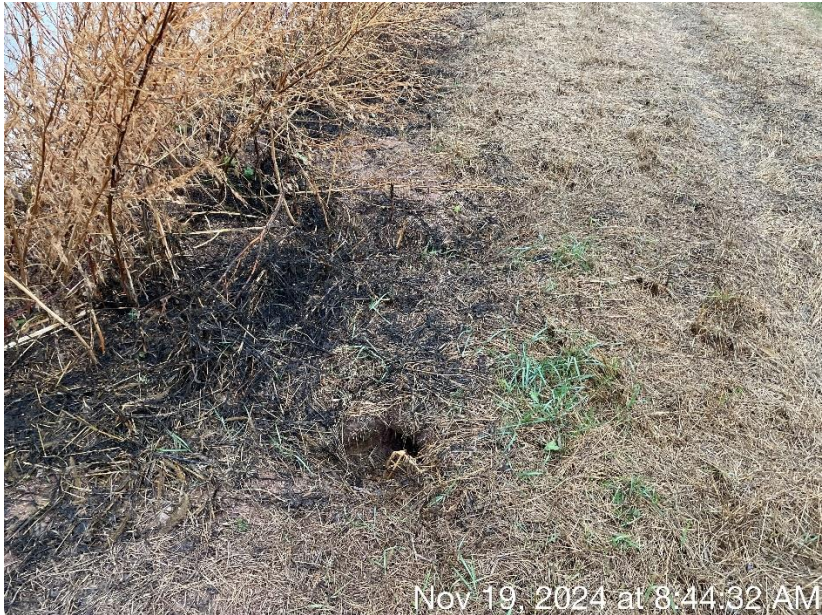
Photo 25. Animal burrowing present in the berm around WSF 5.

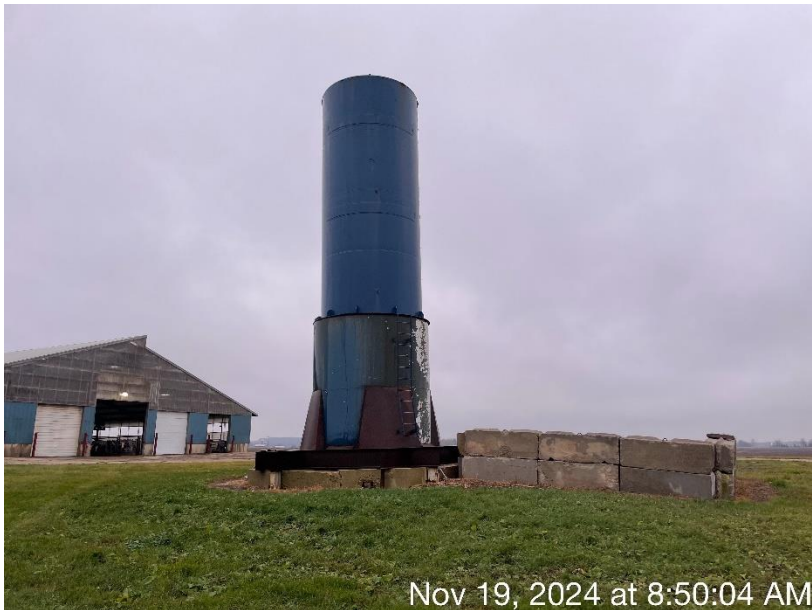
Photo 26. A silo that stores liquid manure for the flush system at the West Site.

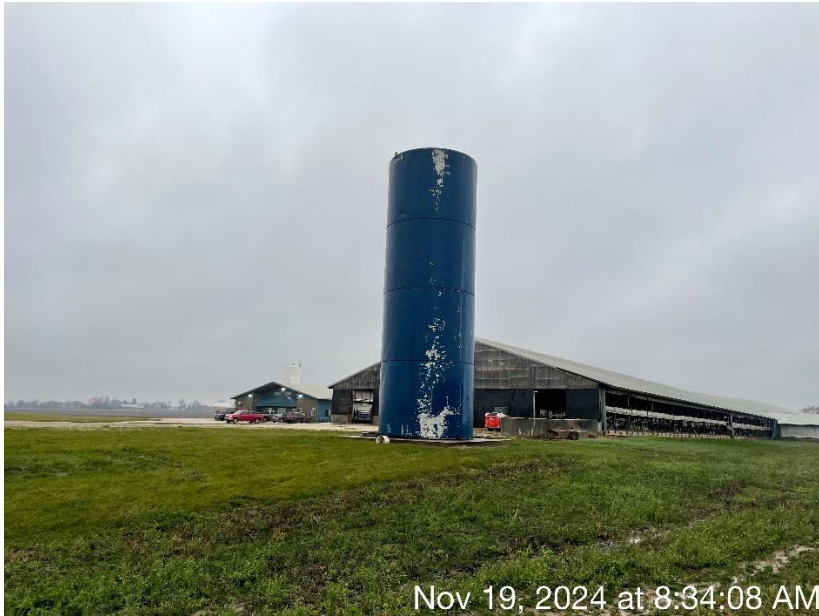
Photo 27. A second silo that stores liquid manure for the flush system at the West Site.

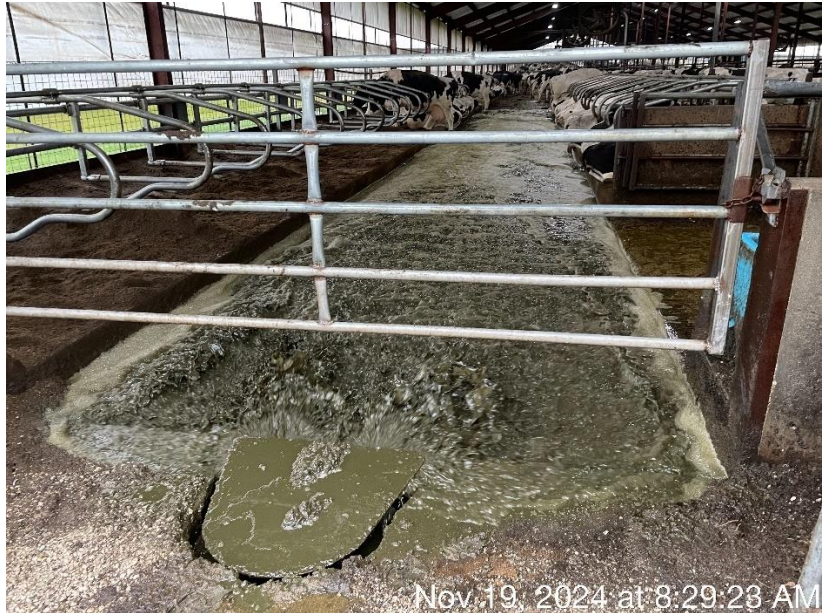
Photo 28. The flush system for the alleys in the freestall barns at the West Site.

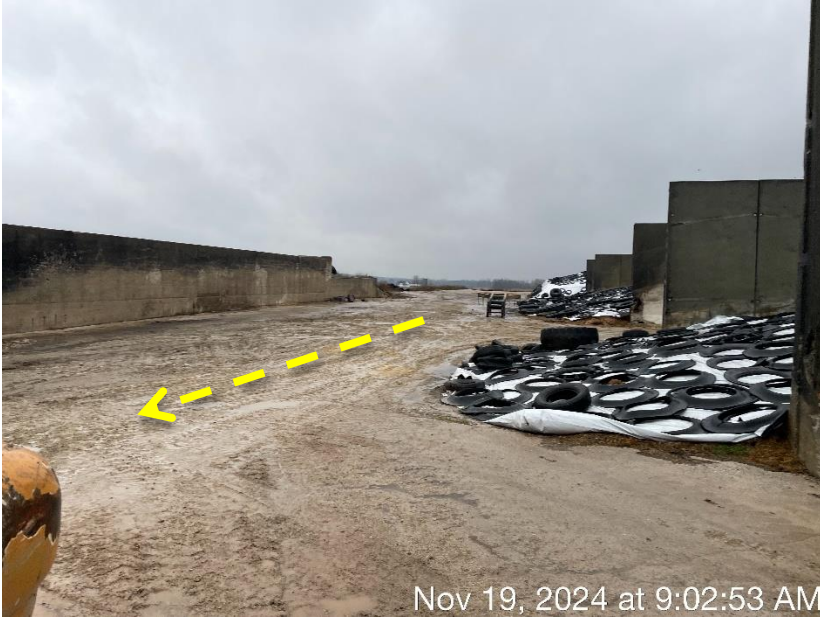
Photo 29. The feed storage area at Tonet Dairy, located at the East Site. The yellow arrow represents the flow path of runoff. This photo was taken facing south.

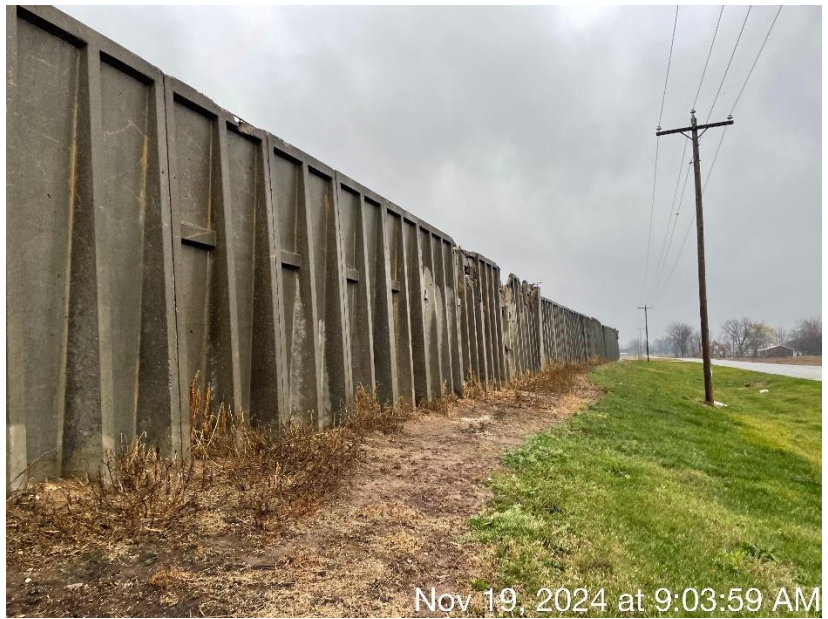
Photo 30. The wall along the west side of the feed storage area at the East Site. The wall was in poor repair, with areas that had cracked or missing concrete.

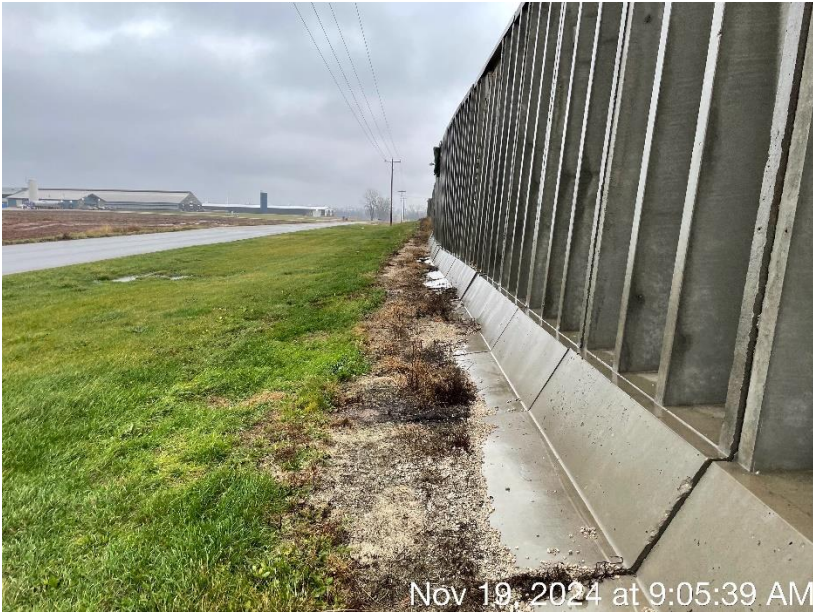
Photo 31. The wall along the west side of the feed storage area at the East Site. The wall was in poor repair, with areas that had cracked or missing concrete.

Broken concrete on the walls on the west side of the feed storage area

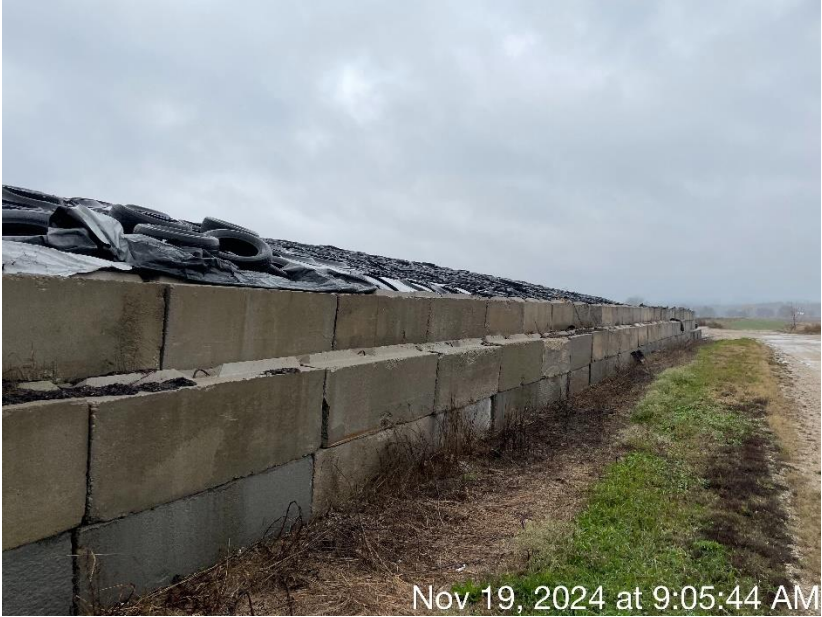
Photo 32. The wall along the south side of the feed storage area at the East Site. The wall is comprised of concrete blocks. This photo was taken facing east.

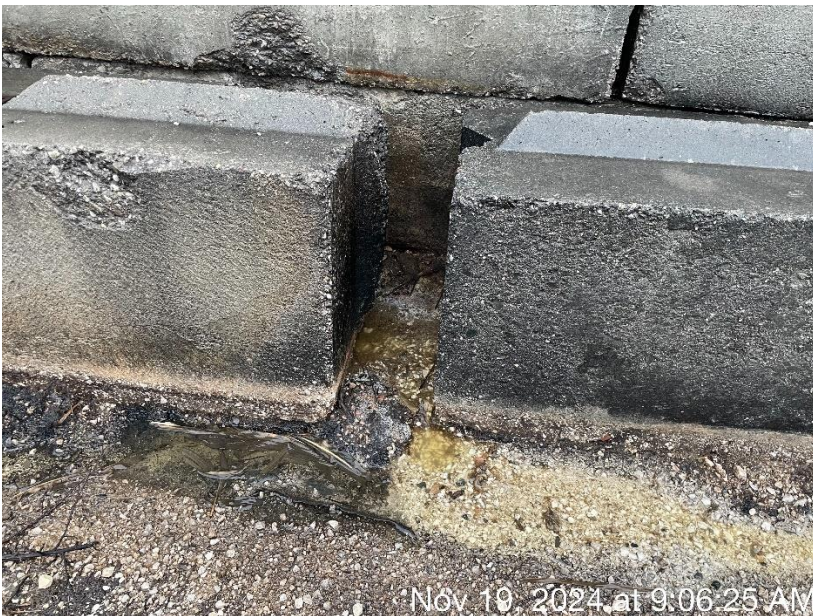
the East Site. There were areas in the feed pad where concrete was missing or broken that would require maintenance. Cracks were present in the bunker walls. Leachate was observed seeping through the southern wall along the feed pad, which consists of concrete blocks. Tonet Dairy placed gravel along the southern edge to direct the runoff back onto the concrete feed pad and towards the collection system. Leachate was also observed ponded off the feed storage area, in a grassy area adjacent to the east side of the feed storage area. Evidence of seepage through the wall along the east side of the feed storage area was observed. Maintenance is required to repair the areas where leachate is leaking through the walls around the feed storage area.

Photo 33. An area where leachate and process wastewater seeps through the southern wall along the feed storage area at the East Site.

Repair concrete walls around the feed storage area at the East Site to prevent leachate and process wastewater from continuing to seep through the walls

- Submit documentation of actions take to repair the walls around the feed storage area **by August 31, 2025**

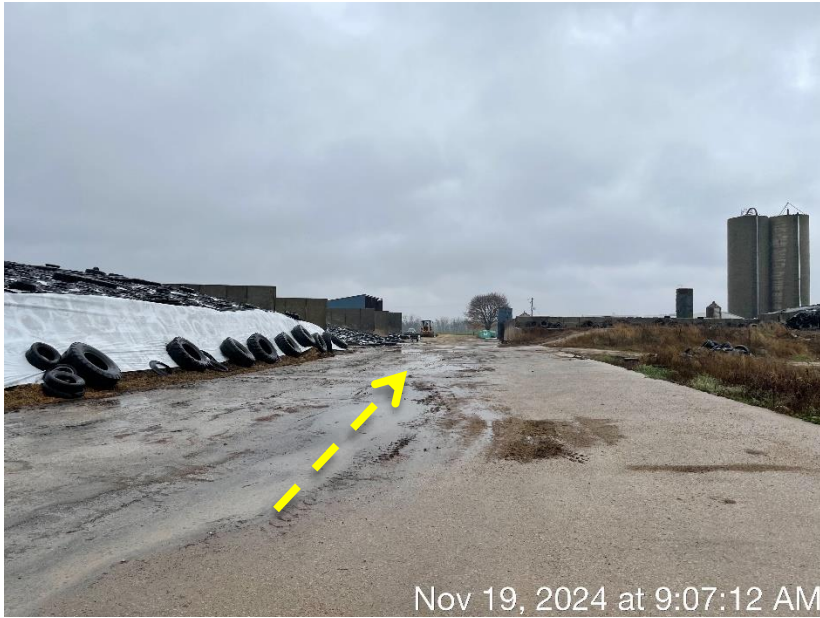
Photo 34. The flow path of runoff on the feed storage area at the East Site. This photo was taken facing north.

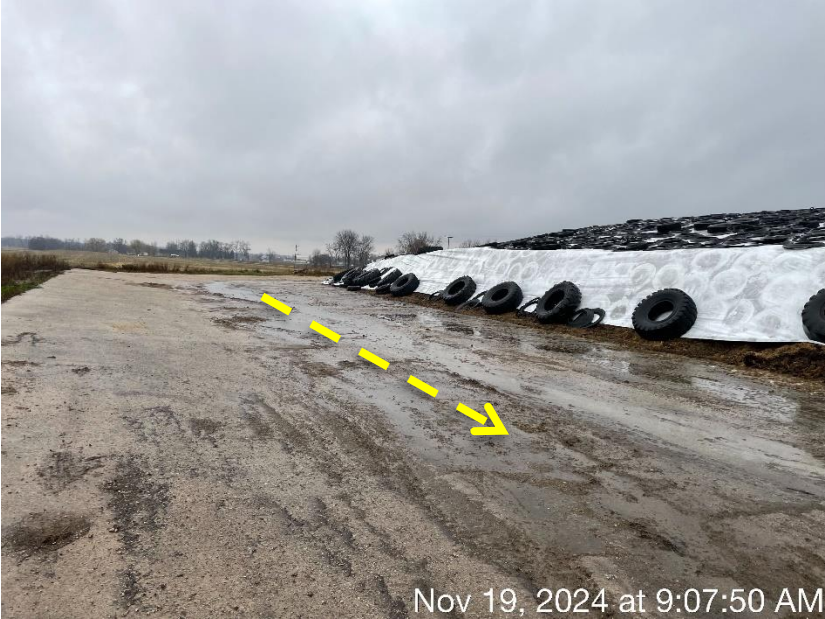
Photo 35. The flow path of runoff on the feed storage area at the East Site. This photo was taken facing south.

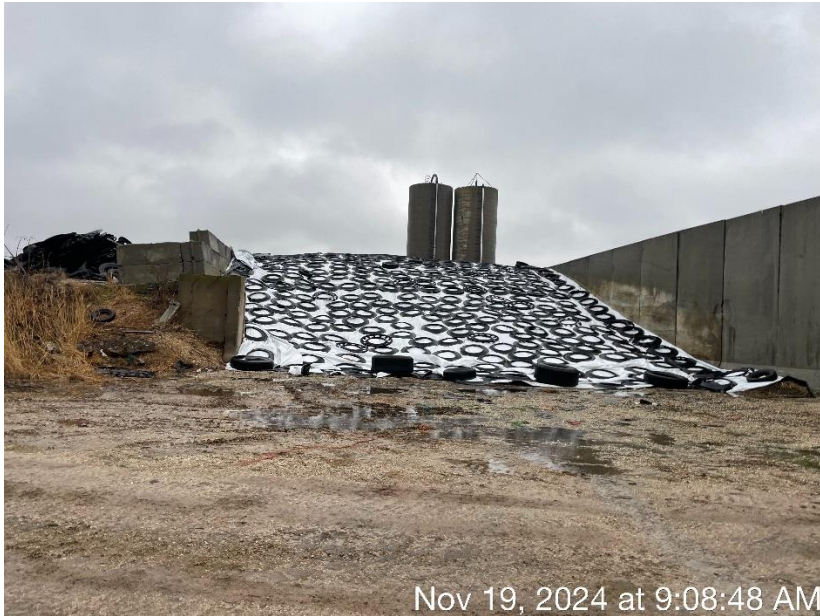
Photo 36. A feed bunker located on the feed storage area at the East Site. Runoff from the bunker flow north. This photo was taken facing north.

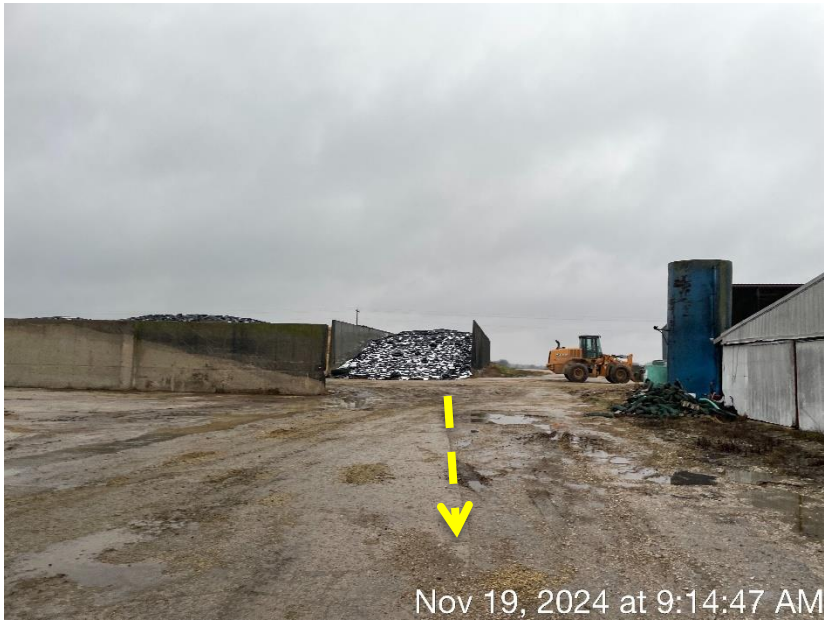
Photo 37. The flow path of runoff on the feed storage area at the East Site. This photo was taken facing west.

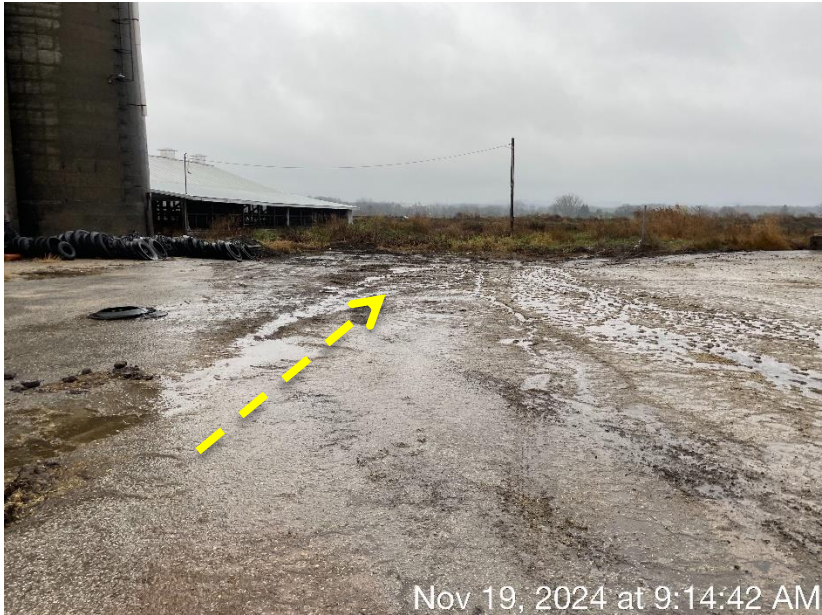
Photo 38. The flow path of runoff on the feed storage area towards the collection inlet located on the east side of the storage area.

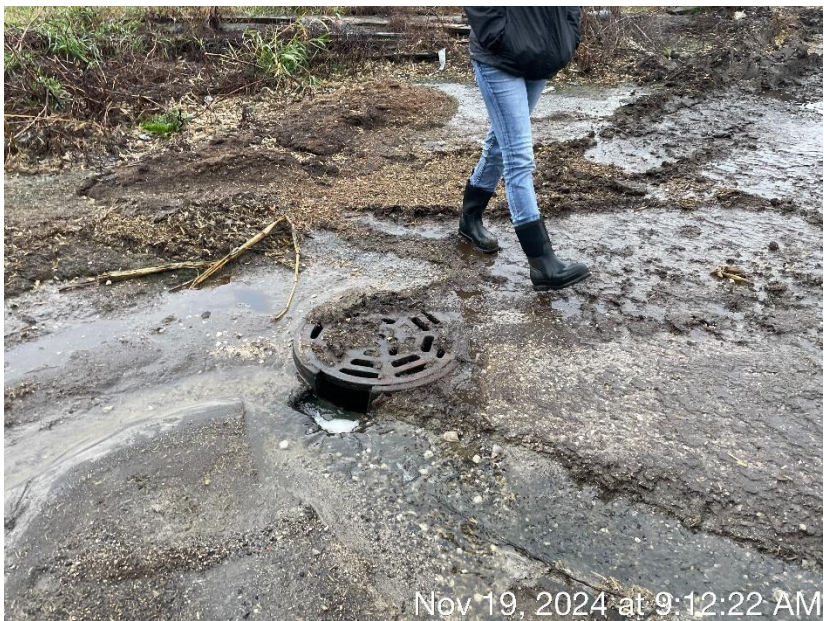
Photo 39. The collection inlet that accepts runoff from the feed storage area and conveys the runoff to WSF 3.

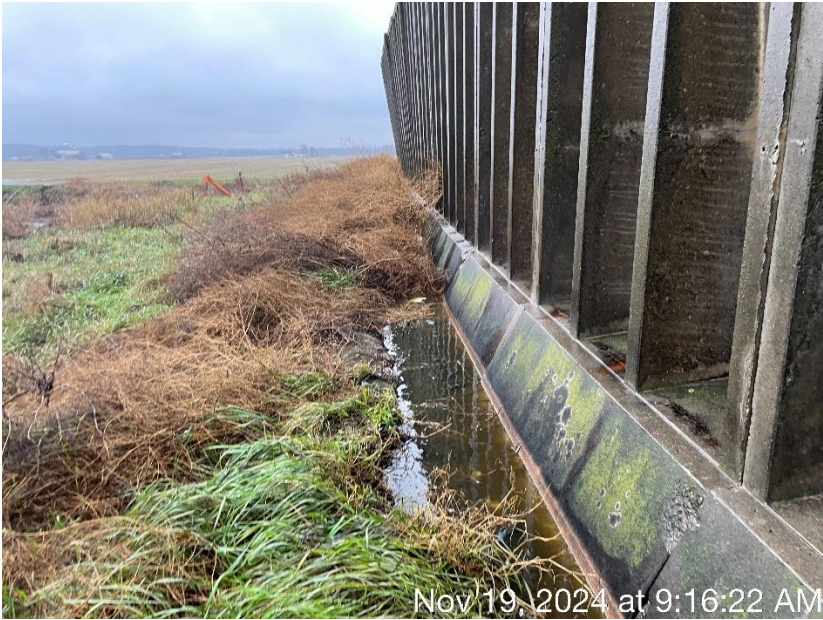
Photo 40. Leachate that seeped through the concrete wall on the east side of the feed storage area. This photo was taken facing south.

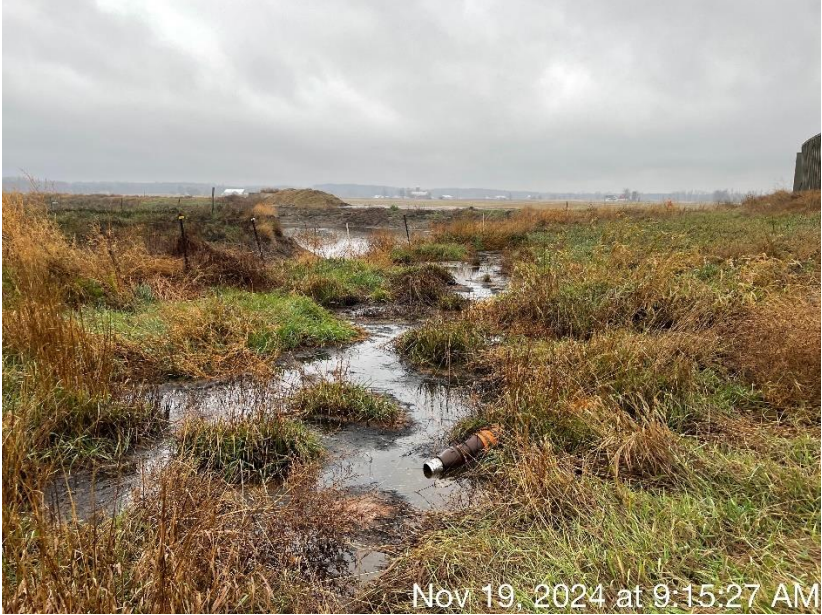
Photo 41. Ponded leachate and process wastewater in a grassed area between the feed storage area and WSF 2. Leachate seeped through the wall along the east side of the feed storage area.

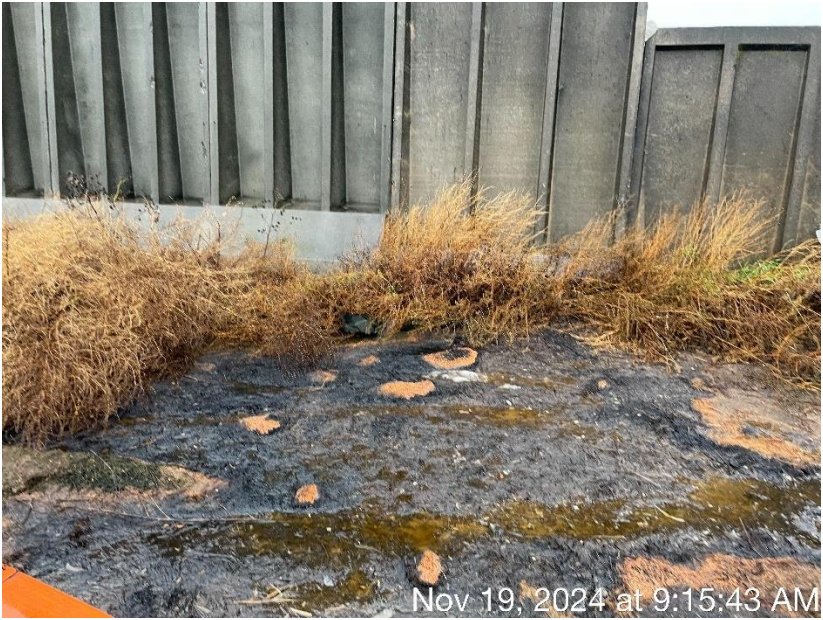
Photo 42. Leachate that seeped through the concrete wall on the east side of the feed storage area.

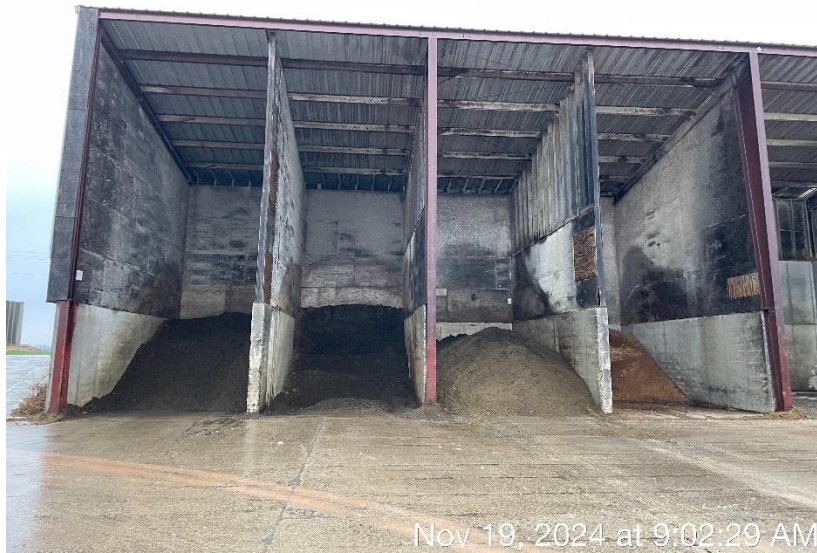
Photo 43. Commodity feed storage located on the northwest corner of the production site at the East Site.
