Permit Fact Sheet

Permit Number	WI-0062235-05-0
Permittee Name and Address	Ebert Enterprises LLC N6939 Cty Hwy D Algoma, WI 54201
Permitted Facility Name and Address	Home Farm- N6939 County Road D, Algoma, WI 54201 Tonet Dairy- N7521 Tonet Rd, Luxemburg, WI 54217 Tonet Dairy- N7518 Tonet Rd, Luxemburg, WI 54217 Longfellow Farm- N6388 Longfellow Road, Algoma, WI 54201 K Farm- 5083 County Road K, Algoma, WI 54201 S Farm- E5639 County Rd S, Algoma, WI 54201
Permit Term	August 01, 2026 to July 31, 2031
Receiving Water	Unnamed tributaries within the Ahnapee River Watershed, and groundwaters of the state.
Discharge Type	Existing source CAFO per NR 243.03(23) as the facility has been permitted since 2002.

CAFO Compliance Report (1/31/2025)

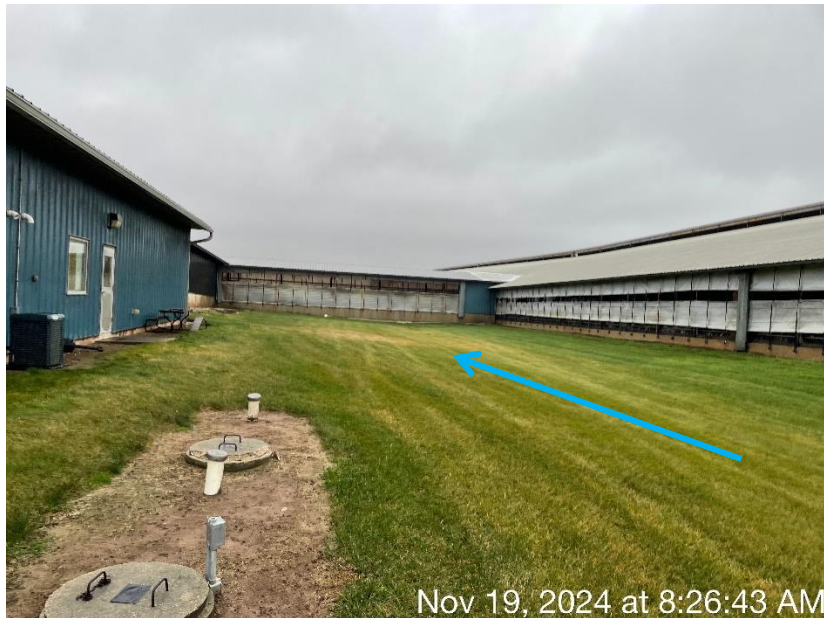
Photo 44. A grassed swale located between the milking parlor and a freestall barn at the West Site. The blue arrow represents the flow path of stormwater to a collection inlet.

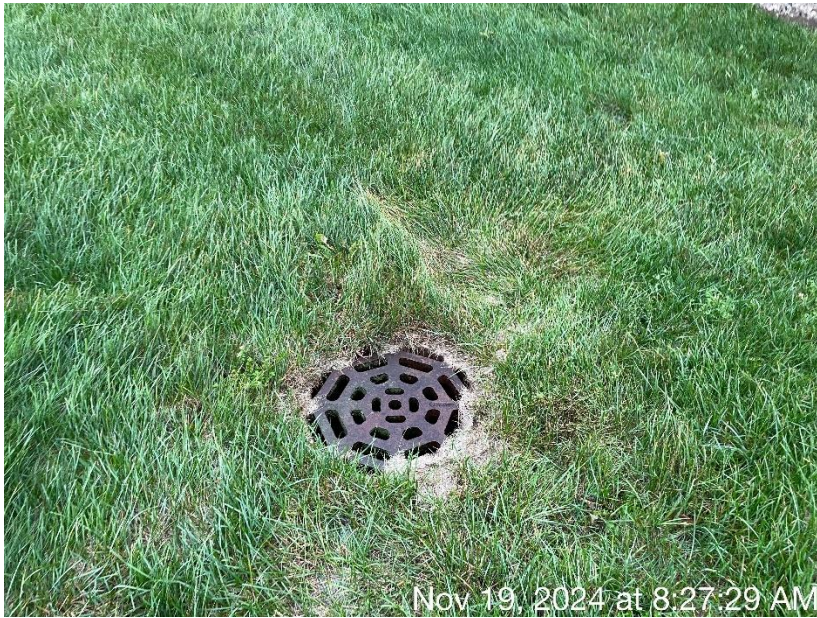
Photo 45. A surface inlet located between the barns at the West Site. The inlet was free of debris.

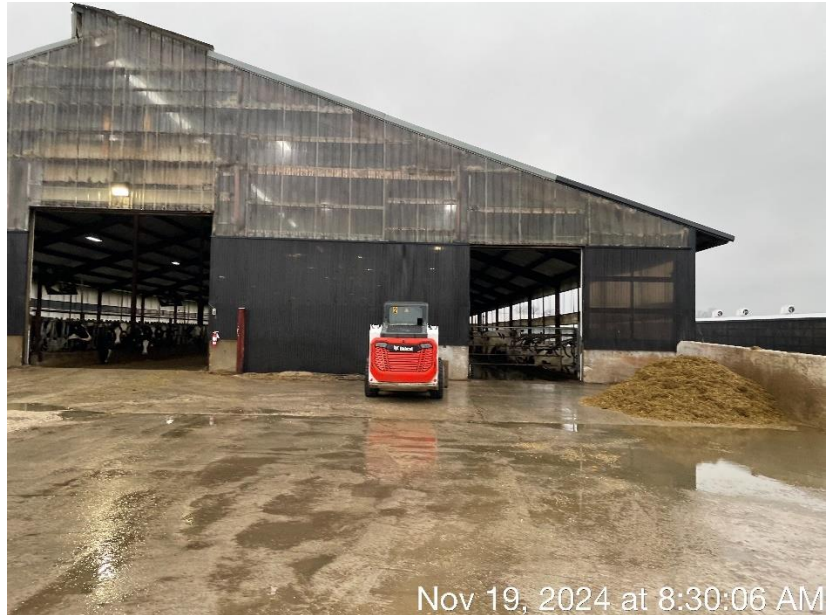
Photo 46. Outside of a freestall barn at the West Site. Refusal feed is pushed to the push wall in the foreground of the photo.

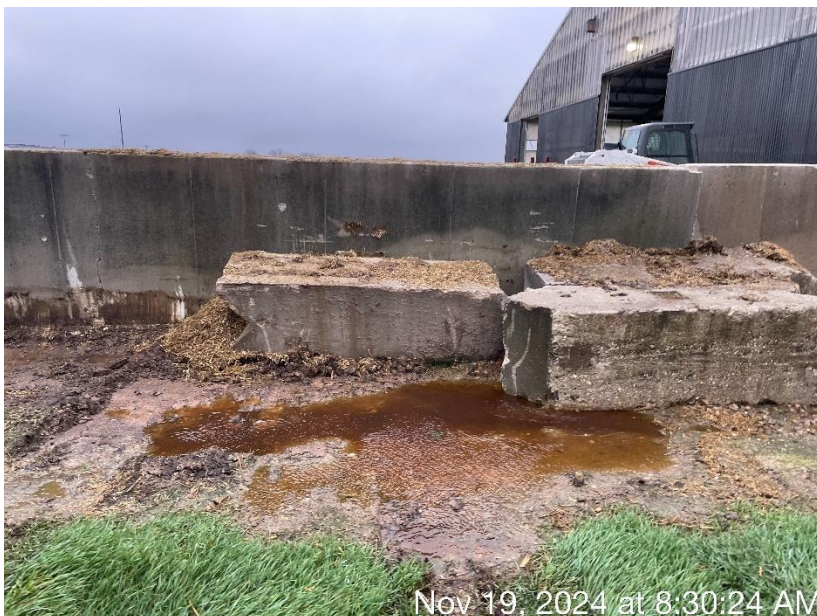
Photo 47. A small amount of process wastewater present on the back side of the push wall pictured in Photo 46.

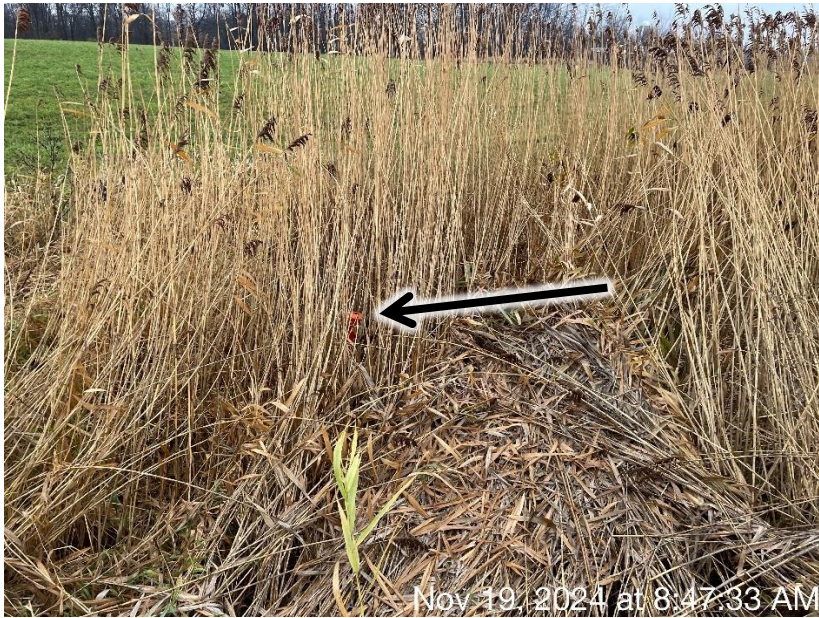
Photo 48. A tile inlet located on the northwest corner of the production site at the West Site, identified by the black arrow.

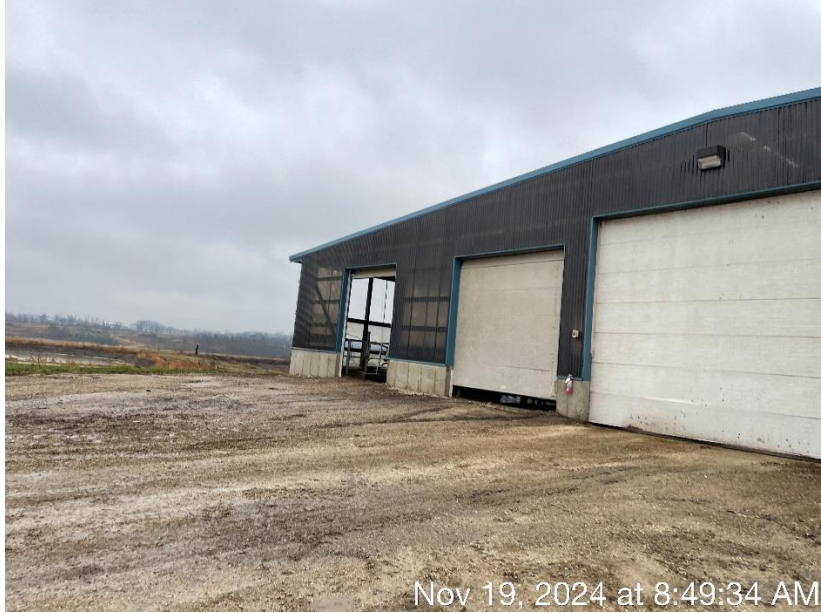
Photo 49. The west side of the northernmost freestall barn at the West Site. A small amount of manure tracking was present during the inspection.

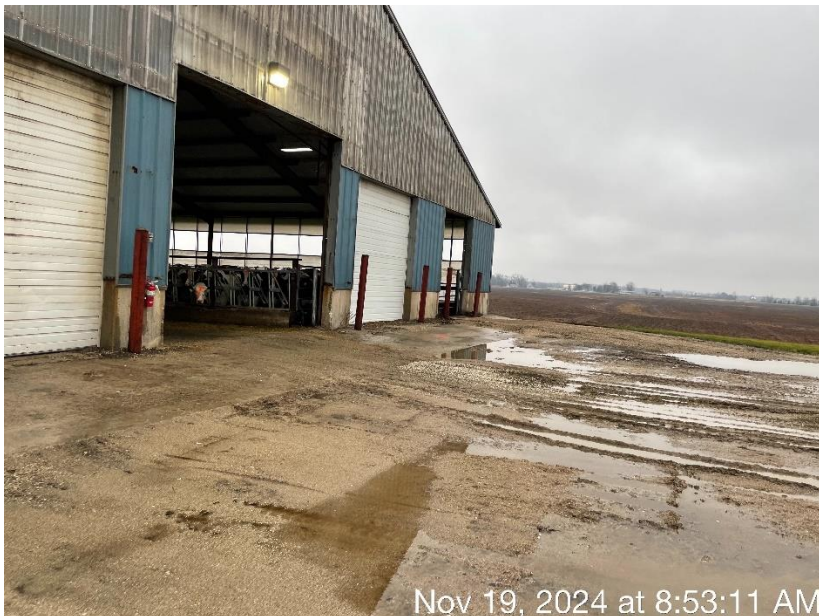
Photo 50. The west side of the southernmost freestall barn at the West Site. A small amount of manure tracking was present during the inspection.

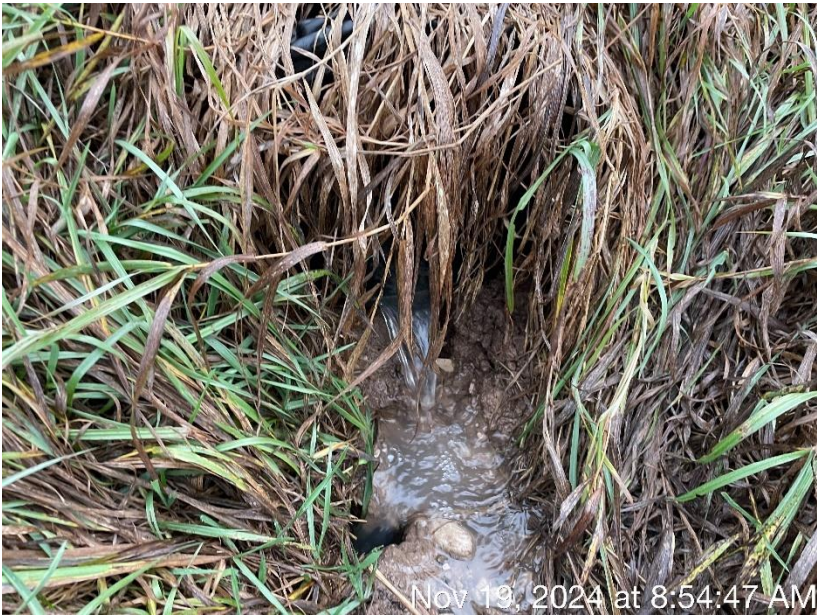
Photo 51. An outlet associated with the stormwater collection inlets at the West Site. The water discharging appeared to be clear, with no indications of contaminants.

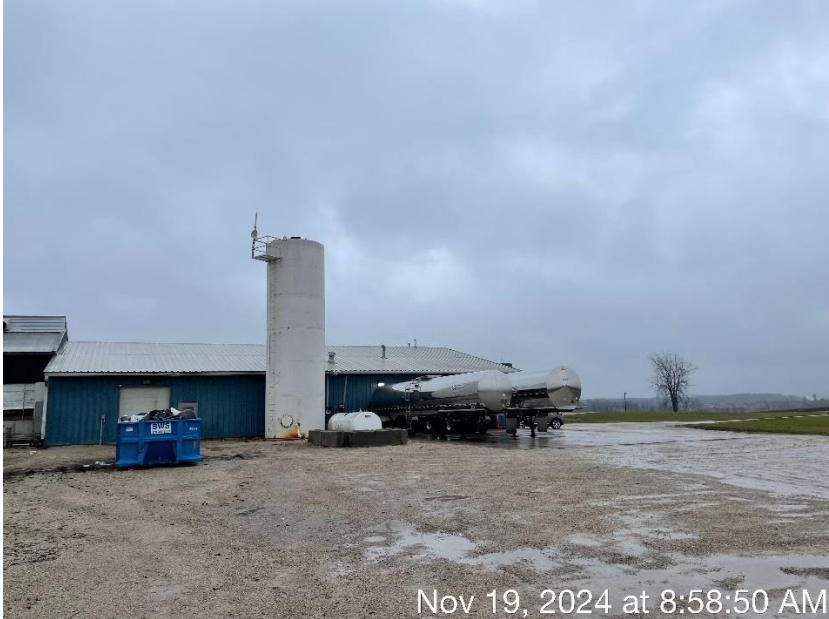
Photo 52. The driveway surrounding the milk loading area at the West Site.

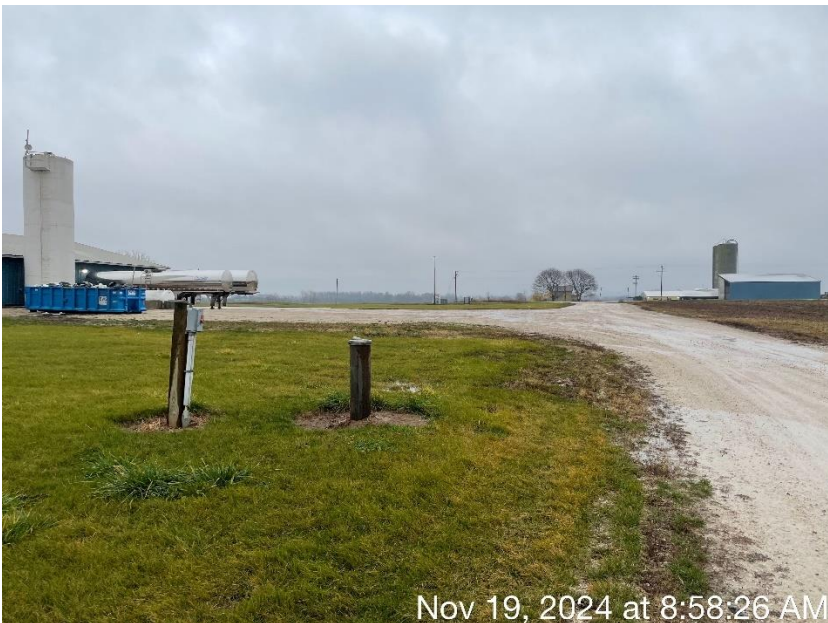
Photo 53. A well located on the south side of the West Site that supplies water to the farm.
