Permit Fact Sheet

Permit Number	WI-0063061-04-0
Permittee Name and Address	El Na Farms LLC; 4029 Pheasant Road Algoma, WI 54201
Permitted Facility Name and Address	El Na Farms LLC; 4029 Pheasant Road Algoma, WI 54201
Permit Term	January 01, 2025 to December 31, 2029
Discharge Location	(Main Site) E4029 Pheasant Rd, Algoma, WI 54201; E ½ of the NE ¼ T25N R24E S34, Township of Lincoln (Heifer Site) E4082 County Rd S, Algoma, WI 54201; SE ¼ of the SE ¼ T25N R24E S22, Township of Lincoln
Receiving Water	Unnamed tributaries within the Ahnapee River Watershed, Lake Michigan Drainage Basin, and groundwaters of the state.

El Na Farms LLC is an existing Concentrated Animal Feeding Operation in Kewaunee County, WI. El Na Farms is owned and operated by the Lonnie Fenendael. As of January of 2024, it has 1,750 milking and dry cows, 450 large heifers, 550 small heifers, and 400 calves (3,355 animal units). El Na Farms plans to expand to 5,040 animal units by the end of 2024. El Na Farms will annually generate approximately 31,527,283 gallons of liquid manure and process wastewater and 4,300 tons of solid manure. After the expansion, El Na Farms will generate 43,288,817 gallons of manure and p

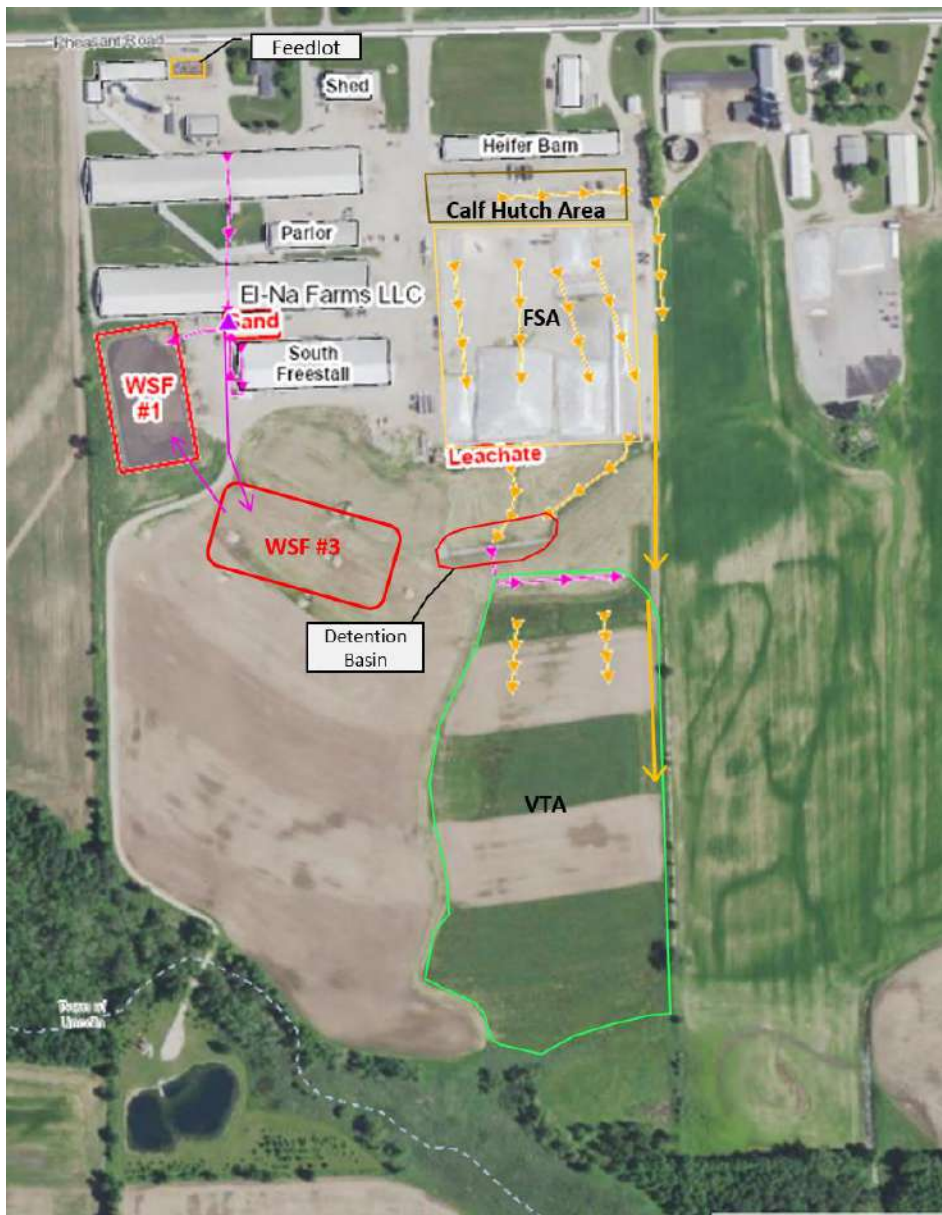
Aerial Map 1. The aerial map to the left illustrates the production site at the Main Site for El Na Farms, LLC. The Main Site is comprised of two liquid waste storage facilities, three freestall barns, one outdoor feedlot, one calf hutch area, one heifer barn, one feed storage area, a sand separation building, and a vegetated treatment area to handle runoff from the feed storage area and calf hutch area. The pink arrows represent the manure transfer system. The yellow arrows represent the flow path of process wastewater from the calf hutch area and feed storage area to the vegetated treatment area.

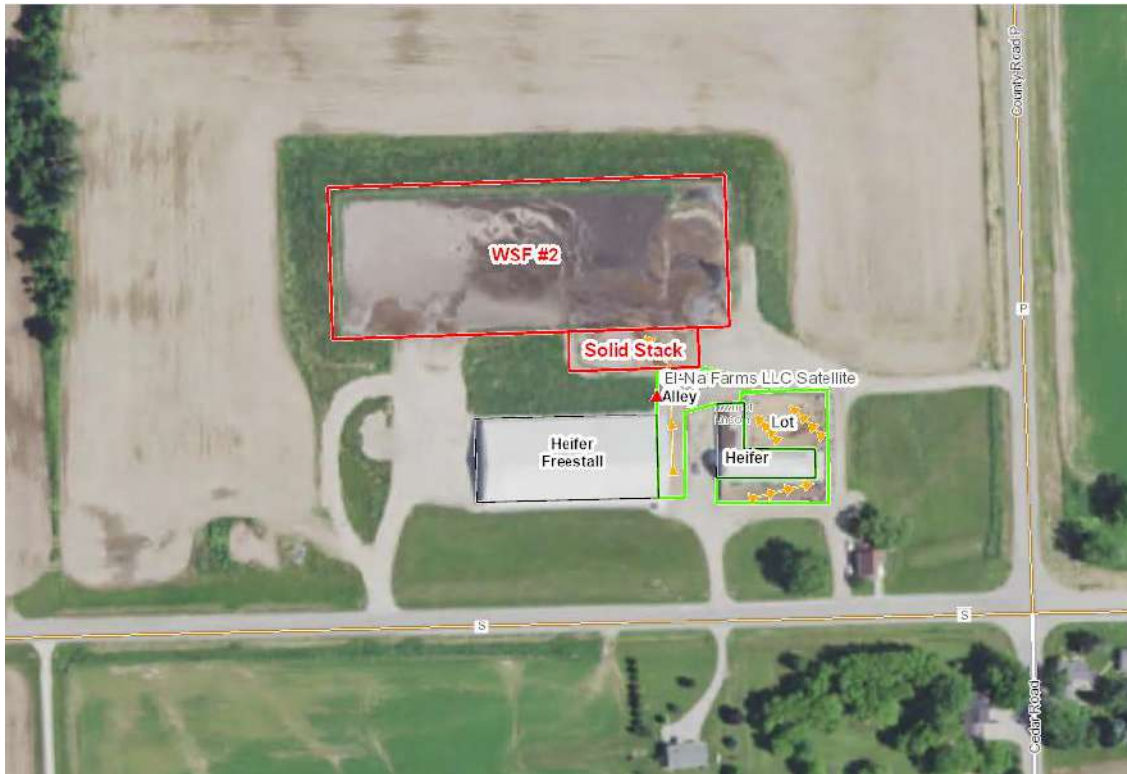
Aerial Map 2. The aerial map above illustrates the production site at the Heifer Site for El Na Farms, LLC. The Heifer Site consists of one liquid waste storage facility, one solid stacking area, one outdoor feedlot, and two heifer barns. The yellow arrows represent the flow path of process wastewater from the feedlots and manure scraping alley.

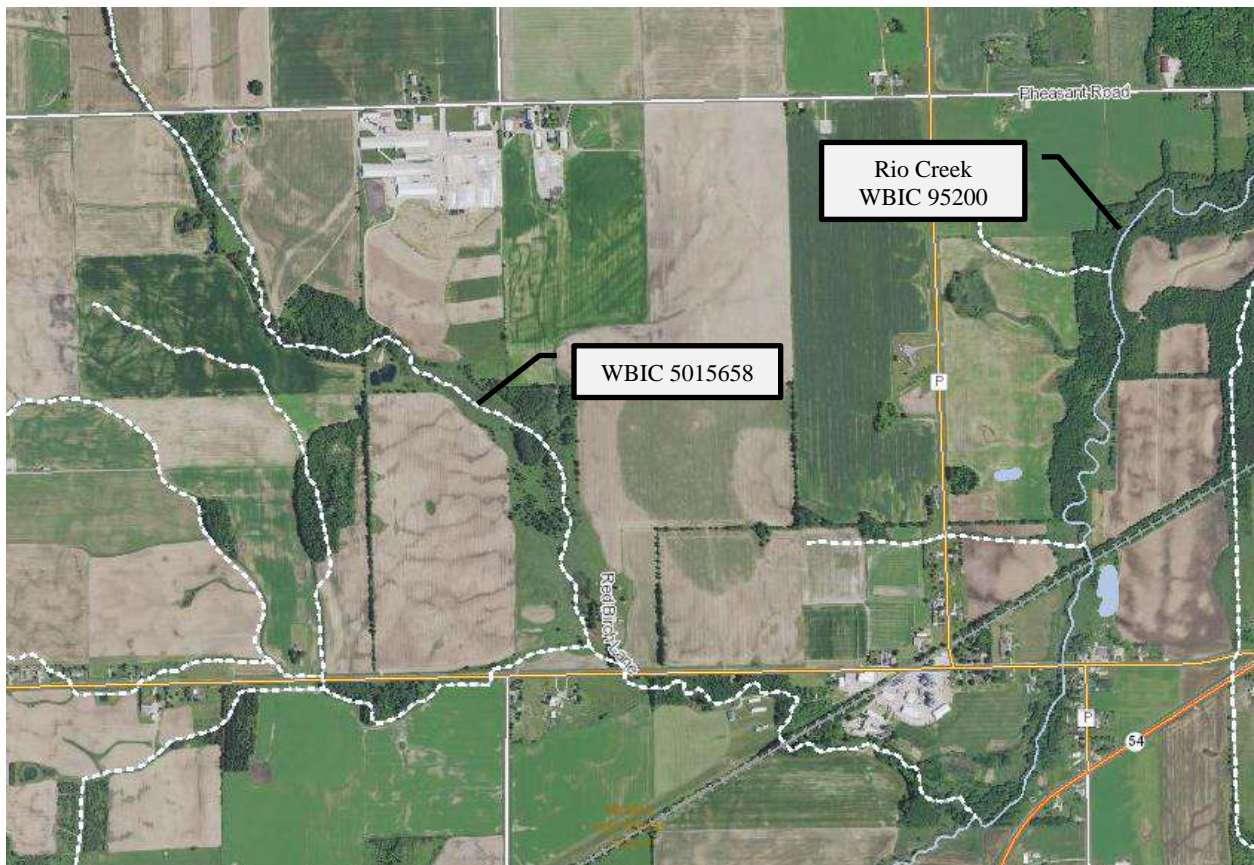
Aerial Map 3. The aerial map above illustrates Main Site and nearby surface waters. An unnamed tributary (WBIC 5015658) to Rio Creek is directly south of the production site, flowing west to east, eventually discharging to Rio Creek. The aerial image was obtained from WDNR Surface Water Data Viewer.

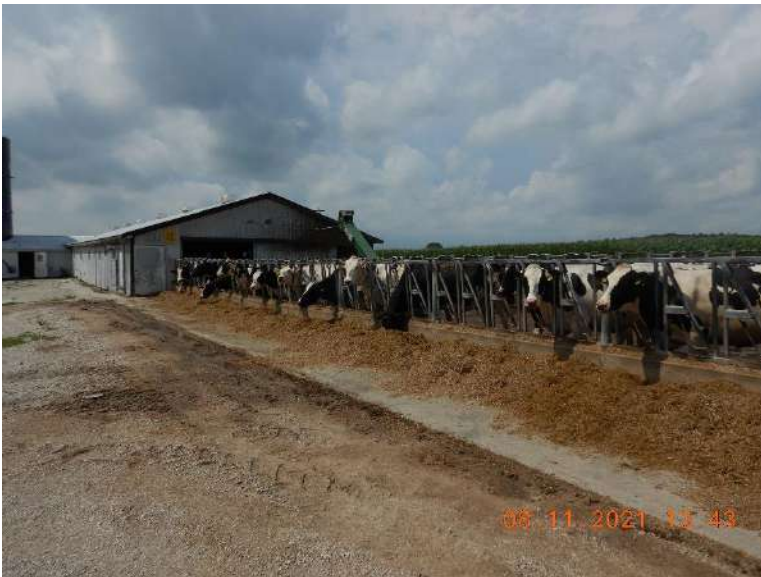
Photo 1. The outdoor concrete feedlot located at the Main Site. The feedlot is located on the north side of the production site. Runoff from the feedlot gravity flows to the center, where it collected until it is augered into equipment to transfer the waste. This photo was taken facing northwest.

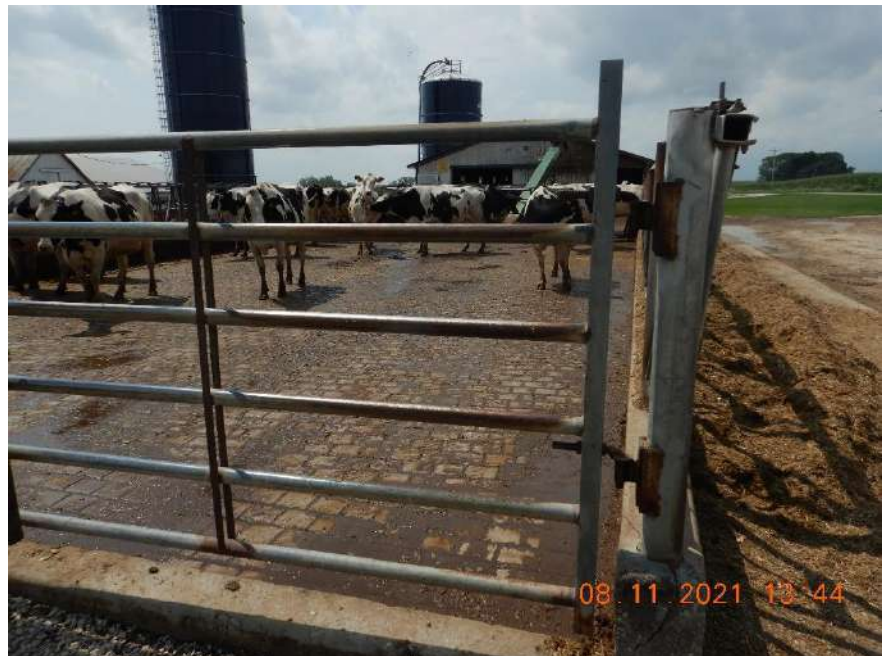
Photo 2. The outdoor concrete feedlot located at the Main Site. The feedlot is located on the north side of the production site. Runoff from the feedlot gravity flows to the center, where it collected until it is augered into equipment to transfer the waste. This photo was taken facing west.

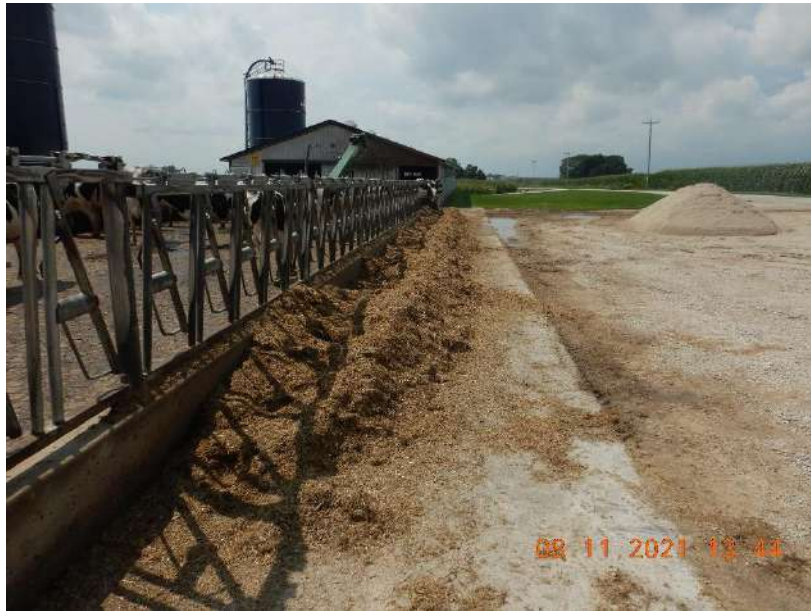
Photo 3. The outdoor concrete feedlot located at the Main Site. The feedlot is located on the north side of the production site. Runoff from the feedlot gravity flows to the center, where it collected until it is augered into equipment to transfer the waste. This photo was taken facing west.

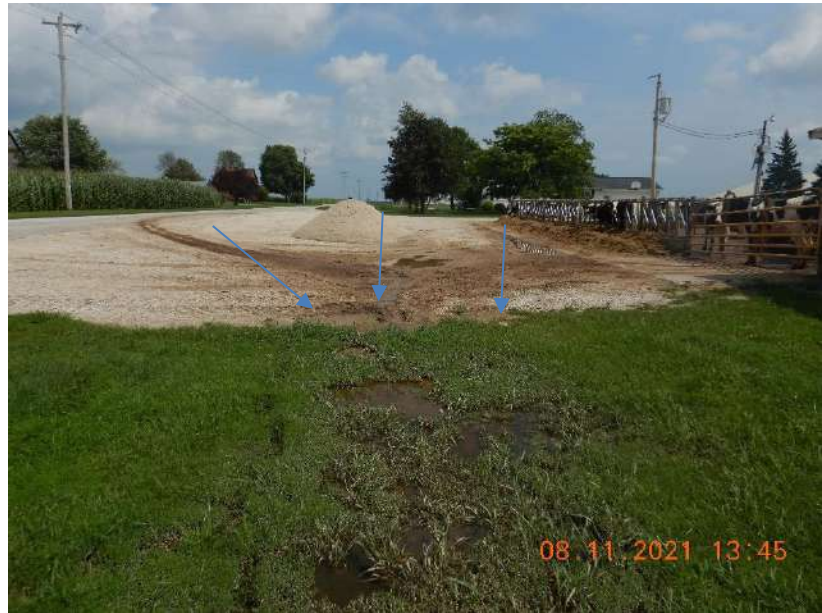
Photo 4. Drainage from the driveway adjacent to the concrete outdoor feedlot at the Main Site. The blue arrows represent the flow path of stormwater from the driveway. This photo was taken facing east.

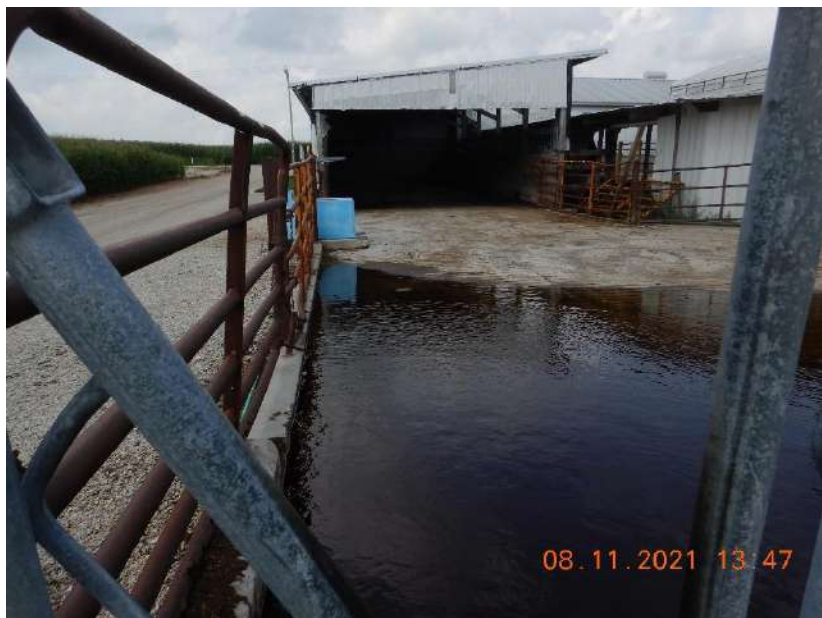
Photo 5. An abandoned outdoor feedlot located on the northwest corner of the production site at the Main Site. This photo was taken facing north. The only animals that have access to this lot are fair animals for a short period of time.

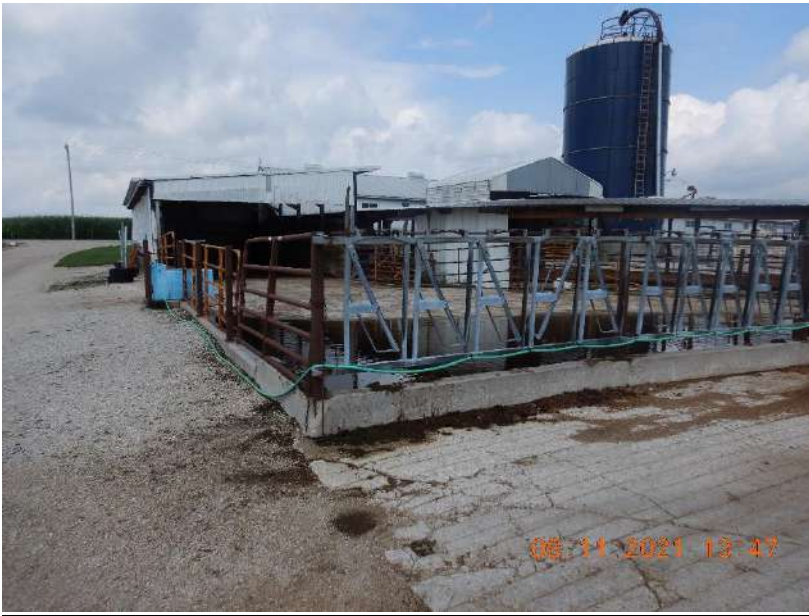
Photo 6. An abandoned outdoor feedlot located on the northwest corner of the production site at the Main Site. This photo was taken facing north. The only animals that have access to this lot are fair animals for a short period of time.

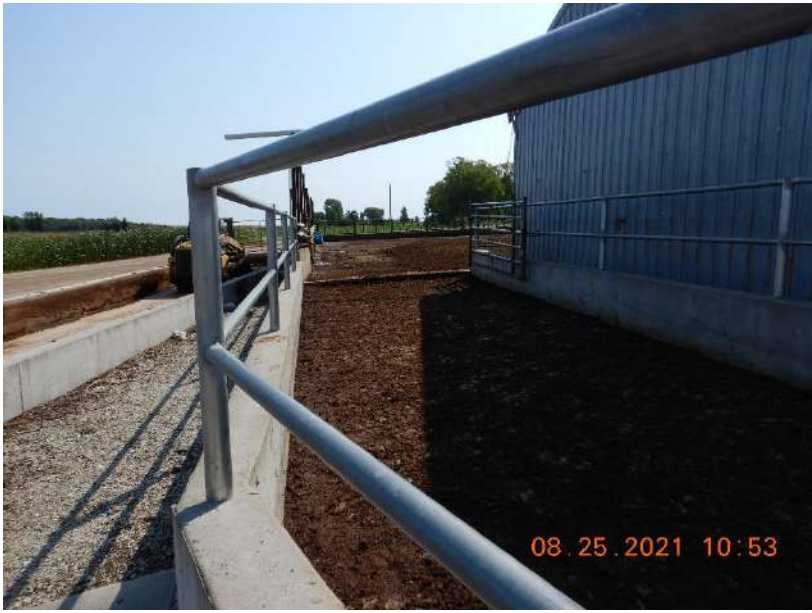
Photo 7. The outdoor feedlot at the Heifer Site. Runoff from the feedlot gravity flows through a series of concrete swales and into the onsite liquid waste storage facility. This photo was taken facing east.

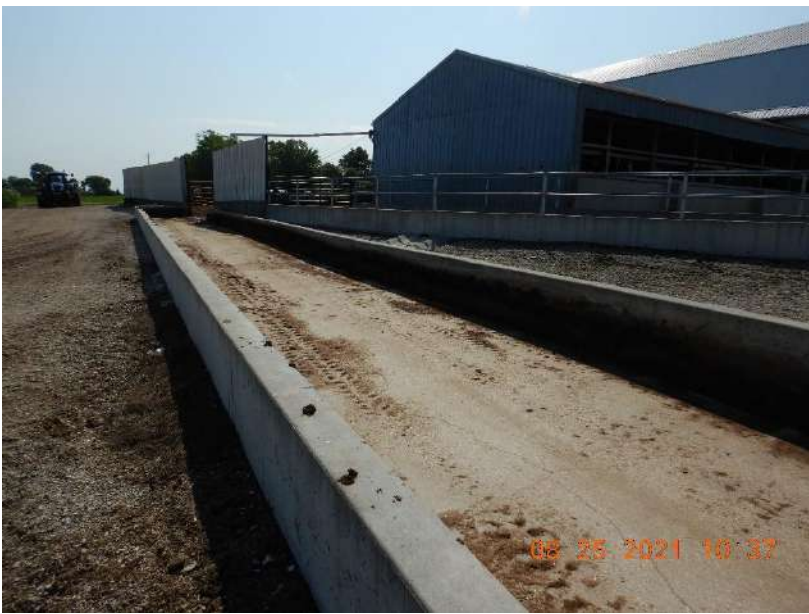
Photo 8. A concrete swale located north of the outdoor feedlot at the Heifer Site. Runoff from the feedlot gravity flows through the swale and into the onsite liquid waste storage facility. This photo was taken facing east.

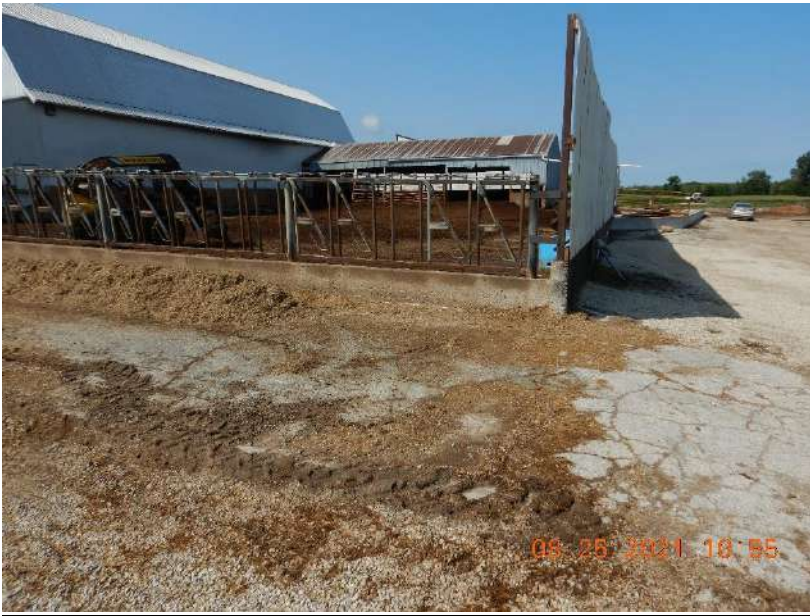
Photo 9. The outdoor concrete feedlot at the Heifer Site. Feed was scattered on the ground, east of the feedlot. This photo was taken facing west.

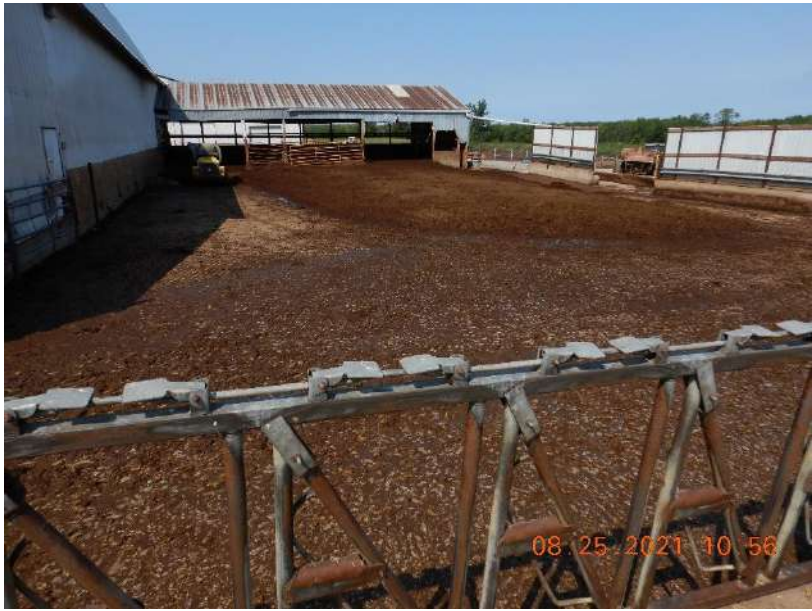
Photo 10. The outdoor concrete feedlot at the Heifer Site. Runoff from the feedlot flows northwest through a series of concrete swales that gravity flow to the onsite liquid waste storage facility. This photo was taken facing west.

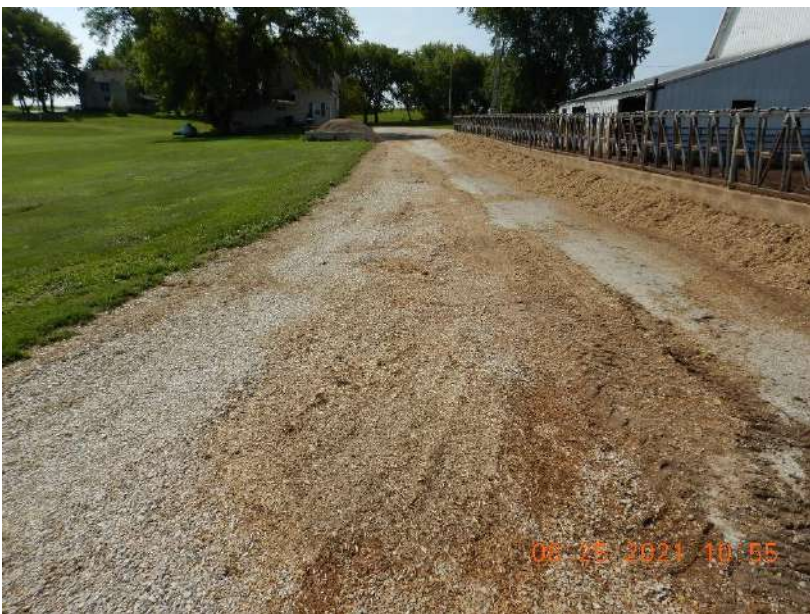
Photo 11. Scattered feed on the ground east of the outdoor feedlot at the Heifer Site. Better housekeeping and feeding practices will prevent discharges of pollutants. This photo was taken facing south.

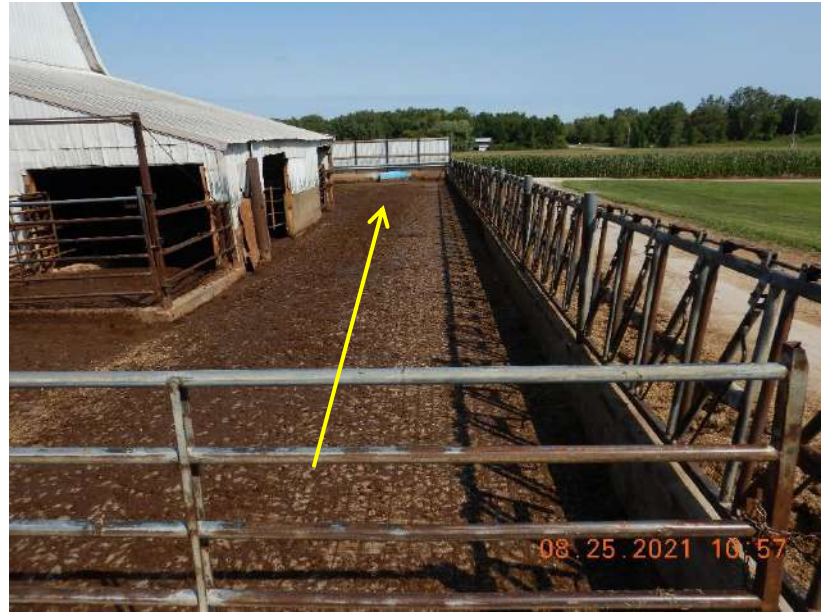
Photo 13. The outdoor feedlot at the Heifer Site. Runoff flows north towards the runoff control system, represented by the yellow arrows. This photo was taken facing north.

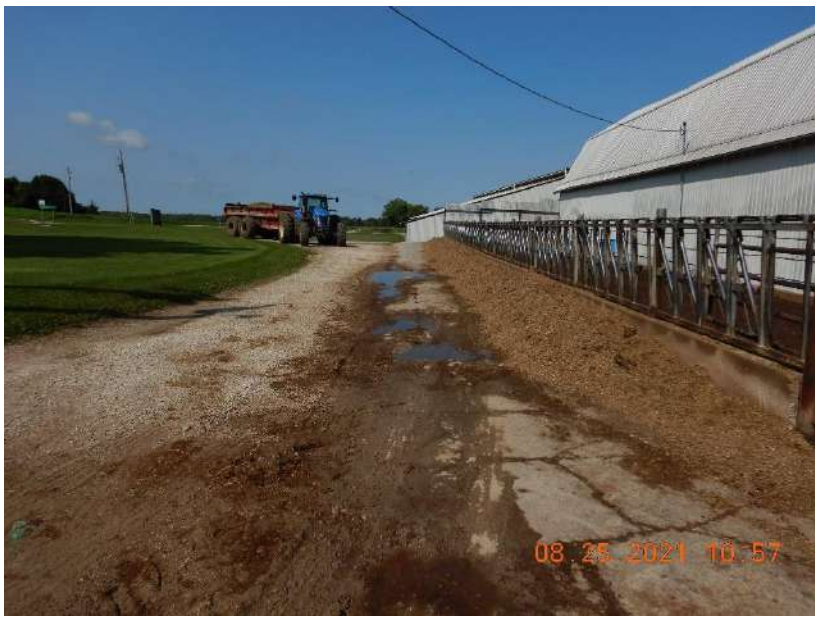
Photo 14. The south side of the outdoor feedlot at the Heifer Site. Runoff from this area flows east and then north towards the runoff control system. This photo was taken facing west.

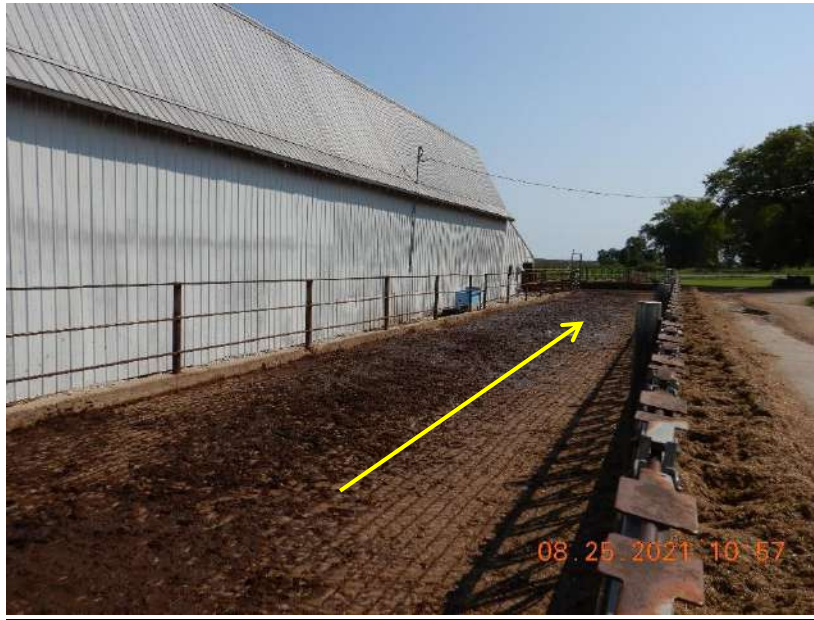
Photo 15. The south side of the outdoor feedlot at the Heifer Site. Runoff from this area flows east and then north towards the runoff control system, represented by the yellow arrows. This photo was taken facing east.

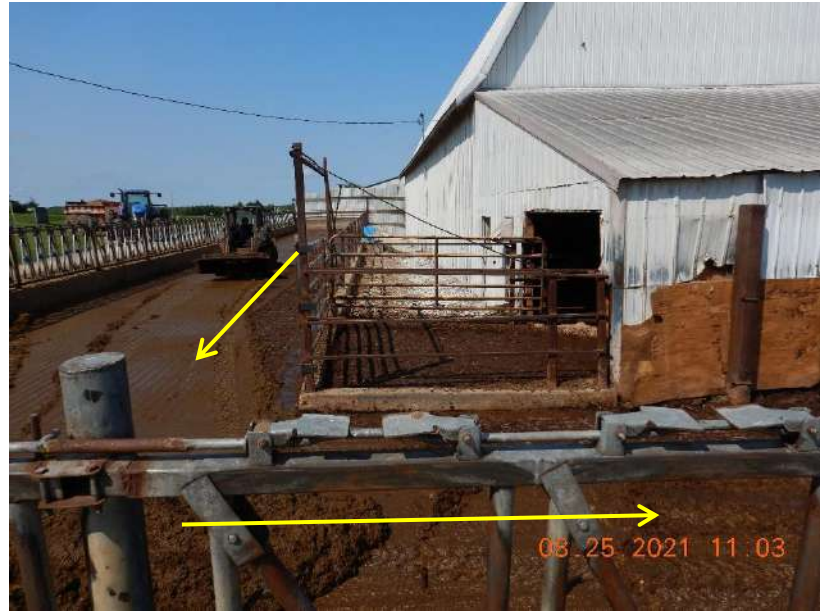
Photo 16. The southeast corner of the outdoor feedlot at the Heifer Site. Runoff from this area flows east and then north towards the runoff control system, represented by the yellow arrows. This photo was taken facing west.

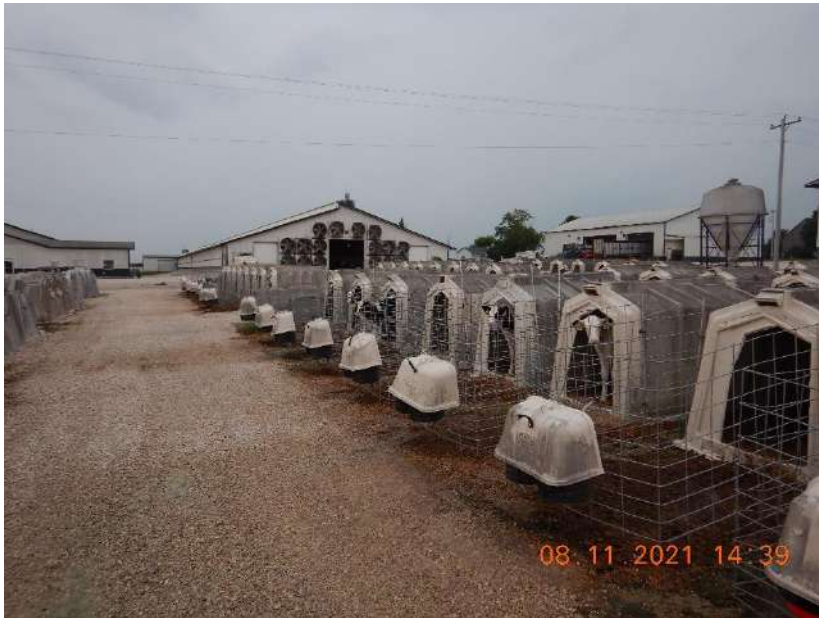
El Na Farms utilizes an outdoor calf hutch area at the Main Site. The calf hutch area is located north of the feed storage area, on the east side of the production site. The calf hutch area is sits on a gravel pad which is on a compact clay liner. The gravel pad was in good condition. Runoff from the calf hutch area flows from northwest to south east, where it enters a concrete swale. The swale conveys runoff south to the vegetated treatment area (VTA). Once runoff leaves the concrete swale, it follows a concentrated flow path on the east edge of the VTA. The flow path caused gully erosion and prevented runoff from evenly distributing over the VTA. The flow path dissipates as it flows south down the VTA.

Photo 17. The outdoor calf hutch area located north of the feed storage area at the Main Site. Runoff from the calf hutch area flows east and south towards the runoff collection system. This photo was taken facing west.

Required Action	Due Date
Complete Engineering Evaluation: Retain a qualified expert to complete an engineering evaluation for the calf hutch runoff control system and report the name of the expert to the Department.	03/31/2025
Written Description of Existing System: Submit a written description of the existing runoff control system and its adequacy to permanently meet the conditions in the Production Area Discharge Limitations and Runoff Control subsections and s. NR 243.15, Wis. Adm. Code. (See Standard Requirements for report details.)	08/31/2025
Plans and Specifications: Submit plans and specifications for Department review and approval to permanently correct any adverse runoff control conditions in accordance with Chapter 281.41, Wis. Stats., and Chapter NR 243, Wis. Adm. Code.	04/30/2026
Corrections and Post Construction Documentation: Complete construction of runoff controls that permanently correct any adverse runoff control conditions in concurrence with and approval by the Department, by the specified Date Due. Submit post construction documentation within 60 days of completion of the project.	12/31/2026

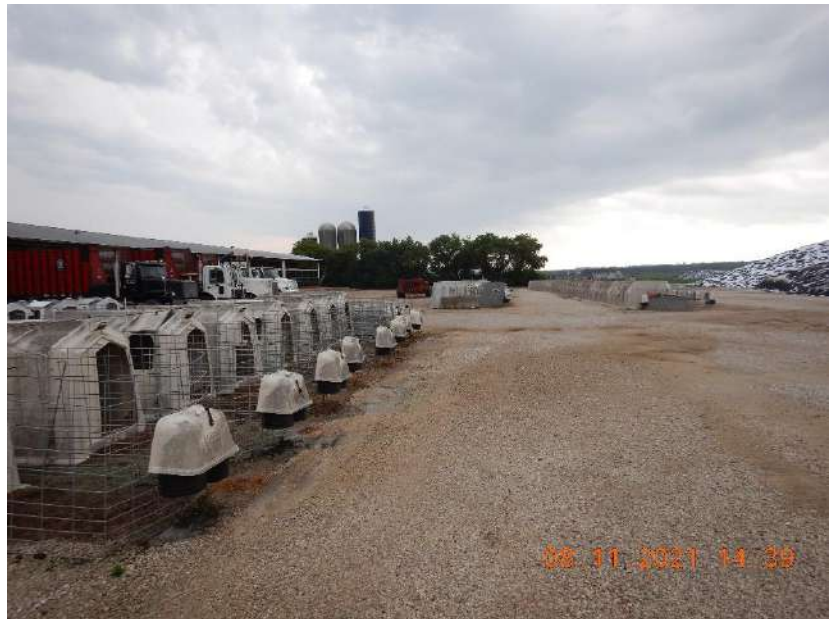
Photo 18. The outdoor calf hutch area located north of the feed storage area at the Main Site. Runoff from the calf hutch area flows east and south towards the runoff collection system. This photo was taken facing east.

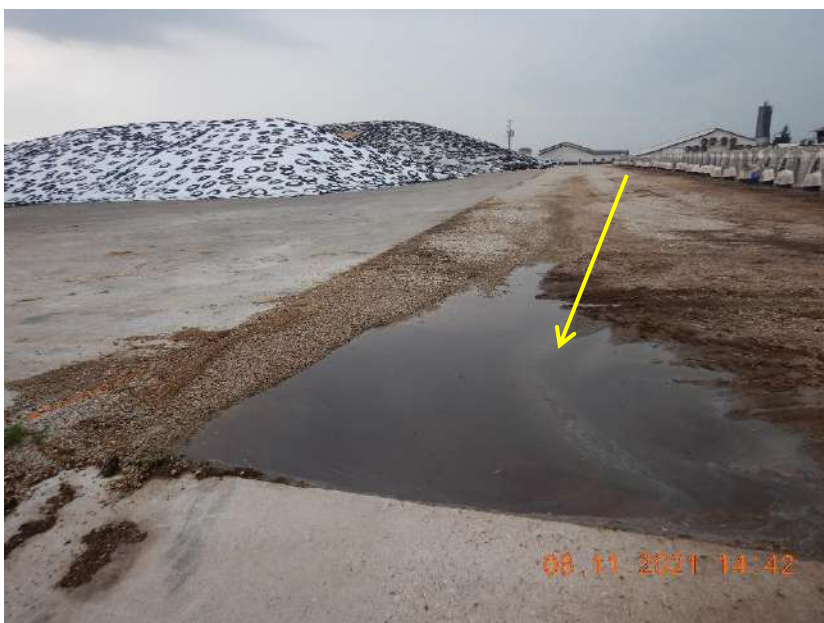
Photo 19. The outdoor calf hutch area located north of the feed storage area at the Main Site. Runoff from the calf hutch area flows east and south towards the runoff collection system. This photo was taken facing west. The yellow arrow represents the flow path of runoff towards the runoff control system. The ponded area in the foreground allows sediment to settle out prior to entering the concrete swale.

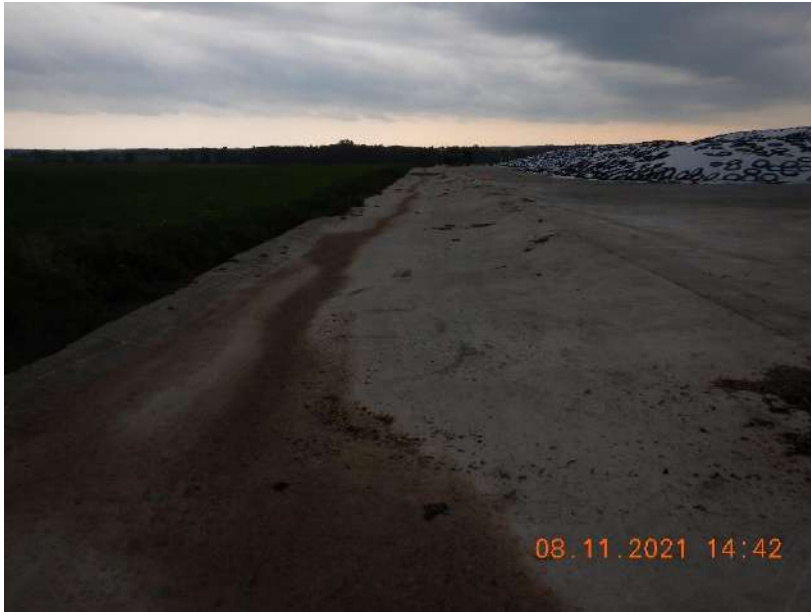
Photo 20. The concrete swale that conveys runoff from the calf hutch area to the vegetated treatment area. Runoff flows south on the swale towards the VTA. This photo was taken facing south.

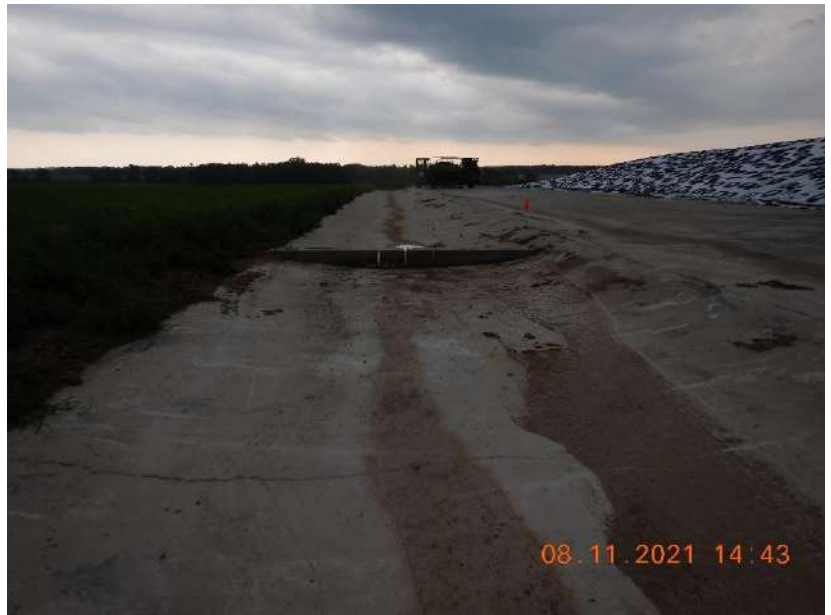
Photo 21. The concrete swale that conveys runoff from the calf hutch area to the vegetated treatment area. A concrete bar allows solids to settle out and liquid to continue south towards the VTA. This photo was taken facing south.

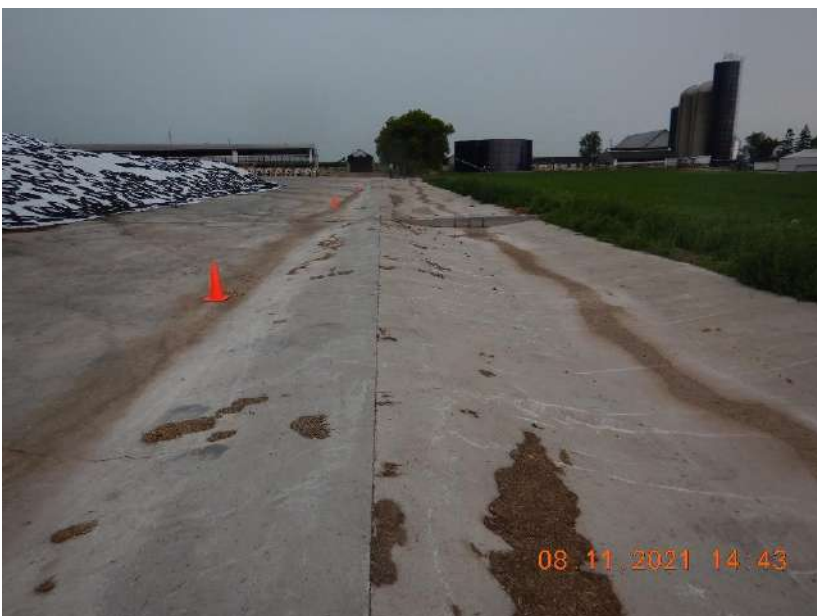
Photo 22. The concrete swale that conveys runoff from the calf hutch area to the vegetated treatment area. Runoff flows south on the swale towards the VTA. A concrete berm separates the feed storage area and the concrete swale. This photo was taken facing north.

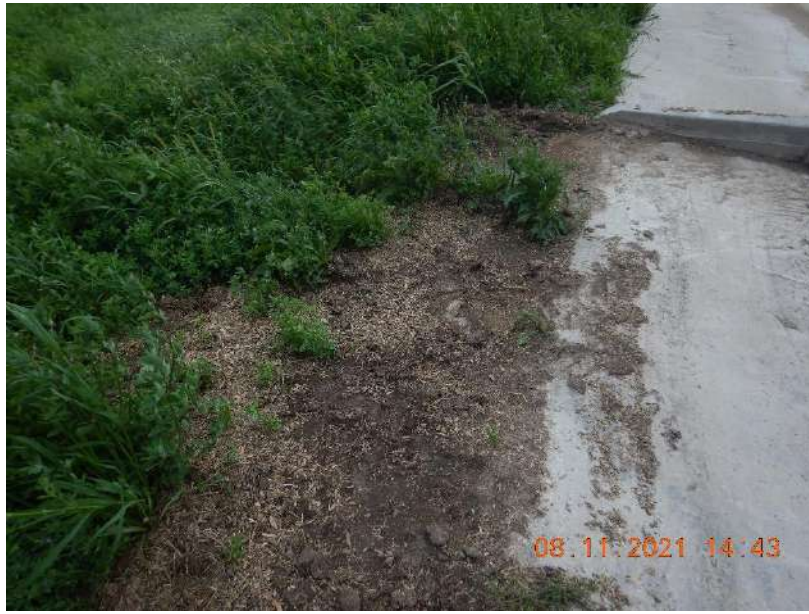
Photo 23. Bedding/feed solids present outside the concrete swale that conveys runoff from the calf hutch area towards the VTA.

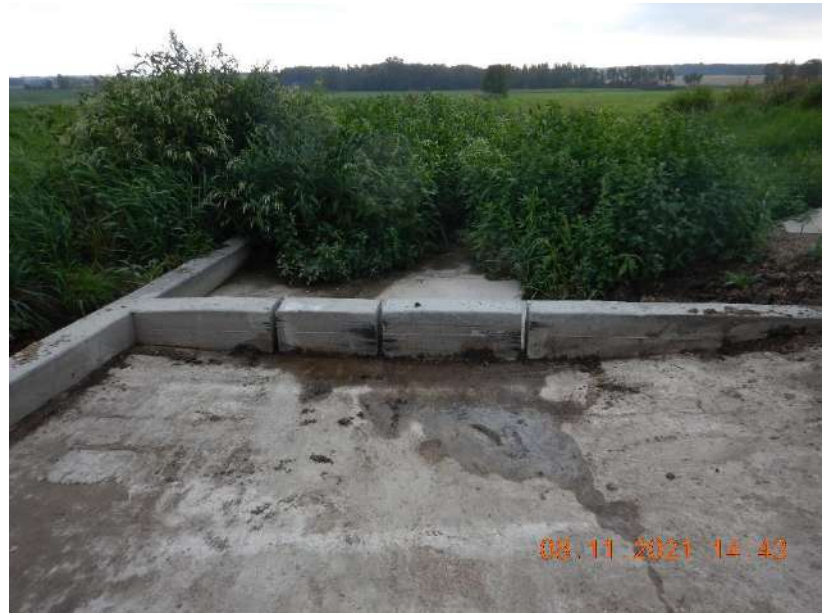
Photo 24. A concrete bar that settles out solids and allows liquids to continue to the VTA. This photo was taken facing south.

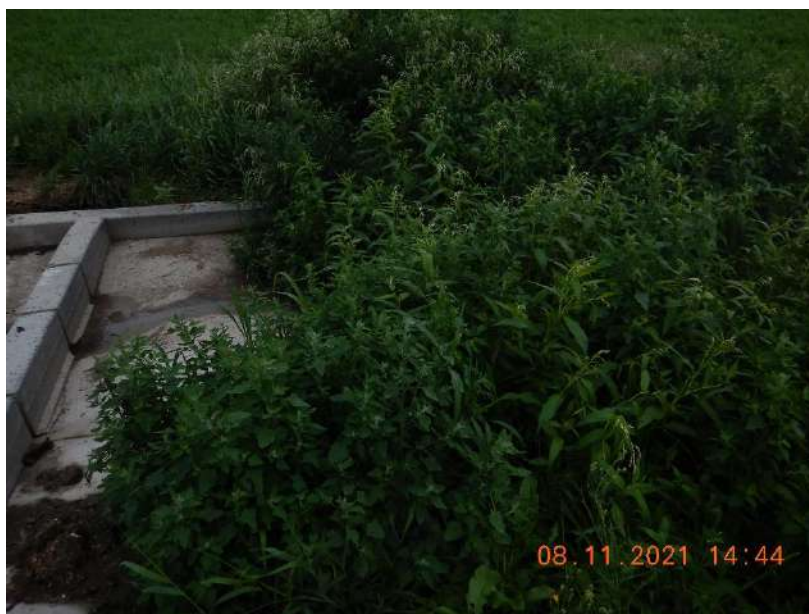
Photo 25. The end of the concrete swale where runoff from the calf hutch area enters the VTA.

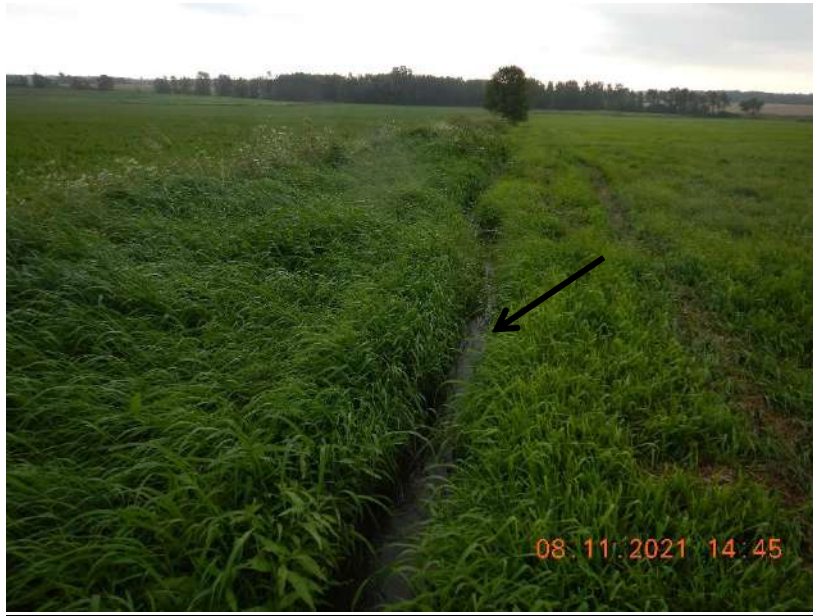
Photo 26. Runoff from the calf hutch area in a concentrated flow channel on the east side of the VTA.

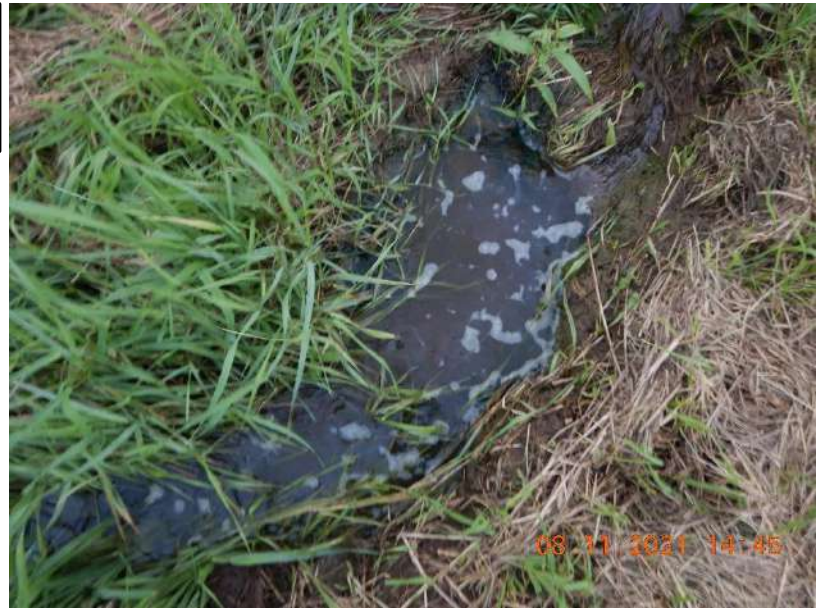
Photo 27. Runoff from the calf hutch area in a concentrated flow channel on the east side of the VTA.

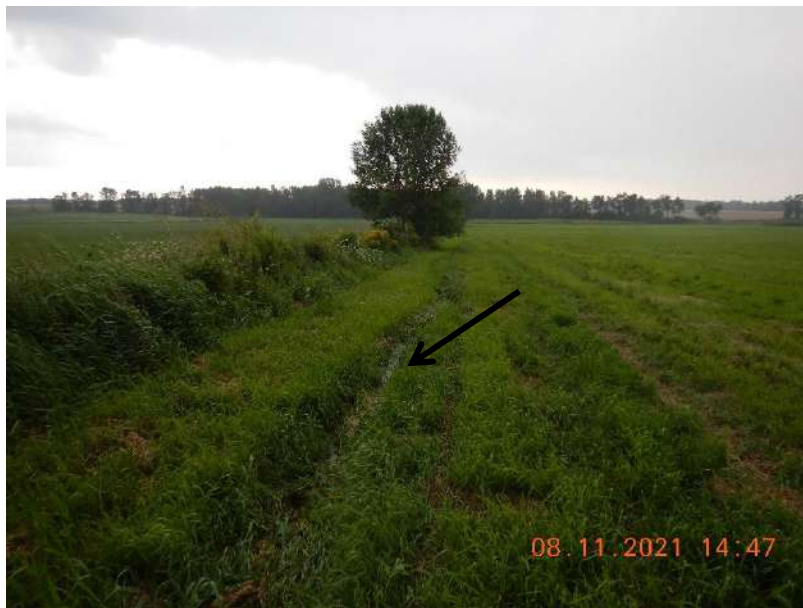
Runoff control systems are not well-maintained, in good repair and in compliance with permit requirements.

Photo 28. The east side of the VTA, where runoff from the calf hutch area created a concentrated flow channel with erosion. This photo was taken facing south.

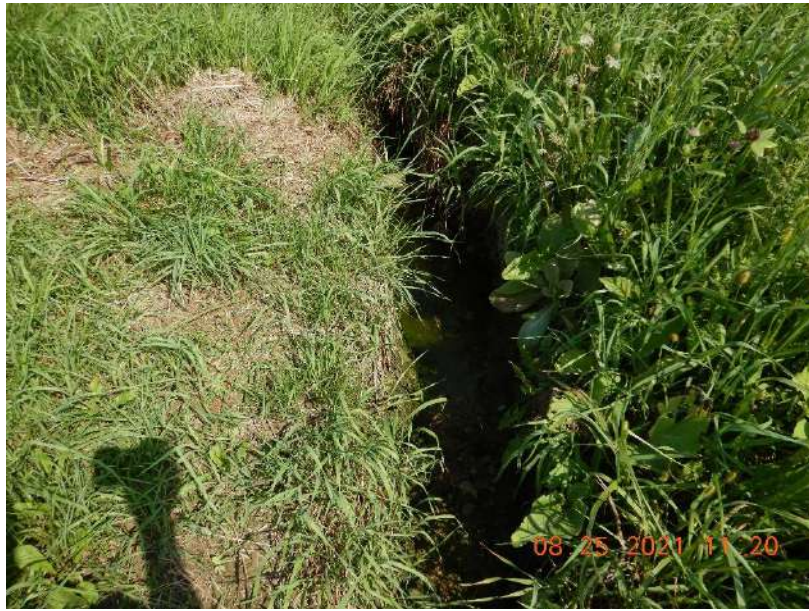
Photo 29. Gully erosion on the east side of the VTA created by runoff from the calf hutch area.

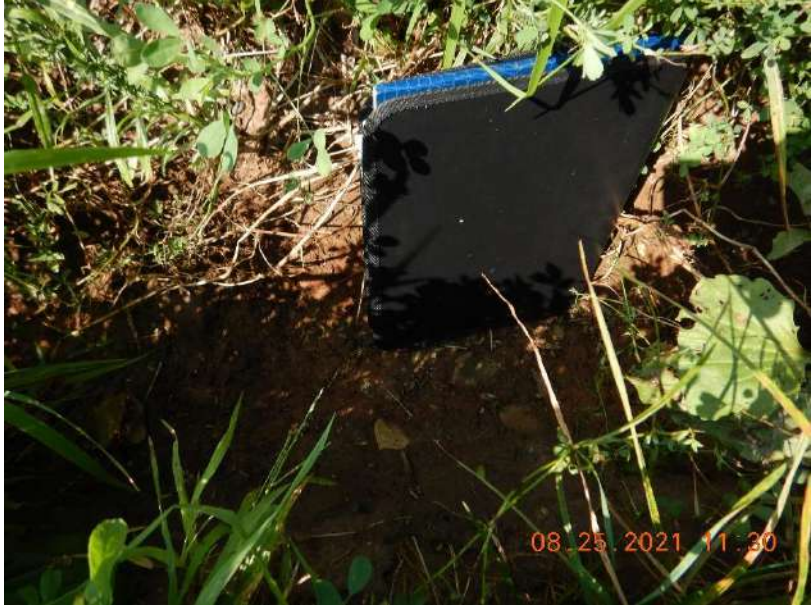
Photo 30. Gully erosion on the east side of the VTA created by runoff from the calf hutch area. A note pad is used to scale the depth of the erosion.

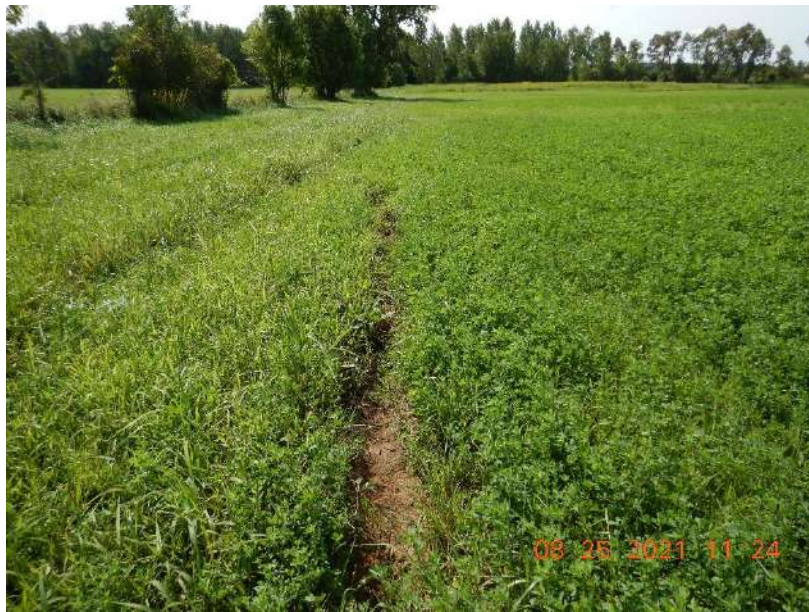
Photo 31. Erosion on the east side of the VTA created by runoff from the calf hutch area. This photo was taken facing south.

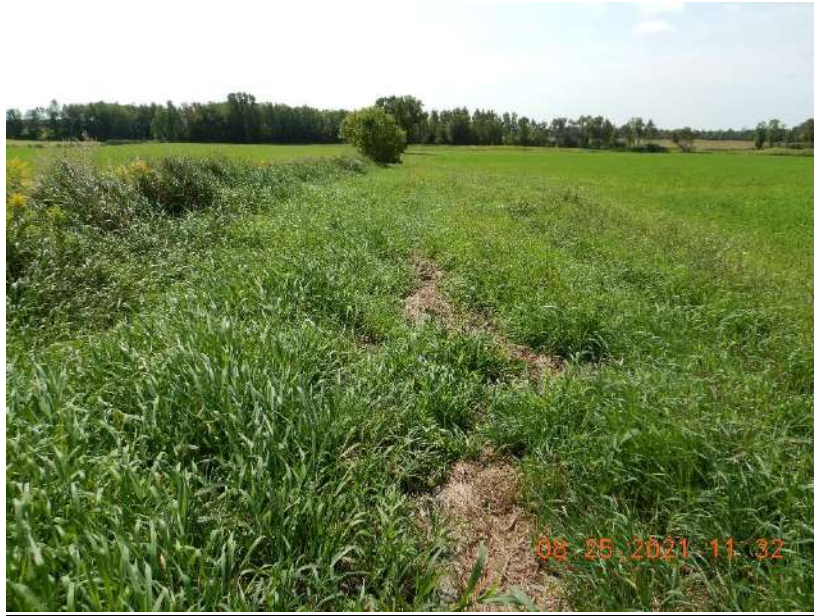
Photo 32. The east side of the VTA where runoff from the calf hutch area follows a concentrated flow channel. This photo was taken facing south.

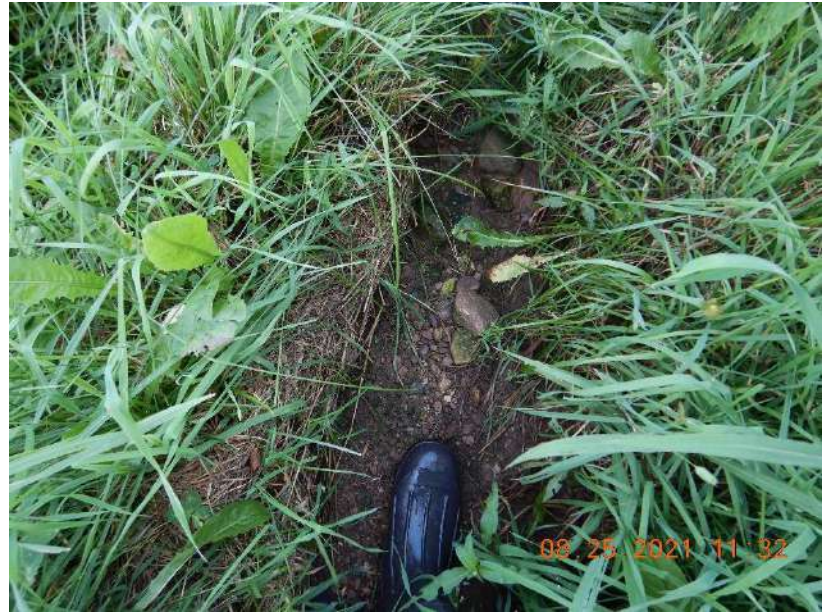
Photo 33. Gully erosion on the east side of the VTA created by runoff from the calf hutch area.

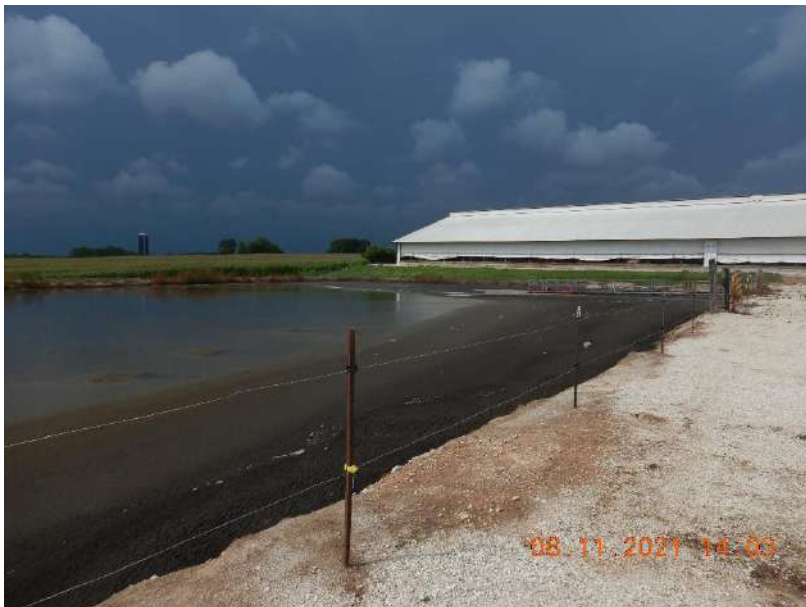
Photo 34. WSF 1 at the Main Site, located on the west side of the production site. WSF 1 is a clay WSF built in 2000. This photo was taken facing northwest.
