Permit Fact Sheet

Permit Number	WI-0063061-04-0
Permittee Name and Address	El Na Farms LLC; 4029 Pheasant Road Algoma, WI 54201
Permitted Facility Name and Address	El Na Farms LLC; 4029 Pheasant Road Algoma, WI 54201
Permit Term	January 01, 2025 to December 31, 2029
Discharge Location	(Main Site) E4029 Pheasant Rd, Algoma, WI 54201; E ½ of the NE ¼ T25N R24E S34, Township of Lincoln (Heifer Site) E4082 County Rd S, Algoma, WI 54201; SE ¼ of the SE ¼ T25N R24E S22, Township of Lincoln
Receiving Water	Unnamed tributaries within the Ahnapee River Watershed, Lake Michigan Drainage Basin, and groundwaters of the state.

El Na Farms LLC is an existing Concentrated Animal Feeding Operation in Kewaunee County, WI. El Na Farms is owned and operated by the Lonnie Fenendael. As of January of 2024, it has 1,750 milking and dry cows, 450 large heifers, 550 small heifers, and 400 calves (3,355 animal units). El Na Farms plans to expand to 5,040 animal units by the end of 2024. El Na Farms will annually generate approximately 31,527,283 gallons of liquid manure and process wastewater and 4,300 tons of solid manure. After the expansion, El Na Farms will generate 43,288,817 gallons of manure and p

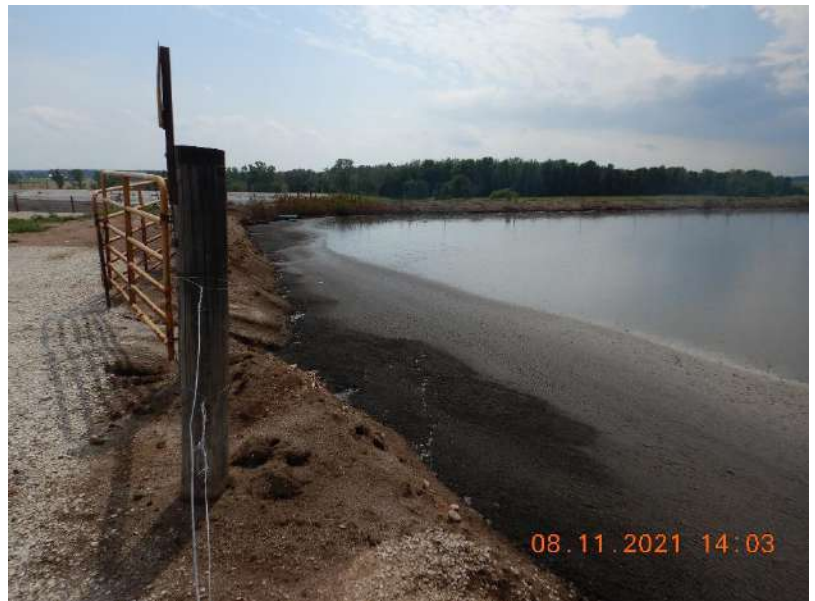
Photo 35. WSF 1 at the Main Site, located on the west side of the production site. WSF 1 is a clay WSF built in 2000. This photo was taken facing south.

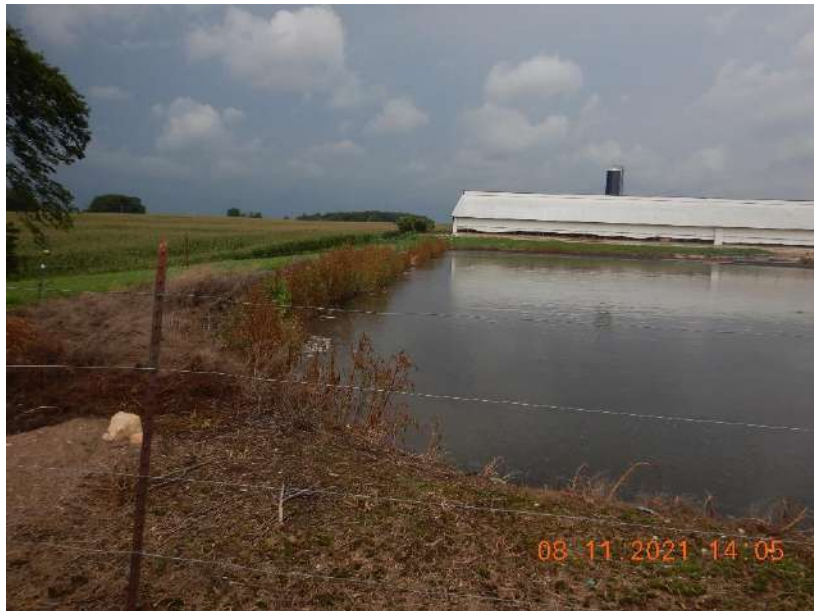
Photo 36. WSF 1 at the Main Site, located on the west side of the production site. WSF 1 is a clay WSF built in 2000. This photo was taken facing north.

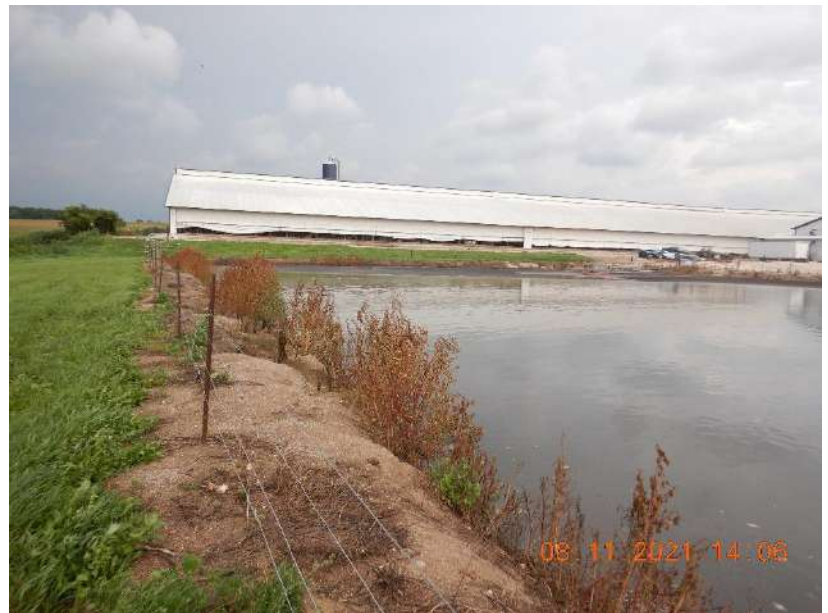
Photo 38. The maximum operating level (MOL) marker present within WSF 1 at the Main Site. The marker is present within the western berm.

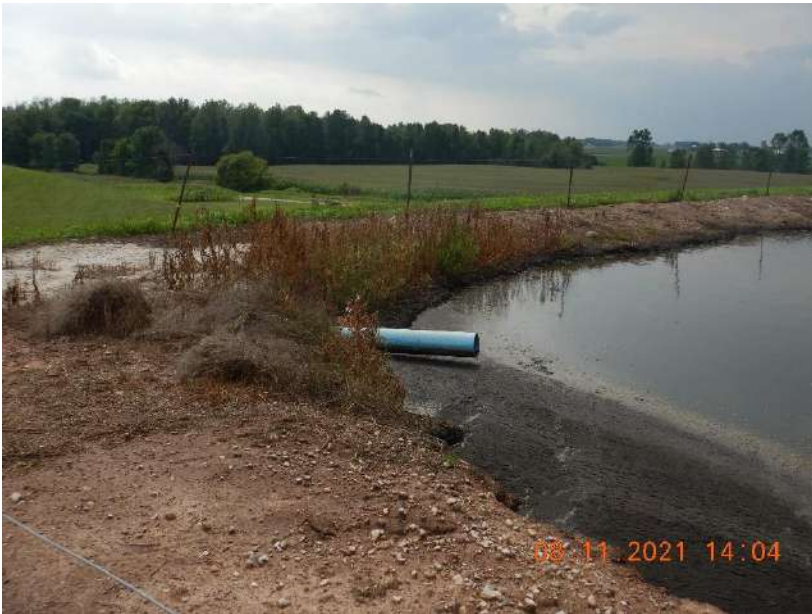
Photo 39. The overflow pipe from WSF 1 to WSF 3. Once levels get to the MOL, waste enters the pipe and gravity flows to WSF 3. This photo was taken facing southwest.

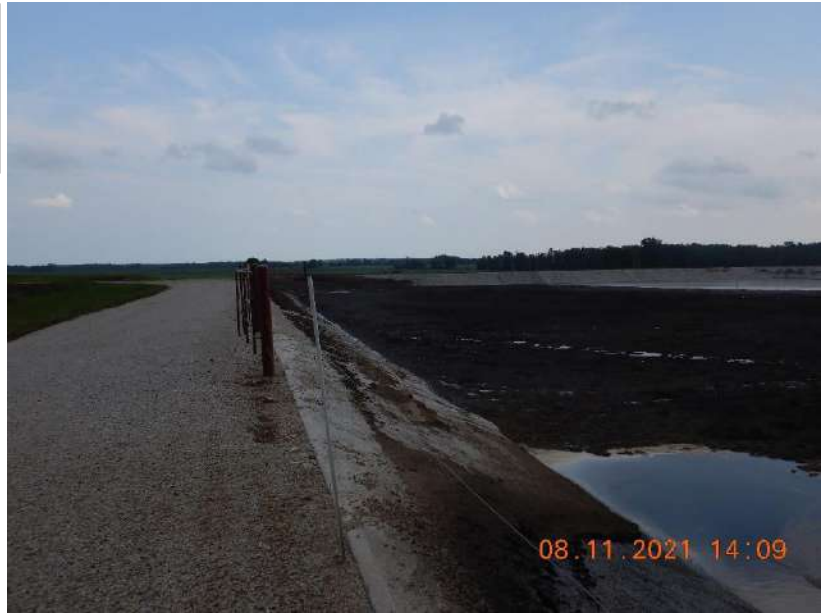
Photo 41. WSF 3 at the Main Site, located on the south side of the production site. WSF 3 is a concrete structure built in 2020. This photo was taken facing north.

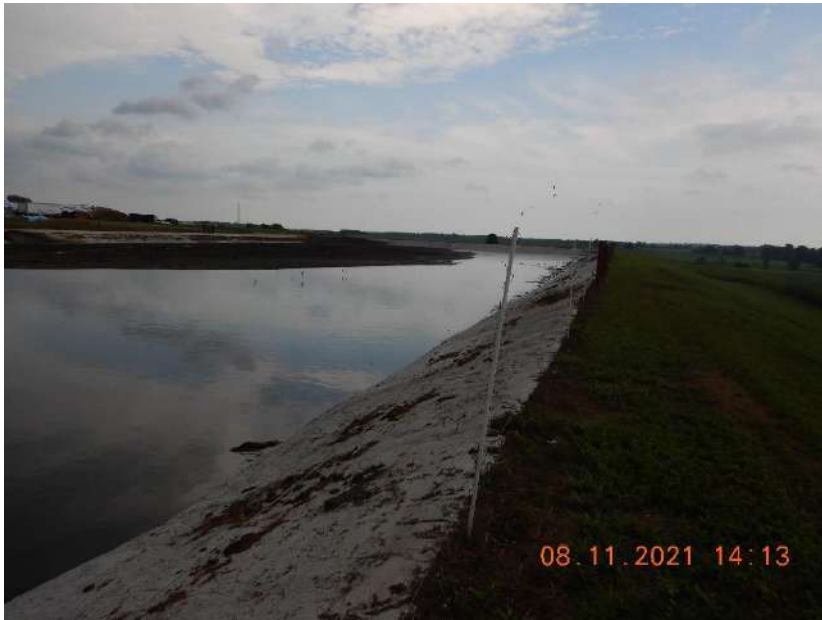
Photo 42. WSF 3 at the Main Site, located on the south side of the production site. WSF 3 is a concrete structure built in 2020. This photo was taken facing east.

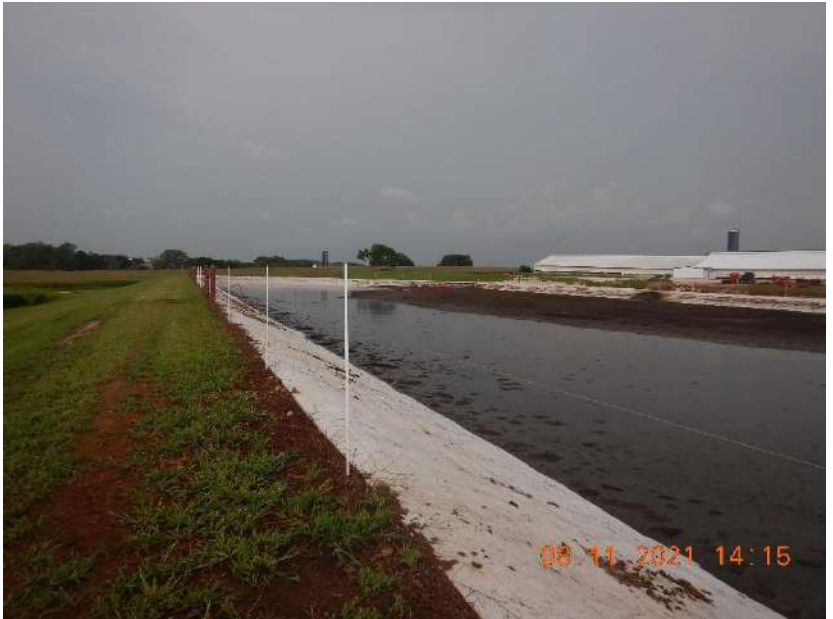
Photo 43. WSF 3 at the Main Site, located on the south side of the production site. WSF 3 is a concrete structure built in 2020. This photo was taken facing west.

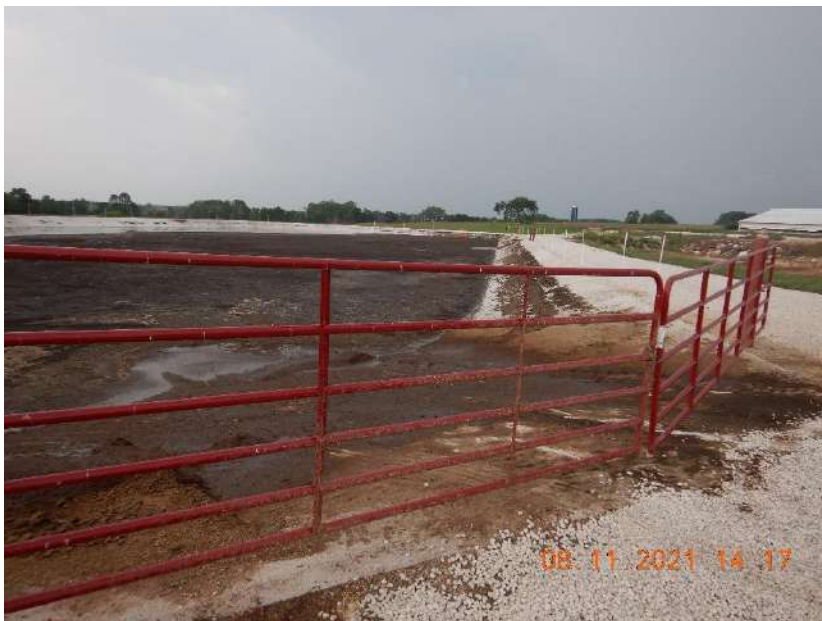
Photo 44. WSF 3 at the Main Site, located on the south side of the production site. WSF 3 is a concrete structure built in 2020. This photo was taken facing west.

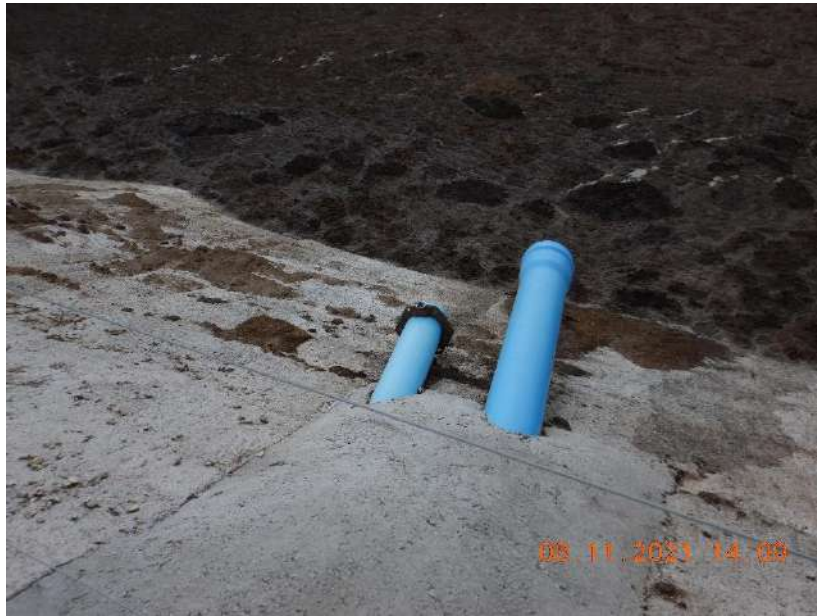
Photo 45. Outlets that discharge waste into WSF 3.

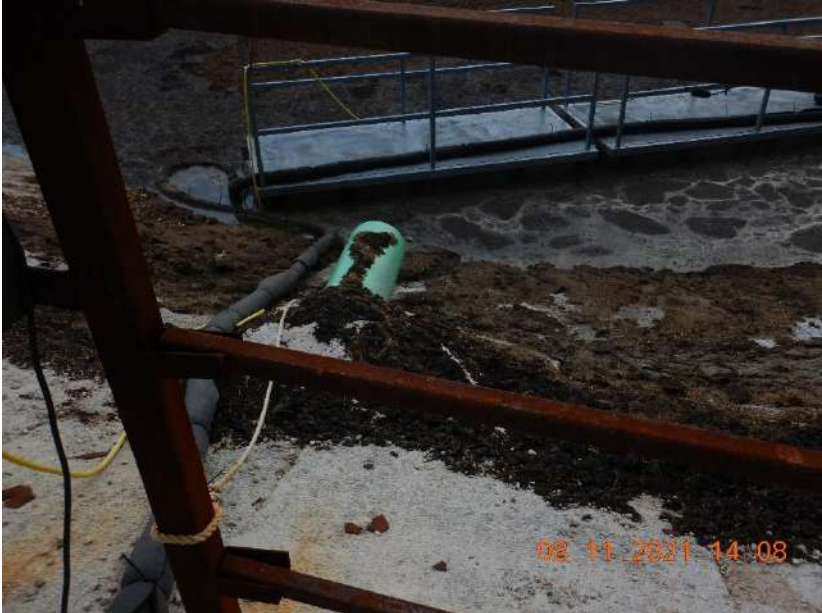
Photo 46. The outlet of the overflow transfer pipe from WSF 1.

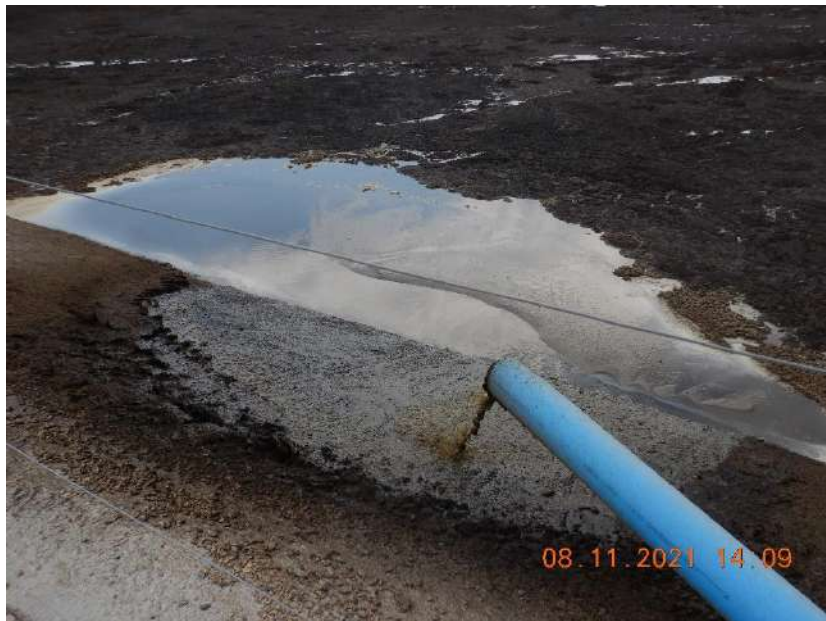
Photo 47. The outlet that discharges manure that is transferred from the sand separation building.

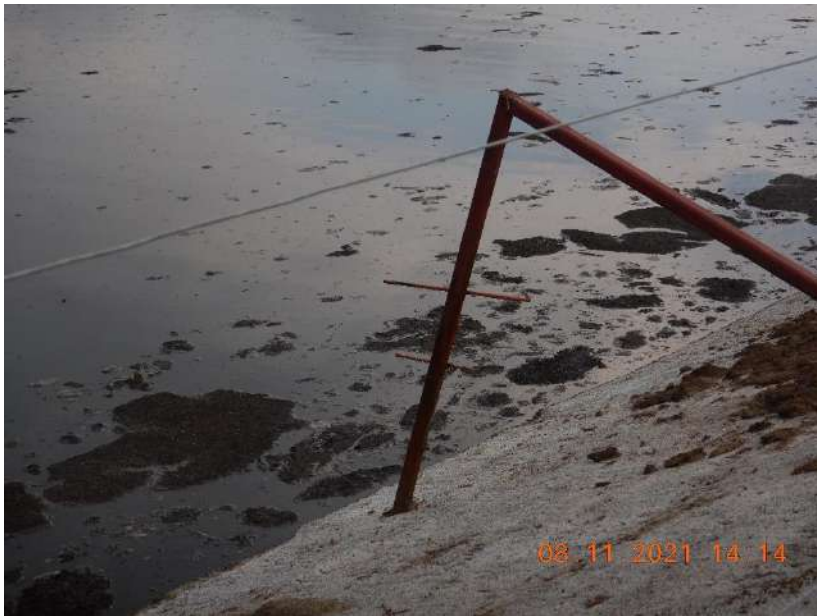
Photo 48. Permanent markers present with WSF 3. The top marker represents the MOS. The bottom marker represents the MOL.

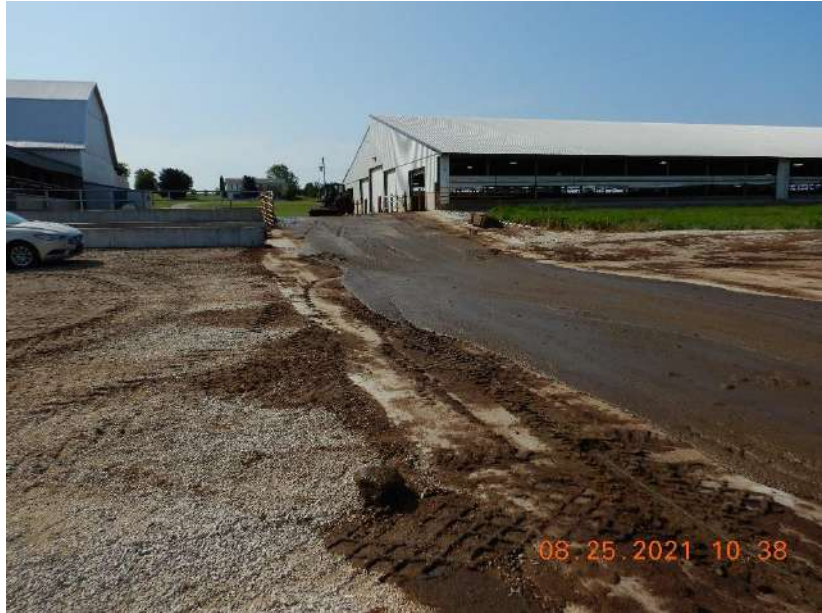
Photo 49. The concrete swale that manure is scraped from the animal barn at the Heifer Site. Manure is scraped from the barn and into WSF 2.

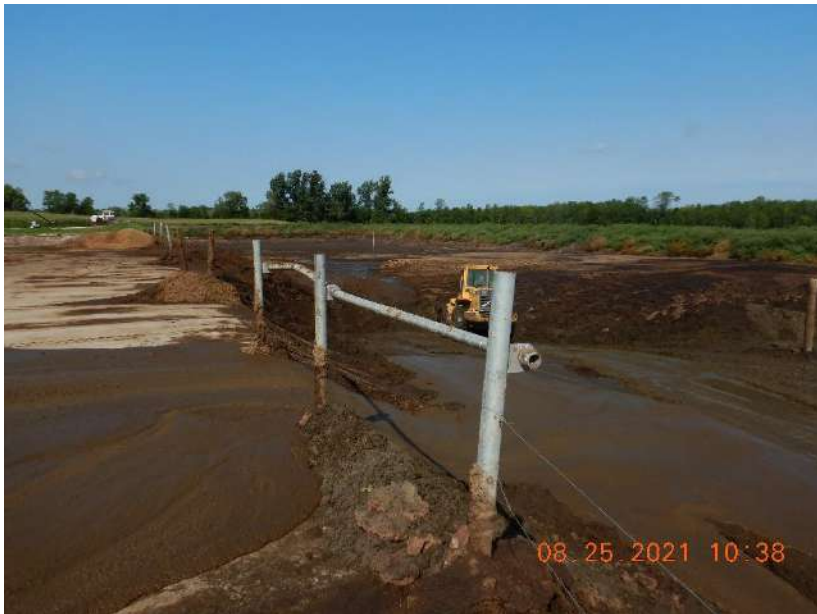
Photo 50. WSF 2 at the Heifer Site, located on the north side of the production site. Sand was being removed from the WSF at the time of the inspection. This photo was taken from the southeast corner of the storage facing west.

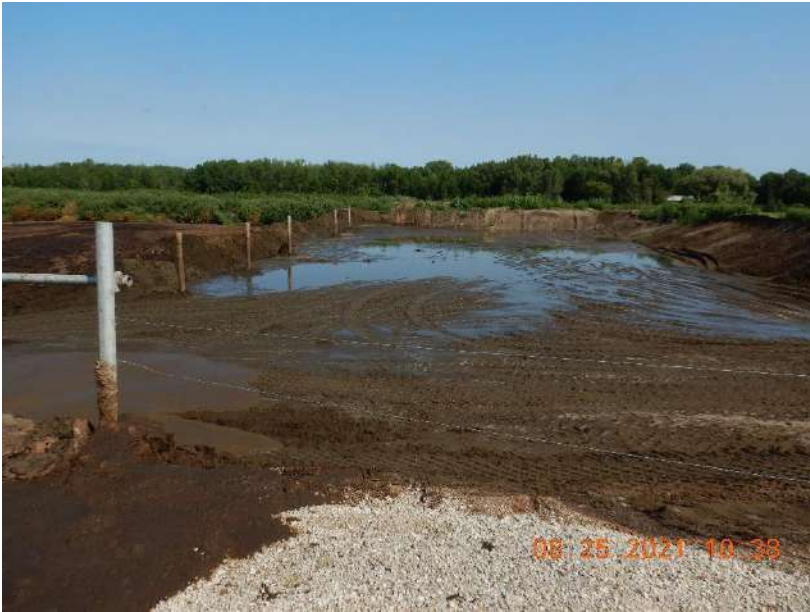
Photo 51. WSF 2 at the Heifer Site, located on the north side of the production site. Sand was being removed from the WSF at the time of the inspection. This photo was taken from the southeast corner of the storage facing north.

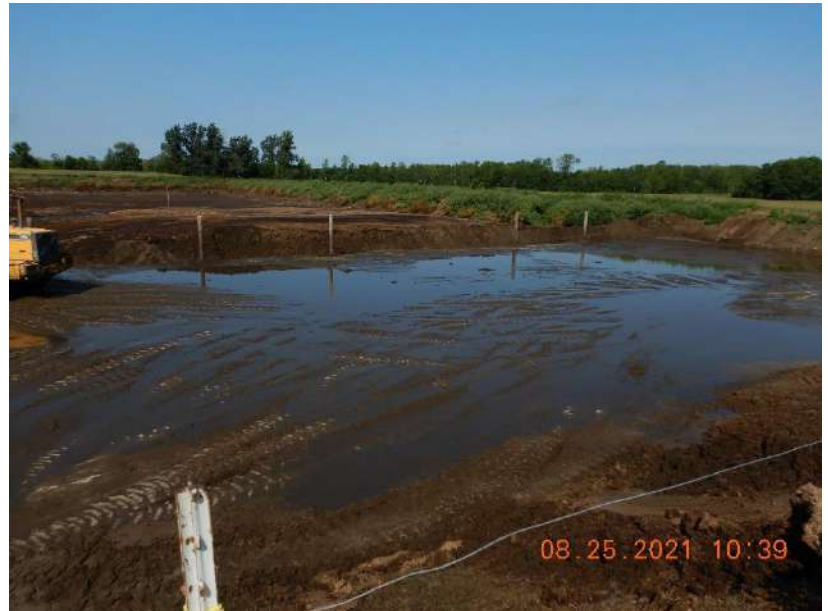
Photo 52. WSF 2 at the Heifer Site, located on the north side of the production site. This photo was taken from the east side of the storage facing northwest.

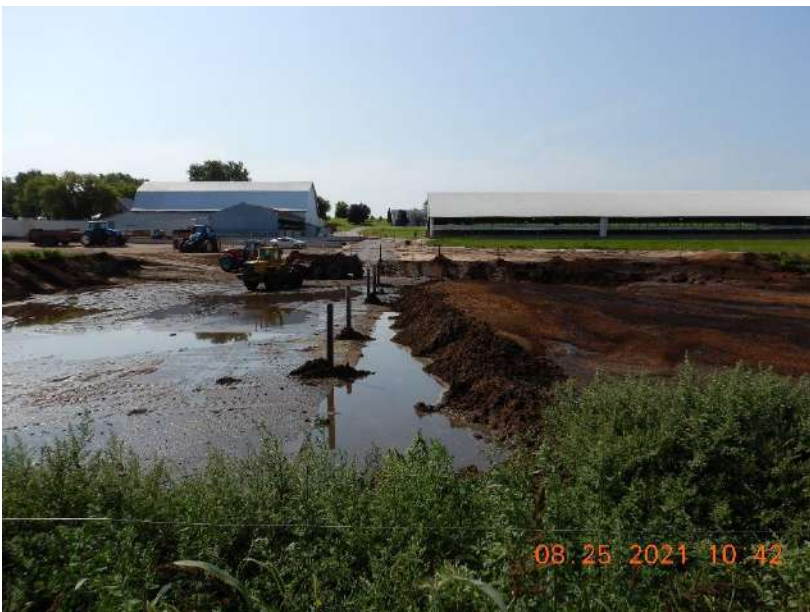
Photo 53. WSF 2 at the Heifer Site, located on the north side of the production site. Sand was being removed from the structure at the time of the inspection. This photo was taken from the north side of the storage facing south.

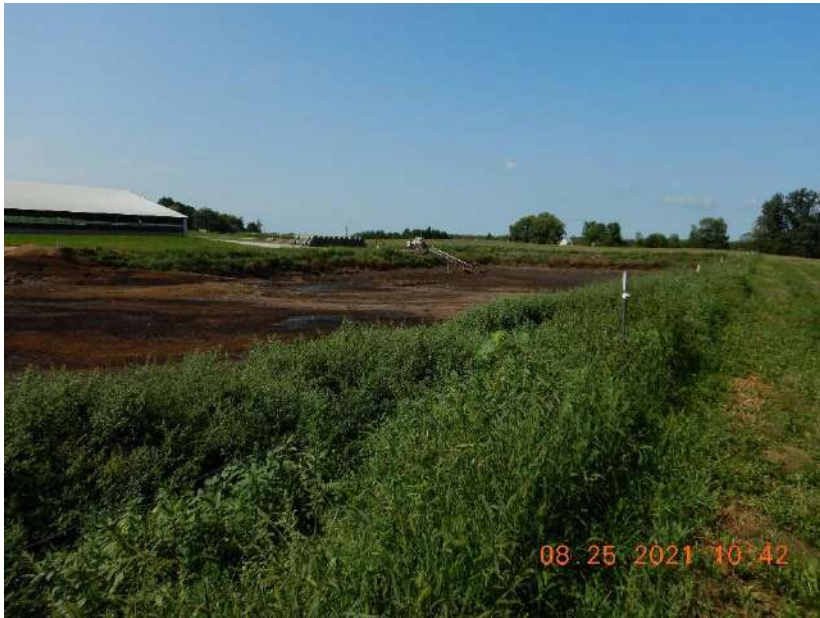
Photo 54. WSF 2 at the Heifer Site, located on the north side of the production site. This photo was taken from the north side of the storage facing west.

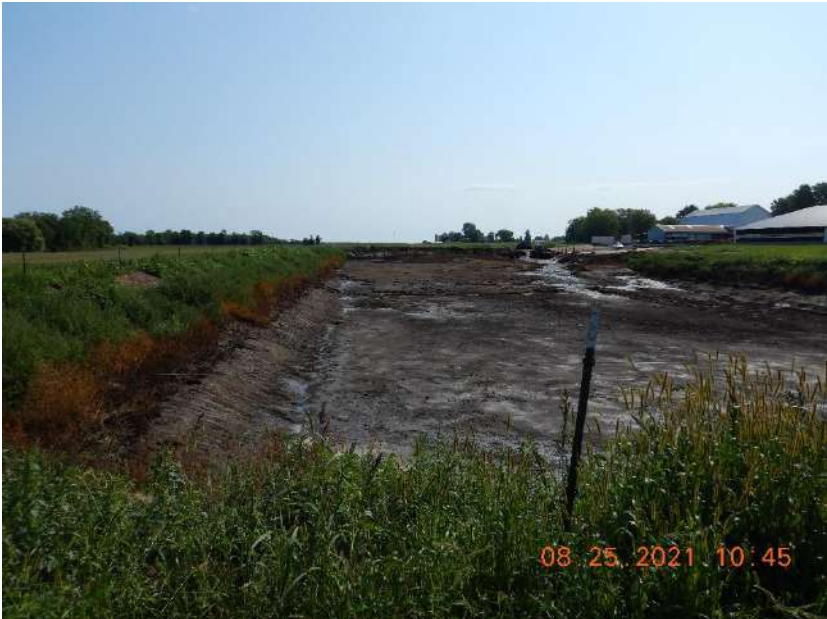
Photo 55. WSF 2 at the Heifer Site, located on the north side of the production site. This photo was taken from the west side of the storage facing east.

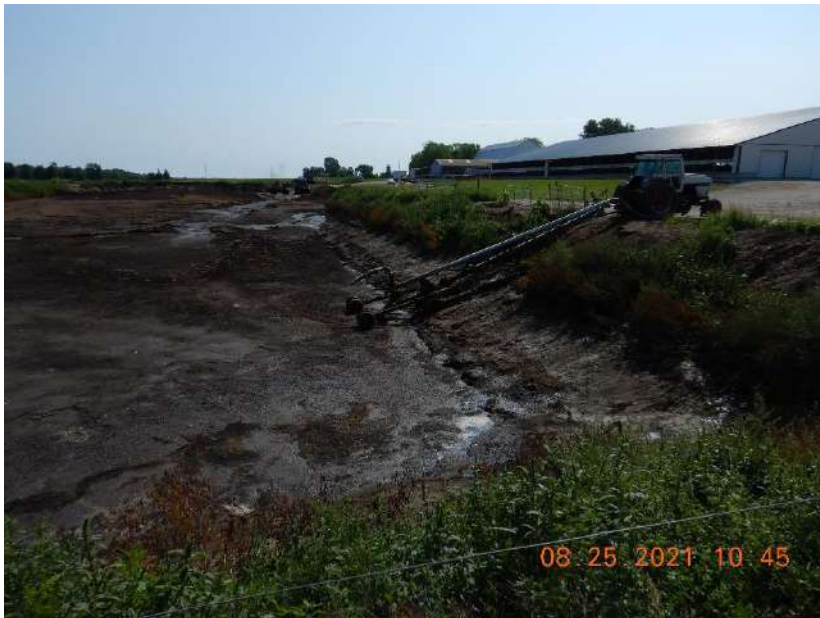
Photo 56. WSF 2 at the Heifer Site, located on the north side of the production site. This photo was taken from the west side of the storage facing east.

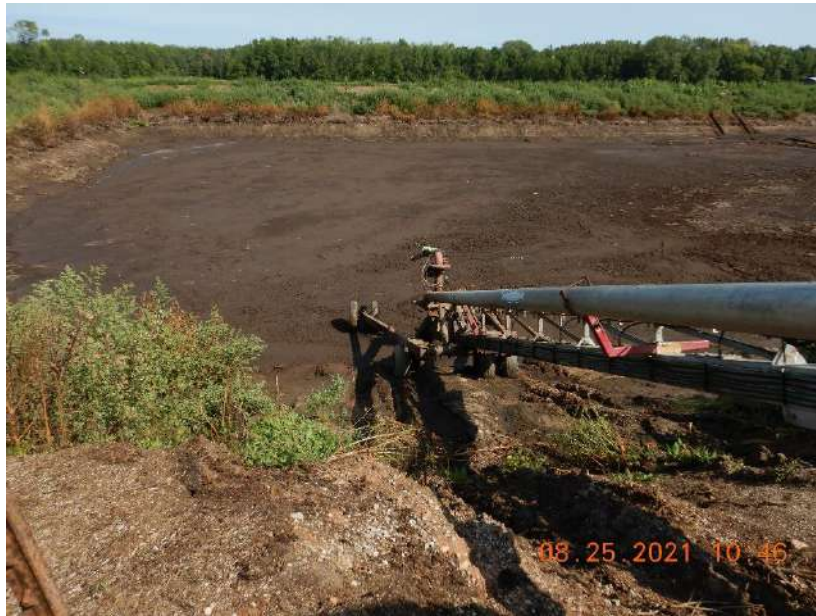
Photo 57. The agitation area in WSF 2 at the Heifer Site. This photo was taken facing north.

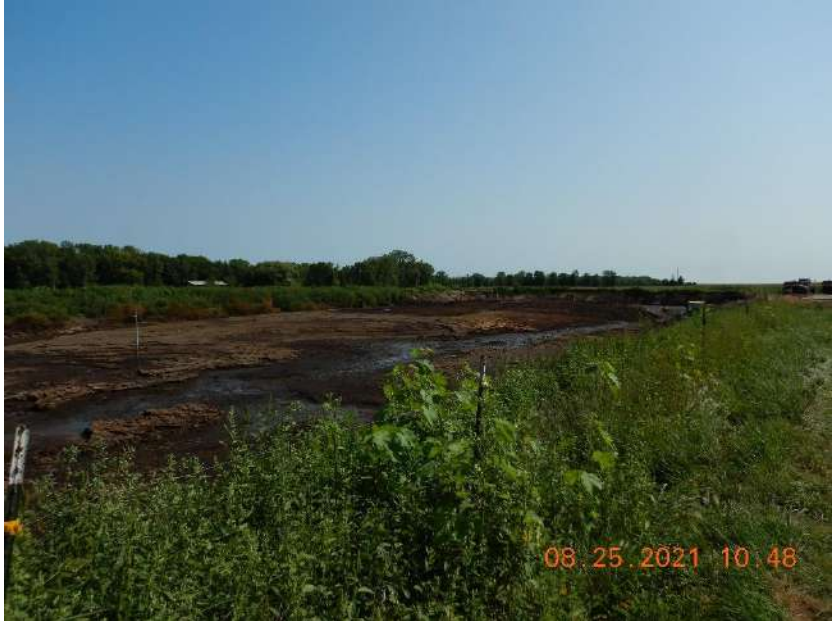
Photo 58. WSF 2 at the Heifer Site, located on the north side of the production site. This photo was taken from the south side of the storage facing northeast.

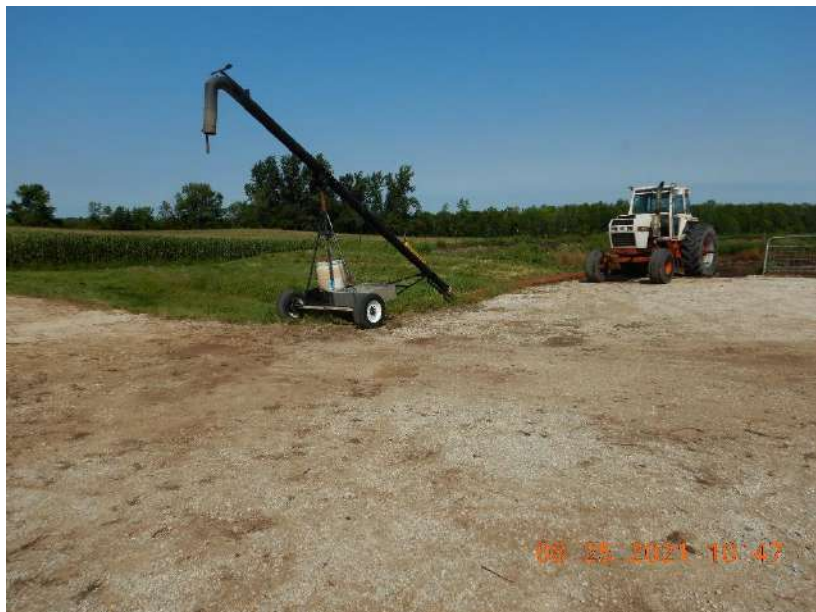
Photo 59. The manure loading area at the Heifer Site, where semitrucks are loaded with liquid manure during land application practices.

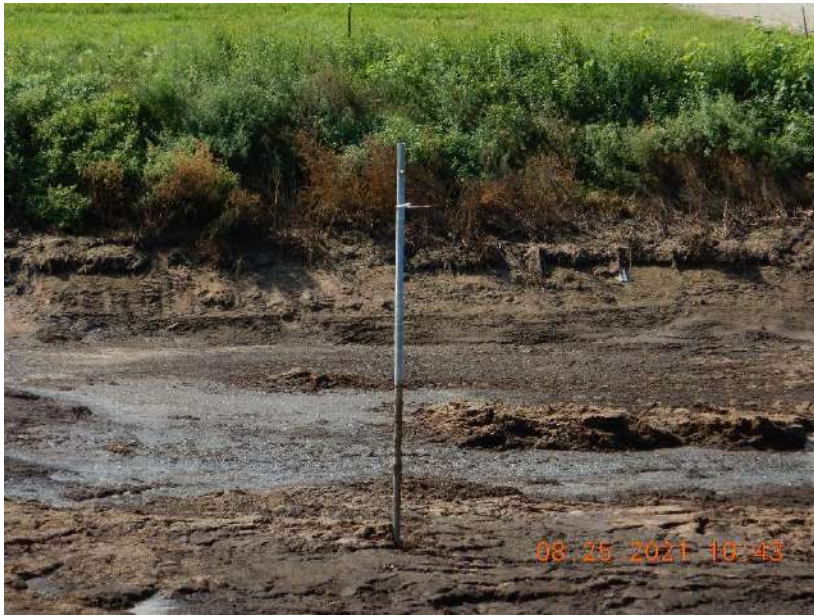
Photo 60. Permanent markers present within WSF 2 at the Heifer Site.

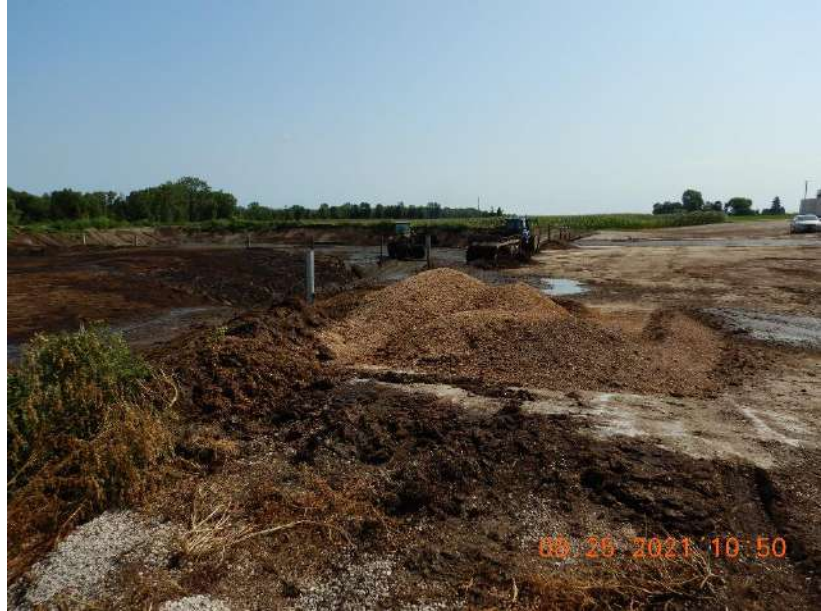
Photo 61. The west side of the solid manure stacking pad located south of WSF 2. Runoff from the stacking pad flows north directly into WSF 2. This photo was taken facing east.

At the Heifer Site, El Na Farms utilizes one liquid WSF and one solid manure stacking pad. WSF 2 is located on the north side of the production site and accepts manure and process wastewater from the outdoor feedlots, animal barns, and solid manure stacking pad. WSF 3 is an earthen WSF with a concrete bottom. The earthen berms were in good repair, with no signs of erosion. Sand bedding was being removed from the WSF using heavy machinery and land applied during the inspection. The solid manure stacking pad is located adjacent to WSF 2, on the south side of the storage. Runoff from the stacking pad flows south, directly into WSF 2. Manure solids and runoff from the storage pad were observed outside of the storage area. Fenendael informed Salscheider that because they stacked the solid manure so high, leachate discharged from the stacking area. The location that leachate discharged to drains through a grassed swale that terminates in a nearby cropped field. There was no active discharge occurring during the inspection. Better management of the solid stacking area will prevent unpermitted discharges in the future.

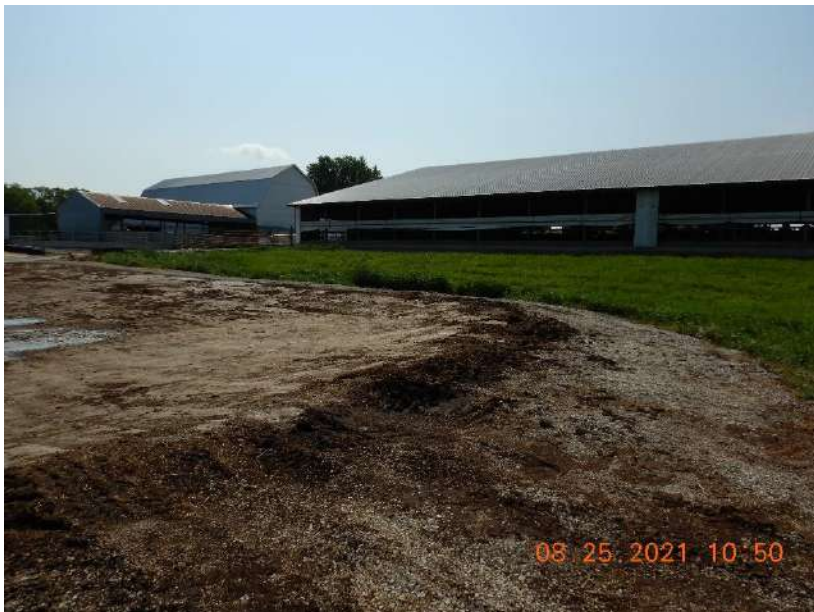
Photo 62. The west side of the solid manure stacking pad located south of WSF 2. Runoff from the stacking pad flows north directly into WSF 2. This photo was taken facing southeast.

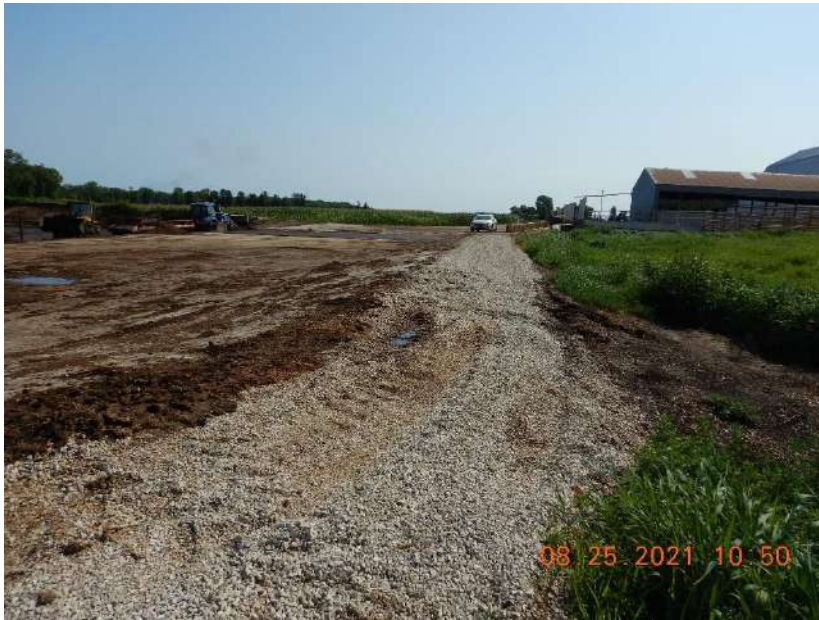
Photo 63. The south side of the solid manure stacking pad located south of WSF 2. Runoff from the stacking pad flows north directly into WSF 2. This photo was taken facing east.

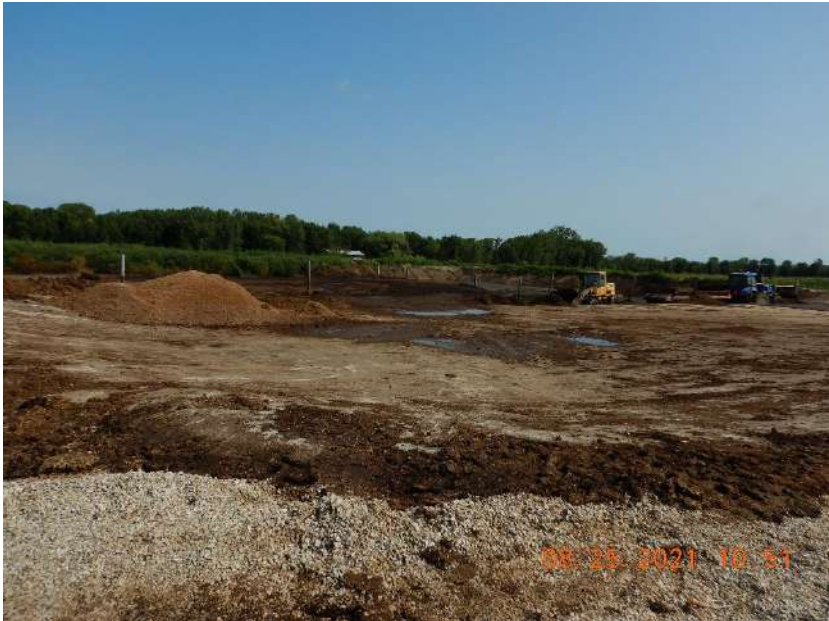
Photo 65. The south side of the solid manure stacking pad located south of WSF 2. Runoff and solids were present outside of the stacking area. This photo was taken facing north.

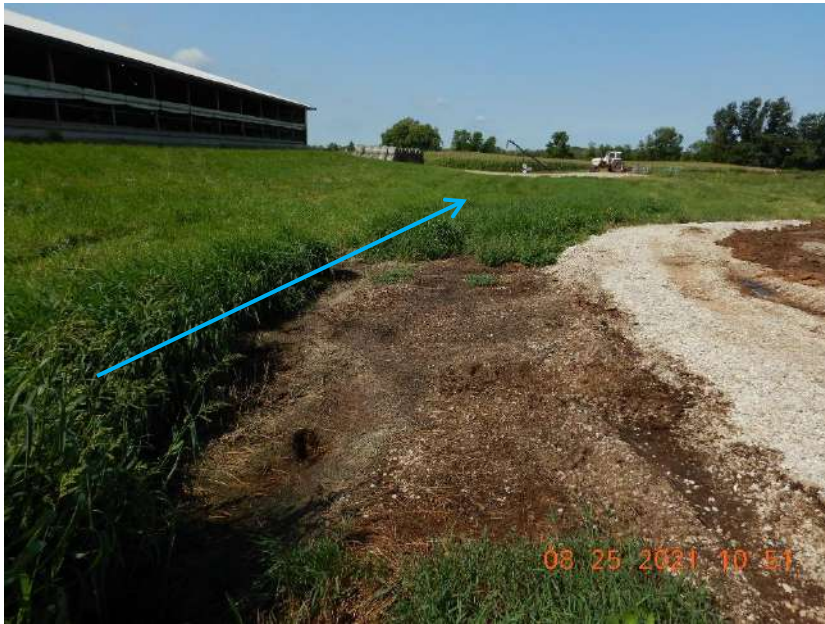
Photo 66. The south side of the solid manure stacking pad located south of WSF 2. Runoff and solids were present outside of the stacking area. The blue arrow represents the flow path of stormwater in the grassed swale. This photo was taken facing west.

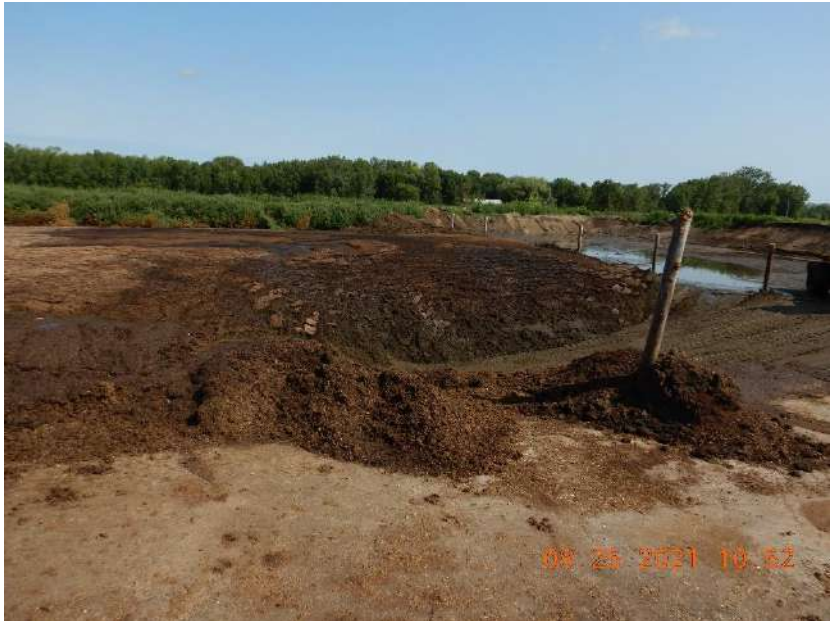
Photo 68. The location where runoff from the solid stacking area discharges into WSF 2 at the Heifer Site. The yellow arrows represent the flow path of runoff towards WSF 2.

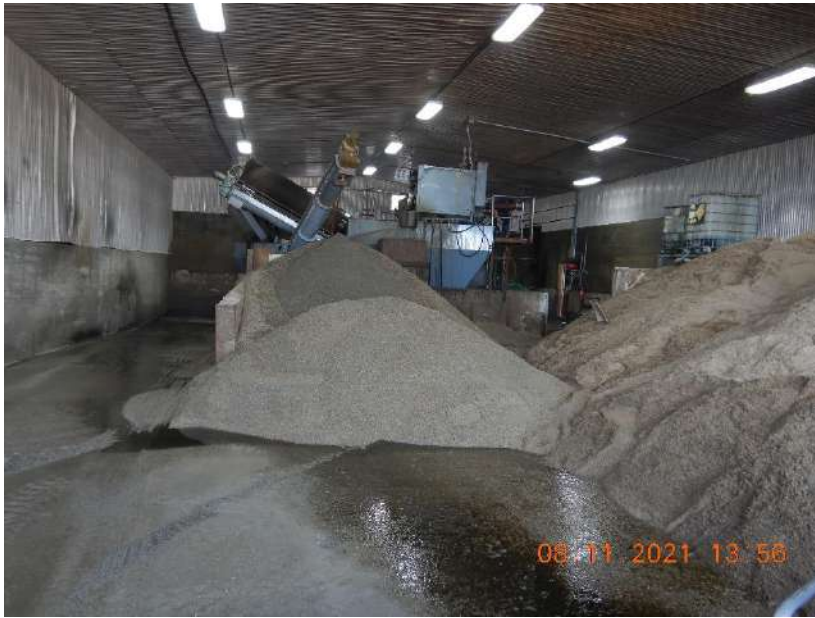
Photo 69. The sand separation building, where sand is removed from the manure, cleaned, and stored until it is reused for animal bedding. Leachate from the sand gravity flows back to a reception basin located behind the removal equipment.

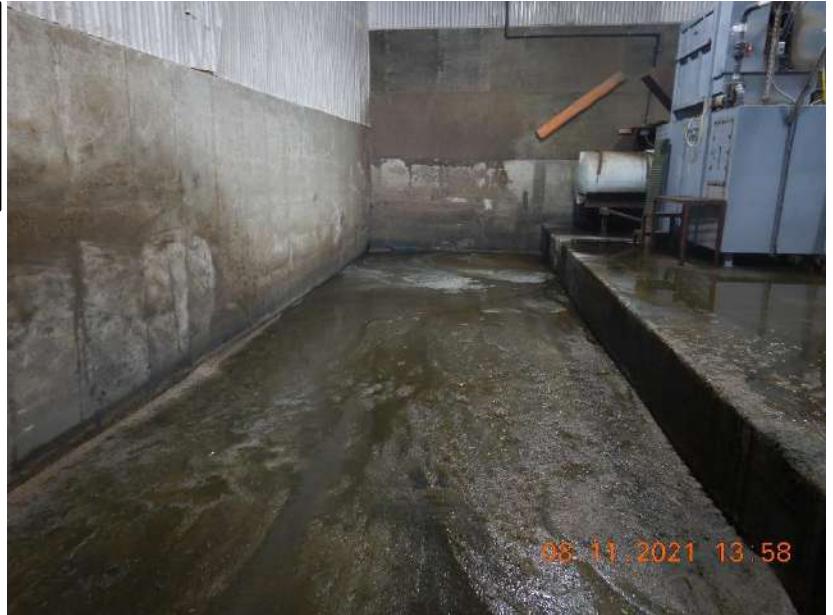
Photo 70. Runoff from the separated sand piles gravity flowing towards a reception basin to be comingled with the manure transfer system and transferred to the on-site waste storage facilities.

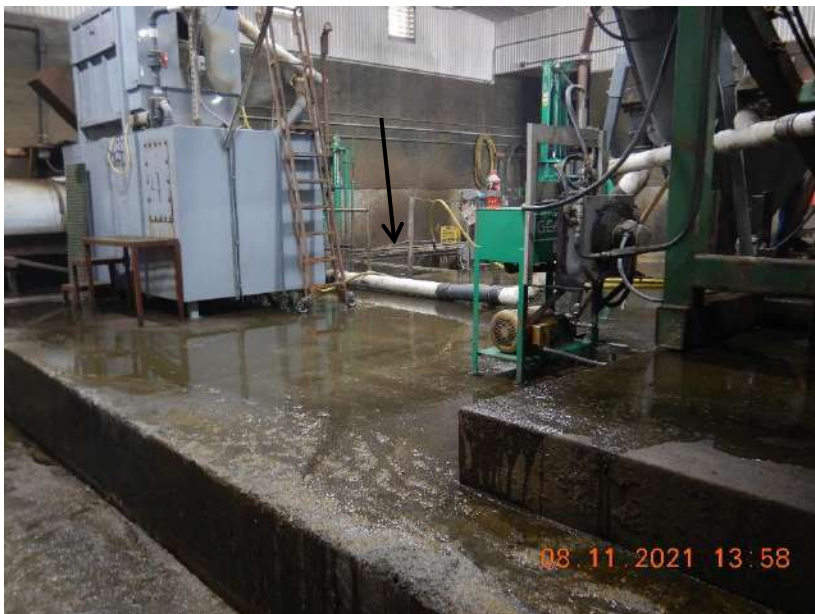
Photo 71. The reception basin for the sand separation building can be seen in the background of the photo, identified by the black arrow.

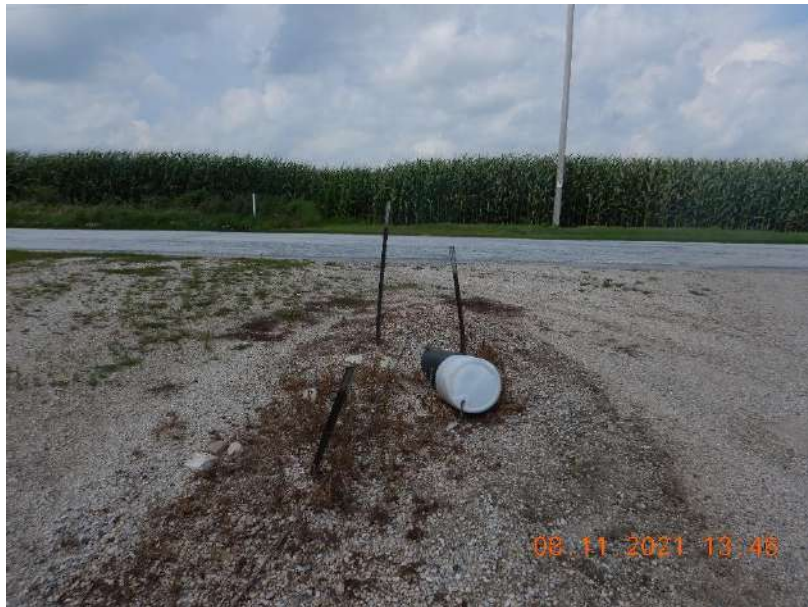
Photo 72. A manure transfer line located on the northwest corner of the production site that can transfer manure from the Main Site to the Heifer Site. This photo was taken facing north.

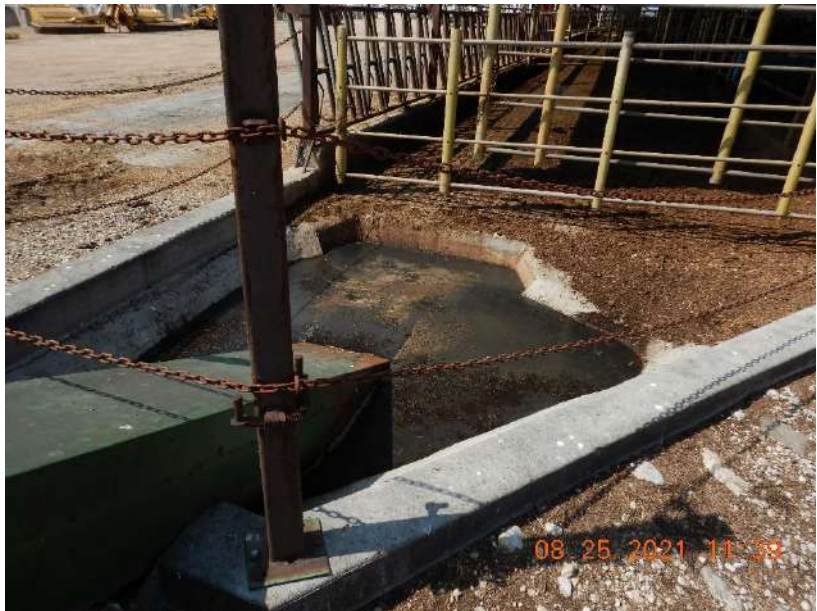
Photo 73. A reception basin at the east end of the heifer barn at the Main Site. Runoff enters the basin and is pumped directly to a manure tanker.

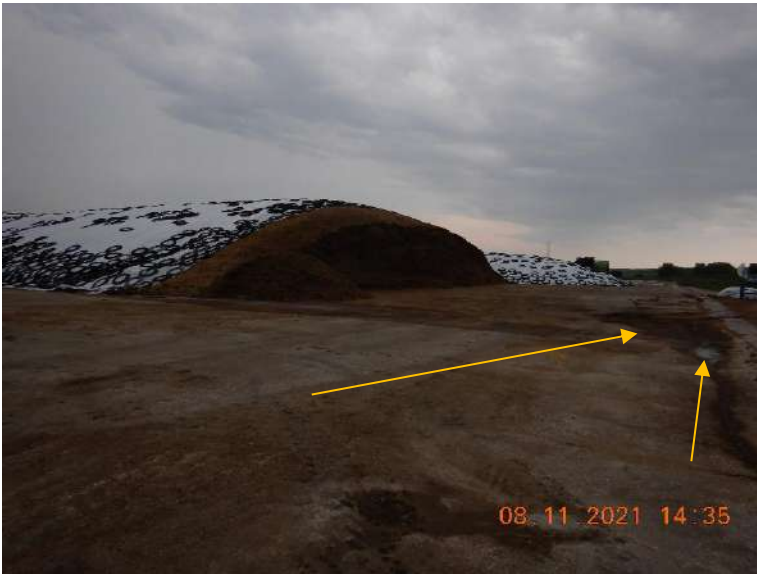
Photo 74. The feed storage area at the Main Site. Runoff flows from north to south and enters one of two runoff control systems. The yellow arrows represent the flow path of runoff. This photo was taken facing east.

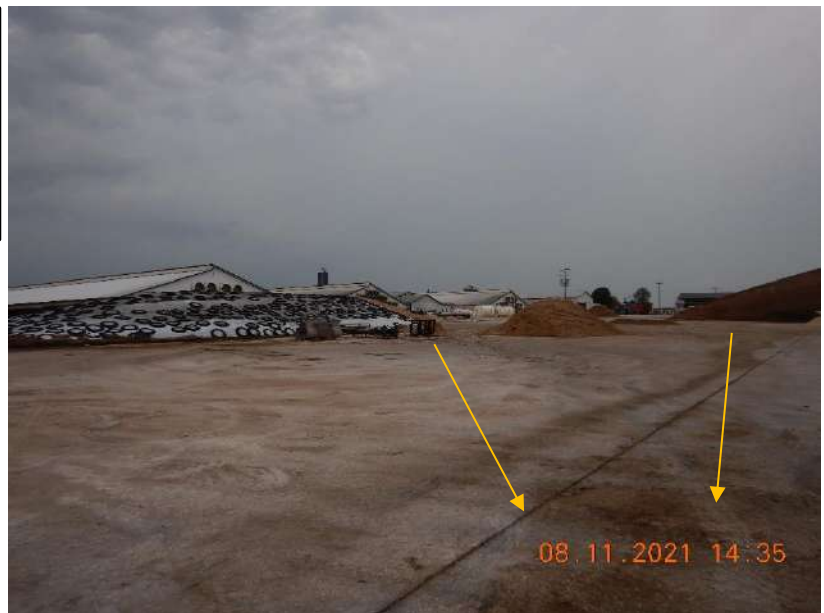
Photo 75. The feed storage area at the Main Site. Runoff flows from north to south and enters one of two runoff control systems. The yellow arrows represent the flow path of runoff. This photo was taken facing north.

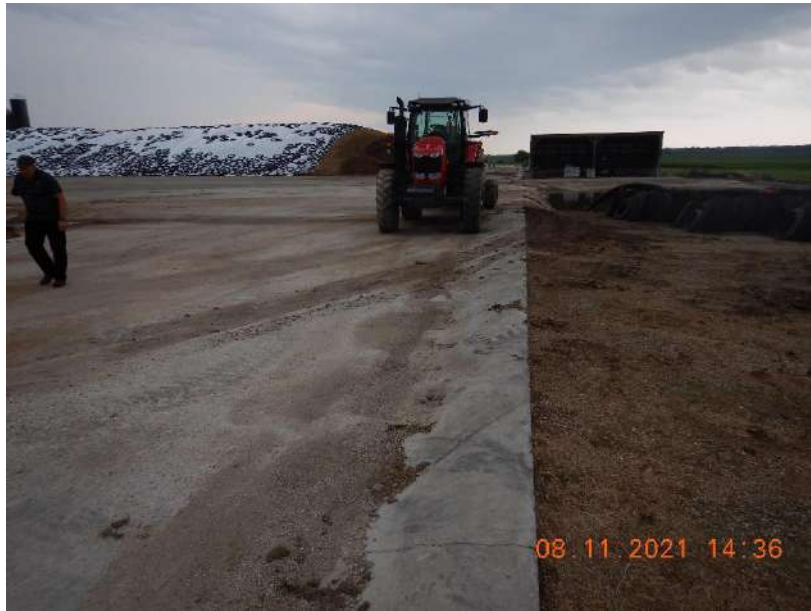
Photo 76. The feed storage area at the Main Site. Concrete curbing on the south side of the FSA prevents runoff from discharging and conveys runoff to the runoff control system.

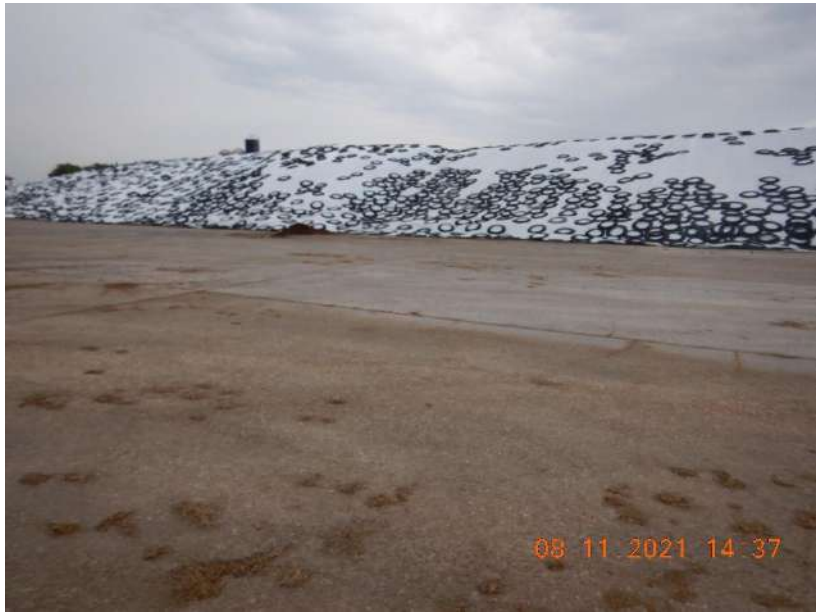
Photo 77. The feed storage area at the Main Site. The concrete pad was in good condition with no signs of degradation.

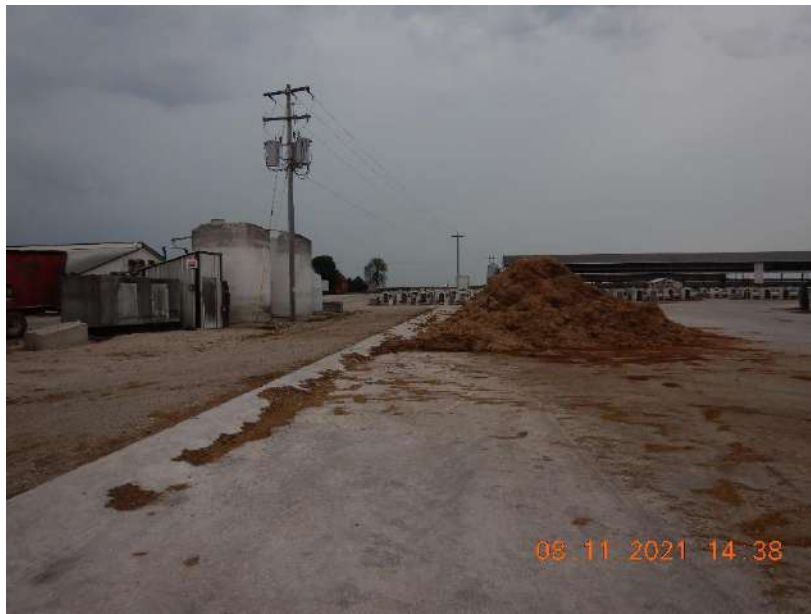
Photo 78. The feed storage area at the Main Site. Concrete curbing on the west side of the FSA prevents runoff from discharging and conveys the runoff to the runoff control system. This photo was taken facing north.

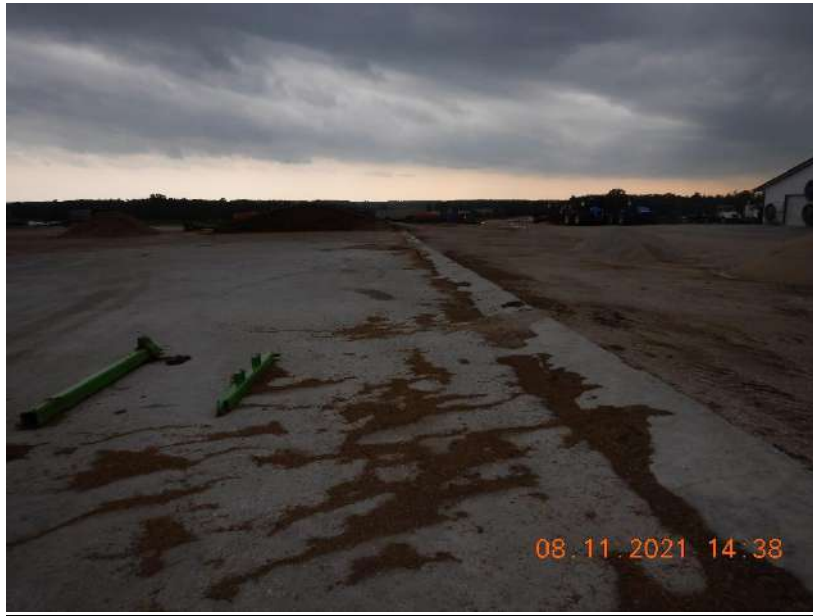
Photo 79. The feed storage area at the Main Site. Concrete curbing on the west side of the FSA prevents runoff from discharging and conveys the runoff to the runoff control system. This photo was taken facing south.
