Permit Fact Sheet

Permit Number	WI-0063061-04-0
Permittee Name and Address	El Na Farms LLC; 4029 Pheasant Road Algoma, WI 54201
Permitted Facility Name and Address	El Na Farms LLC; 4029 Pheasant Road Algoma, WI 54201
Permit Term	January 01, 2025 to December 31, 2029
Discharge Location	(Main Site) E4029 Pheasant Rd, Algoma, WI 54201; E ½ of the NE ¼ T25N R24E S34, Township of Lincoln (Heifer Site) E4082 County Rd S, Algoma, WI 54201; SE ¼ of the SE ¼ T25N R24E S22, Township of Lincoln
Receiving Water	Unnamed tributaries within the Ahnapee River Watershed, Lake Michigan Drainage Basin, and groundwaters of the state.

El Na Farms LLC is an existing Concentrated Animal Feeding Operation in Kewaunee County, WI. El Na Farms is owned and operated by the Lonnie Fenendael. As of January of 2024, it has 1,750 milking and dry cows, 450 large heifers, 550 small heifers, and 400 calves (3,355 animal units). El Na Farms plans to expand to 5,040 animal units by the end of 2024. El Na Farms will annually generate approximately 31,527,283 gallons of liquid manure and process wastewater and 4,300 tons of solid manure. After the expansion, El Na Farms will generate 43,288,817 gallons of manure and p

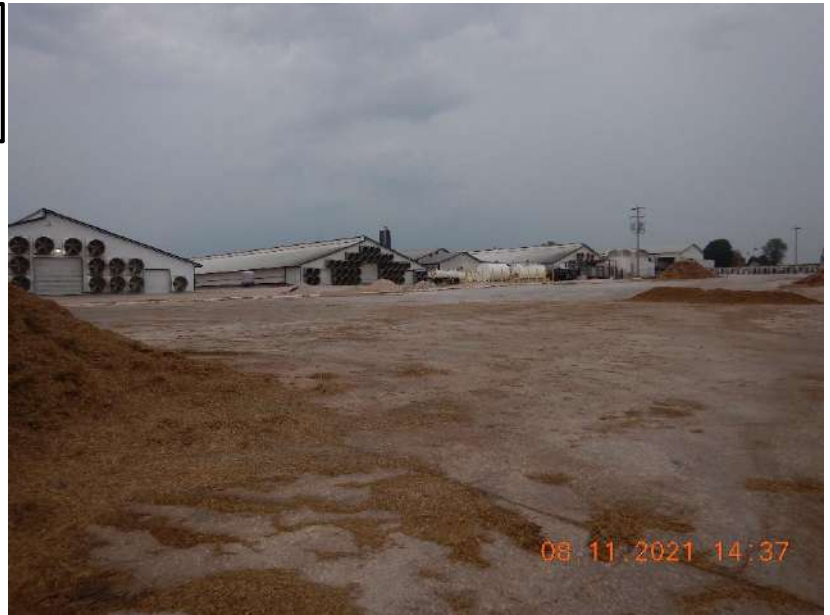
Photo 80. The feed storage area at the Main Site. The concrete pad was in good condition with no signs of degradation.

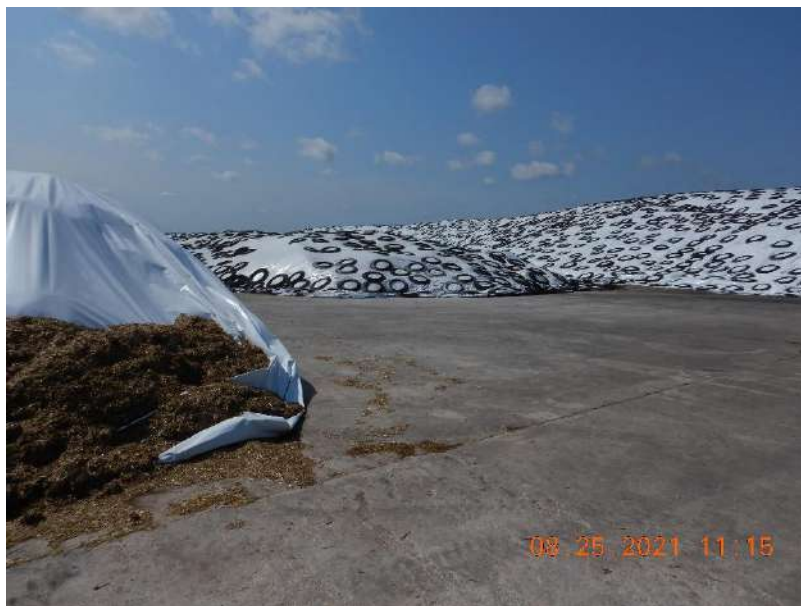
Photo 81. The east side of the feed storage area at the Main Site. The concrete pad was in good condition with no signs of degradation.

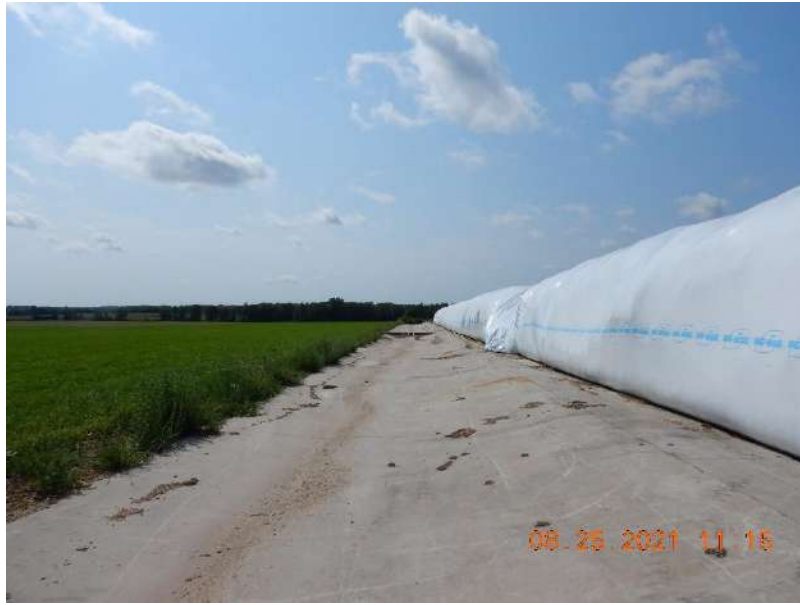
Photo 82. The east edge of the feed storage area at the Main Site. The concrete pad is sloped west to prevent runoff from leaving the east side of the feed pad. This photo was taken facing south.

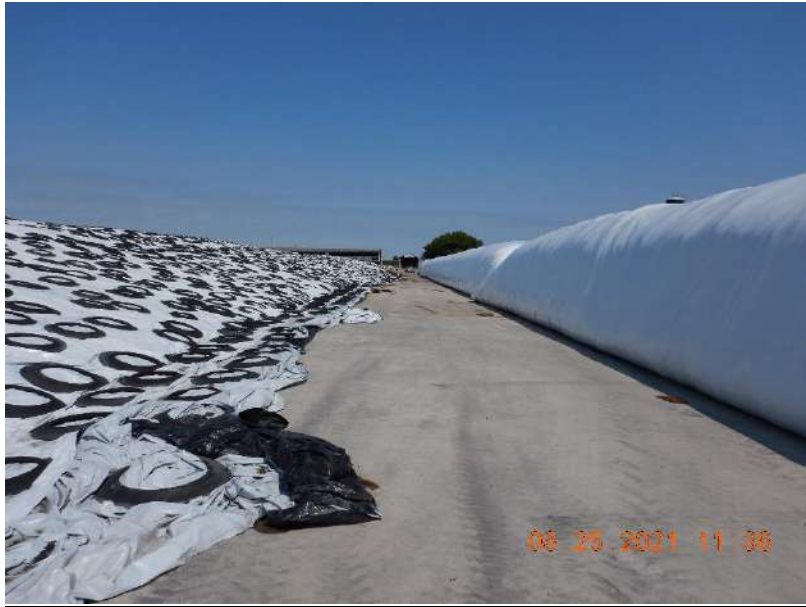
Photo 83. The east side of the feed storage area at the Main Site. The concrete pad was in good condition with no signs of degradation.

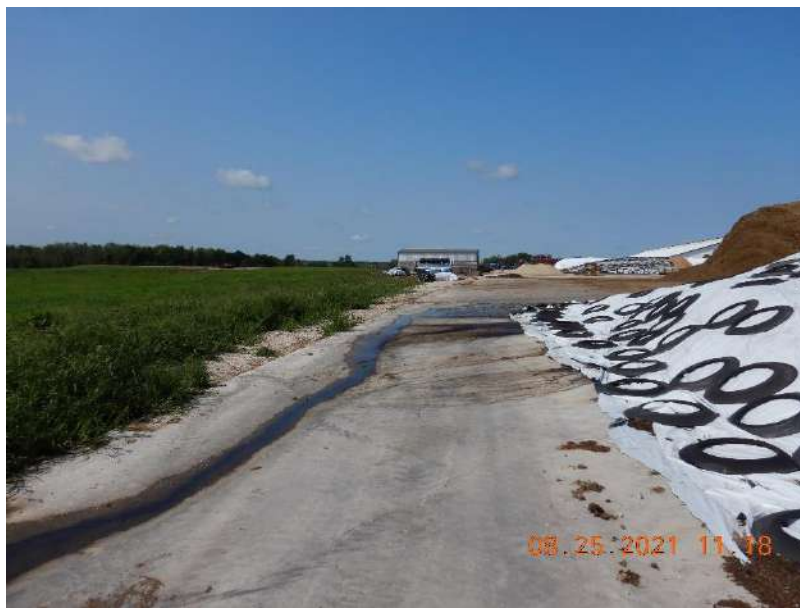
Photo 84. The east side of the feed storage area at the Main Site, where runoff flows from north to south and enters a grassed swale that conveys runoff to the detention basin, located south of the FSA.

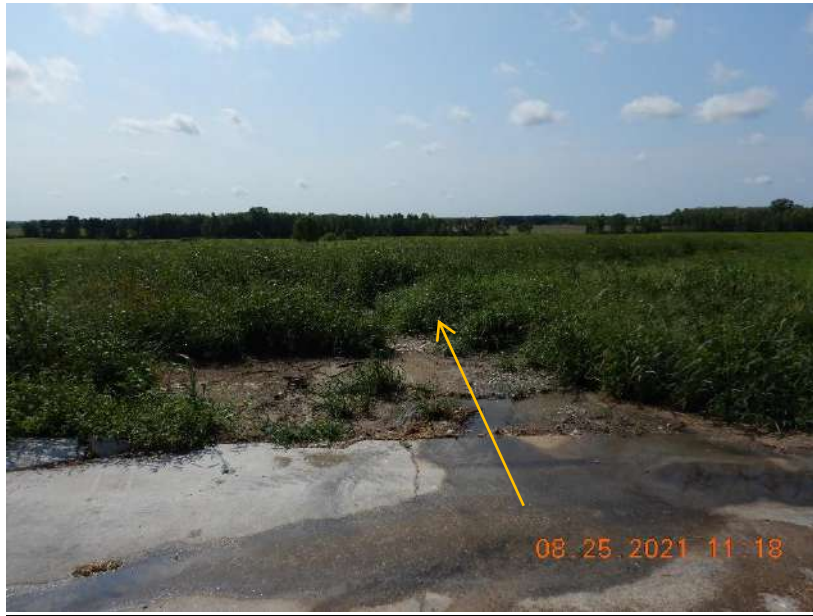
Photo 85. The grassed swale that conveys runoff from the east side of the feed storage area to the detention basin, located south of the FSA. The yellow arrow represents the flow path of runoff. This photo was taken facing south.

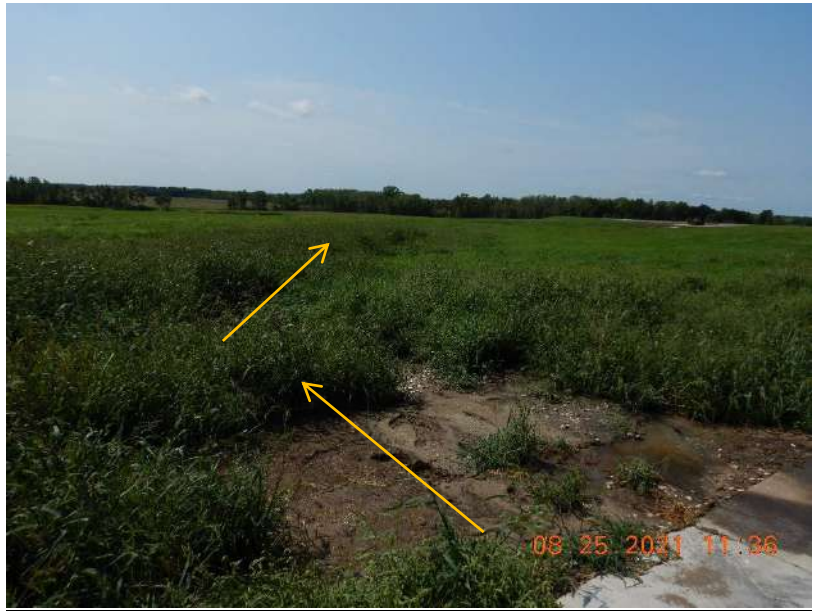
Photo 86. The grassed swale that conveys runoff from the east side of the feed storage area to the detention basin, located south of the FSA. The yellow arrows represent the flow path of runoff. This photo was taken facing southwest.

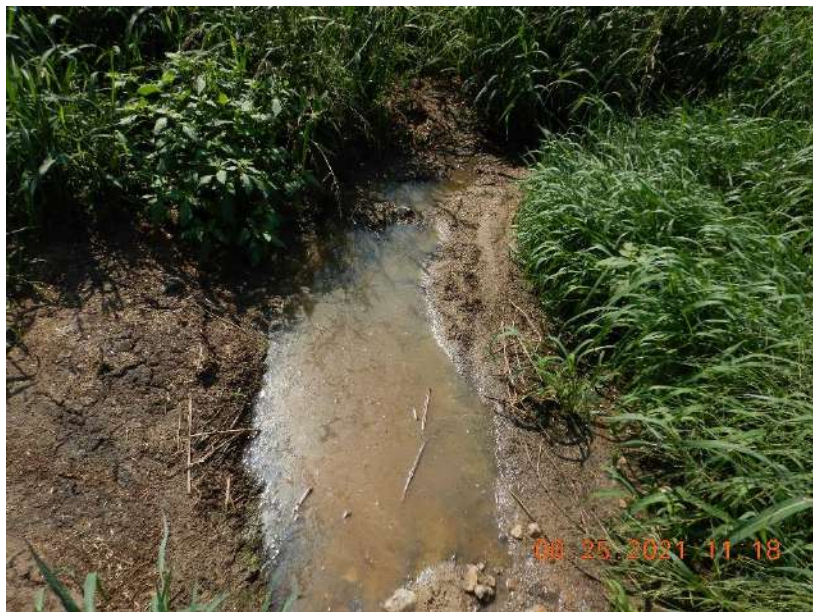
Photo 87. Runoff within the grassed swale that conveys wastewater to the detention basin.

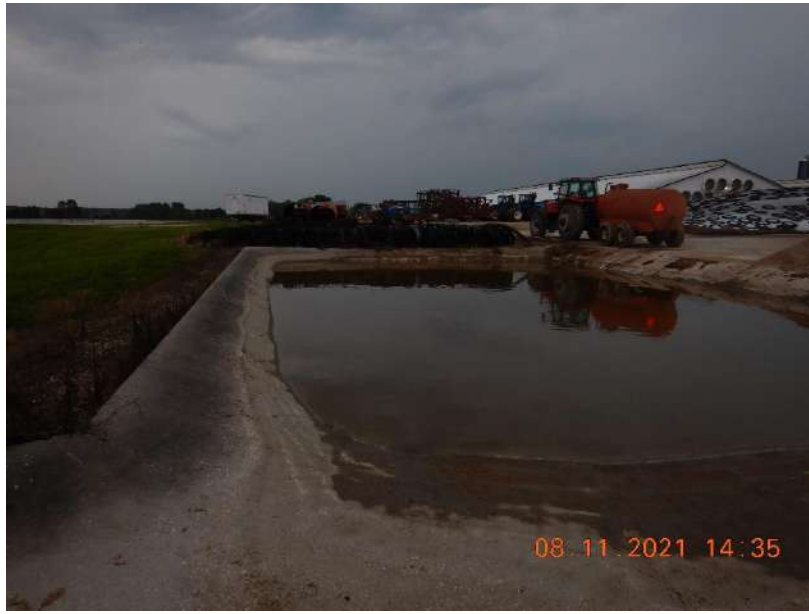
Photo 88. The leachate basin that is located on the south side of the feed storage area. The leachate basin accepts leachate and first flush from the west side of the FSA. Runoff overflows via the toe drain on the southeast corner of the basin and flows to the detention basin. This photo was taken facing west.

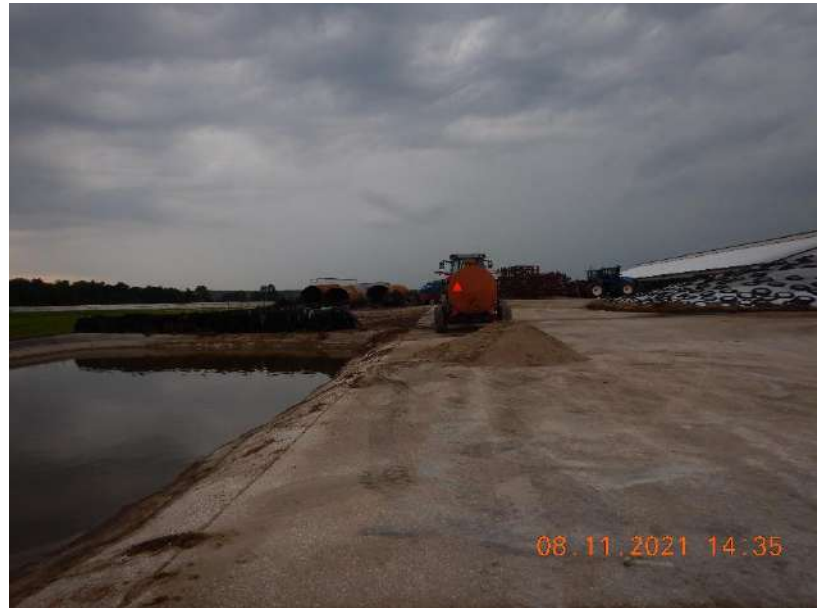
Photo 89. The leachate basin that is located on the south side of the feed storage area. The leachate basin accepts leachate and first flush from the west side of the FSA. Runoff overflows via the toe drain on the southeast corner of the basin and flows to the detention basin. The VAC truck that transfers waste to the onsite WSFs can be seen in the photo. This photo was taken facing west.

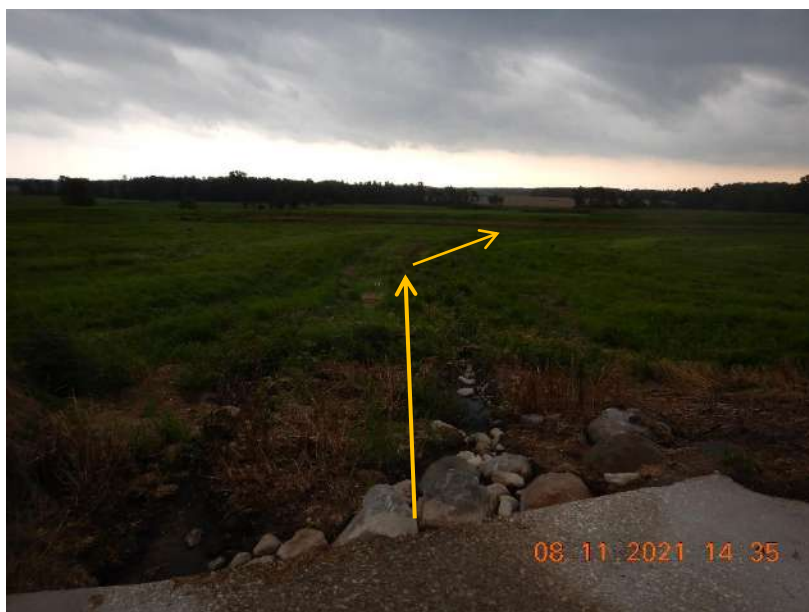
Photo 90. The toe drain where runoff overflows from the leachate basin and gravity flows to the detention basin. The yellow arrows represent the flow path of runoff. This photo was taken facing south.

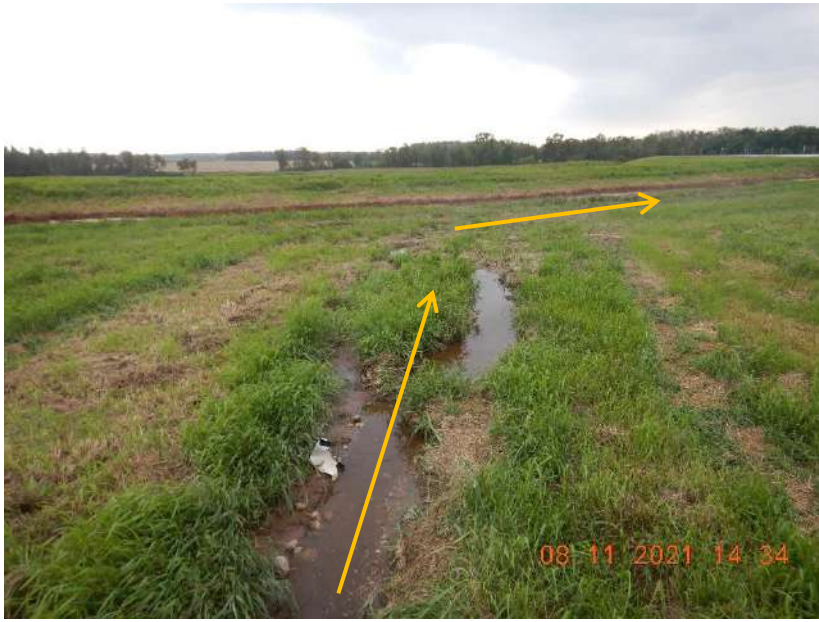
Photo 91. The flow path of runoff from the leachate basin to the detention basin. The yellow arrows represent the flow path. This photo was taken facing south.

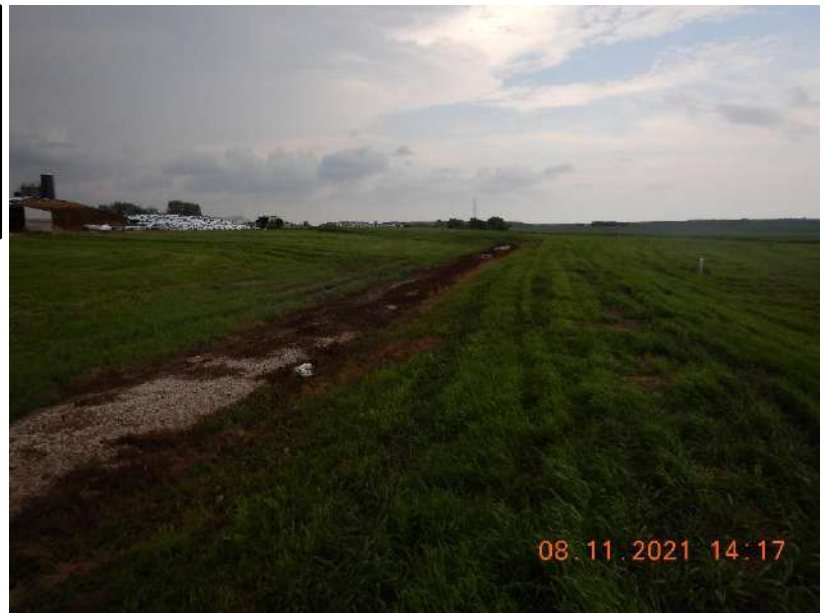
Photo 93. The detention basin located south of the leachate basin and feed storage area. The detention basin accepts overflow from the leachate basin and runoff from the east side of the feed storage area. This photo was taken facing east.

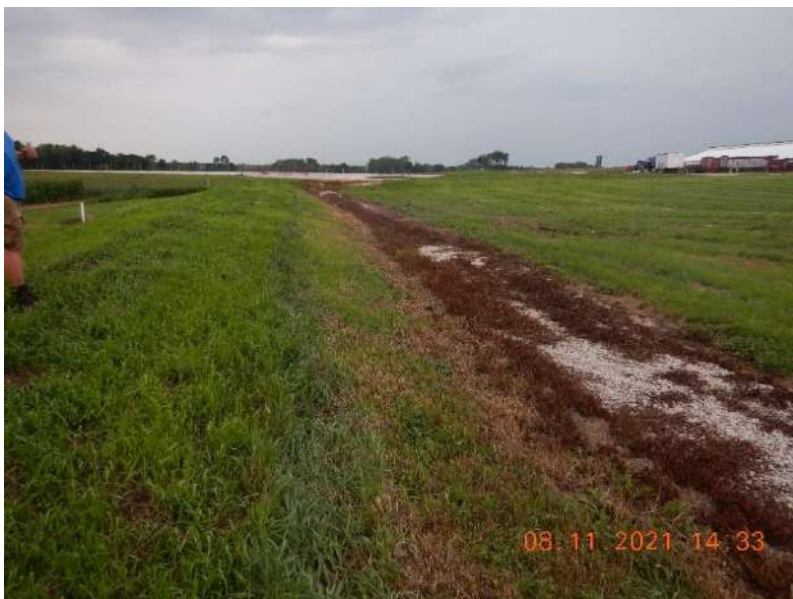
Photo 94. The detention basin located south of the leachate basin and feed storage area. The detention basin accepts overflow from the leachate basin and runoff from the east side of the feed storage area. This photo was taken facing west.

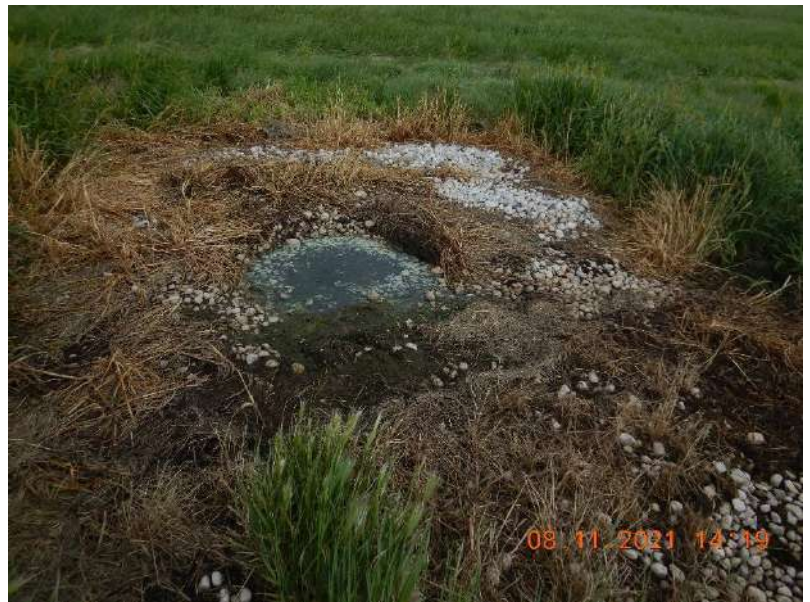
Photo 96. One of five bubblers that are used to evenly distribute runoff across the vegetate treatment area.

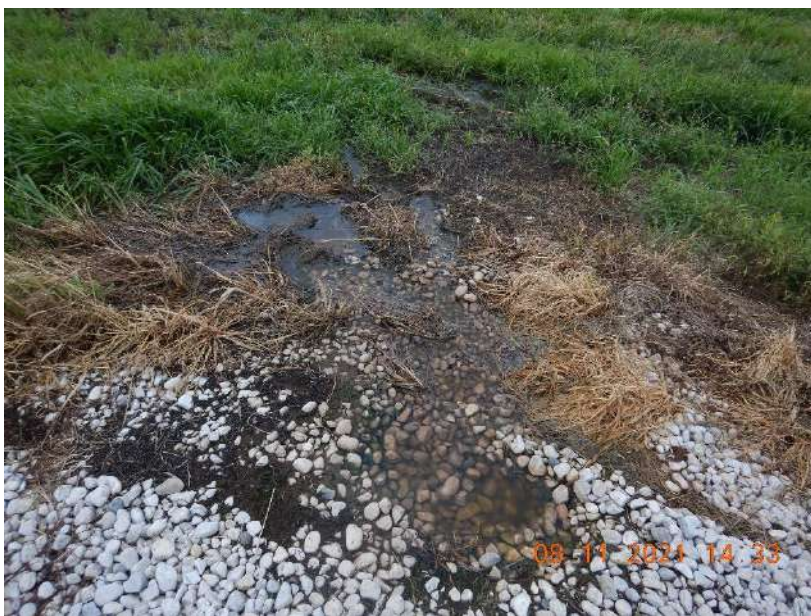
Photo 97. The vegetated treatment area located south of the detention basin. One concentrated flow channel was present from one of the bubblers, as its elevation is lower than the rest resulting in more runoff being discharged from the bubbler. This photo was taken facing south.

- Manure Tracking present outside of northern freestall barn and runoff flows towards clean water surface inlet
- Unvegetated stormwater swale located between the freestall barn
- One bubbler within the vegetated treatment area discharges more than the other bubblers, causing burnt vegetation and concentrated flow
- Calf Hutch Area runoff controls cause gully erosion and does not evenly distribute across the VTA
- Evidence of discharges from the solid stacking area at the Heifer Site was present
- Spilled feed solids were present around the production site at the Heifer Site.

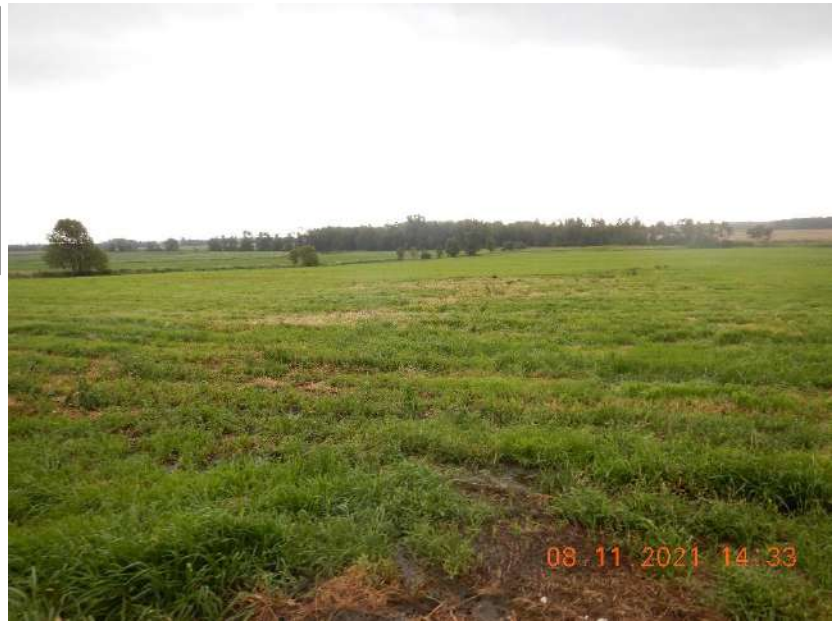
Photo 99. The vegetated treatment area located south of the detention basin. Pictured dead vegetation was killed from excess runoff from one of the bubblers. This photo was taken facing north.

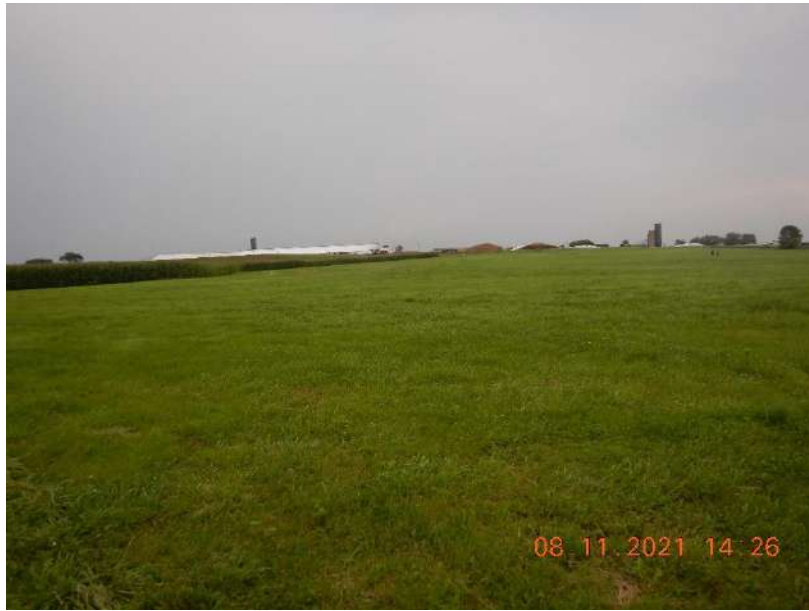
Photo 100. The vegetated treatment area located south of the detention basin. This photo was taken facing north.

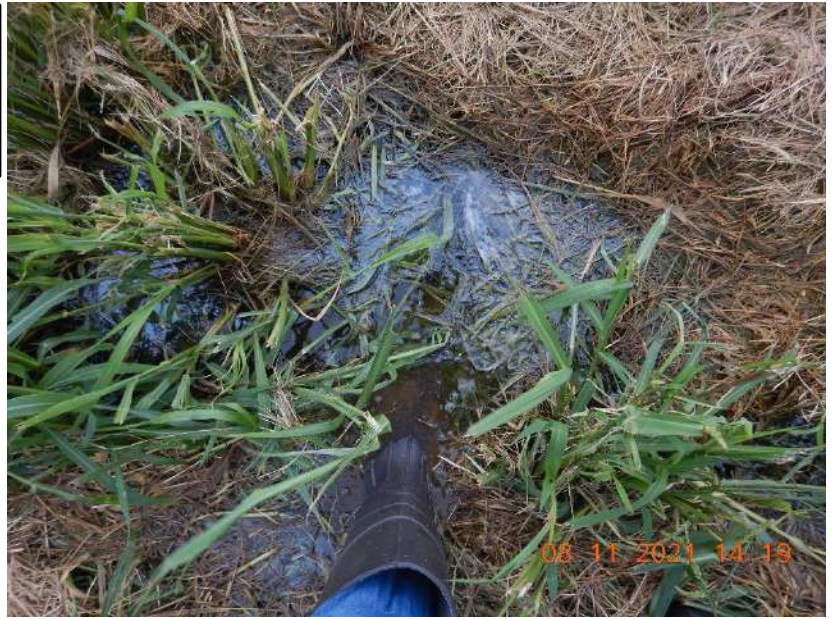
Photo 101. Ponded process wastewater within the vegetated treatment area. Ruts within the VTA has prevented runoff from smoothly distributing across the VTA.

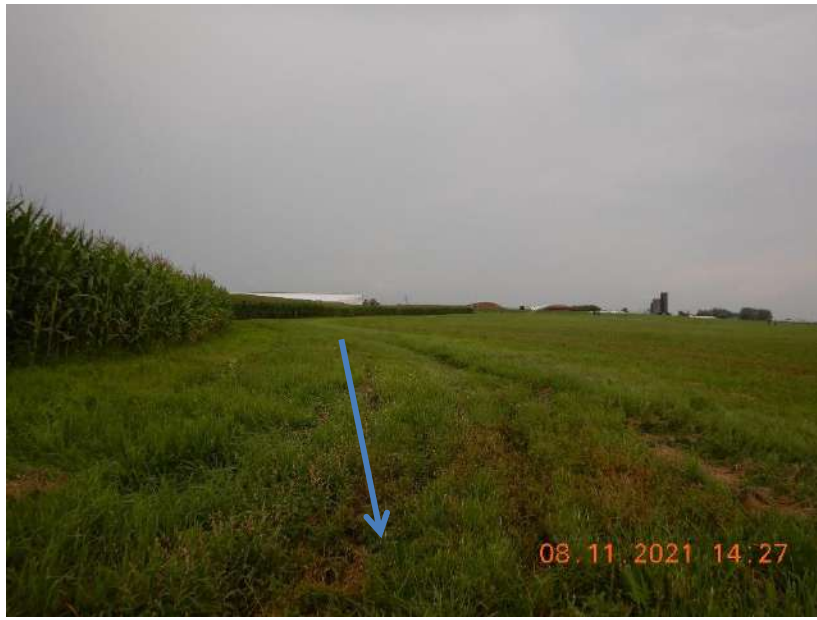
Photo 103. A grassed waterway present west of the vegetated treatment area. The blue arrow represents the flow path of runoff down the waterway. This photo was taken facing north.

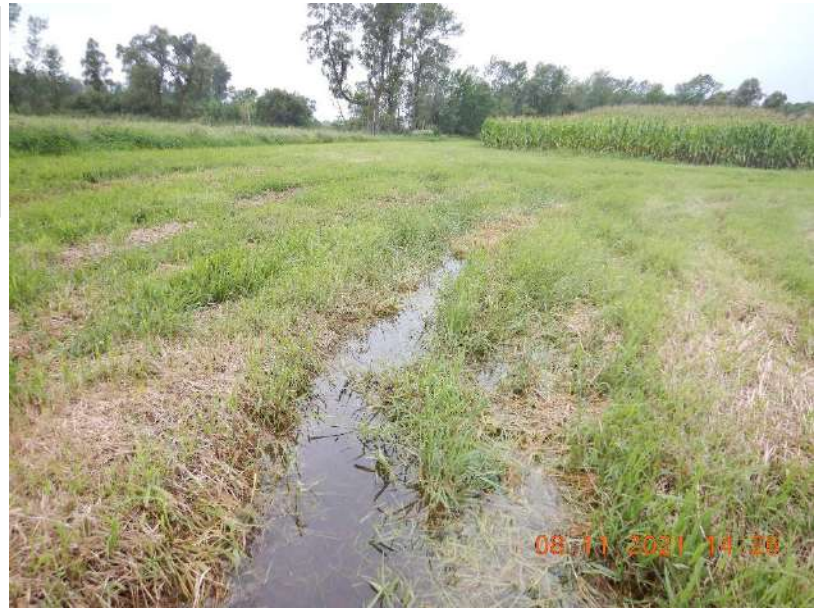
Photo 105. Pondered stormwater on the south end of the vegetated treatment area. There was no evidence of process wastewater on the south end of the VTA.

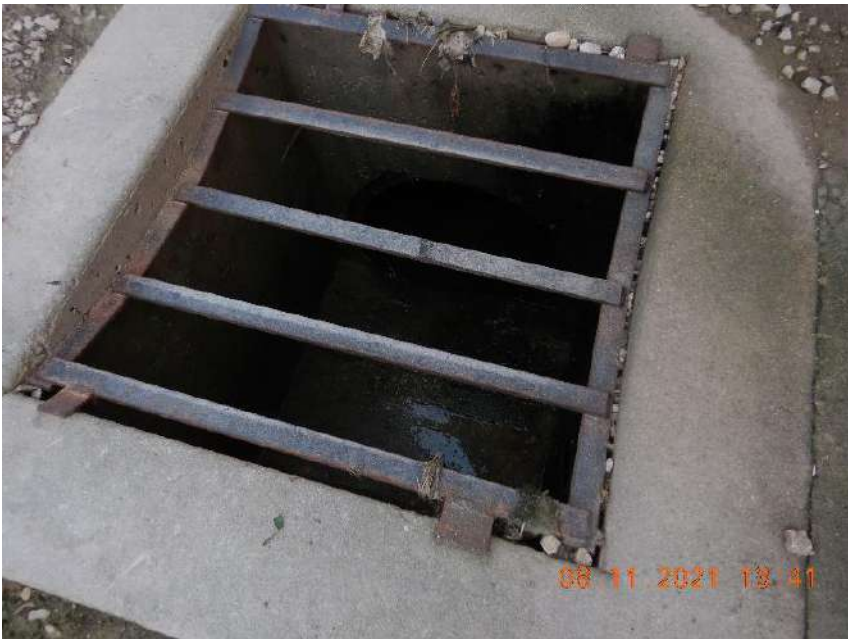
Photo 106. A stormwater inlet that accepts clean water from a driveway at the Main Site and diverts the water off-site.

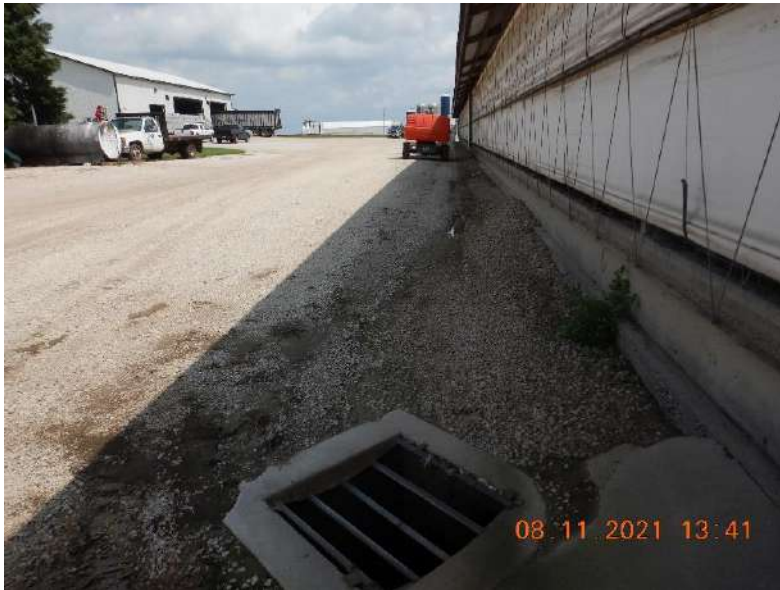
Photo 107. A stormwater inlet that accepts clean water from a driveway at the Main Site and diverts the water off-site. This photo was taken facing west.

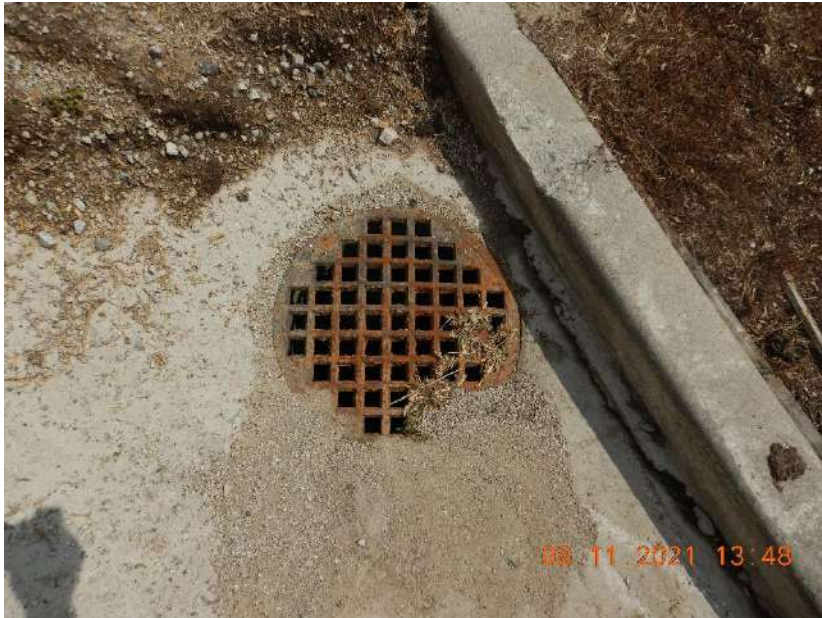
Photo 110. A stormwater inlet located on the south side of the driveway pictured in Photo 104. The inlet accepts stormwater from the concrete driveway and diverts it off-site.

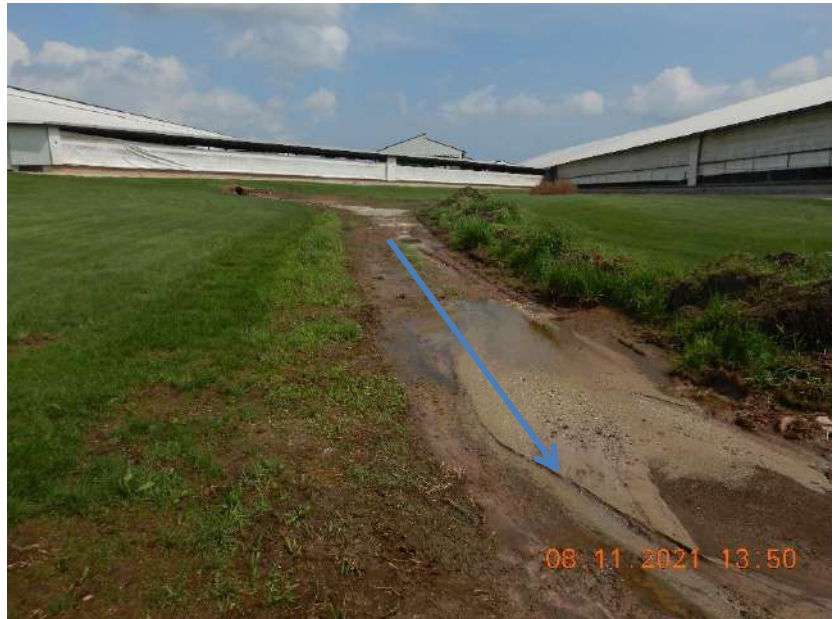
Photo 112. A stormwater culvert that discharge clean water to the grassed channel pictured in Photo 106. The blue arrow represents the flow path of stormwater.

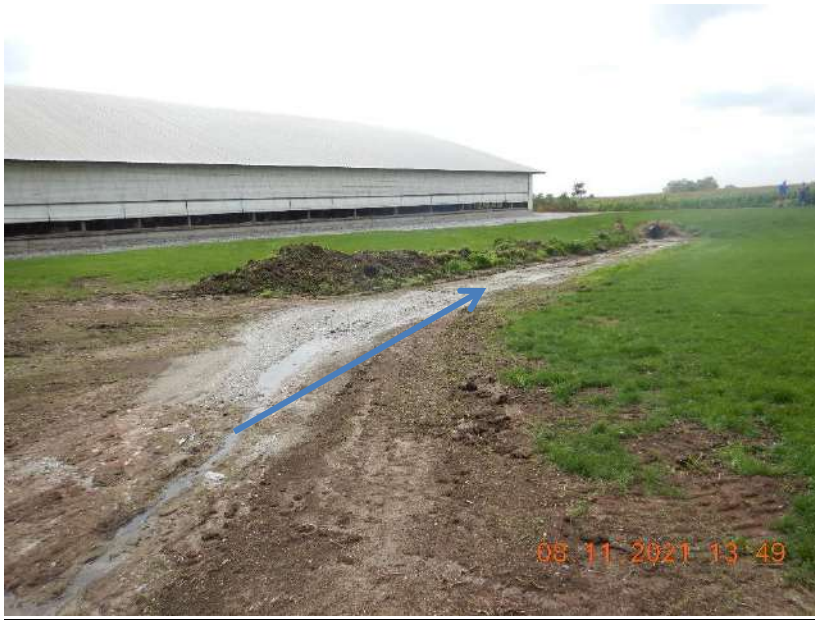
Photo 113. A stormwater channel located between the larger freestall barns. El Na Farms had recently cleaned the vegetated channel and is going to reestablish vegetation. The blue arrow represents the flow path of stormwater through the channel.

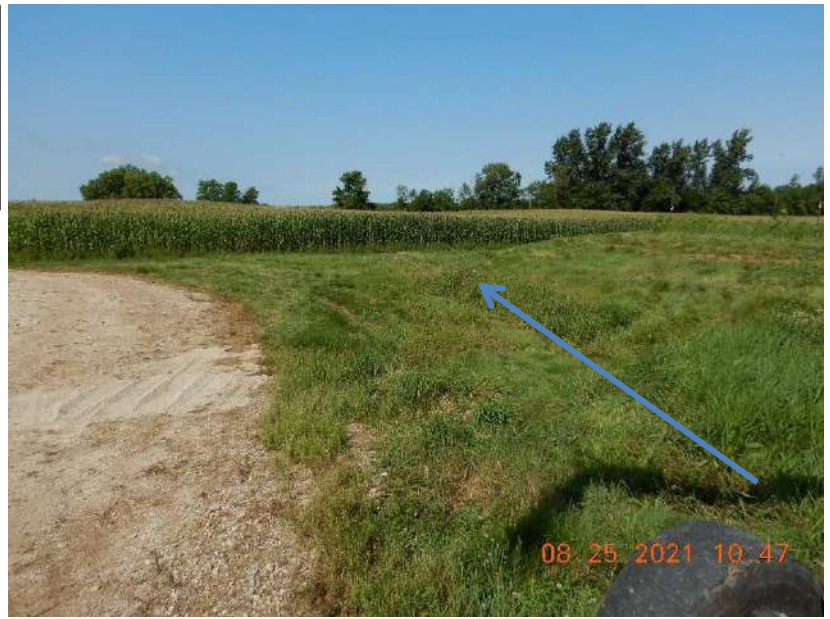
Photo 115. A grassed stormwater swale at the Heifer Site that conveys clean water off-site. The blue arrow represents the flow path of stormwater through the swale. This photo was taken facing east.

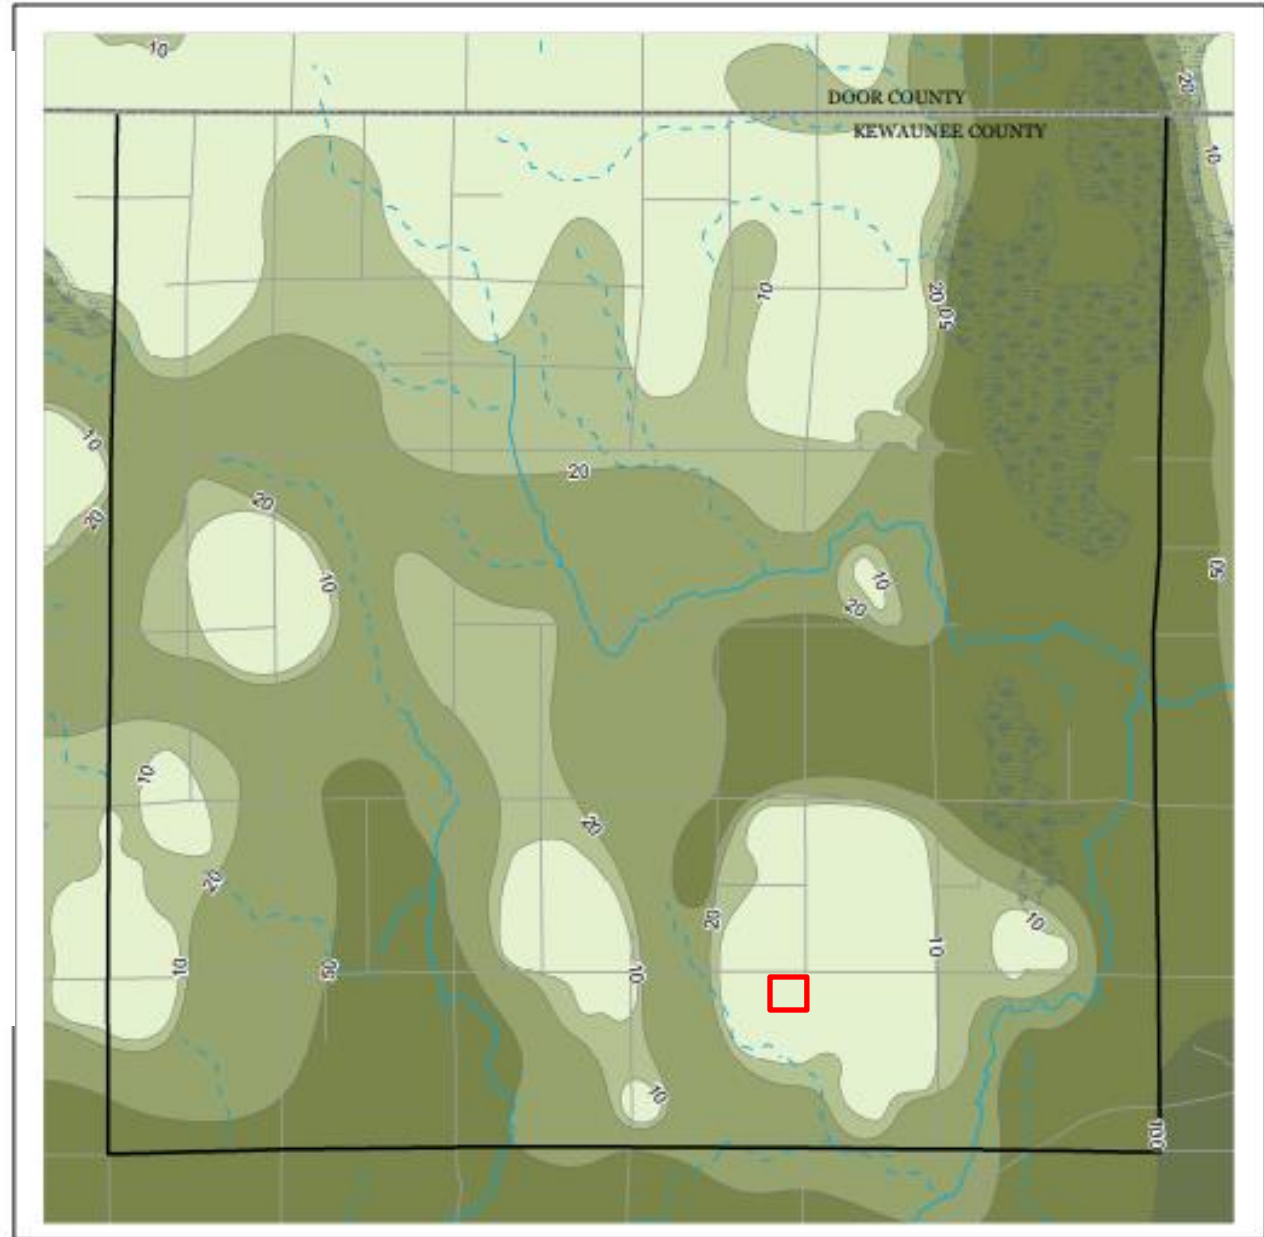
Figure 4 – Depth to Bedrock Map Excerpt from Hydrogeological Characterization of the Town of Lincoln, Kewaunee County, Wisconsin. 2017. Red square indicates approximate location of El Na Farms production area.

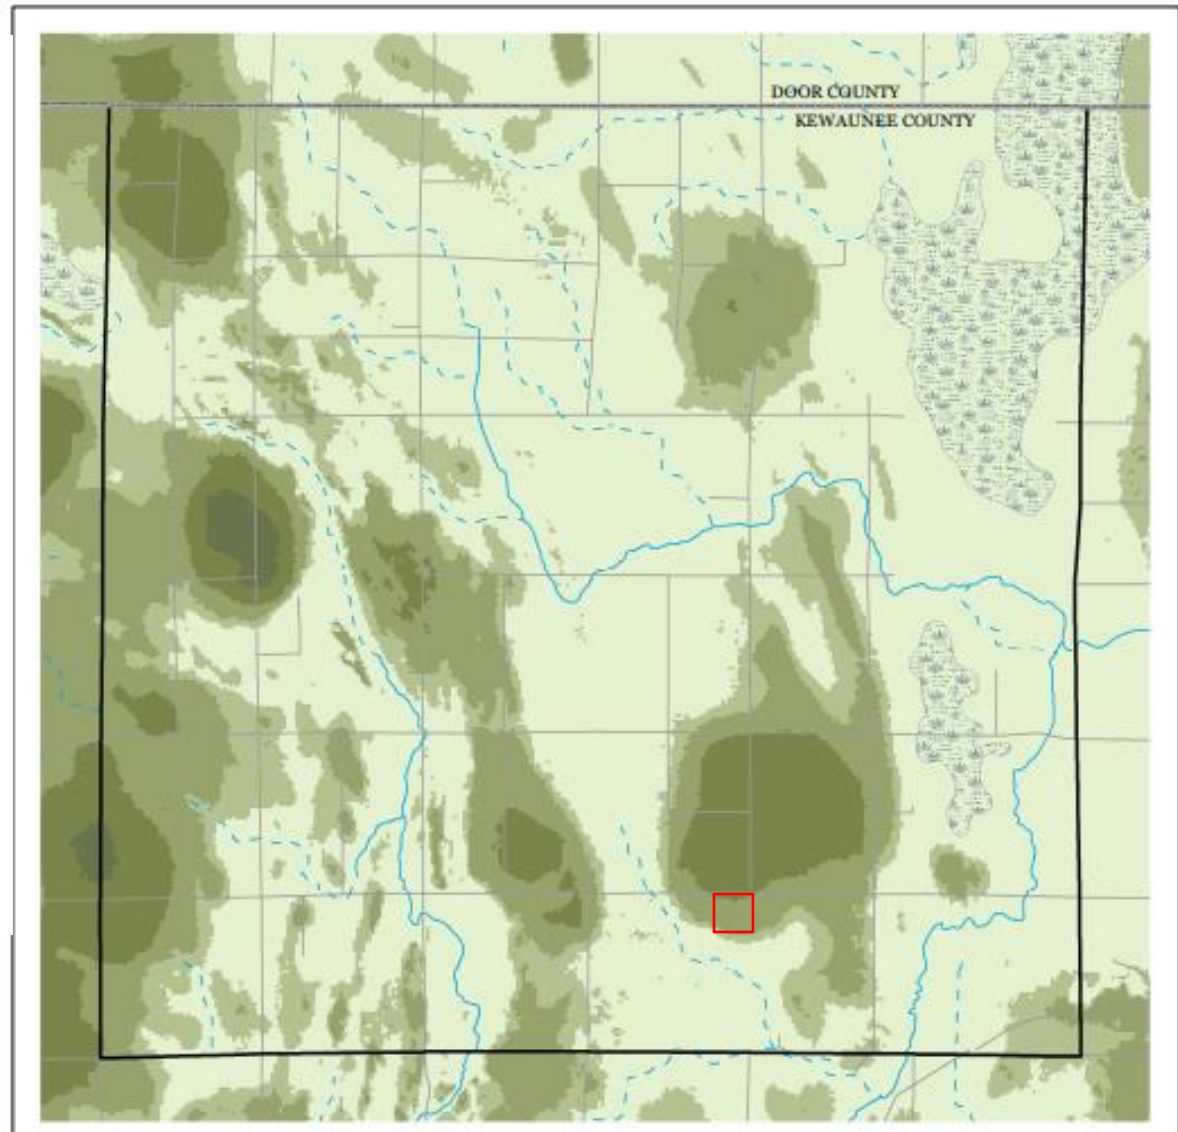
Figure 6 – Depth to Water Table Map Excerpt from Hydrogeological Characterization of the Town of Lincoln, Kewaunee County, Wisconsin, 2017. Red square indicates approximate location of El Na Farms production area.

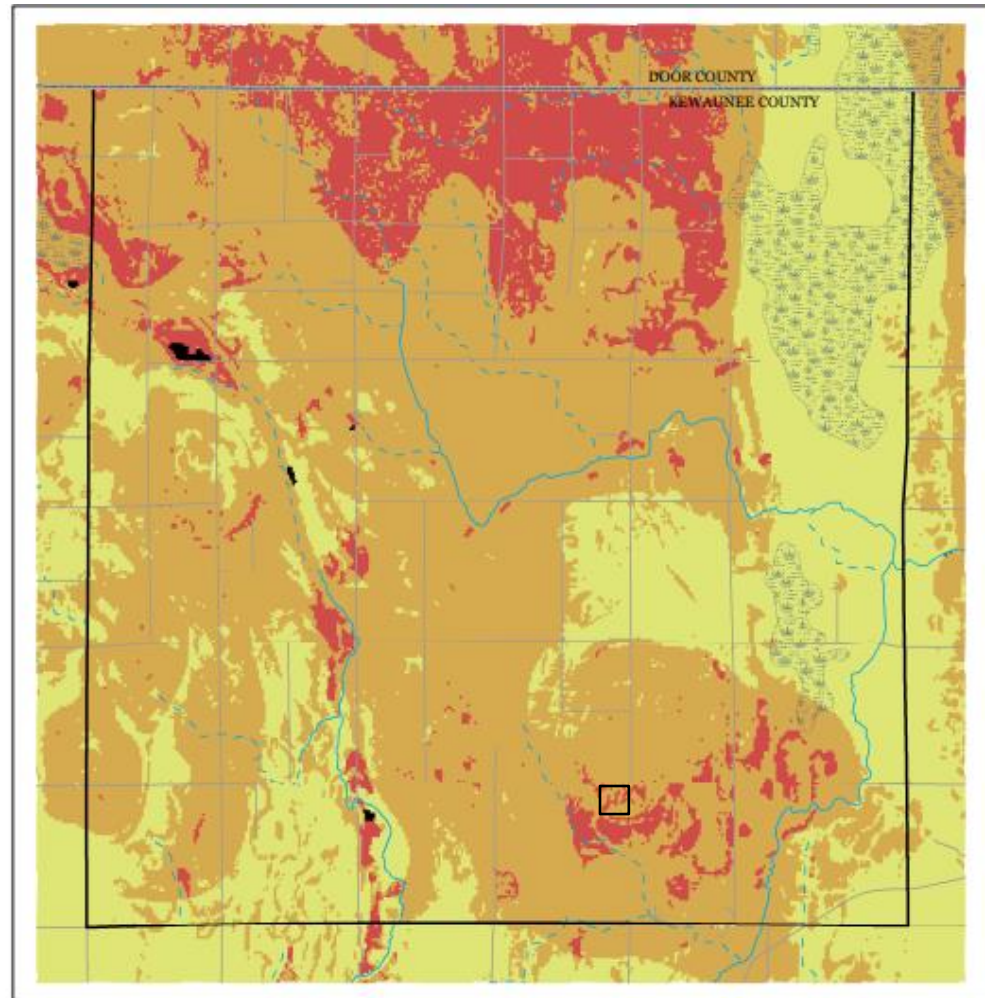
Figure 7 – Groundwater Contaminant Susceptibility Map Excerpt from Hydrogeological Characterization of the Town of Lincoln, Kewaunee County, Wisconsin. 2017. Black square indicates approximate location of El Na Farms production area.
